# The Tenth Regular Report

## ACCU Nara International Correspondent

The ACCU correspondents periodically send reports on cultural heritage protection activities in which they have been recently involved. This is a collection of seventeen reports submitted by international correspondents in the Asia-Pacific region.

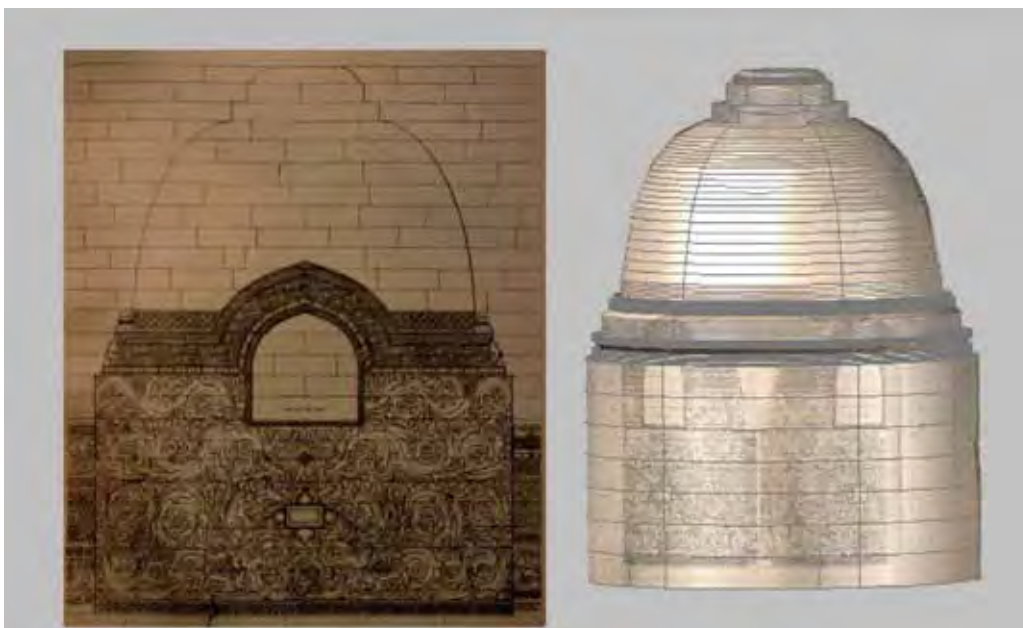
Plate : 8

The original shape of Dhamekh: after drawing of the western projection

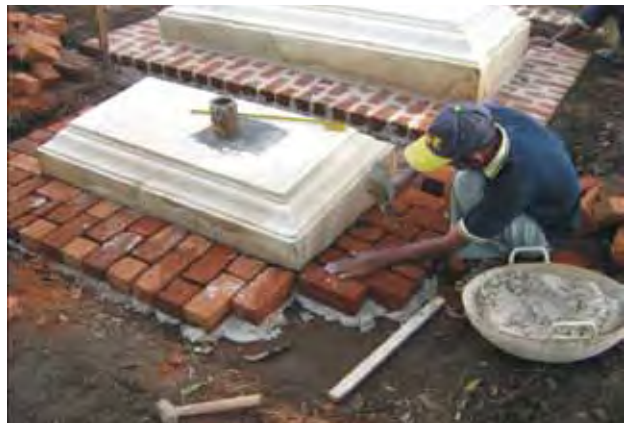
Construction of brick platforms in lime mortar where originals were missing

Brick platforms laid in lime mortar were constructed and left un-plastered around tombs to prevent stagnation and seepage of water. The collapsed tombs as well as missing portions were first cleared of all the vegetation and ficus growth using ammonia based chemical solution following which well-burnt bricks, laid in lime mortar, were used for reconstruction. Where, in good condition the original flat bricks were reused after carefully cleaning it off the mud and mortar. The ornamental details in fine and coarse lime mortar were recreated after studying the missing portions referring to similar tombs in the premises. Some intricate embellishments were redone in fine lime plaster only as the details were minute and

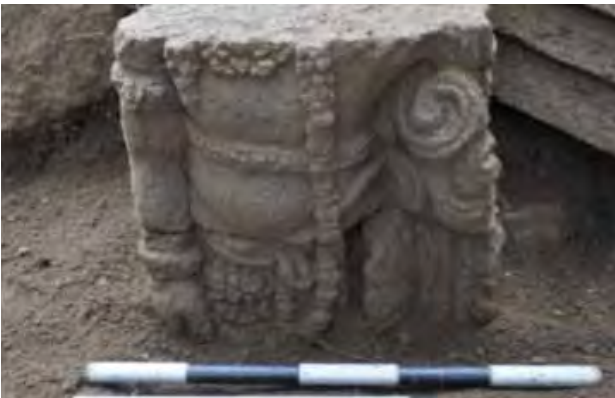
Figure 5. Box B2 was opened to determine the outer boundary of the wall in the south and the possibility of in situ reliefs. Soil strip activity indicates that the corner part of the temple is intact.

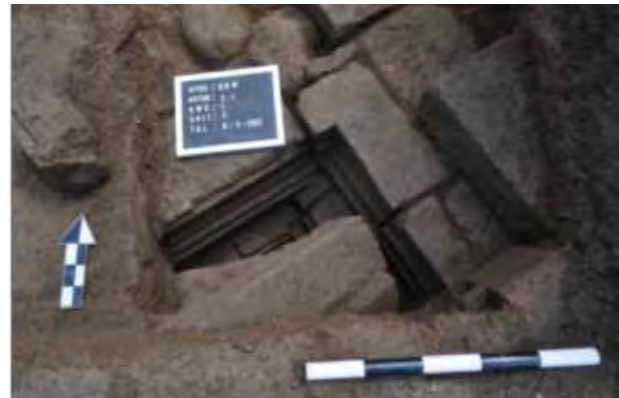
Figure 6. At Box B4, a statue relief was found, which was positioned at the middle of the wall dividing the front and back corner part in the same of length.

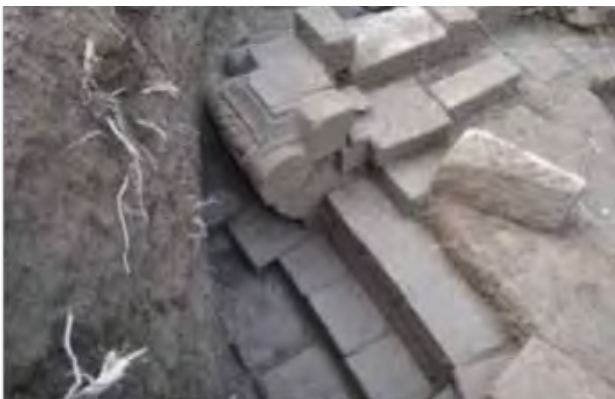
Figure 7. Box C1 was opened to observe the details of the front wall of the temple directs to the north. The corner between the front wall and stairs cheek was found at the depth of 91 cm.

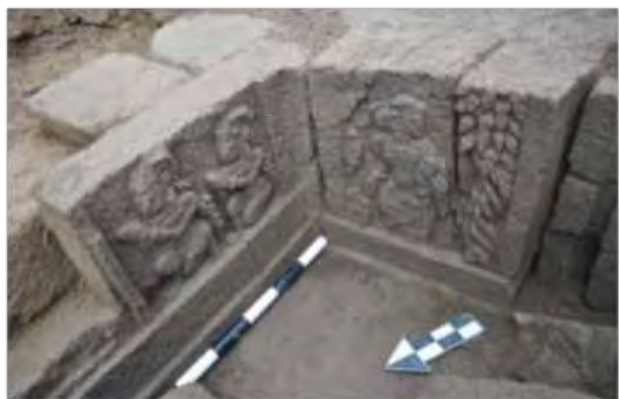
Figure 8. Box C1, at the depth of 170 cm from soil surface; there were 4 stairs found in this box, and it is assumed that there was one more stair buried in the soil (top part of this stair was appeared).

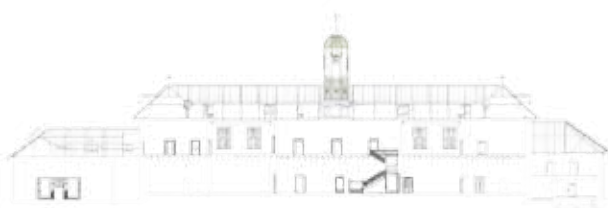
Figure 1. A building section based on documentation 2011

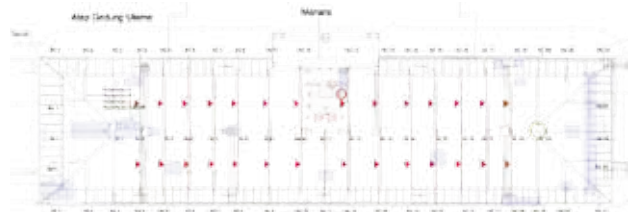
Figure 2. Mapping on damage in the attic floor and the bell tower

**Symptom 3:** There was a crack in the one horizontal balk of central gutter, and deformation can be seen on the next three horizontal balks which were spanned parallel between wooden truss columns.

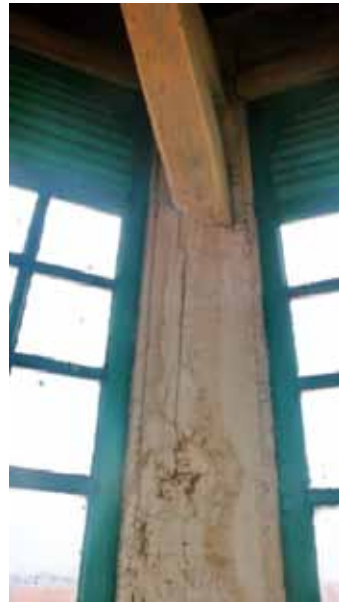
Photo 6. Defects on the tower column structure

The relation of the symptoms in the bell tower defect indicates un-levelling of the wooden structure on the bell tower. The potential risk is to provoke imbalance of the tower. The structure calculation will have to be conducted to find the point where the un-levelling started along with structure consolidation. The Bell Tower needs periodical monitoring on the stability of the structure.

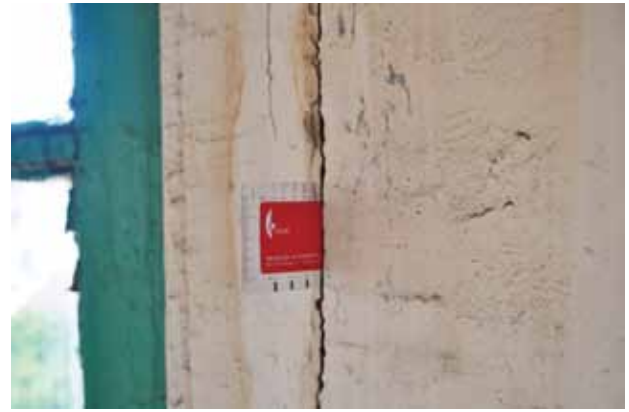
Photo 7. Cracks of 3 cm depth on the wooden column

**Symptom 2:** Combination of a crack (3 cm in max depth, 80 cm in length) and decomposition (12 cm diameter on the surface) in the end of the cracked wooden column.

**Assumption:** The existing crack was caused by the small preliminary one that had been made by manual defective work of making a traditional joint. Because it located in the high position, the wood experienced aggressive expansion-shrinkage which caused extension of a crack up to 80 cm length long in the slow duration. The rain water, caught into the crack, stayed and penetrated to the end of the crack. In the wet and high humidity environment, bacteria came and destroyed the wood cellulose in that point and gave an opportunity to the lichen to grow, and the decomposition of wood. The risk was more serious on the secondary cause on decomposition rather than the crack itself, because it can destroy wood cellulose faster to weaken physical strength than the slowly extended crack. The risk was high because the crack located in the high tower that was always exposed to rain water.

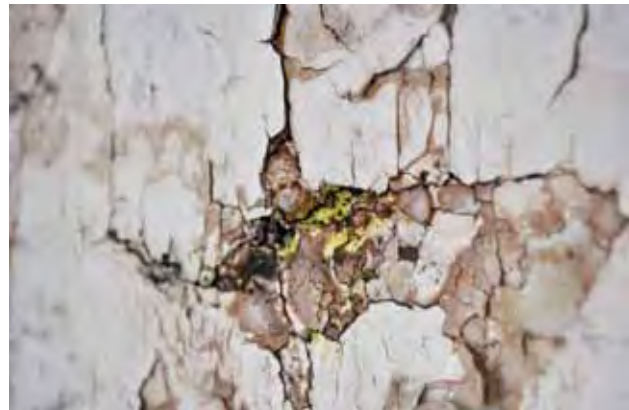
Photo 8. Decomposition on the wooden column

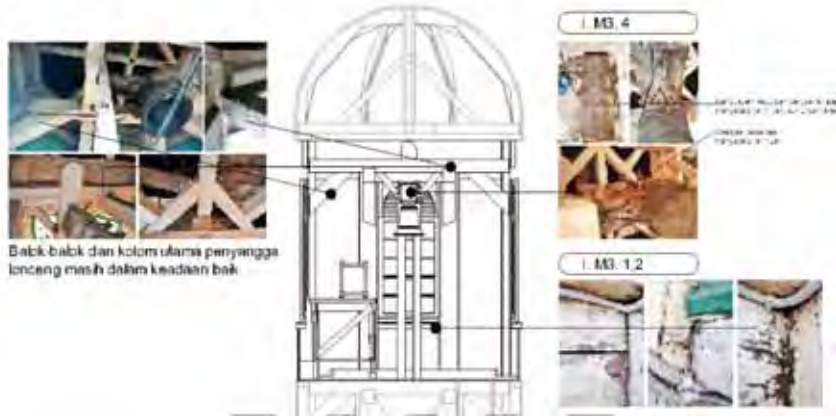
Graphic 1. Physical defects on the dome of the bell tower

Physical defects on wood materials ranged from early stage of decomposition, porosity, hollows caused by severe porosity, shrinkage, and discolorisation. Those damages are shown in the graphic below.

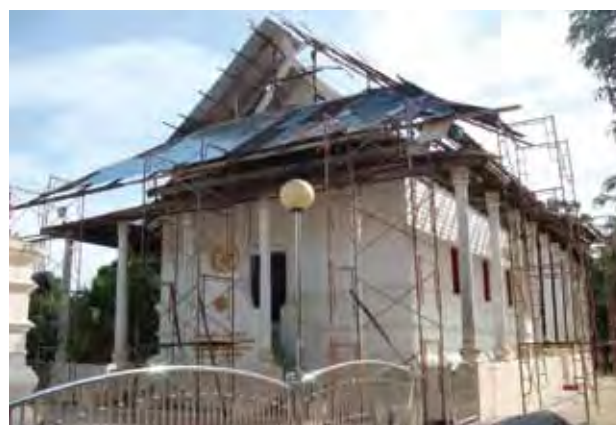
Temporary zinc-sheet roofing was built as a shelter to protect Ubosoth (Bothd) from heavy rainfall

The existing clay tiles roofing (*singora*) were leaking due to cracked roof tiles and defective roof joints. Before the roof restoration work began, temporary zinc sheet roofing was built as a shelter to protect the building from heavy rainfall. After the temporary roofing was built, broken clay tiles and termite-infested chengal timber battens were dismantled carefully. The clay roof tiles and timber batten were in such poor condition and cannot be salvaged. New clay glazed roof tiles were used to replace the existing clay tiles. New *chengal* timber battens were obtained from local sources. These new replacements are of similar profile and material to the original ones. Before fixing the new roof tiles and timber batten, pest control specialists were engaged to conduct anti-termite treatment using effective chemical spray and injection at the building perimeter.

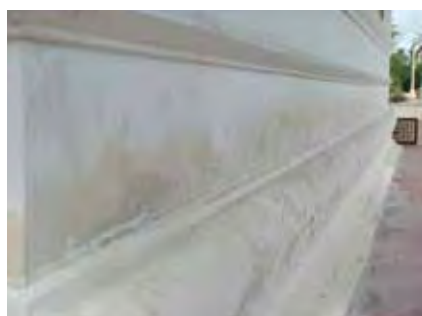
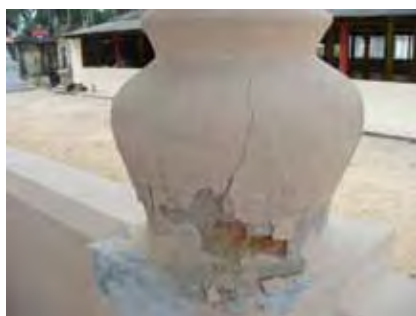
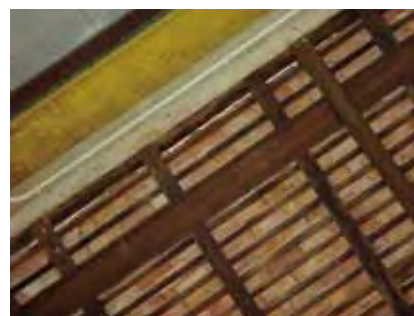
Dampness, broken plaster and termite infestation are some of the common building defects found at Ubosoth (Bothd)

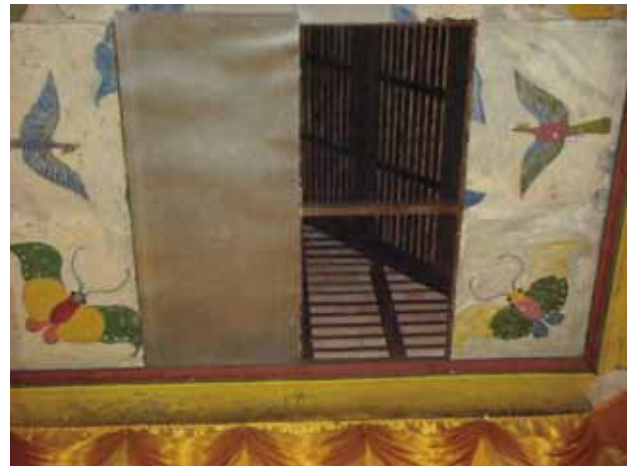
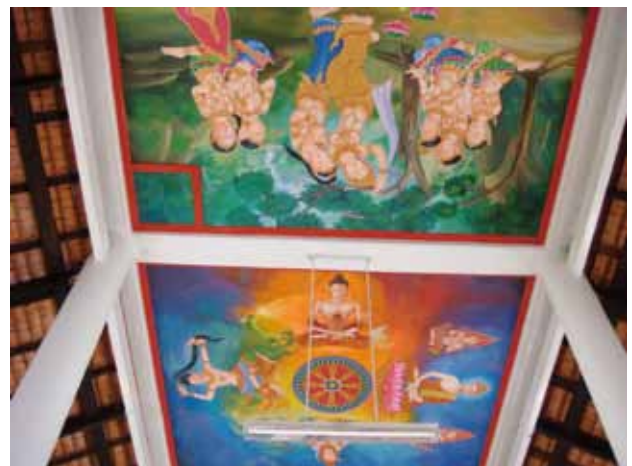
The existing rusted zinc sheet ceiling of Ubosoth (Bothd) was replaced with new zinc sheets of religious Buddhist paintings

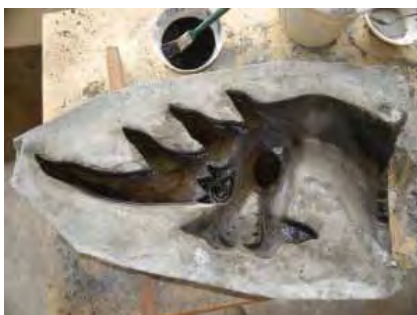
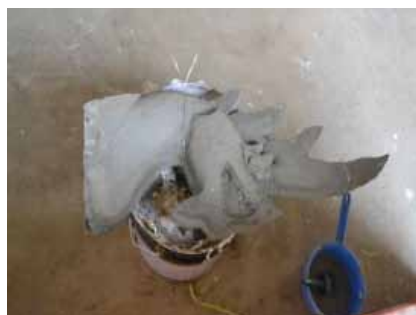
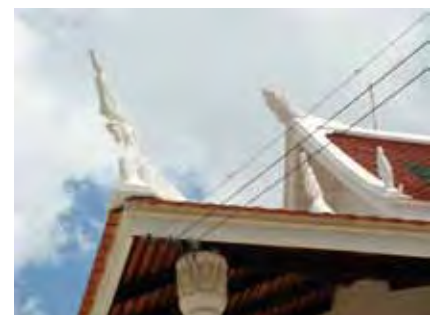
New dragon motif at the roof edge was produced using a mold of similar profile

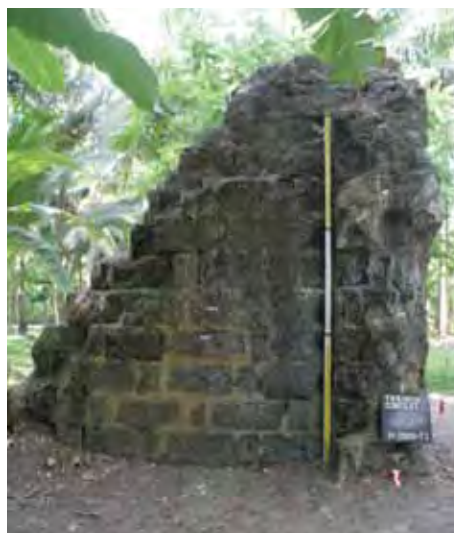
Figure 2. Remaining buttress attached to the northwest pillar (Photo by A. Tesoro)

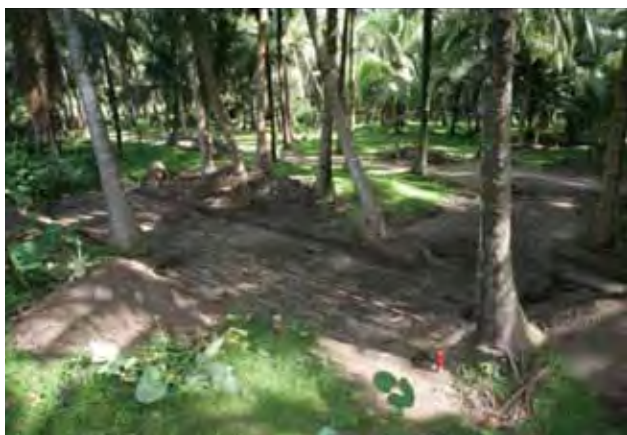
Figure 3. The L-shaped flooring found west of the main ruins in the old church complex of San Juan, Batangas (Photo by A. Tesoro)
