# The Eleventh Regular Report

公益財団法人 ユネスコ・アジア文化センター文化遺産保護協力事務所  
Cultural Heritage Protection Cooperation Office, Asia-Pacific Cultural Centre for UNESCO (ACCU)

The ACCU correspondents periodically send reports on cultural heritage protection activities in which they have been recently involved. This is a collection of sixteen reports submitted by international correspondents in the Asia-Pacific region.

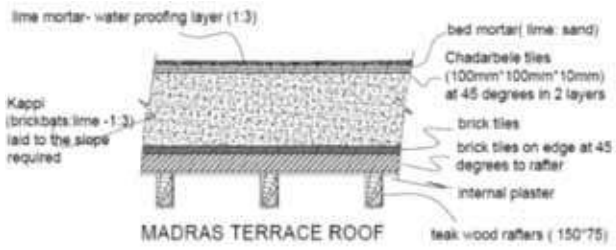
A typical cross section of Madras Terrace Roof

especially Tamilnadu, Karnataka and Andhra Pradesh. It constitutes of large wooden primary beams running along the shorter span of the room and wooden joists of an approximate size of 15 cm × 10 cm size (or 15 cm × 7.5 cm) placed at a c/c distance of 30 cm perpendicular to these beams and spanning them, together supporting the entire flat roof above. Where primary beams are not required due to short spans, these timber joists are inserted within the wall with a gap left all around the timber section edges to facilitate its expansion and contraction and permit evaporation of trapped moisture and humidity. Such edges prevent an easy infestation of termites. A layer of 'terrace bricks' measuring 15 cm × 7.5 cm × 2 cm approximately (may vary slightly with regions but essentially thin bricks) are laid on edge in lime mortar along diagonal rows supported closely by the wooden joists below. In some cases flat brick tiles are laid above this layer to accommodate the lime concrete roof which predominantly acts as the water proofing layer for the entire system. It is very important to drain the terrace rainwater by providing sufficient slopes and this is achieved by laying brick bats and lime in the ratio 3:1 to required thickness and consolidated using a wooden rammer. This layer is allowed to solidify and dry well carefully taking precautions to avoid cracks under intense summer heat by covering it up with hay and sprinkling water. For additional precaution flat square tiles measuring 10 cm × 10 cm × 1 cm are laid in two layers in lime mortar and the whole is finished off in course lime mortar as the final finish for the entire roof system. The soffit of the ceiling is also finished off in course and fine lime mortar to hide the diagonal bricks and give a clean appearance.

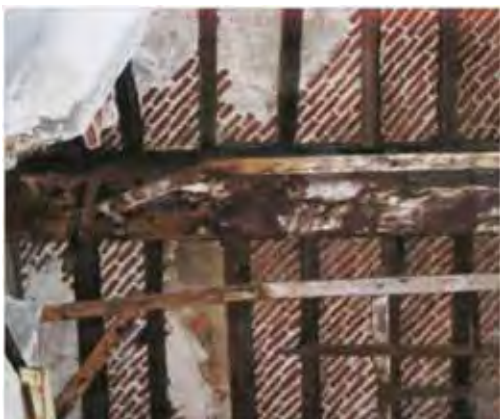
Delamination of ceiling plaster and exposure of terrace bricks, debonded joists and moisture laden primary wooden beam

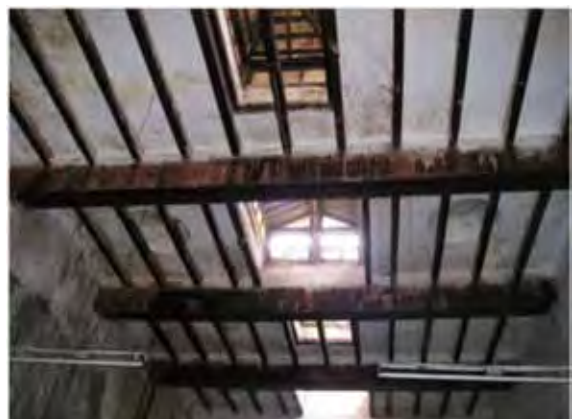
A typical Madras Terrace Ceiling with primary beams and secondary joists deteriorated due to water seepage and vegetation growth

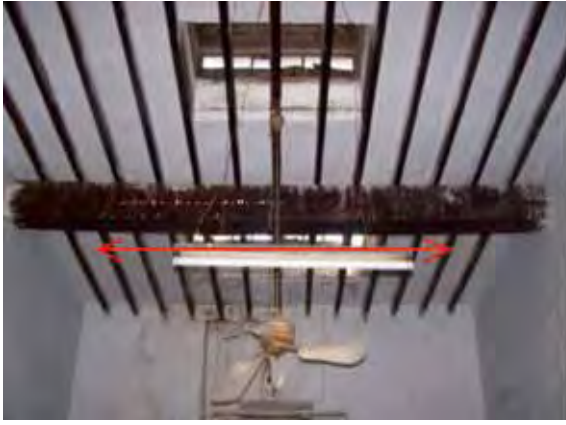
Deflection of primary beams and secondary joists as well as shear cracks can cause structural failures

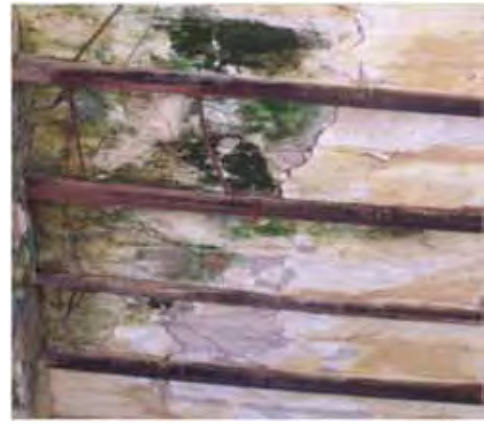
Vegetation growth and penetration of its roots allows seepage of water and debonds the joists from the ceiling

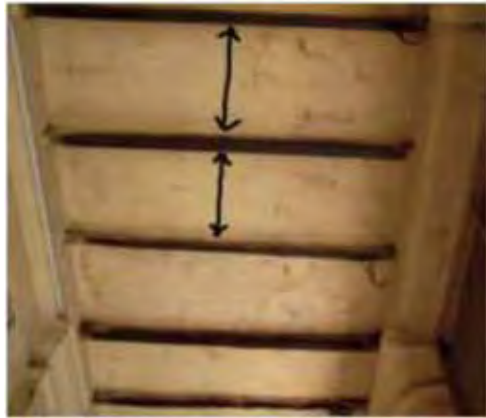
Where the primary timber beams have deteriorated beyond repair, I - beams of calculated dimensions can be inserted. Variation in interspacing causes eccentric loading

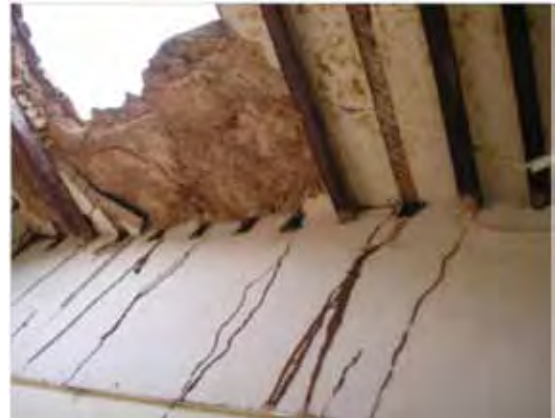
Extensive termite infestation led to deterioration in the wooden joists and eventual collapse of the roof

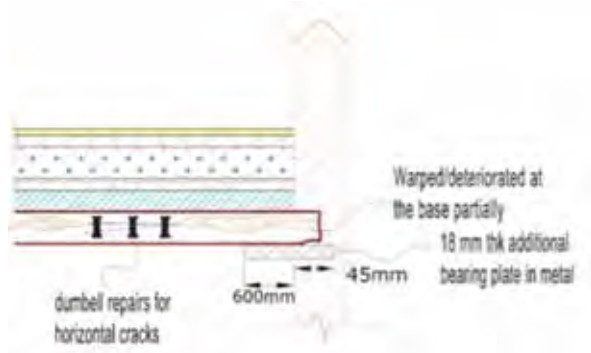
Where the edges of the wooden beams have deteriorated at the base where they rest on the wall plate/wall, a 1.8 cm thk. metal plate can be introduced below the wooden beam as an additional bearing. It can project out up to a length of 60 cm and go in up to a length of 45 cm.

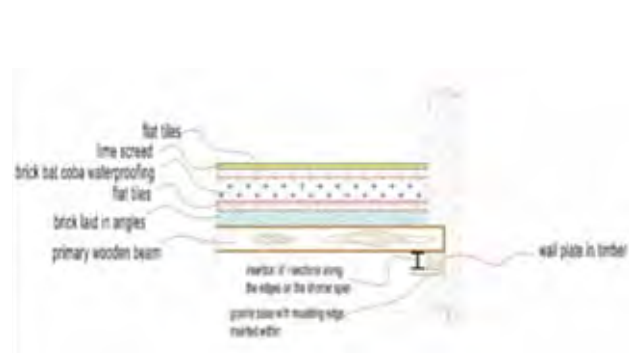
Insertion of I-sections along the shorter span for additional support

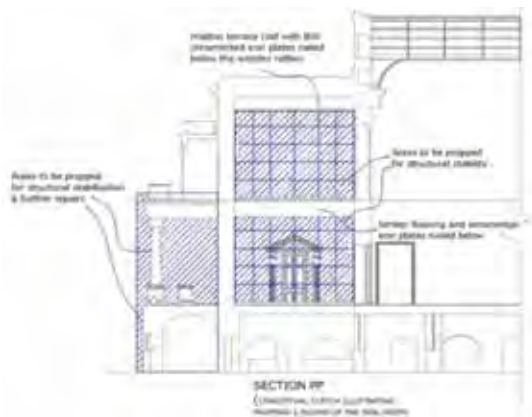
A simple & effective propping of both the first & upper ground floors have to be undertaken using casuarina poles spliced suitably to achieve required height, supporting the secondary timber joists and primary beams, with neoprene padding on the top and gunny bags on the floor, before starting any repair works. Wooden ply shuttering to be undertaken between joists to relay the bricks at angles, where required and to facilitate curing etc. during part reconstruction & total water proofing. The dead and live loads of the MT roof and the scaffolding erected on the first floor (oval room) shall be well supported by the scaffolding erected on the upper ground floor oval room and the total arrangement shall be regarded safe, if executed carefully by an experienced team. An alternative to casuarina poles would be the cup lock scaffolding that will be supported on 'runners', running parallel and just below the madras terrace wooden rafters on the floor and shall transfer most of the vertical load to the walls laterally.

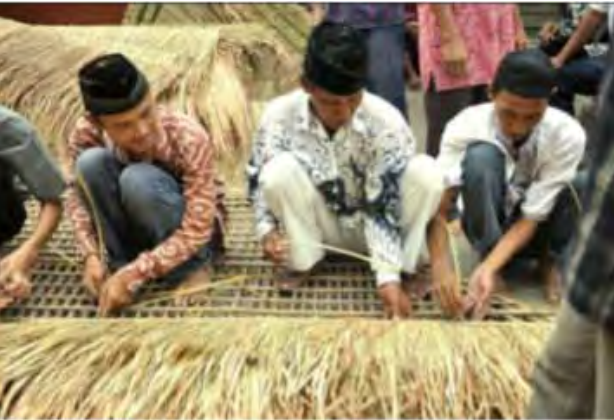
The installation of new *welit* to the old wooden frame

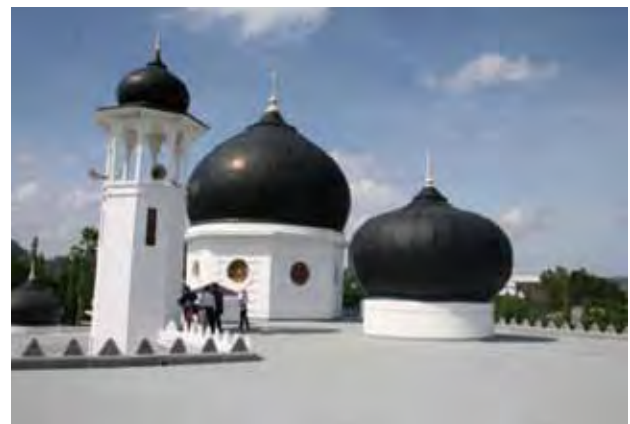
The Alwi Mosque showing its concrete flat roofs after the application of waterproofing system.

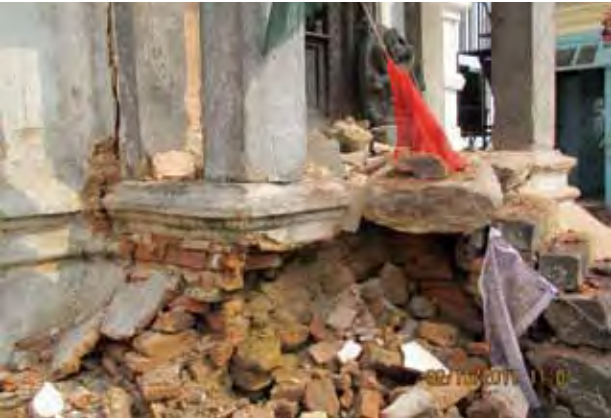
Severely damaged just above the foundation

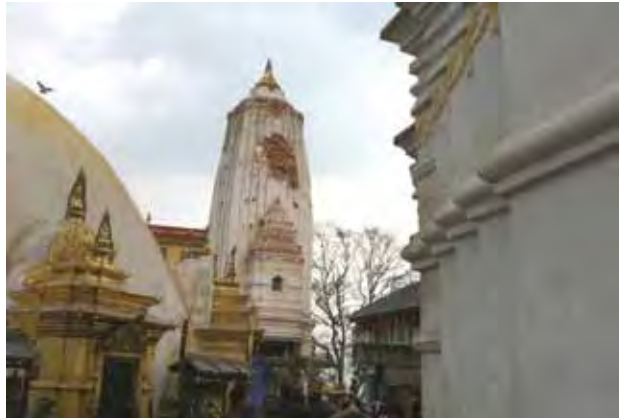
Damaged northwest part

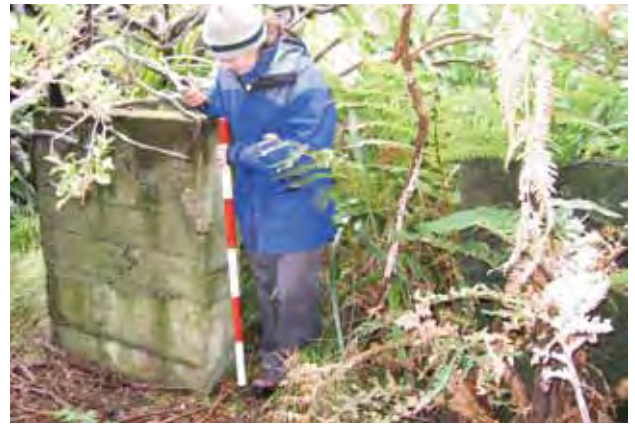
Figure 18. Foundations of the Managers' house showing the entranceway (NZHPT 2007). See Figure 17.

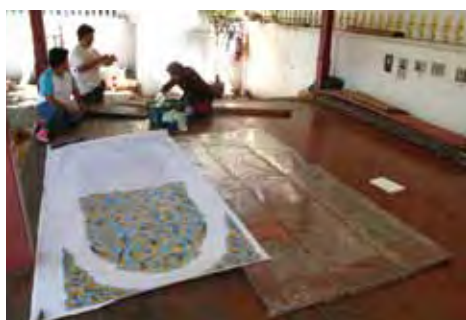
Fig. 5. Processes of corridor ceiling restoration work; Examination and record of each layer of decorations
