ACCU Nara  
International Correspondent

Vol.12 2013

# The Twelfth Regular Report

Cultural Heritage Protection Cooperation Office, Asia-Pacific Cultural Centre for UNESCO (ACCU)

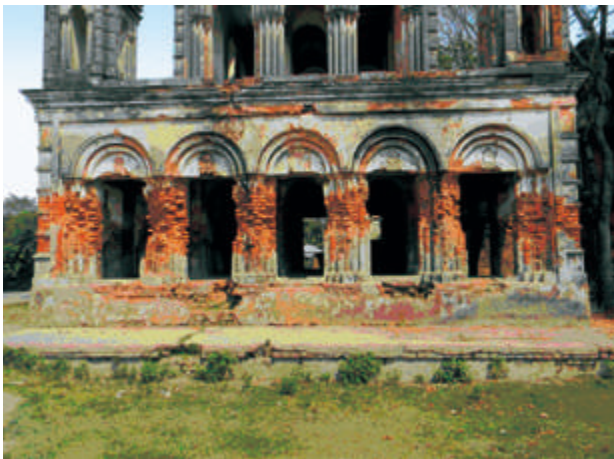
Ground floor

**Ground floor:** Taota *Dol-Mancha Nava Ratna* Temple is a square-shaped temple. The ground floor contains four arms and every arm is 33 feet long and 14 feet 6 inches high. The 36 columns were constructed on the ground

floor and its remarkable feature is that there is no wall around the entire temple. Actually it is a column-based architecture. There are 20 entrances on all sides in the ground floor and they are provided with semi-circular arched openings and ornamented with semi-circular pilasters. From the exterior columns, 3 feet 8 inches space in width and a long corridor have been made in the middle of the circumambulatory passage, and again 12 columns have been constructed just like the first one with 12 openings. In this square space, there is a corridor of 3 feet 3 inches for circumambulating with 4 columns just in

Every column has been placed at a certain distance and the geometrical and mathematical calculation has been followed for the construction. Under the cornice of the ground floor, it was beautified by one line leaf and the floral design. The *Garuda* stucco image (Vehicle of the Hindu God Vishnu) established in the four corners below the roof.

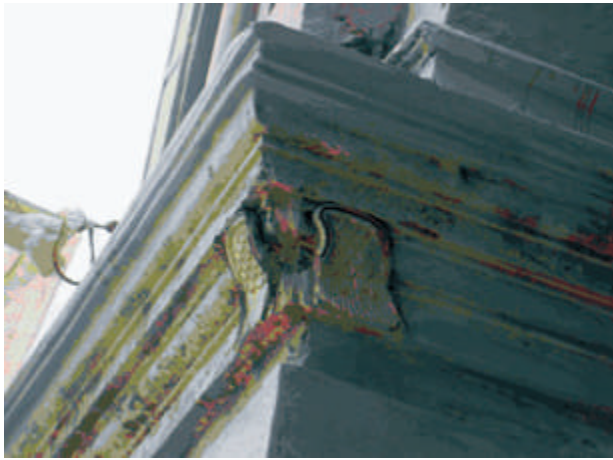
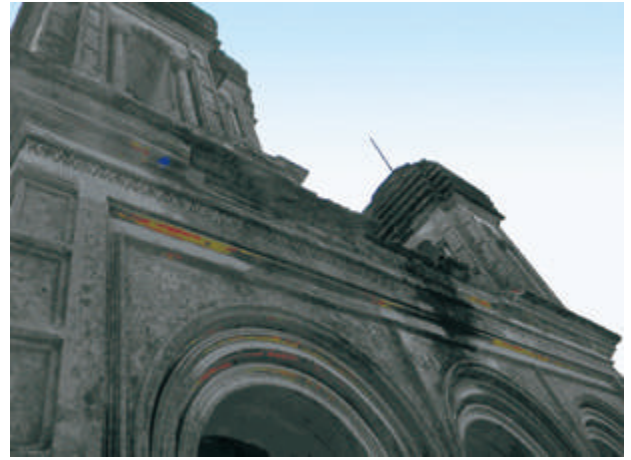
Before conservation

supervised by an assistant archaeological engineer and an archaeologist. For a long time this temple was badly damaged, which is why the worship provisionally closed. After conservation, the Hindu community will start this kind of worship again.

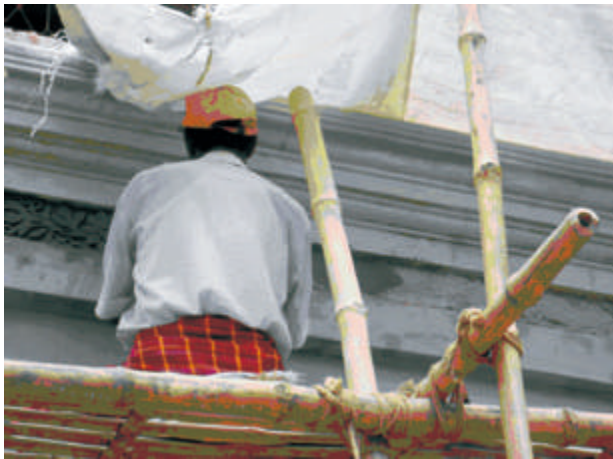
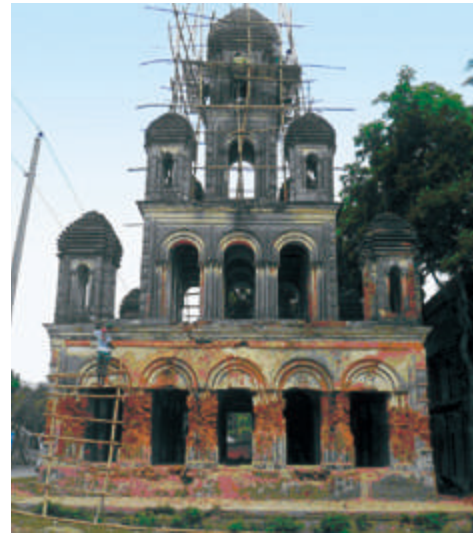
During conservation

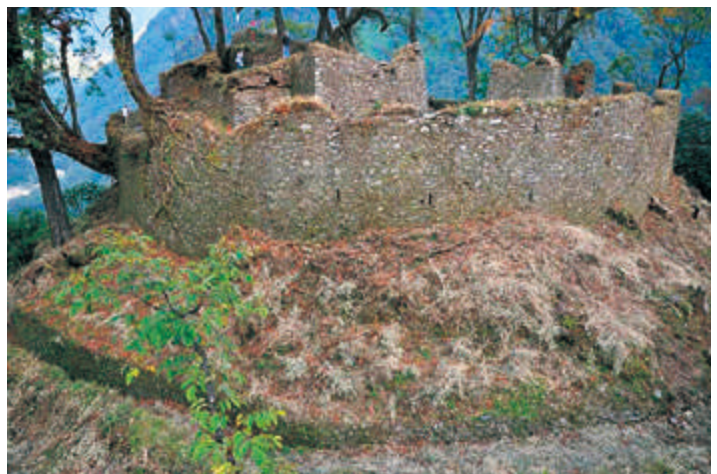
Overview ground plan of the *Obtsho Dzong* ruin Photo:DCHS

The position 1, probably *Utse* of the *Obtsho Dzong* is the main building measuring 11x15m connected by the stone steps on the eastern wall, possibly of later construction due to the fact that the stone

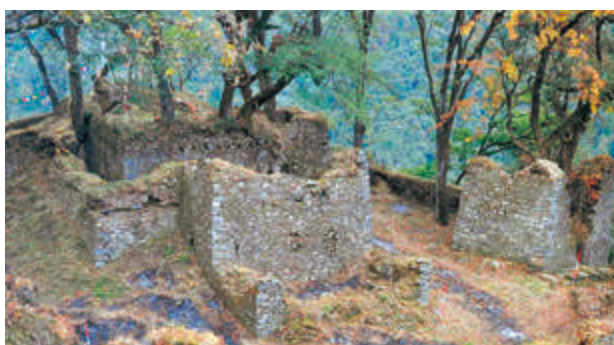
*Utse* and surrounding buildings (Positions 1,2,3,4,5,6,7,8)Photo: DCHS

steps are randomly constructed and also it starts from the part of the collapsed eastern tower (structure 6).

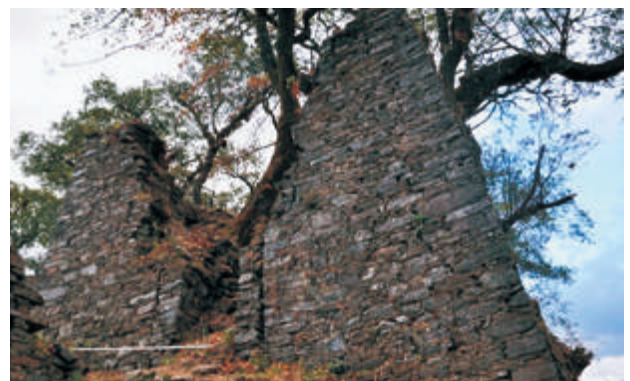
Entrance gate/watch tower (position9) Photo: DCHS

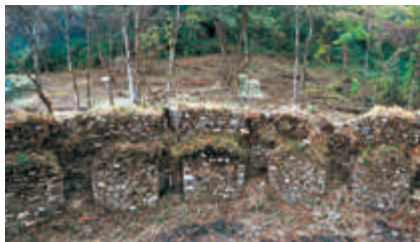
Semicircular defense wall (position10)  
Photo: DCHS

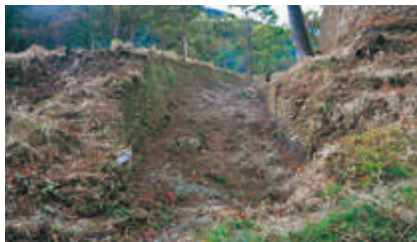
Defense trench surrounding the Dzong complex (position11) Photo: DCHS

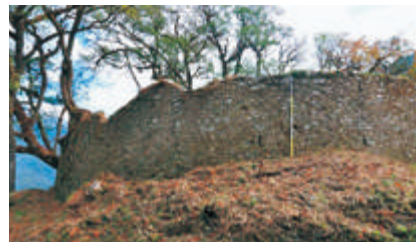
Semicircular defense wall from outside (position10) Photo: DCHS

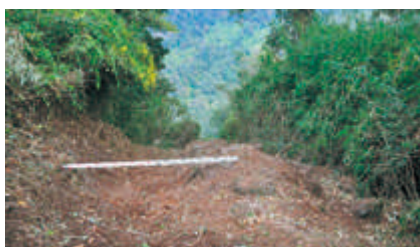
Structure outside the Dzong complex (position12, 13,14) Photo: DCHS

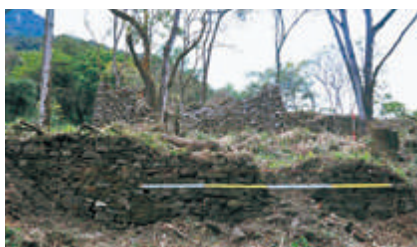
Original path (position15) Photo: DCHS

The position 15 is the original path /access to the *Obtsho Dzong* which led to the *Punakha Gasa* footpath discovered during the documentation. The path is 2m wide and is fully covered with vegetation.

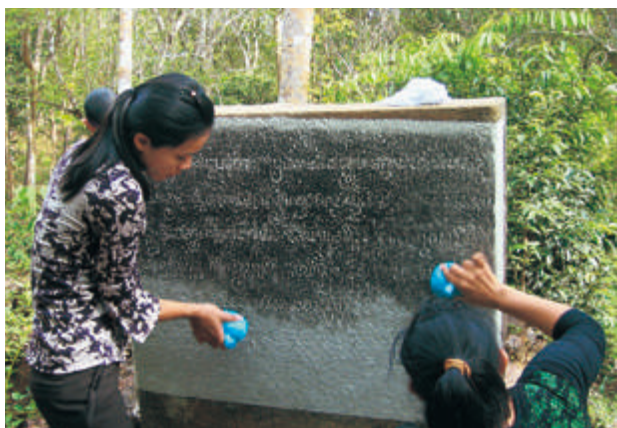
Fig. 4: Rubbing of the N20-3 Tower inscription, K.439. (Photo: Khom Sreymom & Ham Seihasarann)

The rubbing technique with the Chinese ink is a practical application for recording characters from the surface of the stone. Fruitful resources from these rubbing, reading and comparing epigraphy studies would be a contribution to a new greater historical finding in the future (Fig. 7&8) and a booster in conservation science. Other new cutting-edge technology such as three-dimension scanning shall be needed in improving the quality of the present. However, the work is the stepping stone toward nomination of Sambor Prei Kuk as UNESCO's World Heritage in the future.

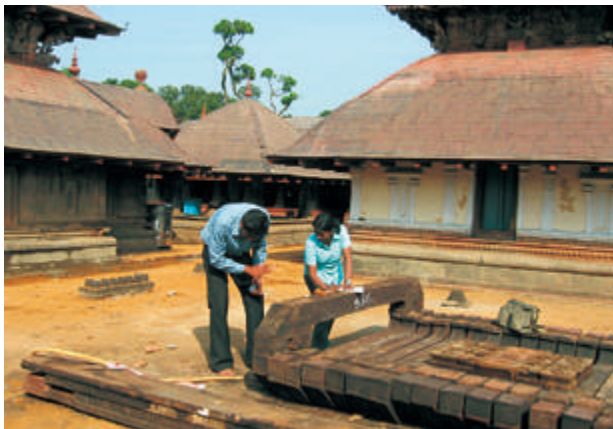
Condition assessment of the wooden members belonging to the sloped roof system

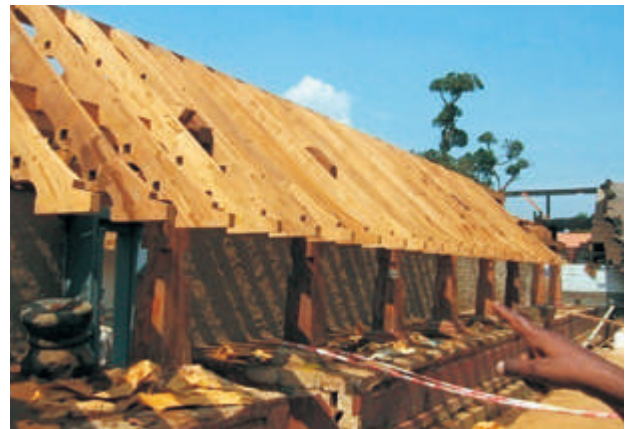
Parts of the inner prakara sloped roof system that is totally replaced by new wooden members

The first major wooden restoration work involved removing and recycling the wooden members of the roof of the inner prakara structure. Prior to the involvement of Ravi Gundu Rao and Associates certain portions of the wooden roof were completely dismantled assuming that they needed total replacement. Vast portions of the sloped roof were redone using new wood before the expert intervention, and reassembling had already started. Some of the dismantled members were however

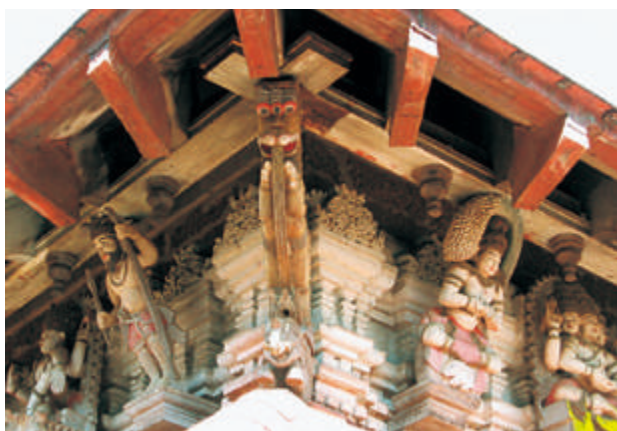
Wooden figures and figurines found below the sloped roof that required removal of paint and spot repairs

It was observed that all the decorative members (that were also an integral part of the structural system) that formed the ceiling and roof structure of the structures within the inner prakara were painted over using oil paints over the past few decades as a part of charitable funds and donations. Although these were done in a very attractive manner and served well as a protective coating against the seeping moisture and dampness, the experts doubted its authenticity. Samples of the paints used on the surface of motifs and figures were collected and studied by experts from the NRLC Lab (National Research Laboratory for

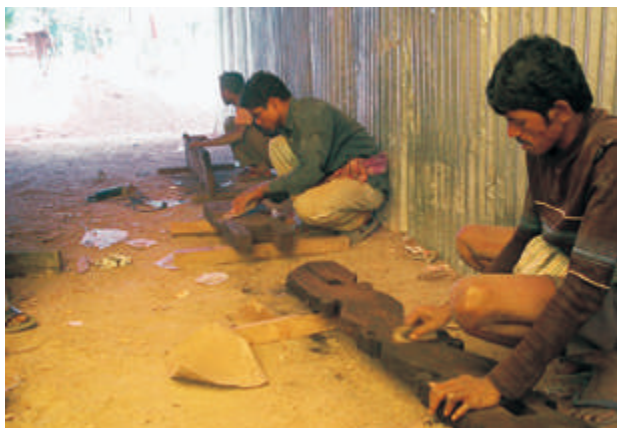
Carpenters recycling the original wooden members of the sloped roof system-cleaning, re-polishing and attaching new members to deteriorated portions maintaining the original joints

assessed in detail and only very few members were found to be deteriorated beyond reuse. These were carefully documented and numbered appropriately according to where they belonged originally with the help of expert carpenters and repair works undertaken using matching wood and original joinery details. Repair works followed cleaning of the members and reassembling the sloped roof. An anti termite treatment was undertaken at different stages of assembling the roof.

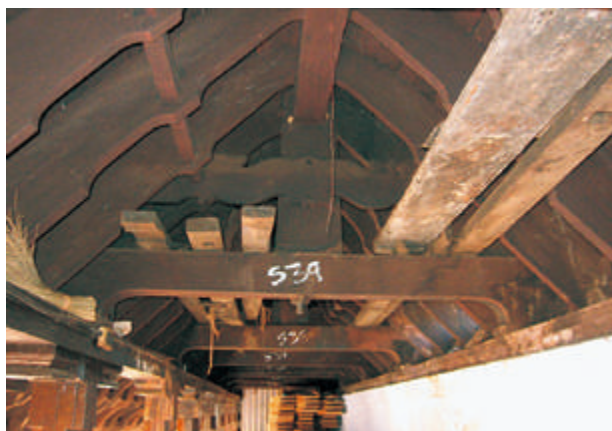
The wooden structural system of the sloped roof before restoration - an interior view

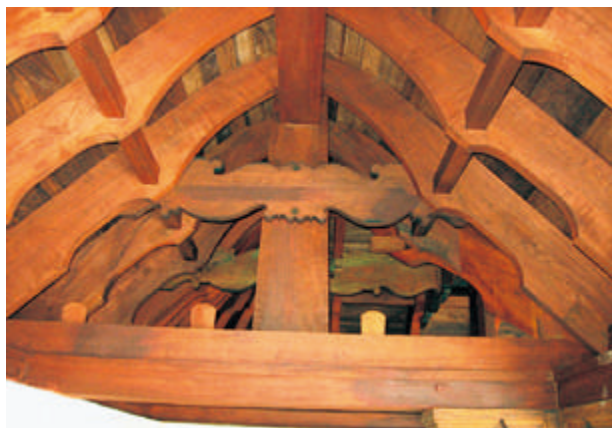
The wooden structural system of the sloped roof after restoration- repairs, cleaning, anti-termite treatment,

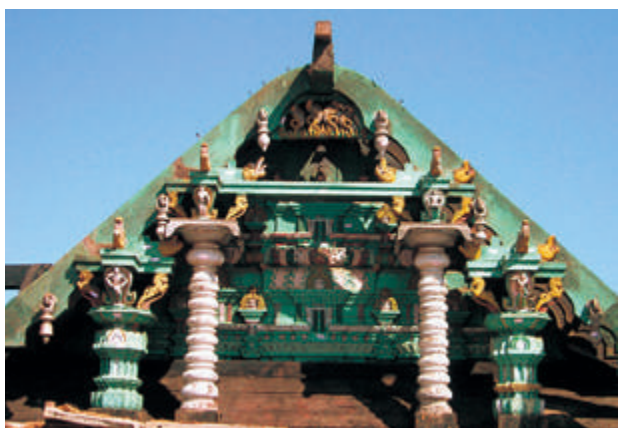
The elaborately treated gable ends of the sloped roof whose several members were deteriorated from inside due to insect attacks

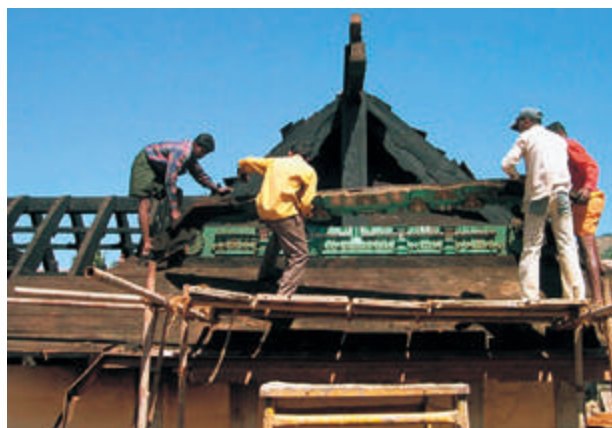
Dismantling of the gable after cataloguing under progress to re-carve /repair the members as well as remove oil paint

The members were carefully dismantled by experienced carpenters in the presence of conservation architects and a unique system for cataloguing the same was devised so as to aid in reassembling. The members belonging to each sub-shrine were stored separately in different rooms that were well ventilated and under high security. The removal of paint pigments from these intricately carved members was also undertaken in batches by skilled workers under the control of able supervisors and on this scale, was one

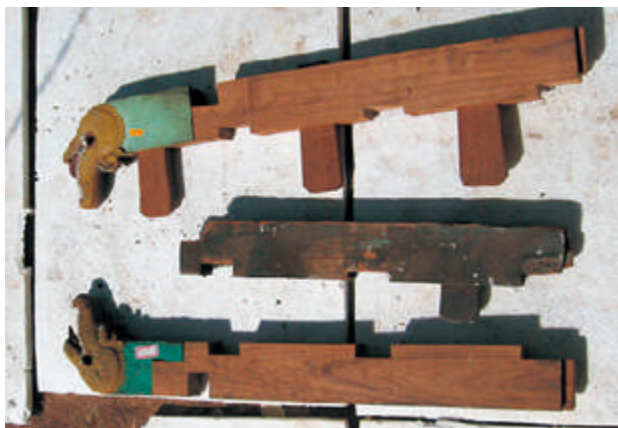
Retaining the original carved details and replacing only the dilapidated support system where necessary using original wood from other discarded larger members to retain authenticity

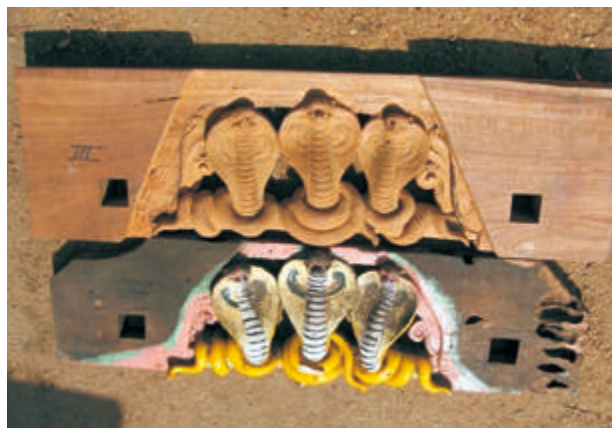
Total replacement of carved members by re-carving and copying the original details

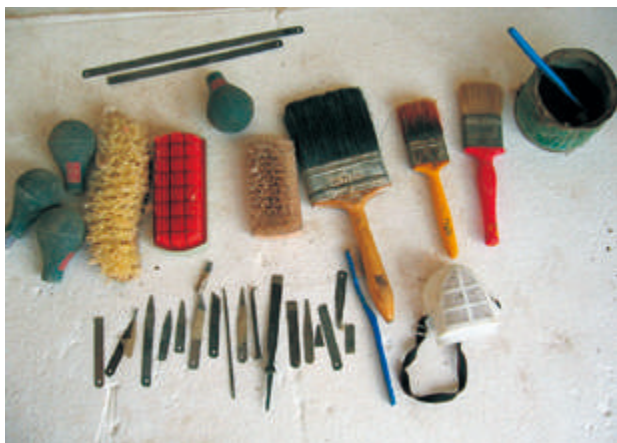
Tools used to remove the oil paint from wooden surfaces

of its kinds in the region. The chemicals used were Paraffin Wax, Microcrystalline Wax, Methyl Isobutyl Ketone (MIBK), Mineral Spirit and Pentachlorophenol powder. The cleaning involved dissolving the lacquer and the paint pigments using the above chemicals as per the defined methodology prescribed by the NRLC LAB and carefully scraping the finer details off the paint using brushes and blunt scrapers/knives. The cleaned members were then treated with a coating of anti-termite chemical (Termiseal) followed by coatings of rosewood colour and wax (waterproofing) respectively, the colour and chemicals all approved by the NRLC LAB. Adequate precautions

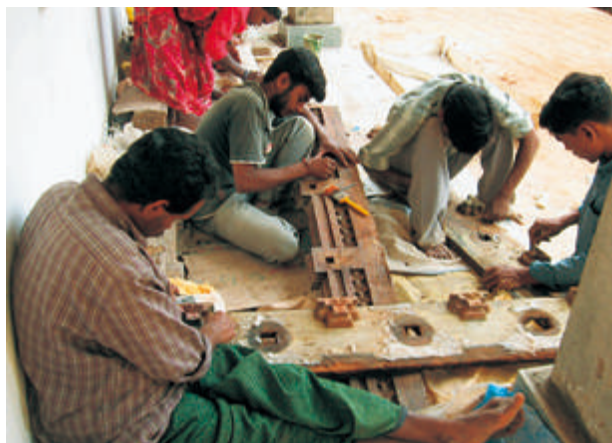
Cleaning of the ornamental details and removing the colored paint pigments

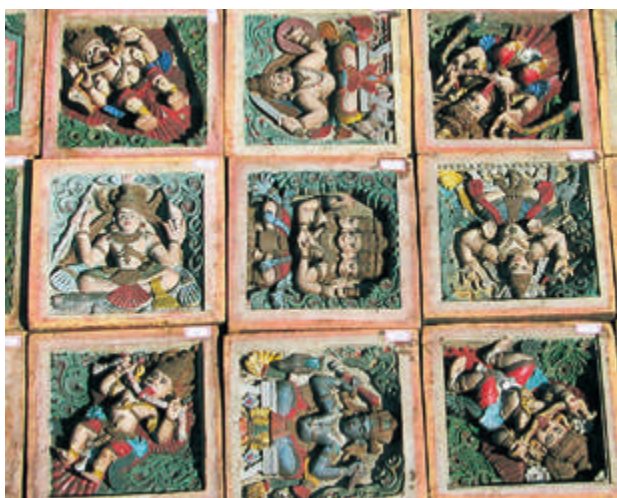
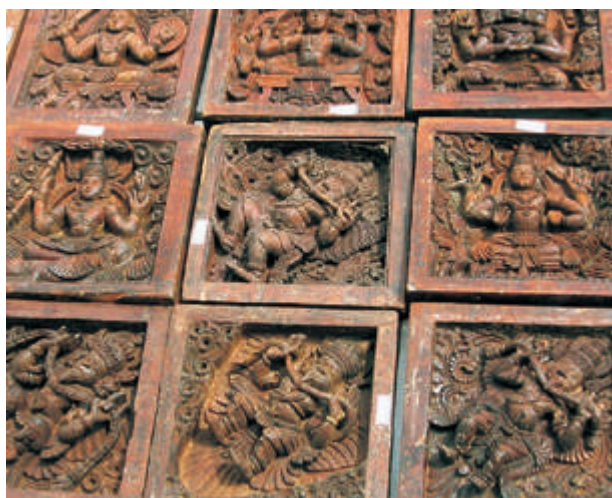
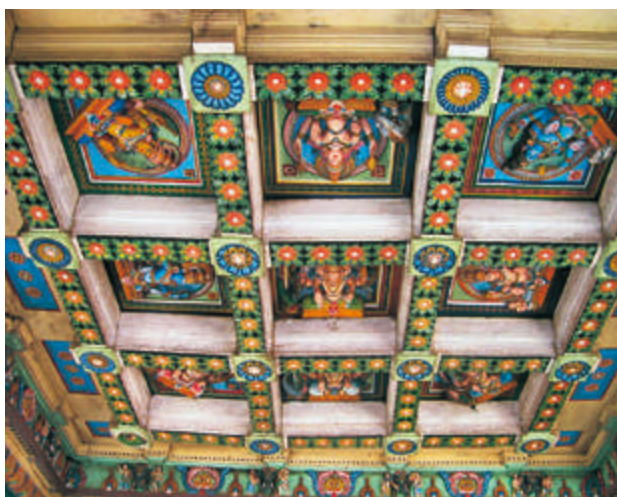
Before dismantling and removal of colored paint pigments

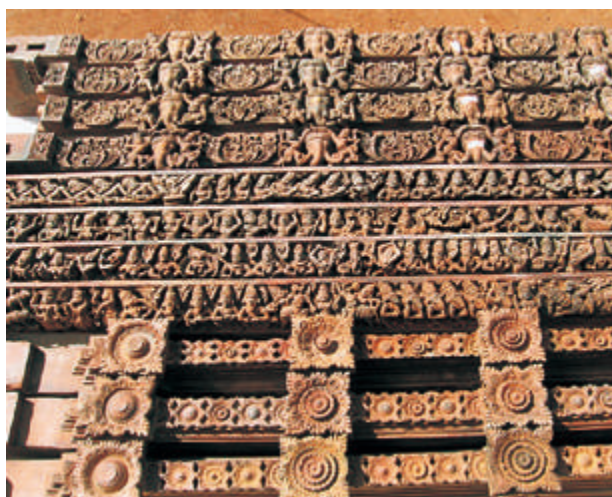
After removal of colored paint and before polishing

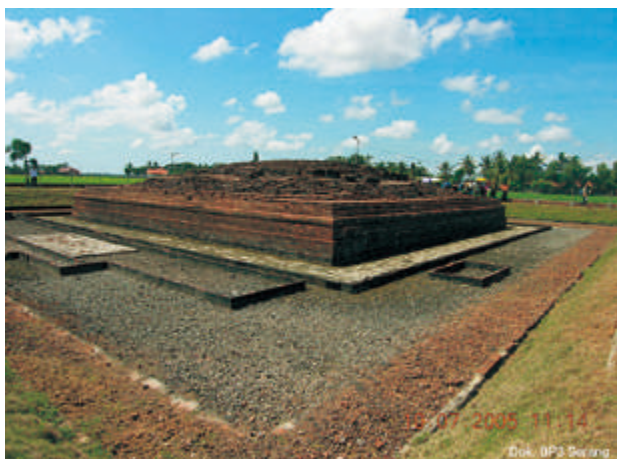
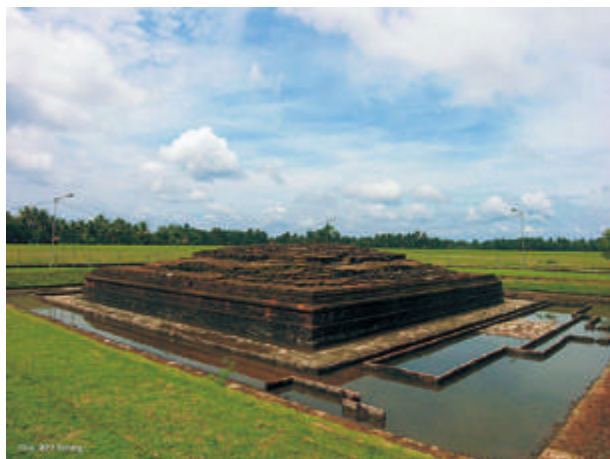
Condition of Jiwa Temple at Batujaya Site in the dry and rainy season  
Documentation: BPCB Serang

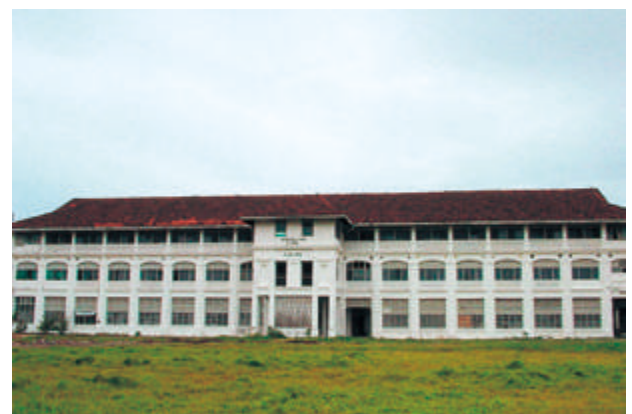
View of the south elevation portraying the repetitive windows, keystones and pilasters that reflect the image of an educational institution.

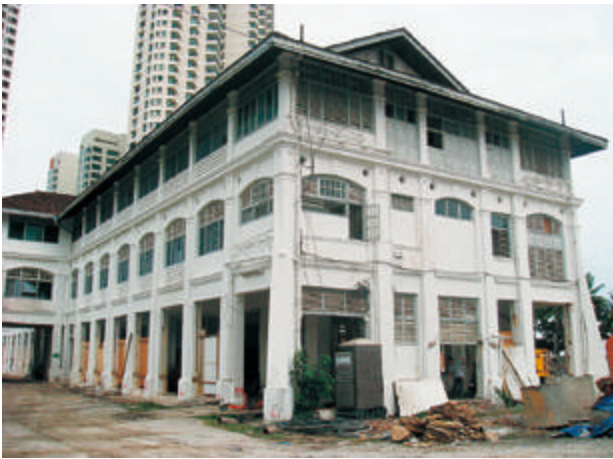
A buttress-type structure can be seen at each corner of the St. Joseph's Novitiate.

Built symmetrically with a high portico attached in the middle of the south façade, the St. Joseph's Novitiate was designed in a Colonial style that is adaptable to the tropical hot and humid climate of Penang. This style is evident in its building elements including large openings, high ceiling, wide corridors and high doors at the exterior facades. The exterior façades of the building were designed with repetitious windows, keystones and pilasters to reflect the image of an educational institution. Some of the common building materials used at the St. Joseph's Novitiate are plaster, timber, granite stone, bricks, Marseille roof tiles, cement and stained glass. A buttress-type structure can be seen at each corner of the St. Joseph's Novitiate.

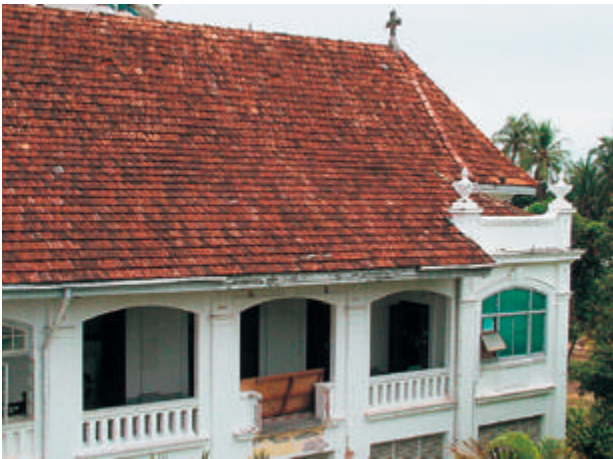
Condition of the Chapel before restoration.

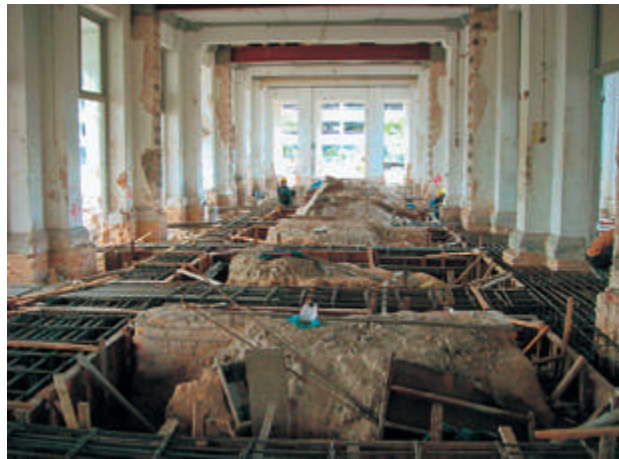
Prior to the construction of the new pile foundation, a new ground floor of concrete slab-and-beam system was introduced to support the existing brick columns.

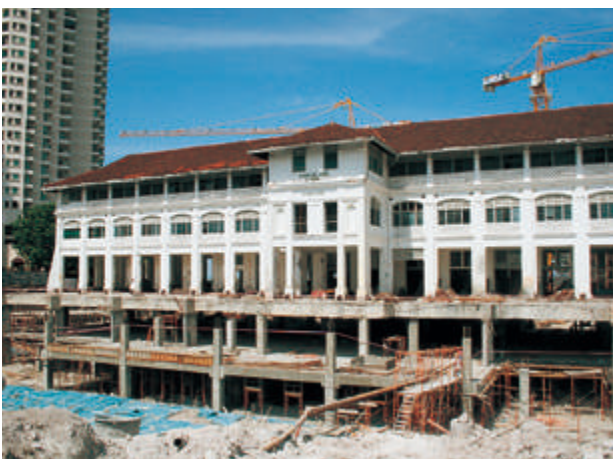
The construction of two levels of basement car parks underneath the St. Joseph's Novitiate was based on the underpinning process, a solution adopted to provide the new pile foundations.

One of the major challenges facing the restoration of the St. Joseph's Novitiate was to construct the two-level basement car parks underneath the building as required by HPSB to accommodate the number of visitors and tenants to the Gurney Paragon shopping mall, offices and residential towers. The consultant architect and structural engineer worked together to safeguard the building and to ensure that no cracks or structural failures occurred during the construction of the basement car parks. The St. Joseph's Novitiate was built with load bearing brick walls and columns that rested on either stone slabs or old brick mats footings. There were reinforced concrete beams span between the brick columns supporting timber joists and floorboards above. Initial investigation revealed that the building was structurally sound and in good condition to allow for the underpinning process.

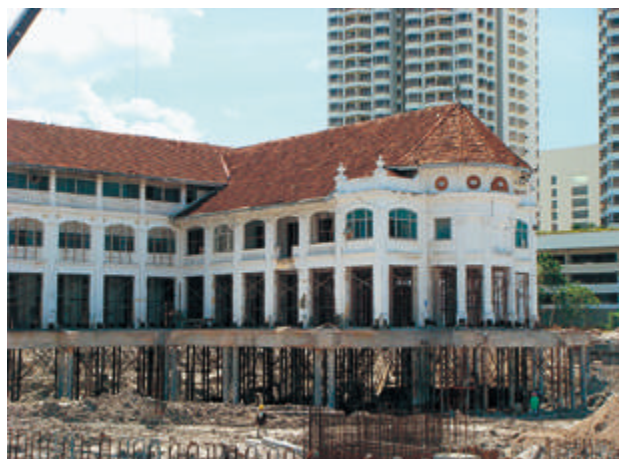
View of the St. Joseph's Novitiate standing independently in the middle of an open field supported by series of micropile shafts, a one-of-a-kind engineering feat in the country.

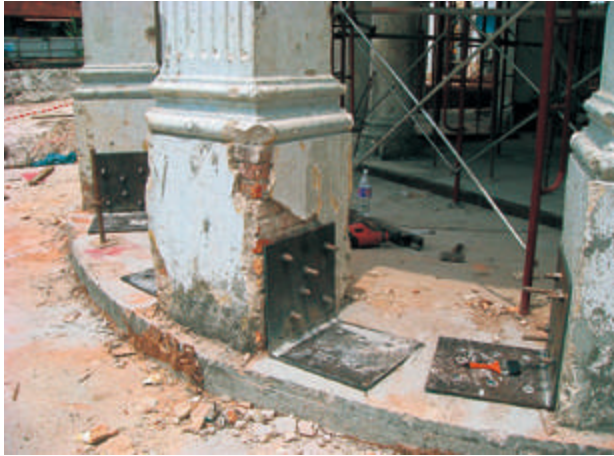
During the construction of basement car parks, L-shaped steel plates were bolted onto the existing column bases and the newly cast ground beams.

To prop the building throughout the construction of basement car parks, L-shaped steel plates with stiffener plates were bolted onto the existing column bases and the newly cast ground beams. This would allow a temporary load path for transferring part of the existing column loads to the newly cast ground beams. Heavy-duty scaffolding as temporary propping system was also installed inside the building to support the building upper floors and beams. Small excavators were used to carefully dig out the earth beneath, allowing the old foundations to drop and removed from the building. More micropile shafts, later encased in concrete with steel bars to become reinforced concrete columns, were installed to support and bond together the two basement concrete slabs. To prevent the micropile shafts from buckling, temporary bracing was fixed.

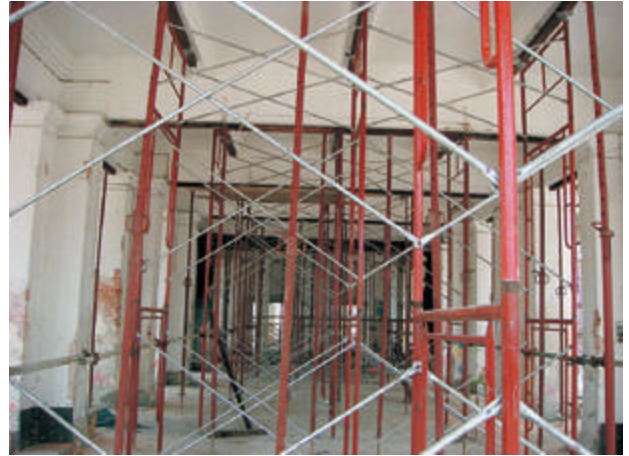
Temporary propping at the ground level of the St. Joseph's Novitiate during the construction of basement car parks.

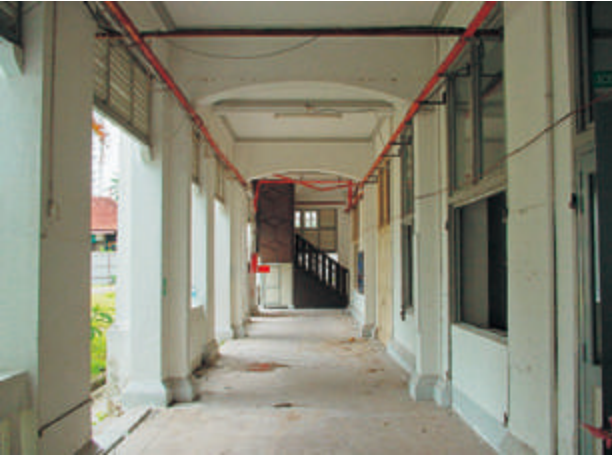
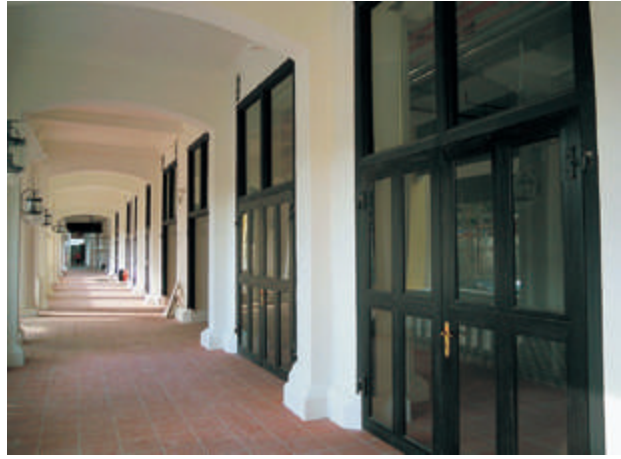
Views of the corridor at ground level before and after restoration.

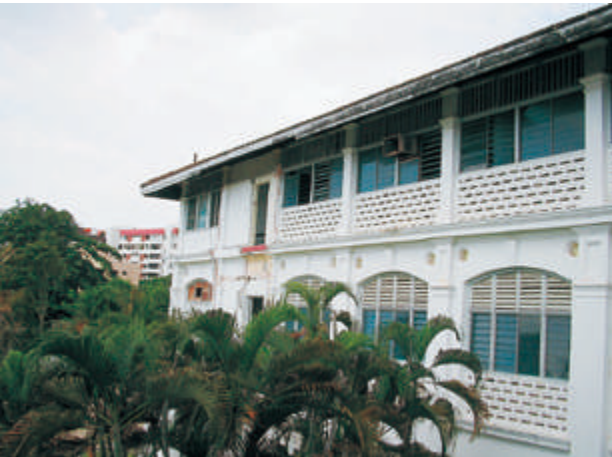
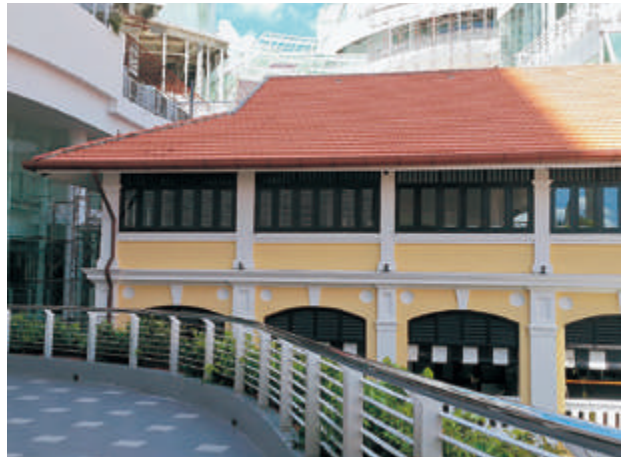
Views of the east wing of the St. Joseph's Novitiate before and after restoration.

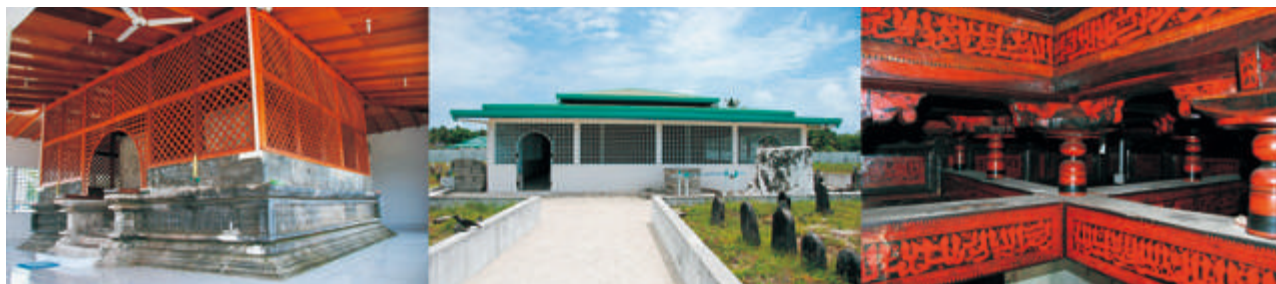
H. A Ihavandhoo Ancient Mosque

building has a hypostyle layout with a prayer hall with no “Dhaalas”. The mosque is built on a highly decorated coral stone platform with coral stone wall and timber roof structure. The roof is two tiered with a modern metal roofing finish. It has a highly decorated coffered ceiling with a stepped recess. The columns are made from timber. With its fine carvings, entrance steps, carved wooden doors, lacquer calligraphy and decoration, the quality of workmanship is among the finest in the country.

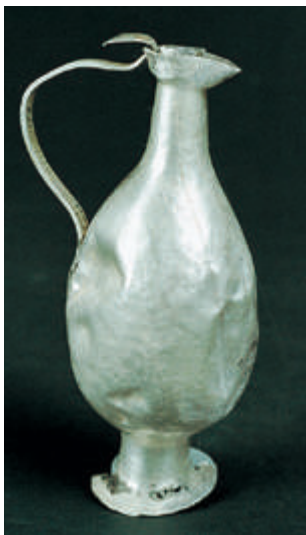
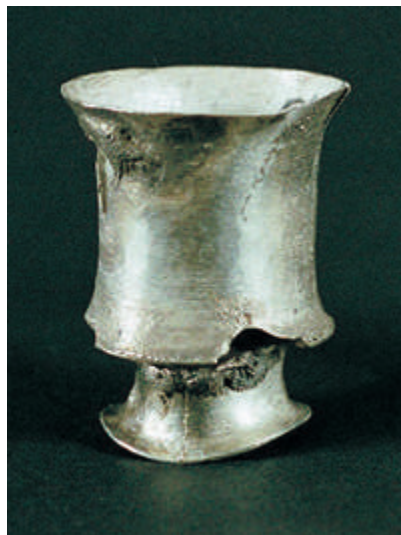
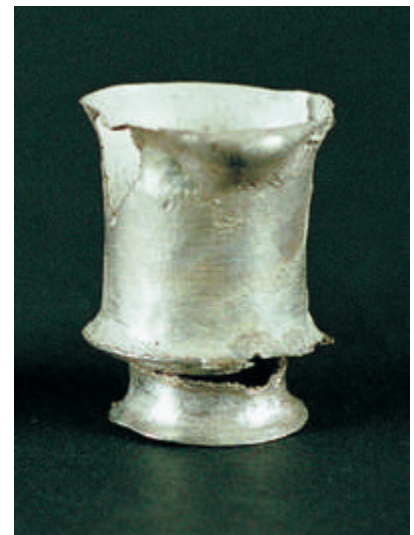
Khushoo Tsaidam's silver vessels:  
Fig. 1. Jar; Fig. 2, 3. Cups; Fig. 4-6. Vessels with long handle

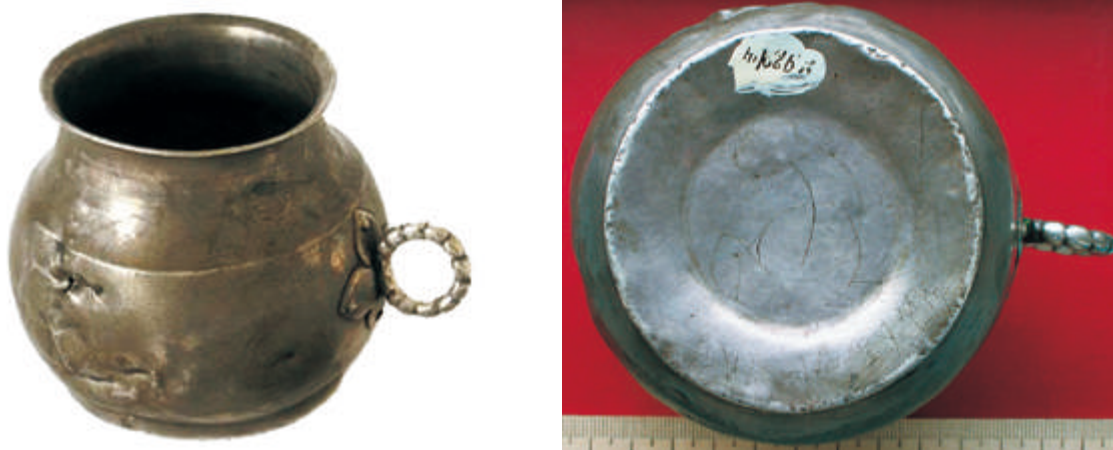
Fig. 8. Silver vessel and its bottom found from Tuyakhta, Russian Altai

31 runic characters engraved with a sharp tool in a single line and around the narrow circle of the bottom (Fig. 8). It is 1.5 cm between the inscription and the circle of bottom. Its character type is similar to that of the Uighur period (745-840 AD) runic inscriptions (OSAWA &..., 2011, 140, 142).

Such silver vessel as it has a wide mouth, keeled body, flat bottom, low direct base, handle consists of many circled little balls and runic inscription on its bottom occurs in Ancient Turkic grave goods of the 7th-9th century in Russian Altai (Fig. 8) (KISJELJOV, 1951, Table LII; SAVINOV, 1984, 124-125; OVCHINNIKOVA, 1990, 63; KUBARJEV, 2005, 312). Also it has been represented in some stone statues of the 7th-8th cc (SHJER, 1966, 77, 87; KUBARJEV, 1984, 32; BAYAR, 1997, 63; HAYASHI, 2003).

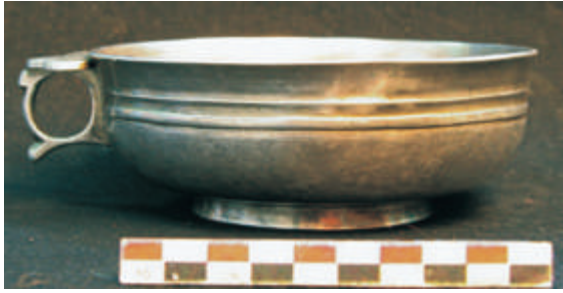
Fig. 10. Silver cup found from Mongolia

citizens. Thus, a silver cup, which was one of the artifacts, was described by me (Fig. 10).

The cup has a low body. A handle and a round base joined to the body by welding. Body height is 5.2 cm, and the weight is 0.42 kg. Rim is quite flanged, measuring of 0.2 cm thin and 14.2 cm in diameter. Wall of the body is almost direct. Wide and narrow bands are around the upper body (Fig. 10, 14). Space between the rim and the upper narrow band is 1.1 cm. Total 9 palmette decorations of 2 kinds were engraved under the bands and around the body (Fig. 10, 15). There are 3 thin rounds joined to each other on the top of a typical Sogdian-styled handle (10, 12, 14, and 17). The rounds are very suitable to be pushed by a thumb. The biggest one, which is at the center, is 2 cm in diameter. 2 smaller rounds are 1.4 cm in diameter. The base is 7.6 cm in diameter, 0.8 cm high and thickness or 0.25 cm.

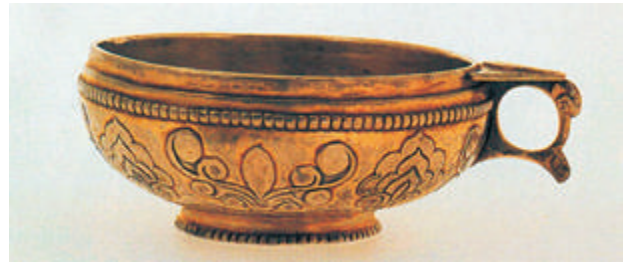
Fig. 11. Gilded silver cup found from Tibet. Late 7th-8th cc. Pierre Uldry collection, the Rietberg Museum, Zürich /HELLER, 2003/

Spaces between the above-mentioned 9 palmettes have been ornamented with many semi-circular images (Fig. 15). The same palmette pattern appears not only in many Sogdian-styled silver vessels (Fig. 11), but also in work of nomadic art.

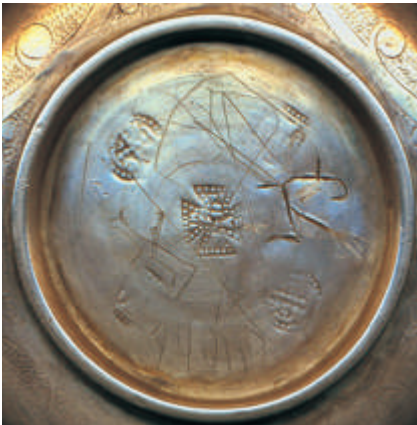
Fig. 13. Bottom of the cup from Mongolia

The circular base is 6.7 cm in diameter. The plain surface of the bottom or inner side of the circular base has been engraved with such representations as 5 crosses, inscription, mounted man, 'hook' tamga, sword, dagger or short sword, 'mountain goat' tamga and some disordered images (Fig. 13, 18).

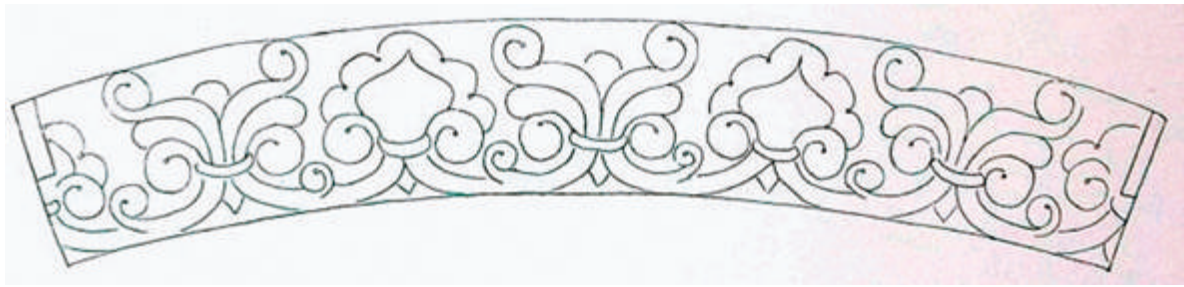
Fig. 16. Palmette decoration of the silver cup found from Central Asia (?). Second half 8<sup>th</sup> - first half 9<sup>th</sup> c.

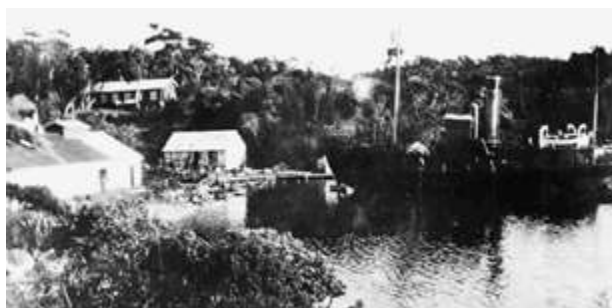
Figure 2. The Base ca. 1928 showing a whale catcher at the start of the slipway at medium tide (Photo: Southland Museum & Art Gallery).

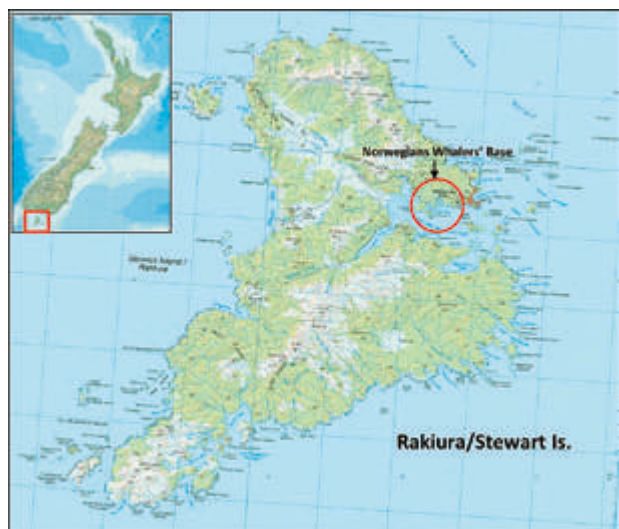
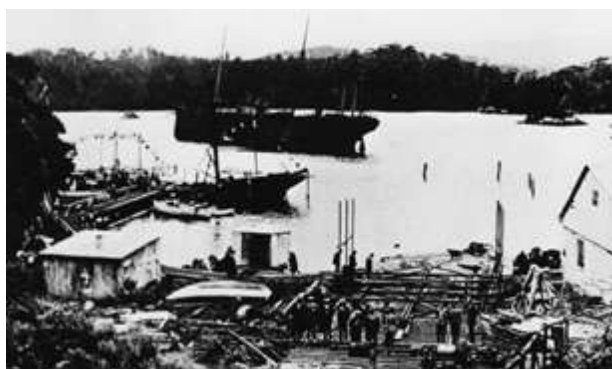
Figure 3. The Base ca. 1927 showing the slipway (centre), built on top of Prices' 1865 slipway, and the *Othello* jetty (far left) (Photo: Southland Museum & Art Gallery).

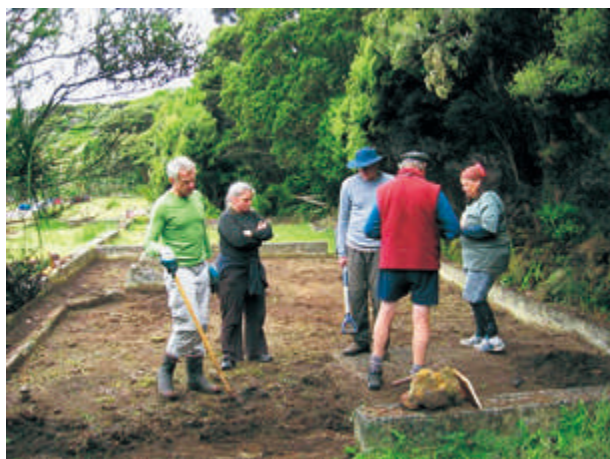
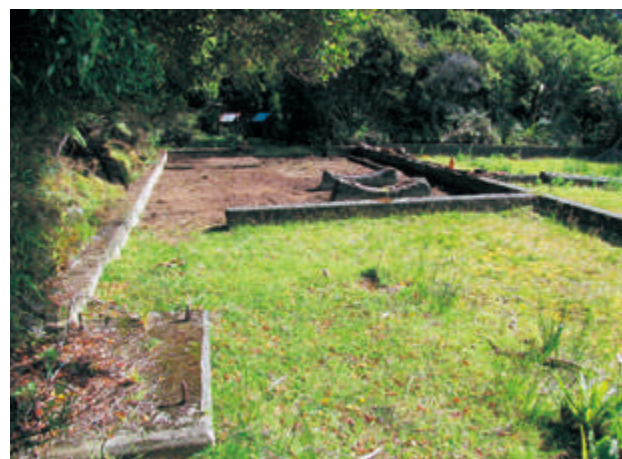
Figure 8. The Workshop cleared of vegetation and the boiler room turfed to reveal the structure (Photo: NZHPT).

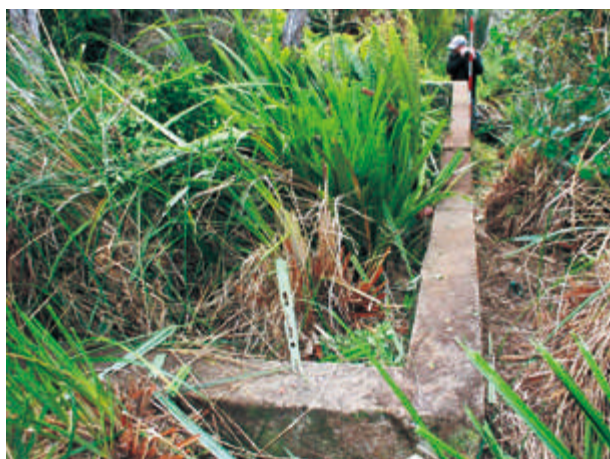
Figure 9. The foundations of the Managers House after vegetation clearance (Photo: NZHPT).

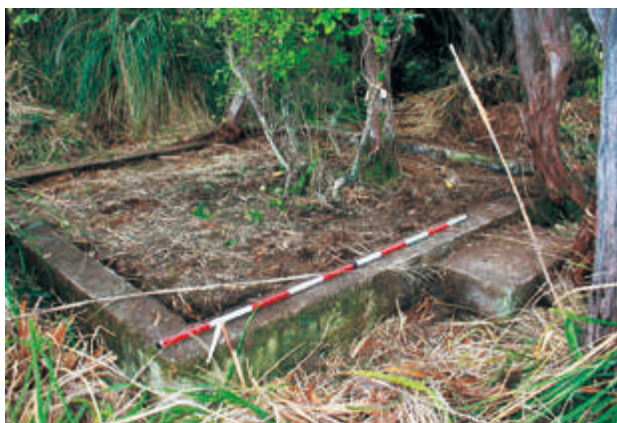
Figure 10. The foundations of the Tin Hut, where the Bases' diver initially resided (Photo: NZHPT).

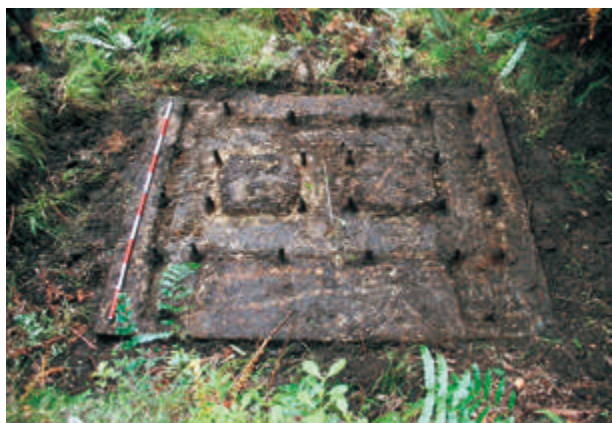
Figure 11. The foundations of the Winch base (Photo:NZHPT).

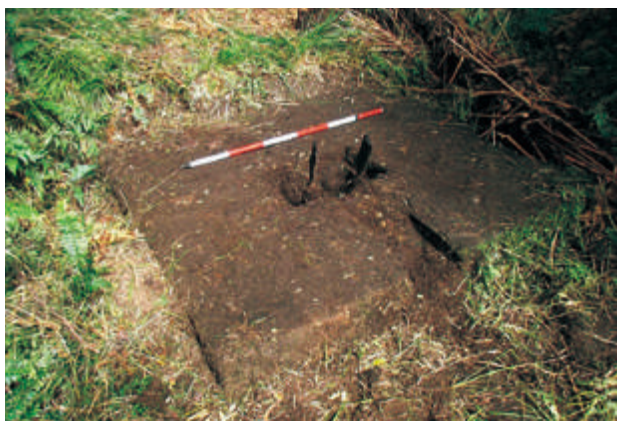
Figure 12. The foundations of the winch pulley base located 52m down slope from the winch (Photo:NZHPT).

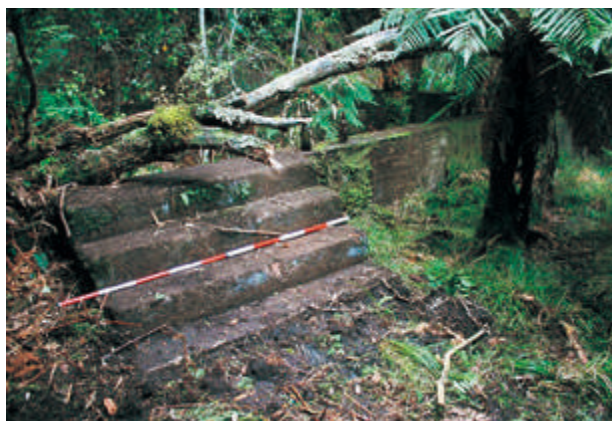
Figure 13. The foundations of the Carpenters' Shop (Photo:NZHPT).

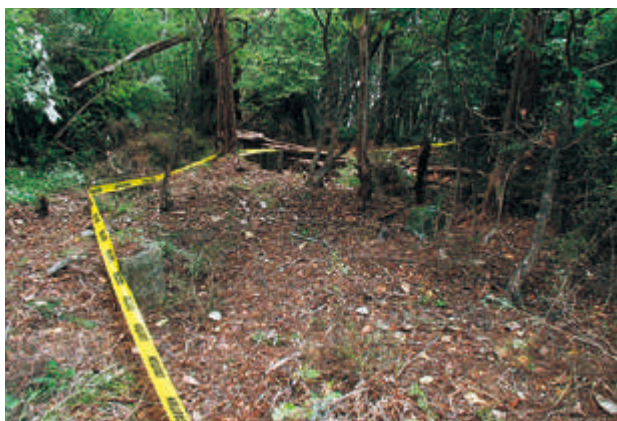
Figure 14. The piles on which the Bunkhouse was positioned. The kitset Bunkhouse was brought over from Norway and after the Norwegians left the Base, it was rebuilt in Oban where it resides today (Photo:NZHPT).

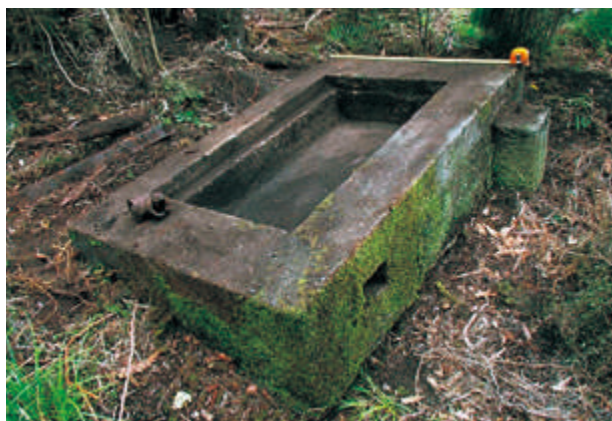
Figure 15. The concrete wash basin uncovered from the bush at the south end of the Bunkhouse piles. The scale is at 1m (Photo:NZHPT).

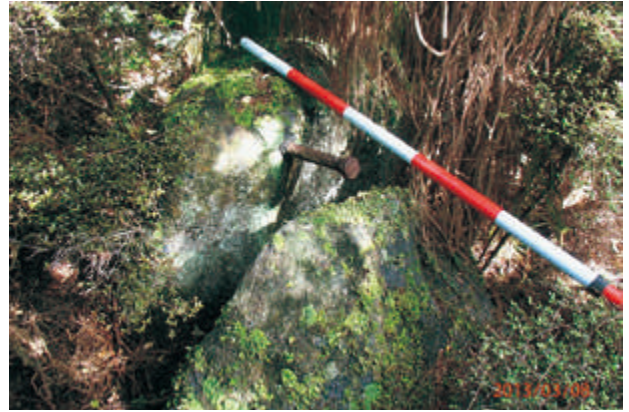
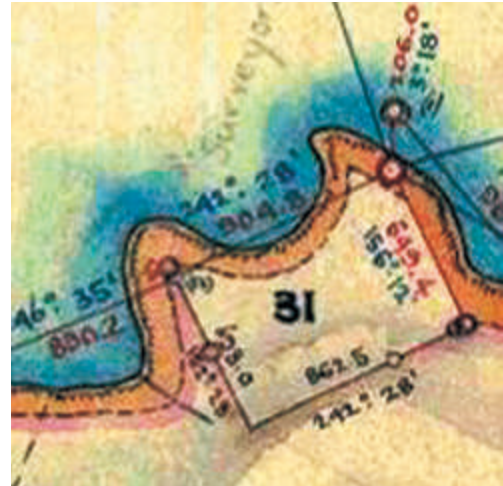
Figure 19. Top: Natural split granite rock with bolt which held the Norwegian flag. This rock was also used as a survey trig point as early as 1878 (Photo: NZHPT). Bottom: Survey map SO 2848 from 1893 showing the trig point (circled) on the eastern side of the headland (source: LINZ).

top, a large wooden stake with the top foot of the stake painted white, or a cairn built using stone or earth. If a natural feature was used, it would be one that stood out from any of the surrounding landscape features. The survey found a large split granite rock used by the Norwegians to set their flag pole in was the location of the 19<sup>th</sup> century surveyors mark established by at least 1878 (Figures 19). Bearings off this rock found that only from this point could other geological features be seen as noted on an 1893 survey map.

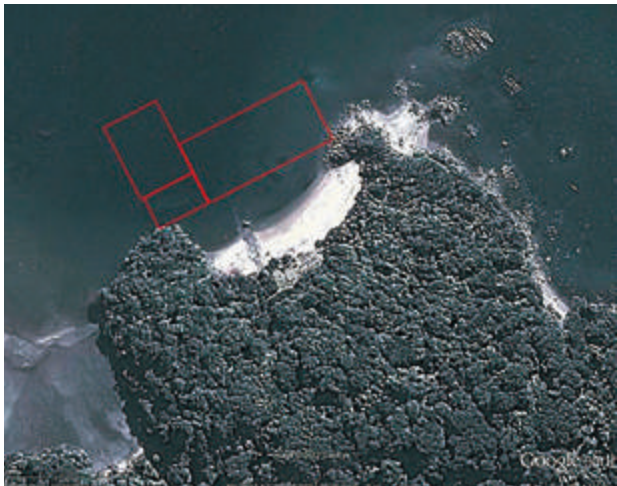
Figure 20. Marine archaeological survey area (Graphic: SCHIP & Subsurface Ltd with Google earth satellite photo).

The survey area extended from the high tide mark to *ca.* 130m into the inlet (Figure 20). Any heritage items within the inter-tidal environment were mapped by the terrestrial based archaeologists while the marine archaeologists concentrated on any underwater remains. The underwater survey was non-invasive i.e. visual only. The most important artefacts recorded in the inter-tidal survey area were the twelve discarded whale chaser propellers as these items have been at the most risk of removal by fossickers and collectors of marine heritage (Figure 21, 22). The dimensions of the propellers were measured and any distinctive features, such as ice damage to the propeller blades and whale chaser boat identification marks, were recorded on drawings of the items (Figure 23). Other key objects of interest also recorded was one of the slipway rollers, winch drums, which can be seen in their original position in historic photographs of The Base, the Swedish boiler, which came to rest in its position today from a failed attempt to salvage it in 1946, and the dimensions and makeup of the slipway for the shipyard (Figures 24 to 26). In this tidal environment, the timbers from the slipway had largely survived, though the level of preservation was quite variable, compared to those revealed during bush clearance
