ACCU Nara  
International Correspondent

Vol.12 2013

# The Twelfth Regular Report

Cultural Heritage Protection Cooperation Office, Asia-Pacific Cultural Centre for UNESCO (ACCU)

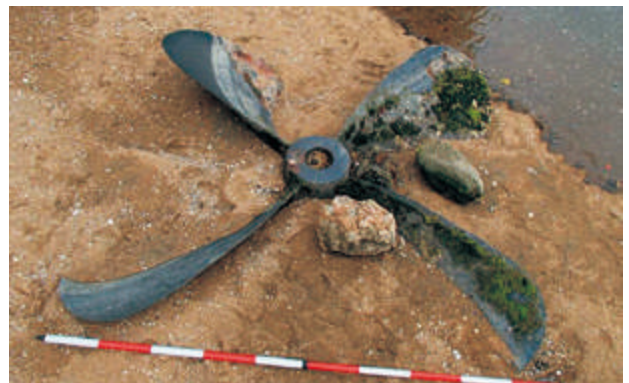
Figure 22. Whale chaser propellers discarded on the beach. The survey identified that different designs of propellers were present. These propellers are possibly a later design (ie. late 1920s) as they are made of an alloy and are a sleeker more light weight design. Other propellers are a more robust solid steel design and appear to be much heavier (Photo: NZHPT).

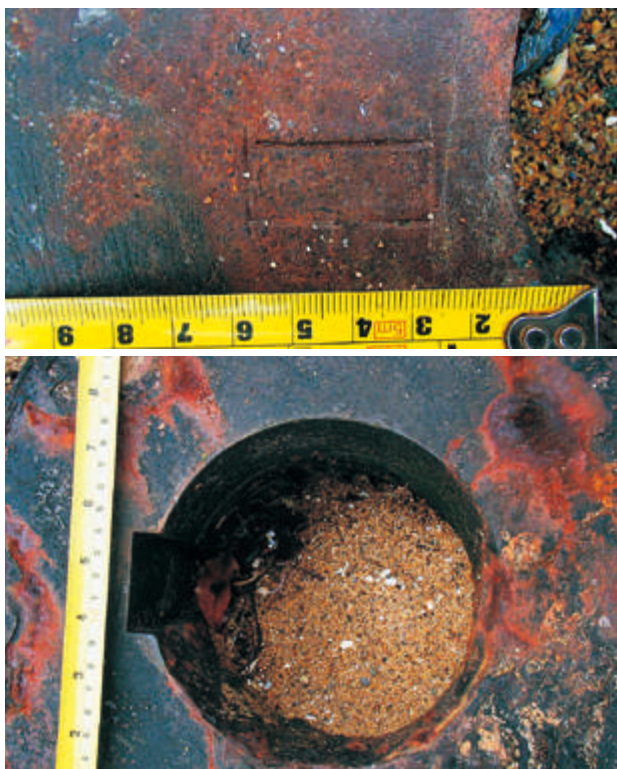
Figure 23. Distinctive marks on propellers were recorded so they could be identified individually if illegally removed. The propeller in the top photograph is marked as belonging to the Star II whale chaser. The bottom photograph shows a distinctive 'chuck' feature which was used in later propellers to make removing them easier from the drive shaft (Photo: NZHPT).

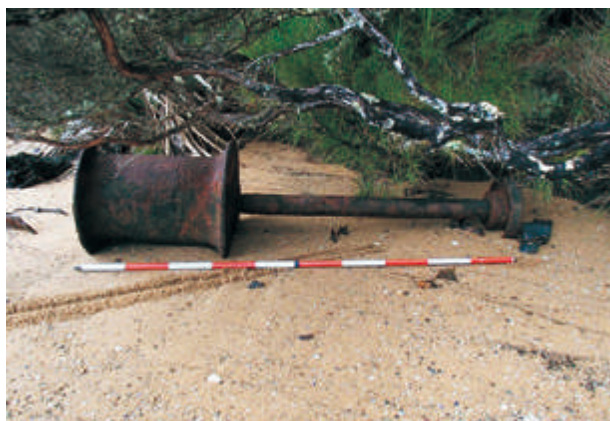
Figure 24. Winch cable drum on the beach (Photo: NZHPT).

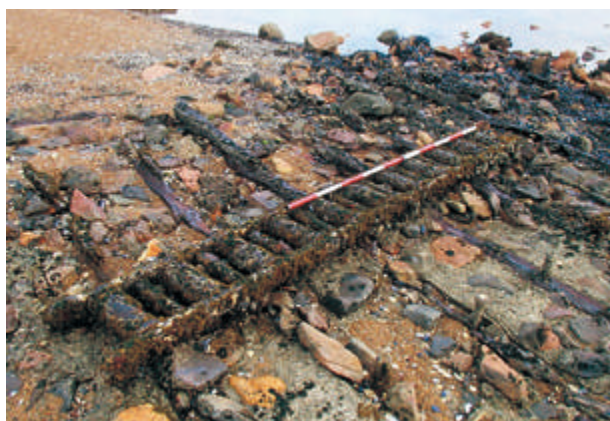
Figure 25. A slipway roller lying on the slipway exposed at low tide (Photo: NZHPT).

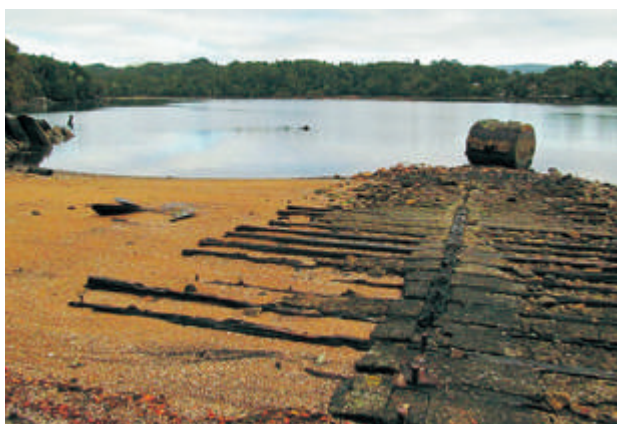
Figure 26. The slipway exposed at low tide showing the timber and concrete construction. The boiler from the workshop lies where it was abandoned in 1946 (Photo: NZHPT).

It was found that the construction of the slipway below the low tide mark was quite different from that above this level as seen on the beach. The investigation confirmed the historic account that numerous granite boulders were dumped on the soft sea bed to build a solid and stable base for the slipway (Figures 27, 28). The slipway timbers were then lowered onto this base as sections and connected one after another by the Base diver who used a 'John Brown' diving suit with air pumped to the suit from a divers air pump located on a pontoon floating above the diver. The rails were then bolted down onto the completed timber base. Only one of the rails is present today still bolted to the timbers. Recorded lying down the centre of the slipway was a concrete strip on which the central roller rail would have originally been fixed. The total length of the slipway from the high tide mark and out into the inlet was 76m (The total length of the slipway being 101.3m measured from the concrete pulley base).

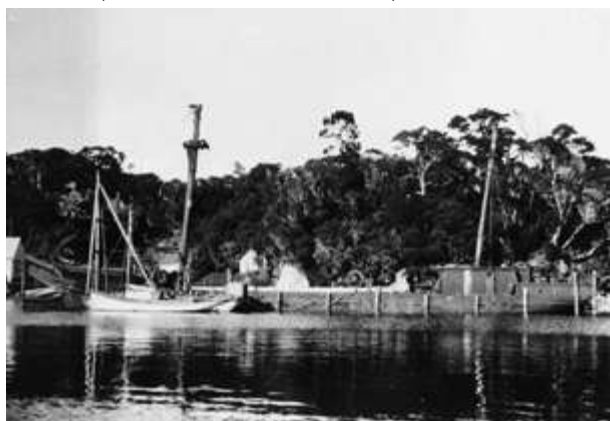
Figure 29. The *Othello* in 1928 fixed in place using bollards driven into the seabed (Photo: Southland Museum & Art Gallery).

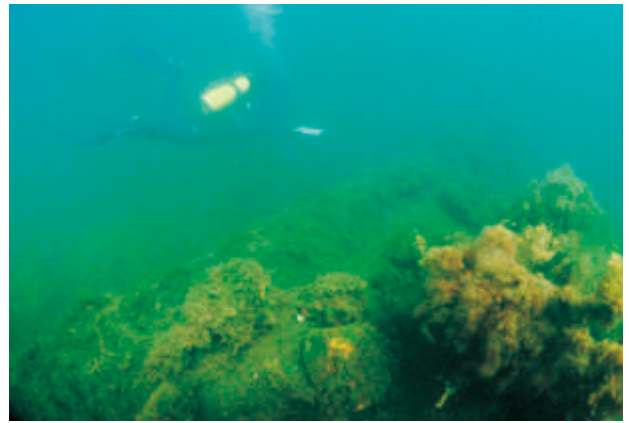
Figure 31. Diver recording the wreck of the *Othello* (Photo: SCHIP & Subsurface Ltd).

The marine survey found that the *Othello* was in a good state of preservation with the hull largely intact (Figures 31 to 35). The original rudder was still in place (Figure 35) and copper sheathing placed along the hull in 1863, used to discourage marine organisms impacting on the wooden hull, was still present (Figure 33). Also found was the hawse pipe, planking timbers, wood and iron knees, a possible mast support, ballast stones etc (Figures 36 to 38). Overall, the wreck still retained its original 1853 main frame and structure and features of its later maintenance such as the 1863 copper sheathing (Figure

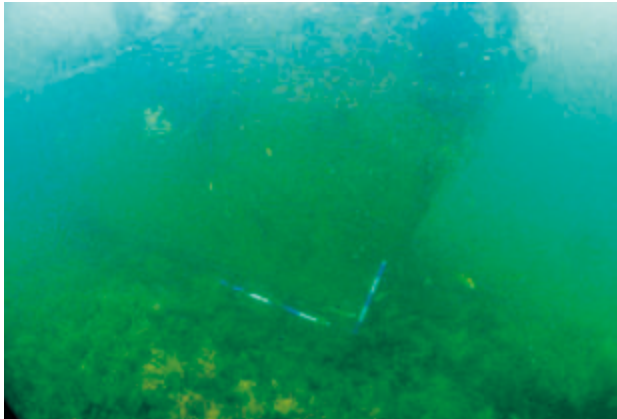
Figure 32. The bow of the *Othello*, starboard side, showing the well preserved form of the wreck (Photo: SCHIP & Subsurface Ltd).

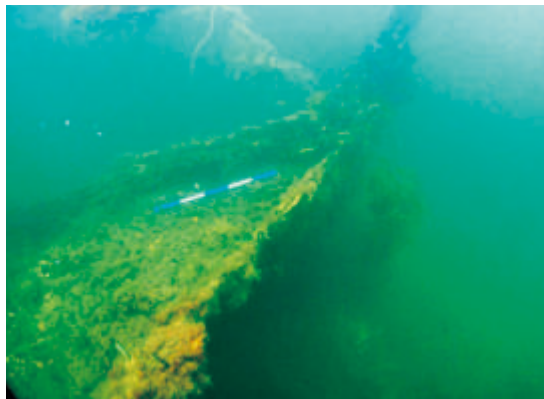
Figure 34. The stern and rudder post of the *Othello* (Photo: SCHIP & Subsurface Ltd).

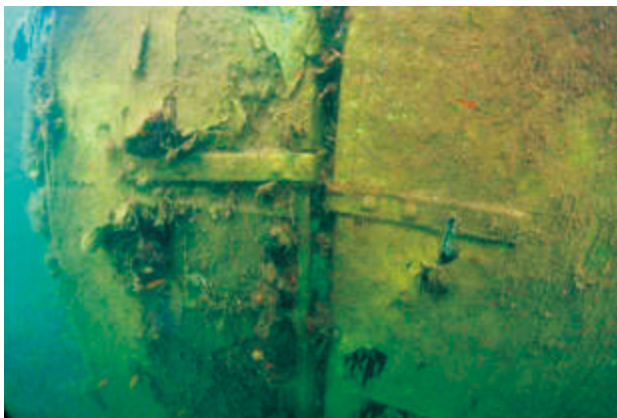
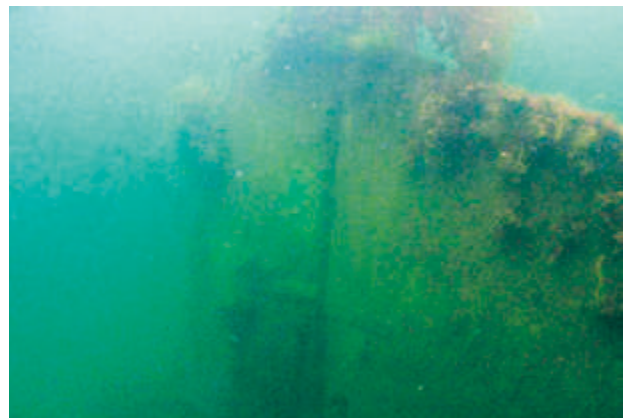
Figure 35. Intact rudder, starboard side showing pintle & gudgeon (Photo: SCHIP & Subsurface Ltd).

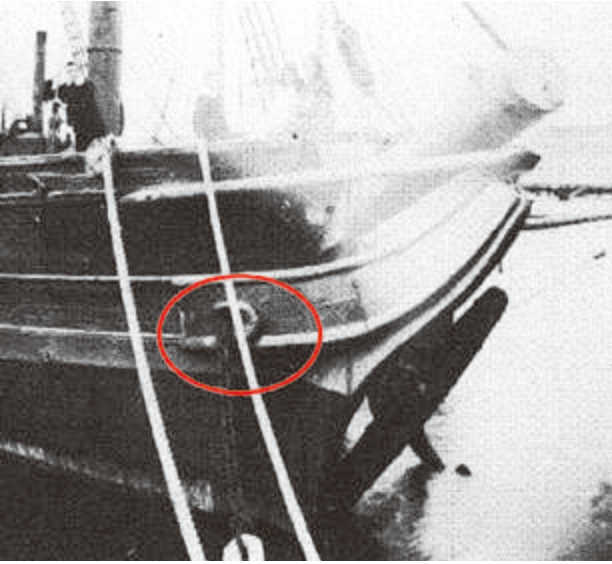
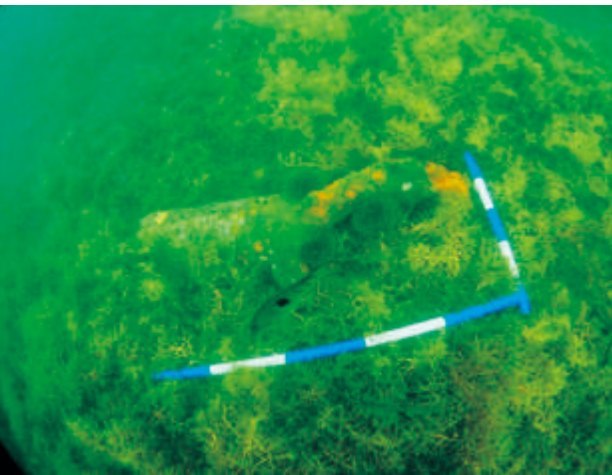
Figure 36. Hawse pipe on the *Othello*, at Bluff harbour ca. 1902, and as found on the sea bed in March 2013 (Photo: SCHIP & Subsurface Ltd).

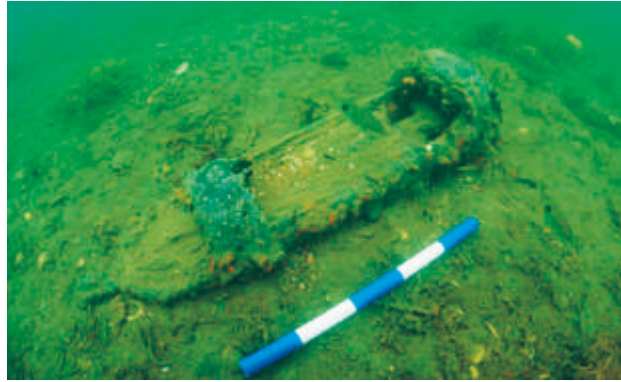
Figure 37. Bracing around mast/bowsprit timber (Photo: SCHIP & Subsurface Ltd).

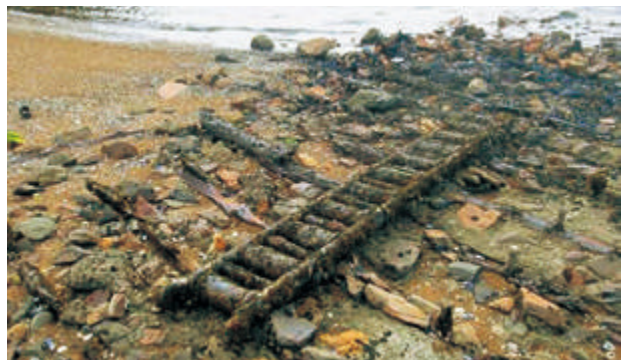
Figure 38. Slipway roller on the deck of the *Othello* and on the slipway (Photo: SCHIP & Subsurface Ltd).

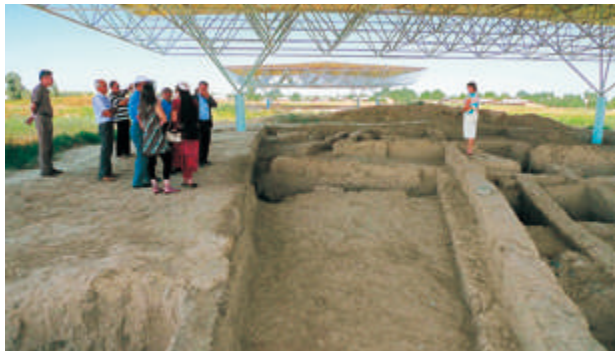
**Group A:** Architectural remains to be unearthed in the coming years and under metal roofs.

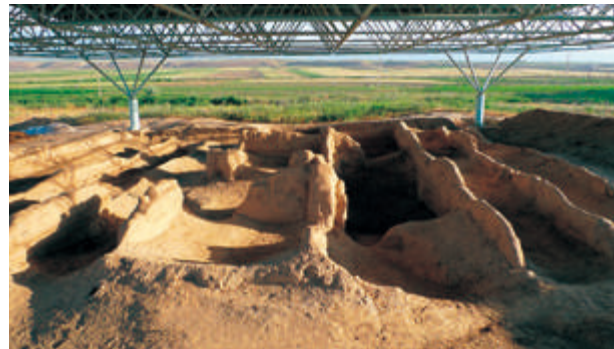
**Group B:** Architectural remains, excavated before the construction of the metal shed and to be subjected to minor destruction.

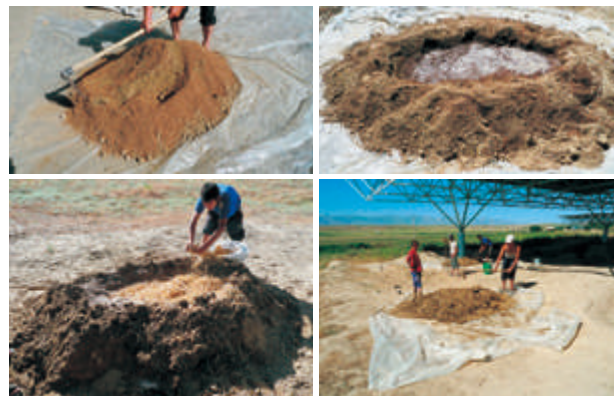
**Manufacturing Method:** The basic material used in large quantities (90%) is loess. Hay and water were added together to reinforce and stirred several times to make it lubricant.

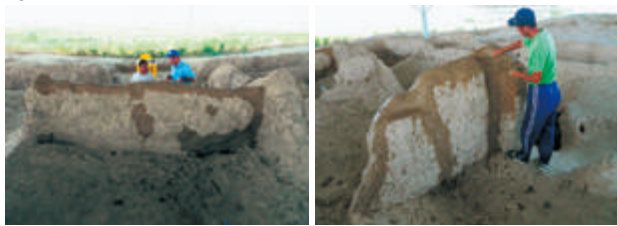
**Method of use:** Prepared lubricant was applied to the object and closed by hand pressure or pressed with a tool against it.

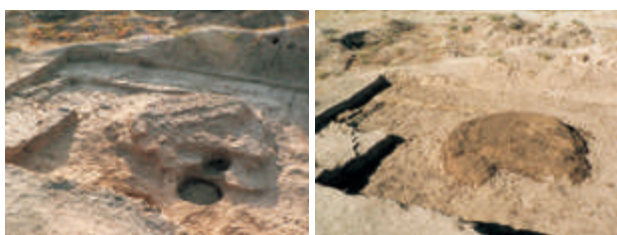
2. Round-storey pottery kiln in the horizon 3 of the eastern section of the excavation II.

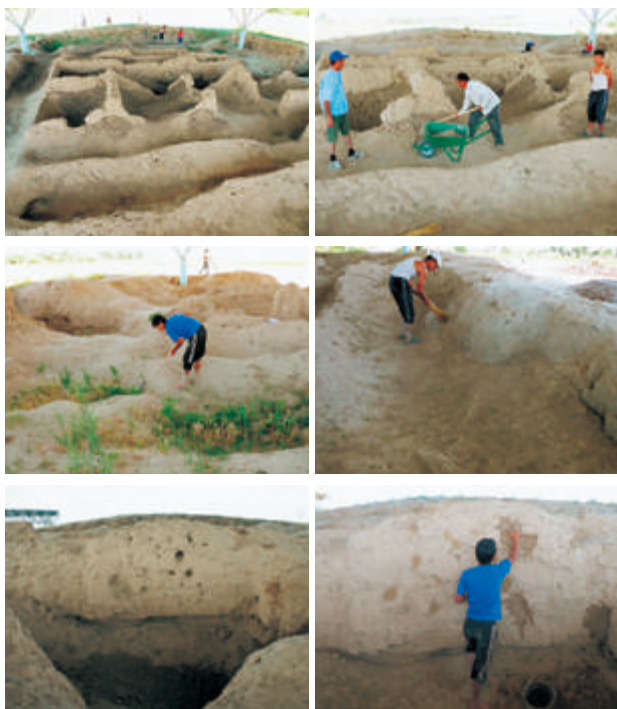
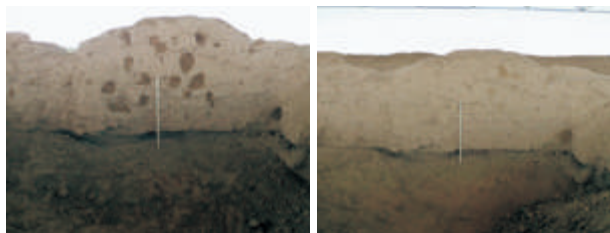
3. Excavation III. The remains of the monumental building area of over 225 m<sup>2</sup>. The walls are built of mud-brick whose size is 57–60 x 26–30 x 10–12 cm. The entire complex is covered with a metallic structure.

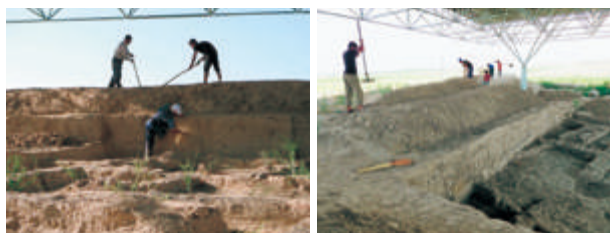
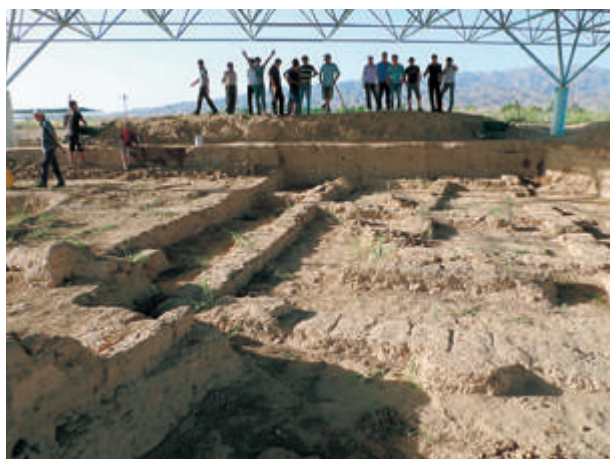
5. Excavation IX. The remains of a building area of over 80 m<sup>2</sup>. The houses are built of mud-brick walls whose size of 45h x 30h x 12 cm. The preserved height not exceeding 30 cm.

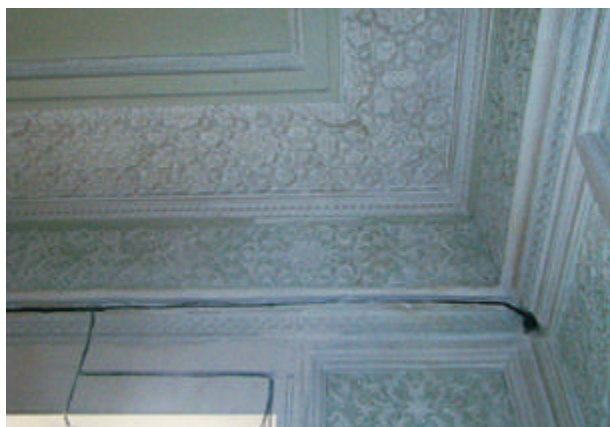
2. Cracks above cornice on the wall.

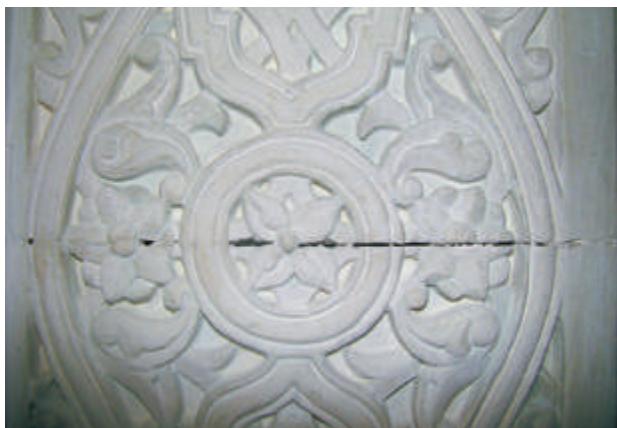
3. Seams between Ganch panels.

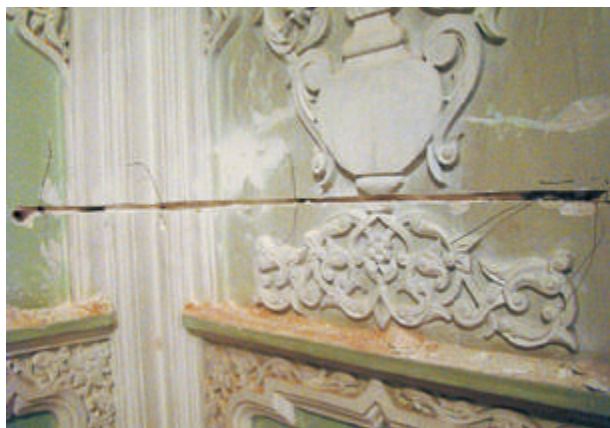
4. Part of ornaments and cornice with cracks.
