ACCU Nara
International Correspondent

Vol.13 2014

The Thirteenth Regular Report

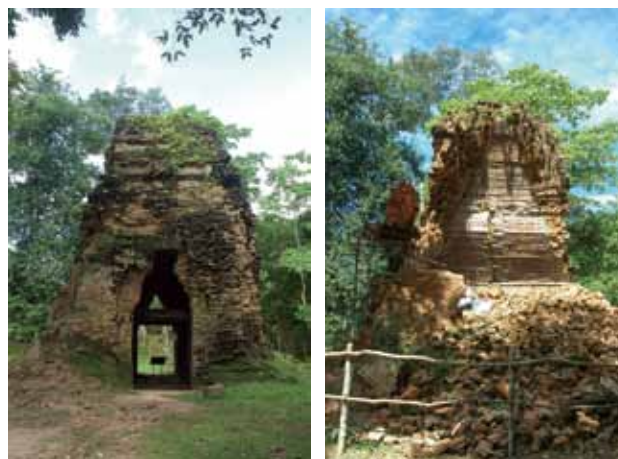
Fig 1 & 2. S2 Tower before and after collapse on July and August 2006 (Photo: Chan Vitharong/SCP)

Interior clearance: As already mention, the clearance work within the S2 chamber were implemented by SCP in 2004. The rainstorm in 2006 caused the building to collapse and the space of the interior partly covered by the collapsed brick fragments. Again the interior clearance is conducting this activity.

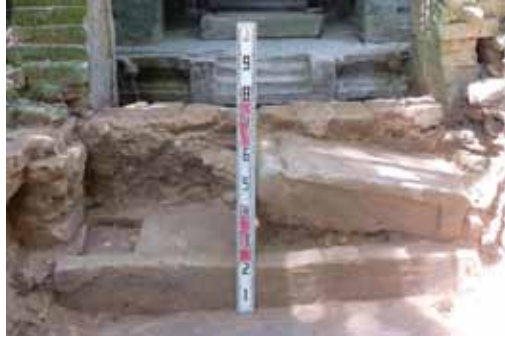
Fig 7 & 8. Western door sill, found from the excavation and after consolidation (Photo: Hin Sophorn & Chan Vitharong)

- Application of injection filling to delaminated surfaces and joints: the delaminated surfaces and joints of elements, brick and sandstone; they are probably best to re-fill areas with adhesive materials, as necessary (Fig 7 & 8). They will be applied with improved epoxy resin mortar which after the experiences from the SCP. The joints in bonded or cracked areas have been treated and consolidated with improved mortar. For the large broken elements, stainless-steel screw bolts are used to join them.
- Application of new materials: Even though trying to keep the authenticity of monument, the project also uses new bricks to apply on artificial brick materials. The new are supposedly the 'proper' material to protect the original surface from the rain water leakage (Fig 9 & 10).

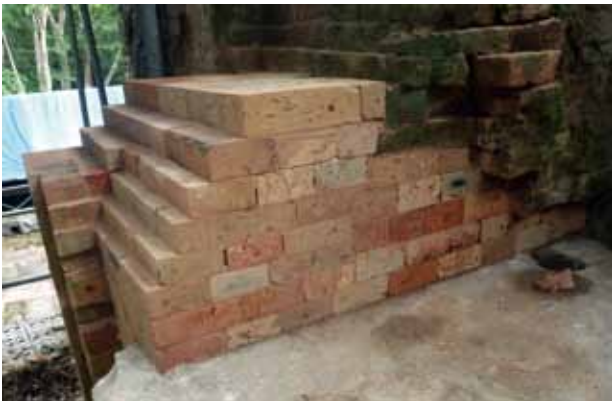
Fig 9. New brick materials have replaced to support the structure (Photo: Hin Sophorn)

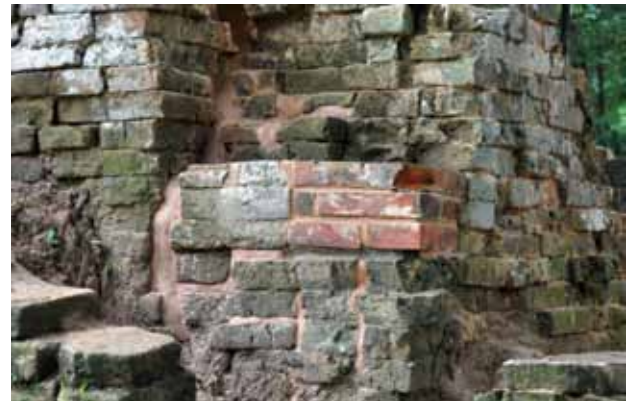
Fig 10. Consolidated bricks and new brick materials (Photo: Chan Vitharong)

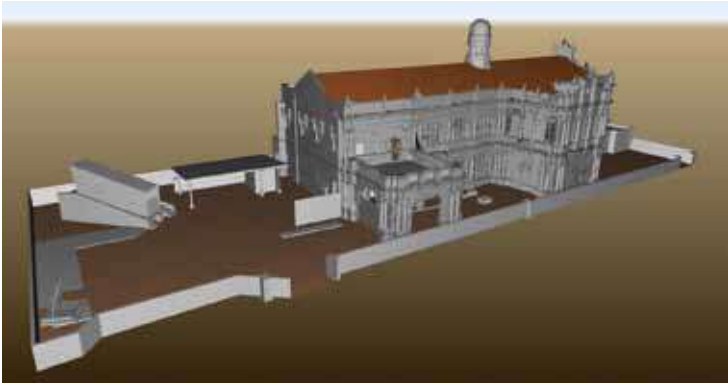
3D model of the building showing its external facades and surroundings

Colour information generated from panoramic images was applied to the 3D point clouds to produce a true colour point option.

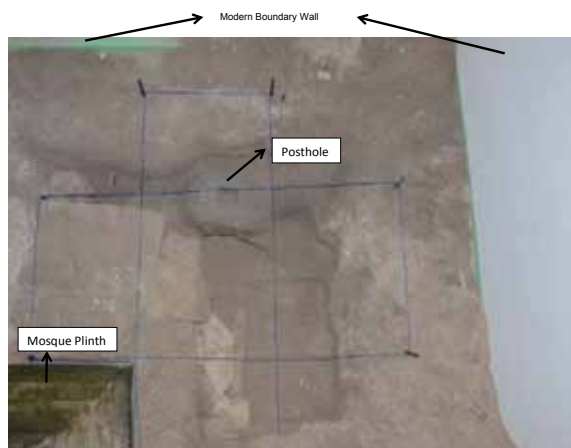
A. Dh Fenfushi Ancient Mosque: View of the Trench from the top

To confirm the posthole theory, we dug the opposite corner (south west) of the mosque. Unfortunately we were unable to find any postholes there. However, we found a coral stone block similar to the blocks used in the front wall of the mosque (cut, carved and designed) buried under the foundation stones in the center of the back side (north) of the mosque. We also found large quantities of red oxide and few shells from this trench. The excavation of the Northern quarter also had three layers of coral stone blocks as the foundation stones and we found few shells and live roots within the soil. Nothing significant was found within this quarter. Due to limited time and resources, we decided to call it an end to the test excavations at this site when we reached the third layer of the coral stones. An important note to consider at this site is that the locals have recently constructed a boundary wall very close to the mosque complex. Therefore, the absence of a posthole in the south west corner of the mosque might be that it was removed while the locals were working on the boundary wall. The whole concept of the mosque having pillars at each corner as support for roof structure during earlier times remains questioned and need further testing.

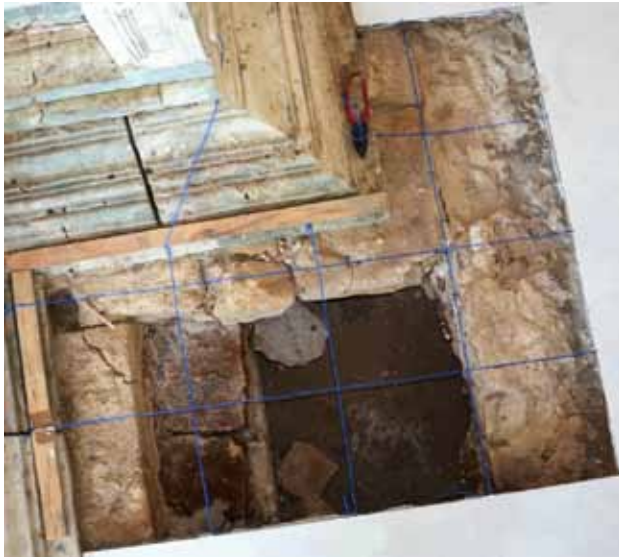
HA. Ihavandhoo Ancient Mosque: View of the Trench from the top

Excavations at the northern quarter revealed a much worked on coral stone wall that stretched from either ends of the trench. Due to the limitations of the excavation, we were unable to find out the thickness

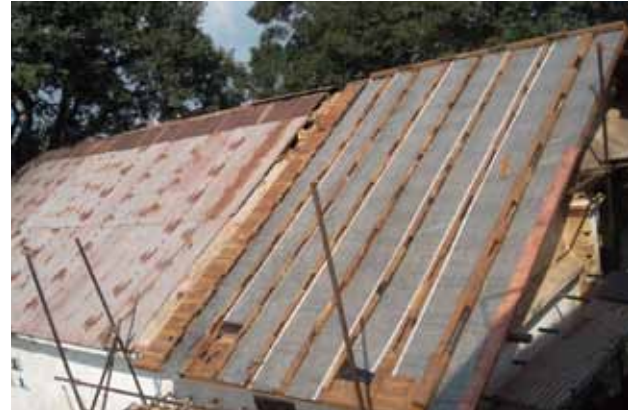
10. Using water proof material : just above the wooden planking

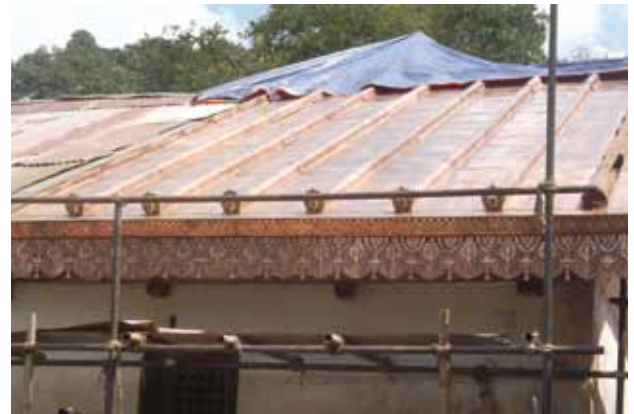
12. One side complete roof work

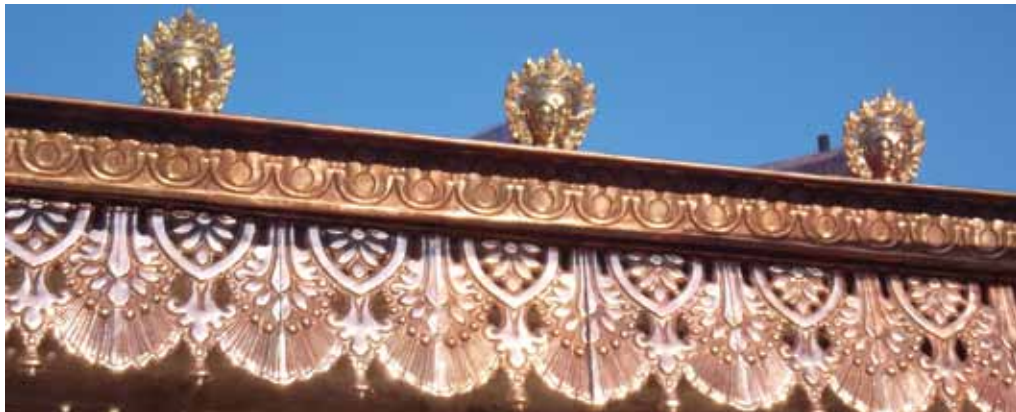
13. Nago head, eve board and jhallar (decoratives)_after completing roof conservation work: one side

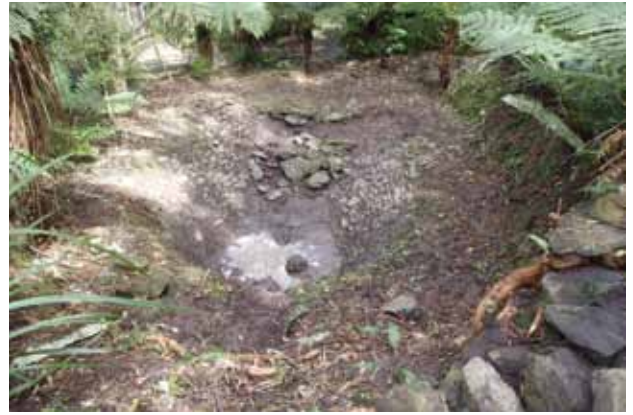
Figure 24. The Lower Pond viewed from the stone hut ruin above the pond (Photo: NZHPT)

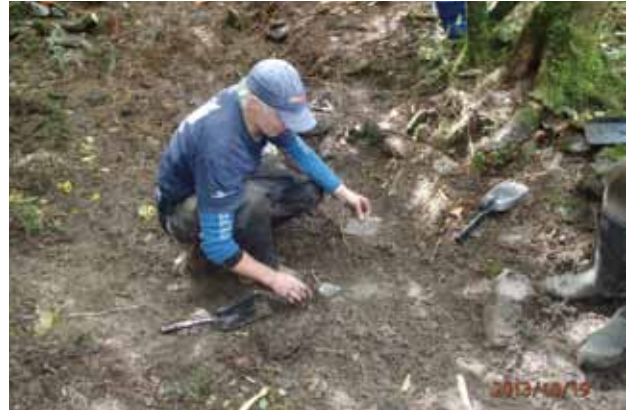
Figure 26. Excavation of the Upper Pond with 19th century Welsh roofing slate found in the fill (Photo: NZHPT)

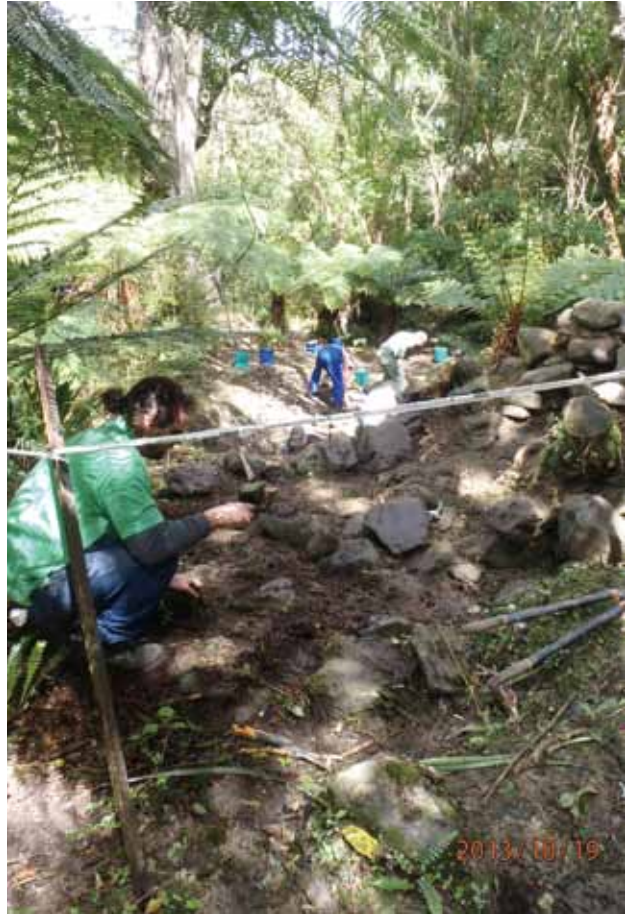
Figure 30. The stone huts ruins during excavation (Photo: NZHPT)

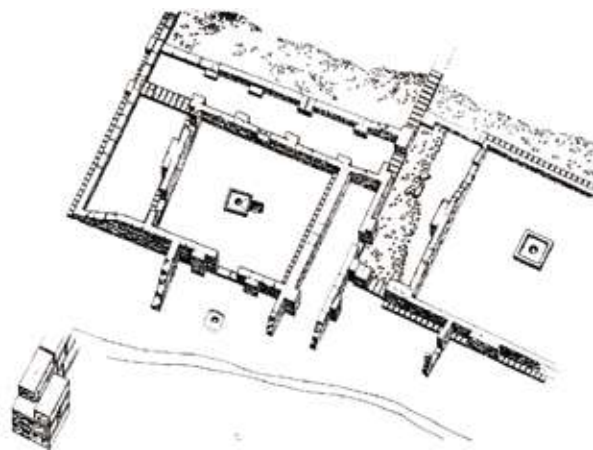
4. Reconstruction the building from excavation IX

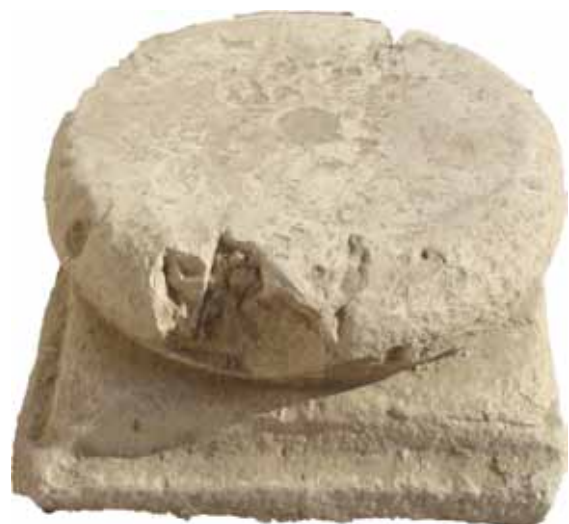
5. Torus-shape profile stone base of column
