ACCU Nara
International Correspondent

Vol.14 2015

The Fourteenth Regular Report

ACCU Nara International Correspondent

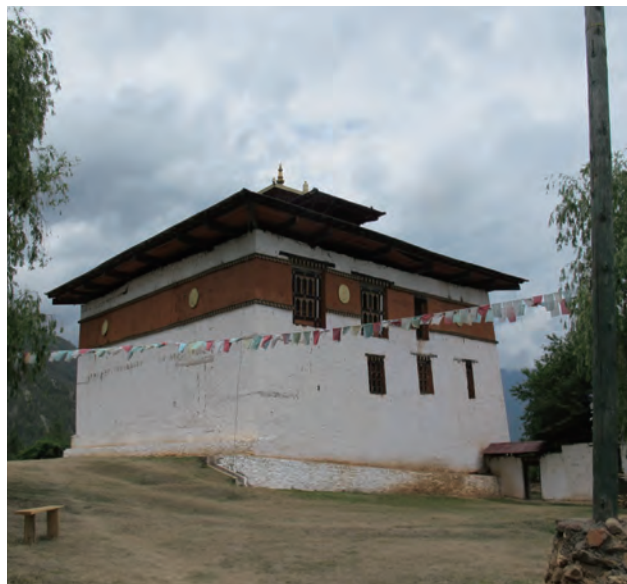
Fig. 3a North west view of lhakhang

The *lhakhang* is a square three-storied building built with stone masonry and mud mortar. The thickness of the walls varies from 1.5 to 2.4 m. The main entrance to the *lhakhang* is from the east. The main shrine room, marked with red dotted lines (see Figs. 1 and 2), is a double height room. The process of age, decay, weathering and almost absolute lack of maintenance have gradually weakened the structure and steadily worsened the condition of various parts and elements of the *lhakhang*, such as masonry walls, timber *kachens* and joists, and flooring timber, as well as *zbali*, wall paintings and so on. The September 2011 earthquake caused further substantial damage to the structure. Fig. 3a is the view of the *lhakhang* before renovation.

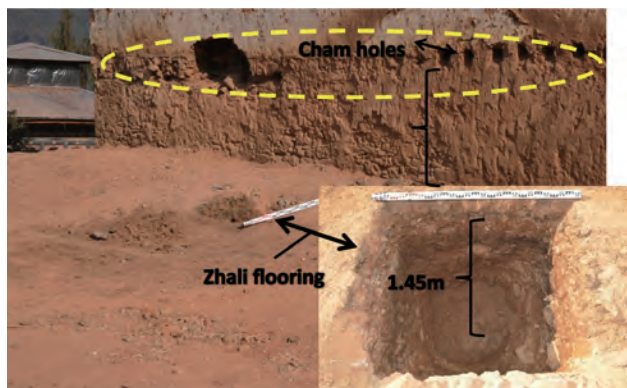
Fig. 5 -Shows the remains of Cham holes on the outer facing of northern wall and the Zhali flooring at 1.45m below the present ground level (sector E)

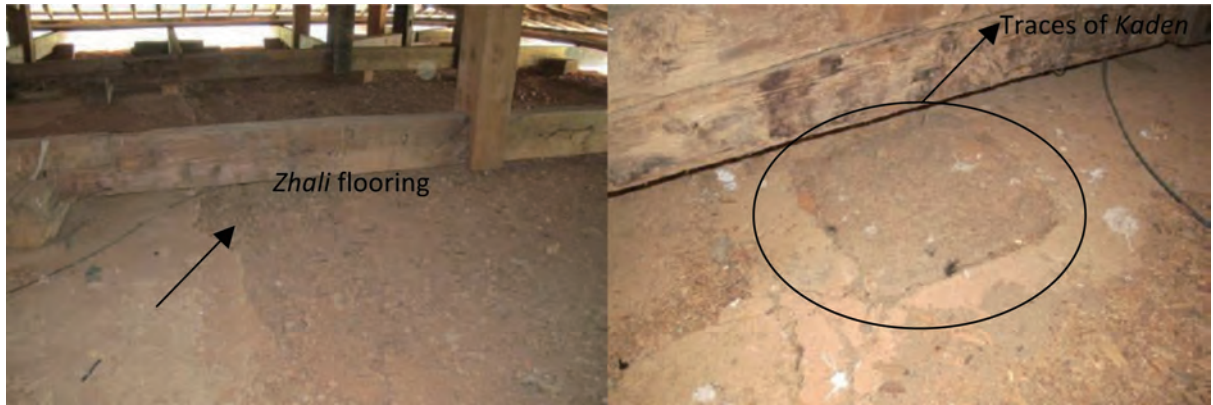
Fig. 7 Zhali flooring and shape of kaden on top of roof floor

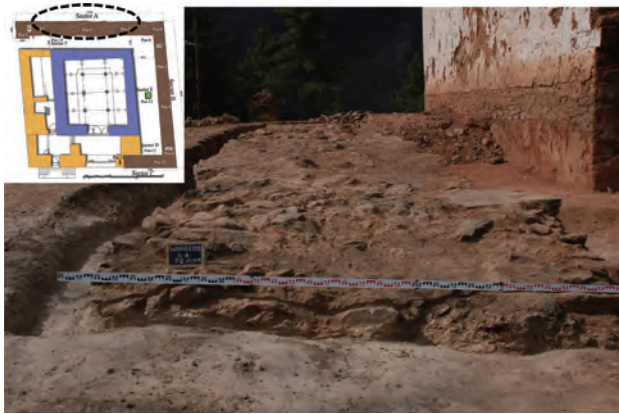
Fig. 8 Old remains of stone foundation discovered on the western side (2.8m thick wall)

As mentioned earlier, while the renovation works were proceeding at the site, some remains of the stone foundation were discovered in a southwest and northwest direction (see Figs. 4, 8, 9, 10, 11) surrounding the main inner sanctum. Fig. 4 is a plan showing the part of the

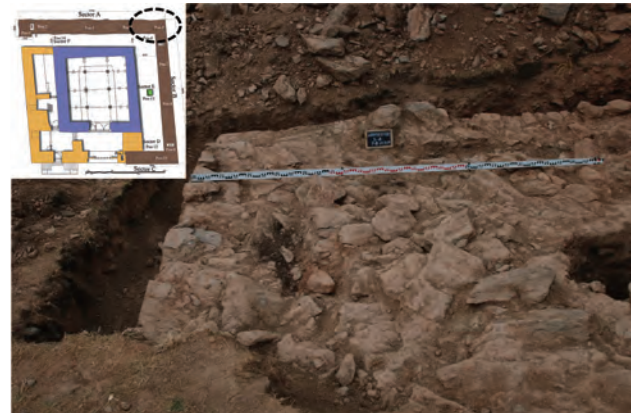
Fig. 9 Corner old remains of stone foundation discovered (at junction of west and north wall)

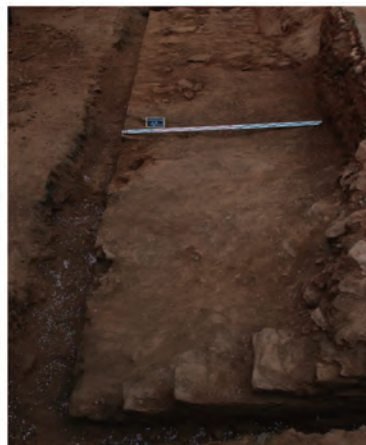
Fig. 10 Corner old remains of stone foundation discovered (at junction of east and north wall)

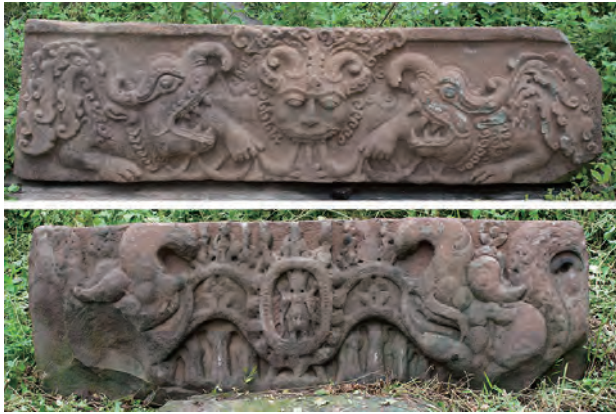
Fig. 3: Decorative lintels from sites in Thala Borivat.

With the *in situ* investigation, a numbers of movable objects can be listed and inventoried under various categories such as decorative lintels (Fig. 3), pedestals (in sets), sacred drainage outlets (Figs. 4 & 5), statues and stone inscriptions. Identification of each object

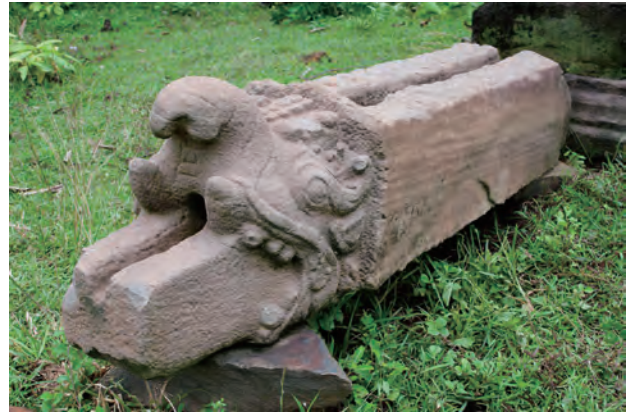
Fig. 4: Drainage outlet with Makara head, Ba Deum.

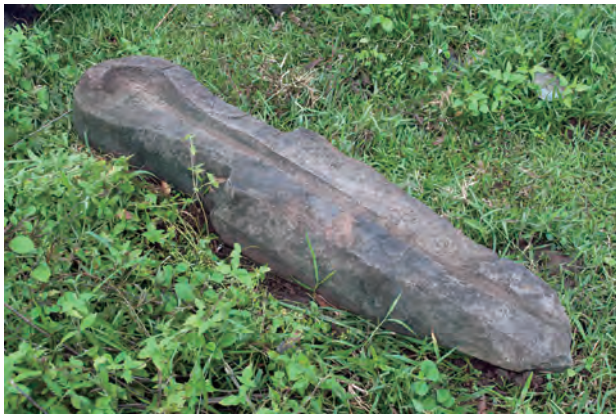
Fig. 5: Part of a drainage channel, Thala Borivat.

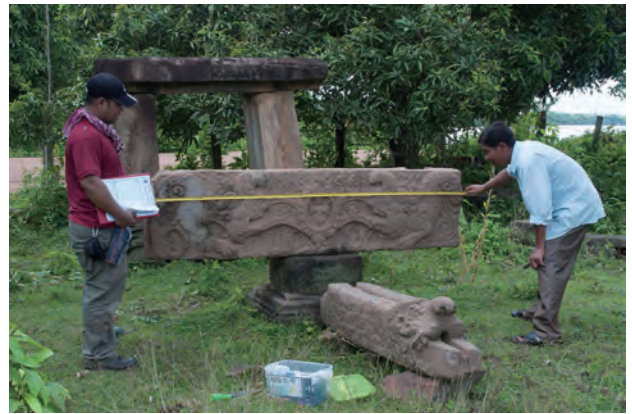
Fig. 6: In situ work.

is important to prove its authenticity. Therefore, identification is included in the digital photography, including the dimensions and provenance of each object (Fig. 6). For inscriptions, ink rubbings have also been done as part of this documentation (Figs. 7 & 8). Those artefacts can be dated back to the Bronze and Iron ages towards the Angkor period (802-1432 CE). However, the most decorative lintels can be classified in the Sambor Prei Kuk style (early 7th century CE).

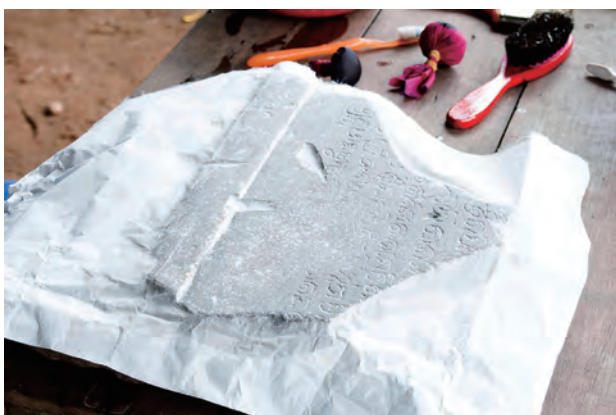
Fig. 7: Inscription rubbing at a local residence.

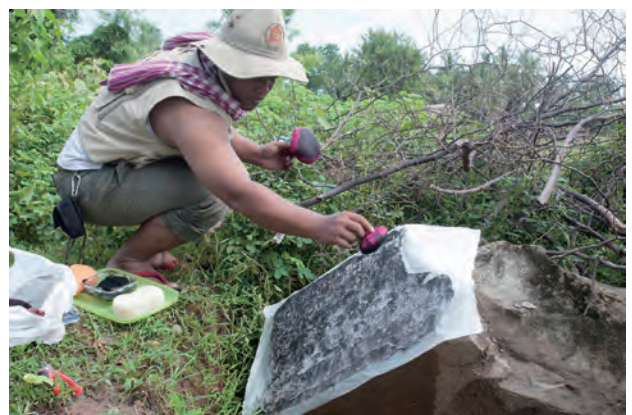
Fig. 8: Inscription rubbing in situ.

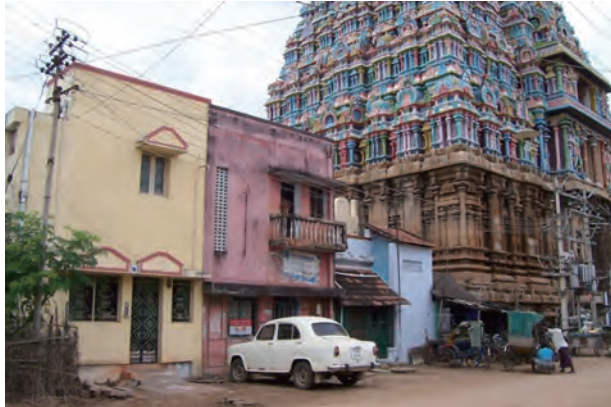
Houses and other public/private buildings encroach the historic monuments

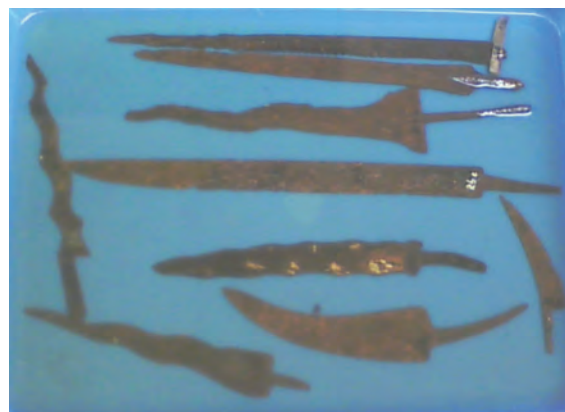
Rusty daggers were soaked in coconut water

The materials used to conserve the daggers at Old Banten Site Museum were coconut water and lime juice. The

rusty daggers were soaked in coconut water for 24 hours. After being soaked, the daggers were rubbed with lime , and brushed gently using a toothbrush.

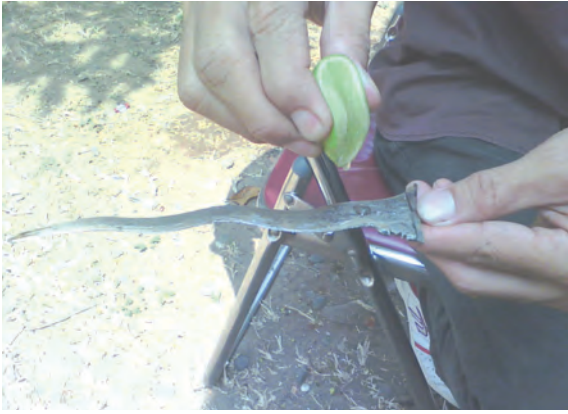
The daggers were rubbed with lime

daggers were then rinsed with running water until they were completely clear of the lime juice and coconut water. Then the daggers were dried. The results were quite satisfactory. The rust that had originally been attached to the daggers had disappeared.

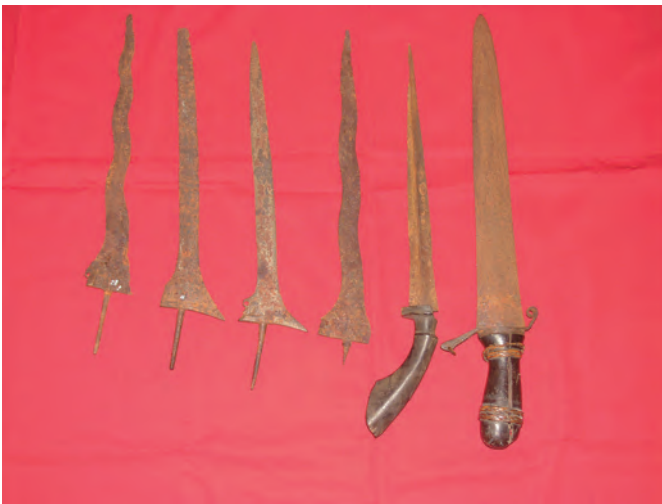
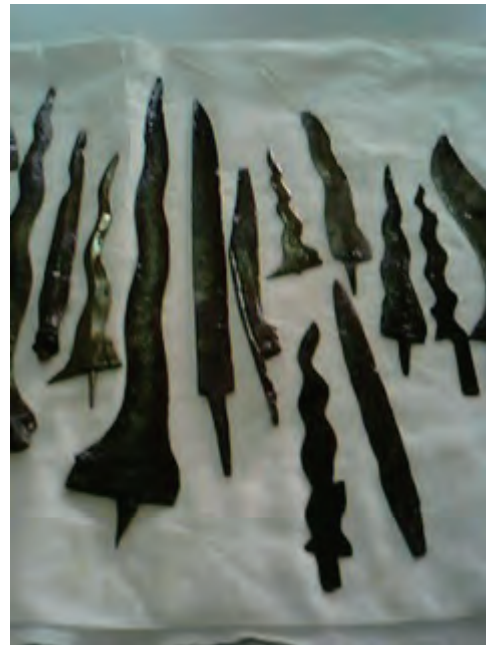
The daggers, before and after conservation

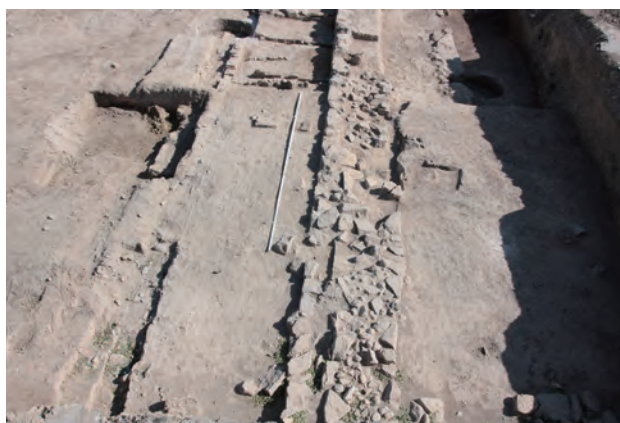
Territory of Shakhristan, the ancient city of Taraz. Possible Madrassah: stone wall

The outer wall is composed of 3-4 rows of granite stones and has a width of 1.3-1.9 m. The height of the stone wall is 0.4 m. The stone wall consists of large flat processed flagstones. Based on the thickness, it can be assumed that the wall also performed a defensive function. The internal longitudinal wall of the construction is located at a distance of 2.5 m to the west from the first wall. The wall is built of burnt, laid flat bricks with sizes of 26 x 15 x 3 cm to 30 x 15 x 5 cm. These two longitudinal walls are divided with clutches of stones and form a long structure with four cell-type rooms. Room number 1 - 3.1 x 3 m, has a subsquare shape. The northern edge is clean. In the southwestern part of the room there is no brickwork. Room number 2 - 2.1 x 2.5 m has a subrectangular shape, the long side being oriented east-west. Room number 3 - 2 x 2.5 m has a subrectangular shape, the long side being oriented east-west. Room number 4 - 2.07 x 2.5 m is similar to the previous ones. These rooms are possibly part of a larger complex. In total, these rooms occupy half of the two main 9.2 m longitudinal walls and are located in the northern part of the structure. The remaining southern part of the structure is free from settlements.

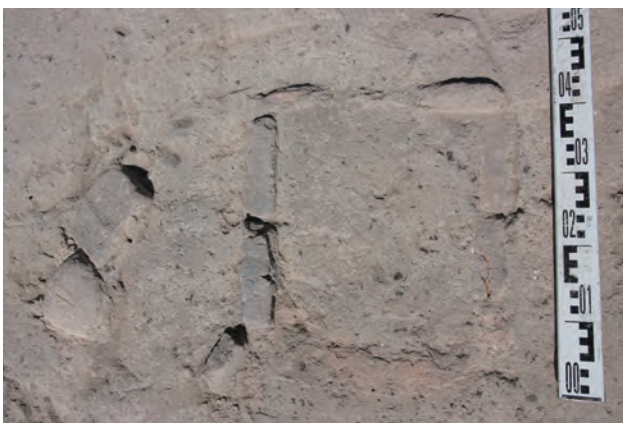
Territory of Shakhristan, the ancient city of Taraz. Possible Madrassah: fireplace

At a distance of 9.5 m to the west, there is a similar structure with five rooms. The outer wall of this structure is also built of worked stones, and the width of the walls range from 1.4 m to 1.6 m. The inner longitudinal wall is built of burnt bricks, the dimensions of which are 30 x 15 x 4 m. The rooms are separated by one layer of masonry work and numbered from the northern edge. Room number 1 - 3.1 x 3.1 m, has a subsquare shape; room number 2 - 2.4 x 3 m, has a subrectangular shape, the long side being oriented east to west; room number 3 - 4 x 3 m, is of subrectangular shape, the long axis being oriented north-south; room number 4 - 2.6x2.8m, has a subrectangular shape and is oriented east-west. Closer to the eastern part of this room (possibly near the exit) in the middle, there is a fireplace built of vertically embedded bricks extending 5 cm above

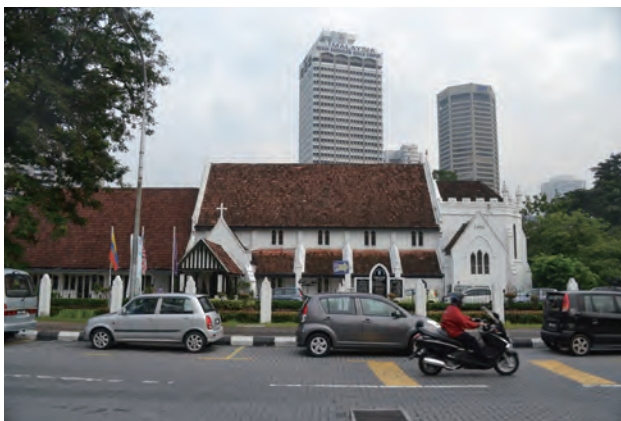
Services held at St. Mary's Cathedral were often interrupted by the sound of heavy traffic and loud music coming from the nearby Dataran Merdeka festivities

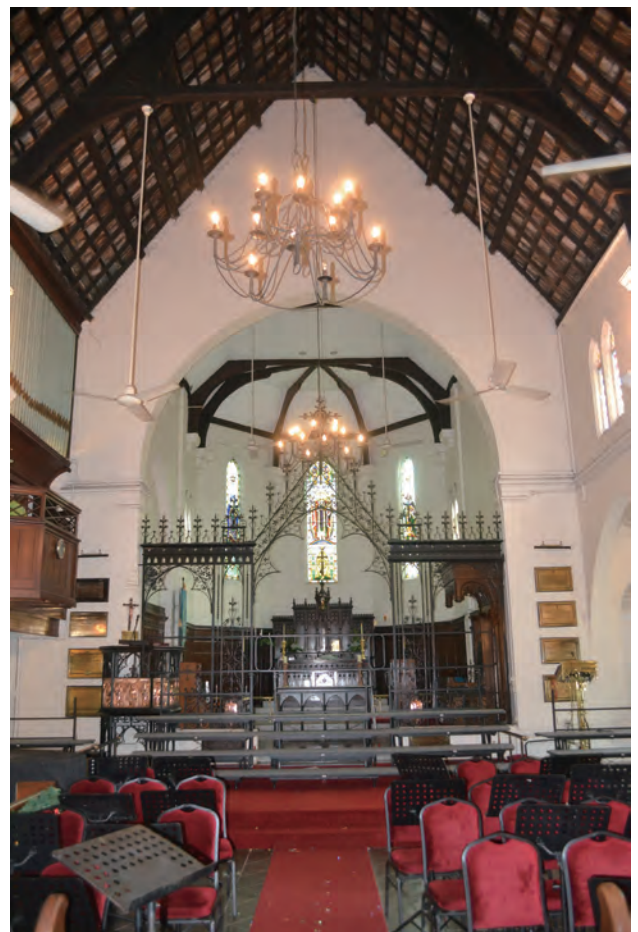
The interior of the main hall before conservation, with Marseille roof tiles and timber battens able to be seen from inside

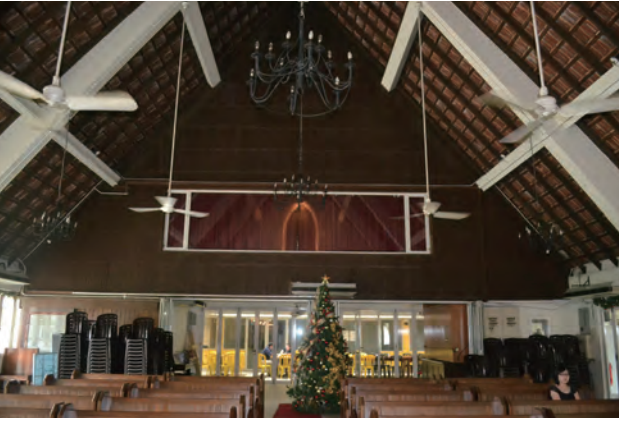
The interior of Jubilee Hall before conservation

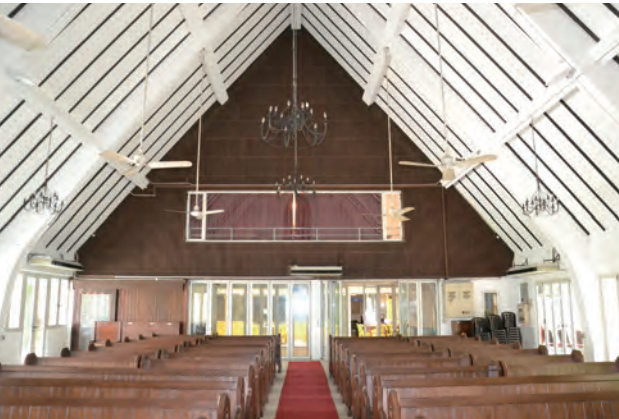
The interior of Jubilee Hall after conservation

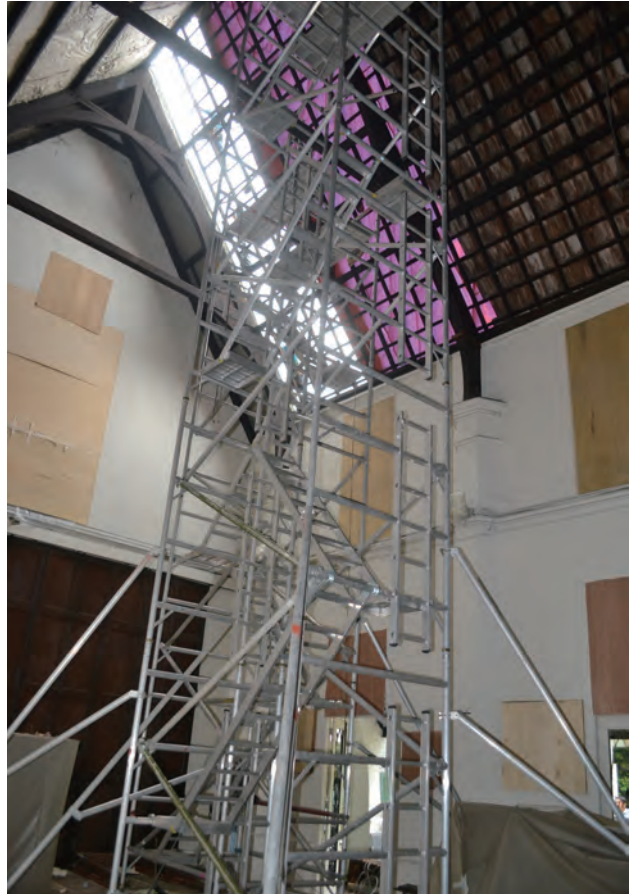
Mobile temporary scaffolding was set up inside the main hall to provide a strong working platform for installing a layer of acoustic treatment on the ceiling and for changing the rotten timber batten on the roof

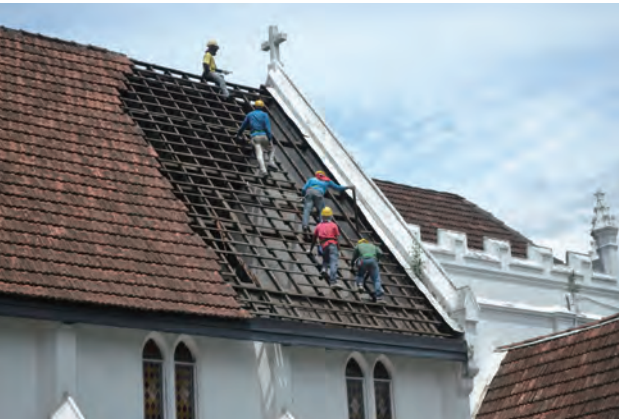
Existing Marseille roof tiles were carefully removed in batches, brought down and cleaned at site before they were re-installed on the roofs

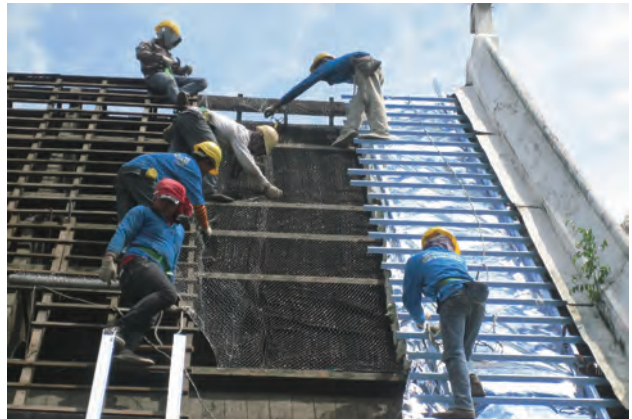
For energy efficiency and noise reduction, the roof structures were insulated with wire netting, rock wool and aluminum foil

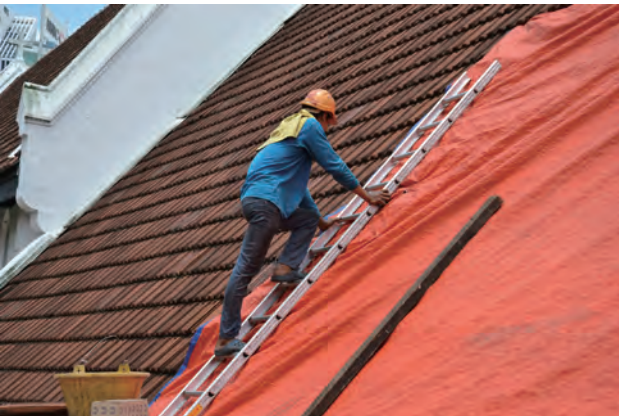
Waterproof plastic sheet covers were used to protect the exposed roof structures during rainy days

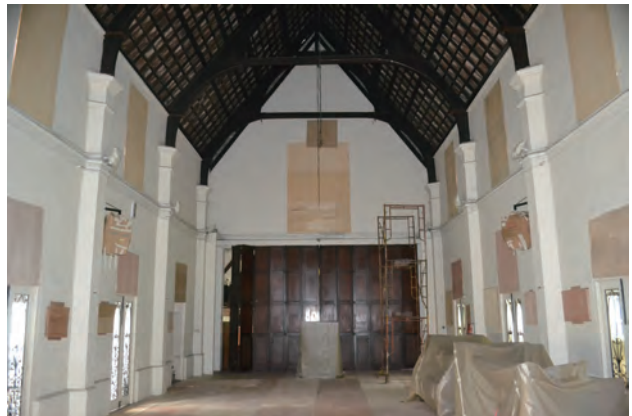
Prior to the conservation works, all furniture and electrical fixtures in the main hall were removed, the organ and pulpit were covered with plastic sheets and the interior floors were protected with plywood sheets to prevent any damage during construction

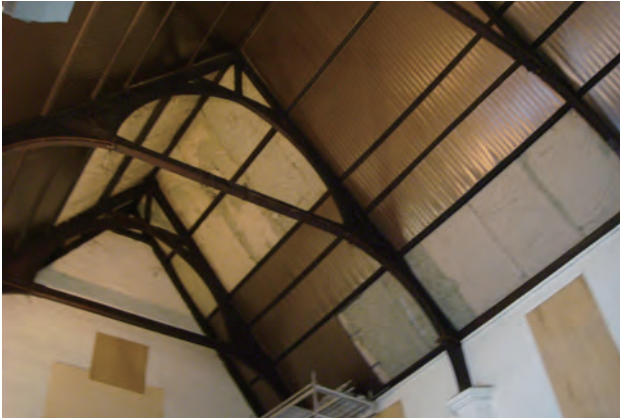
The installation of an acoustic control layer and metal strips linear ceiling at the main hall during construction

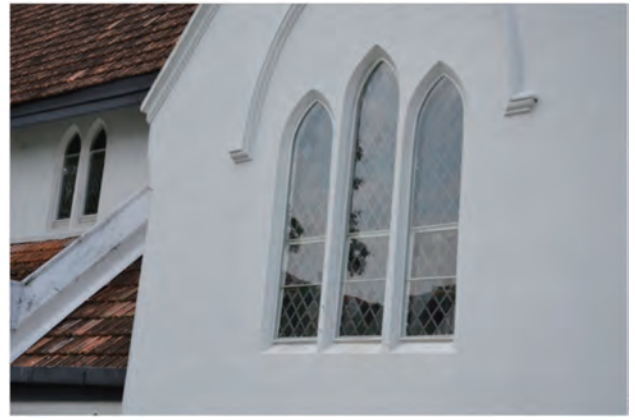
All stained glass lancet windows were fitted with an additional glass panel in order to minimise noise disturbances

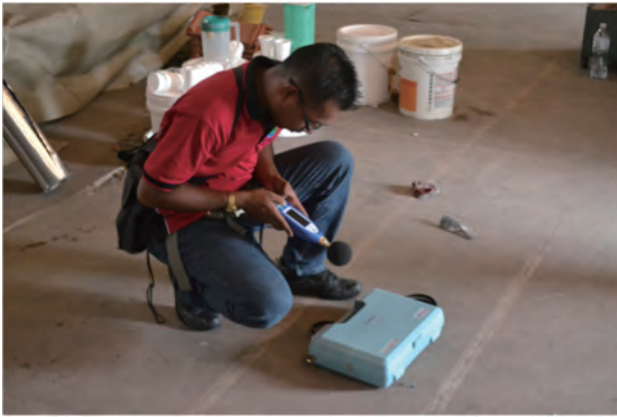
Several noise level experiments were carried out by experts at St. Mary's Cathedral in order to determine the noise level caused by the activities at the nearby Dataran Merdeka, and to gauge the effectiveness of the acoustic treatment

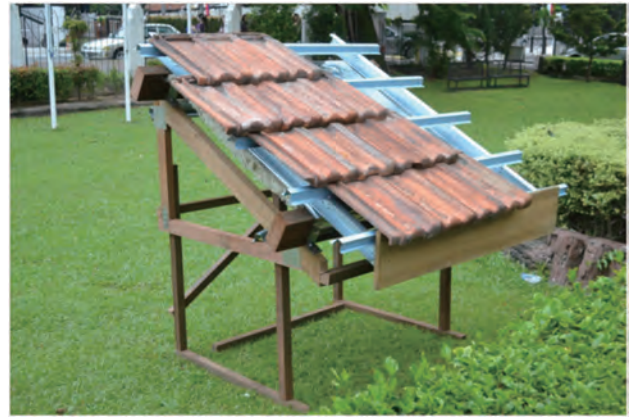
A roof mockup insulated with wire netting, rock wool and aluminum foil was set up at site for technical references

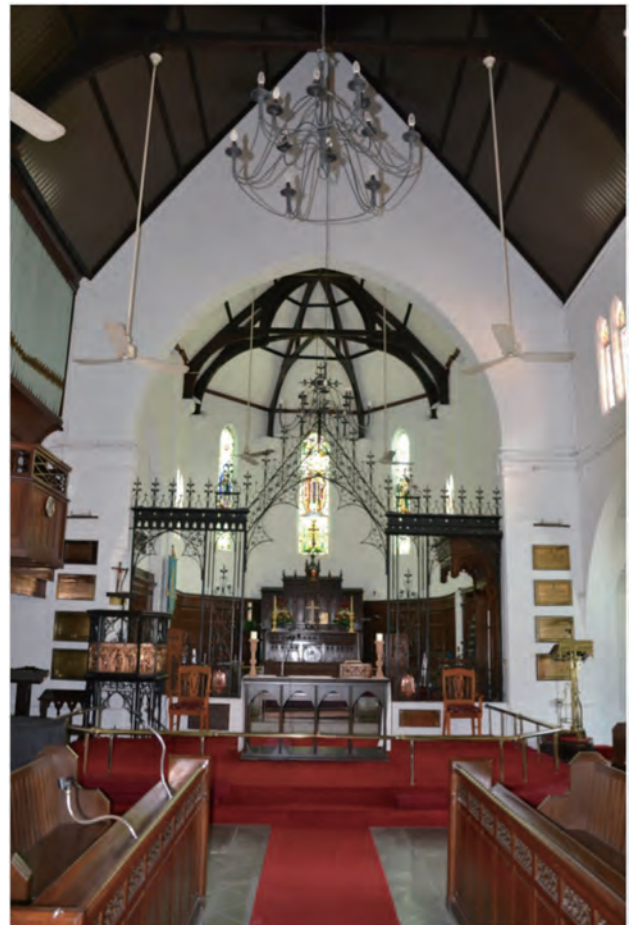
The interior of the main hall after conservation with the new acoustic control layer and metal strips linear ceiling

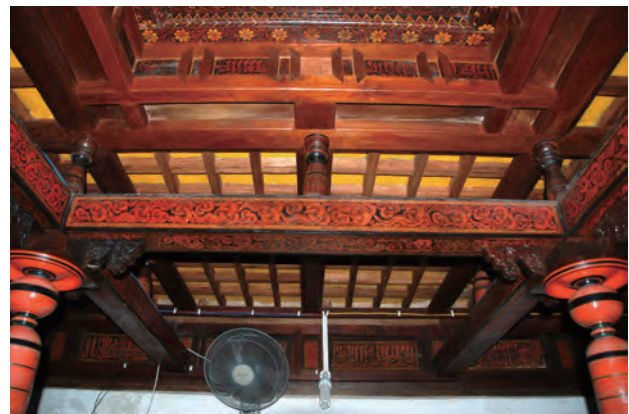
Interior of the Mosque showing the lacquer work

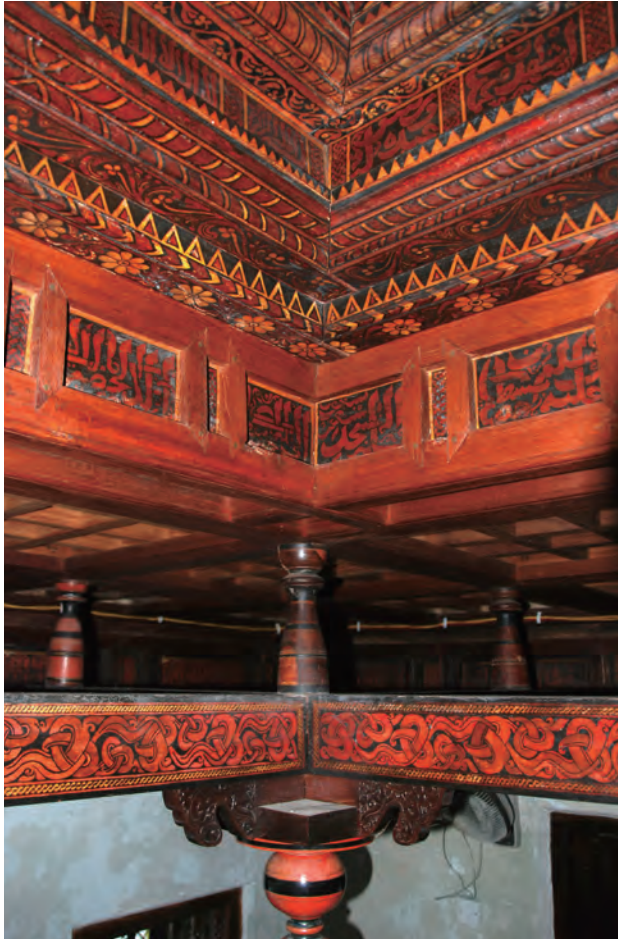
Interior of the mosque showing lacquer work with geometrical designs and Arabic calligraphy

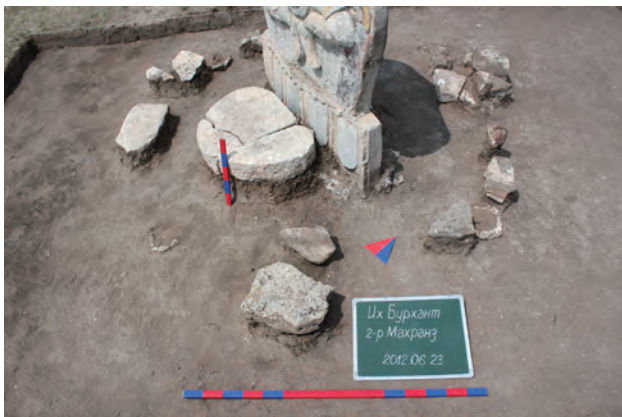
Fig. 8. The site IB.VIIIA. From the south

Only the pedestal of site IB.VIIIA has been broken into three pieces (Fig. 8).

western side of the fence, and at a level 10 cm above the floor of the excavation site. Its dimensions are 59 x 34 cm and 7 cm thick, and it is oriented to 300° azimuth (Fig. 8).

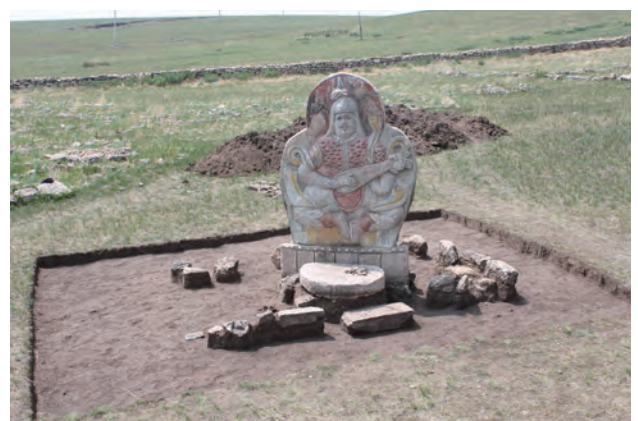
Fig. 11. The site IB.VIIID. From the east

The IB.VIIID entrance stone, one of the fence stones on the eastern side, is located to the east of the stone pedestal. It was at a depth of 16 cm below the ground surface, 10 cm below the pedestal and 2 cm above the floor of the excavation site, the lowest level of the stones of the structure. Its surface is rectangular. Its dimensions are 73 X 32 cm and 17 cm thick. The distance between this stone and the eastern wall of the site is 100 cm (Figs. 11, 12 and 14).

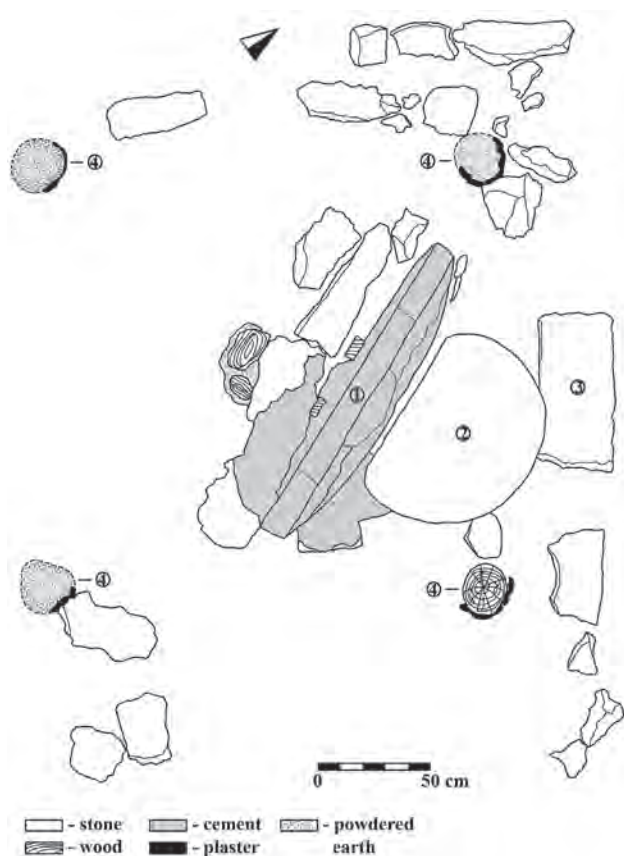
Fig. 12. Plan of the IB.VIII D structure: 1 - Maharaja sculpture; 2 - Stone pedestal; 3 - Entrance stone; 4 - Column remains

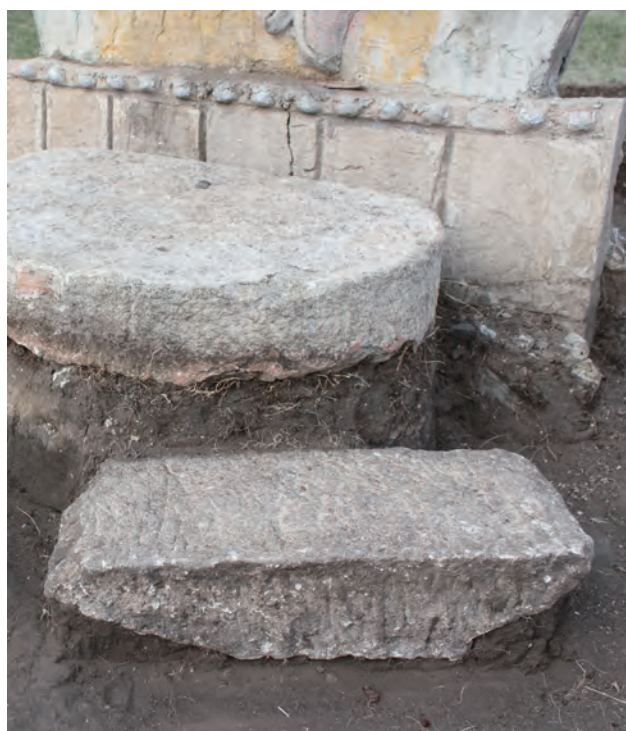
Fig. 14. Entrance stone of the IB.VIII D structure. From the east

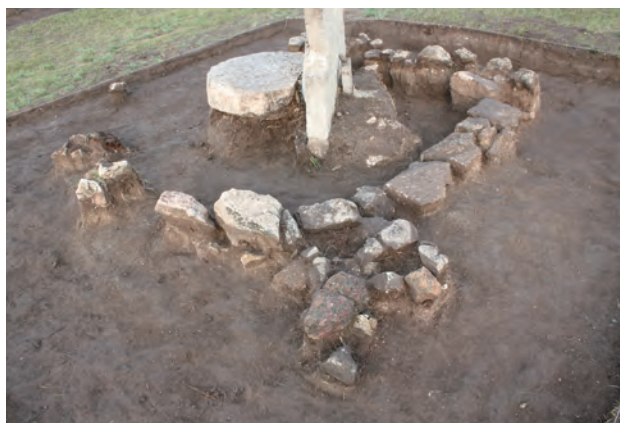
Fig. 13. Stone fence of the IB.VIII B structure. From the southeast

Here, the four structures, oriented in the same direction as the complex, have been symmetrically placed in a rectangular site. A rectangular fence made of stones was around each of the structures. Its longer axis coincides with that of the complex. In some parts of the fence, the stones were in two rows. There is a main road between the structures and it goes from the entrance area of the complex to Ikh Burkhan. Each of the structures had an entrance facing the main road, which had a stone slab. No remains of a special rammed-earth floor were found inside the structure. In the four corners of the stone fence, red-painted wooden columns had been erected on the cylinder-shaped plaster bases. There was also a wooden column (columns) at the center of the structure. Perhaps the structure had wooden walls and a tiled roof. The iron nails found at the site might have been used for such wooden structural elements as columns, walls and the framework of the roof.

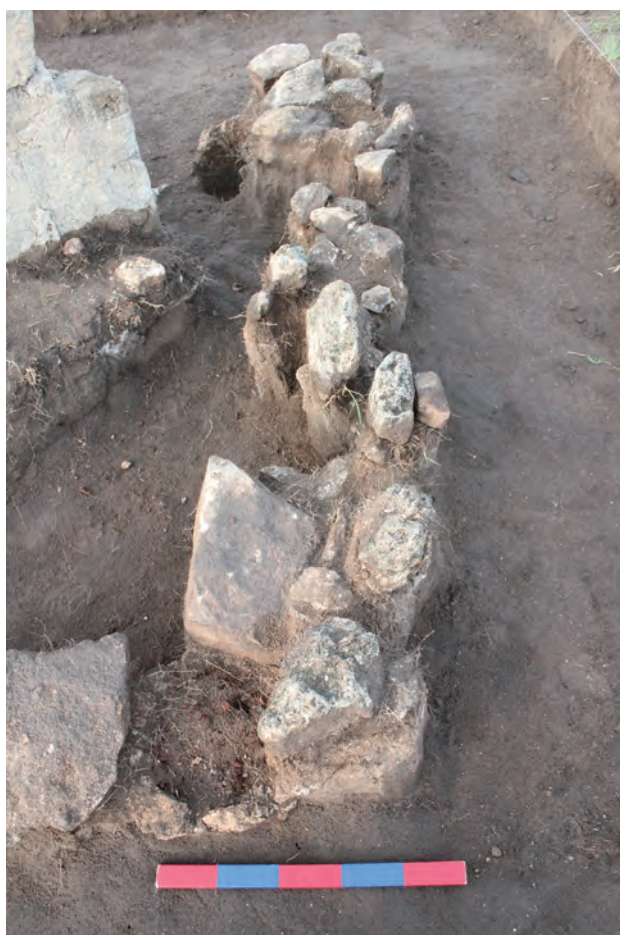
Fig. 15. Column remains in the northeast corner of the IB.VIII B structure. From the east

- Base and bottom of the wooden column (Fig. 15 and 16);
- Base and small fragments of the bottom of the column;
- Base (Figs. 17, 18 and 19);
- Bottom of the wooden column;
- Small fragments of the bottom of the column;
- Hole.

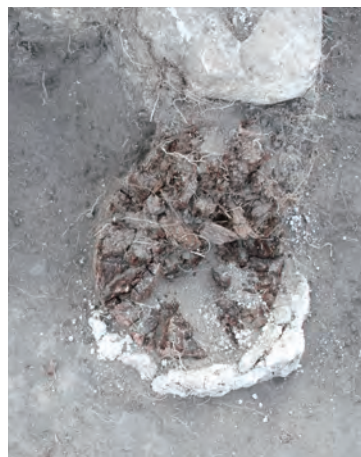
Fig. 16. Column remains in the southeast corner of the IB.VIII B structure. From the south

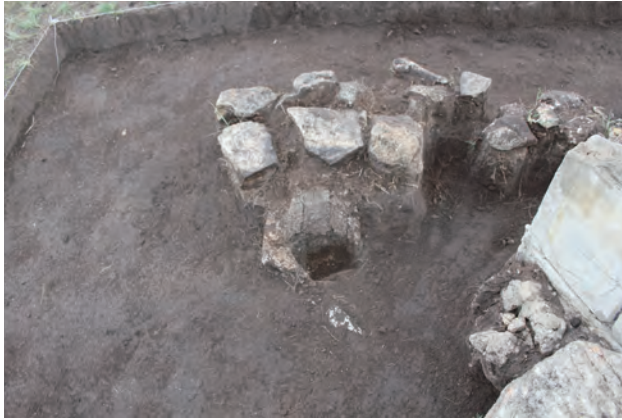
Fig. 17. Column remains in the northwest corner of the IB.VIII B structure. From the south

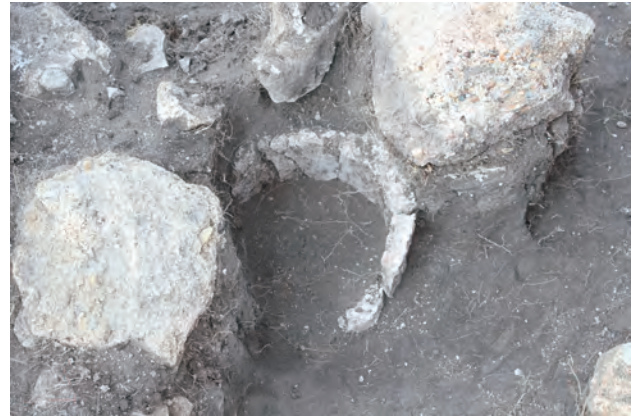
Fig. 18. Column remains in the northeast corner of the IB.VIII D structure. From the west

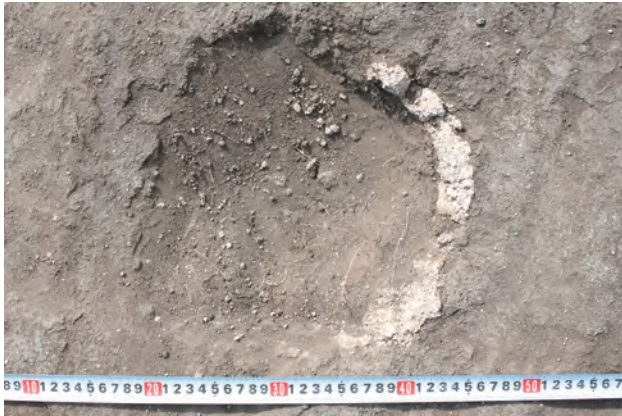
Fig. 19. Column remains in the northwest corner of the IB.VIII D structure. From the south

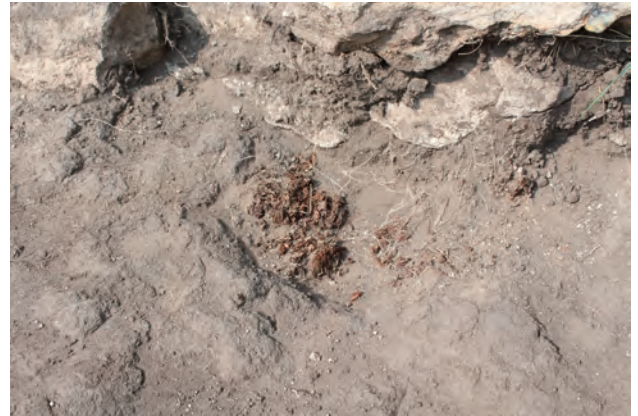
Fig. 20. Column remains at the center of the IB.VIII D structure. From the west

Central column(s). We also found evidence indicating that these wooden columns was not only in the corners, but also at the center of the structure. Two oval-shaped bottoms of wooden columns were in a powdered earthen spot of 37 X 21 cm in IB.VIIID. The distance between the bottoms was 7 cm. The larger, northern bottom was 16 cm in diameter. The smaller one was 12-13 cm in diameter. (Figs. 12 and 20)

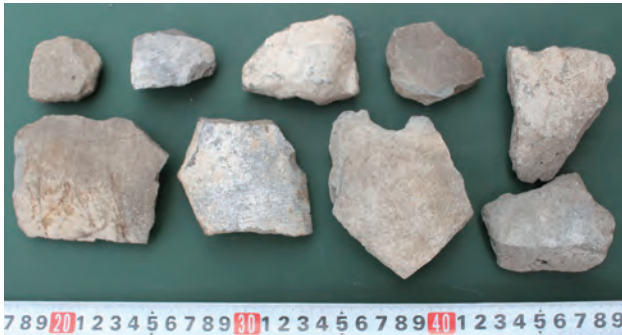
Fig. 21. Pieces of roof tile from the IB.VIII A structure

Building materials Very few pieces of roof tile were found in three structures. The roof tile pieces were 1.7-2.3 cm thick and they had the same features as the roof tiles from other buildings in the complex. Perhaps they had been removed from the ruins of the other buildings, as all were located in the upper part of the site. If the structures had had tiled roofs, more pieces of roof tile would have been found. Although this is doubtful because some pieces of roof tile were revealed in IB.VIIIA, at a depth of 10-20 cm below the ground surface. (Fig. 21)

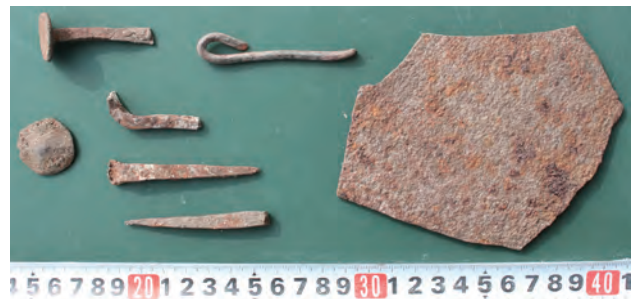
Fig. 22. Iron nails and fragments of domestic metal goods

Four-sided handmade iron nails were uncovered in three structures. Some of them do not have heads. Also a head of a nail was found (Fig. 22). All of these nails were found during the excavation and some of them were at depth of 15-20 cm. The depth and number of nails indicate that these were used for some structural element made of wood originally in the structures. Such nails have also been revealed in the other architectural ruins of the complex.

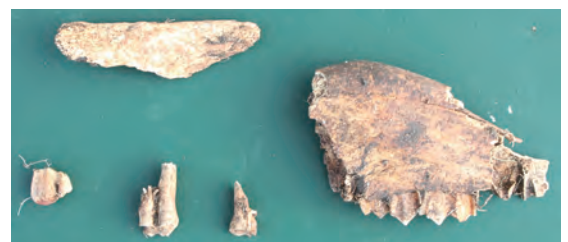
Fig. 26. Small cattle mandible and its teeth from IB.VIII B

Animal bones A few fragments of small cattle bones found by excavation are not traces of sacrifice but accidental remains (Fig. 26/).

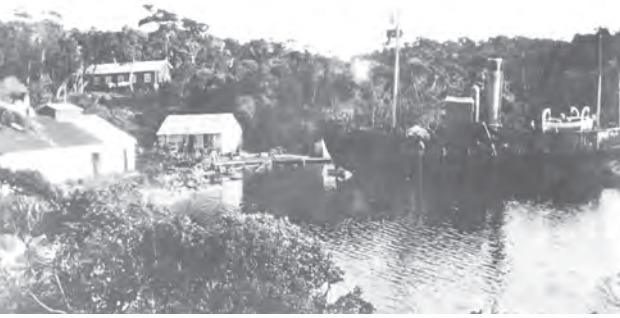
Figure 2. The Base ca. 1926-1932 showing a whale catcher at the start of the slipway at medium tide (Photo: Southland Museum & Art Gallery).

Between 1926 and 1932 the Ross Sea Whaling Company of Sandefjord, Norway established its repair base for whale catcher vessels in Price's Inlet, Rakiura (Figures 1 to 8). The Ross Sea Whaling Company named their shipyard 'Kaipipi Shipyard' but it is also known as 'The Base', 'Price's' or 'The Whalers' Base' (Watt 2006:3). Watt (2006:3) notes that the purpose of the facility was to maintain and repair whale catchers during the southern winter while the factory ships returned to Europe with the whale oil taken during the hunting season from November to February. The fifteen Star whale catchers were repaired at various times at the yard as well as other catchers such as the Karrakatta. The yard consisted of a slipway, workshop (including a forge), cookhouse, carpenters' shop, bunkhouse, winch house, a tin hut and the Othello Wharf, which was a wharf made from the hulk of the 1853 whaler the Othello (the hulk was fixed, not floating). The buildings were weatherboard and built on concrete foundations (pads, footings or piles) with the manager's house and bunkhouse being kitset buildings brought from Norway (these buildings still survive in Oban today). The Base was used for basic maintenance and repairs of the catcher boats as it did not have a foundry to undertake any larger repairs, this being carried out at Port Chalmers near Dunedin (Watt 2006:3).

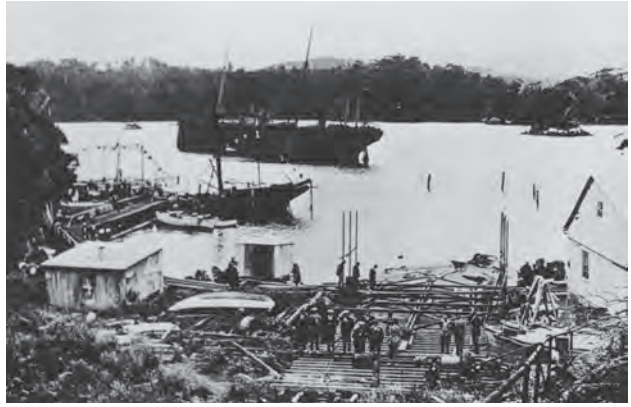
Figure 3. The Base ca. 1926-1932 showing the whale catcher repair slipway (centre) and the Othello Wharf (far left) (Photo: Southland Museum & Art Gallery).

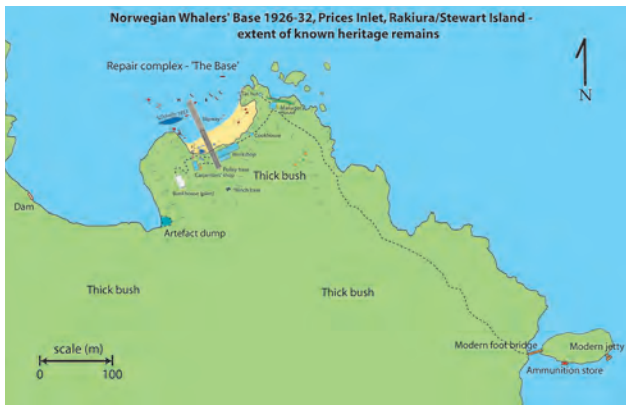
Figure 9. Extent of the Norwegian Whalers' Base as mapped for the declaration
(Graphic: Dr Matthew Schmidt).

In February 2014, a proposal was presented to the Board of the New Zealand Historic Places Trust to have the 1926-1932 Norwegian Whalers’ Base declared an archaeological site. This proposal contained a detailed archaeological assessment of The Base (Figures 9 & 10), the proposed extent of the protection to include all the known terrestrial and marine heritage related to The Base (Figure 11), and support from the landowner and the councils that manage the land and marine area on which the site lies.

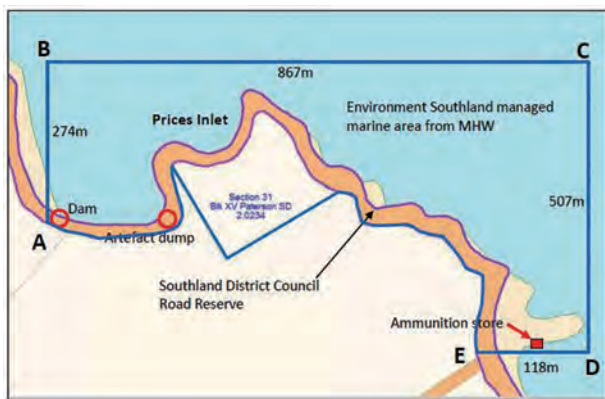
Figure 11. The extent of the declaration area showing the terrestrial and marine boundaries. All terrestrial and marine aspects of the site are now protected as an archaeological site
(Graphic: Dr Matthew Schmidt).

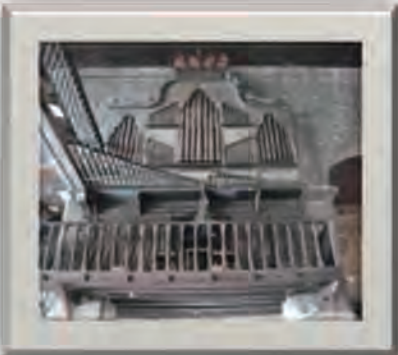
<p>3</p>

<p>Location: Parish of St. Joseph, Las Piñas City Diocese of Paranaque</p> <hr/> <p>The Las Piñas Bamboo Organ, a church component, was declared as NCT on November 24, 2003 built by Padre Diego Cera, Augustinian Recollect Priest from Graus, Spain. He started constructing the organ in 1816 and completed it in 1824 with the installation of the Horizontal Trumpets. Restored in 1973 by Johannes Klais Orgelbau in Bonn, Germany. Major overhaul and re-leathering in 2004 by the Diego Cera Organbuilders. The organ was restored in 1775 and 2004.</p>

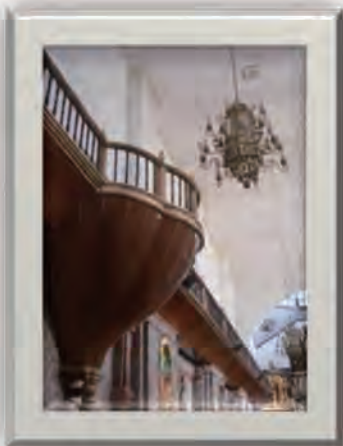
5

Location: Parish Church of San Gregorio Magno
Diocese of San Pablo
Declared National Cultural Treasure
on July 31, 2001

Of the entire organ, only the "swallow nest" on which the organ was erected, has survived.

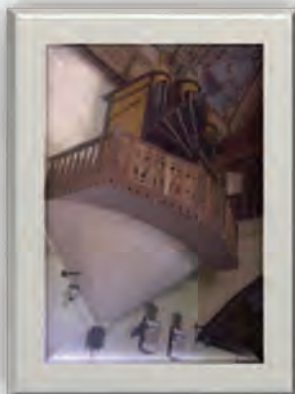
6

Location: Argao
Archdiocesan Shrine of St. Michael
Archdiocese of Cebu

The organ has a complete technical description done by Hans Gerd Klais, in 1978, a study published in "Acta Organologica" (1979) Band 13, when the organ was still playable. It was built when Diego Cera was appointed prior in Baclayon (1815), and has remarkable similarities with the organs in Baclayon, Loboc, Loay

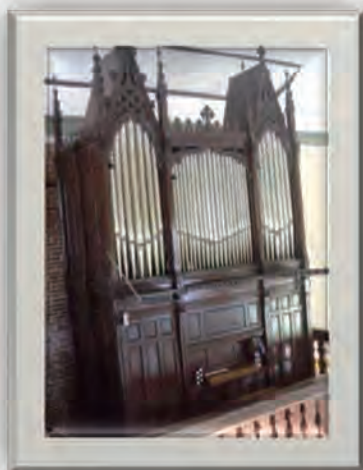
9

Location: Bacong
Parish Church of San Agustin
Diocese of Dumaguete
Declared NCT on July 31, 2001

The organ was built (imported) by the famous Casa Roques Hermanos of Zaragoza, in 1894. It is similar to Jimenez and Bacong. It is different from organs built earlier since the keyboard is NOT divided. Stylistically, it is a modest-size Spanish Romantic organ. (a movement against old-fashioned style was going on, also in music). Restored in 2009.

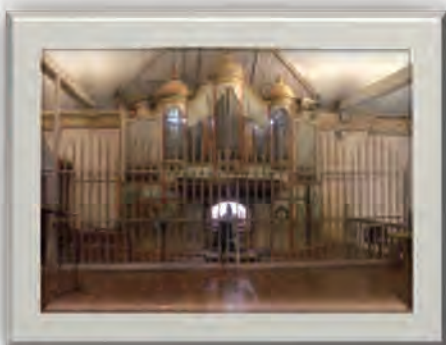
10

Location: Baclayon
Inmaculada Conception Parish Church
Diocese of Tagbilaran
Declared NCT on December 7, 2010

Fr. Diego Cera was prior vocal in this place in 1815 and 1821. It is without any doubt built under his guidance. Unusual is that the organ has two manuals (the other exception is San Agustin in Intramuros). This manual was removed in 1930, and rediscovered by organ builder Cealwyn Tagle while the restoration was going on in 2008.

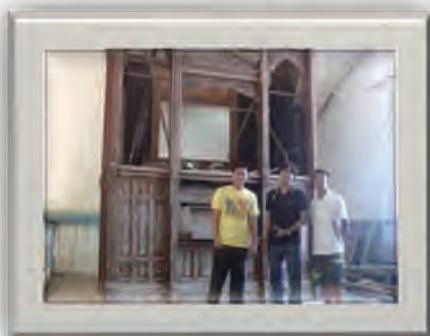
12

Location: Dimiao
San Nicolas de Tolentino Parish Church Complex
Diocese of Tagbilaran
Building declared NCT on June 28, 2011

This organ belongs to the "Diego Cera School", which includes Baclayon, Loay, Loboc, Loon and Argao.

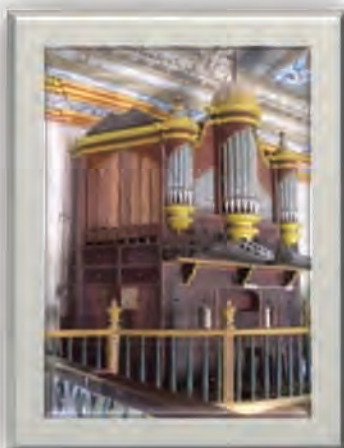
13

Location: Garcia Hernandez
St. John the Baptist Church C.A. 1898
Diocese of Tagbilaran
Declared ICP Category III on September 27, 2013

This organ is built (imported) by the Casa Roques Hermanos, like Bacong and Jimenez. Lost are the organs in Miagao (Jaro), Hinigaran (Bacolod), Duero (Tagbilaran) and Dumaguete, built by the same company.

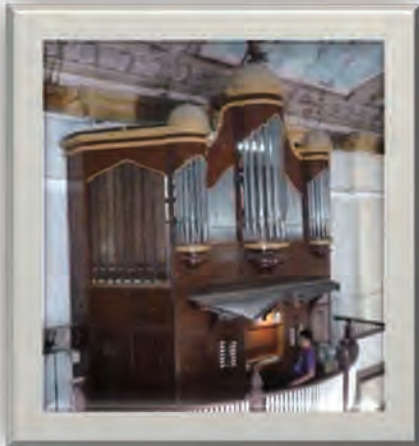
14

Location: Loay
Parish of the Holy Trinity
Diocese of Tagbilaran
Declared NCT on October 22, 2013

The organ was installed in 1841, according to an inscription on the note desk. It is built in the style of the "Diego Cera School". The restorers in 1999 could only recover 60% of the mechanical parts. All the pipe had disappeared. They had been used to make weights for fishing nets. The organ "survived" the earthquake of October 2013, but needs to be protected from the elements while waiting general overhaul.

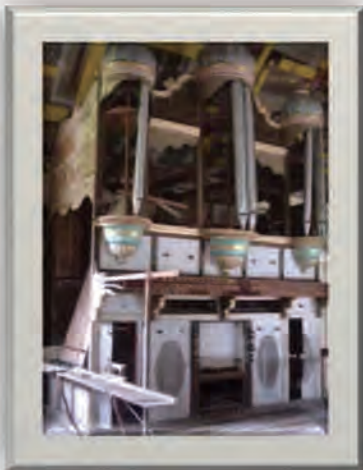
15

Location: Loboc
Parish of San Pedro and San Pablo
Diocese of Tagbilaran
Declared NCT on July 31, 2001

The organ has been built during the first half of the 19th century. It is very similar to the organs of Dimiao and Loay. The town has a very active musical life. The organ can collapse any time, since it is hanging on the wall which has several cracks. The organ will have to be removed temporarily whatever the future plans will be. Restored in 2003.

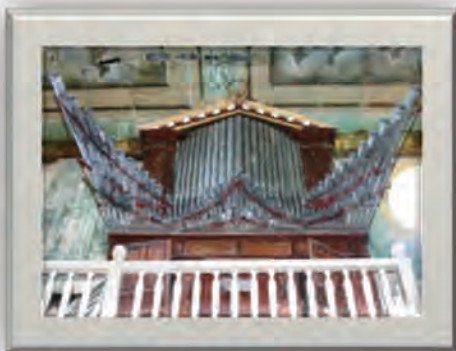
16

Location: Loon
Nuestra Sra de la Luz Parish Church Complex
Legal owner: Diocese of Tagbilaran
Declared NCT on December 6, 2010

This was the most important organ in Bohol, based on the number of "trumpets", the same number as San Agustin in Intramuros. Loon had a choir school (the building was removed to widen the patio) and was in continuous competition with Loboc. It belongs to the "Diego Cera School." The organ was buried under the rubble of the church which collapsed completely. Wooden parts can still be recovered.

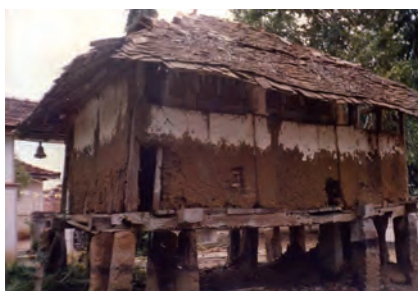
(Fig 1) Wattle and daub building, 19th century AD

It is believed that wattle and daube walls were used before the advent of bricks. (Fig 1) (Fig 2)
