ACCU Nara
International Correspondent

Vol.14 2015

The Fourteenth Regular Report

ACCU Nara International Correspondent

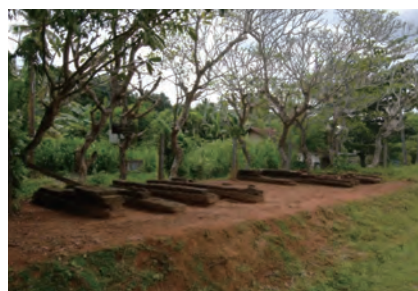
(Fig 2) Ancient brick kiln, 12th century AD

The hard clay layer situated about 10 ft. below the surface is excavated and brought to the surface to be beaten with a mallet into small pieces. These pieces of clay are heaped and treated with water until the required consistency is reached. The mixed clay is made into smaller lumps and put aside for about a week to season. The lumps are then pressed into wooden moulds. The moulds are turned upside down to eject the lumps, now in the shape of bricks. They are then sun dried for about a week. The bricks are placed in a kiln and fired for two days. To avoid cracks appearing in the fired bricks, a small quantity of sand is added to the clay mix. Early man made stronger bricks by increasing the proportion of sand to be added to the clay.

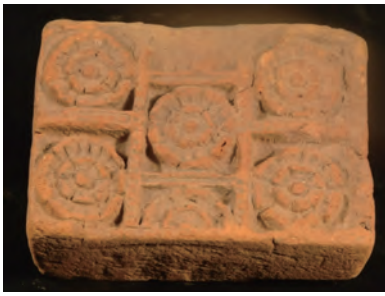
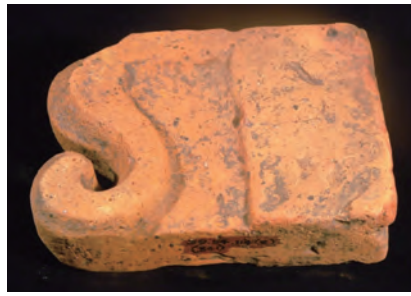
(Fig 5) Artistic bricks

(Fig 6) Artistic bricks

Brahmi script markings were indented in bricks to identify the craftsman or to indicate the grade of his skill (Fig 5) (Fig 6)

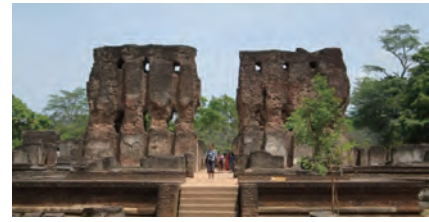
(Fig 7) King's Palace, Polonnaruwa, 12th century AD

The brick wall is strengthened by the thin layer of mortar to bond the bricks. The thick plaster makes the brick wall waterproof. The exterior view of the wall shows the bricks placed one against the other such that the surface is flush while the inner view shows that the bricks are laid with plaster-filled masonry joints. (Fig 7)

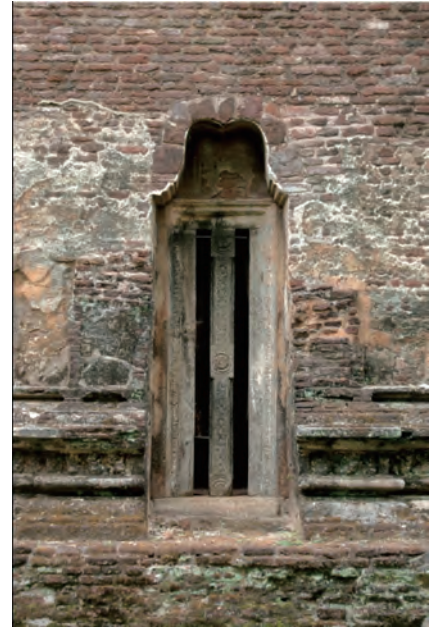
(Fig 10) Lankatilaka Image House, Polonnaruwa, 12th century AD

Leaving several corbels inside the two vertical brick walls and spanning the space by placing bricks on it in a circular manner. (Fig 10)

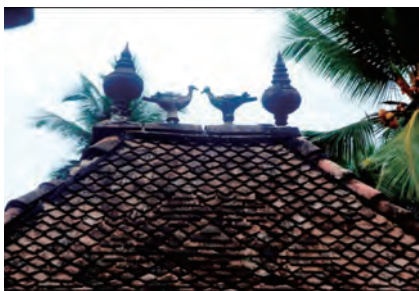
(Fig 17) Tiles in different shapes and sizes

A hitch was fixed under each tile to prevent the tiles from sliding down. Some tiles had holes for nails to fit in. The cut creases on the top surfaces of the tiles helped the water to drain. (Fig 16) (Fig 17)

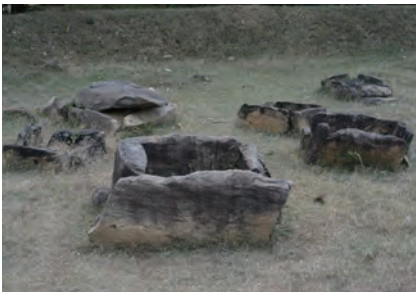
(Fig 20) Megalithic tombs at Ibbankatuwa

Stones not harmed with tools were used in the construction of the megalithic tombs of Ibbankatuwa. (Fig 20)

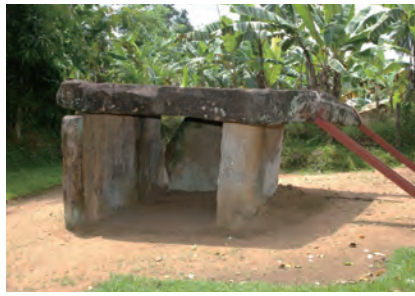
(Fig 21) Cromlech at Padavi Gampola

Even the Padavi Gampola cromlech is a creation made of stone. (Fig 21)

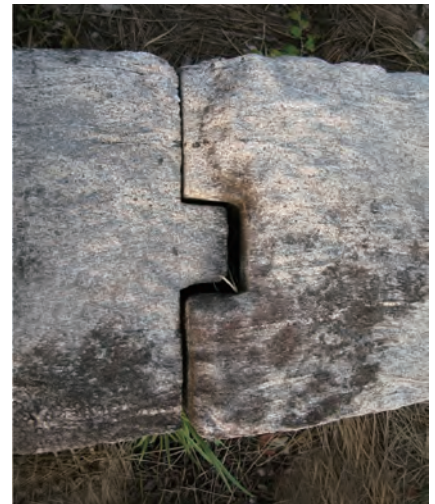
(Fig 25) Rambakan Oya, Anuradhpura period

twin ponds (Kuttam Pokuna) were held together for stability by the use of stone pegs. (Fig 24) (Fig 25)

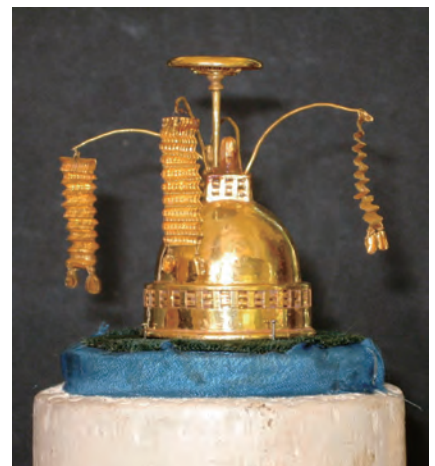
(Fig 31) Model of a stupa found in Deliwala

This model of a stupa belonging to the earliest period of stupa construction has been discovered in Deliwala stupa. (Fig 31)

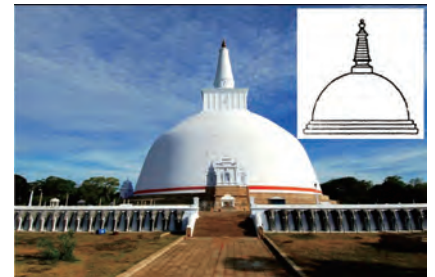
(Fig 34) Bubble shape

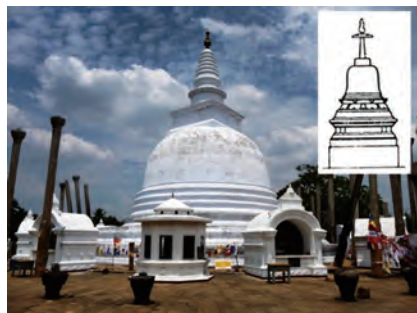
(Fig 32) Bell shape

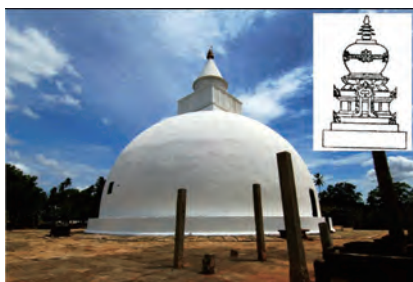
(Fig 33) Pot shape

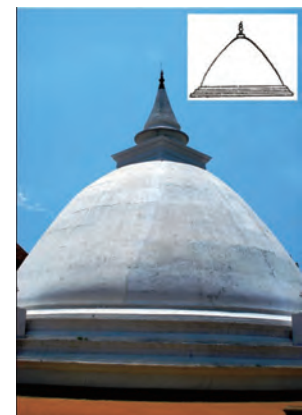
(Fig 35) Paddy heap shape

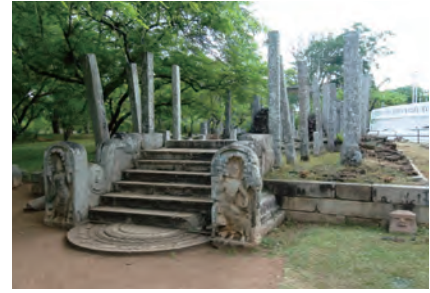
(Fig 41) Near Thuparama, Anuradhapura period

When image worship increased, image houses with inner verandahs of greater magnitude were constructed. (Fig 41)

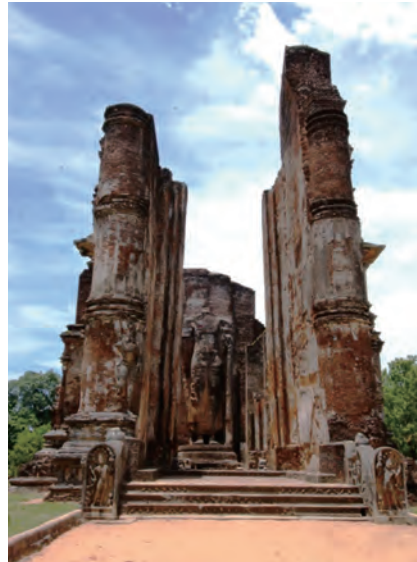
(Fig 42) Lankatilaka image house, Polonnaruwa

During the Polonnaruwa period, image houses of enormous size were built. (Fig 42)

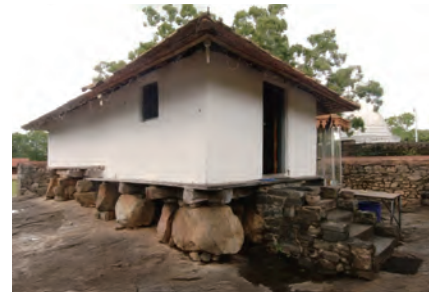
(Fig 43) Tampita Vihara at Kolambagama

In the medieval era with the population shift towards the Kandyan Kingdom (Central Part of the country) the Image houses which are smaller than the aforesaid, known as Tampita Vihara (Temple on Stone, Temple on pillars) were constructed. Wood was the main material used in its construction. (Fig 43) (Fig 44a) (Fig 44b)

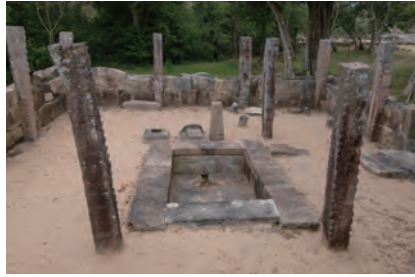
(Fig 49 Arankele, 9th century AD)

Jhanthagara (Bathing House) is another essential item in a temple complex. In this special building, steam was used to augment sweating to induce invigoration and the protection of one’s health. (Fig 49)

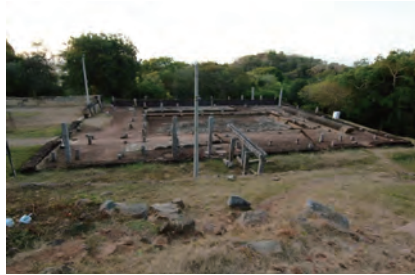
(Fig 50) Kiralagala, Anuradhapura period

In the middle of a Jhanthagara a rock strewn shallow area for bathing, a place to heat water, a place to prepare medicine or anointing liquids and a sewerage system were usually provided. (Fig 50)

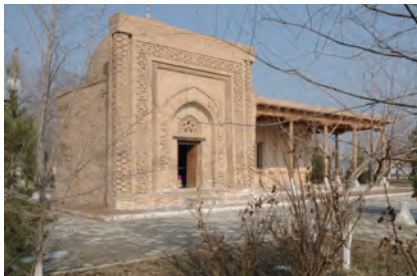
The Mir Sayid Bakhrom is located in Navoi province and was established in the 10th to 11th centuries. The building is a square domed structure of brick, with a decorated portal on the southern side. The history of the construction of the mausoleum is not well known. The name of Mir Said is mentioned in the work of Abu Takhirudja Samarqandy "Samaria," which, along with the absence of external damage to the mausoleum, points to the importance of this person (Fig. 1).

1. General view of the object Mausoleum Mir Said Bakhrom.

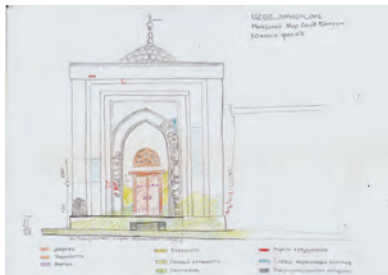
The general condition of the main building is satisfactory; however, on the facades there are definite saline-damaged areas. On both sides of the doorway between the arches with epigraphic inscriptions at a height of 1.9 m, there are regions with high humidity. On the left side of the arch with epigraphic inscriptions, and next to them on the corrugated semipedestal, some bricks are missing. Loss of the brick lining was detected on other portions of the building facade as well (Fig. 3).

3. Drawing of the object with descriptions (mausoleum).

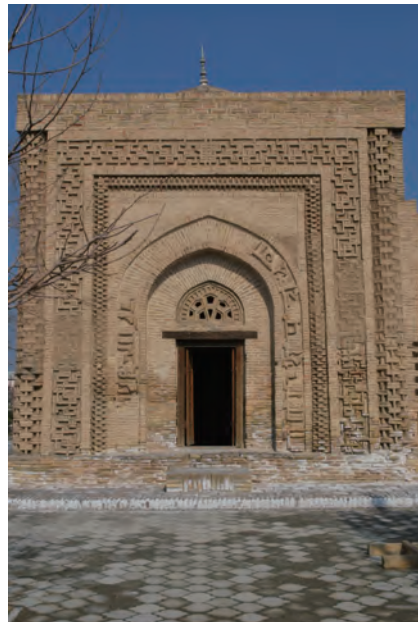
carried out to strengthen the constructed part and most likely, the loss of part of the terracotta decorations (Fig. 2). Condition of conservation of the property: satisfactory state of the object today.

2. Part of the object. Entrance to mausoleum.
