ACCU Nara
International Correspondent

Vol.15 2015

The Fifteenth Regular Report

The ACCU correspondents periodically send reports on cultural heritage protection activities in which they have been recently involved. This is a collection of fourteen reports submitted by international correspondents in the Asia-Pacific region.

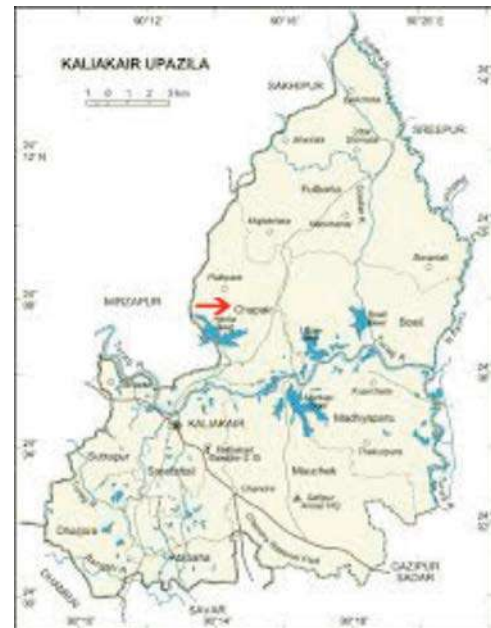
Excavated site: marked in red

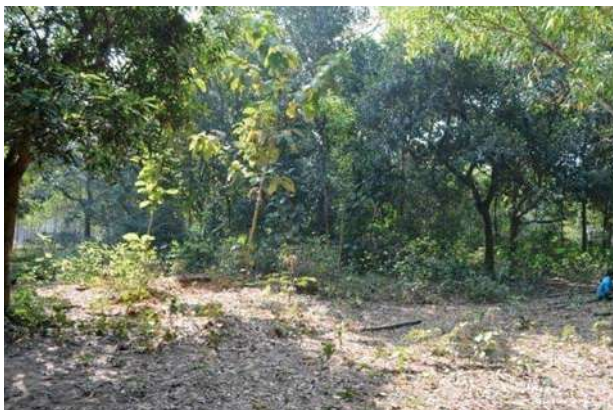
Before clearing

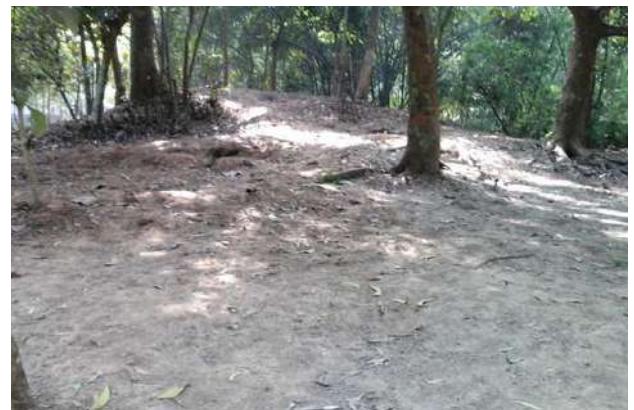
After clearing

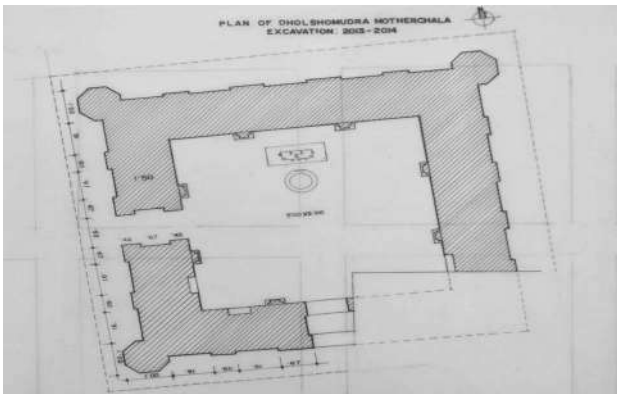
Ground plan of the exposed structure

A short description of the excavation: The excavation was conducted in 12 trenches and the remains of a square ancient building was discovered. The measurement of the exterior side of the ancient structural remains is 8.5 m x 8.5 m and interior side is 5.5 m x 5.3 m, which means that the shape of the architectural remains is square. Every wall is 1.4 m thick. The surviving walls are 35 cm up to 1.3 m. Mostly square-shaped bricks were used in the walls and mostly complete bricks were used in the core filling in the thick walls. Mud mortar was used as a cementing material.

The structural remains had four octagonal turrets in the four corners, but these have almost disappeared, and only a little evidence has survived. Two gateways were found in the middle of the eastern and southern walls. The exterior walls of the building were highly decorated with various shapes and sized ornamental bricks, and the interior walls were decorated with ornamented pilasters. Two stones were found in the floor of the exposed structure.

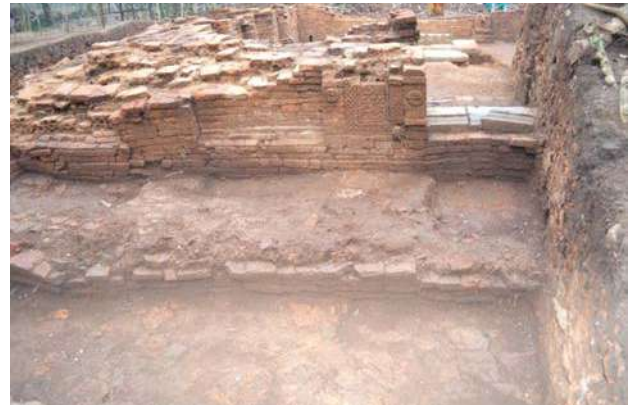
Eastern wall

Eastern wall and gateway: The eastern wall has been exposed horizontally for 5.5 m because of a very big tree standing in the northeast corner of the mound. For this reason the northeast corner has not been excavated. Indeed, a gateway, that is to say the main entrance, has been found in the middle of the eastern wall. The door jamb was made of a black stone which still survives in situ today. Very beautiful ornamentation was on the exterior wall of the eastern wall and turret. But this wall and turret are extensively deteriorated. The corner turret of the southeast corner is octagonal-shaped and its diameter is 1 m.

The eastern door is 94 cm wide but only 90 cm has been revealed. It faces east, and the measurement of the black stone is 90 cm long and 20 cm wide. The middle of the stone is broken with a small hole there for the purpose of closing the door. The main characteristic of these walls is that up to 1 m they are slightly projected and decorated. After that 60 to 68 cm is simply constructed but with two full bloom lotuses engraved on this portion. These features are visible all around the exposed structure.

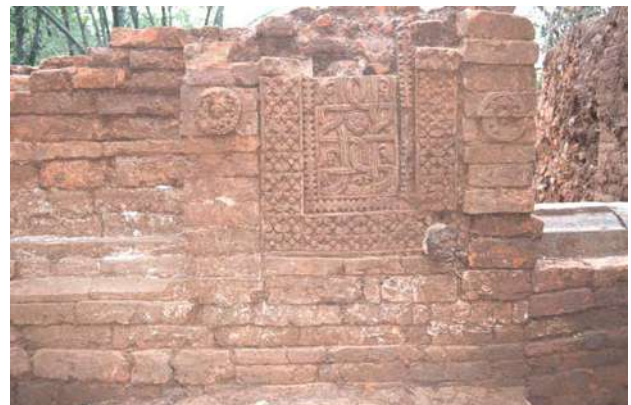
Close up view

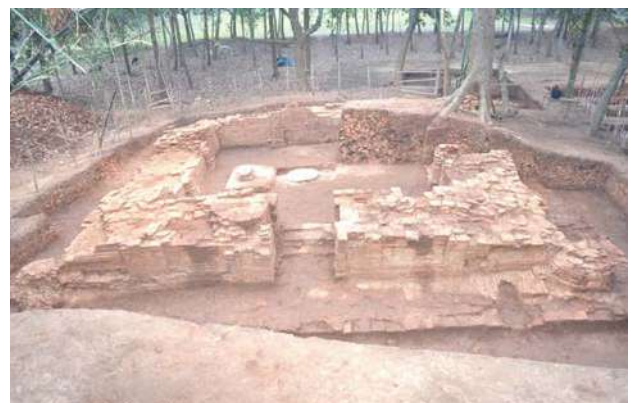
Southern wall: general view

Southern wall and door: The southern wall (8.5 m) has been exposed very carefully. This wall is also 1.4 m thick and the gateway has been installed in the middle. Two sides of the door are highly decorated and covered by ornamental bricks. This wall lasts only 40 cm to 80 cm from floor level. An octagonal turret in the southwest corner was found mostly damaged and destroyed.

On the inner side of this wall two decorated pilasters are visible 36 cm from the door. A water outlet (10 cm long x 5 cm wide) has also been exposed.

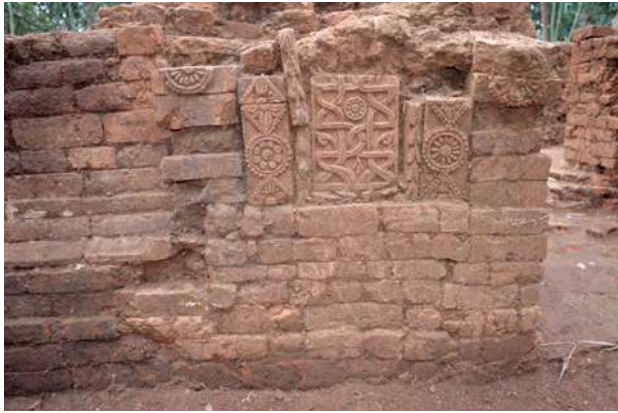
Southern wall: close up view

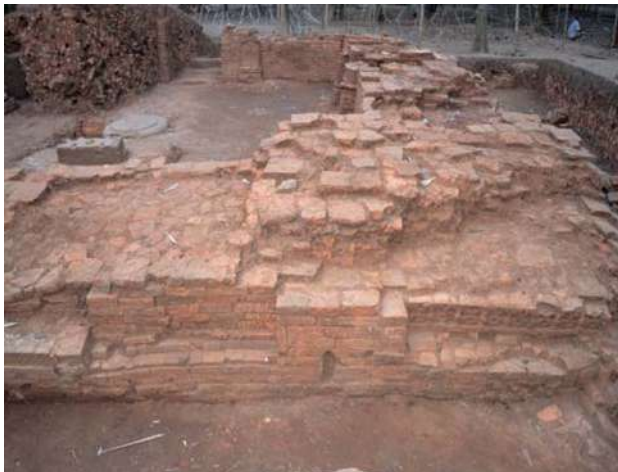
Western wall

Western wall: The unveiled western wall of the structure is decorated with the same techniques and characteristics as that of the southern wall. The wall is also mostly damaged. Only 24 cm to 42 cm of the wall has survived from floor level. Horizontally, 8 m of the wall has been revealed, running north to south. Two water outlets have been exposed. One is in the southwest corner and another is in the northwest corner. On the inner face of this wall there are two pilasters installed at the same distance from the door as per the southern wall and both are highly decorated with ornamental bricks. An octagonal corner turret has been exposed in the northwest corner.

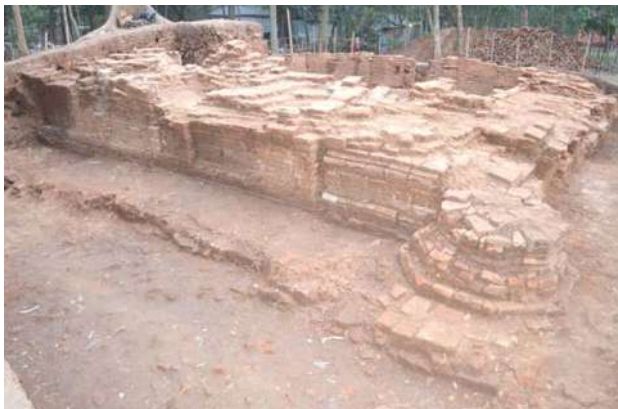
Northern wall: general view

Northern wall: The northern wall has been exposed to a length of 7 m, running from the northwest corner turret to the east. A very large silk cotton tree stands in the northeast corner of the mound. Consequently, this corner has not yet been excavated. The condition of the northern wall

was found to be comparatively better than the others. This wall has been exposed 68 cm to 1.2 m from the floor level of the platform and it is also highly decorated with ornamental bricks.

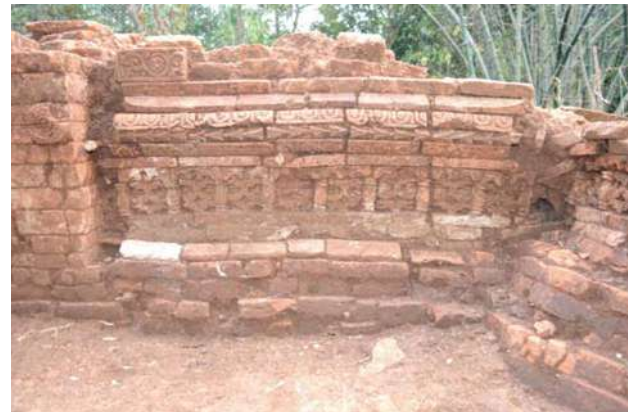
Northern wall: close up view

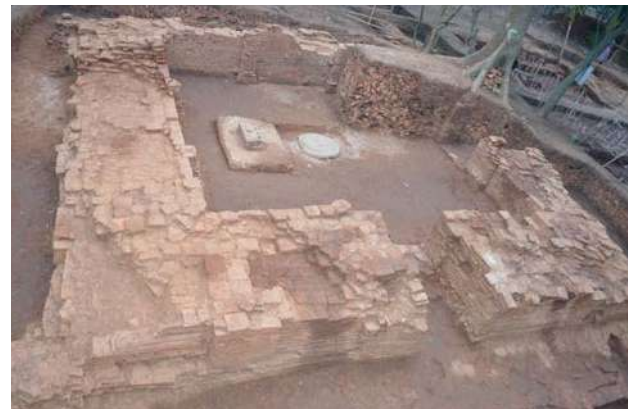
General view of the exposed floor

Preparation of the floor of the exposed structure: The floor of the exposed structure is made of concrete, and the middle of this floor slopes slightly from the four sides of the walls. There are two stones that have been installed more or less in the middle of this square floor. Another concrete floor has been found 68 cm away from the middle of the western wall at an equal distance from north and south (1.77 m). The measurement of this platform is N-S 1.46 m and E-W 1.04 m with a height of 13 m. This platform is made of large-sized bricks and it has been covered with concrete lime plaster.

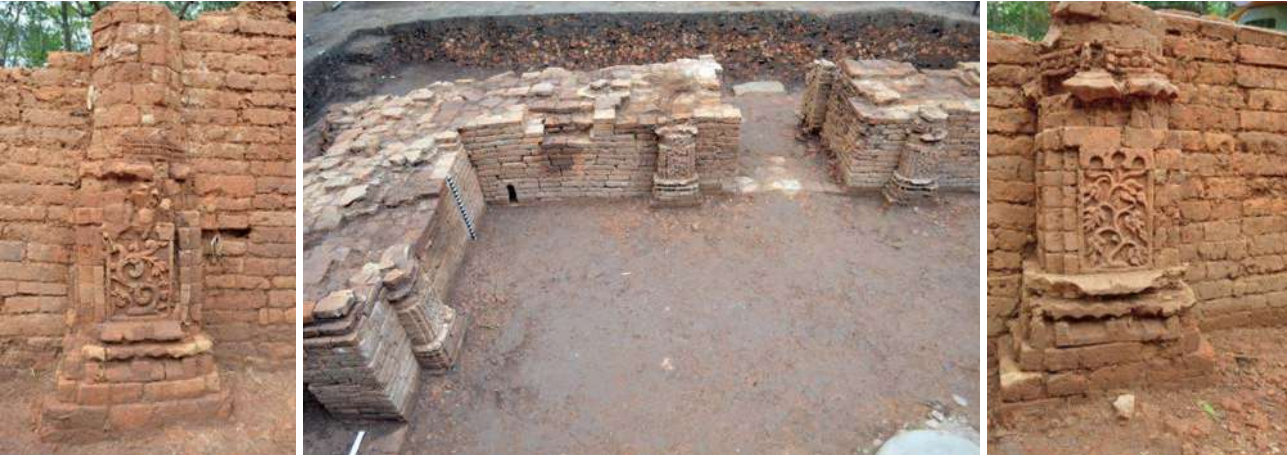
Pilasters

Pilasters: It is known that there are two pilasters installed on the inner portion of every wall of the square structure. Every pilaster is situated an equal distance from one another. All pilasters have been created from the floor of the structure, and the foundations of these pilasters are 44 cm wide and 19 cm projected outwards. They probably used to go up to the top of wall, and every pilaster is beautifully decorated with floral and geometrical designs.

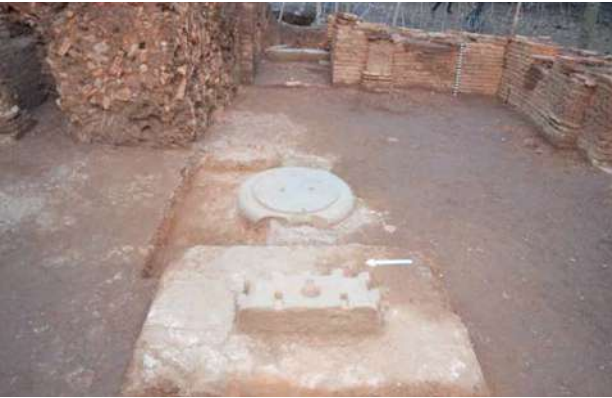
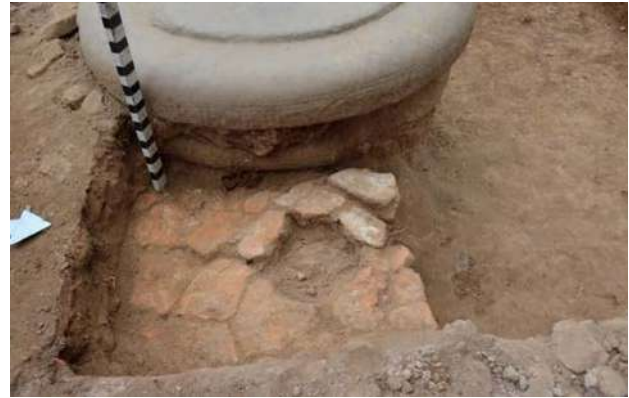
Two stones installed in the floor

There is a black stone on the small platform, which is engraved with a leaf design on three sides, with a hole in

the middle. The hole is 10 cm deep and another two shallow holes are found in the two sides of the large hole. The stone is 61 cm long, 61 cm wide and 21 cm high.

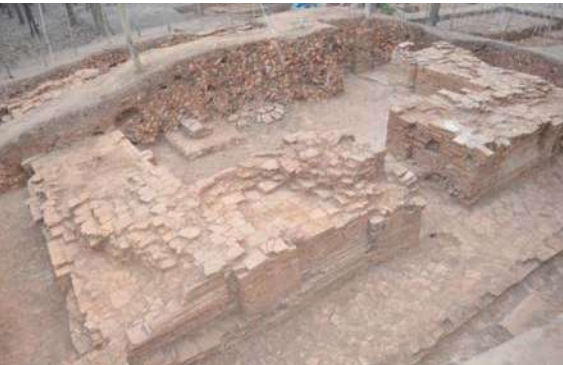
Stratification

Stratification: In the excavated mound only one layer has been found which was full of complete bricks, pieces of bricks, concrete and lime mortar mixed with brick dust. It

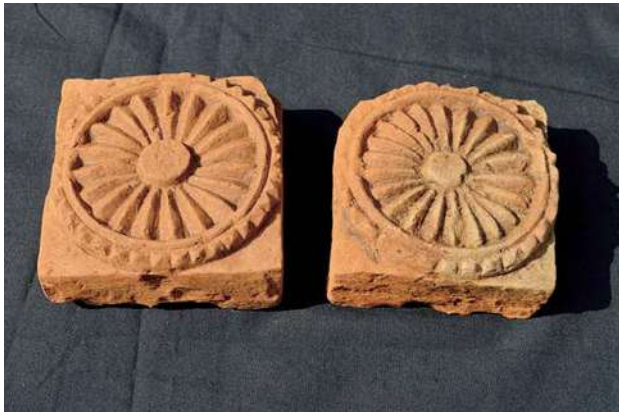
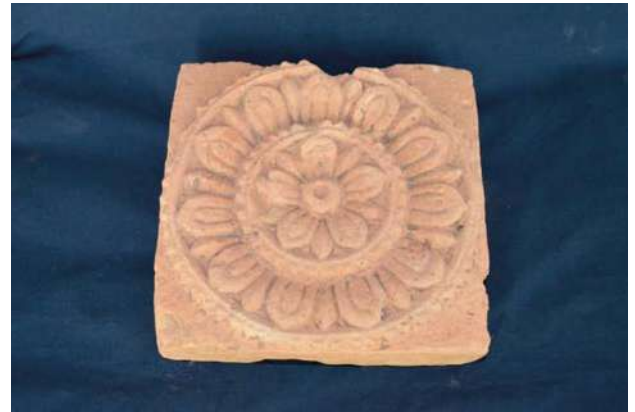
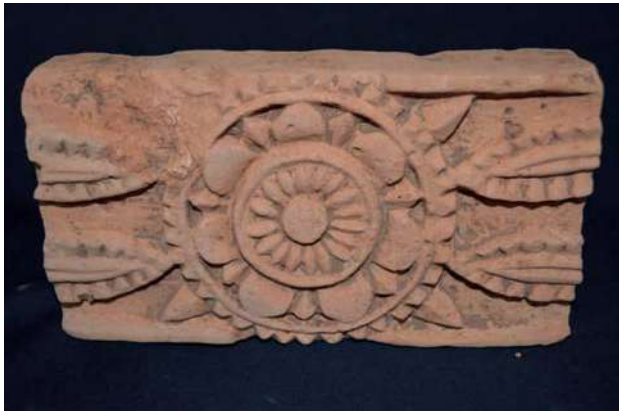
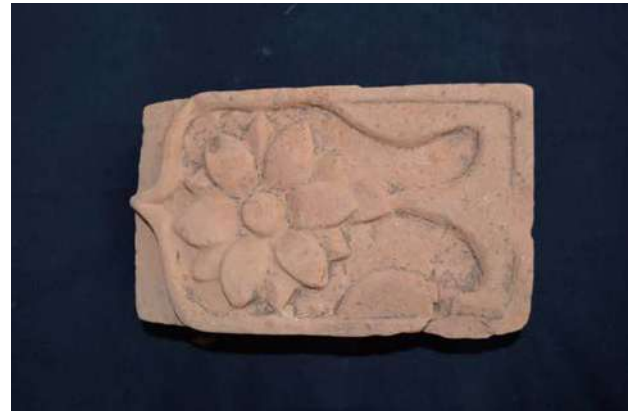
Ornamental bricks

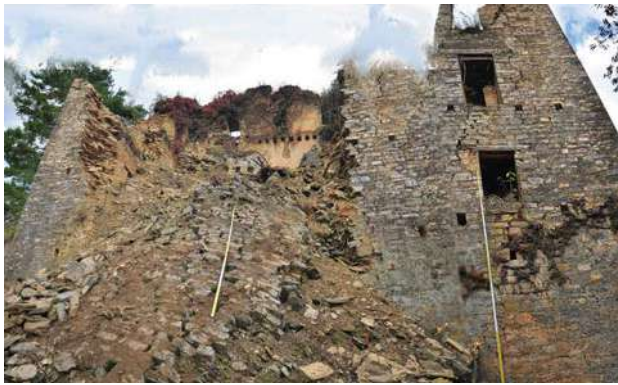
Fig. 2 Front facade of *Utse*: eastern view

Utse (Sector 1) - The main central tower in the middle of the complex measuring 23 m x 14.6 m is built of stone masonry with mud mortar. The middle portion of the wall of the front facade (eastern facade) (see Fig. 2) of the *Utse* has collapsed to ground level. The wall of the rear facade

Although at present, the main entrance door to the *Utse* is not seen or known, it is certain that the entrance to the *Utse* is from the west, as there is no possibility of the entrance being from the east, south or north. Moreover, the middle portion of the wall of the eastern facade had collapsed (see Fig. 2), which further supports the assumption that there were openings, causing most of the wall to collapse.

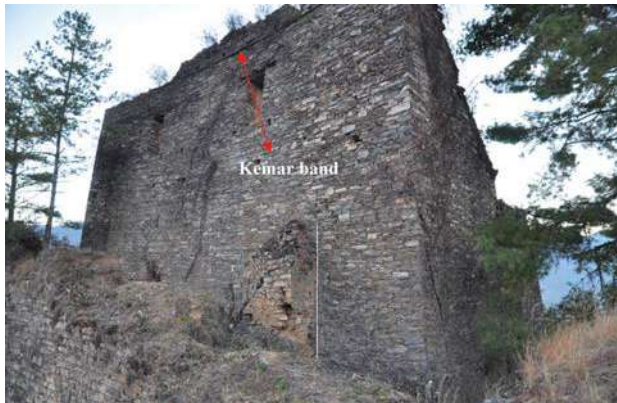
Fig. 3 Rear facade of *Utse*: western view

One can clearly determine that the *Utse* is a five-story building from its present state. This can be calculated from the window openings at each floor level and a *kemar* band level (see Fig. 3) at the top of the structure. Normally, the *kemar* band is traditionally at the top of the structure just

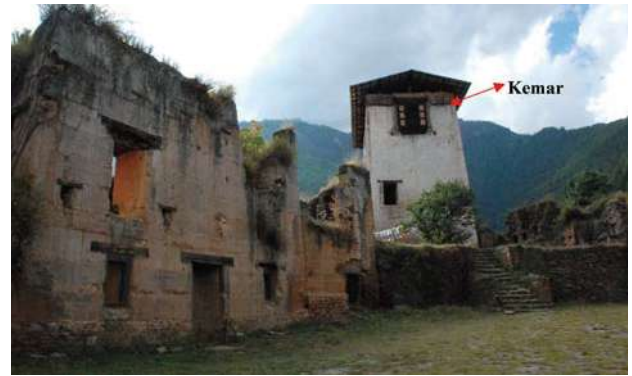
Fig. 4 Drukgyel Dzong. (Photo: Kasumi)

below the roof (see *Drukgyel Dzong* in Fig. 4). The room height can be calculated from the remains of the flooring joist (see Fig. 6), and is approximately 3.1 m.

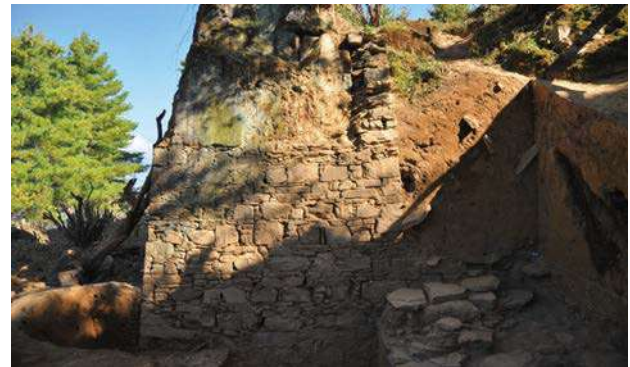
Fig. 8 Excavated area

In order to confirm whether sectors 13, 14 and 15 made up the main entrance building to the fortress complex, a small excavation was carried out during survey and documentation field training. The results of the excavation later proved that the main entrance to the fortress complex is from sector 14 (see Fig. 8). The main entrance building, or sectors 13, 14 and 15 in the west and the *shakhor* (resident building surrounding the main central tower), or sectors 12, 16, 17 and 18, were built with rammed earth.

The findings of the excavation prove that the entrance door is from the west, as there is a clear edge for an opening and flat stones for the steps (see Fig. 8). Further, the nature of the layout of the building (sectors 13, 14 and 15), which is in the middle of two watchtowers (sectors 5 and 6) leading to the main court of the fortress complex and to the *Utse*, proves that sectors 13, 14 and 15 make up the main entrance building

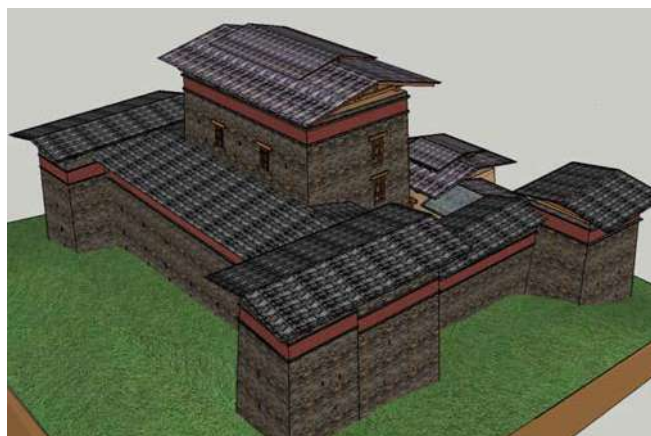
Fig. 12 View from the northeast

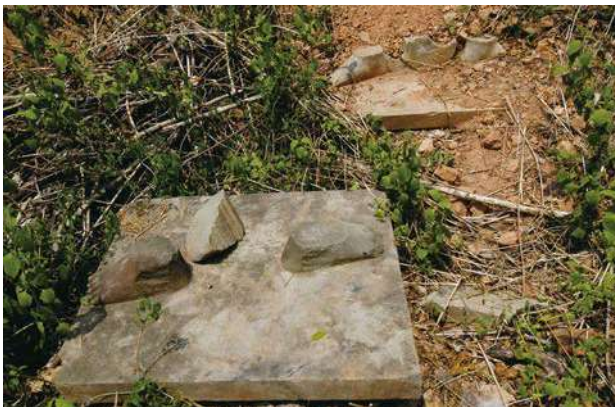
Fig. 3: Sculptures' feet on pedestals in situ

Early confirmations were made by a member of the GACP team, Simon Warrack, as he matched the feet of an abandoned pedestal in situ (at Prasat Chen) (Fig. 3) with a work in a published catalogue (Bunker and Latchford 2004). That sculpture, which was purported to be of Bhima, had been on display at Norton Simon Museum.

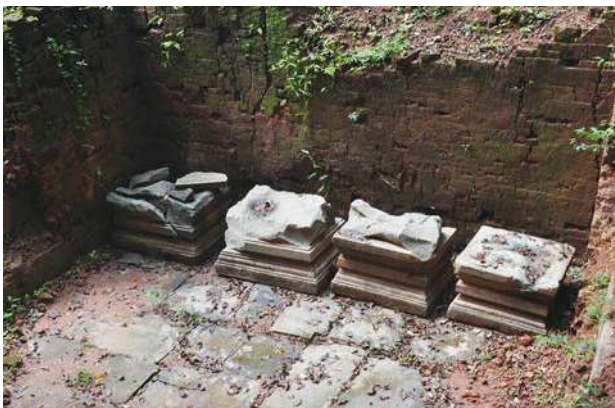
Fig. 4: Another four pedestals found after excavation

public sale. After the United States District Court sought evidence to determine its origin from Cambodian experts with the cooperation of experts from *Ecole Française d'Extrême-Orient* (Figs. 4 & 5), on 13 December 2013, Sotheby's, its client, and federal officials signed a deal to return the Duryodhana to Cambodia.

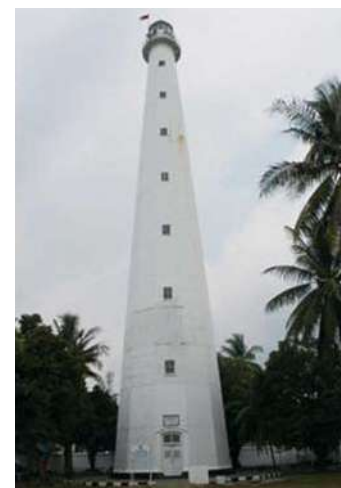
Anyer Lighthouse (Documentation: BPCB Serang)

Anyer Lighthouse is located on the edge of the Anyer-Labuan highway, which juts into the Sunda Strait. If measured from the shoreline, Anyer Lighthouse is about 75 m to the south. The lighthouse building is at latitude $06^{\circ} 04'14.4''$ South and longitude $105^{\circ} 53' 06.8''$ East. The height of Anyer Lighthouse tower is 52.30 m, which stands on a foundation, with the diameter of the base tower is 9.6 m. The distance of the base tower wall to the base foundation is 2.3 m. The base tower which coincides with the foundation, has a profile that surrounds the base tower, with a thickness of the profile is 35 cm.

Anyer Lighthouse is shaped like a cone that narrows upward, with a tilt angle of 88° . From the bottom to the top of the lighthouse there are 16 floors, each with a height of 3 m. Anyer Lighthouse tower was built using steel construction without a frame. The tower wall was built with a cast steel plate mounting system. The steel plates are linked to each other by using bolts and screws. The connection between plates substitutes for a wall frame structure. Each plate connection was designed with a certain thickness and measurement, so the plates were able to bind strongly.

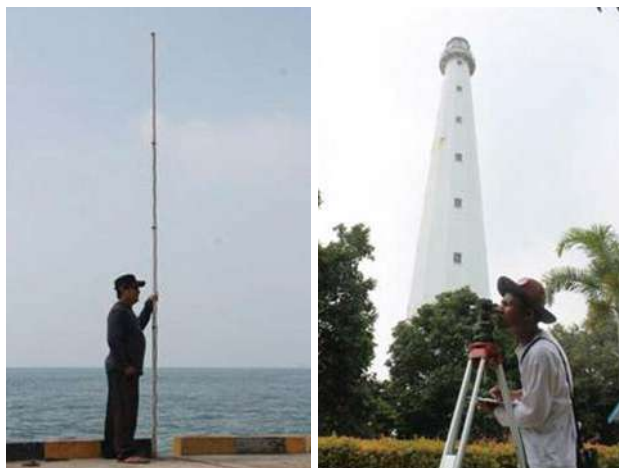
Measuring activity (Documentation: BPCB Serang)

The aim of mapping is to record physical data in the field, which is visualized in the form of images with certain measurements. Through this activity, the layout and spacious of sites can be known accurately. In accordance with the intent of this mapping activity, it results in a map that describes the lighthouse building layout and environmental situation. Plotting for other objects in the map are also performed, especially for other buildings, roads and others that could help to clarify the position of Anyer Lighthouse on the map.

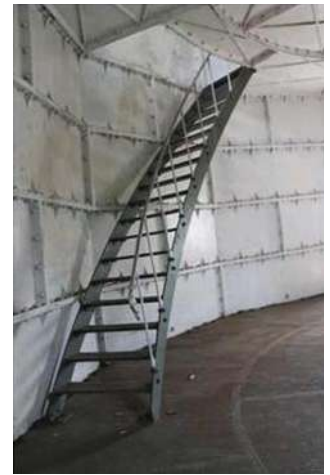
Stairs that connect the floors (Documentation: BPCB Serang)

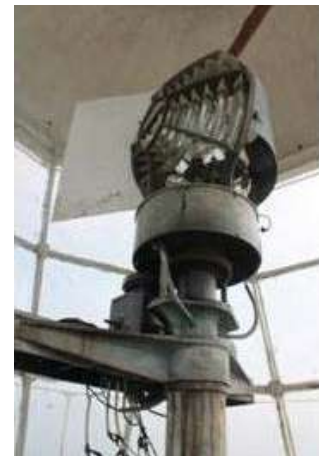
Anyer Lighthouse lamp (Documentation: BPCB Serang)

Besides the bond between the plates, the building construction was strengthened by the foundation and spire, which is connected in the center of the building inside the tower. Each floor in the Anyer Lighthouse tower has similar pattern: each floor is made of 12 mm thick steel plate with a pattern of horizontal stripes on the surface. There are stairs on each floor in order to climb to the next floor. On each floor there are windows in the four compass directions. The top floor of the tower is equipped with a balcony. In the center of the top floor there is a steel structure. The upper end of steel structure is open like a flower. This section is base of the lighthouse lamp holder that is surrounded by glass walls.

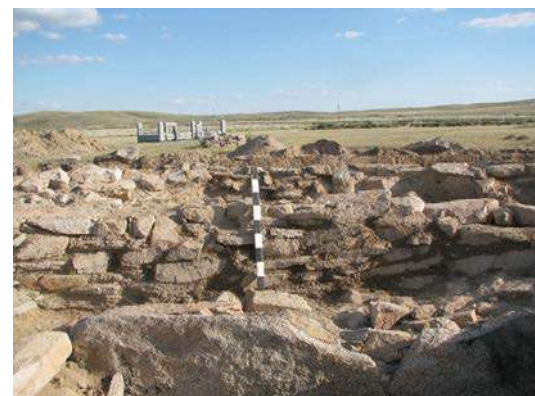
Masonry double fence No 3

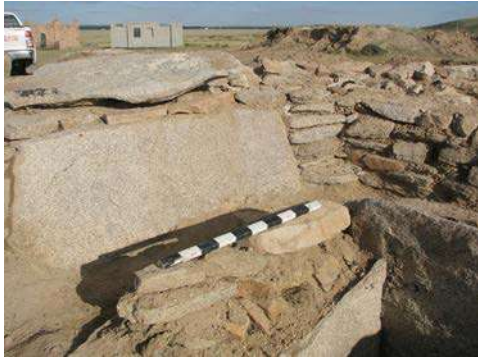
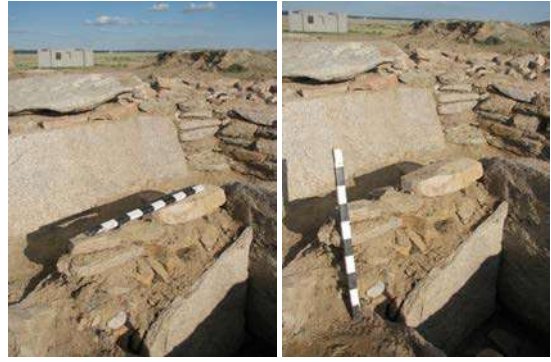
Eastern wall of the burial box

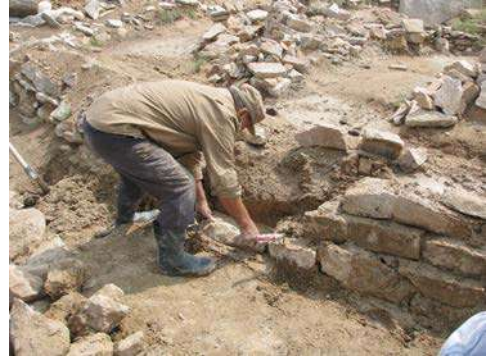
Working time

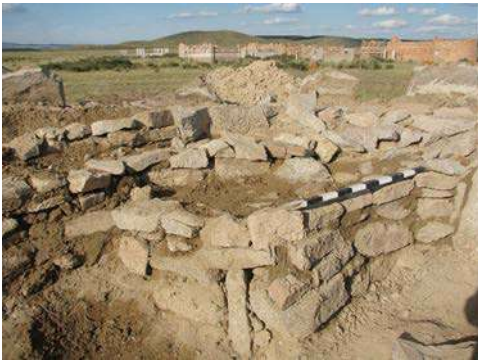
Masonry double fence No 3

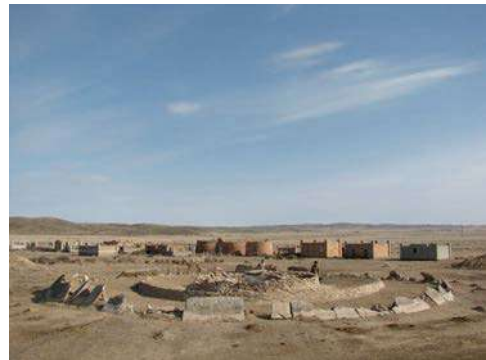
Appearance after reconstruction of the moat, masonry fences No 2 and No 3

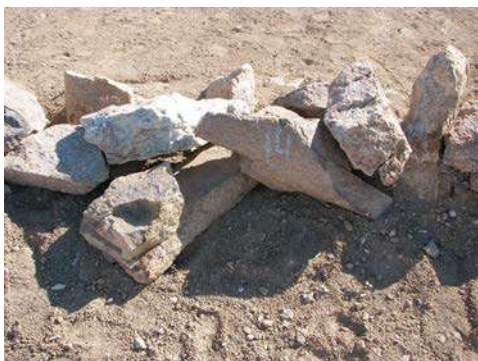
Marking on stone slabs, fence No 1

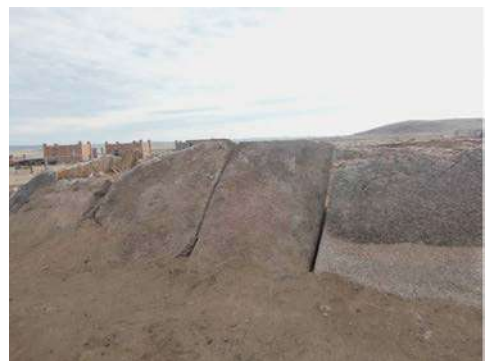
Installation of in-situ slabs of fallen fence No 1

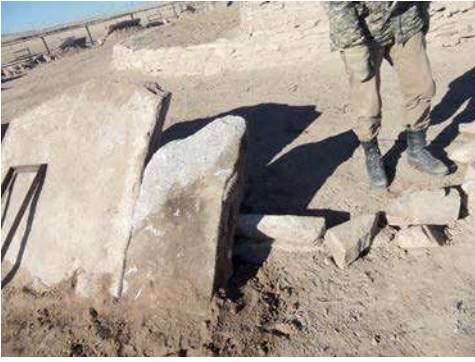
Installing panels for fence No 1

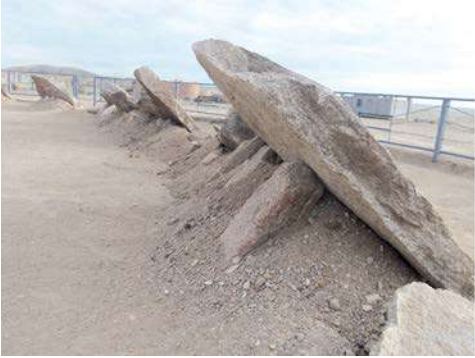
Fixing stone props

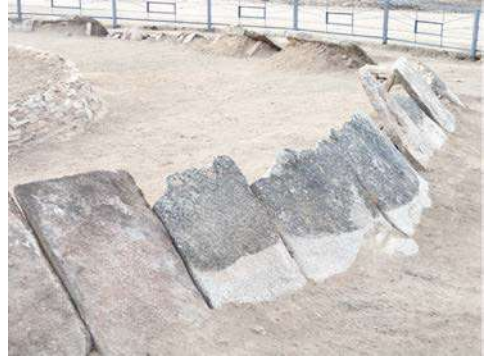
Installation of in-situ slabs of fallen fence No 1

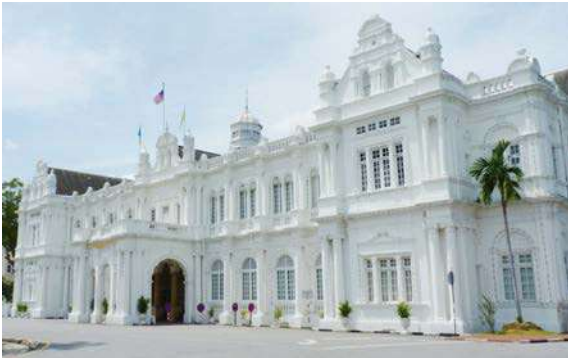
The City Hall Building portrays the Edwardian Baroque architectural style with symmetrical floor plans, pitched roofs, high ceiling with high windows and doors, central domed tower, colonnades of columns, keystones, ornate parapet on roofs, Dutch gables at both ends and in the centre, as well as exaggerated balustrades.

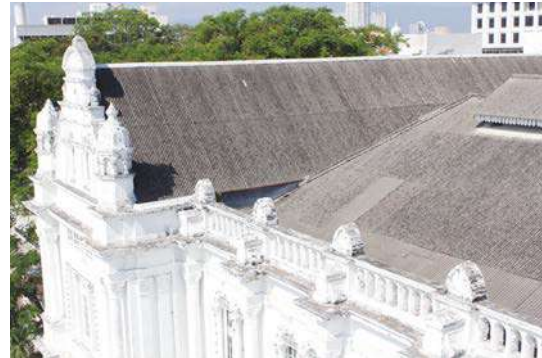
Corrugated asbestos sheets, commonly seen as roofing materials in many buildings in the 1960s and 1970s, were used to replace the original stone slate tiles of the City Hall Building.

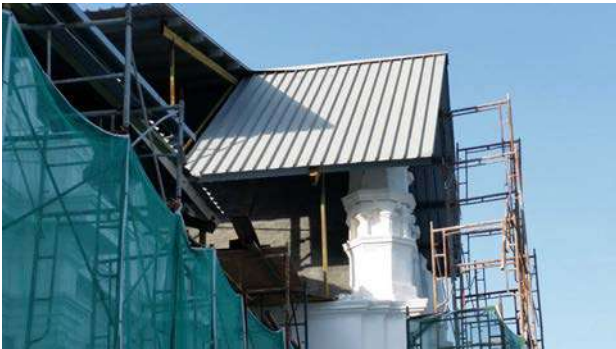
Throughout the restoration of the City Hall Building, temporary roofing using steel frames and corrugated metal decking was constructed above the existing pitched roofs.

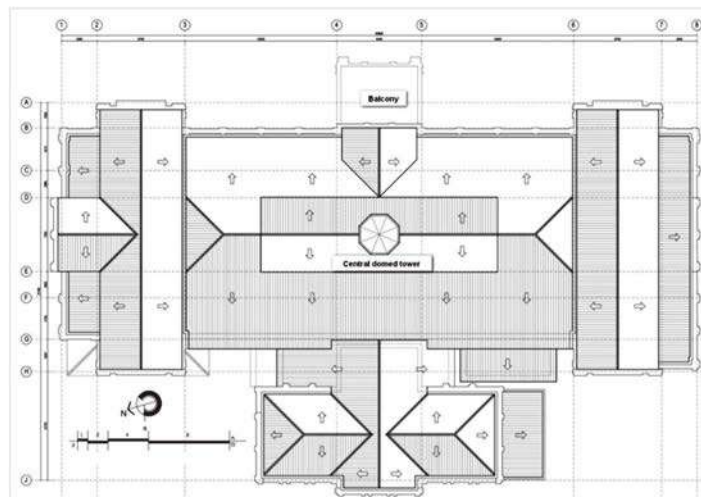
Roof plan of the City Hall Building showing its pitched roofs, central domed tower and front balcony.

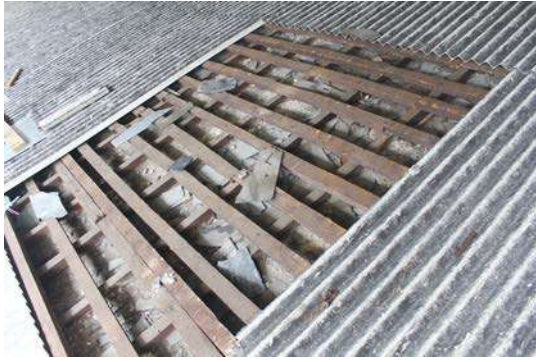
Once the corrugated asbestos sheets were removed, broken pieces of the original stone slate tiles were found scattered on the timber planks.

were inspected and recorded for any defects, particularly termite infestation. Once the corrugated asbestos sheets were removed, broken pieces of the original stone slate tiles were found scattered on the timber planks between timber battens underneath the corrugated asbestos sheets. These broken pieces of stone slate tiles were collected for reference, laboratory tests and analysis.

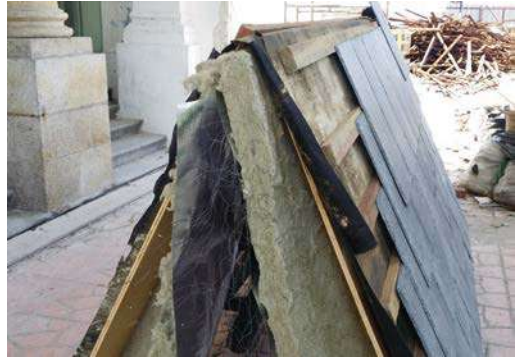
A full-size mock-up of a roofing system using timber structures and stone slate tiles was set up at the City Hall Building prior to any installation.

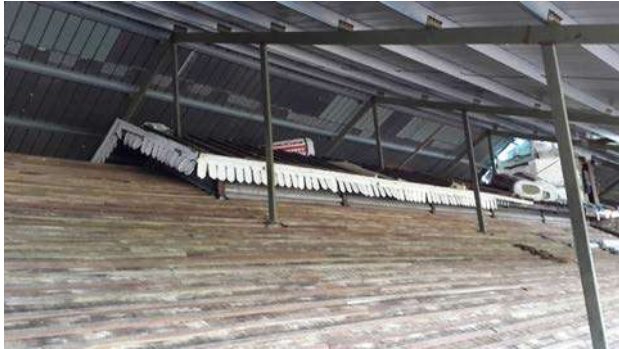
The restoration of the roofs began with an inspection of existing timber planks, rafters, battens and plywood boards once the existing corrugated asbestos sheets were dismantled and removed.

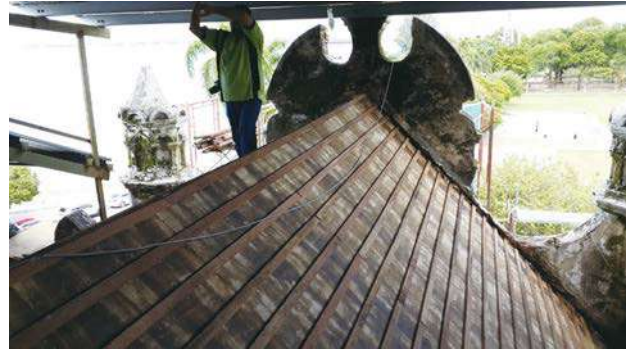
New 2.5 cm x 5.0 cm battens were fixed at 17.5 cm intervals, starting from the lowest end of the roof, over the new roofing felt (bitumen).

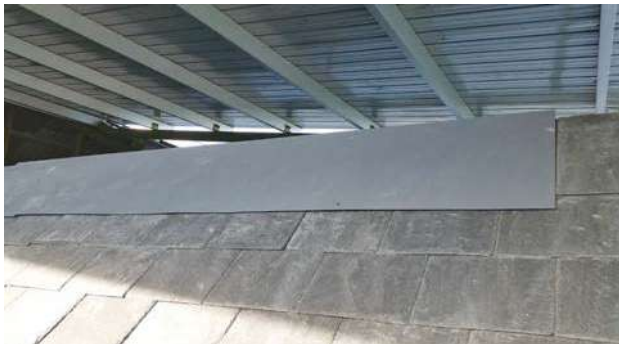
Powder-coated galvanised iron, in a grey colour similar to the colour of the stone slate tiles, was used for the roof ridge cap.

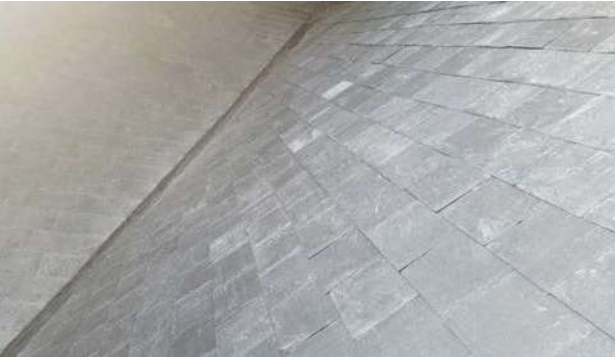
View of the pitched roof of the City Hall Building after the installation of the stone slate tiles.

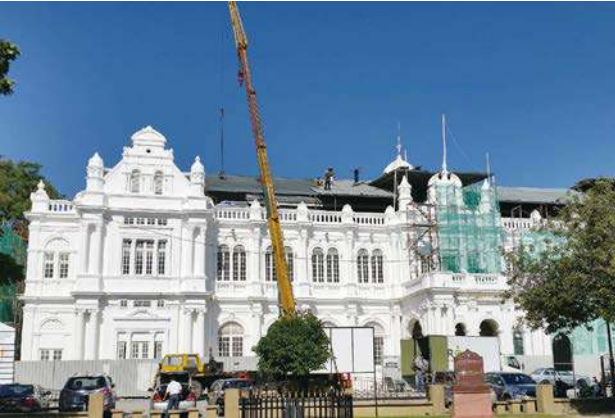
Once the installation of the stone slate roof tiles was completed, the temporary roofing was carefully dismantled and removed using a telescopic hydraulic crane.

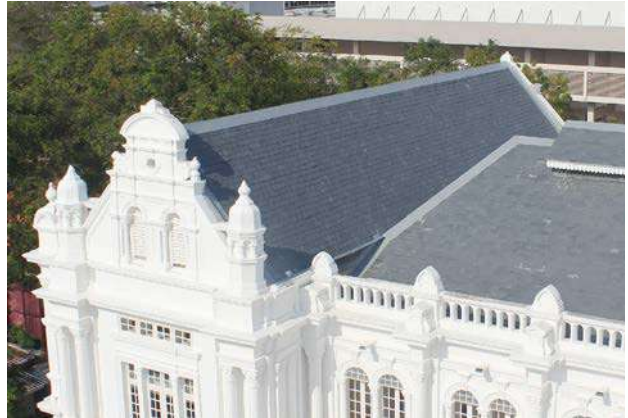
Close-up view of the newly installed stone slate roof tiles at the City Hall Building.

Through its two small nail holes located at the top, each stone slate tile is firmly fixed at the centreline of the roof batten. The nail heads were left to protrude slightly above the surface of the slate roof tiles. Nails were not driven too deeply into the timber battens, because exerting too much pressure on the roof tile could cause it to break if someone steps on the roof. The installation of stone slate tiles began at the lowest end of the roof (first course) and continued upwards in an interlocking manner with 28 cm of overlap. Powder-coated galvanised iron, in a grey colour similar to the colour of the stone slate tiles, is used for the roof ridge cap and valley gutter. Each stone slate tile occupies three rows of roof battens when lying on the roof. One square metre of roof requires 18 stone slate tiles. As each stone slate tile weighs 1.8 kilograms, the total weight for one square metre of roof is 32.4 kilograms. A total of 46,853 stone slate roof tiles were installed by experienced roof slaters and roof tilers at the City Hall Building. Some extra stone slate roof tiles were stored and left within the roof structures for future maintenance and rescue work. Once the installation of stone slate roof tiles was complete, the

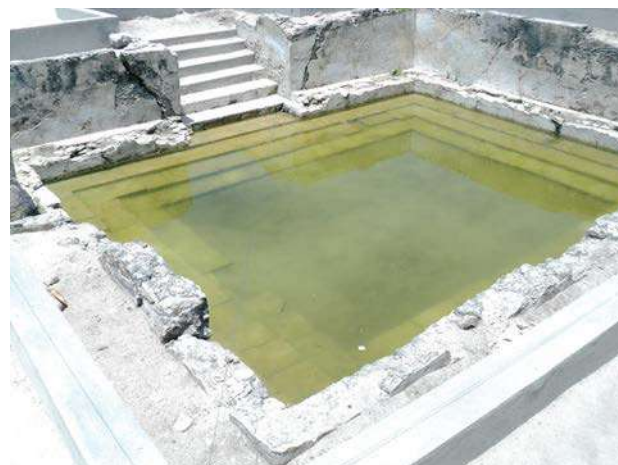
Figure 1: Condition of the bathing tank after MNDF's excavation

The team from the department included an archaeologist and two research officers—one to document the site and the other to prepare a conservation plan for the tank and to clean the tank. The team spent a week working on the site. The work of MNDF had left the tank in a rather harsh condition due to the excavators used to remove the spoil heap, hence the team was unable to reconstruct the tank during this visit. Many of the stones of the tank were badly damaged—some were broken and others had serious cracks in them.

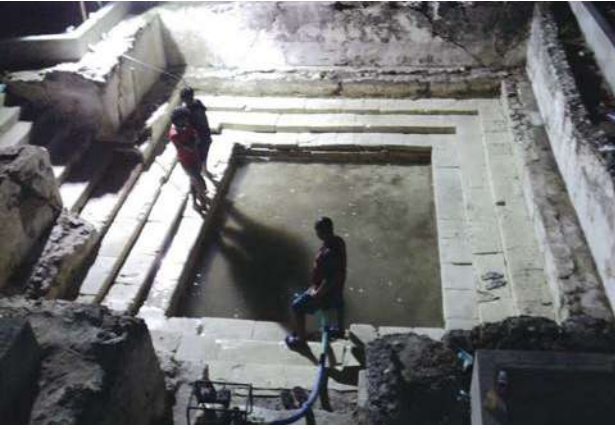
Figure 2: Condition of the bathing tank after DOH's excavation and cleaning

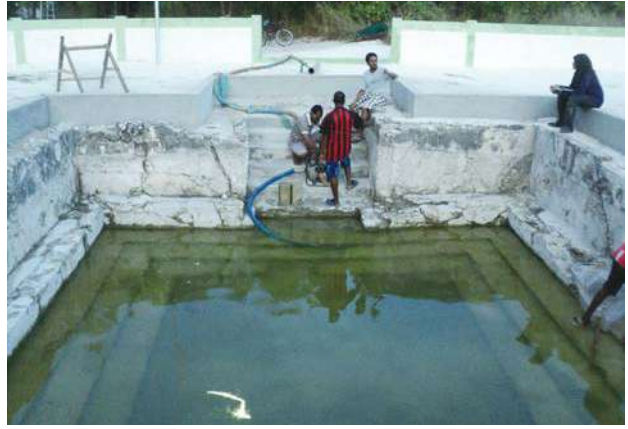
Figure 3: Preparation and placing of water pump to drain the water out

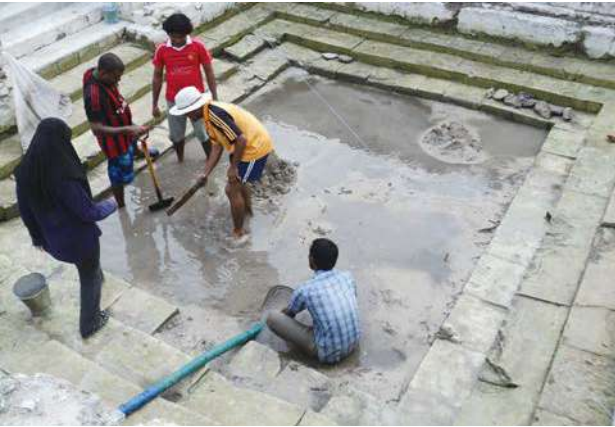
Figure 4: Removal of the spoil heap with spades after water has been drained out

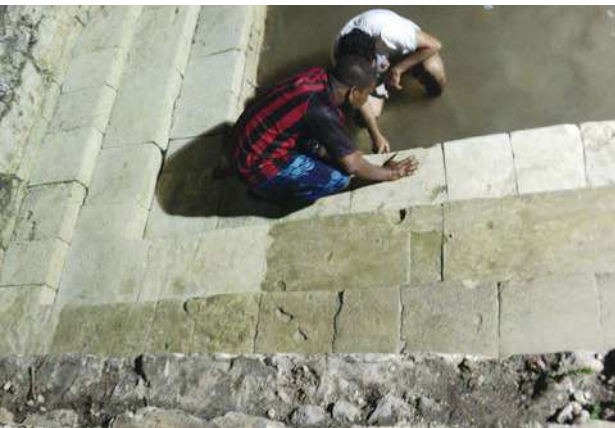
Figure 6: Section of the stones showing the cleaned and unclean stones

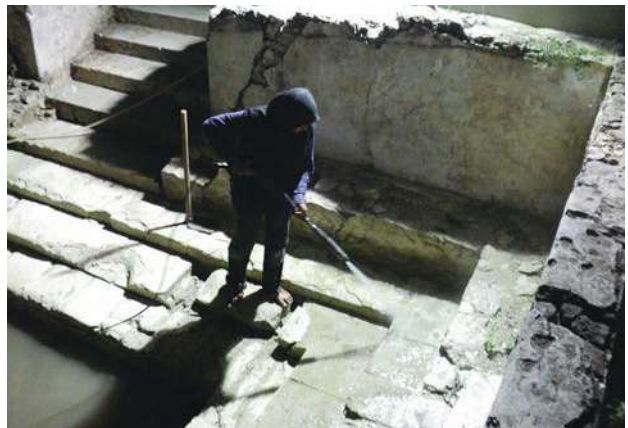
Figure 7: Cleaning the stones with a Karcher pressure washer

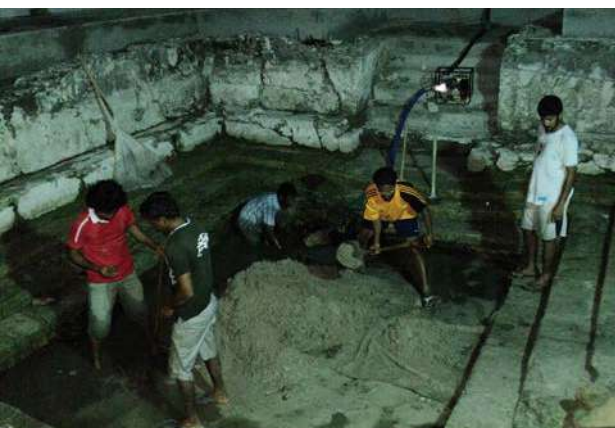
Figure 8: Spoil heap at the center of the tank ready to be taken out of the site for sieving

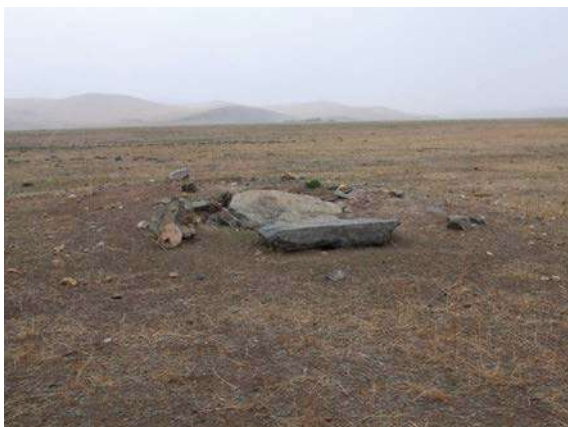
Fig. 1. Offering complex at Tamkhiny Döröv. From the south

There are two holes in a N-S-oriented oval earthen mound measuring approximately 10 m long, 6.8 m wide and 0.3 m high. (Fig. 1) The holes are located along the long axis of the mound.

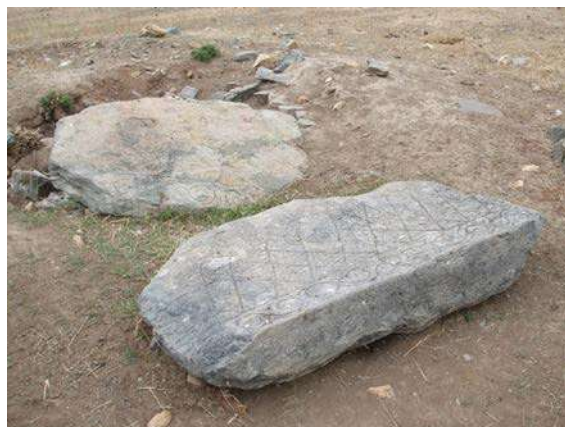
Fig. 2. Stone slabs of the complex

Slab 1. Slab 1 has been laid in front of the southern hole with its top facing the south. (Fig. 2) The upper edge of its exterior surface has been engraved with a 20 cm wide pattern. (Fig. 3) A most interesting image, a very realistic representation of a galloping antlered deer measuring 30 x 16.5 cm, looking to the right-hand side of the surface, has been depicted in the middle of the pattern line. (Figs. 4 and 6) The space below the upper edge pattern is decorated with a rhombic pattern. (Fig. 5) The dimensions of the slab are 166 x 106 x 26 cm.

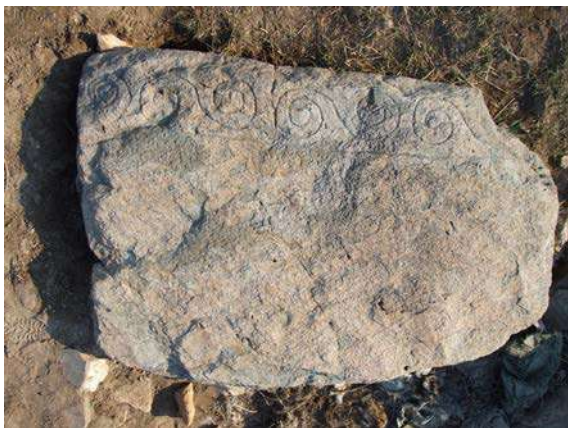
Fig. 7. Slab 2

Slab 2. This has also been removed from the southern hole, its original placement. Now it is located between the southern hole and the slab 1, and at the southern edge of the hole, looking same direction as of the slab 1. (Fig. 7)

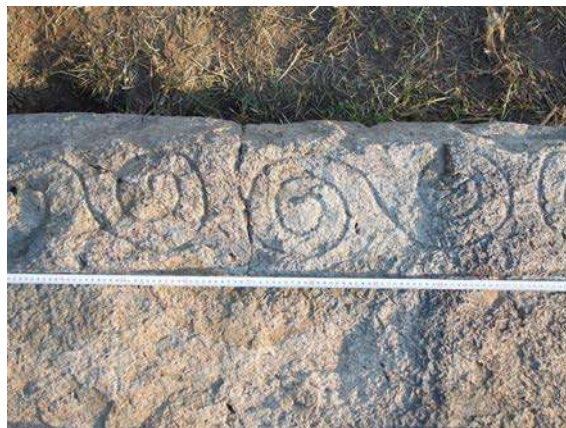
Fig. 8. Upper edge pattern of slab 2

The upper edge of the slab 2 is also patterned like slab 1. (Fig. 9) It is 23.5 cm wide. (Fig. 8) The pattern which was below the upper edge pattern has unfortunately been eroded so much that it has become invisible over time because the slab is made of softer rock. The slab measures 174 x 112 x 15 cm.

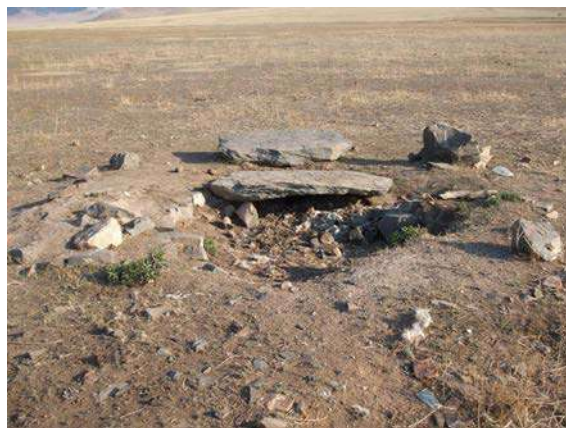
Fig. 10. Looters' hole

There was a variety of rubbish (sheep’s wool, iron wire, pieces of torn clothes, etc.) in the southern part of the hole. (Fig. 10) During the last 20 or more years many people and companies had both legally and illegally engaged in gold mining along the Boroo Valley and in the Noyon Uul mountain, the most beautiful place in this area and aristocratic cemetery of the Xiongnu Empire.

had dug inside the enclosure and removed the slabs from their original placement. (Figs. 10 and 11) Another two slabs are missing. They might have been removed for the building of the above-mentioned canal. The western wall of the hole contains a number of layers, including ash.

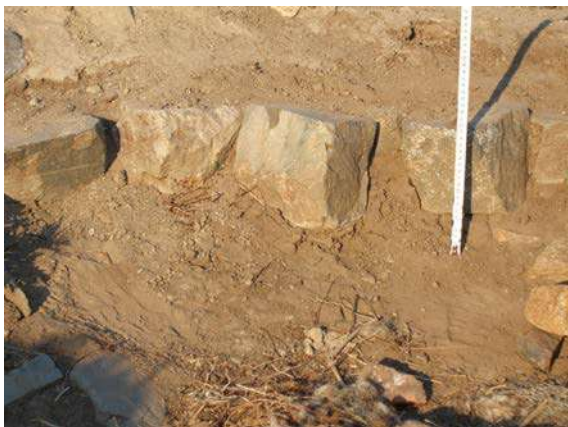
There are stones for enclosing the outside bottoms of the slabs in the left and right walls of the southern quadrangular hole where the enclosure was erected. (Fig. 11) Looters

Fig. 11. Enclosure stones in situ in the eastern wall of the hole

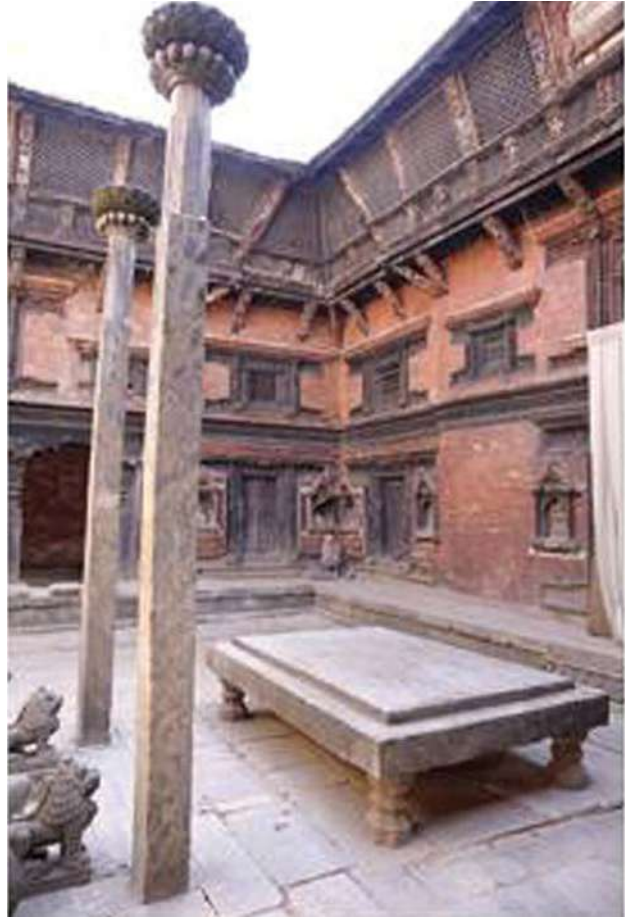
Northwestern Elevation

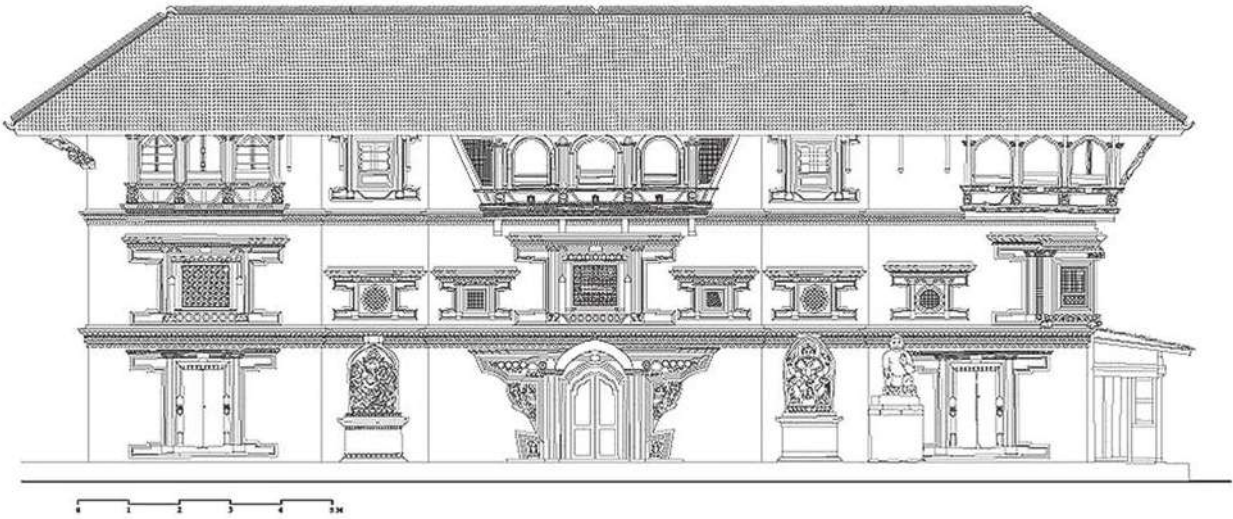
West Elevation

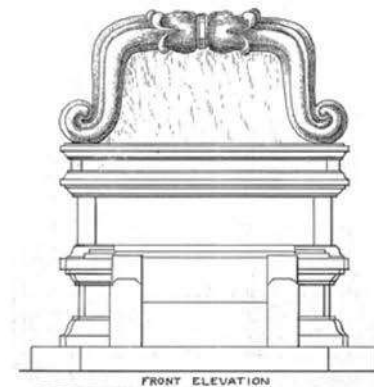
(Fig 63) Plan of toilet

Toilets and urinals of the shroud (Panshukulika) monks (bhikkus) were richly decorated but hygienic. This reflects the rejection of mundane gratification. The waste from these buildings was refined and made safe before being released into the soil. (Fig 63)
