ACCU Nara
International Correspondent

Vol.15 2015

The Fifteenth Regular Report

The ACCU correspondents periodically send reports on cultural heritage protection activities in which they have been recently involved. This is a collection of fourteen reports submitted by international correspondents in the Asia-Pacific region.

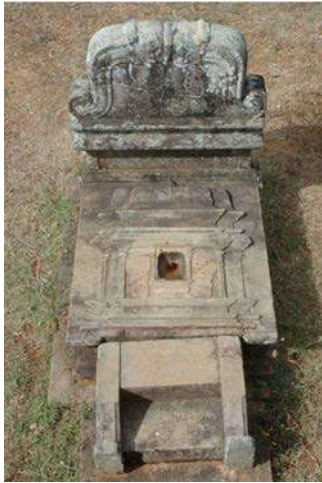
(Fig 64) Tholuwila urinals, Anuradhapura period

The waste discharged from the urinals are directed to a pit consisting of clay pots arranged one on top of the other. The waste is retained in the pots while the water containing the pollutants is refined by charcoal, sand and lime deposited in the pots, and the water effluent is then released into the environment. (Fig 64) (Fig 65) (Fig 66) (Fig 67)

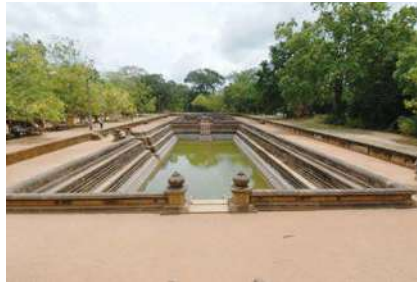
(Fig 68) Twin Ponds, Anuradhapura, Anuradhapura period

In Buddha's time it is said that the monks (bhikkus) fulfilled their water needs from rivers. Folklore mentions that Kuweni was picking flowers from a pond. Ponds existed on the island when Arahat Mihindu set foot on Sri Lanka. Ponds were constructed for bathing and for beautification of the environment. Wells were built for the extraction of potable water. At times, when the water levels were at lower depths, steps were constructed to reach the water. (Fig 68) (Fig 69)

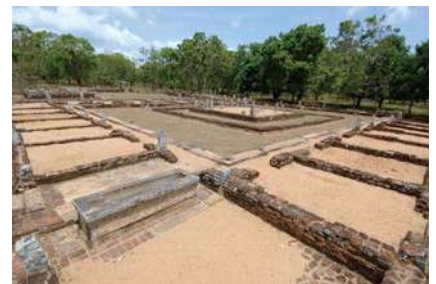
(Fig 74) Hospital, Mihintale, 8th century AD

Hospitals used by large monasteries are still extant. Often these buildings have a central courtyard from which wards extend in four directions. The presence of medicinal troughs on the premises of ancient hospitals is a distinctive sight. Surgical instruments and medicine containers were discovered at the Aalahana Pirivena of Polonnaruwa. (Fig 74) (Fig 75) (Fig 76) (Fig 77)

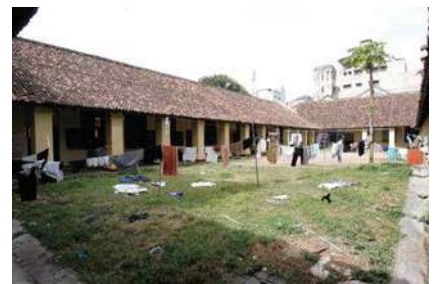
(Fig 77) Medicinal bath, Medirigiriya, Anuradhapura period

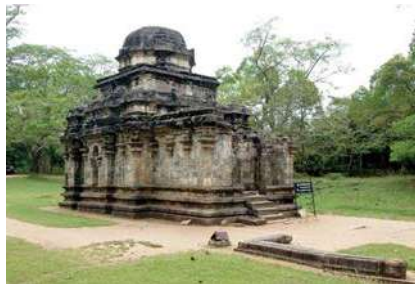
(Fig 80) Shiva Devala No. 2, Polonnaruwa, 13th century AD

A temple (devala) for the goddess Kali, seven temples for the god Shiva and five temples for the god Vishnu are amongst the Hindu temples of Polonnaruwa. Often, the temples were made completely with rock, including the dome. The walls and dome of the temple “Nai Pena Vihara” are made of brick. (Fig 80)

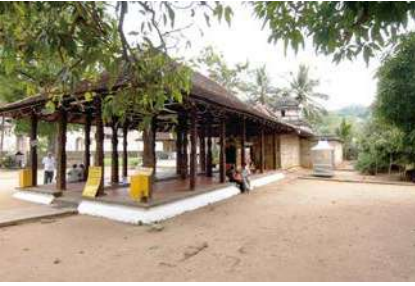
(Fig 88) Natha Devala, Kandy

Often, a devala consists of a sacred chamber known as the “Pe Vena Maduwa” with the statue of the god. Directly in front of this is the “hanudun kudama”, and finally, in front of it, is an open pavilion called a “dig ge”. A Buddha shrine and a kitchen are placed away from the devala, and a parapet wall with a vestibule demarcates the devala premises. (Fig 88) (Fig 89) (Fig 90)

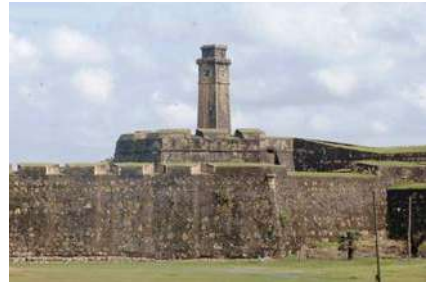
(Fig 96) Galle Fort, 18th century AD

Among the forts of the Colonial period, the Dutch forts stand out as they are attractive. A fort has a wide perimeter mound supported by thick stone masonry and consists of a residential building, service buildings and religious structures. At the corners of the fort are shaped guard posts known as Bastians. (Fig 96) (Fig 97)

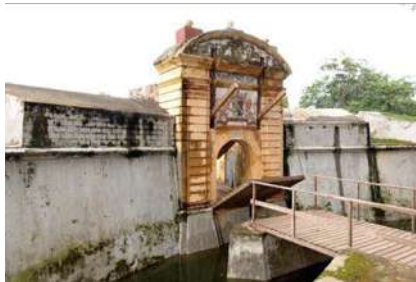
A drawbridge which is operated by levers with a door can presently be seen in the Star Fort in Matara. (Fig 98)

(Fig 98) Timber Draw Bridge, Matara Star Fort, 18th century AD

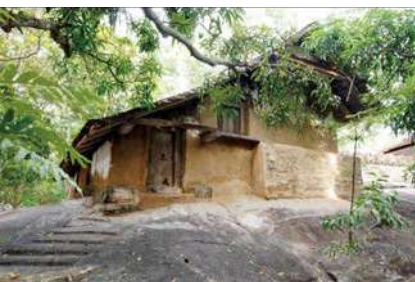
(Fig 100) Library building, Padeniya, Kandyan period

The library of the Padeniya temple is a building of architectural importance. It exemplifies genuine Kandyan architectural characteristics. The Padeniya library (pothgula) was built on a rock with the intention of protecting the library from the threat of termites and pests. This building, which is constructed on an elevated foundation, has a “veli pillā” incorporated with the cast plinth. (Fig 100)

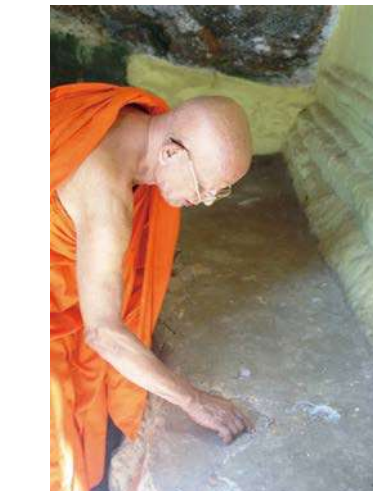
A veli pillā is a sand tray on which one learns to write letters with a finger in sand. (Fig 101)

(Fig 101) Veli pilla, Matale Alu Vihara, 18th century AD

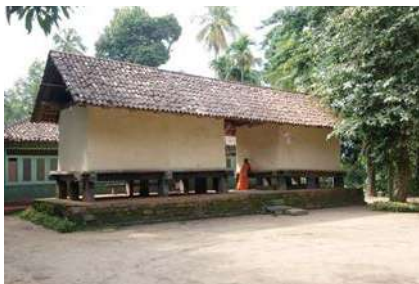
(Fig 112) Granary, Lankathilaka Vihara, Kandy

The granary or “atuwa” or “wee bissa” was constructed on wooden logs fixed on short pillars to protect the stored grains from storm water and pests. (Fig 112) (Fig 113)

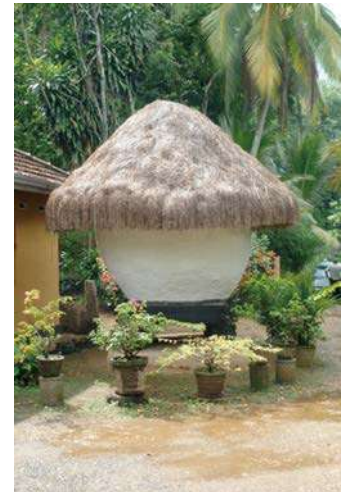
(Fig 114) Granary, Thotupale Manor House, Kegalle

The granary was a wattle and daub structure and plastered with lime. The roof was thatched with straw. When the house belonged to a nobleman, temple or king, the granary was a separate building. (Fig 114)

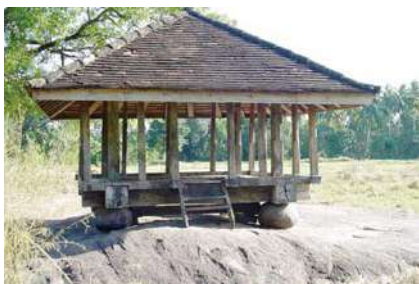
(Fig 115) Wayside resting place, Karagagedara, Kandyan period

A wayside resting place—an ambalama—is a small building used for resting. These buildings were constructed beside the roads used by people who travelled on foot or by cart. Initially the ambalama was simply the shade of a tree without a shelter. Subsequently a tree trunk was placed on two stones under the tree for people to sit on. Later, four timber beams were placed on four similar stones to which four timber columns were attached and a roof constructed. The ambalama is a basic product of indigenous architecture. Some were constructed on stones surfaces with tall pillars to ward off threats from pests. (Fig 115) (Fig 116)

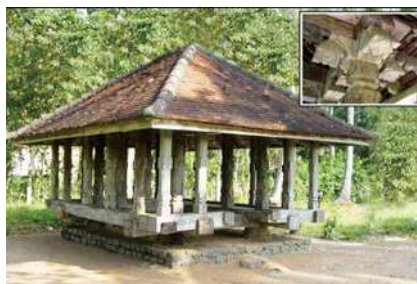
(Fig 116) Wayside resting place, Panavitiya, Kandyan period

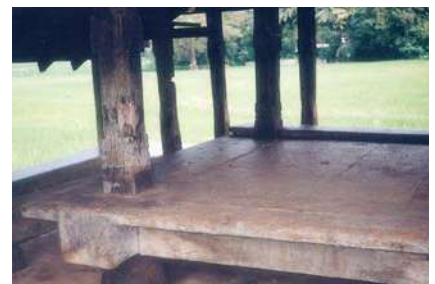
(Fig 117) Wayside resting place, Pandivita, Kandyan period

Panavitiya Ambalama is the most attractive ambalama found in Sri Lanka. Large timber sections are used in the structure to give stability to the roof. (Fig 117)

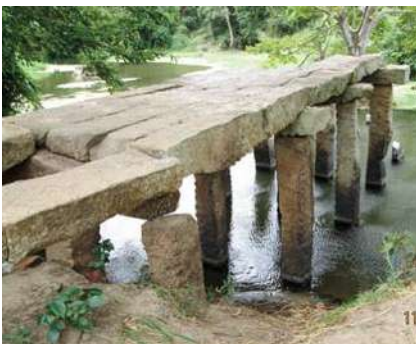
(Fig 122) Timber bridge, Bogoda, Kandyan period

Plank bridges were replaced by more robustly built bridges for safety and ease of use. There are many examples of bridges built with various materials applicable to various periods.

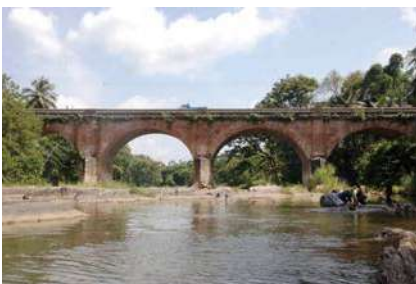
(Fig 124) Steel bridge, Yatiyantota, 19th-20th centuries AD

The British rulers used brick arches and steel frames in building bridges. (Fig 121) (Fig 122) (Fig 123) (Fig 124) (Fig 125)

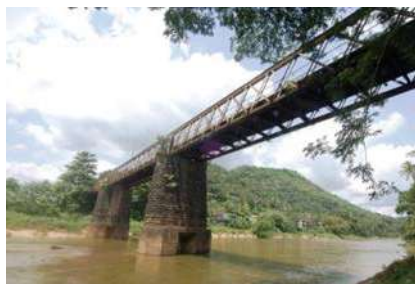
(Fig 125) Suspension bridge, Deraniyagala, 19th-20th centuries AD

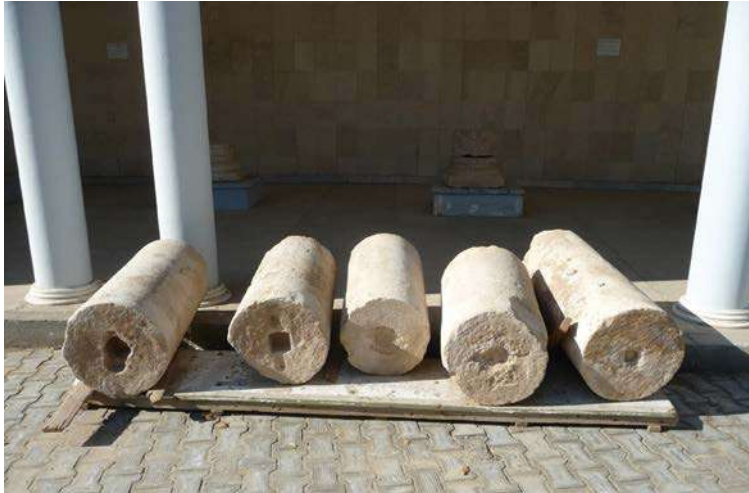
1 a-b. Fragments of Column from Chingiz-tepa.

This group includes stone trunks, which were found on the Chingiz-tepa, one of the hills of the settlement, in 2012. They consist of five drums that are fully intact, but of different sizes: length from 78.5 to 112.5 cm, bottom diameter 43 to 48 cm, and the top 40 to 43 cm (fig. 1 a, b). The drums were carved out of monolithic cylinder-shaped stone. Their surfaces are carefully polished. There are deep square- and round-shaped recesses on the top and round surfaces of the drums. All the barrels, except for one provided with rectangular auxiliary recesses, feature shallows. These probably served to connect the drums to one another, by fastening the stems with the bases on the bottom and capitals on the top. Some drum grooves are filled with lime mortar. They were apparently used to maintain the stability of the drums while being connected. It's possible that the pillars were based on large and solid foundations and supported by stone capitals. The large blocks sizes indicate that the columns, which were built with help of blocks, were probably were decorations of a monumental building. It should be recalled that in ancient times such ceremonial buildings were palaces or temples.

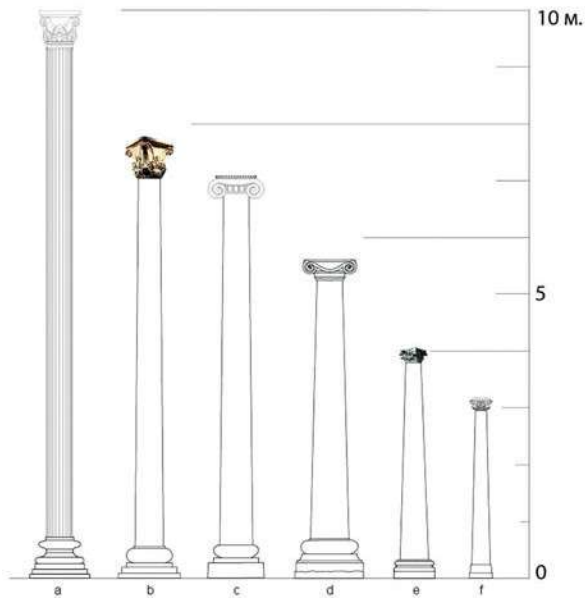
Fig. 2. Bactrian Columns: a) Sacksonokhur (South Tadjikistan), b) Ay-Khanum (North Afghanistan), III-II centuries BC. c) Takhti-sangin, end of IV century - beginning of III century BC; d) Khalchayan, I century BC - I century AD, e) Karatepa, f) Ayrta, II-II centuries AD.
