Vol.16 2016

# The Sixteenth Regular Report

## ACCU Nara International Correspondent

The ACCU correspondents periodically send reports on cultural heritage protection activities in which they have been recently involved. This is a collection of fourteen reports submitted by international correspondents in the Asia-Pacific region.

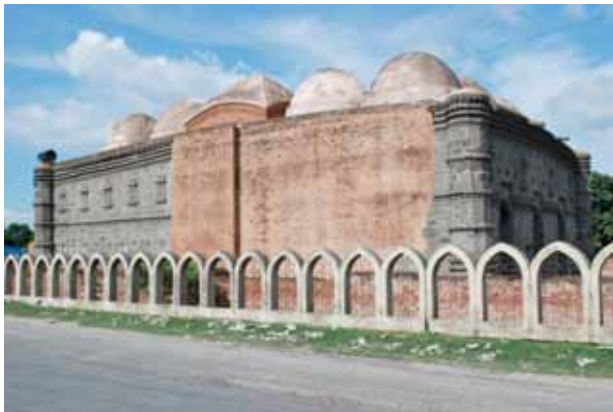
Western wall of the mosque

The exterior surface of the western wall of the mosque is covered with stone, except for the southern part. Most probably this part was damaged by a natural disaster. The entire mosque (exterior and interior wall) is covered by ornamented black basalt. Five multi-cusped arched doorways in the east and five *mibrabs* are on the western wall facing the same direction. Three more doors are on the north and three are on the south. The doors are immaculate and every door enclosed within the rectangular frame is richly decorated. Gargoyles are used on the cornice for draining water.

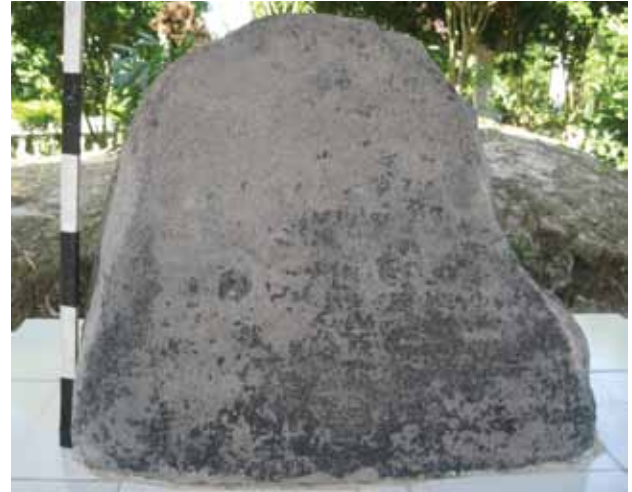
The Palas Pasemah inscription before being cleaned

In 2014, a team from the Heritage Conservation Office of Serang intended to conserve the Palas Pasemah inscription. Before carrying out conservation work, the team made some observations about the condition and damage to the inscription. Based on the observations that were made, the stone of the Palas Pasemah inscription had deteriorated. A reduction in the quality of the inscription material was seen over almost the entire surface of the stone. The stone surface was covered by black stains that were suspected of being an adhesive. The stains had come from the adhesive material when a duplication of the inscription was made in 2004. The duplication impacted the surface of the stone inscriptions, and partly covered the stone surface with black remnants, so that the inscription is difficult to read. Another impact is the stone surface become fragile, so that weathering can easily occur.

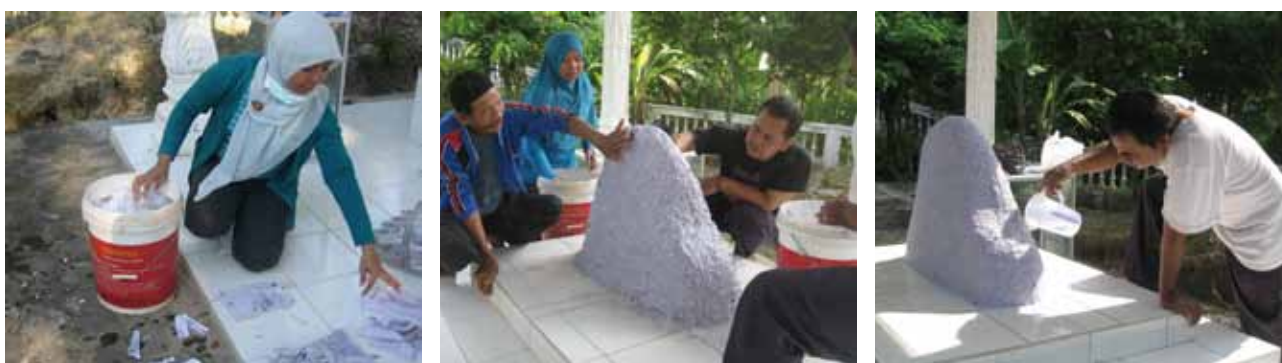
Making paper pulp – sticking the paper pulp – pouring hot water onto the stone

- a. Prepare a container (bucket)
- b. Prepare hot water (10 liter) at a temperature of around 85° Celcius
- c. Prepare as much paper / newspaper as needed
- d. Pour the water into the container (bucket)
- e. Soak the paper in the container
- f. Leave the paper soaking for some time (about an hour)
- g. After the paper is wet evenly, turn it into pulp by tearing it into strips
- h. Then stick the paper pulp onto the stone surface evenly
- i. After that, pour hot water over the pulp that has been stuck onto the stone, so that the heat can last longer. The remnants of the stain can be lifted from the surface of the stone. Repeat up to three times, then allow to stand for 24 hours
- j. After 24 hours, clean the paper pulp from the stone
- k. Rinse the stone with water and dry using a clean cloth or chamois.

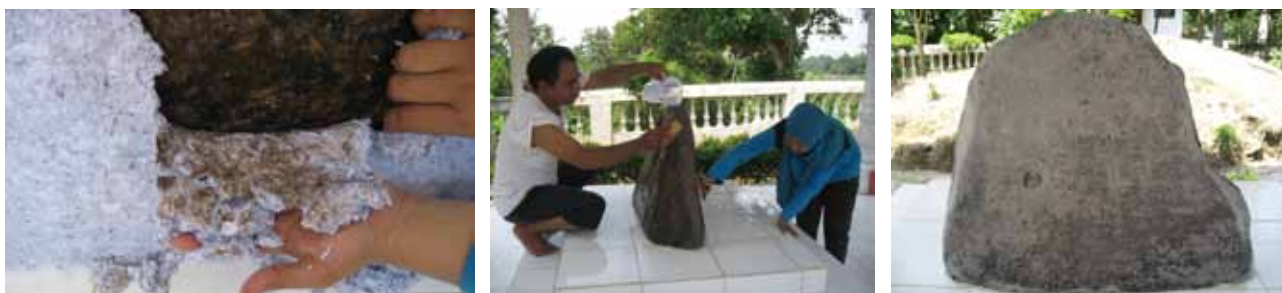
Cleaning off paper pulp - rinsing the stone – Palas Pasemah inscription after treatment

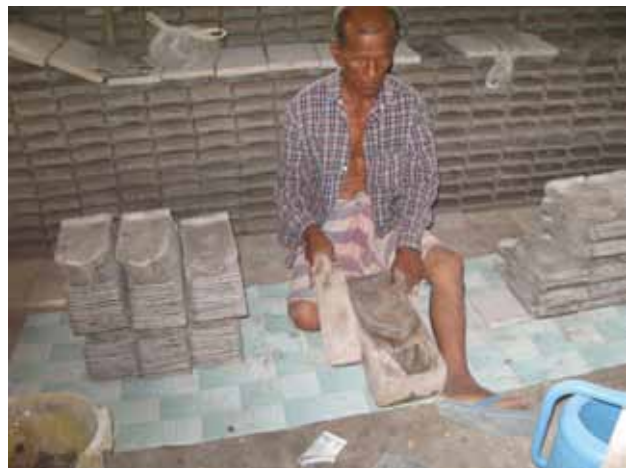
Once dried, the clay tiles are collected and inspected for possible defects.

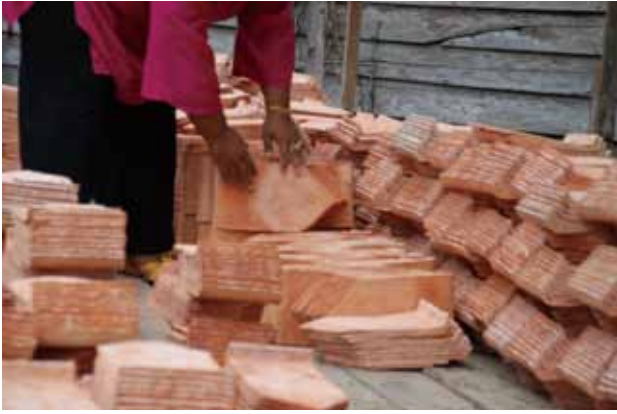
After removal from the kiln, each roof clay tile is inspected for possible overbaking or burning.

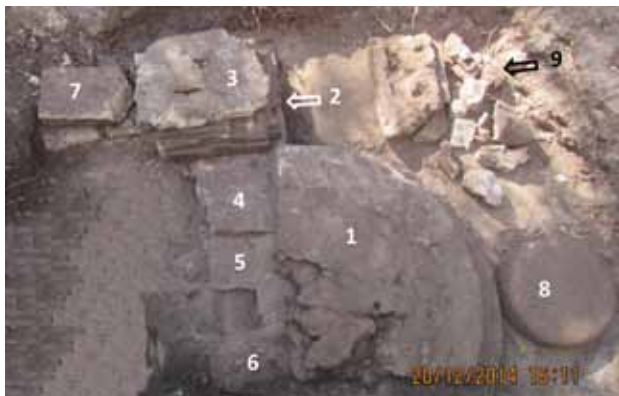
Fig 5: Intact stone structures (Nos. 1-8) and stones recovered within the soil (No. 9) from Trench 1

This trench revealed coral stones of different shapes and sizes and some were carved (Fig 5). The first two stone structures (Fig 5: Stones 1 and 2) were badly damaged and in very bad condition. Stone 2 (Fig 6) was carved and the carvings were similar to the usual stone carvings in coral stone mosques of Maldives. A third flat stone (Fig 5: Stone 3) was placed on top of Stone 2 and this stone had a square post hole at its center (Fig 7). Among the stones recovered in this trench, the best preserved one was Stone 8 (Fig 8). This stone was circular in shape and measured 3 ft in diameter and 1 ft in height. Other remains such as

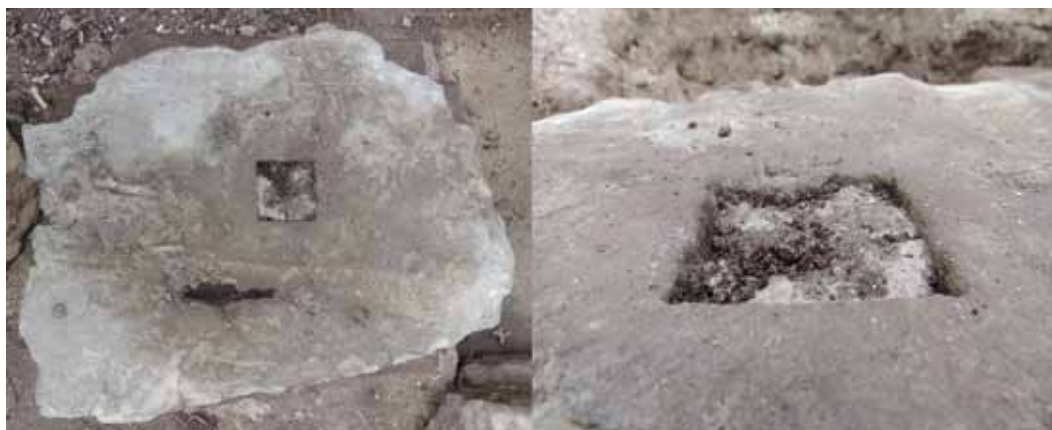
Fig 7: Stone 3 showing the square posthole in the center

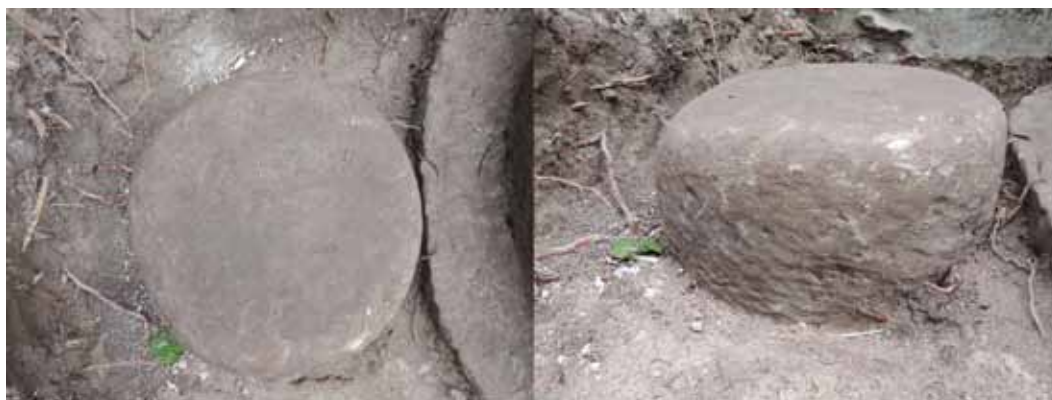
Fig 8: Stone 8 showing the extent of root growth within the soil

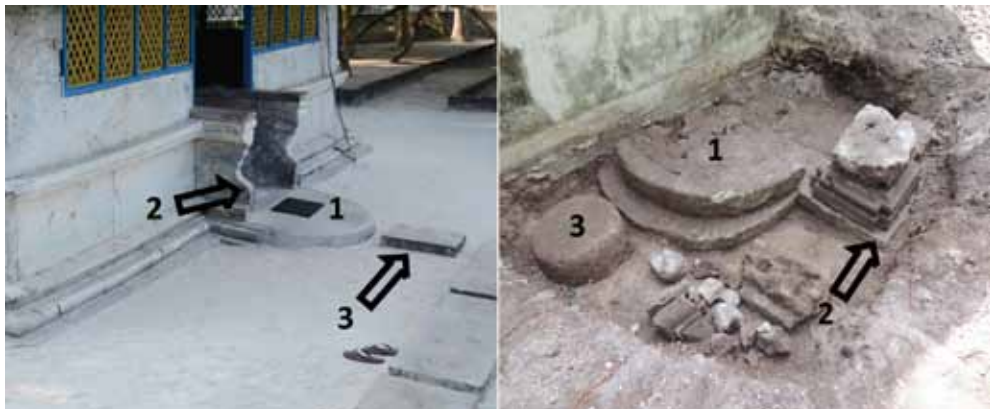
Fig 13: A comparison between the stone arrangements in R. Meedhoo Ancient Mosque and the stone structures recovered from Trench 1

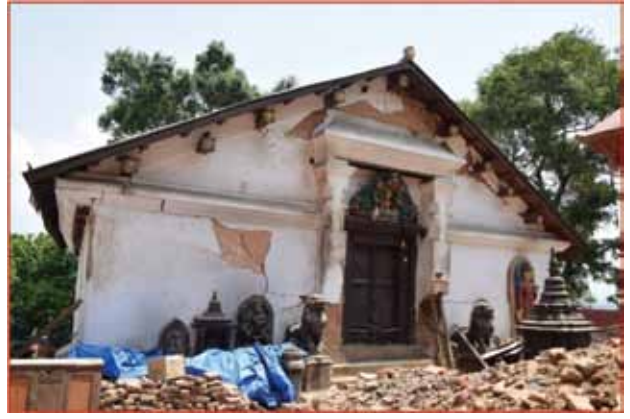
Partially damaged Shantipur Temple due to the earthquake—Swayambhu PMZ

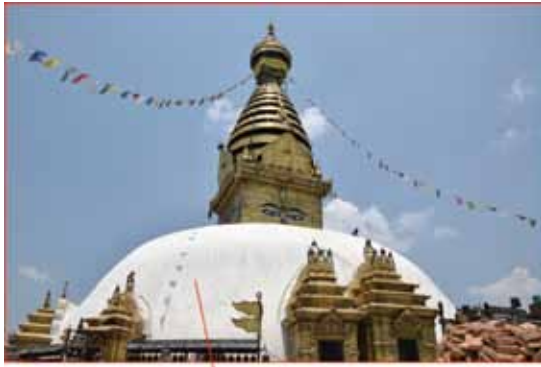
Some cracks developed in the dome of Swayambhu Mahachaitya due to the earthquake—Swyambhu PMZ

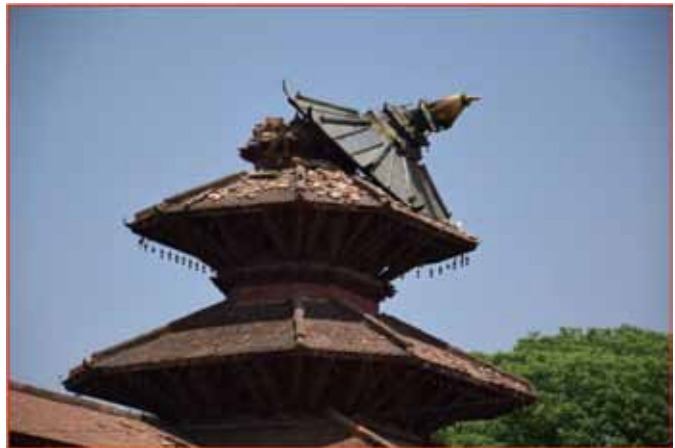
Broken pinnacle of Taleju Temple at Patan Durbar during earthquake

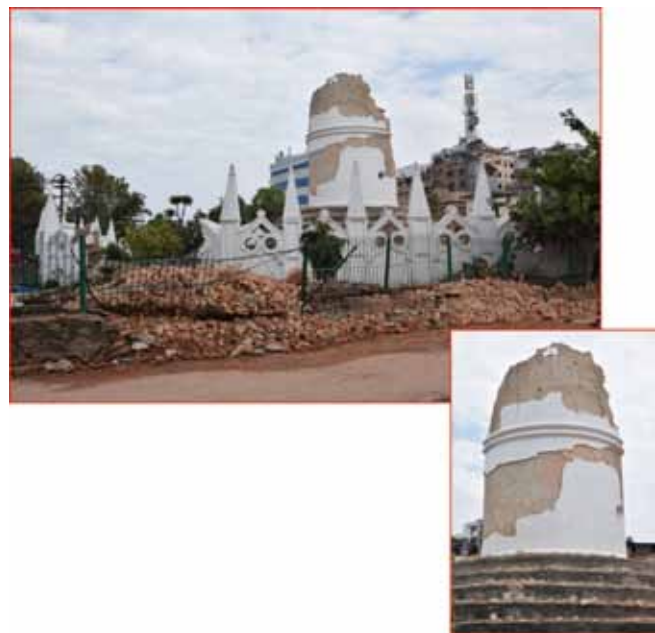
Collapsed Dharahara during the first earthquake on 25<sup>th</sup> april 2015— outside the boundary of a World Heritage Property in the Kathmandu Valley

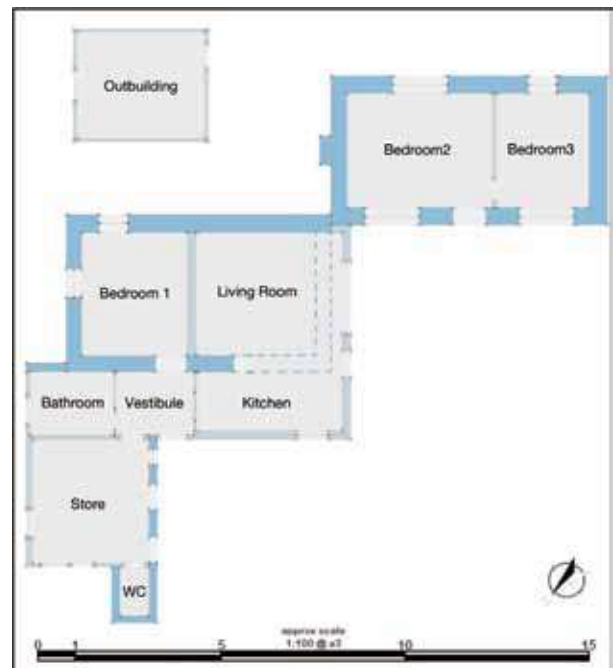
Figure 16. Plan of Beattie's Cottage by Andrew Winter/Jackie Gillies & Associates 2013.

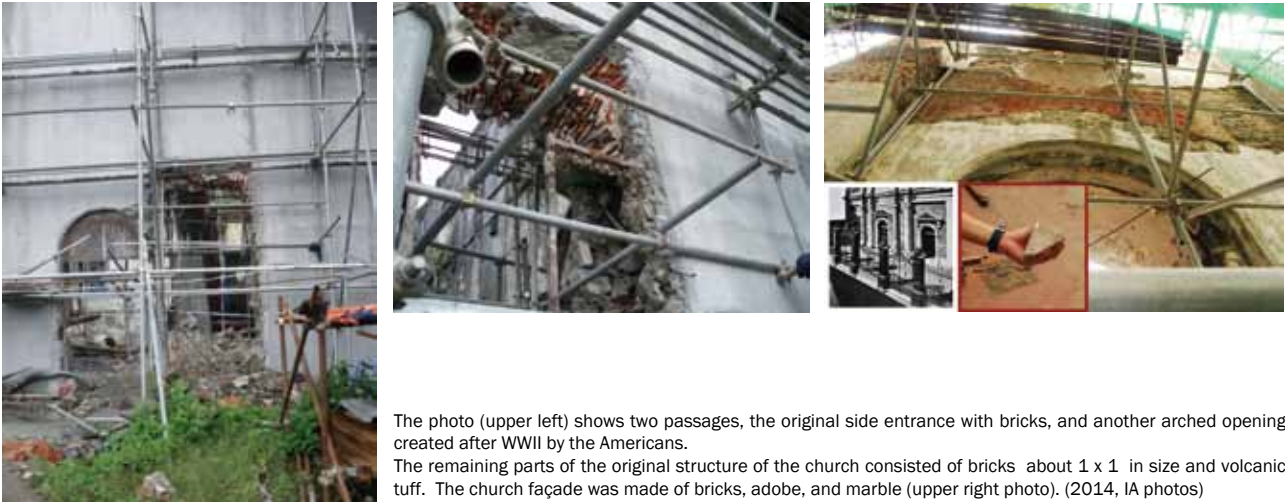
The photo (upper left) shows two passages, the original side entrance with bricks, and another arched opening created after WWII by the Americans. The remaining parts of the original structure of the church consisted of bricks about 1 x 1 in size and volcanic tuff. The church façade was made of bricks, adobe, and marble (upper right photo). (2014, IA photos)

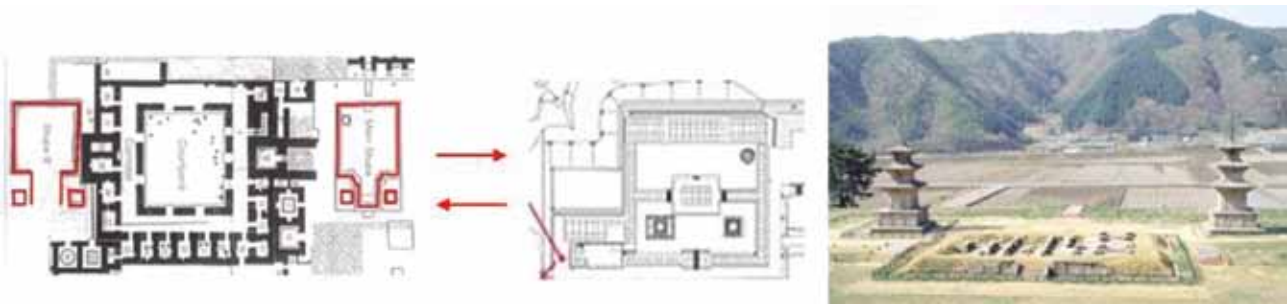
Fig.1 Plan of Stupas in Monastery Complex of Karatepa Buddhist site (Central Asia) & Stone Pagodas at Gameunsa Temple Site in Gyeongju (Korea).
