ACCU Nara
International Correspondent

Vol.18 2017

The Eighteenth Regular Report

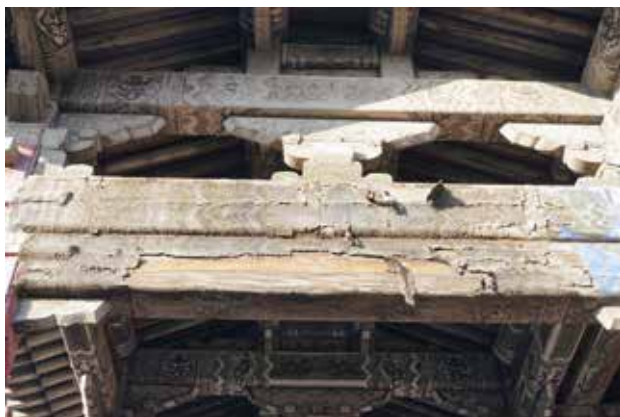
The architectural damage of the Hall of Mental Cultivation

Because annual maintenance is not completely finished many architectural components are seriously damaged. The glaze on roof tiles keeps peeling off, the mortar layers are decaying and coming loose, some components have been lost, and gutters are damaged; the timber structure has become rotten and the sinking of some components is obvious; the underneath layer of colored painting is sagging and partly peeling, the painting on the flying rafters is basically all cracked and peeling off, and some parts have flaked off already; a large section of the oil painting appears to be hollowing, peeling off and even showing the bare wood structure; the decorations on the eaves, silk fabric and paint have been damaged by insects, or are broken or missing; about 90 percent of the surface of the floor tiles in the courtyard appears to be somewhat damaged, and the undulating surface of the ground prevents the confluence of rain to the outlets, resulting in ponding in multiple places. These conditions affect the viewer's safety and the World Cultural Heritage image of the Forbidden City to varying degrees.

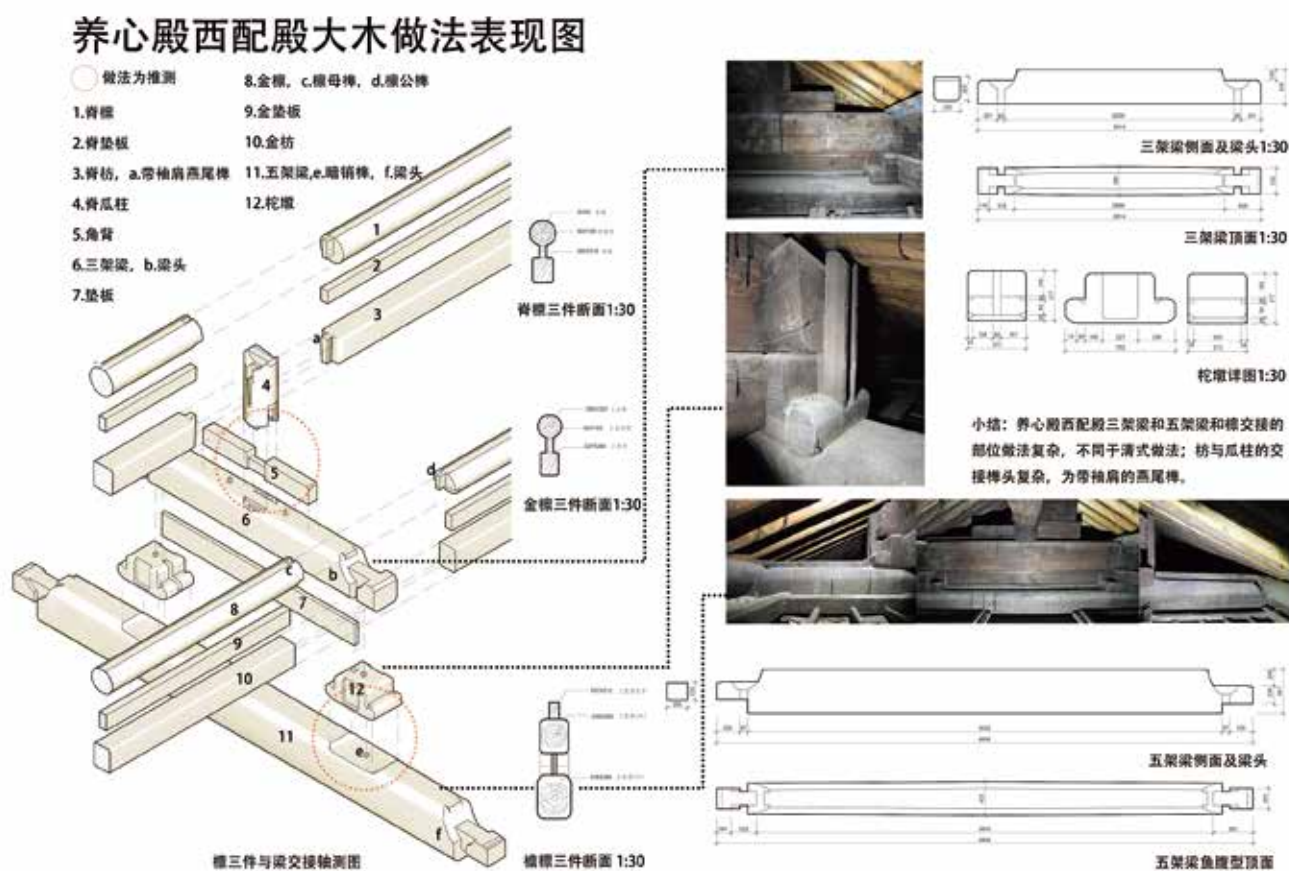
Analysis of timber structure

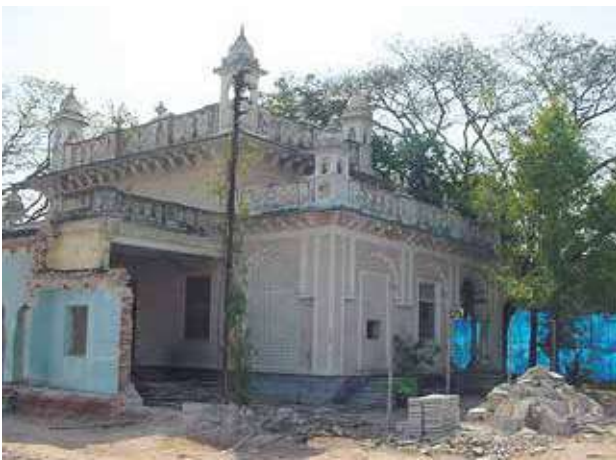
The CIB building before its conservation

on the south-east side of the hall. The walls, constructed with cement mortar not only enclosed the pillars of the structure but also damaged the capital, arches and columns. The century-old CIB building was weakened further due to all the demolition activities around it, and as a result, the roof and walls were rendered fragile. Over the years, various modifications had been made to the structure including dissenting additions and the use of inappropriate building materials, which had further damaged the structure.

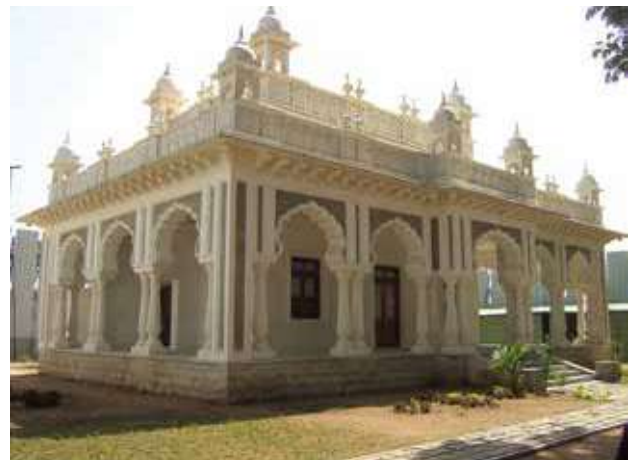
The CIB building restored

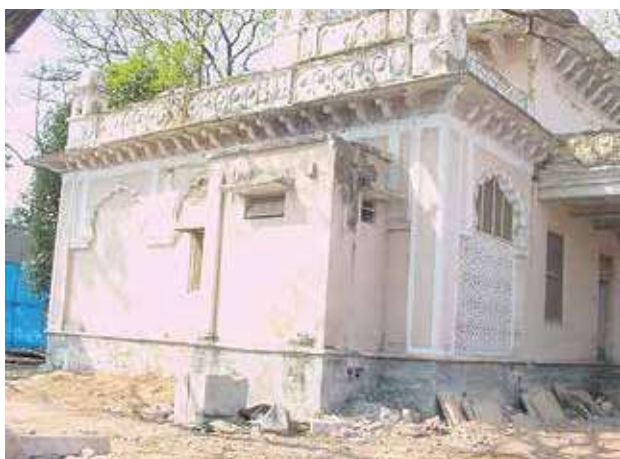
Enclosed verandah before restoration

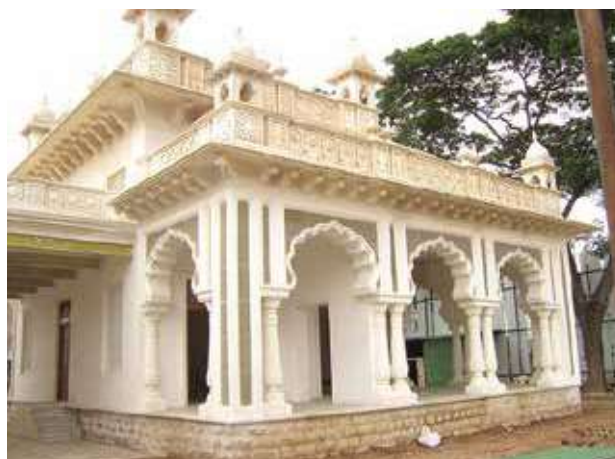
The verandah after restoration

the verandah, damaging the pillars, capitals, arches and the toilet inappropriately added on the south side, were dismantled.

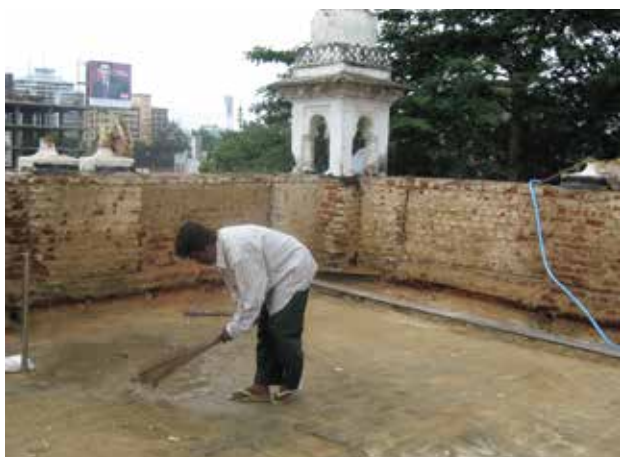
Cleaning of the terrace in progress

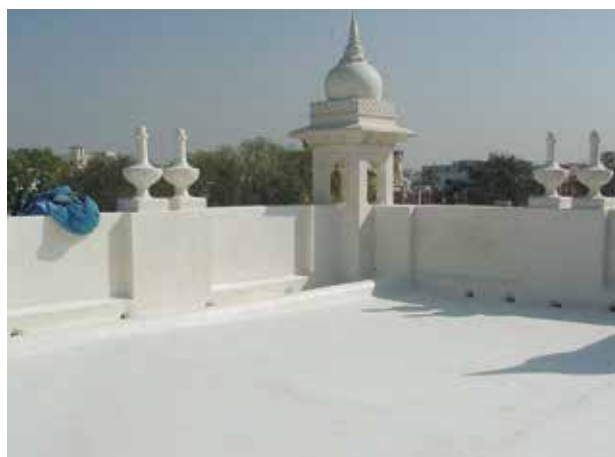
tiles were laid. Another layer of lime concrete prepared in situ by slaking lime stone and adding water with vegetable additives ensured complete waterproofing of the roof.

Waterproofed and finished terrace

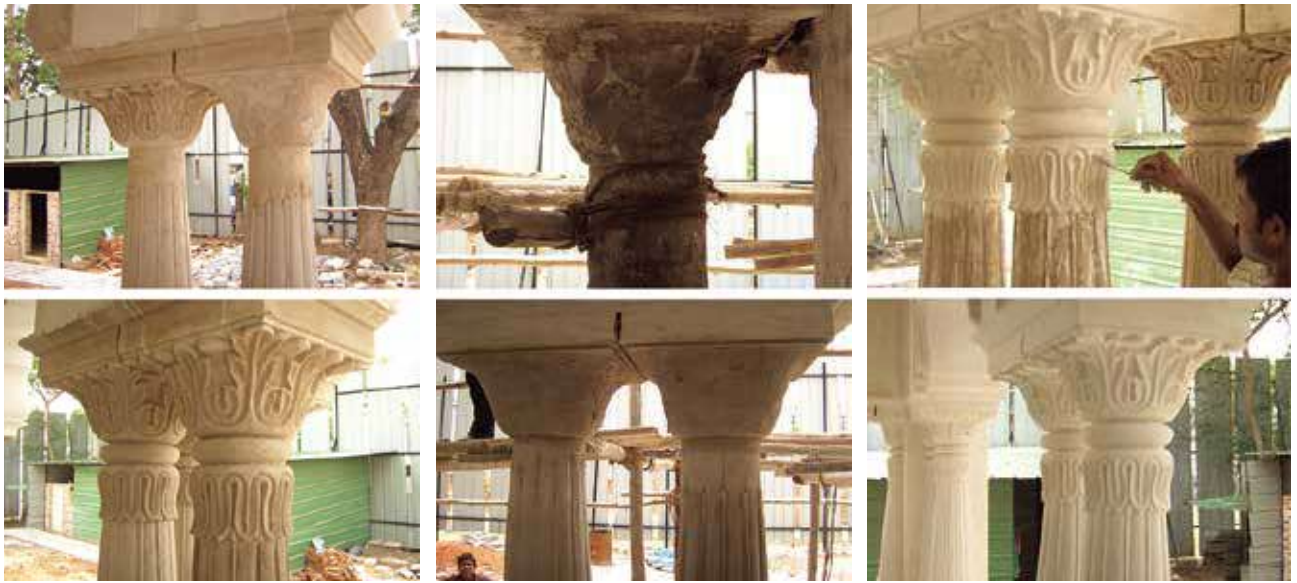
The column ornamentation before and after the lime finishing works

- The interventions made with cement were reworked in lime. The cornices, ornamentation, and other features which were spoilt were redone in traditional lime plaster. The entire building was finished in cebara, a fine

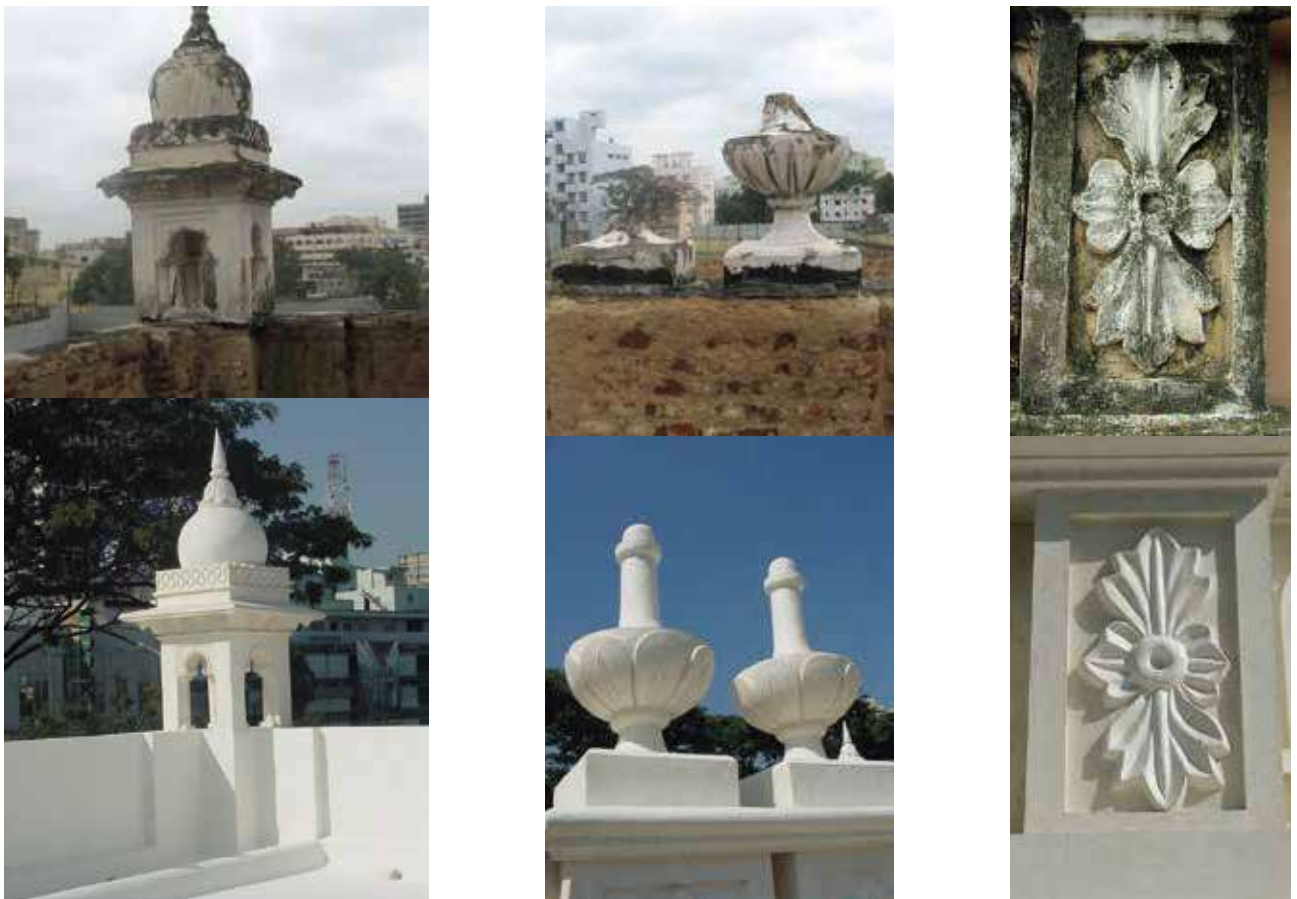
Kiosks, bowl-shaped finials and parapet wall detailing before and after restoration

- The damaged parapet wall, kiosks, vases and decorative ornamentations in plaster on both roof levels were redone. A total of ten kiosks on the roof were dusted with a soft brush and flaked plaster was removed. Twelve bowl-shaped finials were reworked and restored to their original shape and size.
- The projecting chajjas of the roof of the central hall are supported by 48 brackets, and the roof chajjas of the

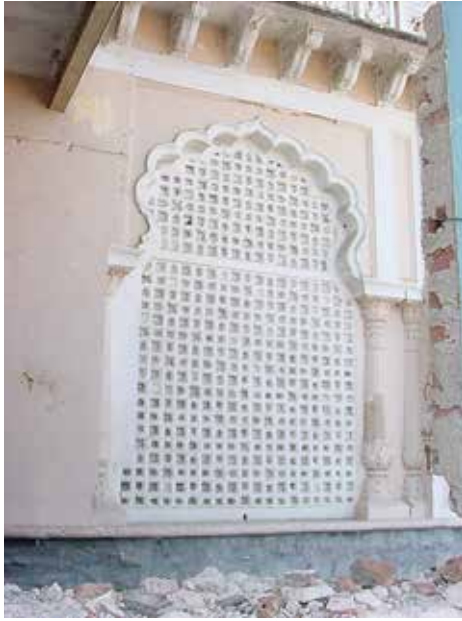
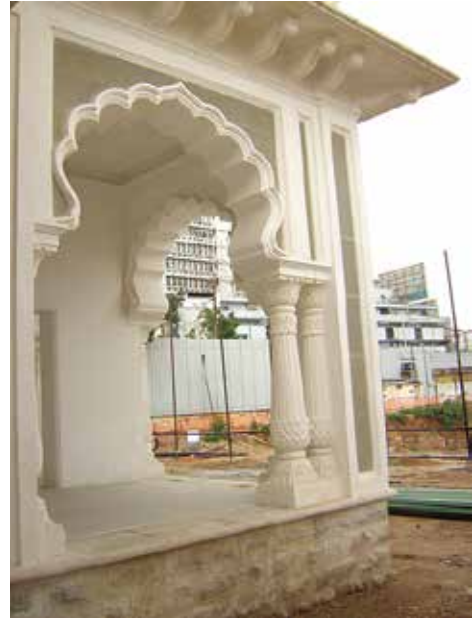
The revamped brackets of the chajja over the verandah before and after restoration

verandah are supported by 76 brackets, most of which were wrecked. These brackets were reworked and restored through the processes of cleaning, scraping of loose plaster and replastering with lime mortar.

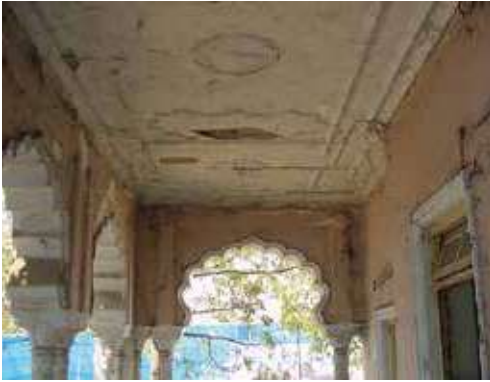
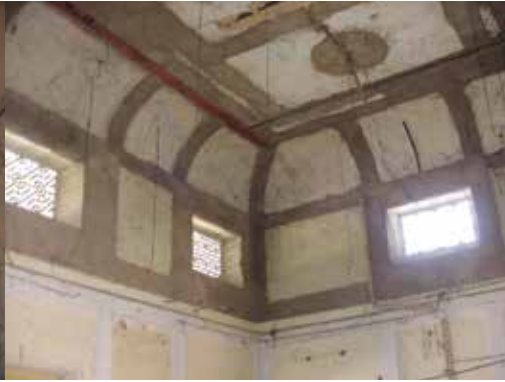
Images of the ceiling before restoration

- In the central hall, the blockage, obscuring the jaali screens of the clearstory windows was removed. The cement repair work done previously to the high ceiling was thoroughly scraped off and lime mortar was reapplied. The steel sections were scraped and an anti-corrosive coating was applied.

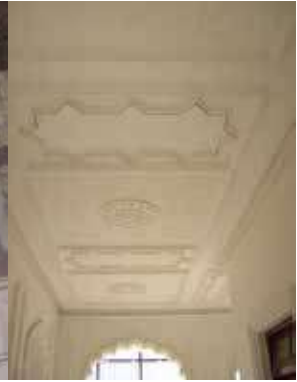
Finished ceiling

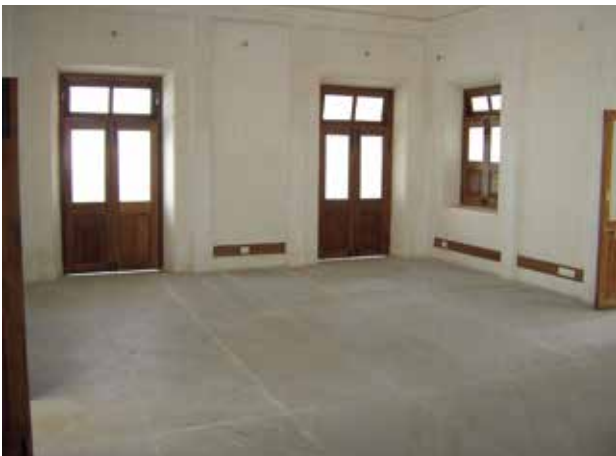
The installed doors and windows

- The door, window frames and shutters were cleaned, polished and installed in the same position, except for two windows on the eastern wall, which were enclosed with jaalis
- The walls, cusped arches and the portion above the capital of the pillars decorated with pilasters and cornices which were restored. The portion above the cusped arch in the exterior façade, which was covered with

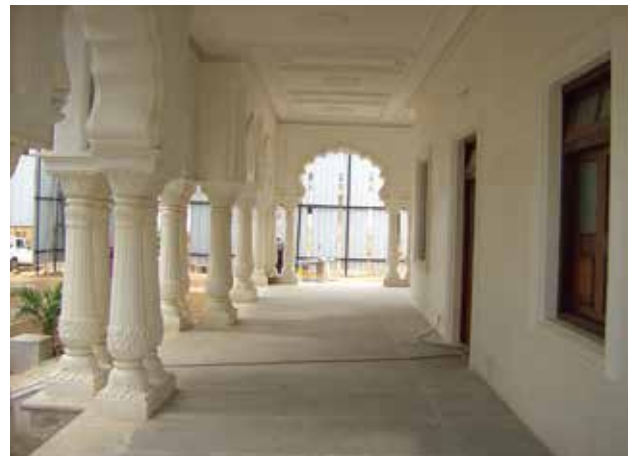
The finished verandah

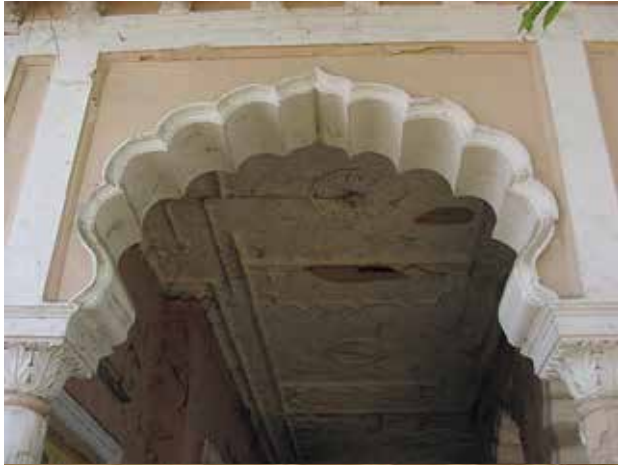
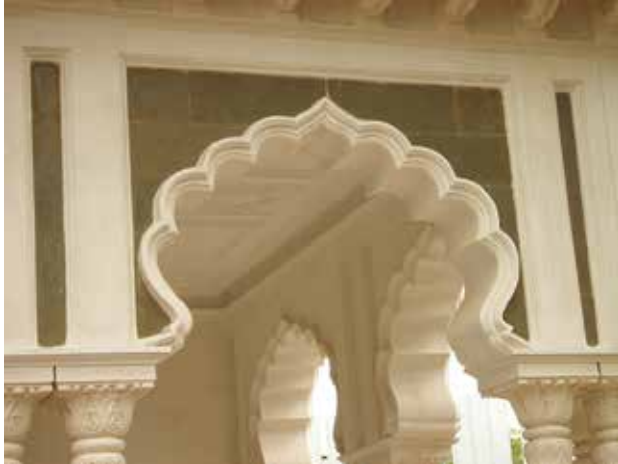
The cusped arch façade with Shahbad stone before and after restoration

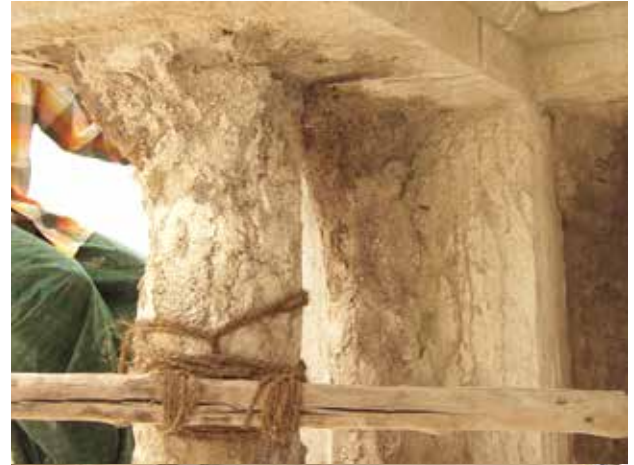
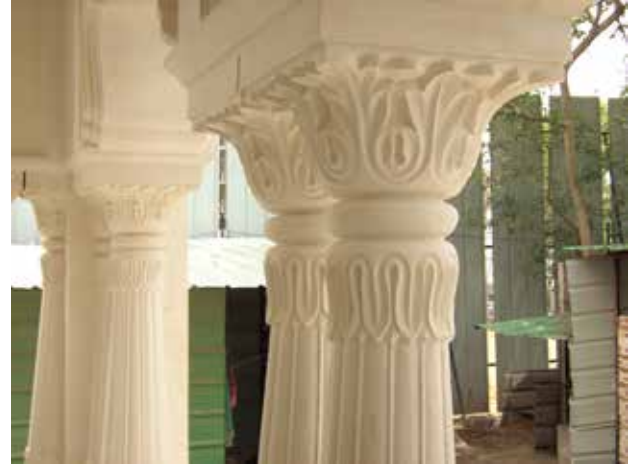
The column capitals before and after strengthening and finishing

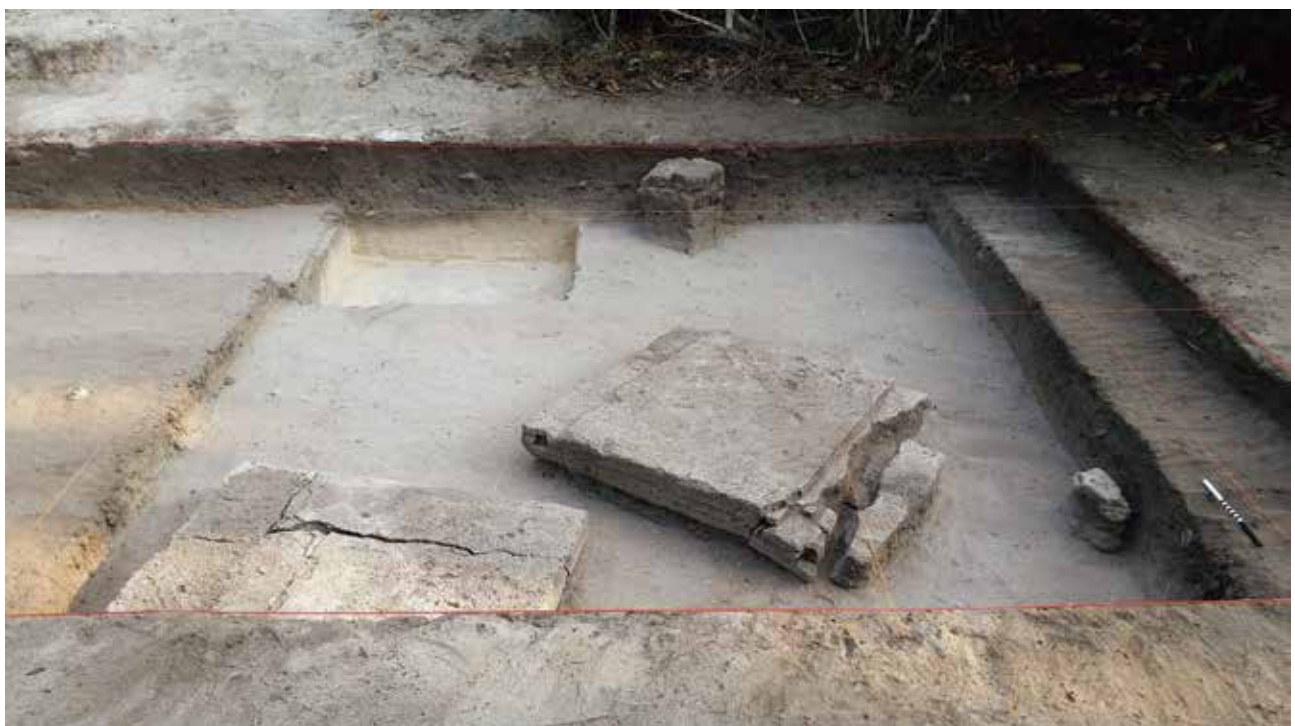
Fig 1: Trench at Ha. Utheemu (Haour 2017)

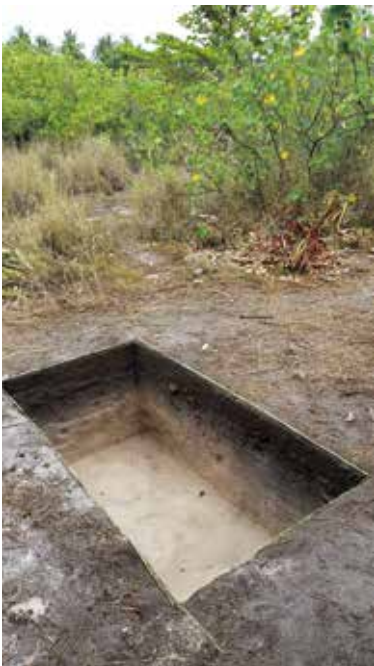
Fig 5: Trench 443 (Christie 2017)

sampled at the western end by digging shovel test pits every 20 m with some amount of clearing through the forest in order to be able to excavate and move around. A total of 45 test pits were dug within this area and the finds were compared with each other to determine where to conduct large scale excavations. Finds included pottery, and faunal and stone remains. After focussing on the particular concentration of materials, seven of these test pits were selected for large scale excavations, which were trenches 325, 321, 449, 544, 631, 443 and 360.

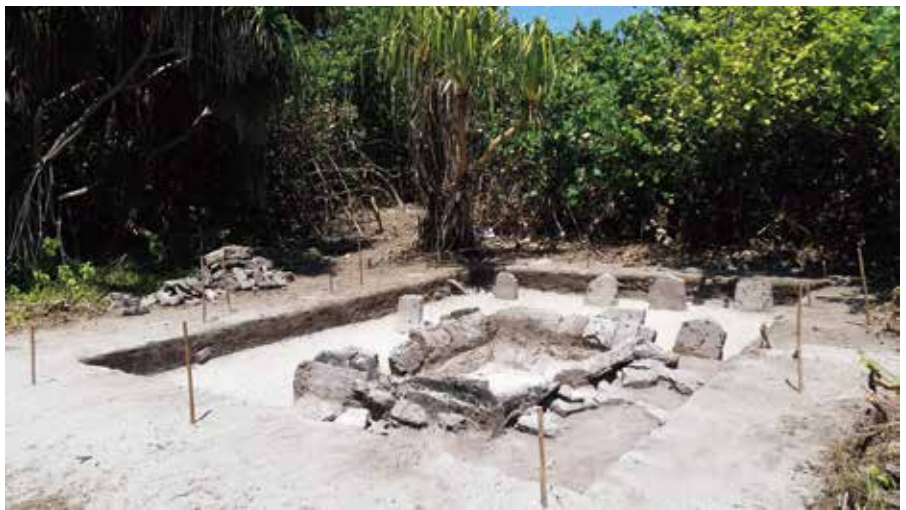
Fig 6: Trench 631 showing funerary features (Christie 2017)

subsequently found to be tombstones in varying degrees of fragmentation. The remaining sandstone rubble was provisionally interpreted as having come from the destruction of the associated rectangular structure. The coral stones in the rubble represented the remains of at least six tombstones. Moreover, a dispersal of many large fragments of Chinese porcelain (mostly fragments of bowls) was recovered and associated with the coral and stone rubble mound.

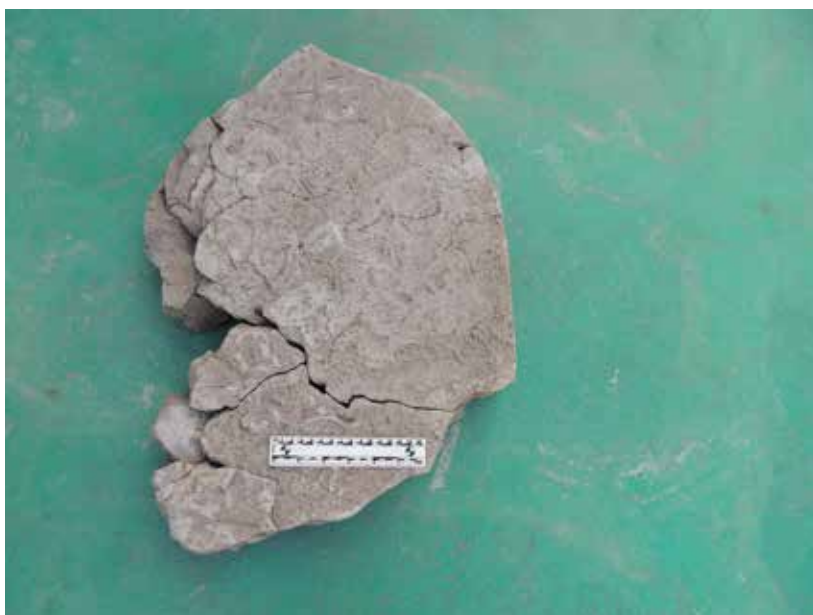
Fig 10: Gravestone from trench 631 (Vigouroux 2017)

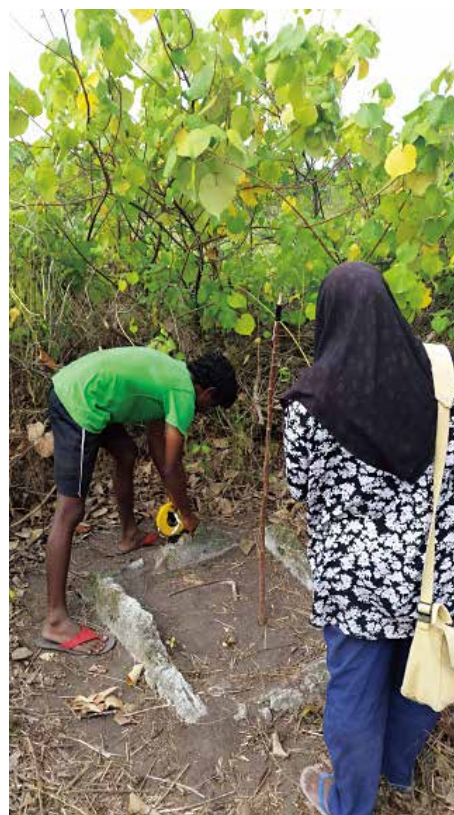
Fig 11: Recording a squared well (Haour 2017)

Moreover, due to the presence of many quadrilined features within and around the study area, an area of roughly 50 x 100 m was surveyed to document and map any stone features including measurements, photographs and GPS points for each feature. This resulted in the recovery of about 21 features (both coral and sandstone) including a probable bathing tank as well as remains of wells, tombstones, walls and other domestic features.

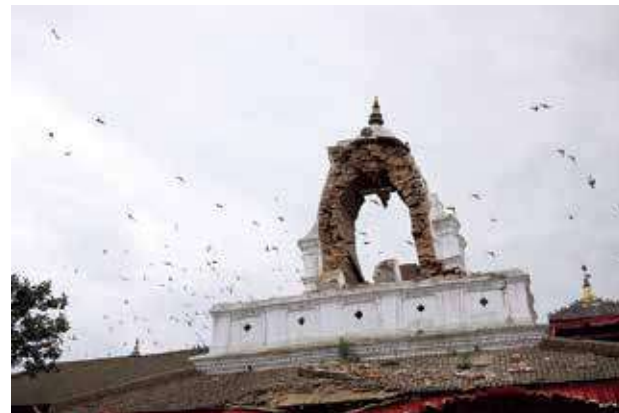
Kageswor Mahadev Temple during the April 25th earthquake.
(Photo:2015-04-25)

The temple suffered major damage during the earthquake of April 2015. The *Shikhara* collapsed and the fall had a considerable impact on the skirt roof, breaking a few rafters on the northern side. Due to violent shaking, the roof was out of plane in many places and a thorough physical assessment revealed that the walls of the solid masonry core were bulging out above the cornice level on the ground floor.

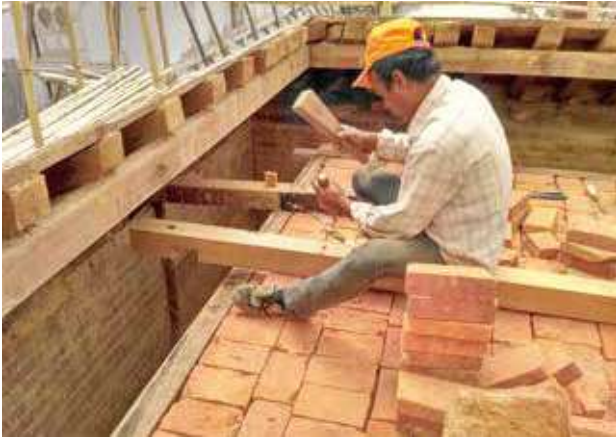
Carpenters preparing the new timber sections on site, which shall replace the affected and non-reusable timber sections. (Photo: 2017-03-31)

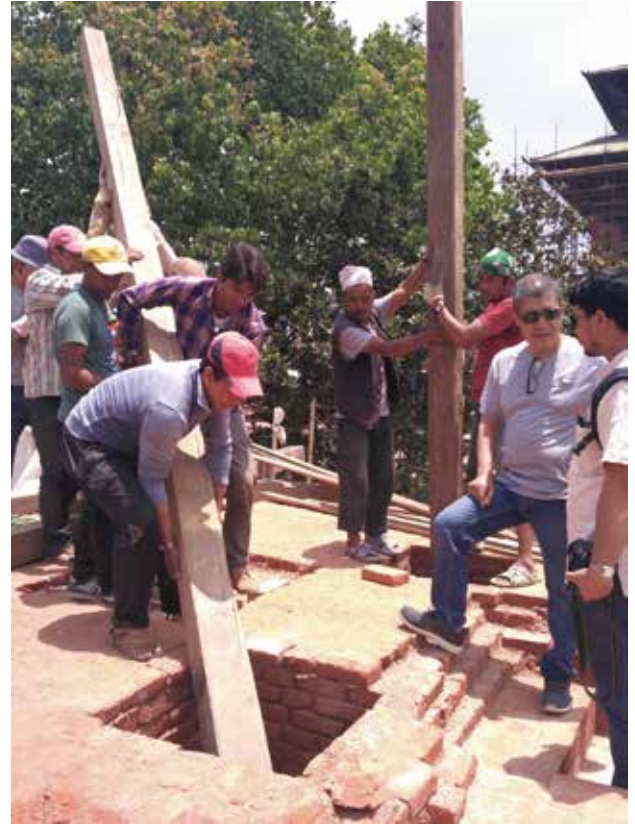
Upright timber posts were erected at four corners of Shikhara. The portion of timber embedded within the brick masonry was coated with bituminous. (Photo: 2017-05-25)

For further protection against rising moisture, all the timber coming in contact with brick masonry was coated with bituminous paint. For those timber members that are to be embedded within the masonry core, copper plate wrappings were provided.

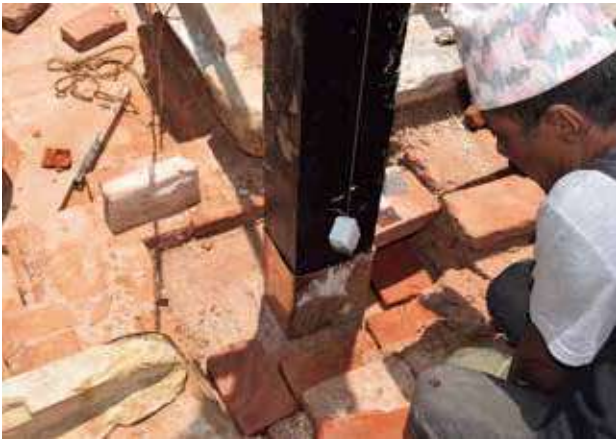
The bottoms of the timber upright posts to be embedded within the masonry were coated with bituminous paint and wrapped with copper sheets for protection against moisture. (Photo: 2017-05-25)

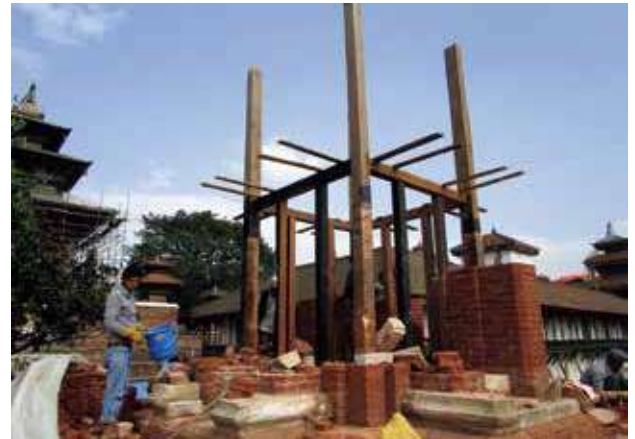
The corner timber posts are tied together at regular intervals with timber tie beams for seismic strengthening. The upright posts on either sides for the sanctum entry are also provided. Such timbers are embedded inside brick masonry and are under constant threat of moisture penetration; to avoid such conditions necessary barriers are provided. (Photo: 2017-06-11)

During the rebuilding of the *Shikhara* in brick masonry, care was taken to provide copper rod ties at regular intervals to tie the thick masonry wall. The brick cornices and the turret details were reproduced to match the original details. At present the lime plaster works on the surface of the *Shikhara* is ongoing.

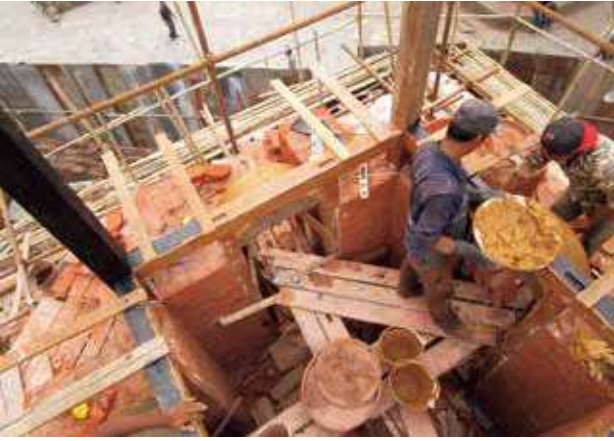
Constructing the arches above the entry to the main sanctum. (Photo: 2017-06-15)

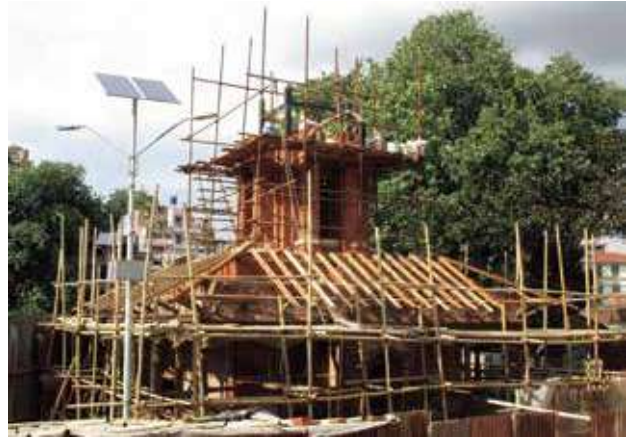
South-west view. The skirt roof rafters are being laid while the shikhara structure continues to rise. (Photo: 2017-06-26)

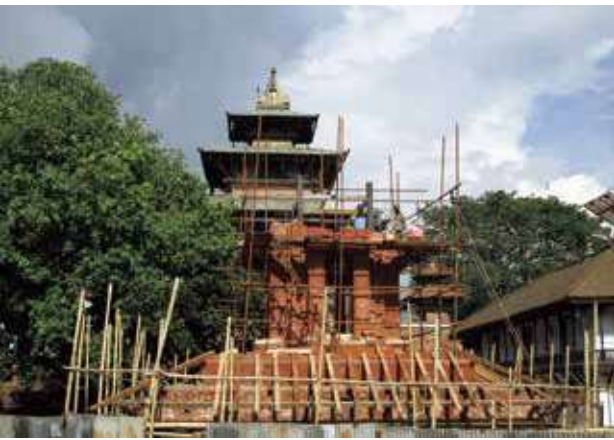
Shikhara structure turrets construction continued with rafters on the skirt roof below. (Photo: 2017-06-26)

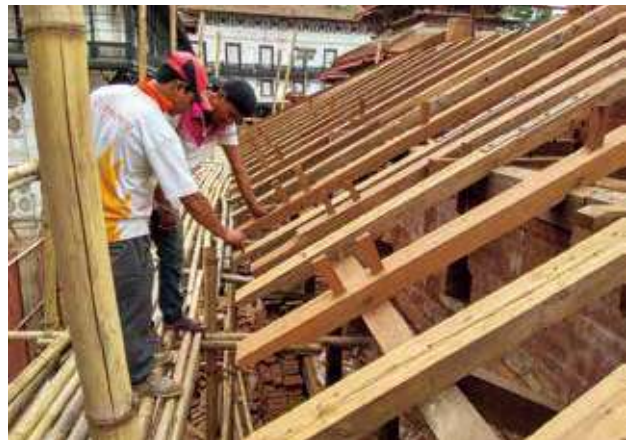
New timbers were used for rafters of the skirt roof. Each rafter is properly aligned and fixed in place using wooden pegs. (Photo: 2017-06-30)

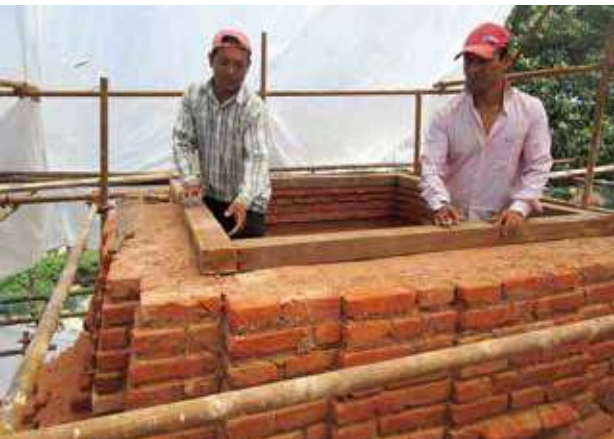
Timber wall plates provided at important levels of the Shikhara. (Photo: 2017-07-17)

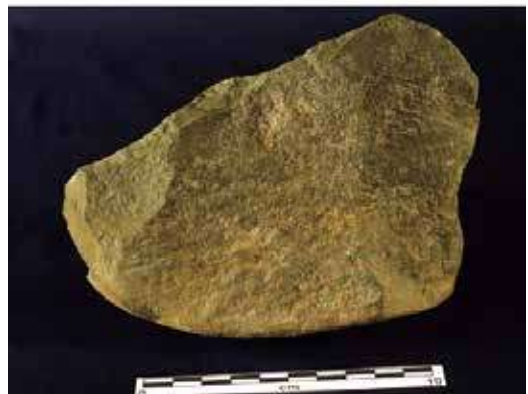
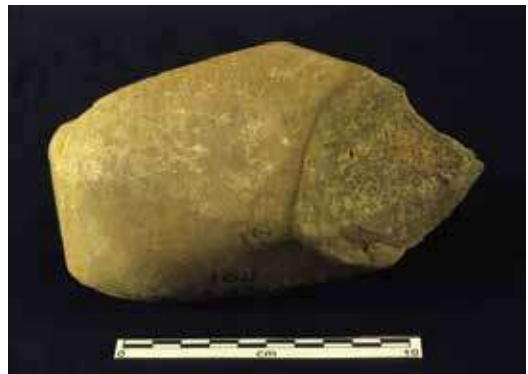
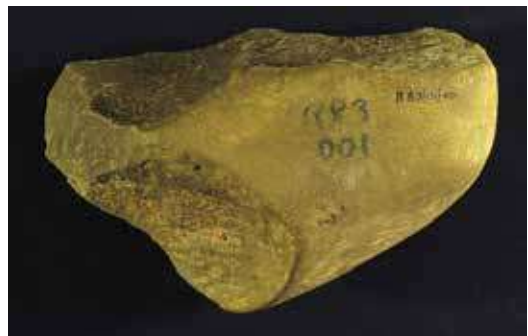
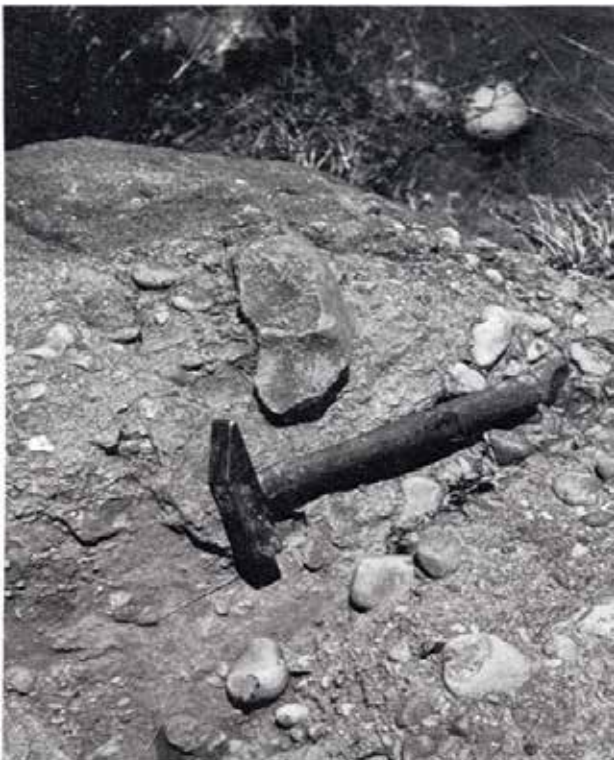
Rawat, Potohar Plateau, Pakistan Gravel deposits, with fresh looking stone tools on the uppermost levels that are dated to two million years. The tools are more likely to have been flaked by hominids

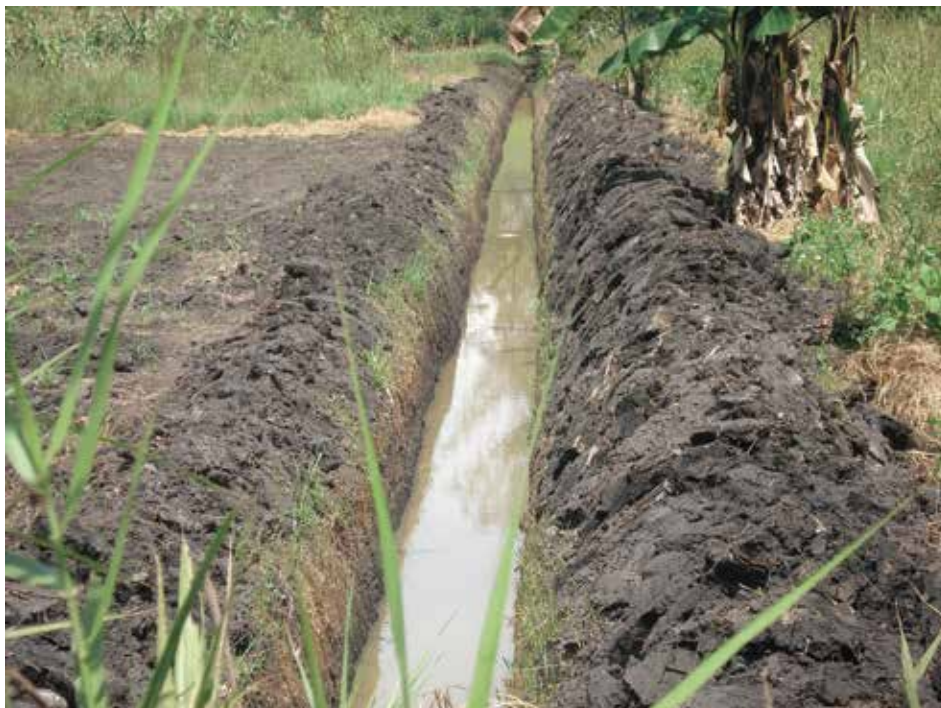
Drain dug by locals near core area/excavated site for gardening (Photo: J. Onga, 2010)

Deep Drainage - Drainage is necessary at Kuk for the maintenance of gardens. However, drains deeper than 0.5m have the potential to seriously impact the preservation of archaeological evidence. The construction of new drains or the re-digging of old drains may lead to the direct damage of buried material. Deep drains may also lead to a significant lowering of the water table, leading to decomposition and oxidation of buried organic materials, and soil formation that would destroy archaeological features and inter-mix deposits of different ages. Locals have been advised not to dig deep drains to drain out excess water for gardening. It is understood that heritage values beneath the soil are maintained by the water level and deep drainage may affect the value if such drains are dug.

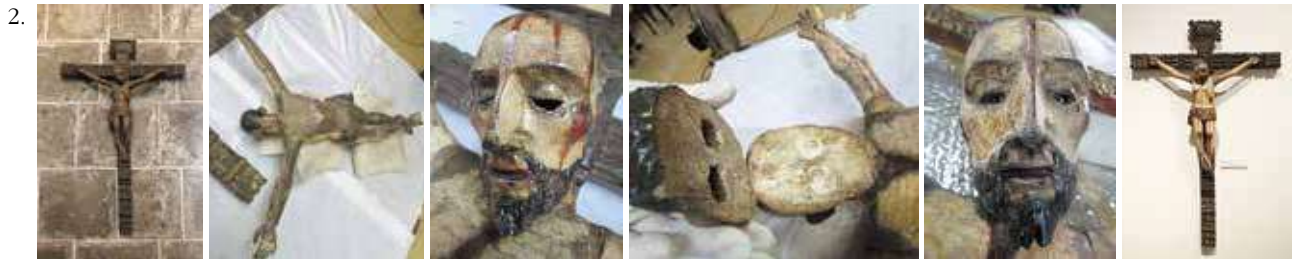
This is another 18th century Mexican Crucifix that measures 139x 90 cm in height. The surface of this Mexican Crucifix had turned dark. There were localized paint and structural losses. From optical observation, one glass eye of the image appeared to be missing. Traces of insect eggs were present on the surface of the cross. Mechanical cleaning was initially done to remove dirt and dust. Solubility tests on the paint layers were done prior to the chemical cleaning process. There are ground and paint losses. Paint colors used for the skin tones and representations of blood in yellow ochre, green, black,

red, beige, and brown are still intact. The depiction of the loincloth around the waist of the image of Christ has traces of gold leaf. The head of Christ is composed of two pieces of wood which are already loosely attached to each other. The missing left eye was found in one of the holes of the eye in between these two pieces of wood. The right eye was full of soil particles. Mechanical and chemical cleaning was done before restoring the eyes and the head. When carried, the weight of this image of Christ is heavy compared to the other Mexican Crucifixes because of the kind of wood used for this image.

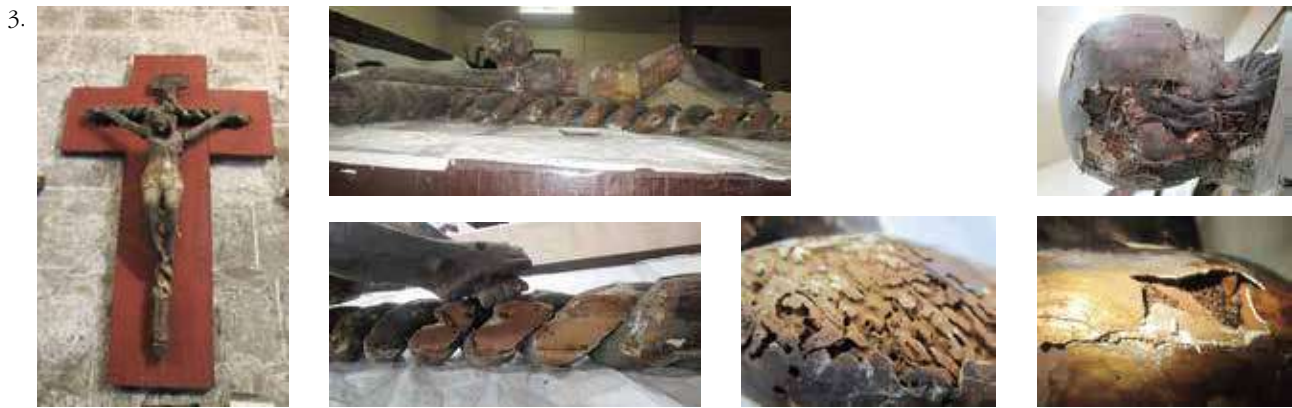
This is an 18th century Mexican Crucifix that measures 175 x 108 cm in height. This crucifix suffered severe damage due to biological attacks. Insect excretions can be found.

There are dirt, dust, stains, and discoloration of paint. Gesso, paint, and structural losses are also evident.

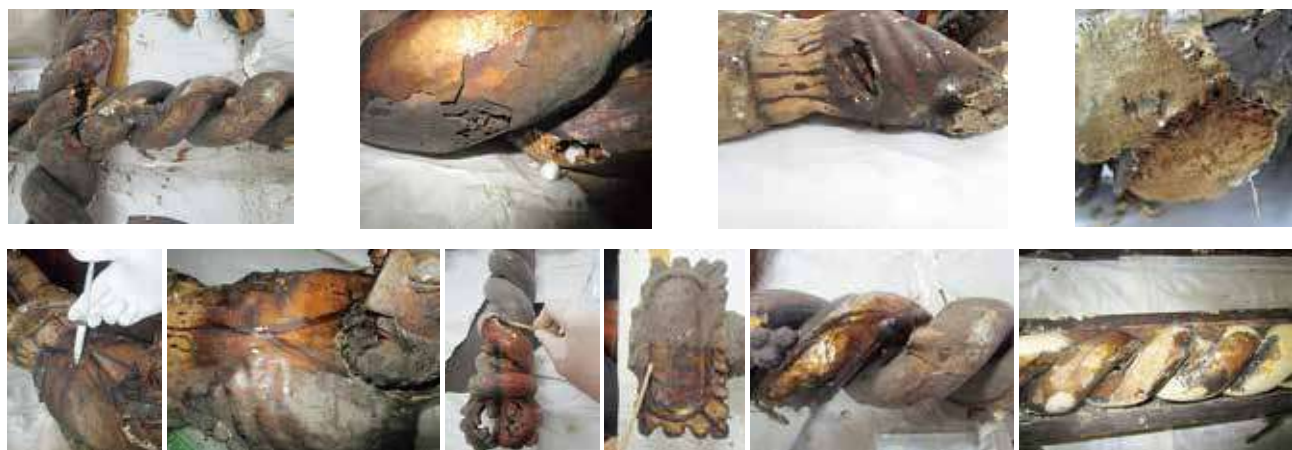
Note the remarkable artistic intent and aesthetic creation of the artist on the wound, blood, and ribs using creative forms, a variety of materials and colors. Except for some small holes and cracks, the paint colors of the blood on the body of Christ are still intact. There is an embossed portrayal of the grape vine on the cross, a Christian symbol. The materials and method used for the body and the cross

The Universal Principles in Conservation and Restoration were practiced during the process. Reversible materials were used for the consolidation of loose paint layers and textile, for fillers, and for retouching. The original paint layers and gilding were softly cleaned and retained. Only the areas with ground and paint losses were retouched. Areas of damaged support were reinforced and maintained. Methods used in the art of retouching were applied. By using this process, the original paint layers and retouched areas are identifiable. It is of great importance that we preserve these works of art for future generations to appreciate and to learn from.

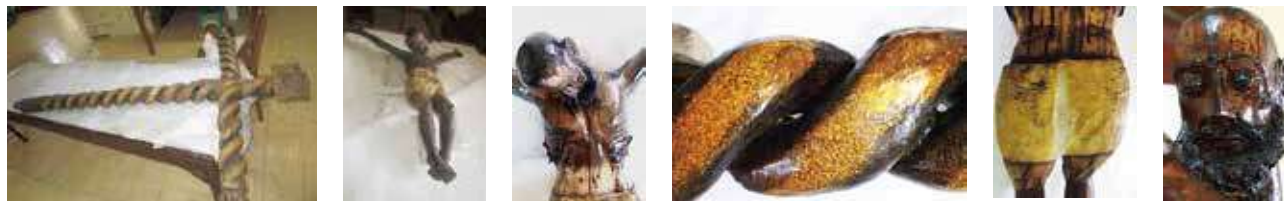
The use of sized cloth or textiles in creating these kinds of crucifixes allowed the creation of multi-material constructions and facilitated easy formation of delicate parts often difficult to carve. Sized cloth also served for restoration or reworking purposes during the restoration of the crucifixes.
