ACCU Nara
International Correspondent

Vol.19 2017

The Nineteenth Regular Report

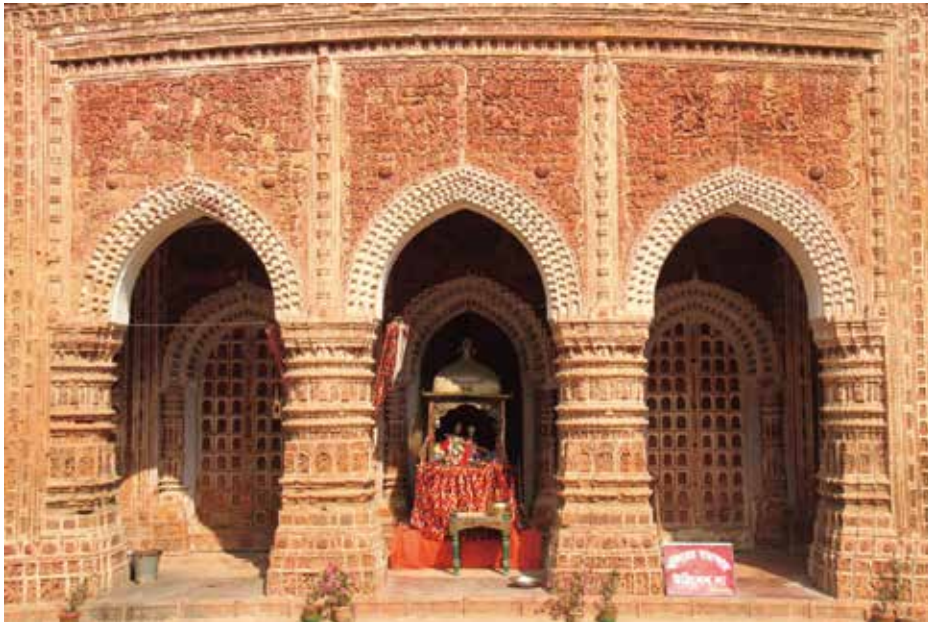
Pillars, pilaster and three arches of the temple.

Architecture: This temple is square in shape and established on a 1-metre-high stone platform from ground level. It is known that the temple was 21.33 m high from the ground level. Every wing of the stone platform is 18.28 m long and constructed in the same square shape of the temple, with every wing being 15.54 m in length. There is a 2.43-metre-wide *varanda* or corridor all around the temple. Every *varanda* or corridor has two large pillars and three pilasters. In the gaps of every wall and pillar there are as many as three large entranceways.

These open passages are constructed with the help of two centred arches. The main prayer chamber of the temple is small in size as well as obsessed. A *Kantajiu* image is placed in this room. There are some small cells around the main prayer chamber. The temple is constructed in the shape of *Dol Mancha* Temple. The 1st floor is smaller than the ground floor and it actually has no rooms. Similarly, the 2nd or top floor is smaller than the 1st. Among the nine

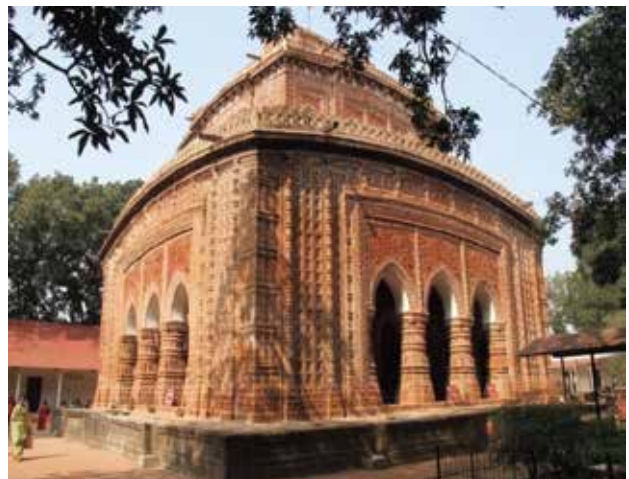
The present condition of the temple.

jewels, four jewels were established at each corner of the top of the roofs of the ground floor and the 1st floor, with only one jewel established on the 2nd floor. But these nine jewels were badly damaged by the terrible earthquake of 1897. The temple was largely destroyed in this earthquake.

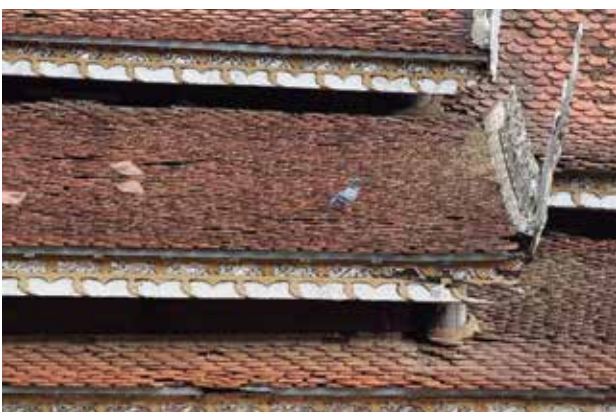
Fig 5. Broken adorned roof elements

- Finials and adorned roof: Cement decorations like roof finials, decorative finials (*chovea*), pediments, and ending finial naga (*neak cheng*) were damaged in many places, and decayed wooden beams support the roof in a saddleback structure (Fig 5).

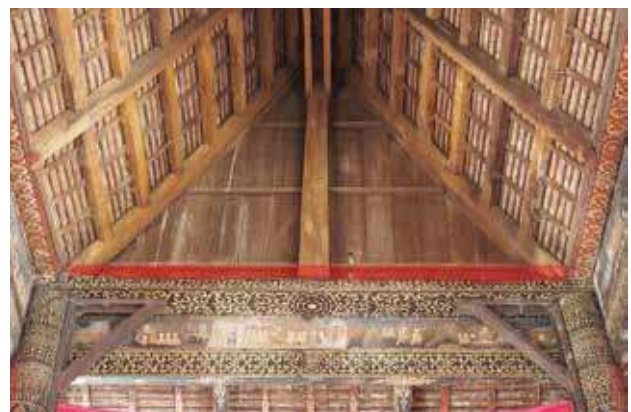
Fig 6. The broken main beam

Since 2013, the main beam, upper wall, and ceiling above the Great Buddha statue fallen down due to the poor condition of the structure of the Preah Vihear, which showed the weakness of this building. This Vihear had not been maintained in years, and its structure and mural paintings were heavily damaged in several main sections as follows:

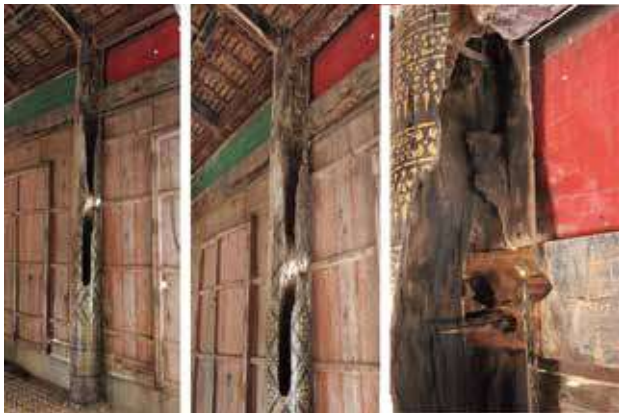
Fig 7. Column condition and detail

- Columns: In total, there are sixty columns which support the entire structure. Each column is lacquered with decorative patterns in stenciled gold. Typically, the lacquer and stenciled gold on each column were scaled and decayed, and the columns were cracked or broken at the top and bottom, with stains caused by moisture and salt. Five columns were at high risk of collapse (Fig 7 & 8).

- Cause of damage: Almost all columns were damaged by the elasticity of wooden material, the humidity of the tropical climate, insects, and human activities including war. Almost all of the columns had lost the center part and bottom (See Fig 7 & 8).
- Treatment: Among the restored columns, those which

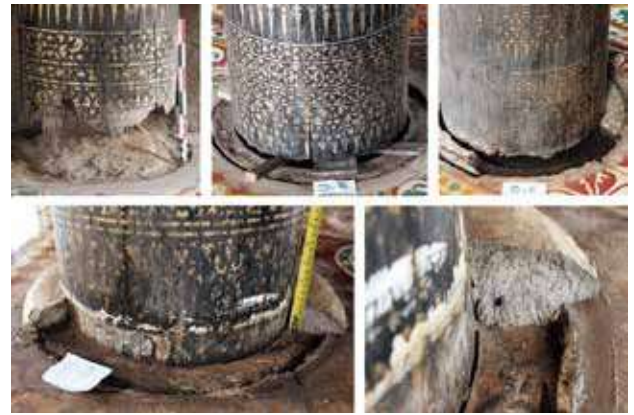
Fig 8. Condition of the bottom of columns

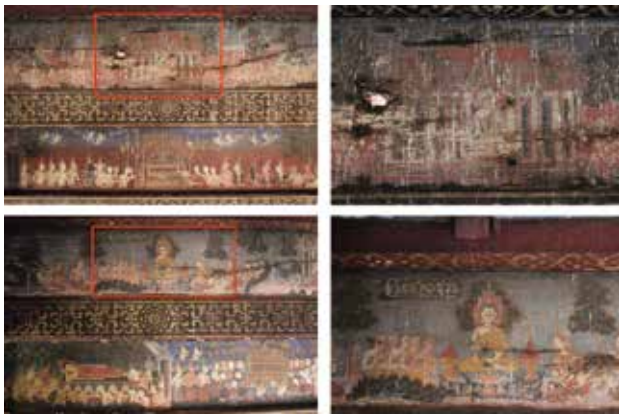
Fig 9. Condition of the upper wall mural paintings

- Mural on upper wall panel: In 2013, one of them fell and was heavily damaged. The pigment was scaled in general and dirty from bat and pigeon excrement (Fig 9).

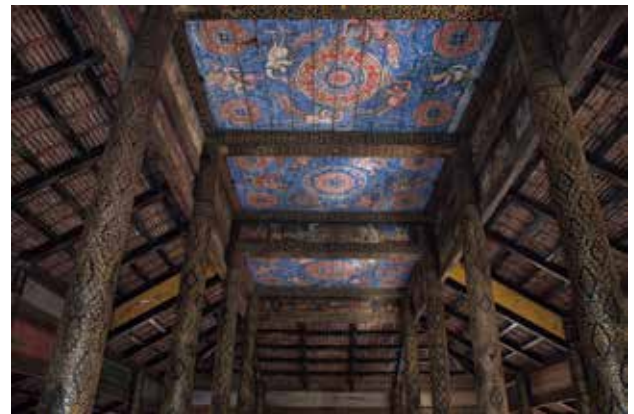
Fig 10. Interior view

Careful study of the condition of the sixty columns which decorate and support the building structure of the Preah Vihear revealed that the majority of them were covered in dust (Fig 10), and that lacquer and gold stenciled decorations had been removed. There were also gaps on the bottoms of the columns and traces of insect attacks on the wood. It was also observed that certain portions were missing from the painted parts.

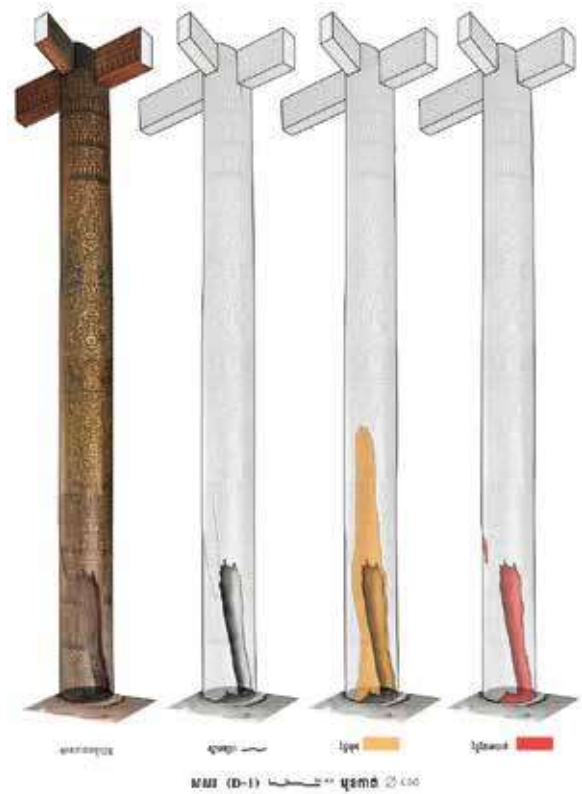
Fig 13. The conservation process for columns

- Emergency treatment of each column by pre-consolidation of the degraded spots of the pictorial layer with an adhesive which removed dust from the surface of the lacquer and gold stenciled decorative motif;
 - Cleaning spots with water and weak ethanol solution, which started with a trial cleaning of the decorative surface of the columns, including both dry and wet cleaning (Figs 11 & 12);
 - Removal of salt from the surface of the lacquer;
 - Replacement of the middle broken vertical hole of columns with new timber for strengthening the structure, and filling the gaps with a mixture of wood sawdust and natural resins (Fig 13);
 - Fixing the scales or gaps on the surface with a mixture of wood sawdust and natural resins or adhesive solution (Fig 14).
- Leveling the structure: Lifting up the reclining structure including the columns to set it at the proper level (Fig 15).

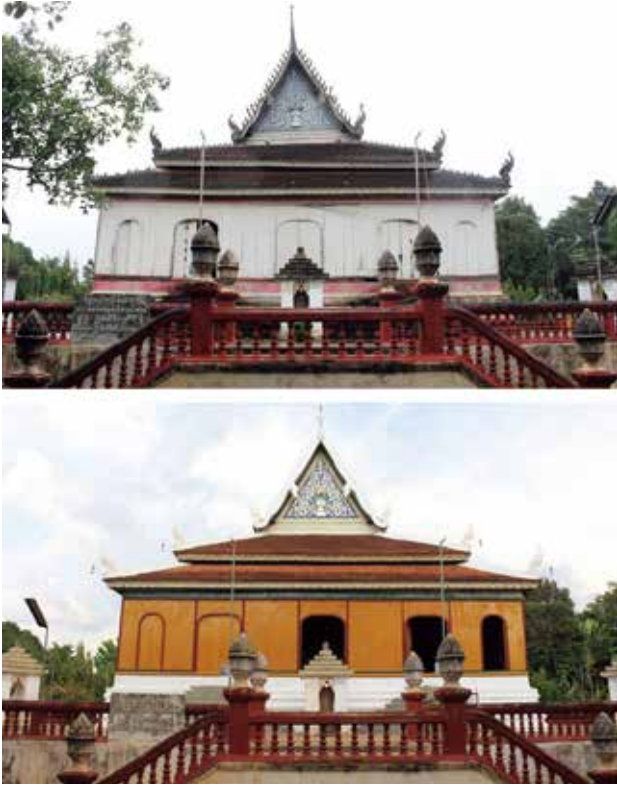
Fig 22. West view: before and after restoration

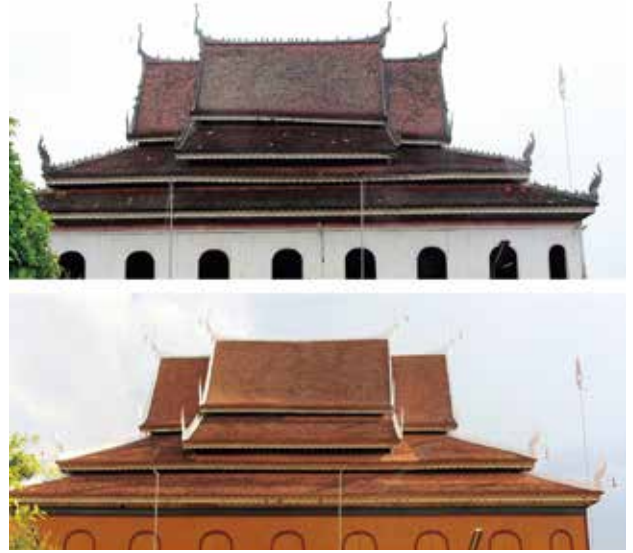
Fig 23. South view of the roof: before and after restoration

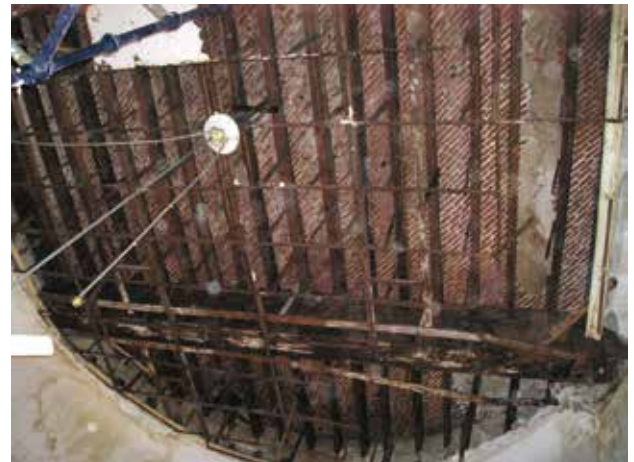
The exposed Madras terrace roof after removal of the false ceiling tin sheets with the deteriorated primary beam

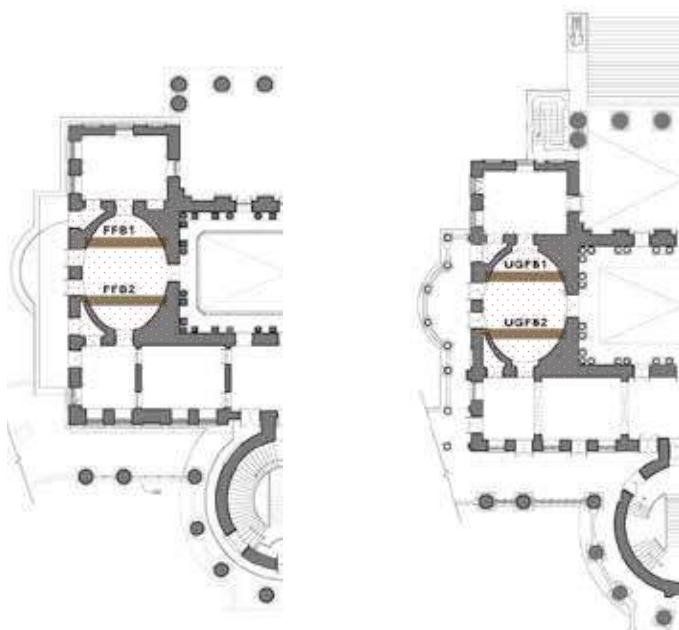
The upper-ground and first floor plans showing the primary beams in position and the roof area under collapse and reconstruction

The original beam (FFB2) from the first floor ceiling collapsed from the terrace, bringing down with it part of the first floor roof, as well as the beam (UGFB2) from the upper ground floor ceiling. The existing condition of the huge teakwood beams, measuring 0.45 x 0.35 x 8.6 m, was thoroughly assessed by conservation architects, a team of skilled carpenters and through Ultrasonic Pulse Velocity testing (Non Destructive Technique) to identify deteriorated sections of the beams, determine their homogeneity and detect the presence of cracks, knots, voids, etc. After assessing the condition of all the beams, it was concluded that the beam UGFB2 had broken into three parts and if

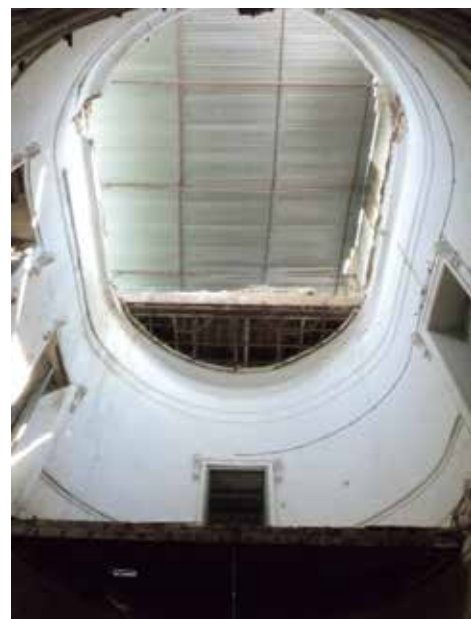
A worm's eye view of the oval room with the exposed temporary sheet roof, after careful dismantling of the Madras terrace roof components and primary beam FFB2. The FFB1 beam remained intact.

The Madras terrace roof over the western oval room collapsed in 2014. A temporary sheet shed was constructed on the terrace above this roof to protect it from rainfall but the collapse was inevitable. The causes as detailed in the previous report were: deterioration of the beam due to termite infestation, rotting of beam ends due to water ingress from the terrace over decades, less bearing of the beam on the masonry wall compared to its size and span covered, and increased dead load from roof due to multiple additional layers of waterproofing.

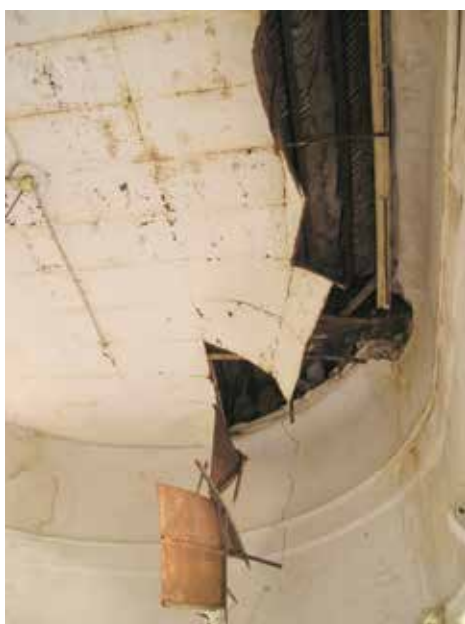
Thin rusted ornamental sections of iron sheets that had detached themselves from the wooden rafters of the oval room ceiling, above which rests the madras terrace roof

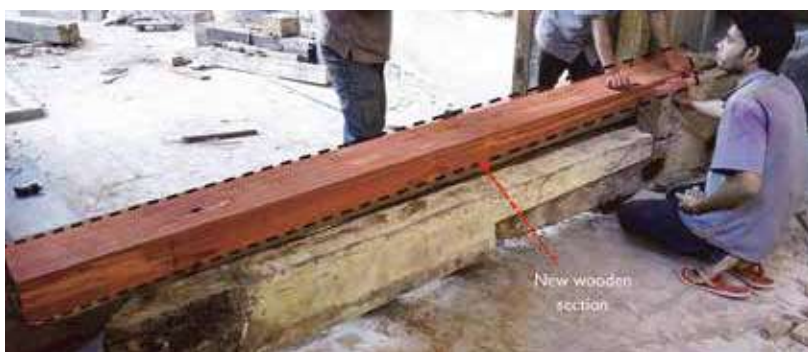
Wooden members of various sizes used to fix the beam FFB2 to replace UGB2

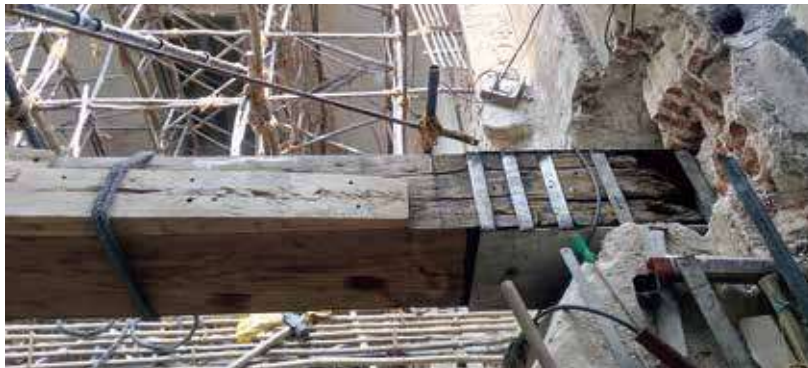
Consolidation and SS capping at both ends of the beam FFB1 in situ

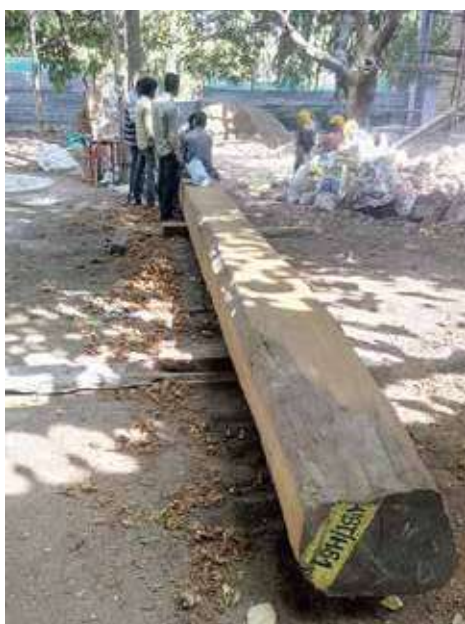
The teak wood procured for the new FFB2 beam

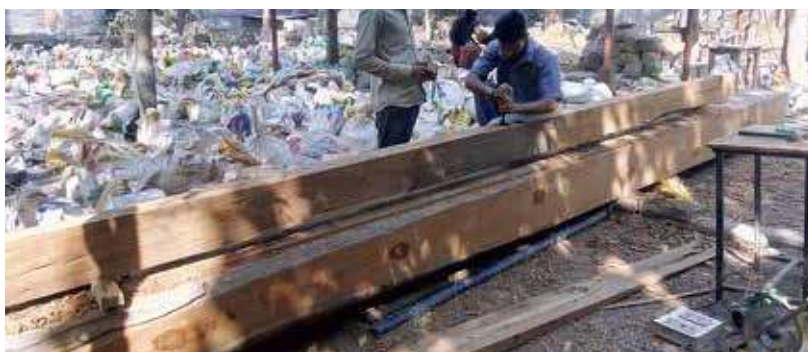
Planing and processing the teak wood for the new FFB2 beam

The deteriorated sections of the beam FFB2 were cut away and all the loose material of the beams, old MS nails and screws were carefully removed and kept for reuse. The size of the original beam that was now available for reuse was 0.40 x 0.30 x 8.3 m. Six wooden members of various sizes were required to fix the beam. These members were cut using the old wood dismantled from the building, which were chiselled and given a smooth finish using a wood planer. The beam was fixed together using four different types of jointing techniques: mortise and tenon joints, nuts and bolts, adhesive, and SS clamps.

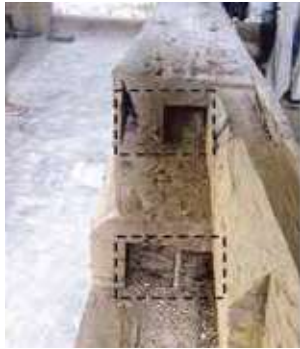
New sections of wood with tenons were fixed into mortise grooves made in the existing FFB2 beam

An optimal combination of all four was chosen to ensure maximum strength and stability for the beam. Since the joint between the old and new wood was a 1/4 section of the beam, ensuring durability and strength was necessary to prevent cracking or buckling. Mortise and tenon joints were required to join different members to the main beam, while nuts and bolts and SS clamps were necessary to hold all the separate wooden members together to prevent any movement amongst them. The joint between the surfaces of the beam parts were reinforced through application of a high strength translucent epoxy resin (Araldite) over the entire area of the surfaces being joined, including the groves.

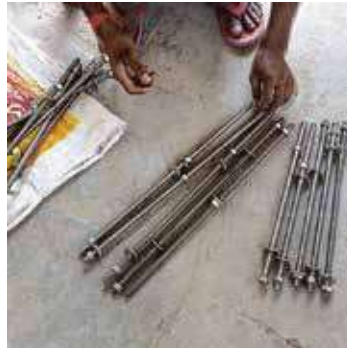
SS rods 500 mm long and 12 mm in diameter with nuts and bolts were used at 1 foot c/c distance, both vertically and horizontally, to hold the parts together

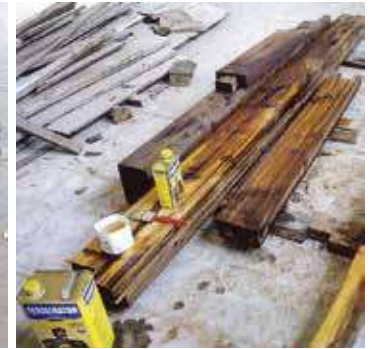
Application of anti termite coating on the new FFB2 and old FFB2

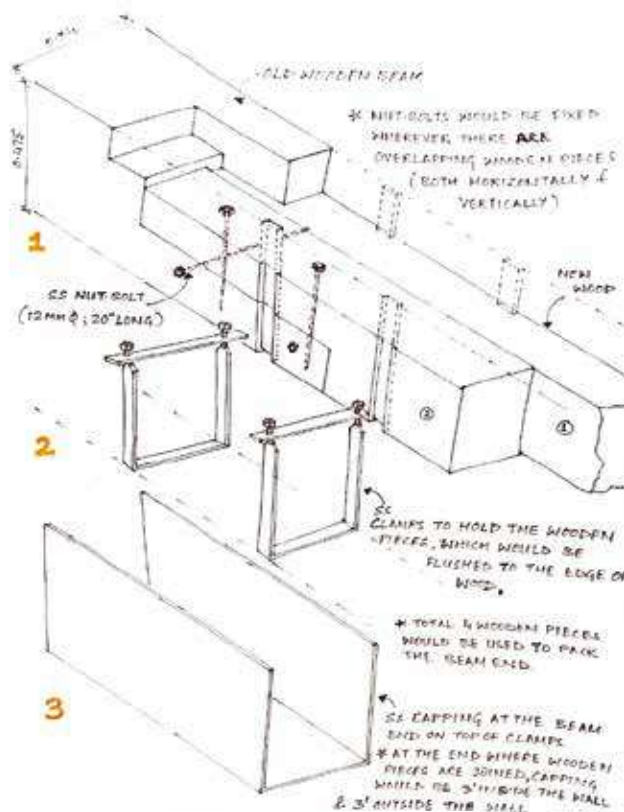
SS clamps (6 in number), each with a width of 25.4 mm, were used to hold the consolidated beam end together. They were coated with an anti-corrosive paint.

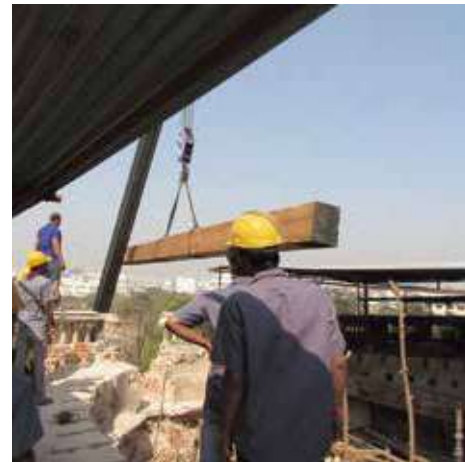
Lifting the new FFB2 beam over the terrace and placing it in position

Once the old heavy beam FFB2 was consolidated and prepared on the ground, it was lifted by a crane over the western balcony and through the door and installed in its exact position in the oval room while manually guiding it to the position of UGB2. The wall bearings were prepared for installation by completely removing the parts of the old beam, and clearing the debris. The whole process required a lot of manpower, patience and precision with controlled movements. The new teakwood beam that was procured to replace the old FFB2 was processed on site and installed with adequate bearing on the wall after clearing the debris. Both FFB1 and UGB1 were consolidated in situ by the carpenter's team. They were in fair condition so it was decided to consolidate the minor cracks, remove the loose material and finish the rough edges to give them a final processed appearance. These consolidated old beams were provided with an SS capping at both the ends in the wall and at the centre. The beam ends were packed firmly with brick masonry in lime mortar in a ratio of 1:3 (lime:sand). There were a total of 75 joists in the whole wooden structural system of the first floor Madras terrace roof. New

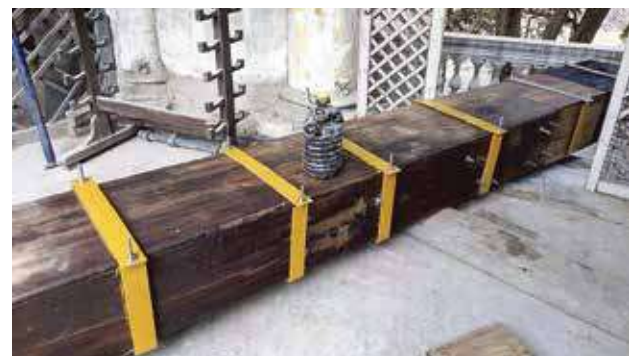
A conceptual diagram illustrating the jointing details of the new members of the beam

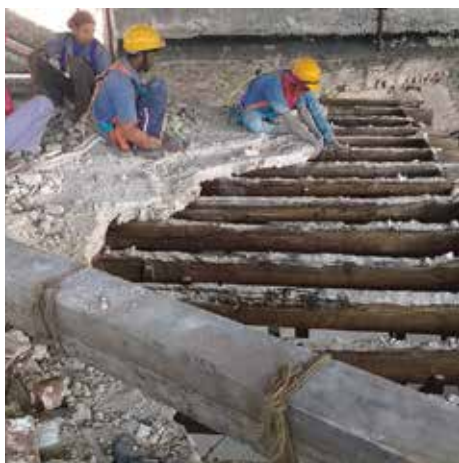
Carefully dismantling the deteriorated lime concrete and later additions on the roof

The collapse of FFB2 and UGFB2 supporting the Madras terrace roof of the western oval room led to the collapse of a large part of the roof. As a result, there was a need to reconstruct the Madras terrace roof over the western oval room. After careful removal of the extant roof, it was observed that the cross-section of the Madras terrace roof was a variation from the typical section, in that it had only one layer of brick masonry (compared to the traditional two layers) over the wooden structural members. The top of the roof was covered with a bitumen layer (later addition) which was first removed. Below it were three layers of *chadurbilla* (flat square clay tiles measuring 10 cm x 10 cm x 1 cm), which were removed carefully and salvaged for reuse. The layer of lime concrete waterproofing (*kappi*) (12.50 cm thick) below the tiles was dismantled, followed by prudent dismantling and salvaging

of the brickwork. The deteriorated wooden joists in Madras terrace were dismantled by removing each rafter carefully while the beam (FFB1) was retained in situ. Thereafter, the temporary GI sheet shelter on the terrace (which had been erected four years earlier to protect the roof) was removed before the beginning of conservation works.

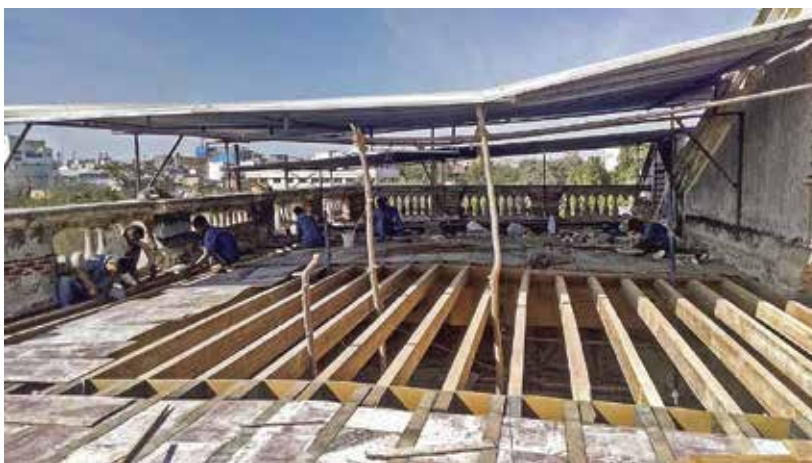
The new wooden rafters in position and ready to receive the thin section of bricks laid at angles

teakwood joists (for replacement of the ones damaged in the collapse) were prepared and installed in the existing groves for joists (brush coated with an approved anti-termite solution and marked with a seal bearing the number and the date of intervention), with one end in the brick masonry, and the other end resting on the wooden beam. The whole framework was allowed to stand for a month (to allow for any expansion/contraction), after which the top of the teakwood rafters were painted with Black Japan (anti corrosive black bituminous paint) for protecting the concealed areas of wood from damage.

Shuttering for laying the brick courses followed the structural framework. The first course of brickwork was laid on edge, at an angle of 45° to the joists. The second course of the brickwork was laid flat, in a direction perpendicular to the first course, and commenced simultaneously as the laying of the first layer progressed. After the laying of the brick courses were completed over a month and allowed to set completely, the lime concreting of the whole roof commenced.

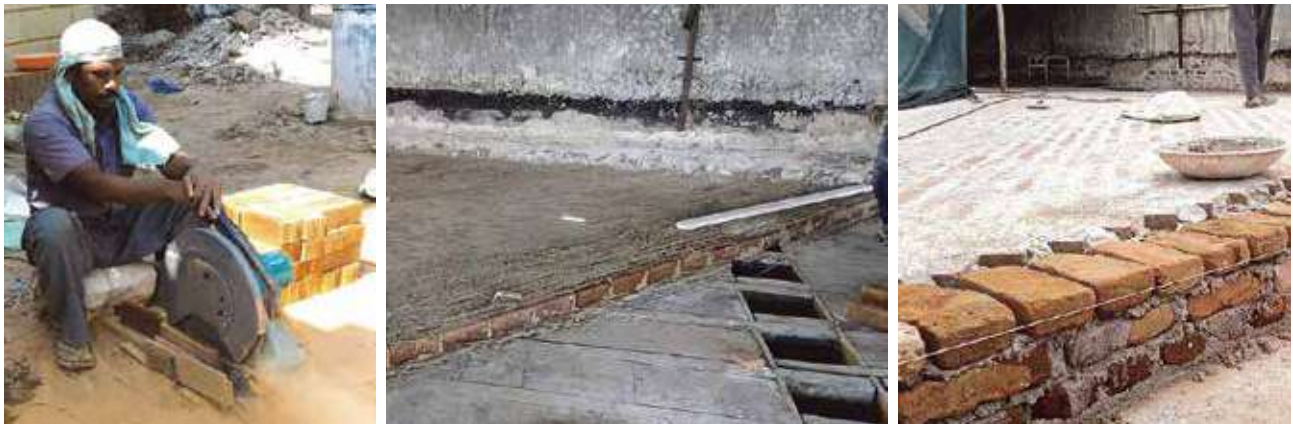
Standard size bricks were finely machine cut into the required size and laid at a 45 degree angle to the joist. Finally, the gap between the teak wood joists on the ceiling was plastered and painted.

The Madras terrace roof uses bricks of a different size from those used for regular construction works. As this size is no longer commercially produced, the option of custom-made bricks was explored. However, considering the huge lead time and quality issues that may arise with the custom making of bricks, it was decided to procure class 1 wire-cut bricks of a standard size (22 cm x 10.1 cm x 8.25 cm), soak them in water and carefully cut them on site into three parts to achieve the required size of 22 cm x 3.25 cm x 8.25 cm.

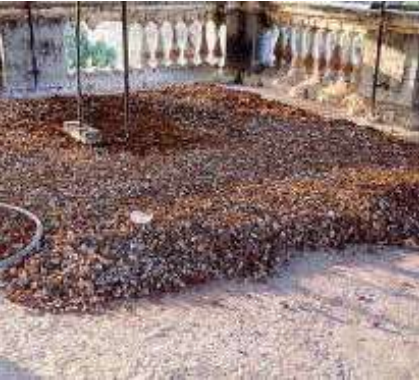
Brick bat cobba and burnt lime (*kappi*) before mixing, laid to achieve the required slope

stored on the terrace. A grouting solution made of slaked lime, water and additives was poured evenly on the cleaned and cured surface of the terrace floor and sufficient absorption into all the surface cracks was ensured. This was followed by mixing and laying a mixture of brick bats and hydraulic lime (*kappi*) prepared the previous day. The casting of a lime concrete roof by this method majorly involves repeatedly ramming the surface using wooden bats to ensure total compactness through the day. All the water is allowed to evaporate through the night, and the second layer of *kappi* is added the next day such that the levels are adjusted and the required slopes are achieved for effective drainage of water. After compaction, the total average thickness of the lime concrete is 17.8 cm (7"), with the maximum thickness at the higher end being 2.8 cm (9") and the minimum at the lower ends being 12.7 cm (5"). After another round of grouting to remove fine cracks, the ramming process is repeated for over a week to ensure total water tightening. The edges are sealed with *gola* (rounding off the corners and smoothing curves at the junction of the horizontal terrace and vertical parapet to ensure water does not accumulate and penetrate) and the entire roof is covered with wet gunny bags for thirty days to prevent the development of any cracks. The terrace is always worked in sections to ensure correct slopes are achieved for every defined patch of surface area.

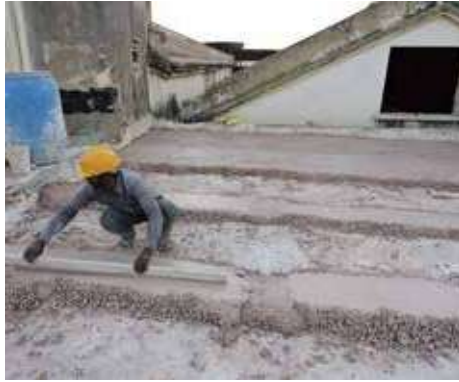
After the second layer of *kappi* was laid, it was levelled with a wooden or aluminium member and further flattened by ramming

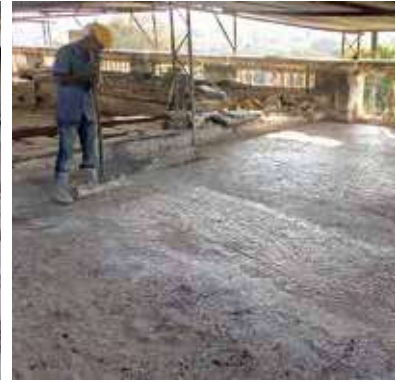
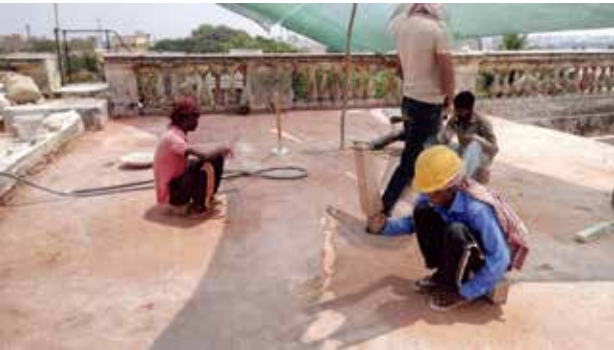
Ramming the terrace with wooden *kurchi*

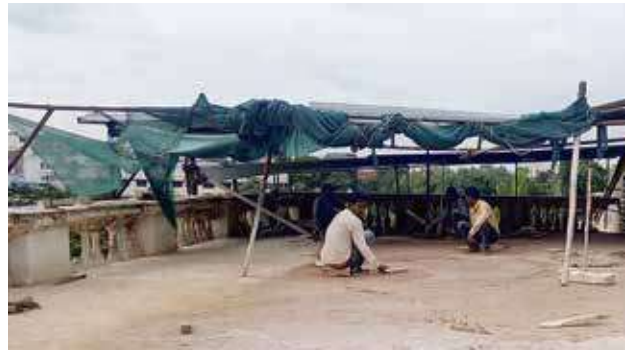
The completed lime concrete roof over the Madras terrace roof, above the oval room

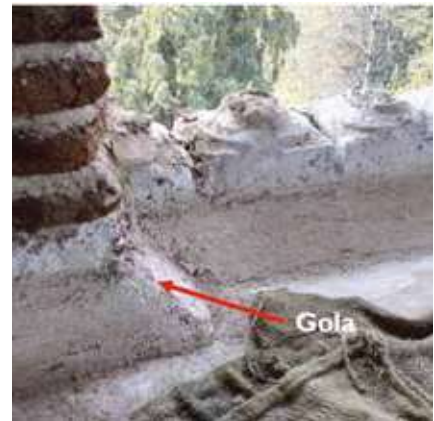
The edges of the terrace roof sealed with *gola* in lime concrete

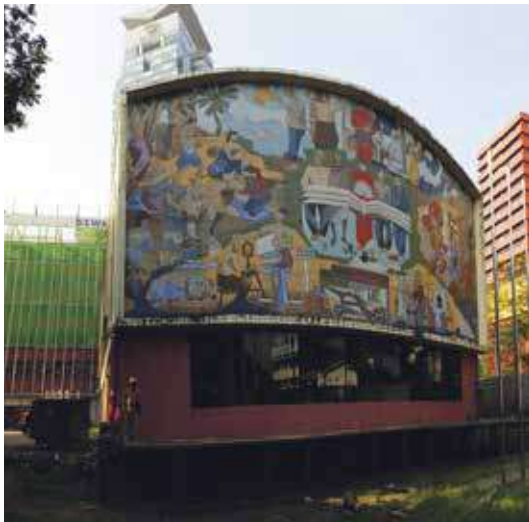
The DBP mural measures 20.2 m in length with varying heights of 9.6 m to 10.8 m.

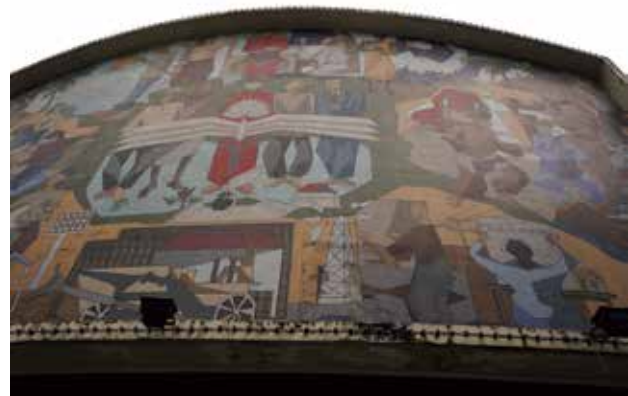
The DBP mural is unique because it was built on a curve-shaped wall.

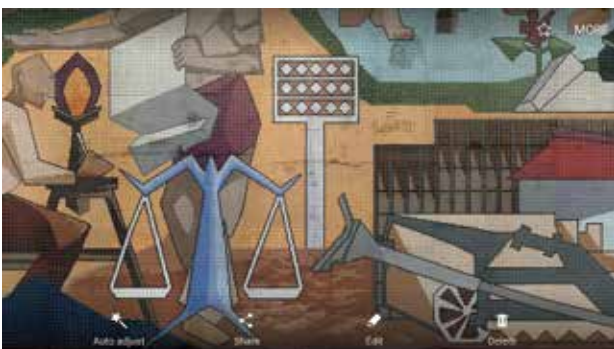
The DBP mural contains more than 1.48 million pieces of ceramic mosaics, with each mosaic measuring 11 mm x 11 mm with a thickness of 3 mm.

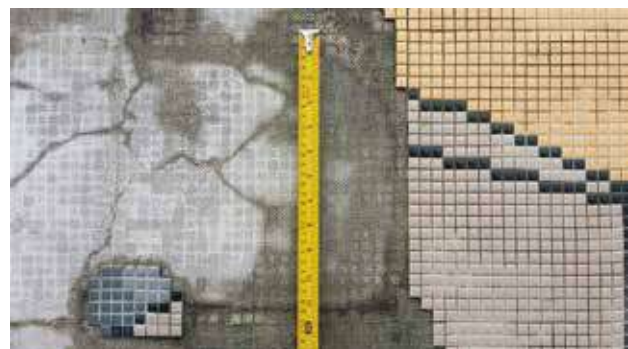
A dilapidation survey was conducted to determine the condition of the DBP mosaic wall, as well as common mural defects and their causes.

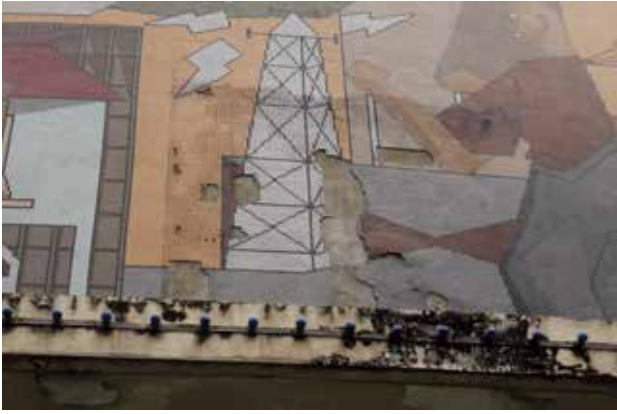
The dilapidation survey revealed that some of the mosaics were loose, detached, broken, missing or had fallen off.

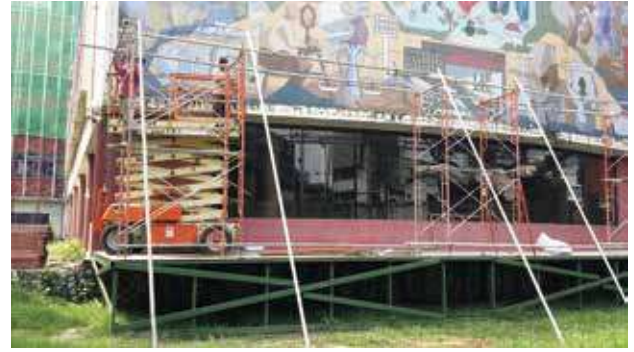
During site preparation, a suitable location was identified on site to build a sturdy working platform to place the scissor lift and scaffolding.

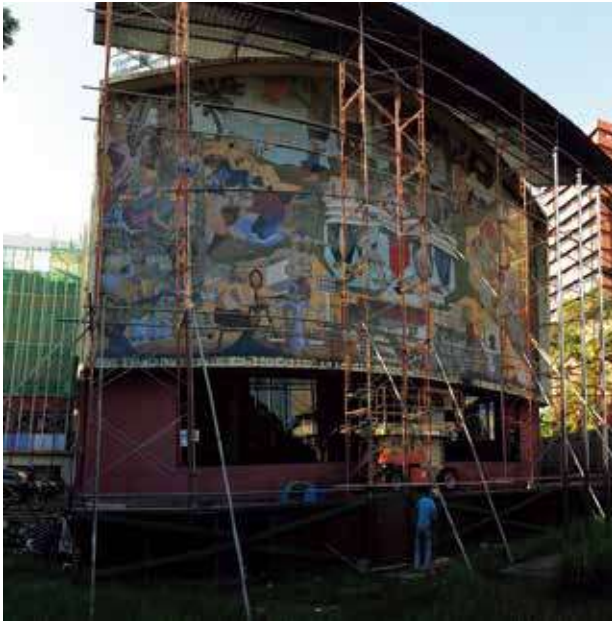
Before reinstallation of the mural, scaffolding was erected on the platform and temporary roofing was fixed on the roof for the entire period of the mural reinstallation works.

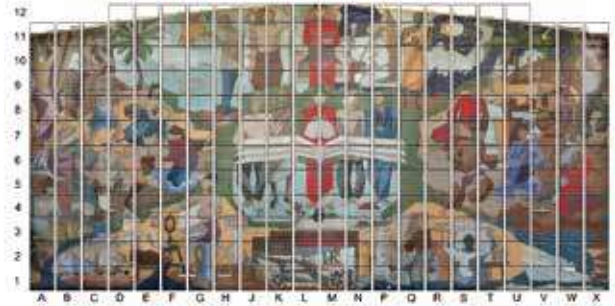
Before high resolution photography was carried out, the DBP mural surface was divided into small grids.

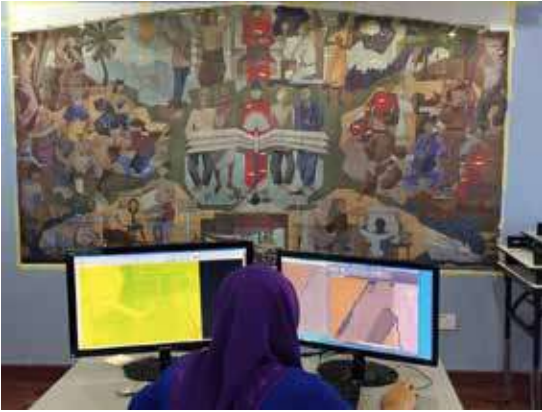
During the mosaic mapping stage, each grid was given a special code to be stored in a computer database for cross referencing and rechecking.

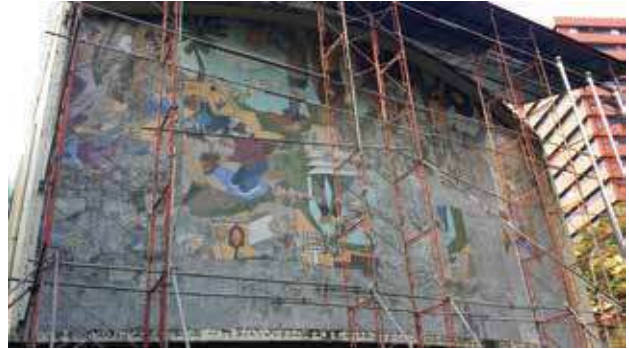
An important stage in the conservation works involved the removal of all mosaics before treating the wall substrate.

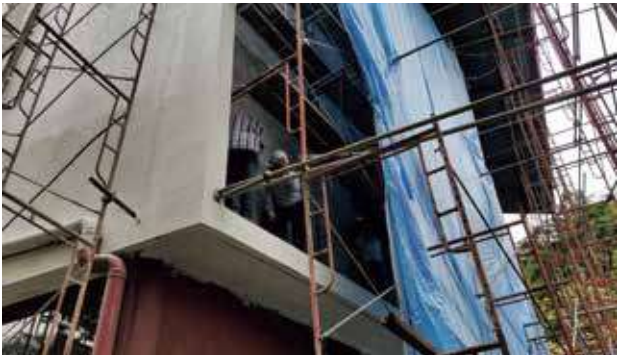
All cracks on the wall substrate were repaired before resurfacing the wall substrate with the same material as the existing one.

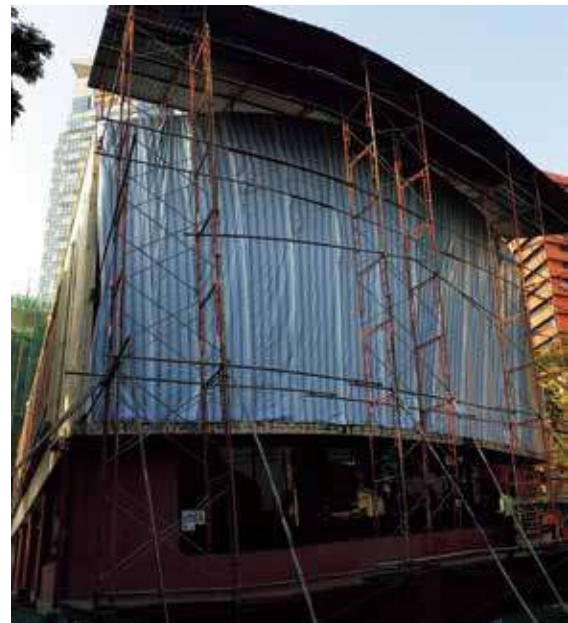
The mural surface was covered with plastic sheets to protect it from direct sunlight and heavy rain.

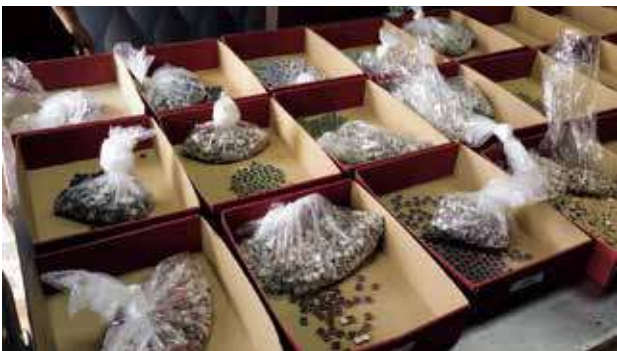
Separation of salvaged mosaics based on different colours and shades.

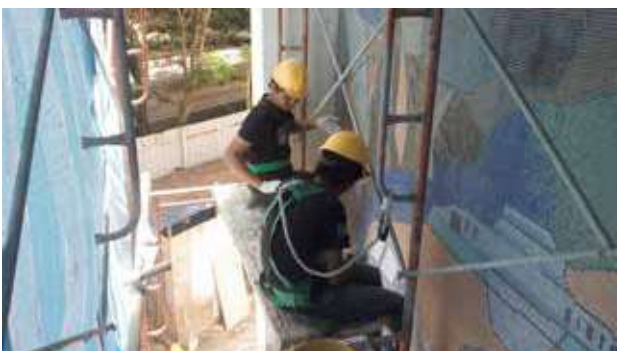
The reinstallation of mosaics began from the bottom left, moving upwards and sideways.

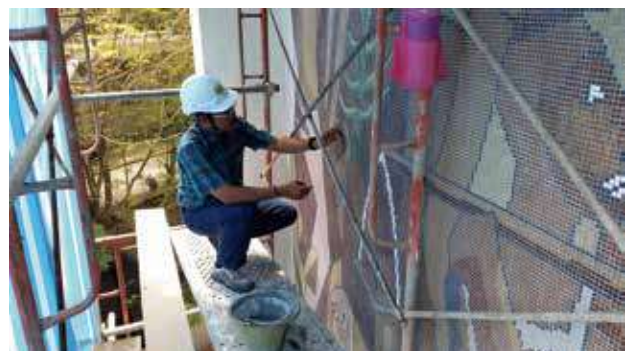
The mosaics were reinstalled based on the grid system established from the captured mural image.

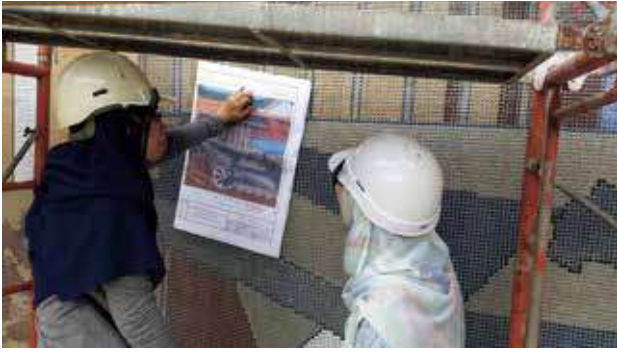
It was important to check the reinstalled mosaics which were positioned according to the grid system.

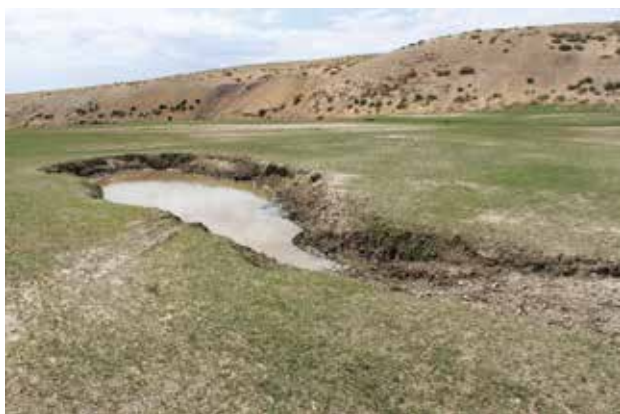
Fig. 27: Slipper-shaped bigger hole for clay mining, from the south east

I also found traces of two holes which is evidence that suggests the artisans of these kilns mined near the site and used the local clay for their ceramic production. The slipper-shaped bigger hole is located to the south east of the site, on the south bank of the river. (Fig. 27) It is oriented east-west and is 27.5x6.9 m in size. Its depth is

roughly 90 cm. Another one is located 7.2 m to the north of the bigger hole. (Fig. 28) It is oval-shaped and oriented south-east to north-west. It measures 4.5x2.7 m. The depth is approximately 65 cm.

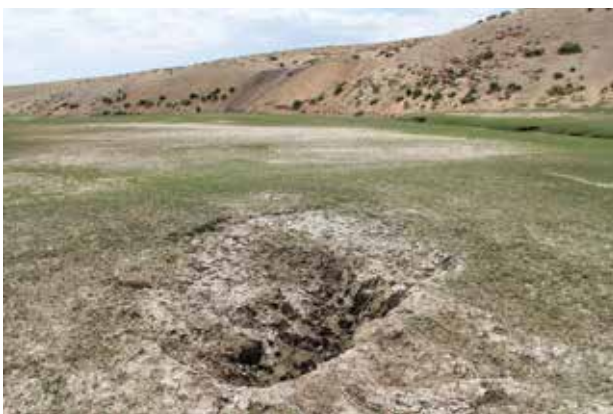
Fig. 28: Smaller hole from the south east

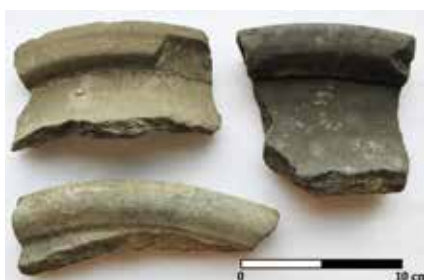
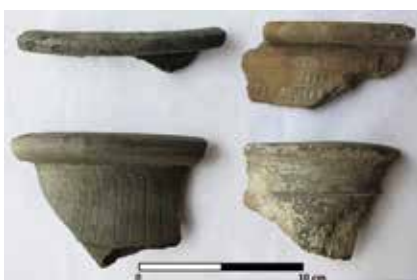
Figs. 29-31: Rim fragments of potteries

The collected fragments show that there were only a few (at least eight) types of ceramic potteries produced at this site. (Figs. 29-31 and 37) The form, size, patterns and other features of potteries of each of the kilns of the site are similar to those of the others. (Figs. 32-36) This means that although the kilns were separate, the potteries were generally of the same type. The kilns seem to have been used not only for a certain purpose but also for only a short time. The types of potteries, including a steamer and large potteries with special patterns, indicate that the Tarnyn Gol kilns most probably belong to the Xiongnu period, particularly to the 1st century BC. (Figs. 29, 34-36 and 38)

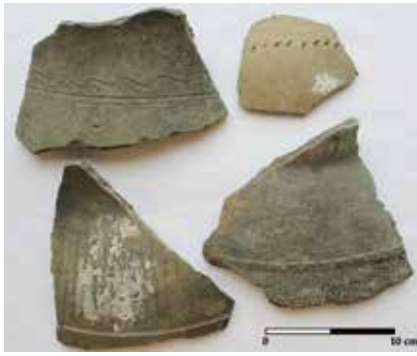
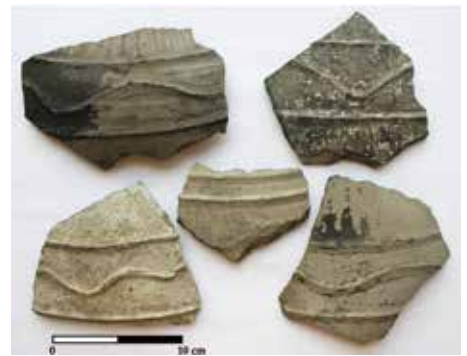
Figs. 32-34: Upper wall fragments of potteries

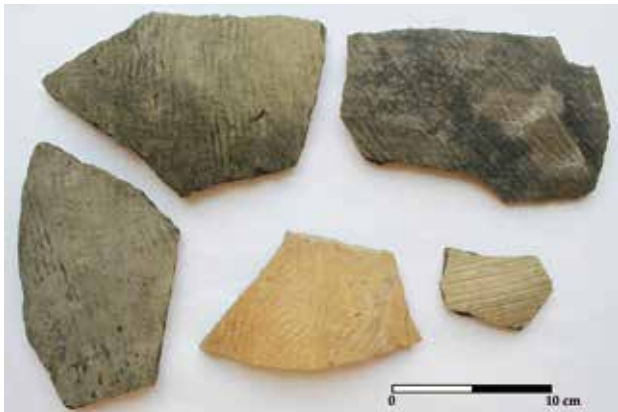
Figs. 35 and 36: Lower wall fragments

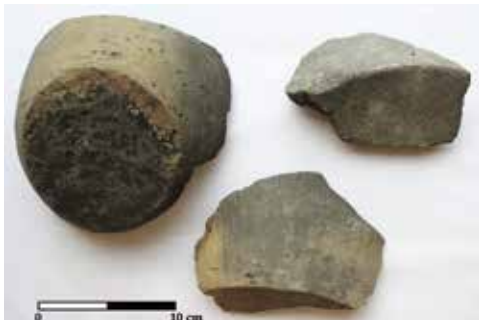
Fig. 37: Fragments with bottoms

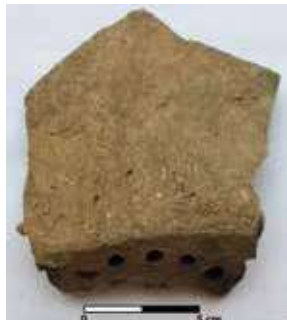
Fig. 38: Fragment of a steamer

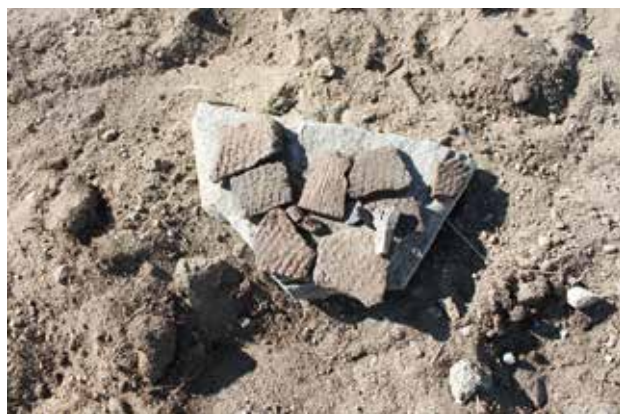
Fig. 43: Ceramic pottery fragments from the mound

Ceramic fragments from the Khuvsgul Lake shore. Between July 29 and August 2, 2017, the author found fragments of ancient ceramic pottery from a terrace named Tsagaan Guvee, the northernmost shore of Lake Khuvsgul in Khankh soum, Khuvsgul aimag. (Fig. 41) In June, 2017, a hole for sauna water was dug in the south east corner of the yard of the tourist camp “Doloon Uul”, which is situated on the terrace. (Fig. 40) The mound, from which the above fragments of potteries were revealed, was piled with earth from that hole. (Fig. 42) The hole is rectangular and measures 200x160 cm in size. (Fig. 44) Its depth is 160 cm. The walls of the holes contain four main layers and the pottery fragments were most likely in two upper darkbrown layers, which are roughly 18 cm in depth. There were found 70 fragments of two different potteries, 31 small pieces of burnt bones of small cattle, and wood charcoal. (Figs. 43 and 45-50) The pottery fragments are ancient artifacts ever found on the northern shore of Lake Khuvsgul.

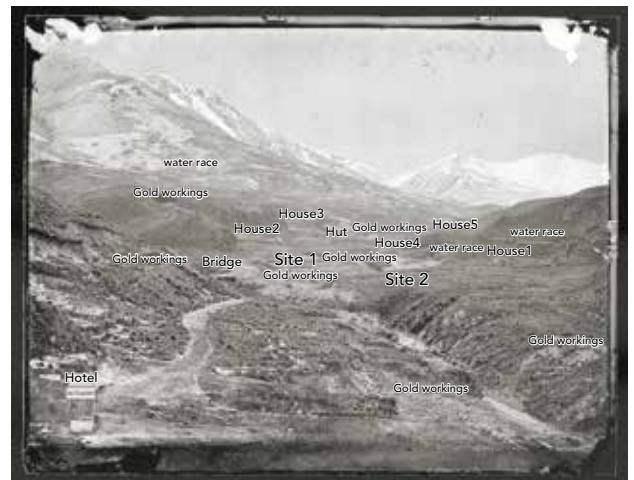
Figure 4. The *Kyburn Diggings* taken by William Hart possibly around 1877. Structures have been identified in the photo by the author such as 'bridge' and 'House 1'. Sites 1 & 2 as they looked in ca. 1877 are highlighted (source: 'Danseys Pass, Kyburn Diggings, Otago, NZ', William Hart, Museum of New Zealand Te Papa Tongarewa Registration No. C.014912).

There is only one known extant photo of the Kyeburn Diggings which is believed to have been taken around 1877 by travelling photographer William Hart (Figure 4) (Source: 'Danzi's Pass, Kyeburn Diggings, Otago, NZ', William Hart, Museum of New Zealand Te Papa Tongarewa Registration No. C.014912). The photograph was taken on a glass plate using the wet collodion process and so produced a very detailed and clear picture that has picked up numerous features in the landscape at some distance (features identified have been notarised by the author). This photo beautifully shows the mining landscape at Kyeburn against a Wintery mountainous backdrop and is, by chance, overlooking the two locations where site restoration works were undertaken for this project (Figure 4). The photo shows remnants of large and small scale mining activities from different periods of mining at the diggings. Water races (such as a large one running along the mountainside on the left of the photo), reservoirs, sluice faces and mining tailings can be seen. Also, on the left side of the photograph a butchery and most likely the edge of a shop and hotel built of timber and corrugated iron can be seen. This is where Danseys Pass Coach Inn is located today built in the 19th century. The photo also shows the location of houses and enclosures, many built of sod turf, as well as the bridge across the true right branch of the Kyeburn.

In Figures 25, 29 to 35 can be seen the two sites (Sites 1 & 2) which were focused on for the restoration works and their equivalent locations are marked on the *ca.* 1877 photograph and 1918 survey map (see Figure 4 & 8). One site lies on the true right of the Kyeburn River by the Danseys Pass Road (Site 1) and the other on the true left of the river on a terrace (Site 2) (see Figures 2 & 3). These photographs show how past earthworks have damaged these sites and how vegetation has encroached on the intact features. At Site 1, earth and vegetation had been dumped into a stone-lined miners' tail race (Figure 38). The aim of the works was therefore to clear vegetation from the intact archaeological features to make them visible to the public so as to detract from the past impacts on the sites. The work required the vegetation to be cut and cleared by hand as machinery would damage the features. A large digger was used to help with the clearance by placing it in a location where it could lift vegetation away but not damage the archaeology. It was also used to dig out the miners' tail race to reveal the remains of the original stone lined walls.
