ACCU Nara
International Correspondent

Vol.19 2017

The Nineteenth Regular Report

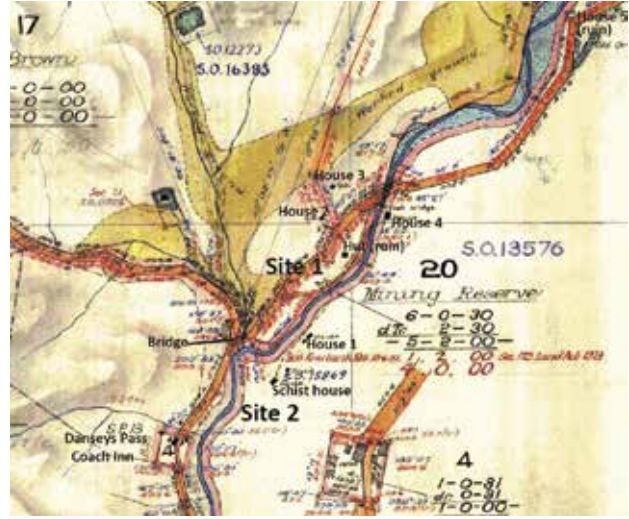
Figure 8. Survey map SO 785 from 1918. Buildings and structures from the Hart ca. 1877 photograph appear to be still present (Map source: LINZ). In addition, this map confirms that some of the gold workings in the location of the restoration works at Site 1 can be associated with named European and Chinese miners.

Historic survey maps provide an indication of the mining, occupation and business activities being undertaken at Kyeburn and sometimes by whom. For example, in Figure 6 can be seen survey map SO 4799 dating from 1883. This survey lists European miners and a Chinese mining company with mining permits within the surveyed permit areas. In Figure 7 is shown a close view of the surveyed mining permit areas. Here can be seen the dams, water races and old gold workings owned by the miners with the Chinese mining company's 'Gee Wee's race' noted as well as the European miners race called 'Meikle's race'. In the cropped survey map SO 785 in Figure 8, a number of buildings and structures are shown such as the bridges, houses, huts, gold workings and the layout of the Danseys Pass Coach Inn buildings. When this survey map is referenced against Hart's *ca.* 1877 photo, it appears that many of the buildings and structures from the 19th century were still being used until this time (see Figures 4 & 8).

In Figures 25, 29 to 35 can be seen the two sites (Sites 1 & 2) which were focused on for the restoration works and their equivalent locations are marked on the *ca.* 1877 photograph and 1918 survey map (see Figure 4 & 8). One site lies on the true right of the Kyeburn River by the Danseys Pass Road (Site 1) and the other on the true left of the river on a terrace (Site 2) (see Figures 2 & 3). These photographs show how past earthworks have damaged these sites and how vegetation has encroached on the intact features. At Site 1, earth and vegetation had been dumped into a stone-lined miners' tail race (Figure 38). The aim of the works was therefore to clear vegetation from the intact archaeological features to make them visible to the public so as to detract from the past impacts on the sites. The work required the vegetation to be cut and cleared by hand as machinery would damage the features. A large digger was used to help with the clearance by placing it in a location where it could lift vegetation away but not damage the archaeology. It was also used to dig out the miners' tail race to reveal the remains of the original stone lined walls.

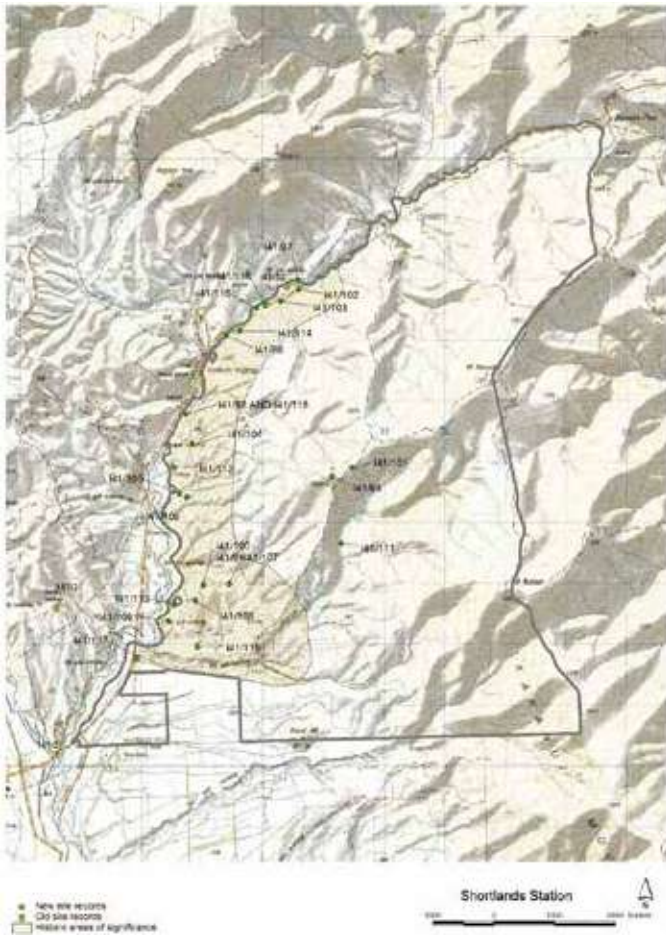
Figure 9. Archaeological sites identified on the Shortlands Pastoral Lease during Briden and Schmidt's survey in 2007.

This large gold field has had very little formal archaeological surveying probably due to it being located on a large pastoral lease (farm) away from the risks of hydroelectric power, viticulture and private development, and due to its isolation. The most detailed survey of this goldfield was undertaken in 2007 by the author and archaeologist Shar Briden when the lease of the property was being reviewed by the Crown. This survey showed that archaeological sites were present all along for the 8km surveyed on either side of the Kyeburn River and up to 3km inland of its river banks (Figure 9). This survey only scraped the surface of what is present in the wider landscape, but confirmed the high intactness of the numerous sites and their extent from water races starting at high altitude in the mountains many kilometres from the mining itself right down to the workings on the Kyeburn (see Figures 10 to 22).

One area from where the public can readily see the Kyeburn Diggings is from the public road which runs up the Kyeburn River called Danseys Pass Road. This road originates in the Maniototo, Central Otago and takes people north over the Kakanui Range at 935masl and down into the Waitaki District. The gold workings come right up to the road at places and can also be seen on the other side of the river from the road (see Figure 9).

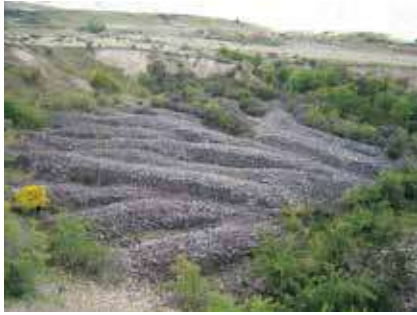
Figure 11. Herring bone patterned gold mining sluice faces and tailings from the 19th century (Photo: Briden & Schmidt 2007). Thousands of stones have been moved and stacked during the mining of the ancient alluvial terrace.

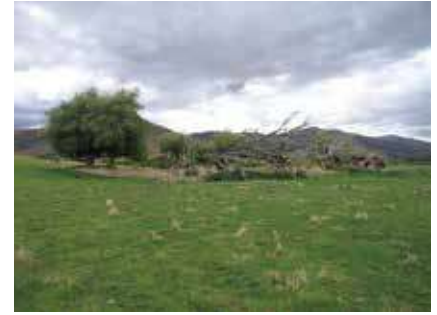
Figure 13. One of the large earth reservoirs sitting high on the hills above the gold workings nearer the Kyeburn River (Photo: Briden & Schmidt 2007).

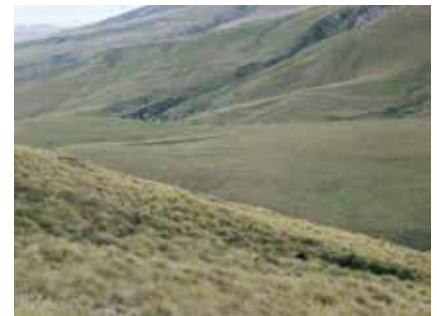
Figure 16. A high altitude mining reservoir made of earth. Four mining water races can be seen skirting the mountainside behind the reservoir with one of these races feeding water to the reservoir (Photo: Briden & Schmidt 2007).

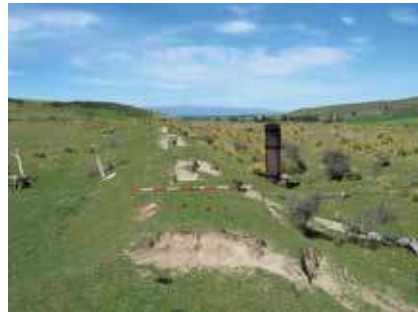
Figure 18. One of the huge earth walled gold mining water reservoirs. The pipework to control the flow of water out of the reservoir and into a 'header' race to the mining area is intact (Photo: Briden & Schmidt 2007).

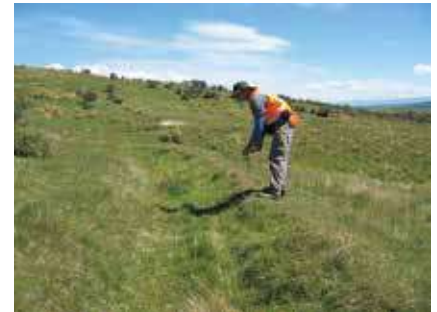
Figure 19. A water 'header' race which took water away from the reservoirs to the gold mining area to be used for sluicing (Photo: Briden & Schmidt 2007).

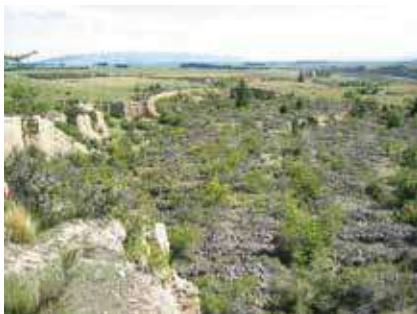
Figure 20. Sluice faces and extensive gold tailings resulting from the mining of an ancient river terrace using water under pressure sourced from reservoirs (Photo: Briden & Schmidt 2007).

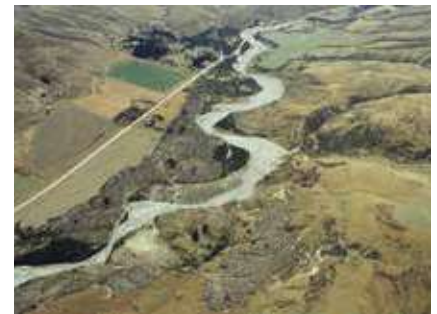
Figure 22. An aerial photograph of the gold workings further down the Kyeburn River from the Danseys Pass Coach Inn. Mining on the left and right of the river can be seen with the mining of the left side of the photograph most affected by vegetation encroachment. This can indicate an older mining area. Note the distinctive group of 'herring bone' gold tailings (Photo: Kevin Jones).

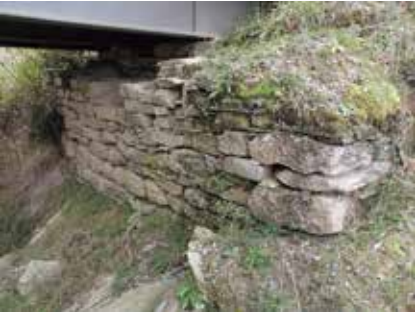
Figure 23. 19th century schist bridge abutments. These are from the bridge that can be seen in Hart's ca. 1877 photograph of the Kyeburn Diggings in Figure 4 (Photo: Matthew Schmidt).

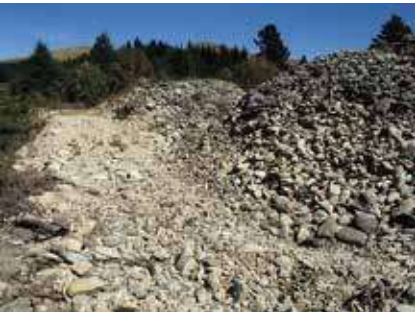
Figure 29. 19th century gold tailings damaged through the bulldozing of an access way at Site 1 (Photo: Matthew Schmidt).

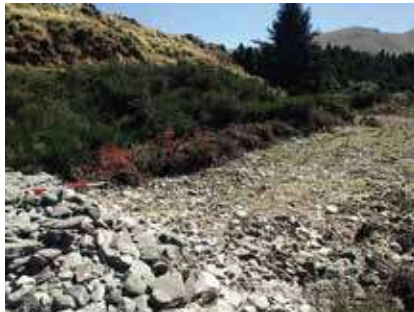
Figure 30. Damage to 19th century gold tailings through using earthworks machinery to clear vegetation at Site 1 (Photo: Matthew Schmidt).

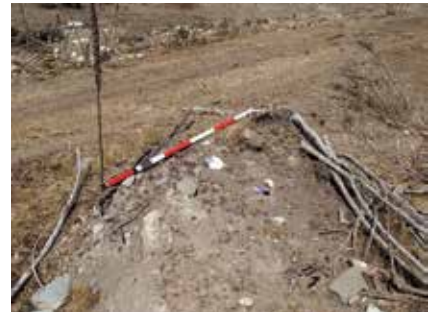
Figure 31. Exposed 19th century rubbish pit from access way earthworks near 'House 1' (Photo: Matthew Schmidt).

Given the significance of the Kyeburn Diggings, damage to its gold mining heritage goes back many years and has been the result of both human and natural processes (see Figures 29 to 38). Earthworks for various Government and private company projects, vegetation encroachment, farming activities, flood events and natural changes in the path of the river have all contributed to the loss of sites. Most of the damage by human processes appears to be in particular locations as a result of initial earthworks for a project and then additional damage being done when the same locations have been revisited over the years for more project earthworks or vegetation clearance. This has contributed to the destruction or large scale damage to sites in the vicinity of the Danseys Pass Coach Inn, along the alignment of Towers carrying the power lines from the Roxburgh Dam (opened in 1956) and where smaller power companies have installed power poles. Day-to-day farming activities over the decades have damaged sites but not to the same extent due to the relatively light impact that sheep farming has on historic mining sites. Common reasons for damage by human activities on Otago goldfields sites are a lack of understanding of the importance of heritage sites and landscapes to local and regional history, changes in attitudes to what heritage is important to people, and an unfamiliarity of the law with regard to the legal protection of archaeological sites.

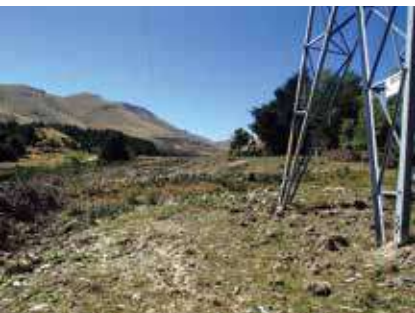
Figure 32. Damage to gold mining tailings and sluicings through past works on a power network tower and vegetation clearance at Site 2 (Photo: Matthew Schmidt).

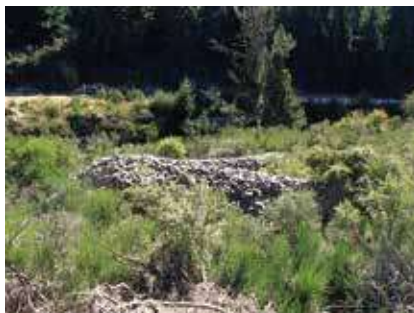
Figure 33. Exotic vegetation encroachment on gold mining workings at Site 2. This site used to be able to be viewed easily from the Danseys Pass Road seen in the background (Photo: Matthew Schmidt).

Damage by exotic vegetation growth on sites would be the next major impact on the archaeology at Kyeburn after earthworks. The exotic pine, broom and gorse has completely enveloped many sites and as the trees and plants growing on the sites and features get bigger, the roots 'blow out' the stone and earth features. For large trees the additional risk comes from wind throw when trees are toppled by high winds ripping up the roots with the tree then falling on top of the site. The heavy vegetation growth also affects the amenity value of the archaeology. In areas where the archaeology can be viewed from a public place, vegetation encroachment gradually hides the archaeology and lessens its value to the public.

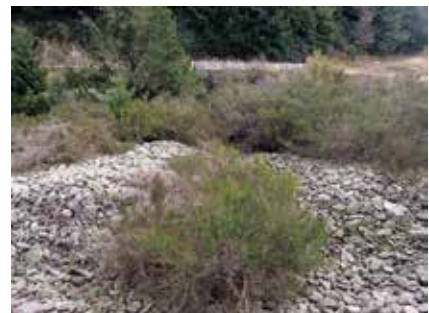
Figure 34. Exotic vegetation encroachment on gold mining workings at Site 2. This site used to be able to be viewed easily from the Danseys Pass Road and the 1877 bridge seen in the background (Photo: Matthew Schmidt).

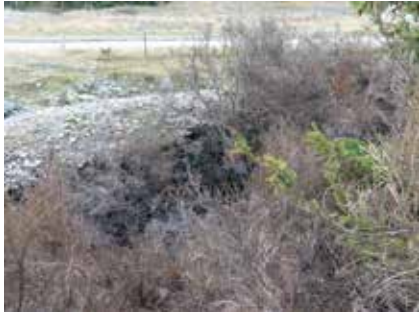
Figure 35. Exotic vegetation encroachment on the gold mining stone tail race at Site 1 (see Figures 43 & 44 below). This tail race also would have been able to be seen from the road in the background (Photo: Matthew Schmidt).

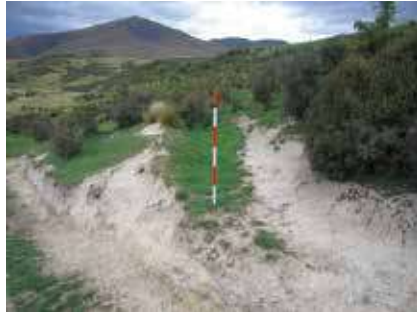
Figure 36. A water race from one of the Kyeburn Diggings large earth water reservoirs which has been cut through by a farm access road (Photo: Briden & Schmidt 2007).

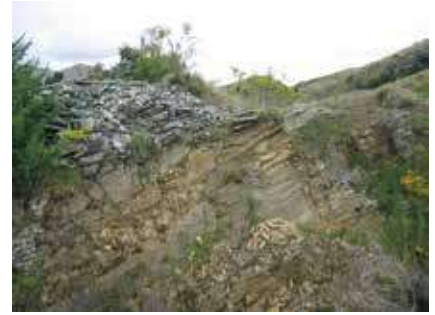
Figure 37. This area of gold workings is falling into the Kyeburn River from erosion of the steep river bank (Photo: Briden & Schmidt 2007).

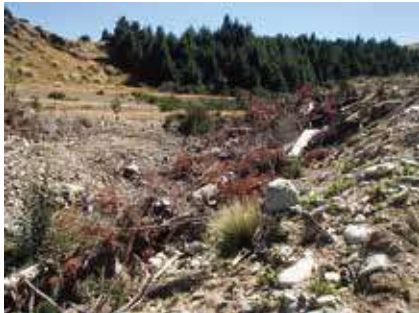
Figure 38. The stone-lined tail race at Site 1 full of vegetation debris dumped in the feature over the years. The race may have originally been ca. 2m deep with stonework along both sides (Photo: Matthew Schmidt).

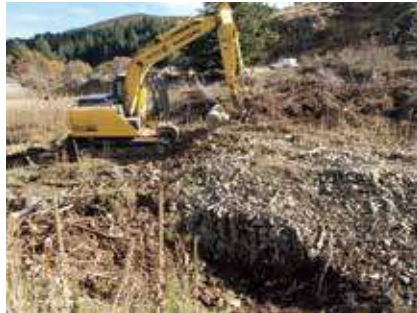
Figure 39. Vegetation being removed from the stone-lined tail race at Site 1 during restoration works by Heritage New Zealand & Transpower. Note the stone revetting (Photo: Matthew Schmidt).

The results of the restoration works can be seen in Figures 39 to 46. Not only do the sites look more visually interesting for the public, but now the remnants of the gold mining activities can be better understood and interpreted for the sites. Of particular interest is the beautifully built dry stone wall at Site 1 built as part of a large tail race to take water and sediment away from the sluicing's (Figures 43 to 44). This race would have had gold saving apparatus in it at some stage and at its base today there will be a layer of sediment which still has uncaptured gold in it. The craftsmanship of this tailrace is of high quality and so the miners who built it were experienced. Looking at the *ca.* 1877 photograph, it appears this tail race was built through the older tailings after this time possibly by the miners noted in the 1883 survey map. At Site 2, the gold tailings are more extensive than in the *ca.* 1877 photograph and as such also show a continuation of mining at this location for some years since the photograph was taken.

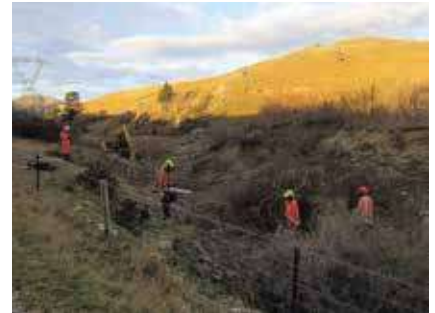
Figure 40. Vegetation clearance work being undertaken by Electric contractors at Site 1 (Photo: Matthew Schmidt).

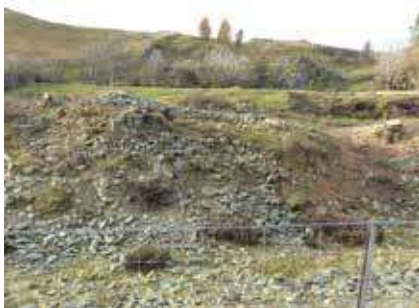
Figure 41. The exposed 19th century gold mining tailings and possibly a hut site (centre of the picture) after vegetation has been cleared at Site 1 from the area shown in Figure 30. These features can now be seen from Danseys Pass Road (Photo: Dougall Campbell, Transpower).

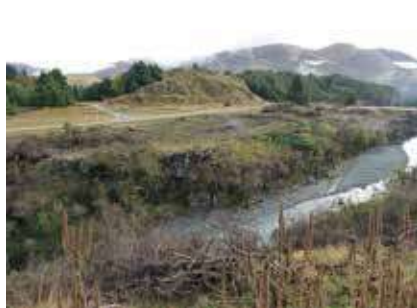
Figure 42. Site 1 viewed from the other side of the Kyeburn River near 'House 1'. The historic mining remnants can be clearly seen as can Danseys pass Road unobstructed by vegetation (Photo: Dougall Campbell, Transpower).

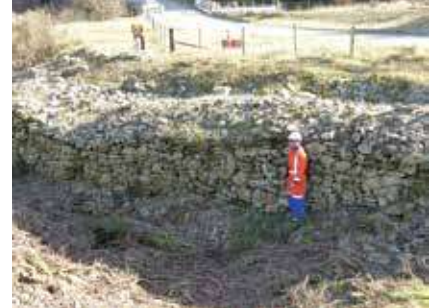
Figure 43. The beautiful dry schist stone walling of the roadside tailrace at Site 1 after vegetation clearance. This is the same tailrace obscured by vegetation in Figure 35. The stone has originated from the piles of gold tailings which used to fill the space next to it. Skilful experienced miners would have built this wall (Photo: Dougall Campbell, Transpower).

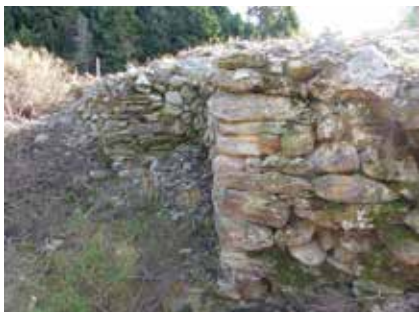
Figure 44. A close view of the dry schist stone wall stonework seen in Figure 43 (Photo: Dougall Campbell, Transpower).

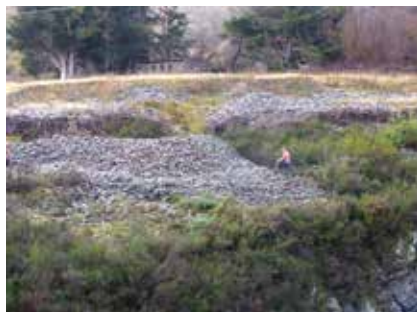
Figure 45. The exposed gold tailings of Site 2 as seen from Danseys Pass Road after vegetation clearance. These are the tailings seen in Figures 33 & 34 (Photo: Dougall Campbell, Transpower).

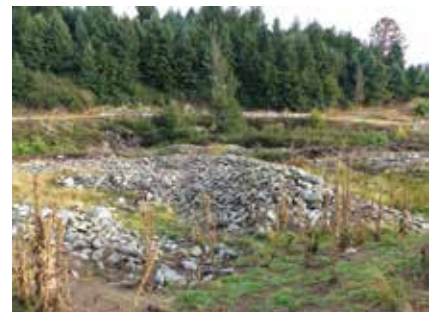
Figure 46. More exposed gold tailings of Site 2 as seen from standing on the site with the road in the background. These are the tailings seen in Figures 33 & 34 (Photo: Dougall Campbell, Transpower).

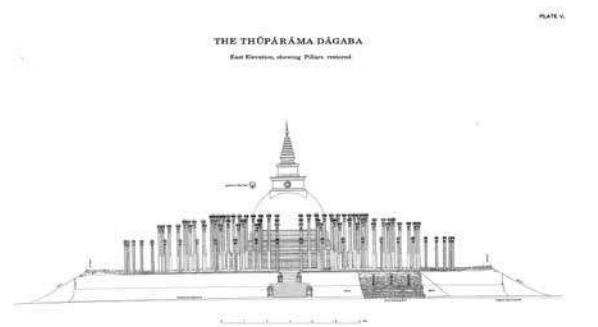
In 1873, under instructions given by the Governor, Sir William Gregory, a survey of Ancient Anuradhapura was carried out by Mr. Casher, and it contained even the measurements of dagabas. Mr. J.G. Smither prepared scaled drawings of ruin structures of Anuradhapura under the direction of Sir J. Ferguson in 1877 and it was released under the title of "Architectural Remains of Anuradhapura" in 1894.

Drawing prepared by Smither

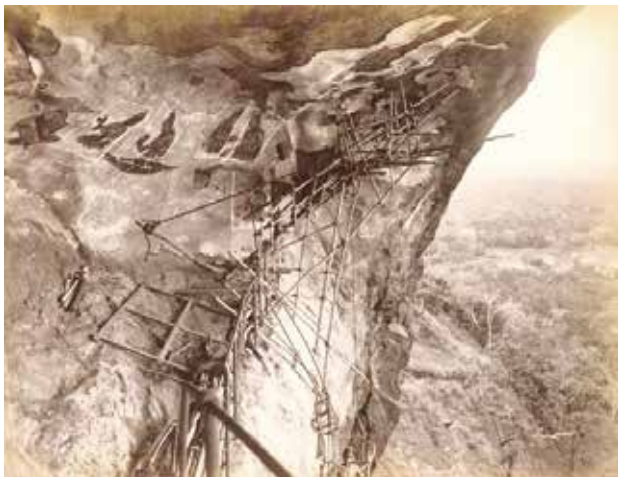
In May 1900, archaeological activities commenced in Polonnaruwa following the same systematic conservation methods as in Anuradhapura. During this period, surveys in Anuradhapura, Polonnaruwa and Sigiriya were completed satisfactorily. Erecting iron platforms and conserving walls in Sigiriya were also done accordingly. Similarly, conservation activities were effected in North Western and Central Provinces and the Kegalle District.

Documentation of Sigiriya and erecting iron platforms

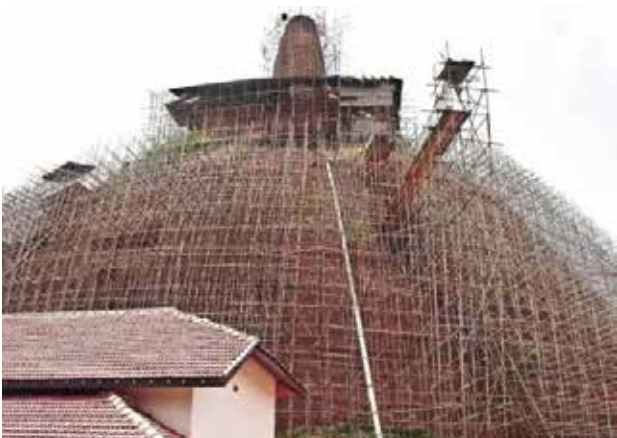
Restoration of Mirisawetiya Dagaba in 1993

After conservation, the height of the Dageba was 192 ft. and the diameter was 145 ft. In this conservation, reinforced concrete rings were used and 1 million bricks were consumed. Similarly, the temple complex was also conserved. This project was completed by employing all the technical staff of the department, who worked day and night.

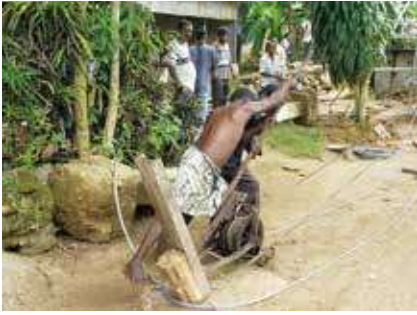
Primary Mechanism used at Ruwanwella Conservation

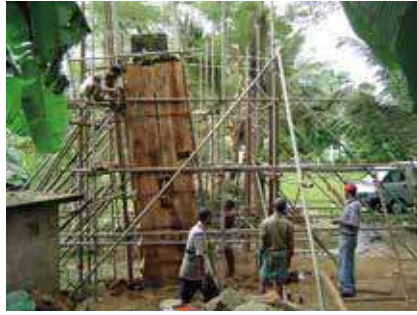
Ruwanwella Fort Entrance, before Conservation

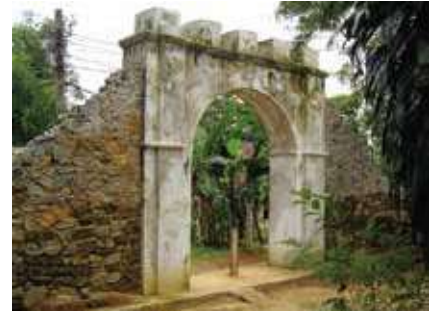
After Conservation

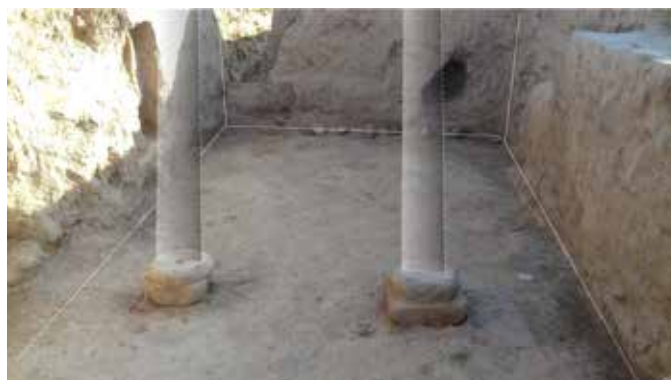
On the south-western side of the monument there was a complex (DT-32) of several rooms that had possibly belonged to a wealthy man. In the central hall (9.35 x 5.15 m) of the complex a large stone base of the eastern-type column widely distributed in Bactria was found, as well as fragments of the capitals of the column. Similar samples of this type of column base have been found at many monuments of ancient Termez and Khalchayan.

2. Room No. 1 with two stone bases

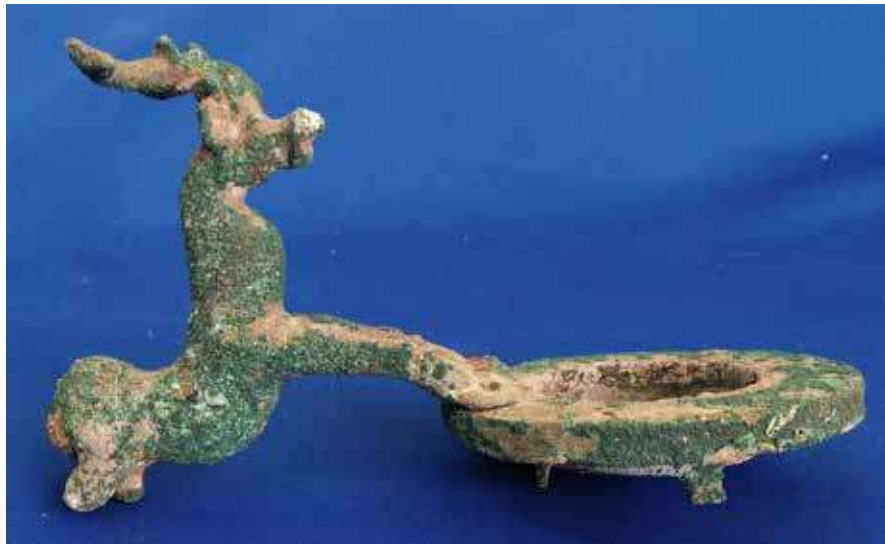
Of particular importance among archaeological items is a brazier (or candlestick) with a zoomorphic metal handle in the form of a horned deer. Presumably, this highly artistic product was intended to kindle an aromatic plant, for example, the medicinal herb “*isirik*” – *peganum harmala* (or Syrian rue) – used for magical purposes, and used during special ceremonies. A candlestick with a similar handle was found in Dalverzintepa for the first time and has no Bactrian analogues as yet. Other similar Bactrian monuments are also unknown. But this pattern resembles a brazier from Iran, dating back to the time of the Arsacids dynasties of Parthia (2nd century BC to 2nd century AD). The only difference is that the handle on the Iranian sample shows a griffin instead of a deer.

6. A brazier (or candlestick) with horned deer metal handle
