ACCU Nara
International Correspondent

Vol.20 2018

The Twentieth Regular Report

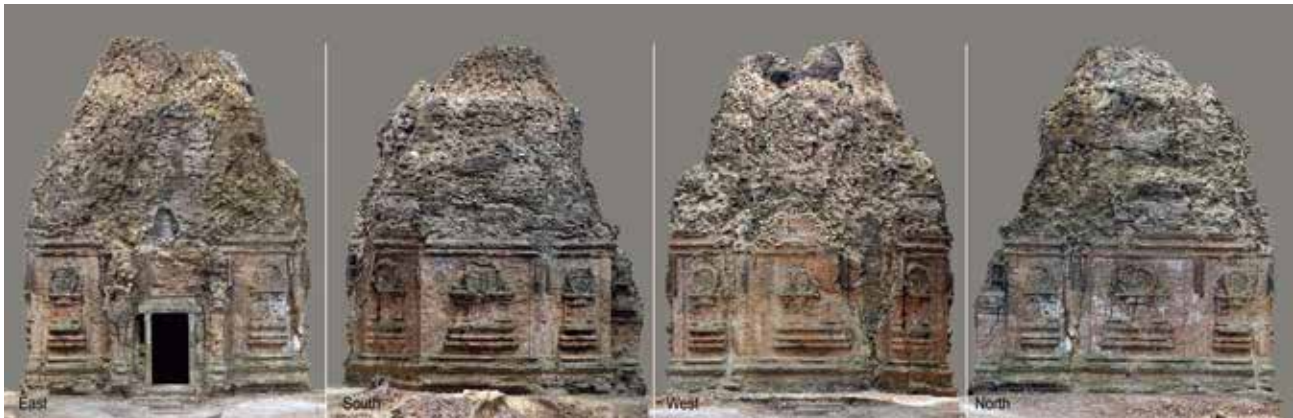
Photoscan images of elevations of the S11 tower before restoration

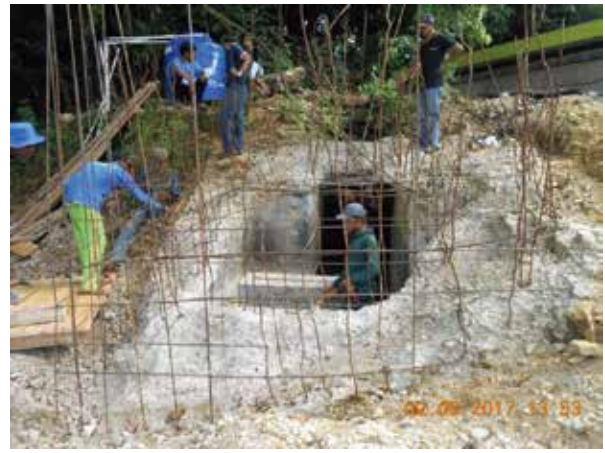
Concrete reinforcement assembly

Demolition of the framework was done about one month after casting the concrete, followed by finishing, which comprised repair of parts of the bunker. All parts of the bunker were fixed so that the shape and size of the bunker were in line with the original.

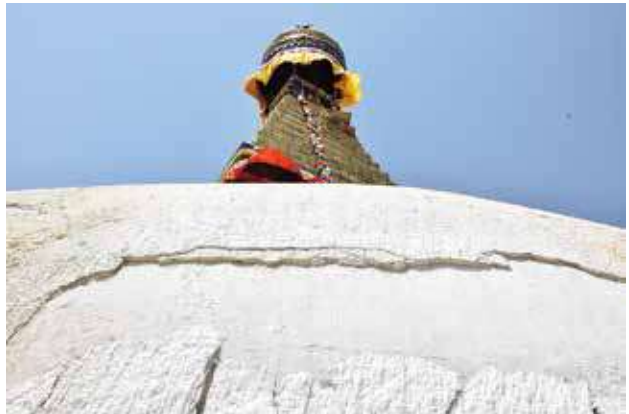
Damaged due to Earthquake 2015

The assessment reported that the upper part of the stupa was severely damaged and must be renovated, however the lower part was not affected that much. But the eastern small stupa, *Rangkarik Chaitya*, was severely damaged. As per the assessment report and the recommendations, temporary protective works were carried out immediately; i.e., scaffolding and shoring for the *bermika* and *trayodasha bhuvana*, covering with tarpaulins, etc.

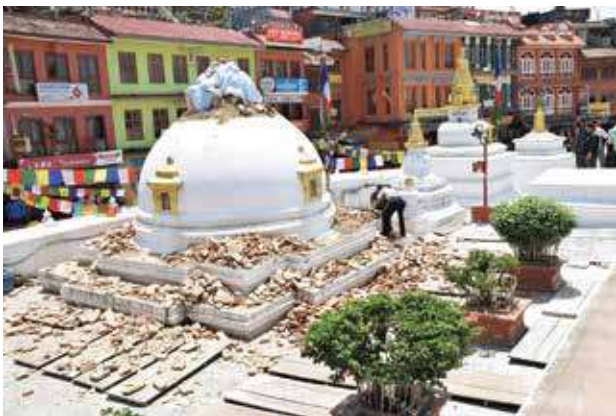
The damaged associated stupa within Boudha Main Stupa

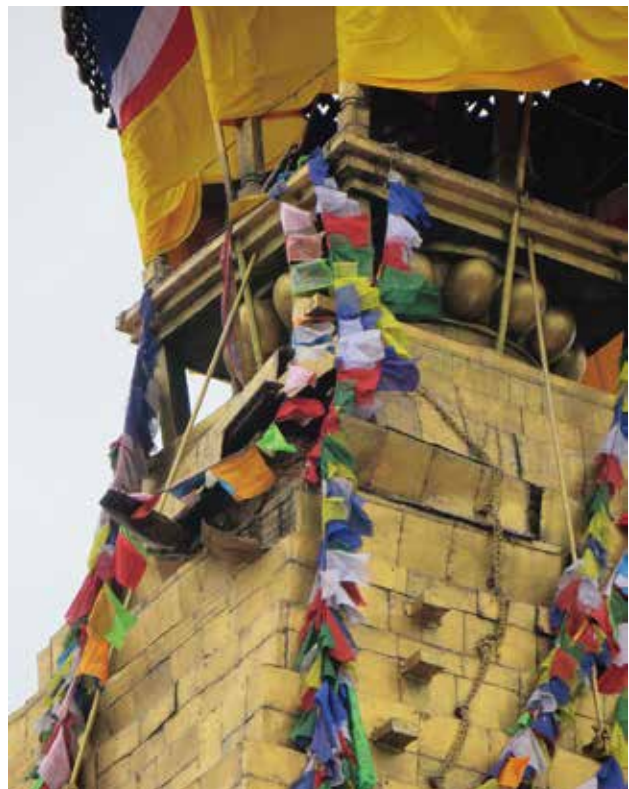
Damaged upper parts of sutpa-trayodasha bhuvana

it was subsequently reported that the upper part of the stupa was damaged severely and must be renovated. As per the site report by the rescue team deployed from the Department of Archaeology, the site was assessed again as a preliminary assessment for the detail documentation, and the diagnosis was to renovate or to take quick action.

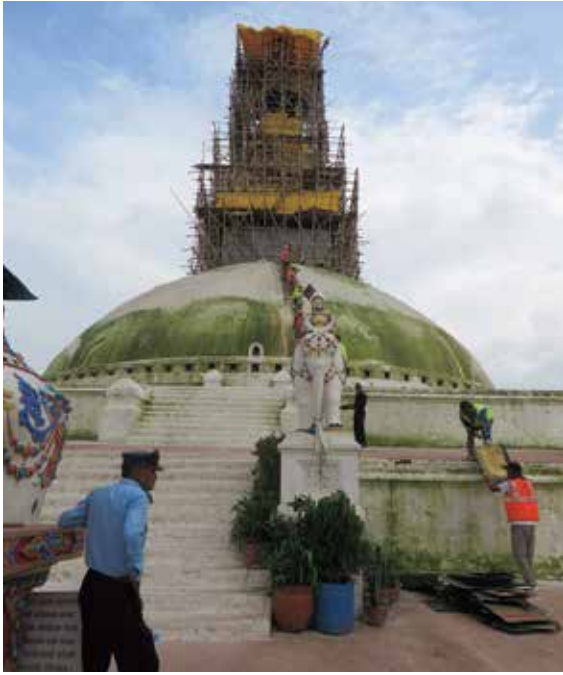
Bamboo scaffoldings prepared for renovation work in the beginning

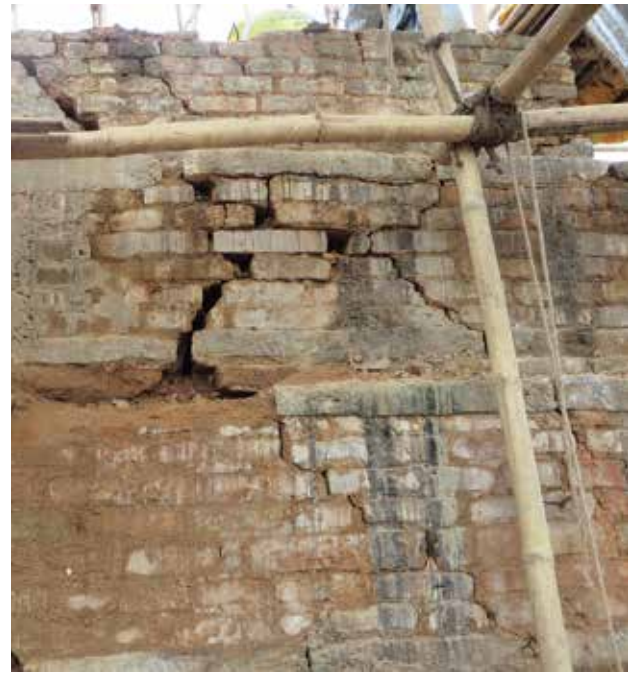
Damaged parts of *harmika*, explored after removing the copper sheets

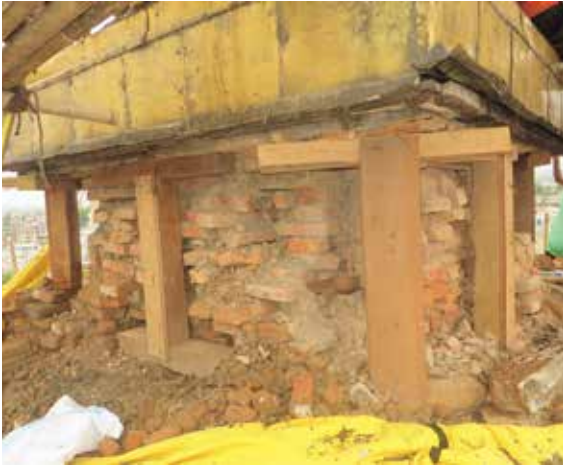
Damaged parts of *harmika*, explored after removing the copper sheets with new support

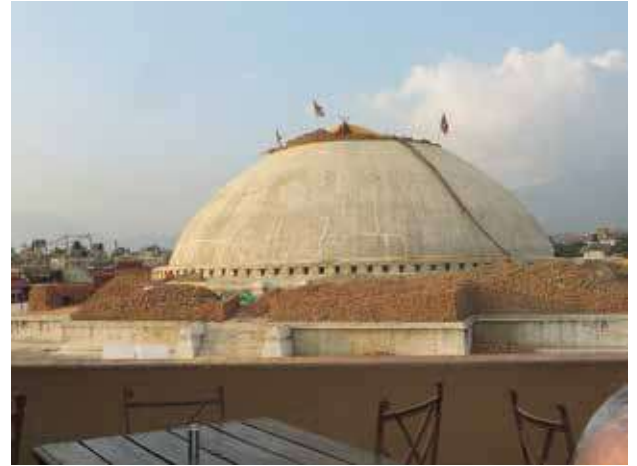
Stupa after opening the severely damaged upper parts to renovate

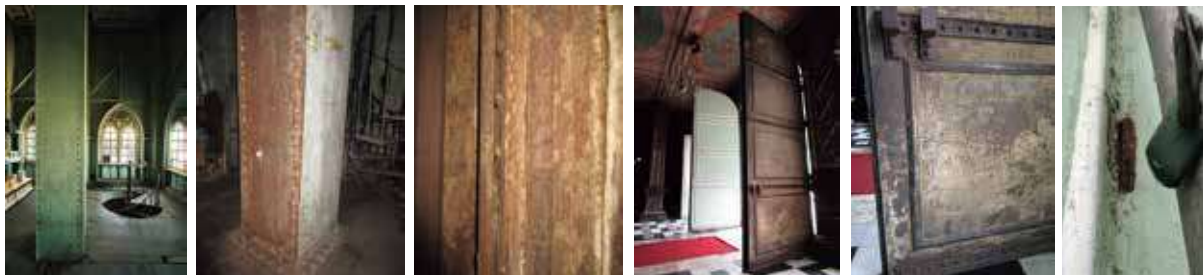
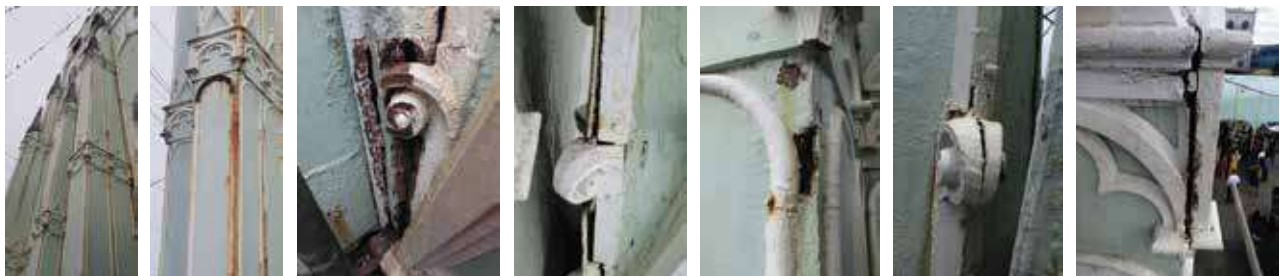
2. Assessment of exterior and interior parts:

The structure is faced with 126 years of corrosion hidden beneath the church paint.

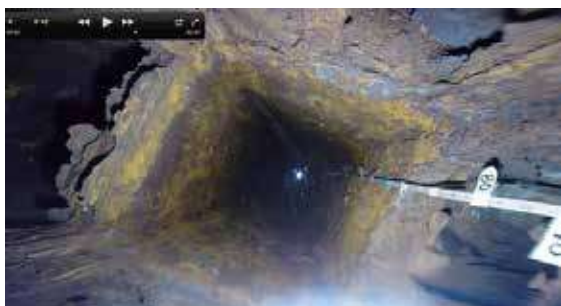
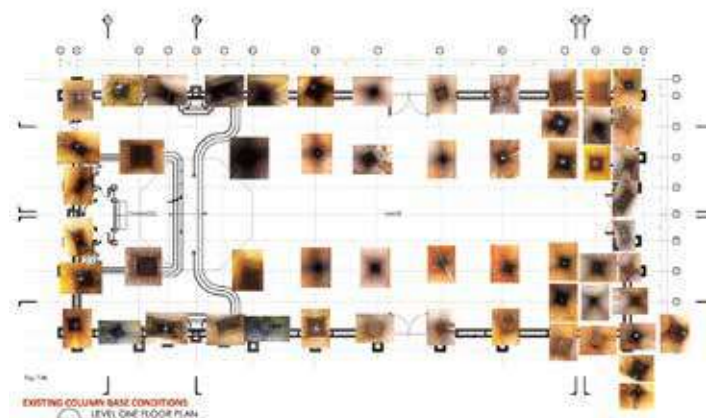
3. Condition of the columns:

Testing and analysis show extensive deterioration of the structure. There are over 300 leaks, large holes inside walls and columns, and pools of water in columns.

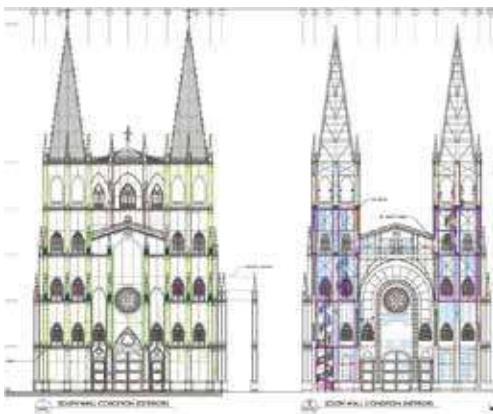
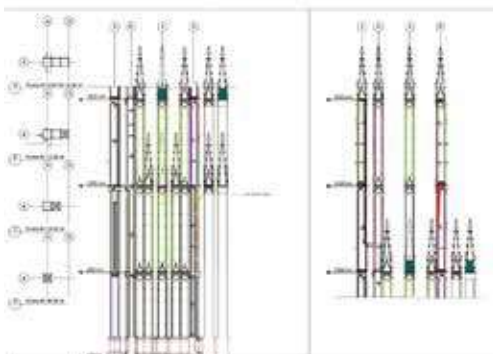
4. General condition:

ATTACHED	
BREAKS IN PAINT	
BULGING	
CEMENT PATCH	
CRACKING	
DULLED CORNERS	
GENERAL LOSS	
LOSS BY OXIDATION	
LOSS (INT. OF WALL PANEL)	
LOSS (CAVITY WALL)	
MISSING BOLTS / PEGS	
OPEN JOINTS	
PATCH B	
RUST LEVEL 2	
RUST LEVEL 3	
STREAKING	
WELDED

FLOOR CRACK BIGGER	
FLOOR CRACK HAIRLINE	
FLOOR DISCOLORATION 1	
FLOOR DISCOLORATION 2	
FLOOR HOLLOW	
FLOOR PATCH	
FLOOR LOSS	
FLOOR SLOPE	
ROTTED WOOD PLANK

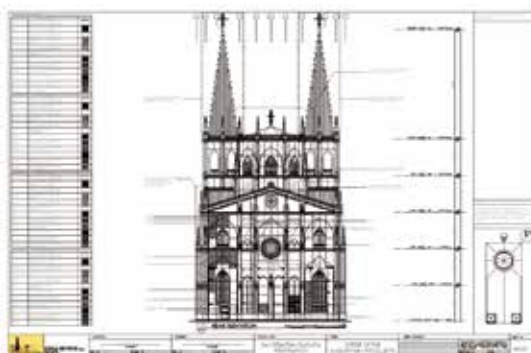
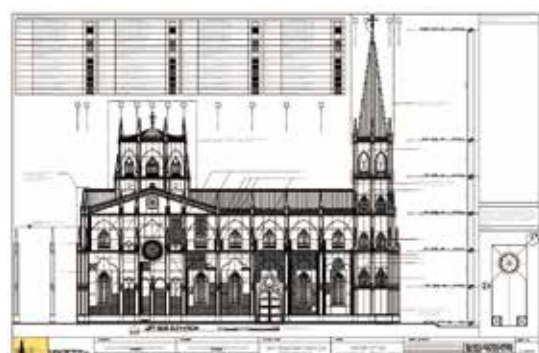
Architectural Design & Repairs (In-House)

Sample Architectural Designs and Repairs:
 Dome column, cornice gap ceiling, steeple flashing,
 dome pinnacle, steeple gutter repairs

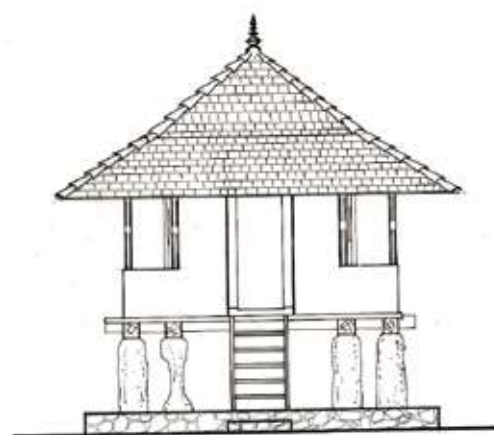
Conservation drawing

After considering structural problems and causes of decay a conservation plan is raised. Accordingly, conservation drawings are prepared and followed by estimates and specifications. Normally a conservation project cannot be restricted to the allocated budget, because conservation decisions change when the conservation works are being done. In some cases an additional amount of money is estimated for unforeseen works.
