ACCU Nara  
International Correspondent

Vol.21 2018

# The Twenty-first Regular Report

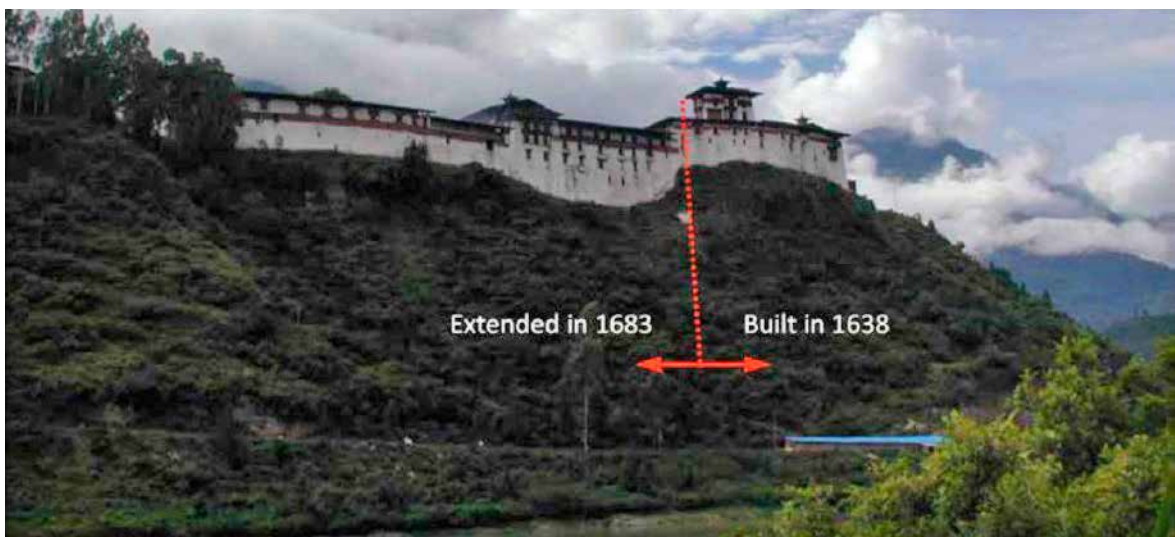
Fig. 9. A view of Wangduephodrang Dzong before the 2012 fire. The walls highlighted in pink are the walls preserved from 1638. Source: DCHS (2016)

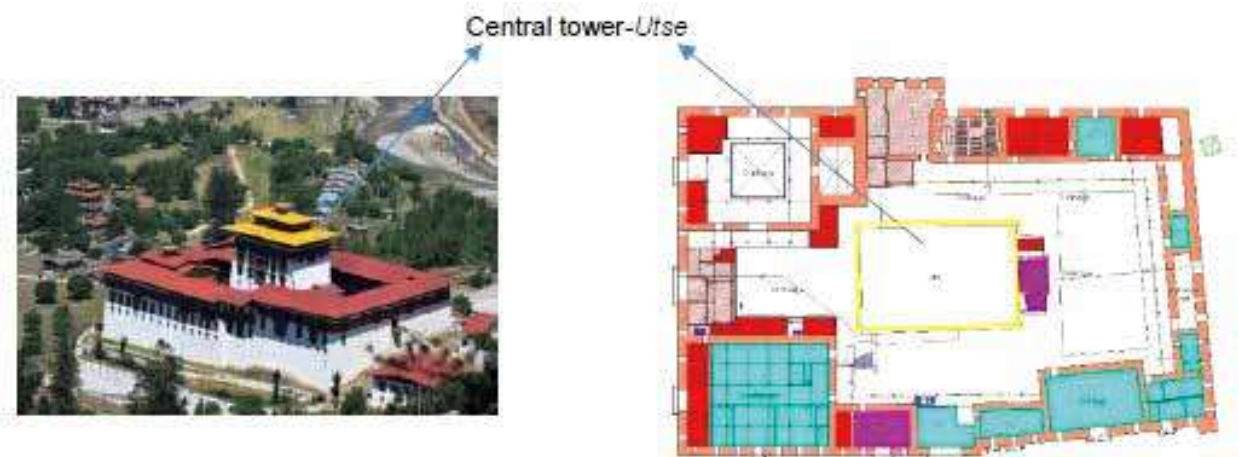
Fig. 12. A view and a plan of Paro Dzong built in 1644. Source: DCAH (2006)

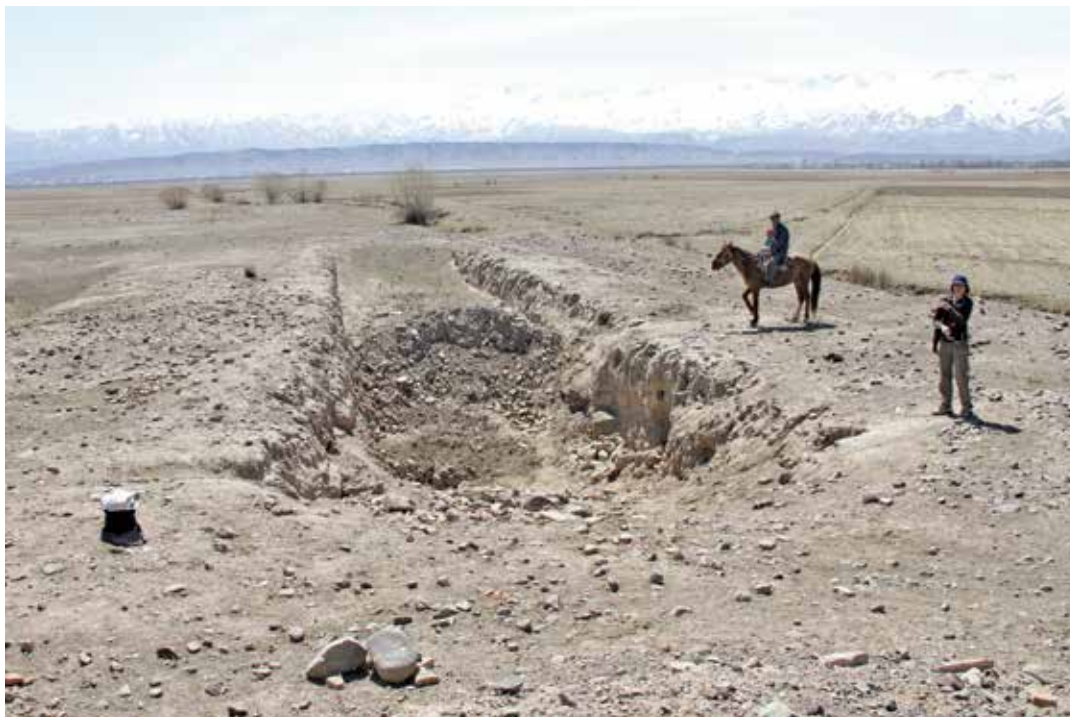
Fig. 1. The location of the Kyok-Tash mausoleum. A view of the site before excavations.

In 2010-2011, one of the residents of Ak-Zhar village, situated about 3 km south-east of the site, carried out illegal excavations in the precincts of the mausoleum. Thanks to the media coverage, the looting sparked a public outcry. However, as a result of the illegal excavations, a big pile of earth mixed up with fired bricks and two holes have appeared in the precincts of the site. Moreover, parts of the dome and walls were apparently destroyed during that illegal action (Fig. 1).

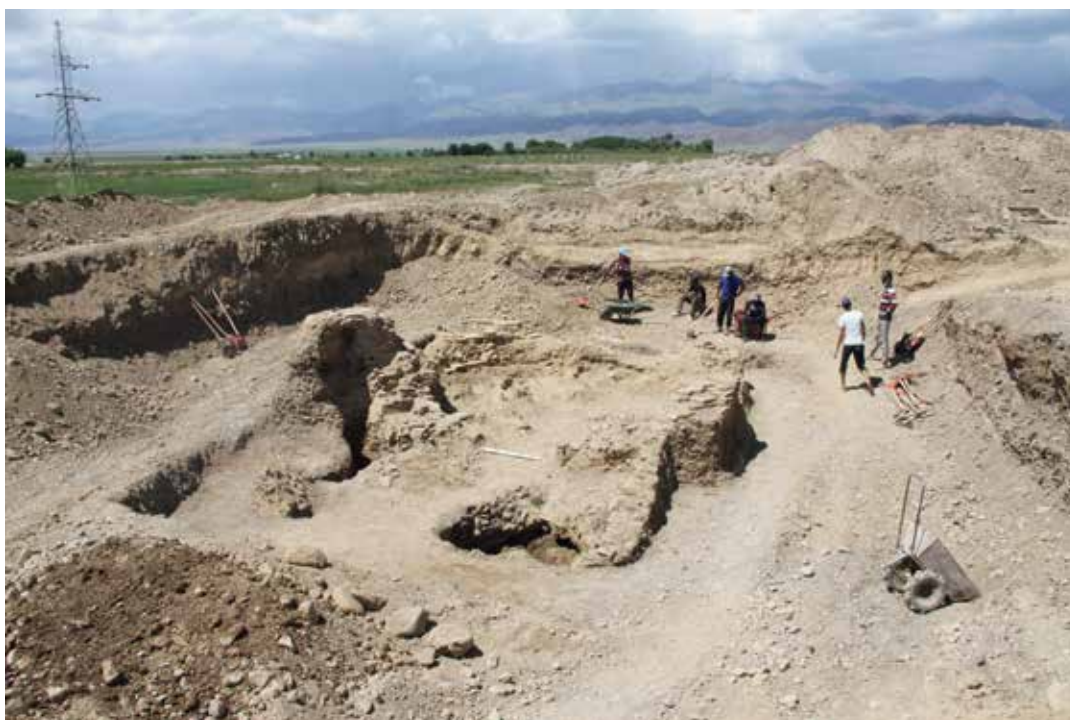
Fig. 2. A view of the partly uncovered site. The upper part of the Kyok-Tash mausoleum.

The mausoleum consists of two rooms: one of them is smaller and rectangular shaped; the other one is larger and square shaped (Figs. 2 and 7). Its walls are oriented in the cardinal directions. An arched entrance doorway is situated in the center of the south wall of the first, rectangular room. The rooms of the mausoleum are connected to each other by an arched passage, which is partly preserved. The second square room had apparently been covered with a spherical dome, of which only the bottom part is preserved. The dome had rested on an octagon formed by the walls and corner arches, i.e. squinches. The squinches were formed by 16 arches, which were set one inside another, gradually growing down into the corner (Fig. 3). The floors of the rooms are paved with two layers of the fired bricks (Fig. 4). They are of the same sizes as those used in the walls. However, in contrast with the wall bricks, the floor bricks' front faces and sides are polished smooth.

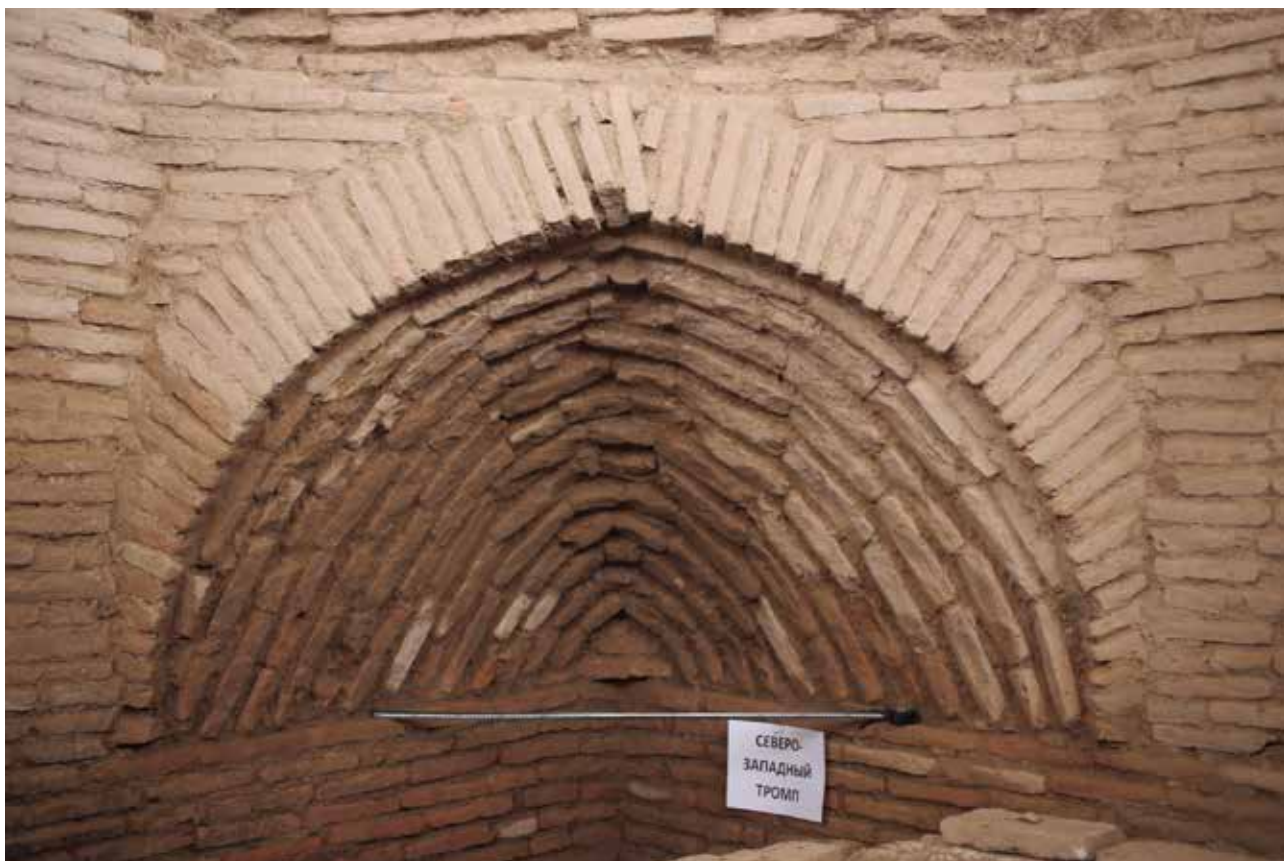
Fig. 3. One of the squinches in the second room of the mausoleum.

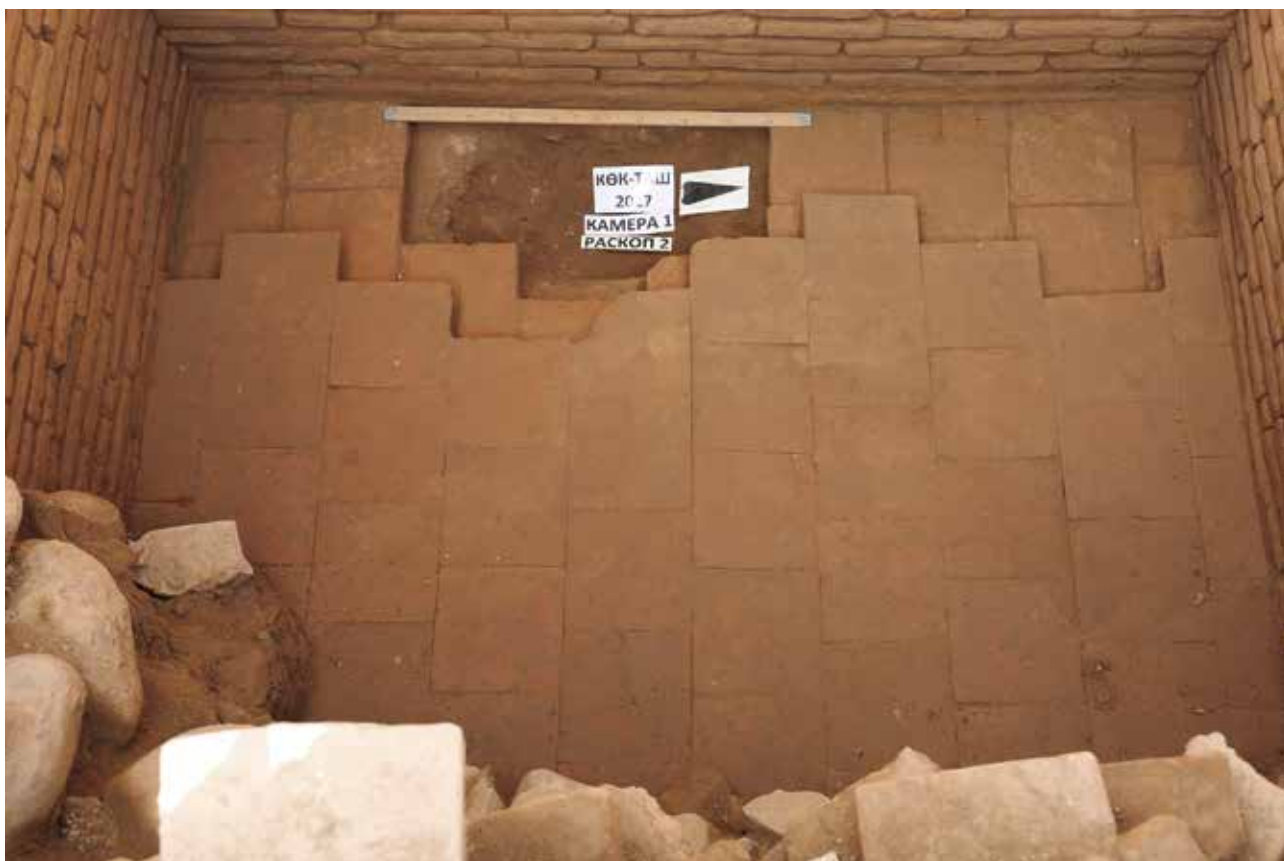
Fig. 4. The floor of the first room of the Kyok-Tash mausoleum.

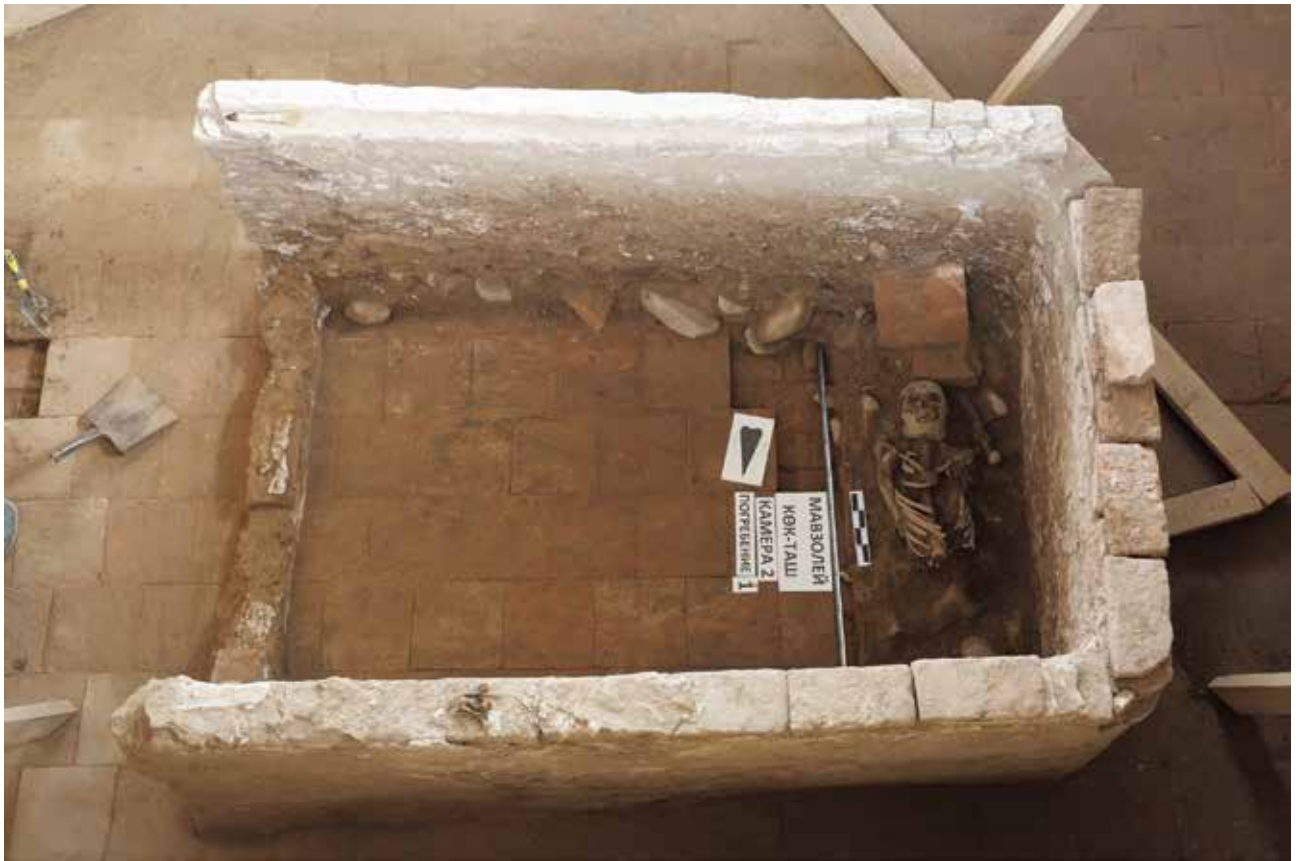
Fig. 5. The burial box of the Kyok-Tash mausoleum.

after the construction of the mausoleum. Only the upper part of a human skeleton, probably female, was discovered in the burial box. The skeleton had been moved from its original interment location. The lower part of the skeleton and a complete human skeleton, probably male, were found outside the burial box, at the western wall of the second room.

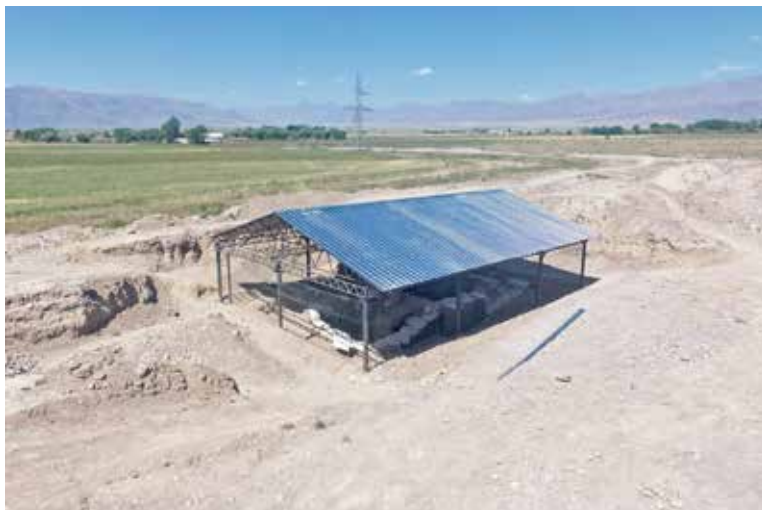
Fig. 6. The metallic shed over the Kyok-Tash mausoleum.

In accordance with the law of the Kyrgyz Republic "On the protection and use of the historical-cultural heritage," preventive conservation measures were implemented after the conclusion of the 2017 excavations. A metallic shed with side fences was constructed over the mausoleum to protect it from the rain and to prevent illegal intrusions to the site (Fig. 6). At the moment, discussions on conservation and museumification strategies are taking place in the Ministry of Culture and Tourism of the Kyrgyz Republic.

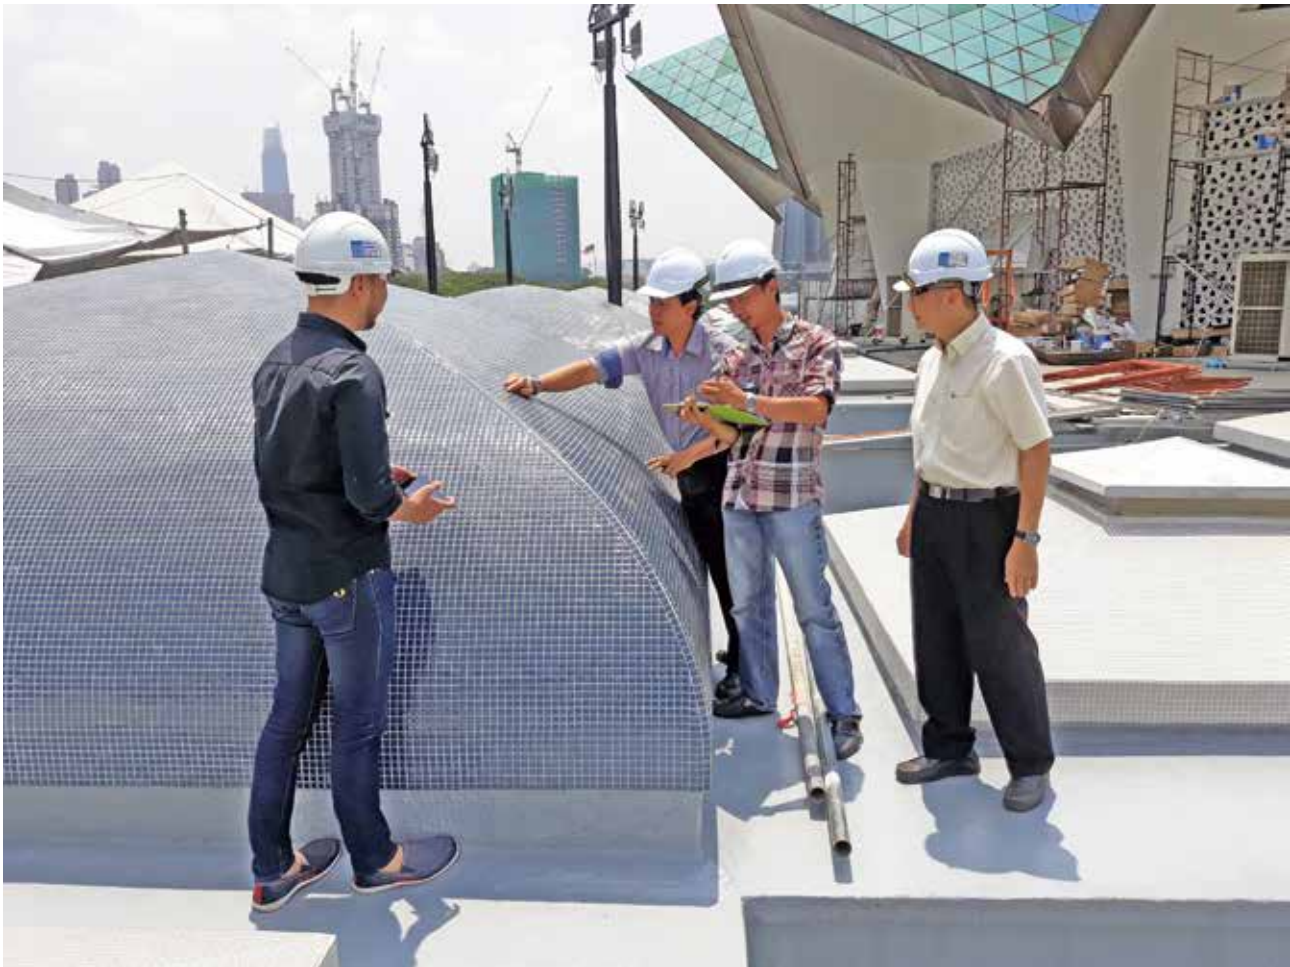
Regular inspections were carried out by all parties to ensure the quality of workmanship after the installation of glazed porcelain mosaics and the application of waterproofing coating on the flat roofs of the National Mosque.

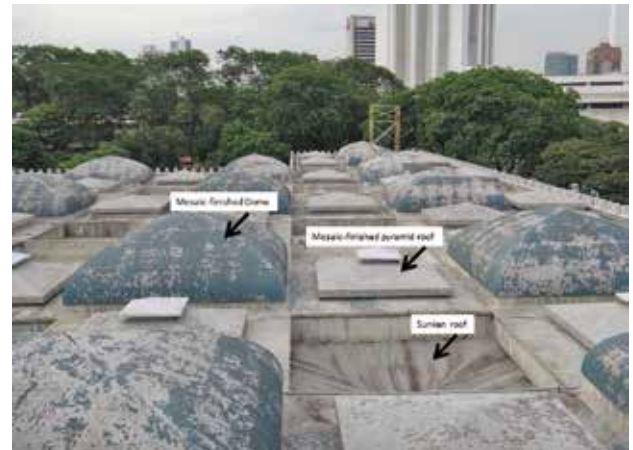
The flat roofs of the National Mosque accommodate mosaic-finished domes, mosaic-finished pyramid roofs, sunken roofs and skylight roofs. Each roof type measures 4 m x 4 m at the base. The height of the dome is 1.8 m, the pyramid roof is 0.8 m and the sunken roof is 1.3 m deep.

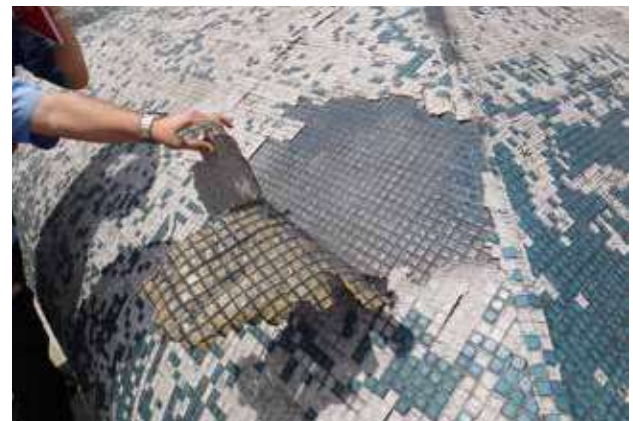
The ageing top layer of glazed porcelain mosaics on the domes of the National Mosque were found to be either missing, detached, loosened or to have fallen off, exposing the old layer of waterproofing coating and the original mosaics. This condition had caused water penetration, trapped moisture and roof leakage onto the prayer halls and other spaces underneath the flat roofs.

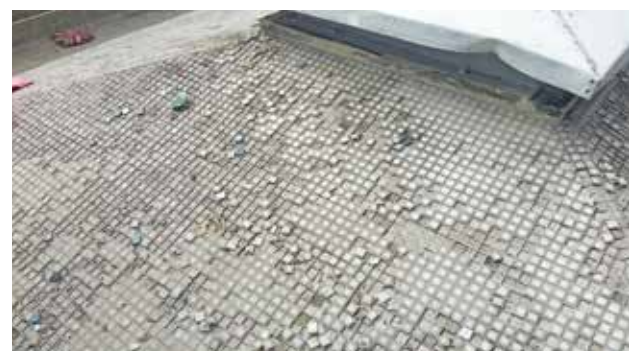
Similar to the domes, the glazed porcelain mosaics on the pyramid roofs were found to be either missing, detached, loosened or to have fallen off, exposing the old layer of waterproofing coating.

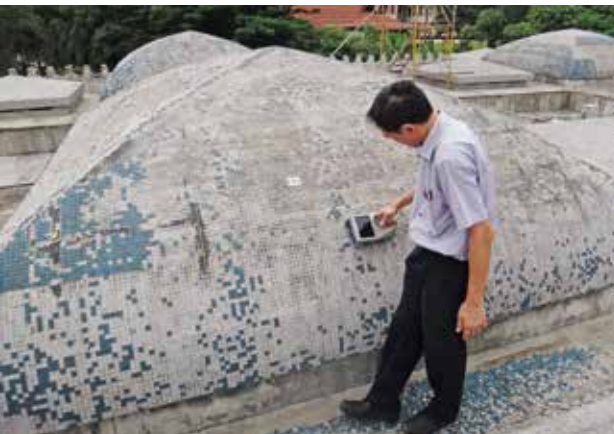
A ground penetrating radar (GPR) scanning device was placed on the dome surfaces to determine the depth or pattern of reinforcement and any embedment or possible moisture trapped underneath the substrate or structure.

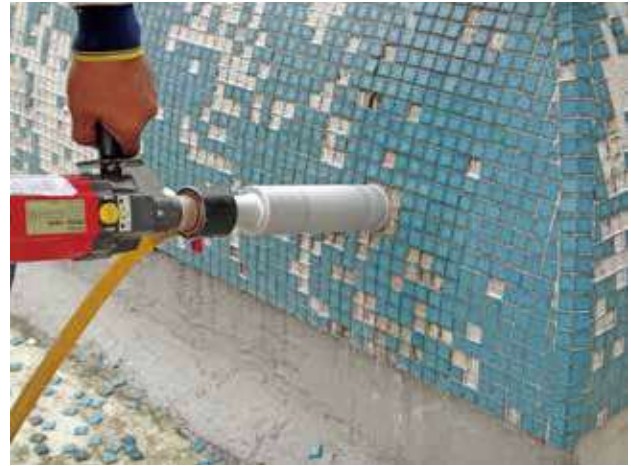
Samples of building materials from the domes including concrete substrate or structure were cored to examine the mineralogical and chemical characteristics (petrography test); and also to determine the elemental composition (X-ray fluorescence test).

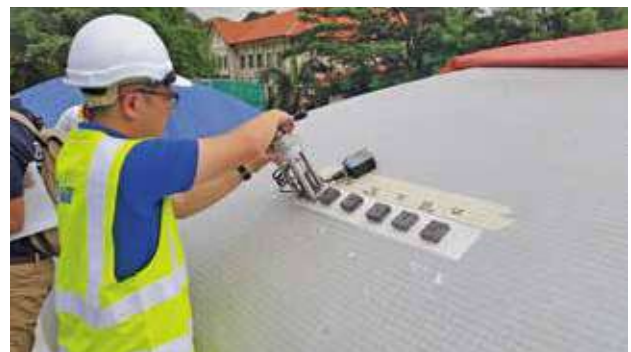
In-situ pull-off adhesive tests were carried out on the dome to determine the bond strength of "Kerapoxy" epoxy tile adhesive between the polyurea coating surface and the existing mosaic layer. The result showed that the average bond strength was 2.5 N/mm<sup>2</sup>, which was acceptable.

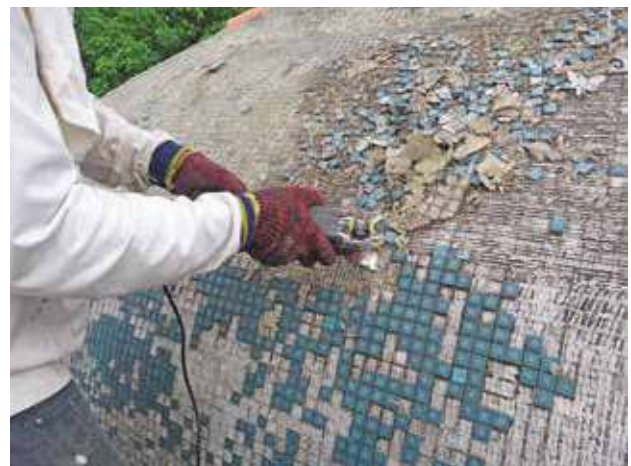
An oscillating tool was used to carefully remove the outer-most or non-original layer of glazed porcelain mosaics on the domes and pyramid roofs until the existing original layer of waterproofing coating was found. The tool reduced the vibration and noise pollution disturbing the public and the conduct of prayers inside the mosque.

1. The mosaic-finished dome and pyramid roofs:
  - i. Entirely remove the outer-most or non-original layer of glazed porcelain mosaics until the existing original layer of waterproofing coating is found by using an oscillating tool. The tool reduces the vibration and noise pollution to a minimum. It provides the least level of disturbance or nuisance to the public or the conduct of prayers inside the mosque.

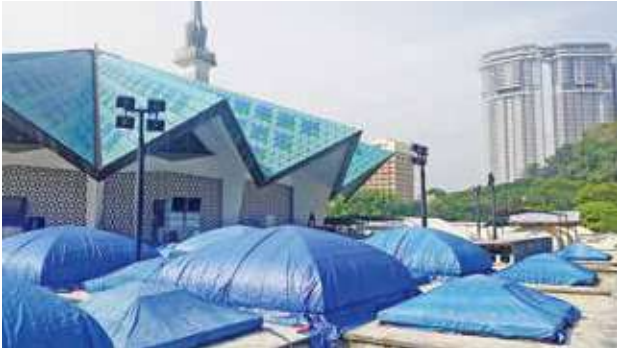
Canvas sheets were used to cover the domes and pyramid roofs after the outer-most layer of glazed porcelain mosaics had been removed. This was to protect the exposed surfaces from water penetration.

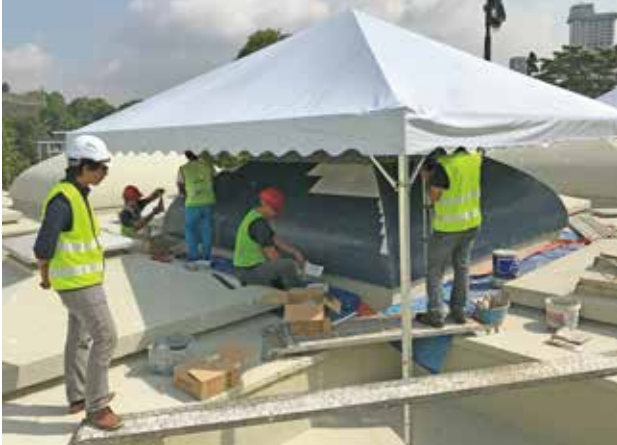
Temporary tents were erected to cover each dome and pyramid roof during the mosaic installation stage in order to protect them from direct sunlight and heavy rain.

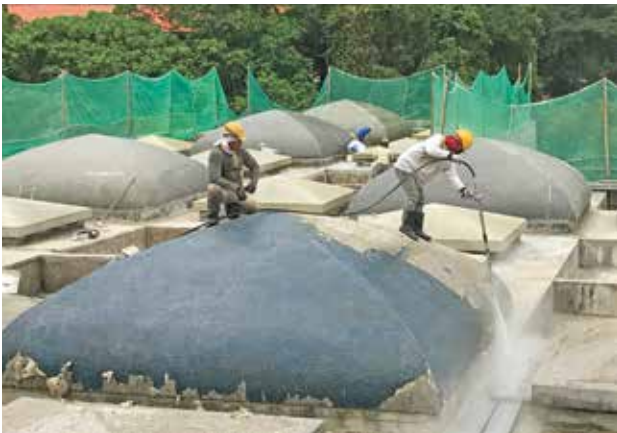
Removal of the existing layer of waterproofing coating on domes by using an 11,000 psi high pressure hydro jet, revealing the original glazed porcelain mosaic in blue.

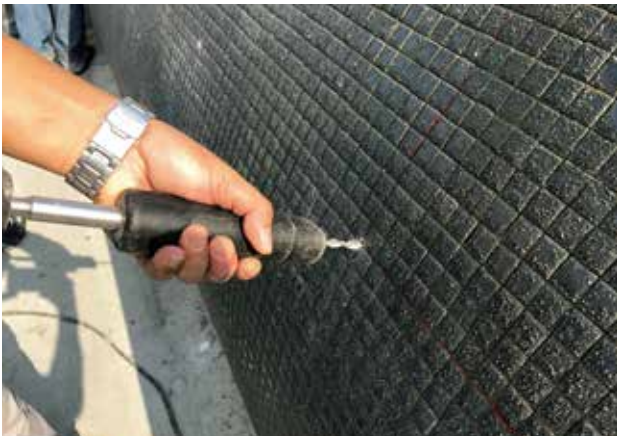
Rehabilitation of the reinforced concrete structure or substrate of the domes was carried out by driving 8 mm-diameter "Helifix-Dryfix" stainless steel helical pins through the pilot holes and into the reinforced concrete structure or substrate.

- i. Delaminated cementitious bedding render underneath the mosaic finish for dome and pyramid roofs to be anchored mechanically into the reinforced concrete structure by using the “Helifix-DryFix” stainless steel helical pinning system.
- ii. Drill 6.5 mm-diameter pilot holes through the bedding render into the reinforced concrete structure or substrate to a depth of 40 mm and at 450 mm intervals.
- iii. Drive 8 mm-diameter “Helifix-Dryfix” stainless steel

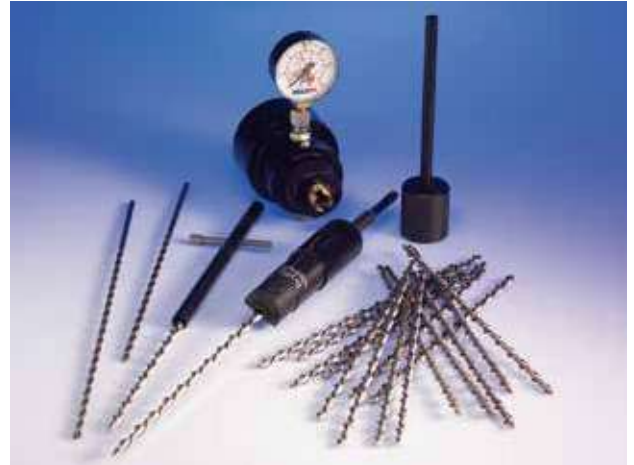
Equipment used to secure and anchor the reinforced concrete substrate or structure of the domes and pyramid roofs, including a load tester, stainless steel DryFix tie-pins and pin drivers.

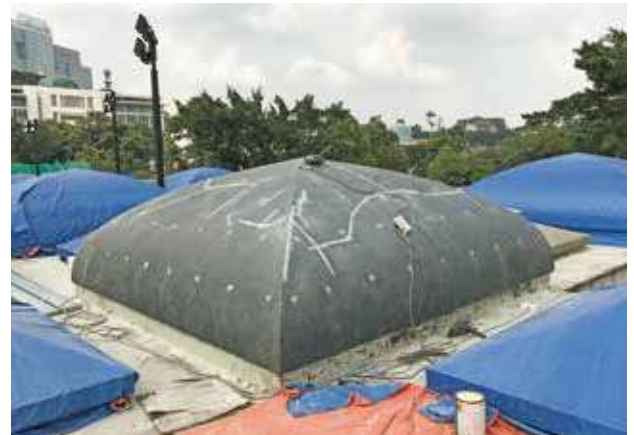
The dome after completion of work using the "Helifix-DryFix" stainless steel helical pinning system.

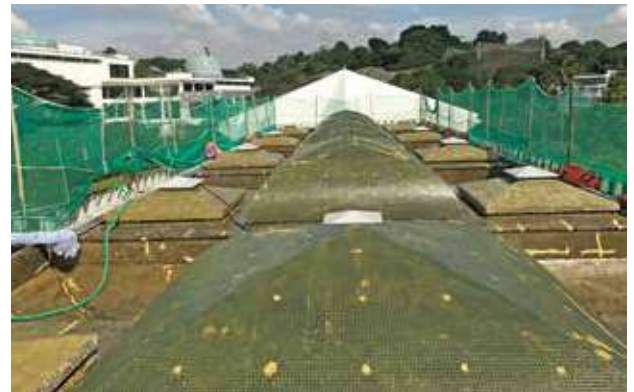
The domes and pyramid roofs were primed with epoxy scratch coat after application of the helical pinning system.

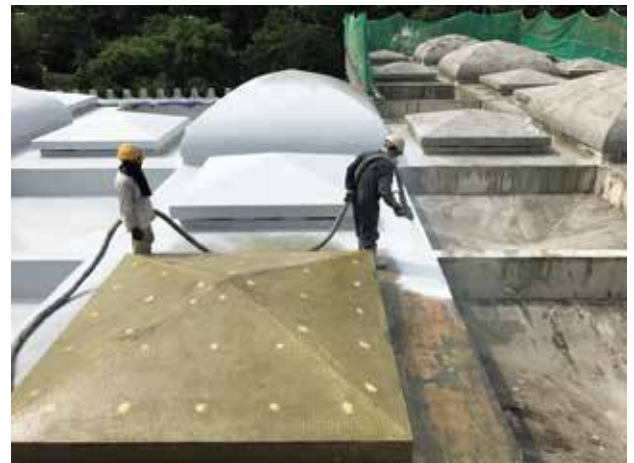
The spraying of 2 mm-thick polyurea waterproofing coating on the primed surfaces of the domes and pyramid roofs.

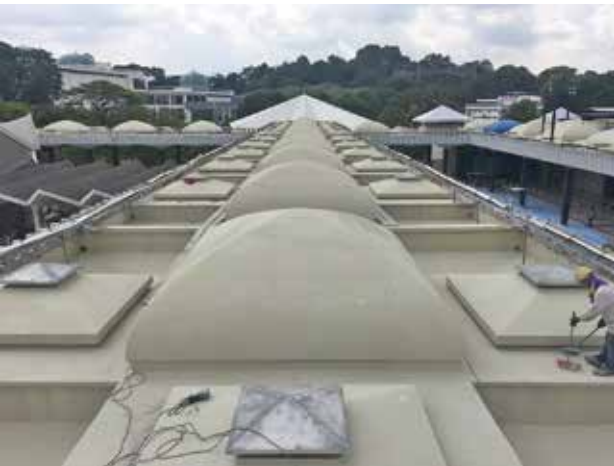
The flat roofs of the National Mosque covered by polyurea waterproofing coating.

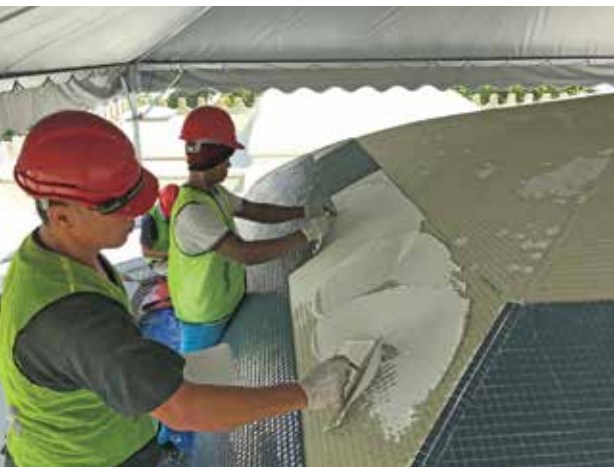
Spreading the tile adhesive on the surfaces of the dome by using a notched trowel before layering the sheet of glazed porcelain mosaics.

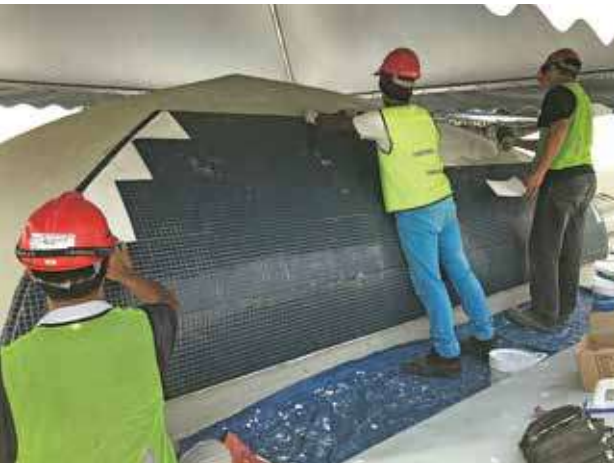
The installation of new glazed porcelain mosaics on the dome was carried out from the bottom layer and working upwards.

1. Lay mosaic to form the ridge of the roof as control lines (4 ridges)
2. Set the horizontal bottom line as a bench mark.
3. Set the vertical center line and begin the first sheet of mosaic at the lowest and center of the dome or pyramid roof, working towards left and right until meeting the ridges at the ends.
4. Follow the sequence at the second tier of mosaic working upwards until the top of the roof.
5. Trace and cut the mosaics to fill in the blank area along the vicinity of ridges.

The layering new glazed porcelain mosaics on domes begins with the first sheet of mosaics at the lowest centre point of the dome or pyramid roof and working towards the left and right until meeting the ridges at the ends.

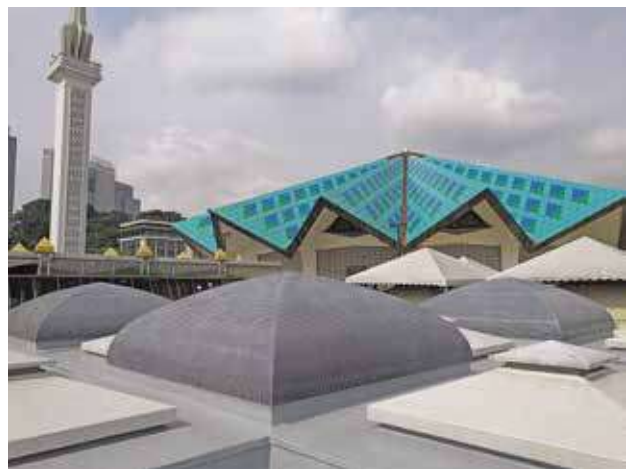
The domes and pyramid roofs of the National Mosque after the installation of new glazed porcelain mosaics.

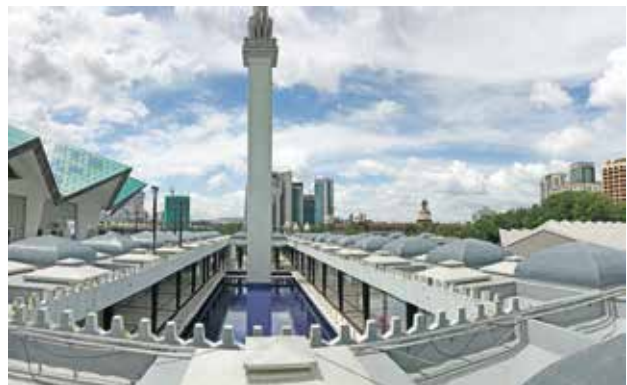
Upon completion, a total of 13,482,953 new glazed porcelain mosaic pieces were used to cover 95 domes and 270 pyramid roofs on the flat roofs of the National Mosque.

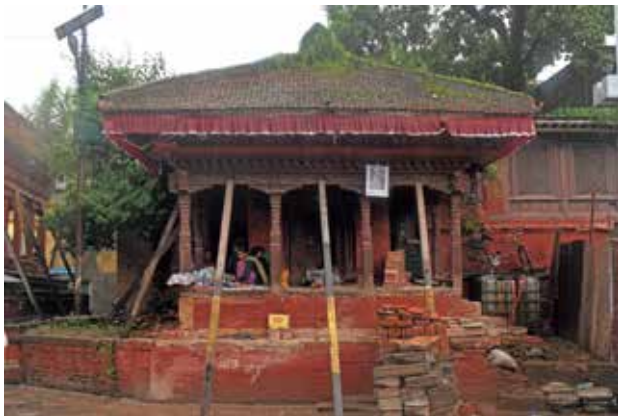
Fig 2. The east elevation of the temple. Raking shores are provided to support the temple roof (2017-07-26).

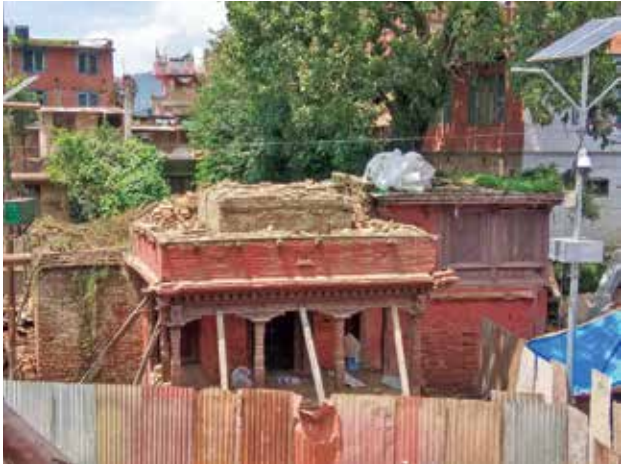
Fig 9. A view of the temple after removal of the roof rafters. The inner sanctum wall on the first-floor level can be seen (2017-08-27).

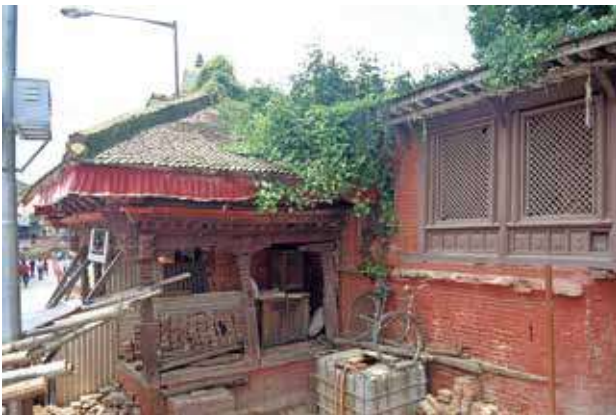
Fig 7. A view from north. The temple is attached to the boundary wall along the western edge. The desolate rear garden and heavy vegetative growth and ground moisture are taking its toll on the temple structure (2017-07-25).

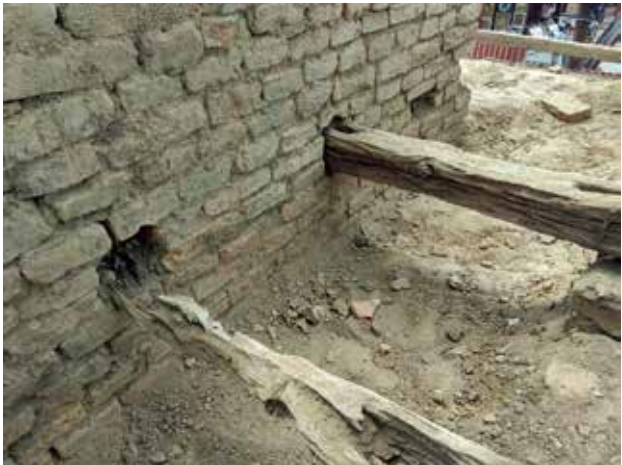
Fig 10. Almost all of the floor joists on the first-floor level were decayed due to wet rot (2017-08-29).

The upper floor joists spanning the outer ambulatory and sanctum rear wall had been damaged by wet rot due to rising damp and the *cbukuls* (wooden pegs) were absent in most cases. The sanctum wall made of mud mortar had been dislocated and was bulging out due to the impact of the violent shaking. Several diagonal cracks were seen in the sanctum wall. The main entry to the sanctum, accessed from the front, was found to be slightly tilted and several joinery connections had loosened and were also decaying due to rising damp. The upper plinth floor,

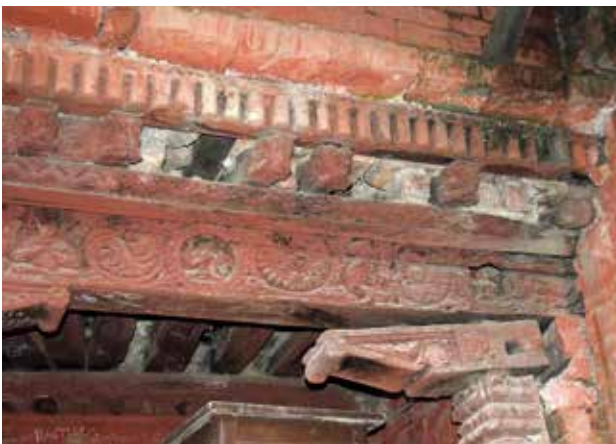
Fig 8. Dhalin khva above the nina are in a critical state due to a long period of exposure to wet rot. The faces carved in dhalin khva are not recognizable. The corner post and meth are dislocated (2017-07-25).

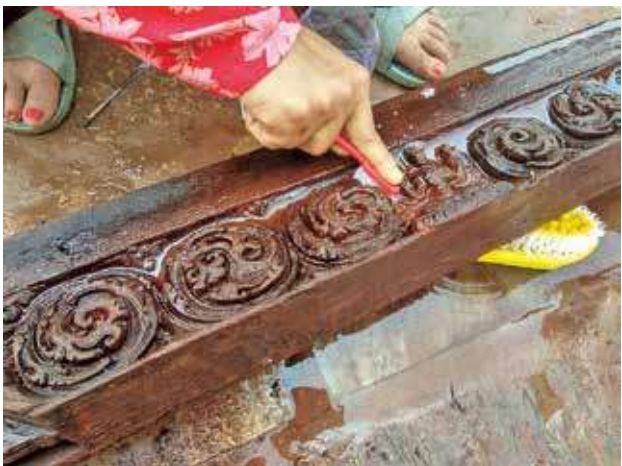
Fig 11. Wet cleaning of the door frame using a soft brush and plain water (2017-10-11).

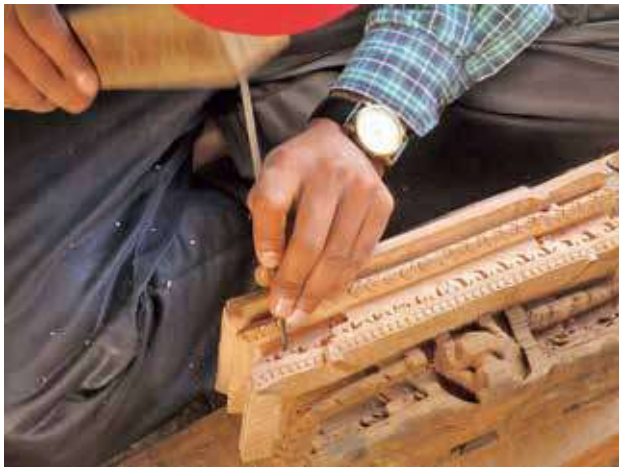
Fig 12. A new timber added to the lion base of the main door threshold being carved. The details are as per the originals (2017-10-26).

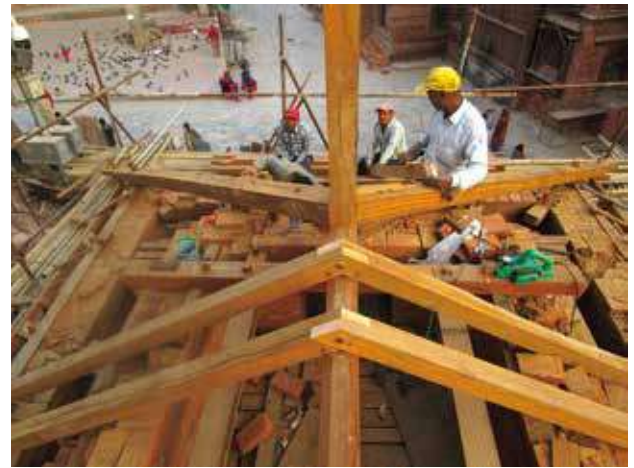
Fig 15. Carpenters laying the roof rafters (2018-1-31).

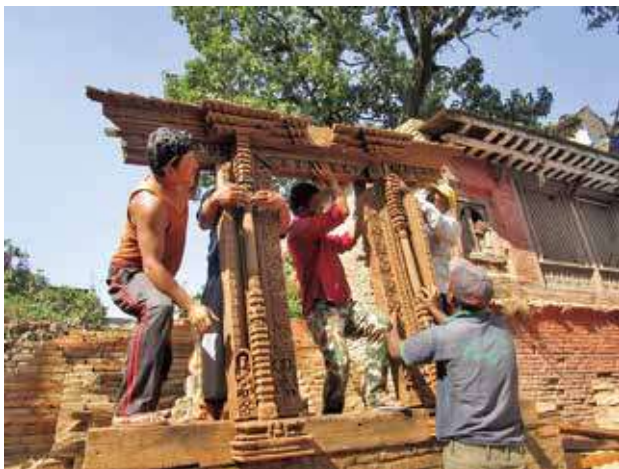
Fig 13. Installing the main sanctum door in its proper position. Such carved doors are assembled from many complex smaller carved members which are correctly put together by master carvers (2017-11-7).

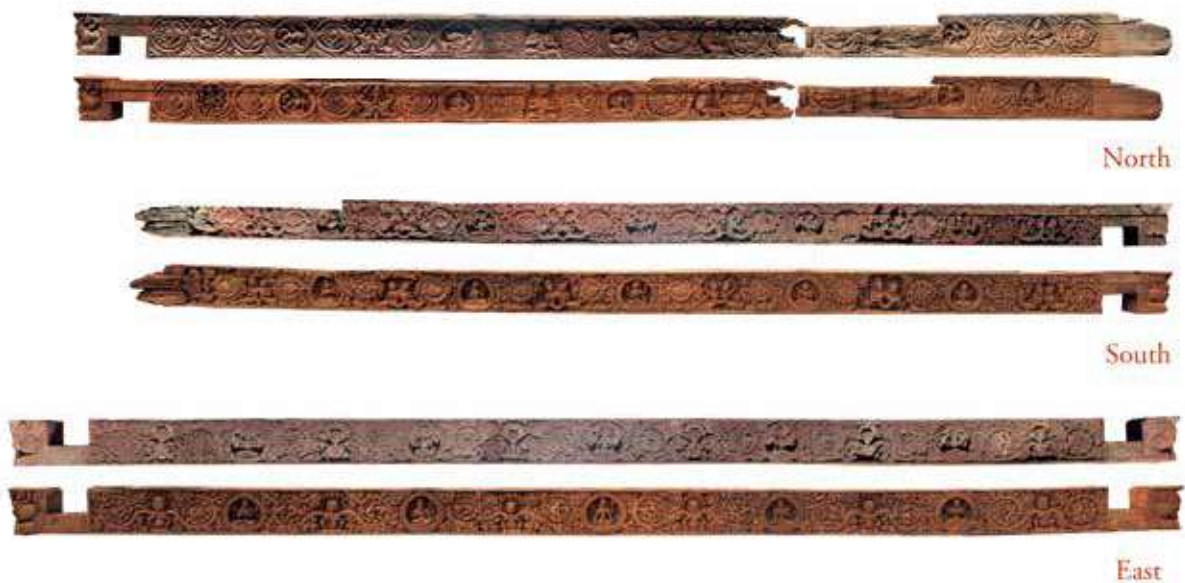
Saraswoti Temple Beam (*Nina*)  
 Before cleaning  
 Photo:10/30/2017 and 11/05/2017 P.S.Maharjan

Fig 14. The Saraswoti Temple beam (*Nina*) before and after cleaning on October 30, 2017 and November 5, 2017.

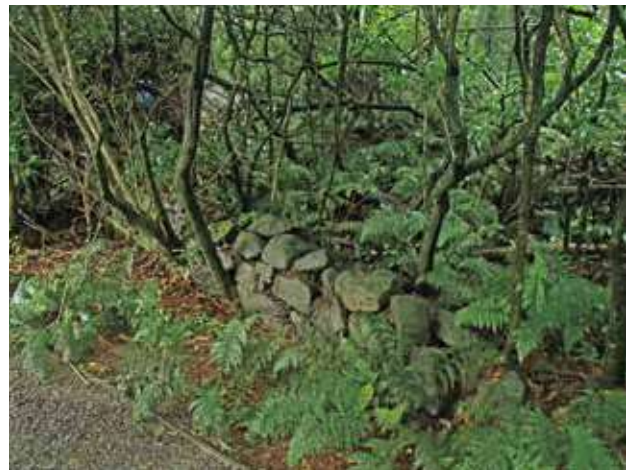
Figure 15. Damage to a wall from a collapsed tree (Photo: Matthew Schmidt).

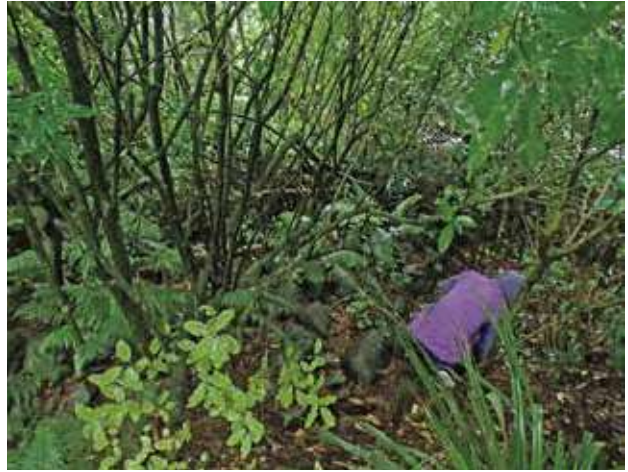
Figure 17. Norcombe Barker chain sawing trees from the fernery interior, vegetation clearance on 29 April 2018 (Photo: Matthew Schmidt).

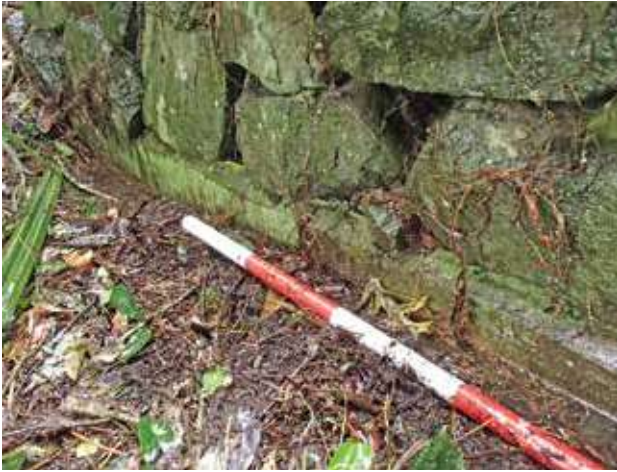
Figure 21. The strip concrete foundation onto which the stone rough stones walls were built, 29 April 2018 (Photo: Matthew Schmidt).

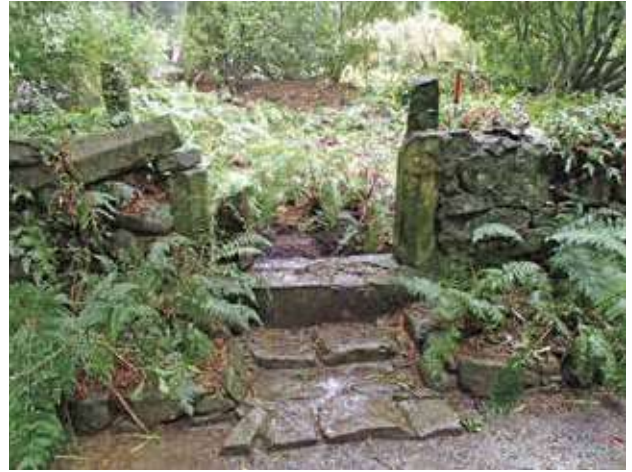
Figure 22. The entranceway with its stone slab steps and side gardens, 29 April 2018 (Photo: Matthew Schmidt).

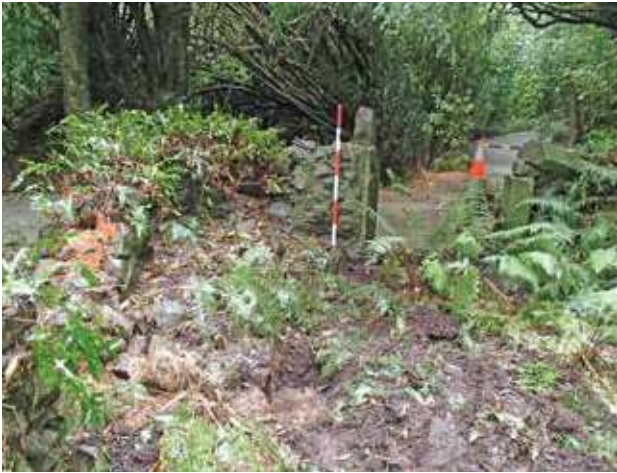
Figure 23. Interior features could be seen after the first stage of works on the fernery such as a stone piles used for growing cascading ferns built in the inside corners of the fernery, 29 April 2018 (Photo: Matthew Schmidt).

At each corner of fernery was stonework which was raised probably to provide a cascade of fern plantings and along the back and side walls of the fernery were raised stone lined growing areas (Figure 32). The collapse of the wall on the left side of the fernery was obscuring the raised area on that side. The floor of the fernery was intact and the bright sandstone path continued all the way around the interior. Currently, the floor is too stained with mud to confirm the use of pavers. Few artefacts were found during the excavation and this consisted mainly of mid to late 20th century pieces of wire and beer bottles. A few fragments of plate window glass were found but so little of it was present it is difficult to ascertain if this came from the fernery roof structure. Mr Purdie is believed to have shot the glass roof and destroyed it (Margaret Barker pers comm, 1 November 2018). A very small feature on top of the right Oamaru stone pillar by the entranceway provided a clue as to

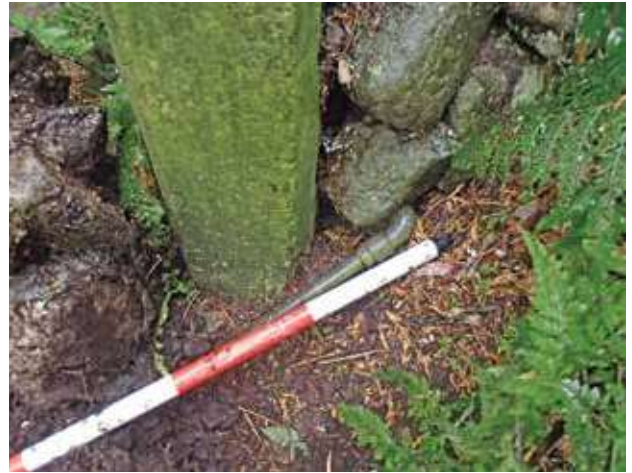
Figure 24. Water pipework coming into the fernery from an exterior water source (Photo: Matthew Schmidt).

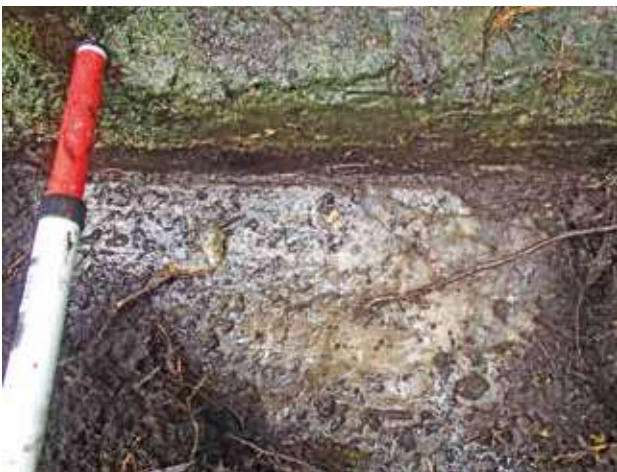
Figure 25. A test pit dug in the interior of the fernery showing what maybe sandstone paving, 29 April 2018 (Photo: Matthew Schmidt).

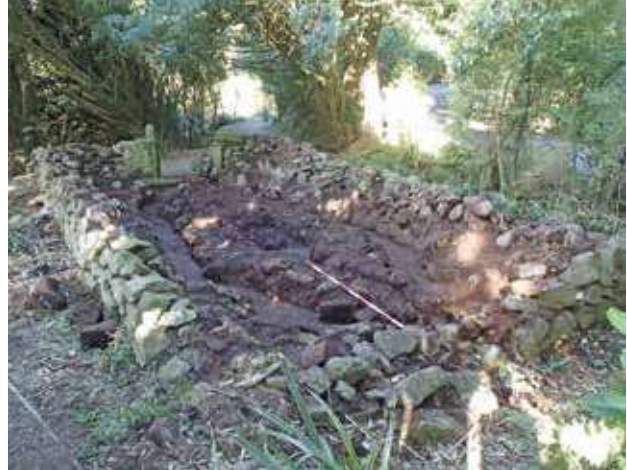
Figure 30. The fernery after the 26 August 2018 excavation showing the layout of the structure. The entranceway is in the background, the pond in the centre and the path leading part way round the fernery interior, 26 August 2018 (Photo: Matthew Schmidt).

intrusive roots was removed from the stonework and the excavation of the deep soil layer from the interior uncovered the layout of the fernery in more detail (Figure 30 to 33). The work found that the fernery had at its centre a stone structure, which would have originally been planted with ferns, with a pond located in the middle. This pond had a cement lining which still had its blue/green painted colouring. The pond had a running water supply originating from an inlet through the back wall which supplied water via a stone channel (Figure 31). It was also found that the water pipe noted in April led to the pond. This pipe may have supplied a fountain in the middle of the pond. More excavation of this central area will confirm these observations.
