ACCU Nara  
International Correspondent

Vol.21 2018

# The Twenty-first Regular Report

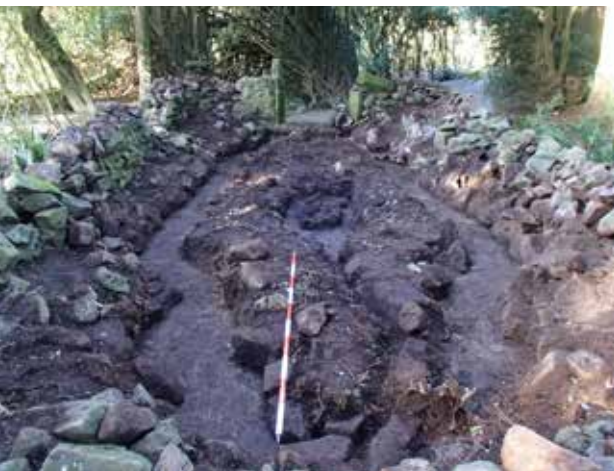
Figure 31. View from the back wall of the fernery where the water source comes through the back wall, along a stone channel and into the central pond. The source of the water has yet to be determined, 26 August 2018 (Photo: Matthew Schmidt).

intrusive roots was removed from the stonework and the excavation of the deep soil layer from the interior uncovered the layout of the fernery in more detail (Figure 30 to 33). The work found that the fernery had at its centre a stone structure, which would have originally been planted with ferns, with a pond located in the middle. This pond had a cement lining which still had its blue/green painted colouring. The pond had a running water supply originating from an inlet through the back wall which supplied water via a stone channel (Figure 31). It was also found that the water pipe noted in April led to the pond. This pipe may have supplied a fountain in the middle of the pond. More excavation of this central area will confirm these observations.

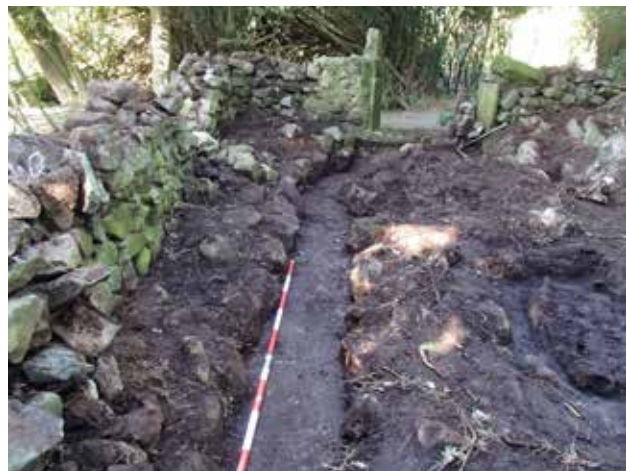
Figure 32. The excavated path and the terraced growing areas on the left side of the fernery looking towards the entrance. The path is muddy hence hiding the bright yellow sandstone floor. The left and right corners of the interior have piles of stones possibly used for cascading fern plantings, 26 August 2018 (Photo: Matthew Schmidt).

At each corner of fernery was stonework which was raised probably to provide a cascade of fern plantings and along the back and side walls of the fernery were raised stone lined growing areas (Figure 32). The collapse of the wall on the left side of the fernery was obscuring the raised area on that side. The floor of the fernery was intact and the bright sandstone path continued all the way around the interior. Currently, the floor is too stained with mud to confirm the use of pavers. Few artefacts were found during the excavation and this consisted mainly of mid to late 20th century pieces of wire and beer bottles. A few fragments of plate window glass were found but so little of it was present it is difficult to ascertain if this came from the fernery roof structure. Mr Purdie is believed to have shot the glass roof and destroyed it (Margaret Barker pers comm, 1 November 2018). A very small feature on top of the right Oamaru stone pillar by the entranceway provided a clue as to

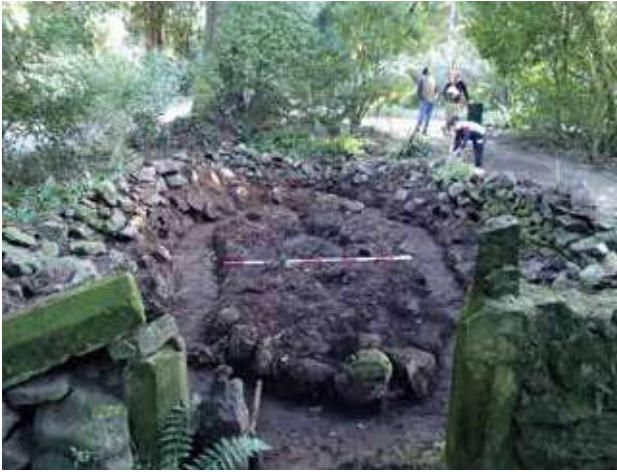
Figure 33. View of the ferriery from the entranceway showing the layout and collapsed back wall and left wall. The water pipe coming into the ferriery from outside and leading to the pond can be seen, 26 August 2018 (Photo: Matthew Schmidt).

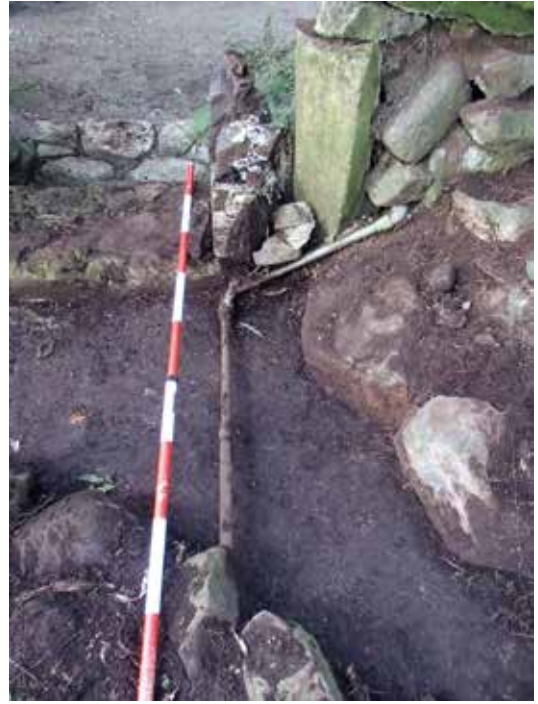
Figure 34. The water supply pipe seen in Figure 33, 26 August 2018 (Photo: Matthew Schmidt).

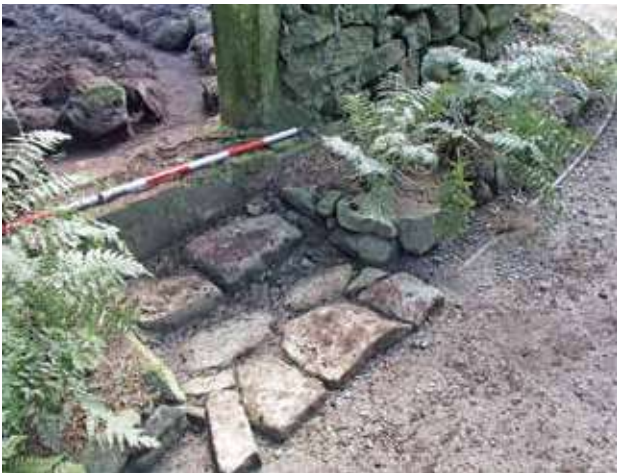
Figure 35. The entranceway steps and side gardens cleaned up, 26 August 2018, (Photo: Matthew Schmidt).

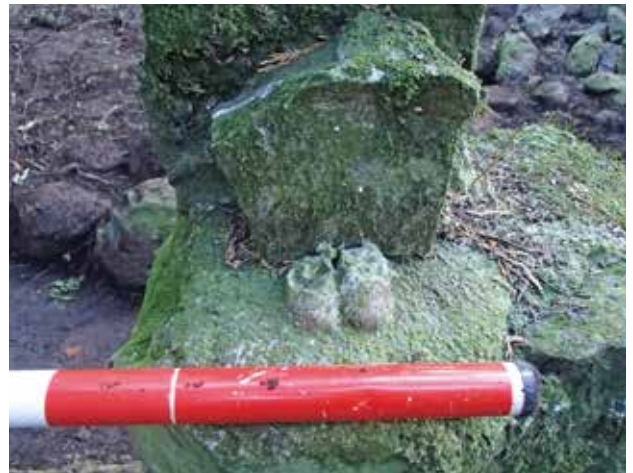
Figure 36. Small concrete boots from a missing statuette which used to be on top of the Oamaru stone entranceway pillars (Photo: Matthew Schmidt).

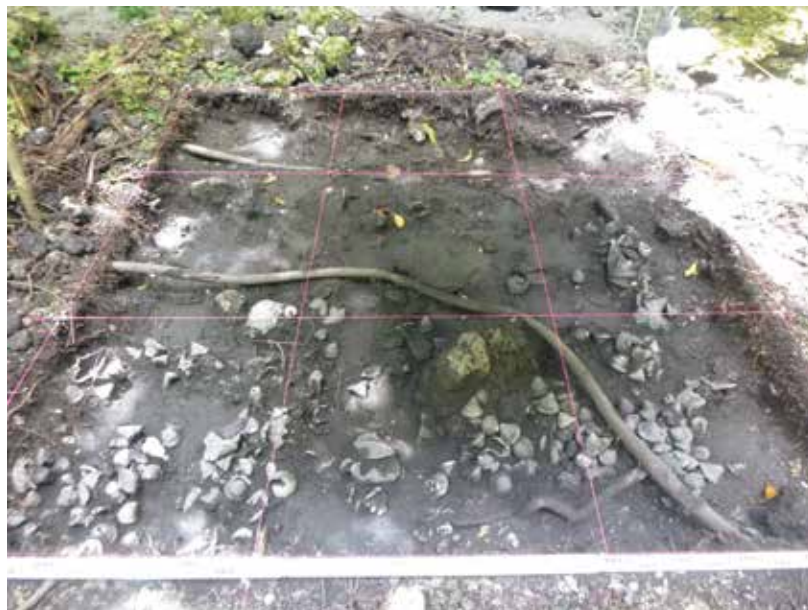
Figure 3. Layer 1, Spit 2-20cm

Figure 3 shows Layer 1, Spit 2. This contains dark, friable soil and many Trochus middens are heaped in one place.

These Trochus middens were counted and recorded as found in Layer 1, Spit 2 - 20 cm below the surface of the soil. There are about 275 Trochus shells and other Tridacna shells of different species. They are found further away from the coral outcrop and heaped in one area. Large roots are seen as one of the disturbances in this area in the upper level. Some trochuses are burnt, which is evidence of the trochus shells being placed over a cooking fire.

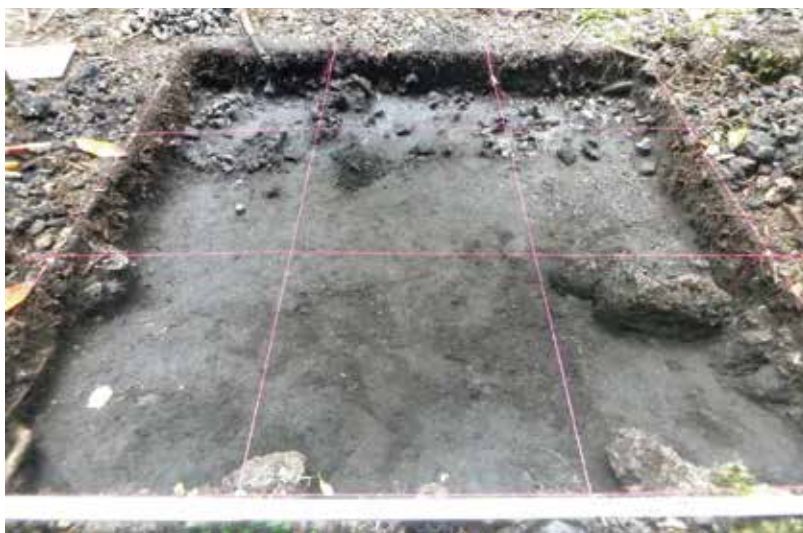
Figure 4. Layer 1, Spit 3 - 30 cm

Figure 4 shows Layer 1, Spit 3 - 30 cm. About 42 Trochus shells have been counted in this level. There are about 15 Giant Clamshell Tridacna specimens among different species. Some Trochus shells are burnt and others are partially damaged

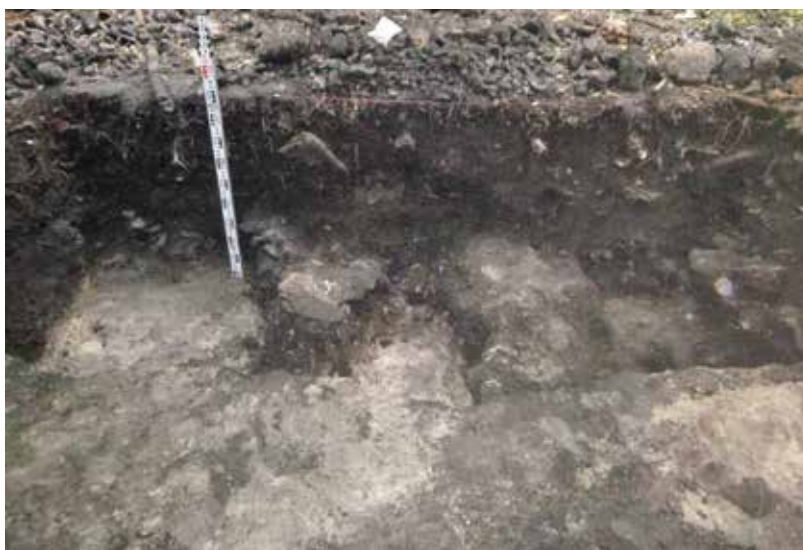
Figure 5. Layer 1, Spit 5 - 50 cm; Layer 2, Spit 6 - 80 cm; Layer 3, Spit 6 - 90 cm

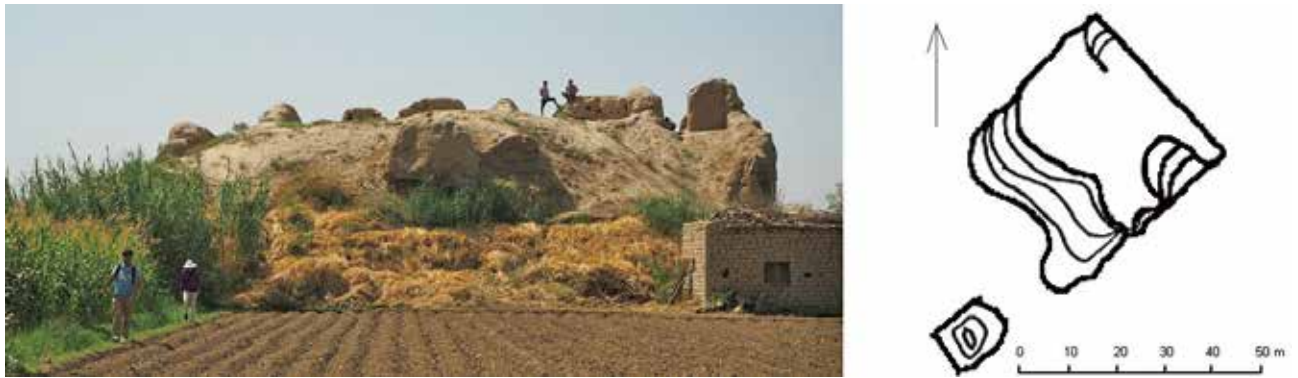
Fig. 2 a, b. The general view and schematic plan of the Balalyk-tepa site (the photo by H. Furusho, the plan by L.I. Albaum)

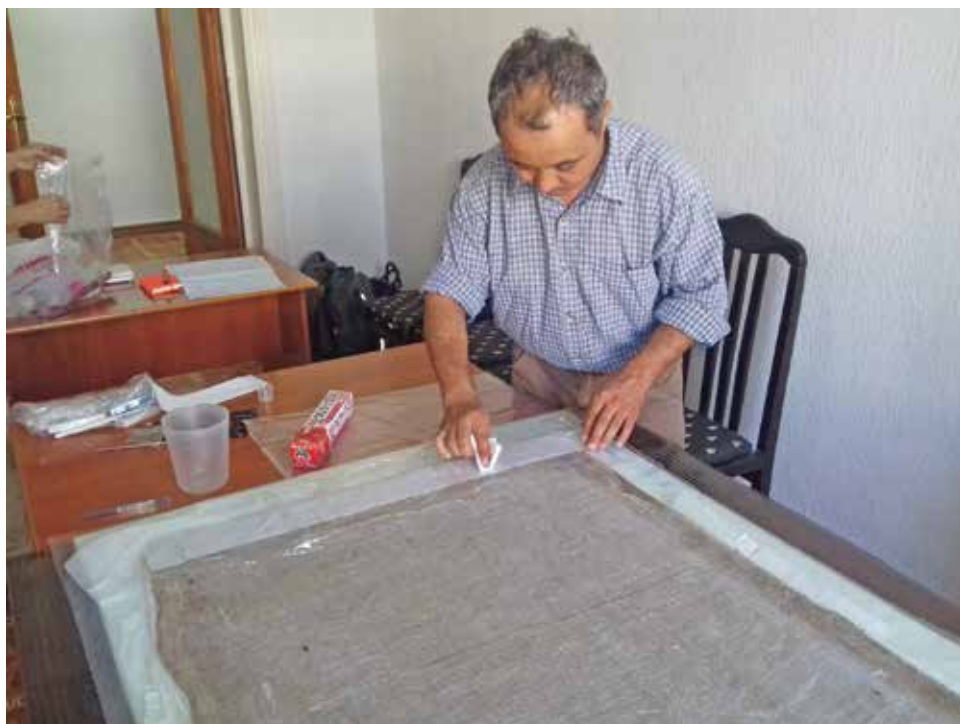
Fig. 3. A fragment of the Balalyk-tepa wall painting before conservation

One of the Balalyk-tepa fragments came to the Termez Archaeological Museum. The fragment, designated as No. 14 (size 68×87.5 cm), belonged to the southern wall of one of the rooms of the monumental monument building. This part of the painting illustrates the feast scene: in the foreground are well-dressed men and women in a seated pose and young servants in the background. Since the fragment was in poorer condition than the others, in 1983, in cooperation with the Russians, it was studied and restored in the State Hermitage Museum (Fig. 3).

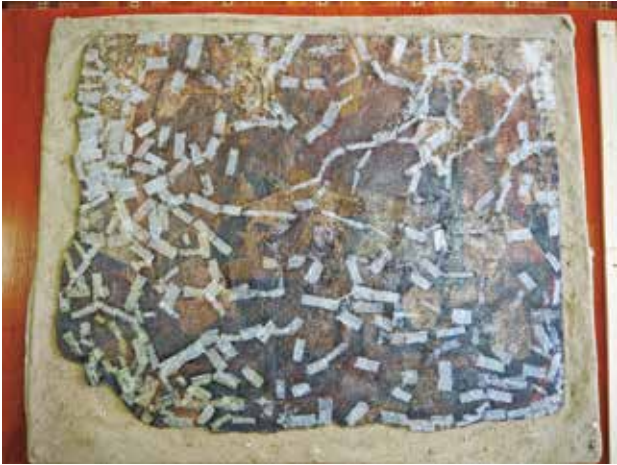
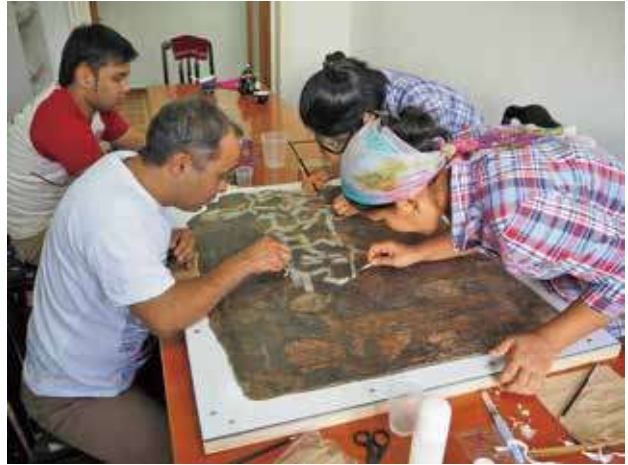
Fig. 4 a, b. A process of the conservation: cleaning and removing the old polymer resin

**Stage 1.** A fragment of the wall painting was carefully studied and photographed using a modern microscope. The surface of the painting was cleaned with a spray. According to the rule, in order to process the back side of the painting, the front of the painting turned to the ground. At the same time, in order not to damage the paint layer and ensure that the surface did not crack, Rayon cellulose paper was glued onto the front part before it was turned over. Gluten glue made from vegetable starch was used for bonding. This glue is easily soluble in water and therefore easy to remove with water. It does not have a negative impact on the exhibit (Fig. 4 a).

**Stage 2.** After the surface of the paper was covered, plastic film and foam rubber were laid under it. A polycarbonate Lexan board was inserted above the foam rubber, then from four sides the outer edges of the film were folded inside. After this, the fragment was carefully and slowly turned. On the reverse side of the painting, a previously inserted protective wooden board and two layers of thick fabric attached with buttons were removed. Also removed were the two layers of gauze, which had been fixed on the ground layer of the painting, by dissolving it with acetone (Fig. 4 b).

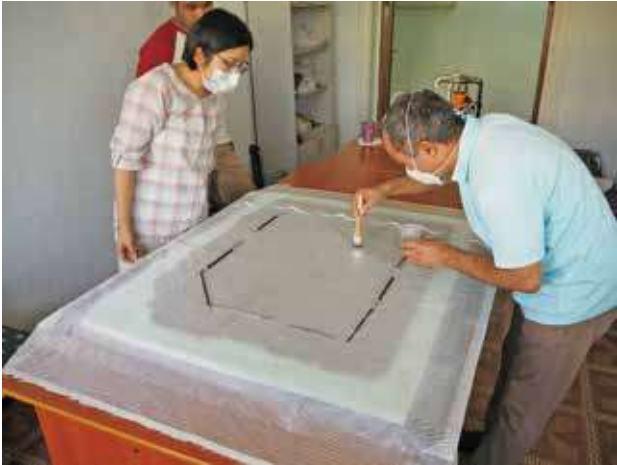
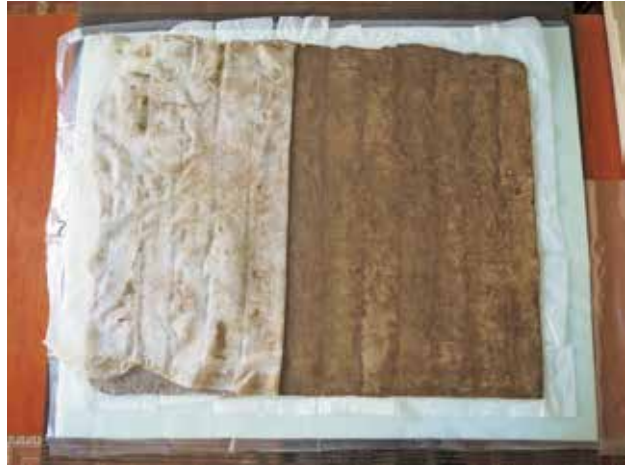
Fig. 5 a, b. A process of the conservation: attaching glass fiber and removing old textile from the back side

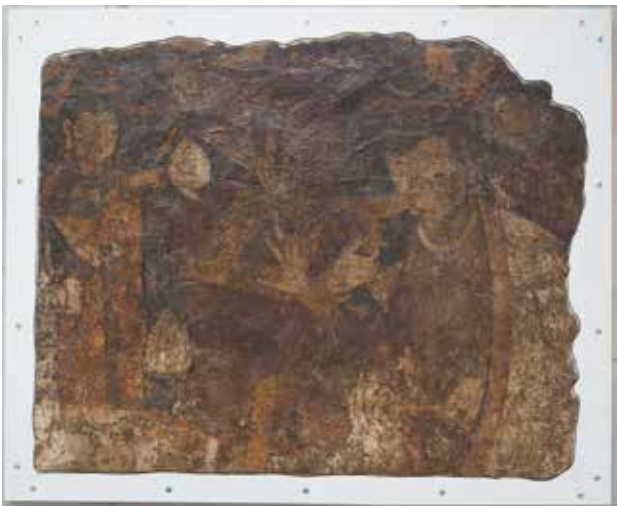
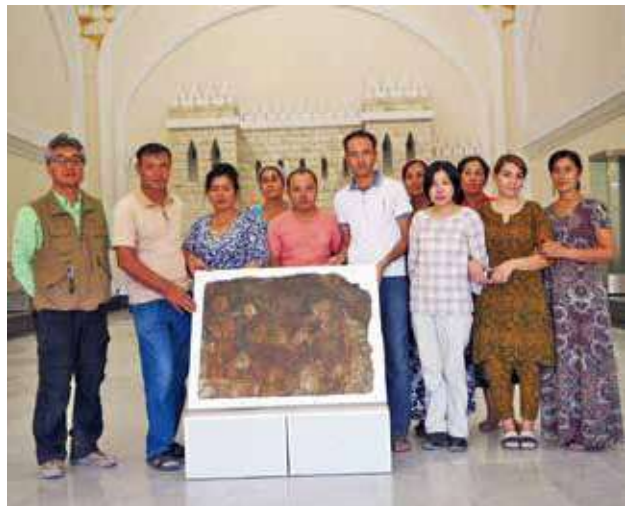
Fig. 6 a, b. The wall painting before conservation and mounting

Thus, this part of the wall of Balalyk-tepa was ready for exposure. In practice the chemicals and raw materials that were widely used during the restoration complied with modern requirements. As a result, a unique museum object was restored. In addition, local specialists were able to share their experience with their foreign partners. Restoration of the paintings allowed local and foreign tourists to come to the museum to view a good example of this medieval work of art (Fig. 6 a, b).
