ACCU Nara  
International Correspondent

Vol.22 2019

# The Twenty-second Regular Report

The ACCU correspondents periodically send reports on cultural heritage protection activities in which they have been recently involved. This is a collection of nine reports submitted by international correspondents in the Asia-Pacific region.

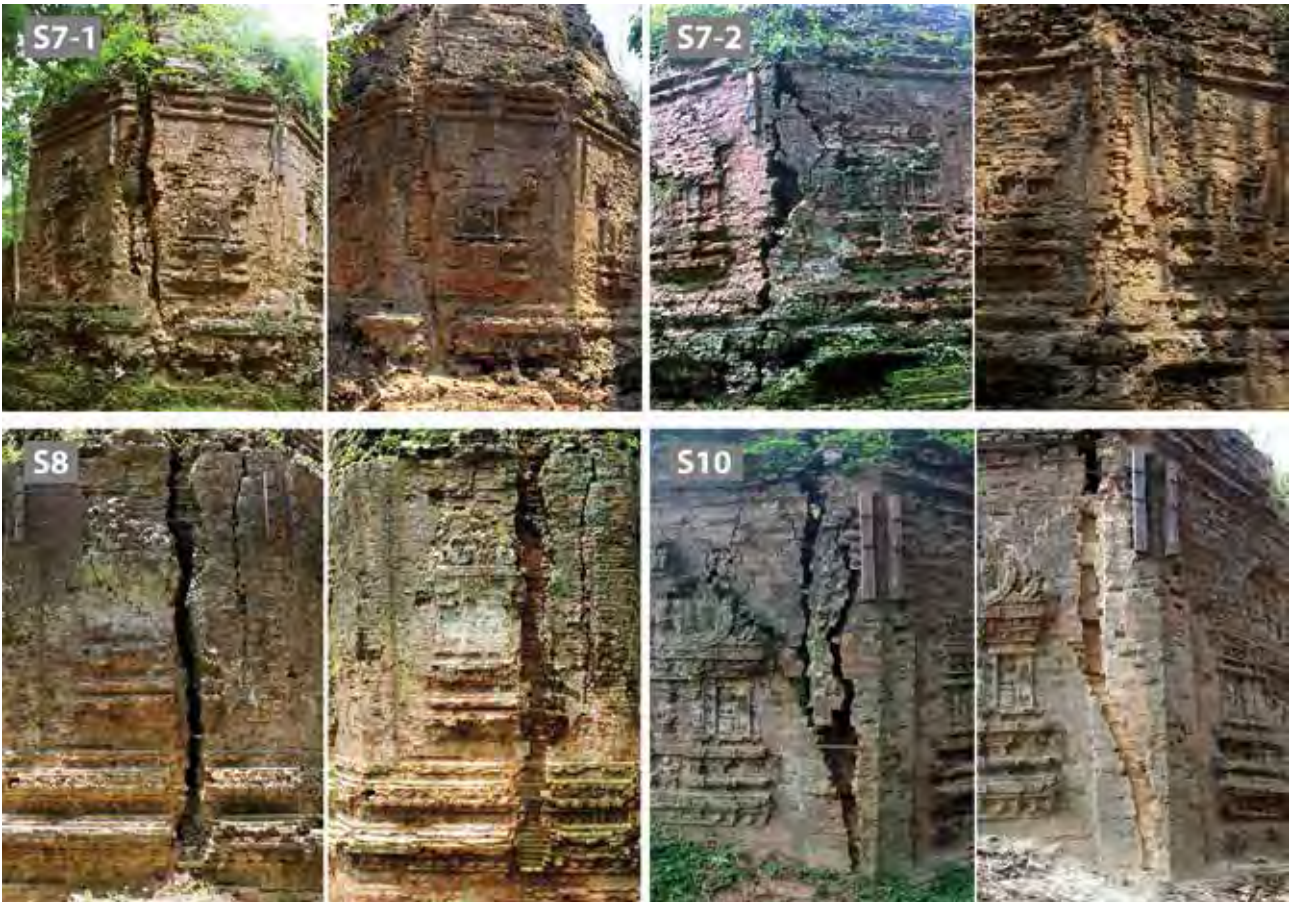
Examples: Partial emergency conservation, before and after conservation.

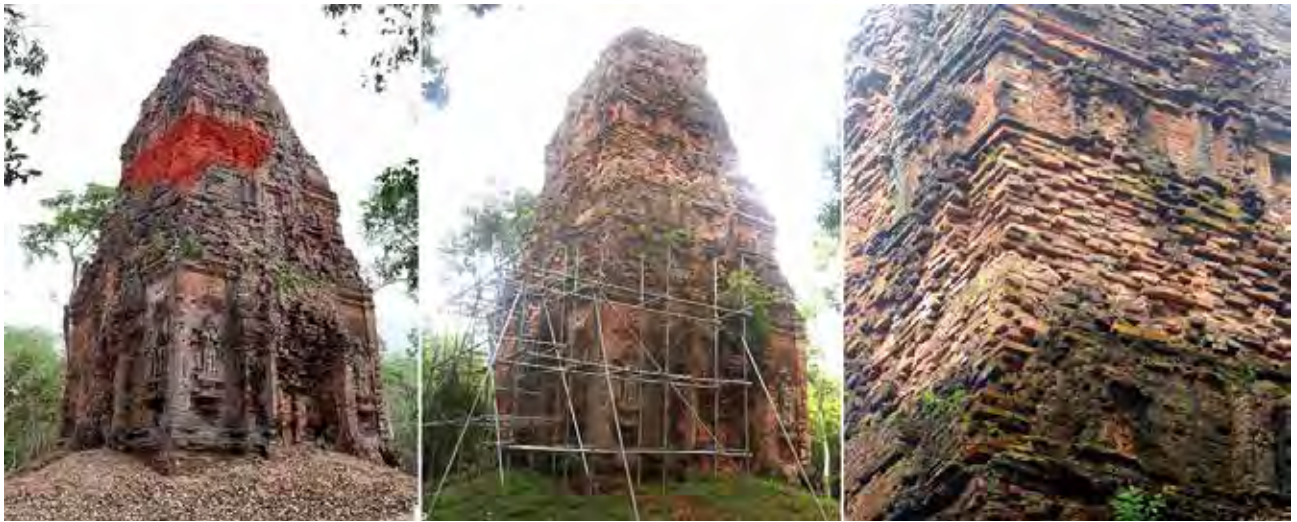
Example: Z1 tower: Partial emergency conservation, before (left), during (middle) and after conservation (right).

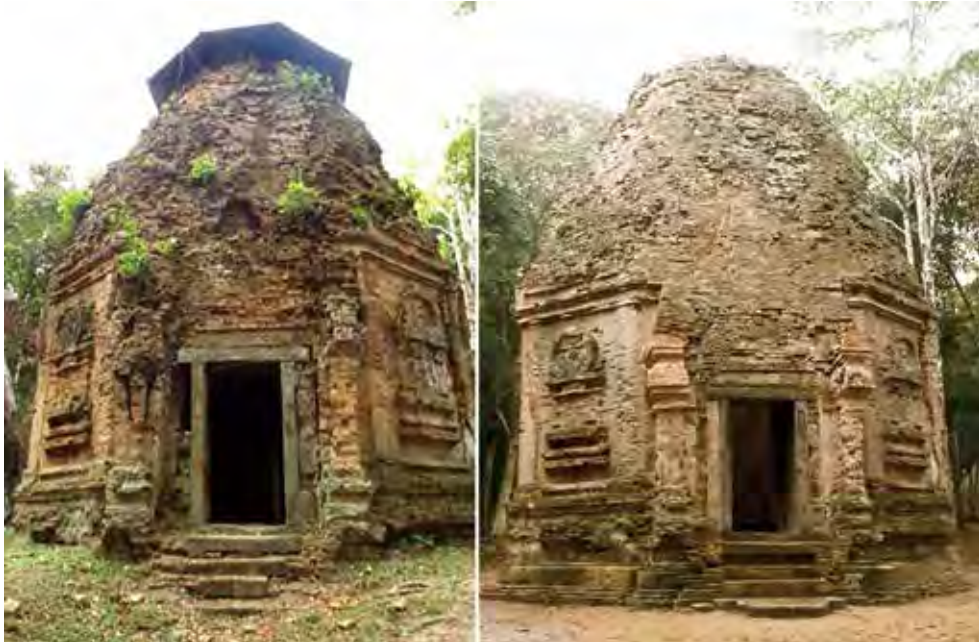
The S11 tower before and after restoration.

As mentioned in the previous report, the S11 tower is an octagonal tower restored in 2018 (see *Report* vol. 20/2018: 9-10). In 2006, the MCFA team installed a temporary cabling harness to reinforce the cracked wall structure. After monitoring the structure, in 2011, MCFA decided to enhance the supported structure with a roof covering. The lessons learned and elements that have been identified as risks of varying degree will be applied to the emergency conservation of other towers and used as a basis for future conservation requirements. As new risks are identified, they will be prioritized and incorporated into the project plan of each tower. Conservation efforts based on current risk analysis knowledge may include

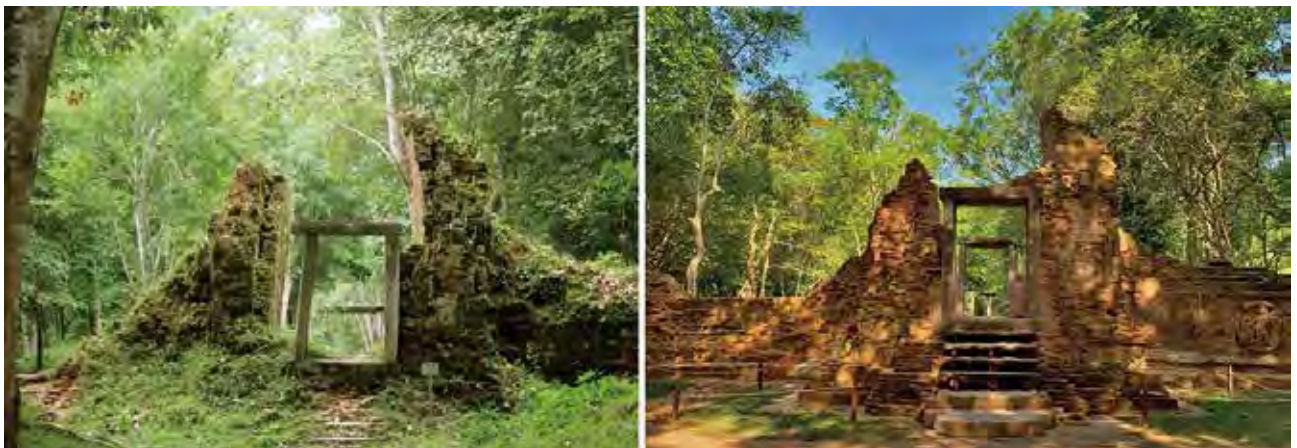
The S5 gate before and after restoration.

- **Western Gate (S5):** Unstable structural walls and door are the main risks for this gate. Walls were encroached on by tree roots. The doorway was inaccessible because of looting and war activities during the time of unrest. Because of the instability of the structure, an alternative route was created that detoured visitors to the southern side of the wall, which damaged the wall.

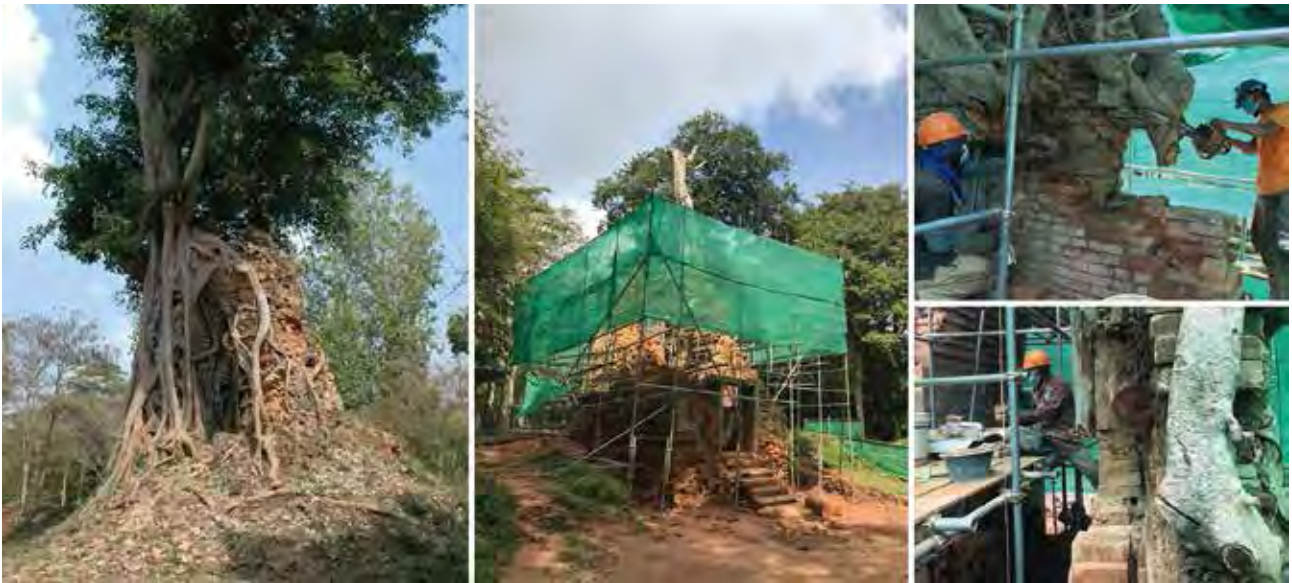
The S3 gate before, and during restoration and activities.

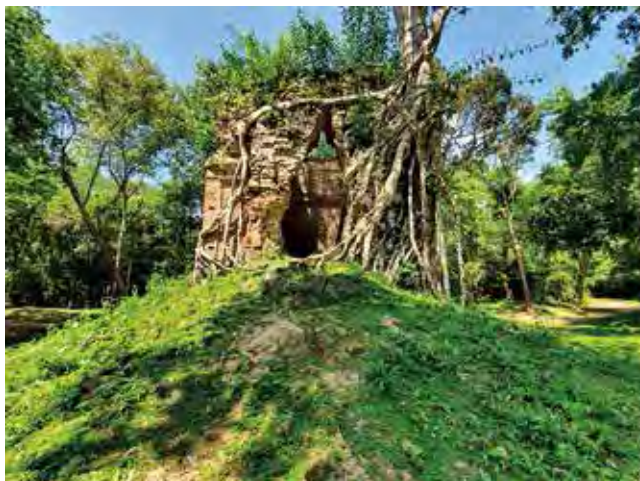
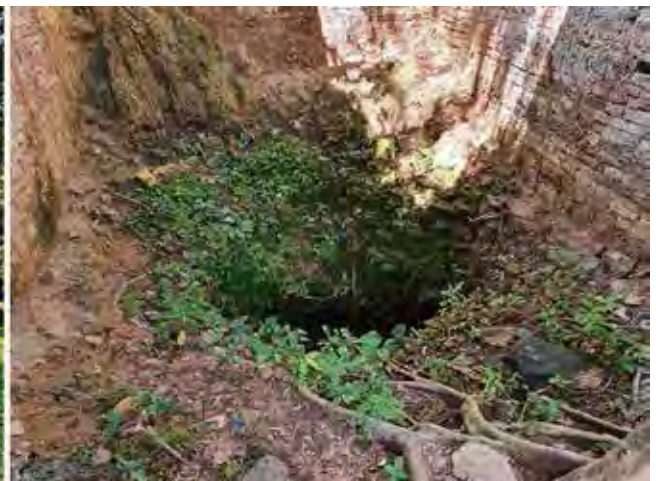
The N24 tower: front view with a pile of looted accumulated soil and foundation (left) and interior illegal excavated pit (right).

During the time of unrest in the country (from the 1970s to the mid-1990s), there were illegal excavation activities in Sambor Prei Kuk. In the middle of the 1990s, the Ministry of Culture and Fine Arts started backfilling the destroyed accumulated foundations to prevent the loss of the fragile structures, mostly in the chamber of the tower. However, these works were conducted in the major three complexes (Prasat Yeay Poan (S), Prasat Sambor (N) and Prasat Tao (C)). From 2004 to 2005, the Sambor Prei Kuk Conservation Project also continued to contribute to reinforcing the lost foundation from the first stage and the rearrangement of the pedestals. This work was not done in the satellite complexes, and the activity has been restarted with the following activity at Prasat Bos Ream (N24).

This project will not only be for the stability of the monument structure, but will also provide a more comprehensive understanding of ancient construction techniques and materials through the profile of the foundation. It is also part of an enhancement of the visiting route for the entire site, not only the three major complexes. This project will also enhance the other satellite complexes.

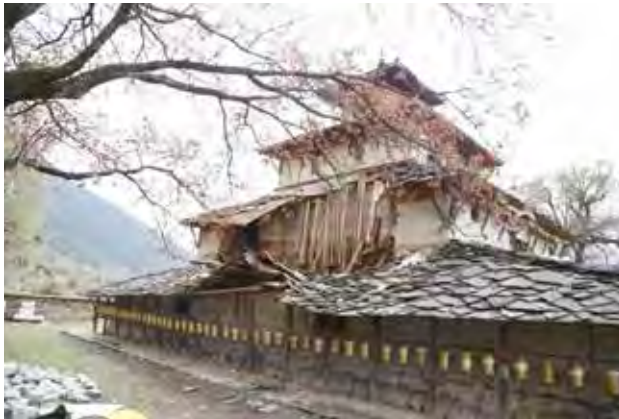
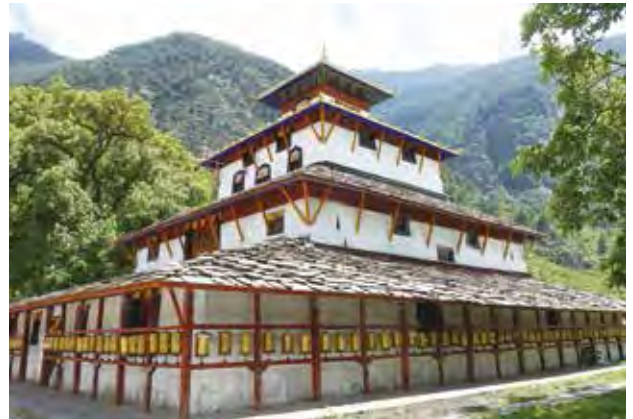
Photos before and after the renovation of monasteries damaged by an earthquake in Pangxing Village, Tibet

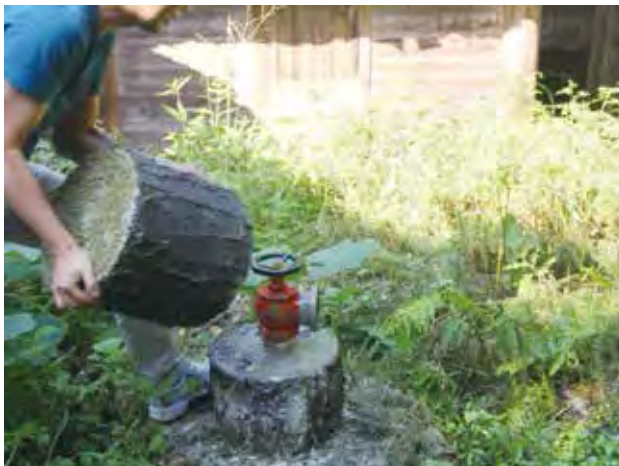
Dengshen Village, Guizhou Province  
—Fire protection facilities coordinated with the village environment

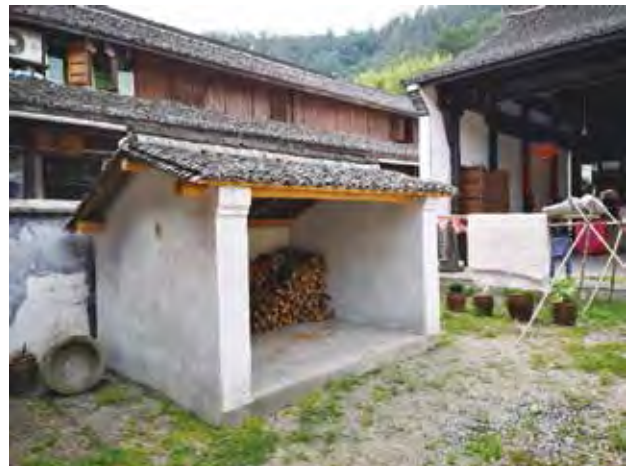
Zhejiang Sizhai Village  
—Restoration of a traditional independent firewood house

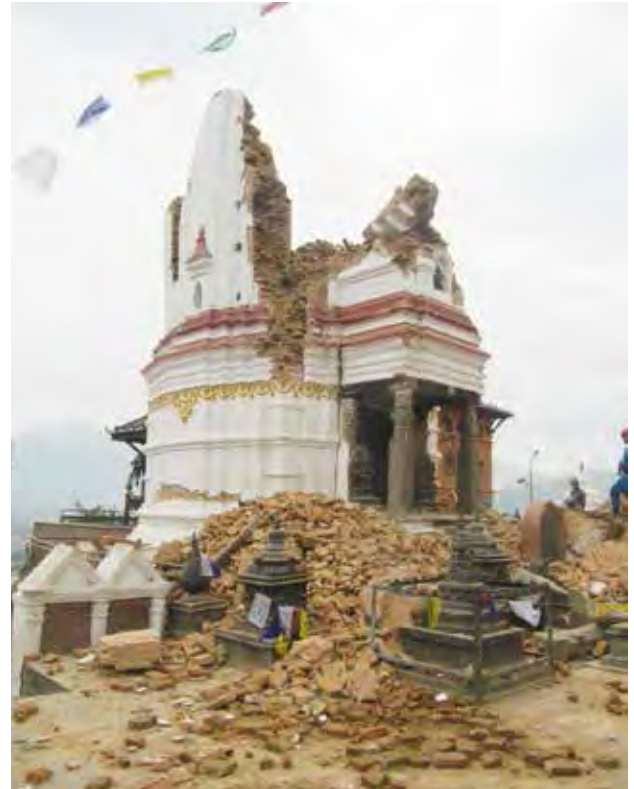
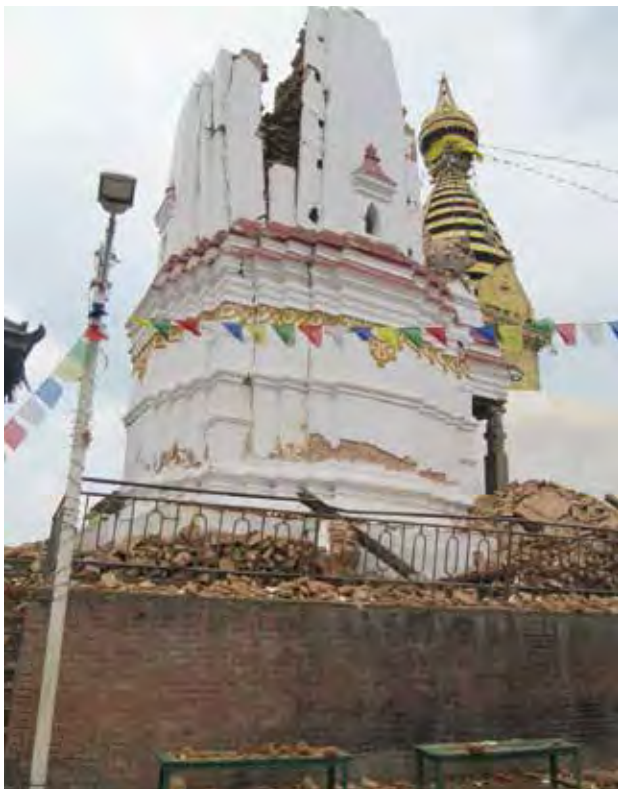
Anantapur Temple damaged by the 2015

Anantapur Temple was on the list of collapsed monuments as it had structurally collapsed; however, a little higher than the first floor (up to cornice level) it was still physically standing, which was very significant for carrying out important studies on this temple during the post-earthquake response, and even in the post-earthquake rehabilitation phase as well. Finally, structural studies came to the conclusion that the remaining parts of the temple were at more risk and could not be strengthened, and the recommendation was that the temple must be dismantled up to ground level. Therefore, the whole structure was dismantled and research was carried out to determine the condition of its foundations before starting renovations.

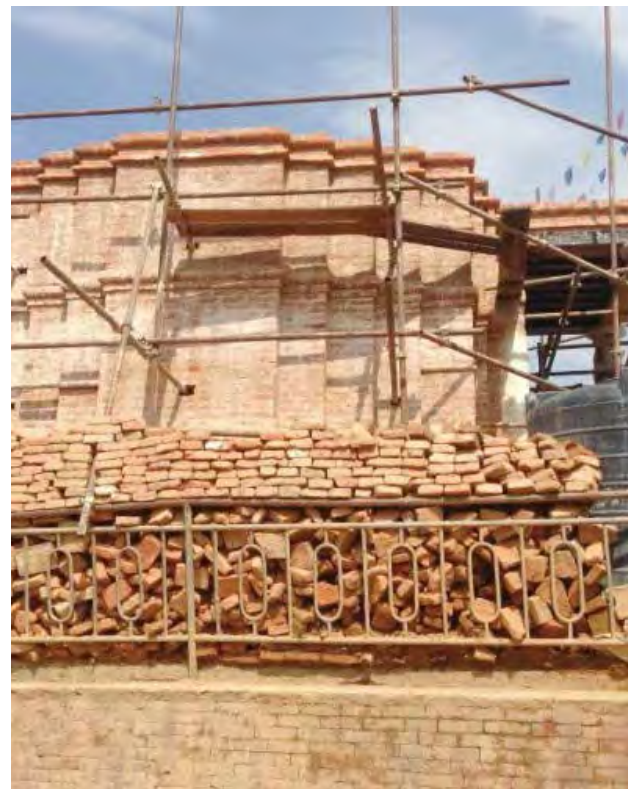
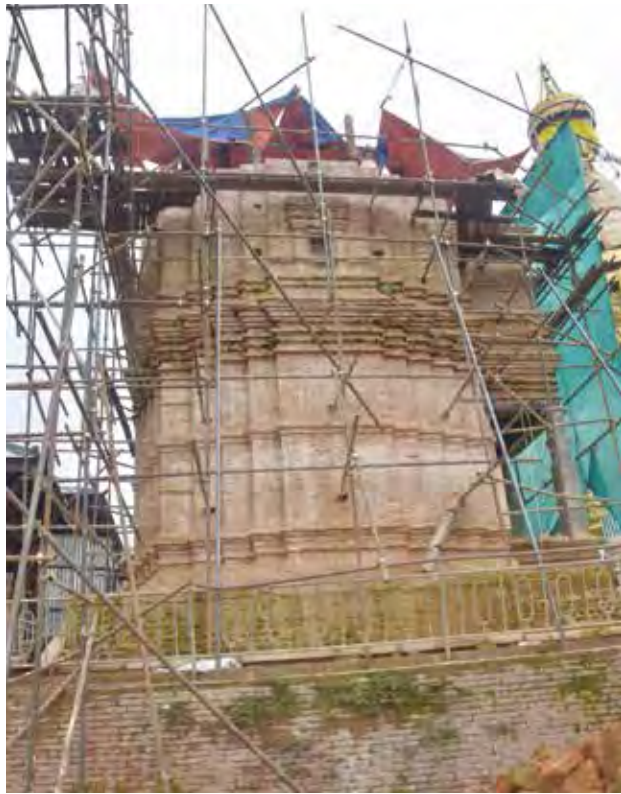
Anantapur Temple during the rehabilitation process

A study of the foundation was also carried out, however the foundation was completely intact; there was no negative impact of the earthquake on the foundation. It was excavated to a depth of up to seven feet; counting from the northern elevation of the foundation, twenty-two layers of bricks were opened, and as all were intact and in the proper position, digging was stopped. As a result, the original foundation was not excavated; however, brick bats and bricks in the overall foundation were found where excavations were carried out.

Therefore, the structure was built on the same foundation but the connections were strengthened using some traditional technologies as well as a few new ideas using traditional construction materials.

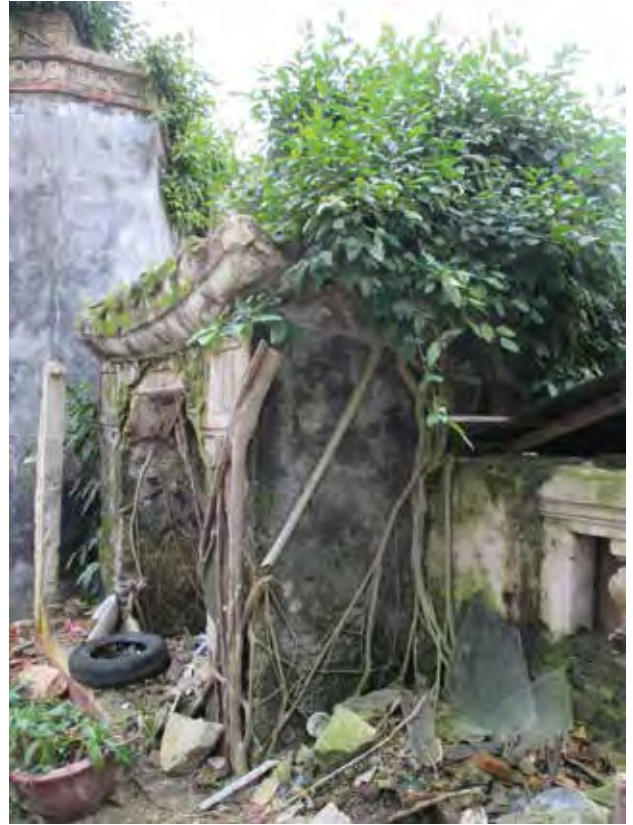
4. Tree roots destroyed the relic.

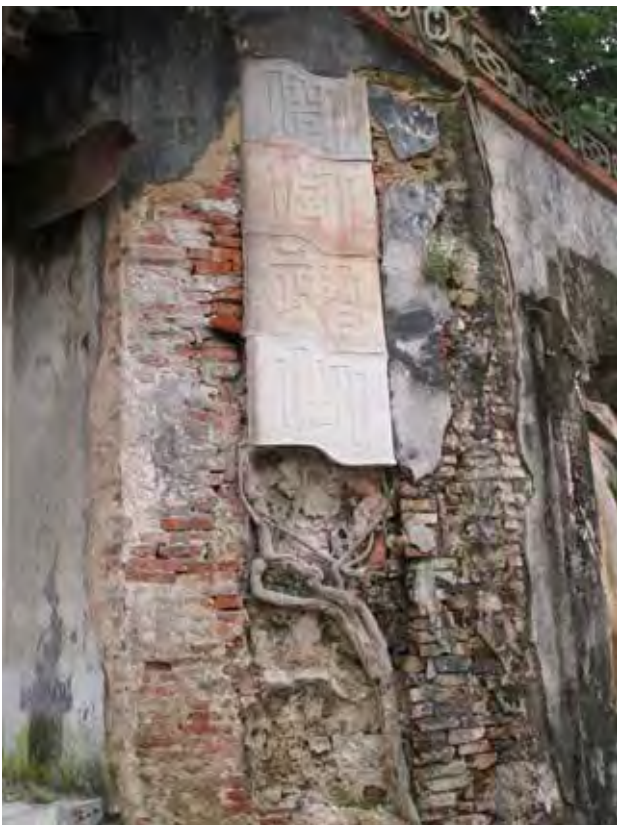
5. Some components had fallen off the wall.

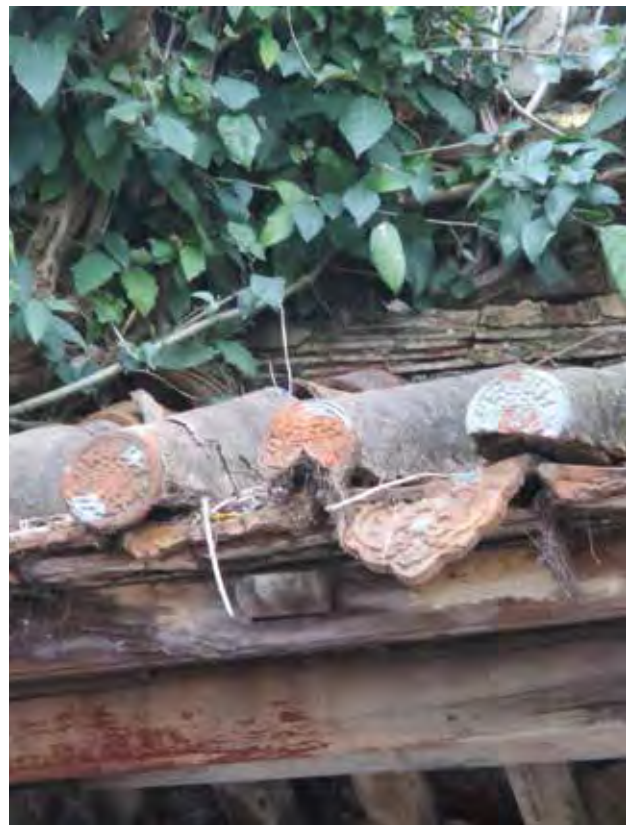
6. The majority of wooden frames had rotted.

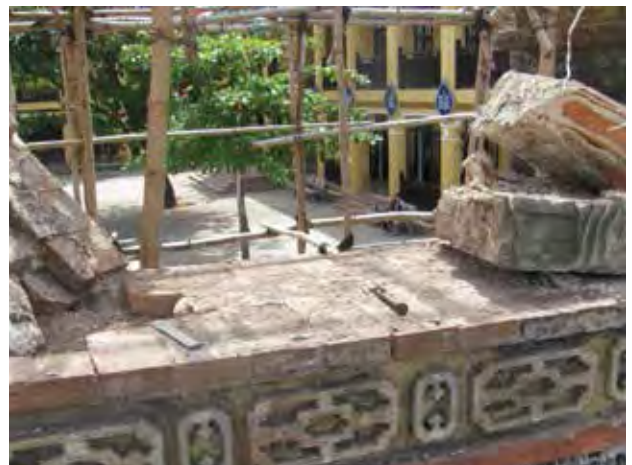
14. Cleaned and reinforced broken elements

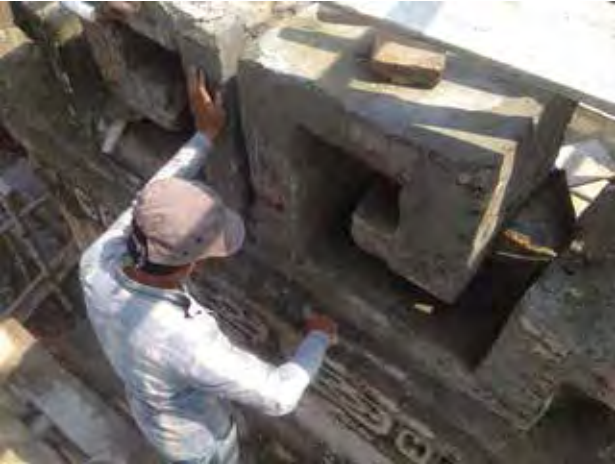
15. Attached, patched broken elements being placed back in their original position

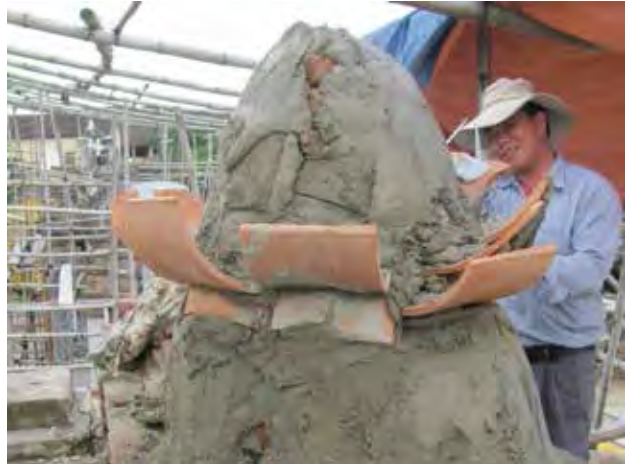
16. Recovered masonry block with bricks, roof tiles and lime mortar

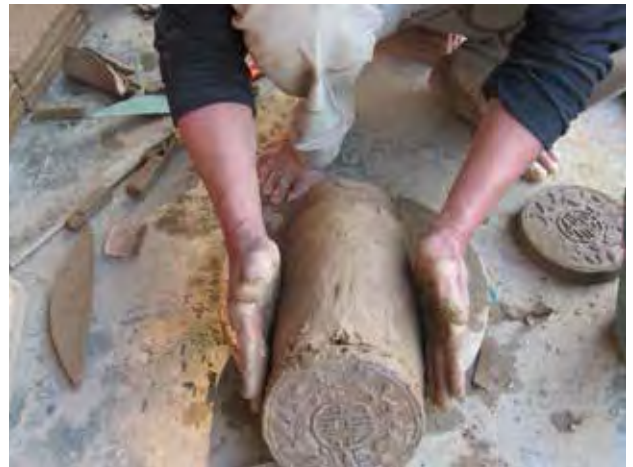
24. Making roof tiles
