ACCU Nara  
International Correspondent

Vol.23 2019

# The Twenty-third Regular Report

公益財団法人 ユネスコ・アジア文化センター文化遺産保護協力事務所  
Cultural Heritage Protection Cooperation Office, Asia-Pacific Cultural Centre for UNESCO (ACCU)

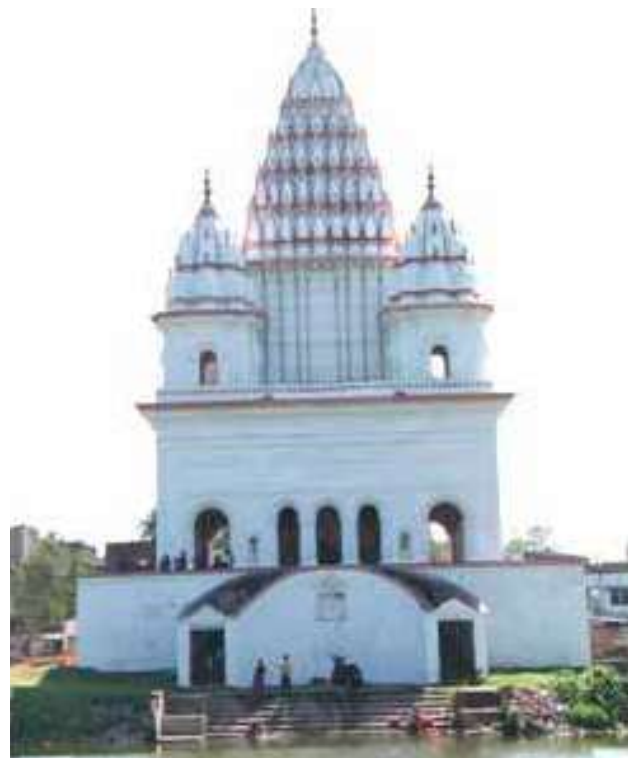
Bara (Large) Shiva Temple

currency. The temple was built on the southern edge of a large pond named *Shib Sagar*. Built according to a square plan, the temple is established on a 4 m high platform, the length of each side being 14.31 m. This south-facing temple has a wide and long staircase rising above the platform. On the northern side of the temple, two sets of stairs go down to a brick ghat. It is thought that both sets of stairs were built for worship by worshippers and devotees. There are four *Rathnas* (jewels) on the four corners of the temple and the central *Rathna* is established in the centre of the temple. For this reason, the temple is known as *Pancha Rathna* Shive temple. The door posts are built of sandstone and feature different types of floral ornamentations. A very large *Shiva Lingam* has been established in the middle of the *Garva Griha* or main prayer chamber of the temple.

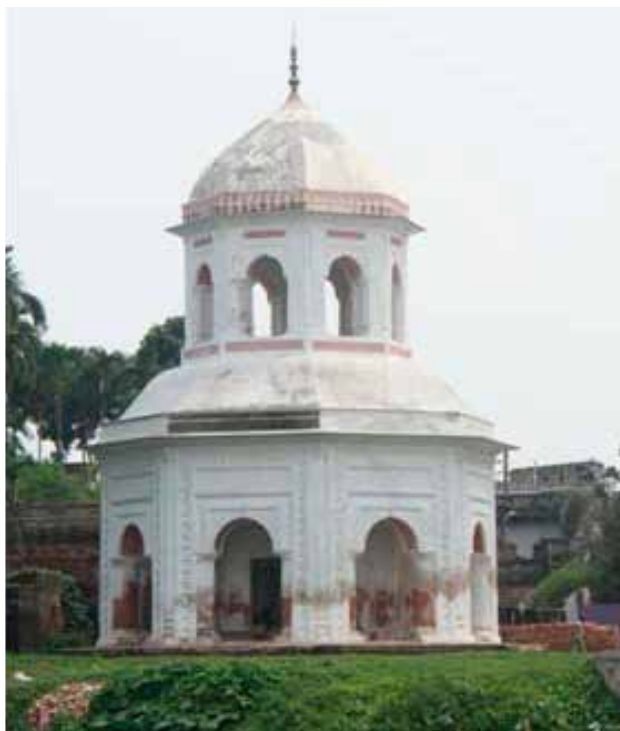
Jagannath Temple or Rath Temple

**(10) Jagannath Temple or Rath Temple:** The octagonal-shaped *Jagannath* temple is established to the east and is extremely close to *Bara Shiva* temple. *Maha Rani* Bhubanmayee Devi built this temple in 1830. This temple is constructed of very thin brick with lime mortar and there are porches around the temple. Each side of the temple has a semi-circular multiple-cusp arched doorway and the exterior walls have panel decorations. The main prayer chamber is established in the middle. The northern and western sides have two arched doorways. Sandstone door jambs are used in these doorways, which feature flower and leaf ornamentation. The second floor is built with the same design and shape. Each side has a multiple-cusp arched doorway. The pinnacle of the temple is covered by a dome-shaped roof with a finial on the pinnacle.

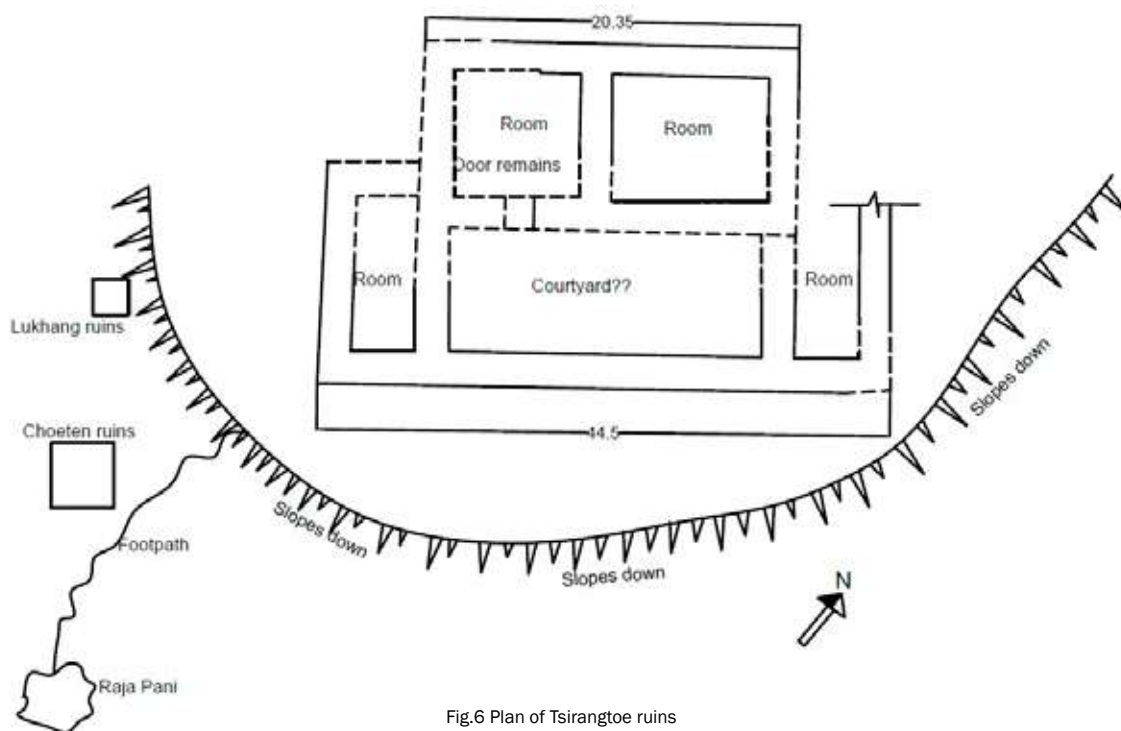
Fig.6 Plan of Tsirangtoe ruins

The main complex of the *Tsirangtoe dzong* ruins is rectangular, measuring 20.35 meters at the rear façade and 44.5 meters at the front with a wall thickness of 1.4 meters. The layout (Fig. 6) of the complex is similar to the layout of some of the old traditional farmhouses, with a courtyard in front of the main building flanked by small rooms on either side of the main residence building. However, deducing from the size and scale of the ruins (comparatively bigger and larger than traditional farm houses), and its location (on top of a hill) shows the amount of wealth, power and authority *Sa Sungpa* had over the *Tsirang* region. On the southern side of the main fortress complex,

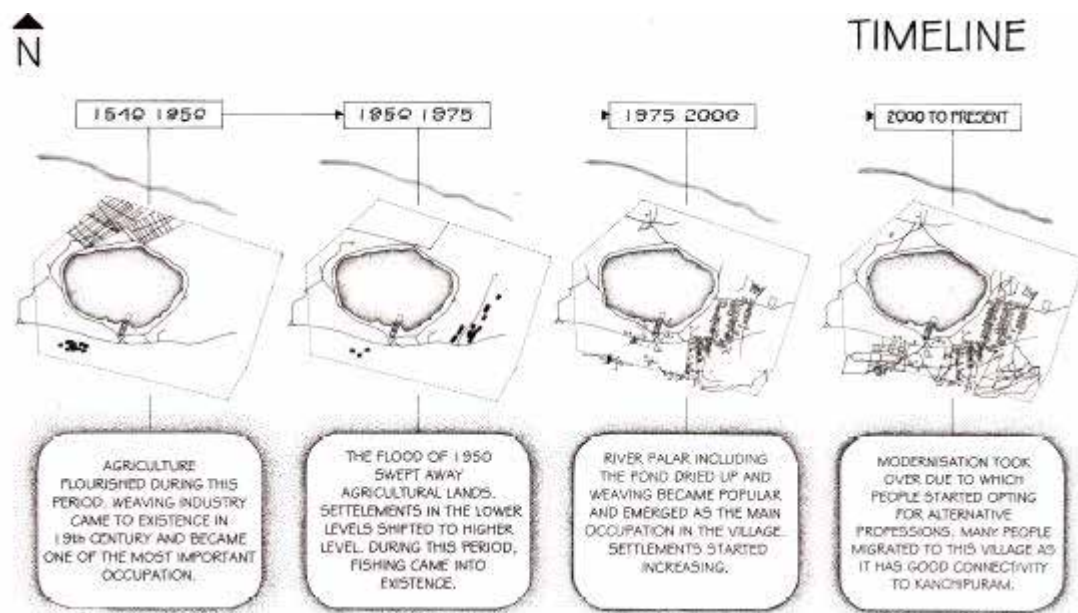
Fig. 2: Timeline of the temple development

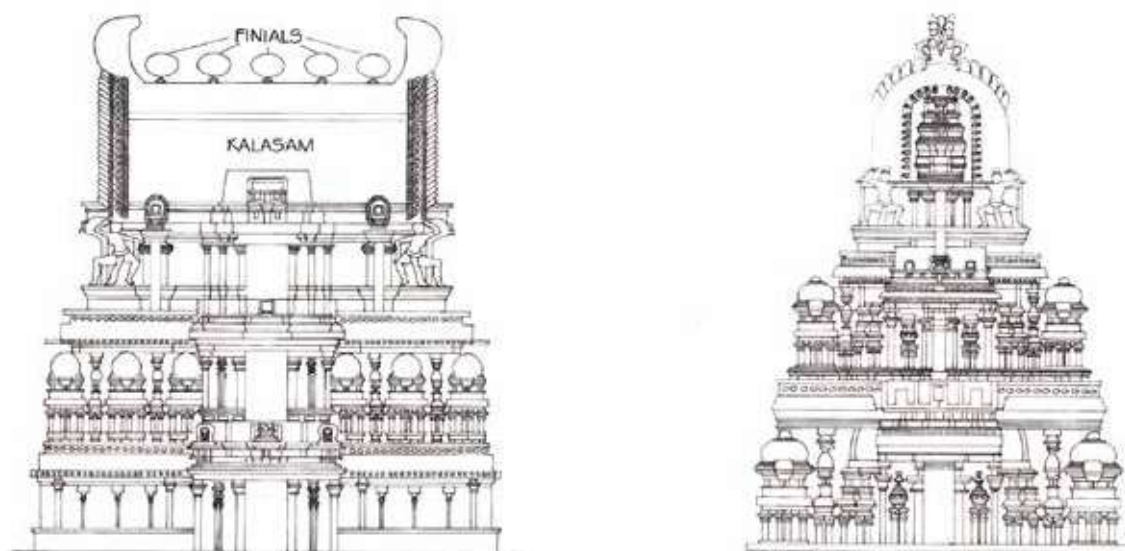
Fig. 5: Details of the Vimana

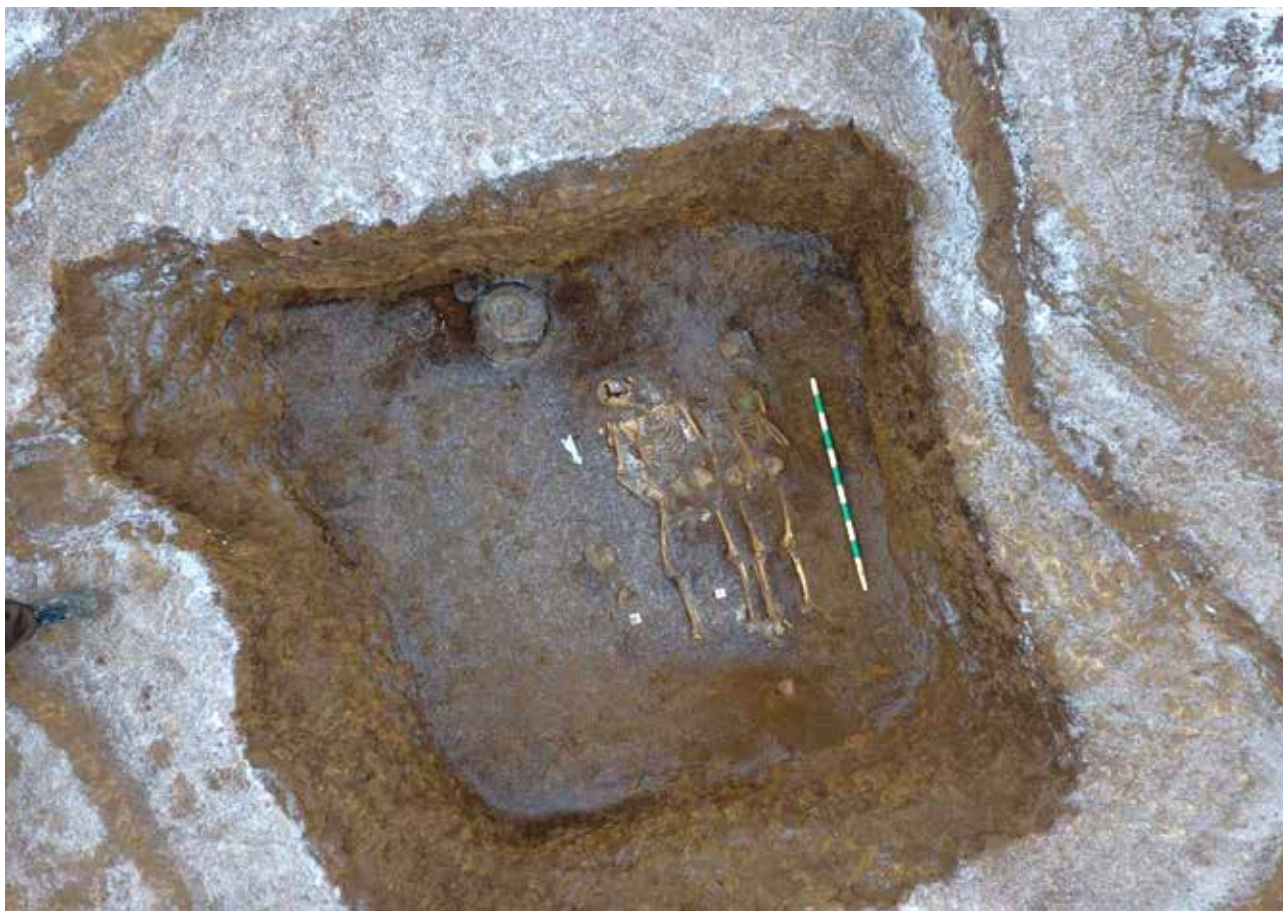
The view of the sepulchral pit after opening. Aerial photo.

The next stage of the work was to excavate the sepulchral pit. This was done by digging out the darker contents of the burial pit, and as we dug deeper, we clearly traced the walls of the sepulchral pit. Within the sepulchral pit we found the remains of ash and fragments of wood flooring. Fragments of human bones were found from a depth of 0.5 m in the southeastern part of the pit. The bone fragments at this depth were most likely raised up to this level by rodents that dug holes to the depth of the skeletons below.

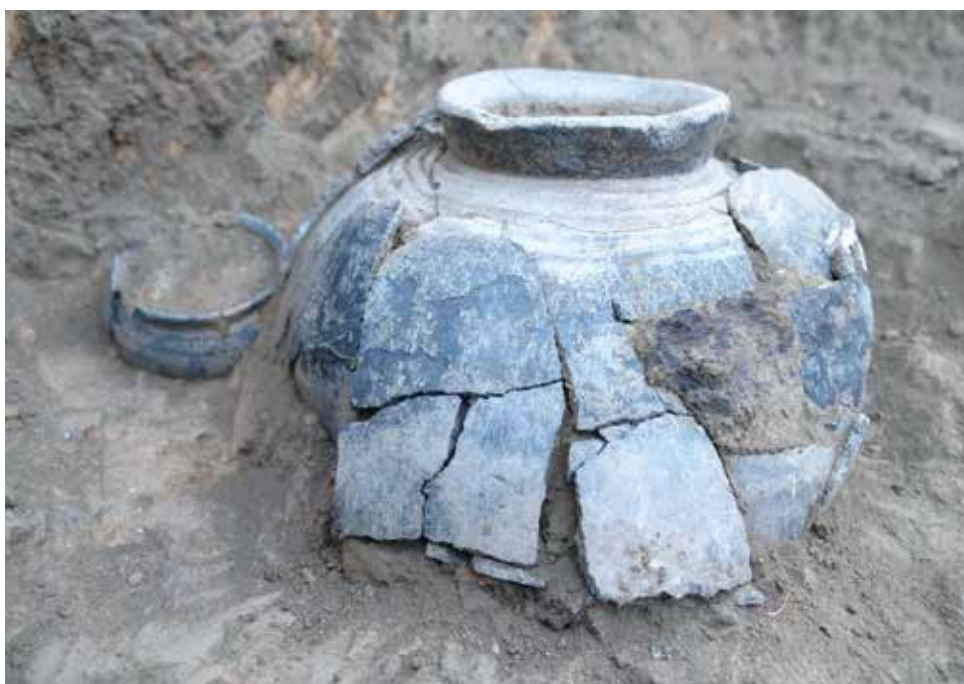
Ceramic vessels No.1 and No.2

Vessel No. 1 is in the shape of a cauldron, and was archaeologically complete. The vessel is globular, ornamented, and made of black clay. The rim diameter is 18.5 cm, the diameter of the body is 40 cm, and the wall thickness is 0.9 cm. Vessel No. 2 is a spherical pot, ornamented, and made of black clay. The rim diameter is 12.5 cm, the diameter of the body is 15.2 cm, the wall thickness is 0.5 cm, and the height is 7.5 cm. After removing the vessels away from the wall, another bronze mirror (No. 2) with a handle was found (mirror diameter 13.6 cm, with the handle 3.8 cm long and 1.8 cm wide) in a good state of preservation.

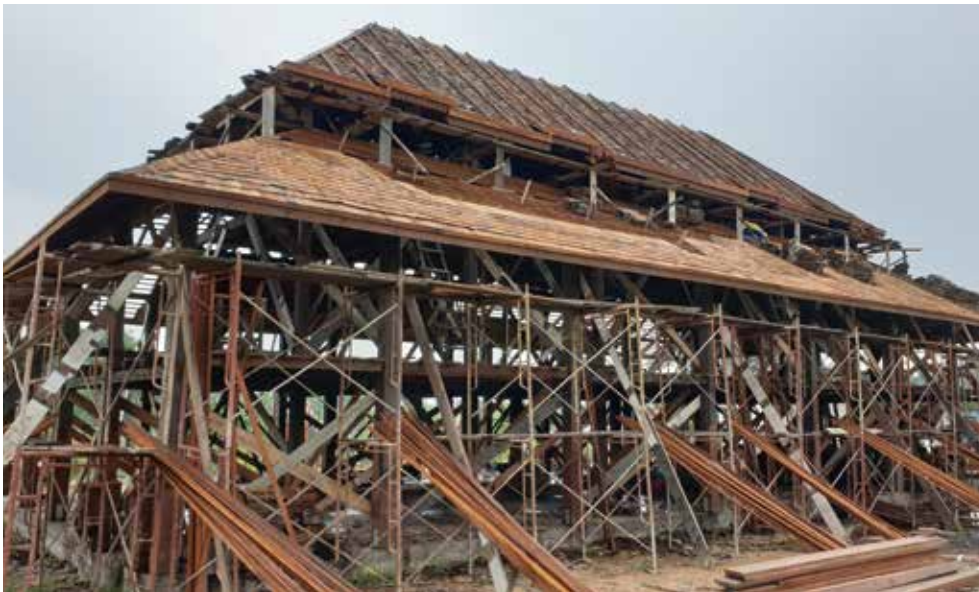
During the conservation works, Fort Lili underwent major refurbishment and restoration including the dismantling of building structures, salvage of building materials, storage, conservation treatment and reconstruction.

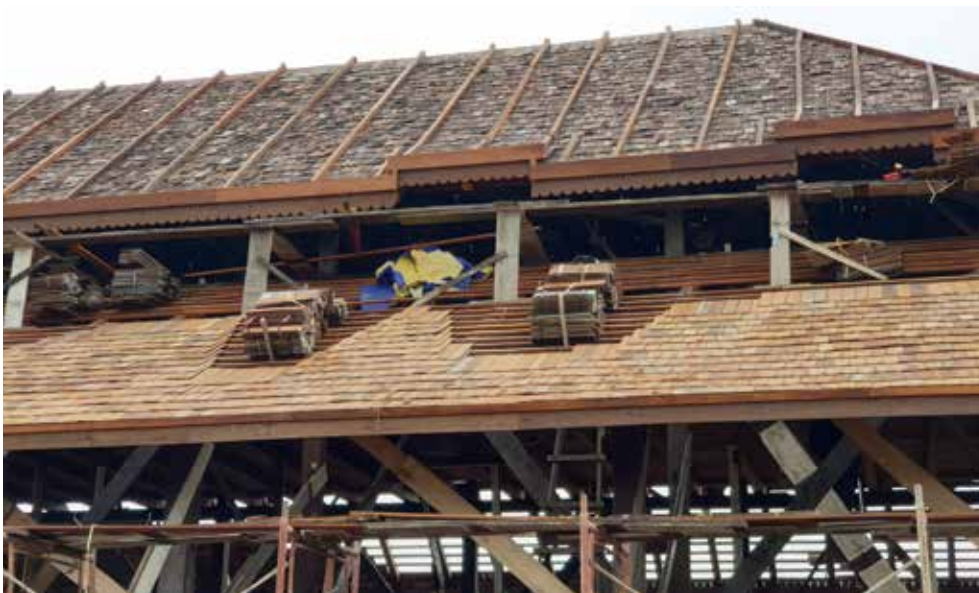
During the conservation of Fort Lili, a double-layered roofing system was introduced to allow the installation of proper insulation while maintaining the visibility of the underside of the *belian* shingles.

of Sarawak and the problem of roof leakage, a double-layered roofing system was introduced to Fort Lili. The roofing system allows the installation of proper insulation while maintaining the visibility of the underside of the *belian* shingles. The salvaged old *belian* shingles were then fixed underneath the roof while the new ones were placed as a double layer above the roof. The new *belian* shingles were then coated for weather protection. All timber structures of the fort were upgraded to *belian* timber. Due to structural instability including sagging of the ground floor level, the entire fort was dismantled, salvaged, treated and reconstructed at the same location. The existing old timber jetty outside the fort, which was used for river transportation, was restored to its original form. The reconstruction of Fort Lili was based on sound conservation guidelines and approved work method statements. Thus, all building elements were re-measured, documented and recorded based on a special coding system before dismantling and salvaging. Apart from conservation works, several new works were carried out at the fort including new toilet facilities, upgrading the existing guard house, stone-pebble apron around the fort, a walkway path on the grounds and a gateway at the new main entrance to the site. To recreate the closest setting to what it was like in the fort's glory days, a shallow depression around the jetty was constructed to signify the old river that used to flow in front of the fort.

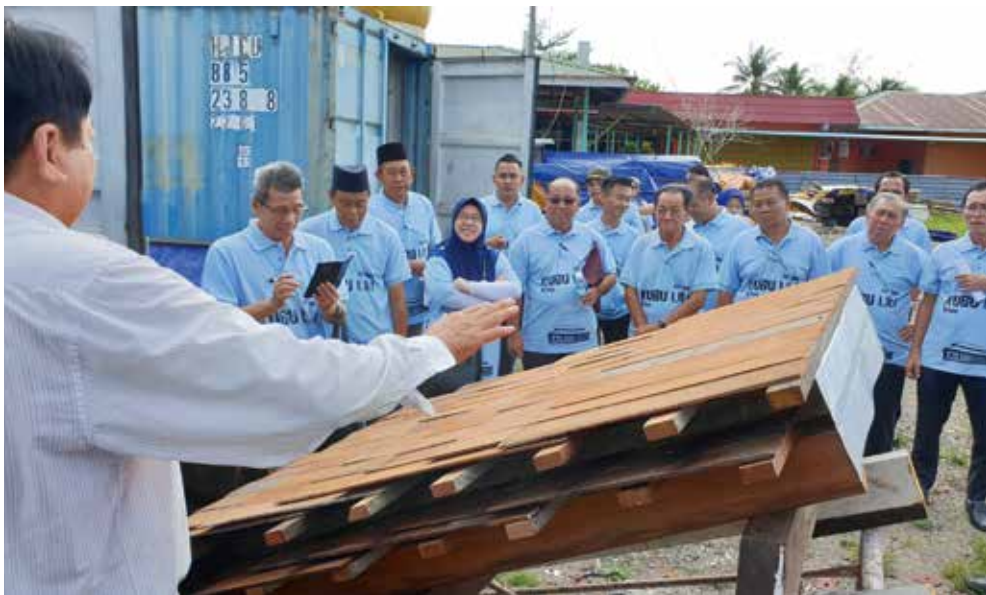
Workshop participants were briefed by the building contractor on the belian roof mock-up of Fort Lili.

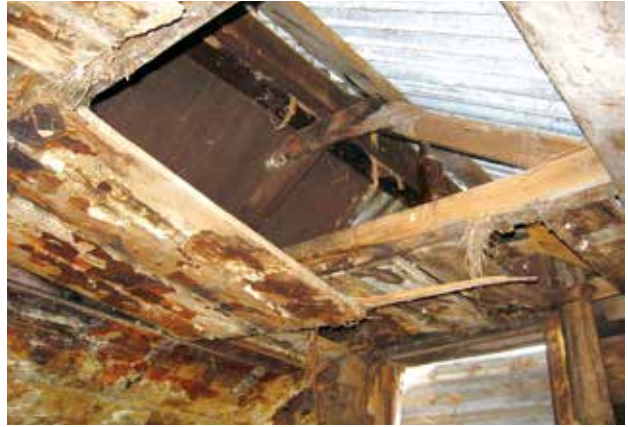
Figure 12. The tongue and groove timber ceilings were in a poor condition but repairable (Photo Matthew Schmidt).

When Heritage New Zealand and Contact first visited the cottage to check its condition in 2008, the cottage was essentially watertight but clearly required immediate conservation work (Figures 7 to 12). Weeds had infested the structure growing over the roof and along the side and back walls, particularly periwinkle. Trees next to the cottage had very large branches overhanging the structure presenting a branch fall risk, a tree had fallen partially onto the back of the cottage, and small shrubs had grown close around the front walls. The interior of the cottage was relatively clean and dry probably due to it being used by various people over the years but it could be seen the back walls of the cottage were damp from earth falling down behind the back wall causing moisture to be drawn into the stonework. The tongue & groove timber ceilings also were damp and rotten in places due

to the storm water not being able to run away off the roof properly and leaking into the interior. The early 20th century wooden floors, which replaced the original floors, were in quite good condition with holes in places but the Phase III, early 20th century extension wooden floor was quite rotten. Fortunately, small repairs done on the cottage over the years had helped preserve the structure such as those done by the Lake Roxburgh Boating Club in the 1980s and the Miller family (Farminer 2014: 18).

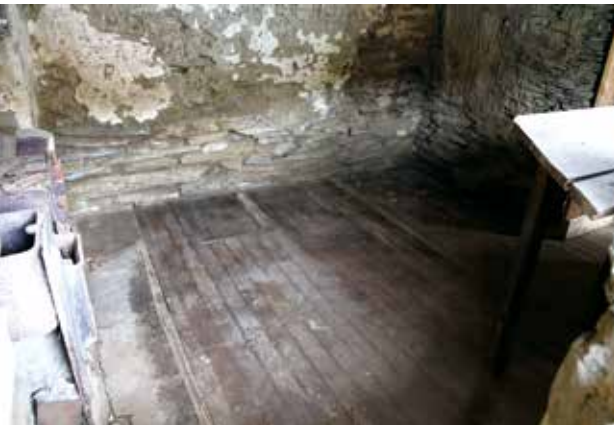
Figure 30. Centre Bay floor cleaned with only minor repairs required (Photo: Matthew Schmidt)

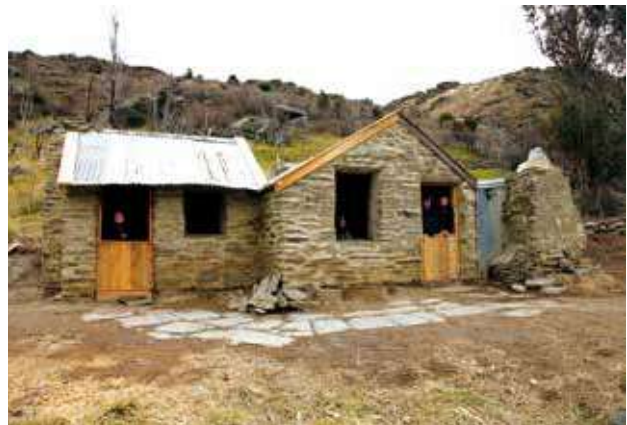
Figure 33. The back of the cottage showing barge boards and capping repaired and replaced, and iron roofing mostly left in place as it was water tight (Photo: Matthew Schmidt).

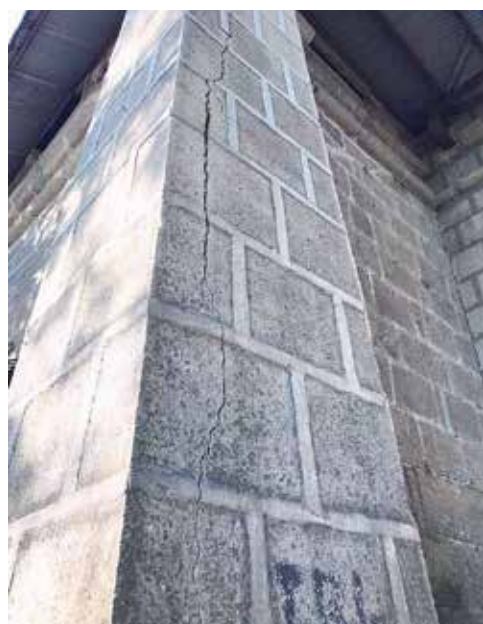
Cracks on wall at Santa Monica Parish

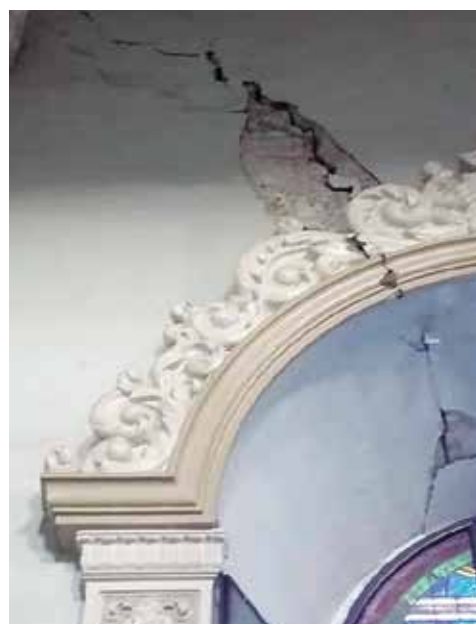
Wall cracks at the Holy Rosary Church, Angeles Parish

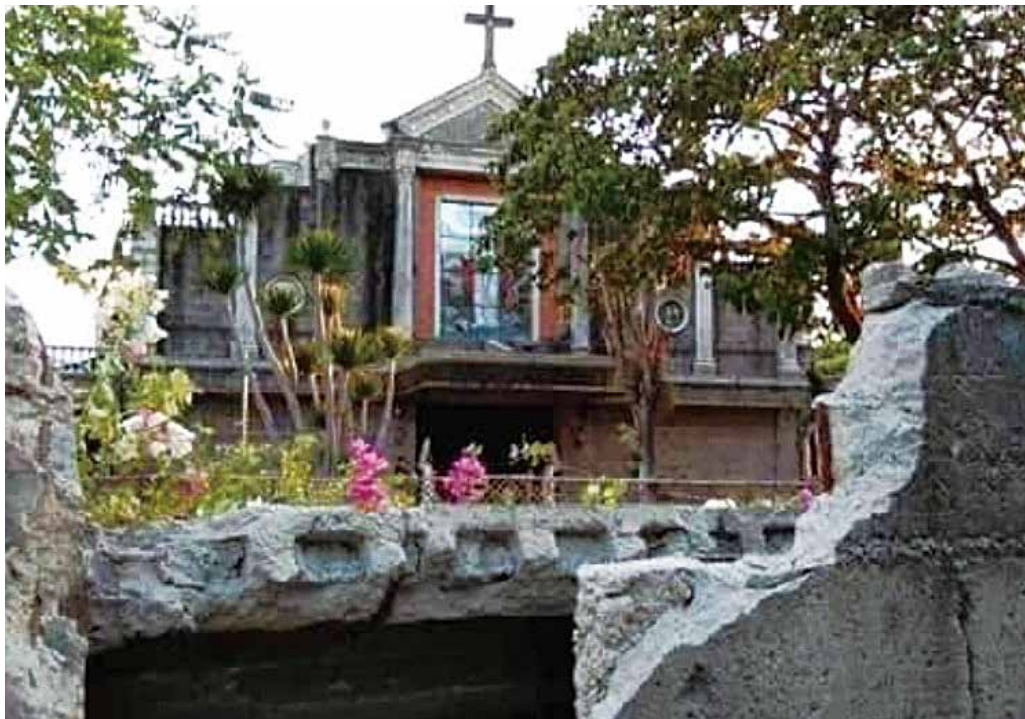
Fence cracks at Monasterio de Santa Clara, Betis

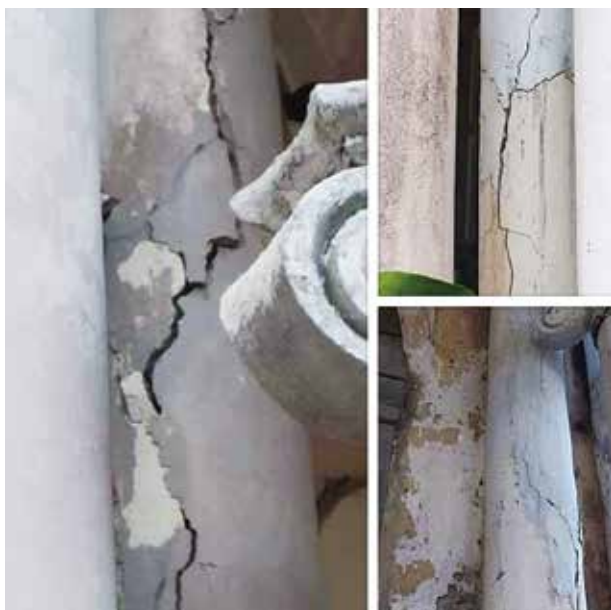
Cracks on columns at St. James de Apostle Parish, Betis, Guagua

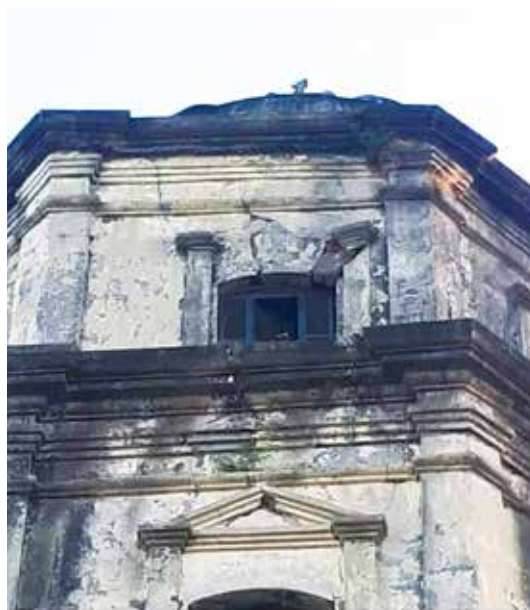
Cracks at belfry of Santa Rita de Cascia Parish, Sta. Rita

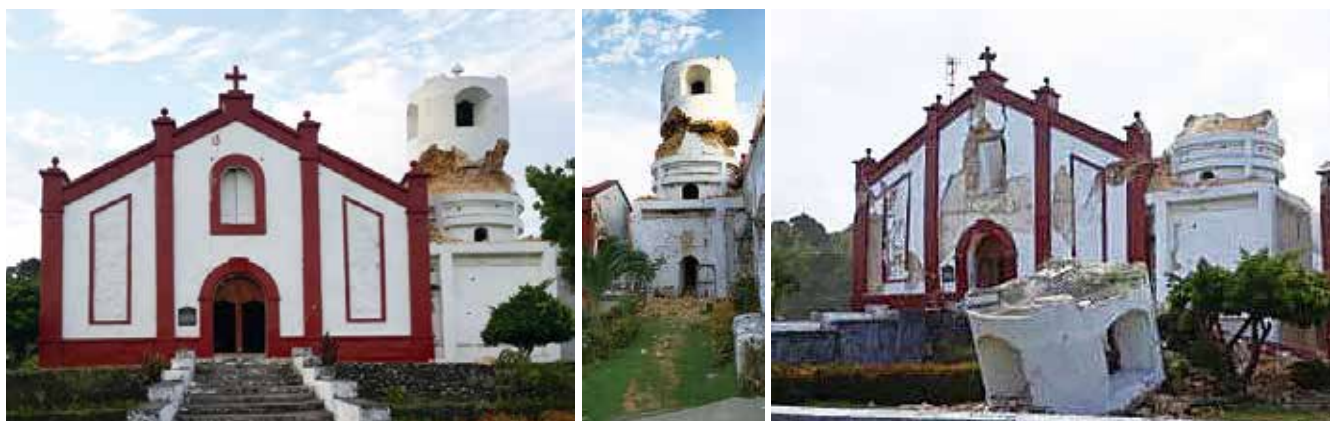
Itbayat Church: The bell tower fell after a series of earthquakes and aftershocks in July 2019
