ACCU Nara
International Correspondent

Vol.24 2020

The Twenty-fourth Regular Report

ACCU Nara International Correspondent

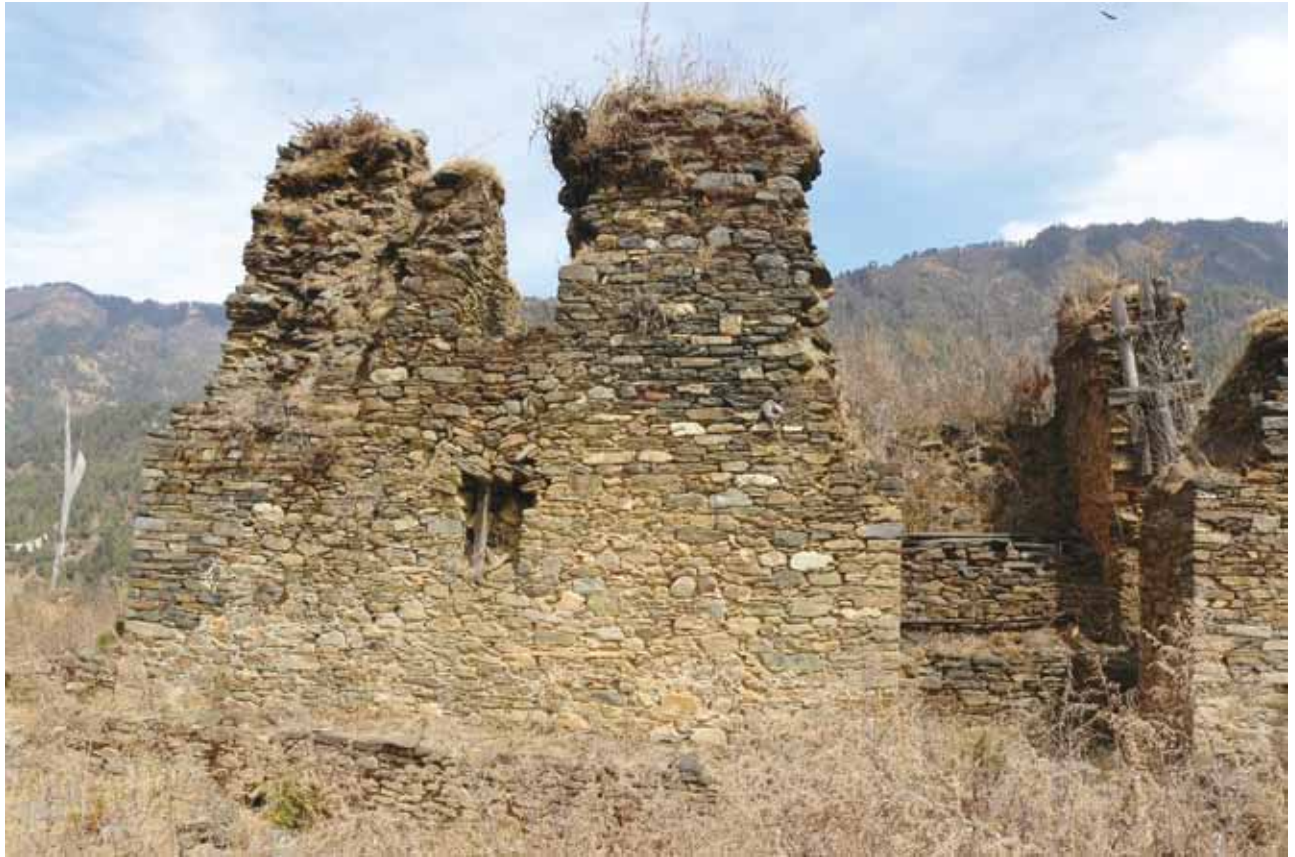
Fig. 2 Before consolidation works of Utse

With the aim of presenting the site to the public and visitors as a model for display and conservation of archaeological heritage in Bhutan, the consolidation of Drapham *dzong* was carried out in April, May and June 2020. The consolidation works were carried out strictly as per conservation principles by consolidating only the damaged portion of walls of the ruins structure (see Figs. 2, 3, 4, 5, 6, 7 and 8). All the walls of the Drapham *dzong* ruins were built in stone masonry with mud mortar. Only the upper section of the walls of the ruins which were damaged over the period were consolidated using the same construction techniques and skills. The larger damaged sections of the walls were repaired using the same technique by maintaining and respecting the same layout, form and thickness of the original walls.

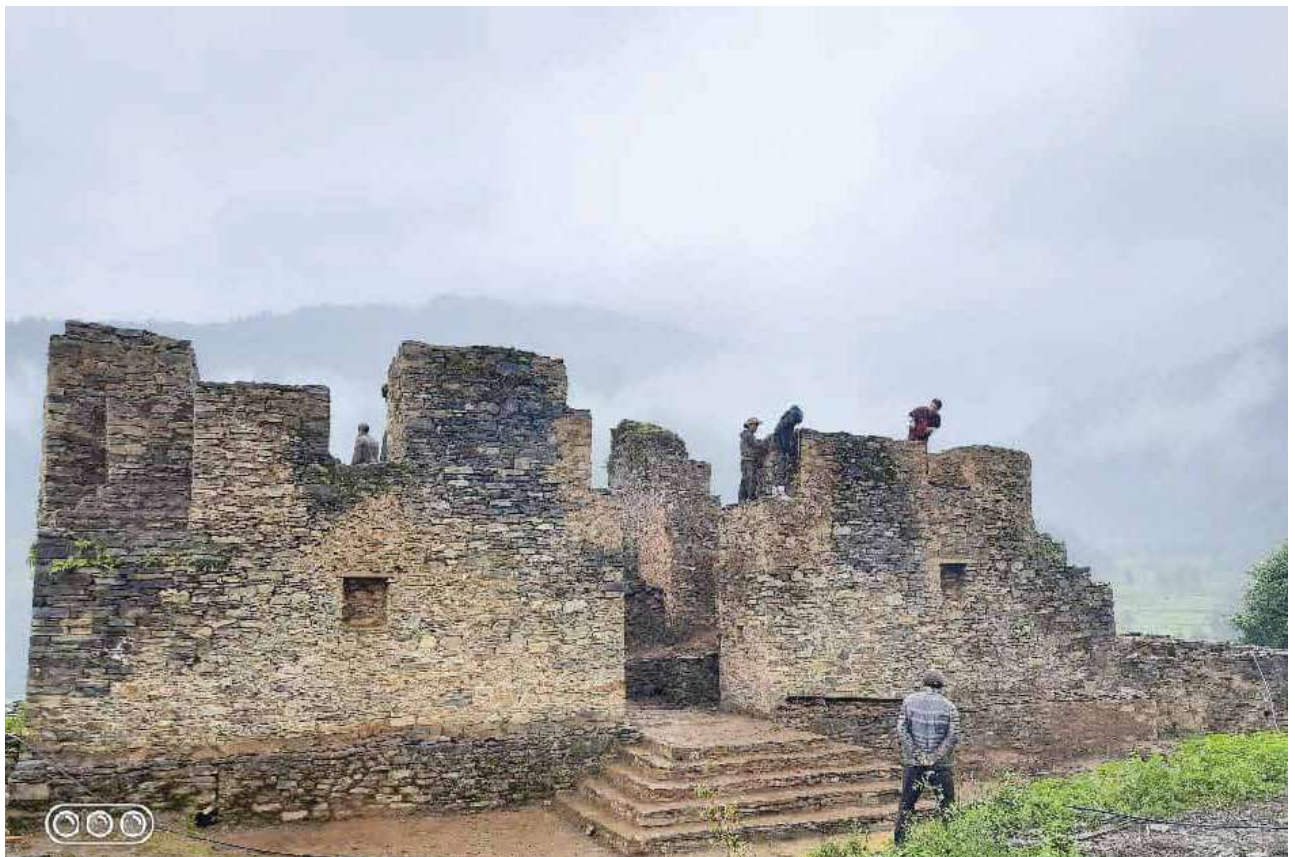
Fig. 3 After consolidation works of Utse

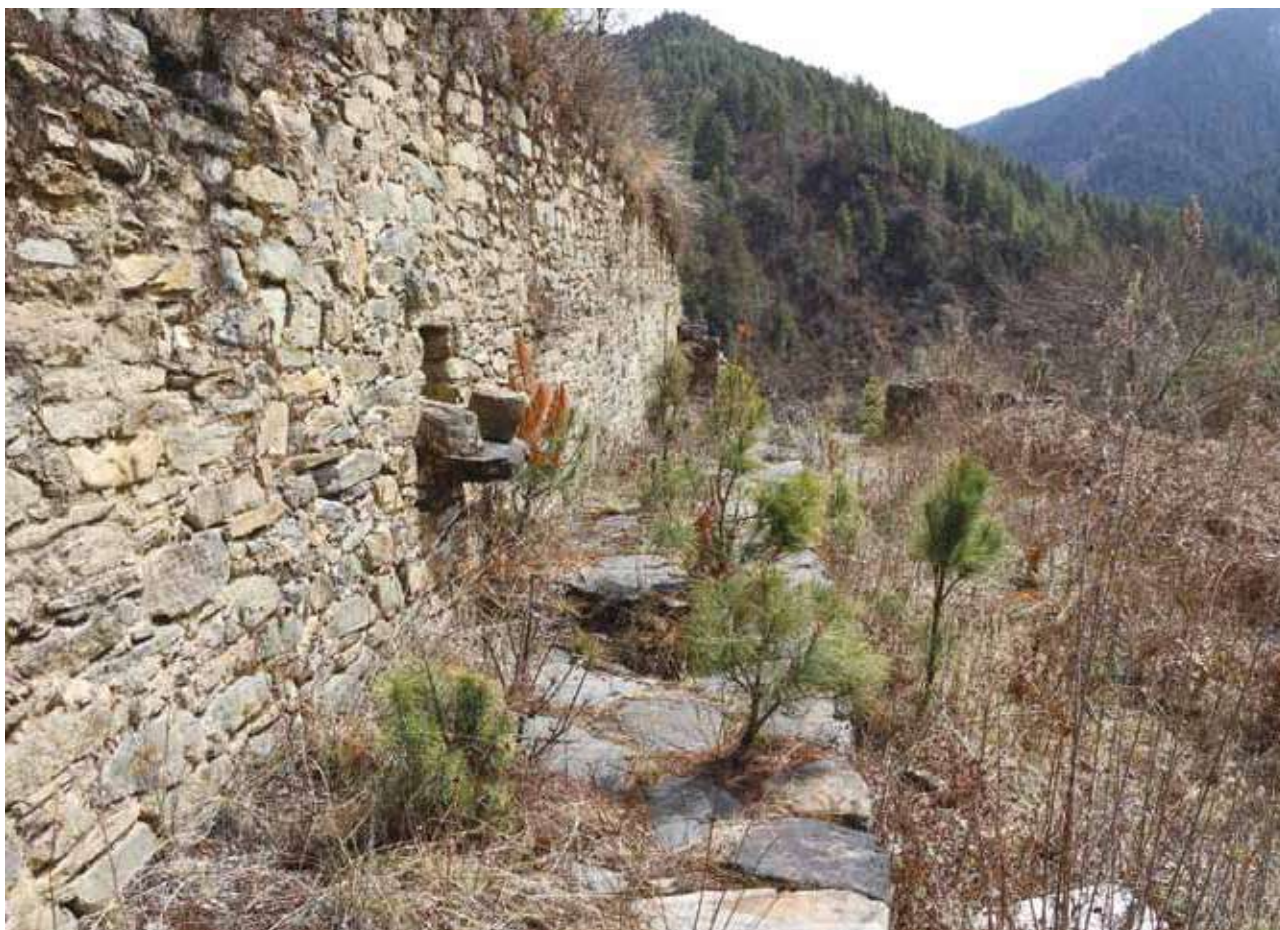
Fig. 4 Before consolidation works at the main entrance of *shabkhor* (surrounding) structure

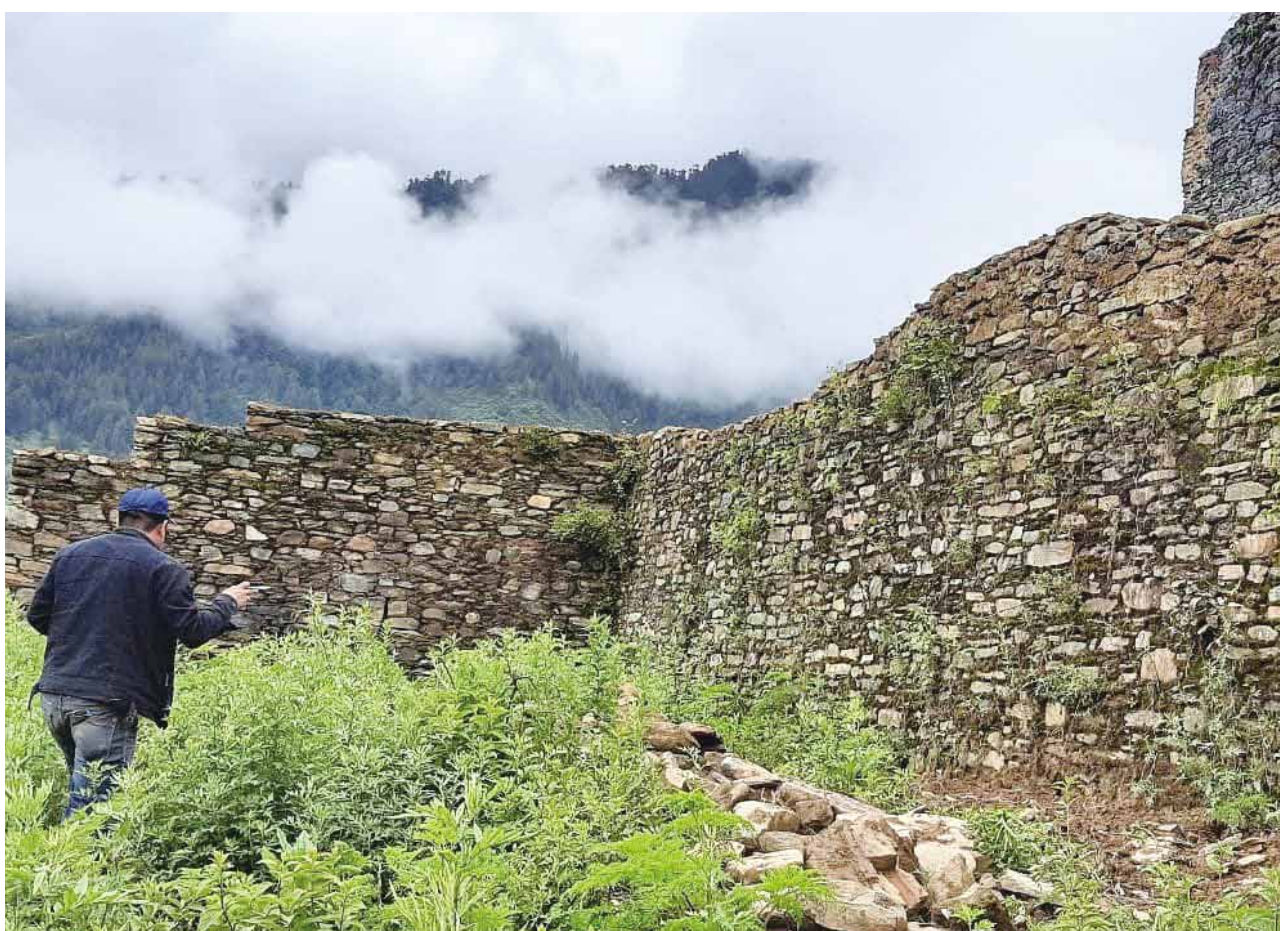
Fig. 5 After consolidation works of *shabkhor* (surrounding) structure

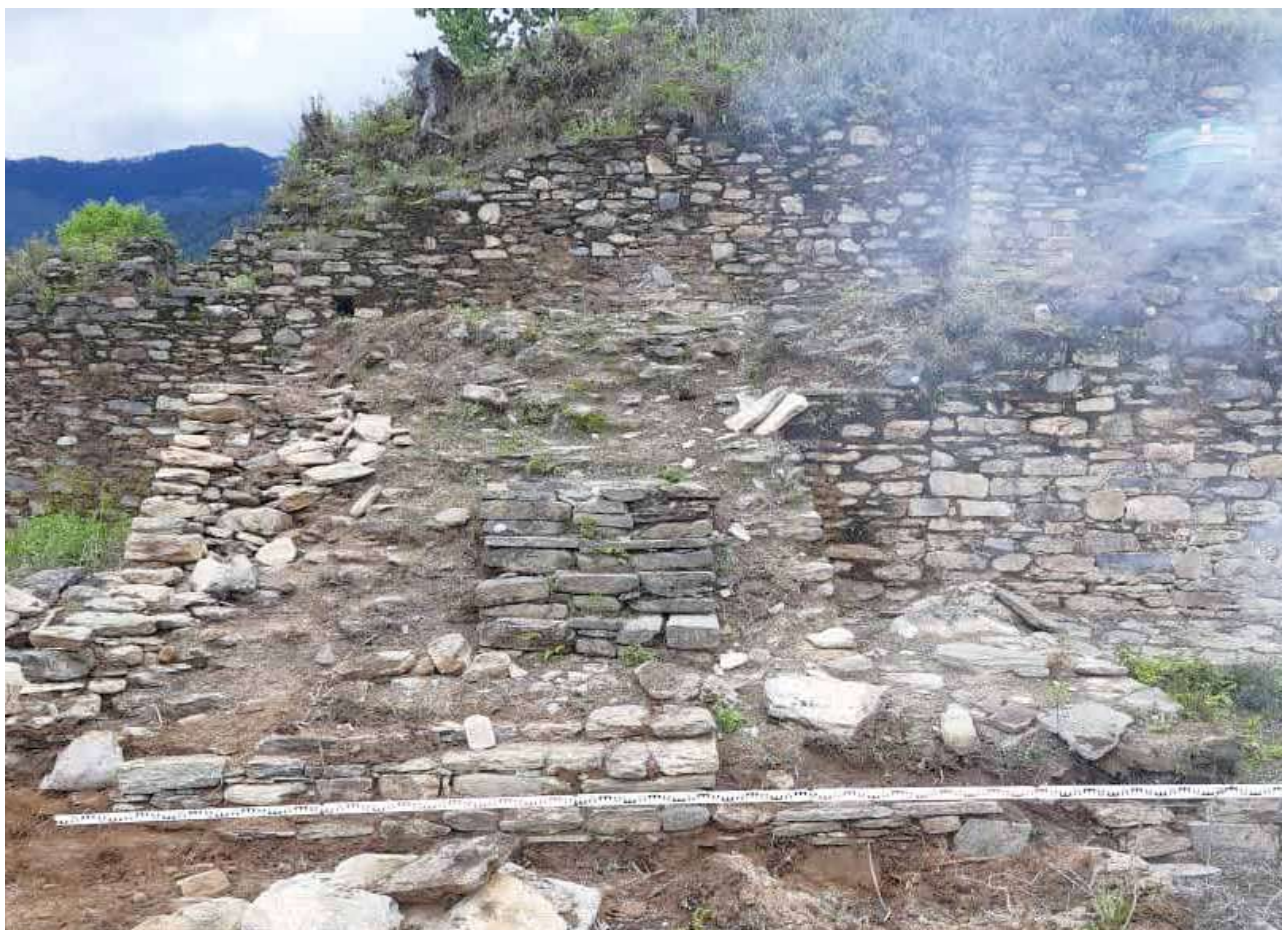
Fig. 8 Before consolidation of main entrance steps to the fortress

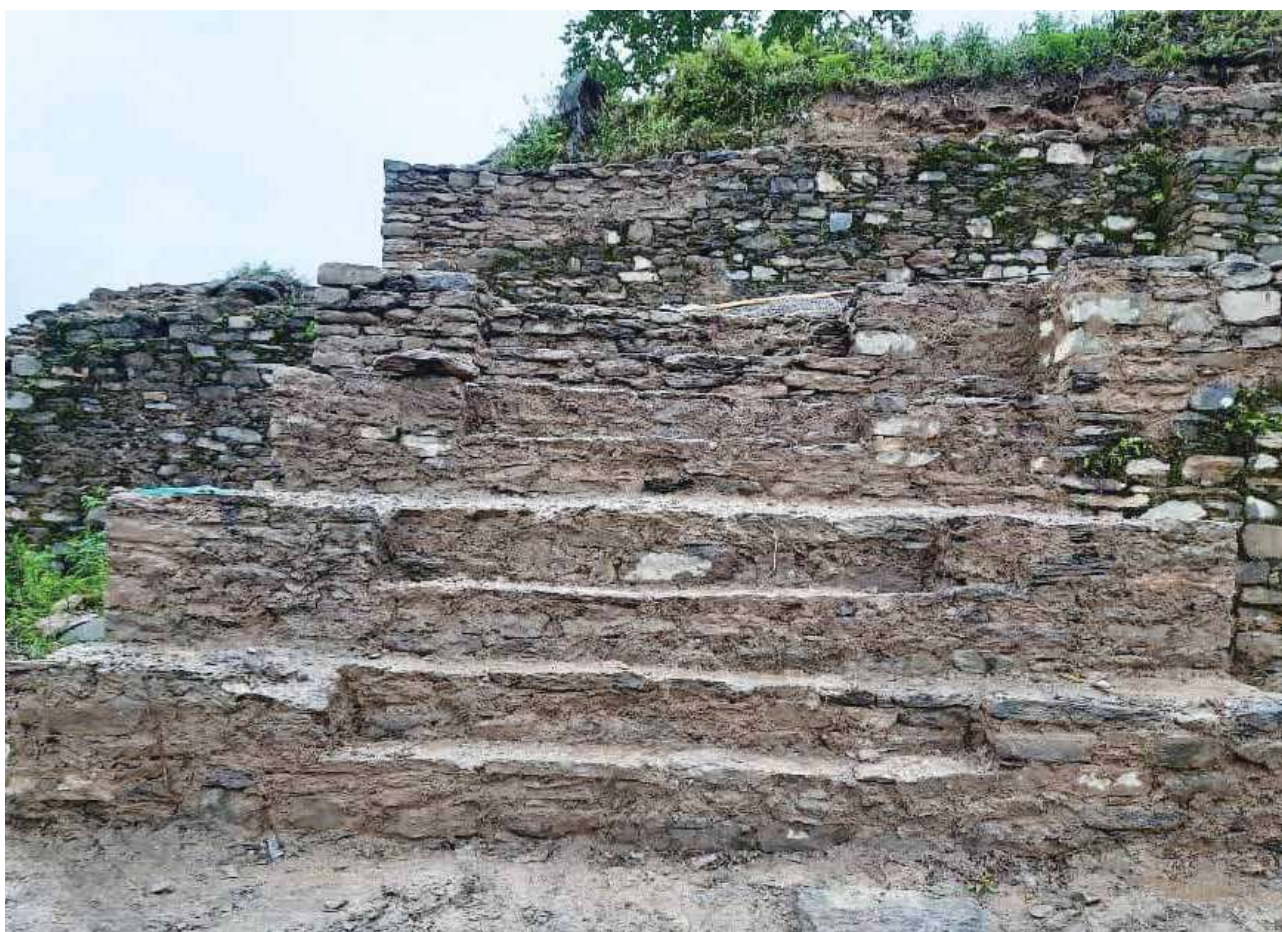
Fig. 9 After consolidation of main entrance steps to the fortress

A plain cement concrete band (5-10 mm thick) was provided on the topmost level concealed by one to two courses of stone masonry as a water proofing layer to protect the walls from rainwater seepage, which is one of the main causes of damage to the walls. A footpath was also constructed from the base of the hill leading to the site for visitors along the old original footpath to the *dzong* (Figs. 9 and 10).

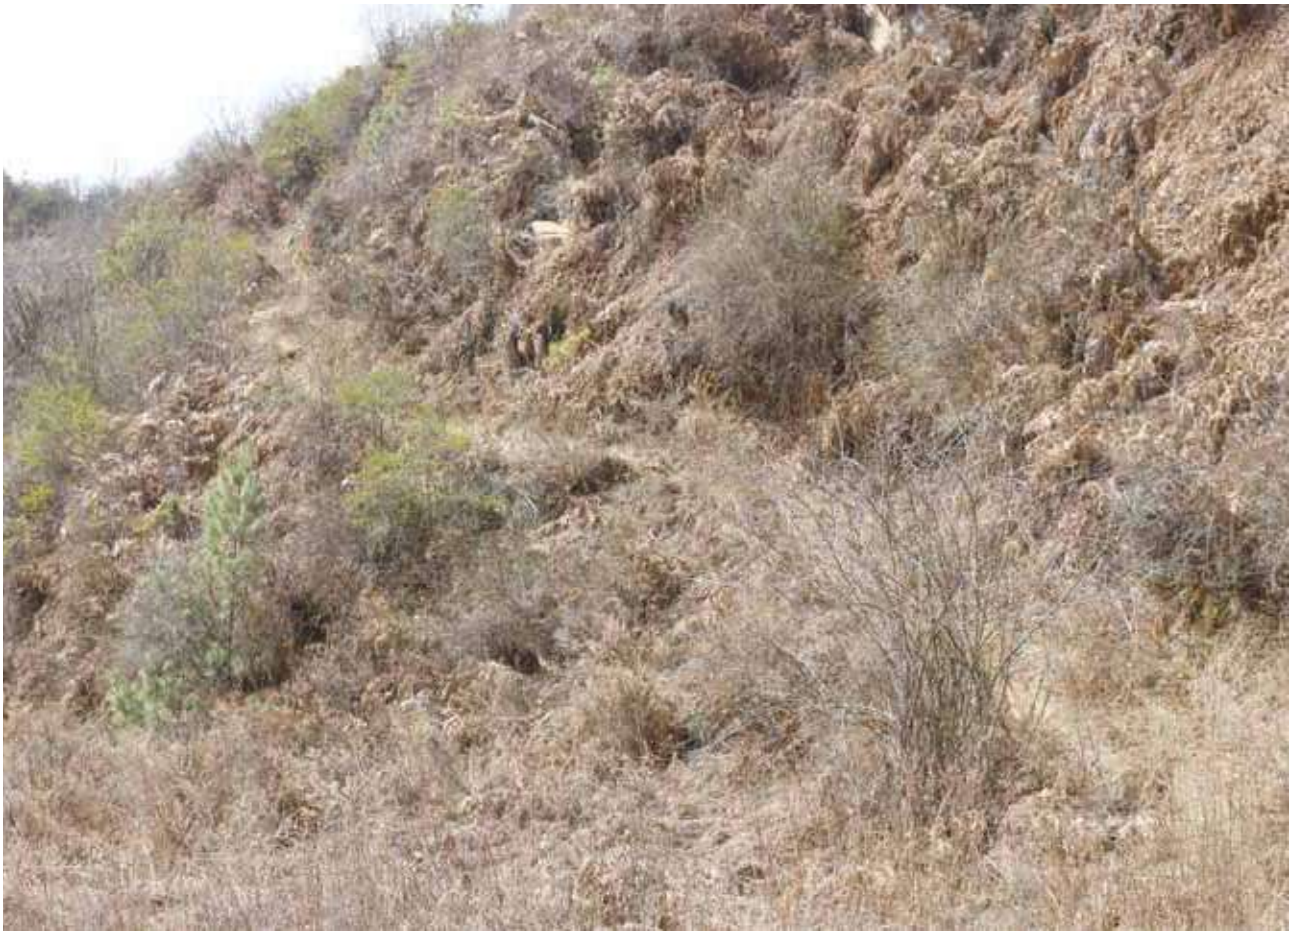
Fig. 10 The footpath to the site before works

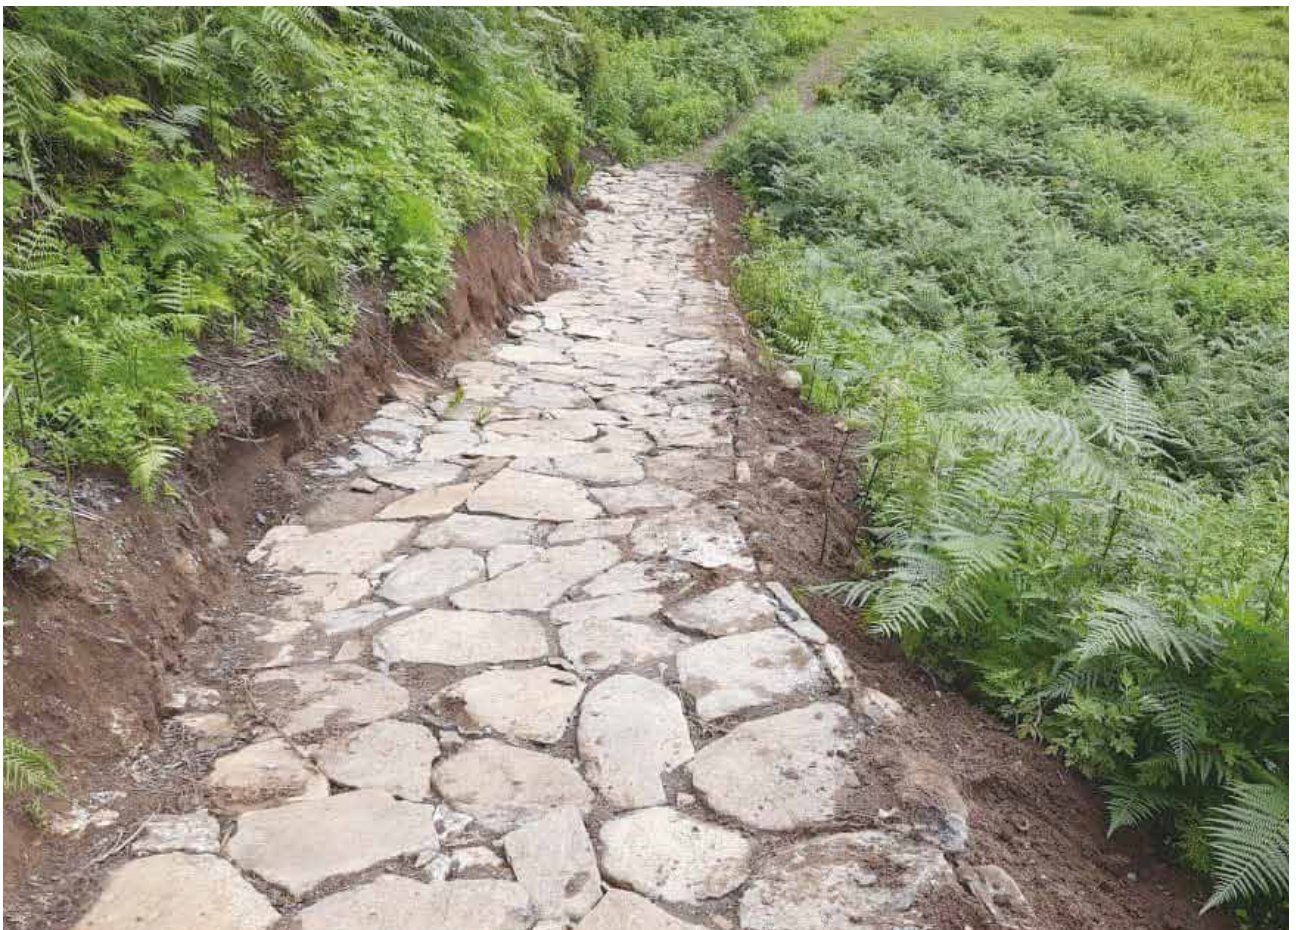
Fig. 11 Construction of the new footpath to the site

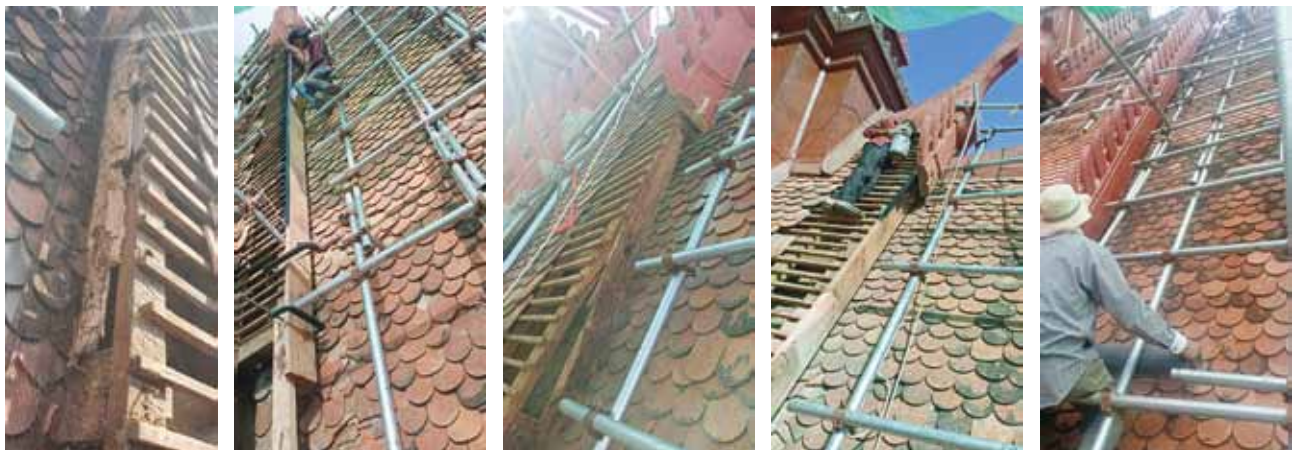
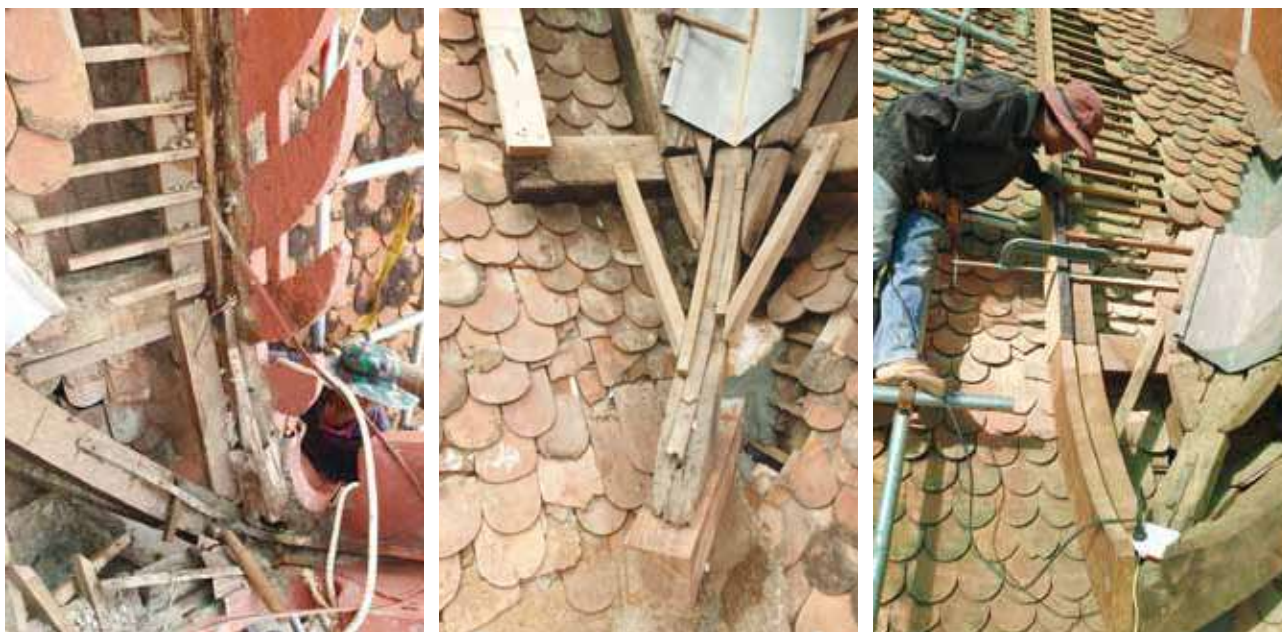
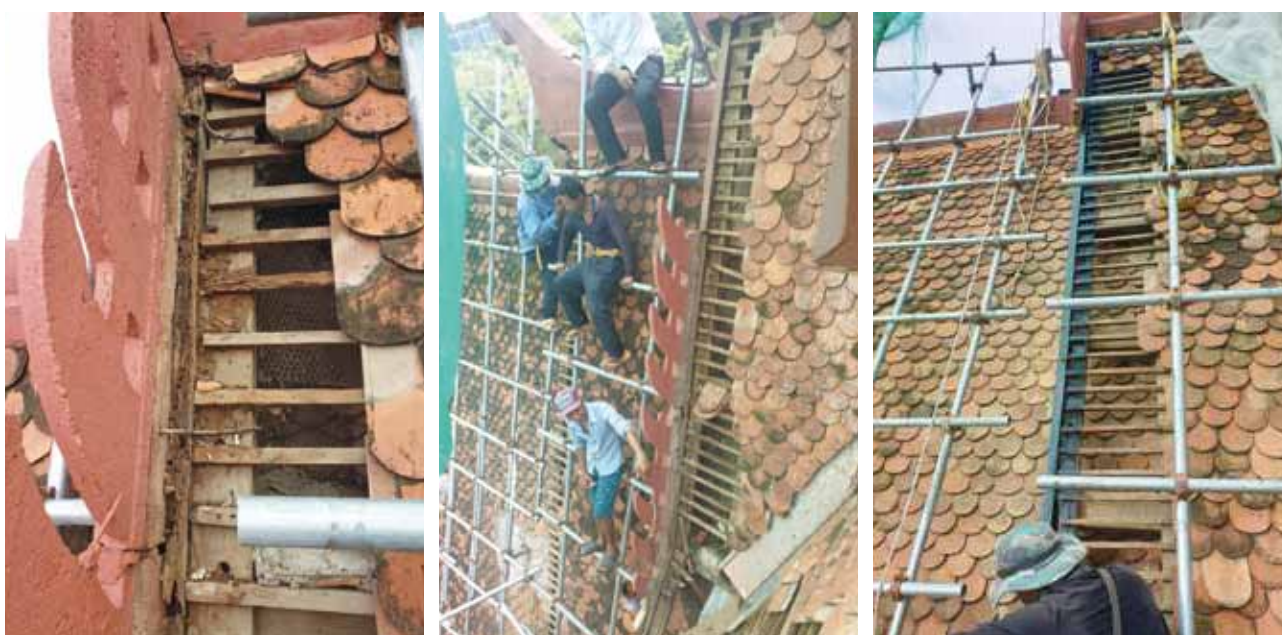
Damaged timber before and after restoration

building. The first project involves roof restoration. The Department of Museum is in cooperation with the Department of Safeguarding and Preservation of Monuments of the Ministry of Culture and Fine Art to provide expertise and techniques to repair roof damage. Here are the steps to be taken: Restore part of the roof, block damage on part of the roof and select which is seriously damaged. Do the documentation (photographs, risk map and report) before, during, and after finishing the restoration. Restore the south-east part of the roof, dismantle roof tiles and take down ornaments to remove decayed wooden timber and the water tank structure of the roof and install new timber. Use traditional paint to protect water proofing on the water tank structure. Then reinstall the roof tiles. Some old tiles are broken so we need to use new tiles by matching the color of the originals to provide the same look.

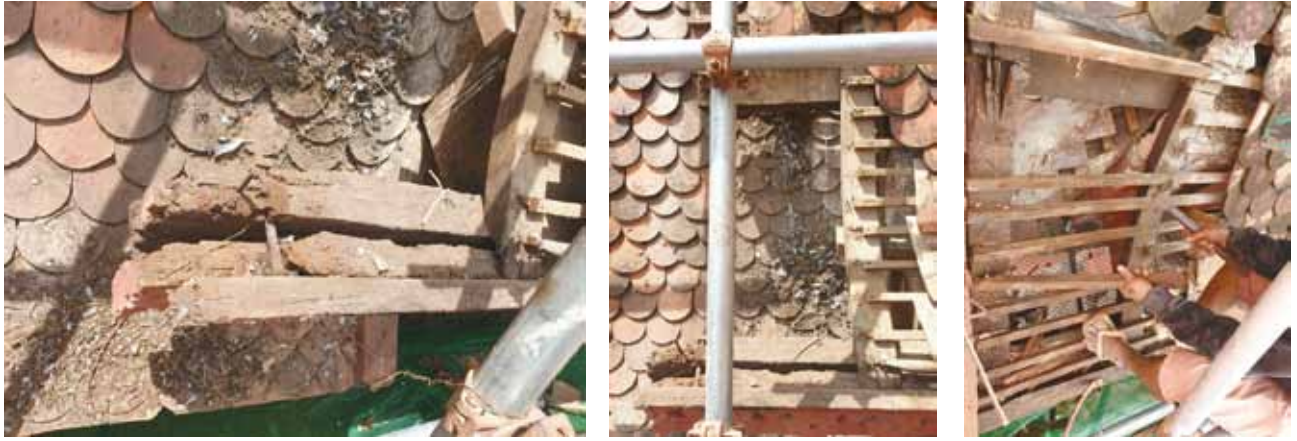
The second project involves protecting the museum building from pigeons. Pigeons are a big problem for the museum building as their nests and droppings cause harm to the roof structure, the building's aesthetics and the collections in the museum. The plan is to install a protective barrier to bar pigeons from the parts of the building where they live. The pigeons live in the space between roof levels, on the window frames, beams, and

The pigeon nest and droppings on the roof

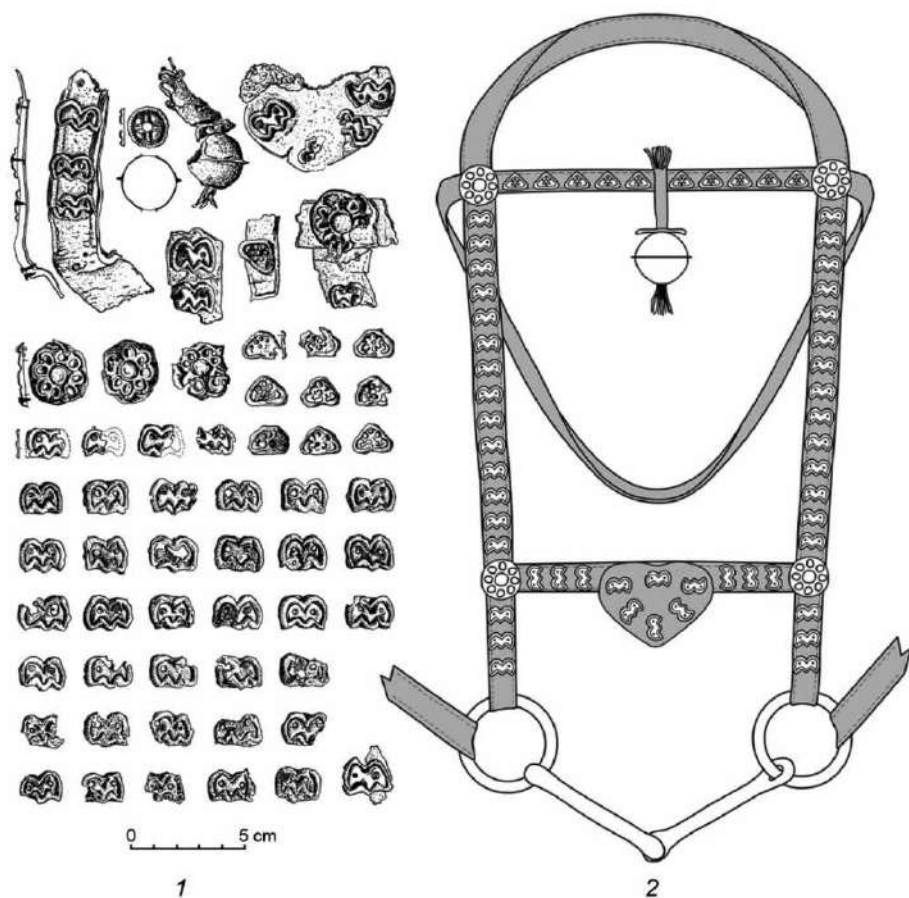
Four remains of bridles have been found in the burial sites of Tien Shan. The bridle from a female grave at the Seki I cemetery is more complete and richer example, which allows us to reconstruct it more easily and confidently. According to our reconstruction, it consists of a leather headstall comprising a noseband, a forehead band, two cheek bands, a crownpiece and a throatlatch, an iron bit, and two lead straps for the reins. The headstall is lavishly decorated with metal plaques and pendants. Large and round plaques are mounted at the juncture of the cheek

Fig. 2. The bridle remains from cemetery Seki (1) and its reconstruction (2)

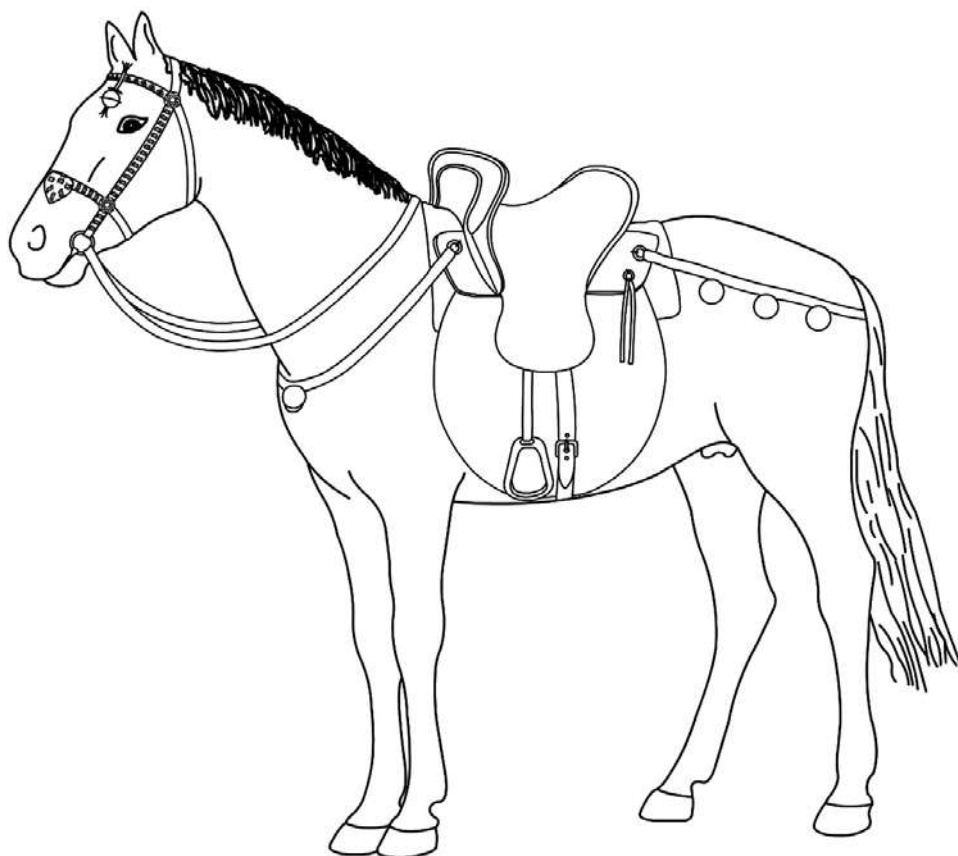
Fig. 3. Reconstruction of the horse harness of the Tien Shan nomads in the 13th to 14th centuries

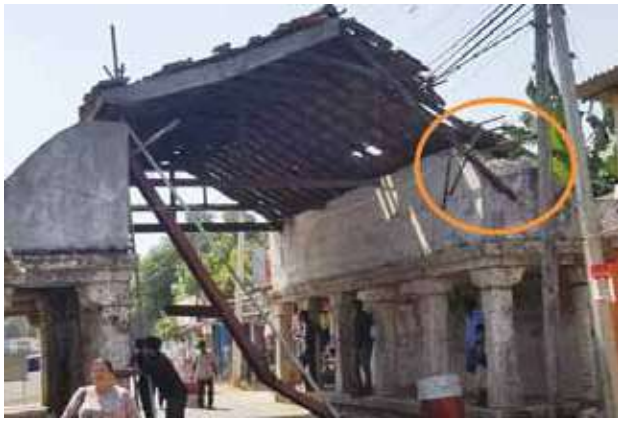
Fig. 5: Madam in 2019—After being damaged

After the last accidental damage, an effort was made by Jaffna Archaeological Office to conserve the monument immediately. The Point Pedro Town Development Society and Point Pedro-Switzerland branch requested the Archaeological Department to conserve the Theru Moodi Madam immediately by allocating a financial contribution through the Divisional Secretariat. Accordingly, with the approval of the Director General of Archaeology, the guidance of conservation officers, and with the contribution of the Central Cultural Fund, the construction works started by restoring the roof and *madam* as it was before, to be handed over to the public.

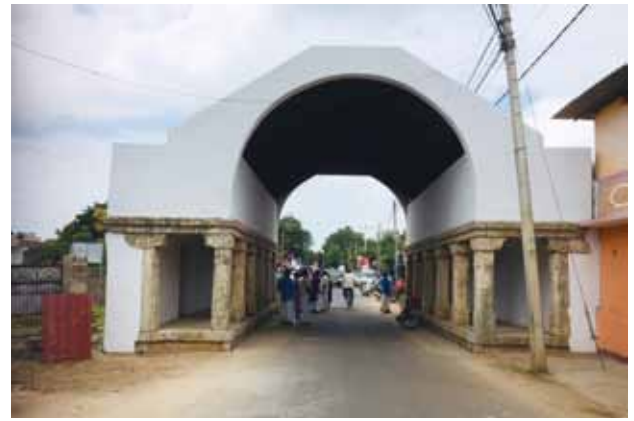
Fig. 6: Madam in 2020—After conservation

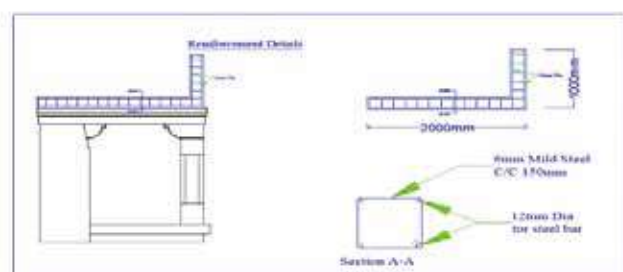
Fig. 9: The square shaped bended iron rod for the arch

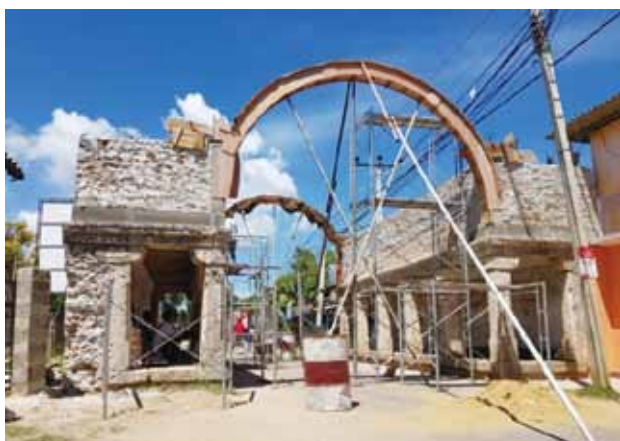
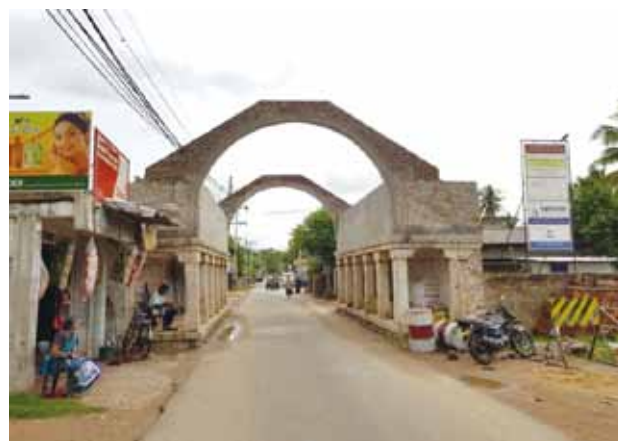
Fig. 10 & Fig. 11: Arch conservation

In 1990s, a roof was installed on both sides of the *madam*; a wall plate was fitted and four iron bars were fitted across the wall, and on the iron pillars a roof arch made with palmyra timber was fitted. The deteriorated and damaged roof structure was replaced by employing trained traditional carpenters found locally. Timber for the roof was fitted in 11 cubits and with the space of 45 cm. Because of insufficient quality palmyra batten (reeps), first-grade timber was fitted as it was. Old tiles were cleaned and additional tiles were also purchased for the balance. Ridge tiles were fixed by cement mortar. At the ends of both sides of the roof, wooden valance boards

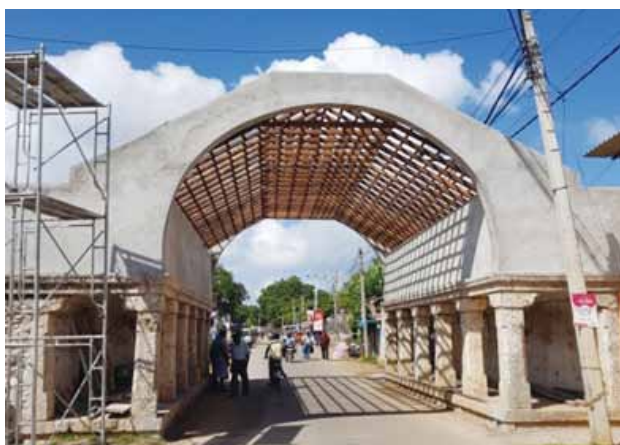
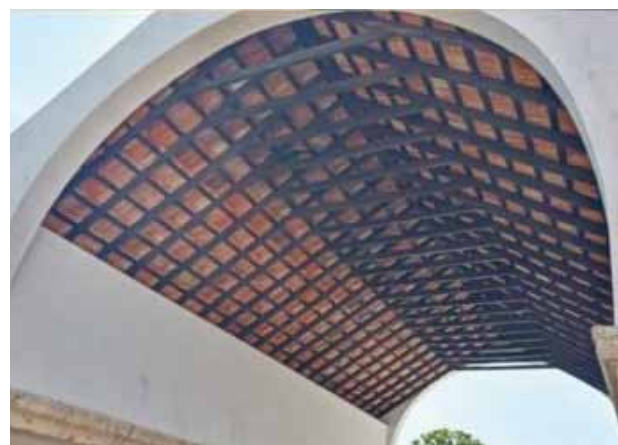
Fig. 12 & Fig. 13: Restructure of the roof

were fixed for the safety of the wood. The wood was coated with preservative oil to increase the durability of the timber (Figs. 12 &13).

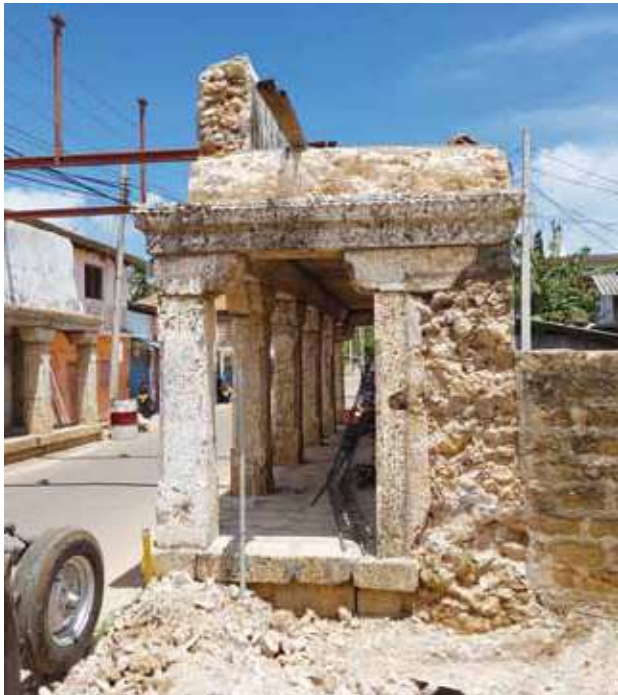
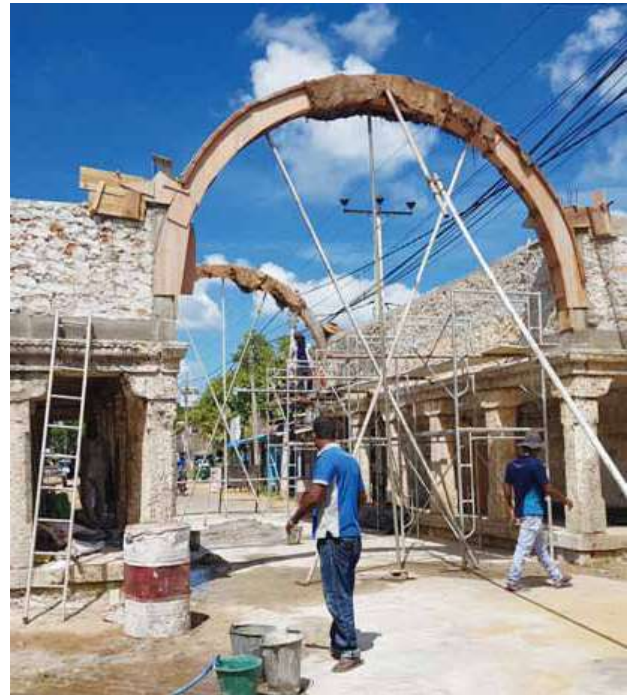
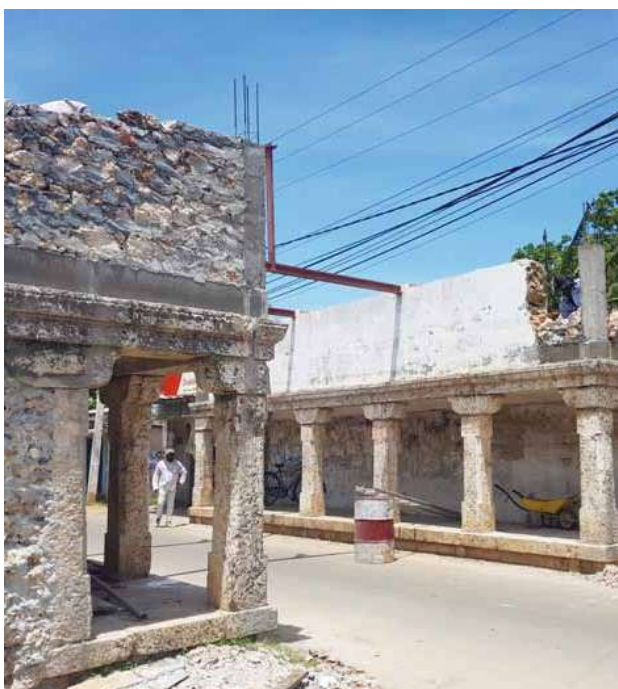
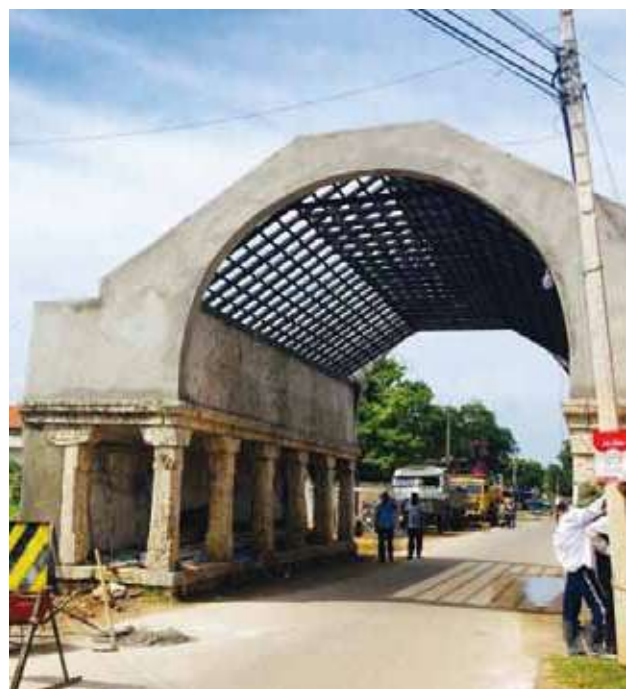
Figs. 14, 15, 16, &17: Wall conservation progress

As peepal (*Ficus religiosa*) tree roots penetrated into the wall near the shop, part of the old wall measuring 65 cm in length and 40 cm in width was removed and rebuilt. The concrete pillar erected by the general public for the protection of the *madam* was removed and the area was restored to its original form (Figs.16 &17).

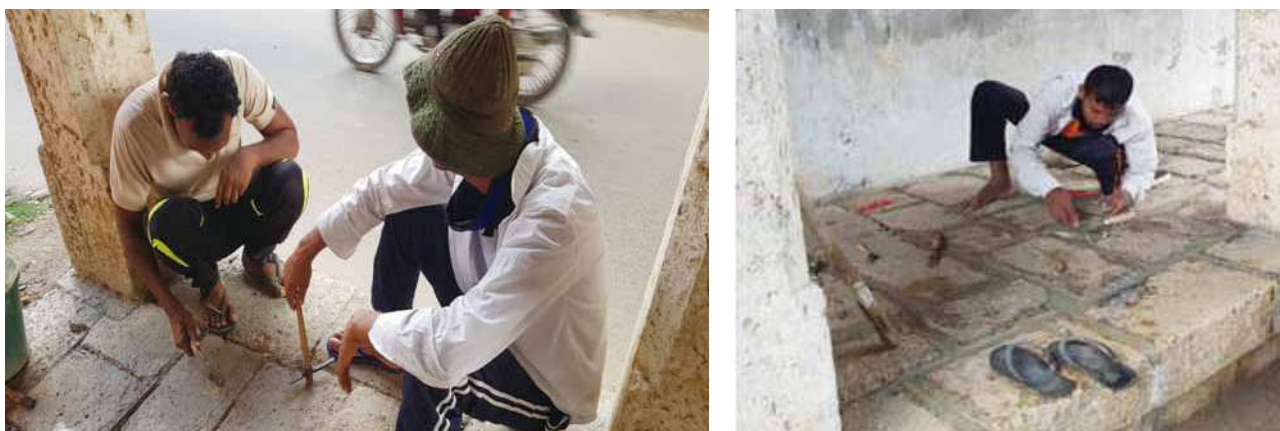
Fig. 18 & Fig. 19: Pointing work before conservation

to human activity and natural factors. The gaps for the stones were coated with the tested cement mixture of lime, termitarium soil, and red roof tile powder in equal amounts (Figs. 18 & 19).

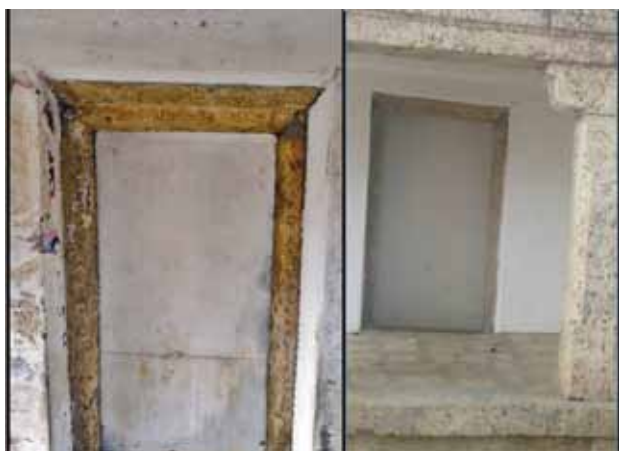
Fig. 20: Before & After, door conservation work

People used to close the entrance with concrete blocks because there was no door. Those concrete blocks were removed and rebuilt with bricks to provide temporary protection during this conservation work. This temporary brick wall will be removed when it is re-fixed in the future.
