ACCU Nara  
International Correspondent

# The Twenty-fifth Regular Report

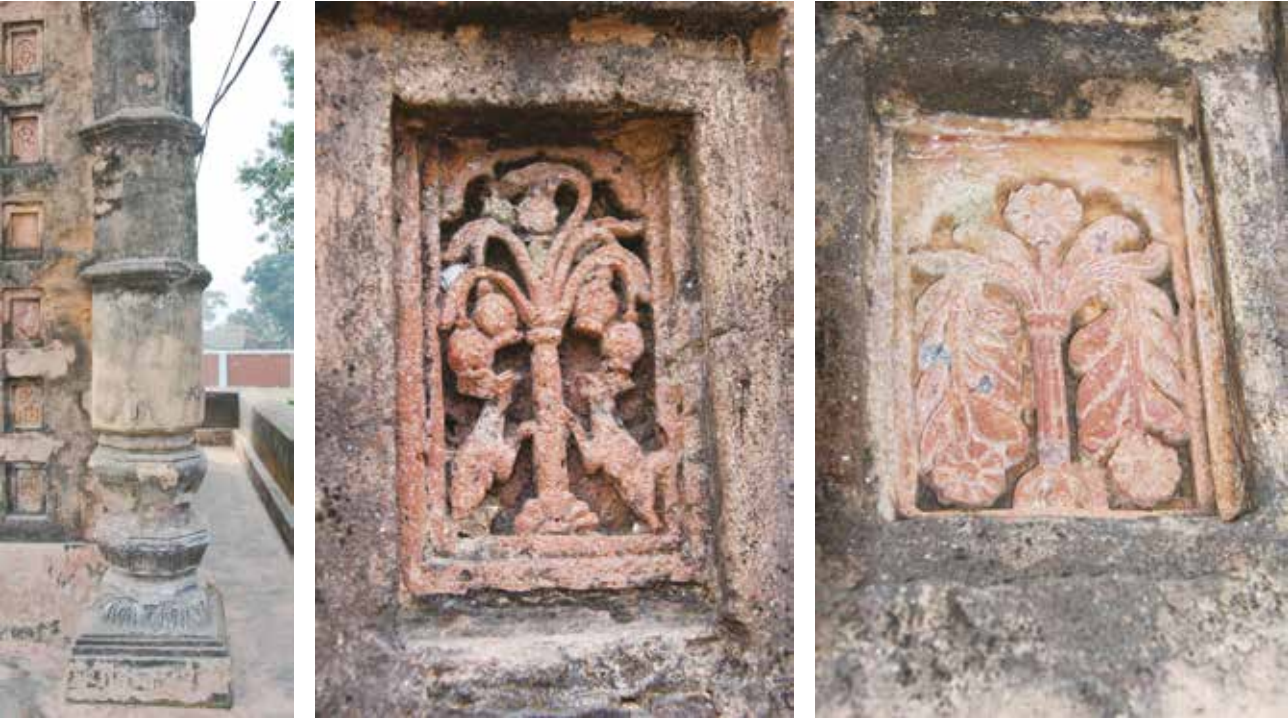
Enclosed by a low outer wall, the mosque forms an oblong structure of brick and plaster. The mosque was constructed with octagonal turrets in the four corners and it has outside dimensions of nearly 12 m × 5 m. In the western (*Kiblah*) wall are three semi-octagonal arched *mibrabs*, with the central one being larger. The central doorway and the central *mibrab* have outward projections with flanking turrets on each side. The eastern wall of the mosque is penetrated with three arched doorways. The central one is larger than the other two. There is an arched window in each of the north and south walls.

General view of Nayabad Mosque and its ground plan

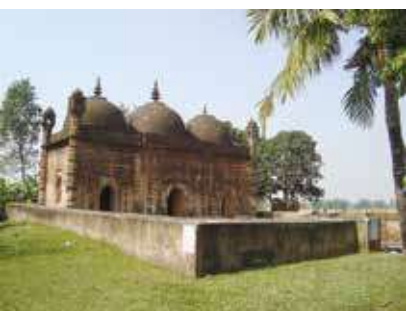
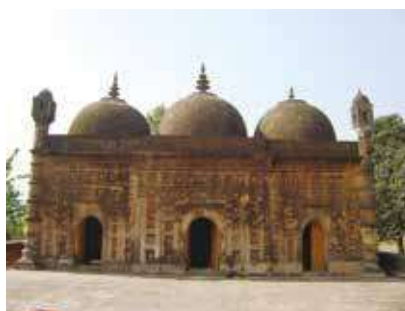
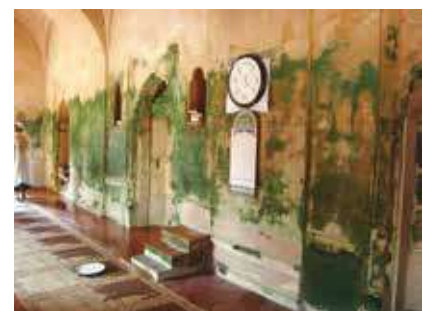
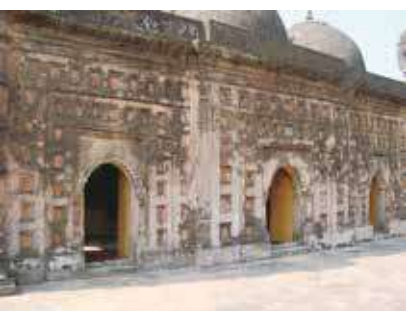
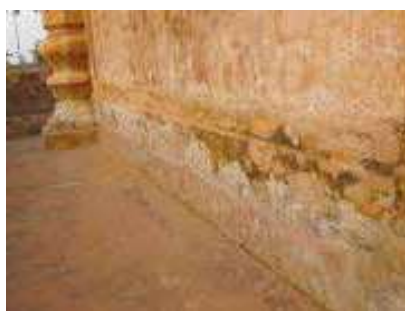
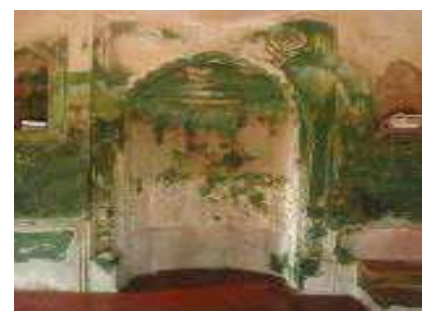
Due to climate change in the country, ancient buildings are now being eroded and facing damage. Nayabad Mosque was facing the same problem. The bricks, walls, domes and ornamentations of the mosque had been damaged. Climate change had also caused salinity, algae and fungal infection on the walls, corner turrets, ornamentations and domes of the mosque.

The inner side and outer side of the mosque were infected with salinity, algae and fungi.

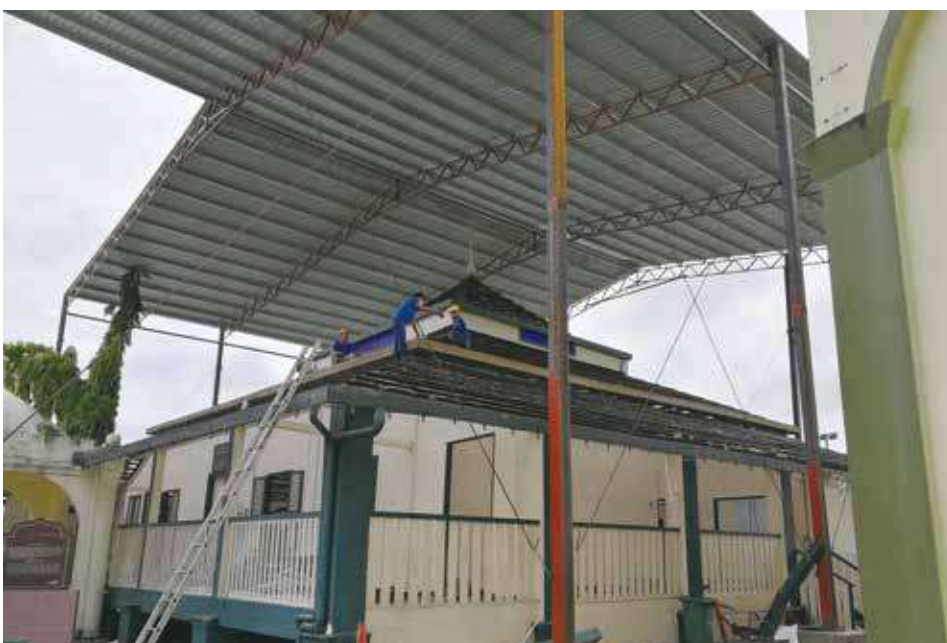
The scaffold roof was the temporary roof system installed at Al Qadim Mosque, supported by steel columns that were secured by bolts and nuts to concrete bases on the ground. The steel columns were also stabilized with cable tie bracing.

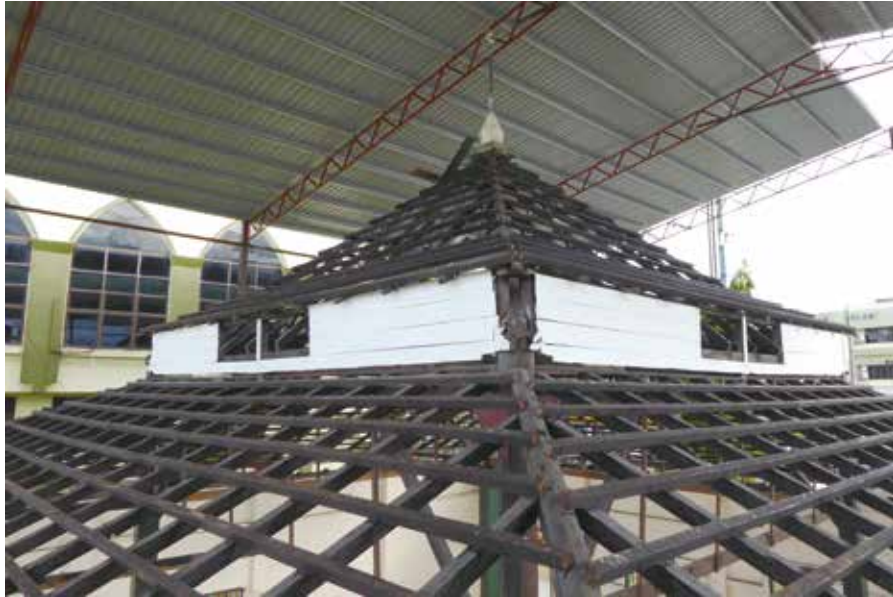
A temporary roof 16 metres high was erected to protect Al Qadim Mosque when the new roofing material was installed to replace the old roof.

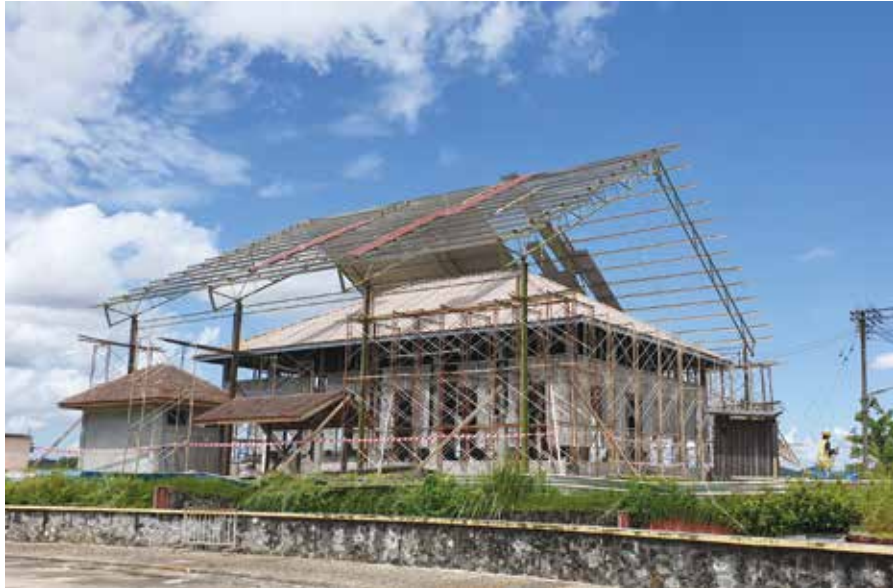
A scaffold roof system 10.5 metres high was erected for the temporary roof at Fort Emma.

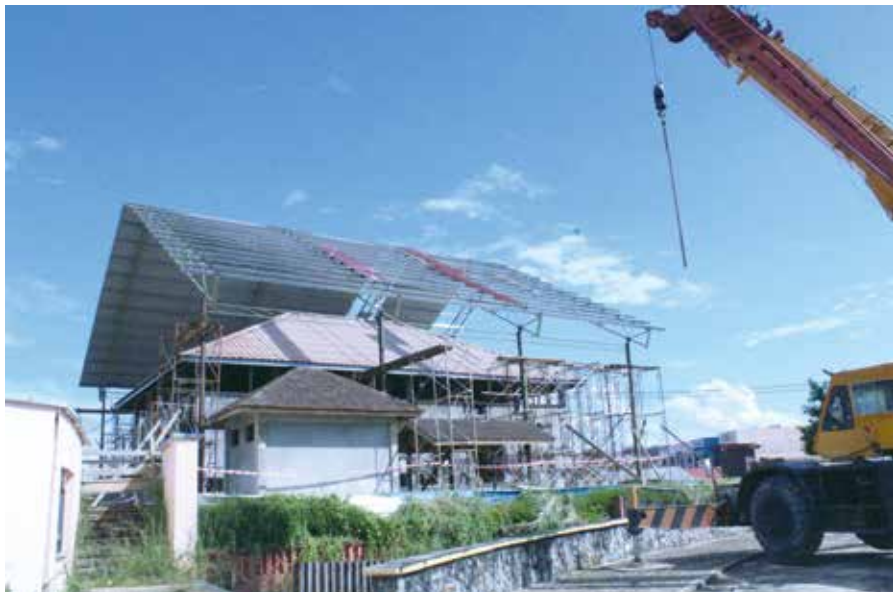
Due to site constraints, a mobile crane was used in the installation of the temporary roof system at Fort Emma.

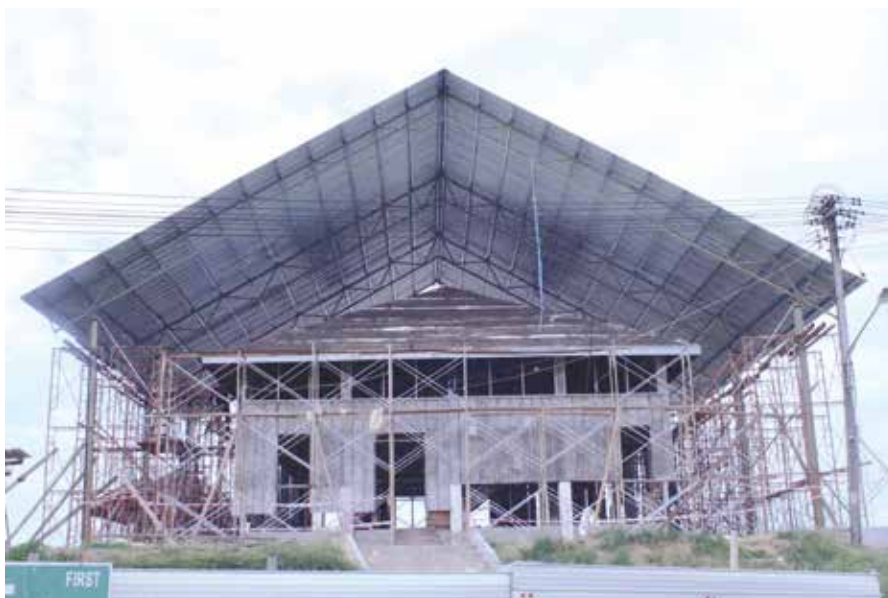
A frontal view showing scaffold roof system that covered Fort Emma, giving full protection to the fort from adverse weather conditions during the installation of *belian* (ironwood) roof shingles

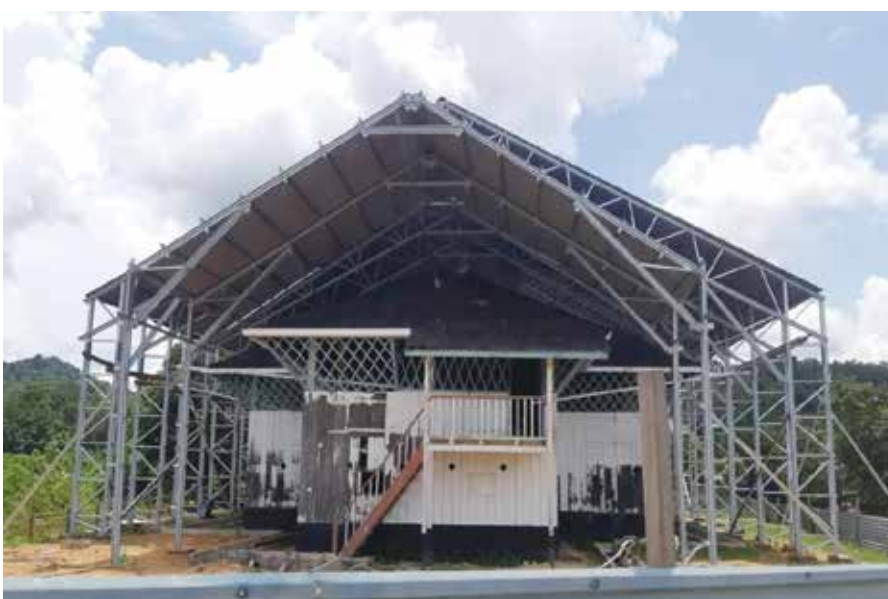
Steel truss frames of 12 metres in height were erected for the temporary roof system at Fort Brooke.

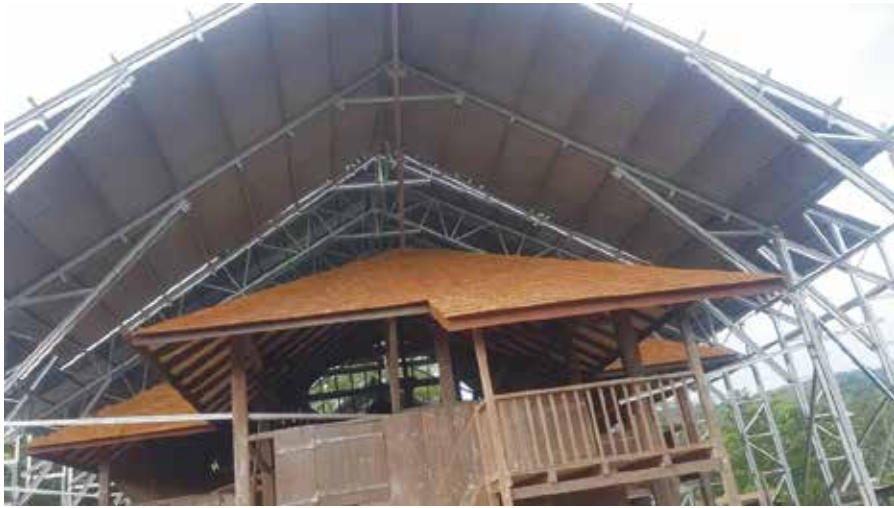
Throughout the construction period, the temporary roof system protected the roof structure of Fort Brooke from harsh weather, dust, and environmental damage.

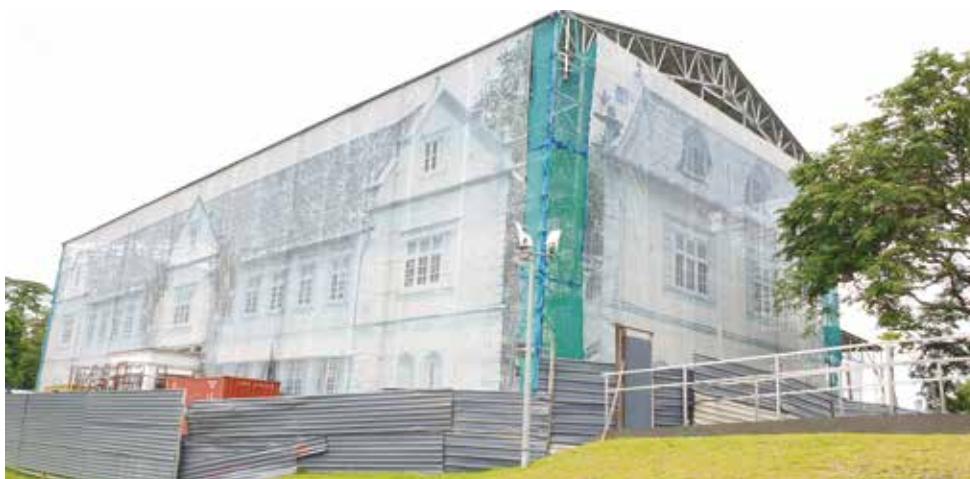
Printed netting or inkjet-mesh tarpaulin, displaying images of the Old Sarawak Museum building facade, installed to cover the building throughout the construction period. This was the first such printed netting introduced in a heritage building conservation project in Sarawak.

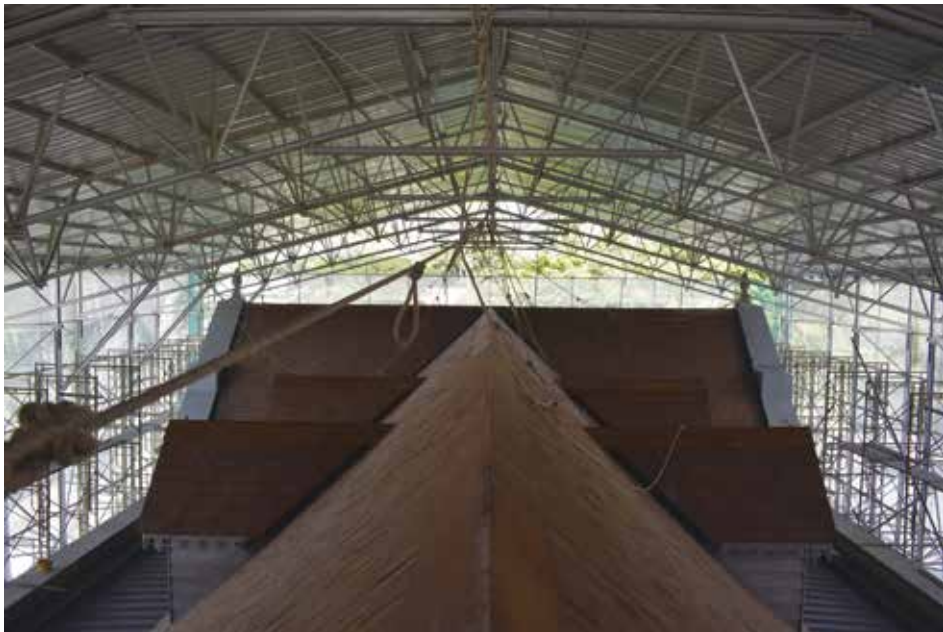
At a height of 14.6 metres, the temporary roof at the Old Sarawak Museum provided a conducive and comfortable work environment.

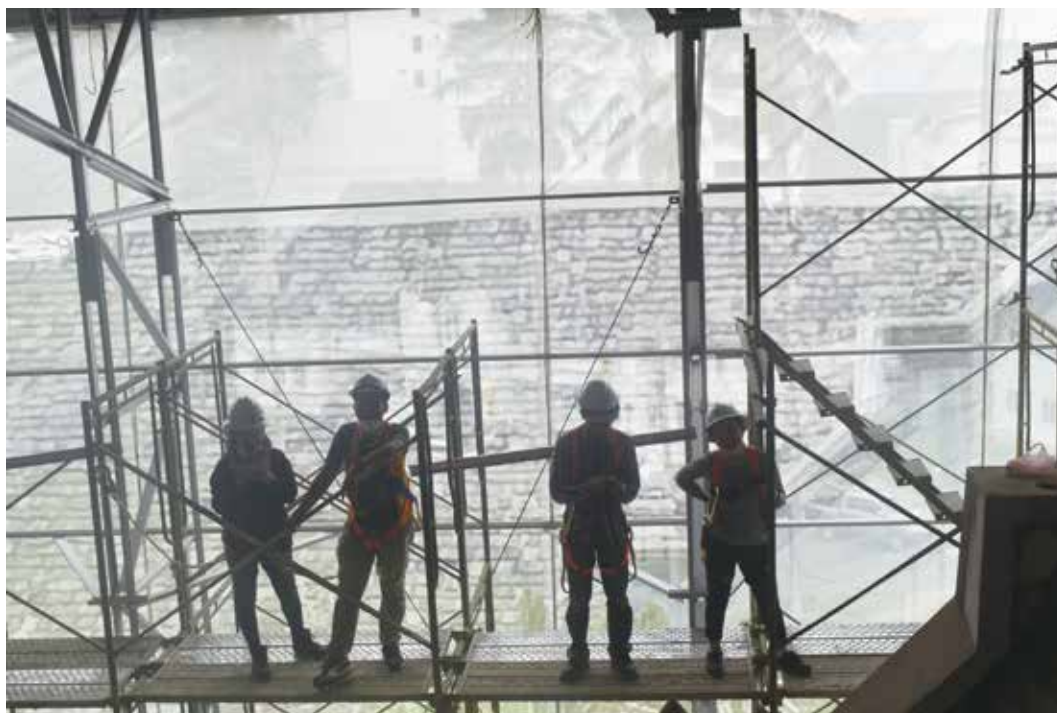
The portal framed roof system at the Old Sarawak Museum incorporated concrete footings, galvanised light-weight steel frames, and fly-bracing cables.

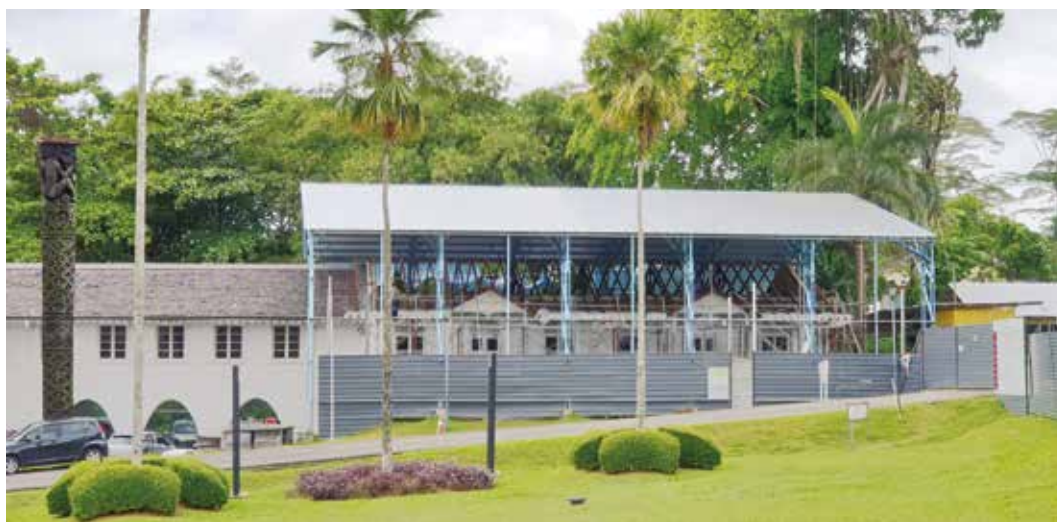
During the conservation of the Curator's House, a temporary roof 6.5 metres high using a portal framed roof system was installed.

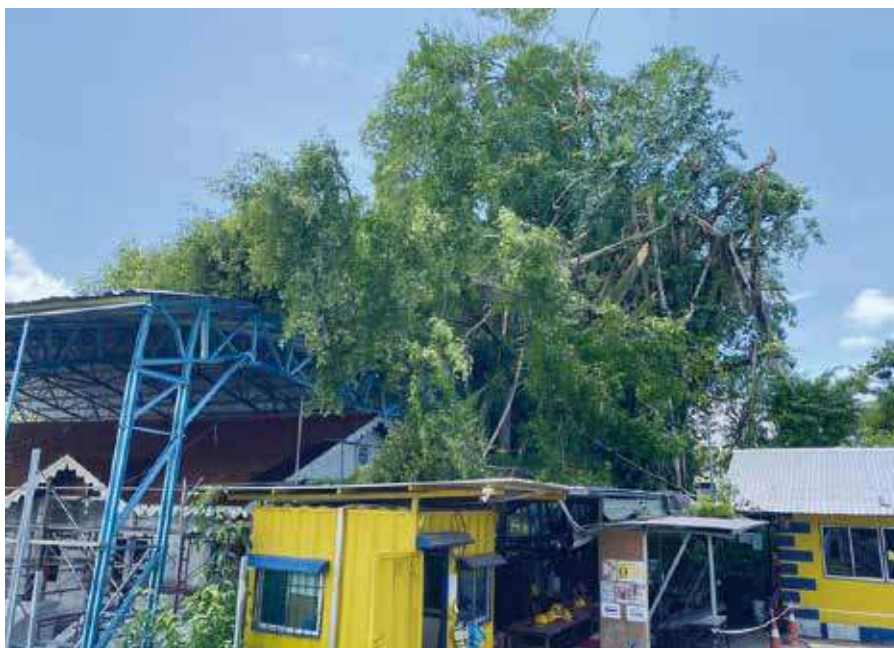
In the evening of 22 August 2020, the temporary roof saved the Curator's House from destruction when a nearby tree fell down during a heavy rainstorm.

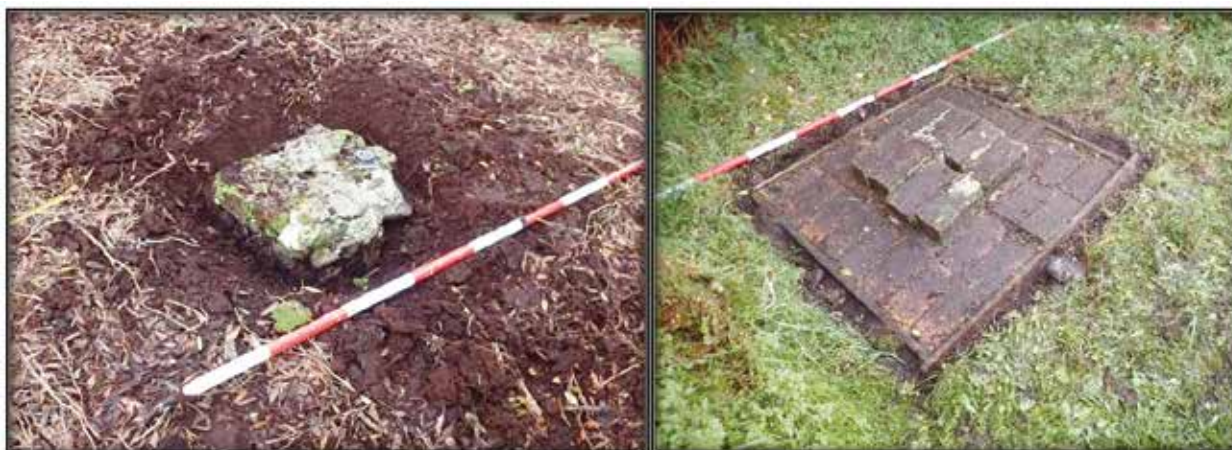
Figure 6. The newly discovered plinth (left) and the plinth at the 1874 German Transit of Venus site (right). Both have 30mm copper pipes at their centre and use the same bricks (Photos: Matthew Schmidt).

Three important heritage features were found during the survey work. The first was a brick, cobble and cement plinth discovered during track clearance work (Figure 6). This plinth matches one located at the 1874 German Transit of Venus site. Further research will determine what this feature is. Jones (2009:93) attempted to date the similar plinth at the Venus site back in 2003 and concluded that it could date from the Ross 1840 expedition era, the 1907 Philosophical Institute Expedition (more likely in Jones mid) or from Eden's 1945, 1947 magnetic measurements. If this new plinth is from the German Venus expedition, then it may be the location of

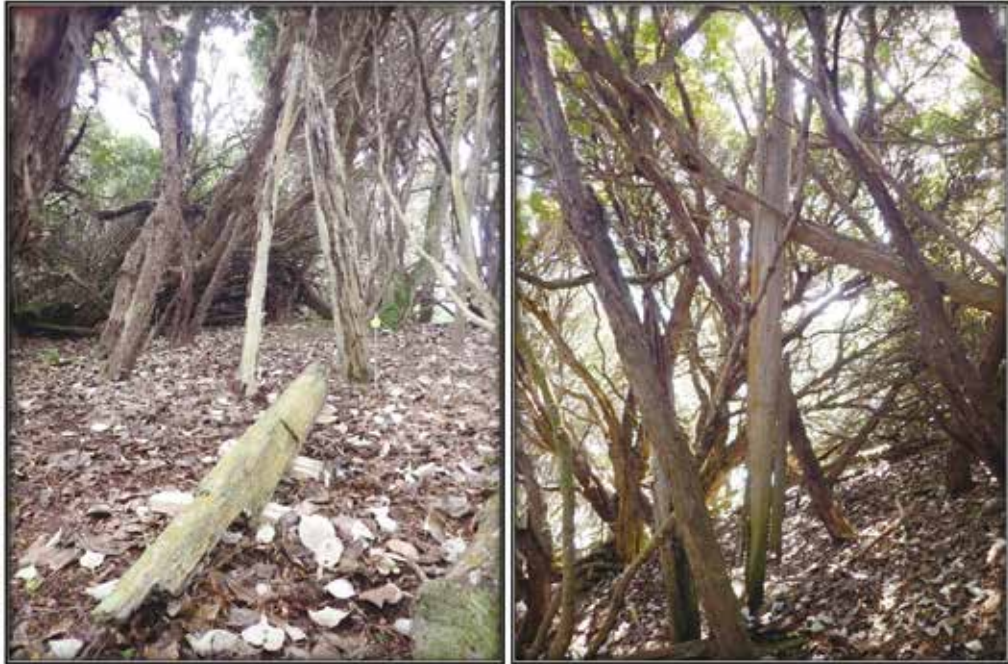
Figure 8. The three pieces of the Amherst 1868 spar: Left image - the piece hung in the tree (left), the section on the ground (center), and in-situ piece (right); Right image - the 4m length of spar hung up in the tree (Photos: Matthew Schmidt)

The Amherst spar dates from 1868 and was once a tall imposing structure set on a vegetation bereft headland (NZAA Site No. AU/25). It was erected to direct people shipwrecked on the island to a castaway depot. Today this artefact lies in three pieces. The base of the spar protrudes 3 m from the ground on an *ca.* 80-degree angle (Figure 8). A 4 m long piece of the spar has cracked off, fallen vertically and lies hung at a *ca.* 60-degree angle against the 'v' of a tree (Figure 8). A third piece of spar 3 m long lies horizontally on the ground (Figure 8). The vegetation cover does provide some protection from the elements for the pieces of spar but the piece lying on the ground is exposed to moisture from below and insect activity. The piece hung up in the tree will be prone to future damage when the weight of the branches holding it up gives way. Sea lions and pigs are a constant issue for the pieces by rubbing past them and, for the piece on the ground, climbing onto or over this artefact. Recognising these risks, the team moved the piece of spar on the ground next to the two vertical sections and built a temporary fence around these using metal warratahs and wire mesh to protect them (Figure 9). The loose piece of spar was also lifted off the ground onto small timber blocks.

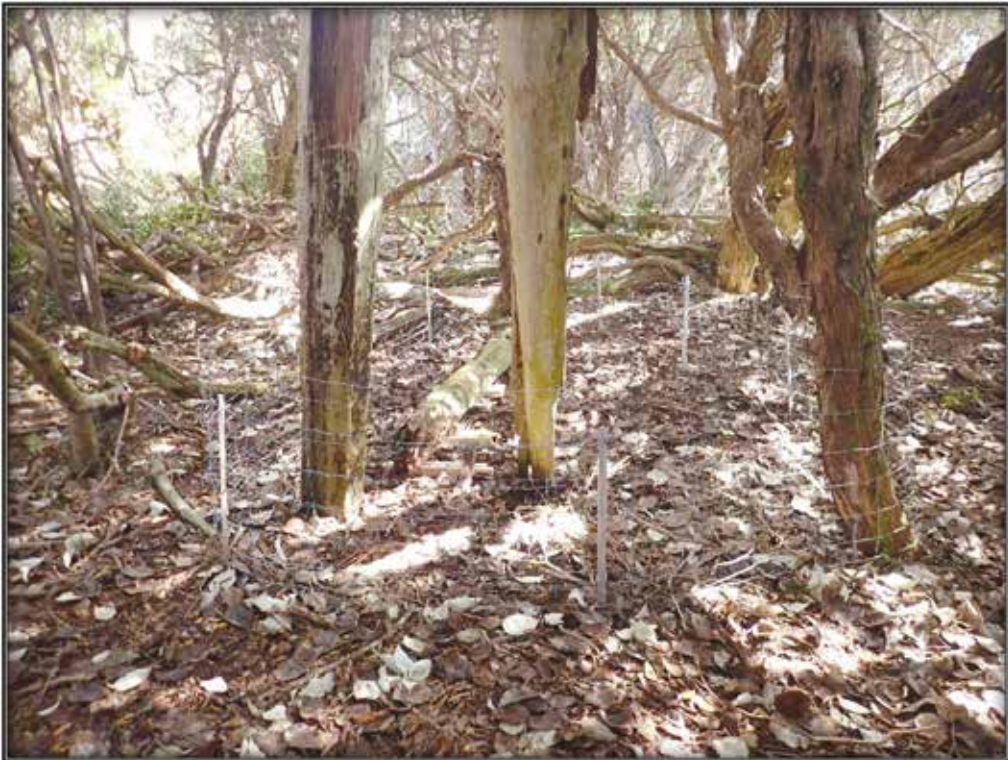
Figure 9. Temporary warratah and wire mesh fencing placed around all the pieces of the Amherst spar (Photo: Matthew Schmidt)

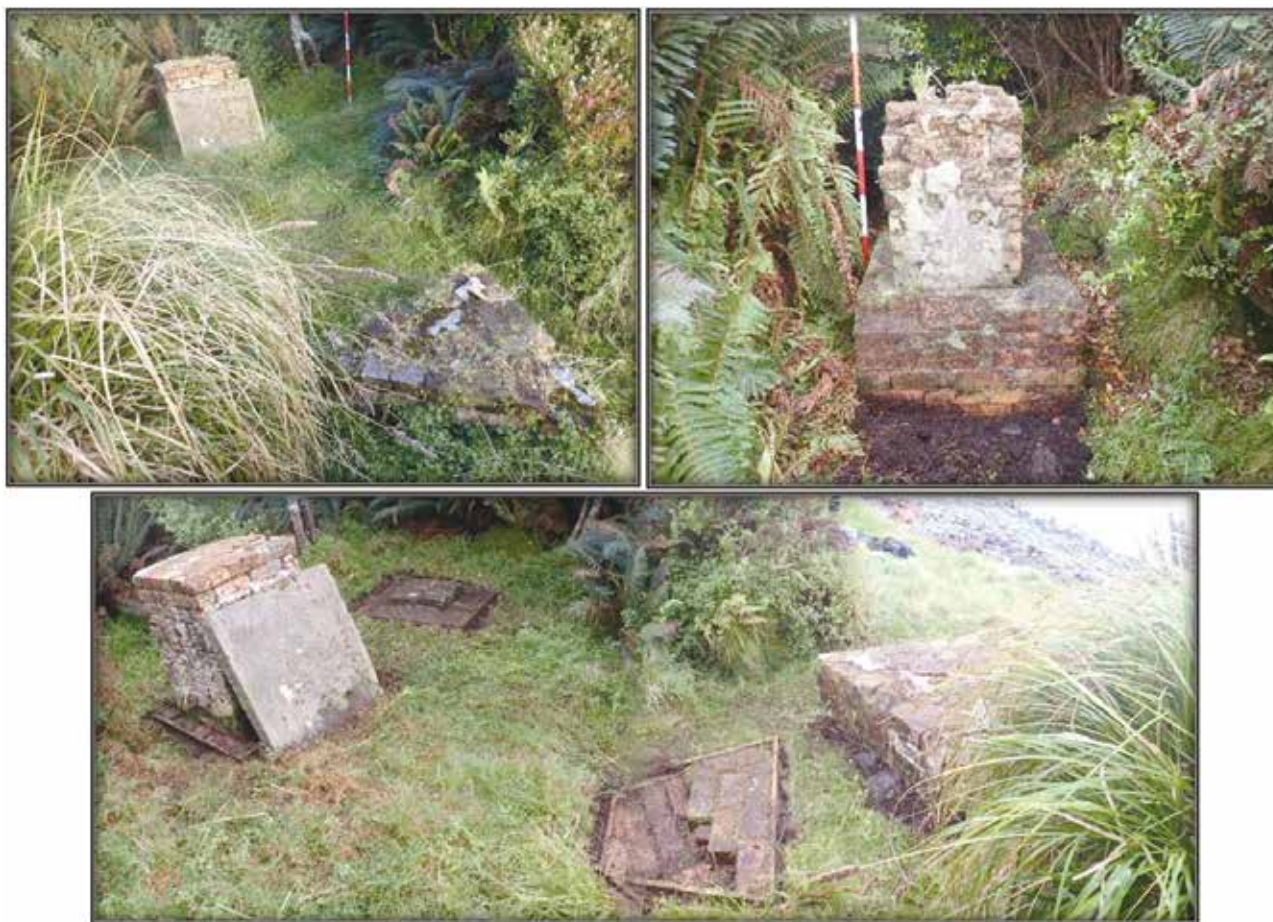
Figure 10. The German Transit of Venus Plinths before (top left) and after vegetation clearance (top right & bottom) (Photos: Matthew Schmidt)

The brickwork of the 1874-1875 German Transit of Venus site plinths and pedestals are sensitive to moisture and vegetation encroachment (NZAA Site No. AU/21). This site required vegetation immediate to these features to be removed but most importantly vegetation and peat build up removed from the plinths and pedestals themselves (Figure 10). One of the plinths was completely hidden by peat and moss build-up and was found through probing. Each brick feature was cleaned down using trowels and brushes and the wooden boxing placed around the structures by past DOC management work exposed and checked for integrity. It was this past boxing which saved three of the plinth bases from deteriorating completely. Interestingly, one of the plinths was not recorded during an archaeological survey in 2003 and must have been found after this visit by DOC Rangers who then conserved it.

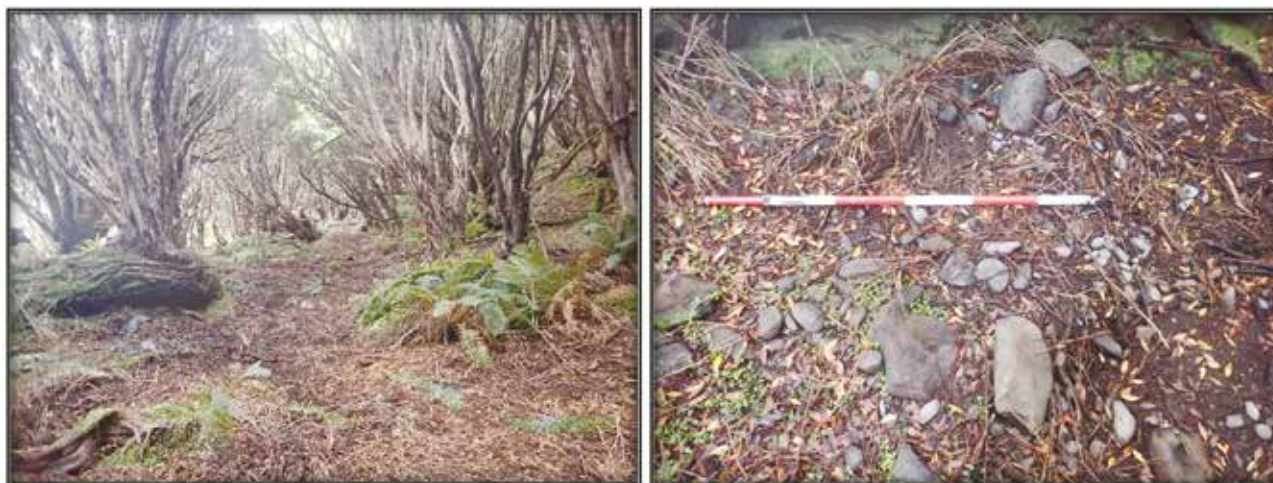
Figure 11. Hardwicke Road cleared of vegetation (left). Close view of exposed road cobbling (right) located below the Rata roots on the left of the left image (Photo: Matthew Schmidt)

Finally, sections of the original 1849-1852 Hardwicke road alignment were cleared so its path could be delineated more clearly as it travelled through the rata forest. This work would also help preserve any buried cobbling from further damage by vegetation growing through the stonework (Figure 11).

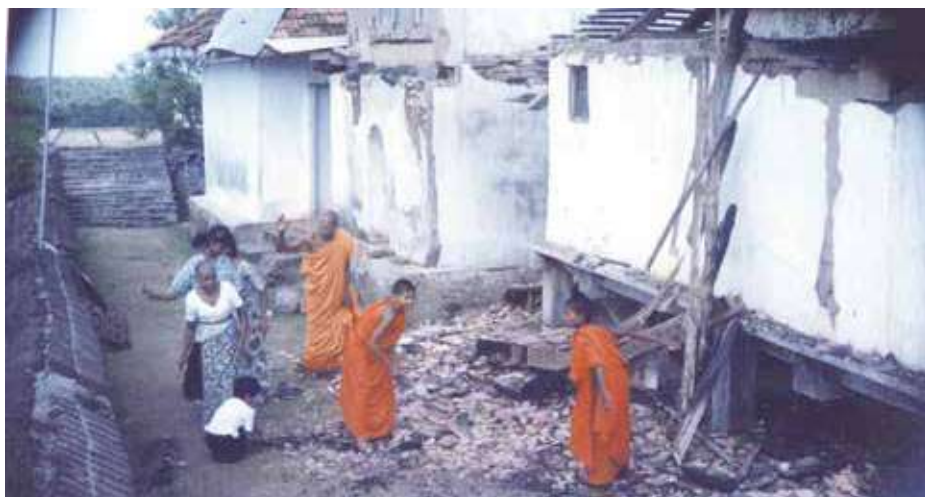
Figure 5. Damage

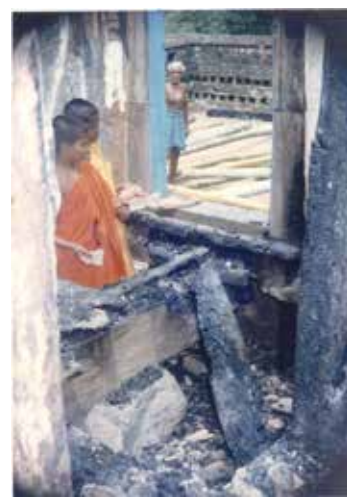
Figure 6. Floor totally burnt

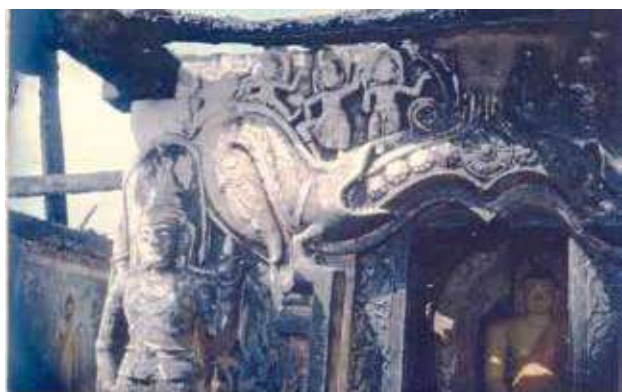
Figure 7. Damage to murals and paintings

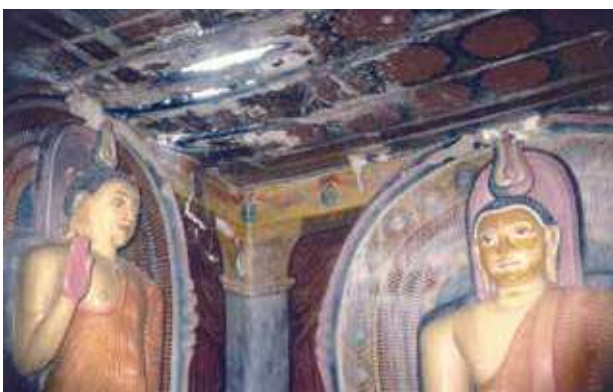
Figure 8. Damage to the decorated ceiling

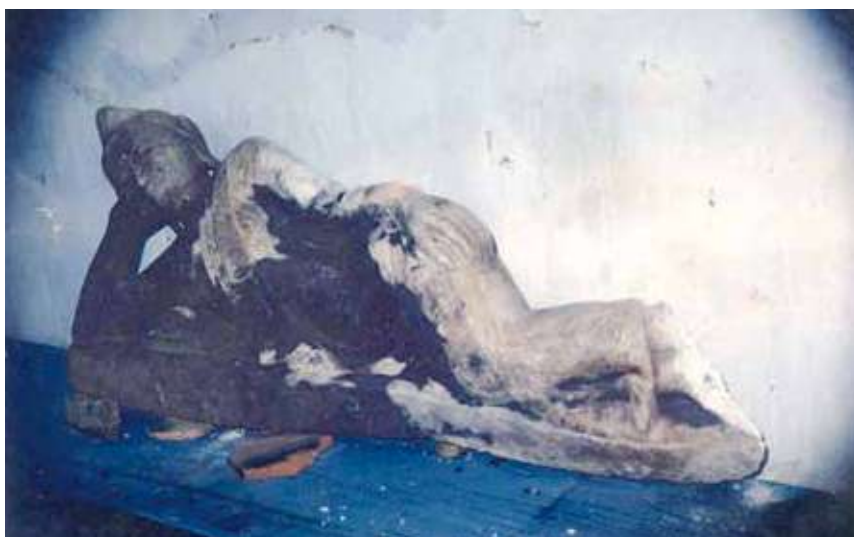
Figure 9. Damage to a statue

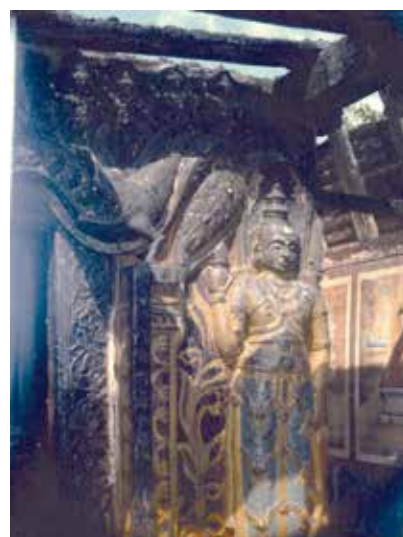
Figure 10. Damage to murals, paintings and statues

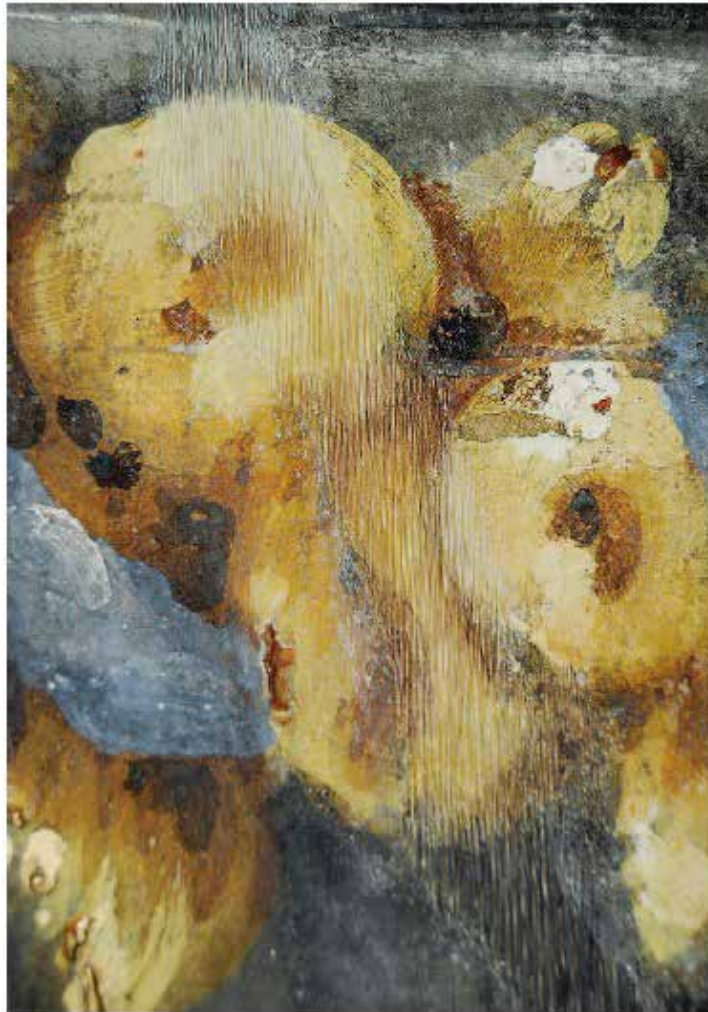
Fig. 2. One of the types of *tratteggio*. Short vertical colored lines for reintegration of an infill, wall painting by Dionis Vidal, Church of San Nicolas Obispo San Pedro Martir, Valencia (Spain) 1694-1700; Photo: 2014, UPV (EwaGlos. European Illustrated. p. 332)

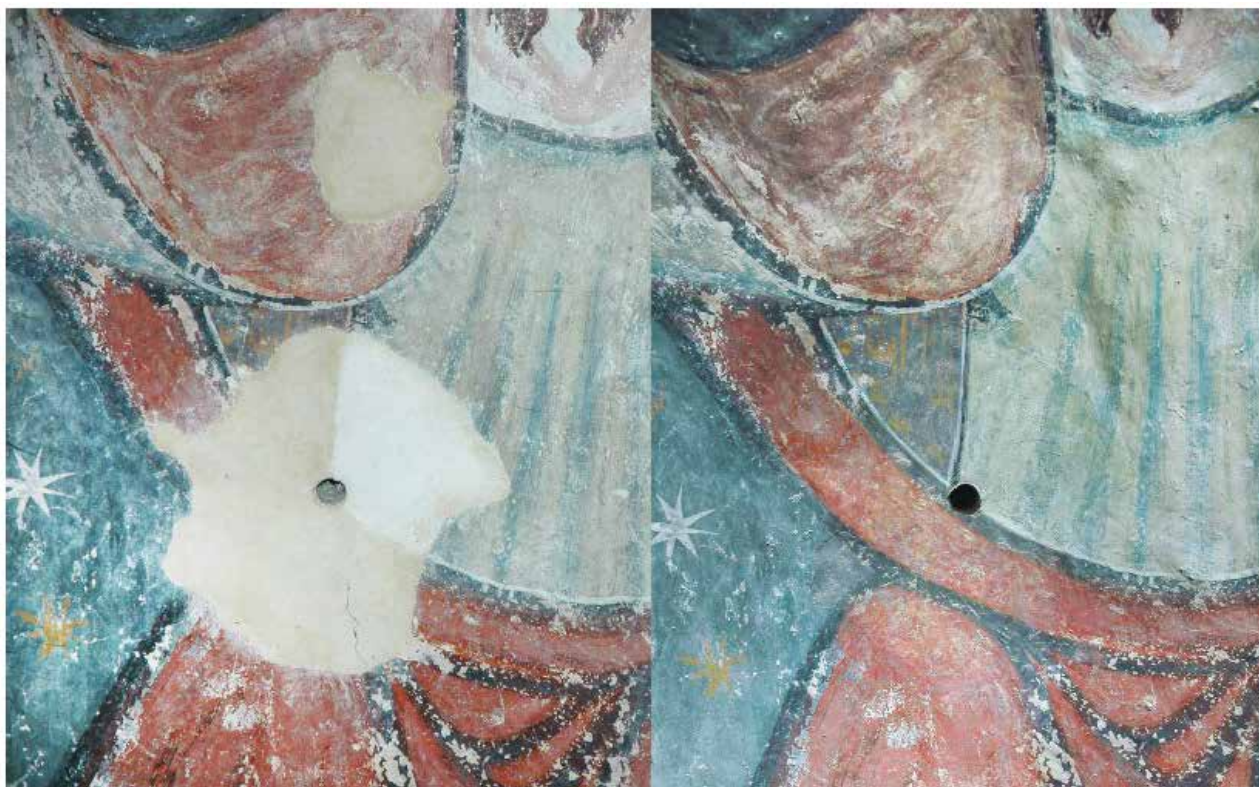
Fig. 5. Before and after mimetic reintegration filling. Church of St. Lawrence, Pozega (Croatia), XI c. Photo HRZ (Ivan Srsha, 2012. EwaGlos. European Illustrated. p. 338)
