Vol.30 2023

# The Thirtieth Regular Report

## ACCU Nara International Correspondent

The ACCU correspondents periodically send reports on cultural heritage protection activities in which they have been recently involved. This is a collection of thirteen reports submitted by international correspondents in the Asia-Pacific region.

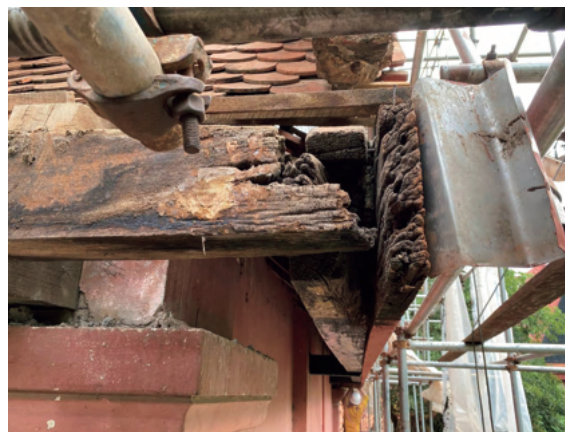
Figure 1-3: Damage to the timber structure inside and outside the roof

The second phase is the repair of the roof on the south gallery (Figure 1), where severe damage was observed after the first phase (the northern part), which we first restored in 2021. As observed, the condition of this damaged part is similar to the previous one, with cracks and decay on both large components such as beams

For the study of the condition of damage of these two parts, the observation indicated that there were similar problems. Rotting and mold were present on the components, such as the tie-beam common rafters, principal rafters, purlin collars, and girders. According to the experience of the first stage repairs, the mold problem does not cause damage to components, but is a sign that the roof is subject to high humidity, which causes termites and rotted timber. Furthermore, the weather could cause decomposition of the roof ornaments such as Neak Cheng, <sup>(1)</sup> Neak Dong Kda, <sup>(2)</sup> and Javea, <sup>(3)</sup> and hollow the wood paneling of the gable. The condition of the defects in the components is as follows:

**Main components:** those in the roof structure are the most damaged, some supporting components (tie-beams rafter and purlin) are very fragile and rotten, and we found that some of standing structure suffered dry rot, with some wet rot at the junction and on prop timber guttering. The cause for this portion is insect infestation and weathering, and moisture from flooding roof tiles (Figure 3), but these large components were not completely damaged. Small timber: almost completely rotten because it is next to the tiles, which are in direct contact with the rain.

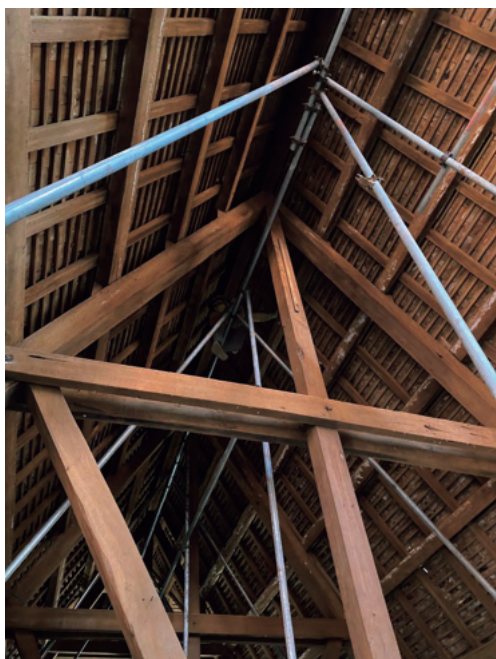
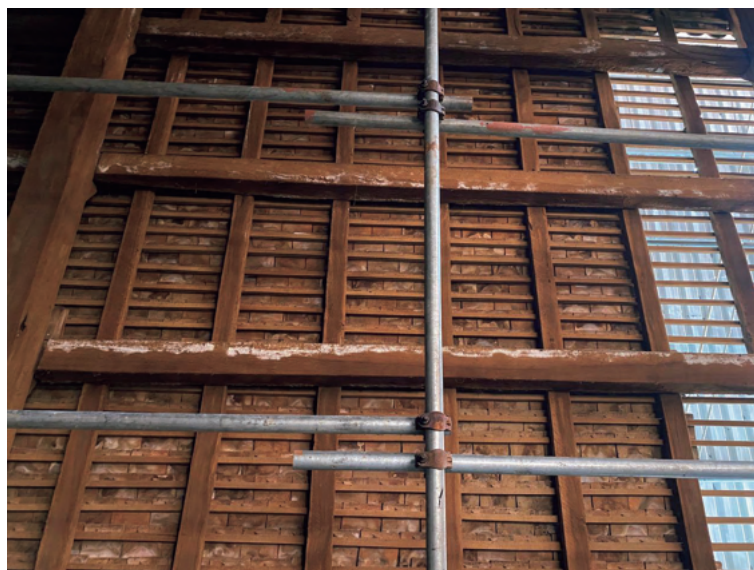
Figure 4(a,b): Mold on the timber of the roof

In this section, besides the decayed or rotten elements, most of the elements were damp and moldy (Figure 4a,b). Tiles are a major challenge that can cause damage issues. Slanted gutters generated holes and trickled on prop timber during rain and flooded into the gallery, also causing damage. One other type of damage is gable wood paneling shrinkage due to climate change that created small holes that splash water into the roof. Moreover, split covers of roof ornaments, namely Neak Cheng, <sup>(1)</sup> Neak Dong Kda, <sup>(2)</sup> Javea, <sup>(3)</sup> and Chong Cheng<sup>(4)</sup> are the cause of petrification of support wooden poles (Figure 5a,b).

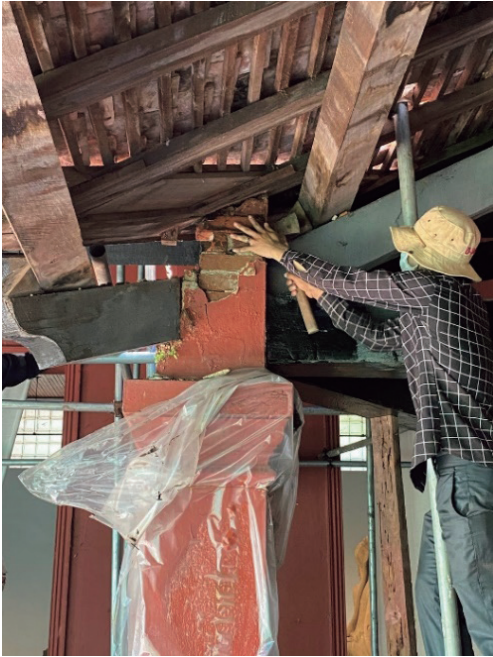
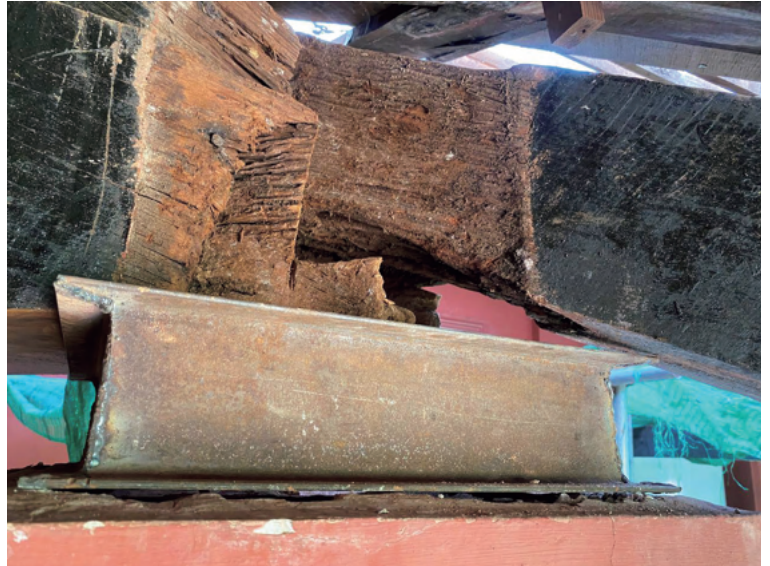
Figure 5(a,b): Dismantle the bricks of the column to remove rot of the timber and reinforce at the junction of components

**Dismantling the damaged area:** Start dismantling the damaged area to check the actual damage situation, make notes and take photos of the condition of damage before starting restoration work to keep as a document for reporting after completion of the restoration project. For disassembly to repair, be very patient and pay attention to each part, especially roof repair components, to ensure that this disassembly does not add further damage. This precaution is necessary to preserve timber as much as possible. All these components of the roof structure need to be reused to avoid complete replacement (Figure 5). On the other hand, these are the repair and dismantling steps to follow:

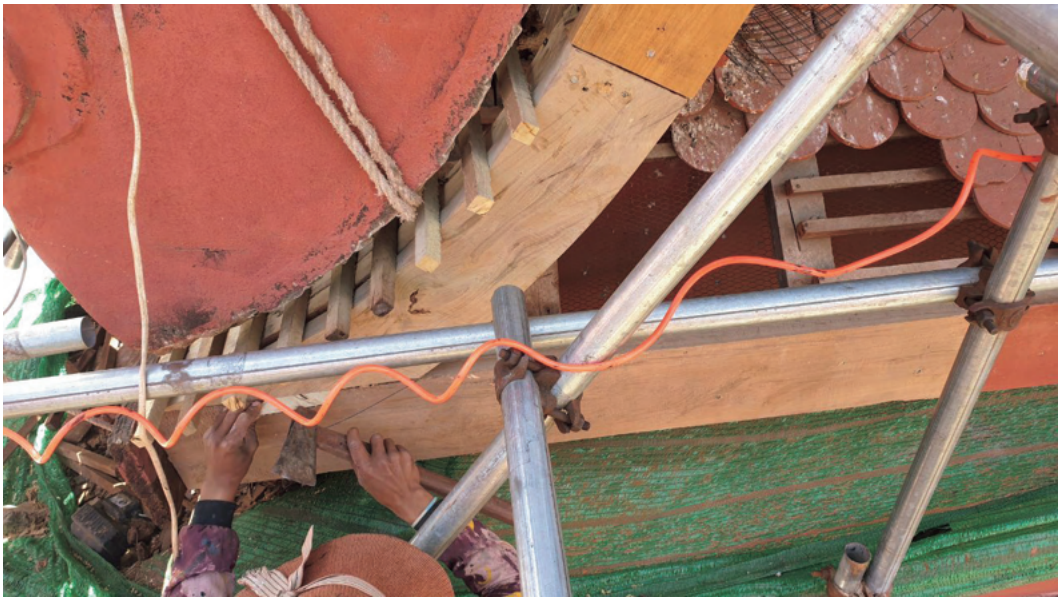
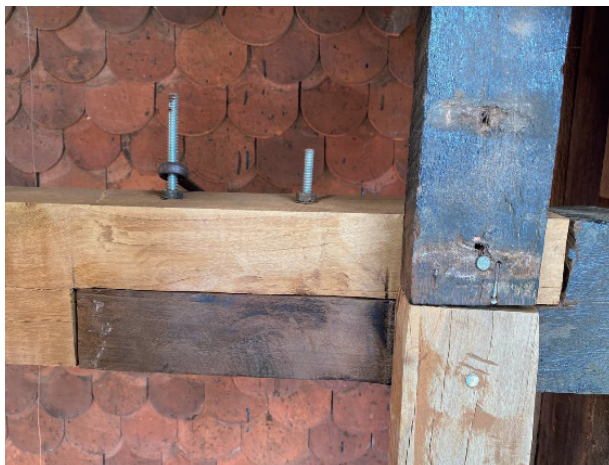
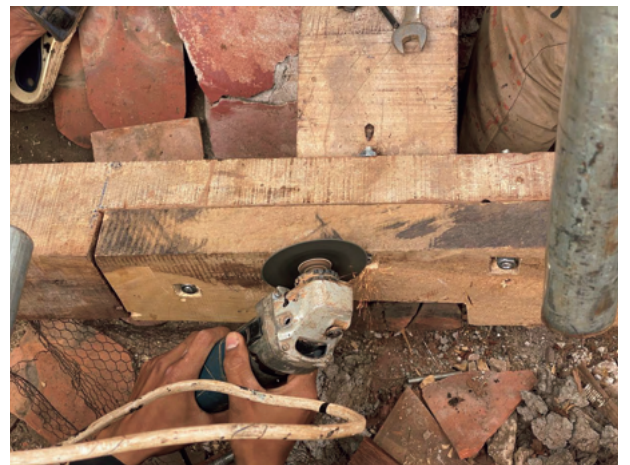
Figure 6(a,b,c): Replacing parts and linking between new and old timber structure

- Repair, clean, and repaint decorative gables and fill the shrinking of the pediment with wooden plate and Nagas-finials. The decorative gables of the pediment comprise two parts, wooden structure and cover mortar which is print as an ornament. But structures of decorative gabled are decay need to be removed and replaced by new timber (Figure 6a,b,c).

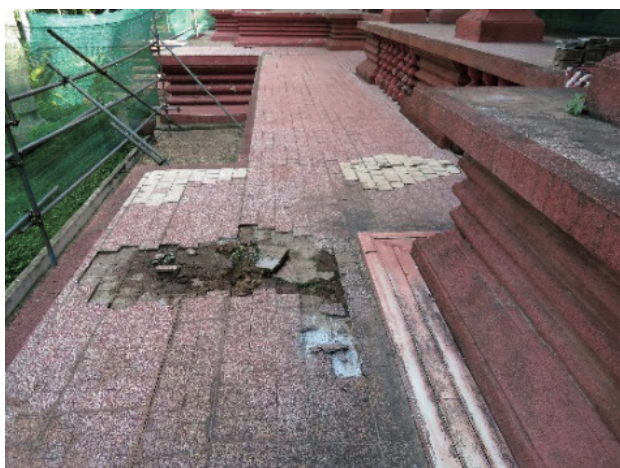
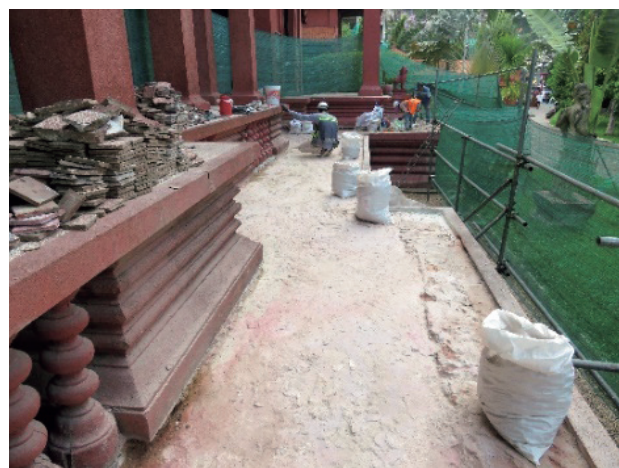
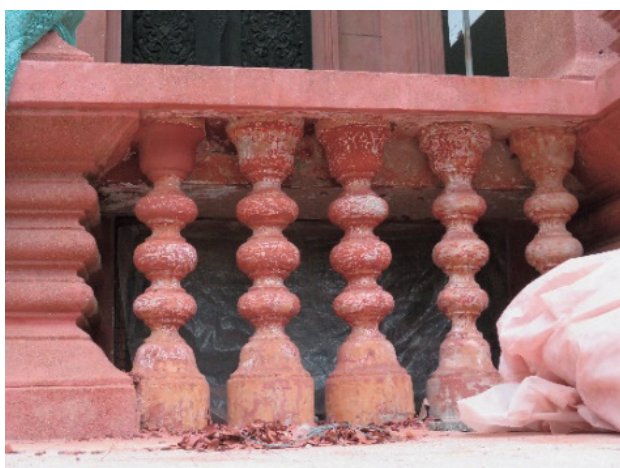
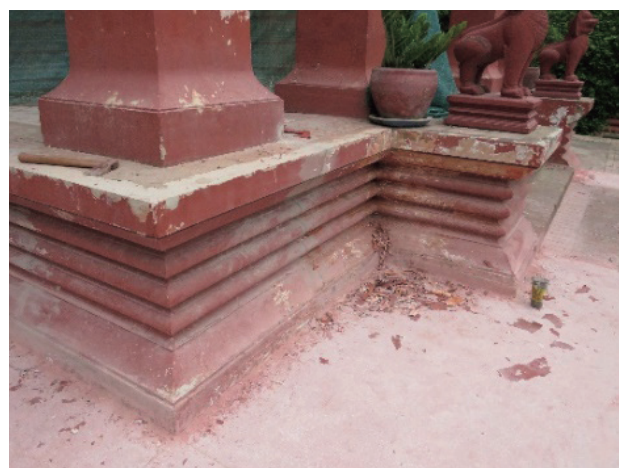
Figure 8(a,b,c,d): The damaged front porch and some of the renovation work

Aside from the roof restoration project, we also repaired the front corridor to prevent water leaking into the basement. Due to climate change and the heat and humidity, the old floor tile burst out through the concrete layer. Currently, the infiltration of water from the front porch into the warehouse is increasing, which is worrying

in that there will be a negative impact on all items stored in the warehouse. This problem has severely affected the building as well as the collections in the building, which needs to be repaired urgently to control the damage caused by the rain dripping inside. This renovation section was started only in the front porch of the museum building from the entrance of the office to the entrance of the library (Figure 7).

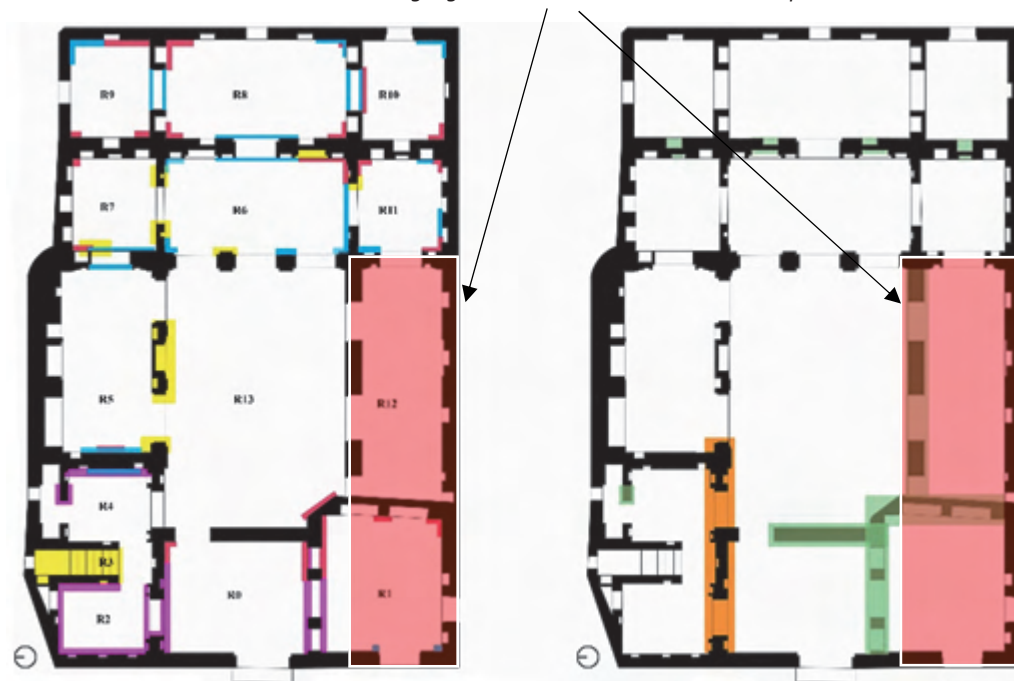
CONDITION ASSESSMENT & POPOSED DEMOLITION  
(Prop No 4/11, Ambica Lane Old Rajpur, Dehradun)

The red highlighted area indicates the basement portion

| <span style="color: red;">■</span> Major Cracking and detachment due to ground settlement | <span style="color: orange;">■</span> to be demolished on First Floor |
| <span style="color: blue;">■</span> Structural Cracks requiring immediate repairs to prevent further damage | <span style="color: green;">■</span> to be demolished on Ground Floor |
| <span style="color: yellow;">■</span> Will require Reconstruction and Repairs | |

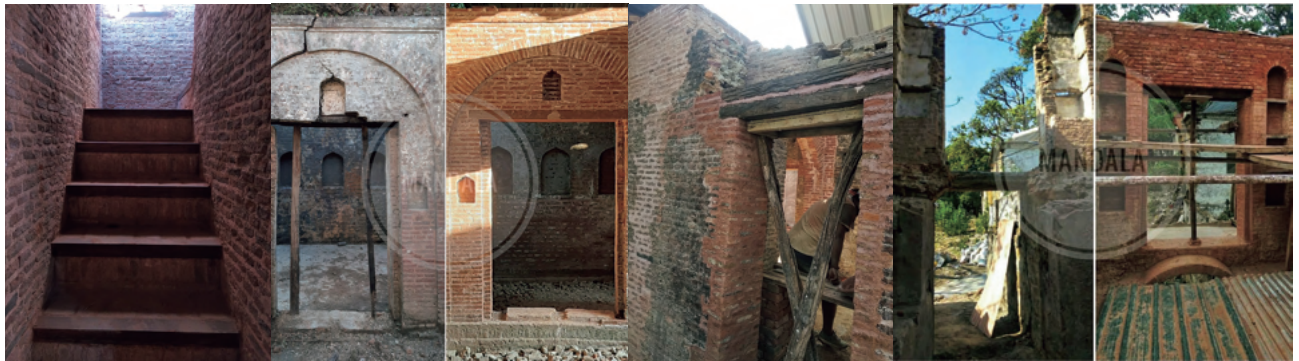
Fig. 7 a, b, c & d. Images of the structure while architectural restoration was undertaken and was in process.  
Source: Studio MANDALA, Artefacts and Habitats Sustainable Solutions

The other major task was to add substantial support to one of the major exterior long walls as it spanned around 12 metres along the edge of the hillock without any external buttress supports and showed settlement damage at multiple points with critical diagonal and vertical cracking as well as bulging. This particular side was kept constantly supported for almost two years with scaffolding all along the exterior side while the repairs progressed on the inner side (Fig. 8c).

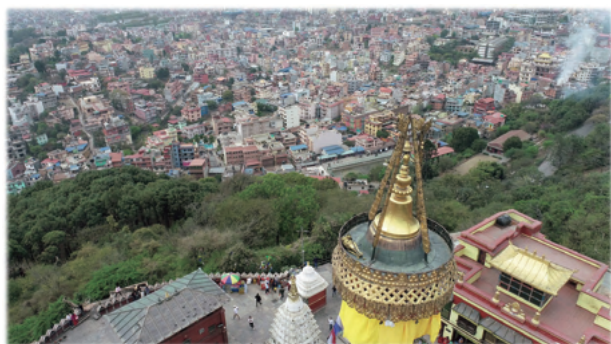
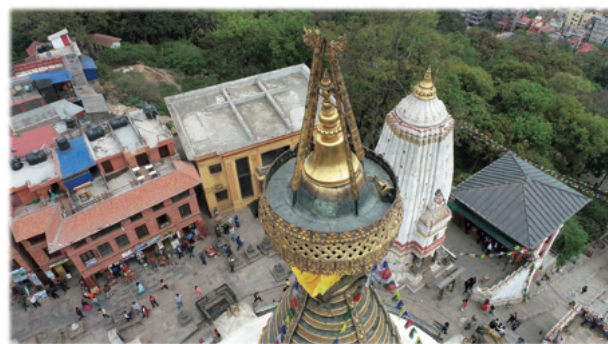
Broken *gajur* lying on the base floor. Drone images.

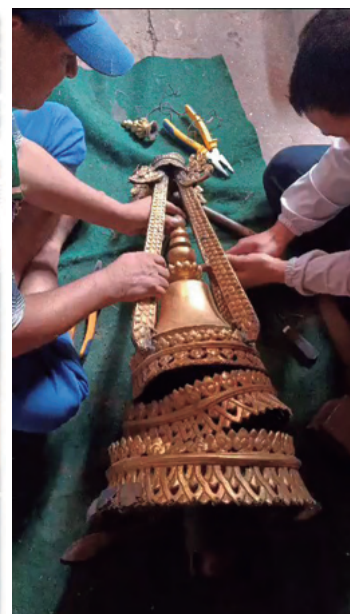
The gajur under repair. Source: FSMC

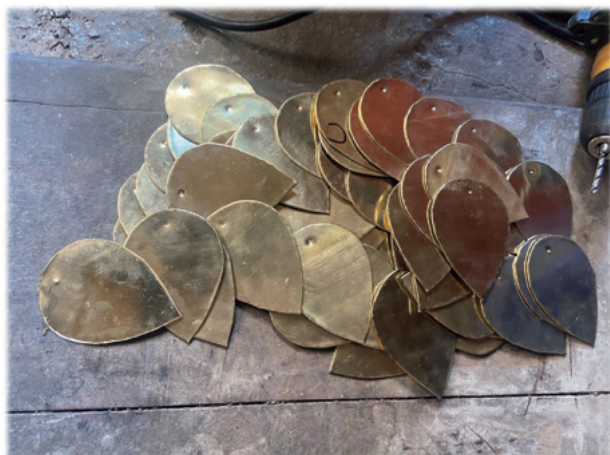
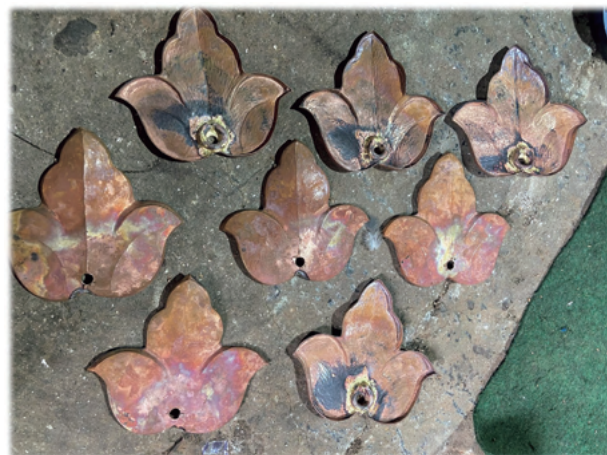
Replacement for missing parts. Source: FSMC

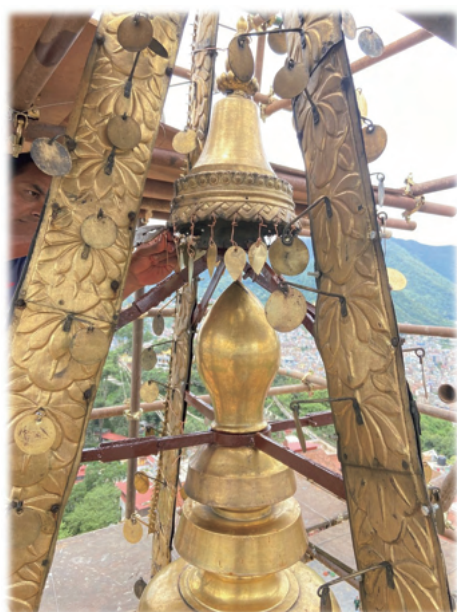
Reinstallation of missing parts.  
Source: FSMC

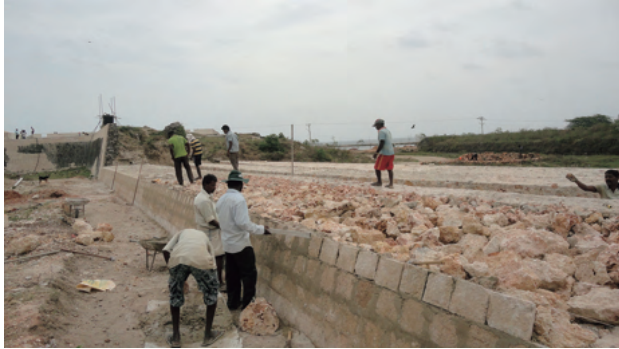
Fig. 12. Damaged rampart between Friesland Bastion and Utrecht Bastion; conservation progress

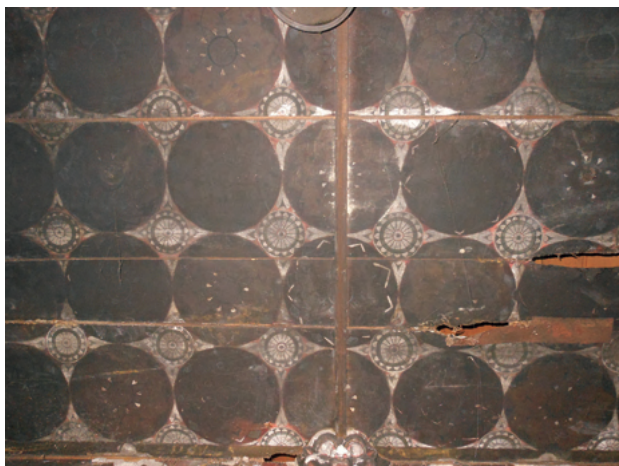
Fig.15. Wooden ceiling before chemical cleaning

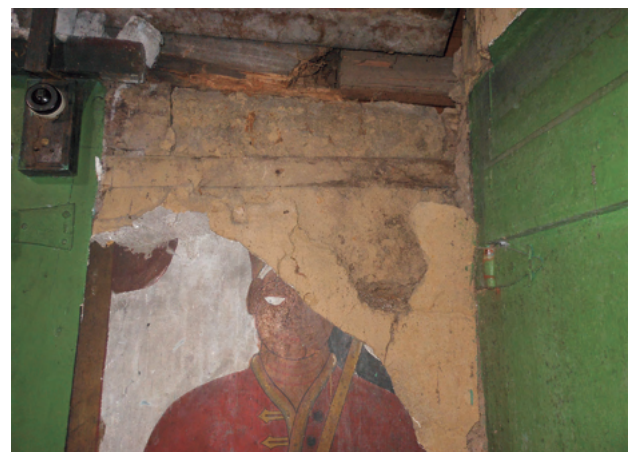
Fig.16. Deep lacunae in the support (wall no. A)

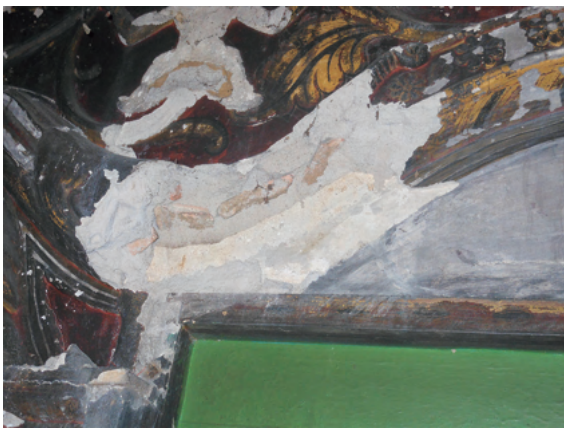
Fig.17. Rendering plaster had broken off from the Dragon Arch (*Makara Torana*) - (wall no. A2)

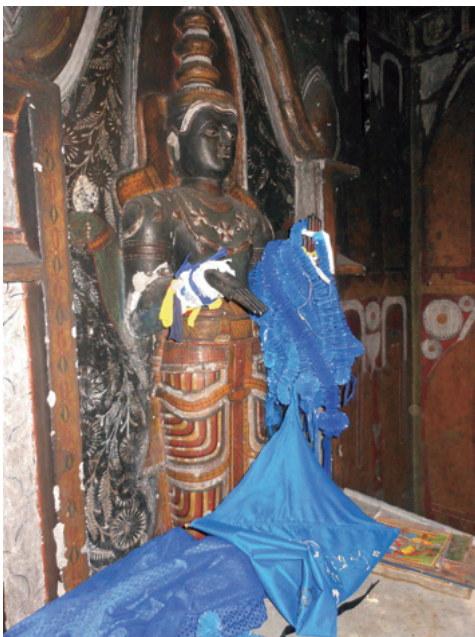
Fig.19. Human abrasions

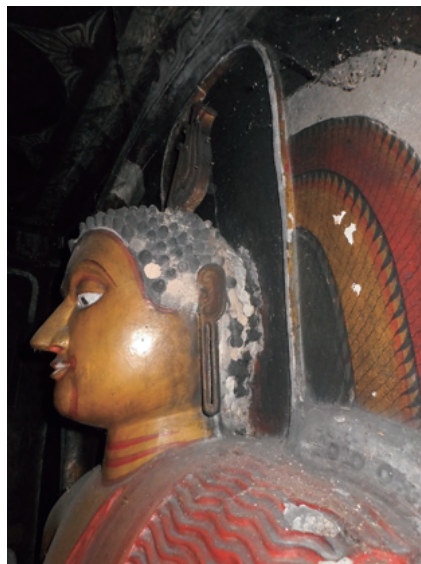
Fig.18. Before consolidation

The initial step in the conservation process involved the preparation of plaster. In this phase, the plaster structure of the walls of the image house was observed with the naked eye, and the raw materials used in the construction of the walls were identified. Accordingly, the clay obtained from ant hills, sand, lime, and small gravel were identified. The same materials were used in the preparation of the plaster for conservation. The strength of the plaster structure prepared was kept at a lower level than the original plaster. Two different types of plasters were made—rough plaster and soft plaster. The rough plaster was made of a mixture of clay and sand without grinding to fine powder at the ratio of 3 sand : 2 clay, with lime water as the bonding medium. The soft plaster sand and clay finely ground and sieved was mixed with lime water at the ratio of 2 fine sand : 1 fine lime, and water. The layer bearing colours was prepared at the ratio of 2 fine sand : 1 fine lime, and water. These types of plasters were prepared in the necessary quantities and kept in air-tight polythene bags for approximately four days to season, before use. To use for consolidation of the cracks in the walls, the soft plaster had to be made in liquid form (grout).

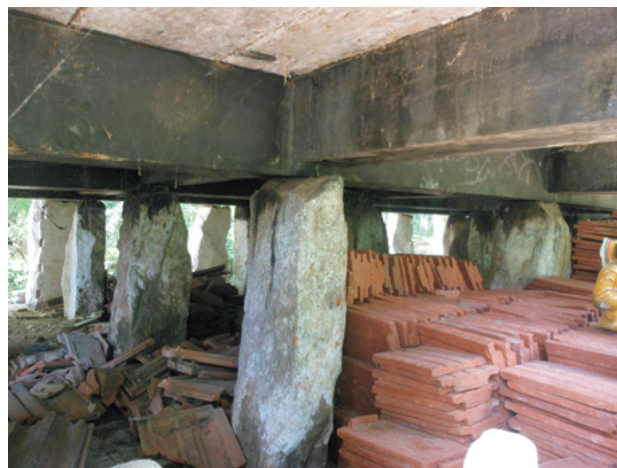
Fig.20. Before cleaning - stone pillars and wooden beams - under the base of the image house

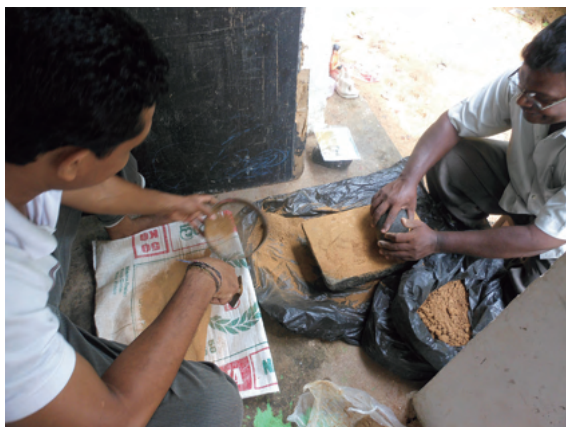
Fig.21. Preparation of clay plaster
