# The Seventh Regular Report

## ACCU Nara International Correspondent

The ACCU correspondents periodically send reports on cultural heritage protection activities in which they have been recently involved. This is a collection of thirteen reports submitted by international correspondents in the Asia-Pacific region.

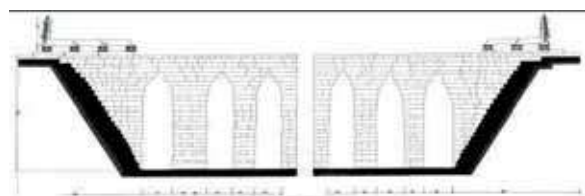
Figure 2: Plan in 2009

The bridge was built of 98% laterite stone and 2% sandstone. The average dimensions of each block for the construction are 50 centimeters in width, 150 to 170 meters in length and 40 centimeters in thickness. The sizes of the bridge are 85 meters in length, 16 meters in width and 10 meters in high. The bridge's body is standing on 20 pillars and 21 corbelled arches. There are four wing walls (four retaining walls) used as stabilizer for the bridge and its foundation (figures 2 and 3).

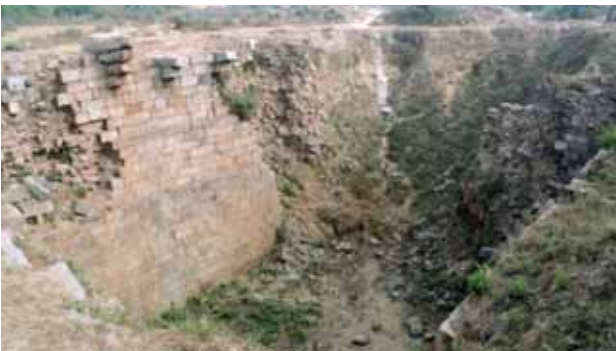
Stepped well (Baoli) in damaged condition

The archaeological excavations were carried out in the habitational area to expose the buried structures. Few house complexes such as granary, path-ways and a bazaar (market) street were exposed and preserved at the site. Interestingly, successive lime floors were also encountered during the excavation and they were also preserved. All the structures were cleared and documented properly then conserved carefully. A damaged step well was also taken up for the conservation. The walls of the step well were fallen and damaged and its steps were buried under debris. Scientific excavation work was undertaken by the archaeologists and all fallen stones were collected and reused in the conservation. Its steps were restored as per the original and walls of the well were strengthened by the pointing.

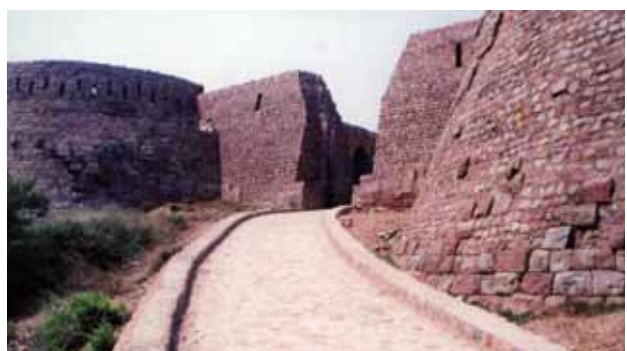
Entrance, after conservation

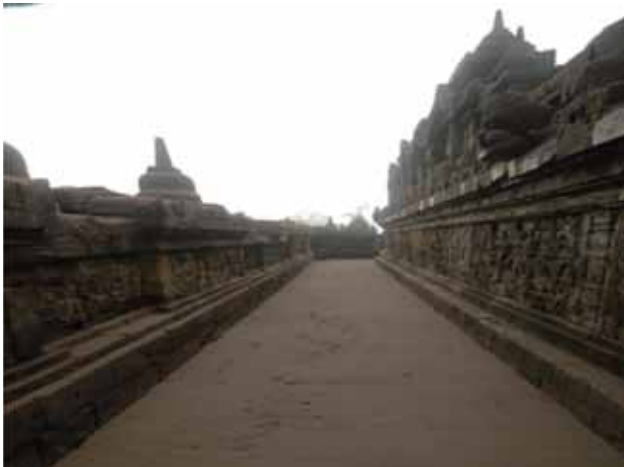
Photo 4. The floor covered with volcanic ash

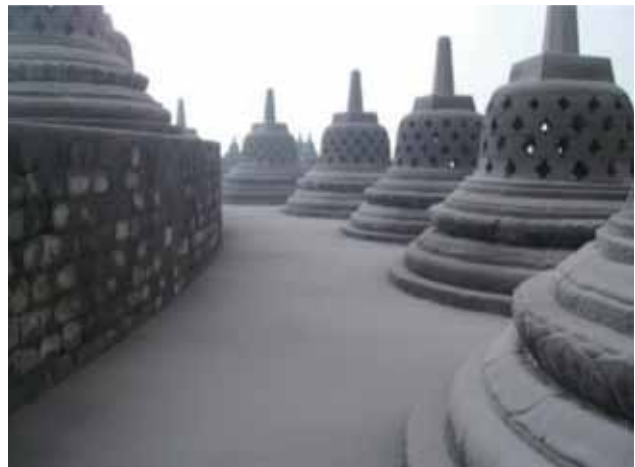
Photo 5. Stupas and gaps in walls covered with volcanic ash

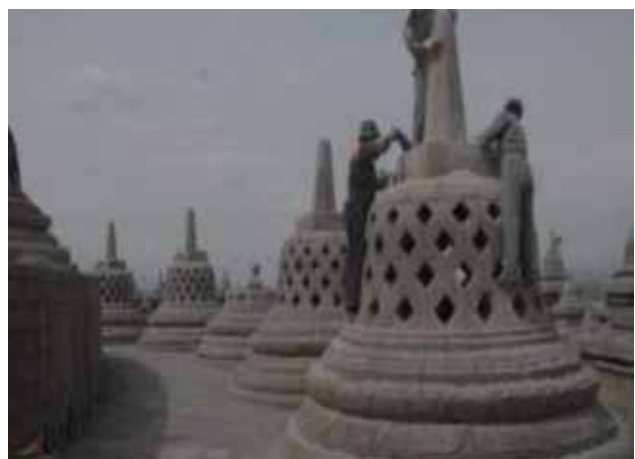
Photo 7. Dry cleaning on stupas

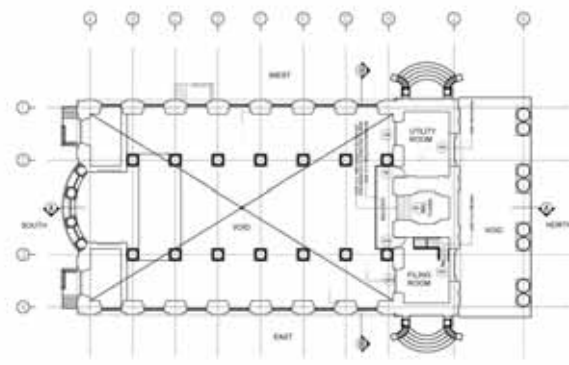
The upper floor plan showing the utility room, filing room and balcony

The St. George's Church was built with clay brick, stone, lime plaster, timber, marble and terrazzo. It has decorative elements on walls including lime plaster swag, rose and garland motifs on the upper parts of the walls and portico. Praying hall (nave), aisles, altar, vestry, instrument room, switch room and children's rest room are found at ground floor. Utility room, filing room and balcony are located at the upper floor. Apart

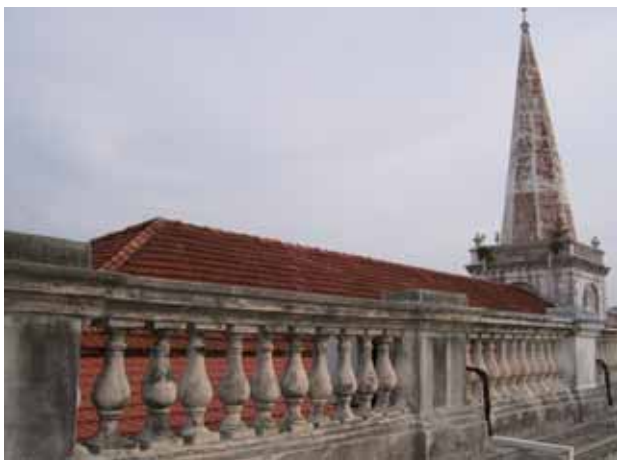
The condition of the pitched roof, balustrades, bell tower and spire before restoration

The St. George's Church was originally built with flat terraced roofs including its portico. Due to roof leakages in the building, in 1864 a pitched roof was constructed above the nave leaving the portico, apse and aisles with flat terraced roofs. Indian V-shaped tiles were then used for the pitched roof before they were replaced with Marseilles tiles in 1907. After the WWII, all flat terraced roofs, particularly above the apse, aisles and portico were

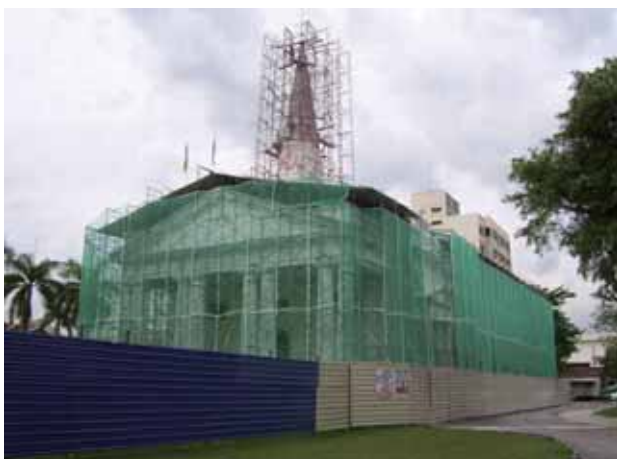
Throughout the restoration work, temporary roofing was installed above the existing pitched roof to ensure that the roof structures were protected from severe rainfalls

Throughout the restoration work, temporary roofing was installed above the existing pitched roof. This was to ensure that the roof structures were well protected from severe rainfalls, particularly when Marseilles tiles were removed and brought down to the ground. Once at the ground level, each tile was inspected, cleaned and salvaged. The cleaning process involved both dry and wet cleaning techniques. In the dry cleaning process, all dirt and dust found on the Marseilles tiles were carefully removed using soft brush and scrapping tools. Any damaged roof tiles were discarded and replaced with new or salvaged tiles of similar profile, size and material. After the dry cleaning, the roof tiles were soaked in clean water for wet cleaning. All cleaned tiles were then carefully stacked on wooden planks to dry before applying chemical sealer for anti fungus.

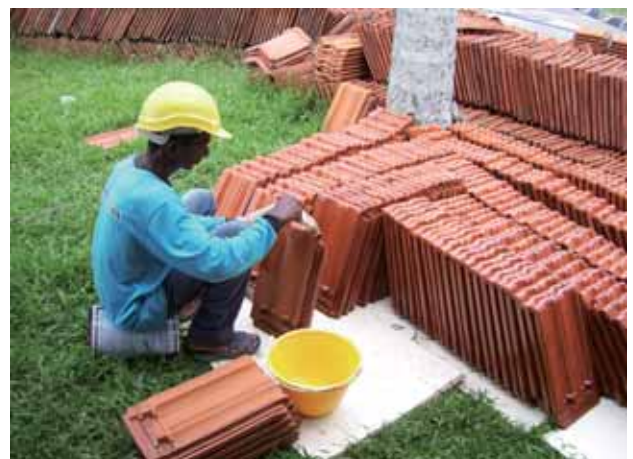
The existing Marseilles tiles were brought down to the ground where each tile was inspected, cleaned and salvaged. The cleaning process involved both dry and wet cleaning techniques

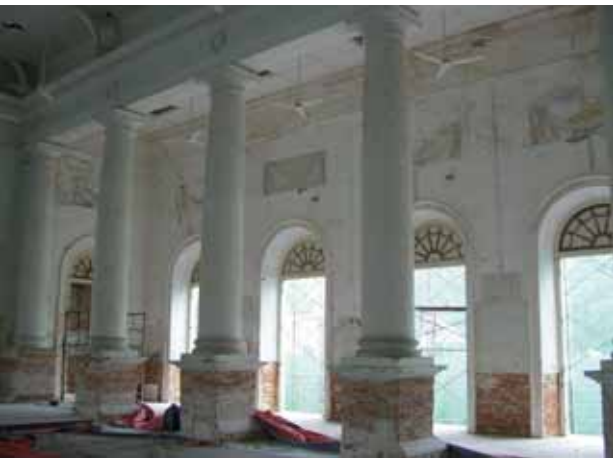
Crumbled lime plaster had to be removed from the lower part of the walls and at the base of the columns which were infected with salt attack and rising damp

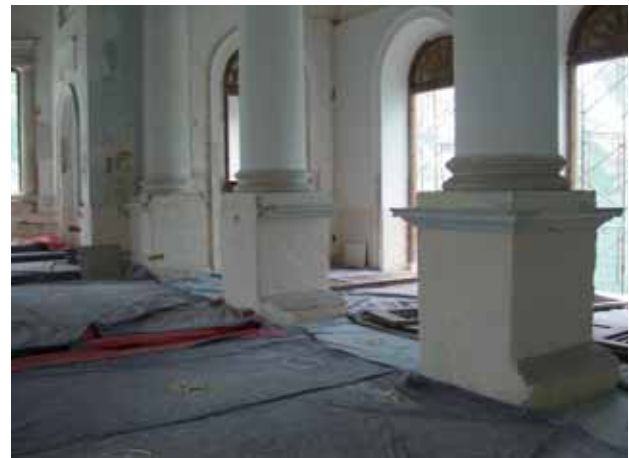
Salt attack was treated through the salt desalination process using a poultice technique called Cocoon before carrying out the injection of a chemical damp-proof course

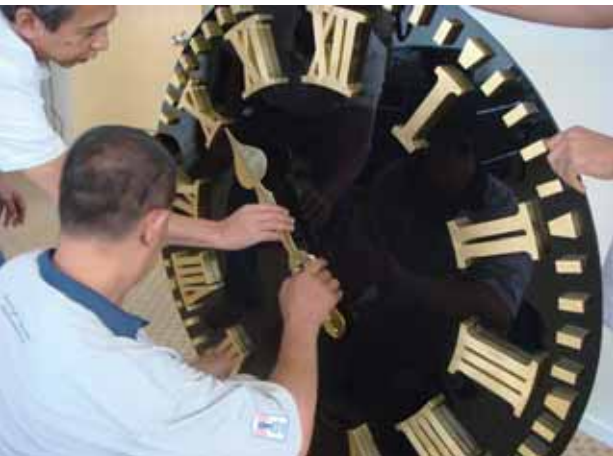
The new clock consists of aluminum minute markers, stainless steel Roman numerals; and stainless steel hour and minute hands which were all gilded with 23.5-carat gold leaf

The restoration works also involved the installation of new clock at the spire. Based on evidence from old paintings and photographs, a working replica of 1.27-meter clock was fixed onto the north side of the spire. With the exception of its clock motor which was imported from Switzerland, the clock was locally made using aluminum plate powder coated to black colour on both sides and polished on the front side. The aluminum minute markers, stainless steel Roman numerals (15.5 cm); and stainless steel hour (53.5 cm) and minute hands (74.8 cm) were all gilded with 23.5-carat gold leaf. This electrical master-slave clock is controlled by the Global Positioning System (GPS) with the accuracy of one millisecond or equivalent to gain or lose one second in 1,000 years. The church bell is controlled by the clock system. The clock has given a new image to the church since it was last removed from the spire after the WWII.

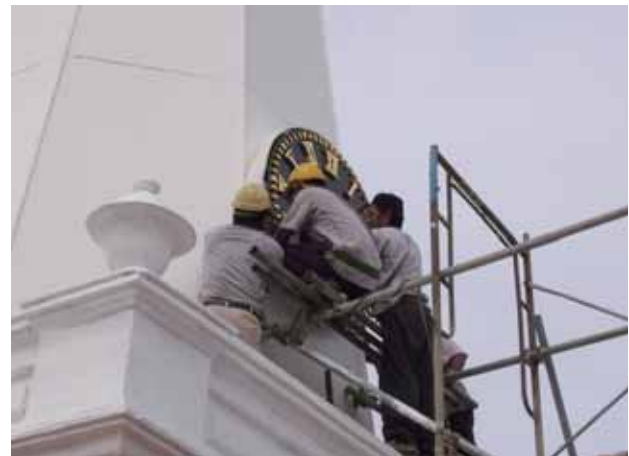
A working replica of 1.27-meter clock was fixed onto the north side of the spire

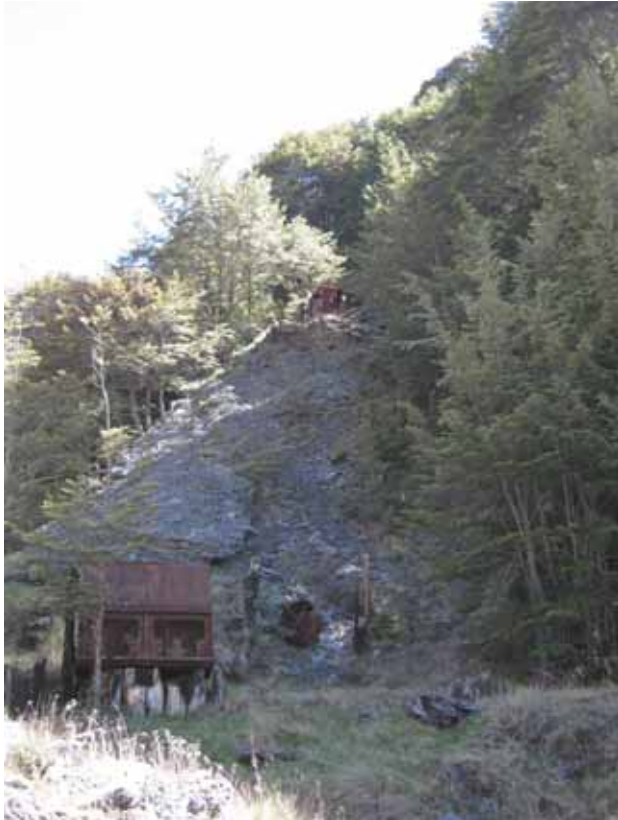
Figure 11. The Phoenix (Achilles) Battery site. Compare with Figure 4. The rock crusher is the top of the photograph and the remains of the battery house in the foreground (Photo; Matthew Schmidt).

The mining heritage which survives is wide-spread and consists of the remnants of the hydroelectric operation, open mines with rail lines intact, stonework/timberwork for mining structures, the foundations of battery sites with their stampers, timber and mortar boxes present, various water power generation equipment such as pelton wheels and Whitelaw turbines, cableway remains, a rock crusher, rock drills etc (Figures 11 to 17). Other evidence

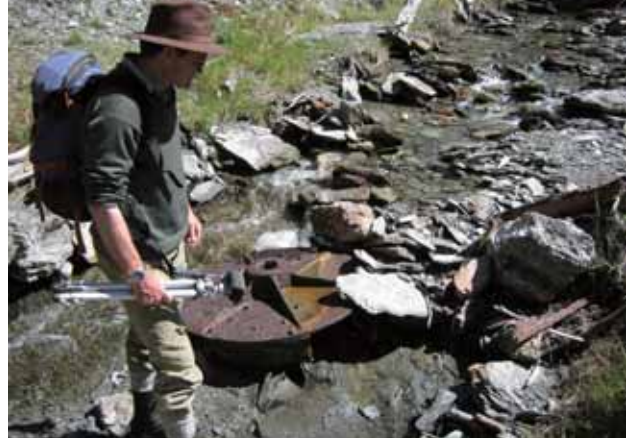
Figure 12. Archaeologist Peter Petchey standing next to part of a Whitelaw Turbine (Photo: Matthew Schmidt).

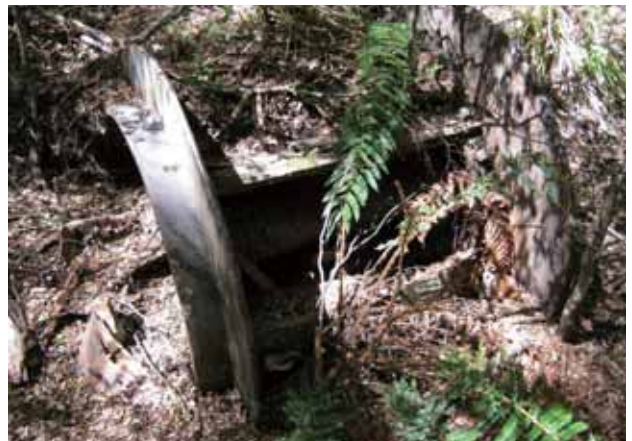
Figure 16. Cableway winding drum(?) with drum timbers intact (Photo: Matthew Schmidt).

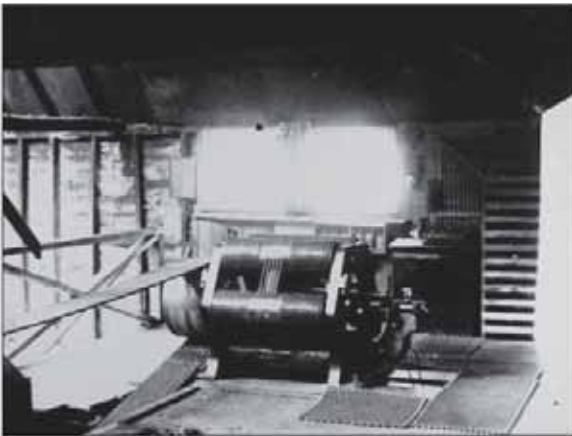
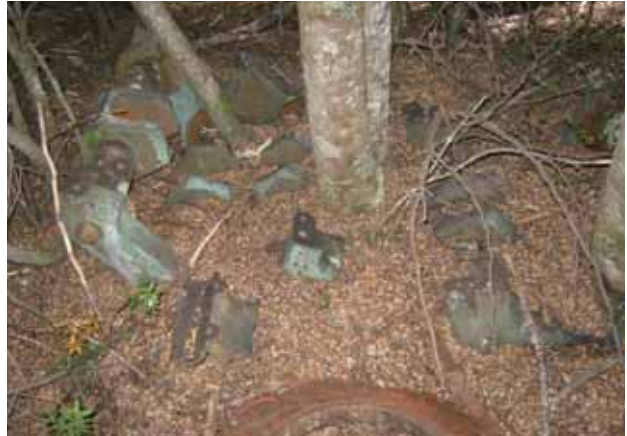
Figure 20. The Anglo-American Brush Corporation Electric Motor at Bullendale. Top: as one of the electric motors looked in 1886 (Source: Petchey 2006:15 & Lakes District Museum, Arrowtown); Bottom: the dismantled motor at the New Main Shaft. The parts are in good condition. Note the native Beech trees which have grown through gaps in the discarded motor parts (Photo: Matthew Schmidt).

As noted above, it is because of the inaccessibility of Bullendale that the key components of the original hydroelectric power system have survived in-situ, these being the two original Anglo-American Brush Corporation Arc Dynamos and an Anglo-American Brush Corporation Electric Motor.

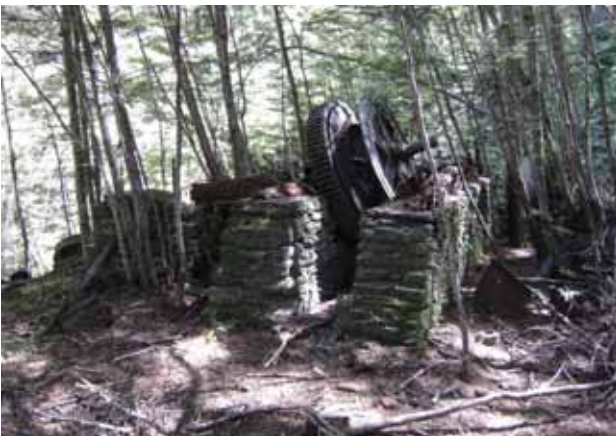
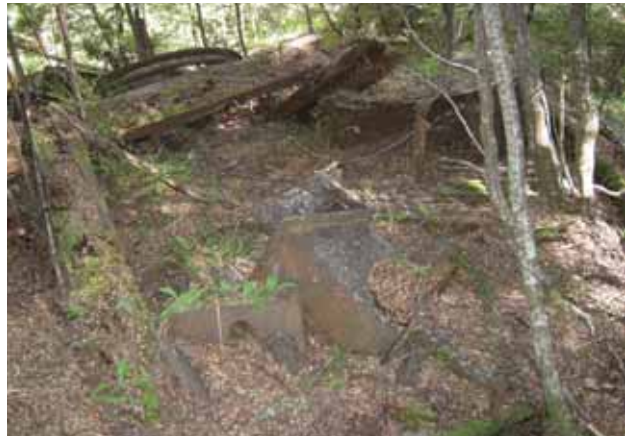
Figure 21. The winding gear structure at the New Main Shaft. Gearing has slipped off the rotten support timbers and onto the structural stonework causing the stonework to bow.

At the Dynamo site, the dynamos, flywheels and pelton wheels are currently exposed to the natural elements and the timbers from the 1986 reconstruction are now rotten. The rotten timbers will be replaced and to further protect the hydroelectric scheme and increase the longevity of the new timbers, a protective building or shelter may be required to be constructed over the power scheme remains. Originally a building did cover the dynamos, flywheels and pelton wheels etc. as shown in Figures 18 & 19, and so a new building or shelter will not be out of place for the site. The new building/shelter, however, may not be as large as the original building so as not to intrude on the isolated and abandoned ambience of the site. These heritage works will be guided by a Conservation and Works Specification Plan.

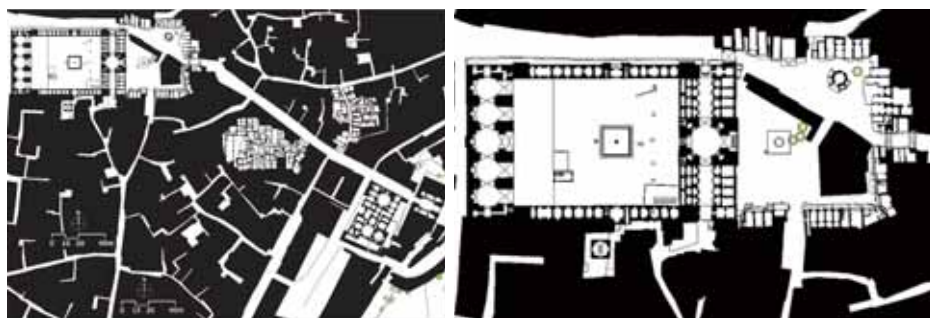
Fig. 4 Left: Plan shows the locations of major thoroughfares and monuments on the Shahi Guzargah.  
Fig. 5 Right: Plan of the entire mosque complex with Chowk.

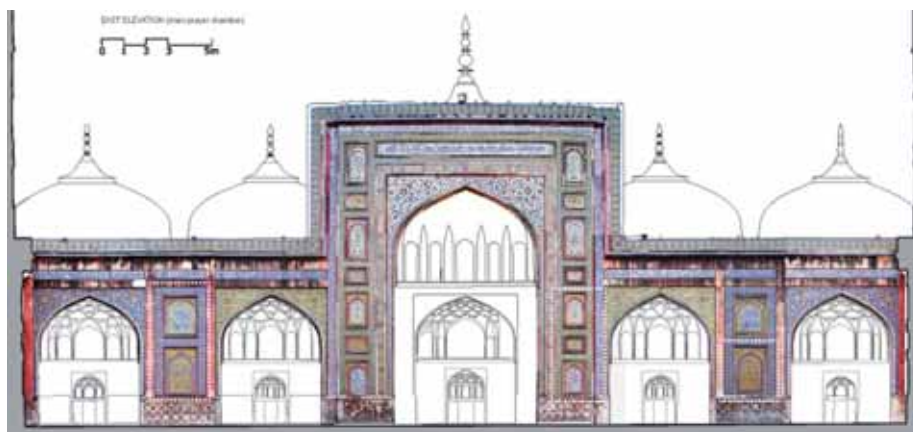
Fig. 6: A photo-mosaic of the eastern elevation of the main prayer chamber. This image is produced with the help of image rectification and is plotted to scale.

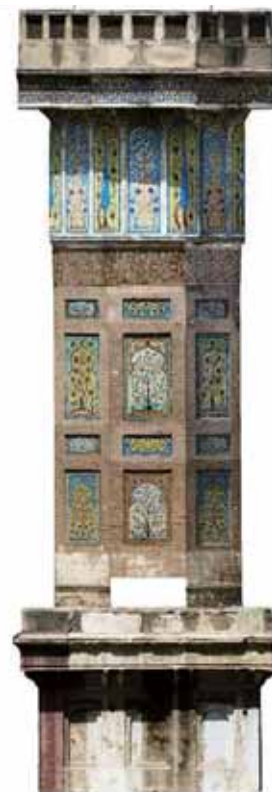
Fig. 7: The southern face of the southeastern minar shows the detail of kashikari and exposed brick work. Detailed investigations show the major damages to the kashikari towards the north side.

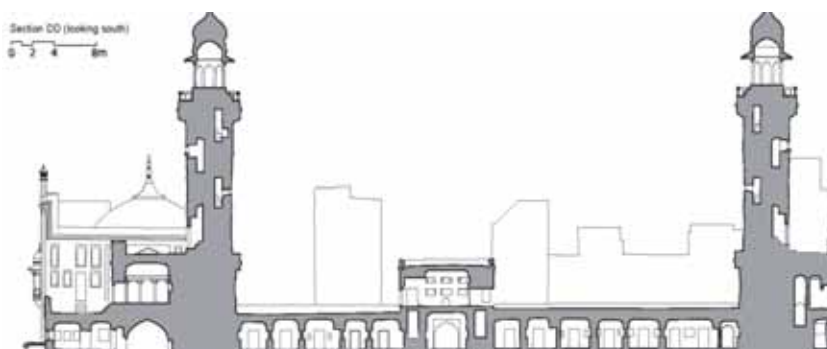
Fig. 12: Longitudinal section of the mosque through the northern most section of minars, hujras, shops at level 0 and main prayer chamber

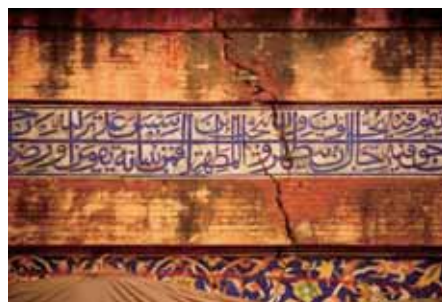
Fig.14: Major crack in the wall above the northernmost archway of the main prayer chamber facing

A programme for the conservation of the mosque is being evolved and will be implemented over several stages. In the first stage structural and architectural investigations have been carried out. Geotechnical investigations of the foundation structure and a detailed electronic documentation of the building have been carried out and are being used to analyze the damage and to assess the quantum of structural interventions and conservation measures. The structural damage that has occurred will be rectified by repair and stitching together of the

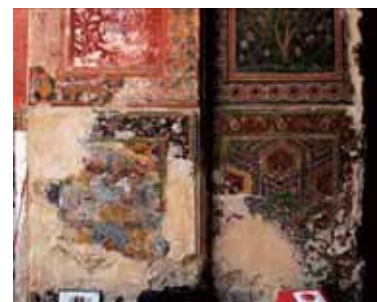
Fig.15: Rising damp in the main prayer chamber has damaged the fresco paint.

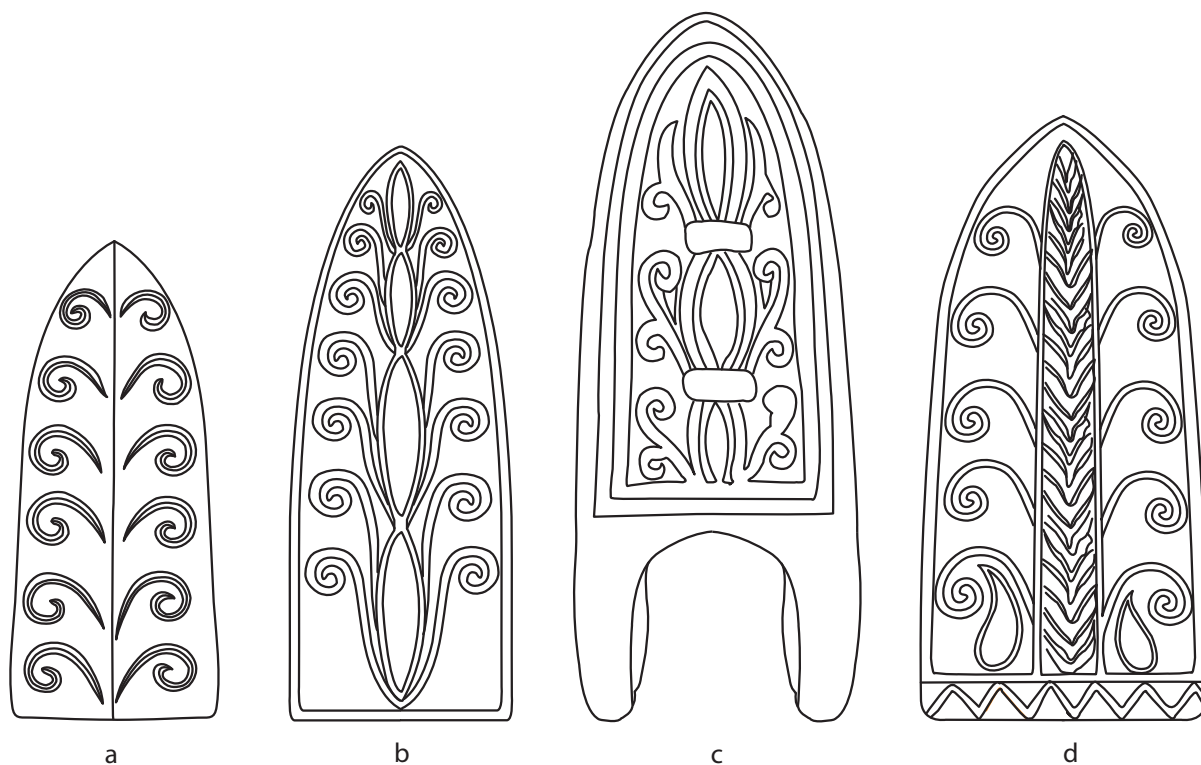
Reconstruction of antefixes

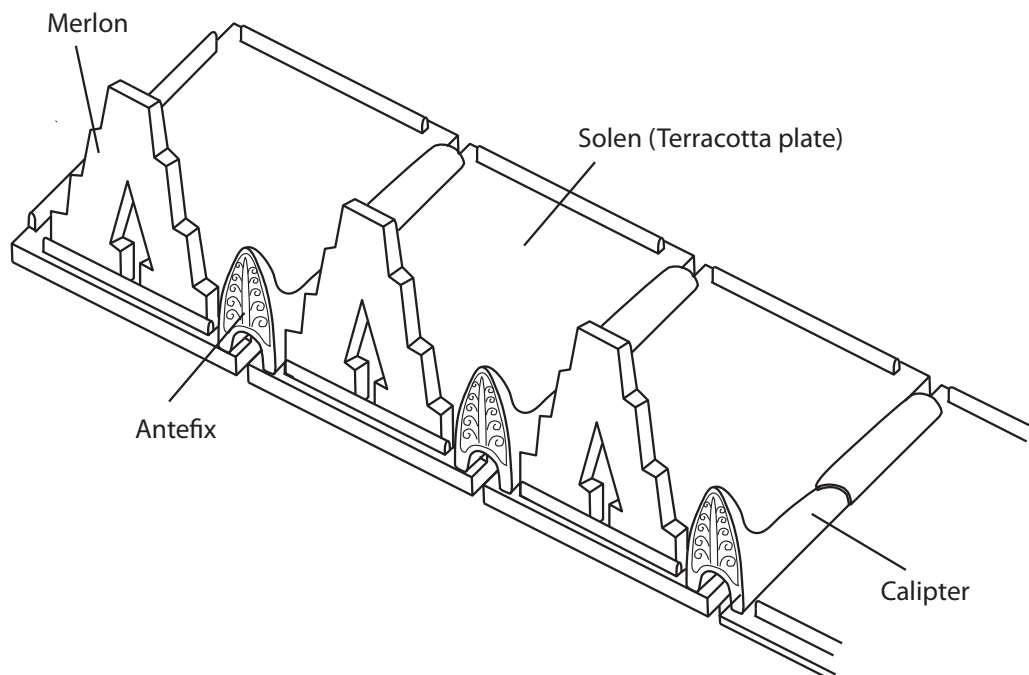
Reconstruction of antefixes in combination with merlons
