ACCU Nara
International Correspondent

The Eighth Regular Report

ACCU Nara International Correspondent

The ACCU correspondents periodically send reports on cultural heritage protection activities in which they have been recently involved. This is a collection of fifteen reports with one special report submitted by international correspondents in the Asia-Pacific region.

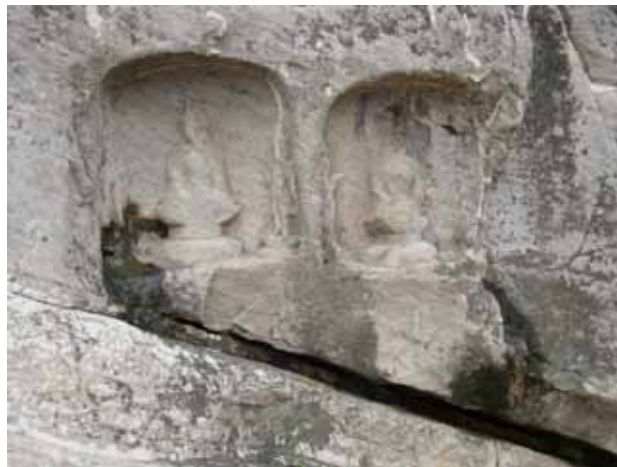
Crevice in the carvings

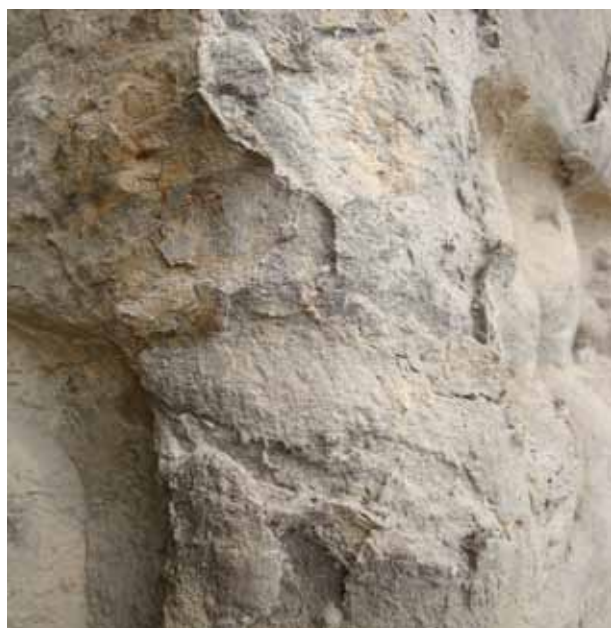
Weathering on the surface of carvings

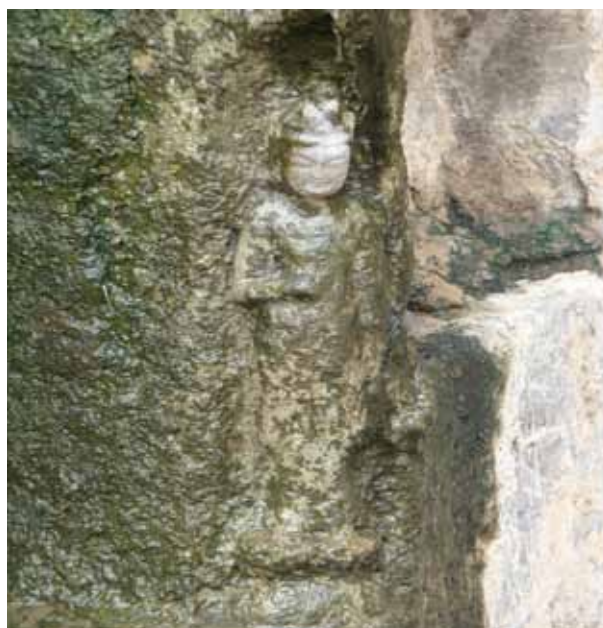
Water and microorganism on the surface of carvings

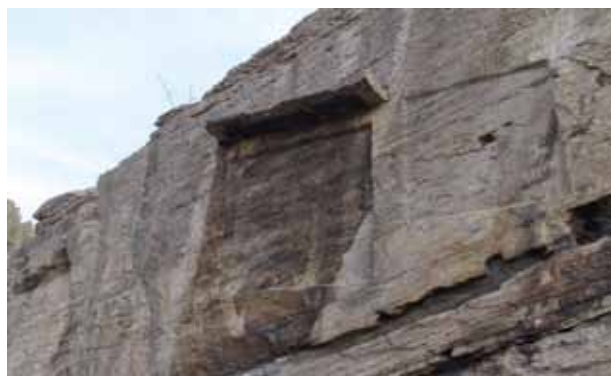
The stone leaking-proof shelf, remains of Tang dynasty

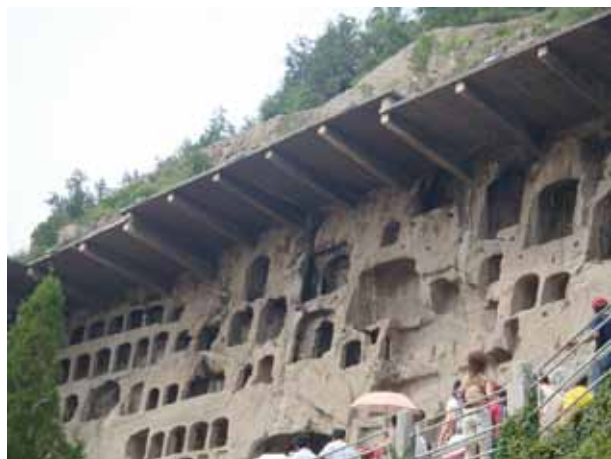
Cement leaking-proof shelves

The Grottoes are in face of many problems. For example, some rocks have been corroded, and some sculptures are covered with solidified magma of limestone. The washing of rains, the weathering of rocks, wild grass and trees are also serious problems. As a result, chaps can be seen in the rock bases of the caves, water leaks through some crevices, and some rocks have collapsed. The surface of sculptures is deteriorating and damaged. From geological point of view, the caves are located in a geological environment of fragile karst with a relatively low capacity and fast environment degrading. Once the rocks and sculptures are damaged, it is difficult to repair them. Ever since the 1970s, planned conservation and repair projects have been initiated and implemented. Reinforcing steel riveting was used in the constructions to strengthen the rocks, a seeping-proof layer of cement was applied

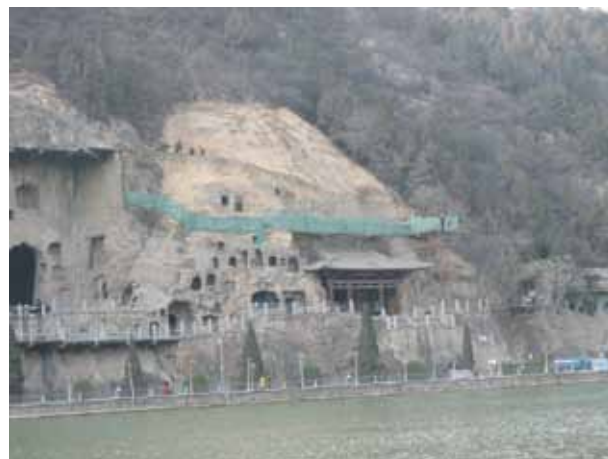
The water-leaking project of caves

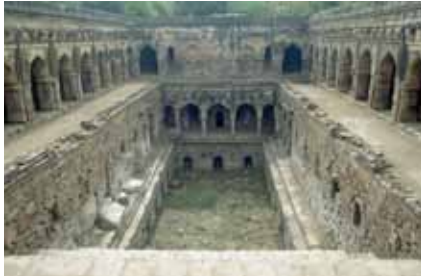
Rajon-ki-Bain (*Baoli*), in damaged condition and filled with debris

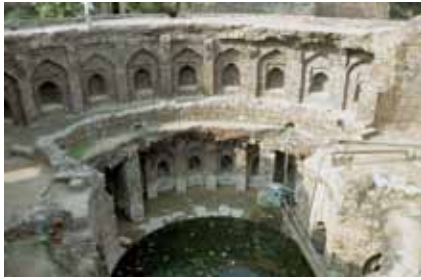
Baoli at Kotla Firoz Shah in damaged condition

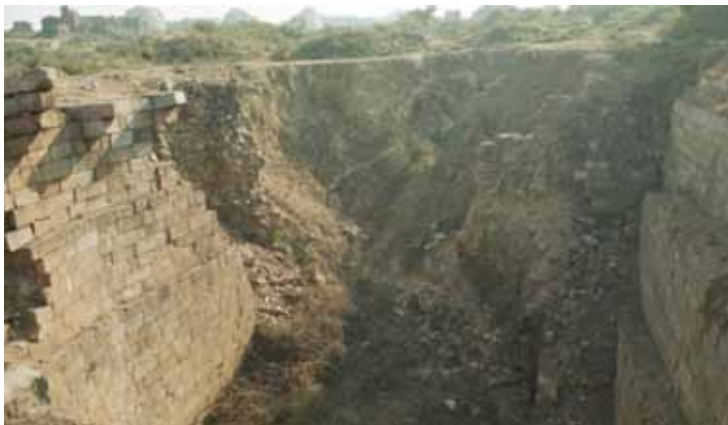
Baoli at Tughluqabad Fort in damaged condition

In the Tughluqabad Fort, palace complex has this fairly large *baoli* excavated deep into the bedrock. To give it a proper shape, masonry retaining walls and staircases were provided. While the outer face of the masonry is of ashlars, the core is of random rubble set in lime mortar. Evidence of a projected platform built on the northern retaining wall for drawing water from the *baoli* still can be seen. Construction of the fort was quarried locally and caused depressions which may have served as water reservoirs for use in dry seasons. The total area of the *baoli* is 414 square meters. The citadel complex has another large *baoli*, which lies in 840 square meters.

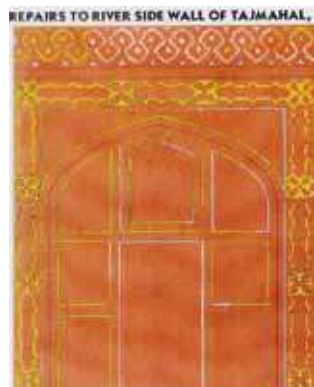
Documentation before restoration: Yellow is the existing and white is the missing inlay.

The process involves preparation of a document detailing existing and the missing inlay pieces as well as the condition of the base stone. The next step is to trace the missing inlay piece and then a thin metal sheet is cut in the desired shape. It is pasted on the slab of stone from which the inlay is to be fashioned. To cut the stone traditional methods are used. A bow of bamboo with string of twisted wires is used to saw the stone fixed on a frame. Sand is used as abrasive with water to run down the excess sand to facilitate a fine cut. Where the base stone is worn out and needs to be replaced. First the pattern is traced on the finished surface of new slab and the grooves are chiseled with traditional tools by engravers. And then the same process of tracing and fashioning the inlay pieces is followed. While procuring the raw material care is taken to get as similar material as possible to the original used. To ensure it, petrographic reports are obtained and comparative reports are also drawn.

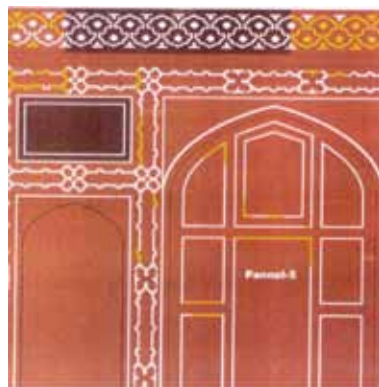
Post-restoration documentation (not of the same panel) : Chocolate is replaced base stone; white is the new inlay.

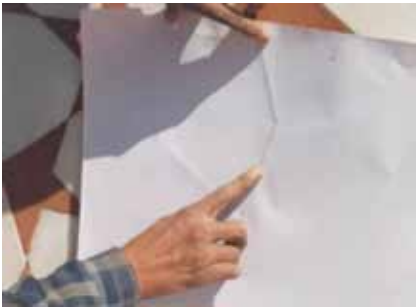
Taking impression of the missing inlay piece with paper

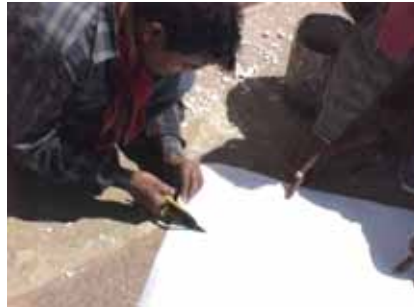
Preparation of format in tin sheet according to the impression

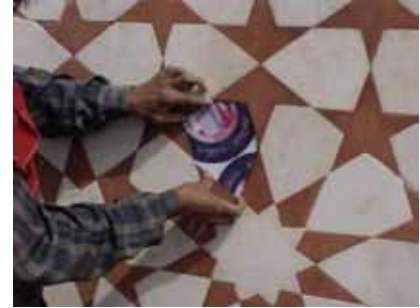
Checking the size of tin format with the missing one

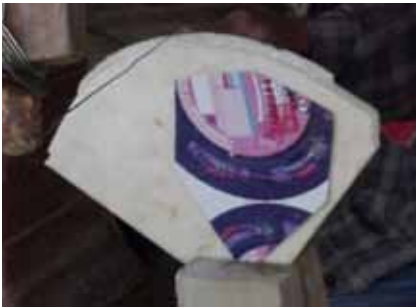
Fixing the format on the frame

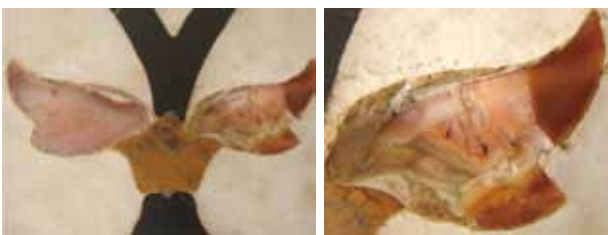
Inherent cracks aided by human vandalism: A broken inlay.

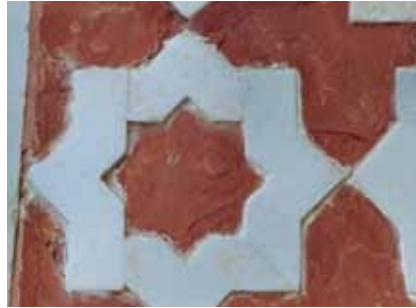
1.a Heavily weathered base
1.b Missing inlay due to deadening of mortar

For the inlay, the main causes of decay are the incompatibility of the two materials used, the mortar behavior and inherent weakness of the base stone. For most of the Agra monuments the base stone is red sandstone except at Itmad-ud-Daula's tomb and Taj Mahal (mausoleum) where it is marble. Red sandstone being a sedimentary rock suffers from inherent weaknesses like exfoliation and fragmenting as well as cracking due to the rusting of iron dowel. The inlay pieces technically are simply set inside a groove made in the base stone with the help of a cementing agent which in case of Mughal monuments is special putty made with a combination of organic as well as inorganic materials.

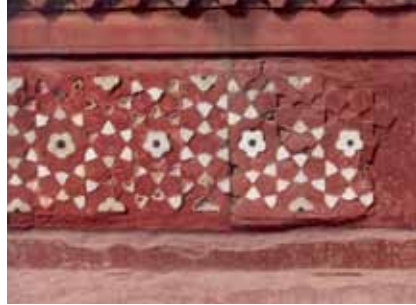
Weathered base and missing inlay pieces, during restoration base stone was replaced and grooved: Itimad-ud-Daula's Tomb

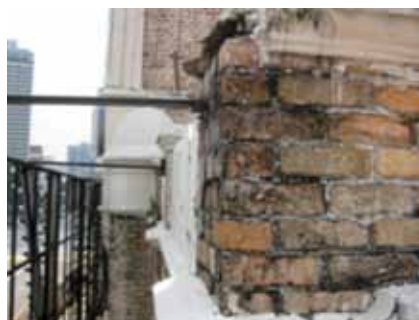
Surface damage on the brickworks

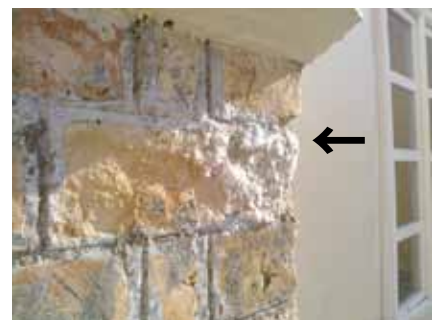
Salt contamination (primary efflorescence) on the brickworks

Salt contamination and rising damp were two common defects found at the building façade. Both defects are closely related. Salt contamination is due to various reasons including the seepage of ground water deriving from the nearby Gombak-Klang River, constant traffic pollution mainly along Jalan Raja, unsuitable chemicals used for cleaning works in the building; and fireworks' carbon dioxide emissions from special celebrations held around the building. Various types of soluble salts are known to cause damages to the brickworks mainly on the walls and columns including sodium chloride, carbonates, nitrates and sulphates of calcium, magnesium, potassium, sodium sulphate and magnesium chloride. The salts, in the form of white powder (efflorescence) and crystallisation (sub-florescence), had caused the bricks, mortar joints and lime plaster to crumble, resulting in a

serious damage to the building. The restoration works involved a salt desalination process through the poultice technique called Cocoon; and the chemical injection of damp-proof course (DPC). The Cocoon method, a mixture of pharmaceutical grade cellulose fibers and distilled water, was applied on affected exposed brickworks. After two weeks of the Cocoon application, the dried-out damp-absorbent material was removed whilst drawing away the salts from the walls and columns. The process was repeated twice to reduce the salt concentration to an acceptable level. The DPC was applied before the second treatment of Cocoon to create a moisture-barrier at the base of walls and columns.

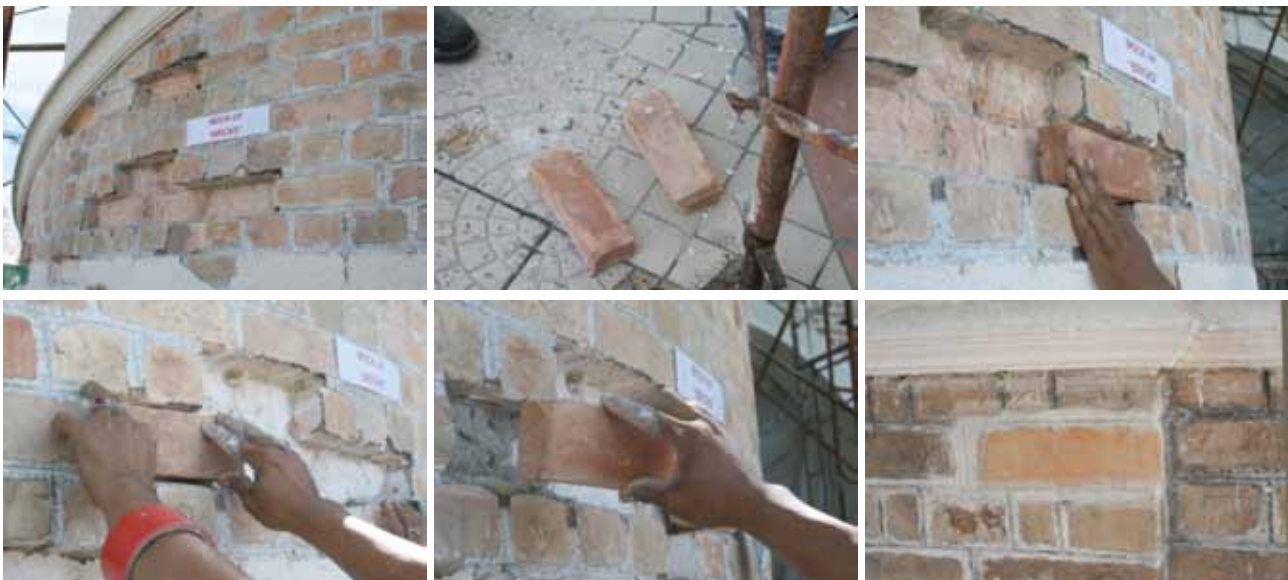
The sequence of brick replacement on the wall

A thorough inspection of the old bricks mainly on walls and columns was conducted by the building contractor prior to the restoration works in order to determine the quantity of bricks that needed to be repaired or replaced. From the inspection, a large number of the old bricks suffered from either porosity or surface damage. The old bricks that were found to be porous had to be replaced with new bricks of the same dimensions, characteristics and strength. These porous bricks were carefully removed using rubber hammer; whilst the broken bricks were treated by patching them up with a mixture of brick dust and fine sand. Since there was no new brick available in the market that matched the old bricks, the building contractor had to outsource the new bricks from a traditional brick kiln in Ekor Kuching, Padang Serai, Kedah, a state of northern Malaysia. The new bricks were traditionally produced under firing temperatures of not more than 1000 Celsius. The mineral content of the raw materials (soil), firing temperature and the atmosphere in the kiln had produced the fired colour of new clay bricks that matched the old bricks. Hence, the new bricks blended harmoniously with the existing old bricks. All electrical wirings, power cables, light bulbs, blocked letterings and signages that were previously fixed onto the wall surfaces were carefully removed. Safety nettings were also fixed onto the scaffoldings to provide protection from falling debris. Any harmful growth, dirt and stains on the brick surfaces and arches were removed and cleaned using controlled water jet and soft brush. The restoration works were carried out in five

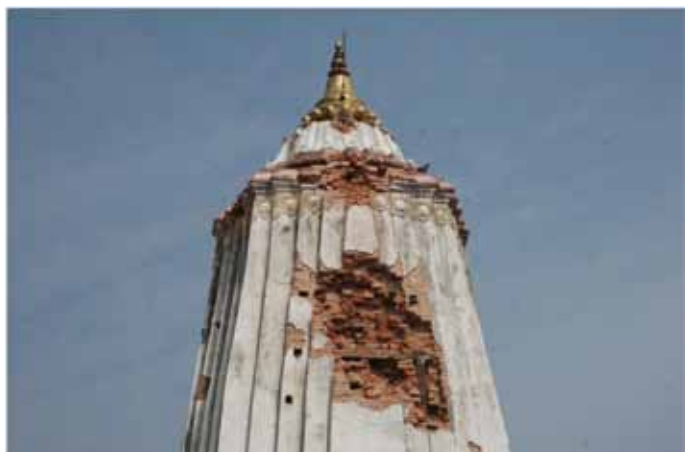
The southern upper part damaged by thunderbolt

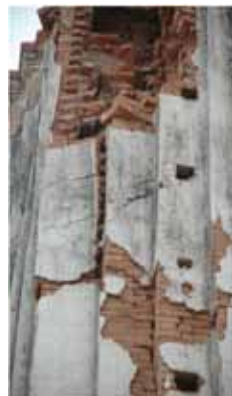
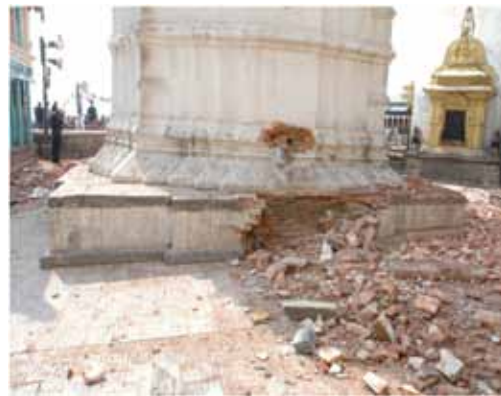
Damaged in the northern lower part of the temple

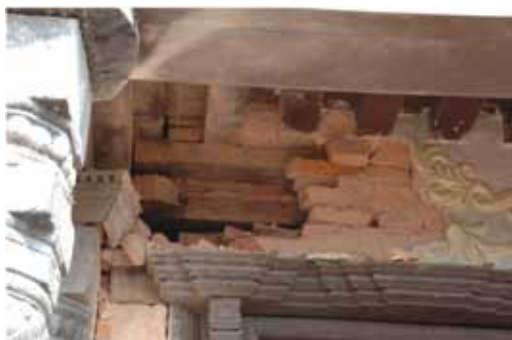
Damaged-above the main entrance gate of the temple

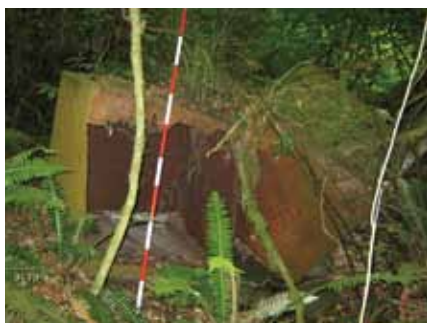
Figure 14. The two iron water stores in the bush in the approximate location noted in Arthur's 1880 map of the hatchery. The stores/boxes may have been the 'filter' used to further clean the water for the hatching boxes (photo: Matthew Schmidt).

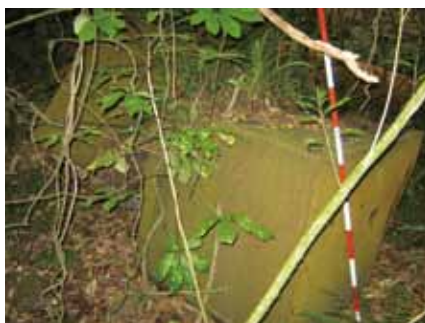
Figure 15. Another view of the possible 'filter' stores/boxes (photo: Matthew Schmidt).
