ACCU Nara
International Correspondent

The Sixth Regular Report

Cultural Heritage Protection Cooperation Office, Asia-Pacific Cultural Centre for UNESCO (ACCU)

The ACCU correspondents periodically send reports on cultural heritage protection activities in which they recently involved. This is a collection of the fifteen reports and two special reports submitted by fifteen international correspondents in the Asia-Pacific region.

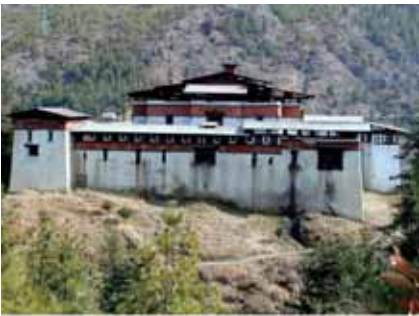
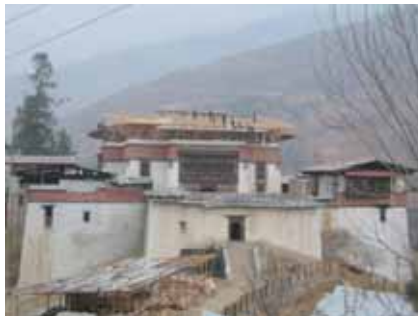
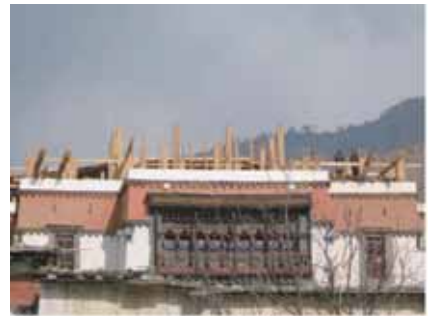
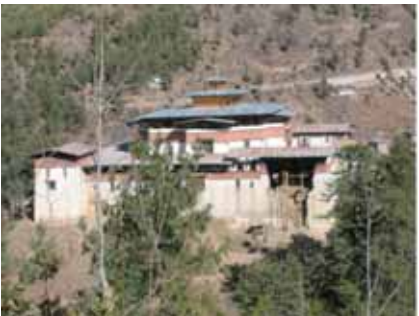
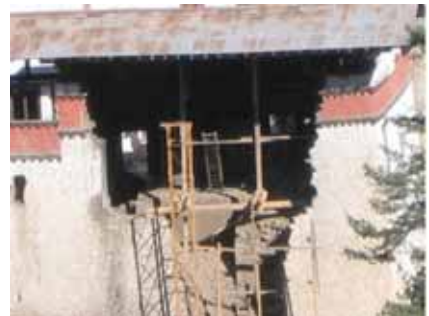
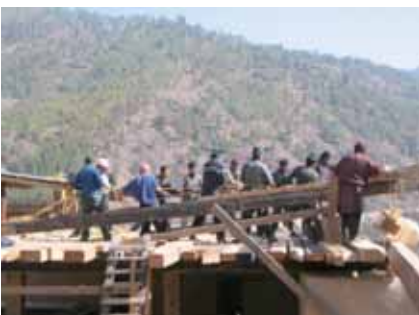
Photographic documentation during conservation of Semtokha dzong

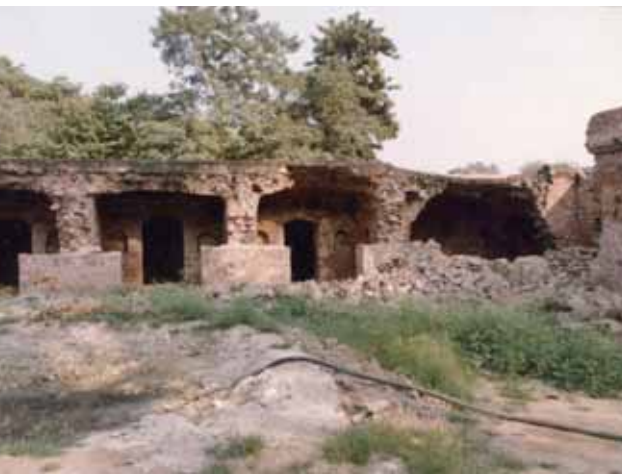
Damaged cells, Arab Sarai (before conservation)

The masonry of the eastern and southern walls had fallen and bulged out in parts. It was reconstructed and the open joints were pointed to arrest the growth of vegetation and water flow into the structure. The decayed and missing rubble masonry of the cells adjoining the eastern gateway was reconstructed and the floors were relaid with lime-concrete. Broken patches of the parapet-

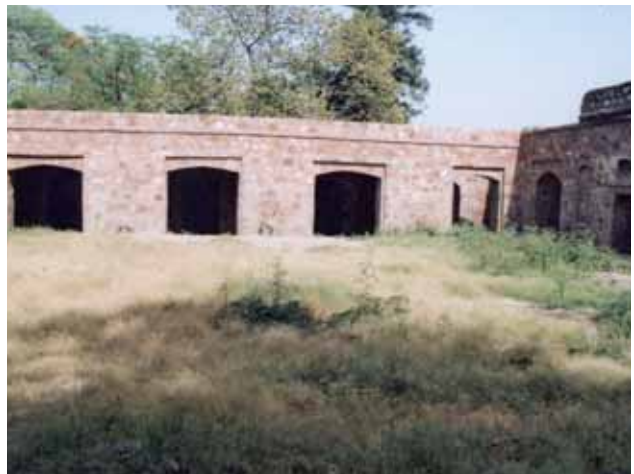
Damaged cells, Arab Sarai (after conservation)

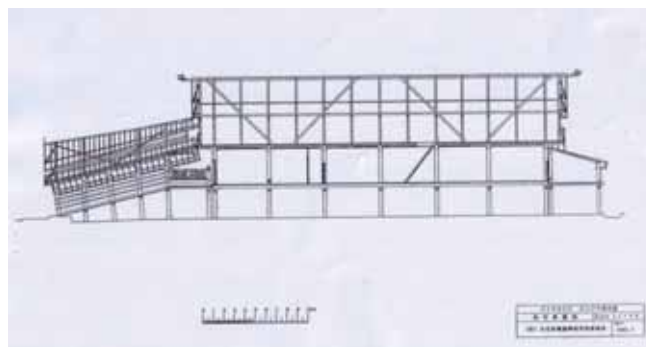
Figure of elevation of the Old Palace of Sumbawa drawn by JACAM, 2002

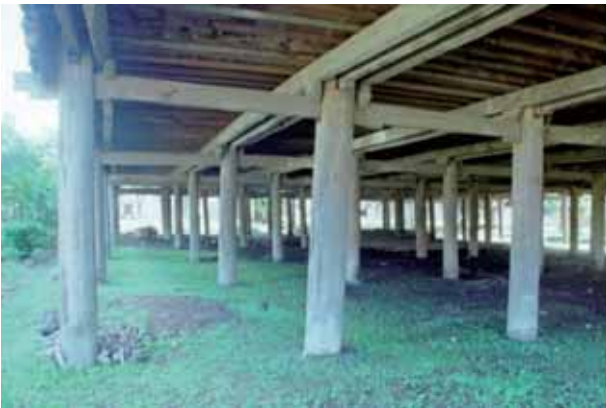
The poles of the building leaned to westward.

caused by the shift of the main building structure; the main pillars of buildings had a tilt to the west. Another problem was caused by the inevitable nature of wood materials: frame floors, floorboards, walls and roofs were partially damaged and weathered.

Based on the study and analysis of building structures on the technical studies in 2001, the method of handling damage of the building was decided as partial restoration. Partial restoration was carried out by straightening the sloping main poles without dismantling all building components. Dismantling of building components was performed only on non-structural members. Before straightening the main poles, the stakes between the poles and the beams should be loose. After that, the main structure was pulled to be straightened, and then tensioned with spikes again.

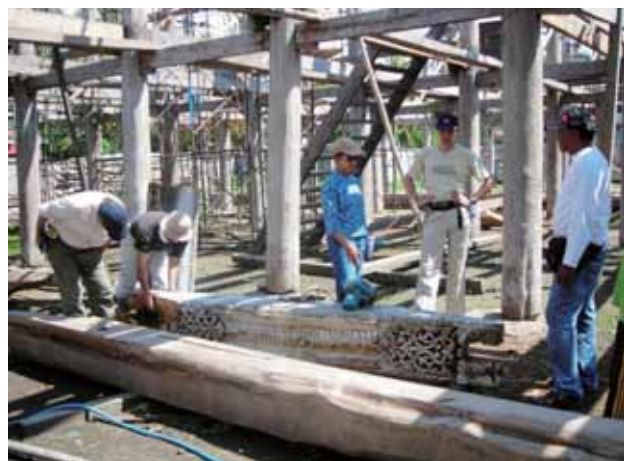
Inspection of the main beam before reinstalling, 2008

beam of a size 35 x 40 cm with a length ranging from 5 up to 6.60 m deteriorated at the top. Based on technical considerations, this element must be replaced. The replaced beams due to damage summed into as many as 26 among 31 beams in total. According to an agreement on a replacement, it was decided to use teak wood of good quality with good size and length of a wooden cross with the original size. To obtain materials for replacement with the same technical requirements, these materials must be imported from Java.

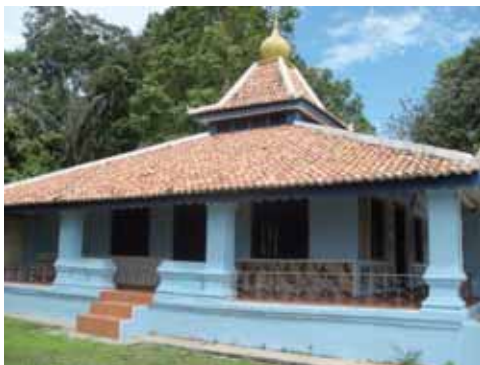
The Old Macap Mosque was designed symmetrically with two-tier roof structures and a small dome on top the roof.

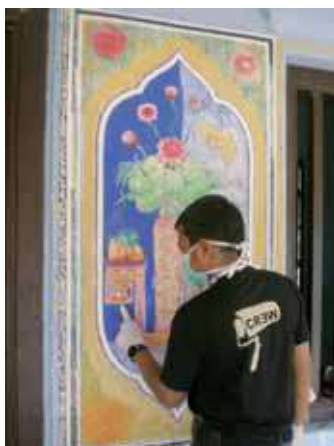
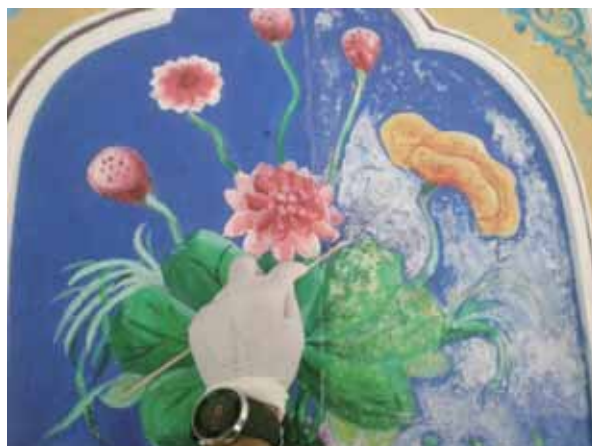
The wet cleaning technique involved the application of cotton tips and chemical solutions to remove the new layers of paints.

The cleaning process involved both dry and wet cleaning techniques. The dry cleaning process was carried out manually by using soft brush, wire brush and scraping tools. All dirt and dusts found on the wall murals were carefully cleaned before applying the wet cleaning technique. The wet cleaning technique involved removing of new layers of paints using cotton tips and chemical solutions such as ethanol and trichloroethylene. Paper pulp technique was also applied onto wall murals which contained high level of moisture. The paper pulp technique requires three to four days depending on the moisture level and weather conditions. Scraping works were also carried out to rectify mainly on over-painted wall murals. During conservation works, plastic sheets were used to protect the wall murals from dusts and rain. All wall murals were later protected with synthetic resin coating of methacrylates (paraloid B 72).

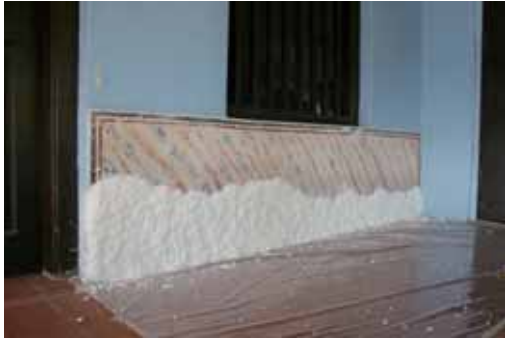
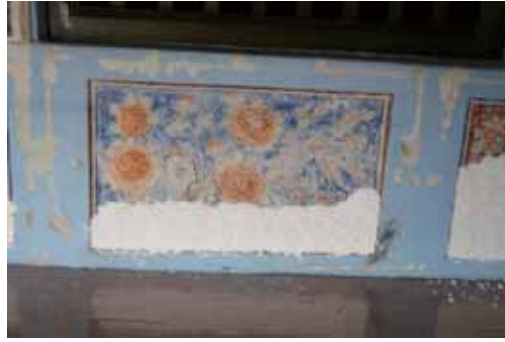
Paper pulp technique was applied to areas which had high level of moisture content.

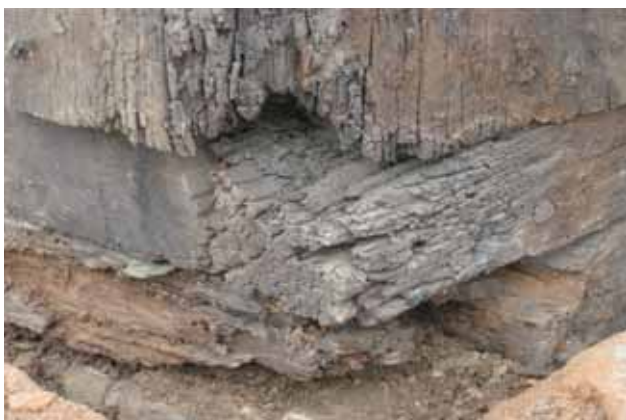
The deteriorated wooden parts of hermika

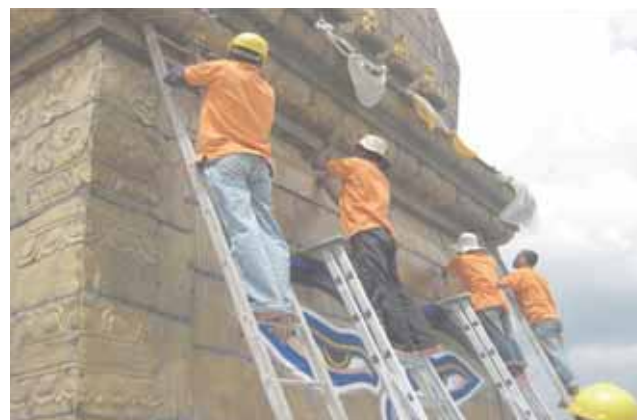
Removing copper sheets for gold gilding

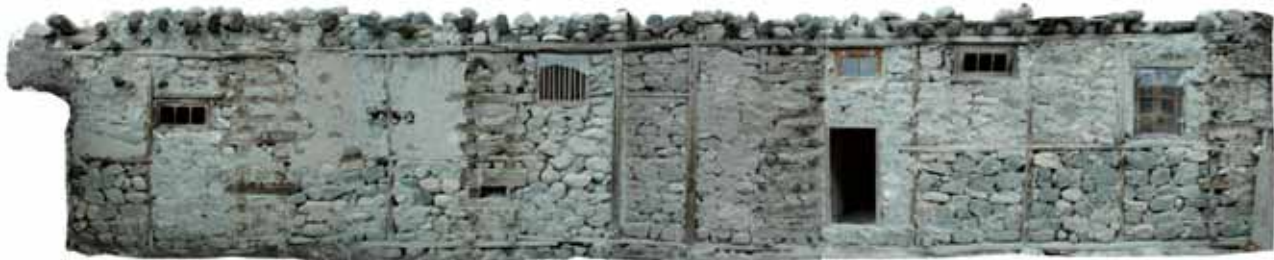
Fig. 4. Rectified photography of western elevation of the 100 year old Darbar Khang

survey. Rectified photography has been used to map the condition of external and internal elevations of the monument and was later converted into vector form.

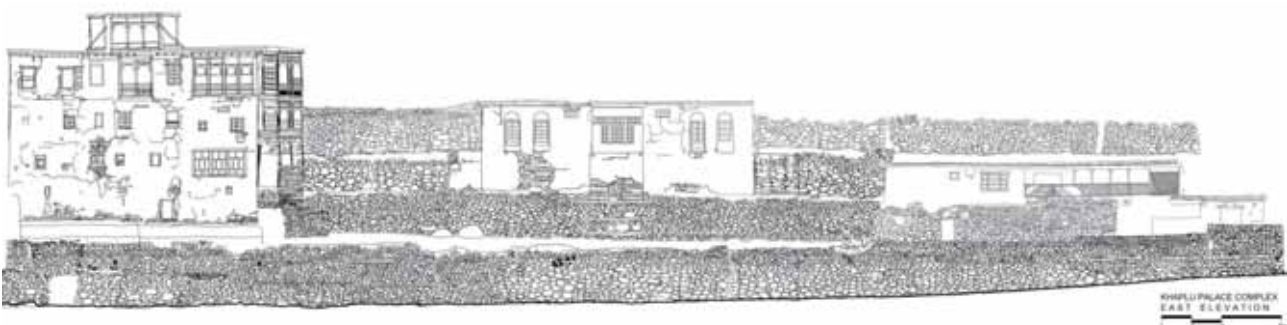
Fig. 5. East elevation of Khaplu Palace site. Hundreds of years old historic agricultural walls and buildings are documented using EDM (total station) survey and rectified photography techniques. This drawing is a 3D wire-frame CAD model.

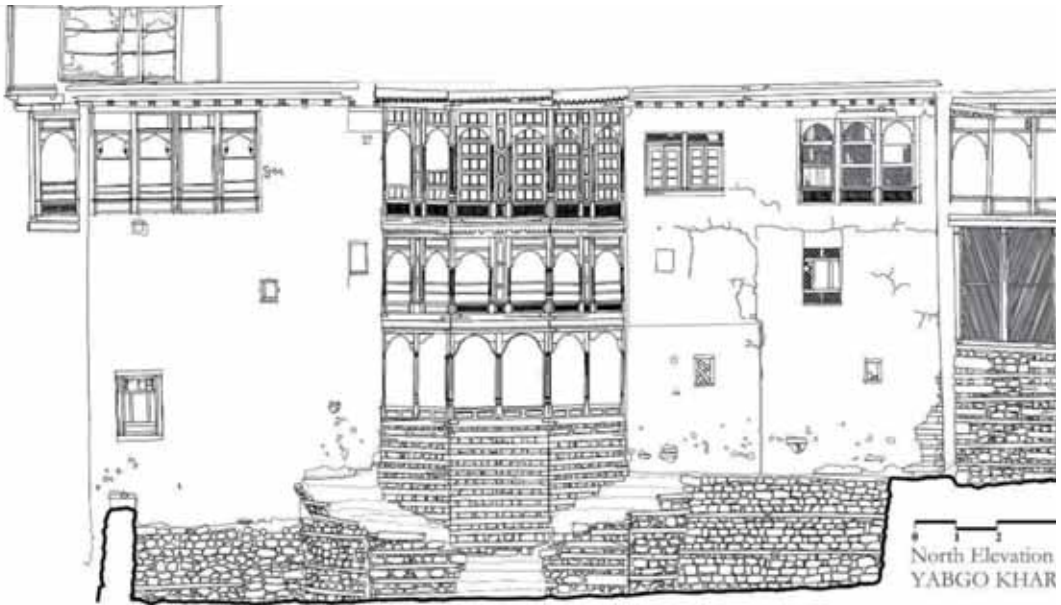
Fig. 14. North façade of Khaplu Palace. The wooden entrance loggia at the centre was the subject of major conservation activity in 2008. This restoration is very closely monitored with total station.

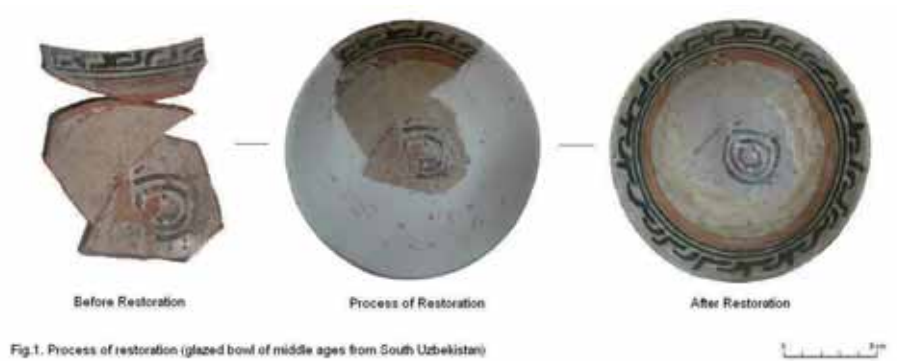
Fig.1. Process of restoration (glazed bowl of middle ages from South Uzbekistan)

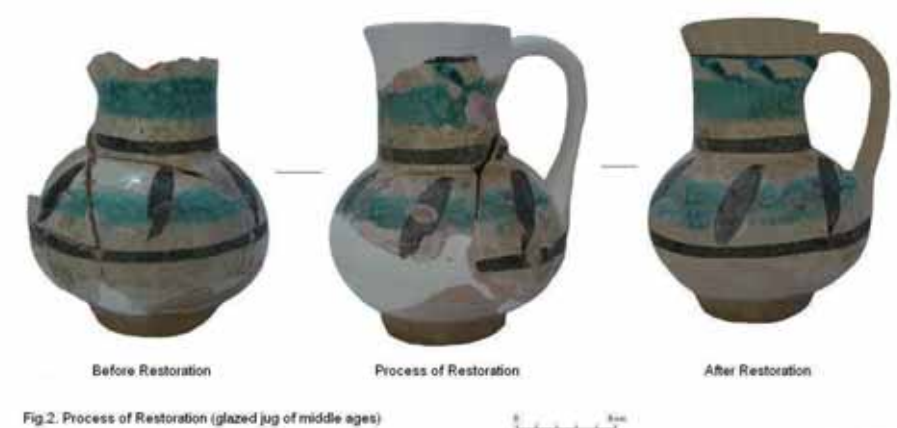
Fig.2. Process of Restoration (glazed jug of middle ages)
