# Disaster Risk Management of Cultural Heritage Based on the Experience of the Great Hanshin Earthquake

Yasumichi Murakami

Director of Cultural Assets Office, Hyogo Prefecture Board of Education

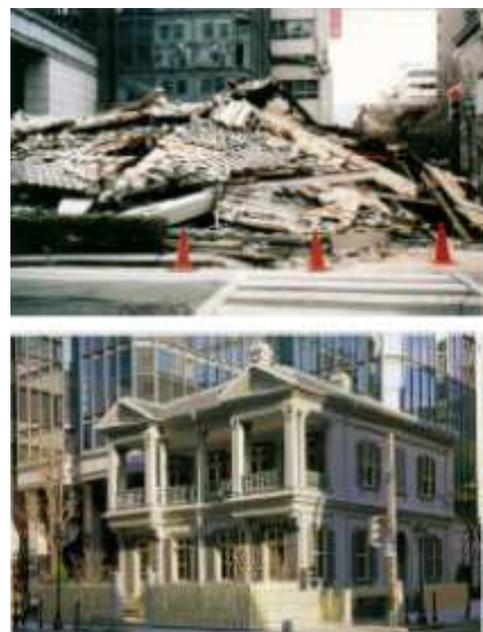
**Fig.11 House 15 of Former Kobe foreign settlement**  
**After Earthquake (Upper)**  
**After Restoration (Lower)**

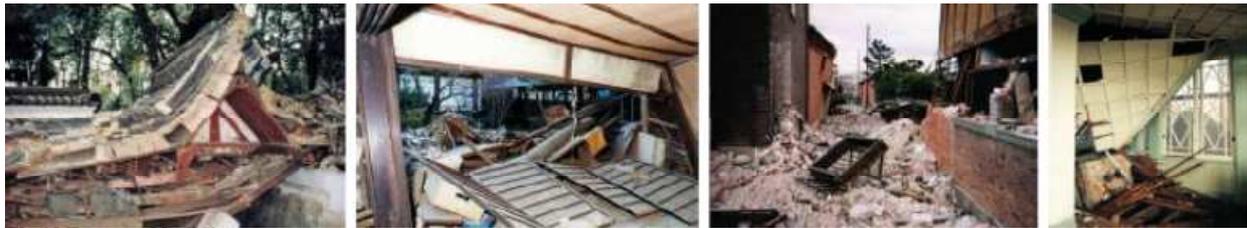
Fig.12 Damaged buildings

The timber buildings, especially dwellings built in the poor conditions immediately after the World War II, were suffered from very serious damage, partly owing to the deterioration of materials as a result of aging. Dr. Prof. Emeritus Nobuo Ito says that the damage was most devastating in wooden buildings with:

- 1) Poor foundations and sills;
- 2) Insufficient diagonal bracing;
- 3) Inadequate connecting elements;
- 4) Insufficient areas of solid wall;
- 5) Heavy roofs.

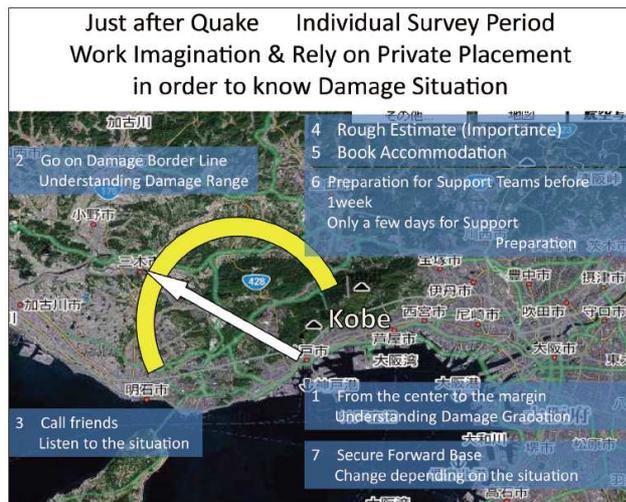
Fig. 13 Initial response

Figure 13 shows the actions this writer personally took immediately after the earthquake. Amid ongoing aftershocks and numerous fires throughout the region, I surveyed areas of extensive damage, and visited the marginal areas of earthquake damage, acquired information from friends, made a rough estimation of the damage, booked

accommodations for a rescue party, and secured a forward base.

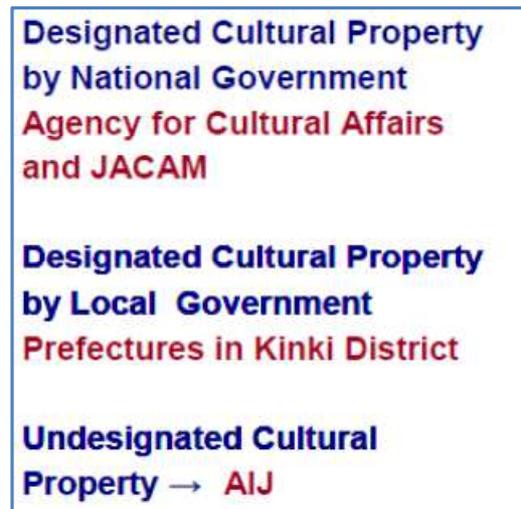
Fig.14 Damage survey system

At the level of prefectures, cities, towns and villages the number of architectural conservator is extremely low. Accordingly, the investigation of earthquake damage to designated buildings by local authorities and undesignated historic buildings apart from national cultural properties was supported by the Architectural Institute of Japan (A.I.J.) instead of local authority staffs. The A.I.J. Committee for the Study of History and Design at the Institute's Kinki Branch took the initiative. And Architectural historians and other researchers from various universities and technical colleges in the Kinki region made a concerted effort to survey the damage to those historic buildings which were already known as a result of earlier research. The report which they produced was entitled "Report of the Survey on Historic Buildings Damaged by the Great Hanshin Earthquake" (Japanese edition, April 1995).

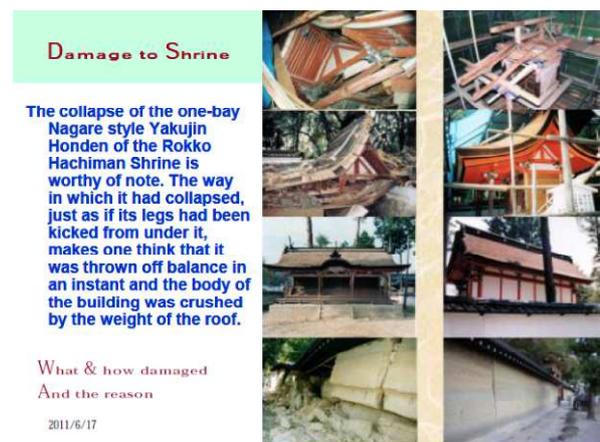
Fig. 16 Damage to Shrine

In the case of shrines, the collapse of the one-bay Nagare style Yakujin Honden of the Rokko Hachiman Shrine is worthy of note. The way in which it had collapsed, just as if its legs had been kicked from under it, makes one think that it was thrown off balance in an instant and the body of the building was crushed by the weight of the heavy roof. There can be little doubt that, as Dr. Kuroda has reported, the main cause was that the roof covering had been changed from cypress bark roofing to heavy classic roof-tile, but it is thought that the rather unbalanced Nagare roof form was also a contributory factor. In the case of the Kasuga style Honden within the precinct, only the veranda collapsed, but if the direction of the earthquake forces had been different, it is thought that this could have led to greater damage. Also, the worship hall (haiden) was leaning over at an angle, similar damage occurred in many cases with this kind of worship hall, it may be said that improving the earthquake resistance of worship hall, with their lack of walls to absorb horizontal forces is a difficult problem.

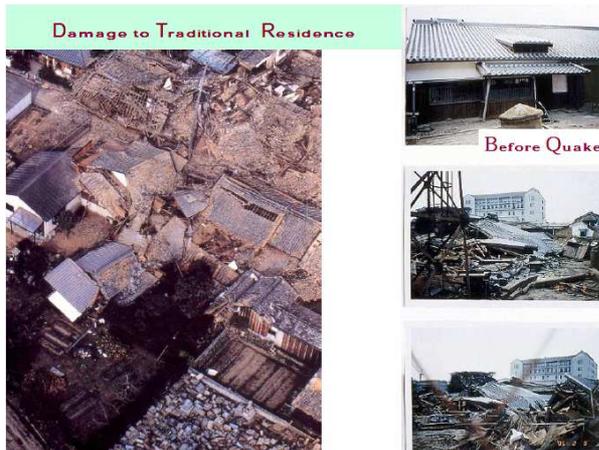
Fig. 17 Damage to Traditional Residence

Among other things, in the earth-floored area (doma) of farmhouses, posts are close together and the surrounding walls are more or less continuous, making this part of the house comparatively strong, whereas the reception rooms (zashiki) at the other end of the house are more open, with fewer walls and posts. For this reason, it is reported, there was a characteristic trend for damage to be concentrated in the reception rooms.

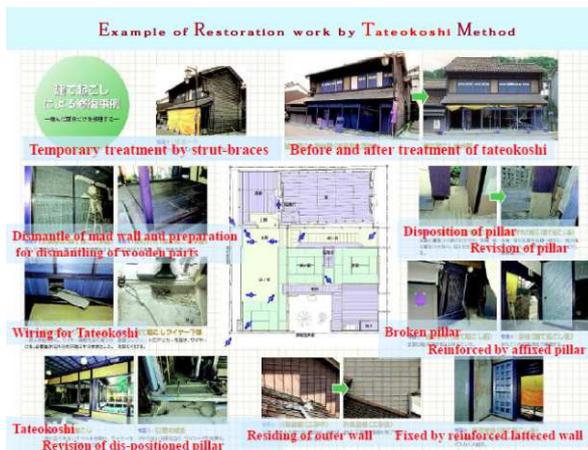
Fig.19 Traditional techniques (Hikiya Tateokoshi) for repair

With the kind of vernacular houses mentioned above, there is a need to inform widely that one of the advantages of the traditional method of building is that, even in the case of severe damage such as cracking of the walls and inclination of the posts, it is possible to repair the structure. Craftsmen known as house pulling carpenters (hikiya daiku) make a profession of moving

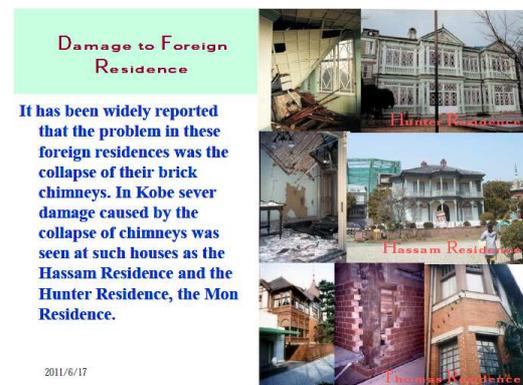
Fig.21 Damage to Foreign Residences

It has been widely reported that the problem in these foreign residences was the collapse of their brick chimneys. In Kobe severe damage caused by the collapse of chimneys was seen at such houses as the Hassam Residence and the Hunter Residence, the Mon Residence, the building of the Chinese Association and the former house of Catherine Andersen in Kitano, as well as the Shioya Hostel of the Takeuchi Oil Manufactory. Since Western style residences in other areas suffered similar damage, this will be a problem for building preservation in the future.

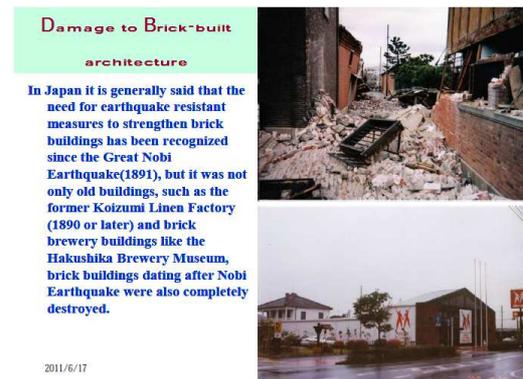
Fig. 22 Damage to Brick-built buildings

However, care is called for when we consider that even in the case of two buildings by the same designer, there could be a considerable difference between the ways of brick structures performed. For instance, at the former Hyogo office of Tokyo Soko (the Ishikawa Building, Sone Tatsuzo, 1906), differential slippage occurred between brick courses, while in the former Kobe Branch of Mitsubishi Bank, there was little damage. It is possible that there may have been steel reinforcement in the floor of the latter building.

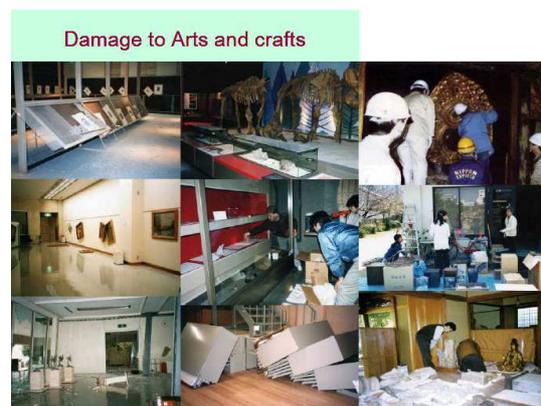
Fig.23 Damage to Arts and crafts and Rescue operation

There were numerous undesignated arts and crafts in the Hanshin region. Their damages were totally unknown since their locations were not listed. Therefore, “Rescue Committee for cultural properties damaged in the Great Hanshin Earthquake” was established in February 17, one month after the Earthquake, in order to prevent disposal and dissipation of movable cultural properties including precious arts and crafts at the time of removing numerous damaged buildings. This Committee was composed of 30 organizations in total, including the Agency of Cultural Affairs, other national organizations, museums belonging to local public organizations such as Hyogo

Board of Education, and private organizations such as NPOs. Movable cultural assets in need of urgent conservation were rescued, and they were temporarily stored at facilities with storage fixtures such as museums in Hyogo Prefecture and other surrounding prefectures.

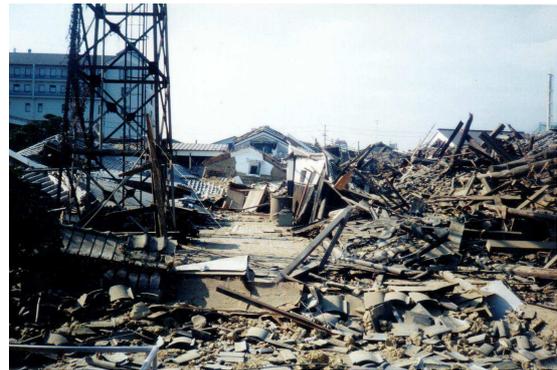
Fig.25 Damage to the factory of SAKURAMASAMUNE

"Brewing tools of Nada" which are designated as important tangible folklore cultural assets and other "Set of brewing tools of Nada" which are prefecturally-designated important tangible folklore cultural assets were damaged because the building where they were kept collapsed. The entire "OHISHI brewing house of SAWANOTSURU Co., Ltd." collapsed, and designated brewing tools stored there were also damaged. About 300 buildings of Japanese sake brewing houses which accounts for 95% of brewing houses, including KIKUMASAMUNE memorial house and the OHISHI brewing house of SAWANOTSURU Co., Ltd, were collapsed.

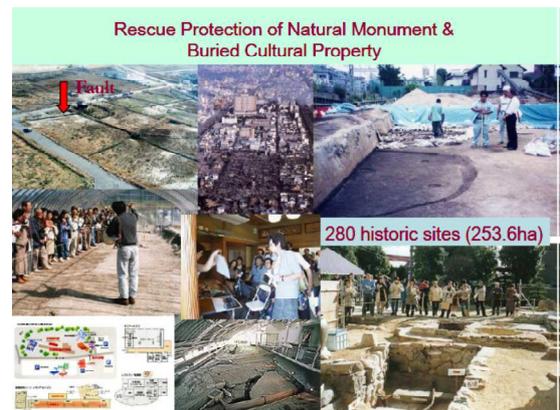
Fig.26 Emergency excavations for buried C.P

From the day of Earthquake to the end of May, 1995, the life line recovery works and individual houses and small apartments related to restoration plan were exempted from notification in accordance with the Law for the Protection of Cultural Properties based on notification from the Agency of Cultural Affairs. In other words, they were omitted from excavation and research. Number of notifications related to the restoration plan roughly doubled compared to the previous year, but excavation and research was conducted at 18% of the number of notifications (30% compared to the previous year) based on this easing measure.

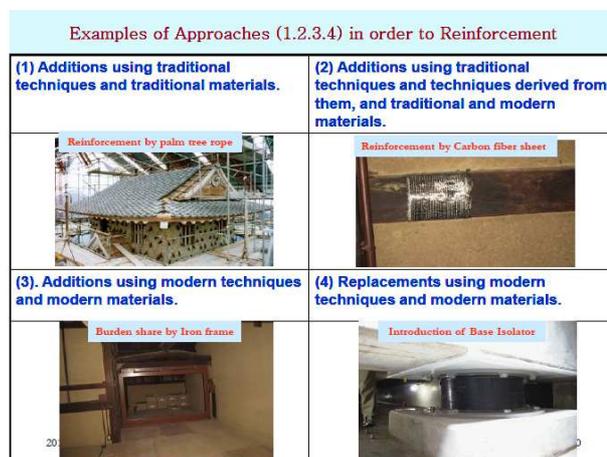
**Fig.28 Approaches for Reinforcement**

1. Additions using traditional techniques and traditional materials.
2. Additions using traditional techniques and techniques derived from them, and traditional and modern materials.
3. Additions using modern techniques and modern materials.
4. Replacements using modern techniques and modern materials.

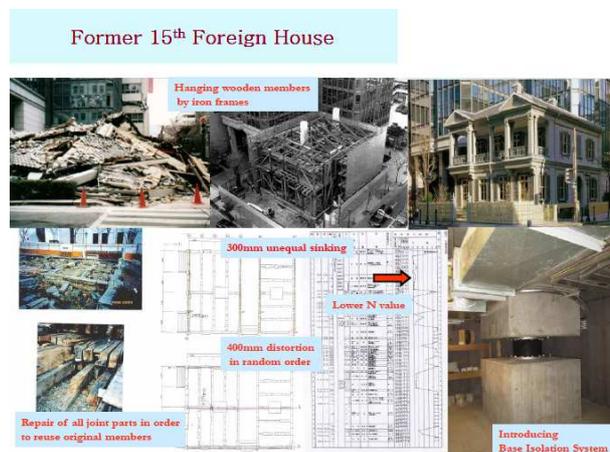
**Fig.30 Example of introducing Base Isolation System**

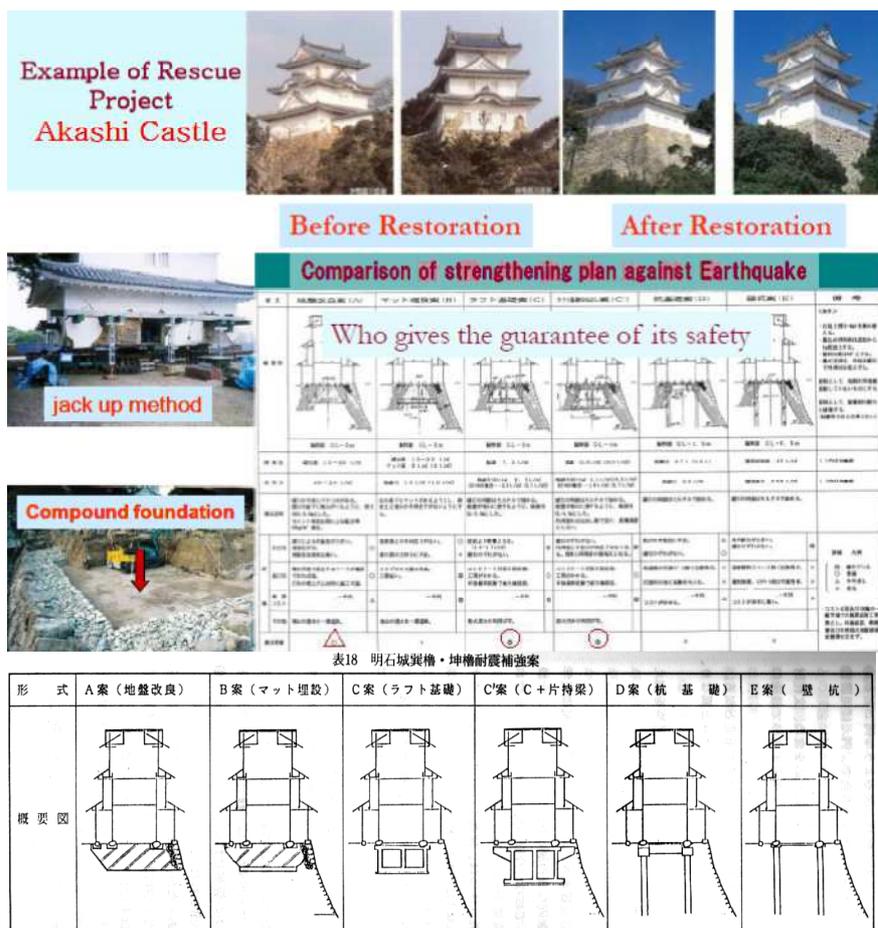
Fig.31 Rescue Project of Akashi Castle

In response, the expert on cultural property conservation offered two opinions. First, it ought to be possible to build the stone walls back up without reinforcement. (The stone walls outside the towers, which are not designated,

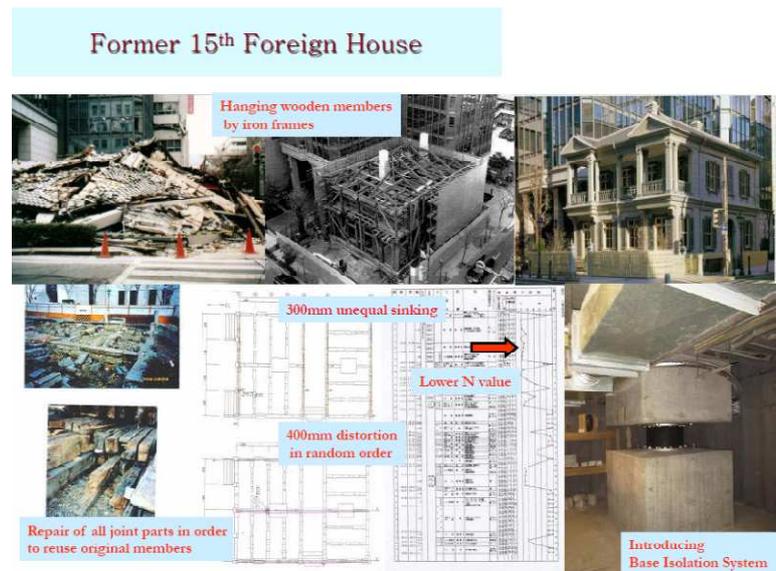
**Fig.32 Rescue Project of House 15 of the Former Kobe Foreign Settlement**

At the second meeting, five construction techniques were presented: a traditional technique, three earthquake-proofing techniques

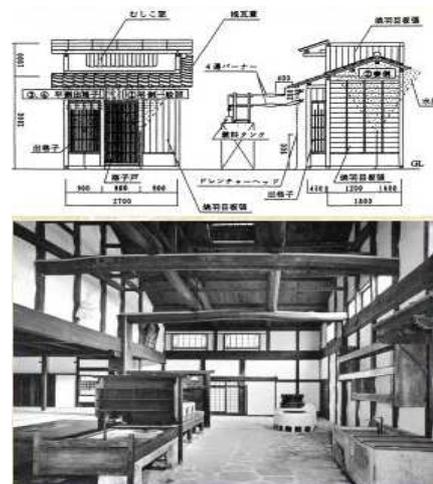
Fig.37 Fire Proof test for traditional wooden House (upper) and Hibukuro design in kitchen (lower)

For example, a water supply infrastructure for extinguishing fire is the main task of fire prevention. However, other ideas must also be examined in the risk management of cultural properties alongside a system for disaster-preventive management. For example, old town houses in Kyoto have a high-ceiling space called a 'Hibukuro ' in their kitchens. This is a spatial design intended for preventing occurrence of fire.
