Preservation of the Imperial Villa Garden Site of Ancient Nara Capital, a Special Historic Sites and Special Places of Scenic Beauty

1. Outline of the garden

4. Preservation/repair for garden stones

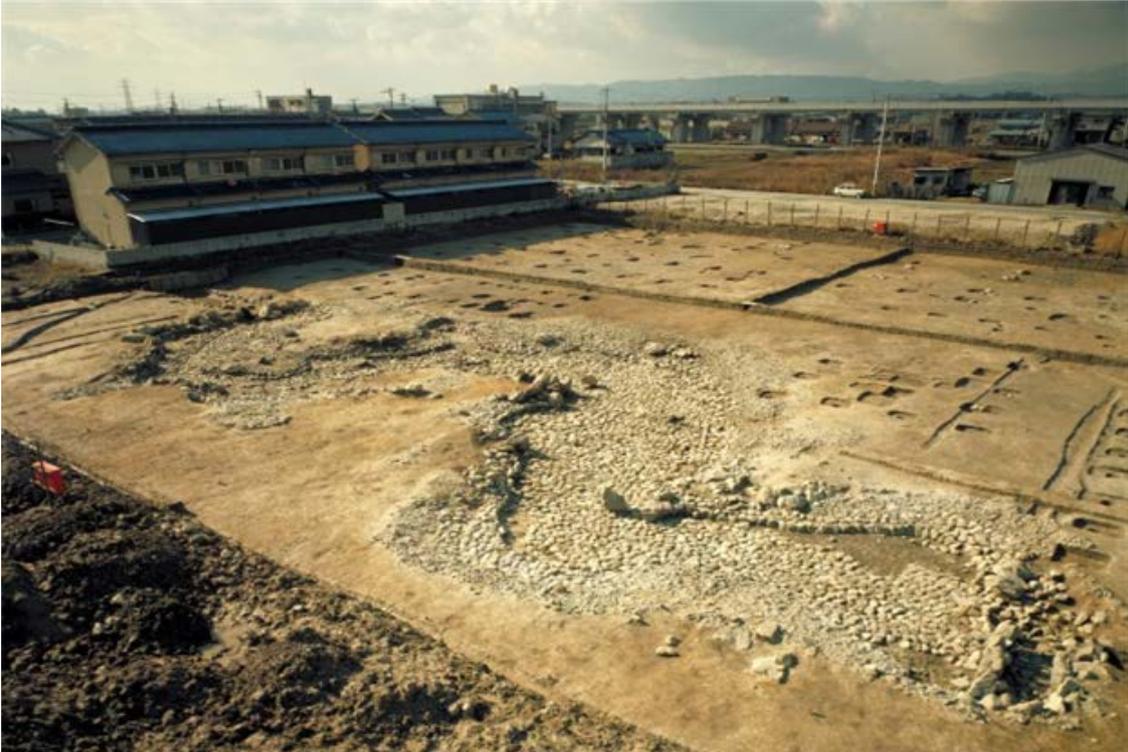
The pond when excavation survey was undertaken (viewed from north-east)

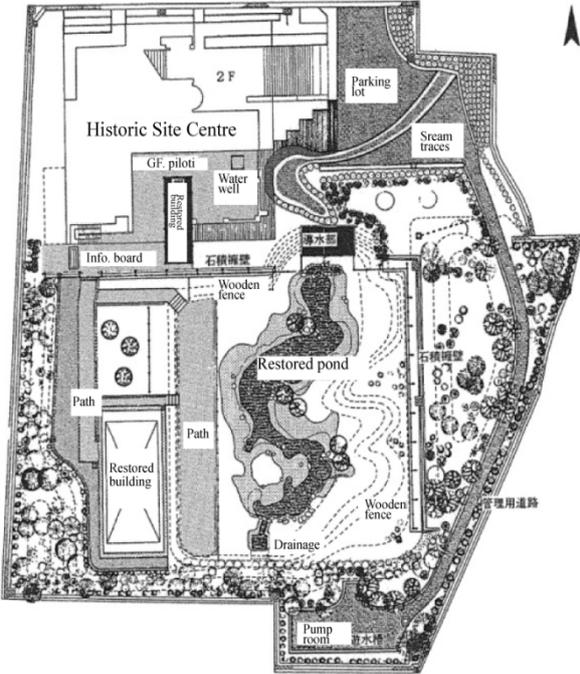
▲ Plan view of reconstruction project in the beginning of 1985

The first preservation project was undertaken as “Restoration and Preservation Work for the Imperial Villa Garden Site of Ancient Nara Capital, Special Historic Site” during the period from 1979, the year following the year in which it was designated as a historic site, until 1985. The site is greatly featured with exposed exhibition of the pond as it was excavated, owing to the comparatively good preservation conditions of stone arrangement. Furthermore, exhibited stones such as garden stones, curb stones, round stone pavement, and paving stones from the bottom of the pond are all excavated originals. For protection of the structural remains, the gravel pavement extending outside the pond was filled up with ground, and above that, it was restored for exhibition. For performing exposed exhibition, some garden stones in poor condition were chemically reinforced. Meanwhile, the building located to the west of the pond and the fences surrounding the pond were reconstructed to resemble those of the Middle Nara period during which this garden was constructed.

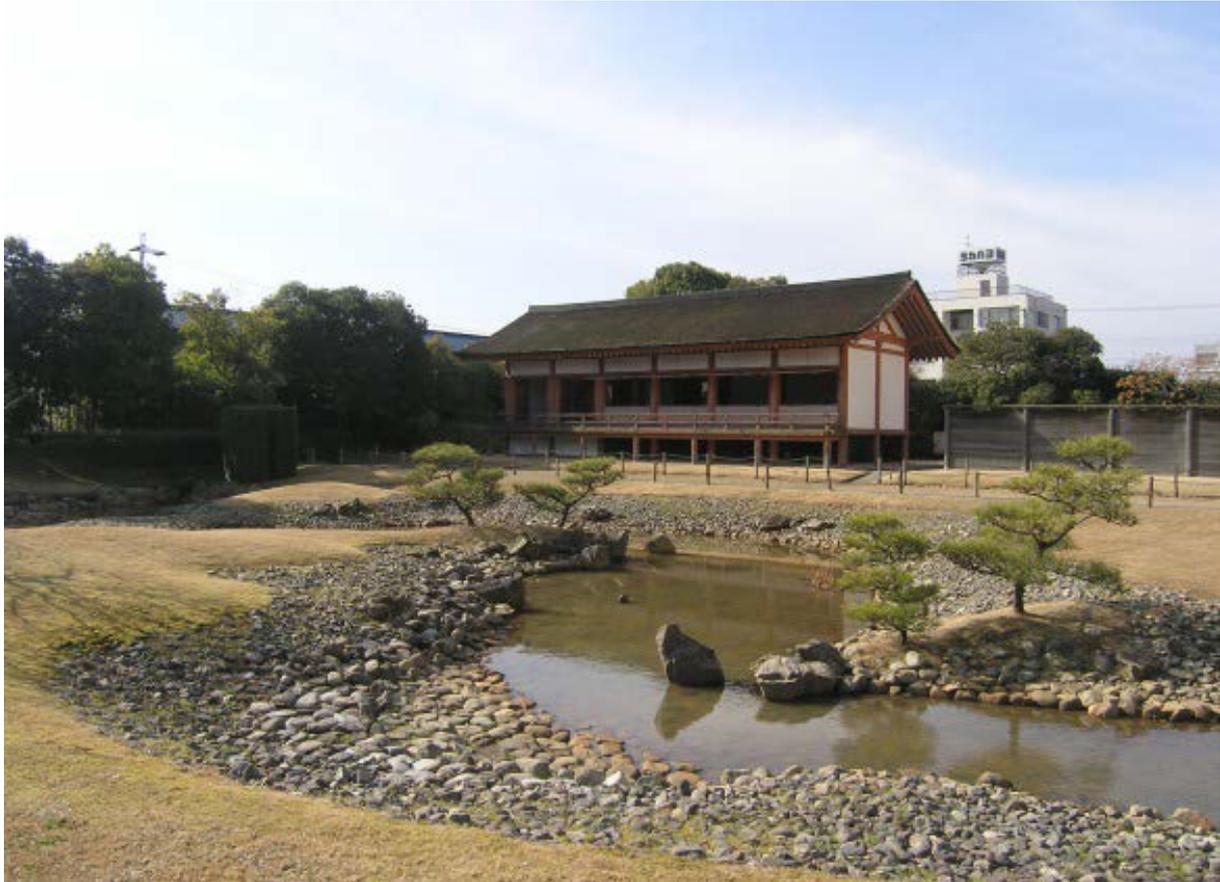
Reconstruction project undertaken during the period 1979-1985 (the pond and reconstructed building viewed from north-east)

In addition, in order to enable visitors to imagine the scene of a banquet being held beside a meandering stream, there is a constant flow of pond water circulated via pumps. Further, to protect the atmosphere of the garden, trees have been planted to prevent neighbouring buildings from directly entering the line of sight of visitors staying in the reconstructed building in the garden.

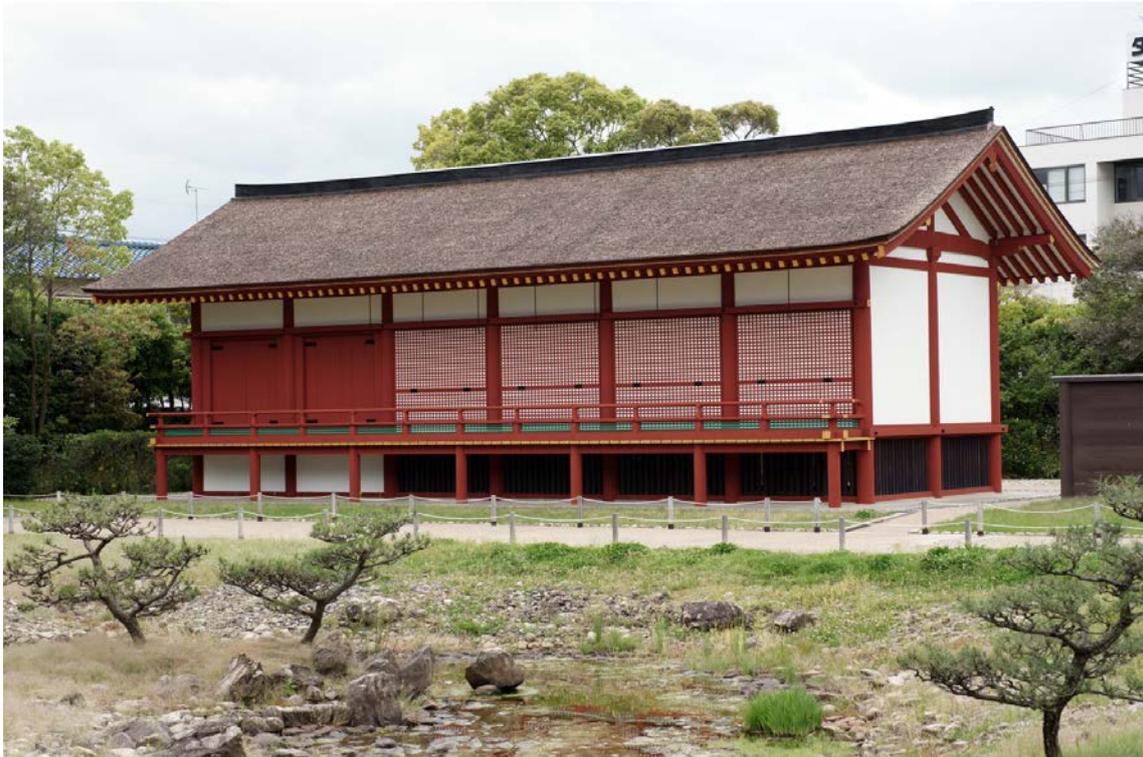
Reconstruction project undertaken during the period 2012-2013 (completely reconstructed building viewed from north-east. The pond in front of the building has not yet been completely reconstructed.)

During the period 2009 – 2011, implemented projects included repair of the reconstructed wooden fences, maintenance/improvement of garden paths, and outdoor-disaster prevention work. Then, from 2012 to 2013, the cypress-bark roof of the reconstructed building was re-thatched, and painting, repair of building fittings, and indoor-disaster prevention work were undertaken. Since 2014, repairs have been made to the pond, as well as repairing garden stones (i.e. “*Keiseki*” stones in Japanese).

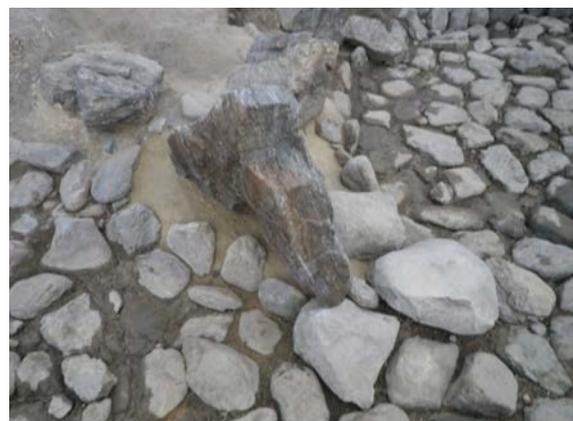
Setting of this ornamental garden stone has been changed after being reviewed through this repair/restoration work.

After all, in principle, the repair/restoration work is based on the policy to retain and use the original stones. It was decided that those garden stones, in need of reinforcement treatment are to be temporarily removed, chemically reinforced; and then, reinstalled in their initial positions. However, depending on the extent of the future degradation over time of the garden stones, the decision to replace them with alternative stones may become inevitable. To retain this historic site as a place of scenic beauty and historic site while maintaining both values, continuous monitoring of conditions of the pond as well as periodic maintenance are indispensable.

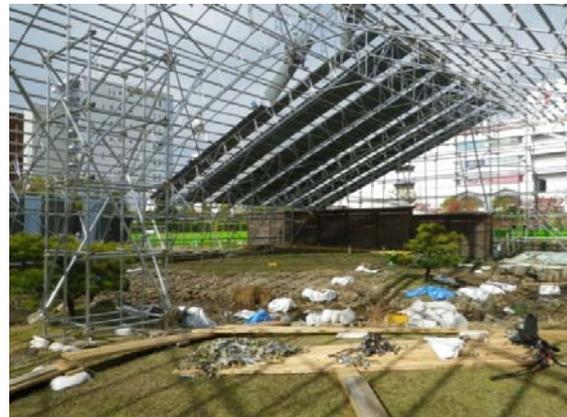
① The entire pond is covered with a scaffolding roof prior to repairs in order to protect the pond from wind and rain.

Furthermore, to prevent rainwater from flowing into the pond site as much as possible, an unlined ditch is dug to surround the pond site. However, to protect other structural remains still buried there, the digging depth is restricted to the surface of the remains.

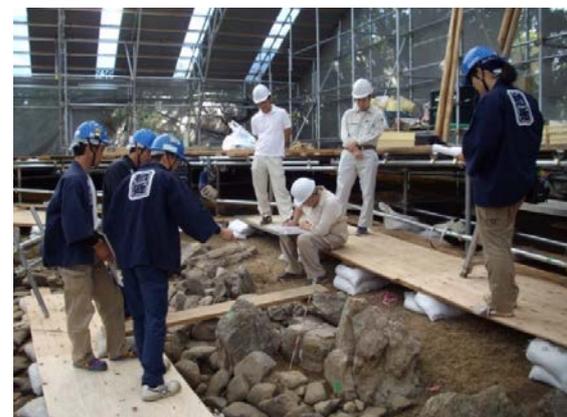
Staff members carefully check areas of the stones, carry out simulations to remove them, and consider the best removal method. At that time, the conditions prior to removal should be carefully photographed.

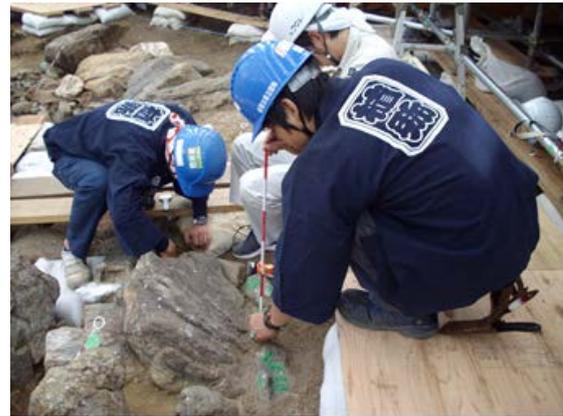
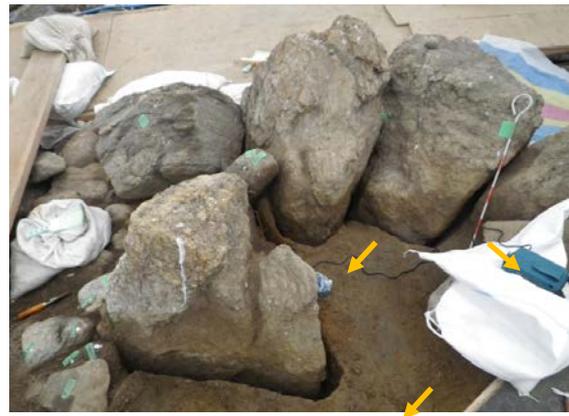
④ If the garden stones have an embedded footing, the surrounding ground is dug out before removing the stones (see arrow marks in the photo on the right). In so doing, it becomes possible to wind a rope even under the bottom of the stones for safe removal. However, as the areas to be dug are also a part of the structural remains, the digging range is restricted to the very minimum. This work progresses carefully, while making records including taking photographs.

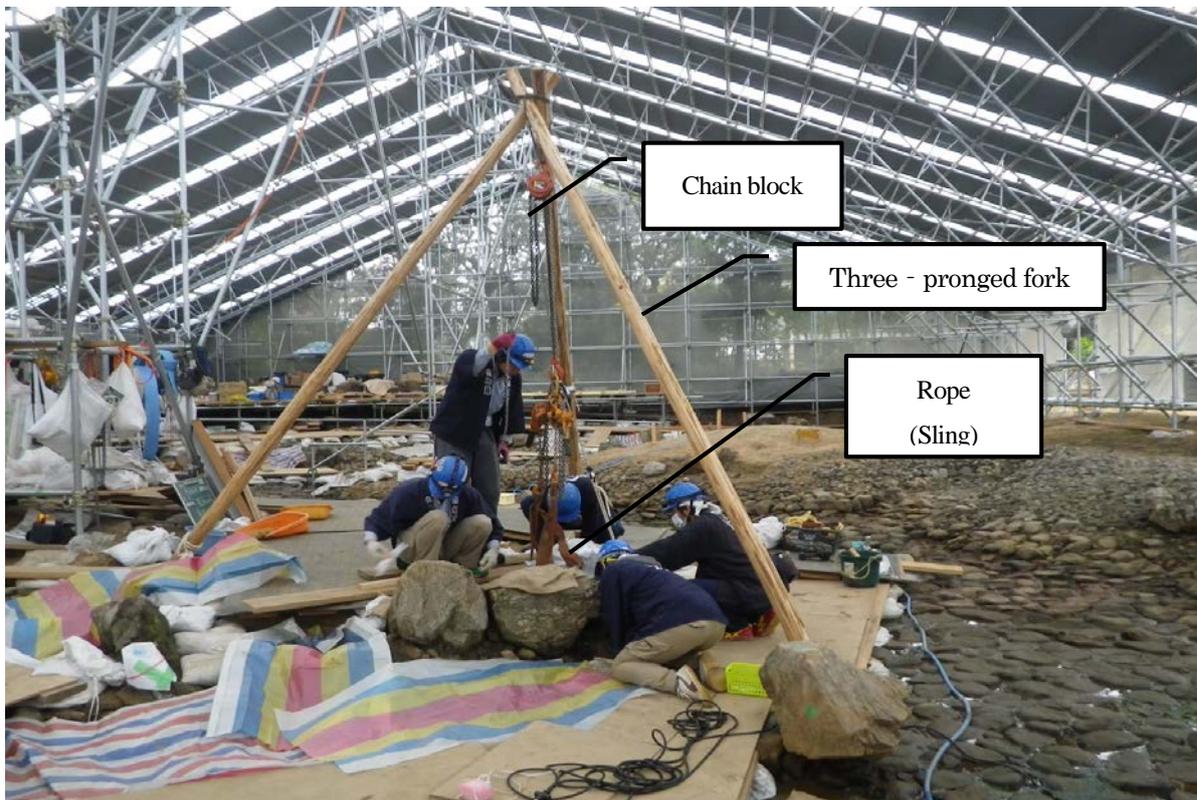
⑤ Workers use a three-pronged fork, chain block and ropes to remove the garden stones. The stones are firmly wound with ropes, and lifted using a chain block composed of a chain and pulley. Using this equipment, even a heavy stone weighing several hundred kilograms can be lifted by the workers.

Two staff members can lift a comparatively light stone,. However, if the stone is quite heavy, and depending on procures for removal, four to five staff members may be needed to pay close attention to prevent slippage and damage to the stone as well as to other structural remains.

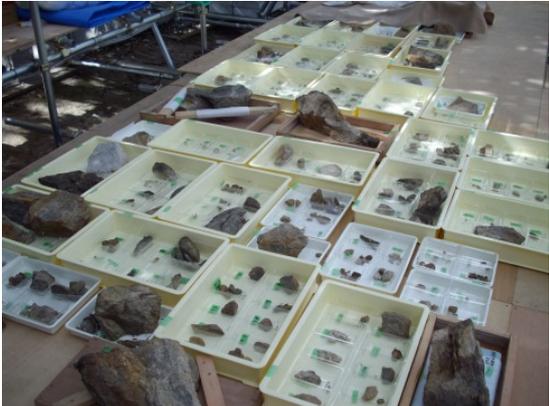
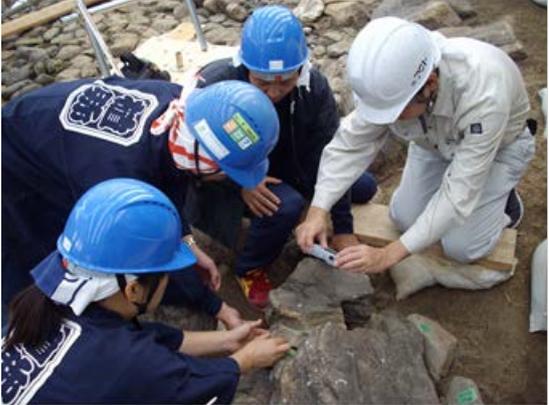
⑥ Some garden stones, parts of which were fragmented, are removed after photographing all of the fragments.

Some stones have in excess of 100

⑨ Fragments also undergo the conservation treatment, and are sorted according to the original stone. In order to restore the original stone, even small fragments are reattached as much as possible, according to the photos taken when it was removed (see ⑥).

The fragments above are attached piece by piece with a green label and photographed, when the fragments and stone are removed. Referring to such photos, the fragments are reattached.

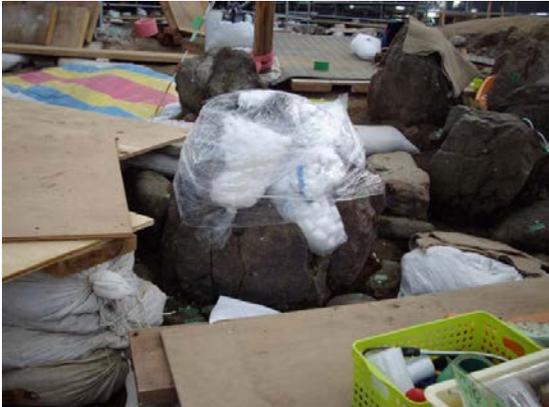
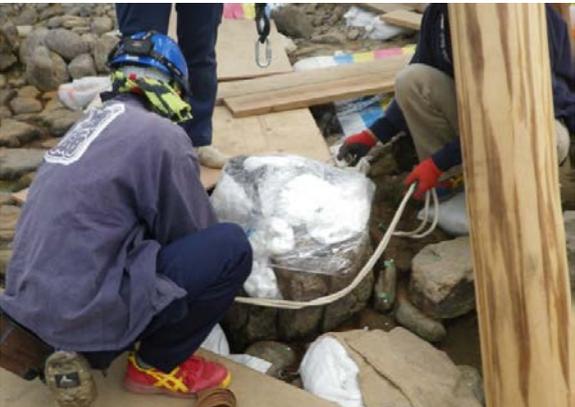
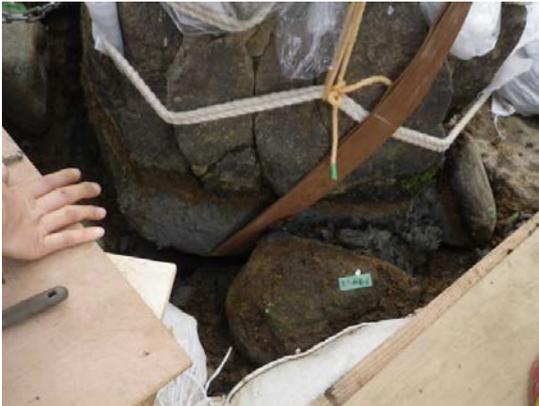
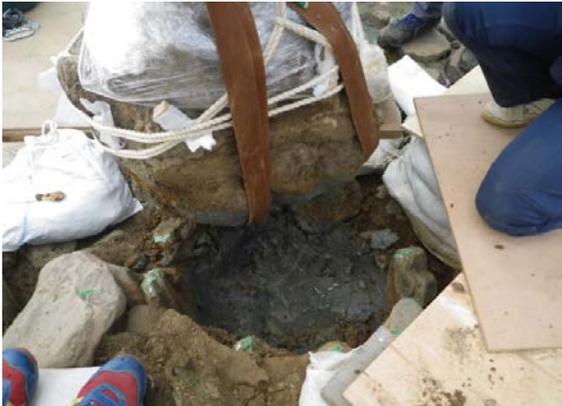
⑦ In case there is a crack on the surface of a garden stone, the crack is padded with buffer materials to prevent damage that could occur while removing the stone. To lift up a garden stone, firstly, the stone is wound around with a rope, which is tied with another rope. After lifting the stone slightly, belt-shaped ropes (slings) are fitted under the bottom of the stone to ensure the safety of the work. After that, the stone is carefully pulled out.

The portion of the lifted stone that was in contact with the ground is covered with plastic sheets, etc. until reinstallation after conservation treatment is applied.

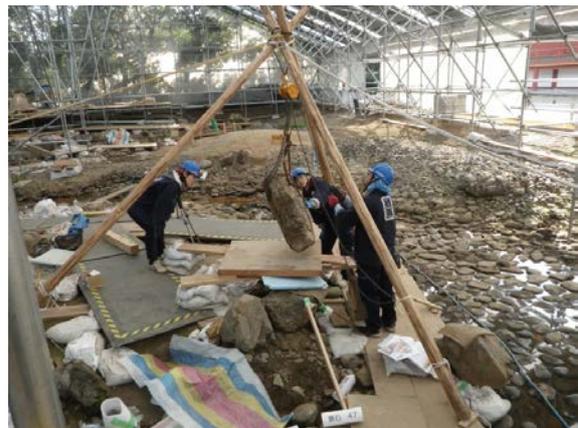
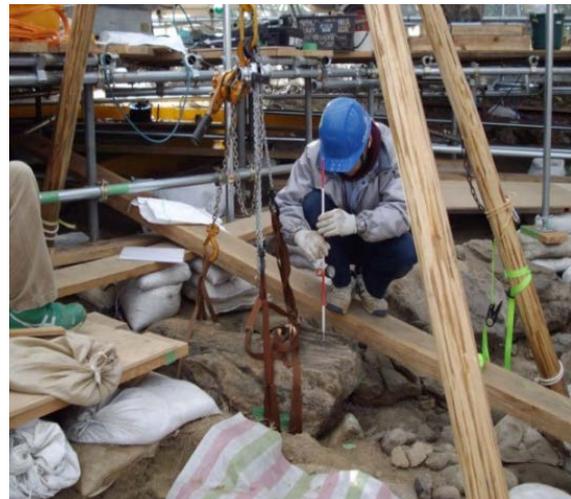
⑪ To reinstall the stones at their initial positions, a measurement survey is performed using the EDM instrument in the same way as during the pre-removal step.

In contrast to the procedure during removal, positional adjustment of the stones must be performed while concurrently carrying out the measurement survey. Measurements are performed repeatedly, while repeatedly slightly moving a stone hung in mid-air. A stone can be reinstalled precisely at the initial position when each measured point is set within one centimetre of the data indicated during measurements taken before removal.

If a stone is deformed through the step of reattachment (see ⑨), it is difficult to reinstall it in the initial position. In such cases, it becomes necessary to determine the initial position, comparing it with the position prior to removal shown in the photos.

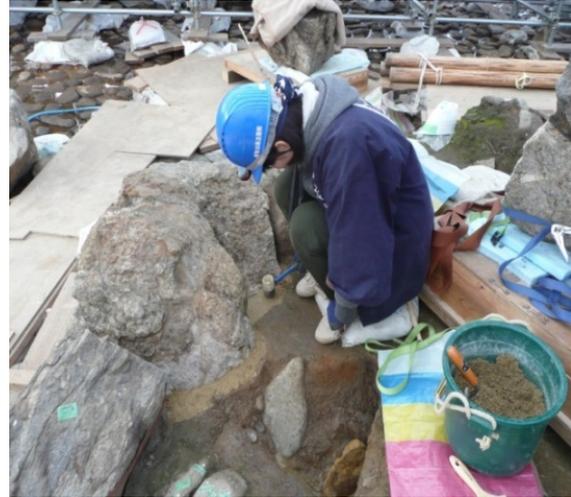
⑫ After reinstallation of the stones has been completed, the gaps surrounding the stones are filled with clay.

In some cases, the clay is filled into the gaps in parallel with the reinstallation operation while the stone is hanging in mid-air.

After everything is finished, the completion status is photographed.
