ACCU Group Training Course 2022

Case Study Reports

Problem and Needs for the Restoration, Preservation, Management and Utilisation of Wooden Built Heritage in India

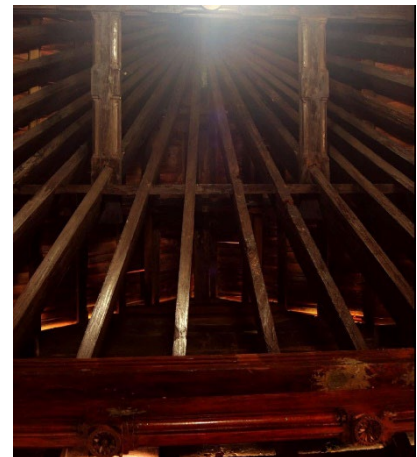
Figure 1. Open ceiling showing roof joinery details of a wooden structure in Kerala

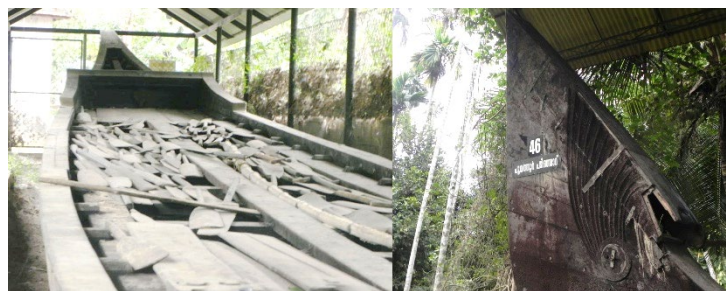
Figure 2. Traditional snake boats of Aranmula, damaged due to flooding

dampness in the wooden walls and cellars of 300-year-old Aranmula houses, and more than 40 percent of the *palliyodams* (wooden snake boats), which are part of the associated age-old tradition of the Valla Sadhya celebration and feast, were damaged. Floods also affected traditional wooden weaving equipment in Chendamangalam, a weaving village in southern Kerala.

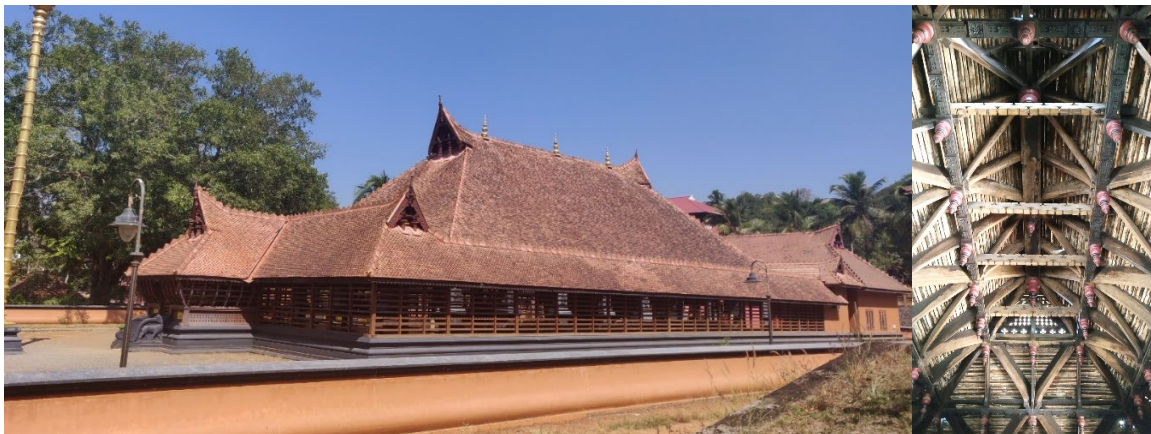
Figure 3. Koothambalams, traditional performance theatres of Kerala, and their timber roof joinery details

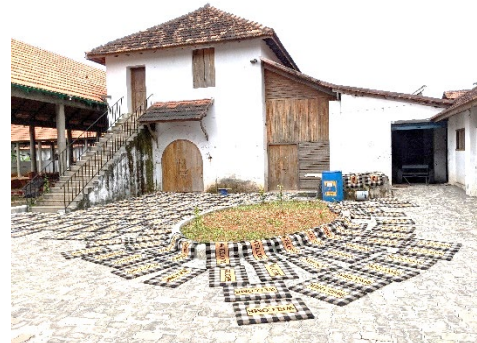
Figure 4. A coir (coconut fibre) society building restored under the Alappuzha Heritage Project

Economically viable approaches like adaptive reuse can be brought into practice through people's participation, which can also result in sustainable economic management. The Alappuzha Heritage Project and Muziris Heritage Project funded by the government of Kerala are examples of such economically reliant program initiatives.

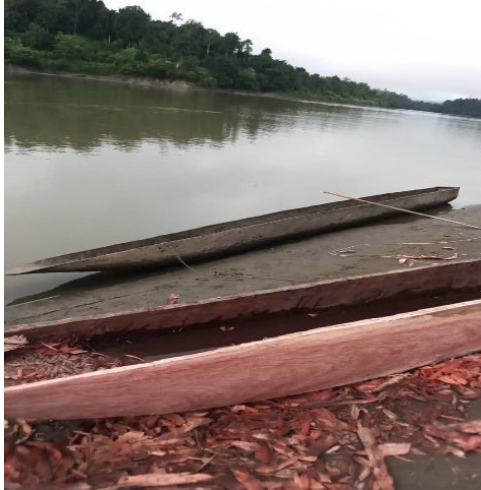
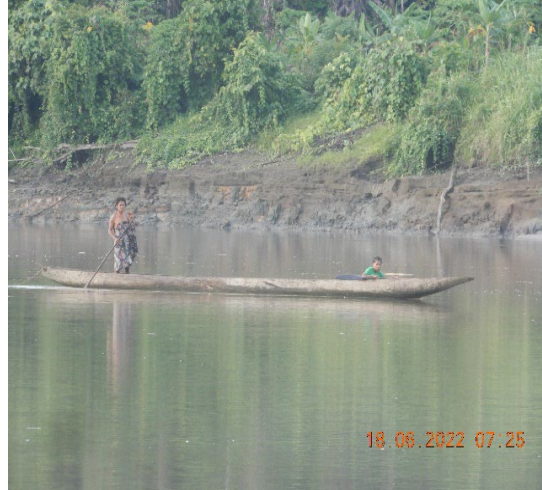
Figure 1: Two photos along the Purari River close to a village, Poroi 2. The left photo shows two canoes, one under construction (front) and the other in use. Photo by Yawan Alo. On the right is a woman with her son in a wooden canoe. Photo by Benjamin Leme, 18 June 2022.

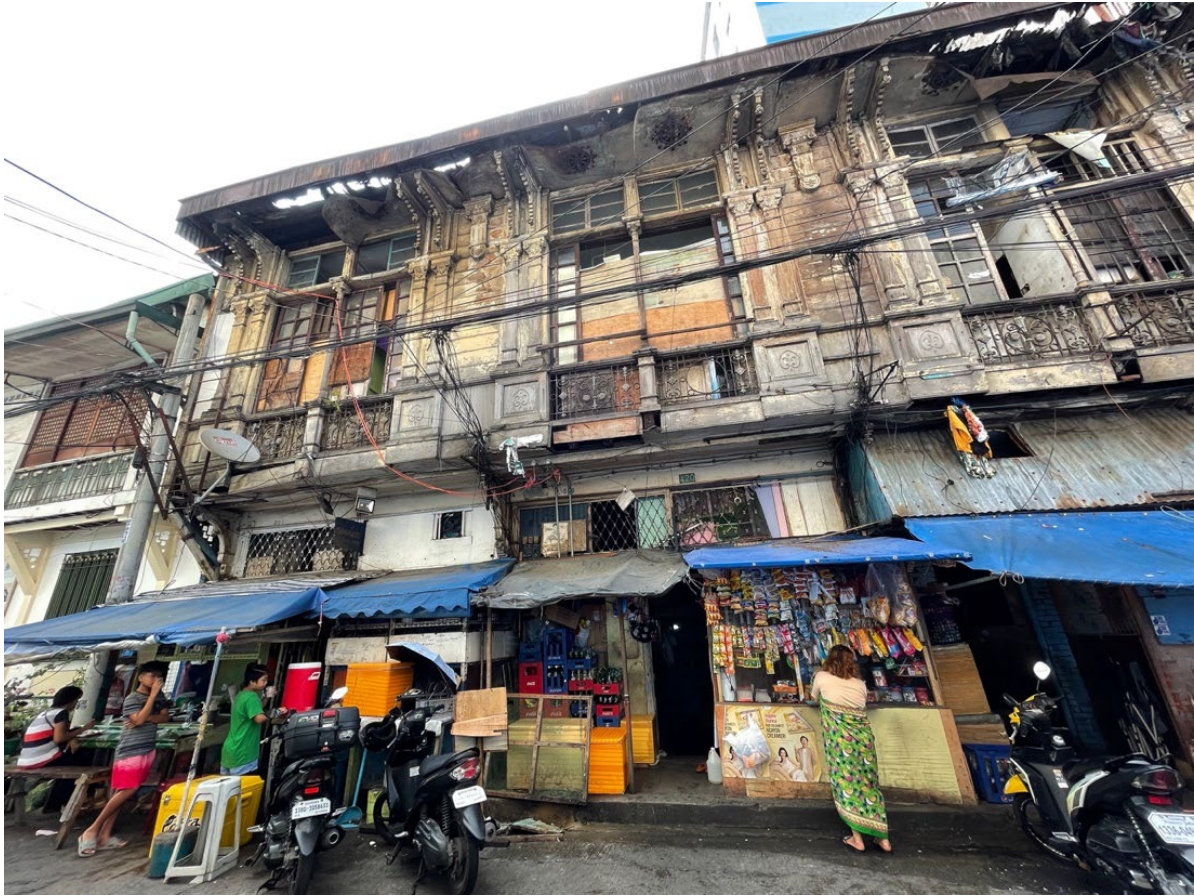
The Boix House in poor condition with informal tenants in Bautista St.

The *bahay na bato* were mostly owned by rich families during earlier times. While some have maintained their good fortune, others were not fortunate enough to keep the resources they had before and are thus unable to sustain the maintenance of the buildings. However, regardless of the ownership of the house, it is most likely that the maintenance will not go beyond minor repairs. The more expensive repairs such as leaking roofs, tilting posts, and rotting wood are likely to be postponed, as the residents may not be willing to shoulder the expenses alone (especially if they are not co-owners, or only have a small share in the building). Non-resident co-owners are likewise unwilling to share in the expenses as they, living elsewhere, do not benefit from the house. All these neglected repairs gradually contribute to the serious physical and aesthetic deterioration of the house. In the event of such unfortunate circumstances, stakeholders are unable to do the repairs necessary for preserving the integrity of the property. Some may resort to selling the property in order to cut their losses. The new owners may then demolish the property and sell the remains as antique parts. The grounds of the property are usually a prime location suitable for new commercial establishments which would give a bigger monetary return to the owner. These are some of the reasons that these Spanish colonial houses are decreasing in number. Another reason is the value of parts taken from the houses that thieves sell openly on the market as antiques. Houses without caretakers are being exploited and parts are taken if nobody is around. Lastly, due to its geographical location the Philippines is prone to tropical

cyclones, which generally produce heavy rains and flooding of large areas and also strong winds, resulting in the destruction of properties and especially these ancestral houses.

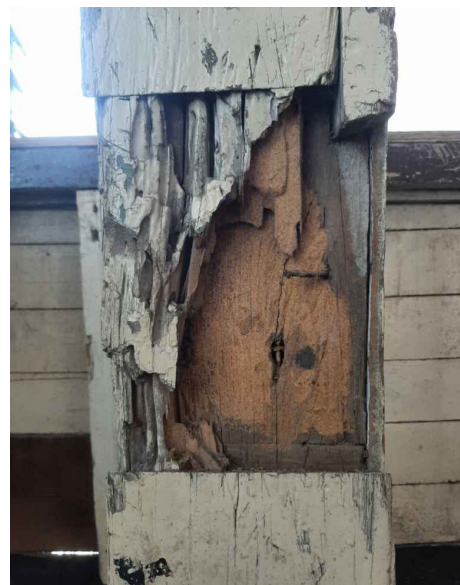
Figure 1. A wooden post in the Old Convent of Manaoag Church showing damage and loss of material. (Photo courtesy of Escuela Taller de Filipinas Foundation, Inc.)

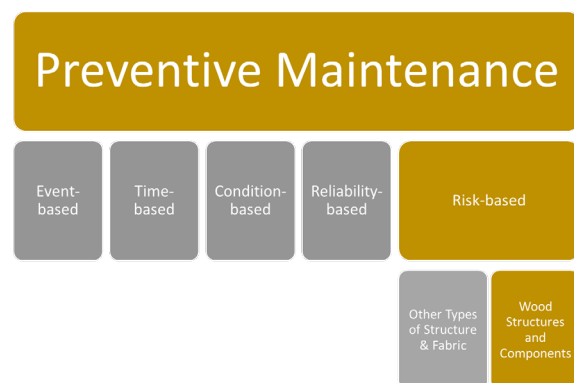
Figure 2. Diagram showing the approach in preventive maintenance. Highlighted items shall be the focus of this study—risk-based preventive maintenance focusing on wooden structures and components.

This study intends to utilize the various concepts in preventive maintenance in developing a guide for wood preservation, but with an emphasis on risk-based maintenance that prioritizes resources for elements that have the highest risk. The choice of risk-based maintenance over other forms or methods (such as event-based, time-based, condition-based, etc.) is primarily motivated by its nature of being economical. By having a risk-based approach in preserving wooden structures and components, maintenance resources (funds, technicians, materials, etc.) are efficiently utilized based on the greatest risk if the structure or component were to fail. Although this study shall focus on wooden structures and components, it should be noted that it should be a part of other similar guides addressing other types of structures or building materials.

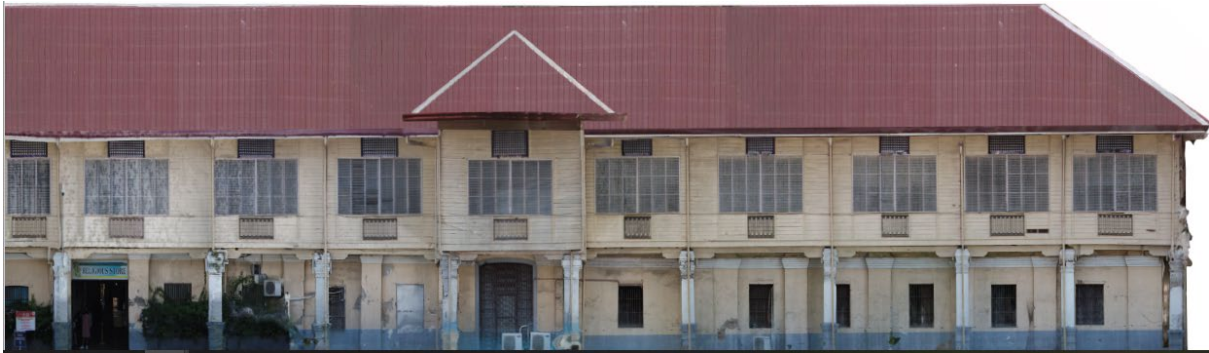
Figure 3. A rectified photo of the front side of the old convent of Manaoag Church. (Photo Courtesy of Escuela Taller de Filipinas Foundation, Inc.)

The structure that will be the subject of this study is the Old Convent of Manaoag Church. Typical of convents built during the Spanish colonial period in the Philippines, the building is composed of a masonry wall at the ground level and a second level made of wood. The building, which has been reused as a school, has been recently evacuated due to its deteriorating state, which presents health and safety risks to the users. The old convent was chosen for this case study of developing a preventive maintenance guide due to the presence of components that can also be found in other heritage structures in the Philippines that extensively use wood as a building material.

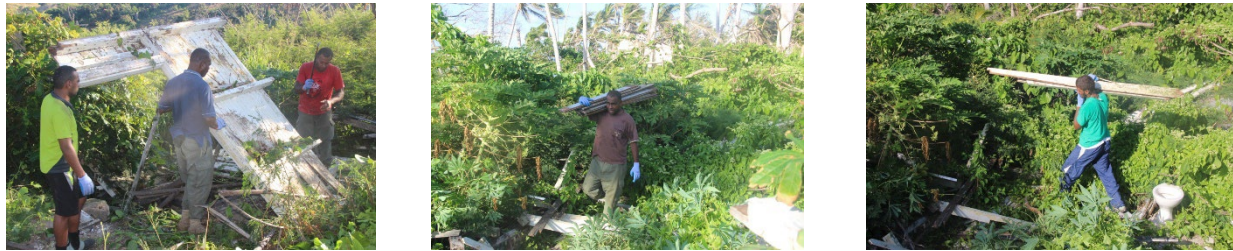
Dismantling the building structures. Images credit: Fiji Museum

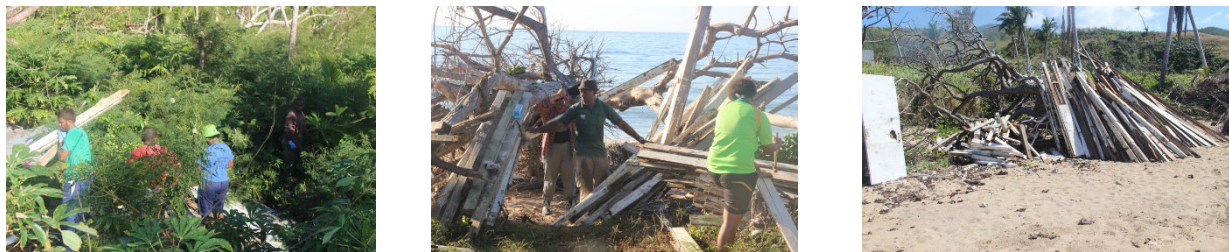
Team lifting the timbers from the site to the beach front; team stacking the timbers according to their sizes and extracting nails. Images credit: Fiji Museum

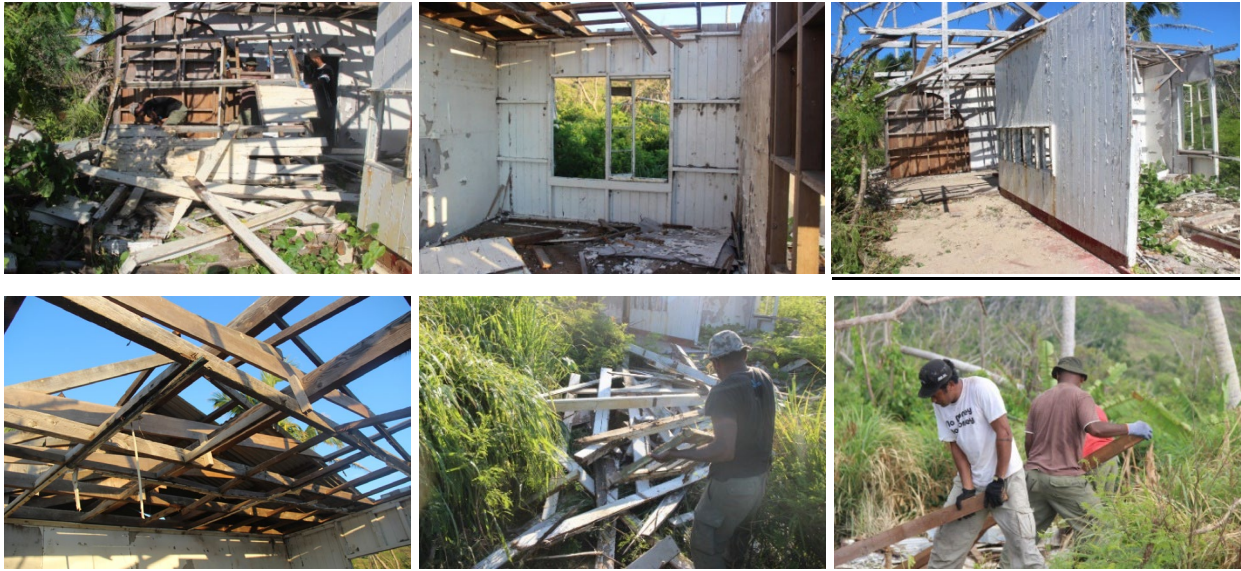
Site B – Nasau

Site B building structure. Images credit: Fiji Museum

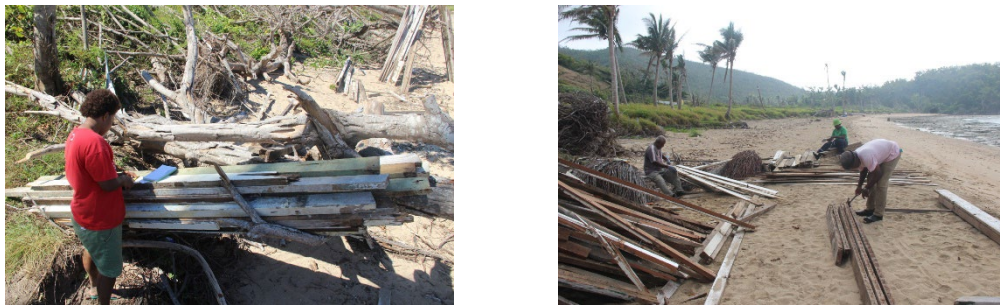
Measuring, extracting nails, piling the timbers according to their sizes. Images credit: Fiji Museum

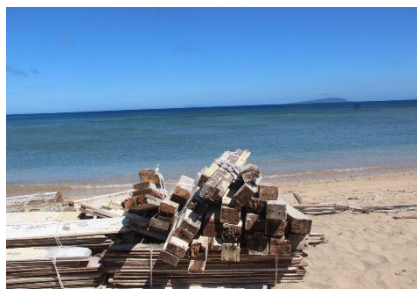
The salvaged materials ready for loading. Images credit: Fiji Museum

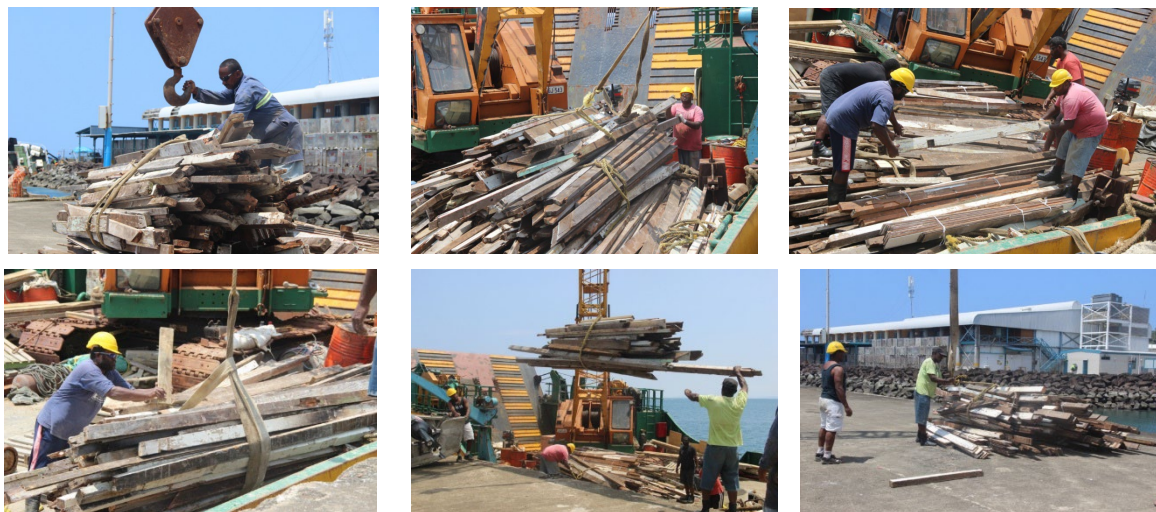
Off-loading at the Levuka wharf

The team was assisted by the *MV Vunilagi* captain and crew with the Public Works Department workers.

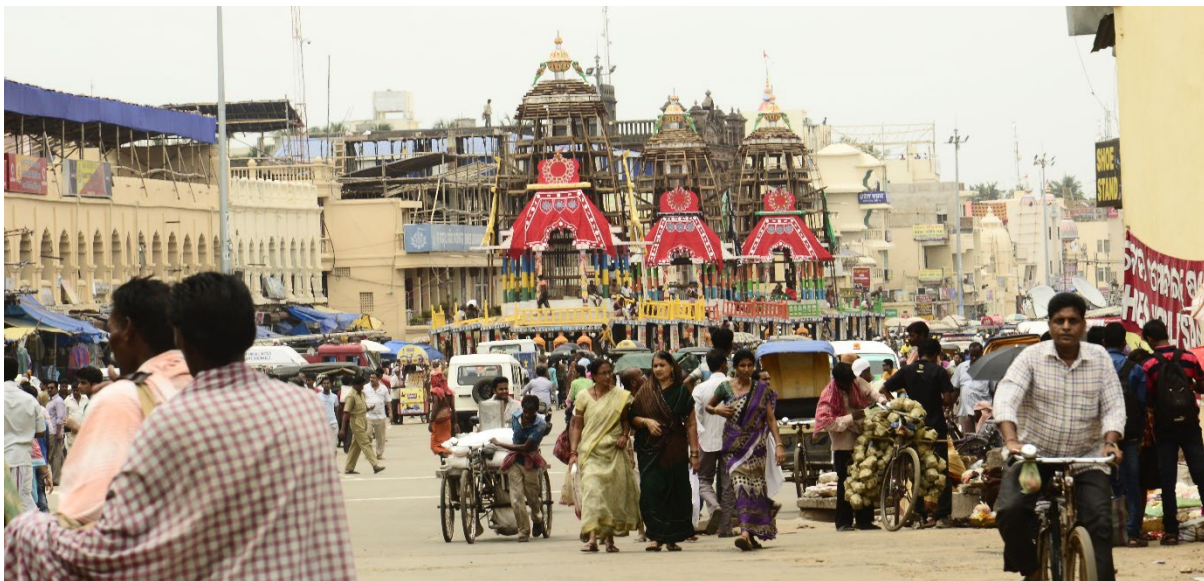
Image 5. Construction of three chariots on Grand Road of Puri, during the Nabakalebara festival, 2015

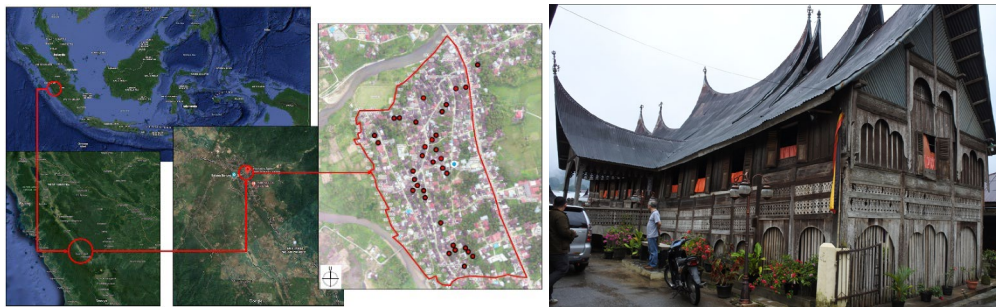
Picture 1. (left) Area map of the location of Saruga on West Sumatra Island, Indonesia, and the distribution of 32 rumah gadang selected in the revitalization program in 2018, from 104 buildings. Base map source: Google Map, 2018; combined by PDA, 2018

Picture 2. (right) Front façade of a rumah gadang. Source: PDA, 2018

In 2018, the Ministry of Public Works initiated the Saribu Rumah Gadang (Saruga) Area Revitalization Project because there was a need to adapt the existing unused *rumah gadang* for the purpose of tourism as designated for the area. *Rumah gadang* is the vernacular house of the Minangkabau people in the West Sumatra region, known for its *bagonjong* (horned-shaped) roof and raised platform floor. Saruga is a traditional Minangkabau settlement, located in the Solok Selatan Regency in West Sumatra. As of 2022, Saruga has the largest number of original *rumah gadang* houses and the least amount of disaster risk settlement area in West Sumatra. It is also a settlement with the most diverse families living together, whereas one or two families occupy most traditional villages; thus, it has almost every type of *rumah gadang*, albeit smaller than the ones in their original locations.

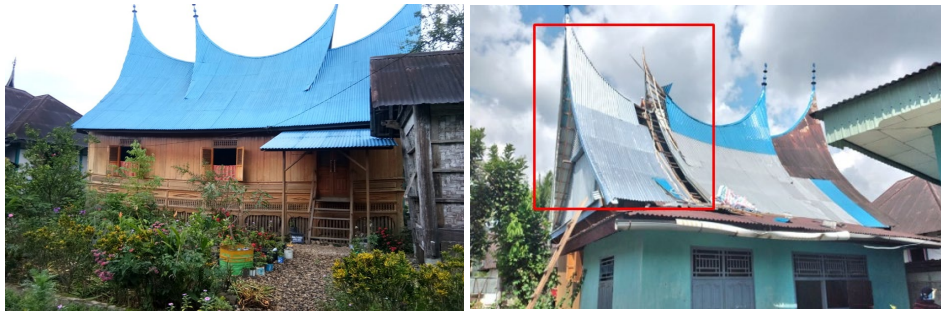
Picture 5. Bagonjong roof that is supposed to be smoothly curving. Source: PDA, 2018

Picture 6. The segmented bagonjong of the same rumah gadang as above. The photo does not noticeably show the segmentation due to the bad angle and reflective light. Source: Directorate General of Human Settlement, Ministry of Public Works, 2020

There were some decisions that the ministry took based on the conservation management plan and the professionals' suggestions. One of them was to employ local craftsmen or *tukang tuo* in the Minangkabau language and local laborers for the entire construction process. At the time, only one elderly *tukang tuo* was residing in Saruga, so he was open to the suggestion of recruiting *tukang tuo* from other areas in West Sumatra. The problem stemmed from local laborers who demanded to work only with Solok Selatan Region's *tukang tuo* and laborers. They strongly rejected anyone from other regions. This ended with the contractor finally complying with the laborers because no middle ground was achieved and they were under the pressure of the construction deadline. The noticeable outcome was the segmented *bagonjong* roof, which was detrimental because it was one of the most significant valued elements of *rumah gadang*. This happened

because the laborers lacked the necessary skills to create the traditional *rumah gadang*, and the *tukang tuos* could not keep up the pace needed to teach every worker the correct craftsmanship.
