ACCU Training Reports 2019

Cultural Heritage Protection in the Asia-Pacific Region

- Documentation, Conservation, and Utilisation of Museum Objects
- Conservation and Management of Wooden Structures
- Photographic Techniques for Cultural Properties

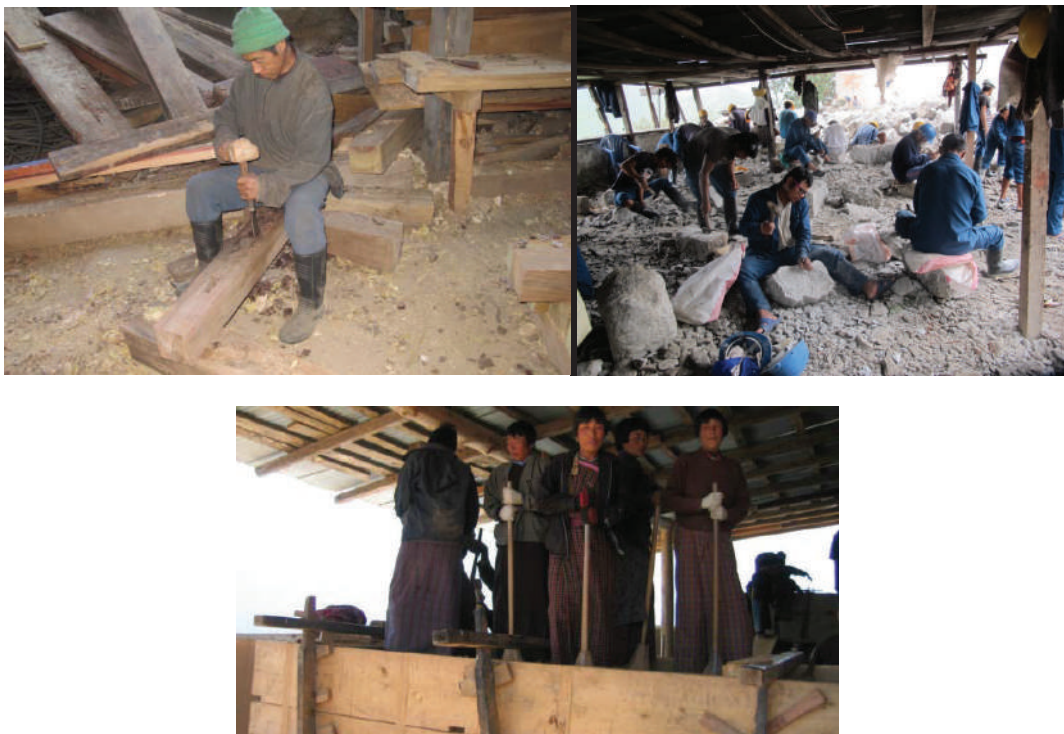
Fig.2 Carpenter working on traditional joinery detail (top left); masons dressing stone (top right); women ramming earth (above)

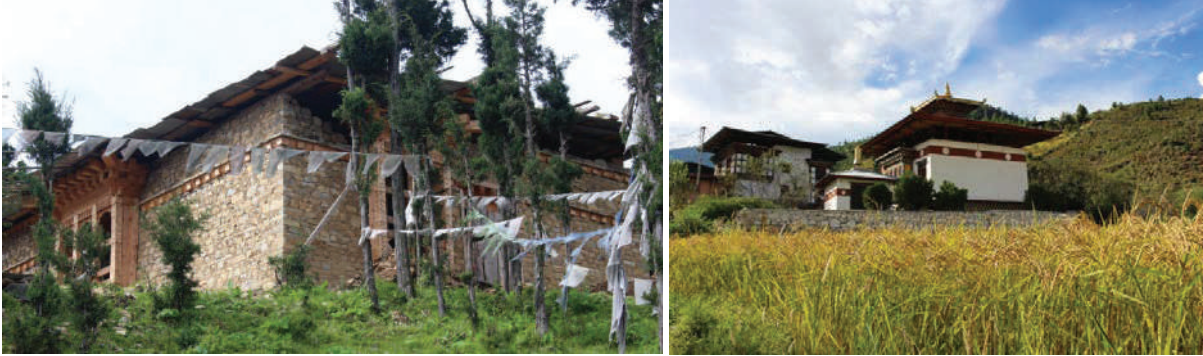
Fig.4 Reconstruction in progress (left) and major alteration to the design (right)

This analysis of the perspective of the owners and community reveals that their consideration of heritage value is solely from a religious/spiritual point of view. The spiritual value associated with a heritage site is one of the important values of the site but not necessarily the only value. At some of the sites, the historical relevance of the structure was paramount, but through reconstruction traces of the original form have been completely erased, thus losing one of the essential values of the site. The relevance to the community and stakeholders is also an important criterion for the management of cultural heritage, but should not be viewed as contradicting the heritage value, and if possible the process of protection should seek to align such relevance with the value of the site.

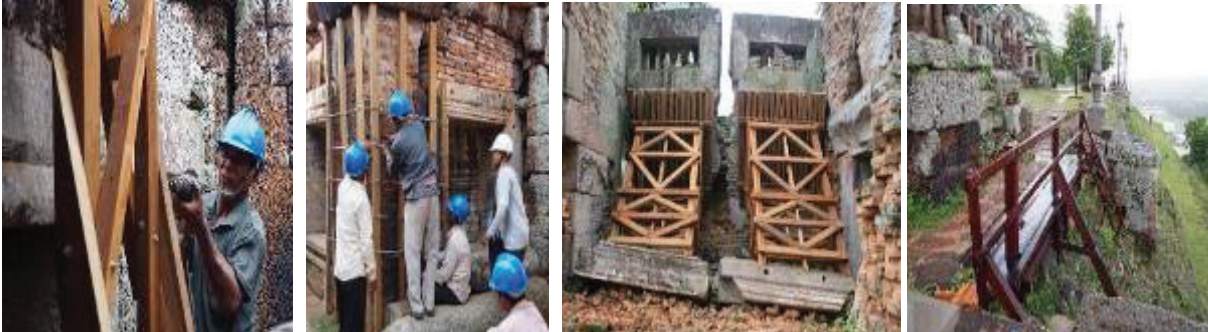
Fig.16–19 Emergency work on monuments

In the meantime, emergency work for the preservation of monuments and old buildings at pagodas and other heritage sites has been maintained by increasing police, guards and security personnel on a more regular basis.

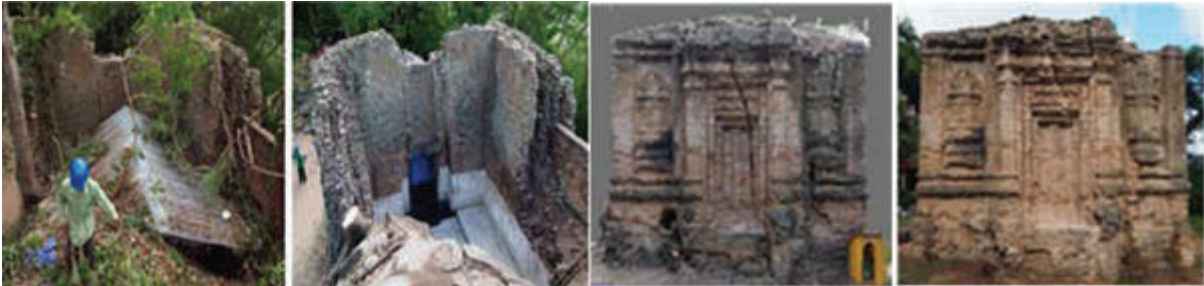
Fig.24–27 Monuments before and after restoration

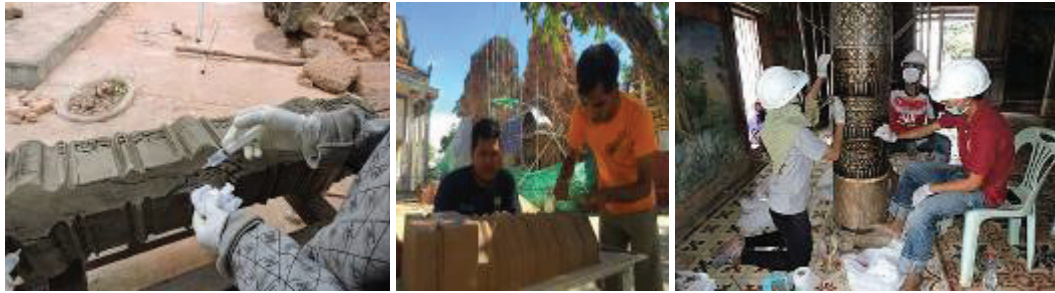
Fig.31–33 Stone decorative conservation and transformation

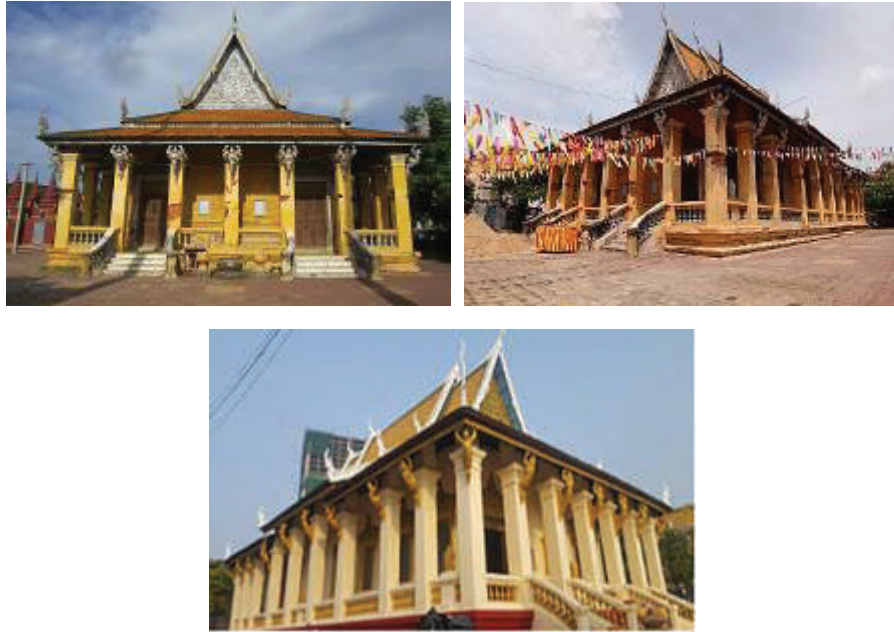
Fig.34–36 Vihear before and after restoration

Without proper maintenance, Vat Chen Damdek Khang Choeung Monastery was severely damaged, and the causes of the damage were structural changes, building life expectancy, lack of moisture maintenance, and especially pest damage.

- Human factors: The monks do not pay much attention to the heritage value of the old vihear.
- Natural factors: Weather, rain, sun and humidity have damaged the structure of the vihear in many places, such as the outer pillars and parts of the walls. Many parts have been damaged.
- Insect/pest factors: Among insects, termites are the most destructive, with the roof of the vihear completely eroded from termite damage.

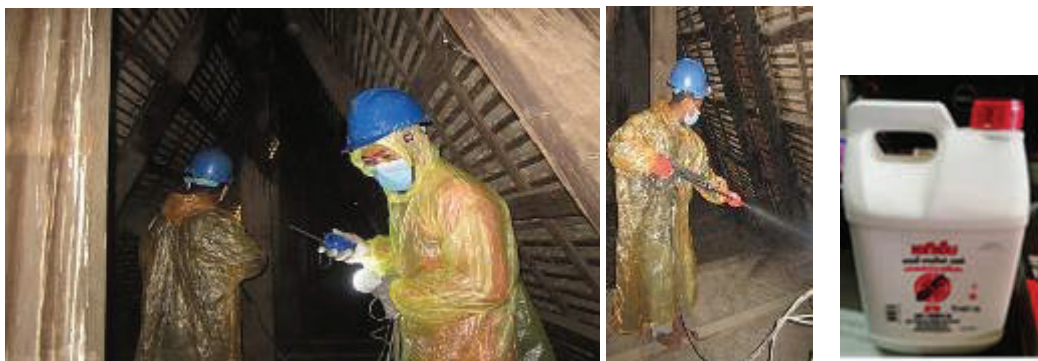
- Removing termites: Termites are destructive to the structure of the vihear.

Fig.37–38 Removing termites from the wooden structure
Fig.39 Poison for removing termites

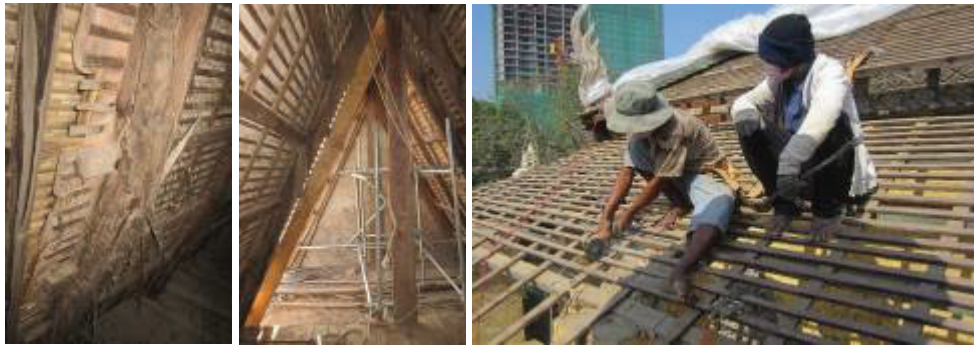
- Restoration of roof accessories and ornaments

Fig.40–42 Repairing the damaged wooden structure of the temple

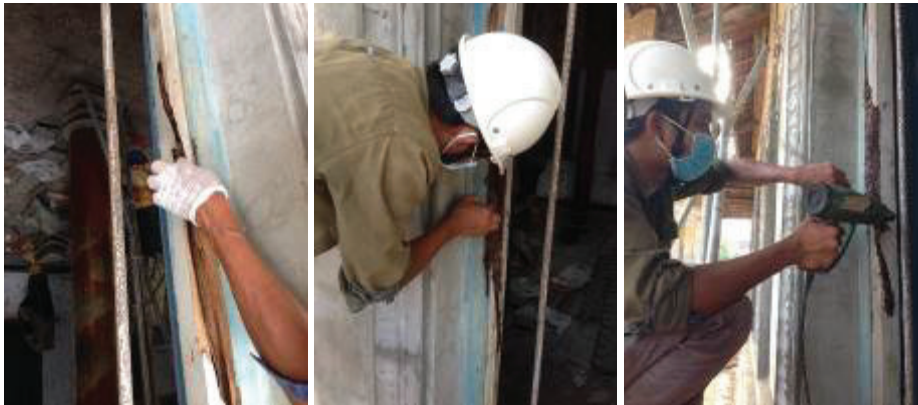
- Restoration of wooden structures destroyed by termites: Reinforcing with wooden supports of damaged and corroded portions (door frames, window frames, roof top).

Fig.43–45 Restoring wooden portions destroyed by termites

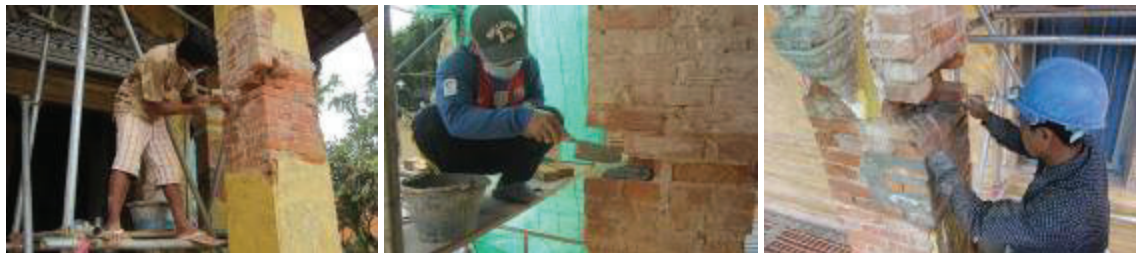
- Restoration of brick pillars: Pillars damaged by natural factors (rain, sun, time...).

Fig.46–48 Repairing brick pillars

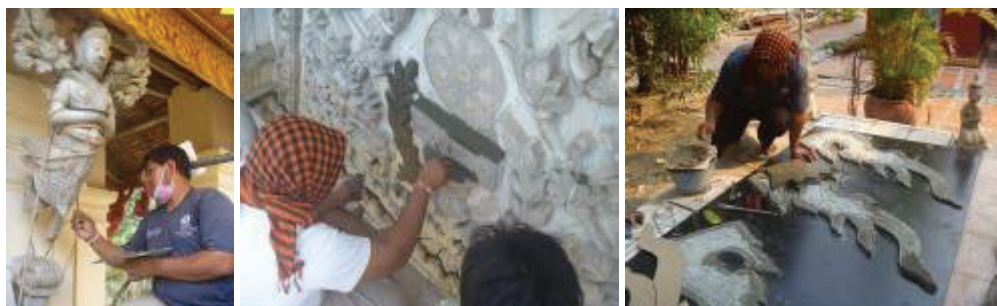
- Repair of sculptures: Most of the sculptures and ornamentation needed repair.

Fig.49–51 Sculpture repairs

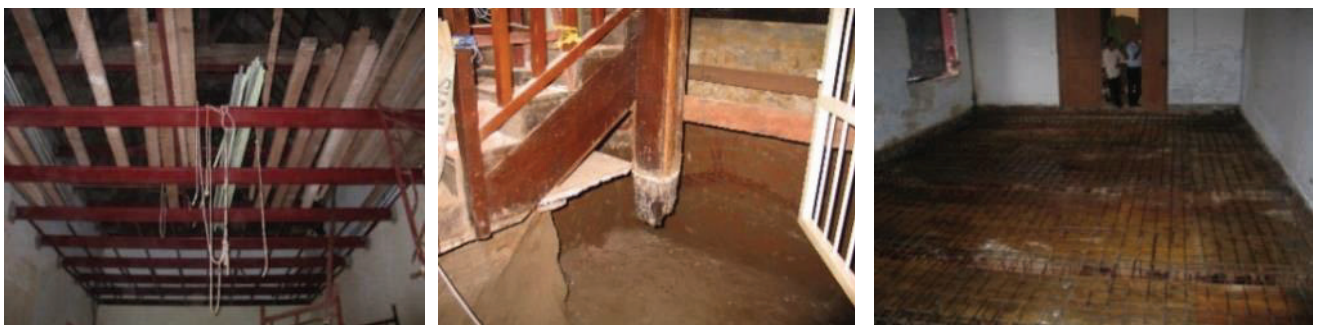
Fig.4 Renovation of the exhibition hall in 2006 (©NMC)

In 2006, through cooperation between the Ministry of Culture and Fine Arts of Cambodia and the French Embassy in Cambodia, a portion of the galleries (Exhibition Hall B) was renovated, with tiles of the floor removed and restored again (Fig. 4), and an old painting on a window repainted (Fig. 5).

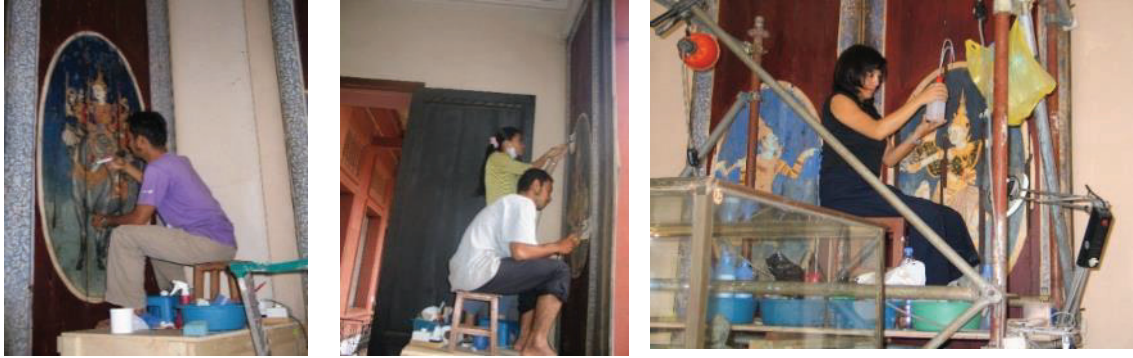
Fig.5 Repair and repainting of a window of the National Museum, 2006 (©NMC)

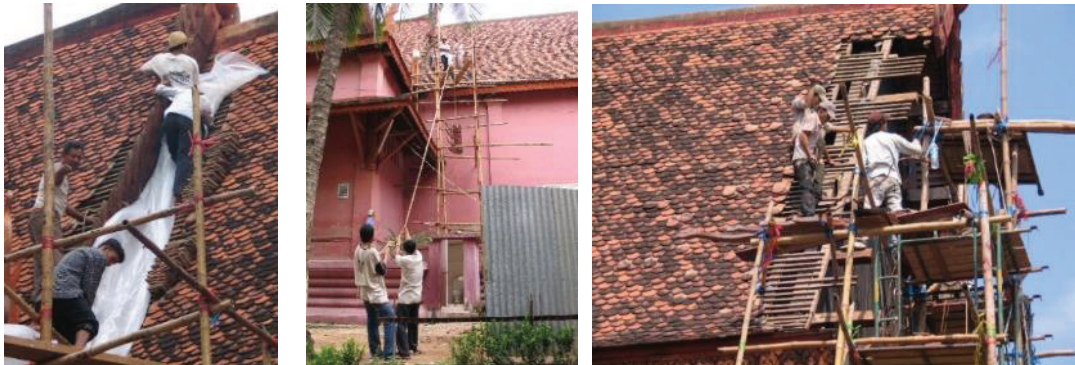
Fig.6 Repairing the roof top, 2008 (©NMC)

In 2008 part of roof was repaired with funds from the national budget. This time the focus was not so much on the structure of the roof but on portions of the roof top, such as part of the tile roof and its ornaments (Bos Sbok, Neak Dang Kda, etc.) and the top of timber structure (Fig. 6).

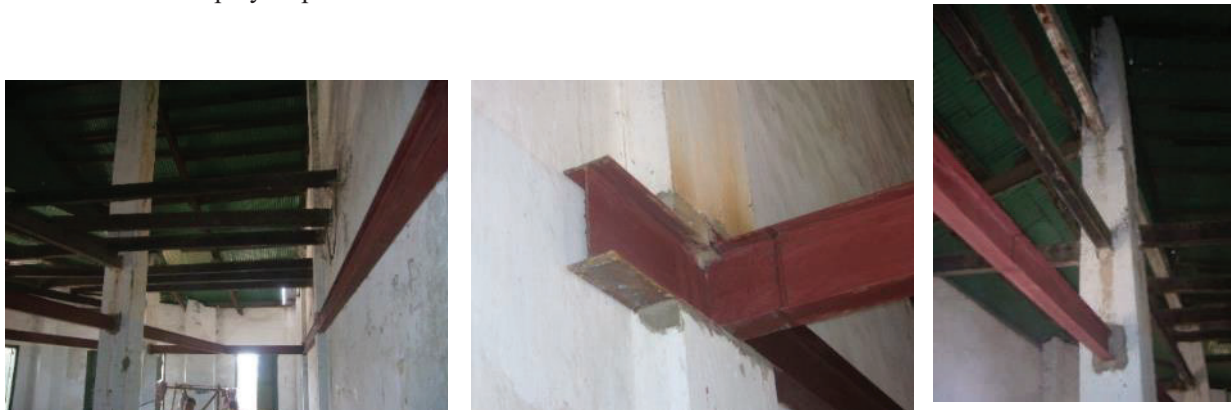
Fig.8 Stabilizing a structure to be dismantled, colonial building in Kampot, 2014

Renovation of a colonial house on a list of UNESCO or culture heritage buildings is not easy, as we have to keep it in the same older style. We can change to a functional floor plan but the building elevation has to keep the current appearance. Accordingly, before renovation or conservation, a record of the existing state is required. This work needs to be careful for all steps, first checking the existing site and old photographs of the building before renovating, then measuring to draft extant plans, observing all structural deterioration of the building to determine what parts should be removed or reused or restored. If the structure is still strong or there is no damage it is better, but if parts of the structure must be removed it is a big problem, as we have to find some technique to stabilize the structure before it is dismantled (Fig. 8). Dismantlement should be done step by step.

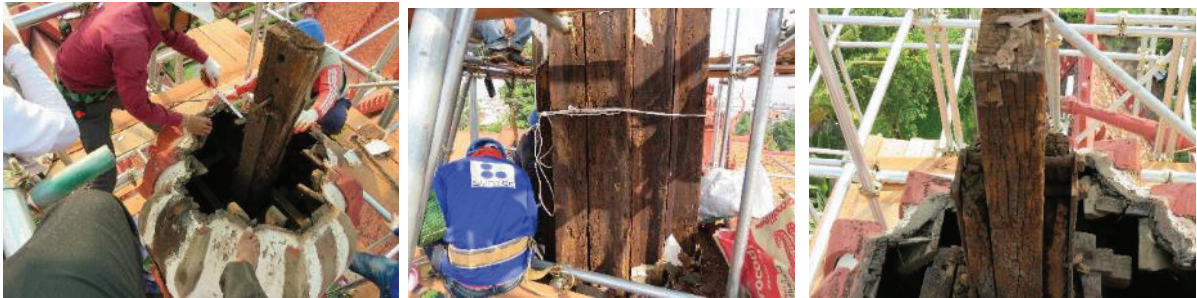
Fig.9 Dismantling an ornamental structure of the roof top (Bos Sbok) 2018 (©NMC)

This describes the techniques used in conservation of the roof top and ornaments of the Museum building. Site preparation is an important step when starting construction. After the site is prepared, taking photos before dismantling and then checking and noting the order of dismantling the structure is needed for restoration. Then removal and repair or replacement of damage can proceed (Fig. 9)

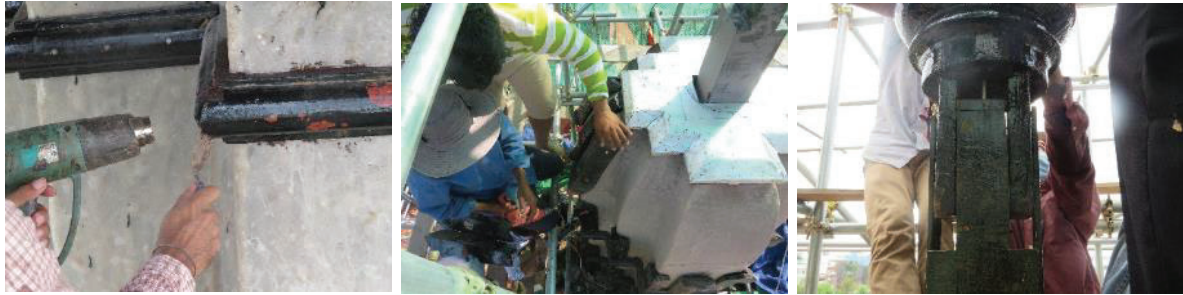
Fig.13 Restitution of the roof top of the Museum building 2018 (©NMC)

The last step is restitution of the structure. This step should carefully follow the reverse order of the dismantlement (Fig. 13).

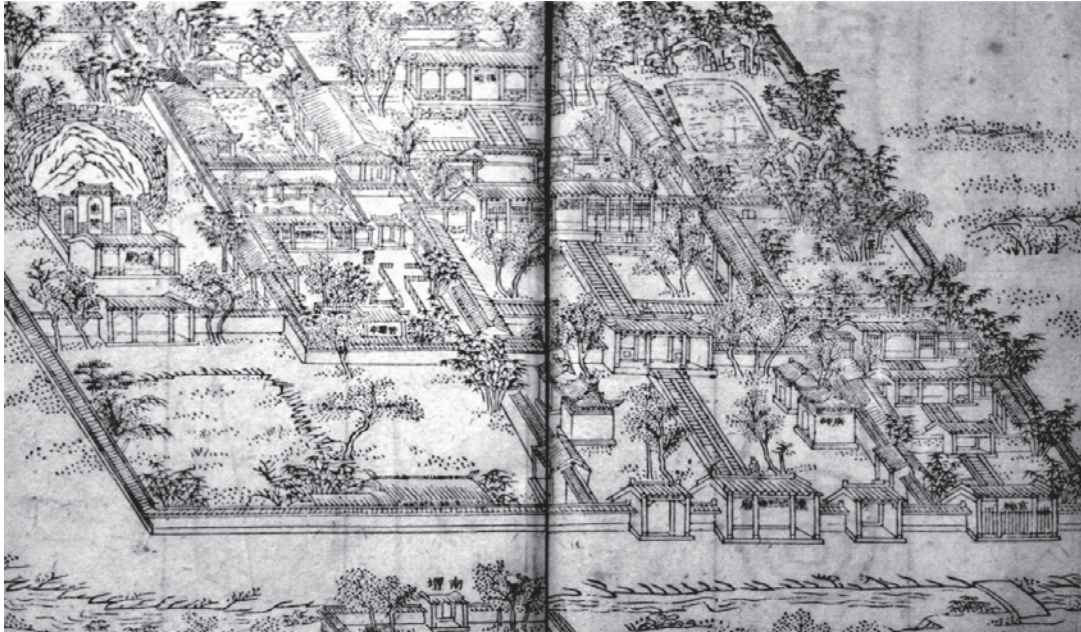
Figure 2. Layout of Wuhouci during the Daoguang years of the Qing dynasty

In 2017 I started to work on a renovation project in Wuhouci, Chengdu, China. Wuhouci dates back to 223 AD, during the Three Kingdoms period (220–280 AD). It consists of the mausoleum of Liu Bei, the emperor of Shu Kingdom, and the memorial halls for him and his most revered prime minister Zhuge Liang. The original buildings of the Three Kingdoms period are completely gone. Because Zhuge Liang was widely known for his outstanding wisdom, war strategies, and most crucially, his loyalty towards his emperor, he became an exemplary figure throughout Chinese history. Many emperors from succeeding dynasties spent considerable sums of money for renovation and expansion of the memorial for people to commemorate Zhuge Liang. The current layout mostly preserves that of the Daoguang Emperor (1821–1850 AD; Fig. 2), with all of the buildings rebuilt in the Qing dynasty.

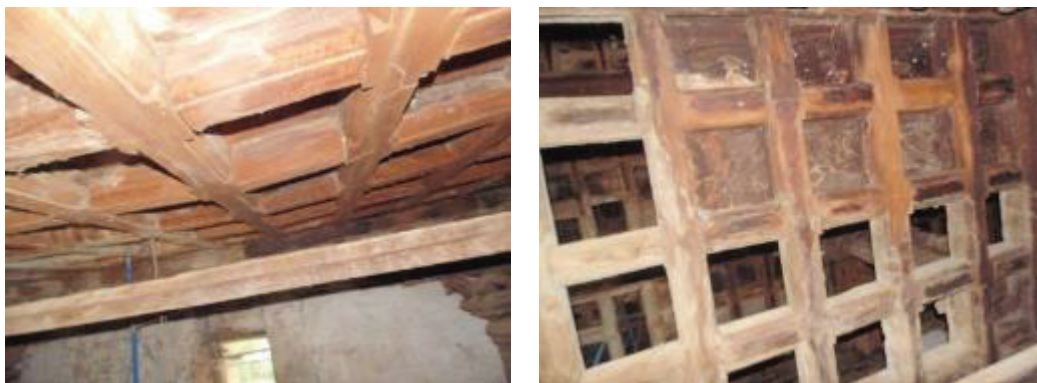
Figure 3. Timber ceiling components showing excess vertical deflection and missing panels

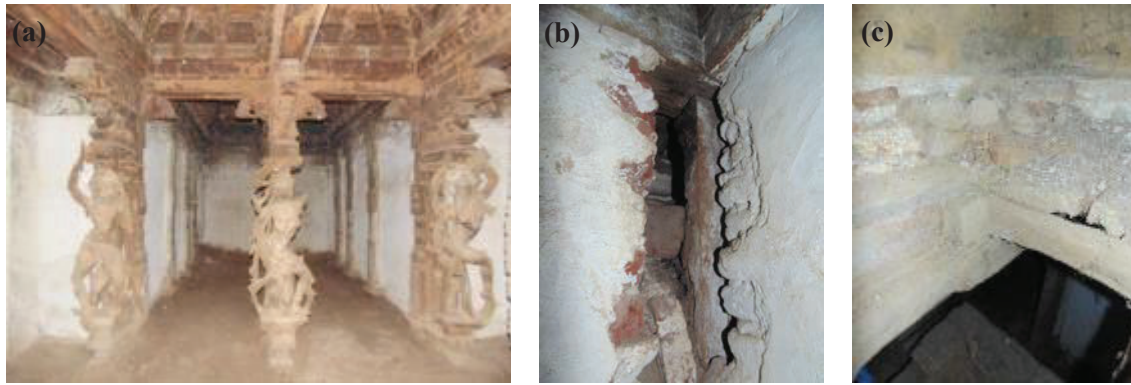
Figure 4. Sculpted columns and timber members embedded in the masonry

The timber post-and-lintel system in the upper floors has some members embedded in the masonry. Due to damage to the masonry or dampness these vertical posts and the horizontal members in the flooring also show various signs of deterioration.

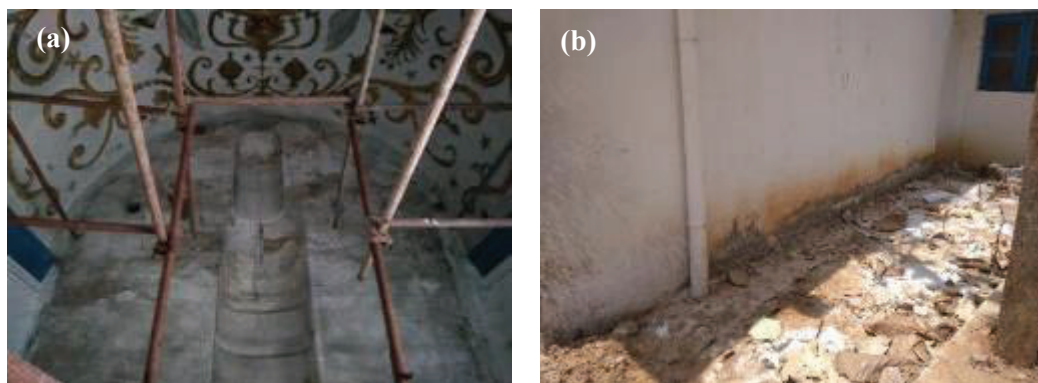
Figure 8. (a) The altar after removal of the wooden panels, and (b) the exterior wall of the altar

The exterior of the altar (Fig. 8b) has no plinth protection, and stagnated water has caused dampness to rise in the walls, the trapped moisture in the plastered masonry being detrimental to the structure.

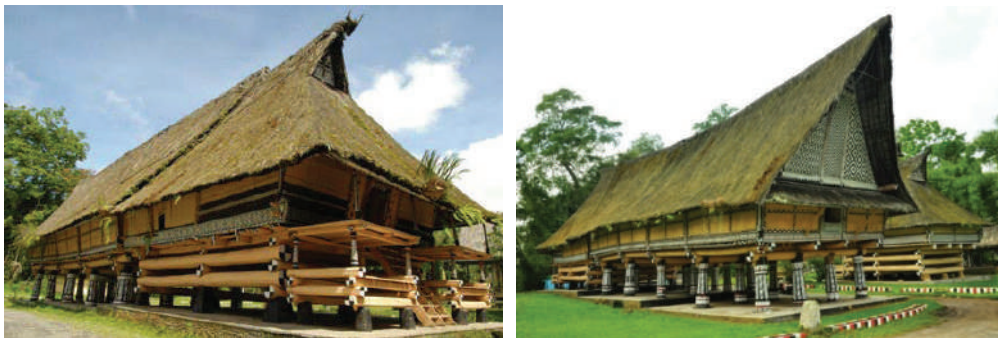
Fig.1 Bolon house, front view (left) and rear view (right)

A Bolon house is a traditional house of the Batak tribe of North Sumatra. The term *Bolon* means “big,” so it was a palace or residence of Batak leaders in the past and at the same time a symbol of the social status of the community. A Bolon house is a building constructed with a large stage-like floor which is a characteristic of the Proto Malayan race, such as the Minangkabau Gadang house, the Kalimantan longhouse, and the Tongkonan Tana Toraja of South Sulawesi. A Bolon house is a building assembled without using nails. The construction system uses bonding with mortise and tenon joints, and also notch joints.

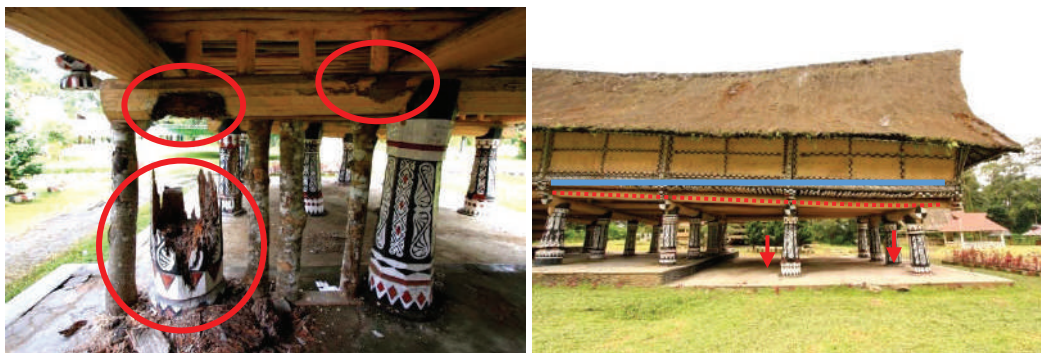
Fig.5 Material and structural damage in the Bolon House

Other damage that is very substantial was structural damage. In the Bolon house there was vertical deformation from front to back, as the rear columns were increasingly sinking into the ground. This was due to the presence of moisture and water saturation conditions in the subgrade so that the carrying capacity decreased and could not function as a grading and load receiver. Therefore, the columns had become deformed so that there was a deflection in the *galang* beams, causing the wood to bend and resulting in fractures. Other structural damage was the occurrence of dislocation, namely changes in the positions of components due to shifts in the directions of the x-, y-, or z-axes. Such damage had occurred in almost all connections between the columns and the *galang* beams, which are the meeting points that must withstand vertical or horizontal loads in the form of shear forces. The occurrence of such deformation and dislocations made the loading less than ideal. As a result, some of the wooden members had broken at the edges. Some small *galang* beams, which are beams under the floorboards, are also prone to this structural damage, and had broken. This is because these beams are subjected to compressive and tensile loads.

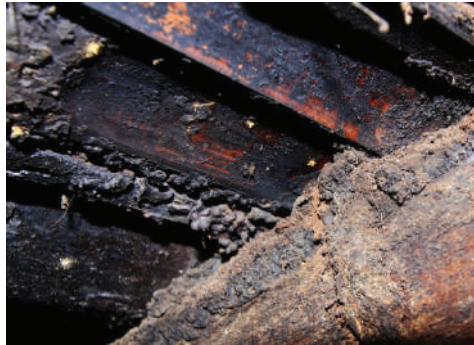
From the observations of the Bolon house, something interesting was learned about the remnants/traces left by the cooking process, namely soot. Wooden parts affected by layers of soot were found in better conditions of maintenance than those not exposed to soot. Soot is like a waxy coating that keeps the wood safe from termites.

Fig.6 Layer of soot on the beam above the kitchen

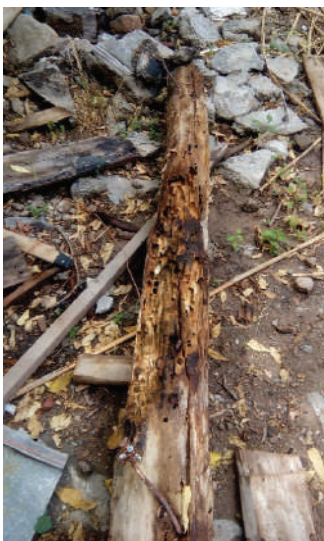
Fig.13 Termite damage

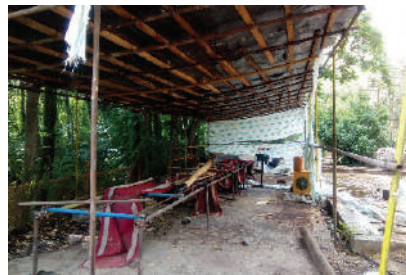
Fig.14 Consistency of wooden beams

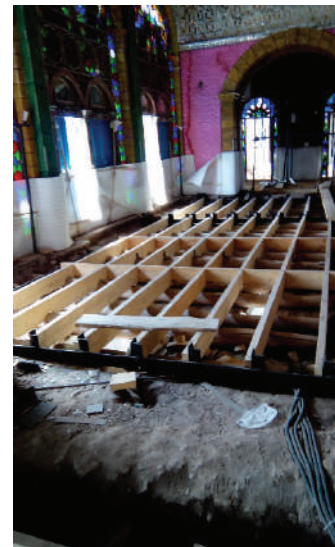
Fig.15 New structure based on an original one.

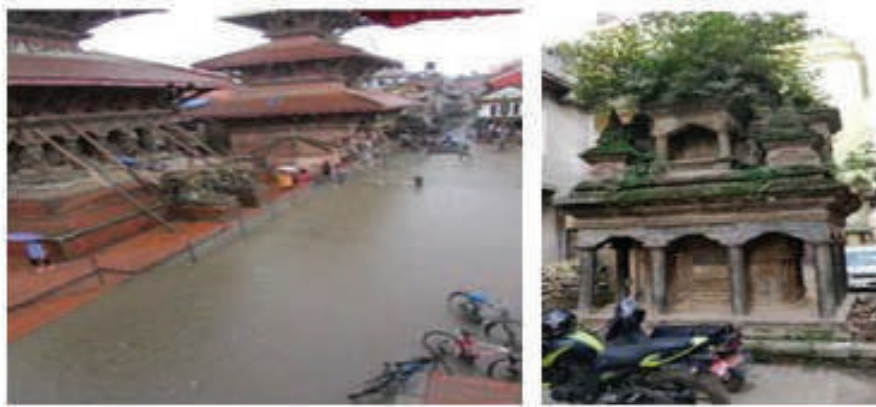
Fig.1 Street runoff entering Patan Durbar square (left); grass/bushes on a monument at Patan (right)

We have experienced problems regarding the procurement system and tendering process from low-bidding contractors in some cases. We have seen cases of dampness causing decay in timber and creating other problems, even while using traditional technology and materials. Due to a lack of proper drainage, street runoff sometimes enters into monuments; feces/excreta of pigeons and other birds also cause the decay of wooden elements and brick walls. Oil lamps and incense sticks lit by pilgrims make surfaces sticky and oily. Sometimes a lack of sufficient expertise within the DoA or insufficient research efforts also create problems. The transfer of knowledge from senior skilled human resources to their juniors is lacking, a gap which causes the loss not only of skills but also of institutional memory, which both degrade the heritage.

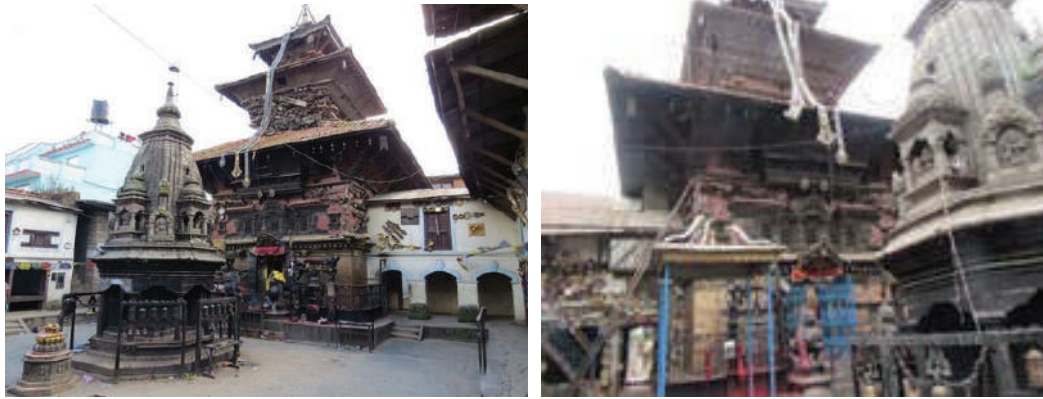
Fig.2 Adinath Lokeshwar Temple, Chovar, after the earthquake (25 April 2015)

The three-storied temple is made of wood and traditional bricks. The walls of the temple are made from structural *ma apa* bricks, and the outer veneer is made with glossy *dachi apa* bricks, using mud as mortar. The wooden posts, doors, and windows are carved with motifs of Nepalese traditional arts and crafts. The sanctum is in the middle of the ground floor. The roof is made with traditional clay roof tiles (*jhingati*) laid on a layer of mud over wooden planks.

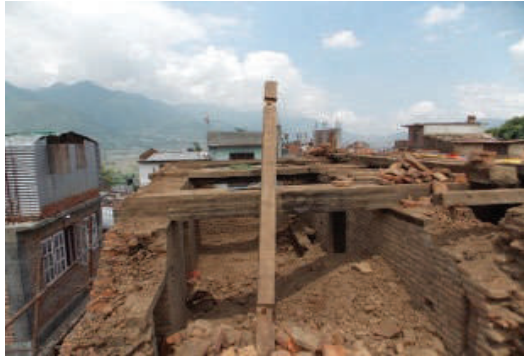
Fig.4 Disassembly in progress

The temple was significantly damaged by the earthquake. Accordingly a careful survey was conducted, with drawings, plans, sections, elevations and detail drawings prepared. After preparation of these documents the rehabilitation work was started in coordination with members of the concerned local community, who have been continuously involved in this project. During the disassembly of the bricks and wooden members of the walls, detail sketches were prepared, photographs were taken, the disassembled parts were stored and reusable members such as carved doors, windows, and wooden posts were separated and the required minimum interventions were done.

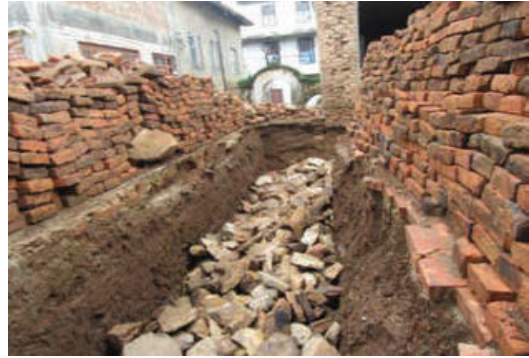
Fig.5 Exploration of the foundation

After disassembly, exploration of the foundation was done. The central main part, the inner sanctum where the icon of the main deity is kept (*garvagriha*), was protected so that no disturbance or distortion would occur during the conservation work.

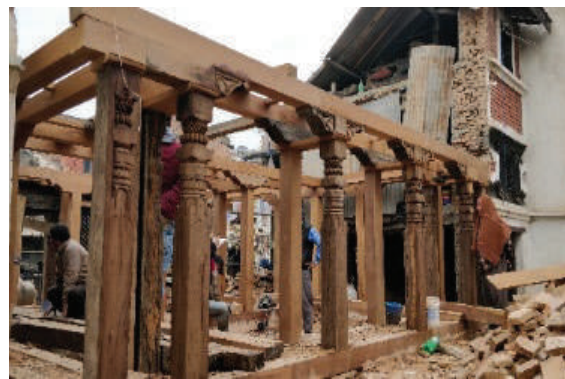
Fig.6 *Thams* (posts) and *nidals* (beams) are erected

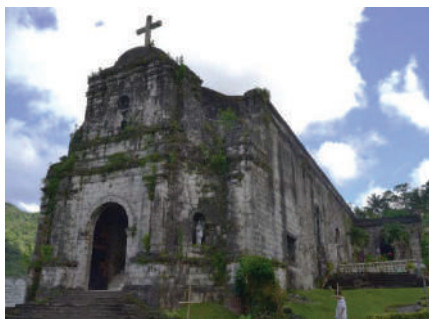
Fig.1 Pre-restoration photograph of St. John the Baptist Parish Church façade, NHCP, March 2017

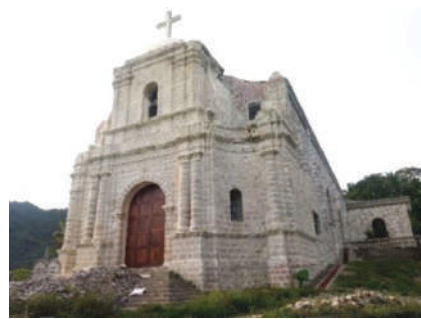
Fig.2 St. John the Baptist Parish Church façade after restoration, NHCP, May 2019

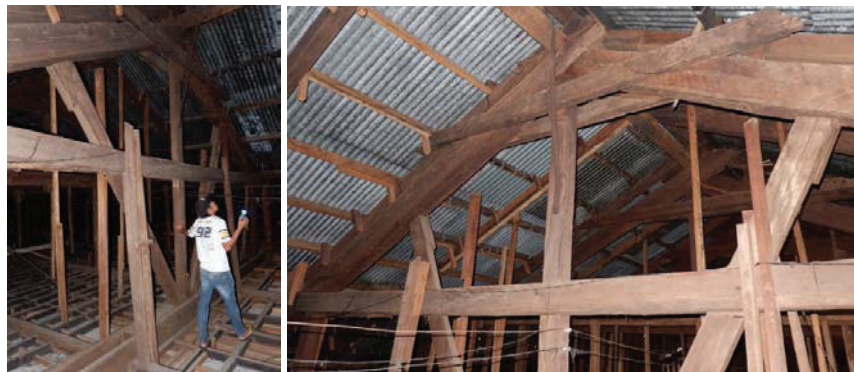
Fig.3–4 Photos of Tabaco Church original timber trusses supporting the ceiling and wooden framing, Arch. Lorilla, 2018 August

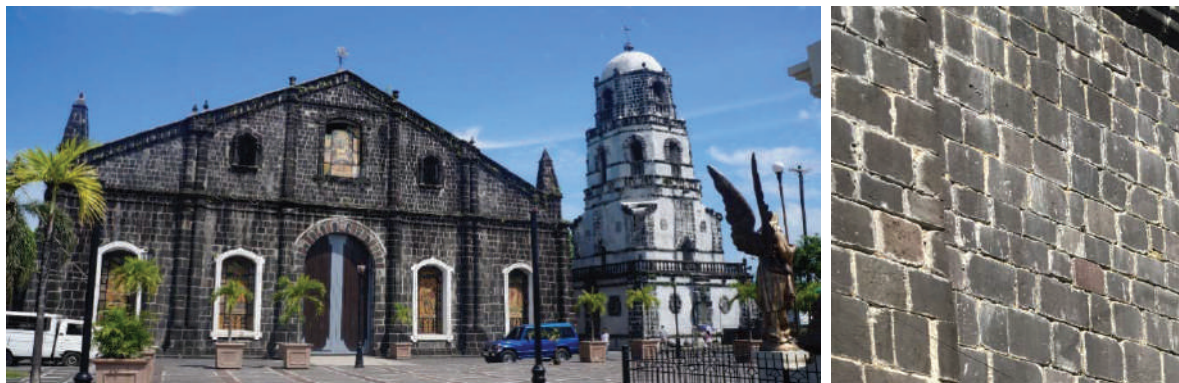
Fig.5 (left) Pre-restoration façade of the Tabaco Church, featuring hewn dark volcanic stones, NHCP, 2017

Fig.6 (right) Detail of the church wall showing dark and red volcanic rocks, NHCP 2018

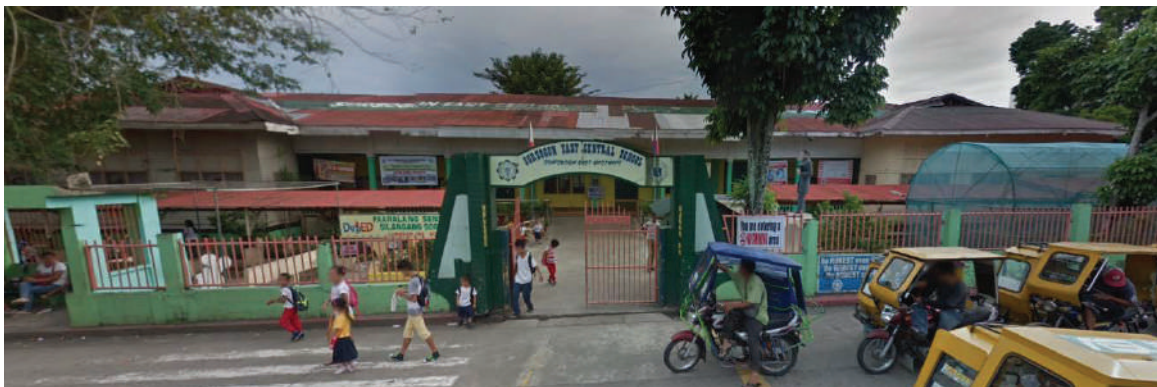
Fig.7 Pre-restoration panoramic view of the Sorsogon East Central School Gabaldon Building, showing the cramped site space

The Sorsogon East Central School is a simple school building which is one of the surviving Gabaldon Buildings located in Sorsogon City, Sorsogon Province. The school building was found to be in a deteriorated condition, with one of its annexes at risk of collapse. The structure posed a hazard for passing pedestrians, including school children. Measures to restore the original parts of the building were undertaken by prioritizing the original appearance, based on the architectural plans. Wooden members of an alternative timber material were used, but were cut to the same dimensions and style of the originals.

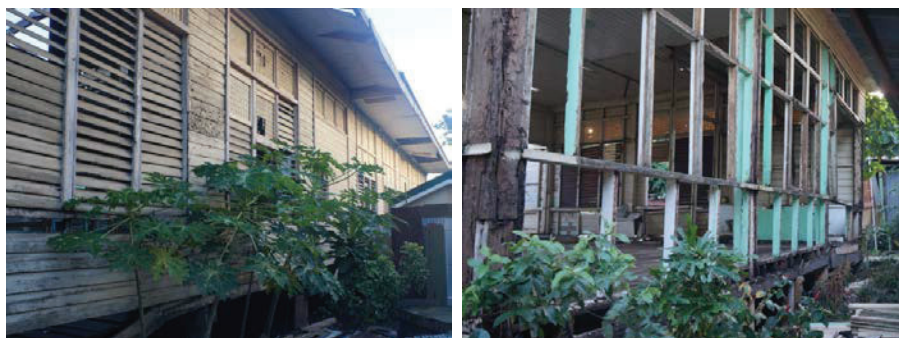
Fig.8–9 Dilapidated wooden components of Sorsogon East Central School
FIGoogle photos, 2017

Decision-making limitations: Scarcity of material resources and the loss of traditional construction methods.

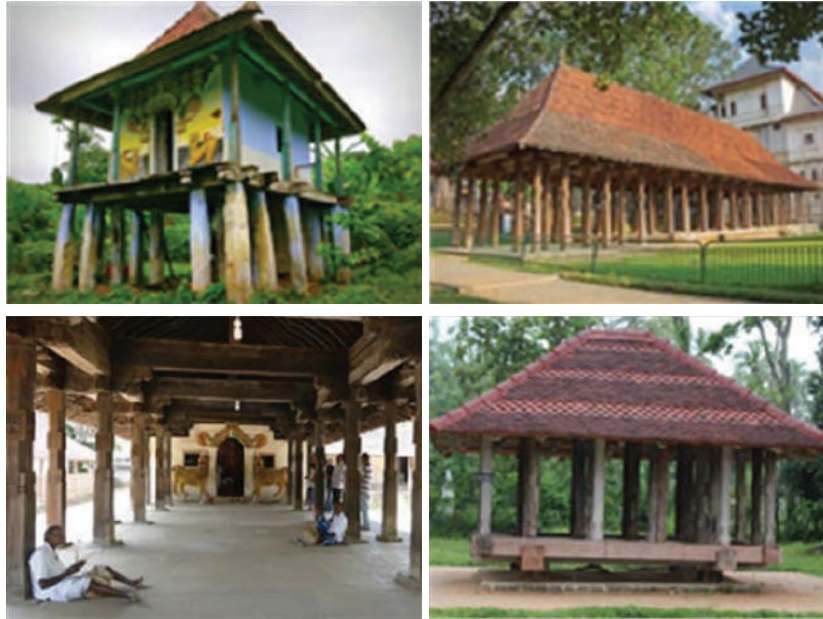
Fig.1 *Tampita vihara, mandapa* (audience hall), *devala, ambalama*

There are examples of early timber construction methods still surviving in relatively well preserved states for building types such as *tampita vihara* (shrines on pillars), *devala* (shrines dedicated to deities), *ambalama* (resting places for wayfarers), and *mandapa* (assembly places for administrative routines).

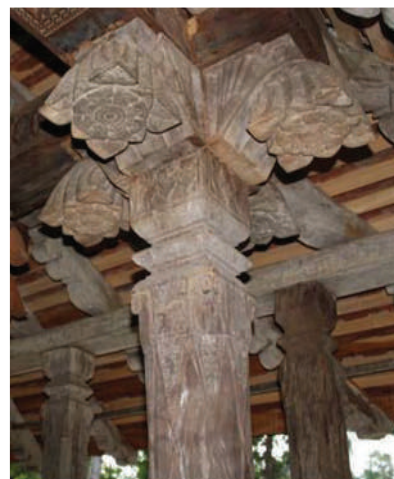
Fig.2 (Left) Section and isometric view of *pekada* (Right) Carved *pekada* at Panavitiya Ambalama

- *Pekada* – This is an intermediate structural element used for connecting beams with columns (pillars). It is a separately carved capitol or bracket. This bracket is made of two pieces, fit together in a crossed manner to comprise a four-faced bracket assembly. The top of the pillar itself is mortised into the bracket through the centre of the crossed parts.

This arrangement prevents the transfer of internal stresses, due to thermal expansion or settlement, from the beams to the columns. It also enables the transfer of lateral as well as vertical loads from the beams to the columns without inducing high local stress at the joints.

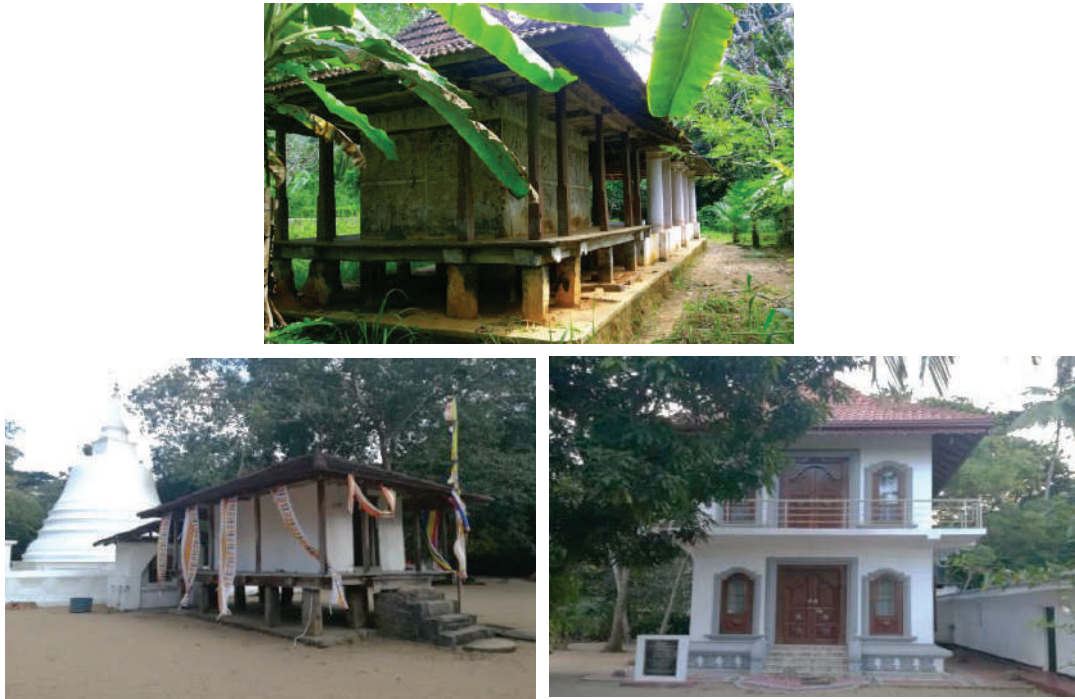
Fig.4 (Top) Abandoned original *tampita vihara*; (Bottom) New image halls

As an example, *tampita viharas* are Buddha image halls which are proportionally small in size. Temple guardians or custodians tend to make new, larger image houses, or make alternative structures to the originals, to accommodate greater numbers of people at a single occasion. Gradually the original image houses are abandoned or closed to the public due to underutilisation (Figure 4). This increases the moisture content inside and promotes biological degradation.

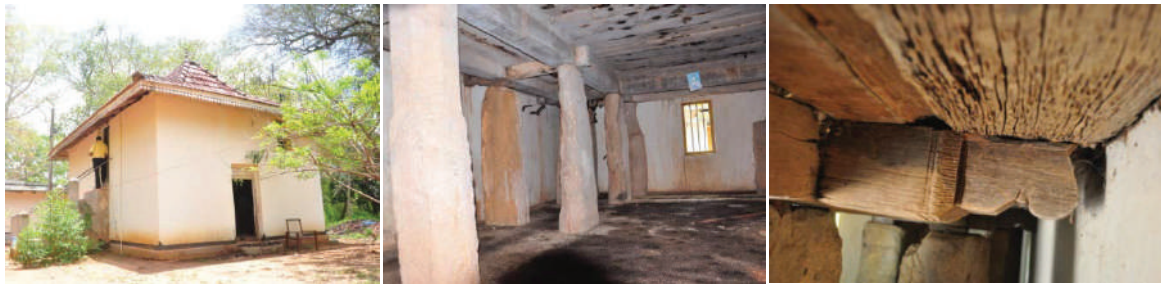
Fig.5 Modified *tampita vihara* and its current interior condition

Figure 5 shows another example of a *tampita vihara* which has been modified as an enclosed building by covering it with masonry walls on all sides. While this was done by the temple custodians to protect the image hall from environmental changes, the increased moisture content resulting from enclosing the space provides a comfortable space for insects and promotes early degradation.

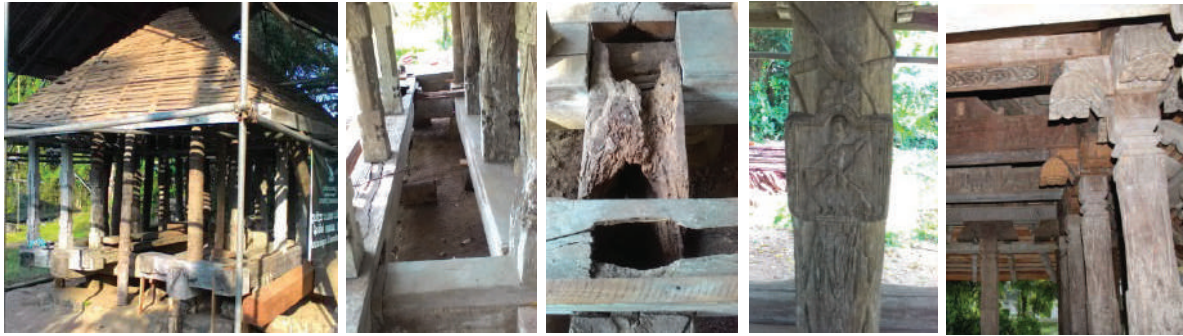
Fig.6 Conservation steps and final appearance

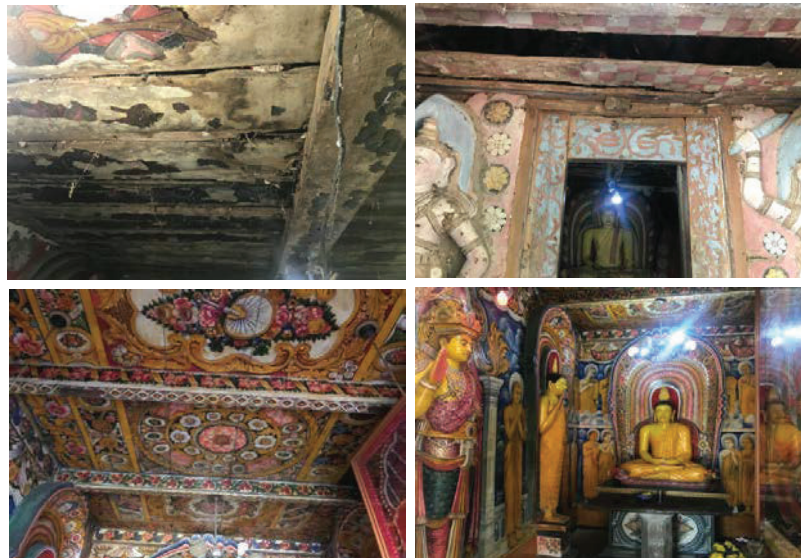
Fig.7 (Top) Image hall scheduled for conservation; (bottom) A well conserved image hall and paintings

“Restoration and renewal of objects of worship and structures to regain their symbolic form and meaning, and the need to appreciate them in their completeness, are among the most significant value systems attached to Buddhist heritage.”² The images in the top row of in Figure 7 show a decayed timber ceiling which may have originally been painted with traditional artwork, and the entrance view of the same abandoned *tampita vihara*. The photos in the second row show a completely restored image hall for a comparison of the spiritual atmosphere.

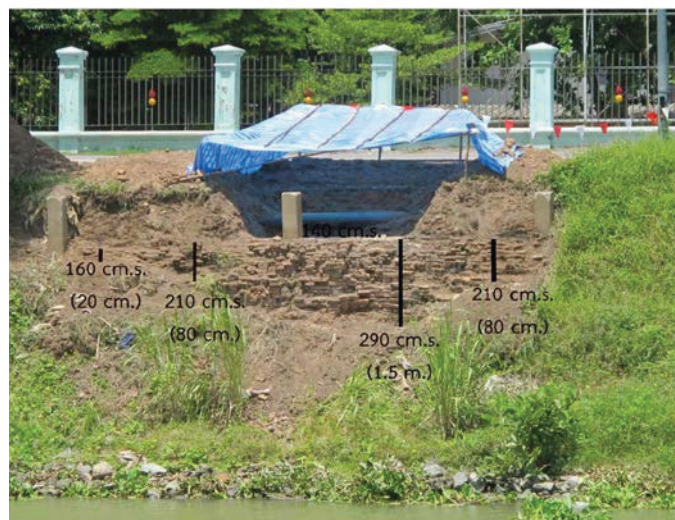
Fig.2 Ayutthaya city wall

especially Wat Chai Wattana. Increasing numbers of visitors subsequently came to Wat Chai, reaching more than 10,000 people daily, and as traditional Thai dress also became more popular, many establishments across from Wat Chai have thrived up to the present day from rentals of Thai costumes. In contrast, regarding the owners of cultural heritage, in many cases they have showed a lack of understanding and inattention to these properties. Due to the legal status as a monument conferred on Ayutthaya Island by an act of Parliament, activities there must be approved by the Director-General of the Fine Arts Department and follow the Department's rules and procedures to obtain permission for building construction. These rules divide the island into three areas, the first on the west side where the most important monuments are situated, the second in the center and the last to the east where the old and modern cities overlap. Limits have been set for each part regarding roof patterns and heights, with the latter set at 8, 12 and 15 meters for the three areas, respectively. Not only personal buildings, but also government buildings that represent the biggest projects have been controlled by this rule. Currently problems arise when construction takes place on or close to a monument's location. In addition to the work for the duration of the contract, the builder's responsibilities include proving archaeologically that the activity will not affect the heritage value of the property. For example, in developing a flood protection system project, carried out by the Public Works and Town and Country Planning Office of Ayutthaya, on Chao Phraya river's bank where the U-Thong Road is located, it was determined from old records that this road originated from the wall of Ayutthaya city which was leveled around 120 years ago. For that reason, archaeological excavation was carried out and the outside of the wall was found, being a brick construction 3 meters thick and more than 1.5 meters in height (Fig. 2), and now a new plan is in process for a dam to protect this wall.

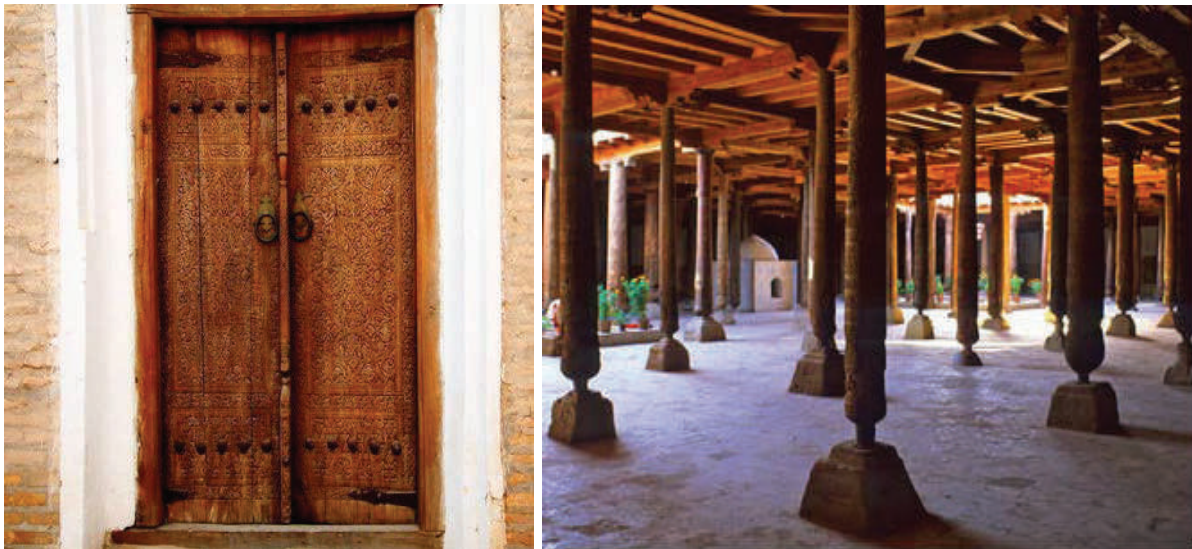
Fig.3-4 Entrance door and interior of Djuma Mosque in Khiva

Ancient carved wooden columns for Djuma Mosque were brought together by inhabitants from all over the Khanate of Khiva. A total of 212 pieces were placed at distances of 3.15 m from each other. Of these, 25 originate from the tenth–sixteenth centuries. Others originating from an ancient mosque include 16 carved wooden columns from the eleventh–fourteenth centuries, 14 columns of the seventeenth–eighteenth centuries, and 135 areas of the building, including pillars (except for eight columns which are in a museum of history of the people of Uzbekistan), plus carved wooden doors on the northern face, and single-leaf carved wooden doors on the southern and western faces of the mosque, have been preserved. One of the masterpieces of wood carving art in Khorezm is the entrance door of the mosque.
