ACCU Training Reports 2019

Cultural Heritage Protection in the Asia-Pacific Region

- Documentation, Conservation, and Utilisation of Museum Objects
- Conservation and Management of Wooden Structures
- Photographic Techniques for Cultural Properties

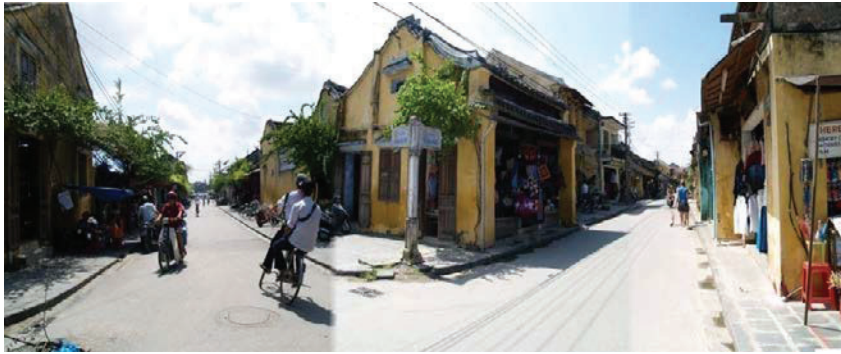
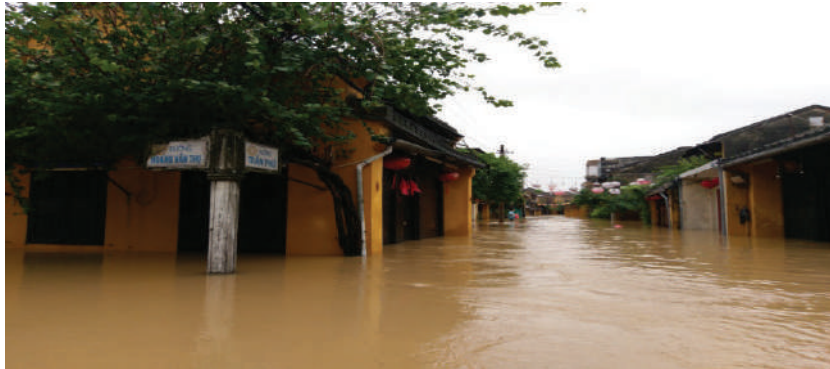
The most pressing problem is the flooding that occurs every year. Water and mud from the river damage the lower parts of houses (both inside and outside) in the Ancient Town, and when the interiors of houses become immersed in water, this causes deterioration. Wooden structures in particular are vulnerable to damage and some of their heritage value is lost every time flooding occurs. Risk management for wooden heritage is limited, and preventing the yearly flooding inside the houses is nearly impossible.

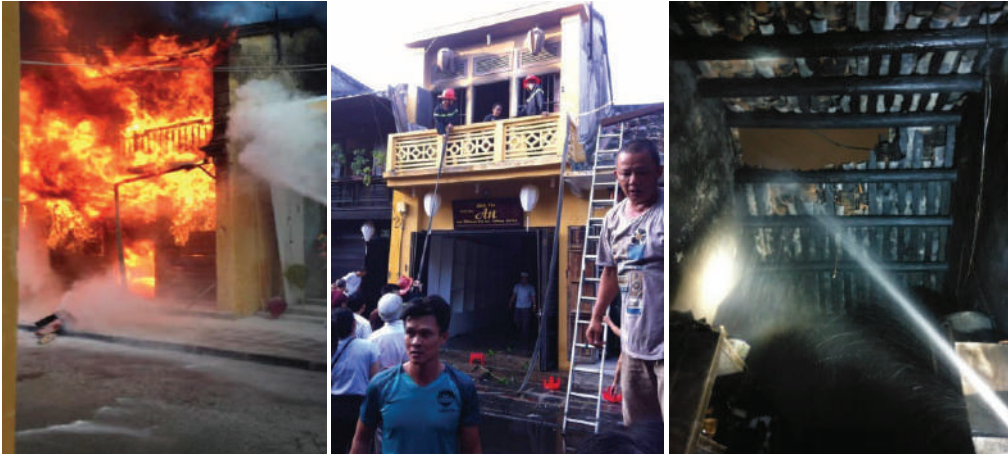
Fires at heritage structures (left to right, photos by HACCHMP and Vuong Phuc Tu Tuoc): 134 Tran Phu, 09/2013; 76 Nguyen Thai Hoc, 02/2017; Fukien Assembly Hall, 10/2017

As wood and other highly inflammable materials are used as building materials, the outbreak of fire is a huge risk. This potential problem is exacerbated in many old houses and restaurants by the use of gas for cooking, and as there are many inflammable materials inside the houses the fire cannot always be extinguished quickly and contained. Additionally, fire prevention measures are not at the highest standards.

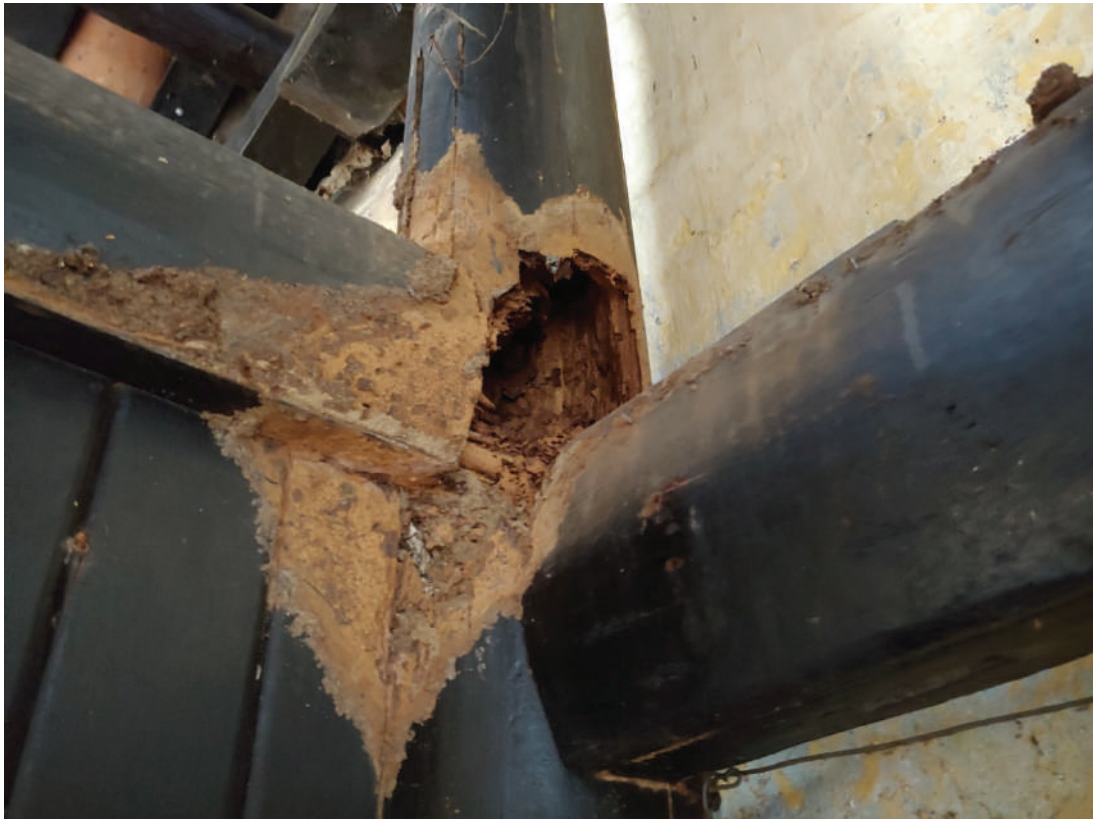
Finally, termites also cause considerable damage, especially to wooden members inside the houses, as illustrated below.

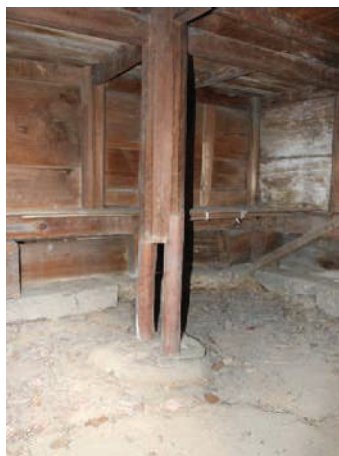
Fig.1
Left: Tenman Shrine used as case site for documentation and evaluation during the training course
Right: Evidence of change (survey traces) seen in the base of pillar.

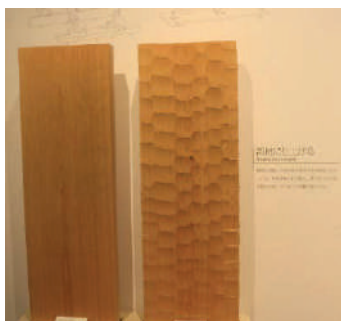
Fig.5 Difference of surface finishing using two different tools, as shown in Takeneka Carpentry Tools museum

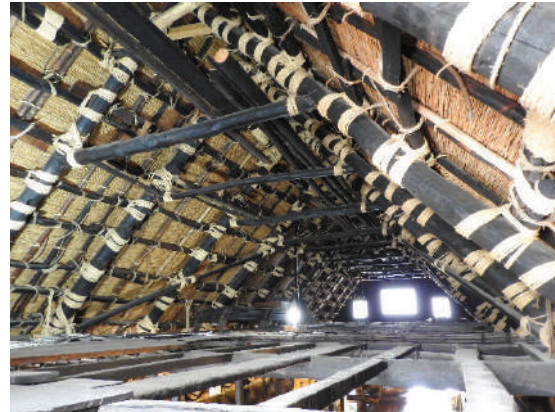
Fig.4 Roof structures at Shirakawa village,Gifu

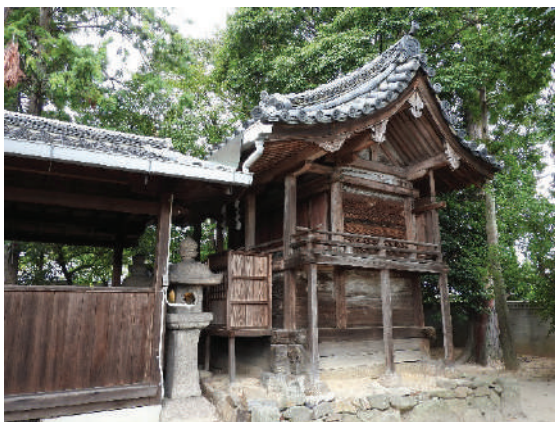
Fig.5 Practical to classification and Risk mapping on Tenman Shrine (Nara city)

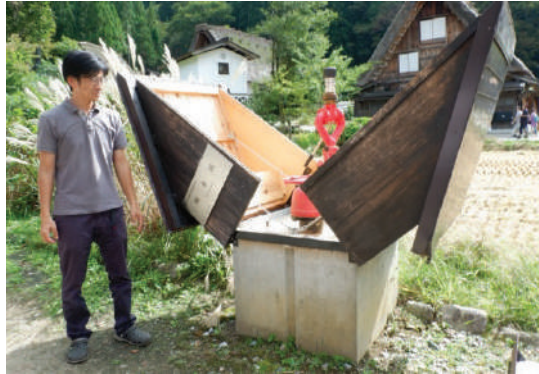
Small building storing fire extinguishers in Shirakawa village

network with communities in the area. It is quite interesting for me to observe how they camouflage hydrants and other fire extinguishers with small wooden buildings in Takayama city, Shirakawa village and Narai, while in Kiso-Hirasawa they camouflage them with the small buildings made of aluminum painted in brown. In addition, what is interesting to me is how they preserve the landscape by hiding electrical wires and poles from the street.

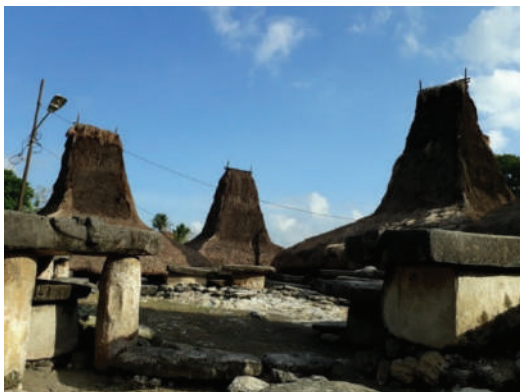
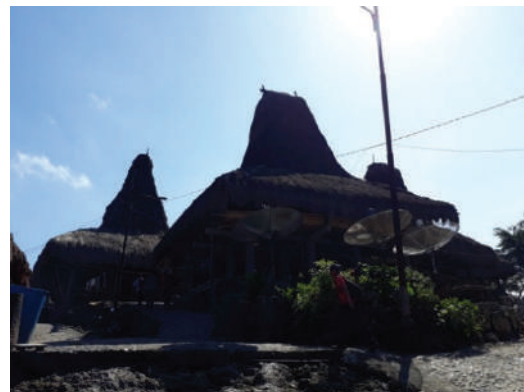
Visible electric cables and poles and satellite dishes damaging the visual landscape in Tarung village (left) and Waitabar village (right) located in the middle of the city in the West Sumba area, East Nusa Tenggara.

Just as Japan has traditional villages with wooden houses, in Indonesia there are many traditional wooden structures. Indonesia is an archipelago with a wide variety of tribes that have their own customs and traditional buildings from Sabang to Merauke. But now, modernity has entered even remote areas. On one hand it has positive impacts but there are also negative impacts. For example, the presence of electricity in remote areas. Unlike Shirakawa village, Takayama city, or Narai where electric wires and poles are not visible on the purpose of the preservation of landscape, some villages in urban area in Indonesia already have electricity but the installation seem to be less organized. The electric cables and poles, as they are not well-arranged, make the rural landscape irregular, disturb the view, and cause the visual pollution.

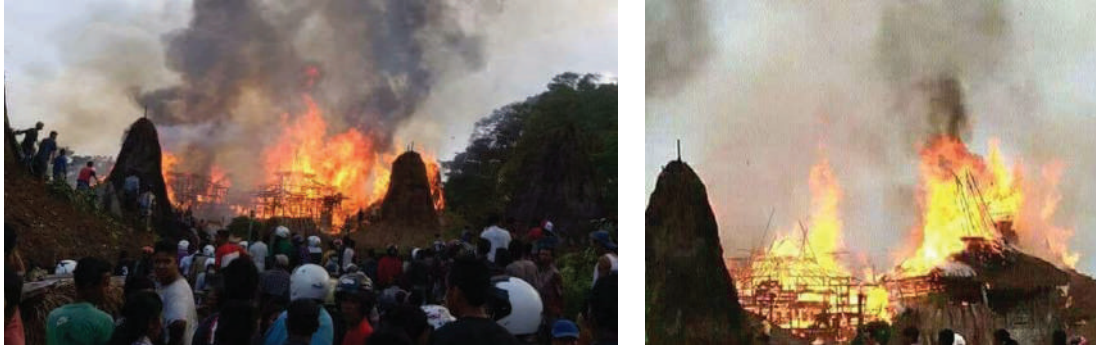
Fire in Tarung and Waitabar villages on October 7, 2017

In addition, some traditional villages in Indonesia which have wooden structures do not have a landscape plan and prepare for facing fire hazards yet. The construction of traditional building is actually earthquake-resistant because the ancestors built traditional houses to adapt to the surrounding environment and nature. However, for the fire hazard, there needs to be preparation by the local government or the local community. There are many activities that can be fire hazard such as cooking activities using firewood in the house, irregular cables and electricity poles, burning garbage and more.

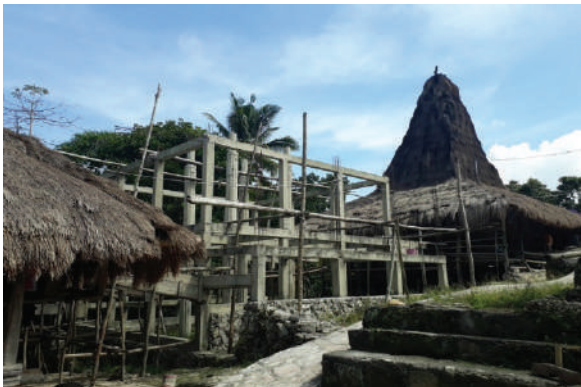
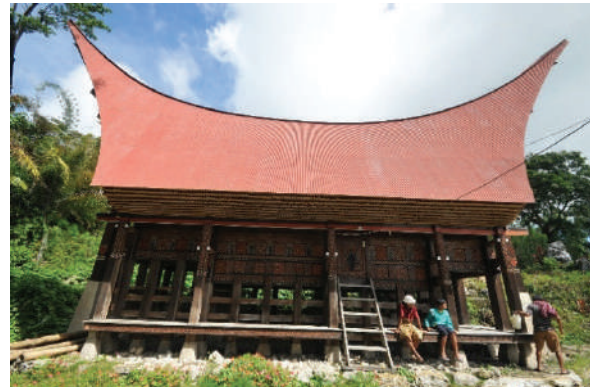
Left: Traditional houses in Sumba using concrete instead of bamboo columns and beams

Right: Traditional buildings in Sillanan, Tana Toraja, South Sulawesi with zinc roof replacing the original bamboo roof

Wood is a natural resource that can be used up if it is not renewed. Uncontrolled logging and forest fires can cause these natural resources to run out. Therefore, the price of wood has become increasingly expensive. Traditional buildings in Indonesia are mostly made of wood, especially some places such as Toraja, Sumba, Simalungun, Nias, etc., using a long and large wood. However, due to the high cost of wood resources, concrete is used for some traditional houses instead of wood materials. In addition, roofing materials such as palm fibre, alang, bamboo, or sago leaves are also increasingly difficult to be found. Because of the difficulty to obtain these materials and the limited availability around traditional villages, many local people are replacing traditional roof for cheap and easy-to-find roof, namely with zinc/asbestos roof.

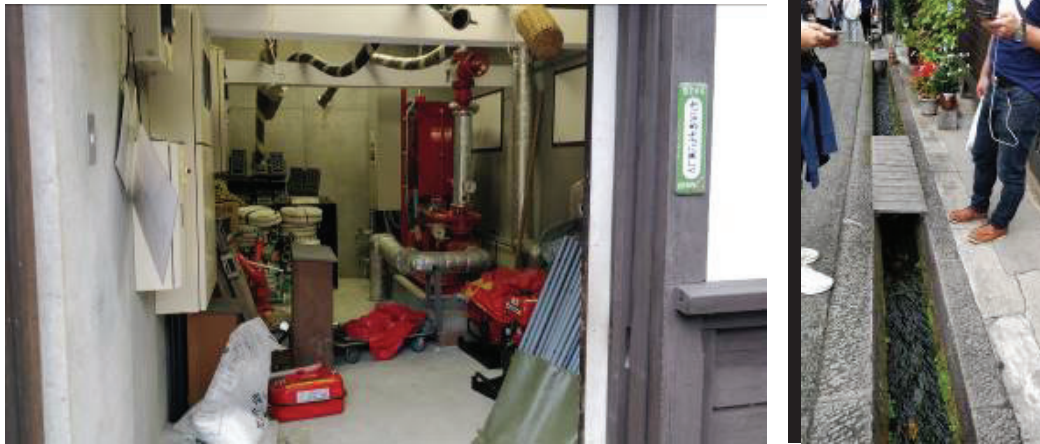
From the theoretical lecture sessions as well as on-site observations, I acquired some knowledge and understandings. The designation system for cultural heritage in Japan which has three levels (national, prefectural, and municipal) is quite interesting and informative for me. I found it more realistic and applicable to other countries too. I also learned about the practices of disaster risk assessment, identification of vulnerabilities, and adoption of mitigation measures like fire fitting systems, well-managed hydrants, auto detection system, open drain for fire that I observed in the preservation district in Takayama city.

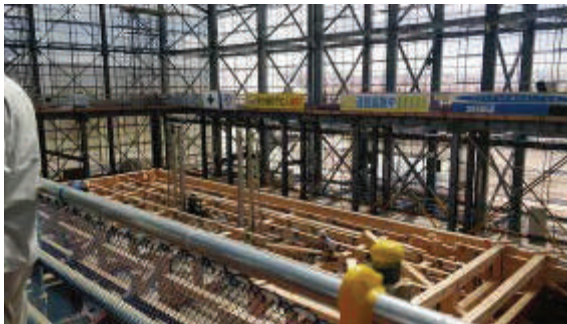
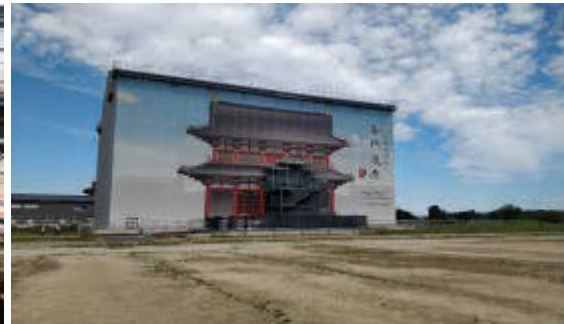
The system appointing the head carpenters for conservation projects is certainly beneficial since main responsibility goes them. The training for young carpenters not only improves their skills but also helps the succession of traditional techniques and craftsmanship. At the reconstruction site of South Gate in Nara Palace Site, I observed traditional way of work using carpentry tools, preservation of craftsmanship, and the modern idea such as installation of iron dampers to mitigate the effects of earthquake and ensure the stability of structures. The installation of dampers is the most significant actions for me as the structure itself should be safe against earthquake or any disasters to ensure the safety of the public.

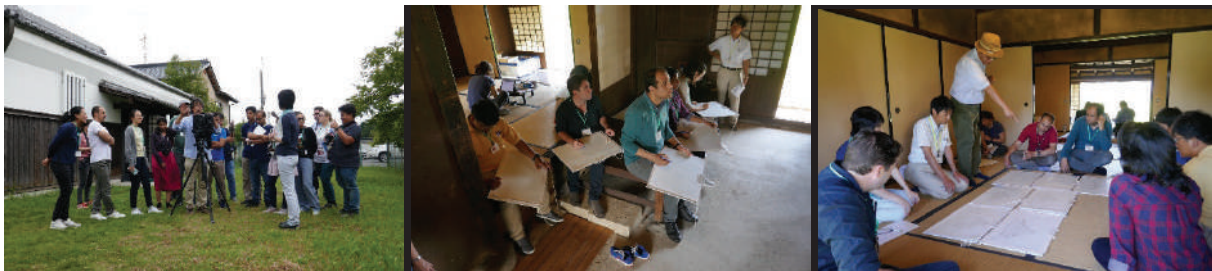
Lack of documentation is one of my issues in the conservation process in Sri Lanka. The two-day practical session at Tanaka Family Residence where we documented Japanese traditional house was a very productive learning experience for me. As an architect, I have documented buildings during my career but this session gave me more precise and accurate documentation skills. I learned it is important to observe each and every corner of the structure and make it into the drawing. The photography session also helped me sharpen my knowledge on photography that is one of my hobbies as well. As the photography is important evidence when making records of heritage sites and monuments, it is the aspect I have to improve for my work.

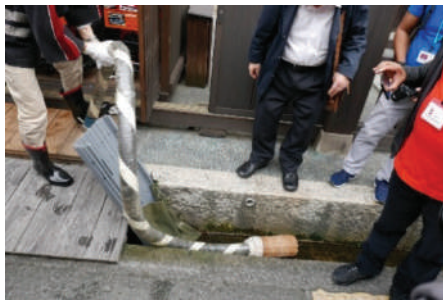
Moreover, risk management is also useable topic as fire and flood often happen in Thailand. The easiest thing that I can apply in short-term period is setting up the fire protection system such as fire extinguishers at location of vulnerabilities and train and teach the officers how to use them. The fire protection system that we learnt from Takayama city is also possible to adapt to my site because there are many ancient canals in Ayutthaya island. To set up the fire protection system utilising these canals is the long-term plan.
