ACCU NARA

GROUP TRAINING COURSE

CASE STUDY REPORTS 2023

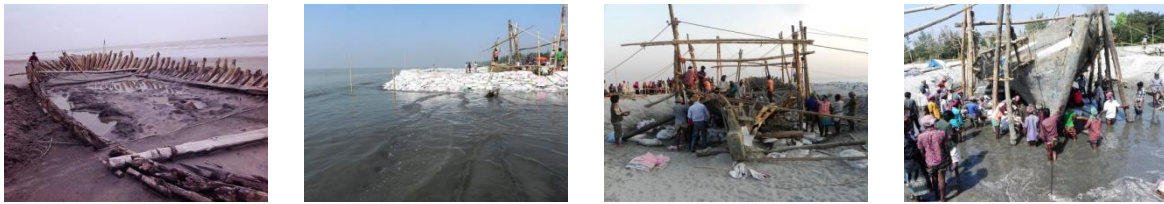
Figure 1: Phases of lifting the submerged wooden 'schooner' during the excavation time at seabed

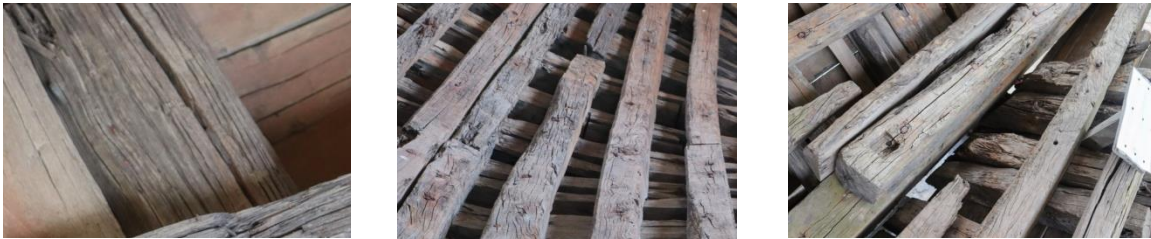
Figure 3: Cracks in wood caused by exposure to storage prior to conservation

The decision to place waterlogged wood in a completely different environment i.e. in the open after excavation, which has been in a certain environment for a long time under soil or water, was not correct. In this case, special precautions were required before excavation under the direct supervision of conservationists specializing in swampy wood. For example: ensuring the safety of the schooner after excavation, ensuring a suitable environment for keeping it and making all preparations for conservation treatment mandatory, etc. Such matters were not followed properly and various physical changes were made in the timbers of various parts of the schooner. These physical changes are usually unidirectional, which greatly hinders proper conservation treatment of submerged wood. In some cases waterlogged wood loses its preservation capacity forever.

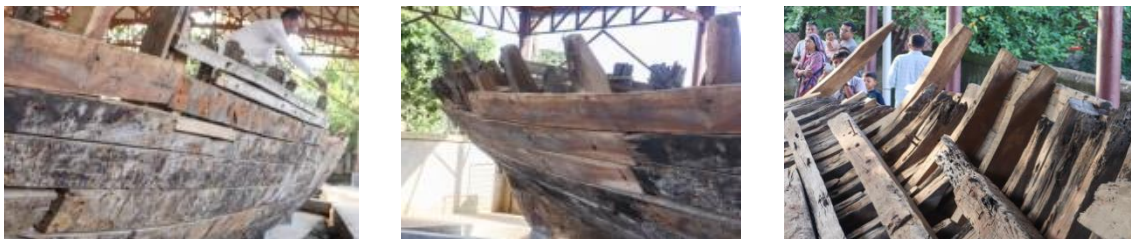
Figure 4: New wood additions in many places.

At present several parts of the schooner's planks are missing in the middle and down the right side. New wood additions in many places done. The decision to add new timber to facilitate safe lifting and transport of the schooner during excavation was a sound one.

Later, after the work, the new timbers were removed and the shape of the original structure could be fixed by using supports in different parts of the schooner in the rehabilitation method. Due to not removing new wood from various parts of the schooner, various changes have taken place in its physical structure. The main structure of the schooner is not in its original shape, many of the timbers have bent and distorted the structure. However, there are many other factors that cause a schooner's main structure to bend.

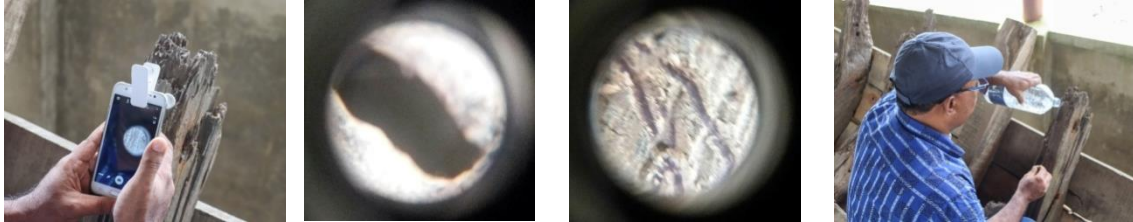
Figure 5: Examination the small wood cellular with a microscope and trying to remove the white spots with water.

A few places on the schooner, examined with a small cellular microscope, showed extensive white coating on the surface of the wood. Despite several attempts with water, the white spots could not be completely removed. These are known as salt deposits.

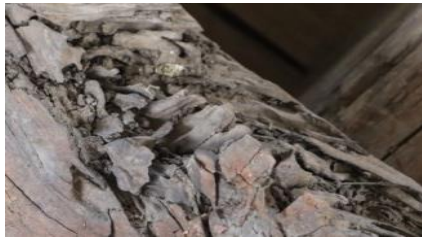
Figure 6: Rotting wood

Several parts of the schooner were found to be rotting and infested with wood. This attack is quickly spreading to other parts of the wood.

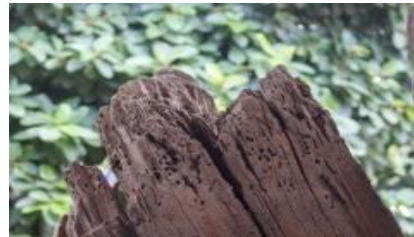
Figure 7: Infested wood

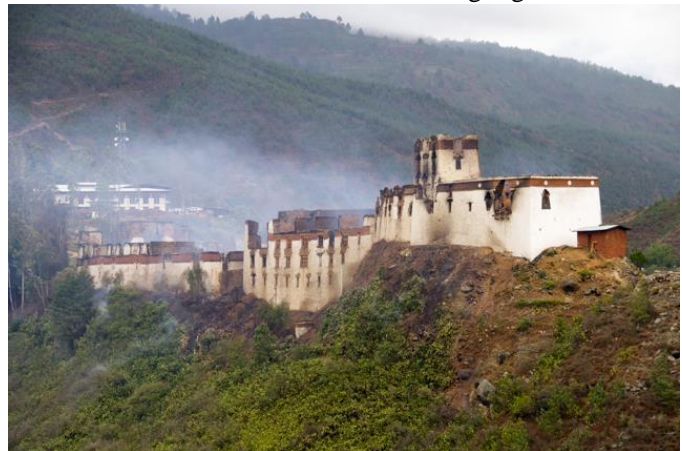
Photo 2. Aftermath of the tragic fire incidence.

Over the centuries, Wangdue Phodrang Dzong underwent several renovations and expansions. Unfortunately, On June 24, 2012, a fire broke out in the Dzong and quickly spread, destroying the entire complex. The fire was a major loss for Bhutan, as the Dzong was one of the most important cultural and historical sites in the country.

The fire's cause remains uncertain, though speculation points to a potential electrical short circuit originating from one of the administrative offices in the first courtyard. While past fires in Dzongs were attributed to butter lamps, modern facilities present the current hazard. With electrification prevalent in nearly all dzongs, subpar wiring or inadequate maintenance of aged systems could lead to short circuits – a predicament that came to the forefront. Since the incident occurred on a Sunday when the office was unoccupied, the fire gained momentum unchecked.

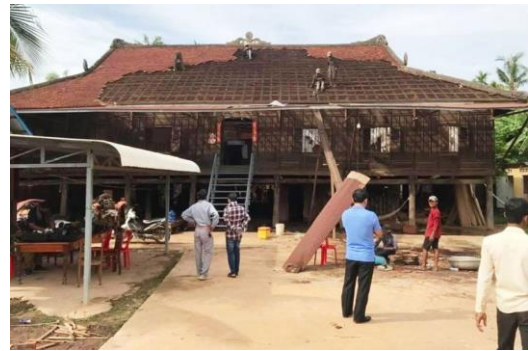
Fig.2 Dismantling Process

The MCFA initiated the purchase of the wooden structure with the intention of rebuilding it in another location. A survey was conducted to undergo structural and architectural assessment of this building before dismantling. This involves accurately documenting the building's features, including measurements, photographs, and drawings. This documentation helped to inform the dismantling and reconstruction job. The whole building was carefully dismantle, as some part of the component damage were required to be repaired or replace by the same material. Then the building was reassembled to its original state.

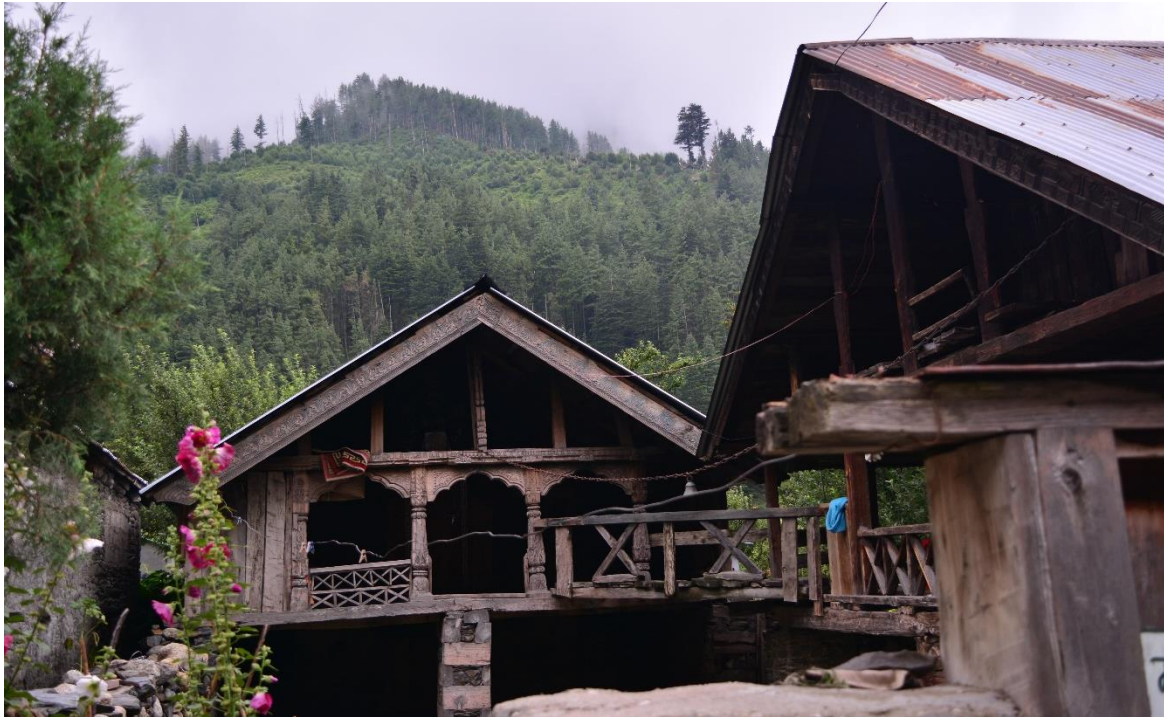
Figure 2 The Traditional Wooden Houses in the settlements of Mukhba and Bagori in the Bhagirathi (Ganga) valley at Harsil.

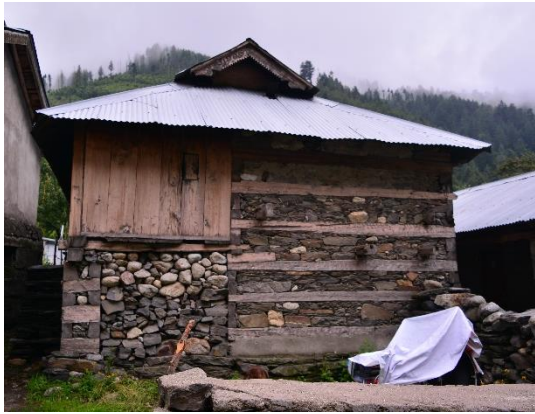
Figure 4 The rear elevation with the horizontal wooden beams and stone infill.

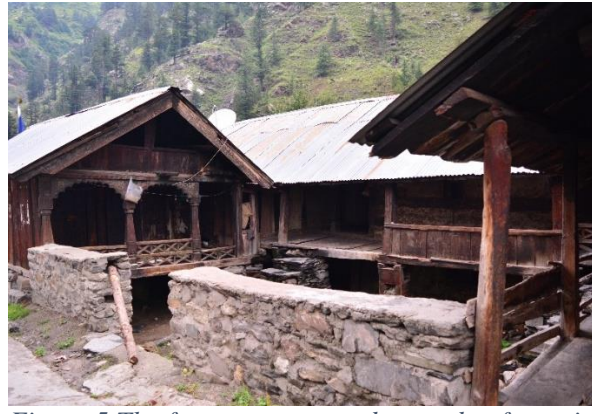
Figure 5 The front entrance and veranda of a typical dwelling

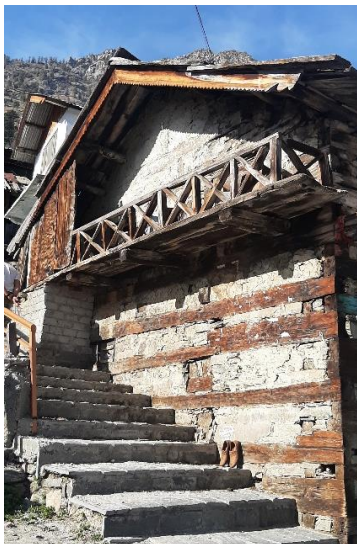
Figure 6 The side elevation of a traditional Koti Banal structure with the horizontal wooden beams and stone infill

In *Koti banal* construction the walls are made of dressed stone and wooden beams which are alternatively stacked up, using a system of dry masonry with wooden beams after every 3-5 courses of stone. The

construction of such structures was largely done by local artisans and involved laying two wooden beams longitudinally parallel to each other with a gap in between which is filled with stone infill/cribbage packed as a filler. The wooden beams interlock at the corners and the external and internal beams of the wall are held together by wooden cross braces or dovetails (Fig 7). The joining of the alternate courses of beams was done using wooden pegs to allow movement at the time of earthquakes. The cribbage inside adjusted and helped in dampening of the vibrations at times of an earthquake.

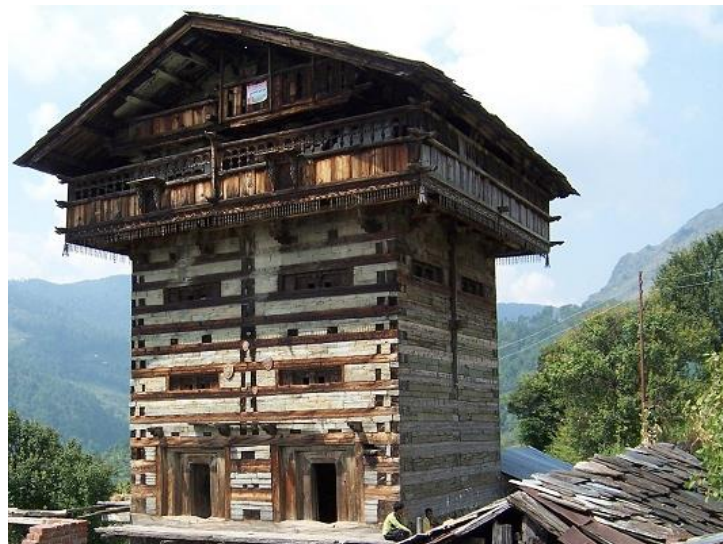
Figure 7 Five storied high Koti Banal structure at Koti village of Uttarakhand (Ref : Rautela, P., et.al.: Housing Report: Timber-reinforced Stone Masonry (Koti Banal Architecture) of Uttarakhand and Himachal Pradesh, Northern India. World Housing Encyclopedia

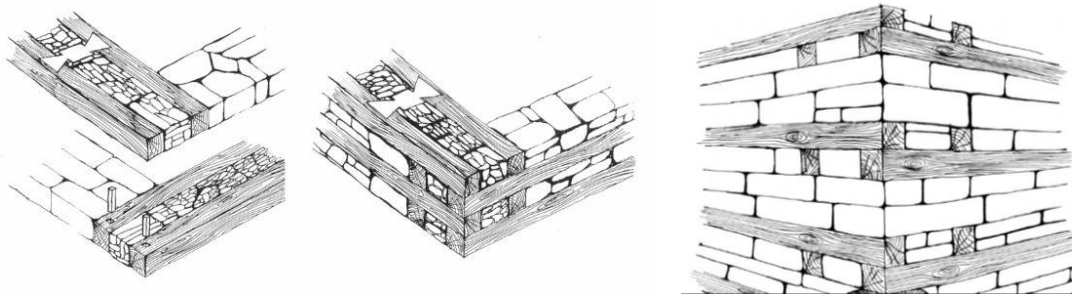
Fig 8. An image showing the construction and joining detail. (Ref: Thakkar, Jay & Morrison, Skye. (2008). Matra: Ways of Measuring Vernacular Built Forms of Himachal Pradesh)

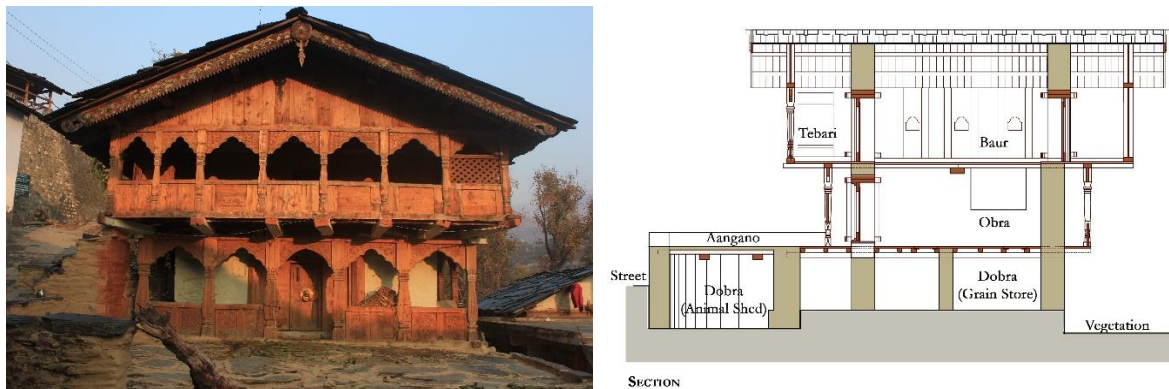
Fig 9. Represents the front elevation of an evolved version of *koti banal* dwelling from a settlement in Yamuna valley, while Fig 10 represents the section of the same dwelling indicating the various parts of the house, where the lowermost floor is used for keeping sheep & goat and the upper floors are used as living areas.

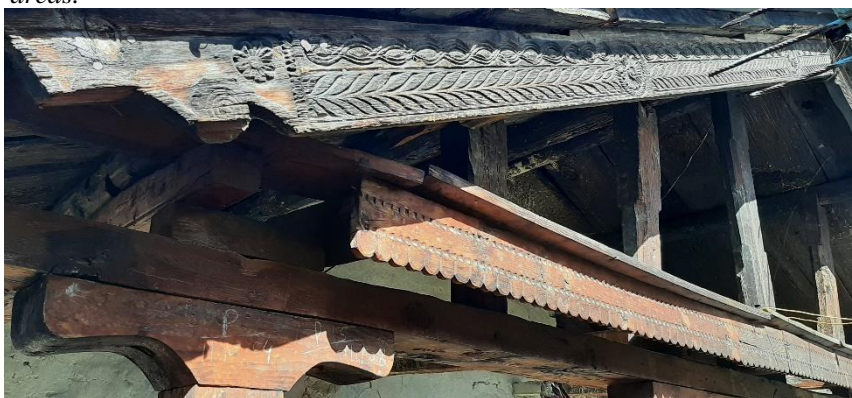
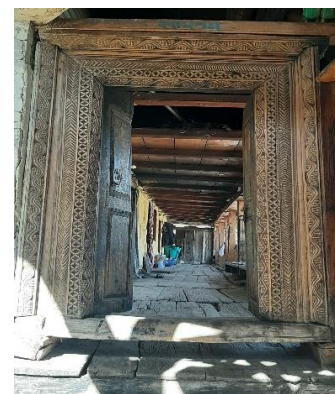
Fig 11. and Fig 12. Apart from construction of the structure, a remarkable level of wood carving and ornamentation can be found in the door frames, brackets, pillars, panels and other parts of the structure in deodar wood which comprises of mostly of geometrical patterns.

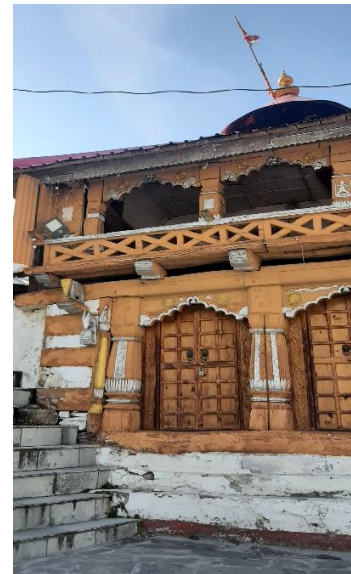
Fig 13. Someshwar Devta Temple at Mukhba after being painted with synthetic paints and cosmetic additions

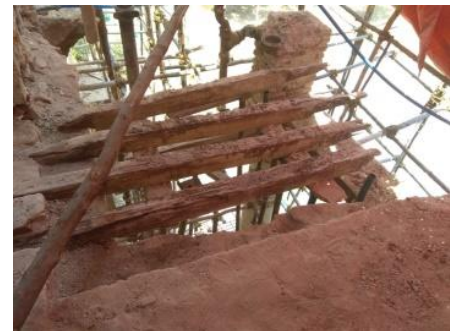
Rotten wooden joists

A significant number of historic wooden members serve as structural members embedded within or supporting the masonry. As a result of all of the above factors, wooden members deteriorated faster than the masonry structure. Due to severe deterioration in situ repair of these members was not possible in most cases. Therefore, the restoration of the historic wood required careful dismantling and subsequent reconstruction of the surrounding historic masonry, which could have otherwise been repaired in situ.

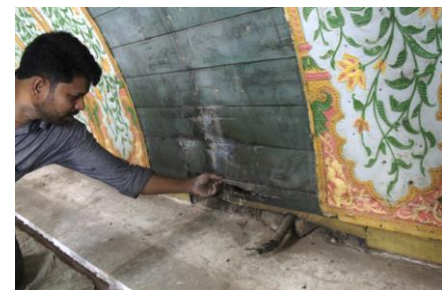
Deteriorated wooden panels supporting papier mache ceiling

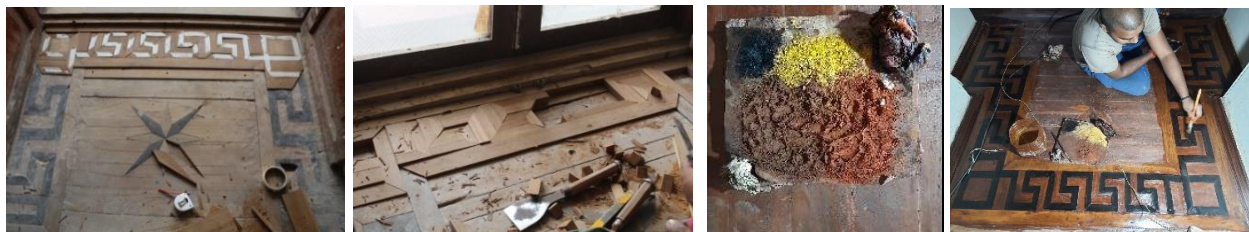
Process of restoration of a parquet border

Historic flooring in Durbar Hall consisted of plain teakwood boardings and a distinctive parquet border comprising of plain as well as black wooden pieces. While a few pieces from the parquet border showed severe signs of deterioration and decay, many pieces were also missing. Geometric patterns and existing wooden pieces from the parquet border were examined to determine the restoration approach for missing wooden pieces. Upon initial visual inspection, it seemed that the black wooden pieces belonged to a distinct wood species; however, the species of this wood could not be identified. Although the species was speculated to be ebony, no archival records or local flora substantiated this hypothesis.

Finding suitable wood of a similar species and quality as the original, especially if it is rare or not readily available, proved to be difficult. Consequently, a decision was made to match the historic pieces by transforming teakwood pieces into ebony counterparts through the application of black colour.

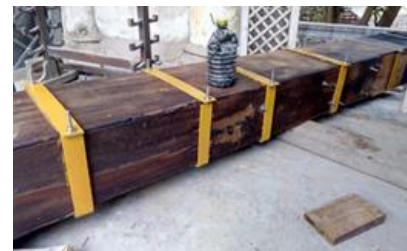
Retrofitted beam

With the collapse of the beam supporting the Madras terrace roof in the Western Oval Room, the project team was faced with the decision of whether to replace the beam with a new one or repair and reuse as much of the beam as possible. After a thorough examination of the condition of the old beam, and discussion with structural experts and carpenters, it was concluded that the good parts of the old beam would be reused to the maximum possible extent and new wood will be added to it to complete the beam to the required size.

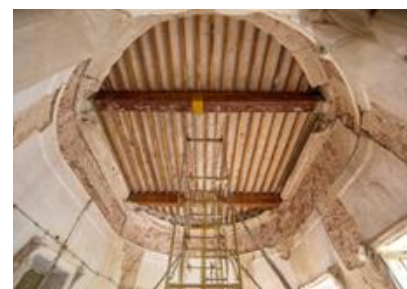
Retrofitted beam in place

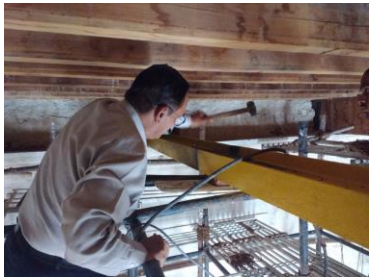
Additional support of I sections added to the system of wooden beams

In the instance of the mentioned beams, they were retrofitted and reused. As time passed, cracks appeared in the roof above. To provide extra support, I sections were introduced. These additions kept the original beams in position but made them functionally unnecessary. This led to exercising approach 4 more in the following conservation strategies.

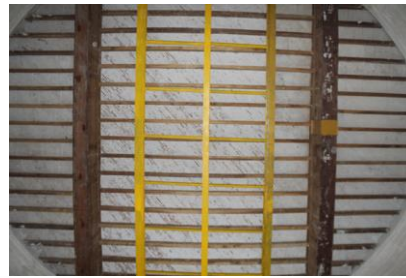
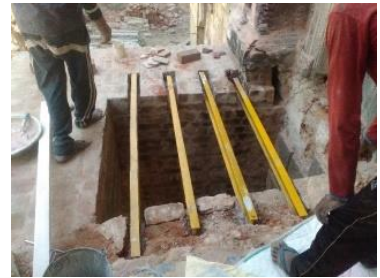
I sections being used to replace

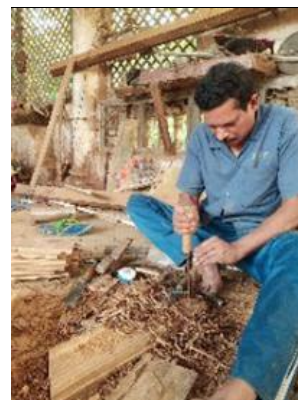
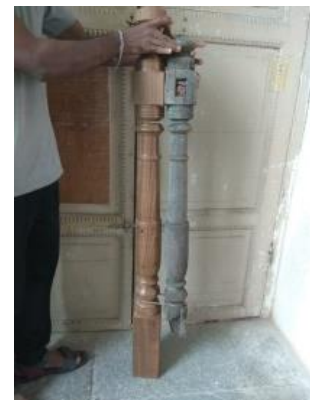
Carpenters reproducing missing wooden posts

The process of reviving the Residency's historical grandeur required craftsmen who possessed an understanding of traditional woodworking techniques. However, identifying such skilled carpenters proved to be a challenging task. Various strategies were employed to address the shortage of skilled carpenters. Collaborative efforts were initiated with local vocational schools and artisan communities to identify and train individuals who displayed a keen interest in traditional woodworking. The recruitment of skilled carpenters from neighbouring regions was also explored.

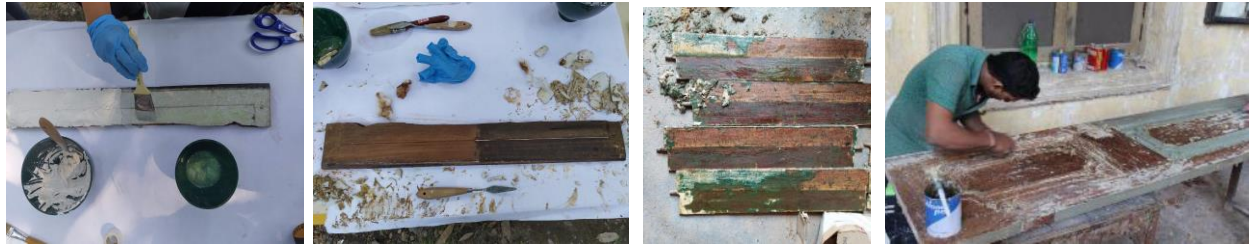
Different techniques used for removing multiple pain layers

Stripping away numerous layers of later-added paint from historical wooden members posed a challenging task. **This process frequently resulted in unintended harm to the wood's surface during the cleaning process.** Varied approaches were required for distinct surfaces, influenced by factors such as their placement within the building (whether internal or external), the functions of the wooden components, and the number of paint layers to be removed.

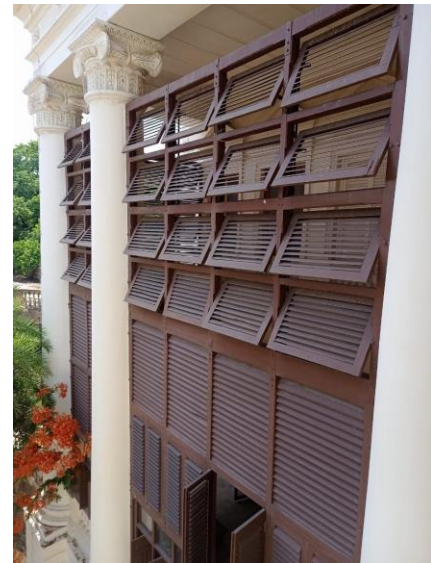
Louvers Southern facade

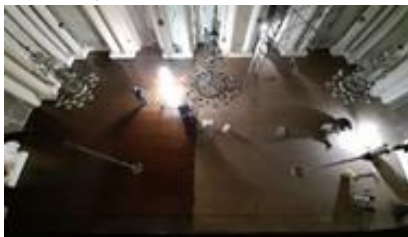
Process – Finishing layer of flooring

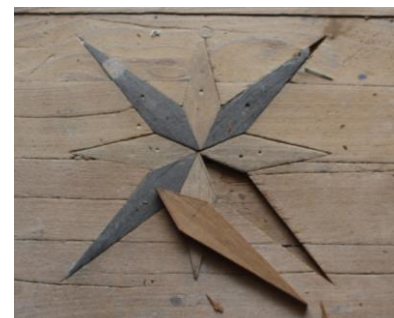
Earlier repairs – Wooden piece painted black to replace original colored wood

As mentioned above, wood deteriorated faster than non-organic materials, leading to more frequent restoration. However, earlier repairs and restoration were carried out in a disorganized manner, only when necessary, without considering long-term conservation. We noticed that various parts like floors, doors, and windows were fixed or swapped with different types of wood, but there were no records of these actions. We only discovered these changes during the restoration process, without any documentation. Developing a conservation plan was tough because we didn't know when the changes were made, what kind of wood was used, and how to improve upon past fixes without reversing them.

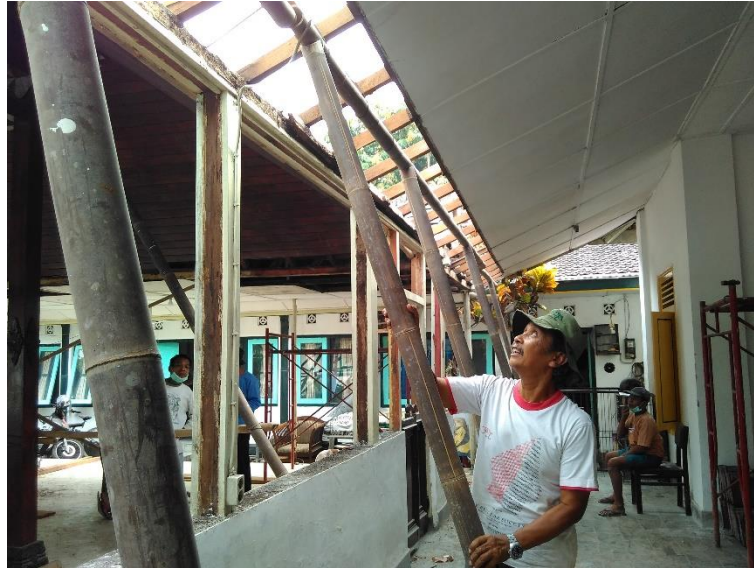
*Picture 1. a senior staff demonstrated how to replace girders by lifting the roof
Source: Regional Office for Cultural Properties Preservation, 2016*

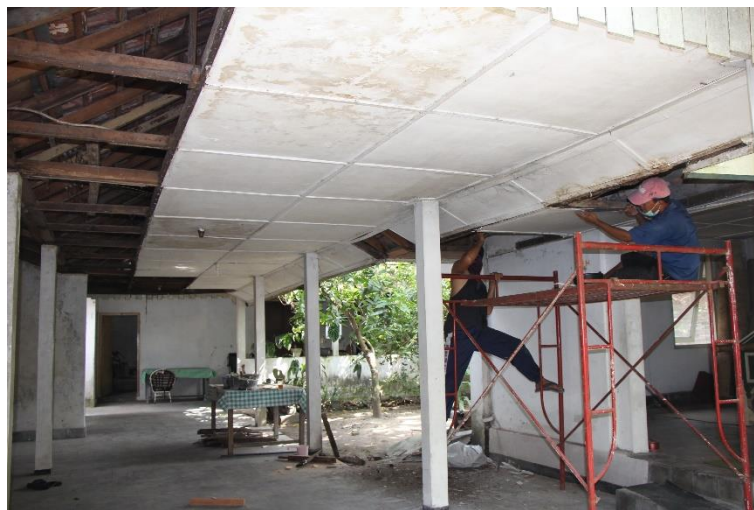
*Picture 1. a senior (carpenter) worked together with a junior staff for replacing ceiling braces
Source: Regional Office for Cultural Properties Preservation, 2016*

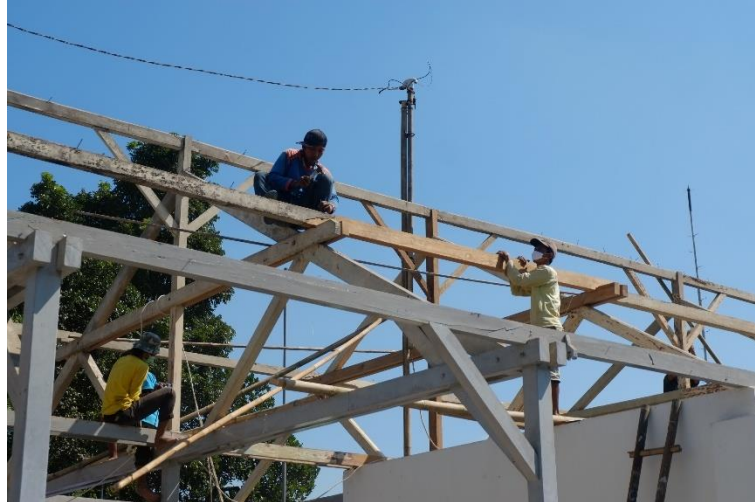
*Picture 3. skillful workers demonstrating replacement of new girder
Source: Galih Nagari, 2018*

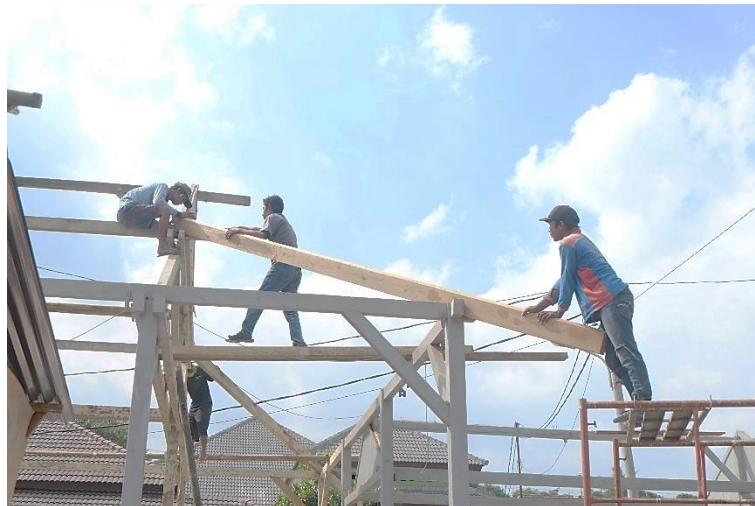
*Picture 4. skillful workers demonstrating replacement of new rafter
Source: Galih Nagari, 2018*

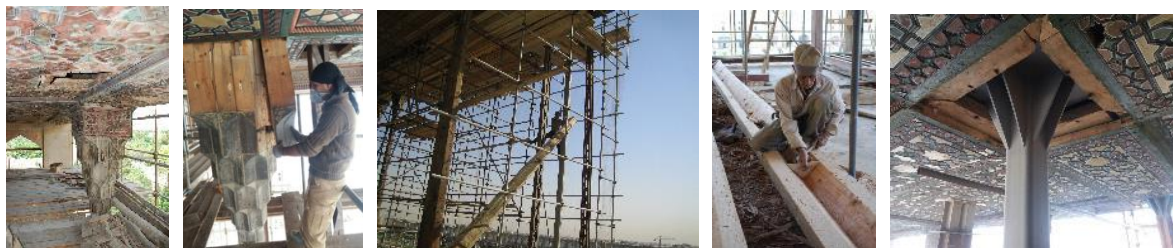
Picture 4, 5, 6, 7, 8: Restoration and strengthening of wooden columns (source: Meidan Emam World Heritage Office archive)

1- Structural problems, including the lack of stability of the columns and the porch structure: The strengthening of the wooden columns of the porch was successfully completed as one of the most complex stages of this project. This work was done by taking down the desired columns with protective and security measures and carving and emptying the inside of the column and installing an iron beam inside it in order to strengthen the column, correct the bending of the column and install it again. In addition, due to the column destruction and subordination corrosion under the columns and the subsequent settlement of the columns and the roof, these parts were strengthened by creating a resistant foundation.

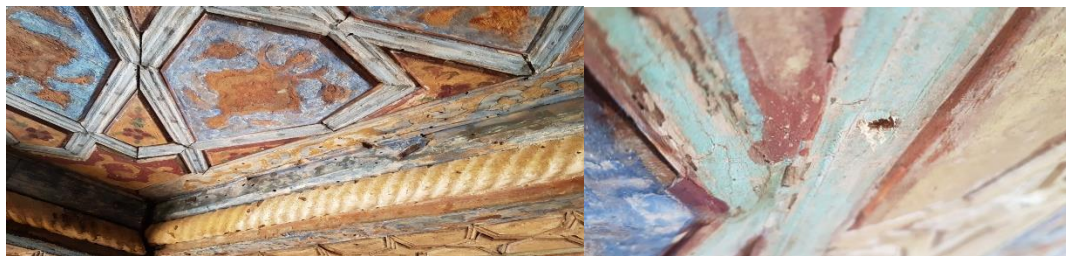
Picture 9 and 10: Holes and damage caused by pest activity (source: Meidan Emam World Heritage Office Archive)

4- Biological problems caused by the activity of insects and bird droppings: one of the biggest challenges that the Ali Qapu building is currently dealing with in terms of wooden structures and decorations is the activity of insects, especially wood-eating beetles and termites, which seems to be in a poor controlling condition. Despite the structural repairs, the existence of these insects is destroying the wooden columns and the roof structure, causing the instability. Measures have been taken in this regard, but none of them have been effective so far. These damages are especially detected during the restoration of decayed parts. Due to the historical value of the Aali Qapu's roof, and the use of plantain wood and colorful decorations and luxurious gilding, it is unfortunately not possible to separate, treat and re-install it. In addition, the use of insect controlling methods such as spraying and injection of poison is not effective due to the depth of penetration of the insect. Also, due to the dust in the city of Esfahan and the atmospheric factors, the existing solutions are not responsive, so currently, no suitable treatment has been found to solve this problem. Moreover to the issue of pests, nesting of birds or their droppings also damages the decorations and appearance of the roof.

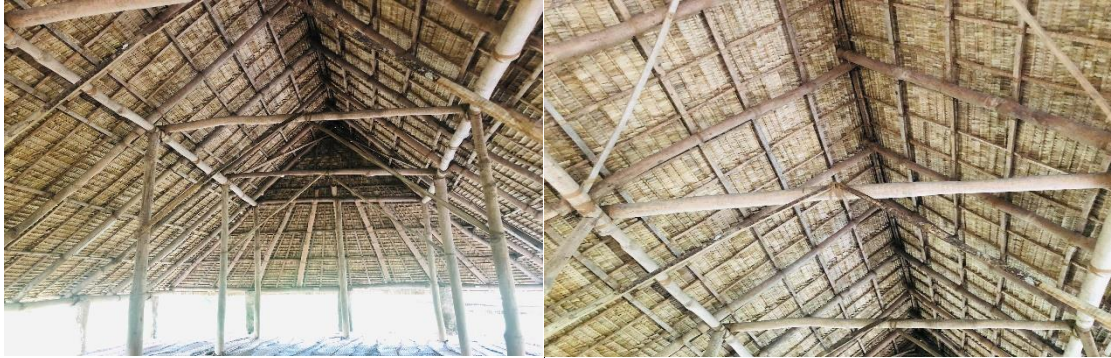
The original and local structure:

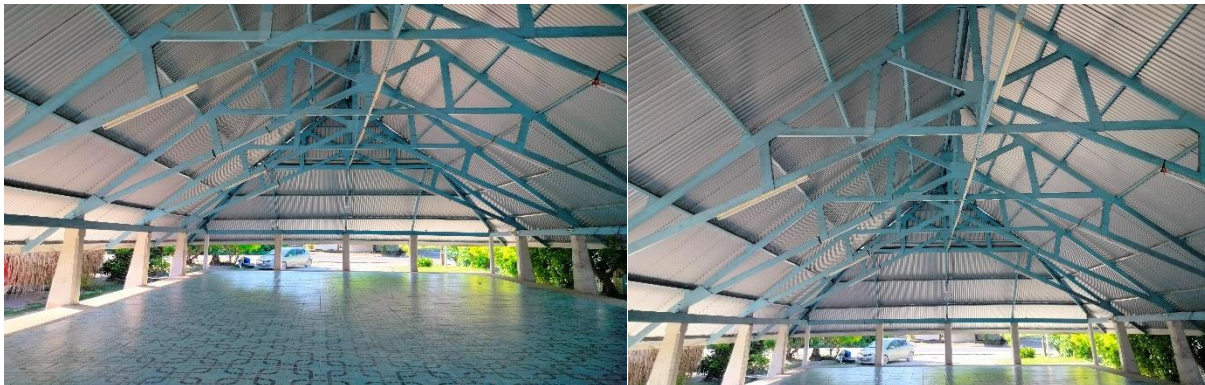
The new modern structure:

The maneaba in contemporary or modern structures and features are not authentic. The cultural significances of the built heritage with cultural practices associated with the traditional procedures of constructing the maneaba have lost. These includes the intangible heritages such as architectural skills, weaving and binding skills and cultural festivals.

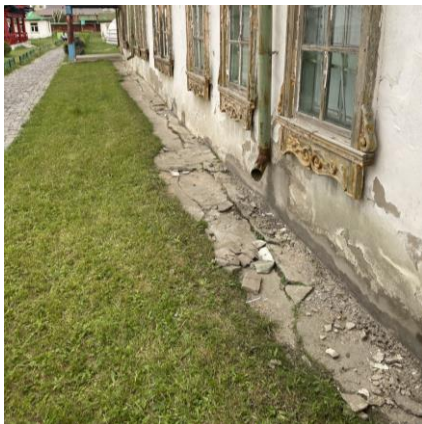
Pic 6. Rain water pipe with no drainage system

A painting by Marzan Sharaw 1912 shows small blue barrels placed under the rain gutters of the Winter Palace (Pic 7.8). But now there is no gutter and drainage system. In Pic 6 there is plinth crack around a building foundation. Rain water and harsh climate could be main cause of wall sink.

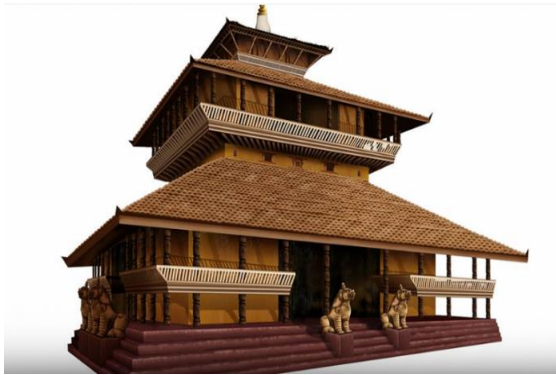
Figure 2 Front façade of Kasthamandapa
Source: (Khabarhub.com.July 29, 2023)

"Kasthamandapa," an illustrious exemplar of the traditional architecture found in the Kathmandu Valley, stands as Nepal's oldest heritage of wooden structures, dating back to the period between the 3rd- 7thcenturies A.D. Distinguished by its fusion of a wooden framework with finely crafted masonry walls, this iconic pavilion was ingeniously built using the timber of a solitary tree. The elaborate carvings adorning its pillars, brackets, and frames are a testament to the artistry of the era. The exceptional amalgamation of wood and masonry in this unique style serves as a definitive manifestation of the rich cultural heritage of the Newar civilization.

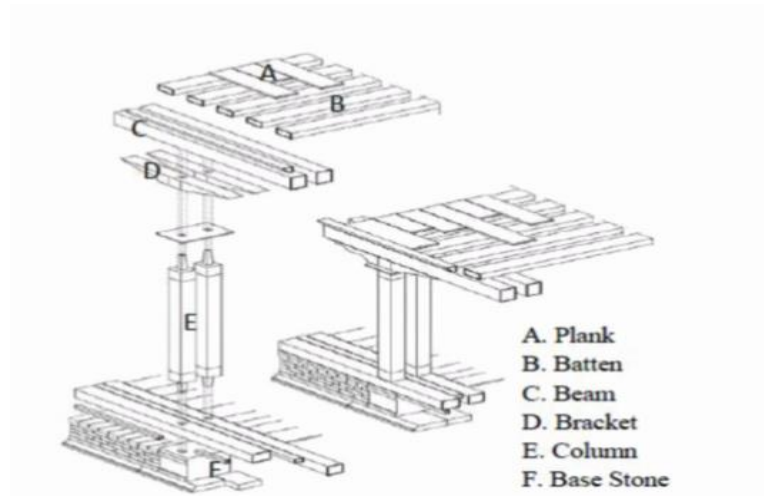
Figure 4 Connection of Structural elements

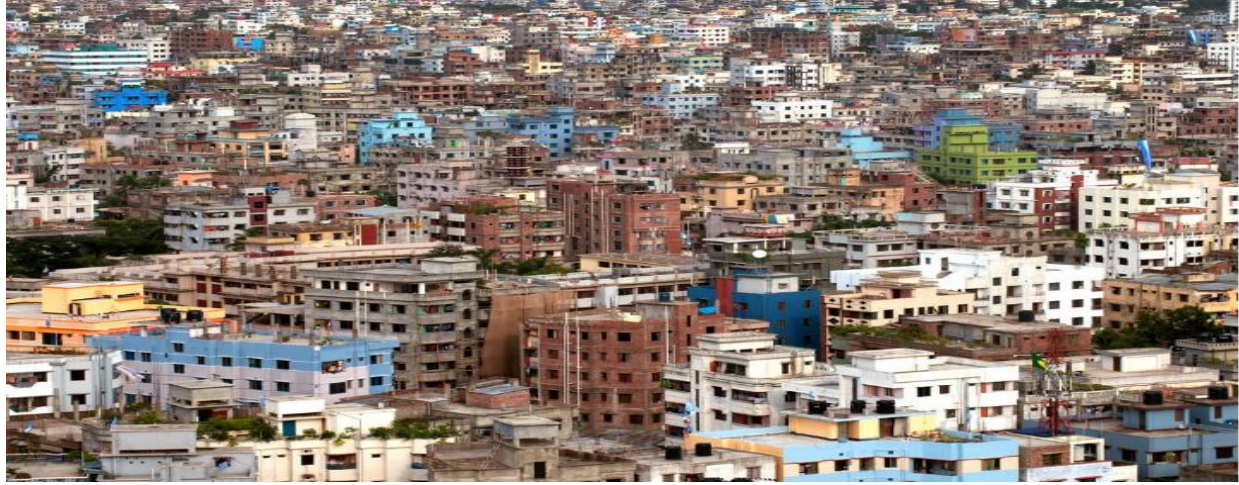
Figure 6: Rapid Urbanization seen in Kathmandu City Source: The Himalayan Times, March 2017

The rapid urbanization and gentrification in Kathmandu are endangering the city's wooden heritage. Unplanned construction, modern building materials, and the changing urban fabric pose threats to traditional buildings. Strict zoning regulations and enforcement are essential to prevent further deterioration and maintain the historical integrity of the urban landscape.

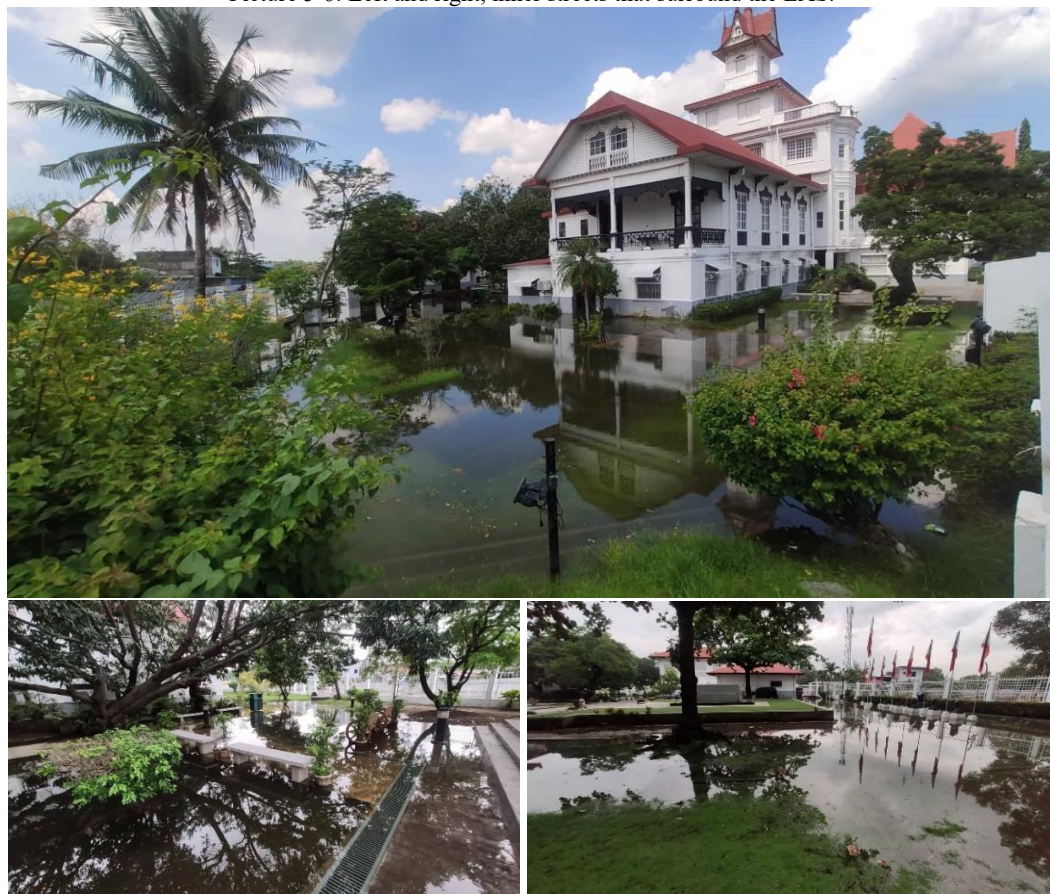
Picture 7-9: EAS complex flooded by high tide (July 2022)

The possibility of sinking of the site is yet to be studied by professionals, but with the signs of continual flooding and the current approved land use that surrounds Cavite, the natural ground level where EAS is built will be left behind since the majority of the main roads and inner roads that connects the surrounding site of EAS is already in the process of being elevated. There is an observed $0.40\text{m}\pm$ level difference compared to the national road and the natural grade line of Emilio Aguinaldo Shrine which makes the EAS lower compared to all the current existing natural grade lines.

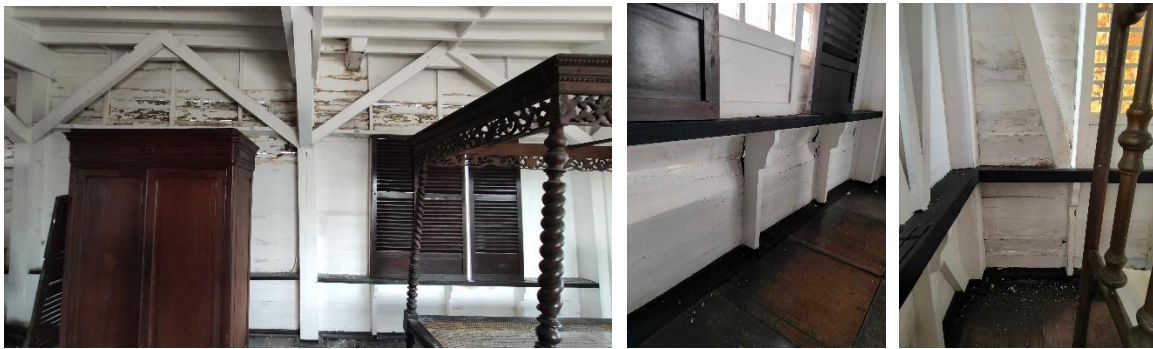
Picture 10-12: Deteriorated wooden components at one of the rooms of at the tower of Emilio Aguinaldo Shrine.

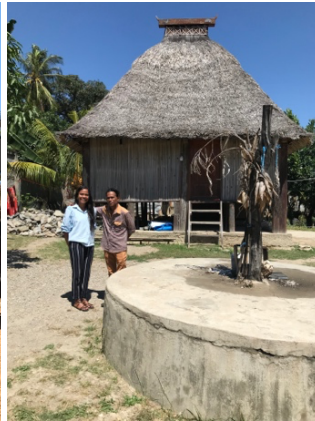
Figure 2-Uma Lulik with Pillars raised/supported; Source: SEAC, 2021

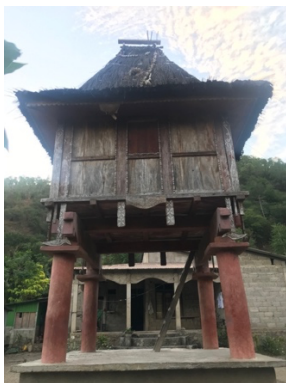
Figure 3Uma Lulik Latuloho with pillars cemented and painted, in Camea Dili/Capital, originated from Tutuala-Lautén; Source: SEAC, 2022

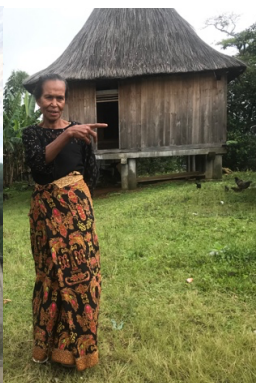
Figure 4Uma Lulik Katuas with pillars cemented, in Fahinehan-Manufahi Municipality; Source: SEAC, 2021

With this long process, both in terms of technical construction and ritual, has caused some of the houses to be rebuilt with modern materials. For examples, the *Uma Lulik* Leobesi (Fig. 8) is in poor condition and they have used a bit of a cement to support the column, and partly structures have also been painted with oils to keep the resistance of wood until they are rebuilt again. In other case, like the *Uma Lulik* Latuloho (Fig. 3), in Dili, its base/foundation used by cement and painted as such as said the generations, in Dili as the city/Capital it is difficult for accessing the local material and the distance is also far, so, the generations that came to concentrated in the capital built themselves *Uma Lulik* as a symbol to be able to reunite and celebrate the importante ceremonies while staying away from their original *Uma Lulik* in Municipality. In the Municipality as *Uma Lulik* of Katuas in Manufahi Municipality (Fig. 4), its column was built with cement,

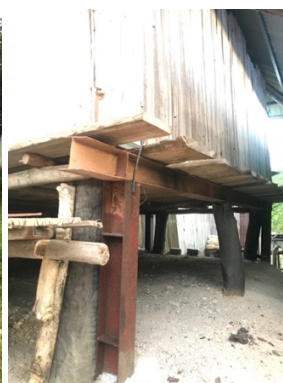
Figure 1Uma Lulik Asumeta with the roof used by Zinc and its column support by the Iron, in Camea Dili; Source: SEAC, 2022;

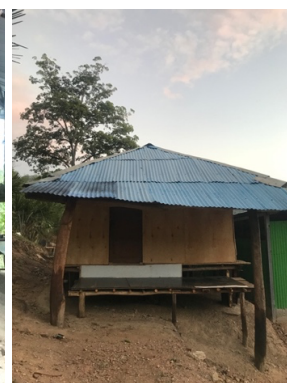
Figure 3- Uma Lulik Darlau Aimet and Berhunu with plants growth on the top of Roof in Manutasi, Ainaro; Source: SEAC, 2019

With all this if this process, noted that, the use of local materials for foundations and roofs is less common by local people. And the utilization of industrial materials is now considered as the biggest problem that Timor-Leste has been facing for several reasons, mainly in Municipalities, where communities no longer use local materials due to a lack of traditional knowledge of techniques and ritual practices and insufficient funding; in contra to the City or Capital, everything has been renovated with industrial materials due to a lack of acces to lcal materials and long distances. Such as the utilization of modern roof material of *Uma Lulik Asumeta* (Fig. 5), located in Dili, is also made of zinc and pinned with iron. It's surprising that spreading modern materials such as zinc cause more leaks than this traditional system. In the other case, as presented in (Fig. 6, 7)is in a poor state of repair because the roof has been partially destroyed by the weather; the plants growth etc.

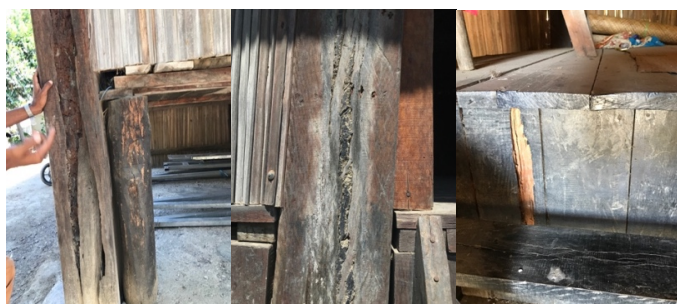
Figure 4 The condition of uma lulik of Leobesi Karketu Mota Ain: The Column that partially destroyed; The collagen of cement to the column; Partly structure that were painted by the oleo; Source: SEAC, 2023; .

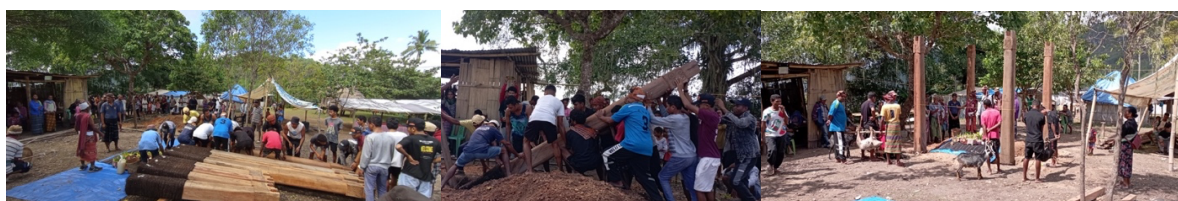
Figure 5-The pillars covering by *arenga pinnata* palm (*tua metan* or *tali metan* in Tetun), of *uma lulik* Hatumeo Koluli in Motalun Bazartete, Likisa; Source: SEAC, 2023

With this problems mentioned above, it's supposed to be applied some methods that are considered appropriate for the conservation plan of *Uma Lulik*. This implementation is based on an example of *Uma Lulik* that has the resistance and durability of being almost a hundred years old. The structures of some examples of this *Uma Lulik*, particularly the roof and foundation, are described in the following methods: For the roof and the foundation, both of which require the use of braided fibras of arenga pinnata/palm (*tua metan* or *tali metan* in tetun) as the covering to better impermeabilize the roof of the house, making the roof endure for more years by preventing water from entering through the grass, preventing it all from rotting.

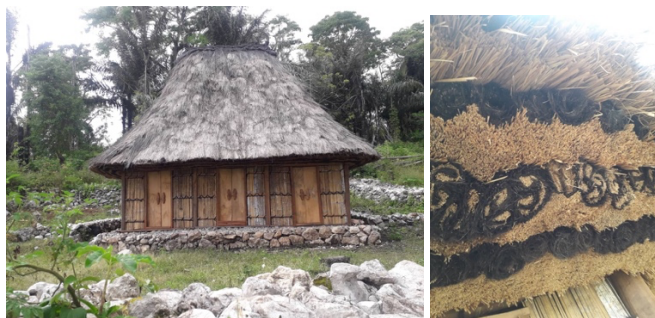
Figure 6 The seven alternating layers of grass and tali metan/arenga pinnata palm (*tua metan* or *tali metan* in Tetun), in Ossu Viqueque ; Source: SEAC,2018;

The other structure is the roof, which is one of the elements facing the same problem as the foundation in East Timor. The process of finding the forage and palm leaf for the roof covering is also the same as for the foundation, it starts with the ritual ceremony to protect from animal and fire. There are two basic types or roof covering. The first consists of using forage /grass to cover the house with a larger amount. To cover the roof, the forage is laid out in the bundles, which are called boan in Mambae. The boan are then placed in rows of several superimposed layers on the roof, fitting one row with the other as if they were roof tiles. The cover formed by the boan varies in thickness from 25 to 40. Somehow, the good insulation from the heat due not only to the nature of the material but also to its thickness, which reaches around 0,5meters and is made up of alternating layers of grass/forage and Gamuti /*Tali Metan*.
