# Disaster Risk Management for Cultural Heritage in the Asia-Pacific Region

Current State and Issues (II) :  
Post-Disaster Recovery and Resilience-Building  
Case Studies

DISASTER RISK MANAGEMENT FOR CULTURAL HERITAGE IN  
THE ASIA-PACIFIC REGION

CURRENT STATE AND ISSUES (II):  
POST-DISASTER RECOVERY AND RESILIENCE-BUILDING CASE STUDIES

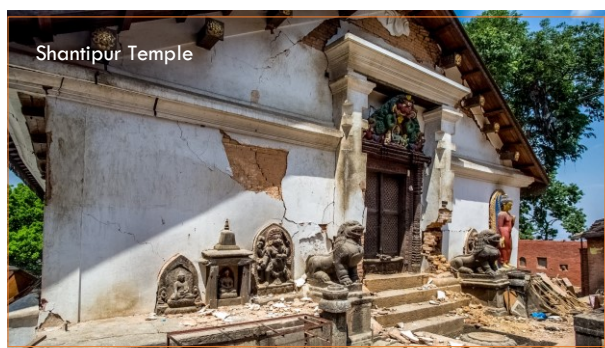
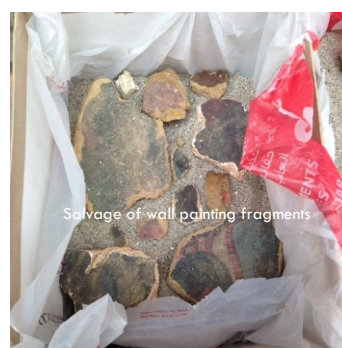
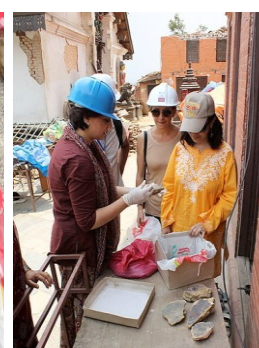
temple was stabilised from the outside, it was possible to detach the remaining parts of the wall painting and place them on a secondary support. The painting fragments were painstakingly pieced together and adhered to the new support.

On my next visit in 2016, I saw the restored wall painting lying on the floor of one of the exhibition areas of the National Museum at Chauni, Kathmandu. The temple priests were divided over whether the restored mural could be used in active worship, or a new wall painting should be commissioned. Before the earthquake, wall painting was used for performing rituals and religious ceremonies. Therefore, during the emergency response phase the priests and their families, the local volunteers, DoA and UNESCO deemed it important to salvage the damaged painting and restore it. However, some priests opposed reinstalling the restored mural in the temple during the recovery and rehabilitation phase.

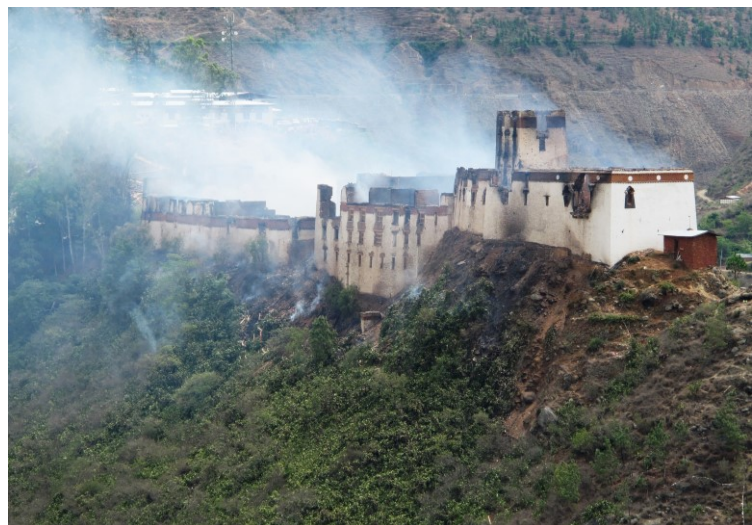
Figure 3. Dzong after fire of June 24,2012 Source: DCHS

While the Wangduephodrang Dzong was undergoing renovation works, the unfortunate fire incident engulfed the entire Dzong in flames on June 24, 2012. The fire had started around 4 pm in the evening and the blaze rapidly spread to the entire dzong razing one of the national treasures to the ground leaving it in ruins apart from its foundation and lowermost portions of the walls.

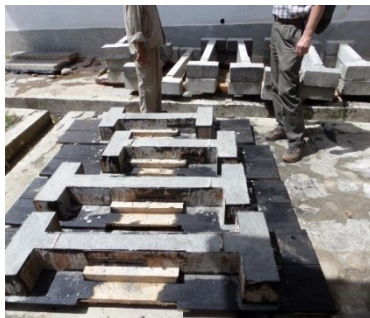
Figure 5. Fritz stone. Source: DCHS

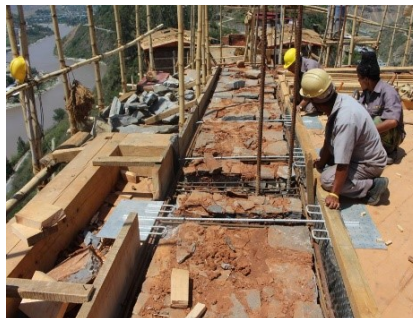
Figure 6. Installation of Wangdue latch  
Source: DCHS

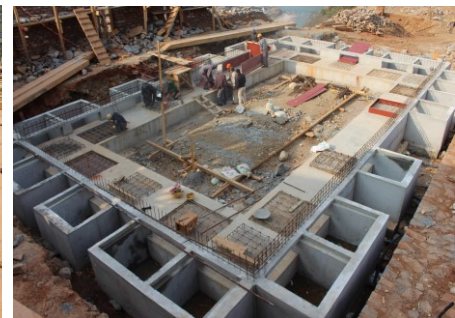
Figure 7. Construction of base isolation  
Source: DCHS

The Utse is equipped with sliding bearings at the corners, the centre of the walls, and the elastomer bearings adjacent to the corners separating the main structure from its base. The bearings were designed to absorb the shock from the ground during earthquakes, keeping the Utse safe.

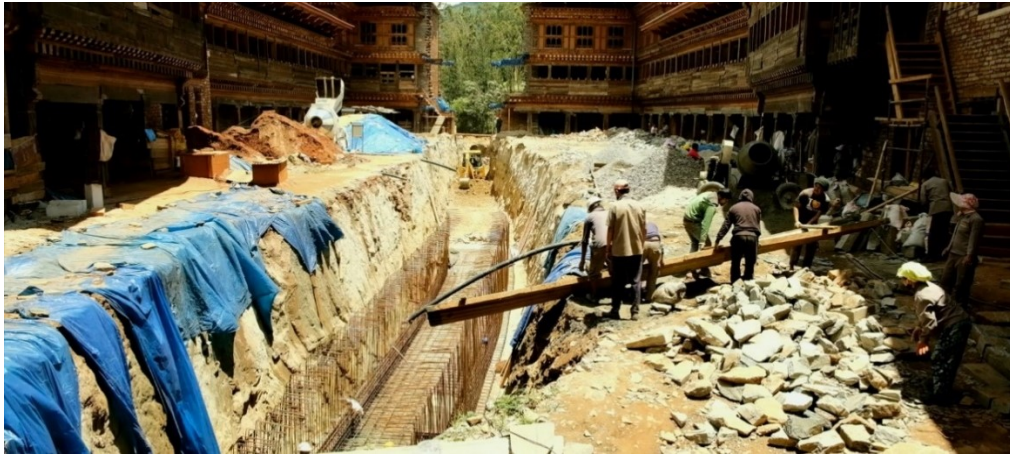
Figure 8. Construction of the service tunnel. Source DCHS

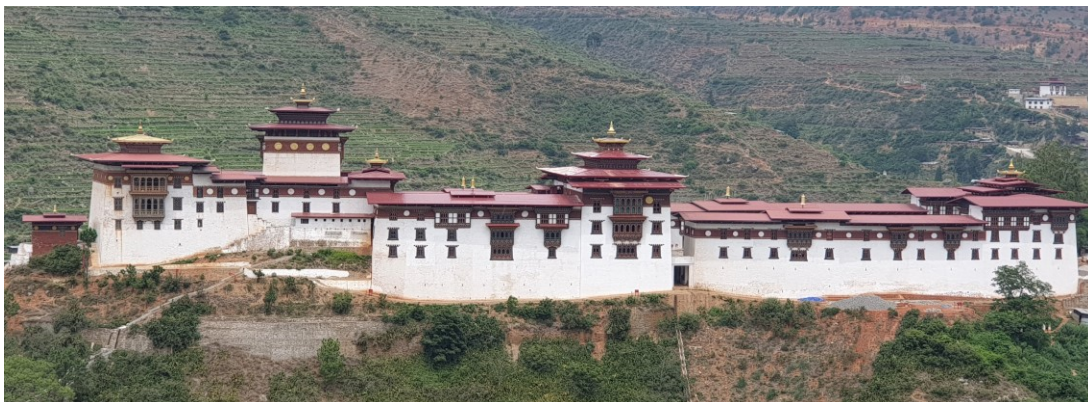
Figure 9. Dzong after Reconstruction. Source DCHS

The overall design of the Wangduephodrang Dzong was reconstructed based on the earlier form and layout of the Dzong. Besides, the incorporation of modern intervention measures, the Dzong was constructed using traditional skills, techniques and materials. However, few alterations especially on door and window openings were made as per the new functions and requirement of the Dzong. With the completion of the reconstruction of the Wangduephodrang Dzong, the Dzong stands as one of the best examples of the integration of state of the technologies with modern strengthening features while maintaining the traditional Bhutanese architecture.

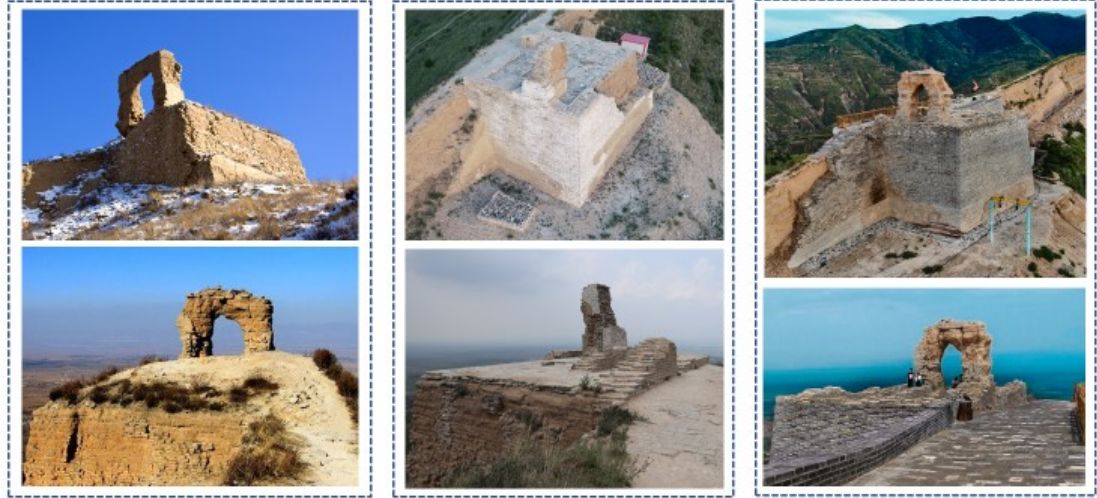
**Figure 1.** The Moon Gate before destruction (left), after the rescue in 2017 (middle), and after the conservation and exhibition project in 2019 (right).

The rebuilding of the Moon Gate faced numerous challenges, of which the most serious one was the impossibility of 3D scanning approach, since the structure had already been destroyed. To deal with this situation, web crawlers were used to obtain over 3,000 pictures of the Moon Gate before its destruction. Based on this collection of images, the project team managed to analyze the full construction process of the Moon Gate, which led to the successful establishment of its 3D model.<sup>4</sup>

To make sure the new Moon Gate to be identical with the previous one, original materials or techniques were not adopted in the recovery. Instead, stainless steel was used to build up the skeleton, while the surface was sculpted by cement according to the 3D model, and details were added by engraving. This scheme reproduced the sense of history that the Moon Gate brought, while its weight was reduced so that it caused less pressure to its basement. Additionally, the new Moon Gate would be able to be removed without damaging the platform at all if necessary. These technical measures fulfilled villagers' wishes to recover their landmark, while at the same time strengthened the Moon Gate structure as well as its platform, mitigating disaster risks for the future.

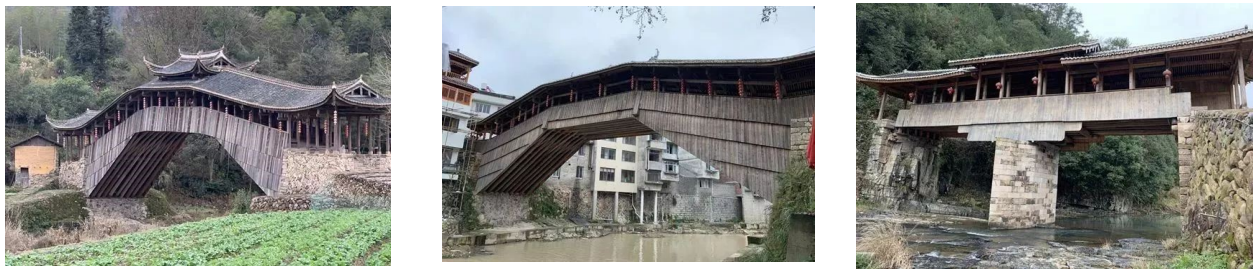
**Figure 3.** Xuezhai Bridge (left), Wenxing Bridge (middle) and Wenzhong Bridge (right) after reconstruction

Besides advanced technologies like 3D scanning and rebuilding simulations, traditional skills for wooden bridge construction also played a key role. Traditional design and practices for building Chinese wooden arch bridges were enlisted onto the List of Intangible Cultural Heritage in Need of Urgent Safeguarding by UNESCO. To ensure the continuous inheritance of this intangible heritage, the inheritors formed groups and were highly respected by the local government.<sup>7</sup>

Thanks to the rich experiences of the intangible heritage inheritors, as well as assistance from modern devices, it took six months to finish identifying the original locations of the wooden components that the villagers salvaged. Also, the inheritors could guarantee that original materials and traditional skills were used in the reconstruction, so that the maximum historical information could be conserved. Modern materials were only adopted near vulnerable joints to strengthen the structure, reducing damage risks under similar disasters in the future.

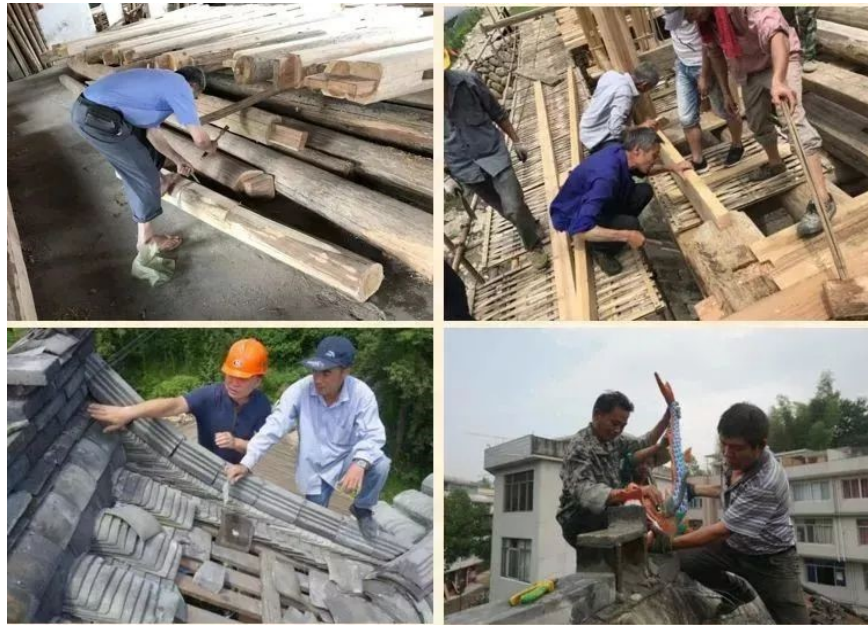
Figure 5. Intangible Heritage inheritors participating in the rebuild of Taishun Bridges

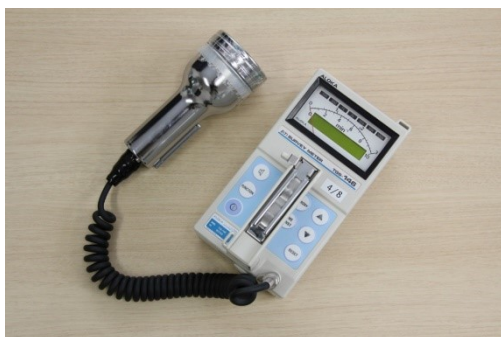
資料に付着した放射性物質の放射線量を計測する GM 式サーベイメーター

Geiger-Mueller (GM) survey meter for measuring radiation dose of radioactive substances adhering to historical materials

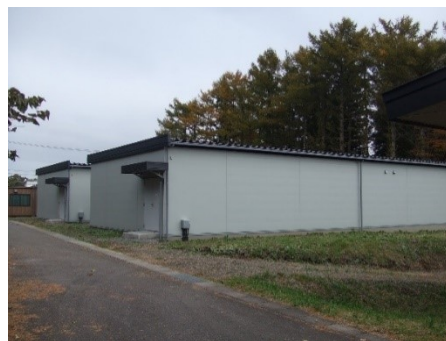
避難指示区域から運び出された文化財を保管する仮保管施設  
Temporary storage facilities for cultural properties salvaged from the evacuation order zone

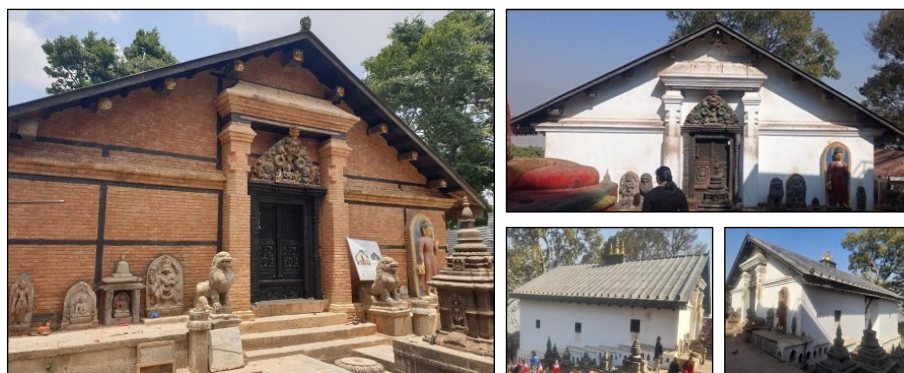
**SHANTIPUR TEMPLE : After Rehabilitation**

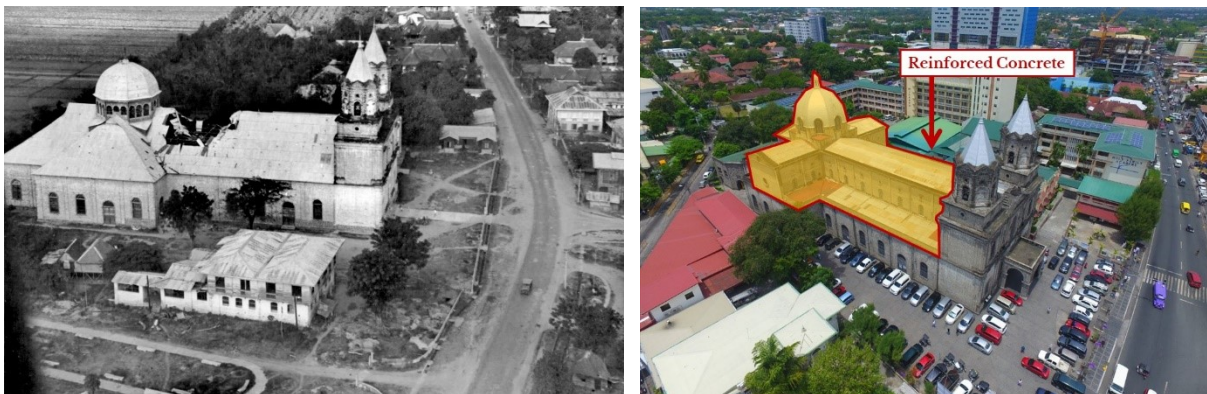
**Image 1** Left photo: 1945 photo of the HRP, showing the gaping hole left by the war aircraft above the church’s nave (Photo by © Robby Tangingco). Right photo: 2019 photo of the HRP. The superstructure made of reinforced concrete we see today was virtually non-existent in the original structure of the church (Photo by © ETFFI).

HRP which is built in 1877 – 1896, has undergone several interventions throughout the years and most of the interventions were deemed incompatible with the original materials and construction methods. These incompatible interventions put the church highly vulnerable to risks. The most prominent intervention in the church is the addition and integration of reinforced concrete structures such as the upper levels of the church, posts and lintels, roof drainage, and the octagonal dome also located on the upper level of the church structure. The church was originally built using unreinforced masonry, specifically pumice stones. The use of reinforced concrete may be attributed to the lack of knowledge of the original construction methods and the convenience using modern materials and building technology. The church’s roof was damaged on January 7, 1945 when a North American war aircraft plowed through the roof of the church.

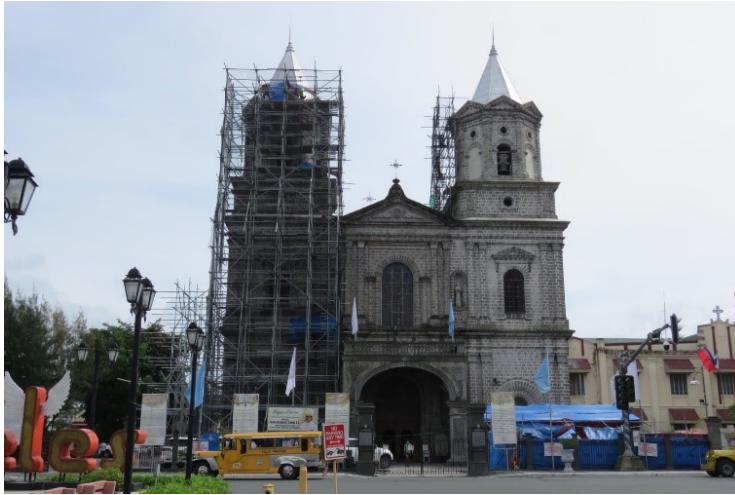
Image 2 The HRP under conservation works (Photo by © ETFFI).

engineers, suggested additional support to concrete superstructure to help relieve the original masonry walls of the weight from the added reinforced concrete structure.
