ACCU Nara
International Correspondent

Vol.26 2021

The Twenty-sixth Regular Report

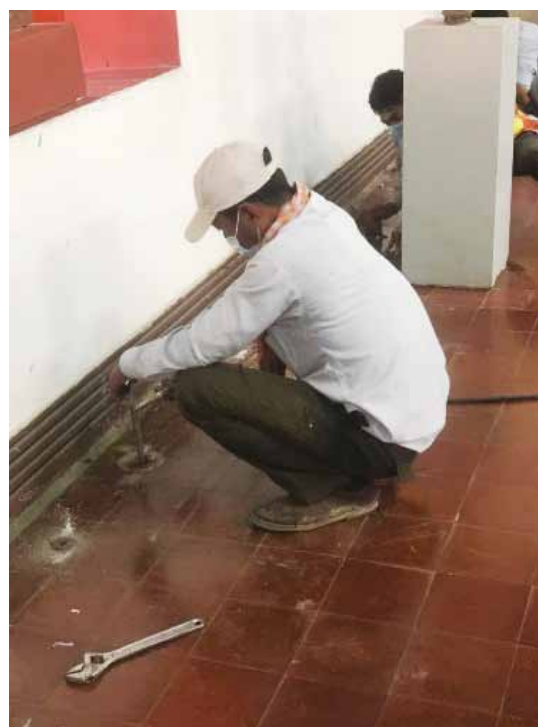
Fig. 3: Termite treatment

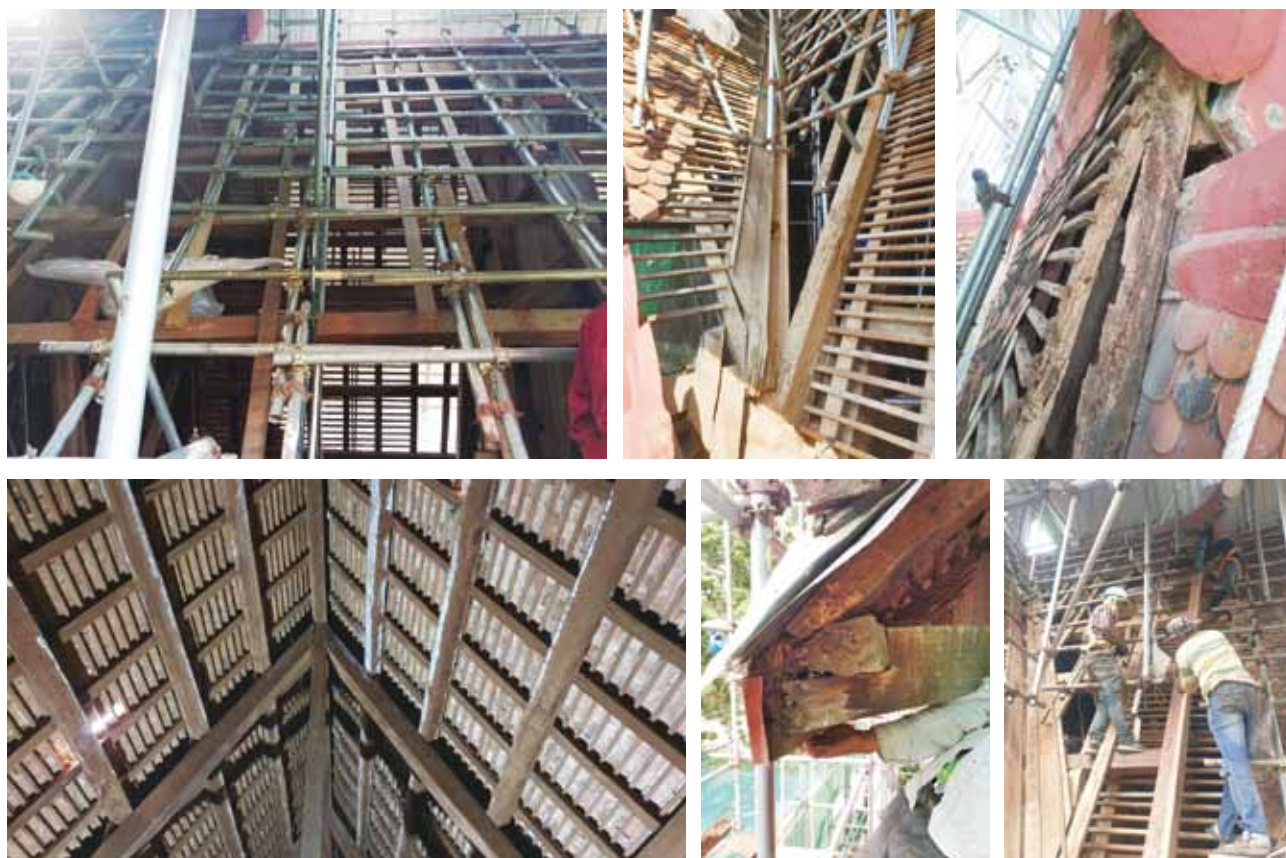
Fig. 5: Damaged timber

Much damage to part of the roof structure was evident upon dismantling work: Timber: most of the timber in this part had decayed, moved and displayed cracks. Roof Beam: damaged beam, cracks, and serious decay. Roof tiles: missing and moved tiles due to birds and exposure to the air. To start this project, the site was covered to facilitate restoration work. The roof tiles were removed to check and treat the damaged structure. Some of timber was removed and replaced. We will try to retain as much as the old structure as we can (Fig. 5).

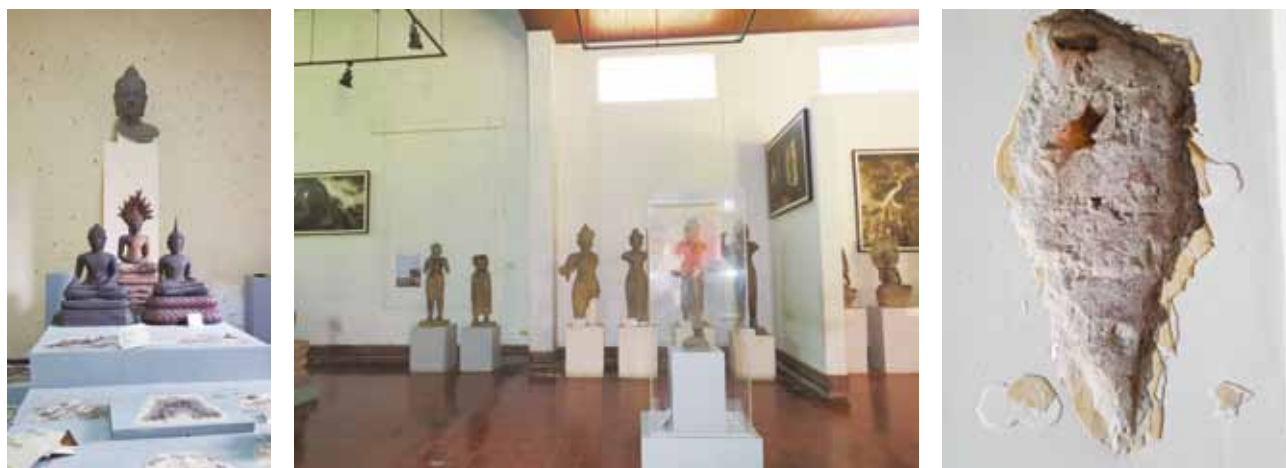
Fig. 6: Dirty wall due to pigeon droppings and peeling mortar

Currently, there is interior wall damage to some parts such as the mortar, and the paint is peeling and dirty due to pigeon droppings and dust (Fig. 6). The bricks of the wall will suffer more decay from humidity if the mortar receives no treatment. The wall damage must be repaired to help preserve the building and to improve its education and publication functions. The plan was to remove all the damaged mortar and replace it with new mortar and then repaint it. This work has resulted in some changes to the gallery giving the exhibition a new look of. For example: Special Buddha Exhibition gallery (Fig. 7).

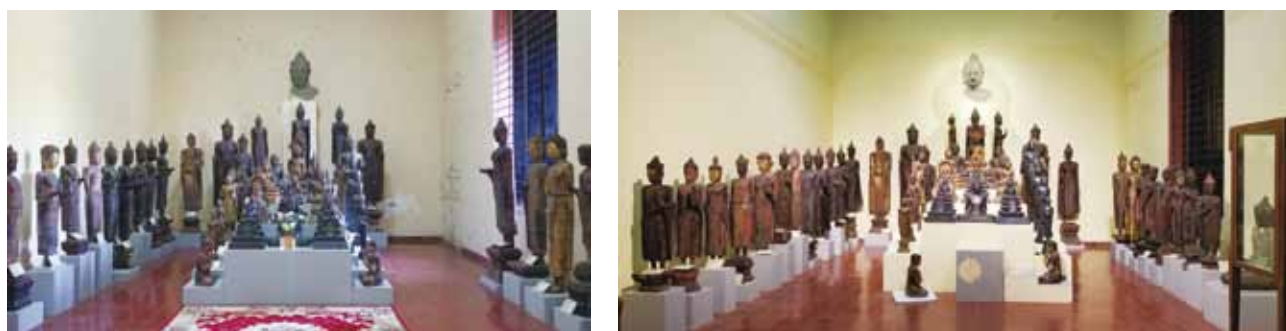
Fig. 7: Buddha exhibition gallery before and after repair of interior walls

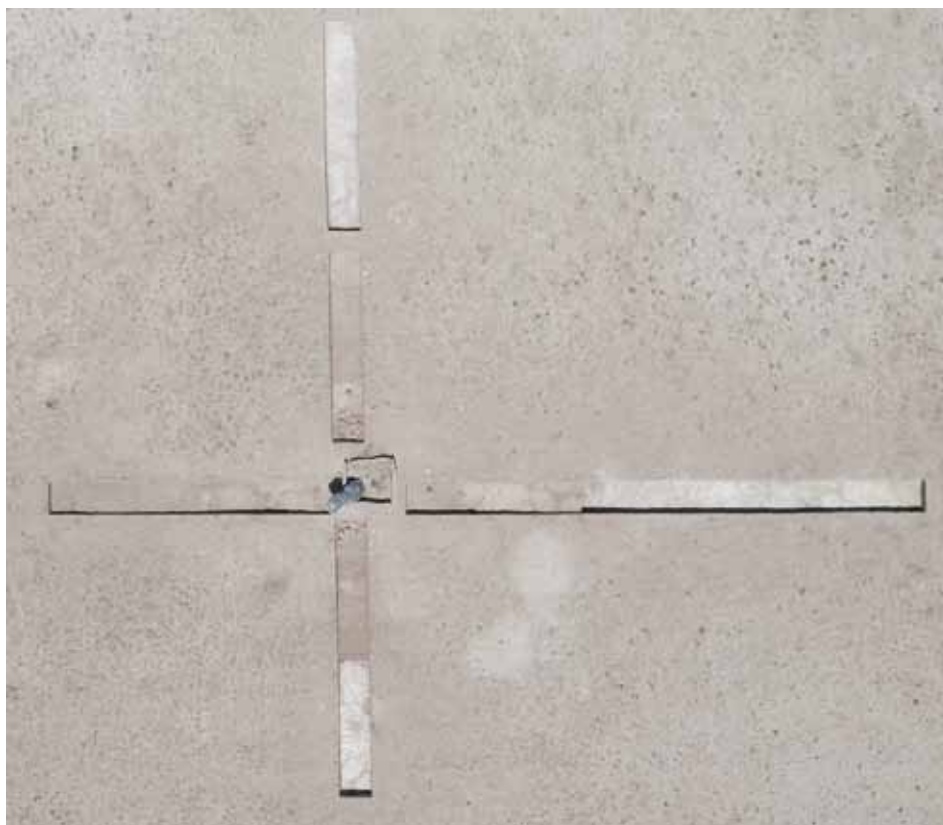
Fig. 3: Tsantyn Denj memorial complex, during the excavation

The features of the site that were only visible to the naked eye were recorded in the drawing of the plan before excavation. It should be noted that this is also consistent with the excavation results. It shows that in some cases, drone imagery may provide false information due to the vegetation of the area. On the other hand, the use of multiple methods and different techniques in field documentation proves that it is better not to rely on a single method or technique. The trenches on all four sides of the enclosure are marked as eastern, southern, western, and northern, depending on which side of the enclosure they were located (Fig. 3).

The total length of the trench is 13 m. Gravelly brown soil from the platform and stones from the slab bottom were found from this trench (Figs. 3 and 4).

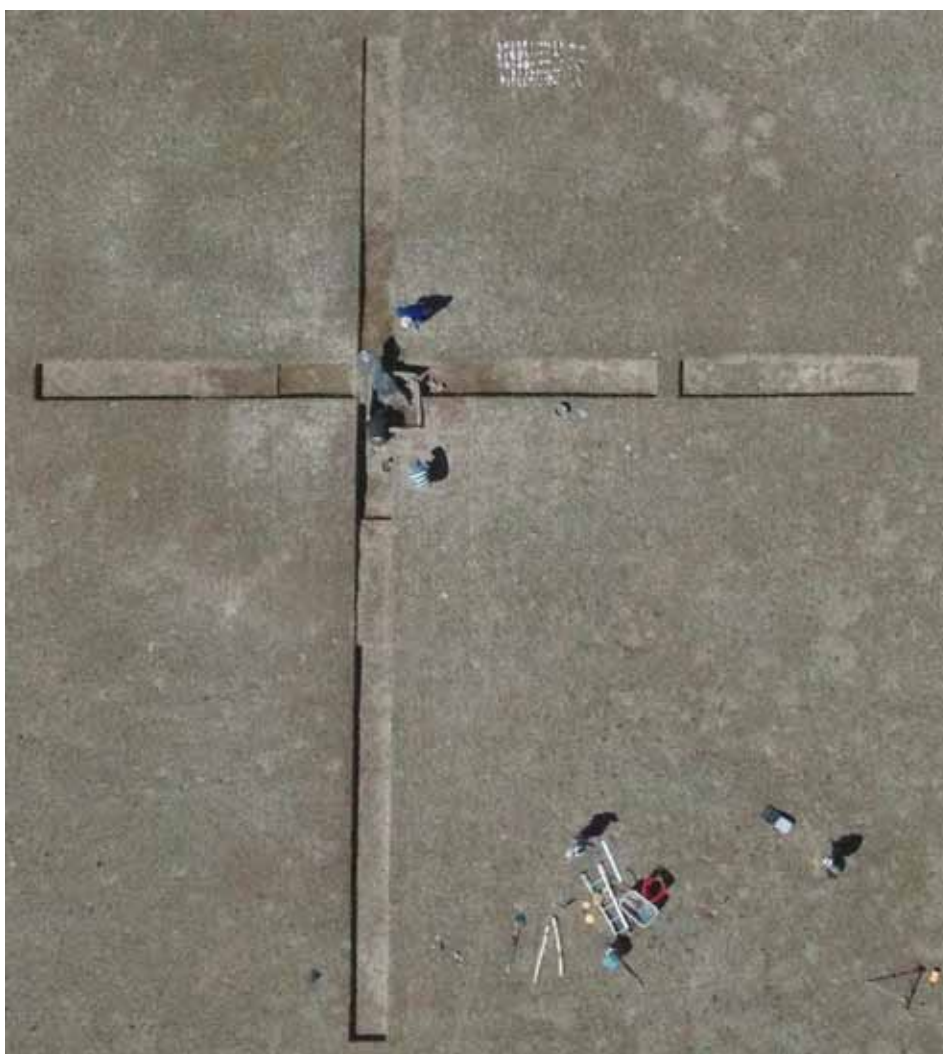
Fig. 4: The memorial complex, after the excavation

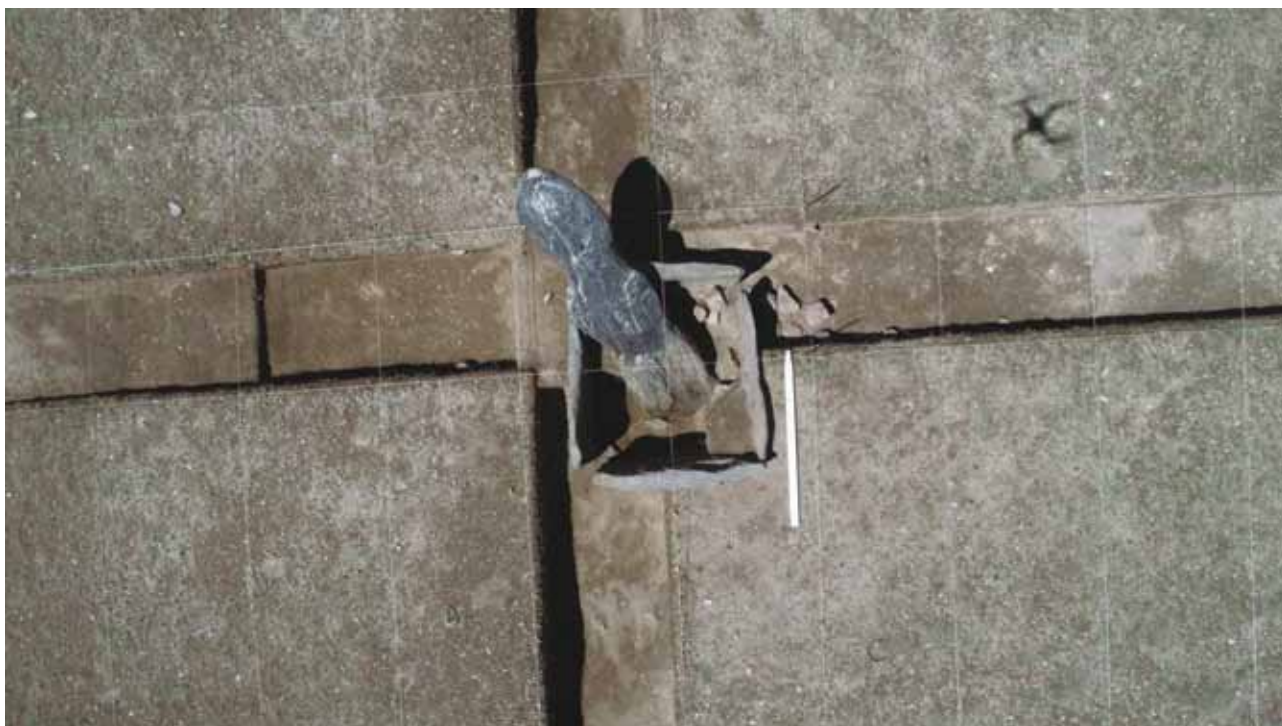
Fig. 5: Excavation of the enclosure

The state of preservation is not so poor. After the excavation inside the enclosure, it became clear that the total length of the statue was 254 cm and the width of the bottom side was 55 cm (Fig. 5). When the inner side of the enclosure was reburied, the stone statue was erected in its original position. It can be said that this prevented the enclosure from being pressed and damaged by the heavy stone statue.

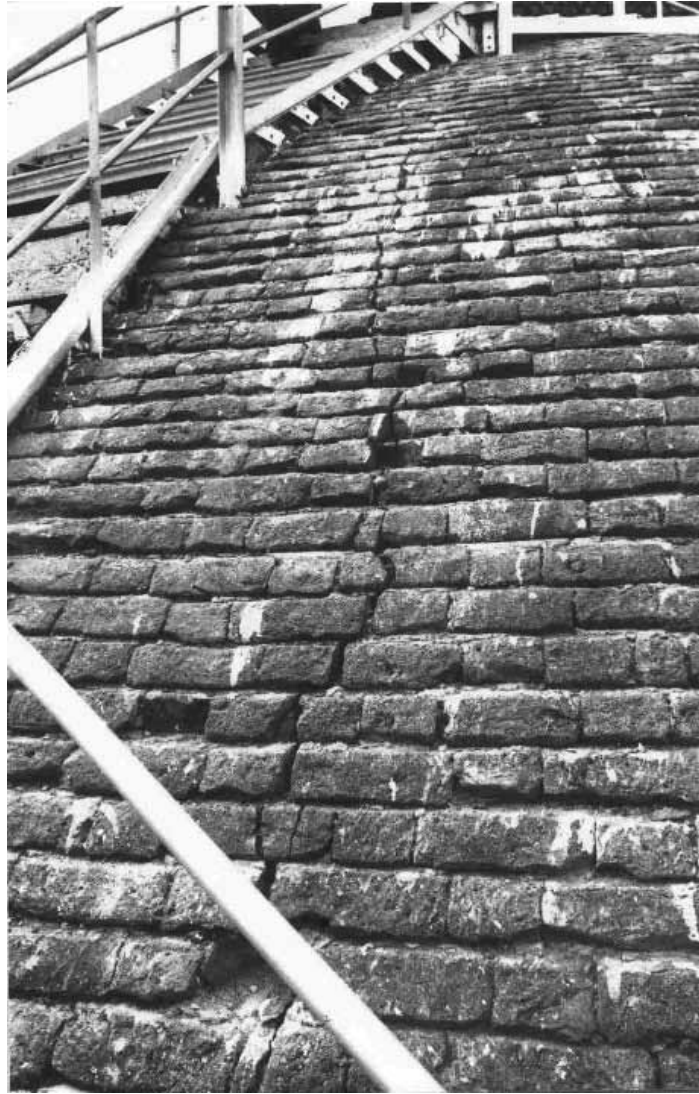
Cracks that appeared on the dome of Mirisawetiya before the failure

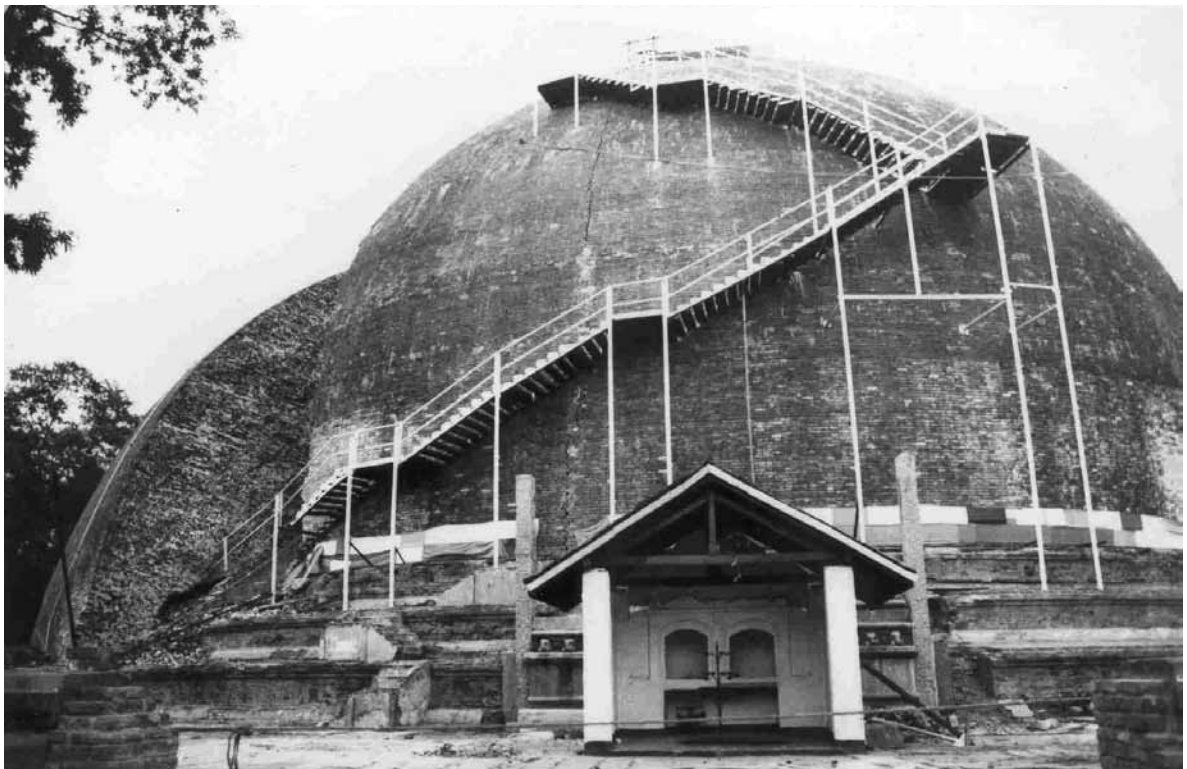
Failure of the restored dome of Mirisawetiya Stupa – Second attempt in the eighties

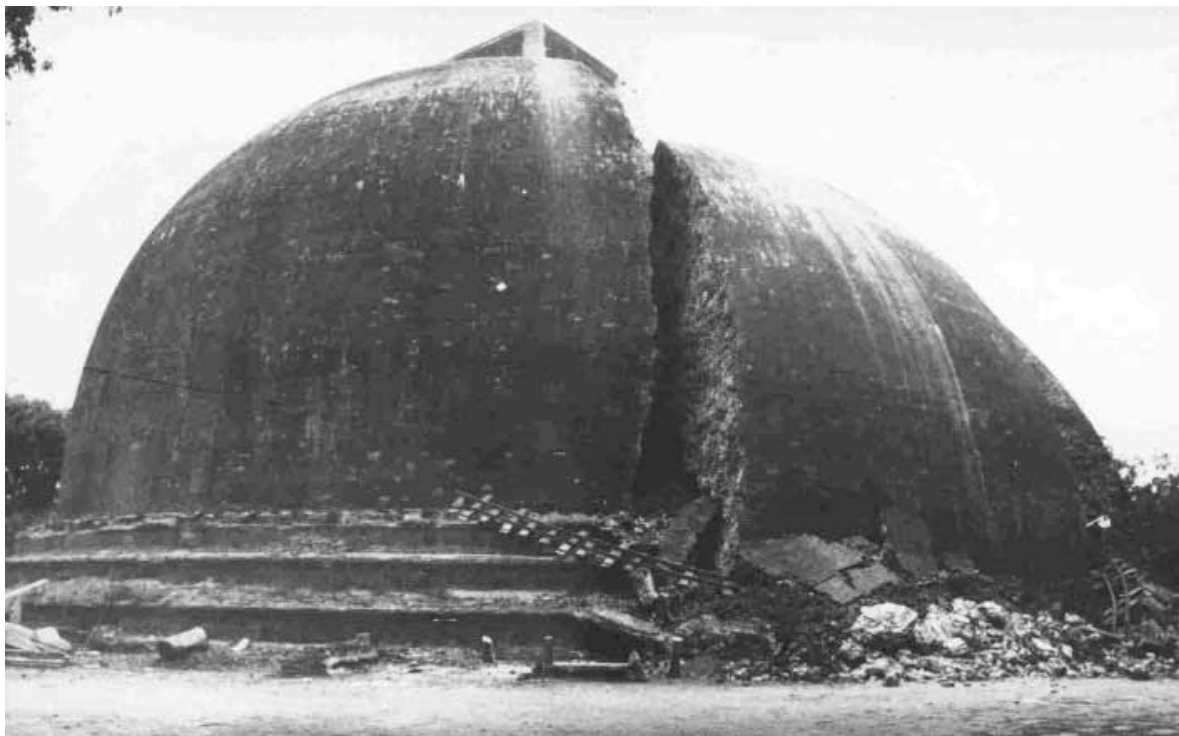
Failure of the restored dome of Mirisawetiya Stupa – Second attempt in the eighties

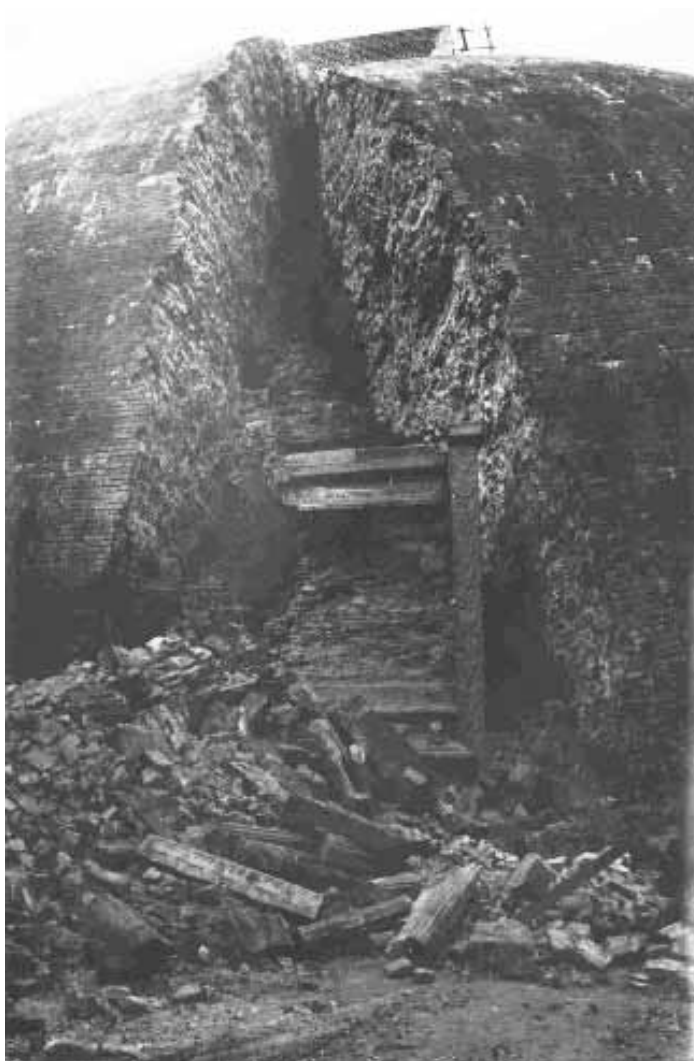
The damaged western Ayakaya

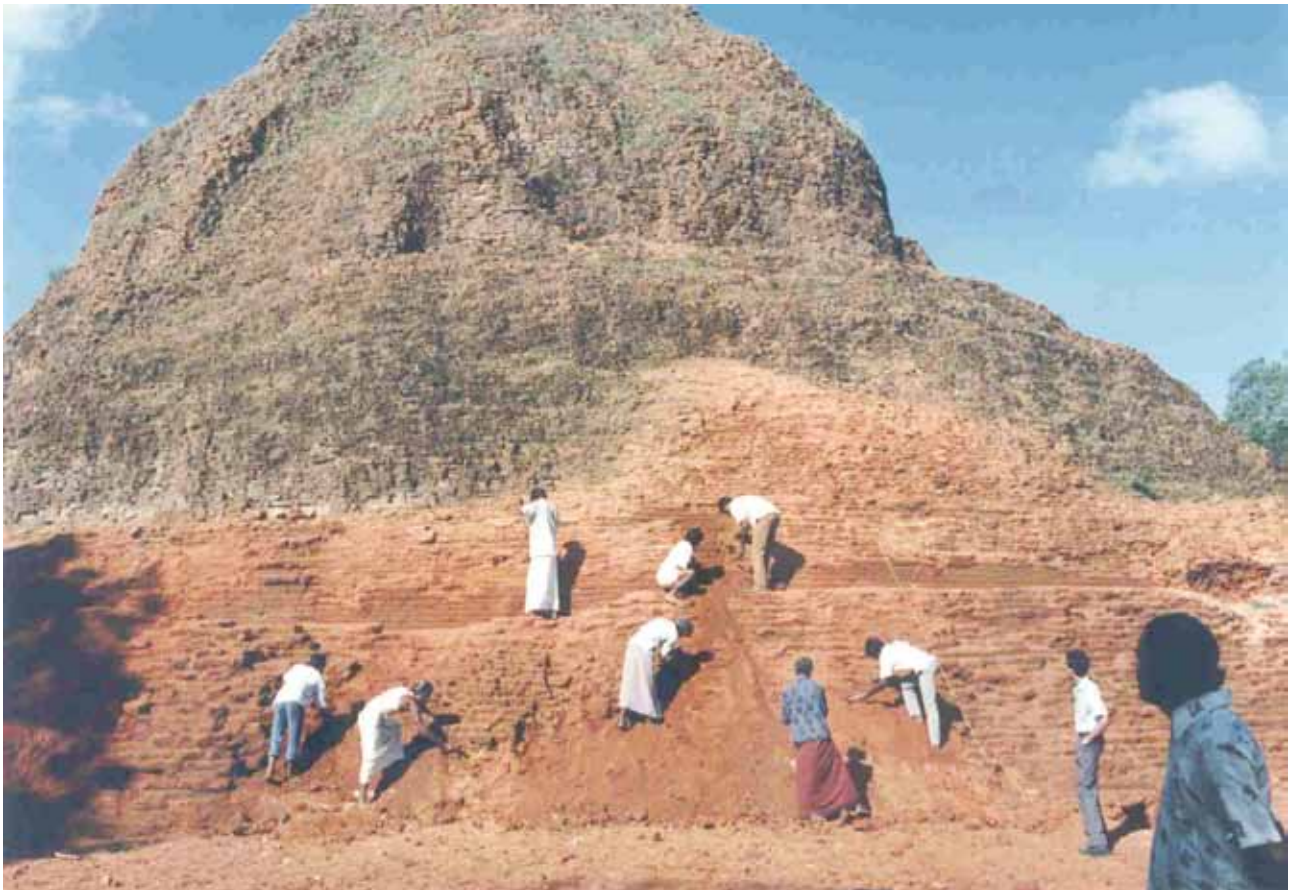
All loose ancient brickwork was carefully removed.

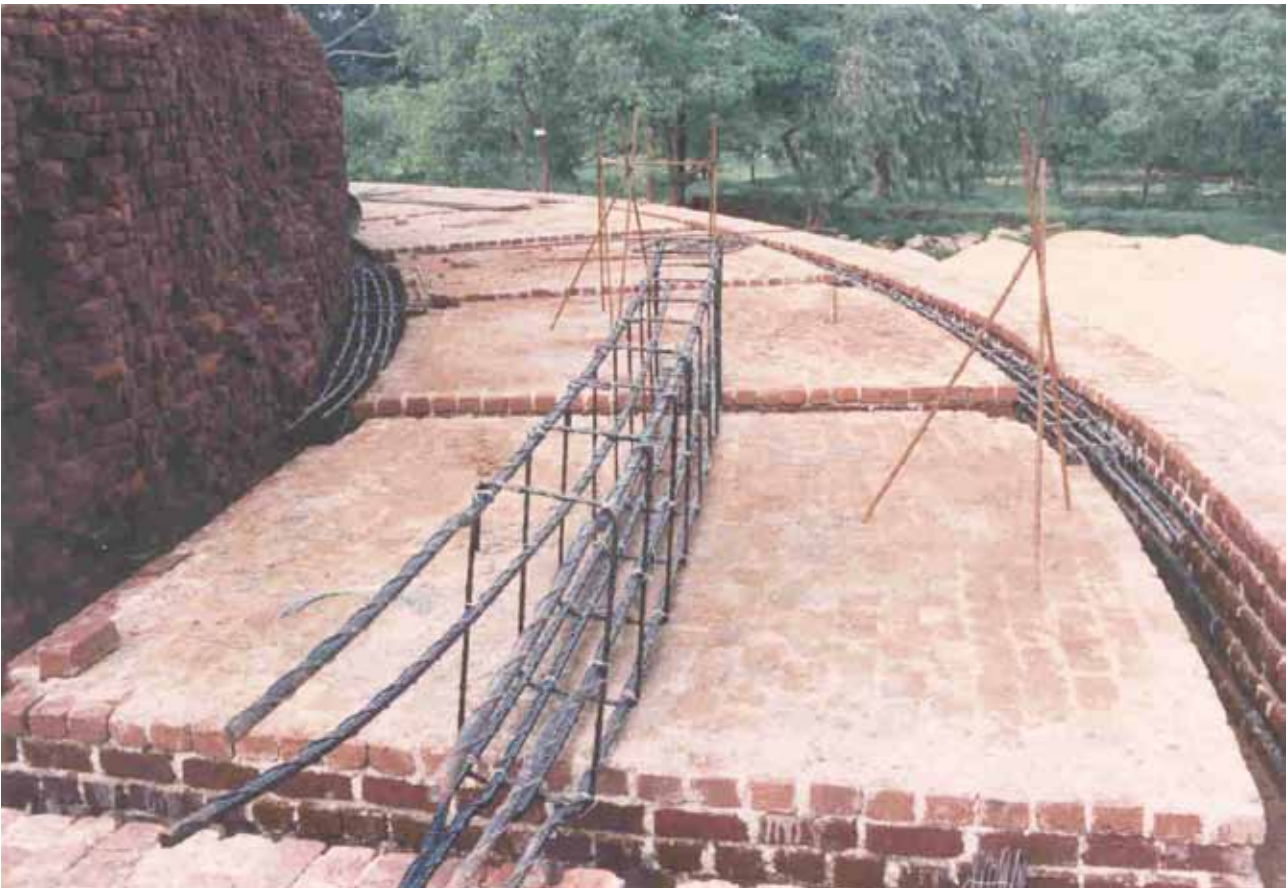
Prior to the casting of reinforced concrete rings

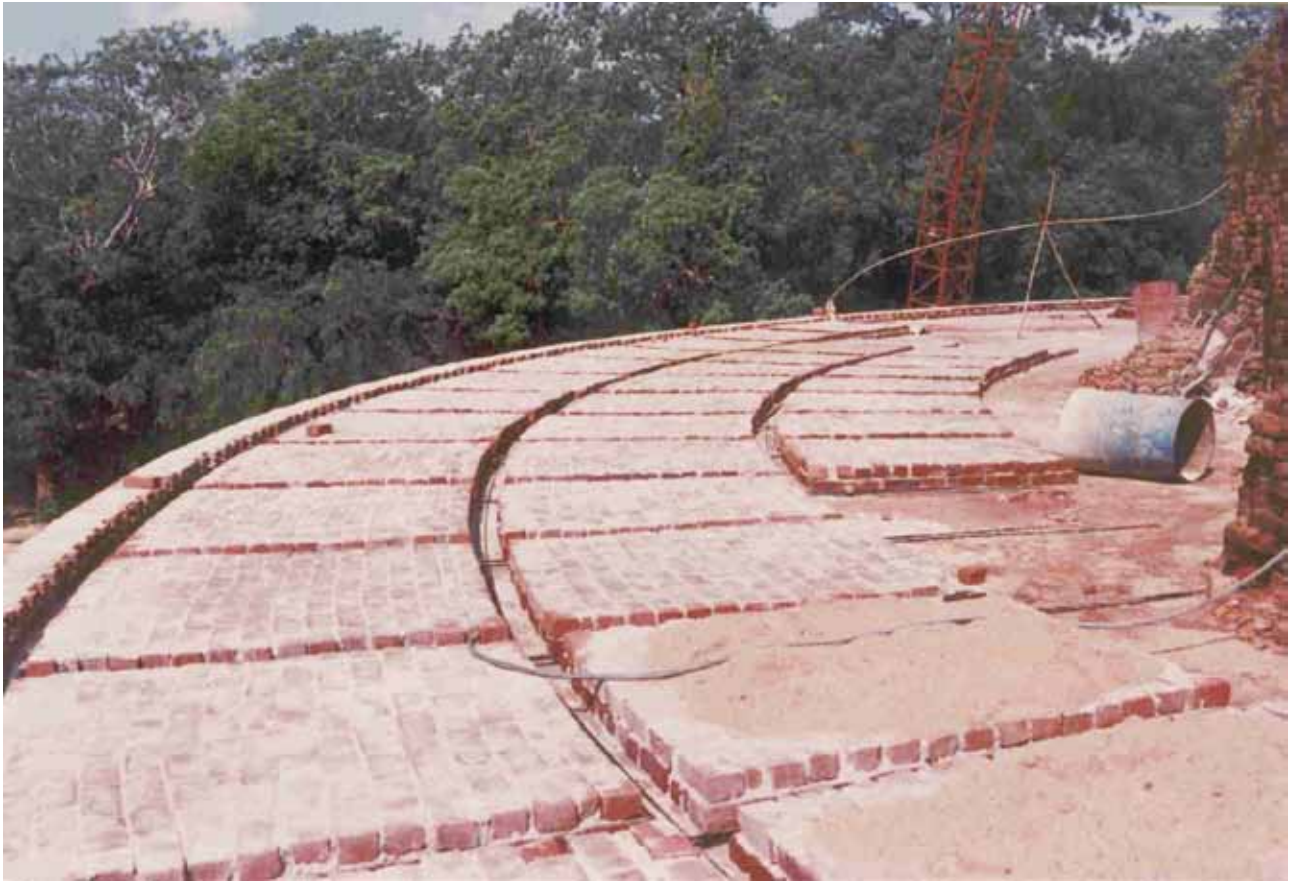
Prior to the casting of reinforced concrete rings

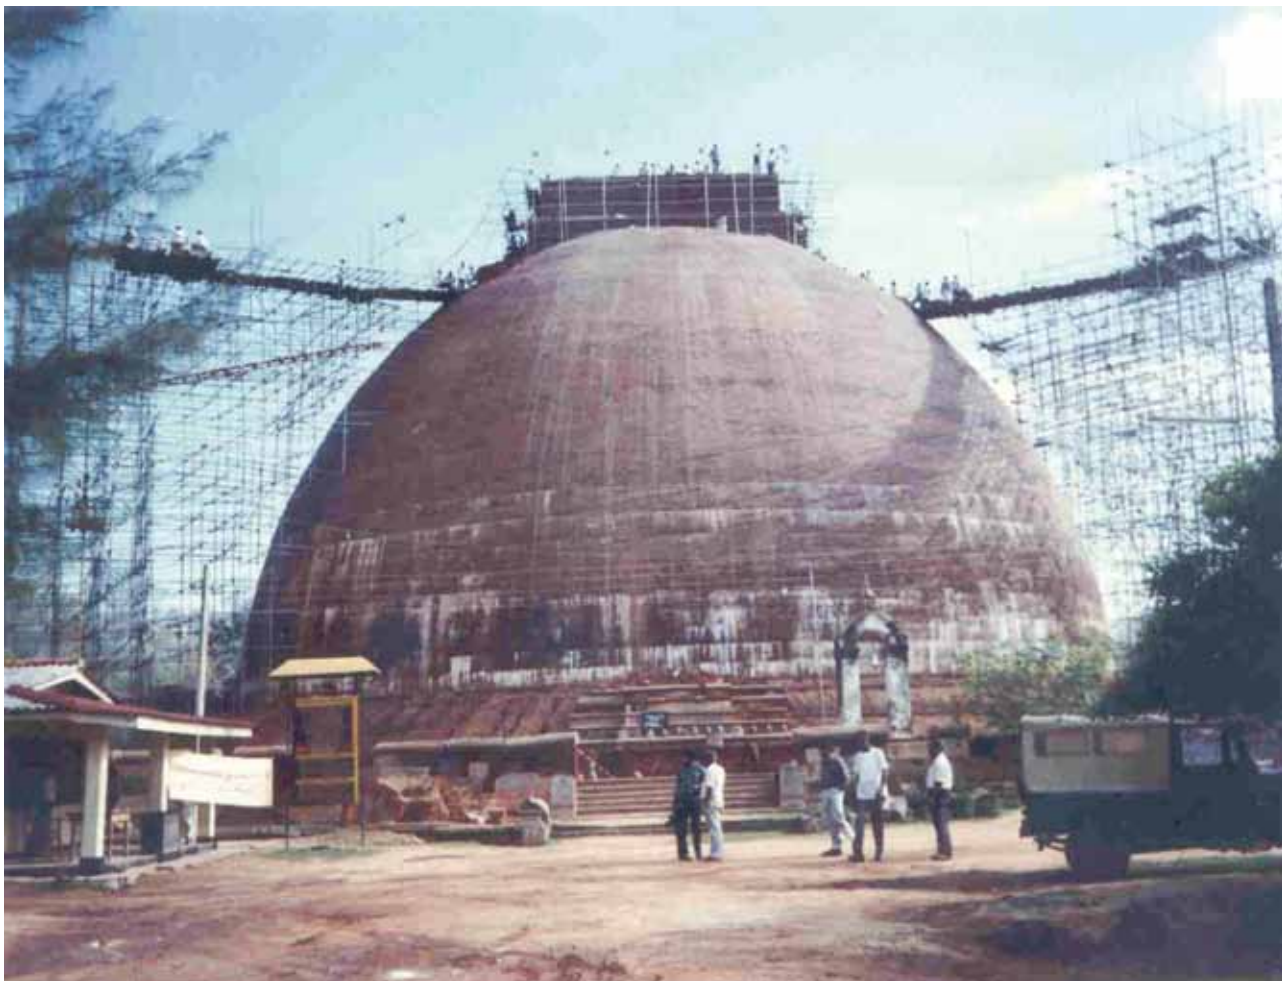
Dome completed—hatareskotuwa partially completed

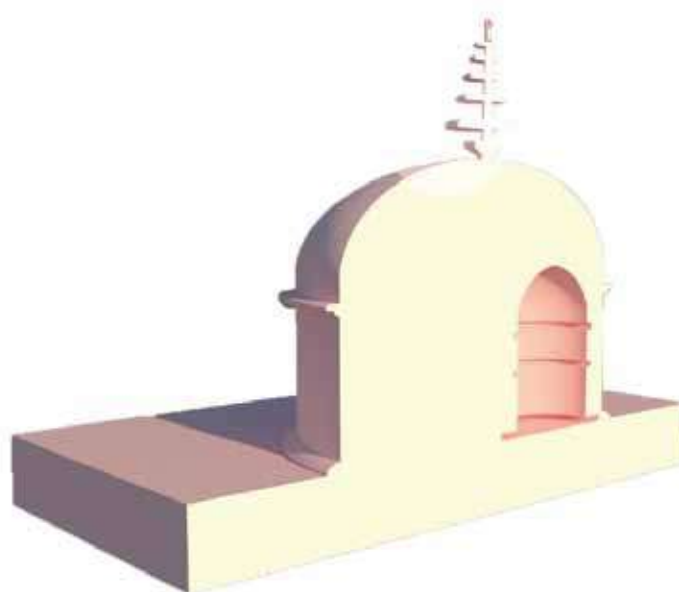
Fig. 4 a-b. Options for 3D reconstruction of the Ayrtaam stupa

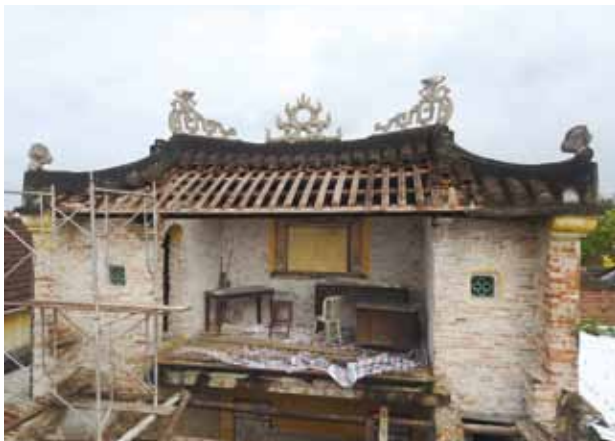
Flaked mortar walls were removed.

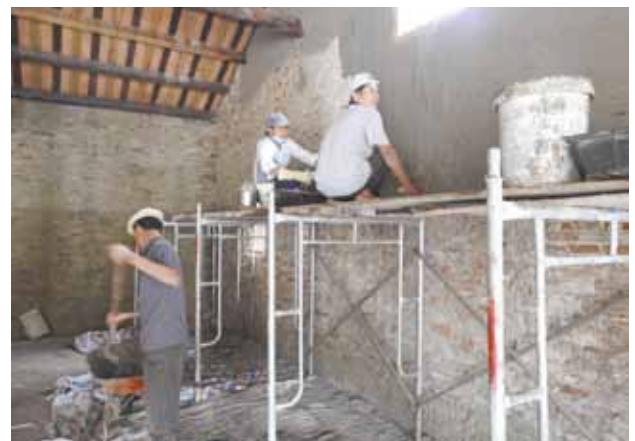
Rendering the walls with lime mortar
