ACCU Nara  
International Correspondent

# The Ninth Regular Report

Cultural Heritage Protection Cooperation Office, Asia-Pacific Cultural Centre for UNESCO (ACCU)

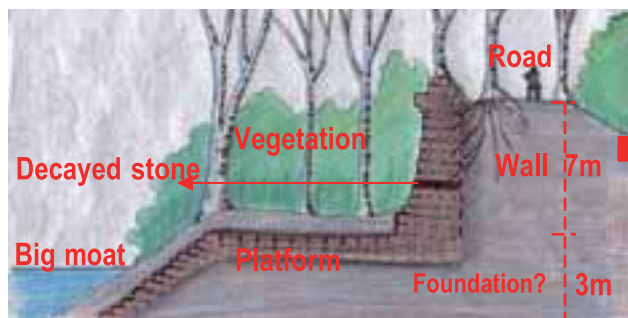
Wall in the normal condition

Responding to that problem, I took the urgent actions to survey damage and found the common reason for each collapsed point as follows (see the risky map and diagnosis figures):

- The rain caused weakness and erosion of the wall foundation.
- After raining, the stone absorbed the water and became loose.
- The tree roots were also the cause of collapse.

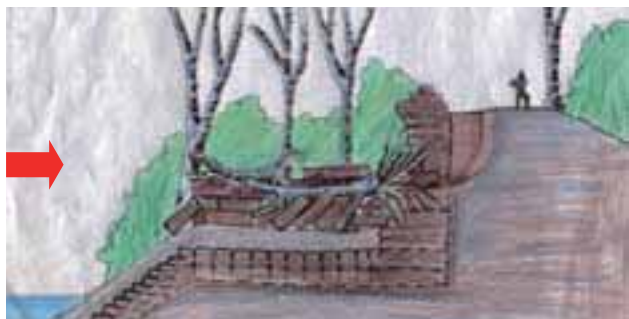
Collapsed wall condition

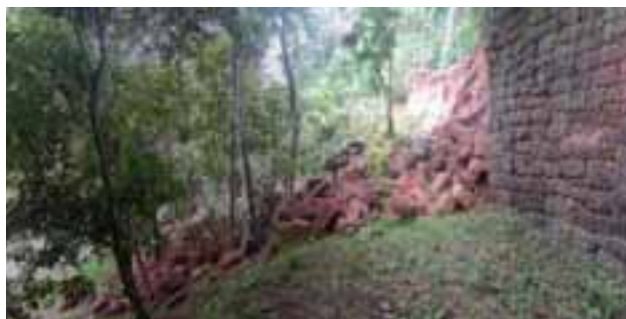
Collapsed wall in 17 m length on 11 Oct. 2011

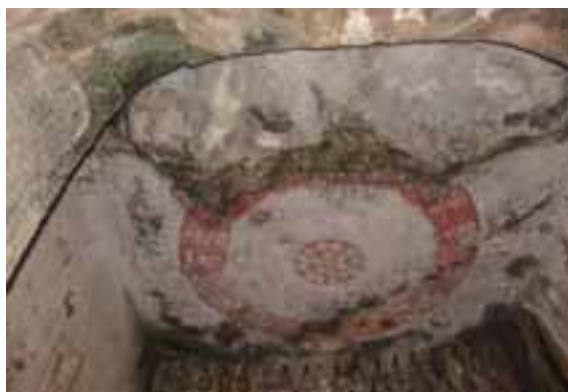
Fig. 1. Leaking water on the roof of the Wanfo Cave

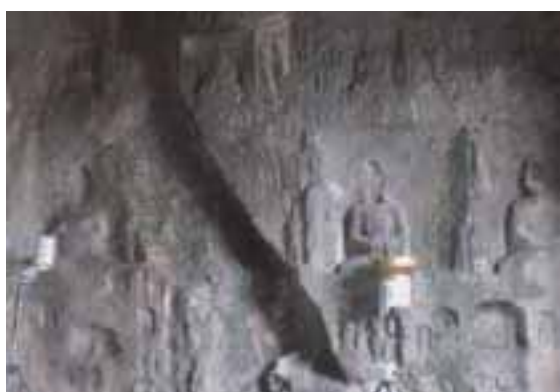
Fig. 3. Leaking water running through cracks on the north walls inside the Ludong Cave

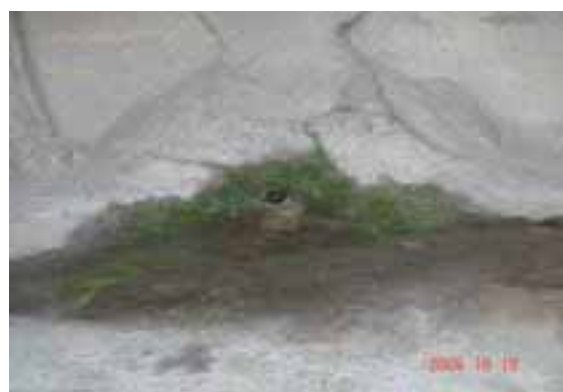
Fig. 4. Biological deterioration on the ground caused by drip water from the roof of the Yaofang Cave

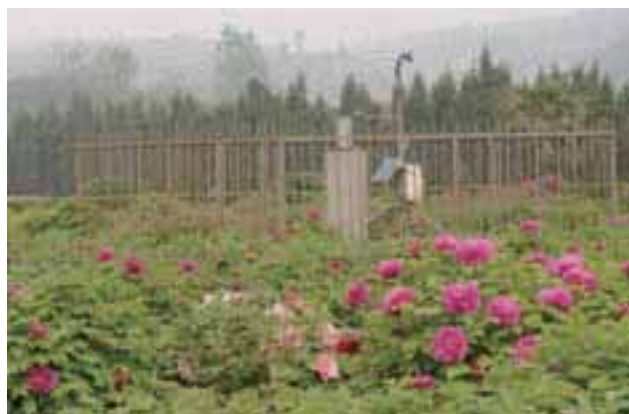
Fig. 5. Weather observation station in the Longmen Grottoes

The outside cave monitoring contents of the leaking water monitoring system include seven items: atmospheric temperature, atmospheric humidity, precipitation, cave leaking water quantity, underground water level, and mountain soil water content.

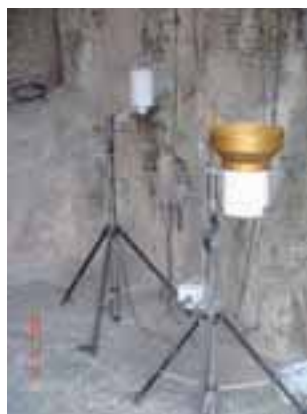
Fig. 6. Temperature and humidity meters and drip measuring apparatus inside caves

Inside caves monitoring contents include six items: temperature, humidity, rock surface temperature, cave leaking water quantity, and leaking water time and area photographed by digital cameras.

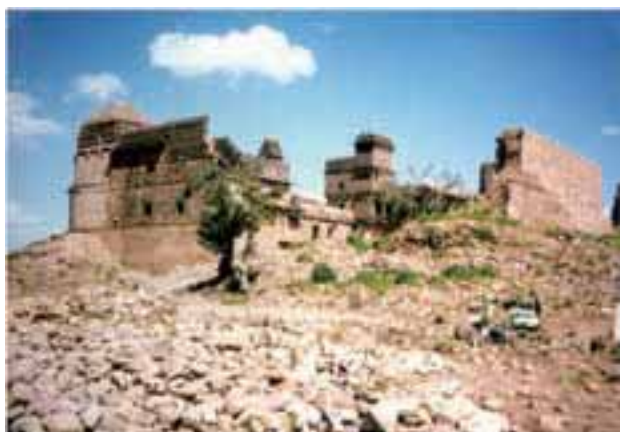
Navkhanda Mahal in damaged condition

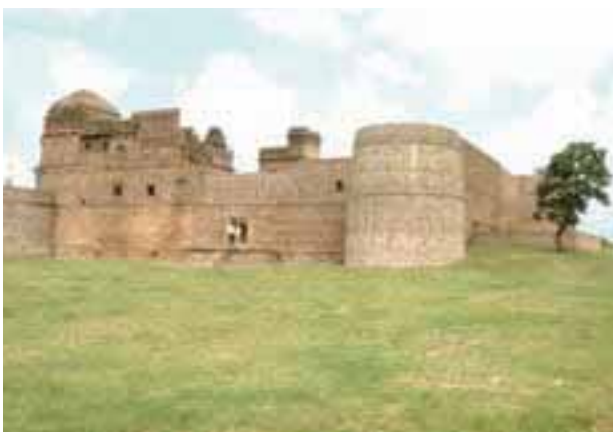
Navkhanda Mahal after conservation and restoration

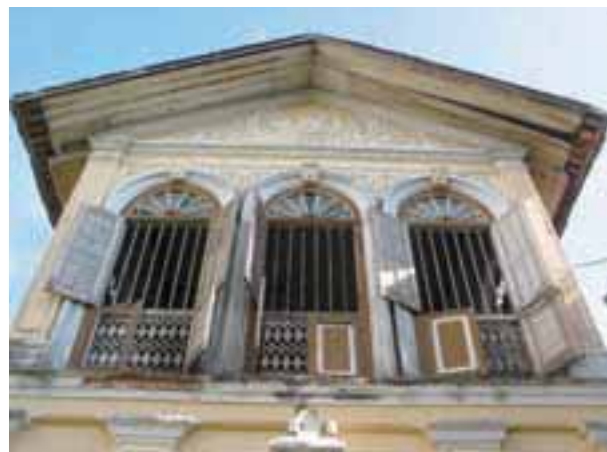
A dilapidation survey conducted on the Teh Bunga House, prior to restoration works, diagnosed serious problems affecting the building exterior and interior

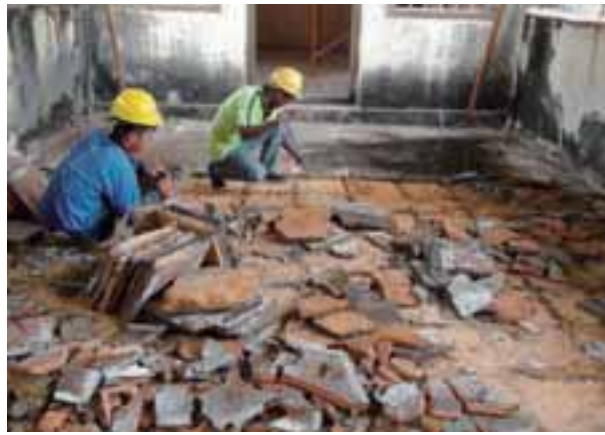
Damaged terracotta floor tiles at upper floor were replaced with the new ones of similar type, material and size as the original.

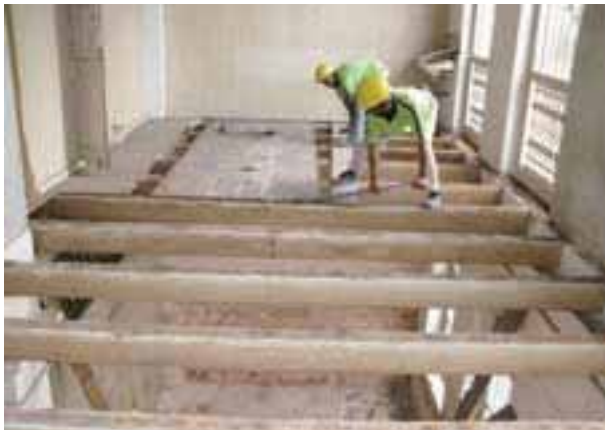
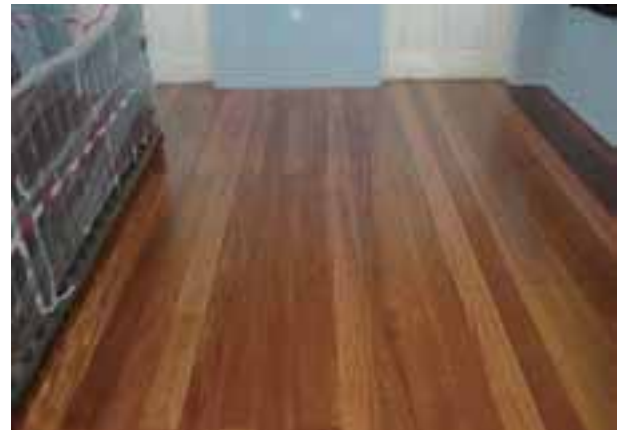
Timber floorboards at upper floor were carefully removed, inspected and replaced with new timber of similar size and species to retain the building authenticity.

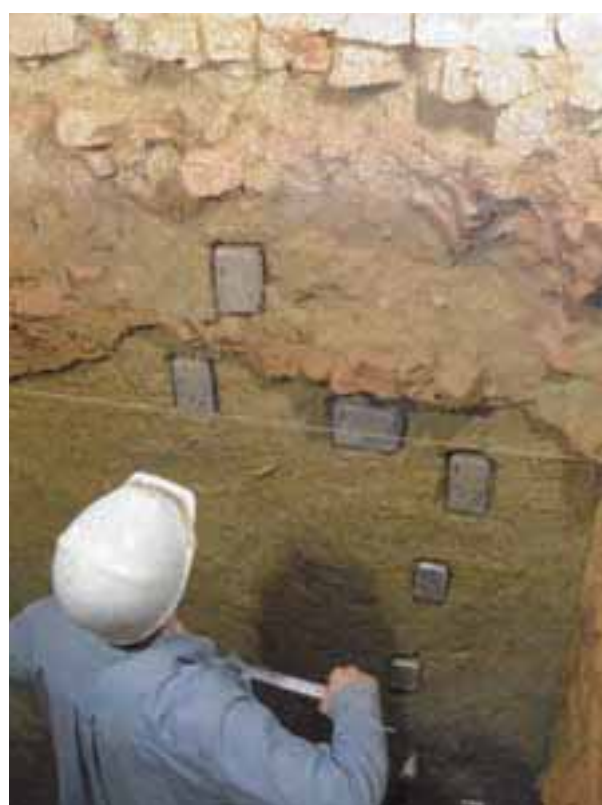
Extracting samples for scientific test for OSL dating, January 2011

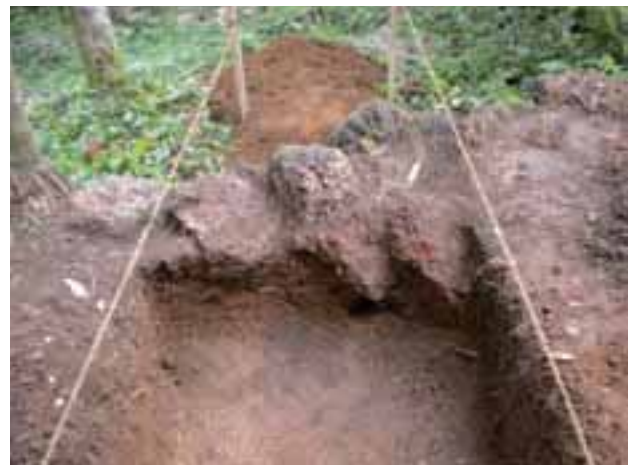
Original wall, unearthed during excavation

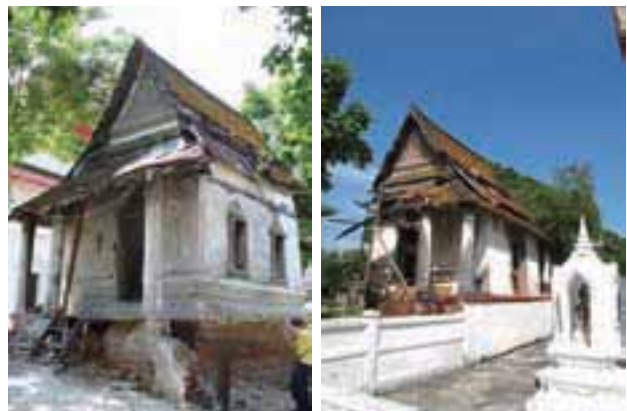
Figure 1: Exterior existing condition of The Tripitaka hall in the preliminary survey: (a) the north, (b) the south

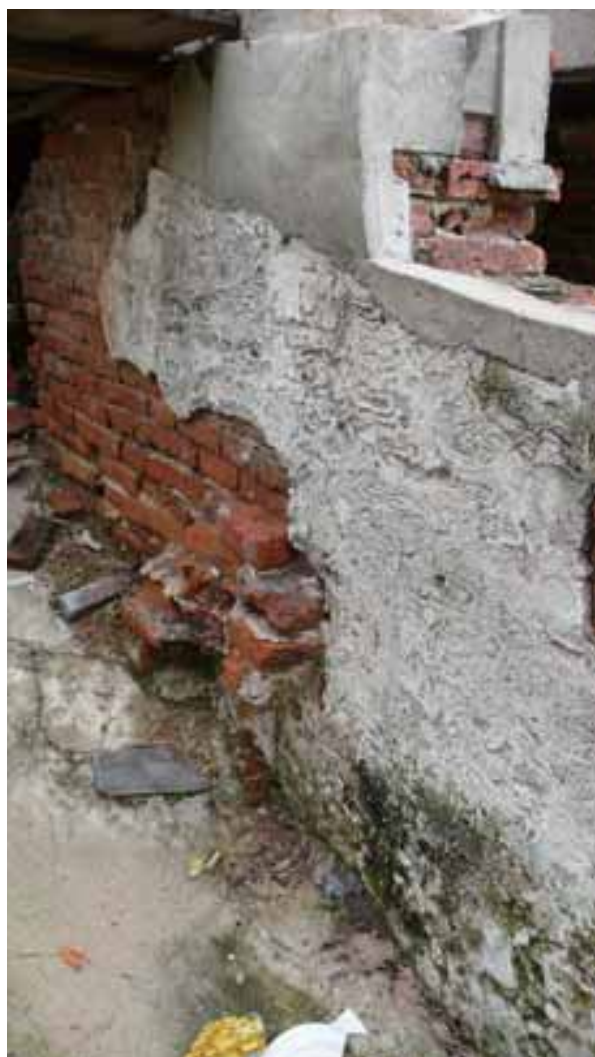
Figure 4: The ruin of brick structure like a wall extending a short distance from the lower part of the building in the north.

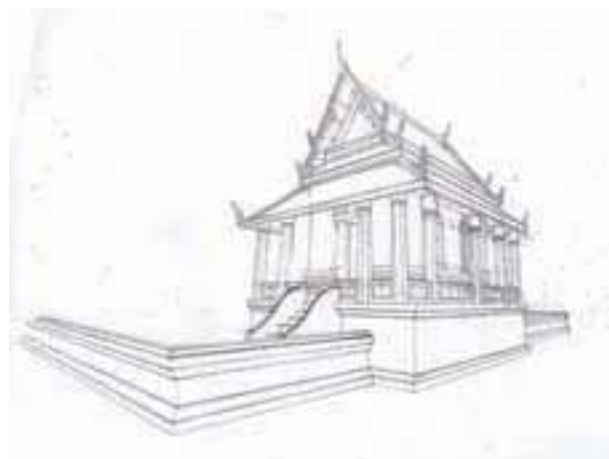
Figure 6: The perspective drawing of reconstruction model of the Tripitaka hall after finishing the preliminary survey.

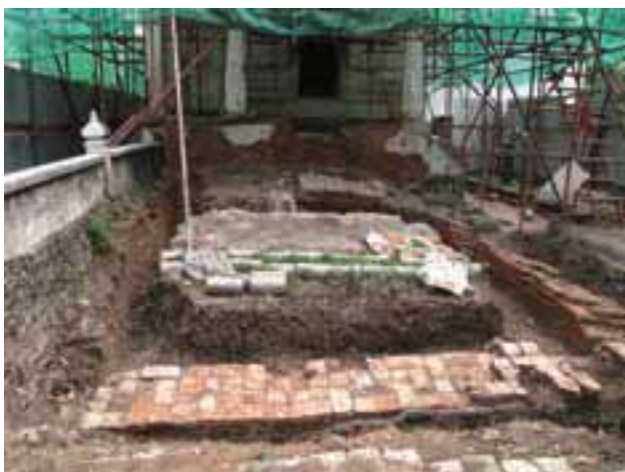
Figure 7: From the excavation, a remaining building base extending from the Tripitaka hall.

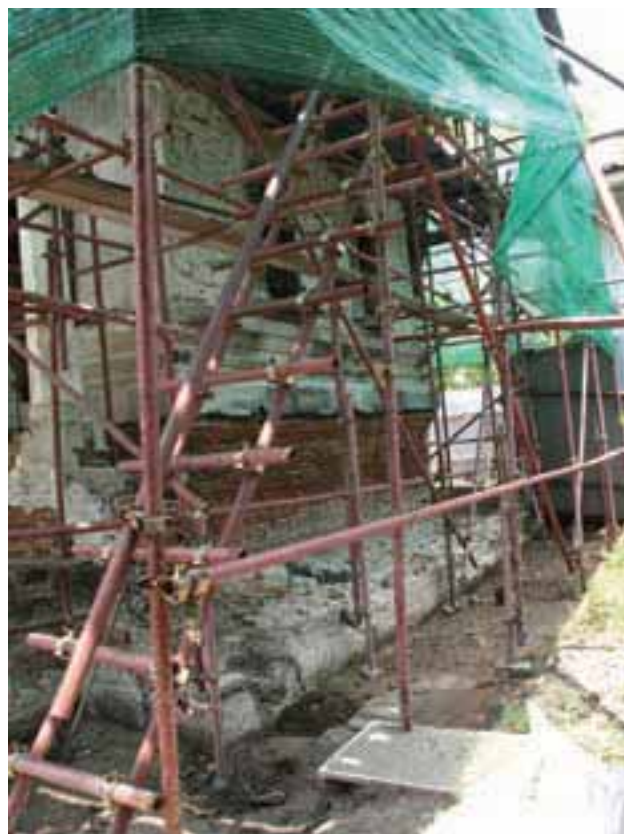
Figure 8: The remaining base structure of disappeared corridor, the brick patio and the gutter after finishing the excavation in the west.

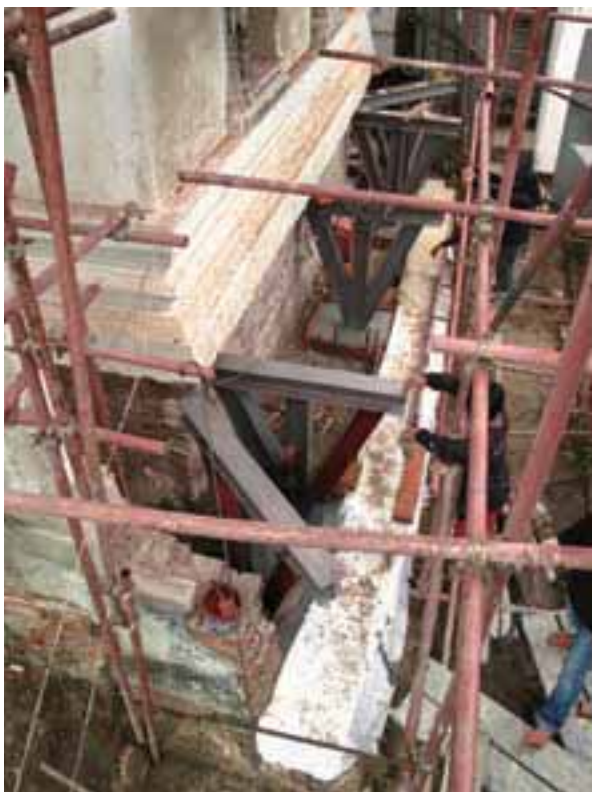
Figure 13: The new structure, I-shape steel, in the west corridor reconstruction. The original remaining structure was protected by the textile to conserve it in the existing state before starting reconstruction.

structure and settlement prevention of the reconstructed structure. However, the original remaining structure was conserved. For the restoration of the wooden structures of the roof and the ceiling, the decayed wooden members were replaced according to its size, its position and its decoration. The technique and style of the restoration was as same as the former. For the roof tiles, they were ordered to make according to the previous style. For the decoration, the deteriorated parts were renovated with the materials true to the original style. The decorating materials were fitted in the same positions as they were. The renovation was done with the traditional technique used in the past.

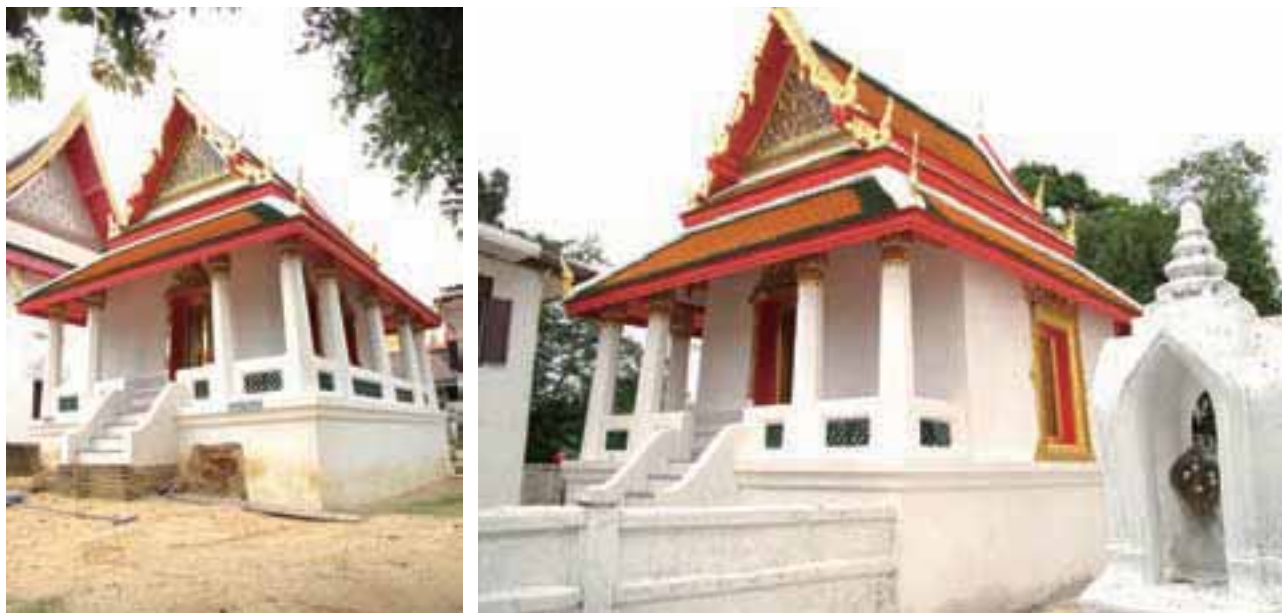
Figure16: The Tripitaka hall after finishing the restoration, (a) the ruin of the extended platform was covered with sand in order to protect damage and stay for restoration in the future. (b) View from the south.
