ACCU Nara
International Correspondent
First Regular Report

Cultural Heritage Protection Cooperation Office, Asia/Pacific Cultural Centre for UNESCO (ACCU)

The First Regular Report

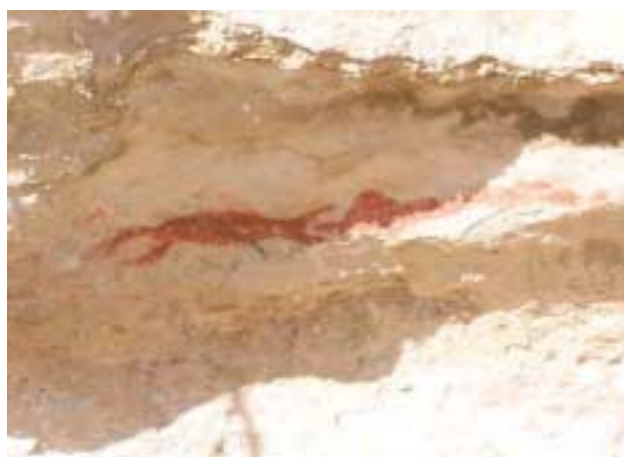
タキロア・ロックアート遺跡細部、2007年8月、NZHPT、撮影:Peter Huggins
"Detail at the Takiroa Rock Art Site", August 2007, NZHPT.
Photographer: Peter Huggins

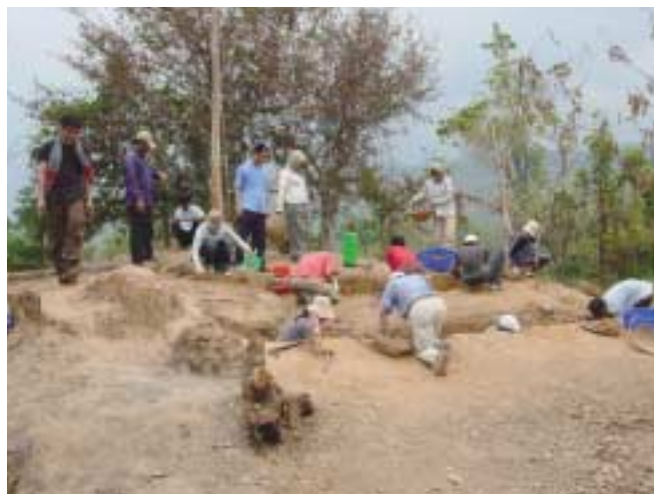
ソ・サイ 窯跡の発掘調査 Excavation at Sar Sei Kiln Site

Nara National Research Institute for Cultural Properties started to cooperate with the Sophia Center for Research and Training and also with APSARA Authority in the Angkor Area. The aim of the projects focused on the excavation of a kiln site in Tani village, from 1994 to 2003. Nowadays, APSARA Authority has already planned to turn the village into an archaeological park by organizing a visitor circuit, car park, information centre, Khmer food restaurant, duplicate ceramic workshop; and constructing a site museum direct on the Kiln Site. Moreover, the Institute has conducted research into other kiln sites such as: Sar Sei Kiln Site, Khnar Po Kiln Site in order to find out about the structure of these kiln sites.

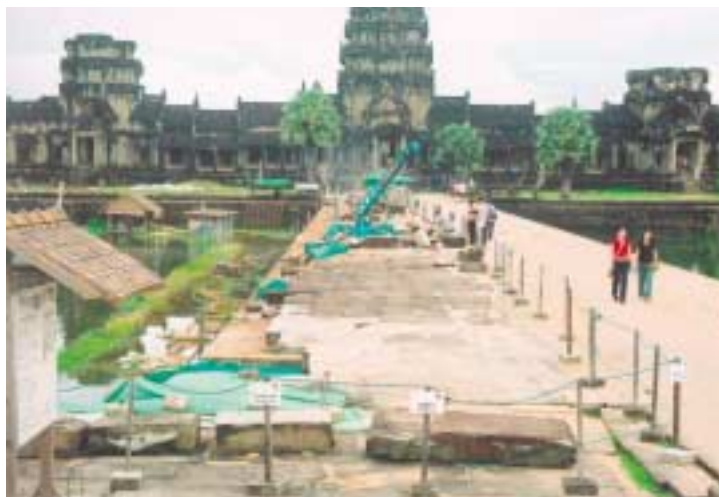
アンコールワット西参道の修復作業
Restoration work at the Western Causeway of Angkor Wat

The mission began its activities in Angkor since 1989 to 2008. The main projects are as follows: the restoration project of the Western Causeway of Angkor Wat temple finished its first step in 2007; the ceremony for the Completion of the Restoration Work was held on 3rd November 2007 presided over by H.E. Sok An, Deputy Prime Minister, in charge of the Office of the Council of Ministers and President of the APSARA Authority.

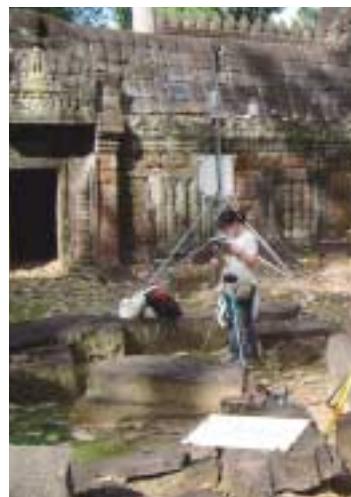
微小気候データの計測
Measuring micro climate data

In December 2006, NRICPT and APSARA Authority signed the Memorandum of Understanding for stone conservation project for next five years. After the field investigation, identification of microorganisms on stone monuments was completed, 41 species of lichens representing 34 genera (including cyanobacteria and green algae) were identified. Mosses include 9 species representing 8 genera and 8 families of Bryopsida, and 3 species representing 2 genera and 2 family of Hepaticae. Now the Institute is planning to do an investigation on the effect of lichens on monument stones and identify their species. Analysis of the relationship between environment and microbiological growth will be also done.

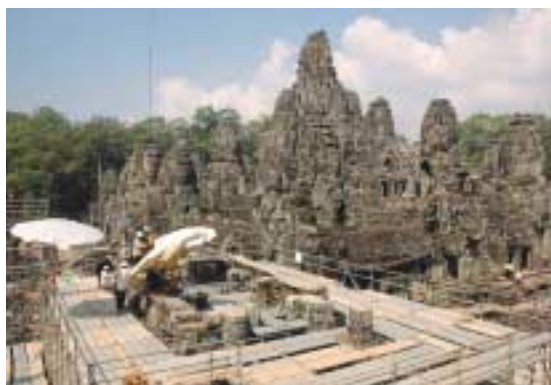
バイヨン寺院南経蔵の解体
Dismantling the Southern Library of Bayon Temple

Due to the former JSA (Japanese Safeguarding Angkor) research and restoration experiences at Northern Library of Bayon temple, Northern Library of Angkor Wat temple and Sour Prat Temple (in Angkor Thom complex), another cooperative project was established in 2004 focusing on the needs of restoration of three identified parts of Bayon Temple of Angkor Thom. They are Southern Library, Bas-reliefs in the inner and outer galleries of the temple, and the Central Tower Complex. It is a five-year project (2005-2010) which is under the cooperation of three parties: UNESCO, JSA and APSARA Authority. The main duties are to restore the Southern Library of Bayon Temple. After completing archaeological excavation survey, dismantling work of upper structure started in 2007. The next stage is to assemble the whole structure before restoration work could take place.

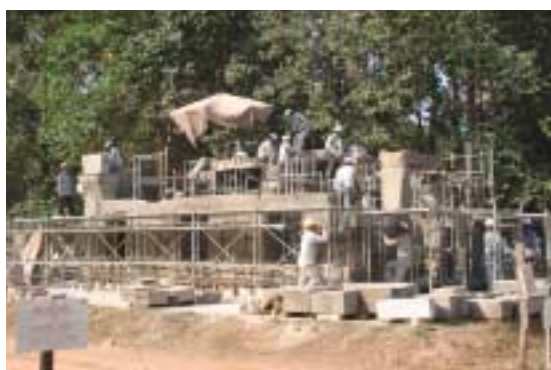
構造の組み立てに挑む Trying assembling of the structure

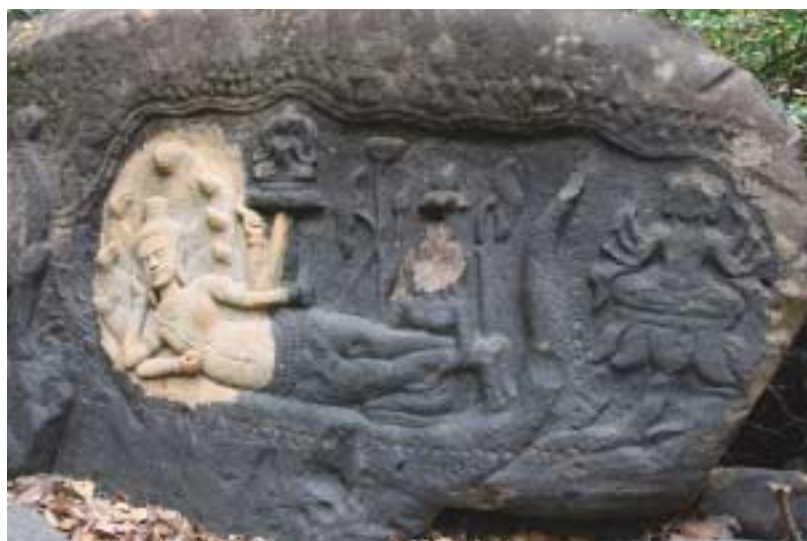
レリーフの修復 Restoration of the relief

One of the bas-reliefs is a reclining Visnu on Naga, which was destroyed in March 2003. Recently, the Department of Monuments and Archaeology I, APSARA National Authority has restored this relief.

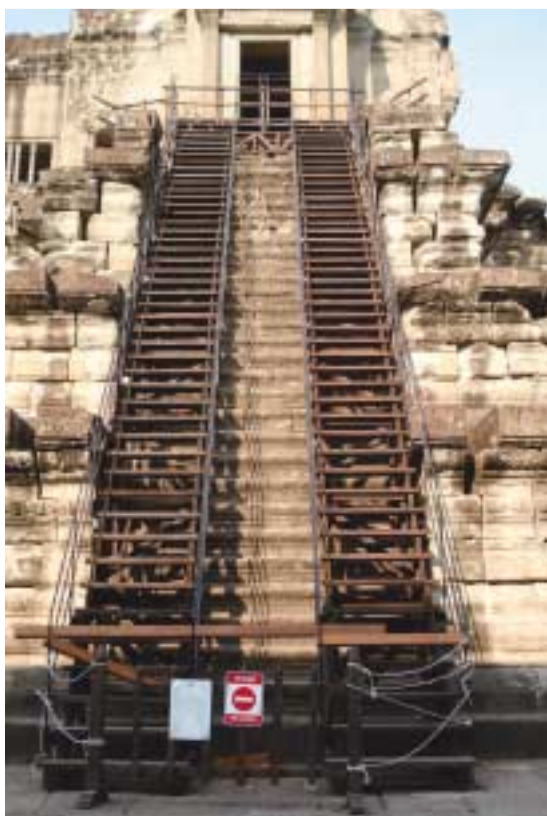
木製階段 Wooden stairs

Day by day, the number of tourists visiting Angkor Wat is increasingly in the rise leaving the temple in great danger. In 2007, APSARA National Authority has practiced a conservation plan for sanctuary of the massive central of Angkor Wat, called Bakan tower by closing for a while. The Department of Monuments and Archaeology I has recently constructed two wooden staircases up to Bakan tower, one staircase is for going up and the other down. The main purposes are to avoid the erosion of the ancient stairs and to allow access to tourists.

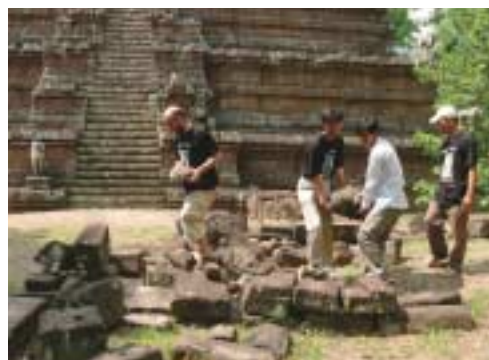
ライオン像の断片の収集 Collecting fragments of lion

Within the framework of the project objectives that were declared in the Memorandum of Understanding between APSARA Authority and the GOPURA Project of Czech Republic in January 2006, GOPURA selected lion and elephant statues discovered in the vicinity of the Phimeanakas temple (in Angkor Thom Complex) for its first object of restoration. Following restoration work, GOPURA intended to reposition the statue to their original places at the temple. The original locations have been identified from surveys carried out by Dr. Olivier Cunin. As a result, we found and collected some of broken statues to wash and draw their fragments for documentation and finally kept them out of reach on the wooden shelves for safety. We also chose the 180cm high lion with the original one leg. Fragments were glued, missing leg was substituted by the piece of sandstone and the sculpture was placed on the left side of the west stairway of Phimeanakas temple in collaboration with APSARA's technical staff.

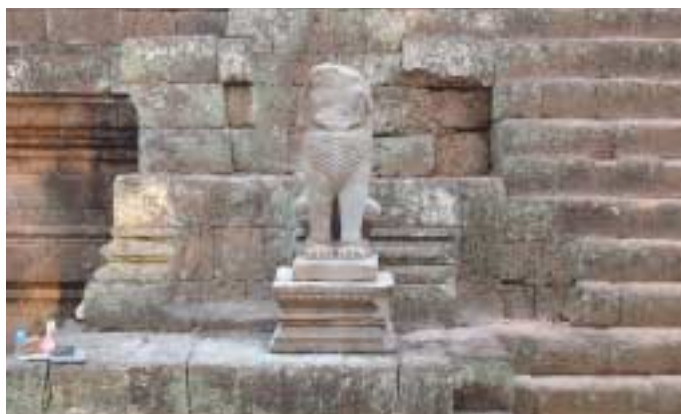
修復後のライオン像 Lion after restoration

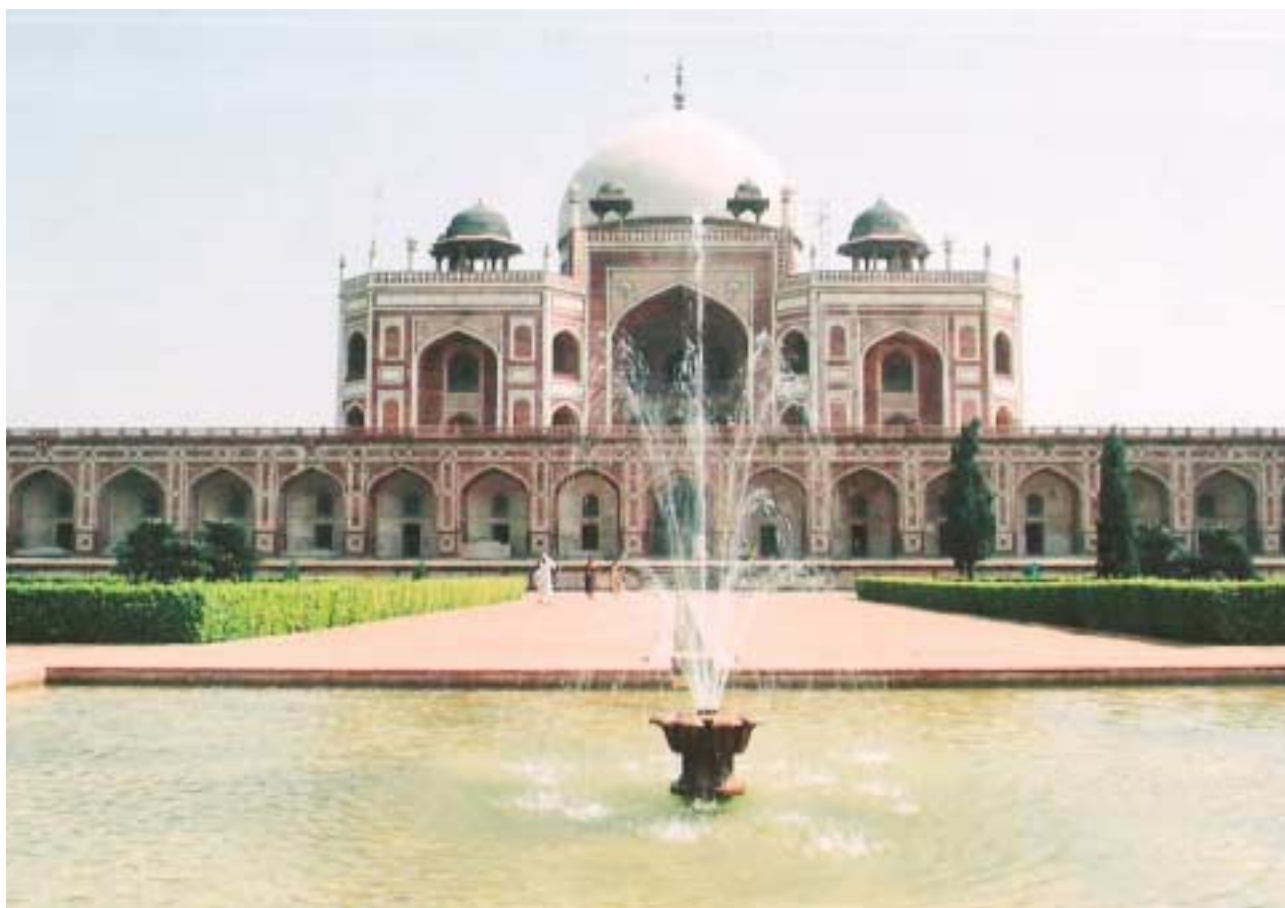
The Archaeological Survey of India in collaboration with the Aga Khan Trust for Culture engaged in a major project to revitalize the gardens of Humayun's Tomb. The development activities were carried out within the tomb enclosure in order to revive the

の修復がなされました。トラック3000台分を超える土が庭園から除去され、庭園と通路を修復するため全長3キロ以上におよぶ緑石の敷き直しが行われました。

雨季に溜まった水を除去して地下水を補充するために128の立坑が掘られ、また庭園の東側にある直径8メートルの2箇所の井戸は、中に入っていた瓦礫が取り除かれて、地下15メートルの深さまで掘り下げられました。水がきちんと流れるように、水路が補修され、給水システムが修復されました。採用された保存修復方法では、節水という点を考慮すると、必ずしも給水システム全体に水が流れることにはならないようです。いずれにせよ、かつて給水システムがこのような形で使用されていたことを示す歴史的な証拠は何もありません。

In order to eliminating the standing water during the monsoons and recharge ground water, 128 recharge pits have been dug and two 8 metres diameter wells in the eastern portion of the garden have been cleared of rubble and excavated upto a depth of 15 metres. The water channels repaired and the system restored for flowing water. The conservation approach adopted, coupled with the need to conserve water will mean that not all portions of the system will have flowing water. In any case there is no historical evidence that system was ever used in this manner.

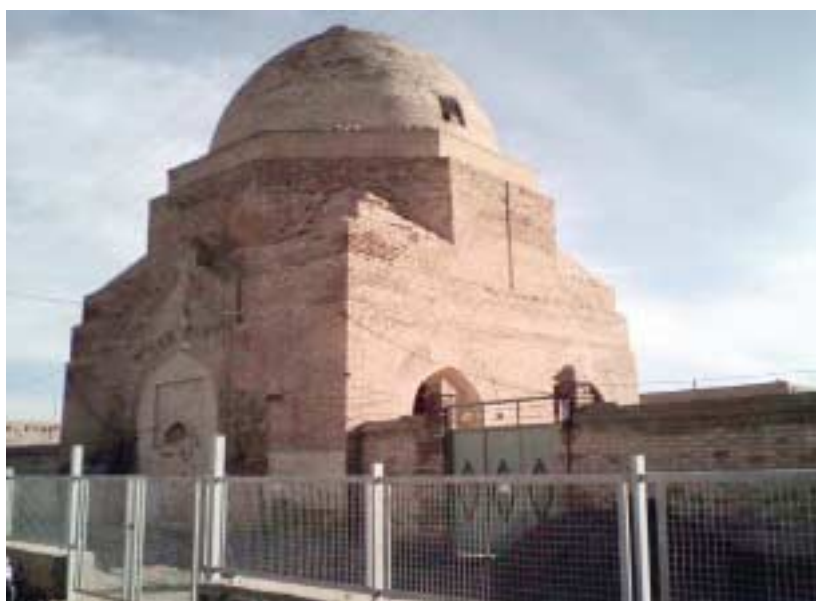
①全体像 General view

モスクの構造は頑丈な石材を積んだもので、壁に使われているレンガはこの時代に特徴的なものです。モスクのドームは正方形の四隅にある4つのトロンプの上にあり、これらのトロンプは耐力壁の上に据えられています。ドームは単層のレンガ積みで、そのレンガには美し

The mosque's structure is solid masonry and the wall material is brick which is the characteristic of the period. The mosque dome sits on four tromps on the corners of square plan and these tromps are settled on the load bearing walls. This dome built as of single layer brick work and attractively decorated by brick masonry, also.

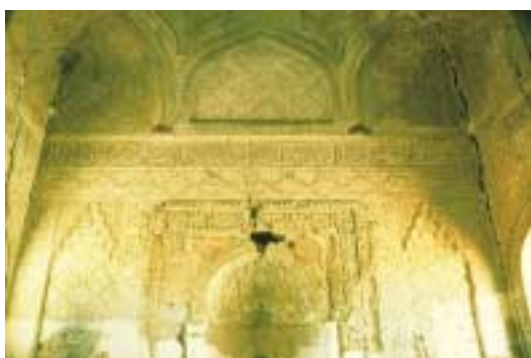
⑥a キブラ壁の屋内の様子、メフラーブの覆いとドームを支えているスキンチ(アーチ)を見上げる
Interior view of qibla wall looking up to the mihrap hood and the squinches supporting the dome

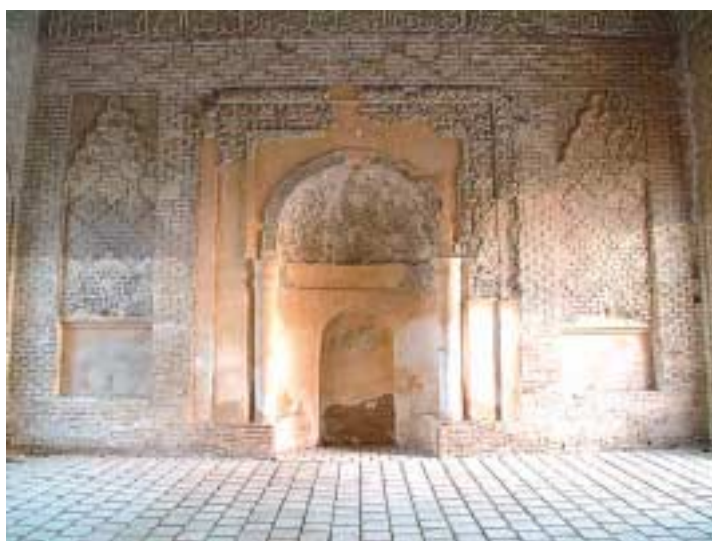
⑥b 修復後 After restoration

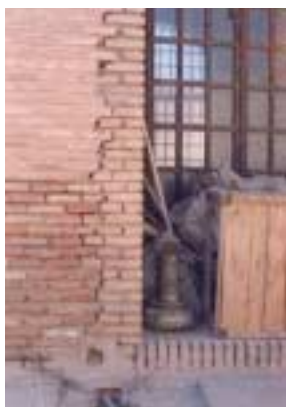
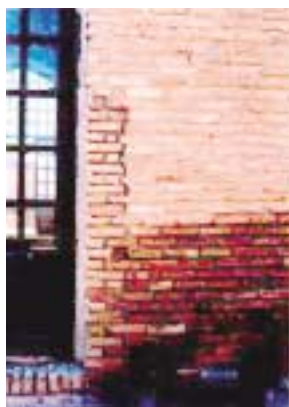
⑦a 修復前 Before restoration

⑦b 修復前 Before restoration

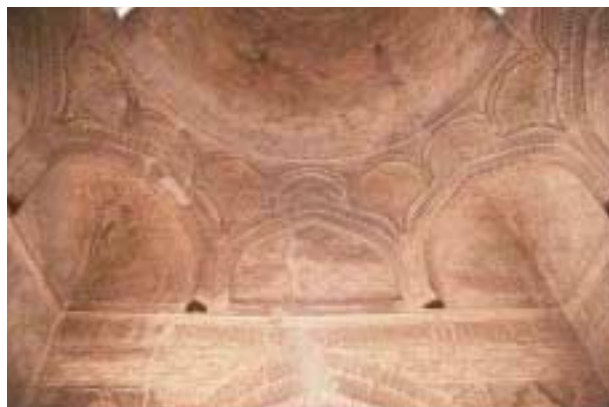
⑦c 修復後 After restoration

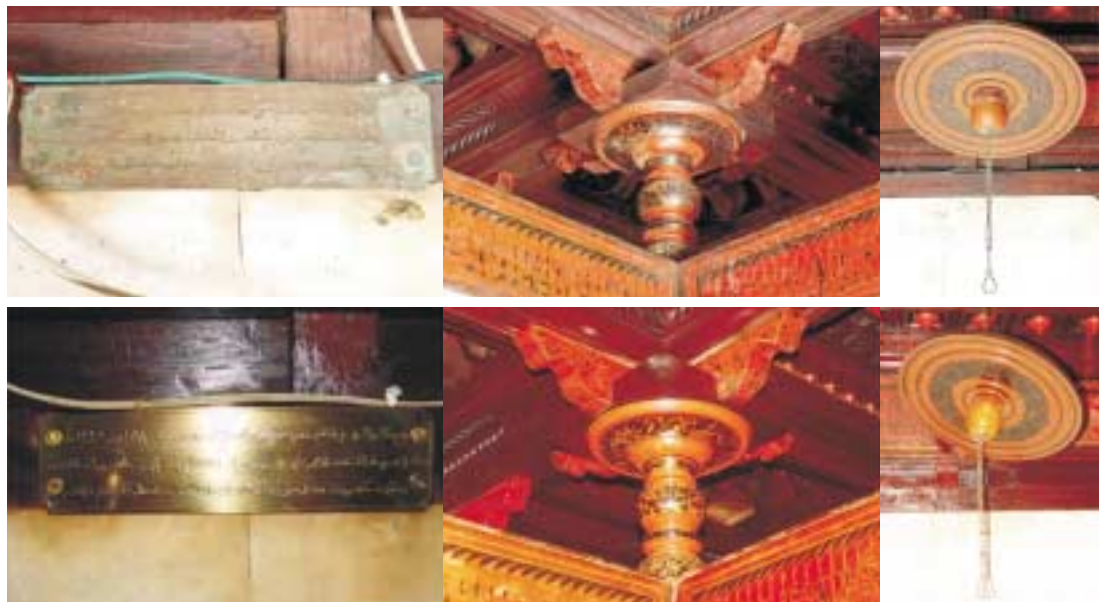
保存修復作業前
Before preservation and restoration

保存修復作業後
After preservation and restoration

First the coral stones were cleaned and the algae formed on them were removed. Though the surface removal was not difficult, a water pressure of 4 kg/cm² was needed to remove the algae which has penetrated deep inside the pores. The cracks and gaps in the coral stones were filled with putty made from lime, coral

The painted wooden members were cleaned with cotton swabs moistened with a mixture of ethanol and turpentine while securing the loosely held paint with a tissue paper wherever needed. After removing the excreta of insects and debris etc with a vacuum cleaner, the cracks and gaps in the wooden members were filled with putty made from saw dust, whiting and PVA emulsion with a fungicide (1% of solution of pentachlorophenol in ethanol). Since most of the wooden members were in fairly good state of preservation and therefore, consolidation of decayed wood was attempted only at few places which was done with injection of diluted PVA emulsion under gravitational force.

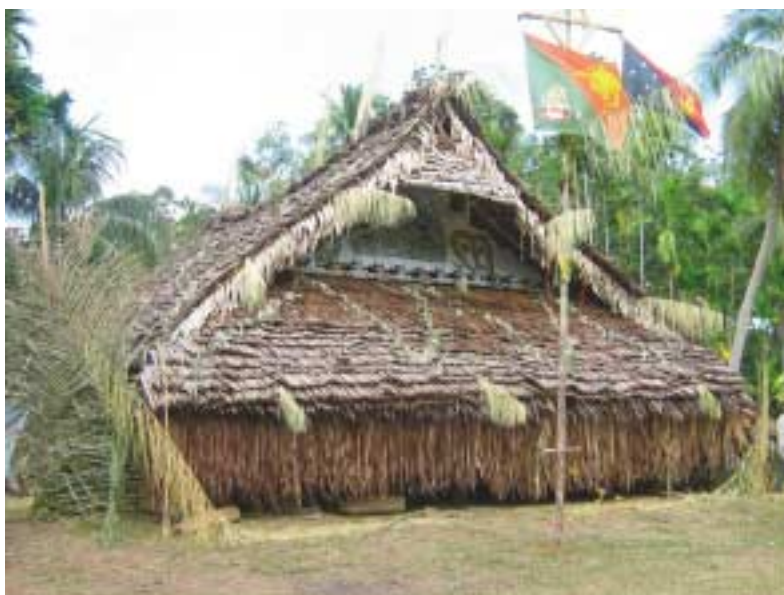
ホロンボ(精霊の家) 復原作業
Restoration work of Horombo(Spirit House)

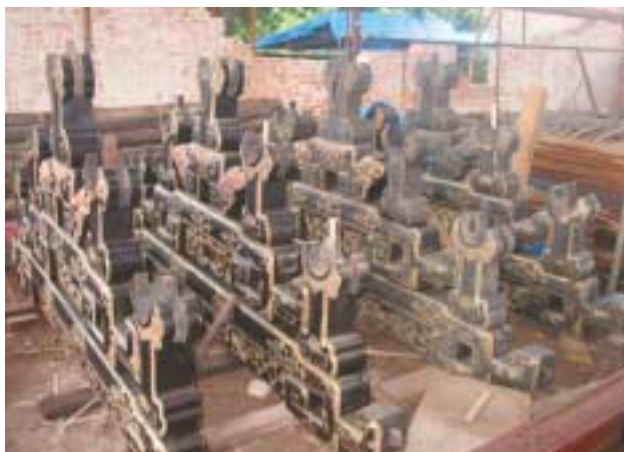
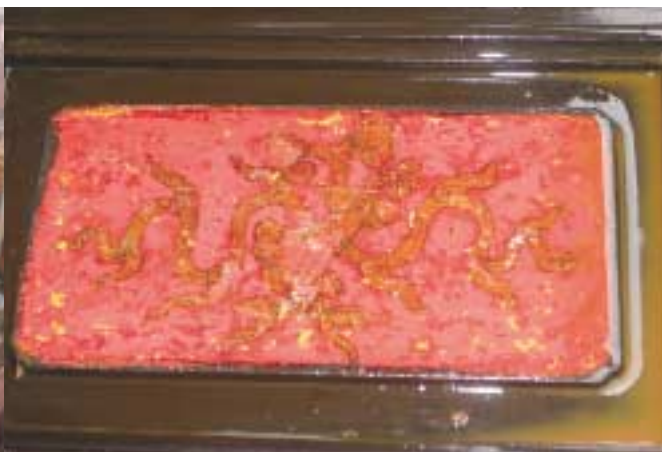
①・②ベトナム、フエの漆塗保存現場 The lacquer conservation site in Hue -Vietnam

生(き)の漆樹液と木細粉を混ぜたもので木造部のひび割れを埋める。

◎1st step: Ket: Filling these cracks of wooden structure by composite containing raw lacquer sap and wooden fine powder.

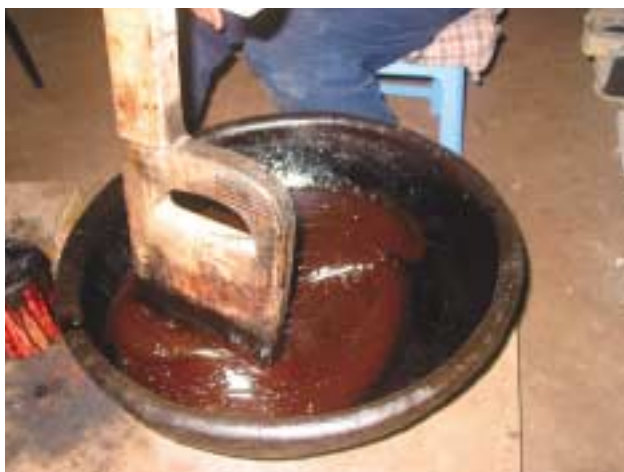
③伝統的な漆の調合方法 Traditional method preparing lacquers

(*) Son Chin: Mixing good quality of raw material lacquer (70°~80°) for 16 to 20 hours.

(**) Son Cam: Using 50% raw material lacquer 70° with 50% raw material 65° with Trau oil. Before mixing with Trau oil, using 10% of composite of raw material lacquer firing to boil, mixing back to composite with kerosene.)

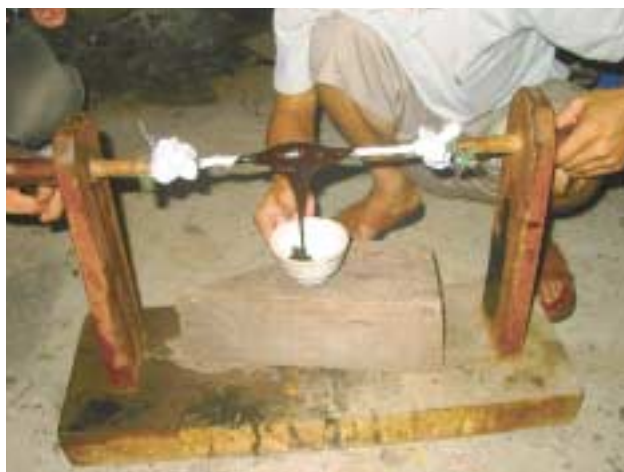
④伝統的な漆の精製方法 Traditional method filling lacquer
