ACCU Nara
International Correspondent
The Second and
the Third Regular Report

The Second Regular Report

ACCU Nara International Correspondents

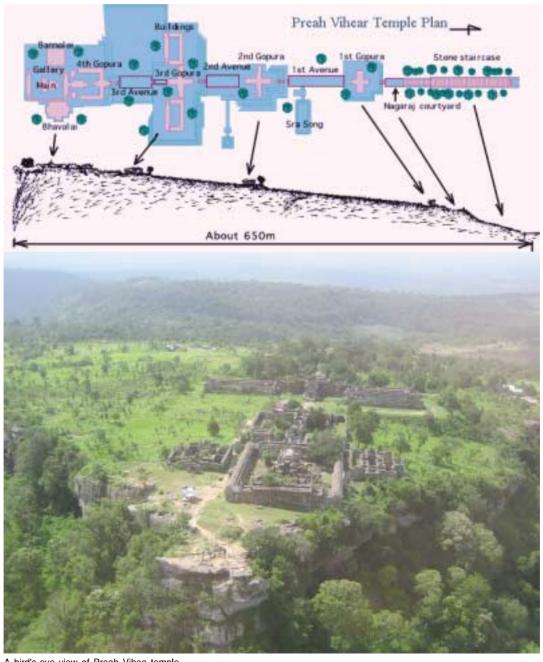
A bird's-eye view of Preah Vihea temple

Preah Vihea temple is standing on a promontory of the Dangrek range of mountains about 625 meters above the sea level and face to the north, at the northern part of Preah Vihear Province and 402 km from the Capital City of Phnom Penh. This secluded temple is well-known for its Khmer architecture.

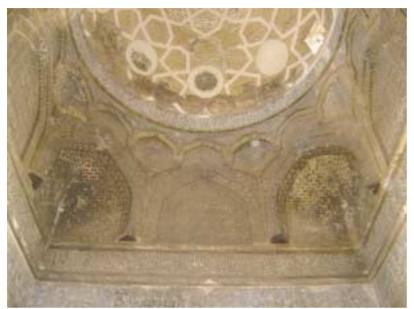
Figure 3: General view of inside of dome

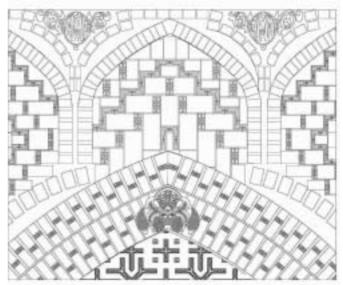
Figure 5: Plaster work example
