International Conference 2011

**“Human Resources Development for Transmission of Traditional Skills:
National Approaches and their Application to Stone and Brick”
(6-8 December 2011, Shanghai, CHINA)**

Cultural Heritage Protection Cooperation Office,
Asia-Pacific Cultural Centre for UNESCO (ACCU)

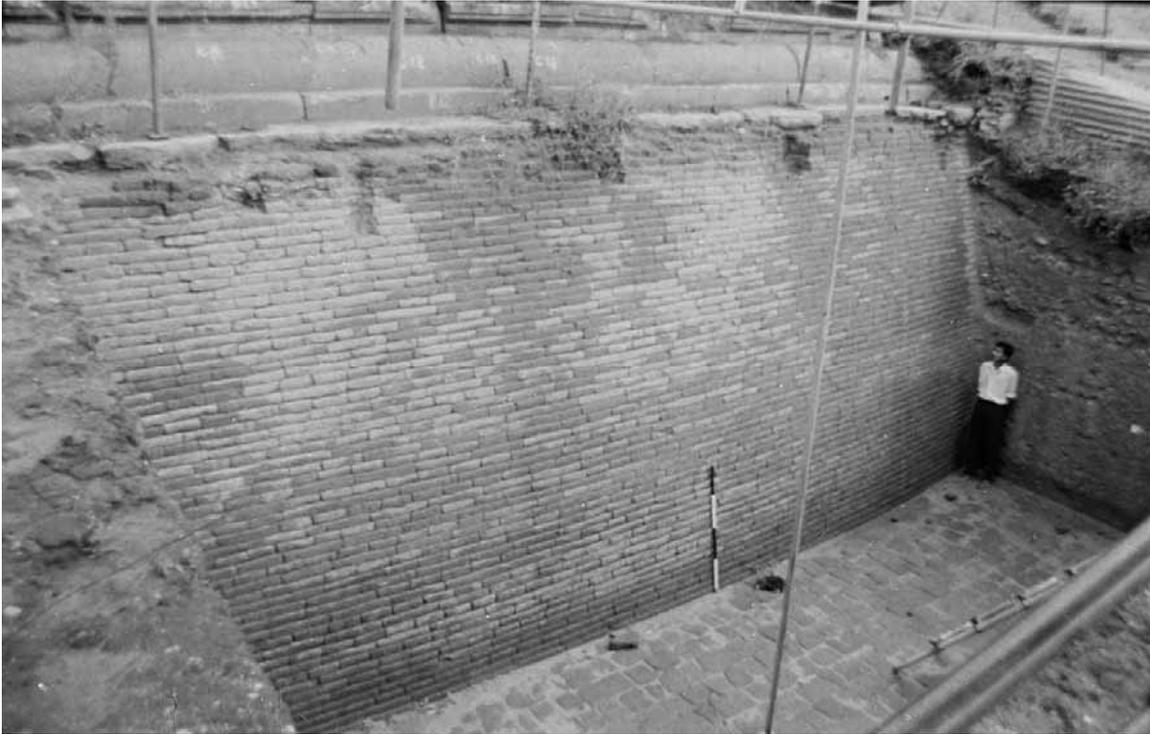
I have no better example than the details of the excavated foundation of the largest stupa in Sri Lanka which is Jetavana, projecting up to 400 feet. Excavations revealed (see the picture below) that even the bottom most layers of brick carrying 62 million for over 2,000 years is in perfect conditions. Builders knew the strength required on the bottom most layers of brick in order not to be crushed under self load carrying millions of them.

Foundation of Jetavana stupa

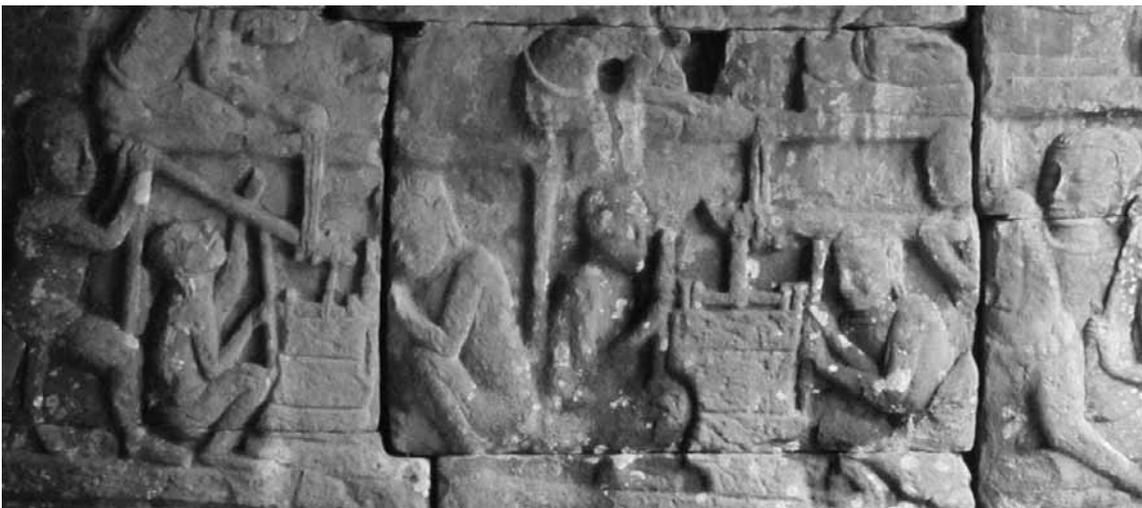
Sculpture from Angkor depicting stone work

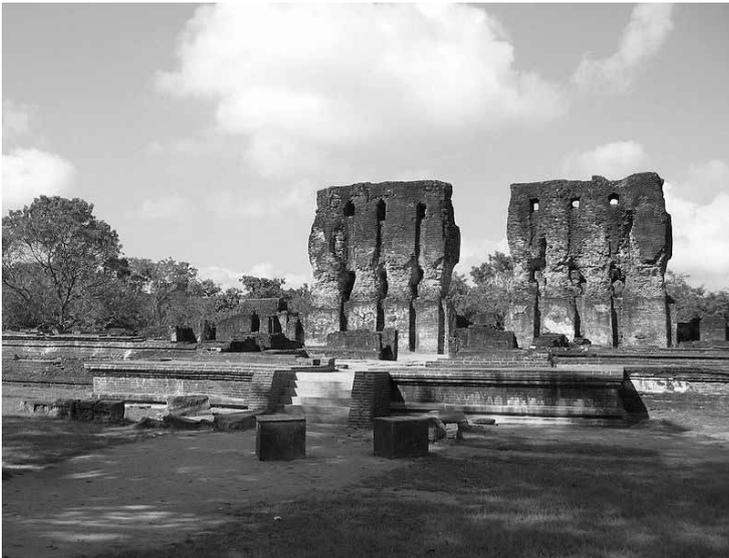
Parakkramabahu Palace, Polonnaruva (12th century AC). Note the vertical crevices and the holes of the brickwork indicates the vertical wooden reinforcements and the horizontal floor beams respectively.

in between filled up with brick masonry to form immensely thick walls. The vertical crevices of the thick brick masonry walls and stone spur stones at the base of such crevices indicate where these timber posts once stood. The outer surfaces of the wooden posts in this instance are flushed with the brick work to be covered by the lime plaster of the brick wall. The cavities left in the brickwork due to the decay of timber posts indicates that dressed wooden posts had been used and their lower and upper parts were square and octagonal respectively in cross section. This was a multi-storey structure and according to the chronicle *Culavamsa*, it was originally seven storeys high.

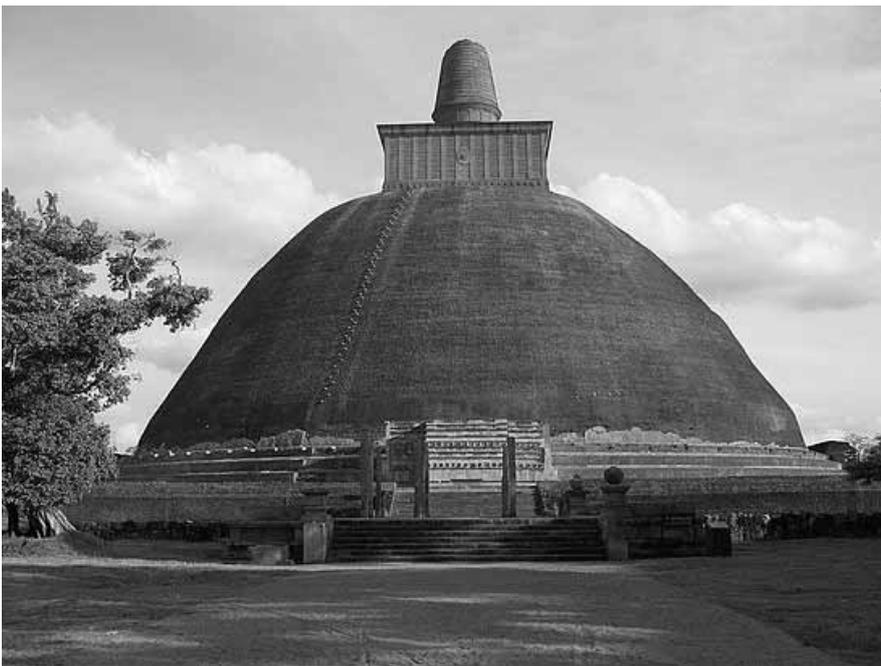
Jetavana Stupa at Anuradhapura, the world's tallest brick structure (4th century AC)

under self weight (Ranaweera 1998). The foundation of these stupas rest on the bed rock and that of Jetavana stupa is about 8 meters deep. The burnt clay bricks used for the construction of these stupas are of high quality with a compressive strength of more than 4 N/m^2 and their dimensions being $450 \times 225 \times 5 \text{ mm}$. It is estimated that Jetavana and Abhayagiri stupas contain approximately 62 and 54 million bricks respectively (Silva 1991). In order to keep the solid built masonry of brickwork intact, slurry type butter clay had been used as the mortar mixture, which is perfectly pliable and compatible with the clay bricks. Therefore this binding medium had made the whole structure a homogeneous mass which is flexible as a three dimensional plain, in order to provide for internal movement of these immense masses due to settlement, expansion and other physical forces. The mortar joints are deliberately made absolutely thinner; almost the bricks on the upper course sit on those of the lower course to transfer the vertical gravitational weight from one layer of bricks to the other, instead of it being made to traverse through the medium of clay mortar, which is weak in compression. Another interesting aspect of these stupas is the verticality of the free standing solid brickwork of the spire of slender proportions (for instance, the height of the spire of Jetavana stupa is about 48 meters) which rose above the square structure of these stupas that withstood the high wind pressure at high elevations.

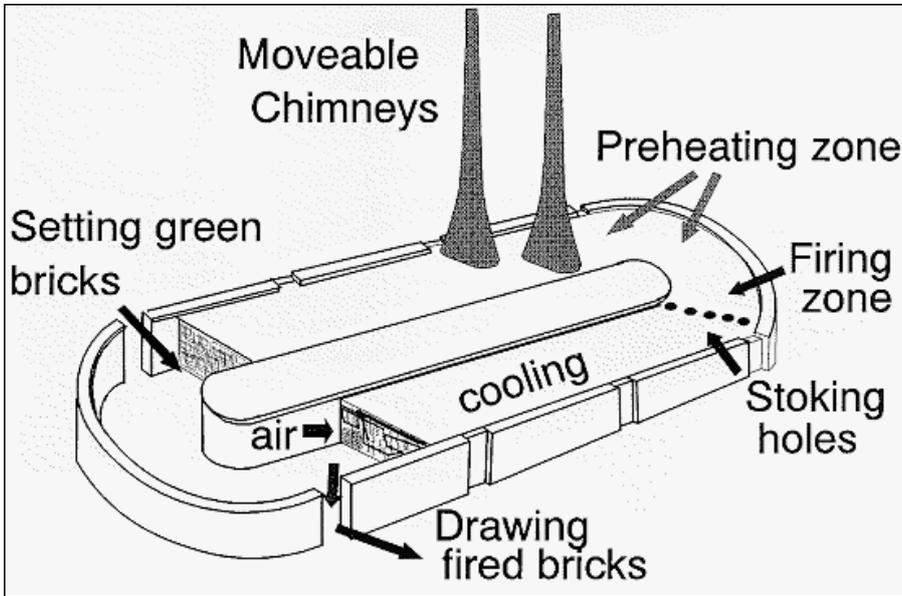
Traditional brick kiln (Bull's Trench Kiln)

Through this process it was possible to revive the traditional skills in producing large sized quality bricks, which has been lost after the 12th century AC in Sri Lanka. This is considered one of the success stories and a landmark achievement in the annals of heritage conservation in Sri Lanka.

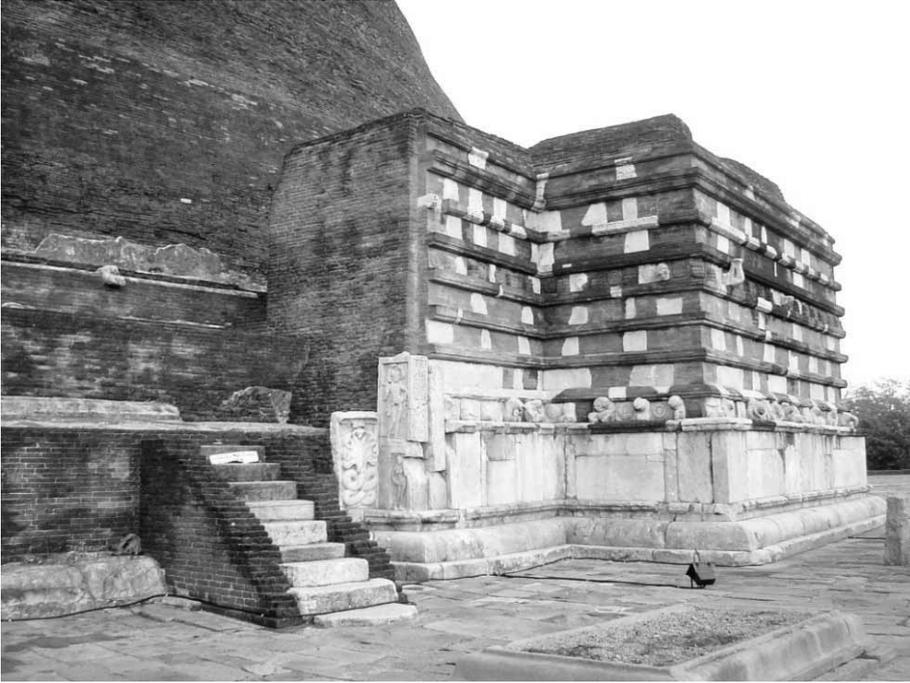
Stone frontispieces of Jetavana stupa showing the filling of voids and missing stone work with brick work

With regard to the missing decorative stone works, such as those of the frontispieces (*ayake*) of the stupas, due to the lack of skilled craftsmen to reproduce these decorative works to match the old, the usual practice is to fill such missing voids with brickwork, as it is also difficult to imitate the original decorative work with plaster work. But the brick filling in such voids gives a contrasting effect with the original work.

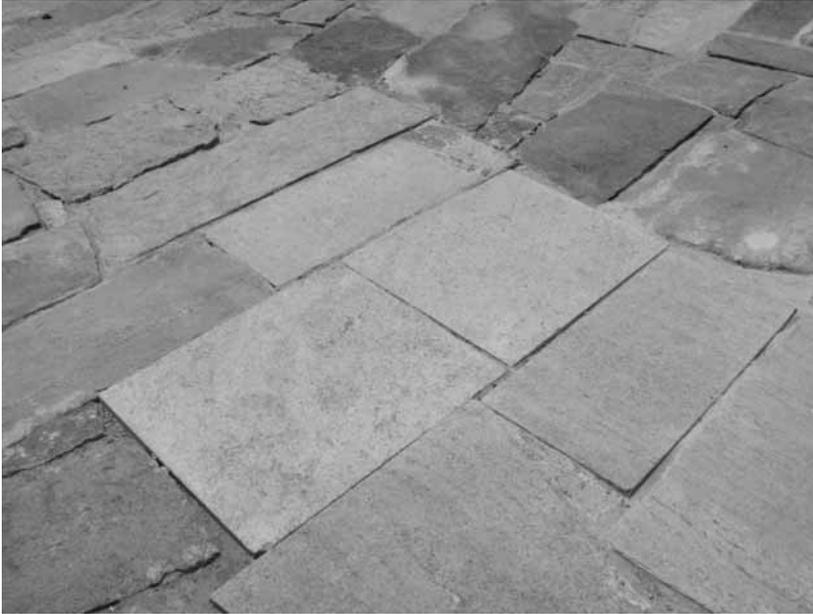
Stone paved terrace of Mirisaveti stupa showing the filling of voids and missing stone work with machine-cut stones

But on the other hand, there is also a tendency to use machine-cut stone for conservation of stone work. Use of machine-cut stone slabs to fill the voids of the stone paved terrace of Mirisaveti stupa at Anuradhapura shows that new stone slabs do not at all match with the size, color, texture, etc. of the ancient stone work and not harmonize the ancient stone work in bonding, width of joints etc.

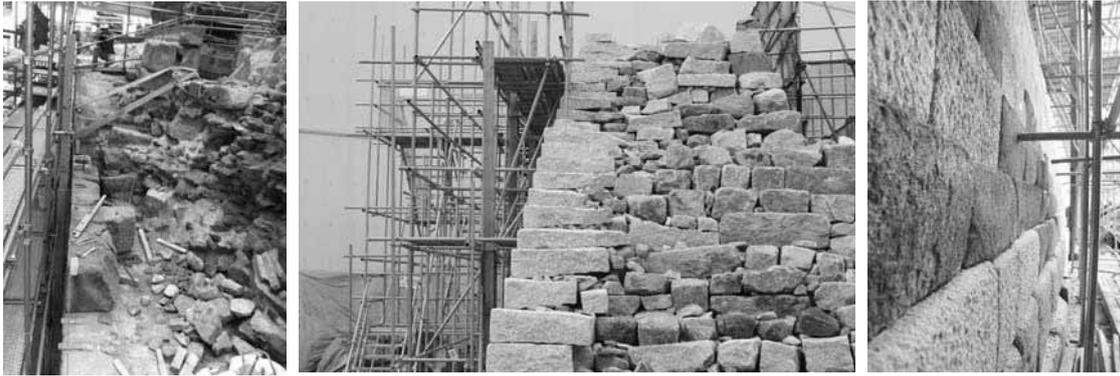
In this case, one of foot stone has been weathered and replaced by a new one. Supporting stones of the footstone are engaged with the facial stone. And their lower part consists of rough rectangular stones, which are stacked orderly like a '#' shape. A base stone of a column-shaped stone located at the lower end of the staircase's side also changed.

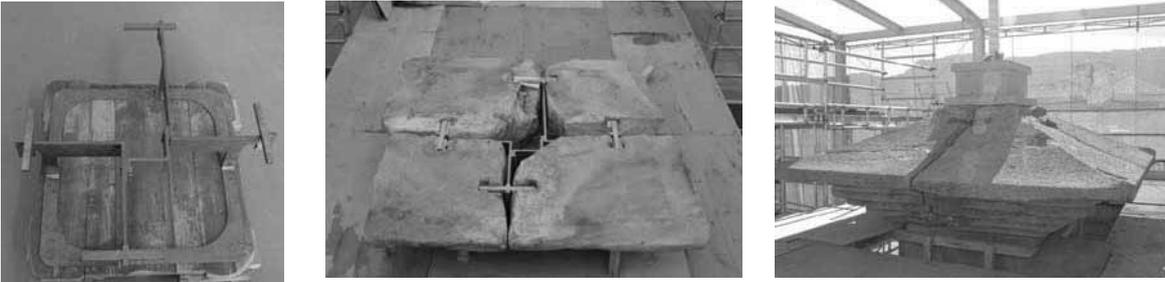
A Buddha statue in Gwancheoksa temple has a large plate-shaped stone on its cap. A few years ago, a serious crack occurred in that stone and there was no alternative idea except reinforcement of it. So CHA also decided to use support structure made of titanium, and it stands in safety still today.

In repair project for Gameunsaji-seoktap which has been done in 2007 by NRICH¹¹, a special structure made of titanium was used. As I have already mentioned, this pagoda was made of tuff of andesite descent, and this kind of stone is capable at carving, but its organization is relatively weak. At that times, each corner of upper part of the body stone of 3rd story were weathered, and it was impossible to reassemble upper stones. So NRICH decided to use support structure made of titanium and then succeed in reassembling.

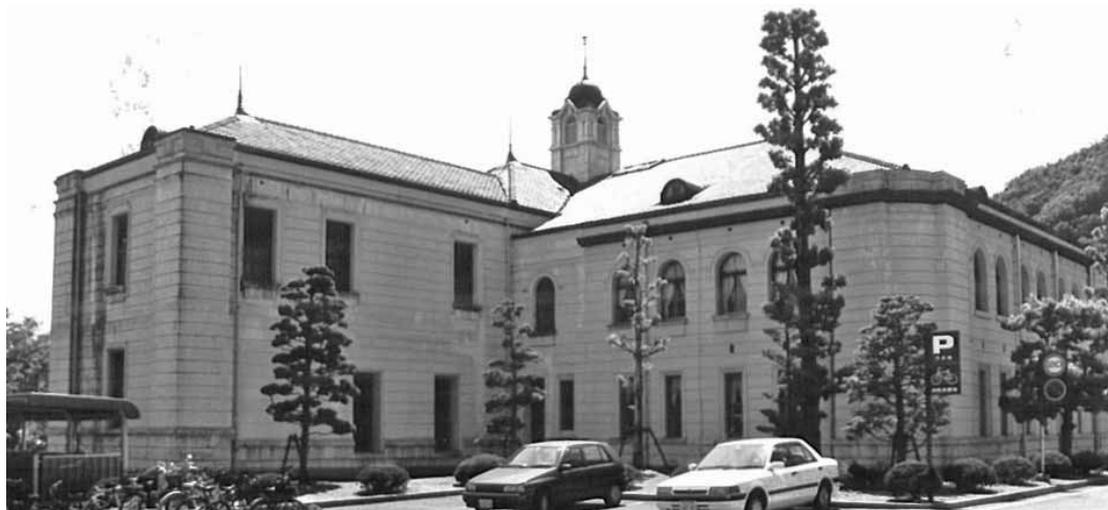
Photo 3: Appearance of northeast side before repair work

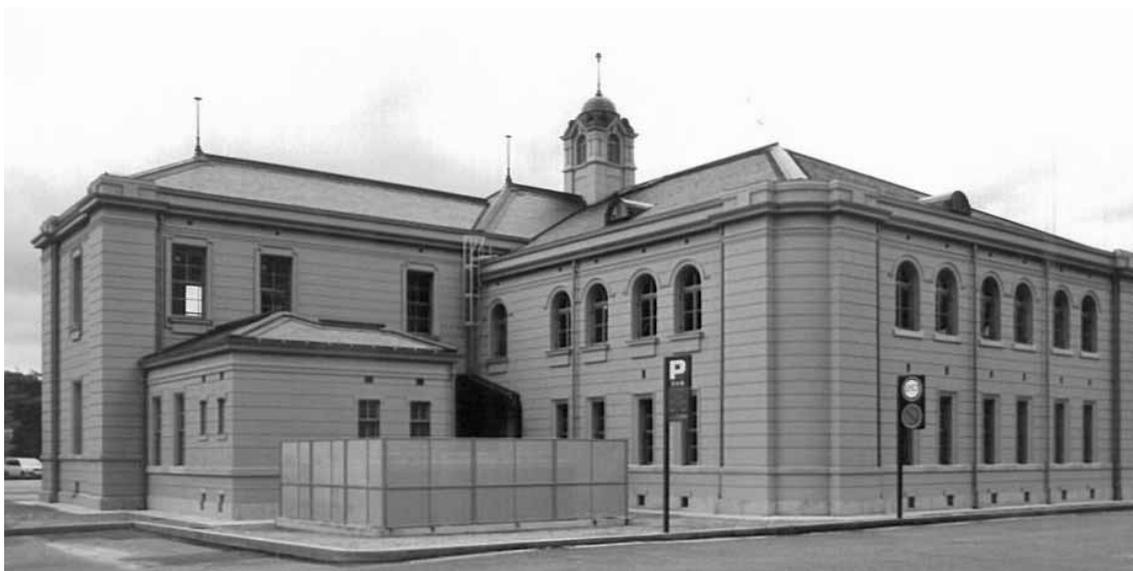
Photo 4: Appearance of completed northeast side

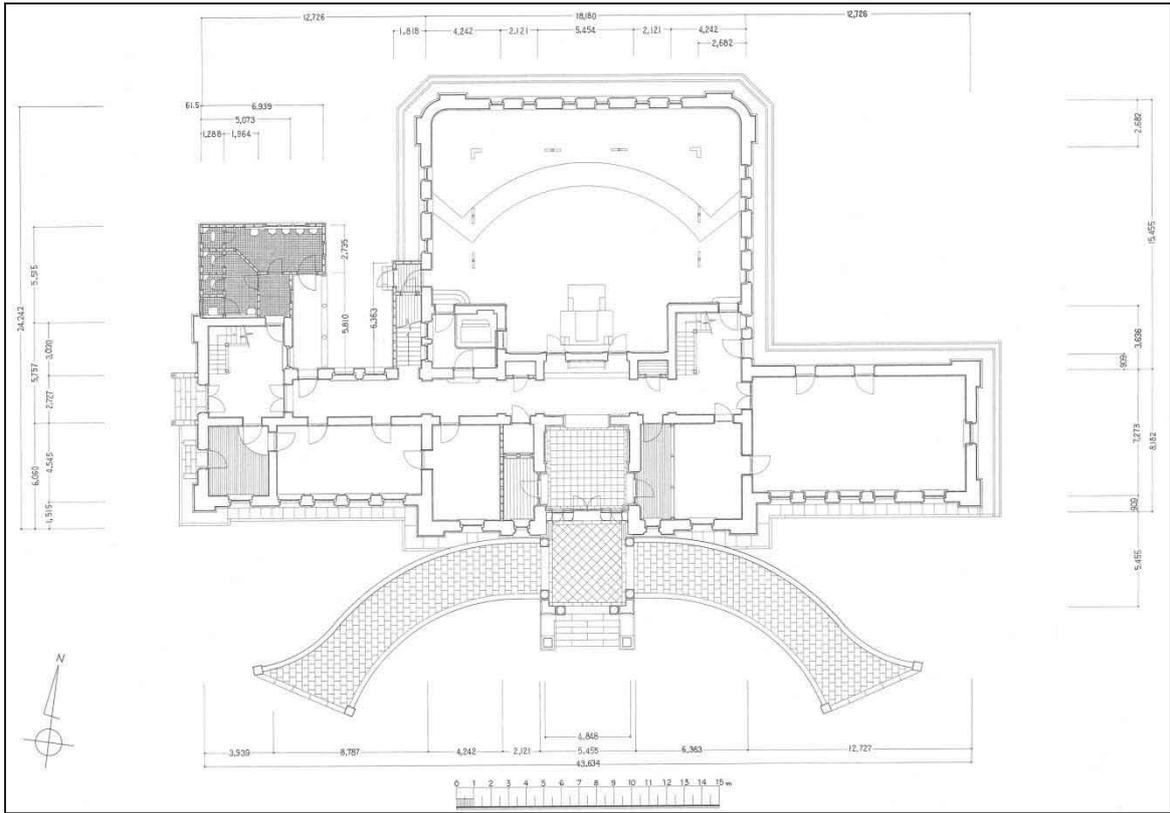
Fig. 1: Plan of first floor before repair work

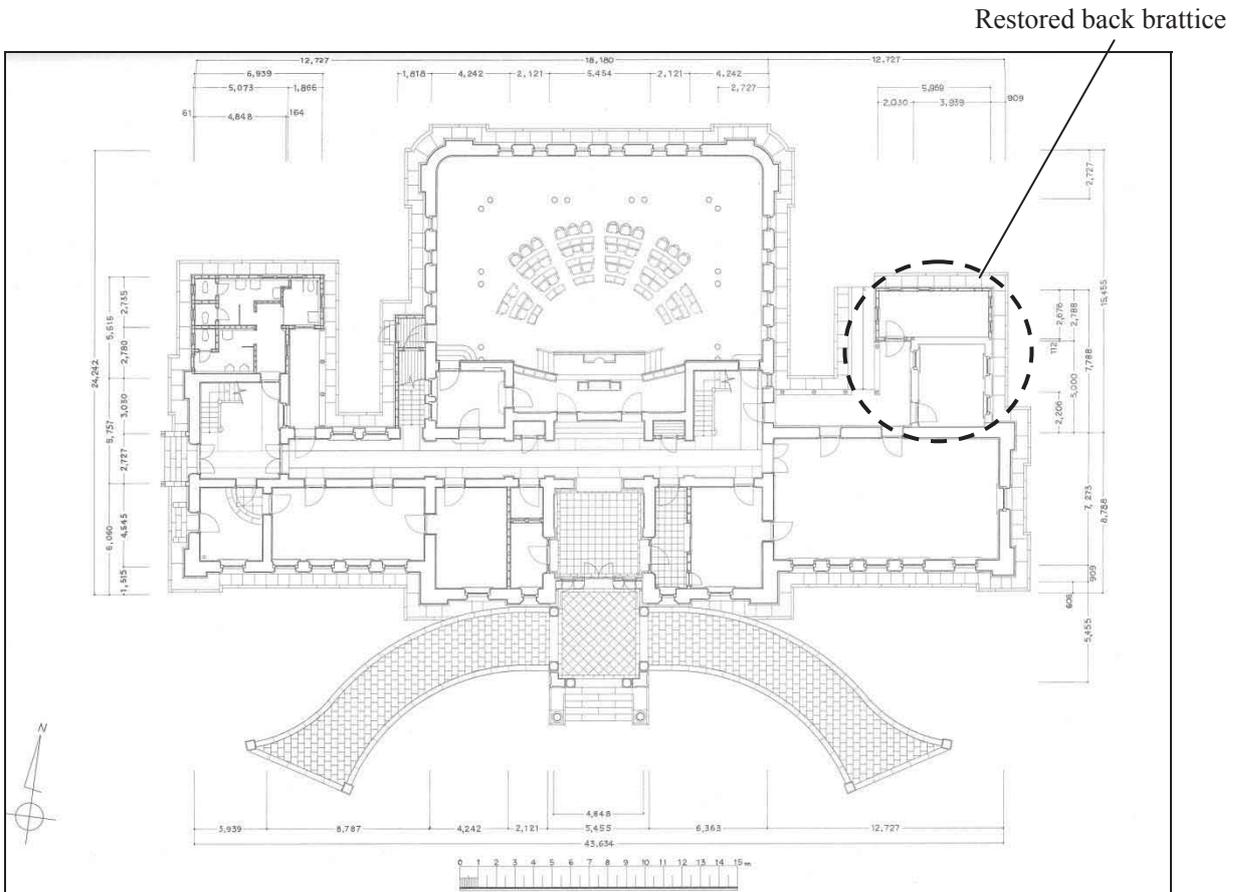
Fig. 2: Plan of completed first floor

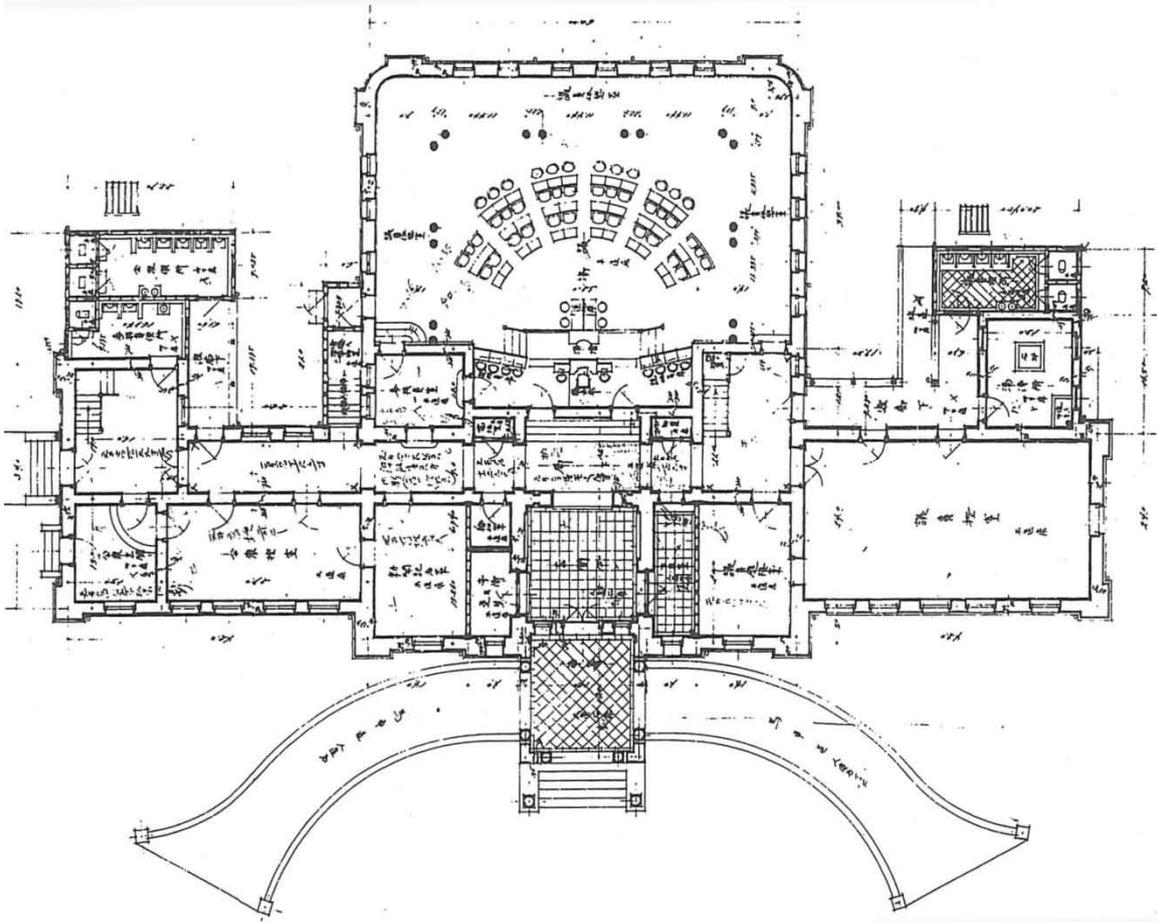
Fig. 3: Plan of first floor in 1916, when the Assembly Building was constructed

Based on this repair policy, a decision was made to restore the back brattice that had been lost in later modifications. Although the portions above ground had been lost, excavation surveys revealed that most of the brick foundation remained in its original state underground. In the excavation surveys, chipping marks on the bricks to which the brattice had been attached appeared upon carefully removing portions of exterior wall mortar that had been applied in later years. Those marks showed the shape and cross section of the plane, and the clarification of techniques through detailed surveys on the existing brick structure made it possible to reproduce the brick-laying technique used to construct the building in 1916.

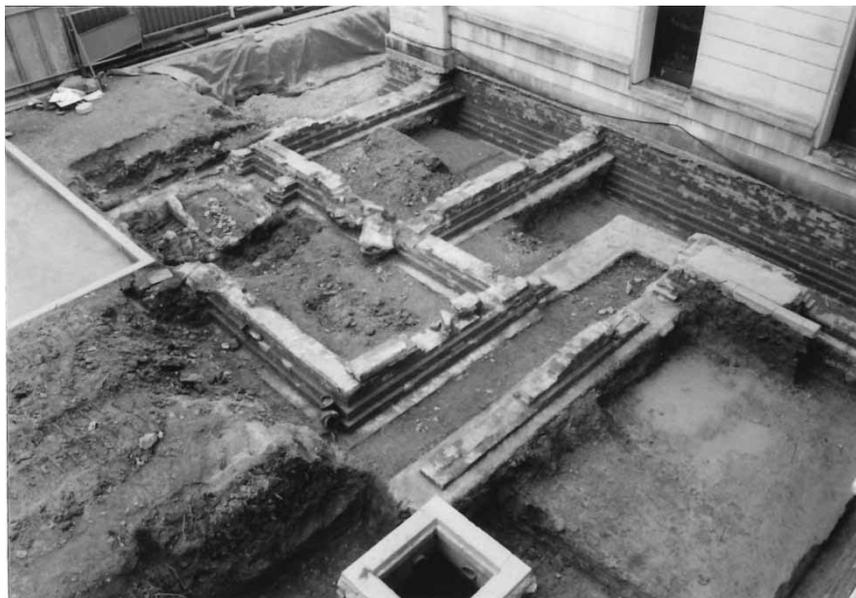
Photo 5: Brick foundation of back brattice found in excavation survey

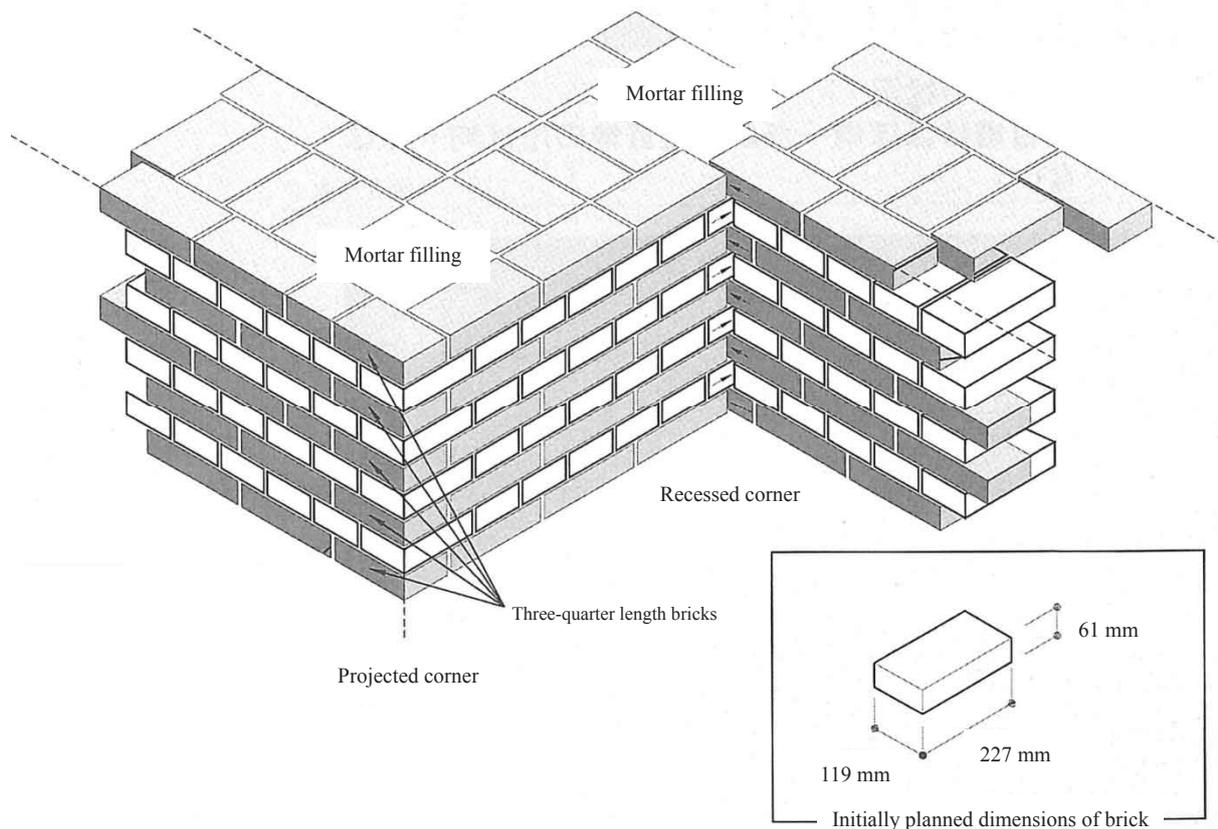
Fig. 7: Pattern diagram of identified bricklaying method

An order was placed for custom-made bricks with equivalent strength to that identified by the test results. Brick-layered samples were prepared and combined with joints of different mix proportions as brick wall models, which were subjected to bending tests to check the strength of the reinforcing materials.

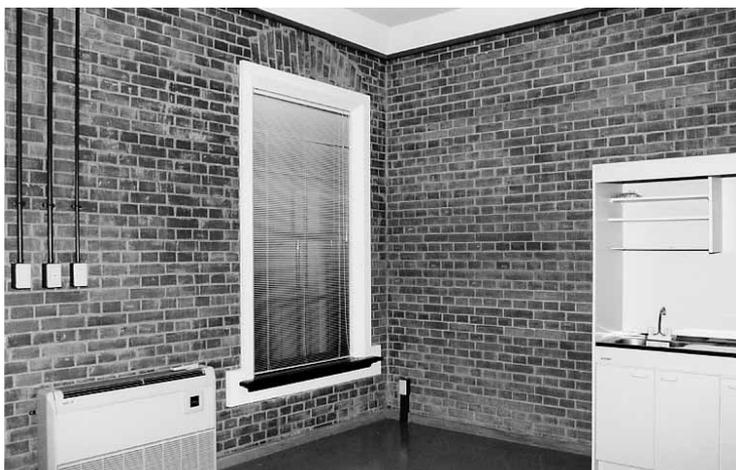
Photo 6: The inside of the restored back brattice is used as an anteroom and hot water service room.

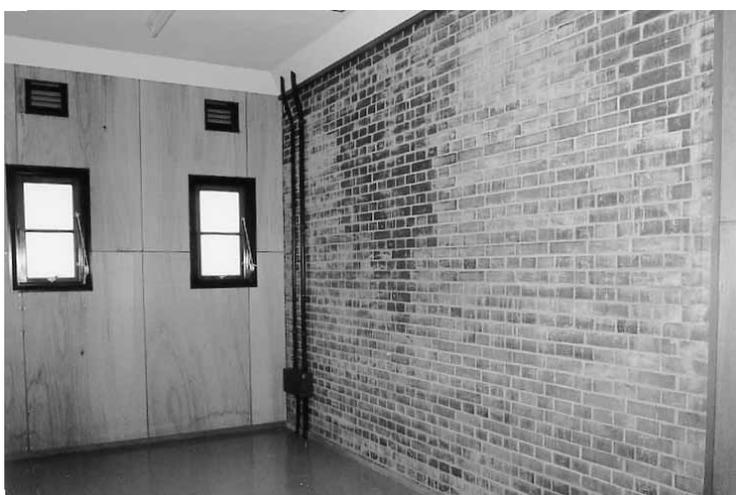
Photo 7: The north part of the restored back brattice is used as a depository.

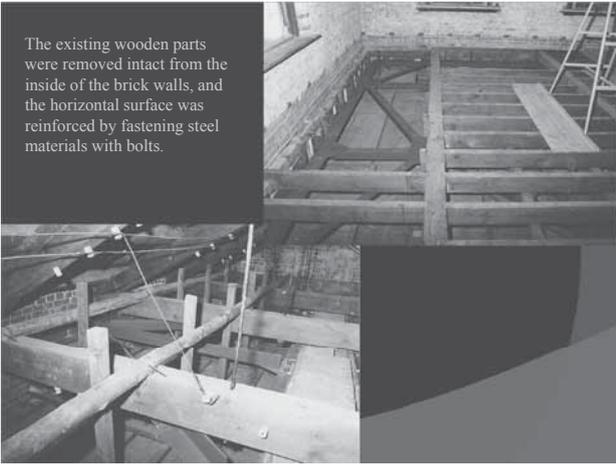
The brick walls of the assembly hall were reinforced by fastening 3-mm-thick stainless steel panels with bolts.

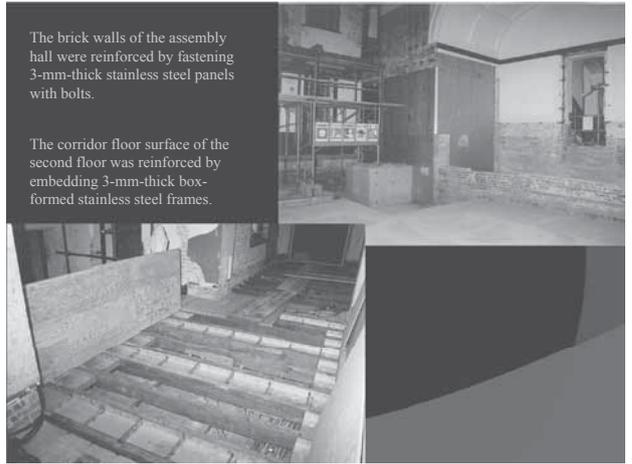
The corridor floor surface of the second floor was reinforced by embedding 3-mm-thick box-formed stainless steel frames.

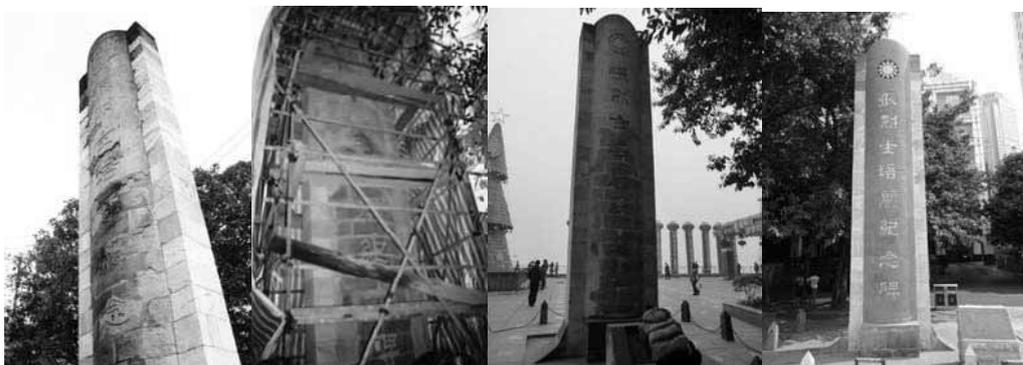
Fig. 1: Monument Zhang Peijue (from left to right: (1)before restoration in 1999, during restoration in 2000, (3) 10 years after restoration; (4) new restoration in Summer 2011)

The monument is made from sandstone and marble. It suffered severe damages after over 50 years exposure to weathering.

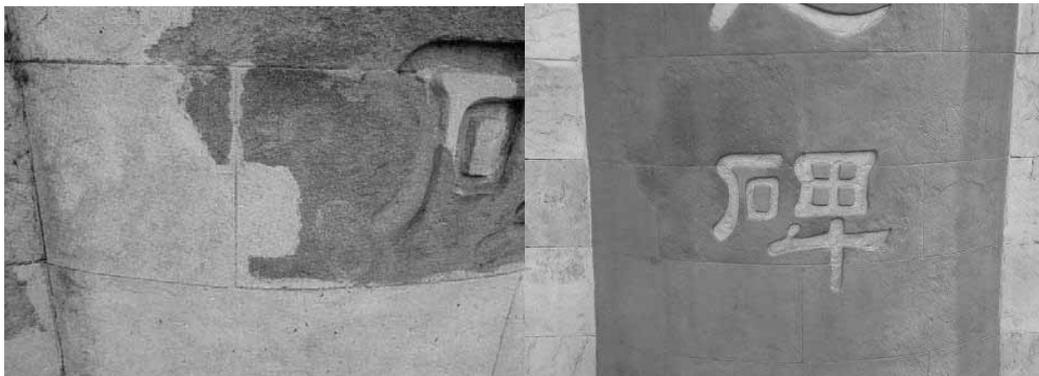
Fig. 2: restoration details after 10 years exposure (taken in 2010, left) and new staining (taken in 2011)

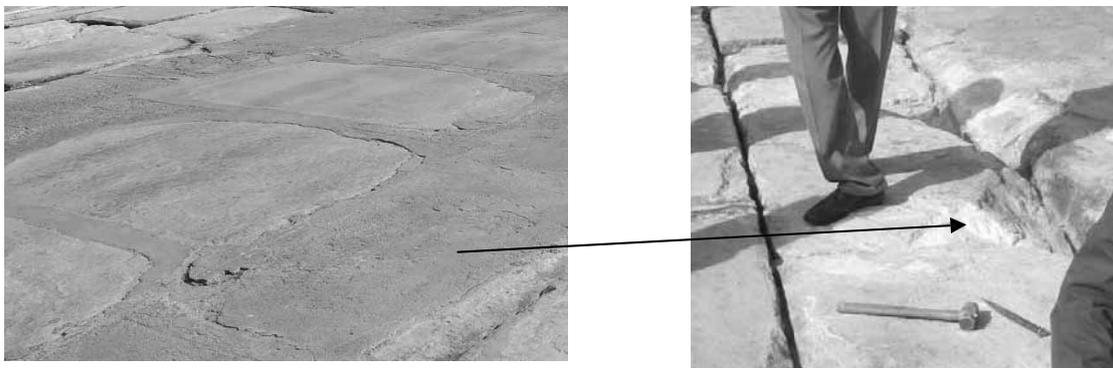
Fig.5: Cement mortar damages historic marble stone

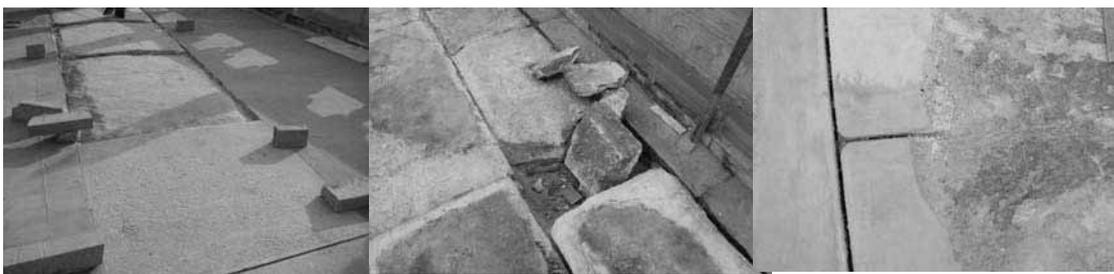
Fig.6: Methods to restoration (from left to right: replacement, piece-in and re-profile)

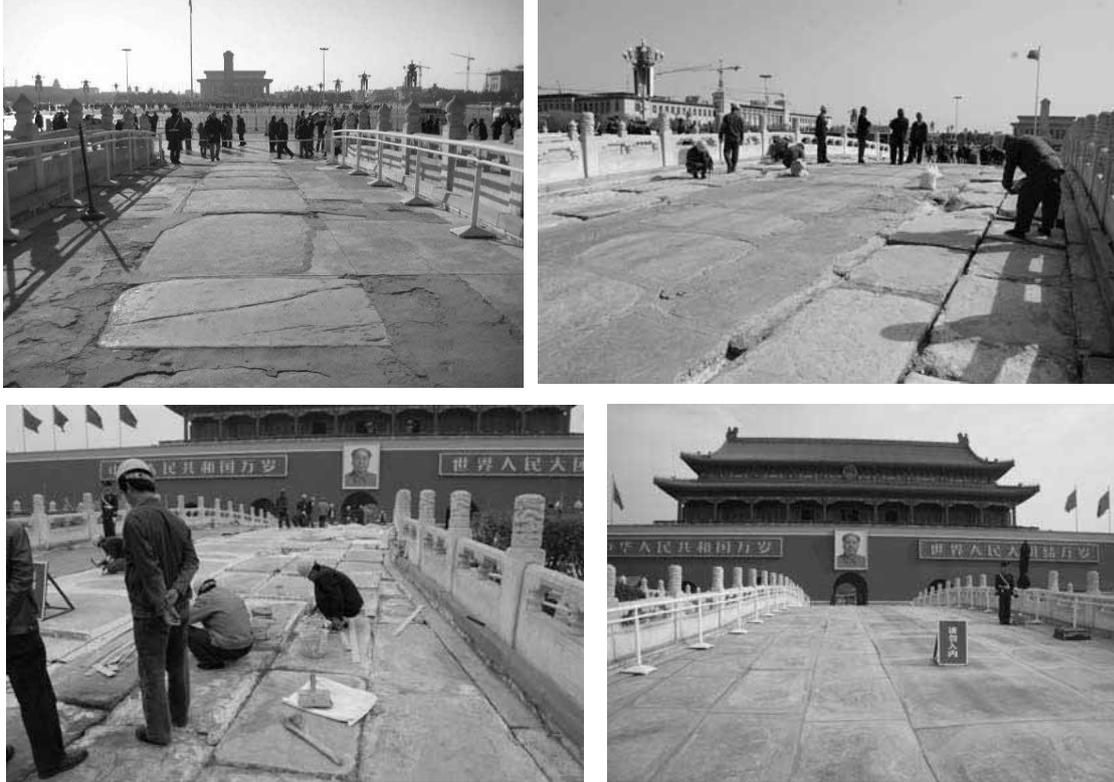
Fig. 7: Yulu Qiao (Emperor Bridge) before, during and after restoration

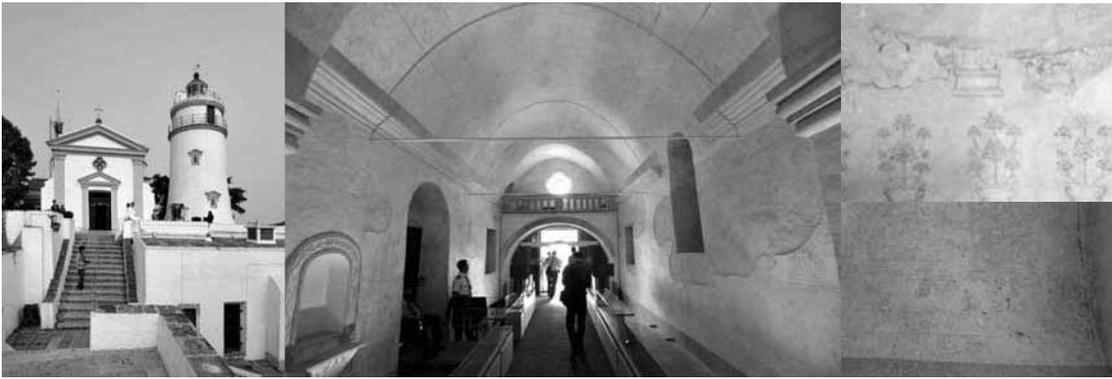
Fig. 8: Documentation, Monitoring, Diagnosis, Intervention Guia Chapel Macao
