Training Course on Cultural Heritage Protection
in the Asia-Pacific Region 2011

**Preservation and Restoration of
Wooden Structures**

30 August - 29 September, 2011, Nara, Japan

Cultural Heritage Protection Cooperation Office,
Asia-Pacific Cultural Centre for UNESCO (ACCU)

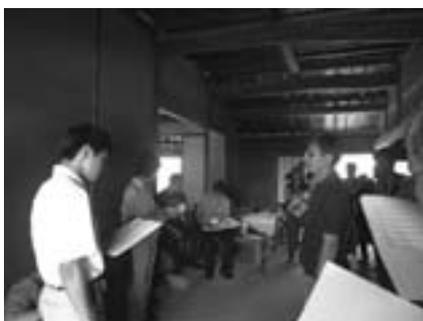
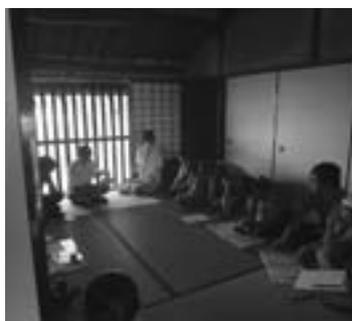
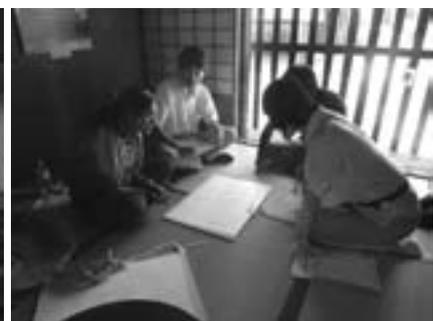
- Explanation of the Japanese drawing instructions for each part of the structure
- Drawing a floor plan in accordance with these instructions

Lecture and practical training at Tanaka Family Residence

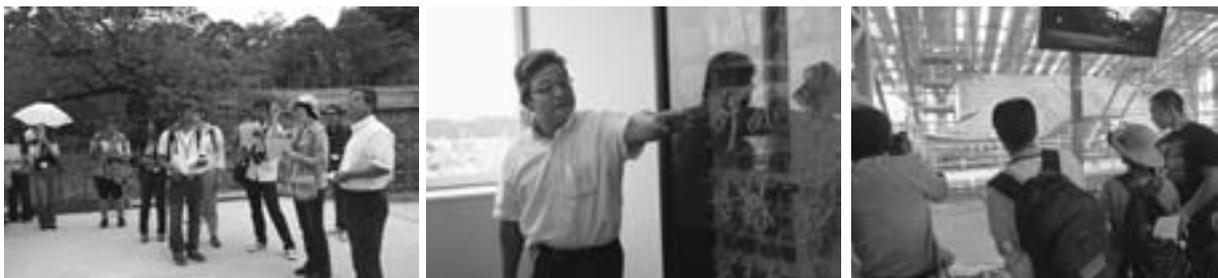
At Himeji Castle, currently undergoing repair, explanations were received of the outline of the current repair, and on materials used for the plaster and roof tiles, while walking through the castle site. As work is being done on the main keep, a temporary building has been put up, but underneath is a facility for viewing the repairs which is open to the public, making it possible to observe the repair of the roof and walls from up close. This is to avoid driving tourists away during the repairs, by providing access to the interior. The participants were deeply absorbed in their observations, on this valuable opportunity to observe repairs of Japanese castle architecture in progress.

On-site lecture at Himeji Castle by Mr Kobayashi

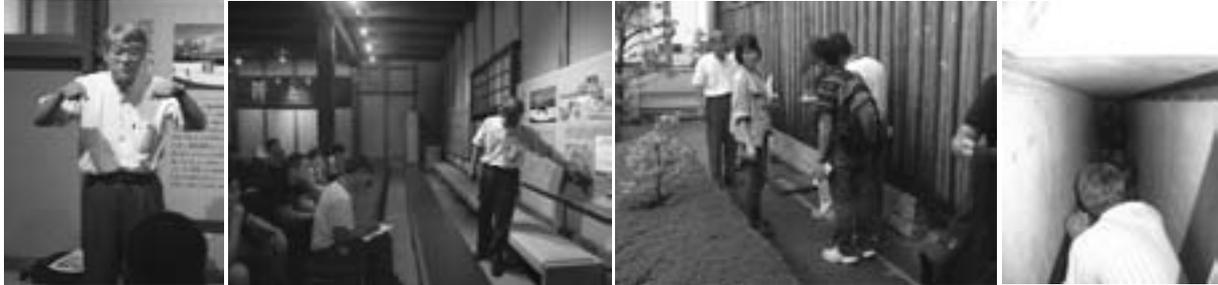
At the Sawanotsuru Museum, after a brief explanation from Mr Murakami about the earthquake damage and the seismic isolation system, the participants went in groups of several persons each to inspect the system in the basement. The others viewed the displays in the museum, such as *Funaba Ato*, the unique remains of sake-brewing and archives of the restoration work of this building.

On-site lecture at Sawanotsuru Museum by Mr Murakami

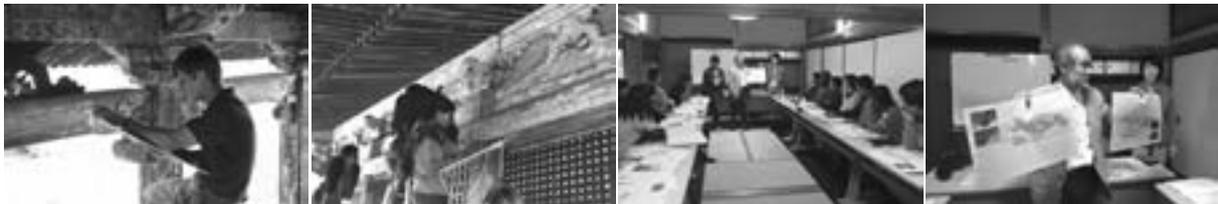
At the Jibutsudō of Tōdaiji, the lecturer Mr Kubodera was asked about the points of caution when making a survey on painting. As the deterioration and peeling of the paint were severe, it was affirmed that meticulous attention was needed when making a survey.

Practical training and lecture at the Jibutsudō of Tōdaiji by Mr Kubodera

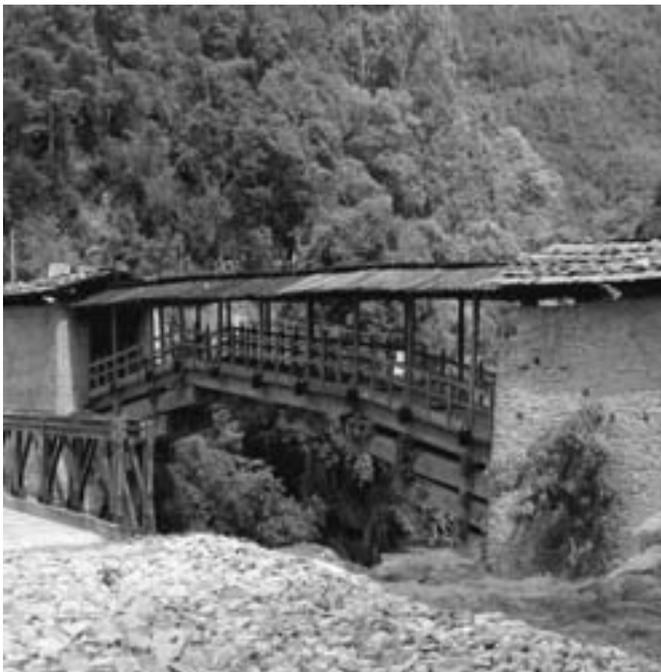
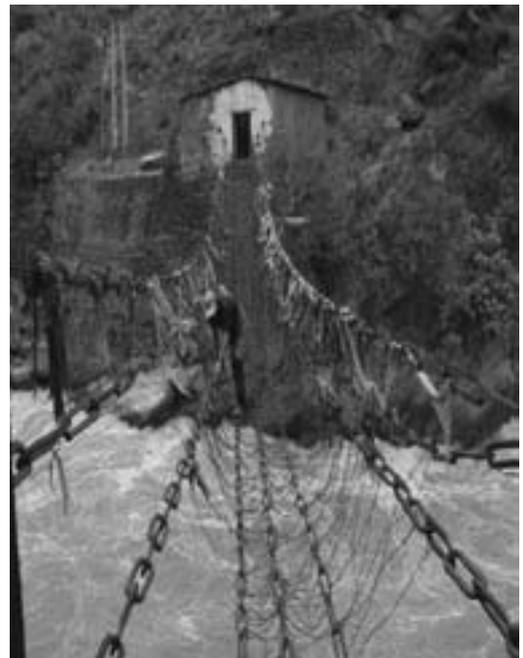
(Fig. 2.6) Traditional Bhutanese bridges

Traditional Bhutanese bridges can be grouped under two types: chain suspension, and a wooden cantilever known as bazam. The former type is normally adopted for wider rivers and the latter for narrower ones. Traditional bridges not only represent exquisite architectural pieces but also feats of engineering which have never failed to fascinate foreign visitors. Bazam is a wooden cantilevered bridge with or without a roof over it, and usually with bridge houses which are tower-like structures on each end.

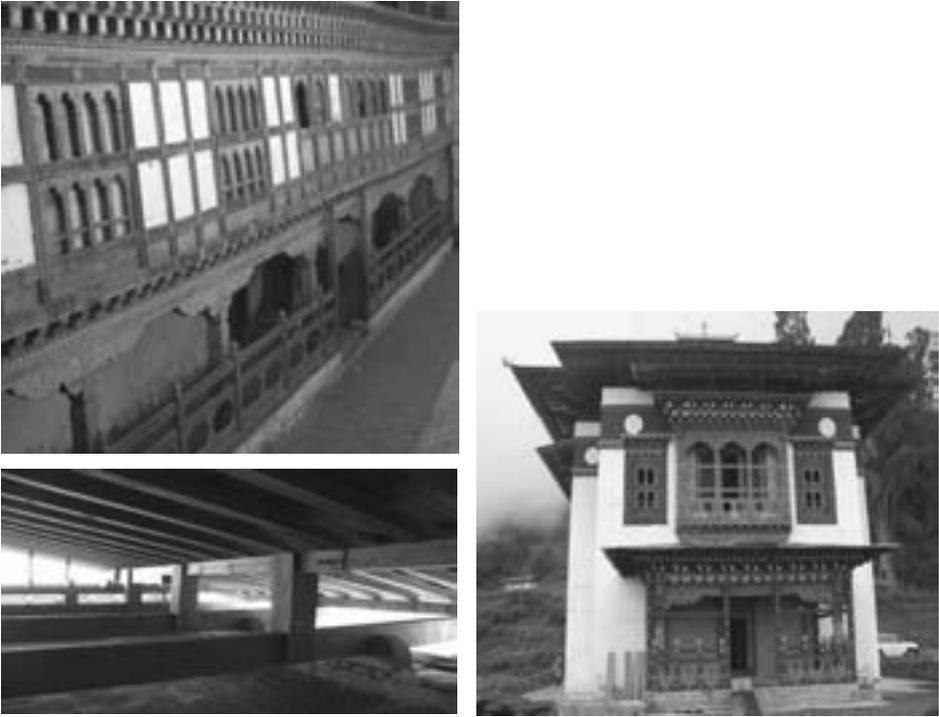
(Fig. 3.1) Typical Bhutanese architecture

The way wooden columns are used in traditional buildings is quite interesting to know. Tapering wooden columns with brackets called kachens, decorated to various degrees depending on the nature of the building, are typical of Bhutanese architecture. These columns are introduced to support the principal beams (dung) and joists for achieving more space inside. The most remarkable aspect of these structures is that they have withstood numerous earthquakes and other natural calamities over a long period of time. However, there is no record in evidence that these were designed to resist earthquakes.

Another striking feature of traditional architecture is the pitched roof, made of timber. The different roof types represent the status in the building hierarchy. Some of the roof types are permissible only for important buildings such as temples, monasteries, palaces, or government buildings. Traditional roofs make use of extremely heavy timber members. It is common practice to create a wide attic, and the space is used for drying and storing crops and meat. Traditional roofs use layers of shingles for roofing, which are kept down with stone boulders.

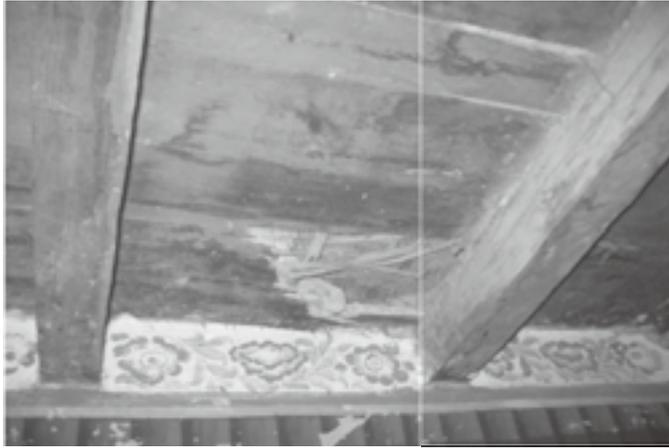
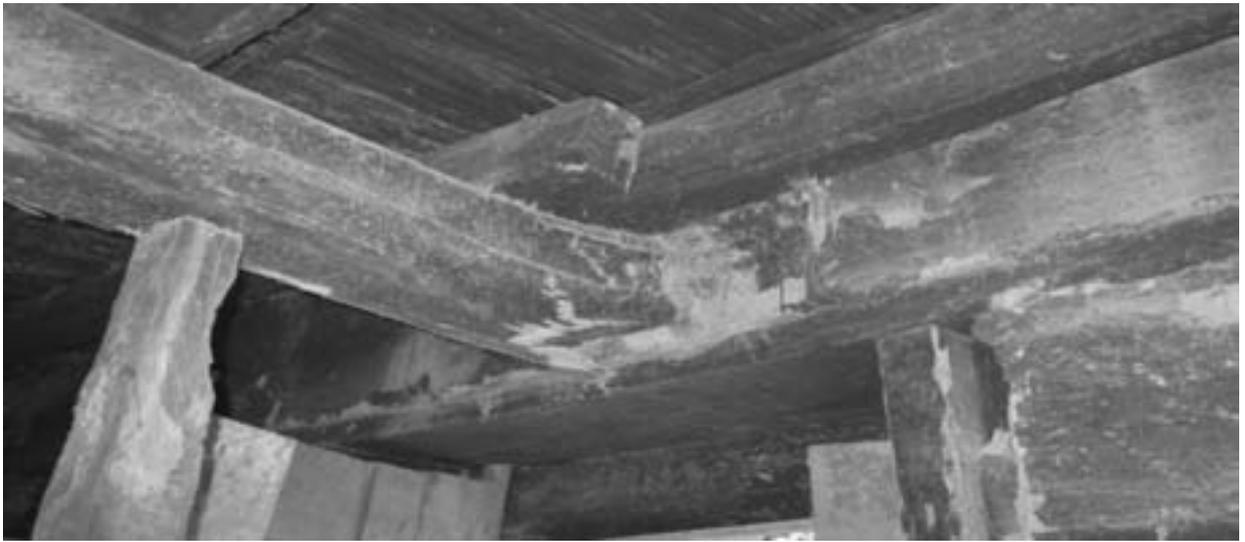
(Fig.5.1) Timber decay

The most widespread and severe problem that persists for heritage buildings in Bhutan today is the decay of timber. In certain cases, the stability of the whole structure is put at risk due to decay of key timber structural members and due to improper structural designs whose shortfalls reveal themselves over time. For example, there are situations where wooden beams and columns are strained under excessive load, as the result of which beams sag and columns sink, bringing the whole overlying structure down with them.

The causes of decay are insects, microorganisms, dampness and weathering agents. Dampness, one of the most common causes of timber decay in Bhutan, is also aggravated or promoted by poor planning and construction faults. However, it is noted that different species have different capacities to fare in particular situations.

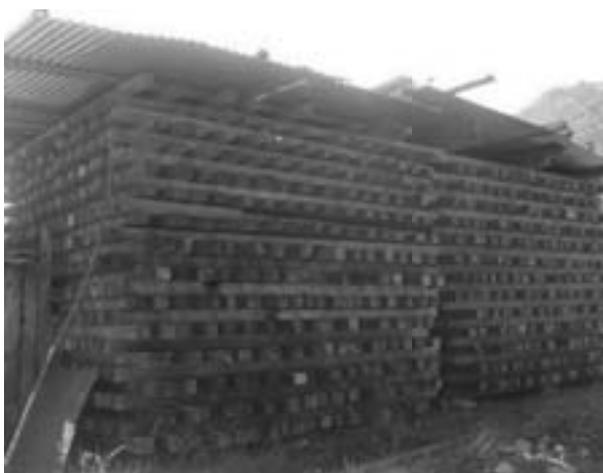
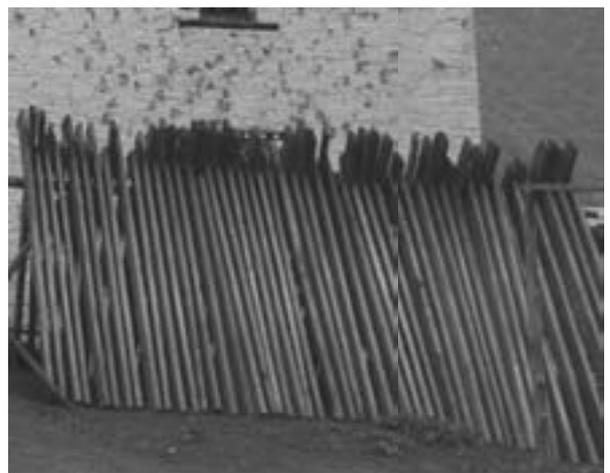
(Fig. 5.2) Traditional way of seasoning timber in Bhutan

Apart from natural seasoning, there is no other treatment applied to timbers. One can easily make out whether timber is well seasoned or not. Timber that is not seasoned well is extremely vulnerable to insect attack and decay, and also starts to shrink or warp under pressure. Although chemicals and preservatives are not used, the paintings done on wood have contributed a great deal to protecting timber for a long time.

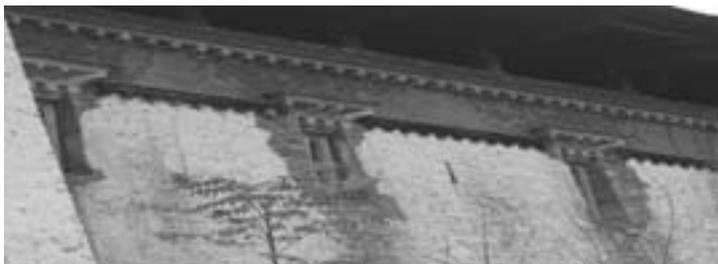
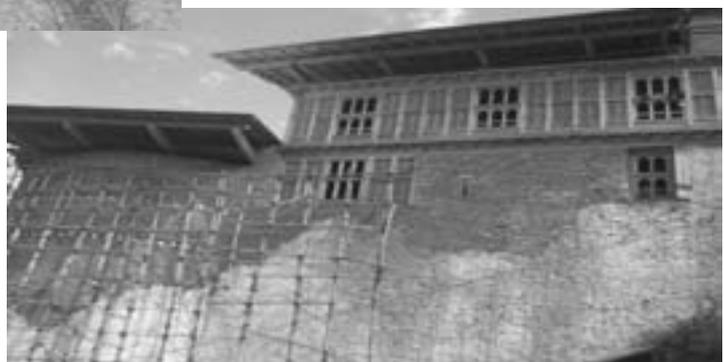
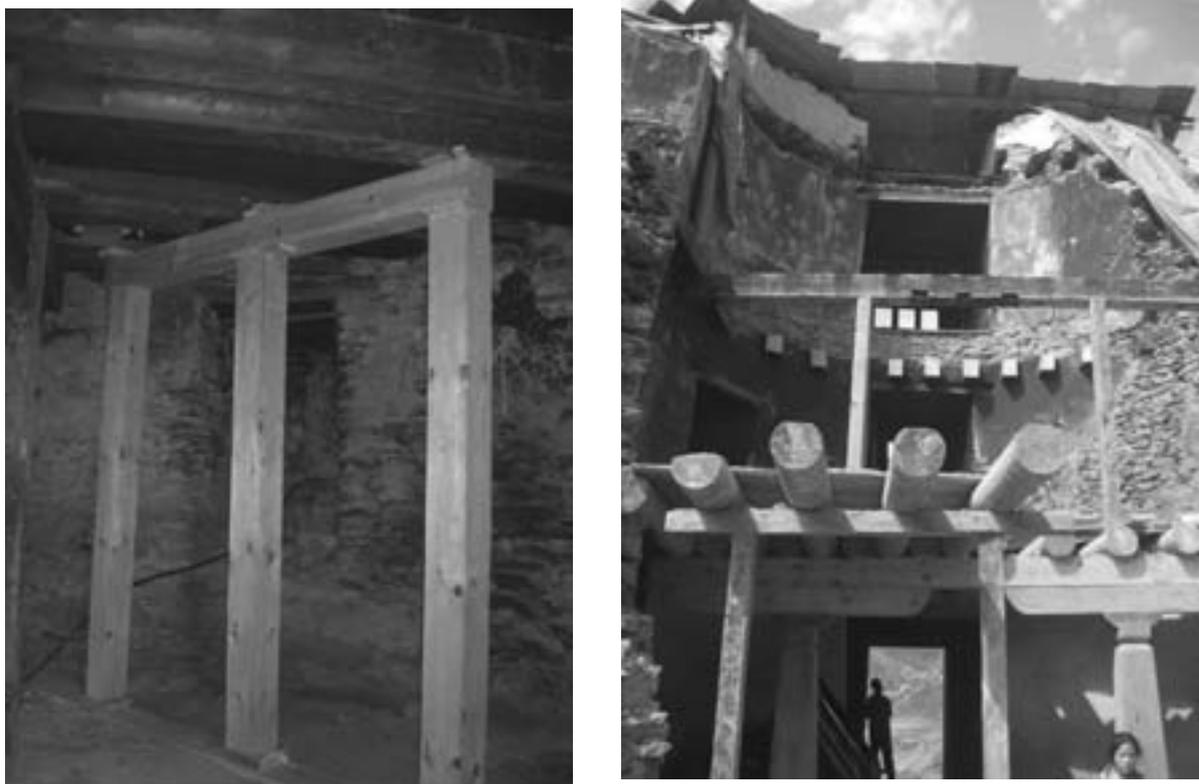
(Fig. 6.1) Restoration techniques

It is necessary to take great precautions in repairing structural members. At the time of replacing floor joists, beams, lintels or columns, the horizontal members are jacked up. The removal and replacement of each member is done in succession from a suitable point. The outright replacement of joists or other similar members is refrained from unless it is extremely necessary. It is necessary to study the original timber species and also assess the strength required for the timber.

Total replacement of a unit is carried out mainly for structural components where structural safety cannot be compromised. However, other non-structural timber elements can be corrected through consolidation, repair or replacement of damaged parts, etc. In conservation, every attempt is made to preserve the original material and existing conditions to retain the intrinsic cultural values.

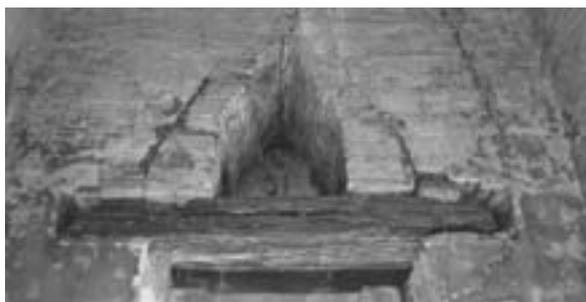
Wooden lintel over doorway: These timbers support the upper load of the doors

Fig. 1 Wooden lintel at Bakong temple

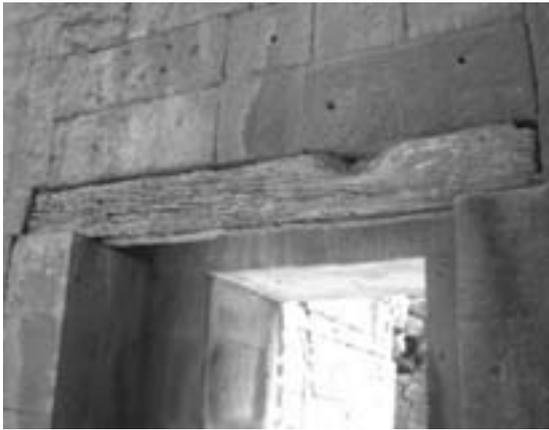
Fig. 3 Wooden lintel, Northern Khleang temple

At Northern Khleang temple located in the Angkor Thom compound, researchers found wooden beams still in their original locations at two places on the doorways of the central temple tower. The function of the beams is to support the stone over the door lintel (Fig. 3). According to several researchers, the age of the beams is perhaps several hundred years old. At present, they are in bad condition and decaying steadily, and they have neither been repaired nor conserved. In spite of influences from India, where numerous wood construction techniques are employed, the Khmers

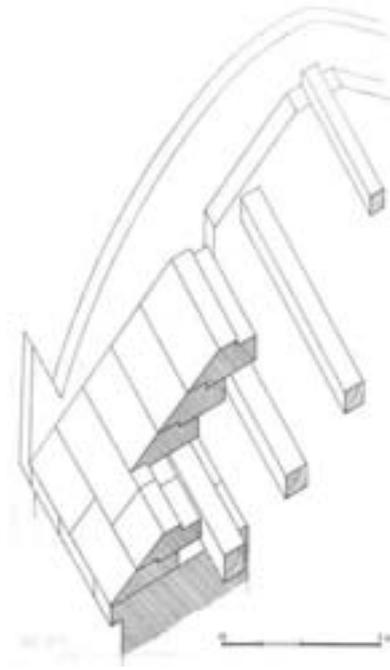
Fig. 9 Reconstruction of a roof covering one of the entrances of the Bakong pyramid

Due to Indian influences on Khmer monumental architecture, Cambodian master craftsmen produced, from the eleventh century, a form of roof covering without completely understanding the techniques involved, known as hooped roofs (models of such roof covering are frequently found in the carvings in India, particularly in Mahabalipuram).

Given this ignorance, these roof coverings were reproduced in Cambodia with considerable incoherence; for example, the roof seems to have been covered by concave tiles which are in practice very difficult to place on a curved surface.

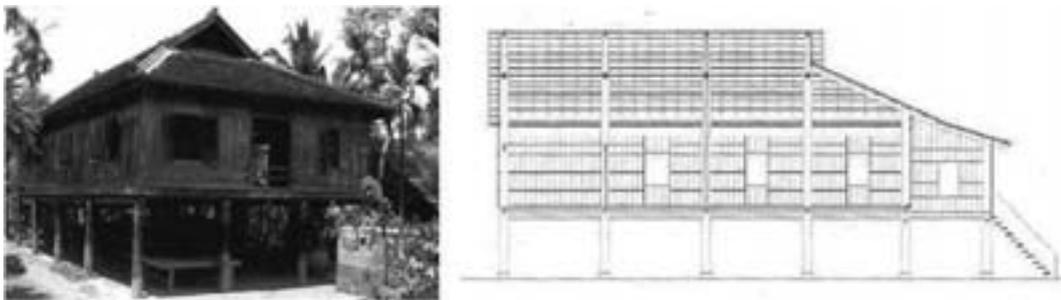
Fig. 12 Photo and cross-section of a *phteah rông daol*

The *phteah rông daol* features a wooden structure much less elaborate than the *phteah keung*: it has no tiered roof, and only the extended awning, *hâp*, at the front of the house, leaving the upper part of the roof plain save for a small gable. The back of the house is left vacant, usually with loosely fixed wood paneling allowing for possible extensions. In the mid-twentieth century, *rông daol* houses seem to have been closely associated with Cham communities. That is why it was always the type of house inhabited by Islamic Khmer. Regarding interviews conducted with their descendants, most of the original house owners were farmers who supplemented their income with activities such as silkworm breeding, tobacco production, or cotton and silk weaving. None of the original owners seem to have had any official title.

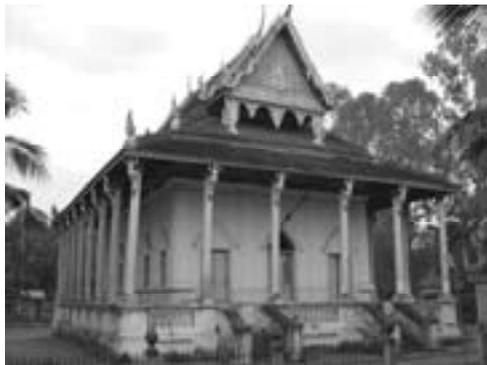
Fig. 16 Ancient prayer hall with a roof structure of wood and core of bricks

Vihàra, uposothàgàr. These are built with four or six lines of columns that divide the space as follows: the central section is called the foundation (*krüh*), the bordering sections on the sides are called the corridors (*ròbieng*), and beyond are the porches (*baing sach*). In this type of building, most examples have two levels of roof and possess at least four roof finials.

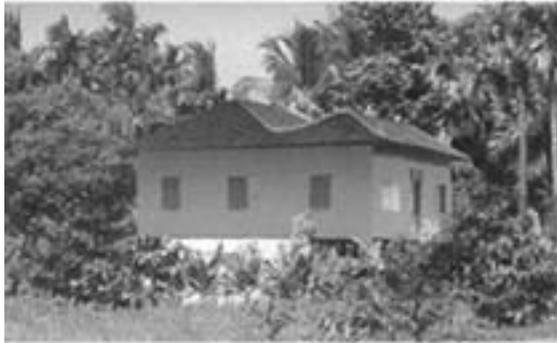
According to observations *in situ* on color use of most of the houses in the protected zones, it does not conform to APSARA's recommendations. One house was painted in yellow and grey tones on the

walls and windows. Visibly, the upstairs and downstairs (additional construction) are distinct from each other (Fig. 21).

Fig. 21 House situated in the protected zone of Angkor Archaeological Park

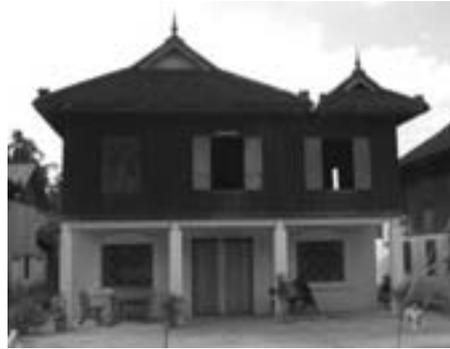
Fig. 22 House in Battambang province

Another house, situated in Battambang province, with new construction at the ground floor which looks recently built or repaired, is totally done in brick, in contrast to the old part of the building (Fig. 22).

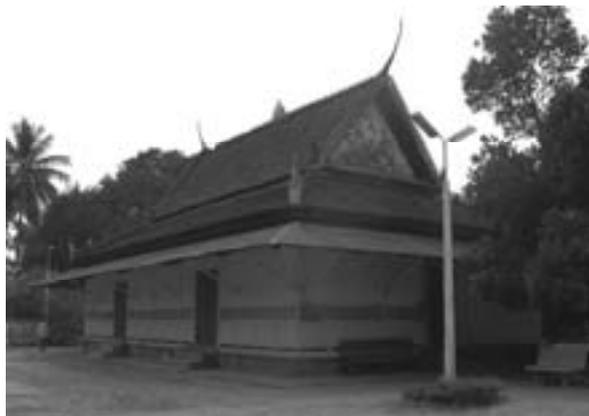
This ancient prayer hall is situated in Siem Reap province. The walls were recently removed and replaced with new wooden planks with grills. The walls were completely painted and covered with an additional layer of zinc. The building as a whole visibly divides into two parts, the roof which maintains its authenticity, and the main body of the wooden structure which reduces the building's historic value.

Fig. 23 One of the ancient pagodas in Siem Reap province

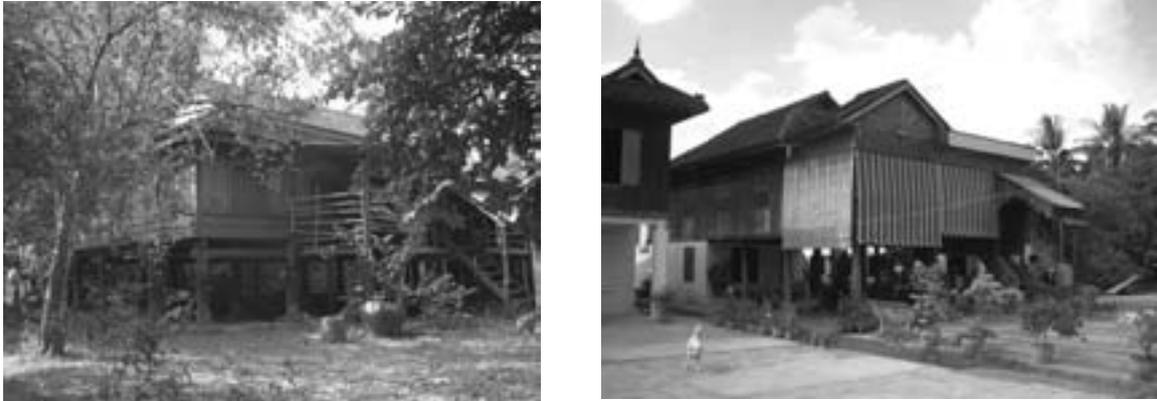
These are examples of houses surveyed in Battambang province. In the first one, a verandah has been added adjacent to the main porch, and in the second, an additional building stands in front of the house, with architectural characteristics contrasting strongly with the old building located to the rear. Though

differing in degree, both houses illustrate negative historic impact caused by lack of adherence to Khmer architectural style.

Fig. 24 Houses surveyed in Battambang province

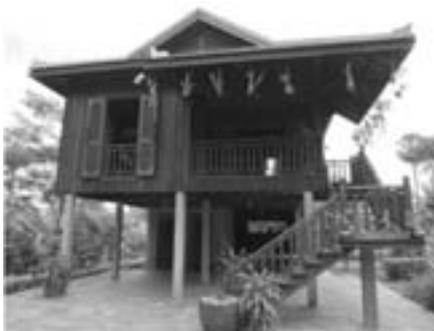
In order to maintain the ancient architectural forms and landscapes in the parks, we need to take into account the painting of houses. Materials on the roof (tiles, fibro-cement, and zinc) must be in red, green or light grey tones; white is prohibited. Walls and windows must be coated in brown or should be kept in the natural color of the wood. In case there is additional construction at the ground floor, it must be in the same color of the main building or light grey, but pink and white tones are prohibited. Below are a model house and water color patterns built and produced by the APSARA authority, which should serve as models for those requesting permission for construction.

Fig. 25 Model house in the protected zone of Angkor park

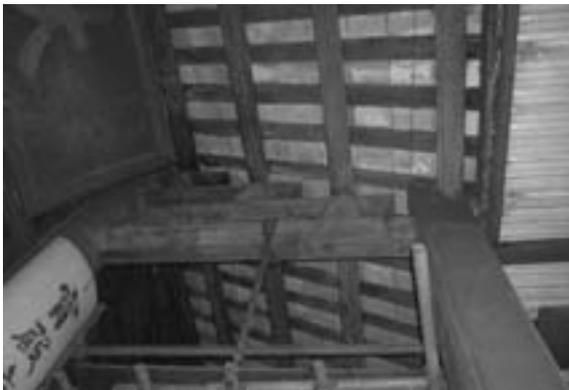
Fig. 1 Supporting the roof of the Main Grand Hall is a Lingnan style lifting-beam with strut-column timber frame

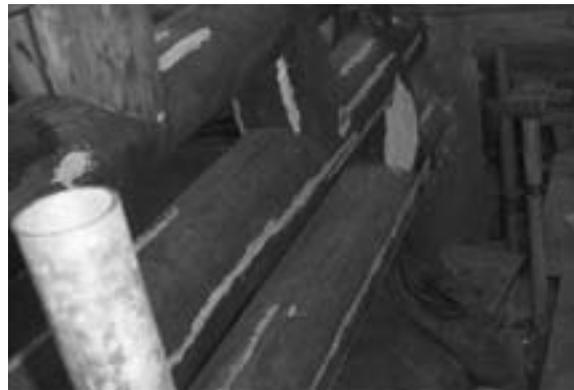
Fig. 2 Timber frame with minor damage was repaired while remaining in place

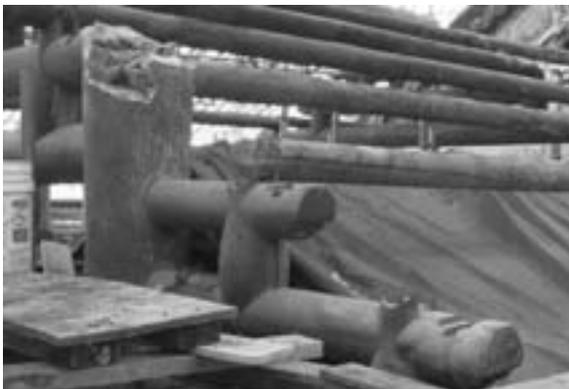
Fig. 3 Timber frame components with of loss structural capability were replaced by matching timber poles

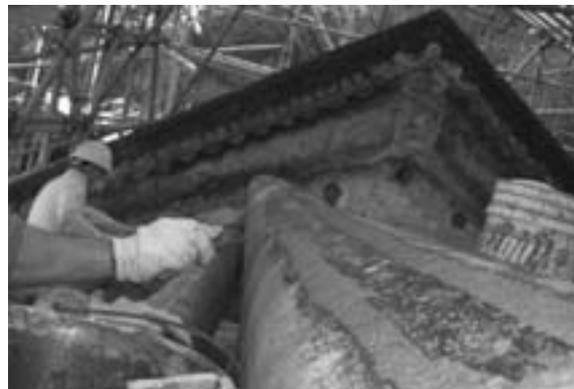
Fig. 4 Filling up the gaps with wood blocks and chips mixed with resin

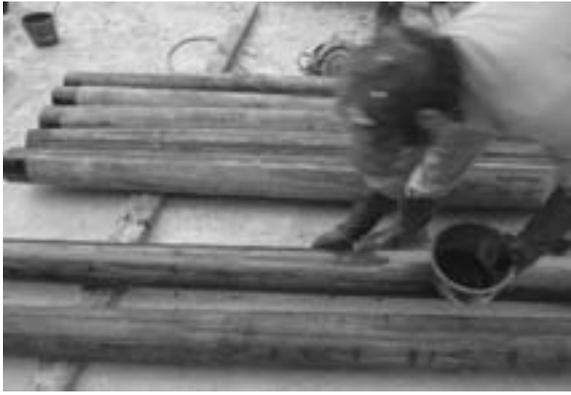
Fig. 5 Timber frame painted with two layers of raw tung oil until soaked wet just like the traditional method

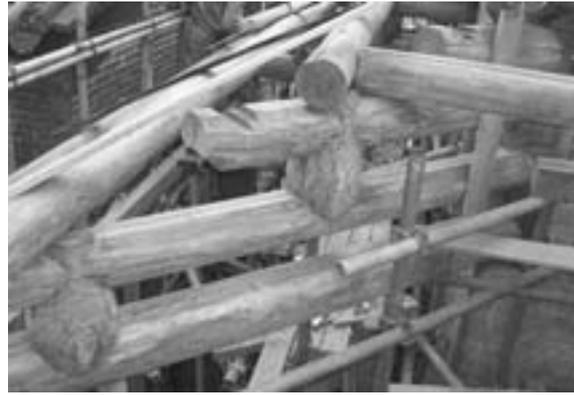
Fig. 6 Replacing part of the timber structure with new members using traditional carved jointing

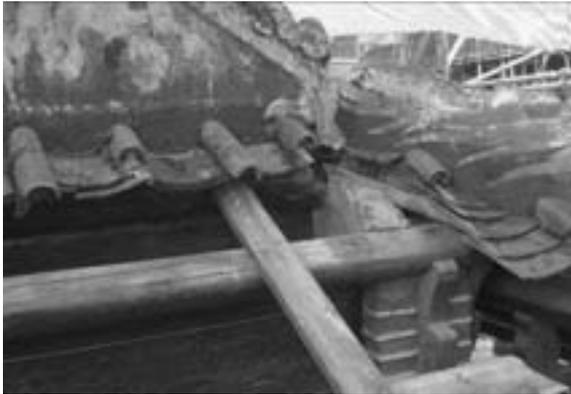
Fig. 7 The gable above roof is incised from the exterior wall under the eaves

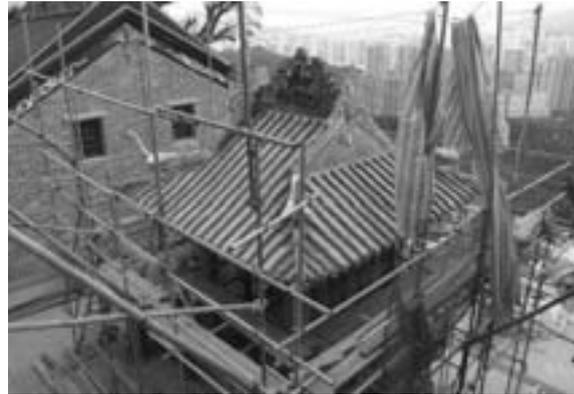
Fig. 8 Hipped and gabled roof is rare in buildings of this small a scale

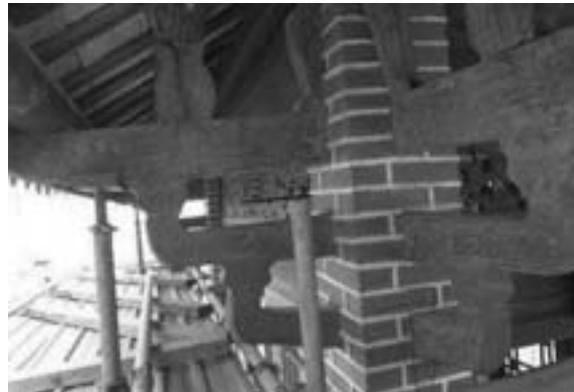
Fig. 10 *Tou-kong* painted in red with faint incised groove carvings of patterns in lotus and clouds

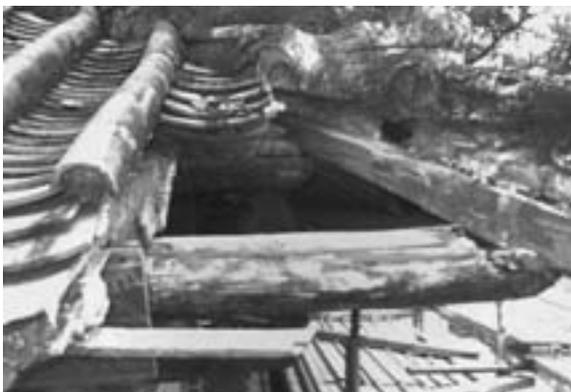
Fig. 11 Occasional sections of overhanging purlins are found to have rotted

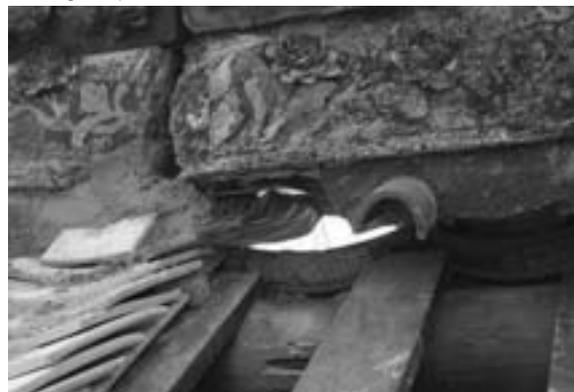
Fig. 12 A major fracture at the middle of the ridge decoration

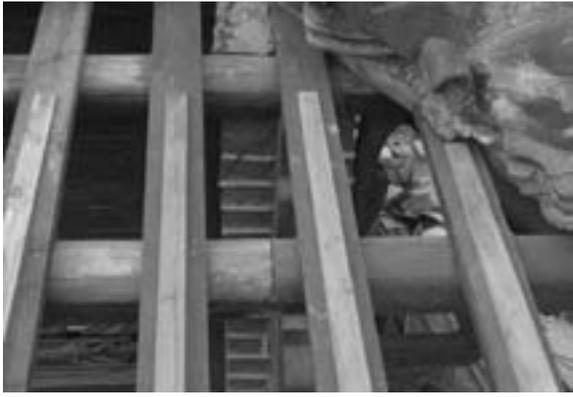
Fig. 13 Local section of rotted purlins replaced by new timber

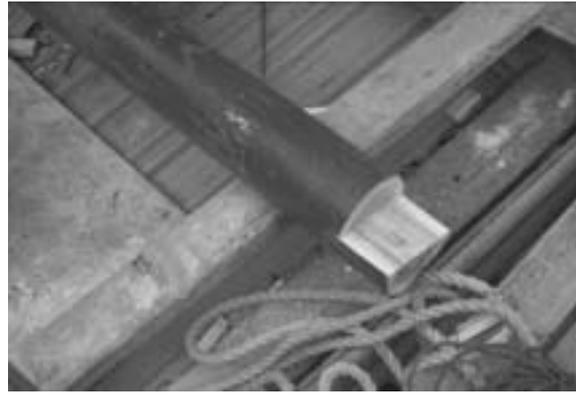
Fig. 14 Local section of rotted purlins fitted back to the main member by traditional crafted joints

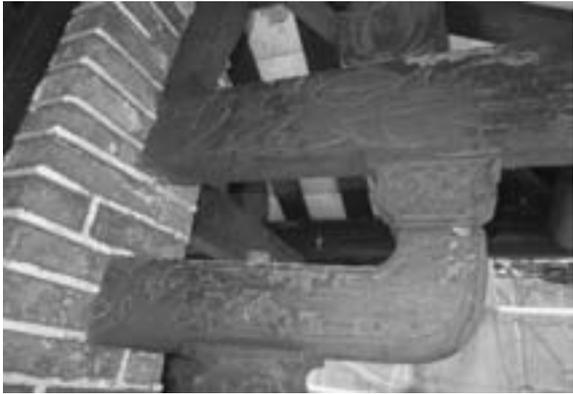
Fig. 15 Repainting *tou-kong* in red with water-based paints

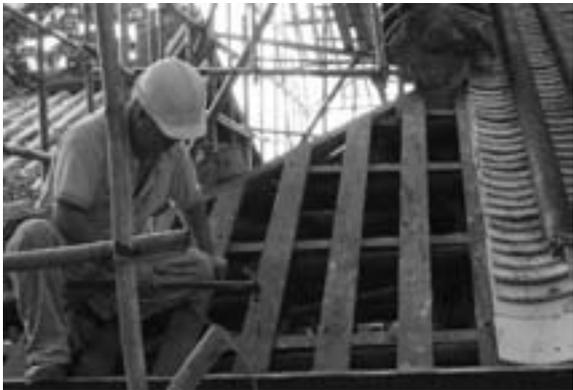
Fig. 17 The roof is the traditional Lingnan "single roll, single pan" tile construction

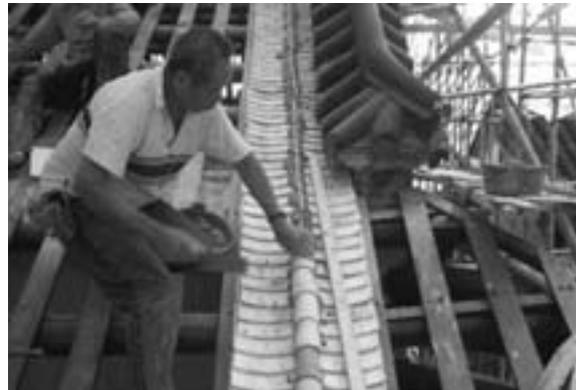
Fig. 18 Using continuous rows of interlocking cylindrical tiles to cover the joint between rows of pan tiles

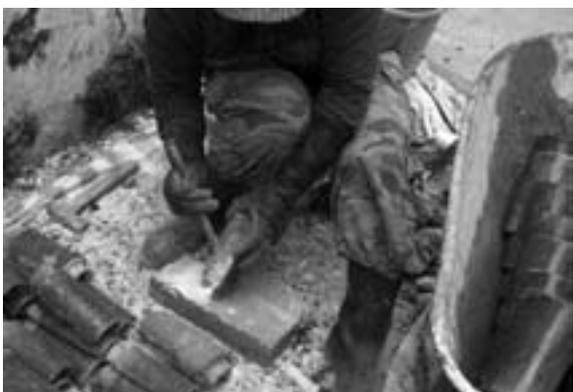
Fig. 19 Cement mortar previously adhering to the roll tiles was carefully chipped off by hand

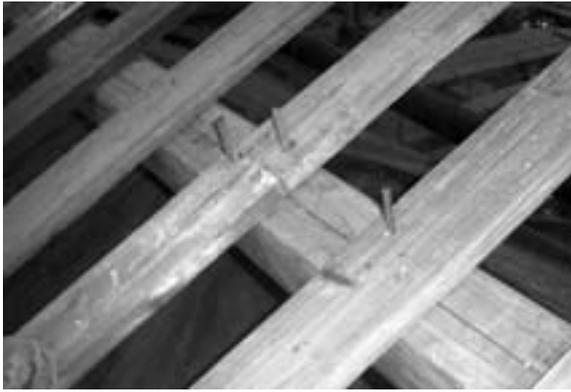
Fig. 21 The team re-introduced a Lingnan traditional technique of fixing with bamboo nails

Use of bamboo nails. Another common failure of Chinese roofs is the collapse of rafter battens that support the tiles. Modern workers in Hong Kong often use iron nails to fix the rafter battens onto the purlins below. This non-traditional method creates potential rusting and eventual deterioration of the timber members. Again, the team reintroduced a Lingnan traditional technique of fixing the components with bamboo nails (Fig. 21). Workers cleverly made their own bamboo nails by cutting domestic chopsticks (Fig. 22). These need to be dried and then dipped in raw tung oil according to traditional practice to repel insects and mould, and improve moisture resistance.

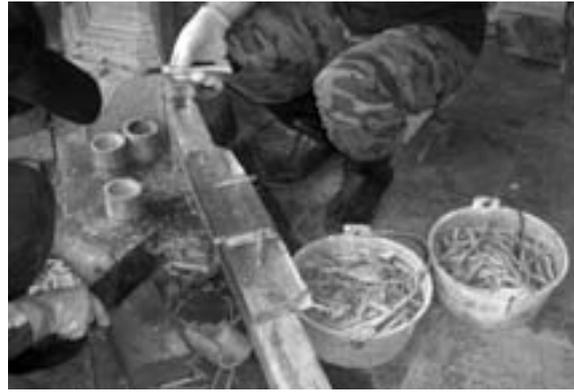
Fig. 22 Workers cleverly make their own bamboo nails by cutting domestic chopsticks

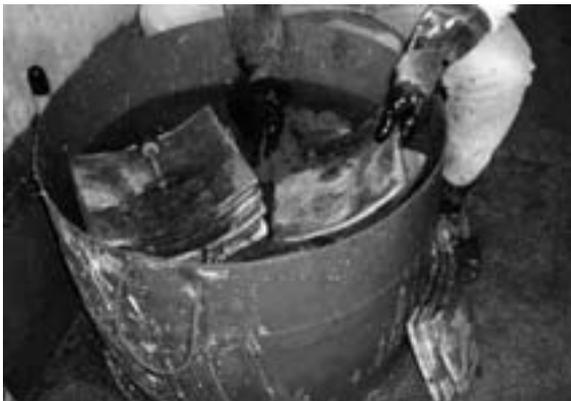
Fig. 23 The salvaged pan tiles were selected, and then thoroughly cleaned of bird droppings and mould

Preparation of salvaged pan tiles. The salvaged pan tiles were selected and thoroughly cleaned of bird droppings and mould (Fig. 23). They were then soaked in lime water for up to three times until they appeared white (Fig. 24). The lime will improve the water shedding properties, repel and prevent insects and mould, and also prevent plants from growing on the tiles’ surface.

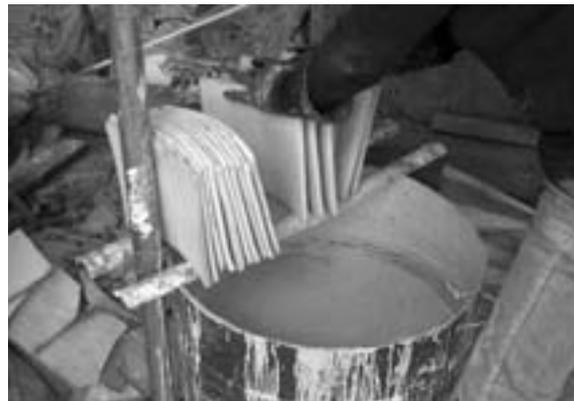
Fig. 24 The salvaged pan tiles were soaked in lime water for up to three times until they appeared white

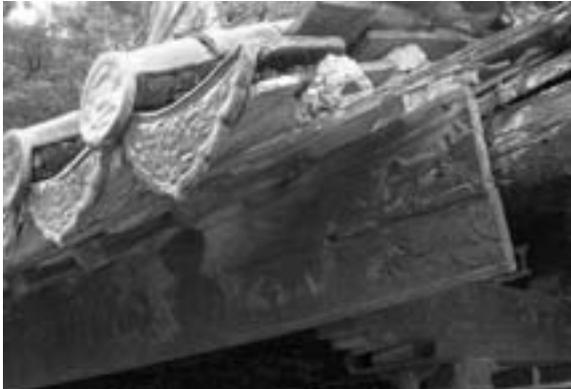
Fig. 25 The existing eave board was covered with dirt and mould at the start of project

The existing eave boards were covered with dirt and mould at the start of the project (Fig. 25). Only shallow incised groove carvings similar to those on the *tou-kong* were seen, but were blurred by later applications of thick paint. The cloud profiles at the edge corners of the eave boards were unfortunately badly rotted. The carvings on the door head lintel frames across columns have a combination of relief and openwork carving (淺浮雕, 通雕) (Fig. 26). Apart from two thin layers of paint and a fracture in the middle, the condition is acceptable without damage to the carving details.

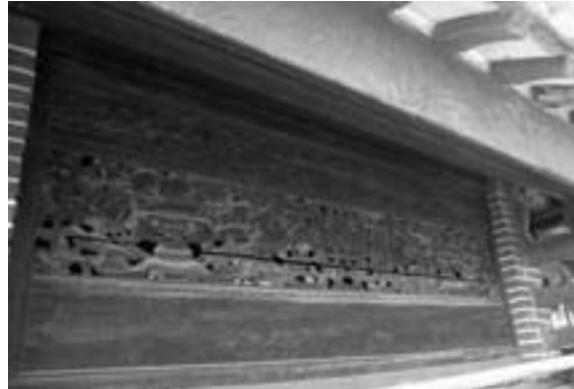
Fig. 26 Combination of relief and openwork carving on the door head lintel frames

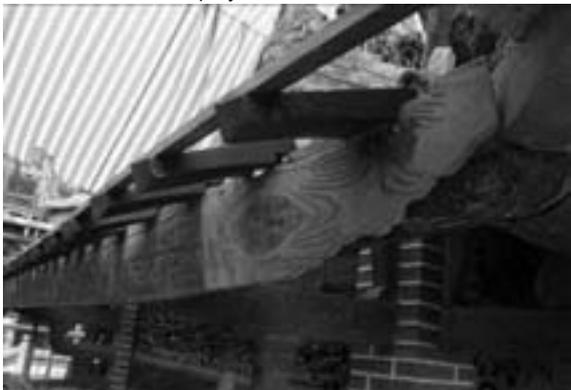
Fig. 27 The rotted corners of the eaves board were repaired *in situ*

Careless handling by workers at the start caused falling and loss of the rotted corners of one of the eave boards. The construction team brought craftsmen from China in an attempt to remake them, but the remade pattern turned out to be mismatched with the original. Repeated trial resulted in the decision to repair *in situ* (Fig. 27). By referring to the offering table under the Sutra Protector Statue inside the hall, guild incised groove carvings were painted in the traditional Ciozhou (潮州) style of “gilt thread drawing” (金線畫) (Fig. 28). In the absence of any other evidence, it is reasonably assumed that the carvings of the eave boards might have been carried out in a similar technique. Hence it was decided to restore with such grooves painted with this traditional method.

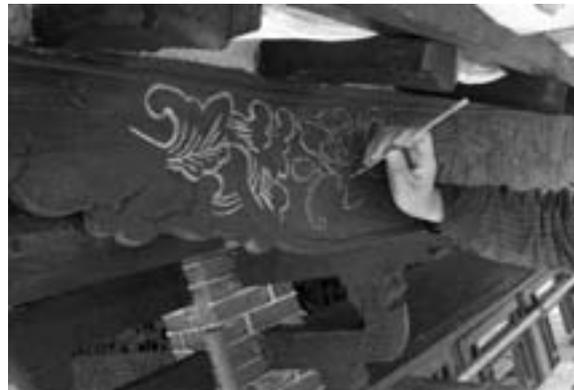
Fig. 28 Restoring grooves painted in "gilt thread drawing"

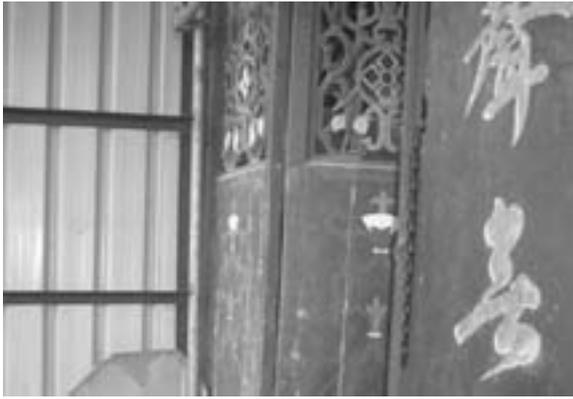
Fig. 29 The existing timber doors with lattice patterns are in good shape with little sign of fracture or rotting

The bodies of the existing timber doors are generally in good shape, with little sign of fracture or rotting (Fig. 29). The surfaces, including the lattice patterns, appearing in bright polychrome, were obviously painted over many times.

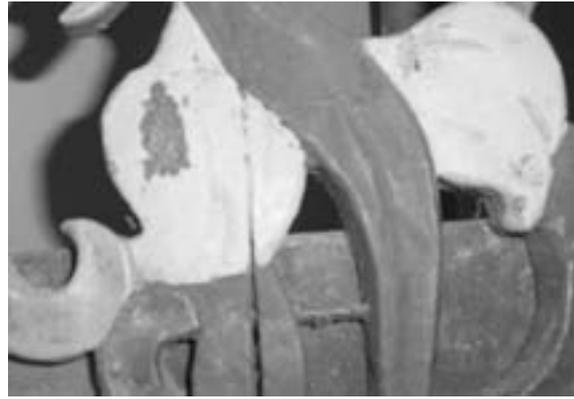
Fig. 30 Cracks and chipped-off corners to be repaired by traditional filling of wood dust mixed with mortar

There is no substantial technical challenge in repairing the fabric, except for minor repairs of cracks and chipped off corners by traditional filling with wood dust mixed with mortar (Fig. 30). The main challenge of the restoration was the colour and texture of the open lattice patterns. It is important that the restored colours appear not brand new, nor should it be deliberately made old to falsify historic evidence. It was decided in the end that the middle main feature patterns be painted in the original bright colours, while the surrounding vine decorative patterns be made slightly dull. Workers applied diluted chemical paint remover to the wood surfaces (Fig. 31). It removes all later oil-based or synthetic paints except the bottommost layer, which is probably half soaked into the wood fabric. It was decided to leave such faint traces of old paints untouched since further chemical or manual treatment may risk damaging the wood grain or craftsmanship. Traces of the very bright later colours left over from when the project started still remain at the edges and corners of these lattice patterns, and are difficult to remove without risk of damage. It was decided to leave these traces alone, to allow visitors to see such evidence. All the door leafs were repainted with mineral dye to the original colours, except one leaf at the far edge, which was deliberately left untouched and remains in the state before the restoration (Fig. 32). It allows visitors to see the authentic historic evidence.

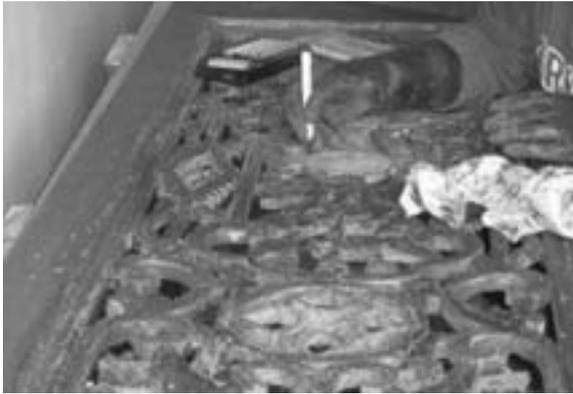
Fig. 31 Workers applied diluted chemical paint remover on the wood surfaces

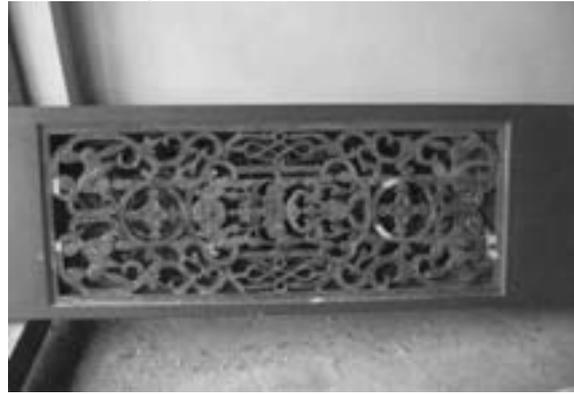
Fig. 32 One leaf of the doors at the far edge was deliberately left untouched

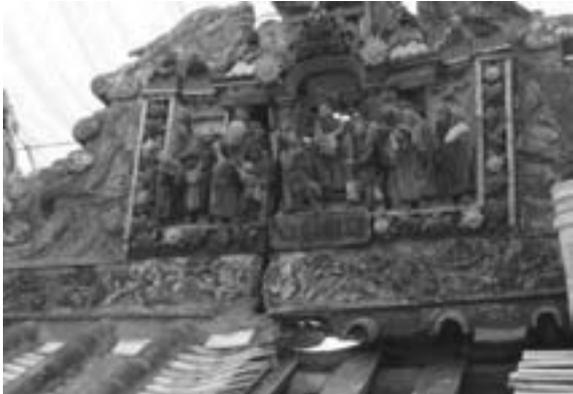
Fig. 33 A major fracture is found in the middle of the group of Si-wan glazed ceramic

Despite occasional cracks and loss of features, the general condition is good and thus illustrates a good quality firing process when originally made. However, the entire composition showed sagging, with vertical fractures caused by failing timber ridge purlins and frameworks below (Fig. 33).

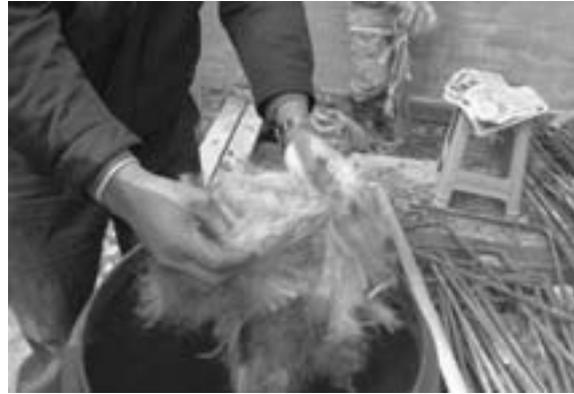
Fig. 34 The method of hemp-mixed lime plaster was eventually tested and applied

After research, a type of traditional plaster common in Lingnan vernacular construction, hemp fibre lime plaster, was found and was it decided to introduce it here. Similar to the local paper pulp plaster technique commonly used in Hong Kong until the 1970s, it is basically a lime based plaster reinforced by the fibre of hemp, thus allowing a layer as thin as 10 mm to properly adhere to a rough brick surface. The final lime colour paint was applied on the plaster while damp, and the resultant plaster is strong (due to the hemp fibre reinforcement), permits natural breathing for the bricks (hence they last longer), and sustains the desired colour of coating. The supply of hemp fibre was readily secured by cutting hemp ropes into small pieces (Fig. 34). This hemp fibre is then added into a wet lime mixture and mixed well by mechanical cement mixers. After trial on site, it was considered an appropriate treatment to address all the various issues of material durability, practical workability, and aesthetic interpretation at the same time. No modern techniques are needed to resolve this challenge.

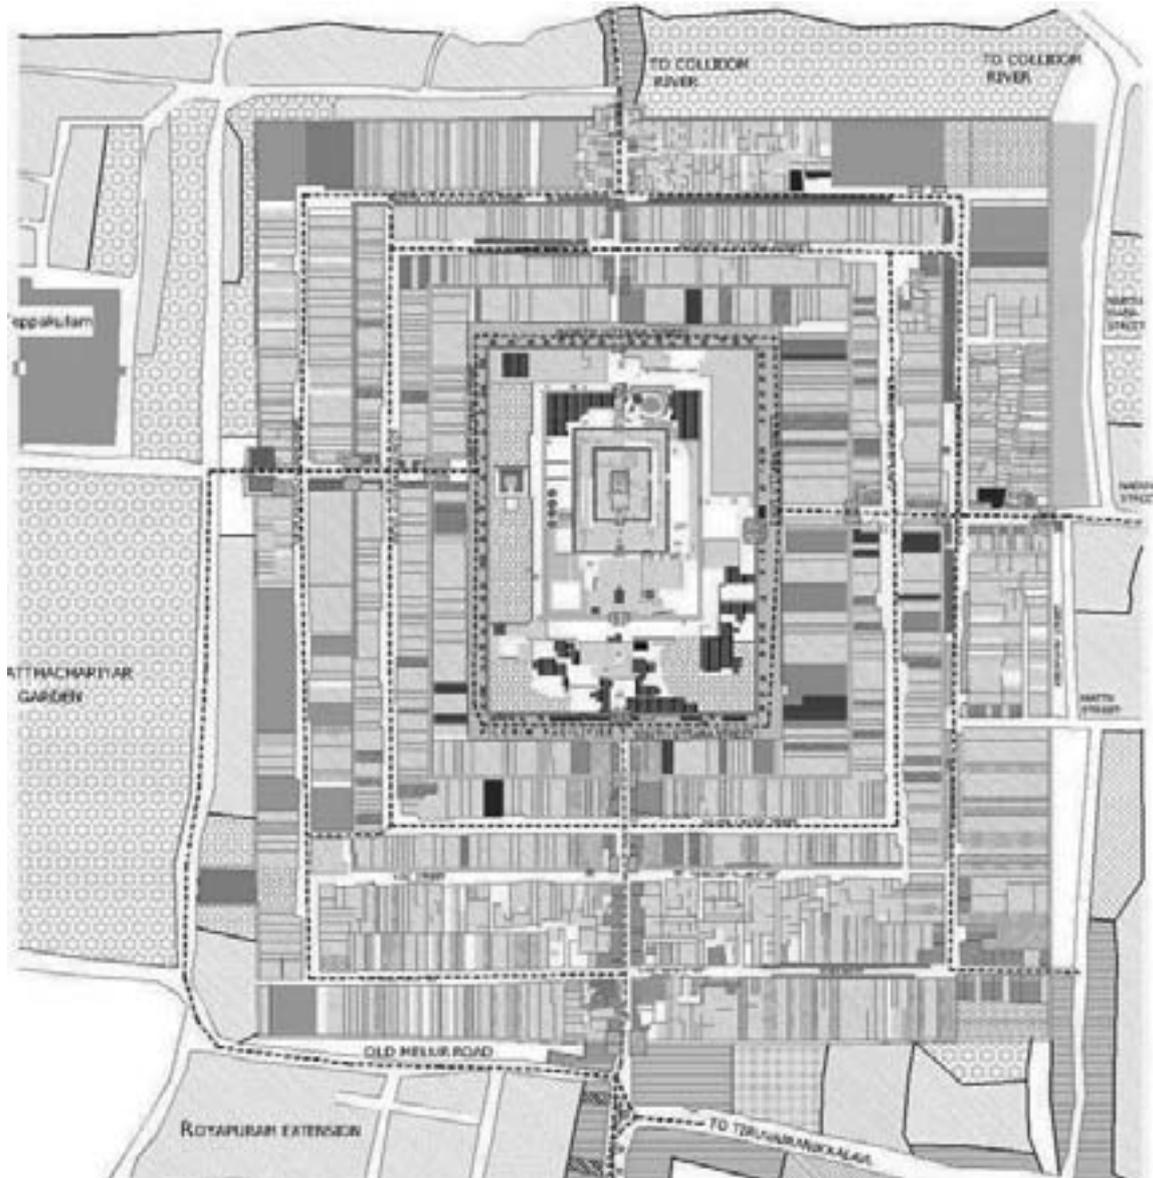
Fig. 4 Plan of a historic temple town (Srirangam, south India) dating from at least the seventh century AD, which took its final urban form in the sixteenth and seventeenth centuries

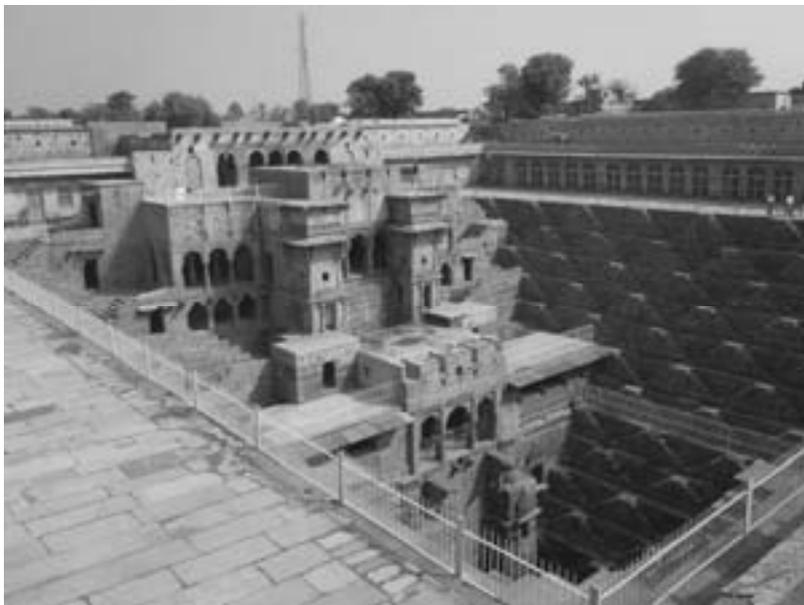
Fig. 9 A stepwell made of sandstone and quartzite in the arid region of western India, in the state of Rajasthan

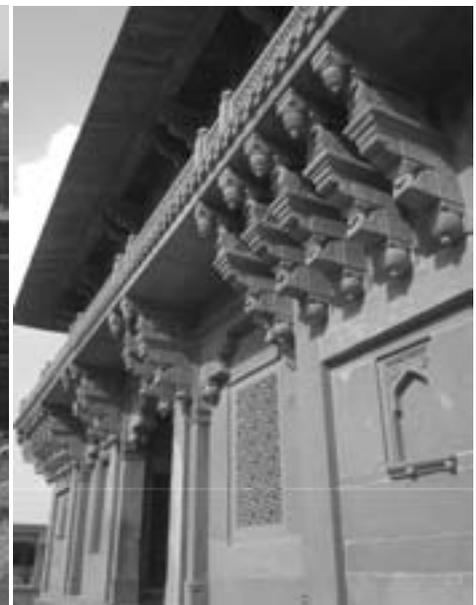
Fig. 10 Exquisitely carved architectural elements of a palace complex, made in red sandstone
