Training Course on Cultural Heritage Protection
in the Asia-Pacific Region 2011

**Preservation and Restoration of
Wooden Structures**

30 August - 29 September, 2011, Nara, Japan

Cultural Heritage Protection Cooperation Office,
Asia-Pacific Cultural Centre for UNESCO (ACCU)

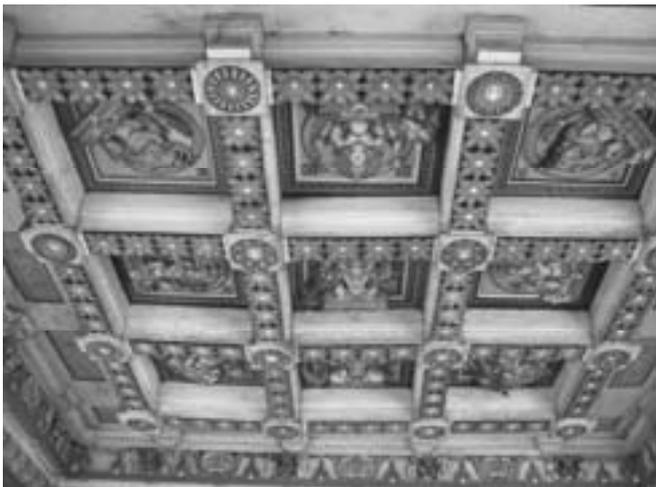
Fig. 13 A wooden ceiling of a pavilion in teakwood within a Hindu temple, originally not painted

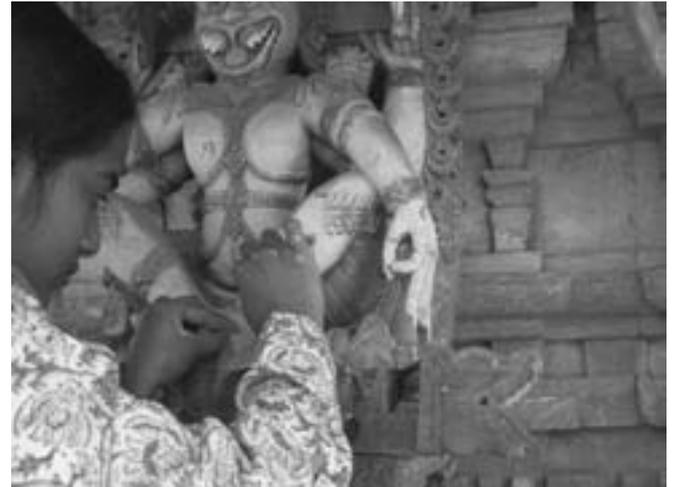
Fig. 14 Collecting samples of paint from a wooden sculpture to test the date and constituents

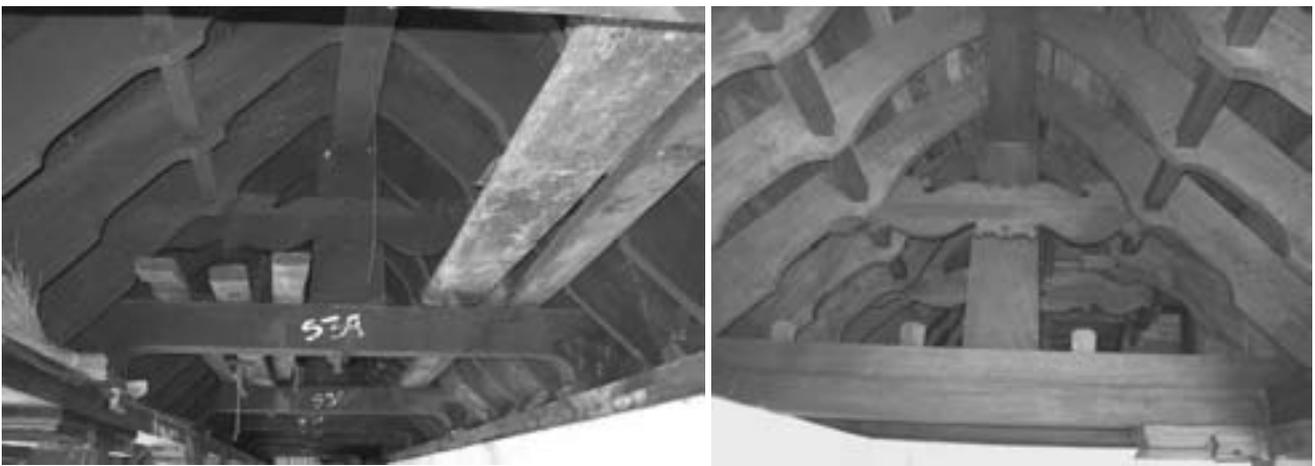
Figs. 15-16 Rafters and purlins of a sloped roof made of well-seasoned and good quality jungle wood, replaced entirely by new wood in an old temple in south India, due to a lack of knowledge of condition assessment and restoration

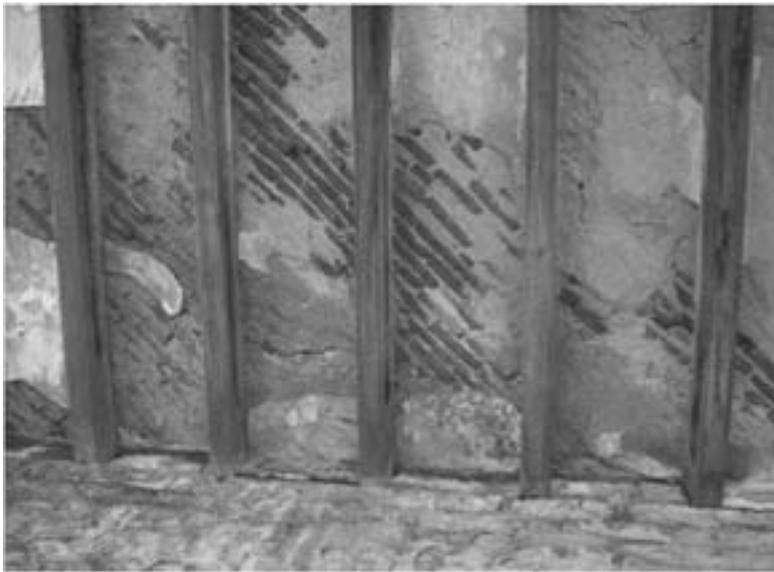
Fig. 17 Madras terrace roof with wooden secondary beams and bricks laid at an angle, partially deteriorated due to water seepage

The Madras terrace roof is a very common traditional roof construction system across India, with greater concentration in southern India. This system of construction used robust wooden beams to span large spaces, above which were placed smaller wooden beams (sizes varying between 8-10 cm in width and 15 cm in depth) at a regular center-to-center distance of 30 cm, or one foot, over which were placed 2-3 layers of bricks in a diagonal manner with lime mortar. A brick bat coba roof tops this entire ensemble and acts as water proofing for the ceiling below. I have been involved in restoring these roofs that had deteriorated to various degrees, especially due to the heavy rainfall that is witnessed in southern India. Some of these roofs have collapsed due to severe termite attack and/or due to failure of the primary beams.

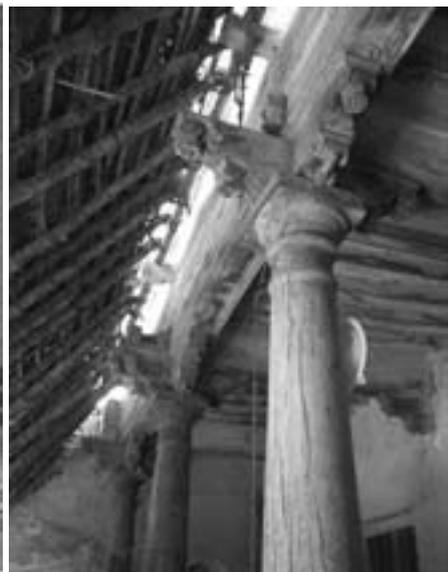
Fig. 18 Wooden columns, carved brackets and beams, in a historic house

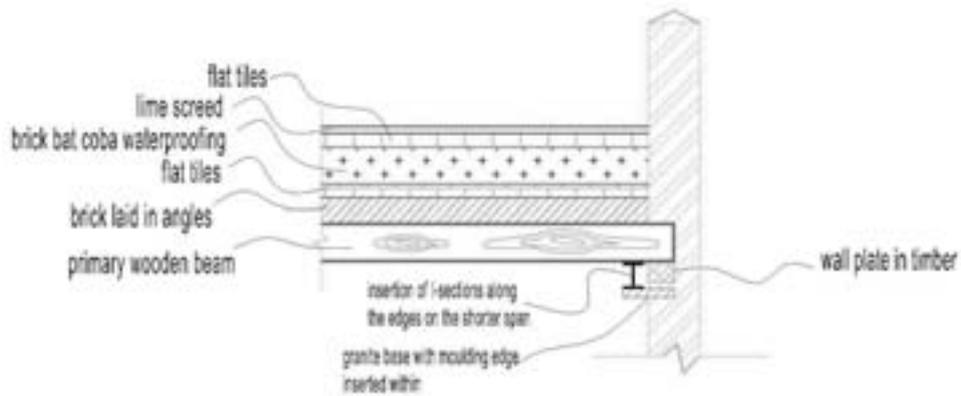
Fig. 19 Typical section of a Madras terrace roof with insertion of I-sections along the ends to prevent sagging, and further support the primary wooden beam that has deteriorated due to water seepage and lack of renewal of the water proofing layers above

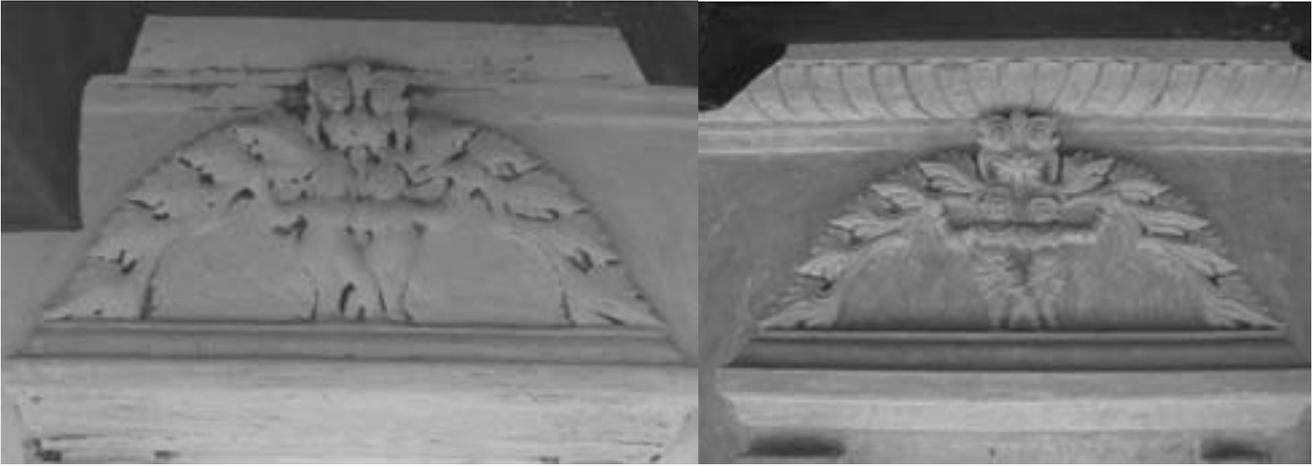
Fig. 21-22 Hindu iconography hidden behind layers of lime-wash (*left*), before careful restoration was undertaken by skilled conservators removing the lime-wash layers with gentle instruments (*right*)

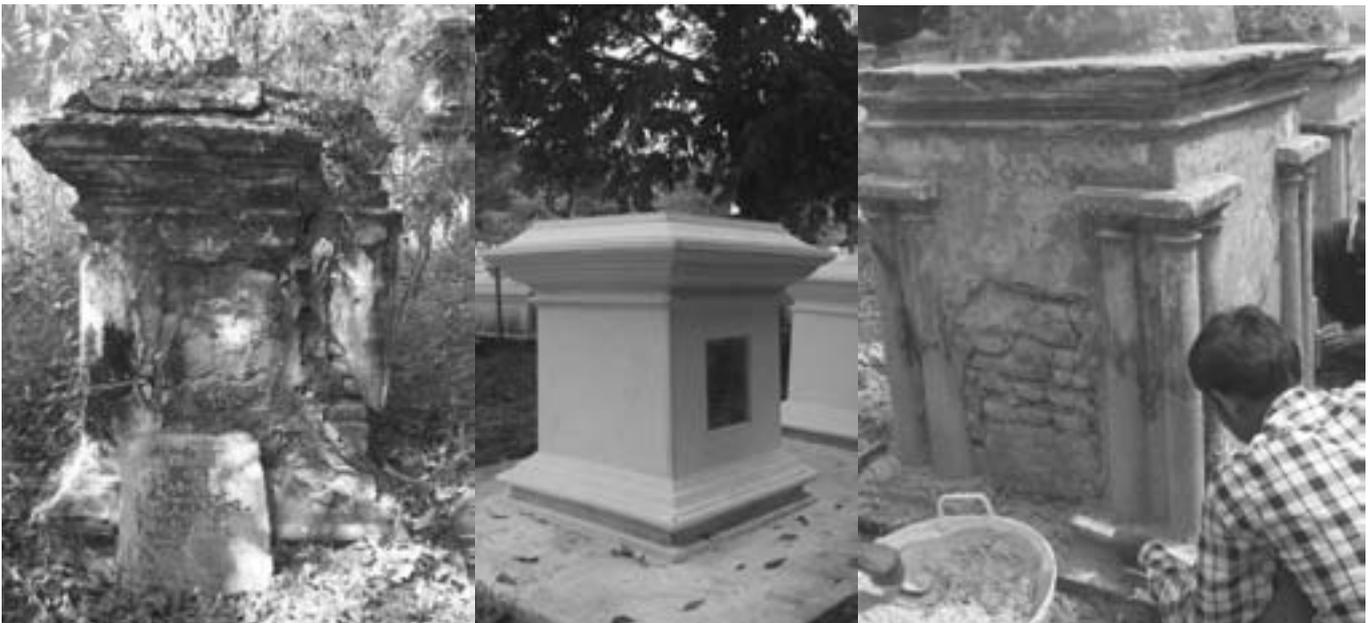
Fig. 23-25 Restoration consisting of vegetation removal, masonry reconstruction/consolidations, lime plastering in coarse and fine lime mortar, restoring lime plaster embellishments and stone plaques for 300 tombs in a cemetery

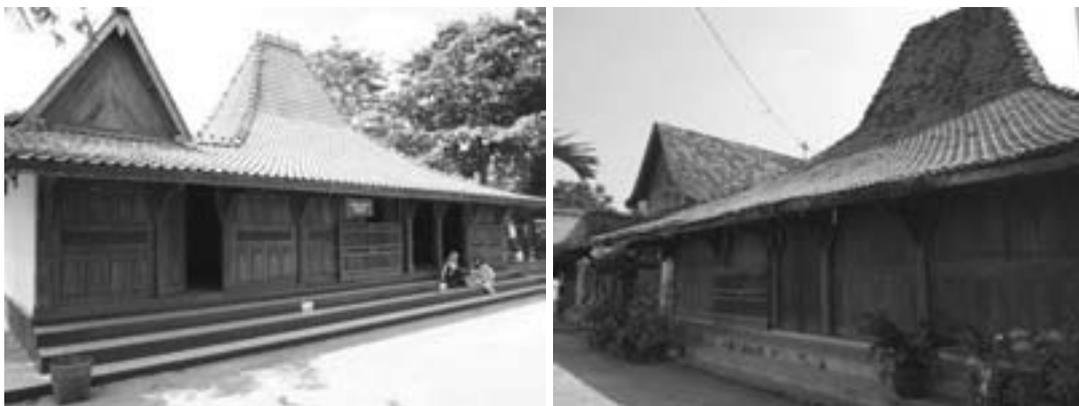
Typical main building of *rumah pencu*

posts and a multilevel floor. The roof structure consists of the components *molo*, *usuk*, *reng*, *dudur*, *takir* and *lumajang*. Some roof decorations are usually put on top of the *molo*. The post system utilized for *rumah pencu* consists of *umpak* (pillar base) and four different rows of posts (*saka*) i.e: *saka guru*, *saka geder*, *saka rawa* and *saka emper* (see picture below). The different levels of floor in *rumah pencu* include the lowest as the *tritisan* (front terrace), a middle floor for the *jogosatru* (living room, room for guests), and the highest giving more privacy to the *senhong* and *gedhongan*, rooms where the house owners sleep, pray, and keep important possessions. Between the living room and these private rooms is a low moveable stair, also made of wood, called *bancik*. The side of this stair is often decorated with carving.

A component that makes *rumah pencu* very special is the semi-permanent wooden walls, called *gebyok*, often heavily decorated, serving as a front wall, and an interior wall enclosing the *gedhongan* and *senhong*. The variety of doors is also interesting. Commonly, there are three different types of doors. One is a sliding square door that looks like a fence, attached to the wooden wall separating the *tritisan* and *jogosatru*. Hinged double doors are attached to the outer wall, and to the wooden wall that separates the *jogosatru* and private rooms. Another type of sliding door with different decoration is seen on the *senhong* and *gedhongan*, and a swinging door is on the side building used for the kitchen. Commonly, each door type is also carved (Nazarudin, 2011; personal observation).

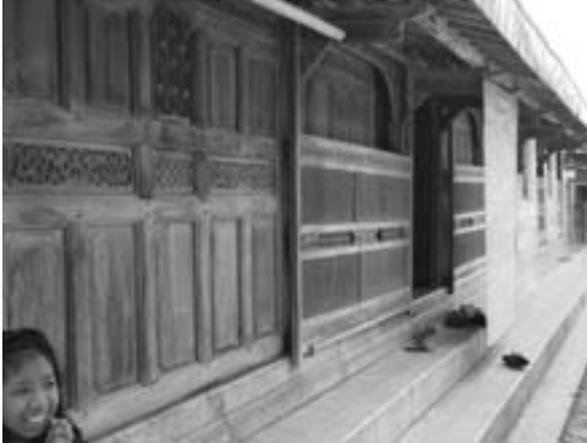
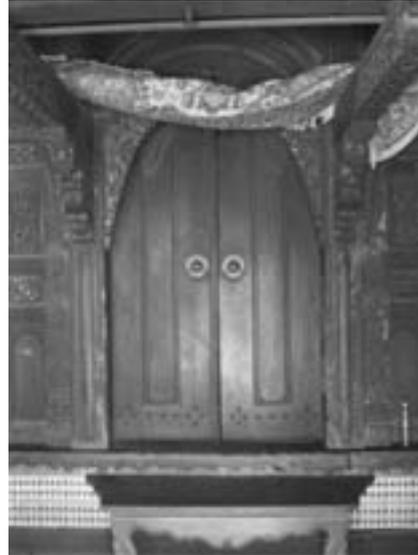
Left: Decorations on the outer wall and sliding door shape show Chinese influence. Right: Double doors separating the living room from the inner private rooms; in front there is a low moveable stair (*bancik*).

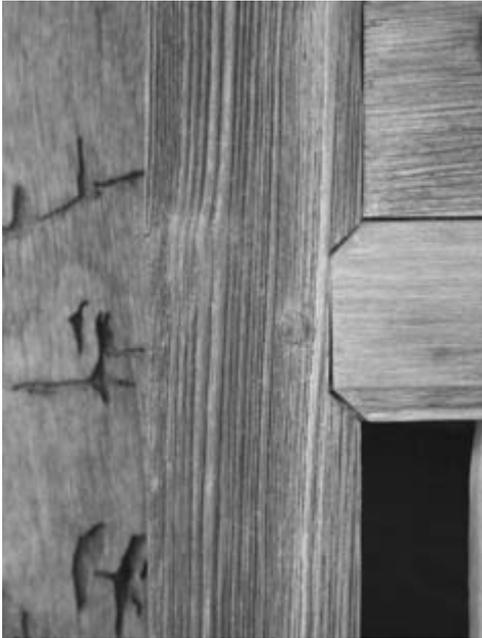
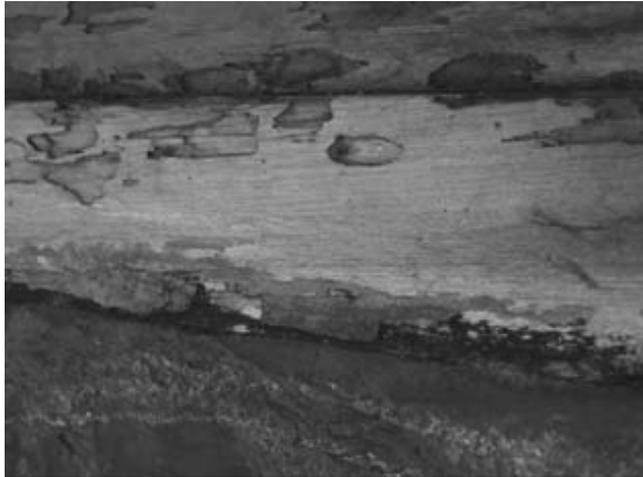
Examples of deterioration of *rumah pencu* caused by insects, ultraviolet light, fungi and humidity

Examples of vandalism (*left*), and damage from ultraviolet light, humidity, and insects (*right*)

Below are pictures showing some current conservation problems of *rumah pencu*. Apart from damage caused by insects and climate which has been identified by local people, there are other causes of deterioration/damage, such as vandalism and fire.

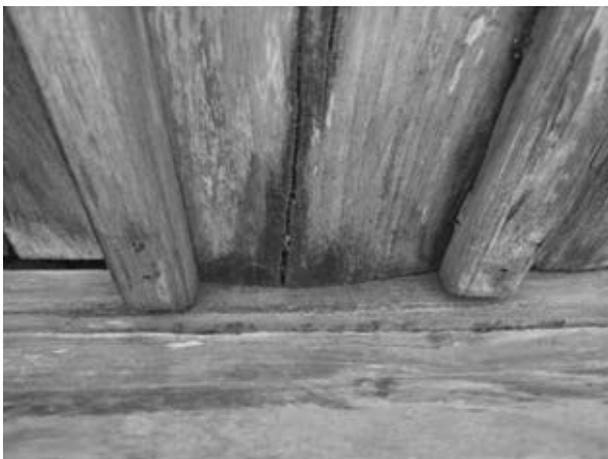
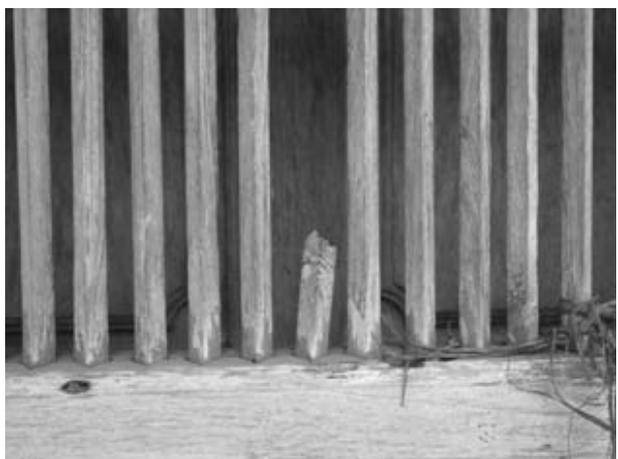
Damage to a the ceiling due to leaking water (*left*), and to a sliding door from climate and human factors (*right*)

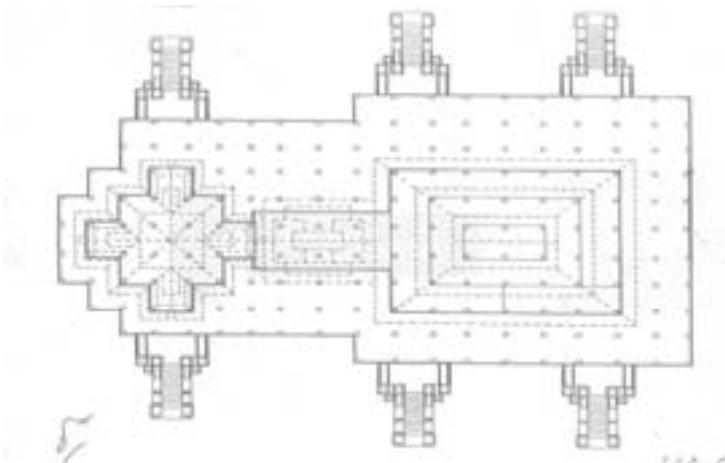
Plan view of Salin Kyaung (Salin Monestry)

To achieve the original condition, the post were lifted up using large jacks and reinforced concrete blocks were used to fill spaces beneath the posts. Not only parts of wooden components such as floors, walls and roofs, but also the traditional Burmese wooden decoration and floral designs on the roof were conserved. The four staircases (in the shape of a mango sprout) were also conserved. The Buddha image of the Kyaung Oo Pyathat was also conserved and is displayed as a small museum.

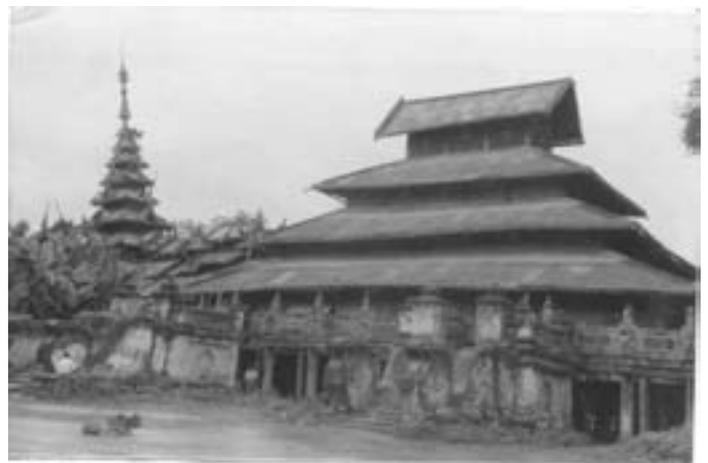
Before Conservation

with nayas (a mythical animal in the form of a dragon) supporting the gallery. Owing to its collapsed condition, the major conservation work was done by Department of Archaeology, National Museum and Library in 2003-04.

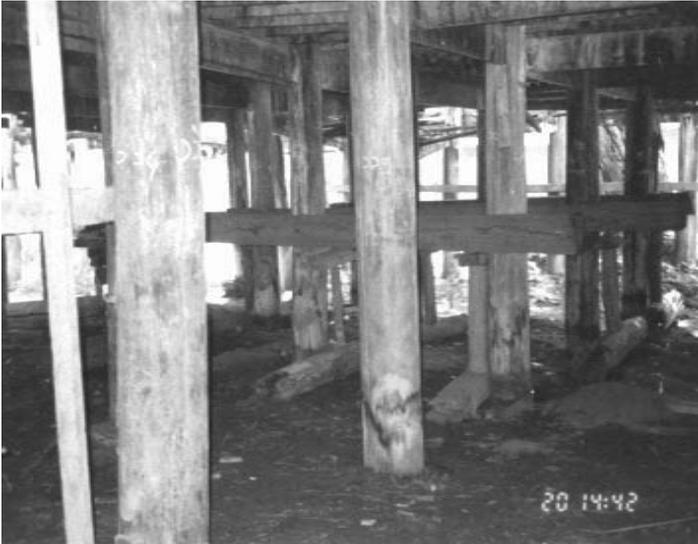
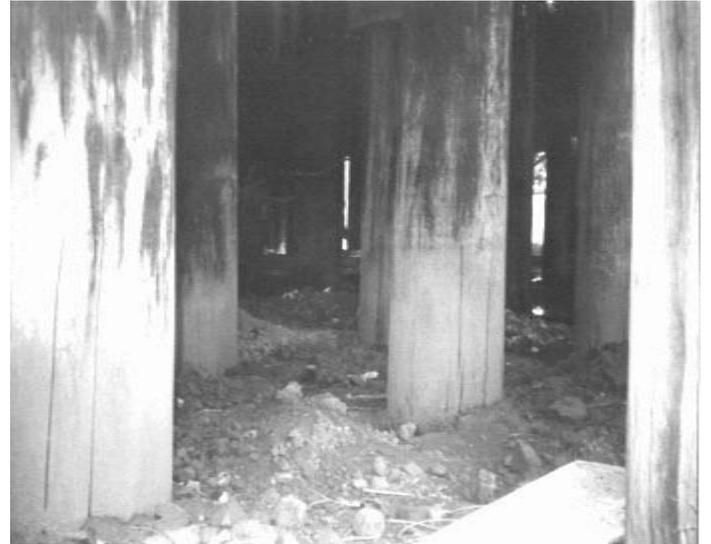
During conservation

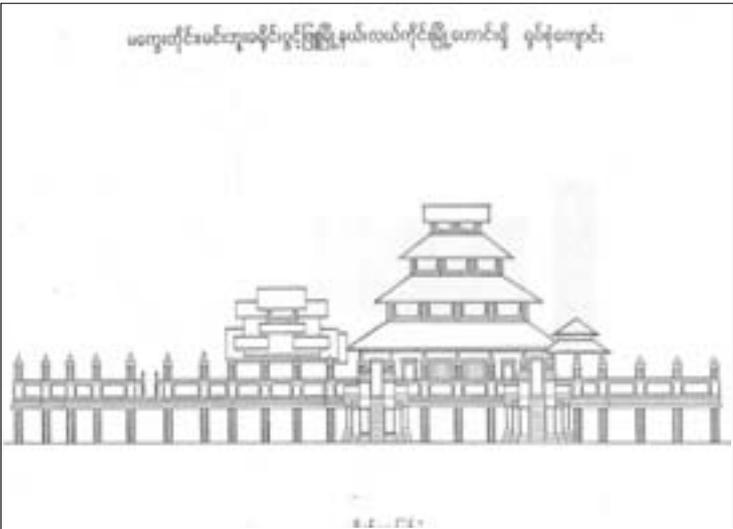
Side view before conservation

This monastery measures approximately 52 m (174 feet) east-west and 21 m (68 feet) north-south, and has been built with a total of 214 teak posts, the largest of which is 15 m high and nearly 30 cm in diameter. It was donated to the order in 1890 by U Anthaw Ni, whose family had it built. The building is of classic cruciform proportions consisting of a shrine room (*pyatthat hsung*), a *sanu hsaung*, a store room (*boga hsaung*), and a corridor. The shrine room collapsed 20 years ago but its posts were

decorated with beautiful carvings. The store room had also collapsed before we restored it. The original composition was in the format of monasteries in the later Kon Baung period style. Along the corridors was a hand railing adorned with sculptures of great Jatakas, the Buddha’s life stories. At present, the passage and corridor are left, though all of the parts were either collapsed or damaged. The work on restoring the hand railing and corridor, decorated with great Jataka, and the traditional sculpture of the Kyaung Oo Pyathat Saung (pavillion, or shrine room), and other necessary works of renovation, restoration and conservation were carried out by the Department of Archaeology, National Museum and Library, in 2003.

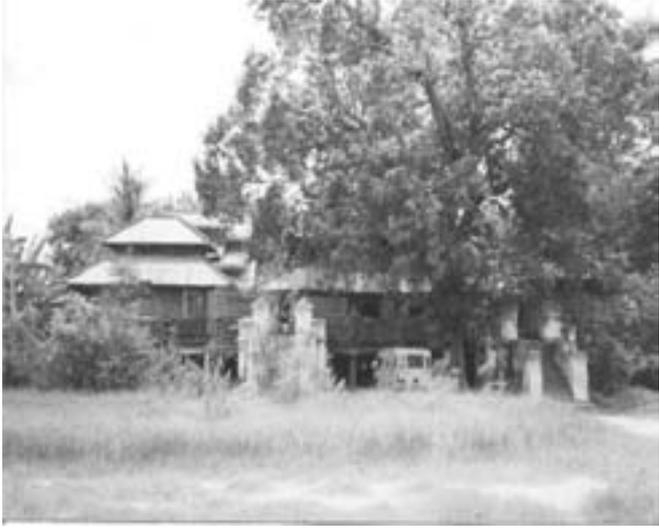
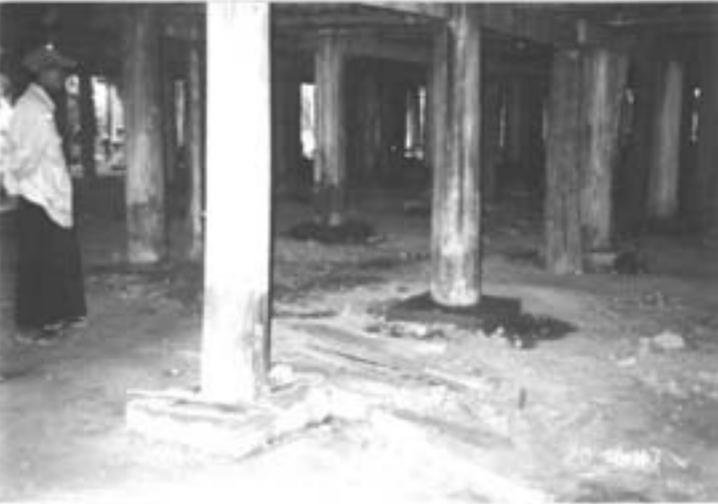
During conservation

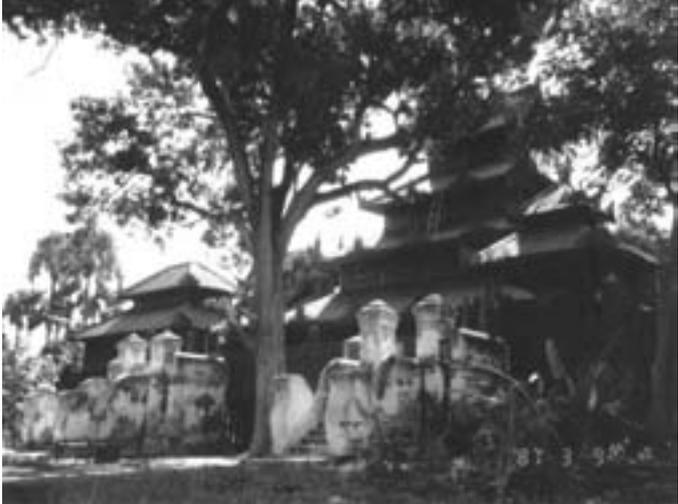
After conservation

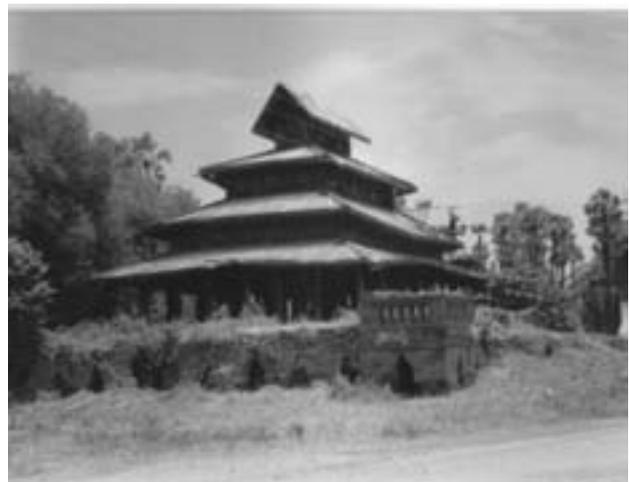
Before conservation

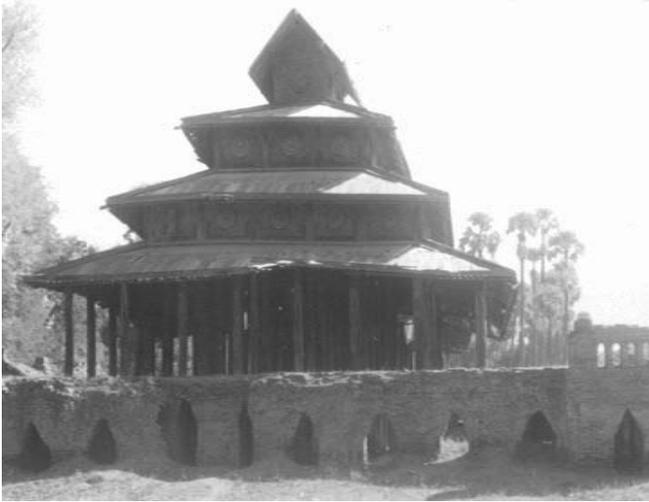
During conservation

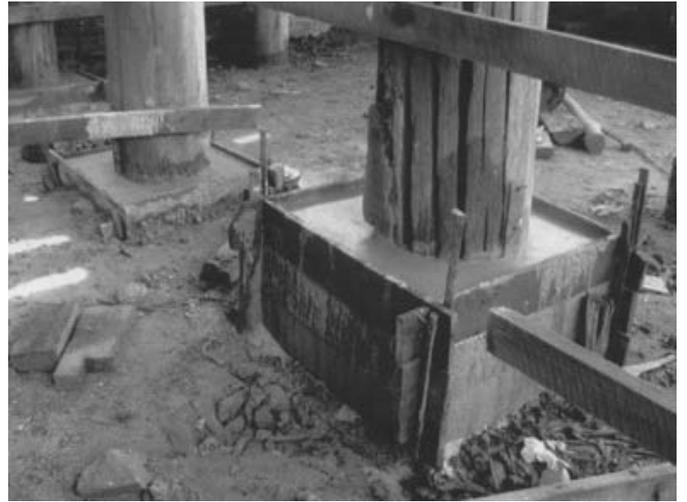
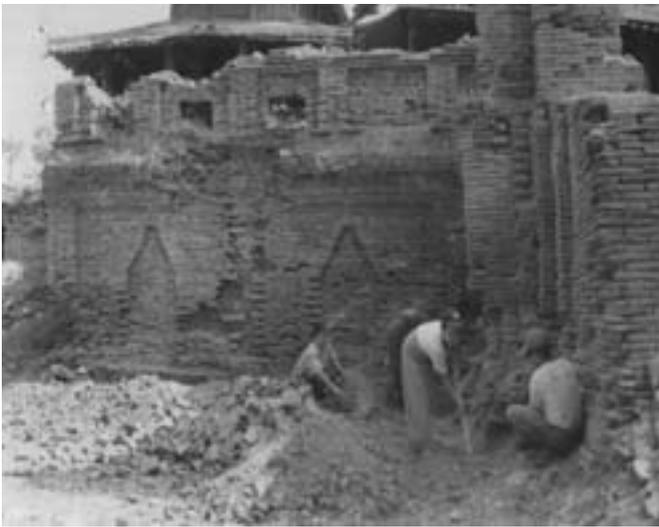
During conservation

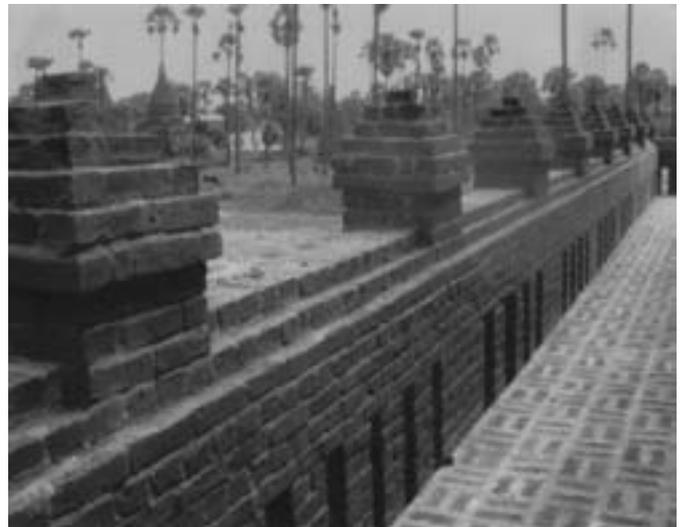
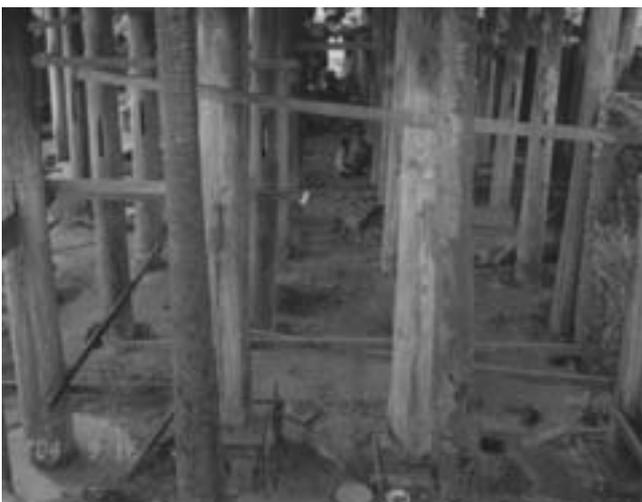
During conservation

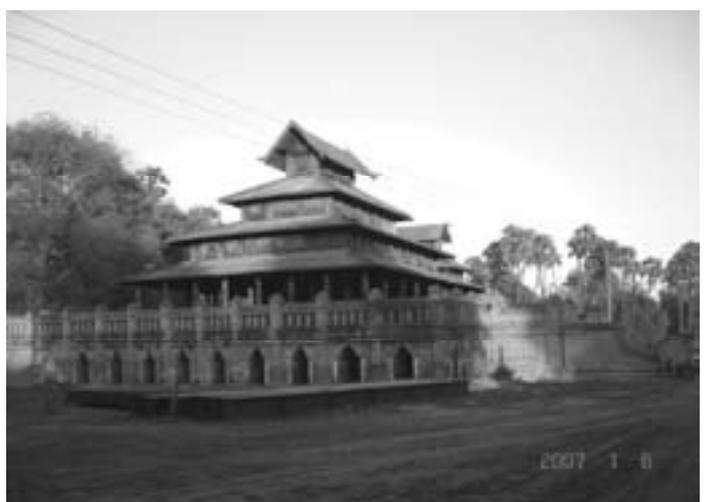
After conservation

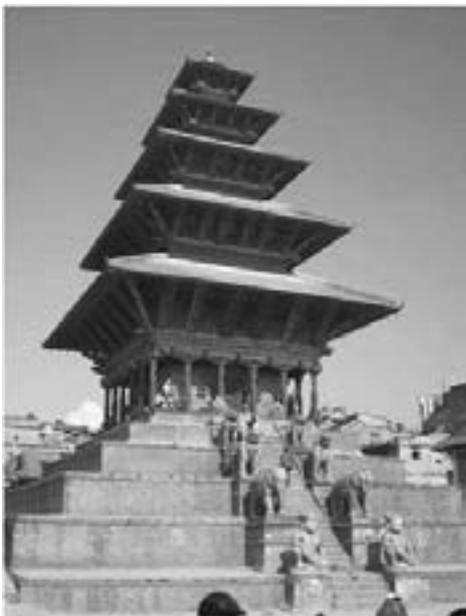
Nyatapola Temple after renovation

The temple is 32.93 m in height, and 22.70 m by 22.70 m in length and width. It was in dilapidated condition before the restoration, with timber members such as joists, rafters, beams, columns, *meths* (lintels) having become weak and losing their bearing capacity as the result of being eaten up by termites, fungus, etc. It was renovated by Bhaktapur Municipality in 1997 at the cost of US \$25,847.

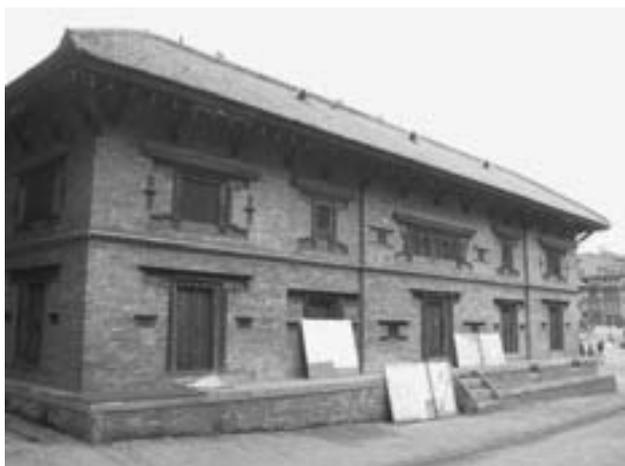
Jhaur Bahi after renovation

Bhaktapur Municipality has supported technically as well as financially the reconstruction of Jhaur Bahi. About US \$3,200 was donated by local people for the reconstruction. Visitors and tourists also contribute indirectly because the Municipality collects money from tourists visiting Bhaktapur. After about one and half years of hard work by woodcarvers and local masons, the reconstruction of Jhaur Bahi was completed. The religious ceremony to celebrate the finishing of the roof was held in September 2002. The size of the square-shaped *bahi* is 19 m by 19 m, with a height of 6.5 m. The total renovation cost was US \$110,063.

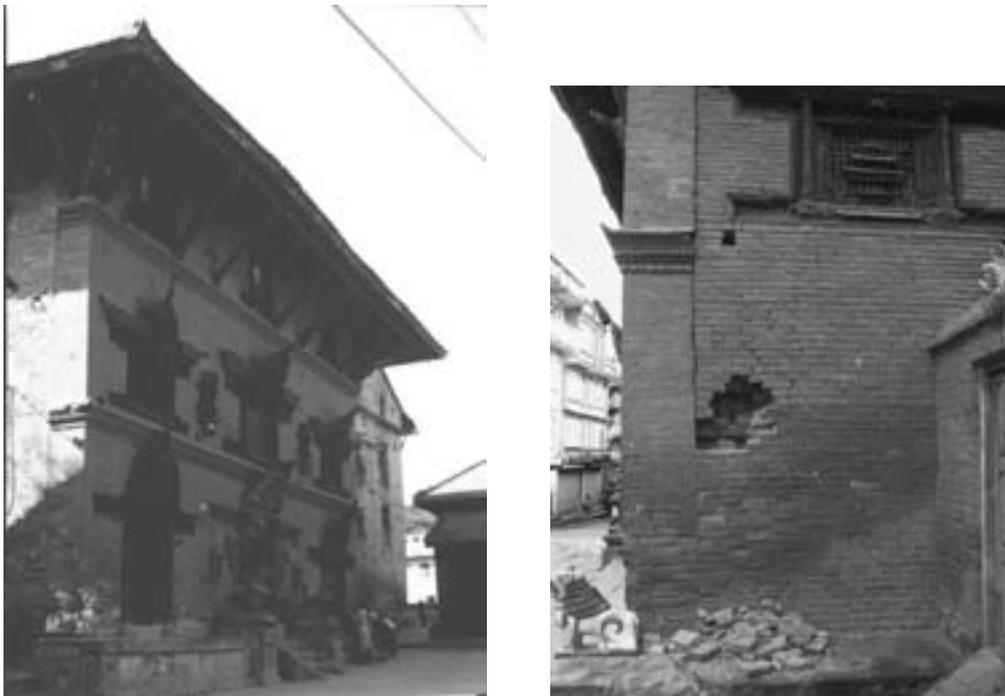
Navadurga Dyochhen before renovation

The main building of the Navadurga Dyochhen complex is a three-storied structure with an approximate size of 12 m long by 4.35 m wide and 9 m high from the ground to the ridge of the roof. The ground floor of the structure has an internal bearing wall 84 cm thick with 14 cm of cladding using *dachi appa* terracotta bricks on the front face. The rear side of the building consists of two 1 m thick mud masonry brick piers with a large opening 5.27 m by 2.36 m in the middle. The side walls are also 1 m thick with mud masonry brickwork. The thickness of the wall is seen to decrease to 74 cm and 60 cm in the second and third floors respectively. Large openings of traditional types such as doors and windows are situated in the front, back and side walls. The size of the doors and windows varies from 66 cm by 125 cm to 75 cm by 230 cm.

The floor component of the building consists of traditional brick tiles (*telia appa*) laid over 10 cm of mud mortar and supported by timber joists. The span of the joists is between two long front and rear walls. The joists are supported over two beams above the rear wall opening, above which the second and the third walls have been constructed.

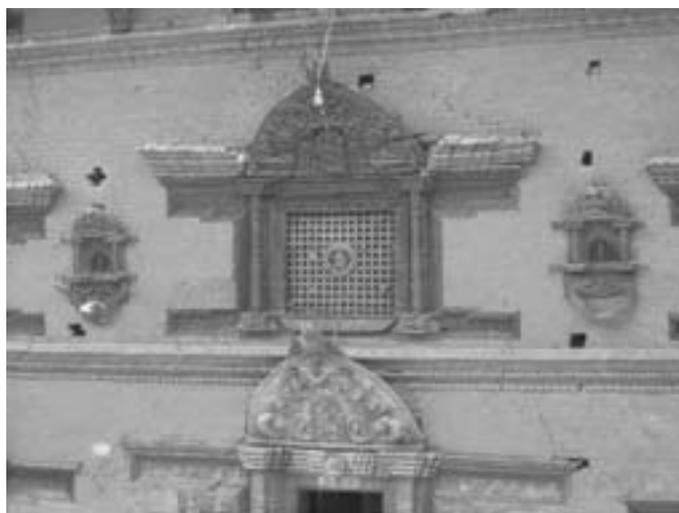
Carved windows with *toran* at front of Navadura Dyochhen before renovation

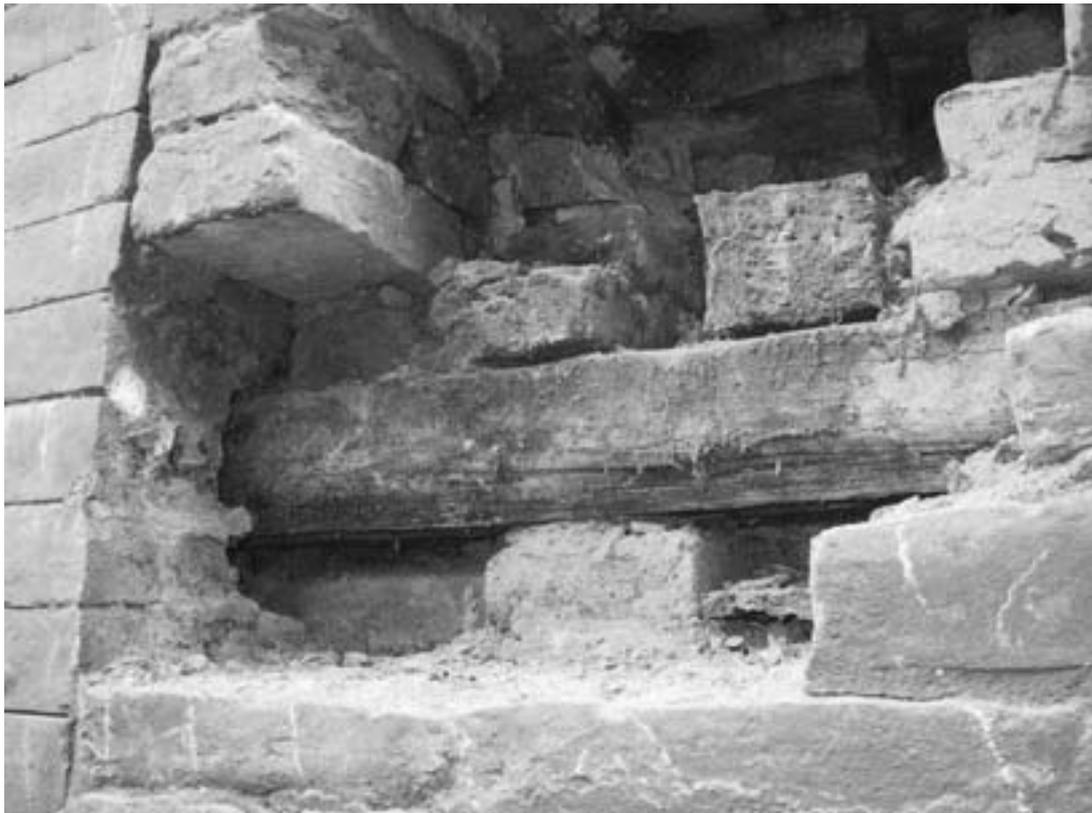
Decayed tie timber seen in a wall panel test

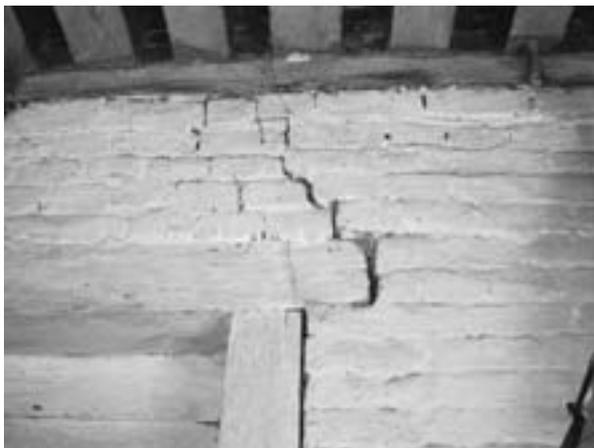
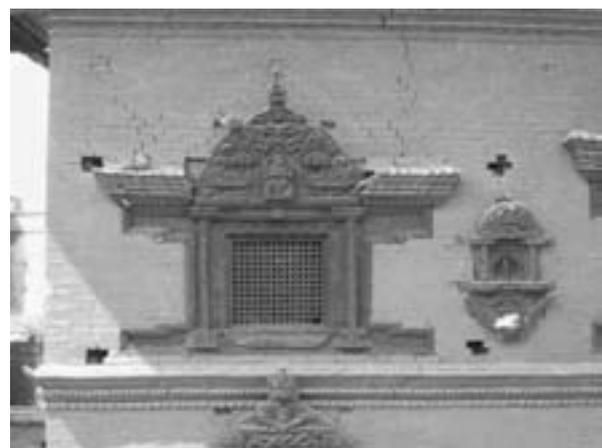
Wall cracks seen in the interior and exterior walls of the *dyochhen*

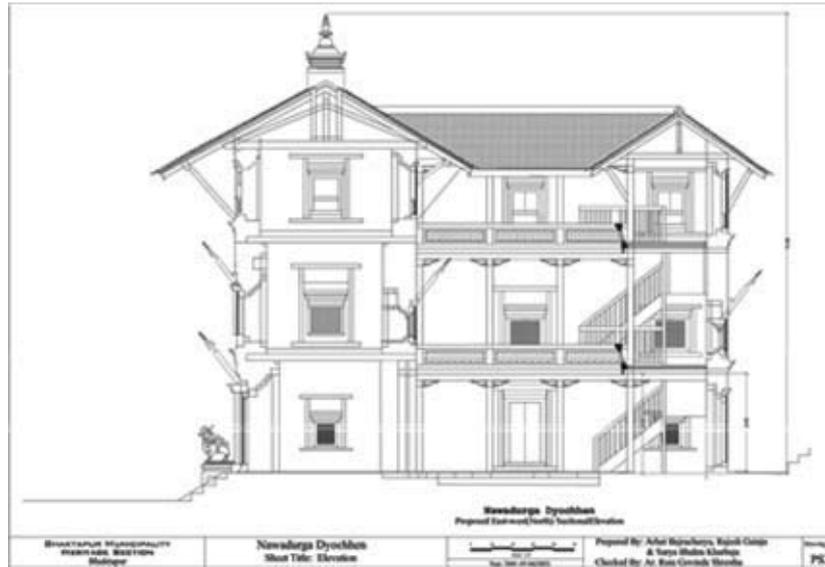
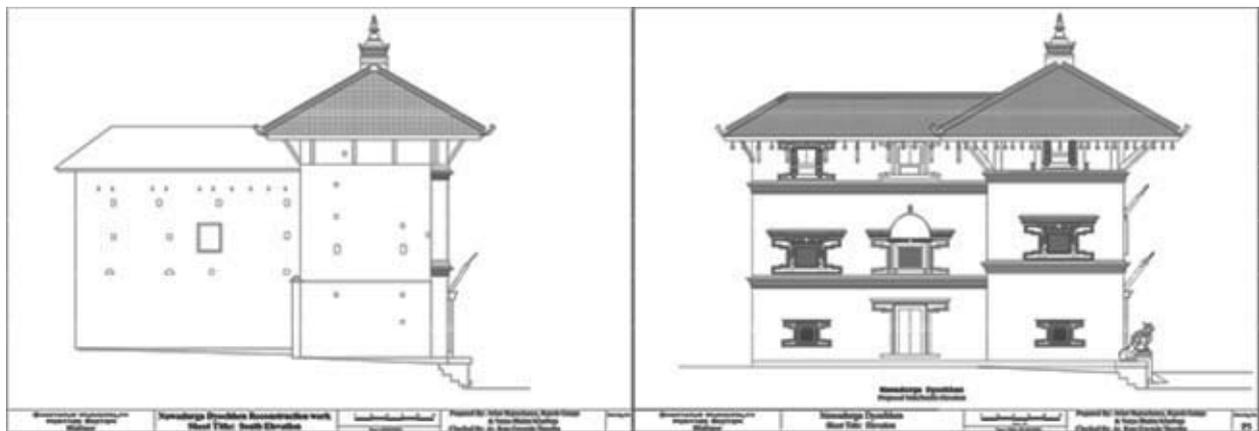
Existing and proposed south elevations of Navadura Dyochhen

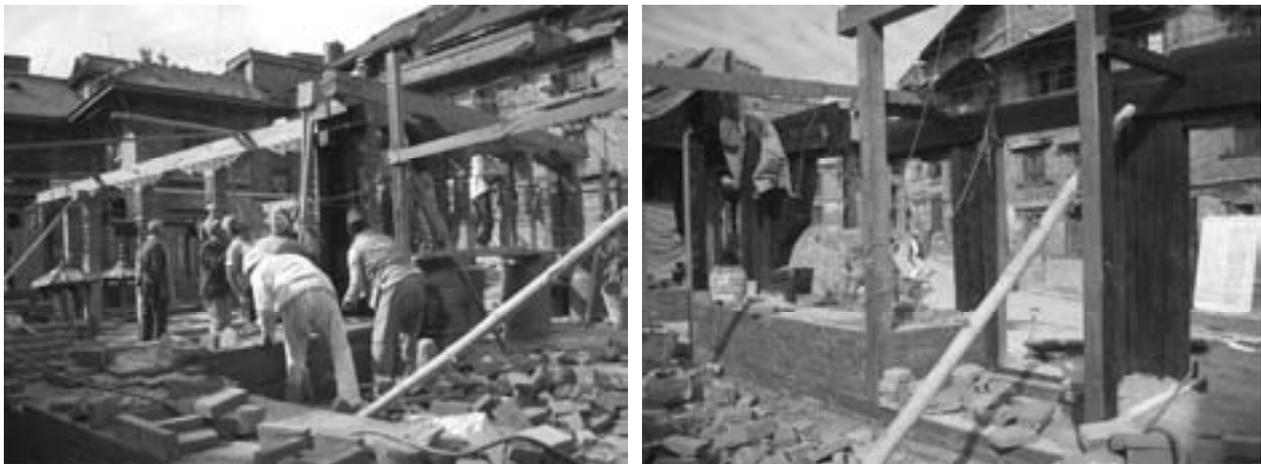
Renovation work going on at the ground floor

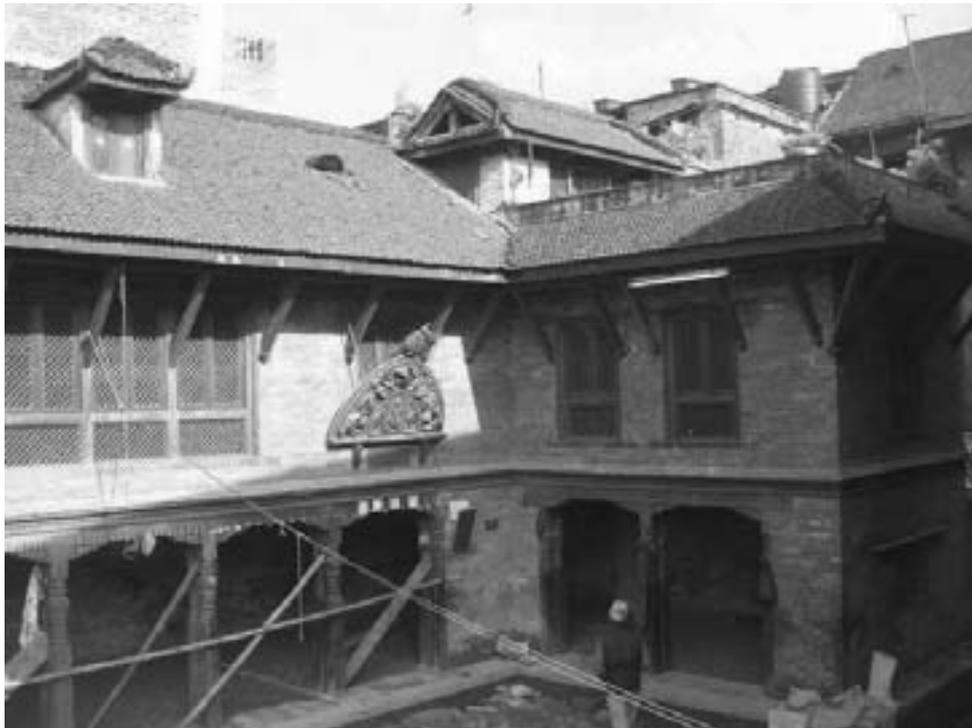
Newly constructed *sattal* for the shrine and Navadurga masks

Work started from the west back courtyard by dismantling the backyard hut (*tahara*) and constructing a *sattal* to place the shrine and Navadurga masks from the main *dyochhen*. After dismantling the existing *dyochhen*, the foundation stone-laying ceremony was performed by Mr. Pancha lal Banbala, the oldest of the Navadurga custodians. Then construction was started from the foundation.

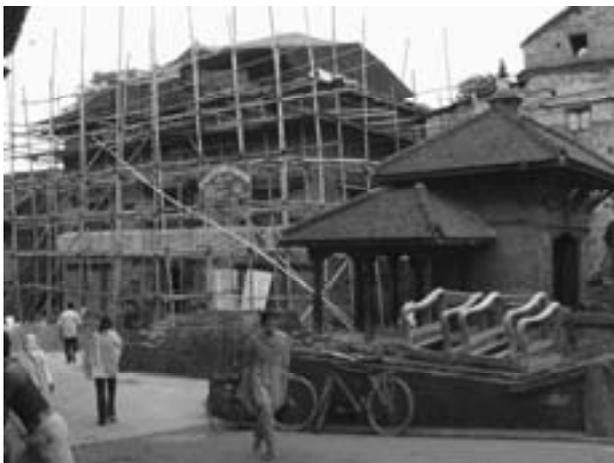
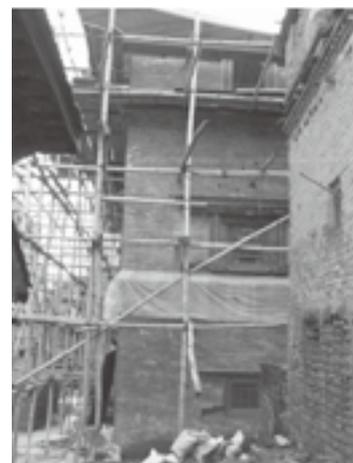
Navadurga Dyochhen during the renovation phase

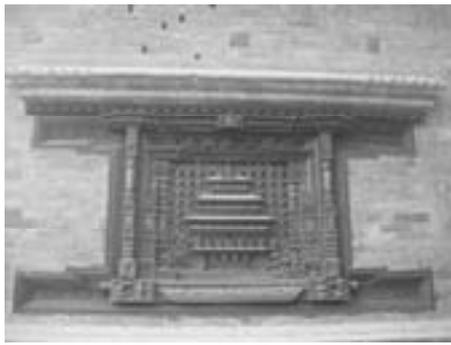
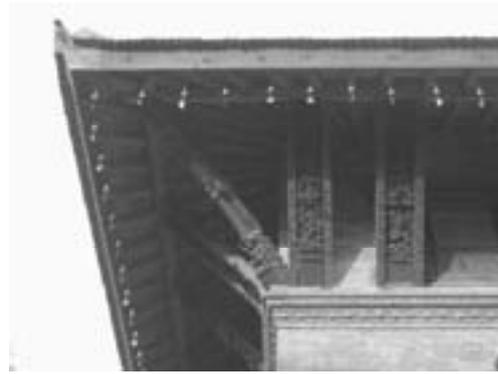
Maximum use of old carvings with new timber supporting struts

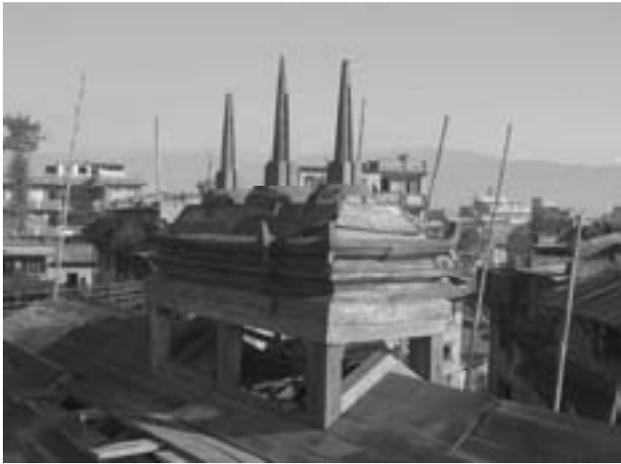
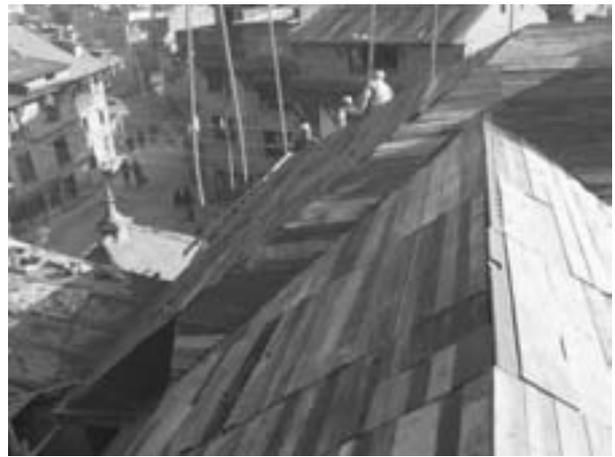
Metal pinnacle (*gajur*) support (*bhangi*) and wooden planking before *jhingati* laying on the roof

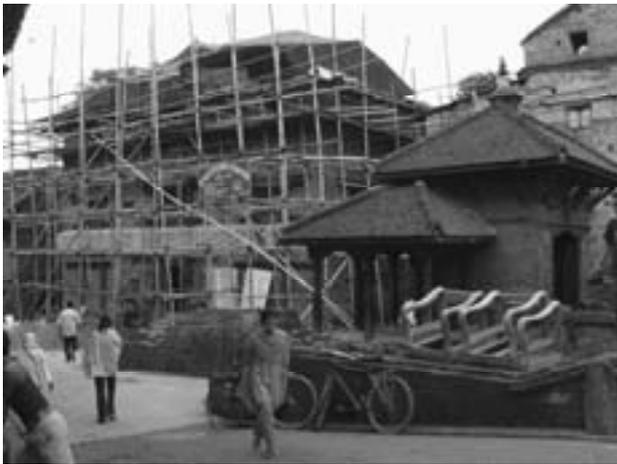
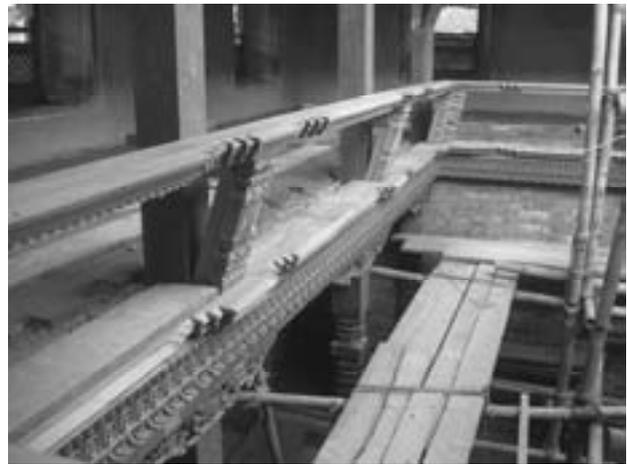
Navadurga Dyochhen in the renovation phase

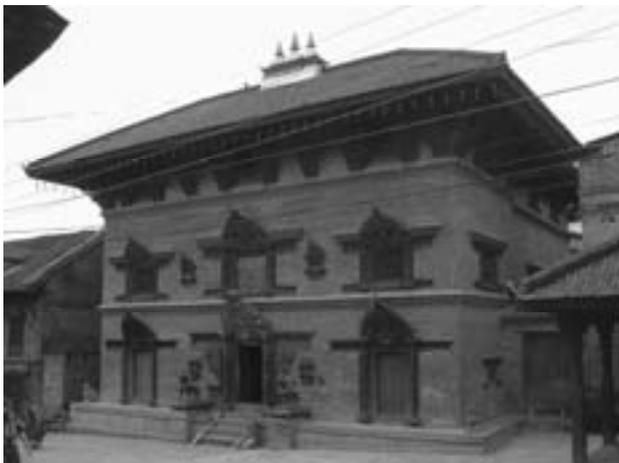
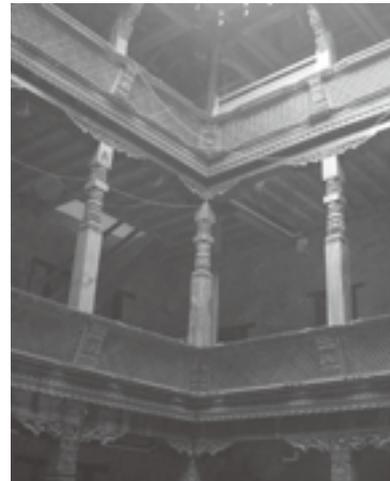
Outer and inner elevations of Navadurga Dyochhen after renovation

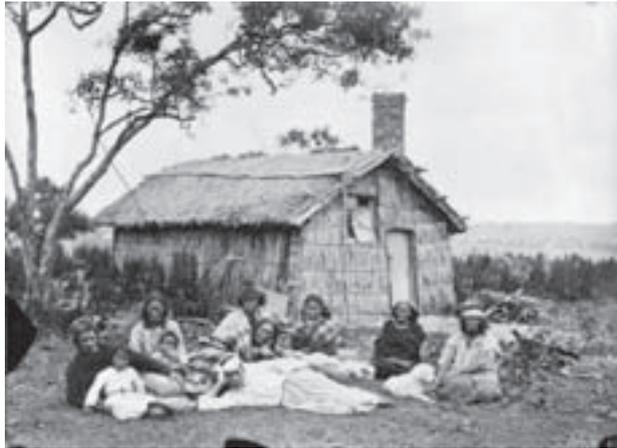
Figure 4: Unidentified Maori group alongside a raupo whare c. 1870s, Alexander Turnbull Library, Wellington, ID: 1/2-003135-F

Whare. These houses are built with perishable materials such as raupo reeds used for thatching, lashed with flax or ti to a timber frame of wood of the manuka tree, nikau, or ponga trunks. Due to the vulnerability of the building materials there are no authentic examples remaining today. A recent archaeological discovery, however, uncovered what is thought to be a ponga whare at Te Aro Pa in Central Wellington. However, only a small portion of the base of the walls remains.

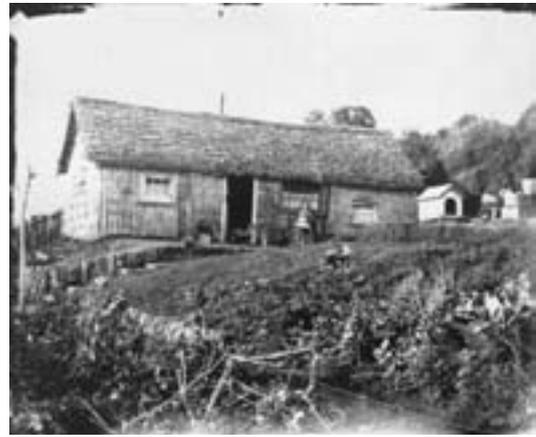
Figure 5: Raupo house near New Plymouth c1860 Alexander Turnbull Library, Wellington, ID: 1/2-011751-F

Raupo houses. Popular with the very early settlers, these were often temporary houses used while a more sustainable house was built. Raupo was a good insulator but very susceptible to fire, and this fact led to the first building regulations in New Zealand banning the construction of such buildings for European inhabitants in built up areas. Due to the perishable materials, there are no authentic examples remaining today (Iasscs, 2005).
