Training Course on Cultural Heritage Protection
in the Asia-Pacific Region 2011

**Preservation and Restoration of
Wooden Structures**

30 August - 29 September, 2011, Nara, Japan

Cultural Heritage Protection Cooperation Office,
Asia-Pacific Cultural Centre for UNESCO (ACCU)

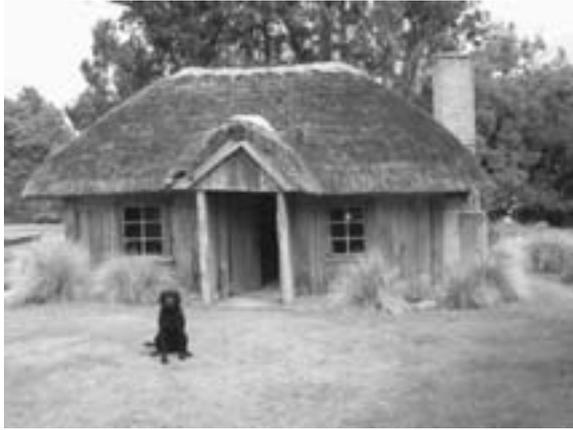
Figure 7: The Cuddy – Exterior, Timaru, NR Jackson, 2010

The Cuddy, Te Waimate Station, Timaru. The Cuddy was built in 1854 by the Studholme brothers, who established a number of large sheep runs after taking up residence in Te Waimate. The Cuddy was based on English precedents but adapted New Zealand materials as a temporary measure. The walls are constructed of vertical totara slabs, with cob pugging on the inside. Snowgrass was used for the original thatched roof, however it was later replaced with corn straw thatch. The two-roomed cottage is architecturally and historically valuable as a charming example of early settlers' ingenuity in house building before dwellings of sawn timber could be built (NZHPT Online Register).

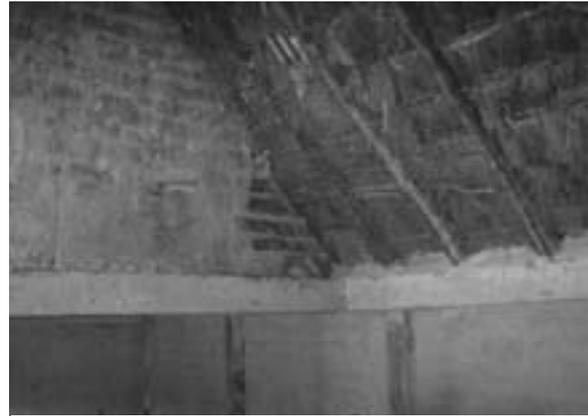
Figure 8: The Cuddy –Interior, Timaru, NR Jackson, 2010

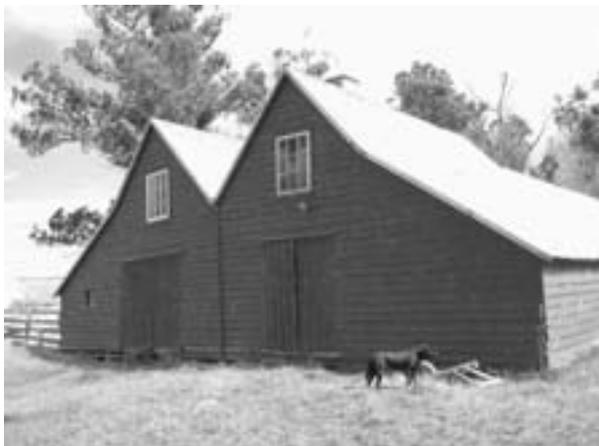
Figure 12: Te Waimate Woolshed exterior, NR Jackson 2009

Te Waimate Woolshed, Te Waimate Station, Timaru. Erected by Michael Studholme and his brothers in 1855, Te Waimate Woolshed is still regularly used. It is of interesting construction, originally having a totara roof over sarking before roofing iron was available. A lot of the timber is adzed, and all the inside timber is pit-sawn totara. The railings are of manuka, preserved by the grease of sheep's wool. It can hold 1,000 sheep during shearing, and the shorn sheep can be kept inside in counting-out pens in wet weather. At one time there were 22 machine stands, eleven on each side of the shed, but today there are only three. One of the internal features is the old Farmers screw wool press, a huge and historic piece of machinery (NZHPT Online Register).

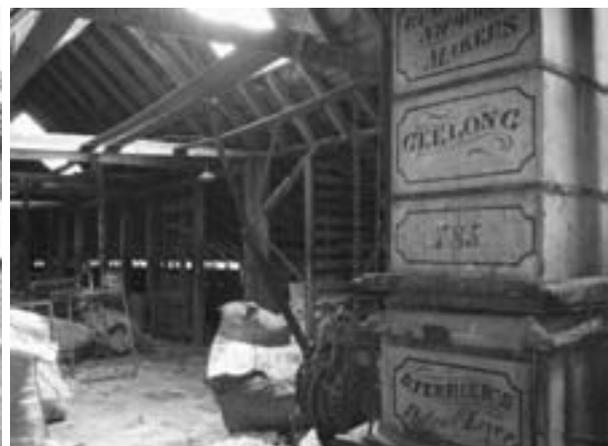
Figure 13: Te Waimate Woolshed interior, NR Jackson 2009

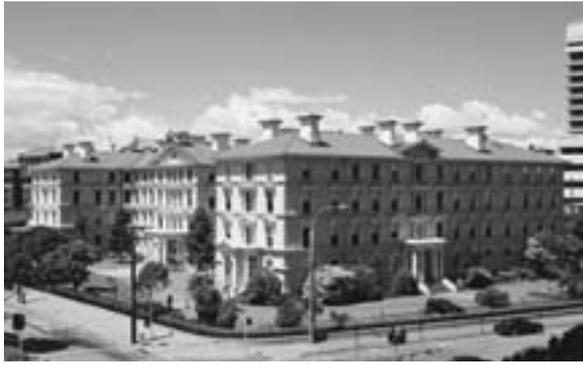
Figure 14: Old Government Buildings, Geoff Mew, 2001

Old Government Buildings, Wellington. These government buildings, completed in 1876, are a remarkable example of timber construction designed by New Zealand's first and only colonial architect, William Clayton, in the classically-derived Italian Renaissance revival style, much in favour for government buildings throughout the British Empire. Bids were originally solicited for both concrete and timber. Due to the sheer cost of concrete, it was eventually decided to build in timber

alone, mimicking stone construction. The H-shaped building included two staircases, eight vaults, 143 rooms, 126 fireplaces, 22 chimneys, two hydraulic lifts, 64 toilets, eight verandahs and seven porticos. The restored building is a key feature in the Government Centre Conservation Area, an historic reserve in its own right, and a popular tourist destination (NZHPT Online Register).

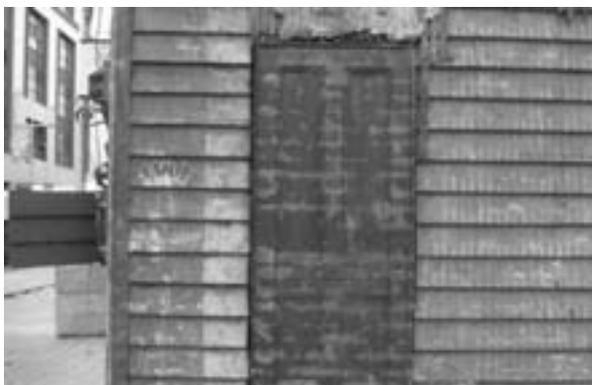
Figure16: Revealed features following demolition of an adjacent building, NR Jackson 2011

the building, with many people signing the petition, was successful (NZHPT Online Register). In 2010 and 2011 a series of earthquakes in Canterbury led to the adjacent brick heritage building being demolished, thus revealing parts of Shand’s Emporium that were previously unseen.

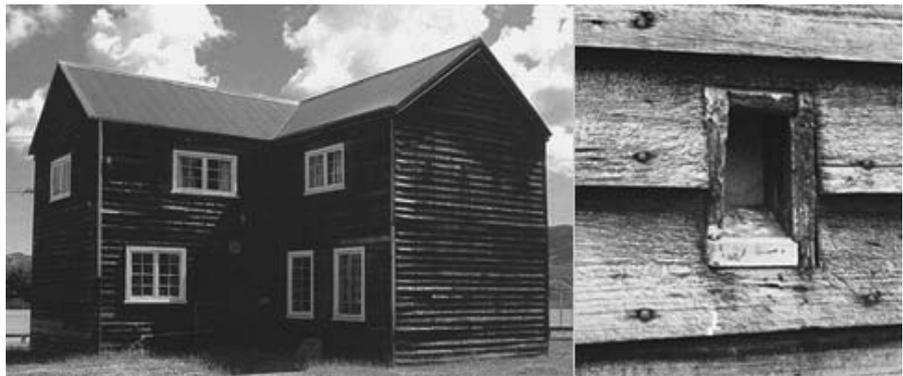
A double-skin timber-clad frame with shingle infill was constructed to provide protection against rifle fire. Loopholes were also built for defenders to return fire. The blockhouse was originally surrounded by a much larger defensive earthwork (NZHPT Online Register).

Figure 22: Wallaceville Blockhouse and detail of gun hole, NZHPT Website accessed 1 Aug 2011

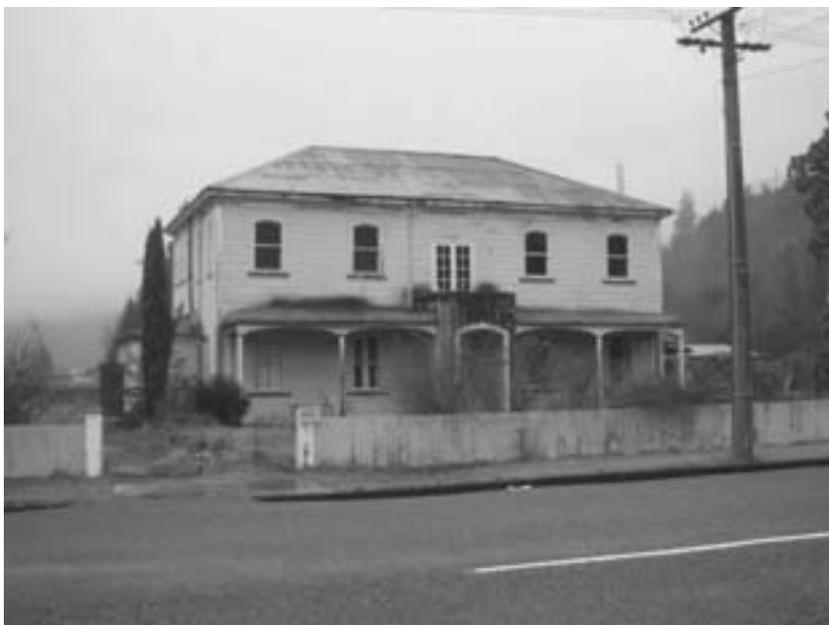
Figure25: Sisters' of Mercy Convent, Reefton damaged by Fire, NZHPT, 2009

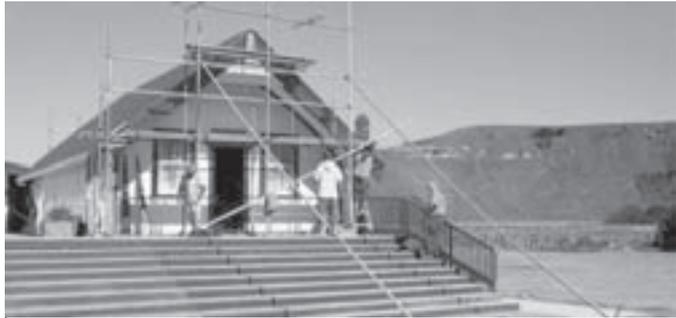
Figure 26: Nga Pataka Wharenuui during flood clean up, Waipapa Marae, NZHPT, Conserving Marae Buildings brochure (undated)

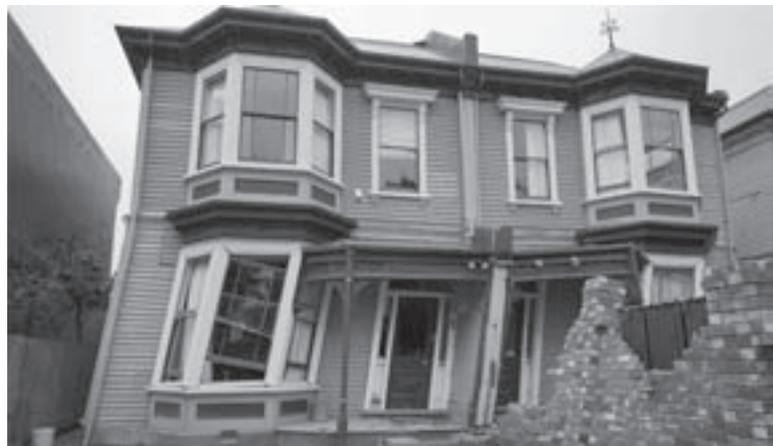
Figure 27: Chester Street Houses, Christchurch, 2011, John Kirk Anderson, The Press

the Central Business District the street the streetscape has changed dramatically with the loss of familiar heritage landmarks and even more non-heritage buildings. While damage to unreinforced masonry buildings has been a key focus with respect to earthquake prone policy work, it was surprising the amount of damage sustained by timber buildings. While not completely failing, many wooden buildings were damaged by earth movement and subsidence. Many structures became 'racked' from the lateral (side-to-side) movement. Particularly in buildings greater than a single storey, and especially where interior walls had been removed, the building was less able to withstand the movement (see Figure 27). In addition, buildings with brick party (shared) walls sustained damage

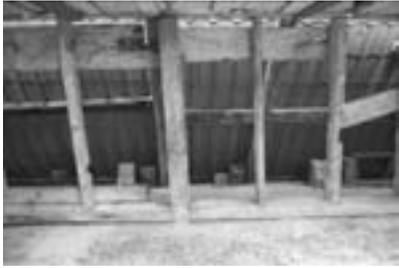
Figure 5

- Termite and dry rot infested wooden parts in major and minor structural members (Figure 5)
- Misaligned and dismantled capiz windows, shutters and wooden grills (Figure 6)
- Deteriorated ceiling sheets, wattle and daub wall plaster (Figure 7)
- Sagging and rotten floors (Figure 8)
- Chipping in the paint on walls and ceilings (Figure 9);
- Missing, dismantled and deteriorated wooden balusters at the stairs (Figure 10)
- Deteriorated and damaged wooden partitions and doors (Figure 11)
- Misaligned doors (Figure 12)

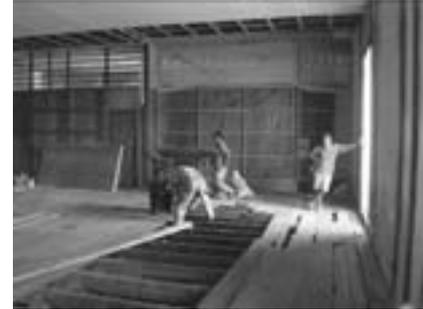
Figure 13

- The tasks of dismantling should be executed as to protect the historic building materials of the structure. Wattle and daub plaster, coral masonry and lime/adobe plasters should be properly protected from any damage or obliteration. (Figure 13)

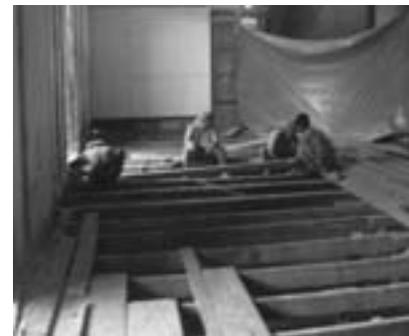
Figure 14

- Each floor should be checked for its structural condition. Sandwiching weak members on either side with treated new wood is worthwhile, but the new wood must be installed correctly for greatest strength. A better option is sistering, where identical lumber is bolted to the member. Better still is sistering with a flitch plate, a 1/4 to 1/3-inch-thick piece of steel or wood. Two flitch plates may also be used to repair localized damage (Figure 14).

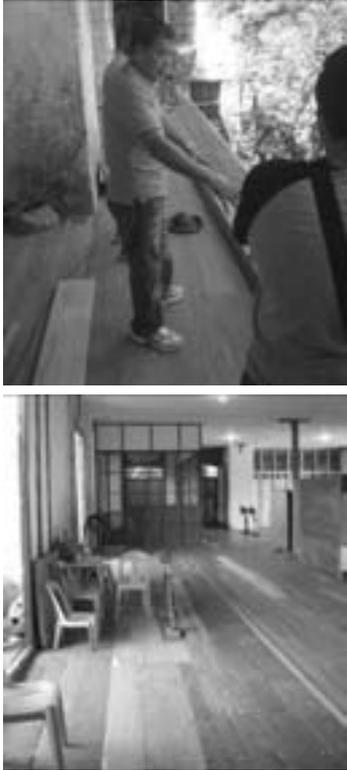
Figures 15 and 16

- *Scraping.* Working on hands and knees, carpenters or flooring mechanics level out any high spots using hand planes and then go over every inch of the floor with scrapers. When drawn across the wood (or finish) at a slight angle, the scraper shaves off paper-thin curls of wood

similar to shaving a beard, leaving a surface that is both smooth and remarkably even (Figure 15).

- *Filling.* The typical filler might be a finely ground, pigment-like material (such as wood dust, marble or quartz dust, or corn starch) mixed with a drying oil binder (typically linseed oil) and thinned with a solvent (turpentine). When mixed to a paste the consistency of mashed potatoes, the finisher applies the filler over the floor with a rag, working against the grain of the wood to force it into holes and depressions. Once the filler had begun to dry, the finisher the wipes it from the floor using burlap or wood shavings, leaving the remainder below the surface in the wood pores. The result is a smooth, level surface ready for final finishing (Figure 16).

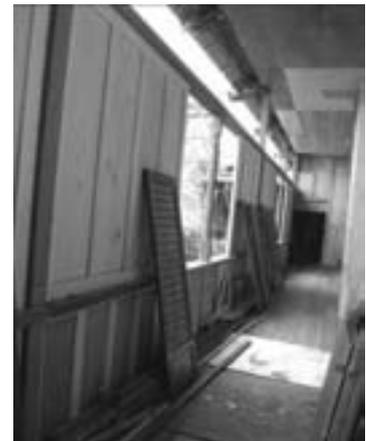
Figure 20

7. Retrofitting of windows and shutters (Figure 20)

- Dismantle sliding window panels and their components for repair.
- Measure the actual capiz window shells to repair or replace. In the case of the shutters or persiana, prefabricate the missing parts.
- Capiz shells for windows are available commercially. Some are already cut into commercially available sizes, similar to those in Baclayon. For simple repairs, cut the portion of the capiz shell frame and replace the missing part, and use silicon sealant to put back the shell and frame.
- For larger repairs, remove one part of the panel frame to remove and re-arrange all the capiz shells.
- Capiz shells are cut easily after soaking in soap and water.
- Use silicon sealant to cover all sides of the capiz shells. This is also useable as waterproofing for other materials.

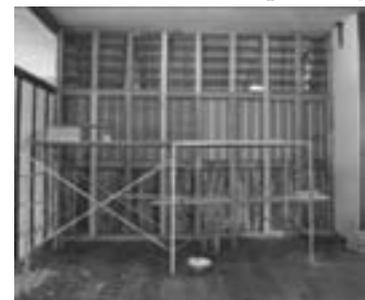
Figure 21

- Re-plastering old wood lath or the *tabique pampango* needs several considerations. Inject bonding grout to the cracked surfaces to seal usable materials, to prevent them from crumbling. Use a 1:1 ratio of calcium carbonate (lime) and

calcium sulphate for the plaster mix. When plasterers work with old lath, each lath strip is re-nailed or weaved and the chunks of old plaster are cleaned out. Because the old lath is dry, it must be thoroughly soaked before applying the base coats of plaster, or it will warp and buckle; furthermore, because the water is drawn out, the plaster will fail to set properly. If new wood lath is installed over old wood lath as the base for new plaster, many of these problems can be avoided and the historic lath can be retained. The wall should still be sprayed unless a vapor barrier is placed behind the wood/bamboo lath (Figure 21).

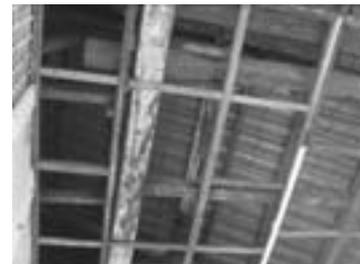
Figure 22

9. Ceilings (Figure 22)

- Fastening should be with common wire nails or common machine bolts where specified or called for.
- Surface woodwork, framework and other woodwn members coming in contact with or embedded in concrete should be painted with two coats of Solignum or Cuprinol.

- Use Narra, Tanguile or Apitong for framing lumber.

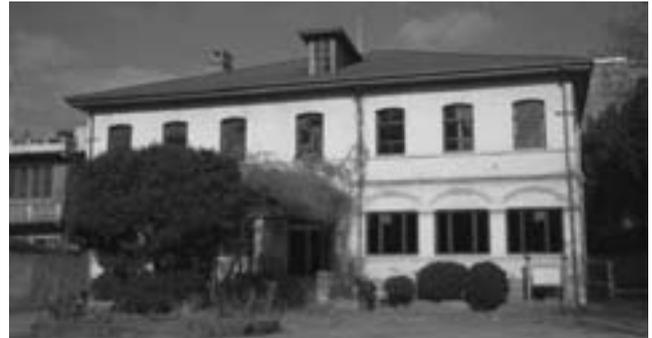
Fig. 2. Jungmyongjeon, Deoksugung Palace, 2007

After investigation during dismantlement, the original plan was thought to have had open brick arches at the front and on the left and right sides, and to have had a veranda. The repairing and restoring was conducted, including internal restoration work. The conservation work started from December 2007 and was completed in December 2009.

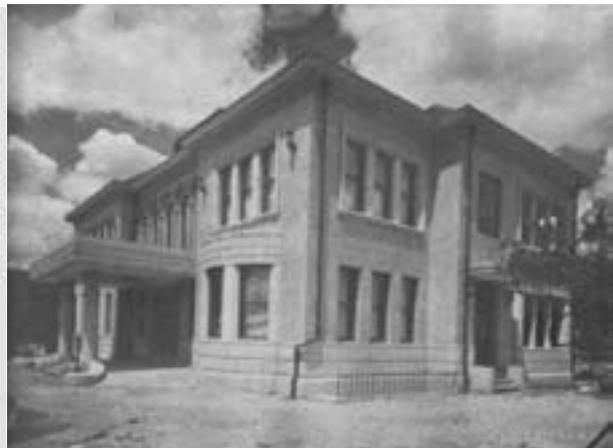
Fig. 6. Gyonggyojang, 1938

The building was constructed of reinforced concrete for the posts, lintel beams, floor slabs and external walls, with partition walls made of brick work. The internal space consisted of not only public space on the first floor, such as a reception room, restaurant and billiard room, but also private space on the second floor such as a Japanese style room (*washitsu* 和室), bed room, library and office, etc. After being constructed, the building was converted to other uses that deformed the internal space. The restoration work of the building has been planned and the design stage is now in progress.

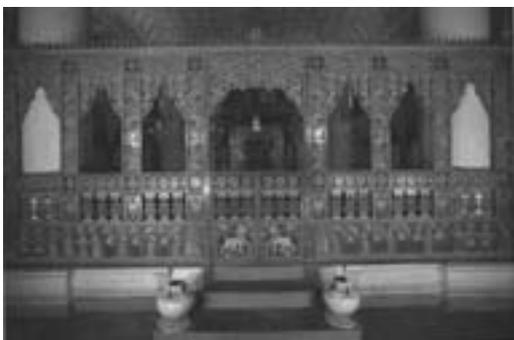
Fig. 15 Karagampitiya Subodharamaya preaching hall, decorated wooden structure

In a mural painting there are two essential components, namely (1) a support such as a wall, wooden panel, paper, cloth, terra-cotta pottery or canvas on which the painting is done, and (2) the paint. The paint is prepared by mixing pigment with a binding medium, such as gum, animal glue, egg yolk, or drying oil. There is also a technique of painting in which no binding medium is required (Figs.15- 20).

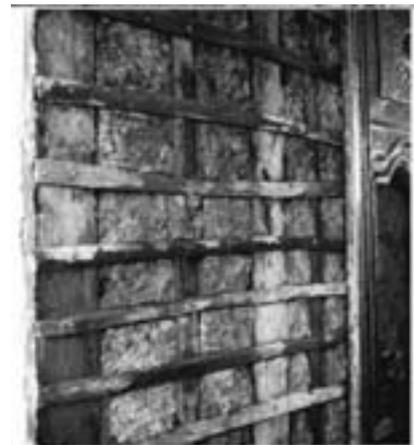
Fig. 22 Structure of mural painting at Dalada Maligawa (Prematilleke and Colombage, 2000)

In the case of a wall painting the ground is the plaster, which itself may be in several layers of rough plaster and then the final fine plaster. Finally, there may also be a layer of varnish as a protective coat on the surface of a painting (Figs. 21, 22).

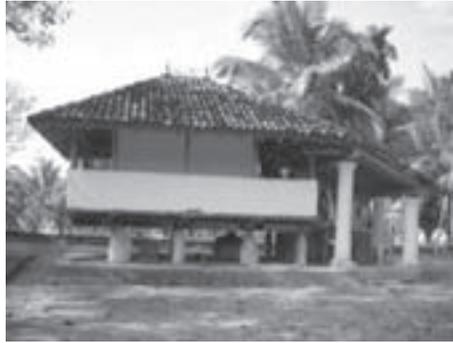
Fig. 24 Batuvita *tampita viharaya* image house (Gampaha district)

Tampita vihara. *Tampita viharas* were constructed on short stone pillars, with the ground floor of the shrine reduced in height, as it served little utilitarian purpose. As the stone columns were needed only to give sacred significance and to keep out dampness and termites, shorter pillars sufficed. The *tampita vihara* tradition might also have developed through foreign influences, especially during the Kandyan period, due to the religious and political ties with countries such as Thailand and Buruma. Most of the image houses and *tampita viharas* now in existence are still unused for ritual worship. However, some of them have either been abandoned and are used or inappropriately renovated, as it is not conventional practice to worship discolored or damaged images or paintings. *Tampita viharas* and image houses are depositories of the Kandyan tradition of mural paintings, and their preservation is

therefore of great significance. All these indicate the necessity of paying attention to the importance of preserving such monuments and the dire need for better conservation practices. The *tampita vihara* tradition has been used not only as Buddhist structures (functioning as *patimagaras*), but also very rarely as image houses for gods (*devalaya*) during the Kandyan period, such as a *tampita devalaya* serving as the Yatawattha temple in the Gampaha district (Figs. 24-26).

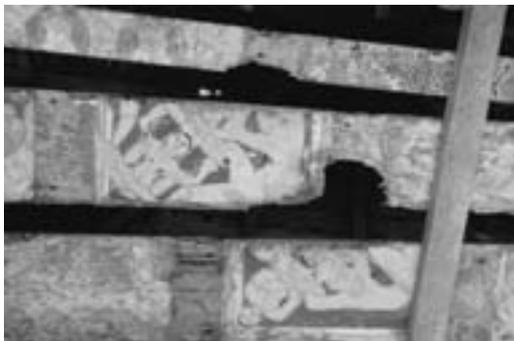
Fig. 27 Arabagama image house (wooden ceiling)

Insect attack. Organic materials such as wood are all vulnerable to insect attack. Insects cause a great amount of damage by weakening structural timbers and many parts of the wood work. Most of the prominent decay in Sri Lankan wooden structures is caused by insects. Among them termites, ants, wasps, beetles, etc, can be seen. Due to termite and other insect attacks, not only are mural paintings damaged but also the wooden frames are weakened (Figs. 27-30).

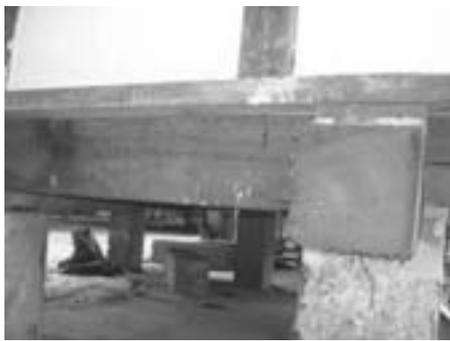
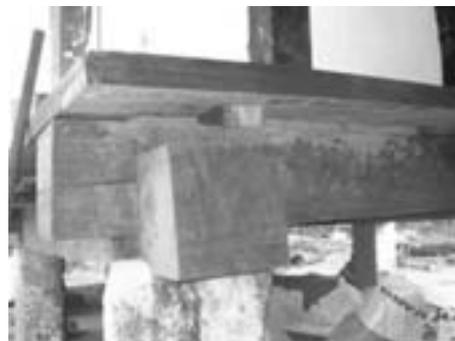
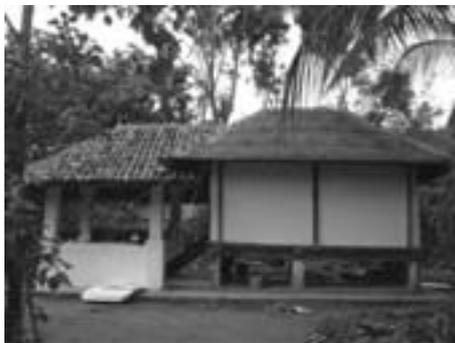
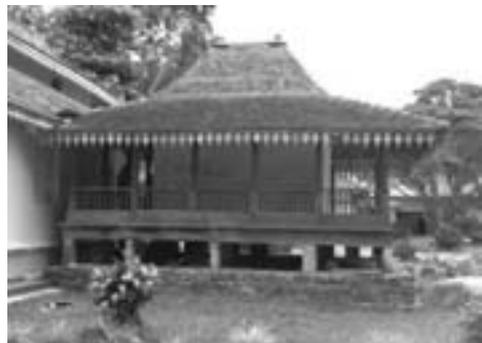
Different types of timber, presenting different problems for conservation, can be classified broadly into three groups: (1) the timber frame as a base to entire the image house (Figs 34-37), (2) timber beams used in the roof (Figs. 38, 39), and (3) timber used for the doors, door frames, windows, ceiling, and railings, often decorated with traditional paintings (Figs. 40-43).

Figs. 34-37 Timber frame as the base to the entire image house

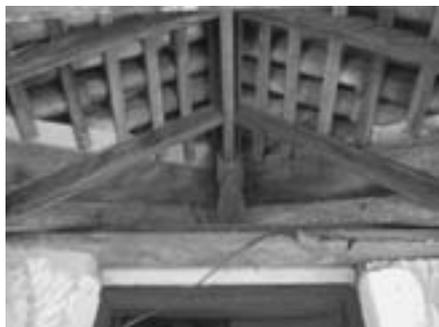
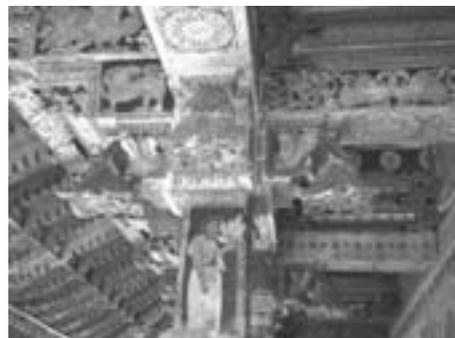
Figs. 38-39 Timber beams used in the roof

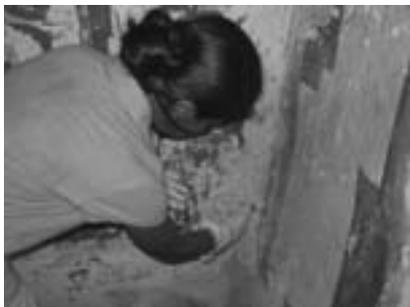
Fig. 45 Applying insecticide

Any work executed must be documented both before and afterwards. All work should be guided by the Venice Charter which must be taken as a whole, the emphasis being on authenticity (Figs. 45-50)

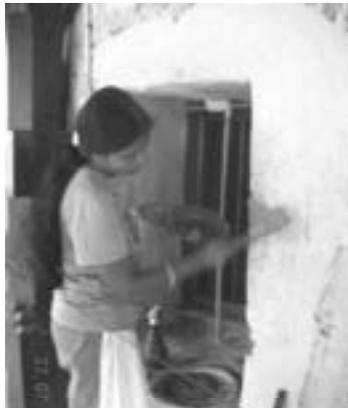
Fig. 46 Filling the rendering

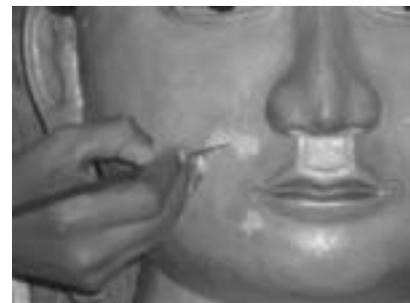
Fig. 47 Reintegration (Dottergio)

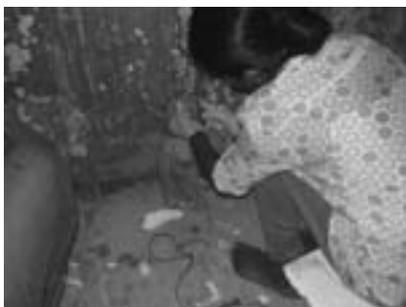
Fig. 48 Consolidation

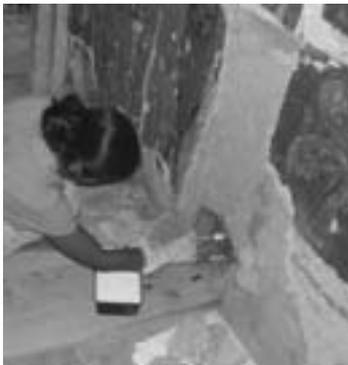
Fig. 49 Applying insecticide

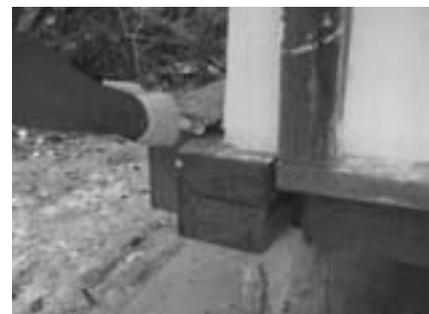
Fig. 50 Applying insecticide

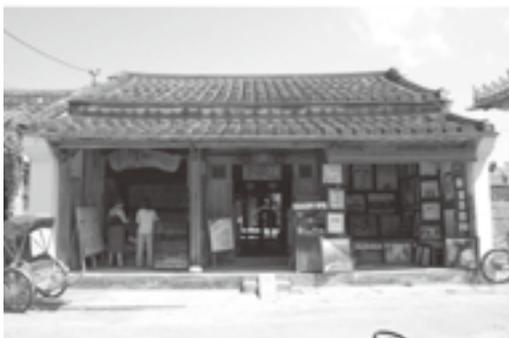
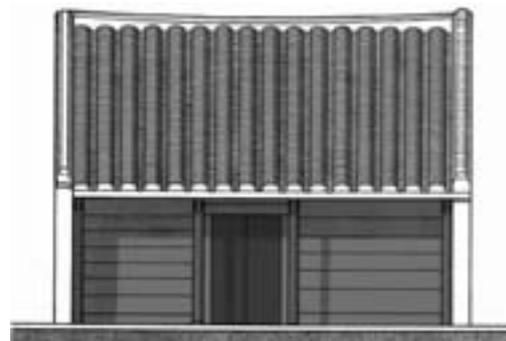
1. One-story building with wooden walls. These are mainly located along Tran Phu St., and date from the eighteenth and nineteenth centuries. A typical example is the house at 48 Tran Phu St.

One-story building with wooden walls

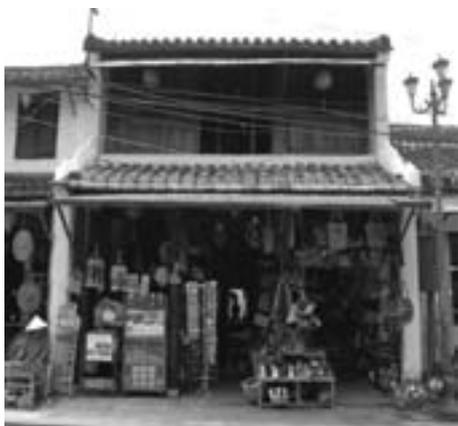
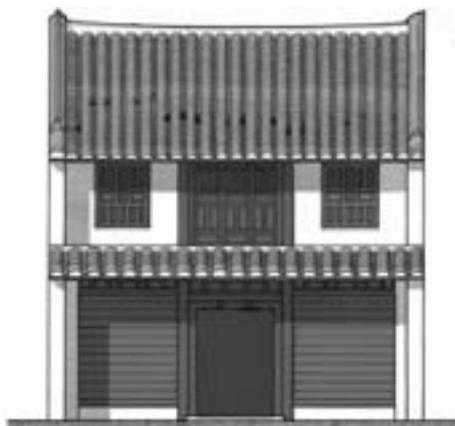
- Two-story buildings with eaves. A typical example is located at 05 Nguyen Thi Minh Khai St. These were built in the late nineteenth and early twentieth centuries.

Two-story building with eaves

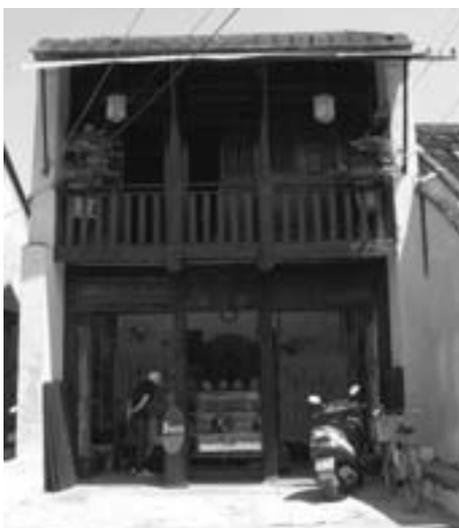
- Two-story building with wooden walls and balconies. These were built in the late nineteenth and early twentieth centuries.

Two-story building with wooden walls

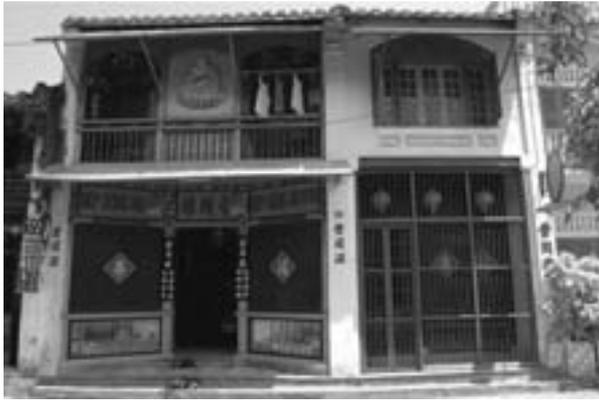
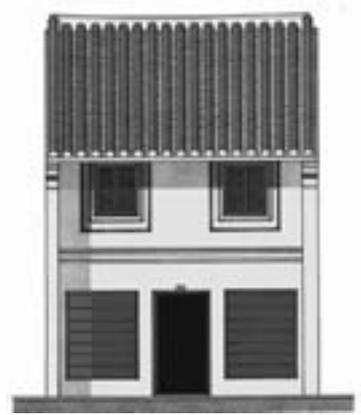
- Two-story brick buildings, which can be seen along Tran Phu St. and Nguyen Thai Hoc St. These buildings were built in the late nineteenth and early twentieth centuries.

Two-story brick building

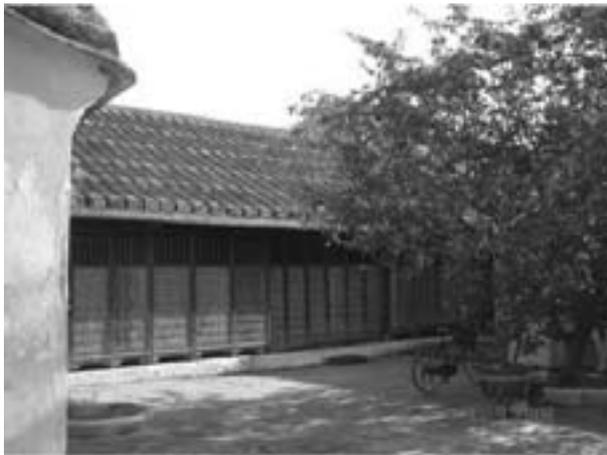
The Truong family chapel

2.3 Family chapels. Family chapels are detached buildings built on a square lot, usually located in small alleys and set back from the street. The lot is enclosed by a fence and there is large garden in the same fashion as for as a shop house. The core plan and structure are the same as the main building of a shop house, but with eaves on all sides. Often, a separate residential building is located at one side of the lot. Family chapels are primarily used for ancestral worship and are places where the younger generation is taught to pay their respects to the ancestors. Family chapels are symbols of strong ties among clan members.

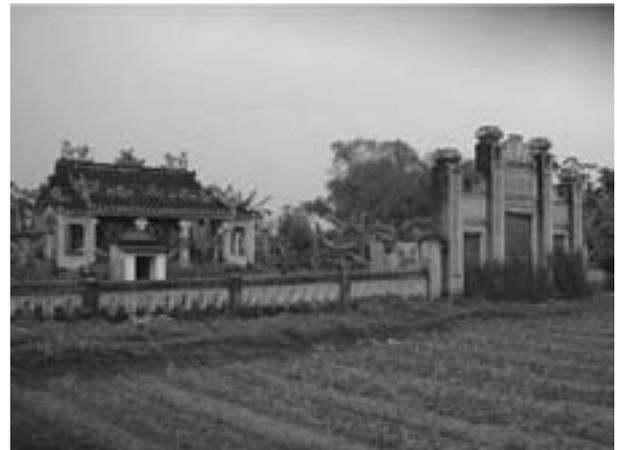
The Kim Bong communal building

2.4 Communal buildings. Communal buildings serve as both religious and cultural centers for Hoi An's Vietnamese and Vietnamese-Chinese communities. Communal buildings are the main places for social and cultural interaction among clan members and people from the same village. They are

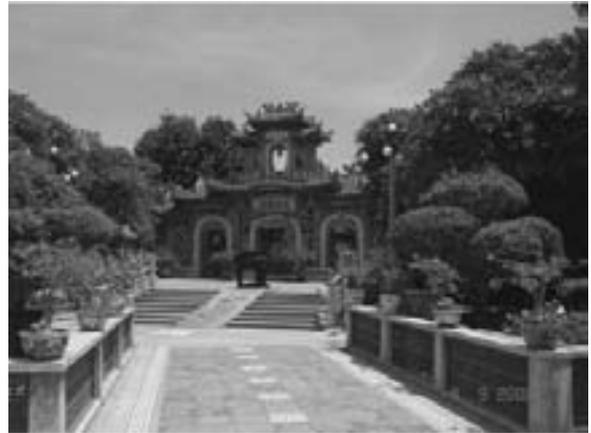
The Phuc Kien assembly hall

2.5 Assembly halls. The assembly halls in Hoi An were built to serve the Chinese community. The halls incorporate Chinese religious and architectural elements conforming to the principles of feng shui, but also integrate architectural and stylistic elements from Vietnamese building traditions. While having similar functions to communal houses, assembly halls have traditionally also served as places in which trade deals are negotiated.

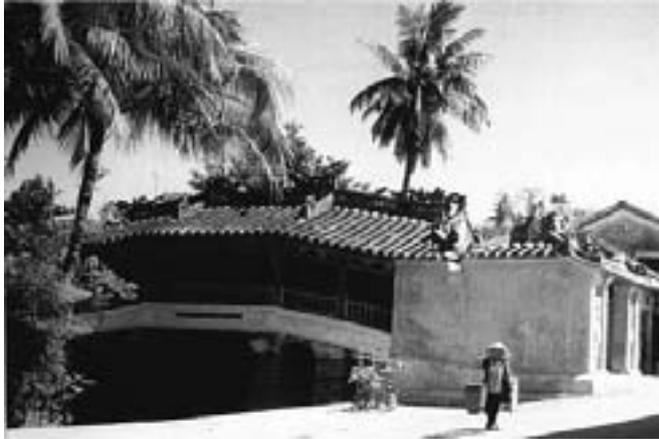
The Japanese covered bridge, a landmark of Hoi An built heritage

3.2 Bridges. One example is the Chùa Cầu (Pagoda Bridge), also known as the Japanese Covered Bridge or Lai Vien Bridge. It is said that this Japanese covered bridge was built in the early seventeenth century by Japanese, and that it relates to the legend of an animal named “Cù.” The creature's head is said to be in India, its back in Vietnam, its spine running along the coast in Hoi An, and its tail in Japan. When this monster moved, there were earthquakes in Japan. The Japanese believed that they built this bridge on its spine, though it is unclear whether this was meant to appease the creature. The bridge has been restored at least six times, though its pillars and supports are part of the original construction.

The bridge is covered, meaning it has a roof. Providing a roof meant that the bridge could act as a refuge from rain for pedestrians, but more importantly, it meant that the wooden structure would last longer in Hoi An's tropical climate. This bridge is arched and has seven spans. It is lined by two

The bridge cannot be said to be in the building tradition of any single past or present group of inhabitants. The structure and decorations of the bridge demonstrate a combination of architectural styles, Vietnamese, Chinese, Japanese, and also the West. Perhaps this is for the best, as bridges are sometimes seen to symbolically link peoples together; the bridge then becomes an image for friendship among Hoi An's inhabitants and visitors.

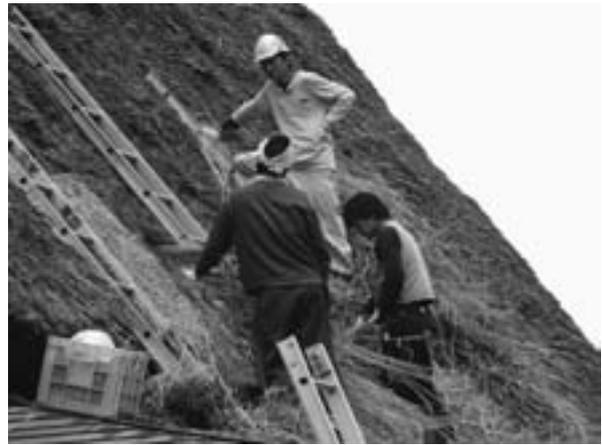
Fig.4 Minor repair work on one of the Gassho houses

The visit to Shirakawa-mura, in the Japanese Alps, was a very pleasant experience for me in terms of its setting. The way that *Gassho* houses are dotted on the hillside, how they are grouped in a small cluster, and also their buildings' size and shape, are features and characteristics which make me think about how much they are shaped by their natural environment. The day we were there, minor repair work was carried out on one of the *Gassho* houses (Fig. 4). Exactly as indicated by speakers in previous week's lectures, the workers were using some modern equipment such as helmets and aluminum ladders (Fig. 5), but the materials and the tools used were the same as they had been for hundreds of years. On the other hand, local residents who are engaged in tourism-related jobs have become busier and competed with each other, and the number of new residents has increased which suggests there are intangible negative changes in local culture. Moreover, the town tends to face enhanced invasion of tourists (Fig. 6) into local people's life, which keeps weakening the feel and spirit of the local communities (Fig. 7).

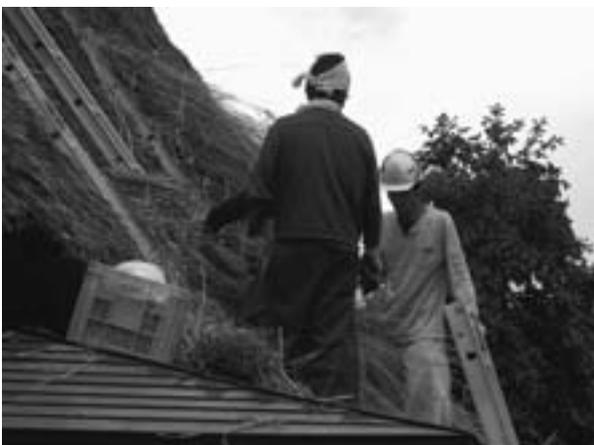
Fig.5 Workers using traditional materials and tools for the repair works

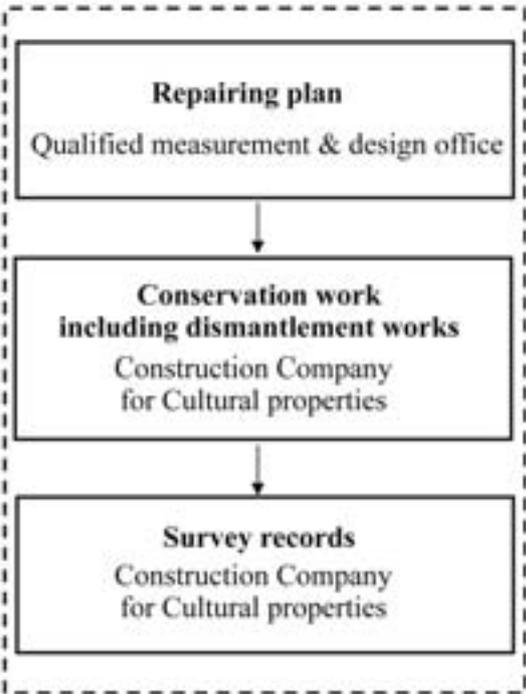
Chart 1. Restoration work in Korea

Those who are qualified, based on the cultural properties preservation specialist system, are permitted to preserve cultural heritage in Korea. The areas of cultural properties preservation specialist system consist of conservation, measurement and design, paintwork on wooden buildings, historic landscapes, conservation science, plant protection, etc. In the case of historic buildings, the engineer who is qualified with measurement and design is permitted to plan the conservation of a building, while a construction company which is qualified in conservation and paintwork on wooden buildings is permitted to preserve a building. Also, the construction company that constructs buildings principally fills out the preservation report.

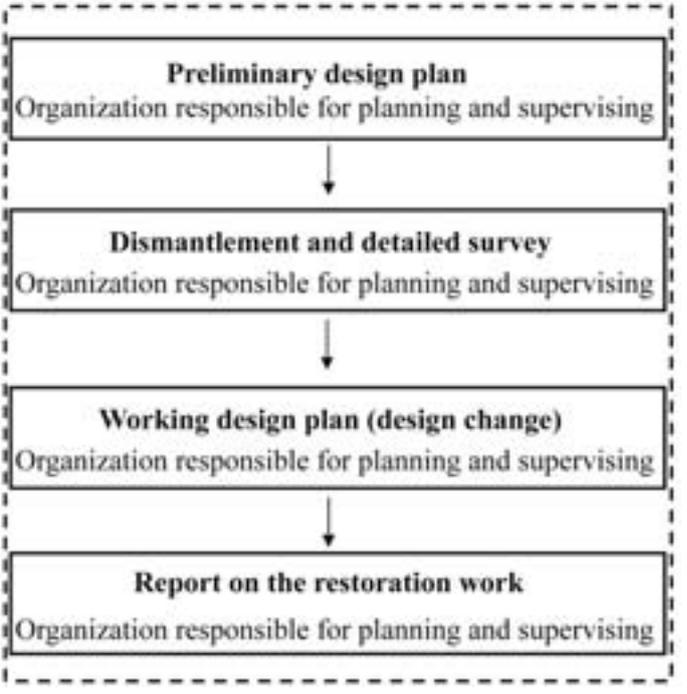
Chart 2. Restoration work in Japan

In the case of Japan, prior to beginning the restoration of a building which is designated as cultural property, they usually conduct a survey on the current state of the building, assess the degree of

As shown above, restoration work requires detailed and comprehensive surveys. For this reason, the constant presence of a design engineer is required at the restoration site if the restoration work involves extensive dismantlement. Once a working design plan is ready, an order is placed with a contractor based on this plan, and the restoration work begins.

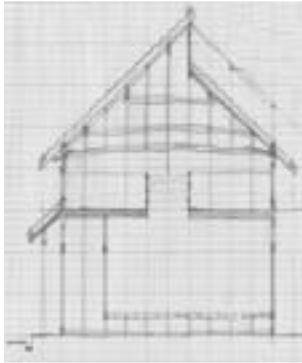
Fig.3. Section drawing, Imai-cho

Moreover, we also should make the restoration drawing by hand and not using a computer program such as Auto CAD. In Japan, the restoration drawing (*honzonzu*) is one of the most important items. Pre-repair and post-repair drawings are made. Restoration drawings are made when radical repair is performed, using A0 size Kent paper and finished in ink with drawing in fine lines. The restoration report is an organized and edited publication of the material compiled and created during the project period, and includes various survey reports, records, photographs, drawings, and documents.
