Disaster Risk Management for Cultural Heritage in the Asia-Pacific Region

- Current State and Issues (I):
Emergency Response Case Studies

ACCU INTERNATIONAL WORKSHOP 2021

DISASTER RISK MANAGEMENT FOR CULTURAL HERITAGE IN
THE ASIA-PACIFIC REGION

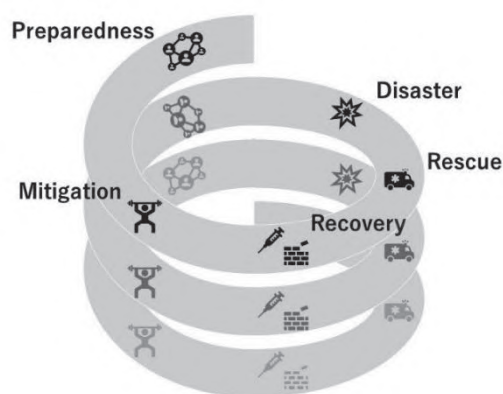
図1 防災スパイラル
Fig.1 Disaster Risk Management Spiral

暴風、竜巻、豪雨、豪雪、洪水、崖崩れ、土石流、高潮、地震、津波、噴火、地滑りその他の異常な自然現象や火災、爆発、放射能事故等の人為的な原因によって、人命や社会生活に被害が生じる事態が災害と定義されている^{1, 2)}。このような災害が発生すると、まず、緊急対応として人命救助と避難対応、ならびに生活に欠かせない水道、電気、燃料、道路等の社会インフラの復旧が優先的にこなわれ、次いで地域の復興が開始されることになる。復興のプロセスにおいては、被害状況の調査等から得られた教訓を活かし、同じ災害を繰り返さないための減災対策が講じられる。ここで完全な減災対策が講じられるならば、再び災害に見舞われることはないということになるが、現実にはリスクをゼロにすることはほぼ不可能であり、ある程度のリスクを抱えた状態にある。そのため、新たに災害が発生した時に迅速な対応をおこなえるように備えをしておくことも重要なプロセスとなる。したがって、復興は「元の状態に戻す」というのではなく、「より災害に強い状態にする」ことで防災のレベルを上げることとなる。防災という概念は、これらの発災後の緊急対応、復興、減災対策、災害時対応策の準備の一連のプロセスを総合したものとなっている^{3, 4)}。災害は繰り返すという考え方に立つならば、この一連のプロセスを繰り返しながら、らせんを描くように防災レベルを上げていくということになる。この一連のプロセスは防災スパイラル（図1）と呼ばれているものである。文化財の防災についても同様のことが当てはまることから、本稿では文化財防災スパイラル (Disaster Risk Management Spiral for Cultural Heritage) と呼ぶことにする。

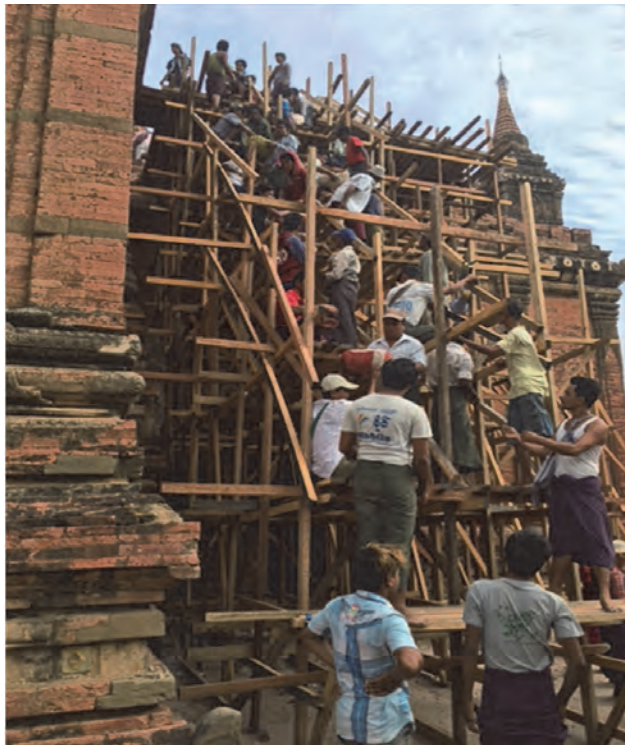
Fig.1 Local community members salvaging historic building fragments in the aftermath of an earthquake in Myanmar in 2016 at the archaeological site of Bagan. They are not wearing appropriate safety gear; Photo: ICCROM.

図1 2016年ミャンマーで発生した地震の後、バガン遺跡発掘現場にて歴史的建造物の破片を回収する地域の人々。適切な安全装置を身につけていない。写真：ICCROM

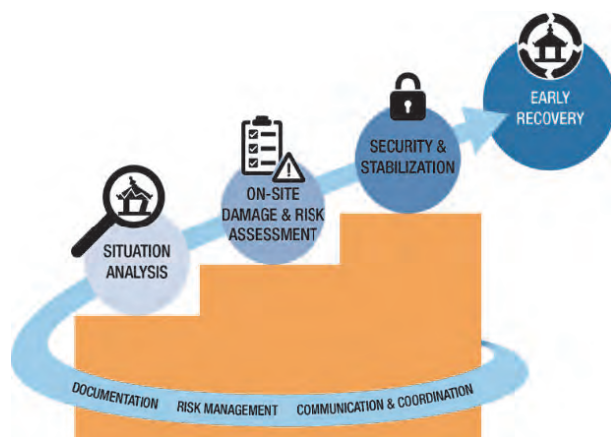
Fig. 3 Cultural Heritage First Aid Action Framework
図3 文化遺産への応急措置方法

Each step of the framework has a separate workflow that can be broken down into smaller actions.

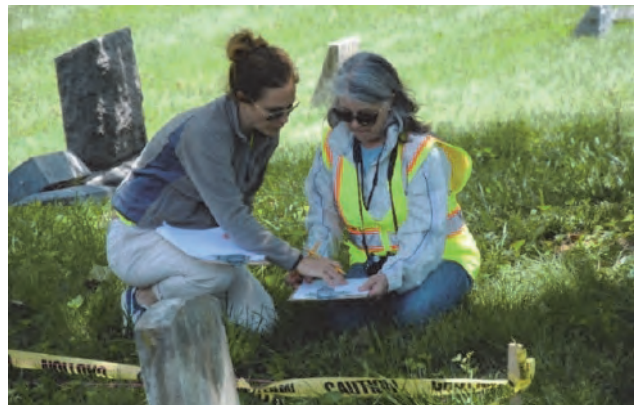
Fig. 5 On-site Damage and Risk Assessment
図5 現地の被害状況とリスクの評価

of the disaster on cultural heritage. It also includes the identification of the risks, which could lead to more damage and hamper recovery. The outcome is a damage and risk assessment report, which is used to prioritise on-site actions for stabilising cultural heritage and reduce risks. The report helps to estimate damage and losses, and can be used to raise funds for recovering cultural heritage (Fig.5).

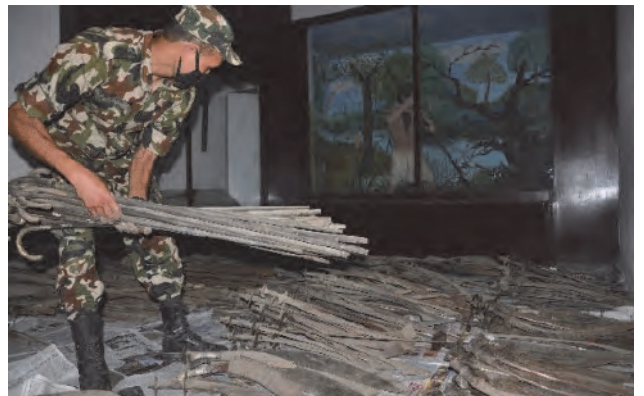
Fig. 6, 7 Security and Stabilization. Source: Aparna Tandon
図6・7 安全性確保と安定化処理 提供：アパルナ・タンドン

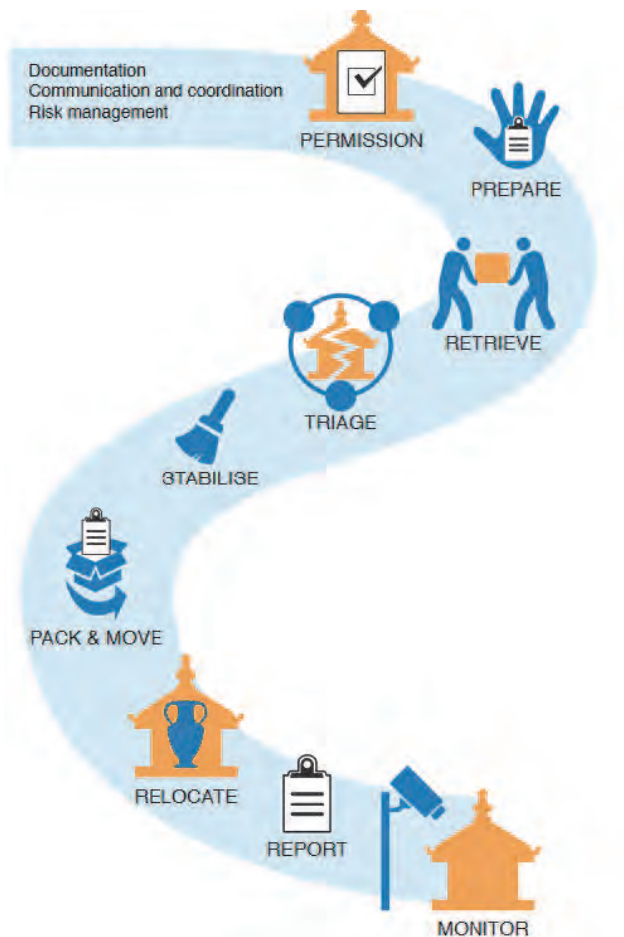
Fig. 8 Post-event Evacuation Workflow
図8 避難ワークフロー

Evacuation comprises packing, transportation and relocation of cultural objects to another temporary location. It involves systematic documentation and safe handling of objects/items during transfer from one location to another (Fig. 8). It should be undertaken only if: the present location is considered unsafe; there is an alternate and safer storage area available and the required logistics are in place to support the operation. This action has legal implications and should be taken after due consultation with the owner(s) of the institution/site.

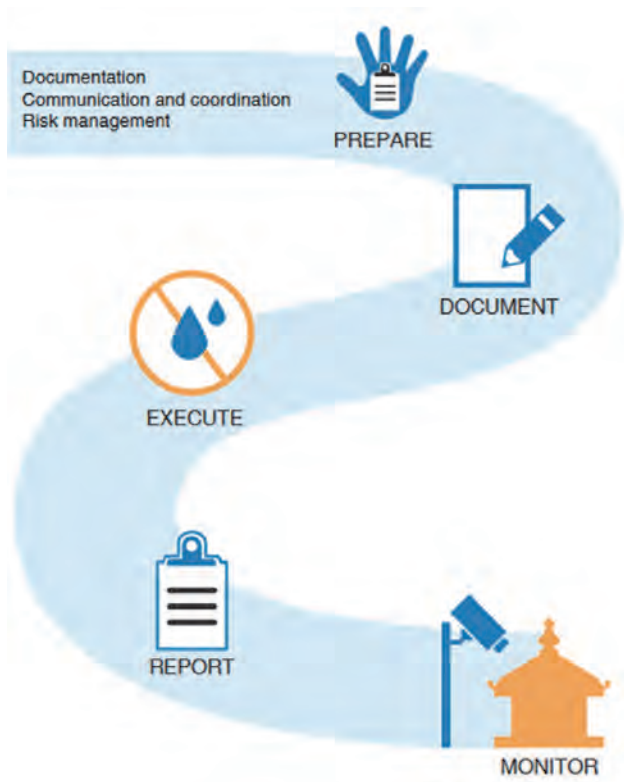
Fig.10 Workflow for Implementing Stabilization Actions
図10 安定化処理

安定化処理とは、回収された遺物や建造物の破片の表面清浄、すすぎ、制御乾燥、状態に応じた修復処理などを施すことを言う。安定化処理を行う場合、作業の詳細な記録を取らなければならない。また安定化処理前後の遺物の状態を、所定の方法に則って記録しなければならない（図 10）。

Stabilization can involve a number of measures such as surface cleaning, rinsing, controlled drying or making customized supports for salvaged objects and building parts. If carried out, the stabilization treatments should be carefully recorded and condition of the object before and after the treatment should be documented within given means (Fig.10).

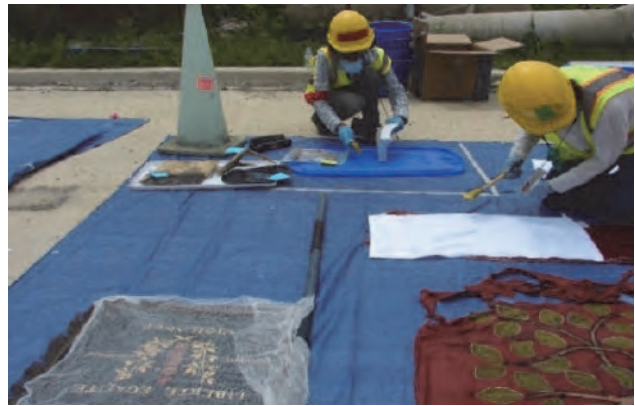
Fig. 9 Salvage
図9 回収

回収（図9）は搬出と同様、あらゆるものの残骸や建物の倒壊現場、その他浸水地帯などの汚染環境から、慎重に遺物や建造物の破片を回収することを

指すことが多い。これには、遺物や建造物の破片が回収された場所の記録を取ることも含まれる。また歴史的建造物が全壊または一部損壊した場合には、その再建に使用するがれき、木材、石材やレンガの選別も行う。回収は、たいていトリアージや安定化とともに実施される。

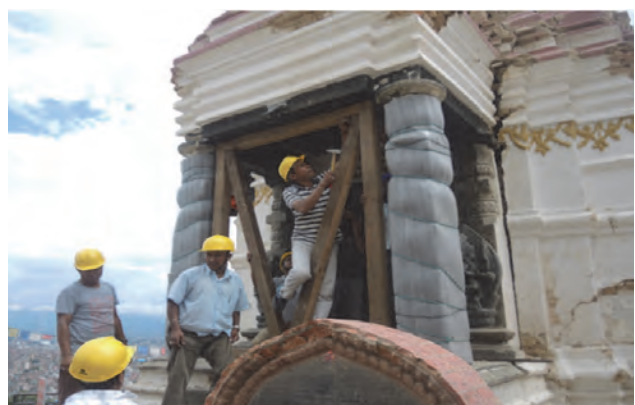
Fig. 13 Emergency stabilization of structures and heavy objects. Source: Aparna Tandon
図13 歴史的建造物の災害時安全化処理 提供：アパルナ・タンドン

この活動は、トリアージの実施後、倒壊の危機に直面している、または他の要因により損傷する可能性のある考古学的遺物や建造物、重量のある遺物の安定化処理を行うために実施する。例えば、壁に支柱を取り付ける、一時的に構造支柱を取り付ける、一時避難所を設置する、むき出しになっている遺物の表面に覆いをかけるなどである。このように、体系的なトリアージ、状況評価や記録化は、現場での安定化処理とともに行われなければならない。

After carrying out triage, this action is undertaken to stabilize heavy objects, archaeological remains or structures that face the imminent threat of a collapse or could be damaged from another source. Examples include shoring of walls, temporary structural supports, erecting temporary shelters, covering exposed surfaces etc. As mentioned above, a systematic triage, condition assessment and documentation should accompany in-situ stabilization.

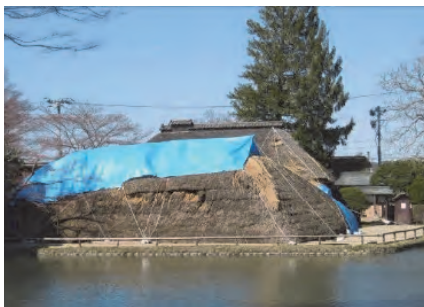
写真1 柱が全て折損した事例
Photo 1. All pillars collapsed

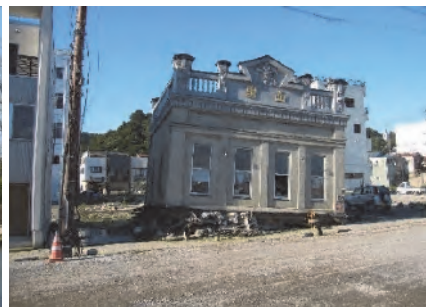
写真2 1・2階部分が流失
Photo 2. Floors 1-2 washed away

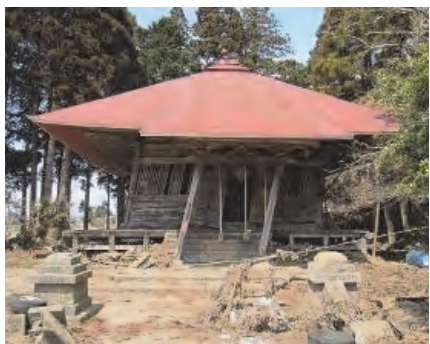
写真3 屋敷林により流失を免れた事例
Photo 3. Saved by windbreak

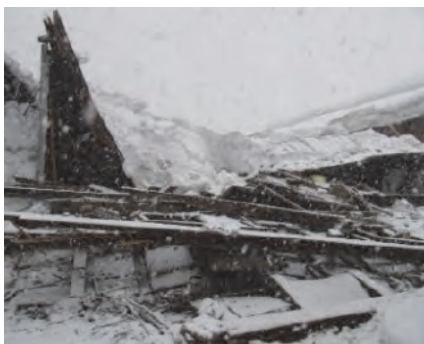
写真4 積雪による被害の増大 (湯沢市教育委員会提供)
Photo 4. Damage increased by snow (Photo: Yuzawa City Board of Education)

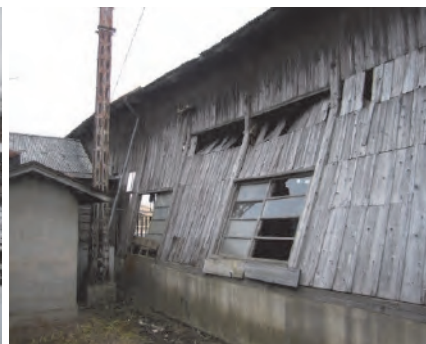
写真5 柱の折損
Photo 5. Damaged pillars

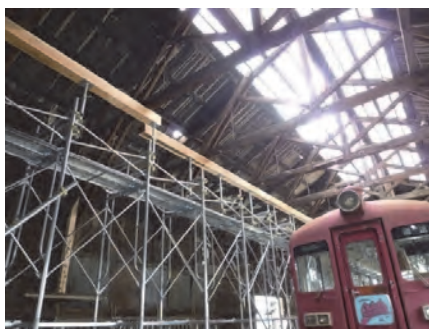
写真6 足場による補強
Photo 6. Reinforced with scaffolding

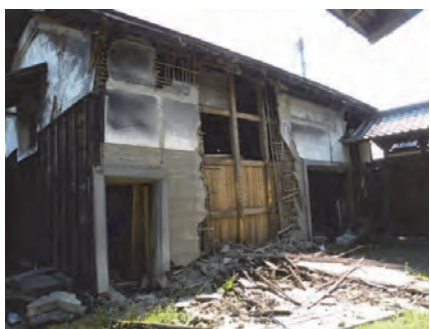
写真8 土蔵の被害状況
Photo 8. Damaged condition of a storehouse

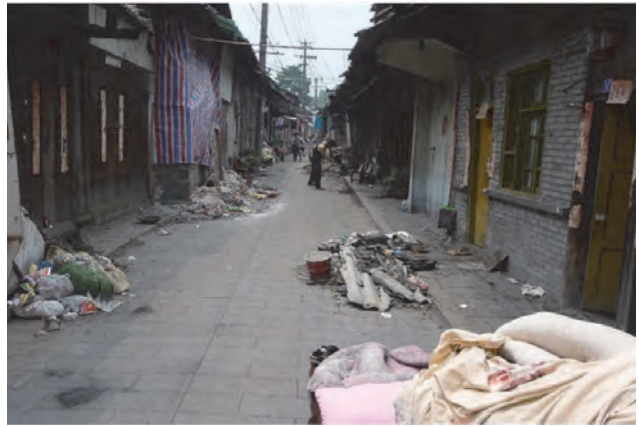
Fig.4 Street Scene after Earthquake (2008)
図4 地震発後の街並み (2008)

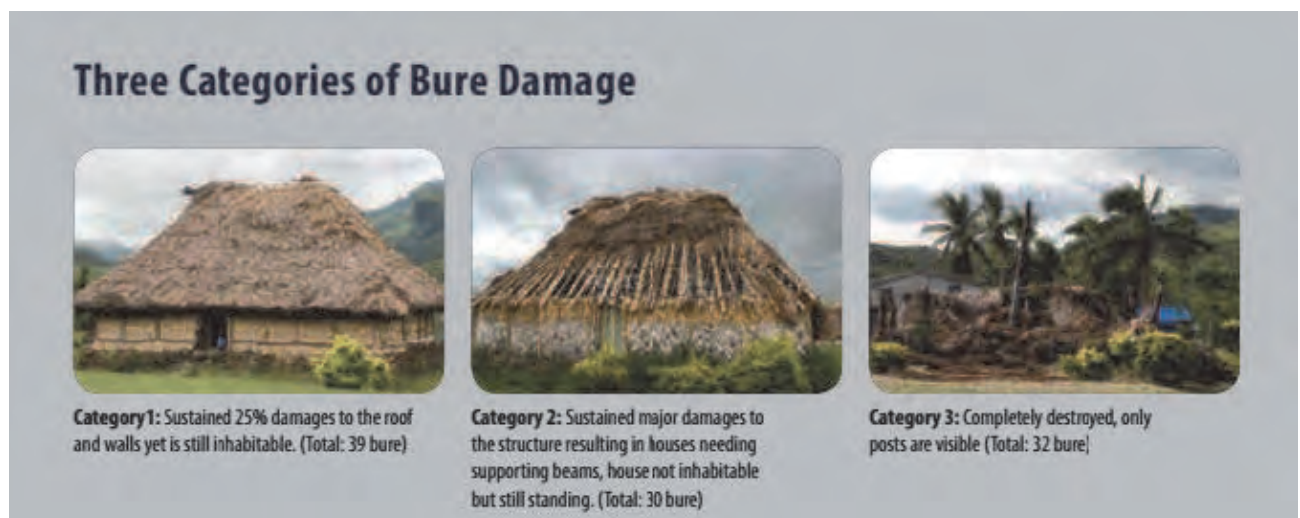
Fig.2 Navala Village damage assessment matrix with total numbers of bure sustaining damages. Source: iTaukei Institute of Language & Culture, Fiji, 2016

図2 被害を受けたブレの合計数を含むナバラ村損害評価マトリクス（提供：フィジー、イタウケイ言語文化研究所〔2016年〕）

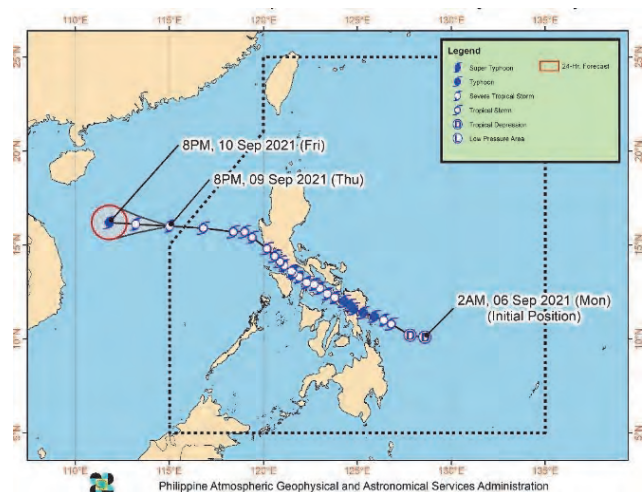
Fig.1 Track of Tropical Cyclone Jolina (PAGASA, 2021)

図1 熱帯低気圧ジョリーナの経路 (PAGASA, 2021)
