GROUP
TRAINING
COURSE
2024

CASE STUDY REPORTS

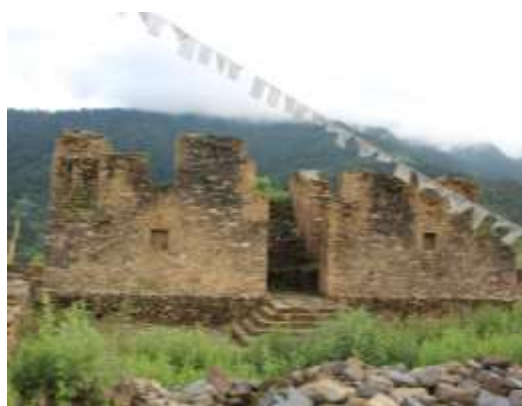
Picture 1. (left) Ruins after excavation.

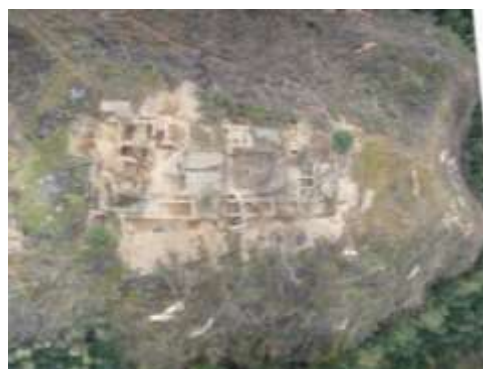
Picture 2.. (right) Overall view of the excavation of the ruins.

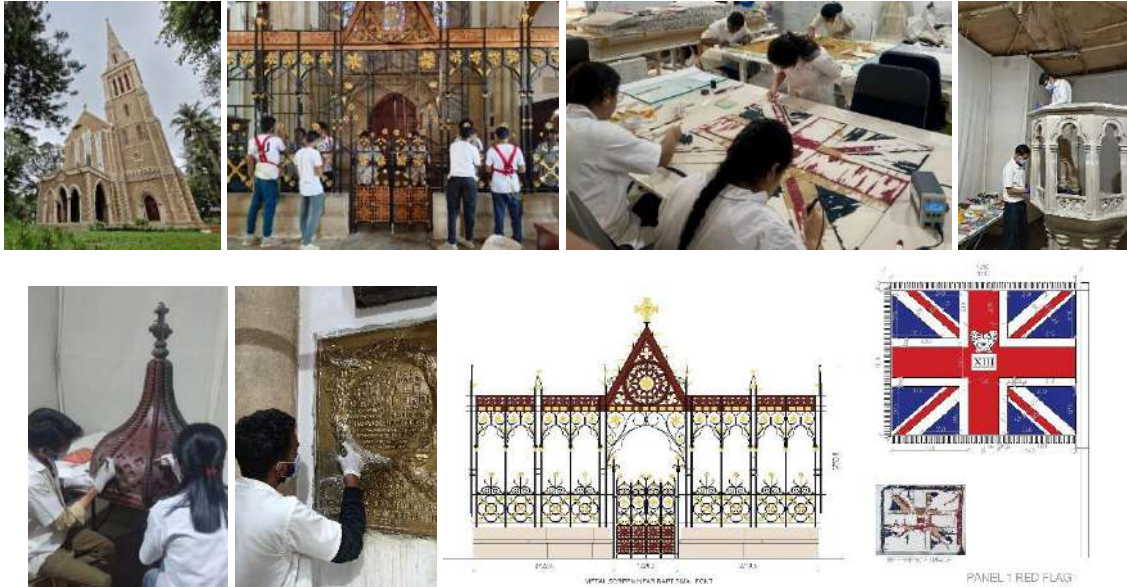
(Top) Figure 5. (Left) The Afghan Church building.
 Figure 6-10. (top to bottom) Conservation and restoration of the metal screen, flags, wooden font cover, metal plaque
 (Bottom right) Figure 11-12. Measure drawings with final colour scheme for metal screen and regimental flag Union Jack-Bombay Navy Infantry XIII. Source: Anupam Heritage lab (India) Pvt. Ltd. 2022-2024

2.1 Project: The Afghan War Memorial Church was built by the British to commemorate the death of the soldiers during the First and the Second Afghan War. It is a Grade 1 Heritage structure as per the Heritage Regulations of Greater Mumbai. The church building and its elements were in dire need of conservation and restoration due to its fragile condition. The project involved restoring and conserving stone and metal memorial plaques on the walls, floors, vestibule area; mosaic walls; baptismal font; metal screens; lectern; pulpit; church bells; Altar reredos; memorial cross; flags (regimental colours).

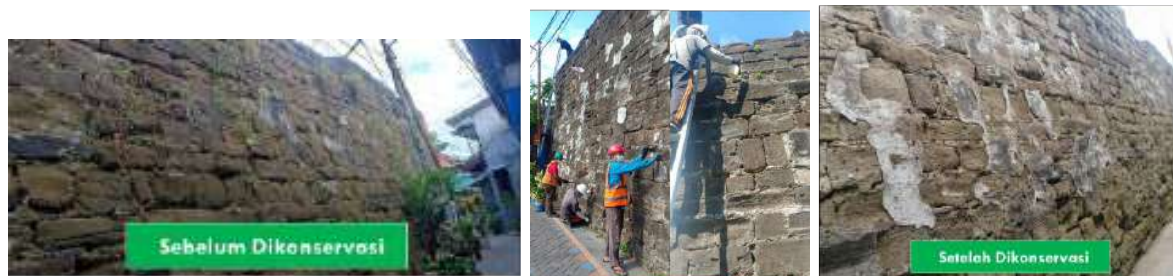
Picture 3. Fort Rotterdam Wall Conservation

Fort Rotterdam's location on the coast presents unique environmental challenges. Exposure to sea winds carrying salt particles accelerates erosion of the fort's stone walls and causes corrosion of iron components. Salt intrusion not only degrades the structural integrity of the fort but also accelerates the deterioration of plaster and other materials. Additionally, sea-level rise and potential flooding pose long-term risks to the site. Coastal erosion is a growing concern for heritage sites worldwide, and if unaddressed, these environmental threats could irreversibly damage Fort Rotterdam.

Addressing environmental threats, particularly the impacts of salting and vibrations, requires a robust conservation strategy. Regular maintenance and restoration work should be carried out to repair damage caused by salt and moisture. The use of green barriers, such as coastal vegetation, can reduce the impact of salt-laden winds and further protect the site from environmental threats. Moreover, raising awareness about the fort's environmental vulnerabilities among local communities and visitors can foster better conservation practices. Additionally, traffic regulations around the fort should be enforced to minimize the effects of heavy vehicle vibrations. Long-term environmental monitoring systems could also be implemented to assess ongoing risks and inform future conservation efforts.

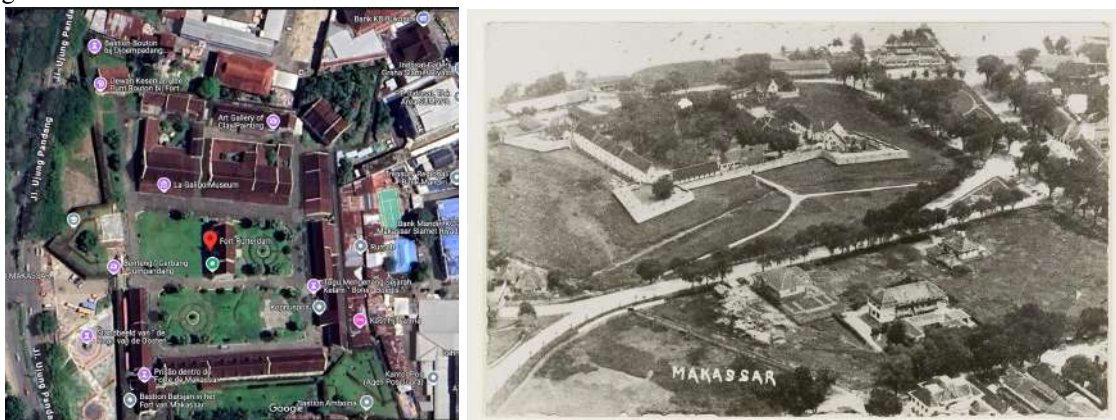
The growth of informal settlements along the eastern walls of the fort presents another management issue. Many of these residential buildings are attached to the fort's walls, with some residents using the fort's structure as part of their homes. This not only accelerates the deterioration of the fort's walls but also complicates conservation efforts. Unregulated development in heritage buffer zones has been a recurring issue in many heritage sites globally. The lack of enforcement of protective legislation and the community's dependence on informal housing have left many heritage sites vulnerable to encroachment.

Picture 2. An aerial photo of the construction of a residential wall that intersects with the Fort Rotterdam wall (left)
Fort Rotterdam in Makassar seen from the air circa 1932 (right)

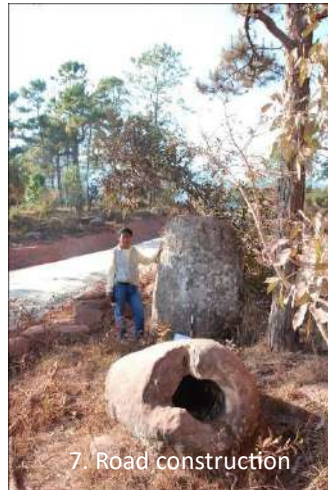
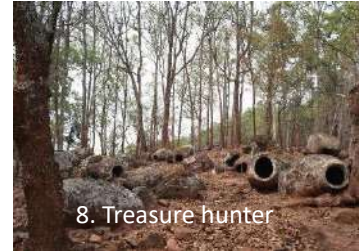
Picture 5,6,7,8,9: [some negative impact to the Megalithic Jars sites from the past;](#)

1. Poaching: Many decades ago, there was a war that was a case of looting and there were the groups of treasure hunters have digging across the mountains, especially is a group of black flag robbers in the late 18th to early 19th centuries (bandit group from China), and the situation of smuggling and digging for cultural heritage properties in the Plain of jars heritage area was happened again in the 1990s because of the opening up of the country for tourism at that time, which resulted in the theft of foreign tourists combined with peoples within the country who did not know about cultural heritage value. The cultural heritage artefacts were dug up for sale, and some of the megalithic jars sites were destroyed due to ignorance of the cultural heritage value of the local people they broke stone jars, jar's lids or disks to make gliding stone, that were caused damage to the heritage of stone jars at the time.

2. Destructive War: The Indochina War, particularly the CIA's Secret War in the Xiengkhouang Plateau from 1965 to 1973, severely damaged the Plain of Jars. The site was subjected to extensive bombing, resulting in significant destruction of the heritage sites.

3. Natural Disasters and Human Activities: Natural factors such as climate change, rain, wind, landslides, floods, forest, fires, and tree growth in and around the jars have contributed to their deterioration. besides that, human activities may the case to effect to the Jars sites such as: infrastructure development, facilities construction, new residence expansion and hydropower dam projects building has further threatened to the jars site.

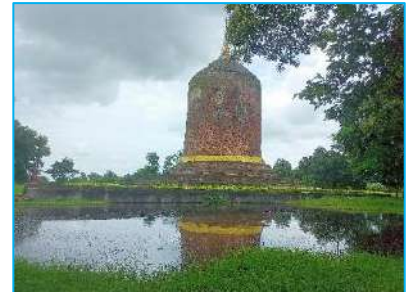
The Baw Baw Gyi stupa was decay mostly by rain water. Because of rain water, the hemispherical dome of this stupa is properly decay. The rain water pass through the upper layer of cement plaster and the cracks of the hemispherical dome. It can cause the erosion of cement mortar in course of time. Rain water can percolate and progress by capillarity within wall from their entry points and cause to break down to the brick wall. Because they can also penetrate through the brick and joints. Disruption of terrace surfaces due to accumulation of rain water filling the pore of the brick. The tremors led to the collapse of parts of ancient structures, with some areas suffering irreversible damage. Immediate restoration efforts were hampered by limited resources, and the long-term effects of the rain water are still being assessed. (Fig_1)

Fig_1, Open monument is affected by heavy rain.

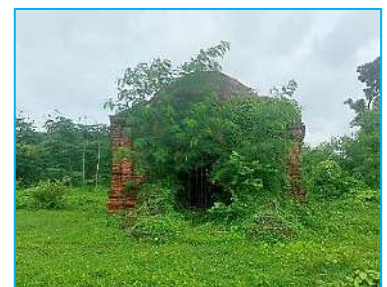
The growth of fungi (moss) and lichens is the biological agent of deterioration because of their trapping moisture. The growths of mosses are direct source of deterioration to the bricks of the structure. They penetrate deep into the brick and squeeze acidic substance which can have solvent action with the brick minerals. And another factor of Vegetation is set up of banyan trees. These trees were set up by the eager well wishes Buddhism's. But the roots of these banyan trees penetrate the soil towards the foundation of the structure and were became decay latter. Moreover, seed of the banyan trees fall on the structure is cause to growing another banyan trees. (Fig_2)

Fig_2, Monument is affected by vegetation growth

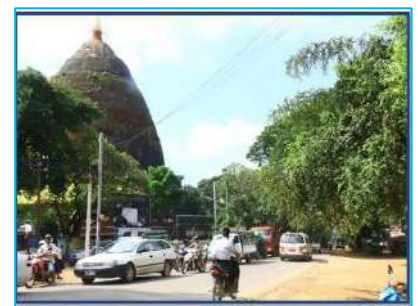
Roads for transportation, bridge construction, home expansion and agricultural land development due to urban growth pose a significant threat to cultural heritage. The expansion of residential areas has increased with the city's development, and document evidence shows that around 200 houses were built or expanded within the boundaries of Sri Ksetra Ancient City from 2013 to 2024. Urban development has impacted ancient monuments and archaeological sites, such as houses being constructed on the arms of the city gate and near the city gate, which can damage the integrity of these heritage structures. (Fig_3)

Fig_3, Monument is affected by development

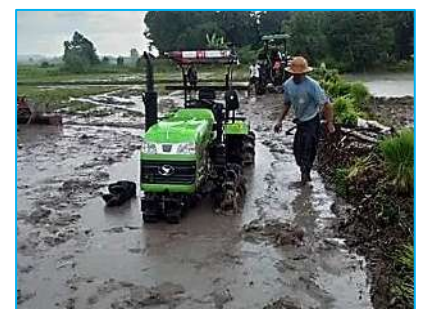
Cultivation is a fundamental livelihood for the local people living in the Sri Ksetra Ancient City. The crop fields significantly contribute to the cultural landscape. In the past, agricultural processes were carried out using cattle. However, due to urbanization, these processes are now often performed using machinery. The use of machinery in plowing fields can damage archaeological remains buried underground. Besides, planting perennials near ancient buildings can obscure the visibility of cultural heritage, decreasing its cultural value. Chemicals like pesticides can cause harmful chemical reactions, leading to the deterioration of artifacts and structures. (Fig_4)

Fig_4, Agricultural activities nearby monument

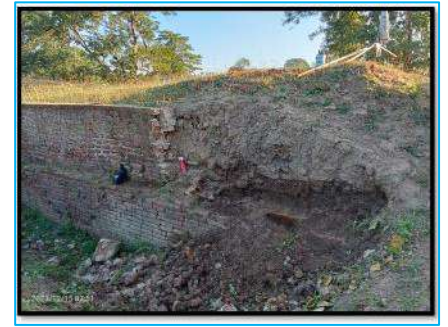
Poor management and conservation can also cause impacts on cultural heritage. The basic factor that causes disaster is the lack of sufficient personnel. I think it is possible because of the lack of financial strength. Conservation should be done at the same time as excavation research is done. Plant growth can cause cracks in excavated areas and roots can cause further damage. If conservation is not carried out, it will cause damage and deterioration. Effective management requires coordination among departments. For example, there are sites that are deteriorating and that cooperation should be done with local residents. (Fig_5)

Fig_5, Palace wall collapsed by poor management & conservation

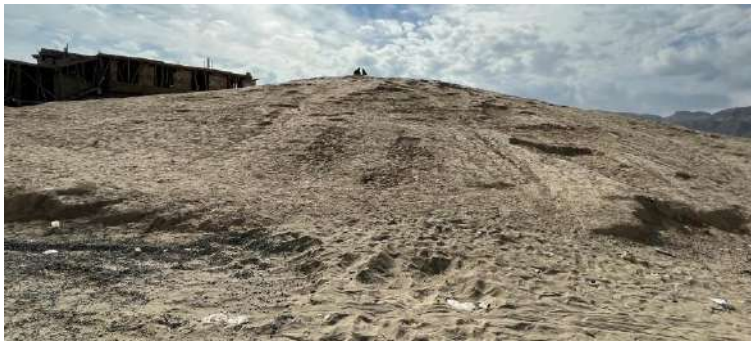
Fig 1. Ahmed Khan Zai Mound

An archaeological site spread over about 60000 sq.m, associated to multiple periods i.e., Iron Age/Quetta/Damb Sadaat/Kechi Beg in (figure 1).

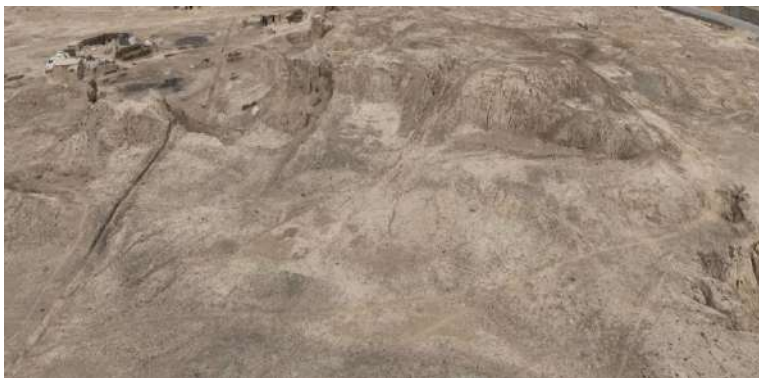
Fig 2. Noushar Mound

The pre-historic mound No.11 is situated close to village Nauhisar at a distance of about 15 km from Quetta city north east of Quetta Chaman Road in (figure 2). The site is about 9 m diameter and 5.5 m high, plain as well as painted pot-shreds found lying on the mound.

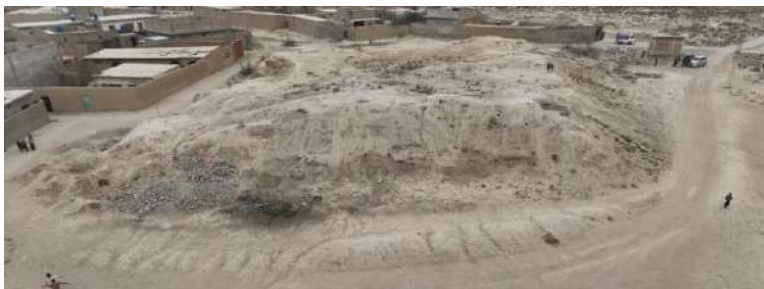
Fig 3. Shaikh Manda

The mound No.10 is situated about 1.5 km south of Quetta airport. It is 365 m long 30 m wide and 5 m high. The mound is littered with potshards and brick-bats. The pot-shards are both plain and painted. Some structures are visible on the upper levels of the site.

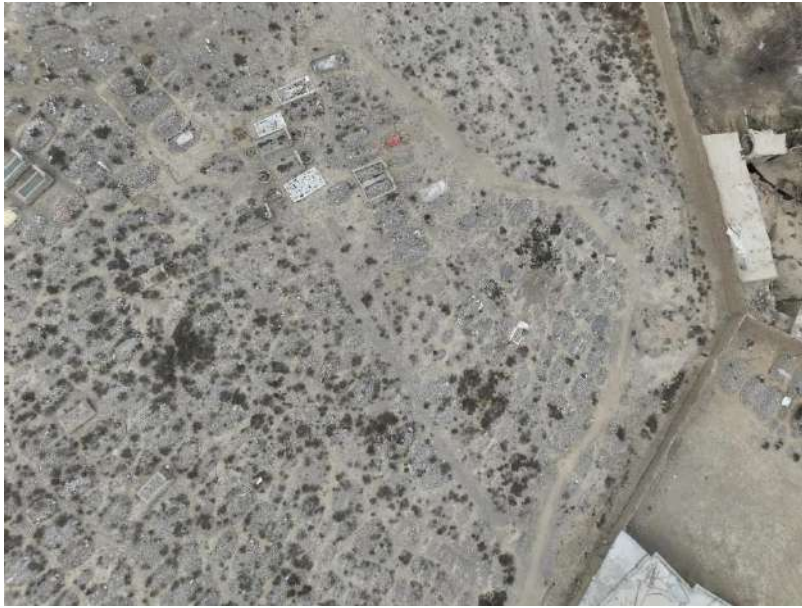
Fig 4. Killi Gul Mohammad

The ancient mound of Killi Gul Mohammad is located one km away from the village Killi Gul Mohammad close to Quetta-Chaman Road. The site is about 400 x 200 m with surviving height of 15 m. Besides the various stages of pottery manufacturing techniques originated indigenously in rough and crude shape were gradually developed to a very refined stage.

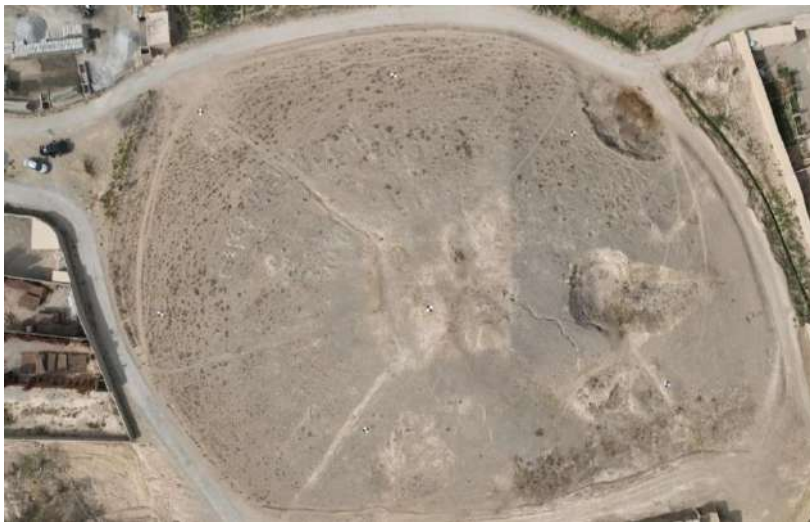
Fig 5. Damb Sadat Site

This site lies 12 km southwards of Quetta city on National Highway leading from Quetta to Khuzdar (figure 5). The site is oval in shape with 73 m circumference and elevation of 15.2 m from the surroundings. During excavations at the site a large number of pottery assemblages and other objects were collected.

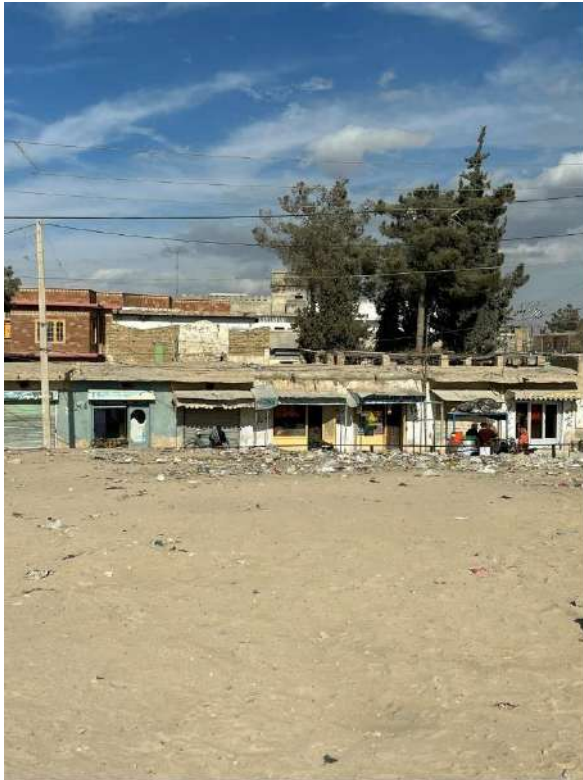
Fig 6. Kechi Beg Mound.

The ancient mound of Kechi Beg is located 8 km away towards south of Quetta city (figure 6). The site is roughly circular in shape and is surrounded by residential and commercial buildings. The site is measuring 52 m in diameter, whereas its maximum height from ground level is 3.6 m. As a result of the excavations large number of potshards, plain and painted were collected.

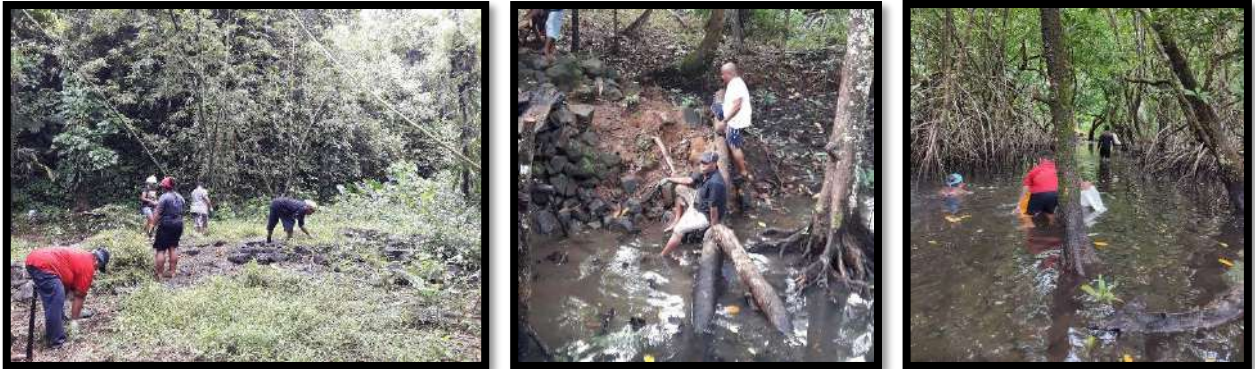
Picture 3. (Left) Community Group working to rehabilitate Beluu er a Ngerutechei Site. Picture 4. (Center) Repairing the 100-year-old foot bridge that was broken in two from a fallen tree. Picture 5. Locals crossing an ancient stone path that is now underwater. Photo provided by McMichael Mutok Jr.

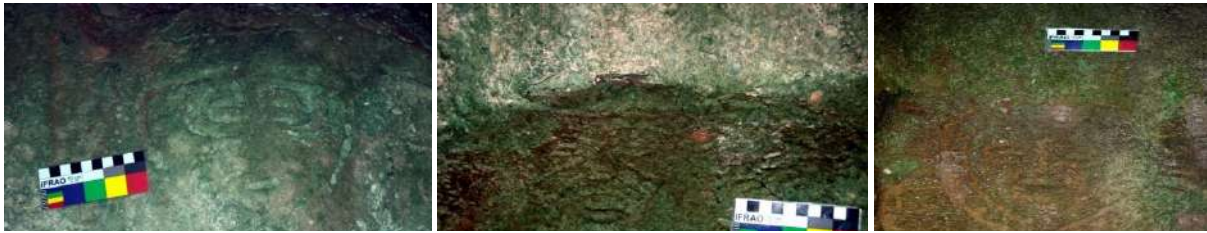
Picture. 3 – 5 (from left to right) the three prints by Lena Hara cave are covered in green fungus.

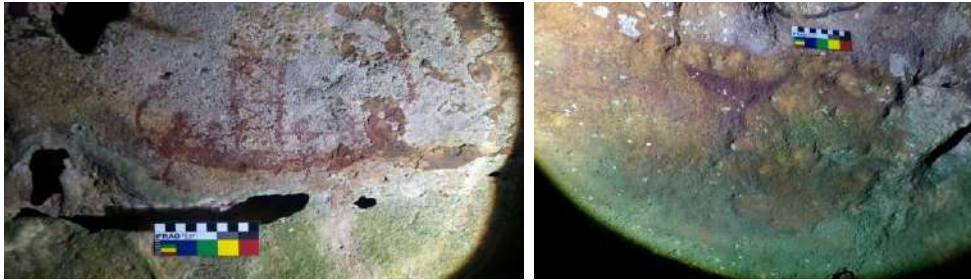
Picture. 6 and 7 (from left to right) the two Lena Hara cave paintings recorded in 2017 were covered by lichens.
