Training Report

Cultural Heritage Protection

**Training Course for Researchers in Charge of Cultural Heritage Protection
in Asia and the Pacific 2011 - Indonesia -
5 July - 4 August, 2011, Nara, Japan**

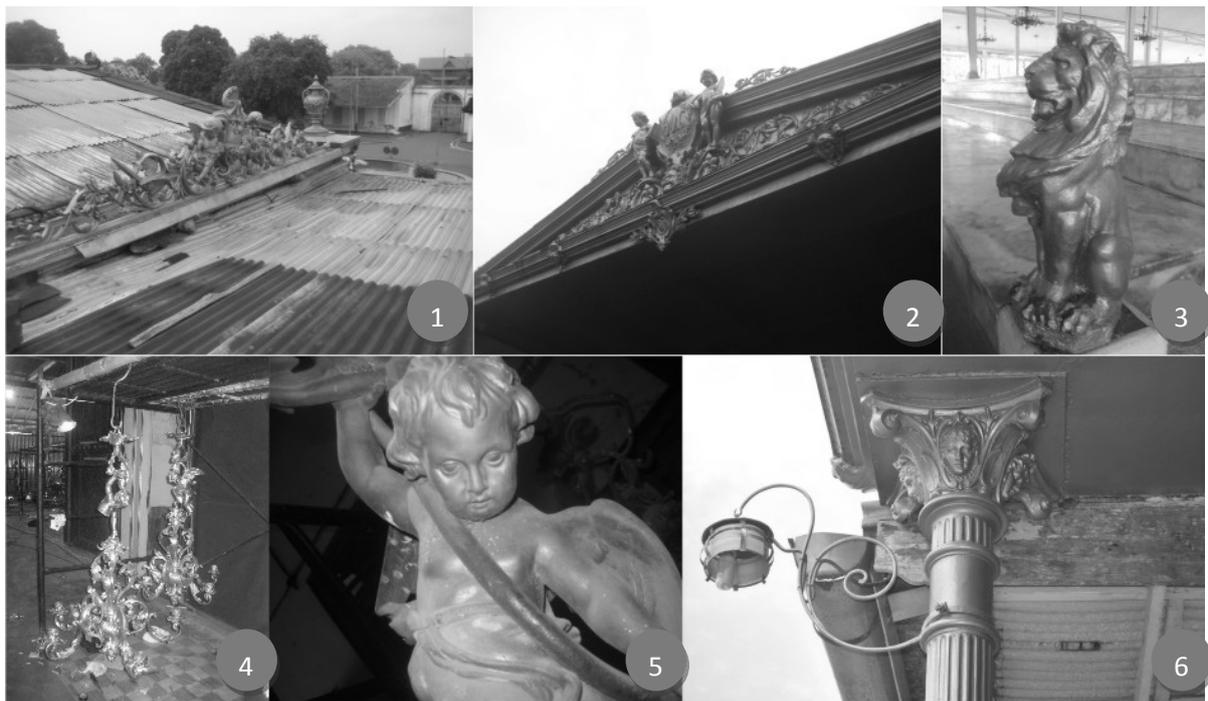
European influence in decorative ornaments: (1) decoration on the roof, (2) front decoration of Pendopo Ageng, (3) statue of a lion in the pavilion, (4) chandelier, (5) details of the chandelier, (6) details of one of the pillars of Pendopo Ageng

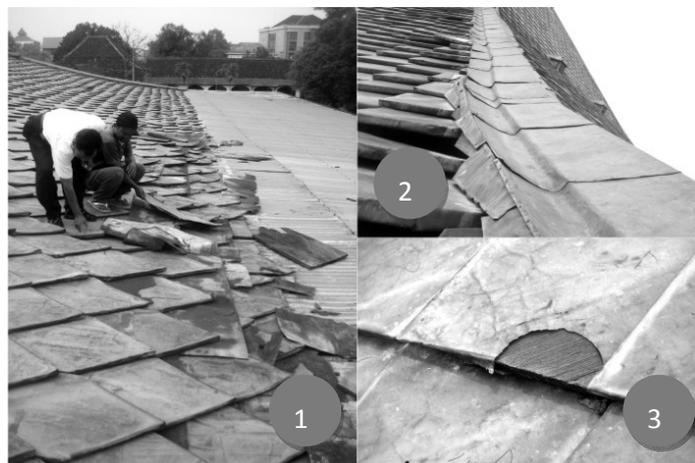
Damage to the roof of Pendopo Ageng: (1) and (2) copper plating on the shingle roof that has rusted and broken, (3) details of a shingle roof with its broken copper plating

Roof. Pendopo Ageng has a roof of shingles, made of *ulin* wood (*Eusideroxylon zwageri*) and coated with copper plating. *Ulin* trees are numerous in Kalimantan, and its timber can last for a very long time. The damage to the roof is mainly due to weather, rust, and the growth of microorganisms on the copper plating, as well as broken shingles.

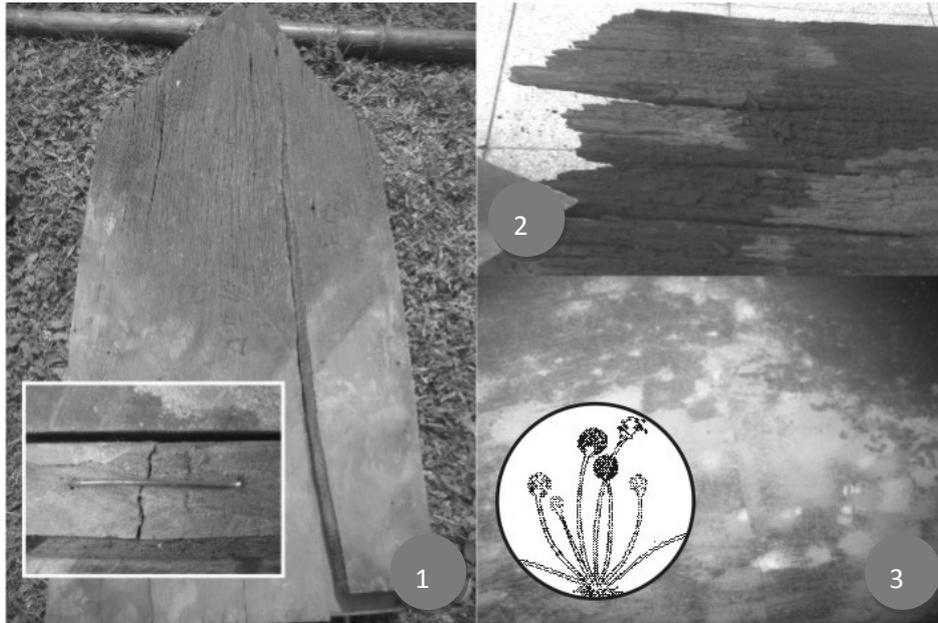
Shingle conditions: (1) broken shingle (*insert*: use of a cramp iron to unite two parts of a broken shingle), (2) weathered shingle, (3) microorganisms that grow on copper plating

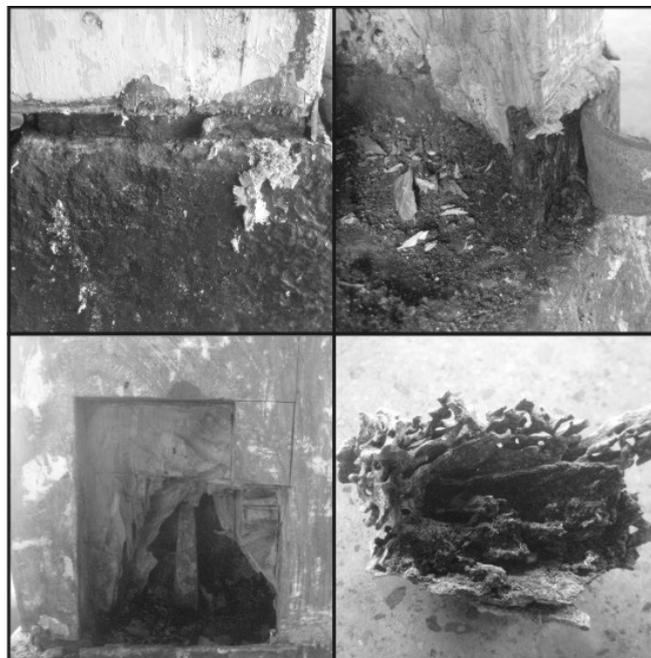
Details of damage on wooden pillars supporting the roof as a result of capillarity and termites

Pillars. Supporting pillars of the roof on Pendopo Ageng also suffered damage, from water through capillary action and termites. Damage was also found at the bottom of the pillars. To overcome the termites, chemical treatment was required.

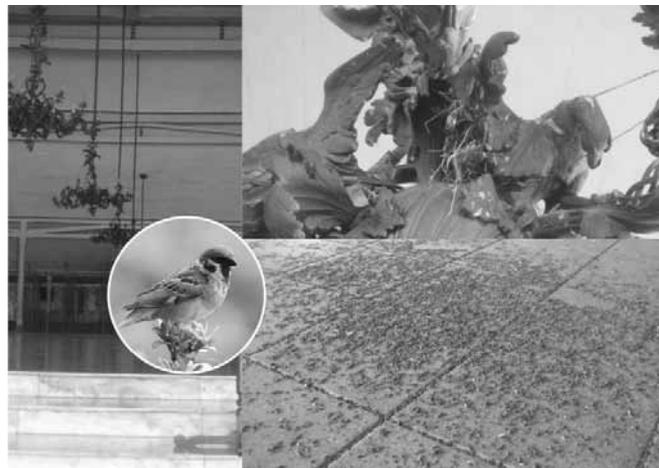
Nests of the tree sparrow (*Passer Montanus*) in the chandelier. Droppings litter the floor, damaging the surface.

Decorative ornaments, floor. Damage to decorative ornaments and the floor was caused by patination and sparrows (*Passer Montanus*). These birds made nests in the crevices of the chandelier, and their droppings littered the floor surface of Pendopo Ageng.

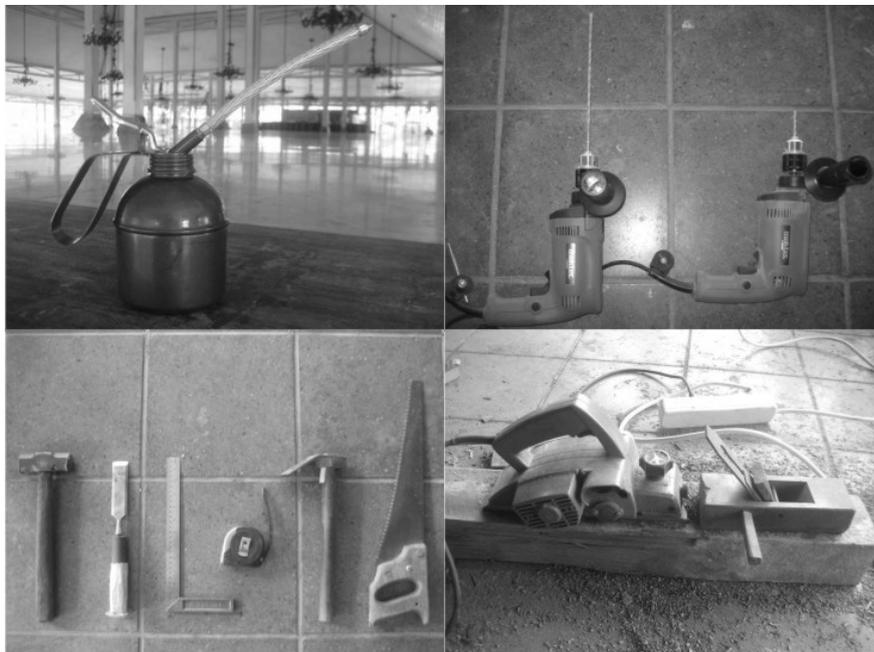
Tools. These include everything needed to support the work of restoration, including equipment and materials that will be used for dismantling, conserving, retrofitting, and reassembling. Tools to support research and documentation also include equipment for excavating, mapping, drawing, and photographing.

Some of the tools used in the restoration of Pendopo Ageng

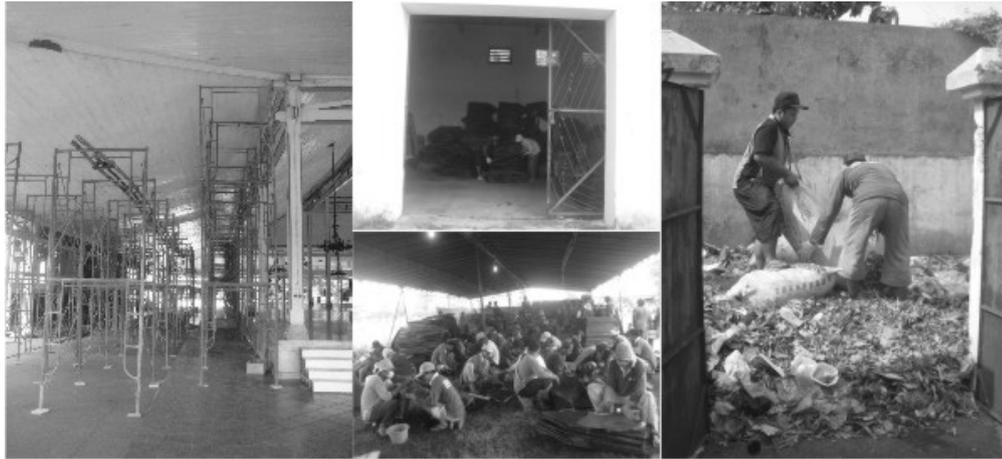
Infrastructure. This includes the work areas, workshops, and temporary shelters for original components of the heritage building that has been dismantled, and the scaffolding.

Infrastructure for restoration used at Pendopo Ageng

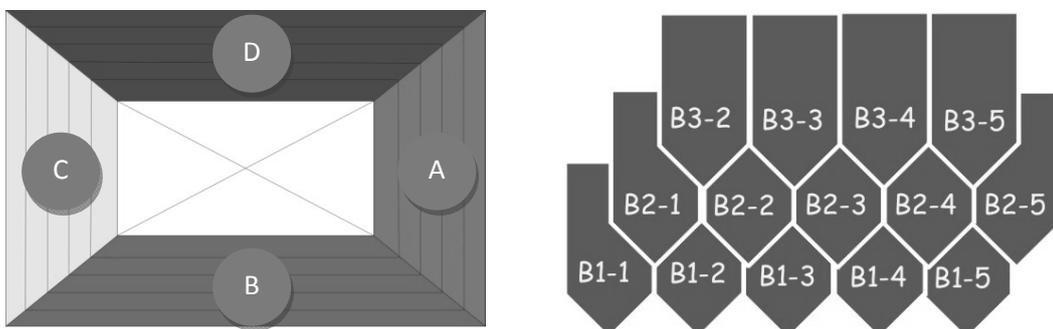
Letters of the alphabet (A, B, C, D) are used to indicate groups of shingles in accordance with the sides of the building. The first number following a letter (e.g., B1) indicates the row, and the final

One principle which must be followed, when dismantling any part of a heritage building, is that each dismantled element needs to be numbered and systematically registered, so that the reassembly process will not encounter any difficulties. The registration system includes the marking or coding of each element before dismantling, and the recording of its original position in the building. In dismantling the shingle roof of Pendopo Ageng, the following registration system was used.

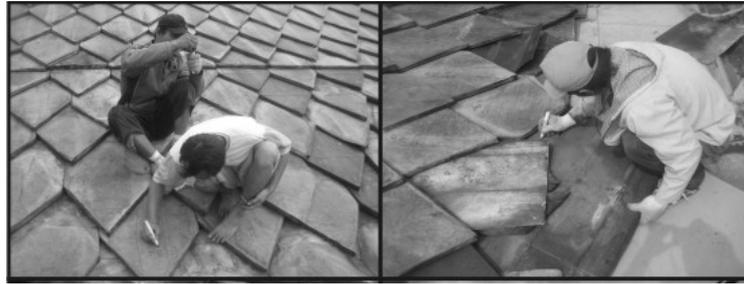
number is the shingle's position in that row. Accordingly, B1-1 means the first shingle from the left on the first row of southern side.

Numbering the shingles prior to dismantling

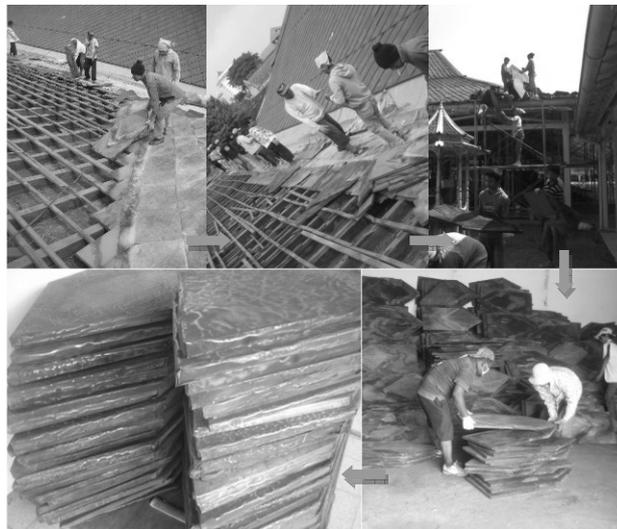
Dismantling the shingle roof after registration is completed

After registration is completed, dismantling of the shingle roof can proceed. This is done carefully, passing each shingle from one person to another until it arrives at the storage room. There, shingles are stacked according to group.

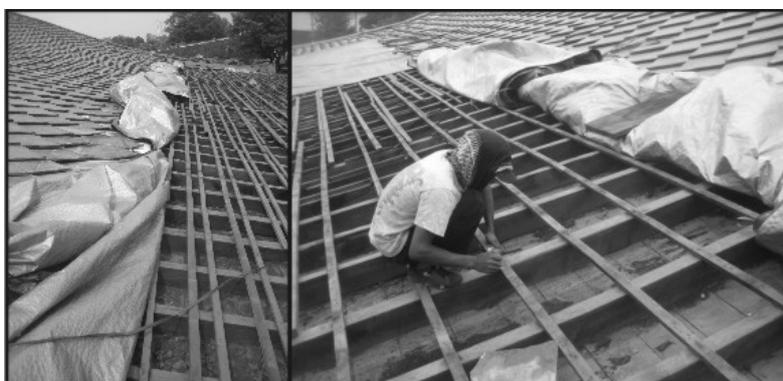
Condition of the roof after the shingles are removed

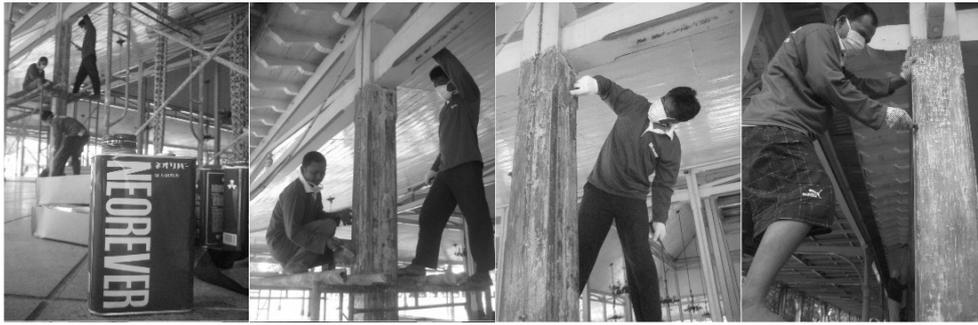
Removing paint from the wooden pillars

Restoration was also carried out on the interior of Pendopo Ageng. After flaking loose paint off the wooden pillars, the remaining paint was removed with chemicals and putty knives.

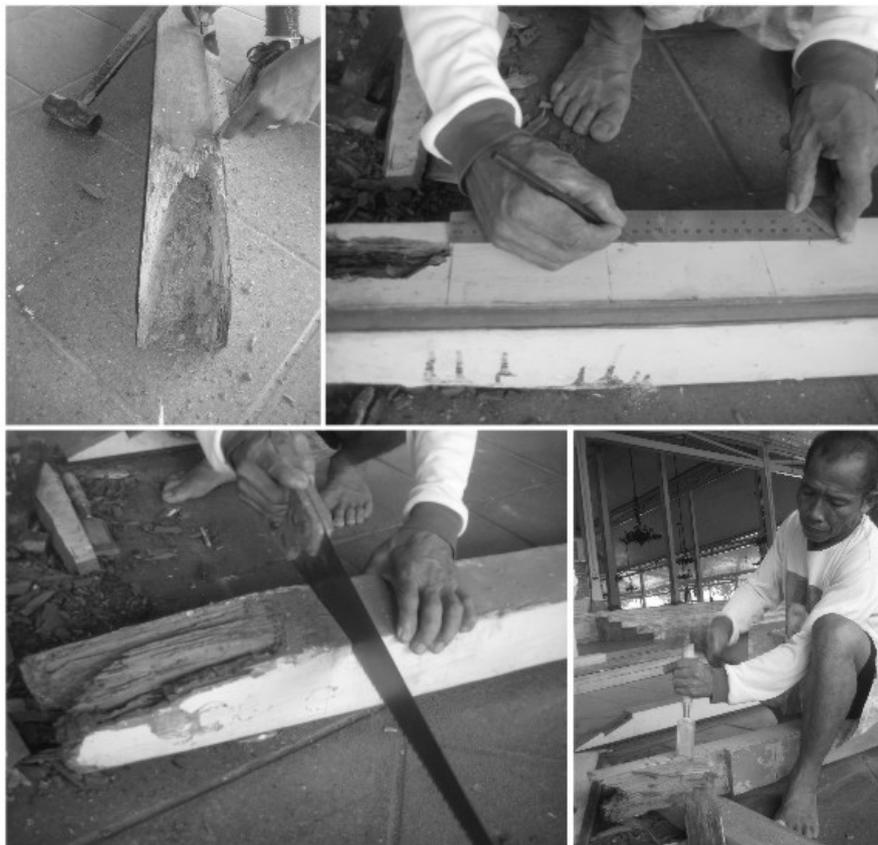
Replacing roof trestlework: (*top left*) identifying damaged parts, (*top right*) measuring to remove the damaged wood, (*bottom*) removing the damaged wood

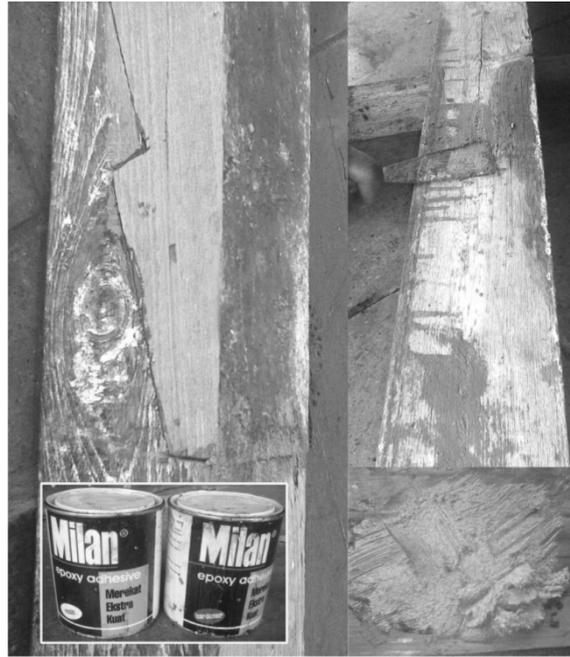
The original wood is glued together with new wood using epoxy, then the connection is camouflaged with wood putty.

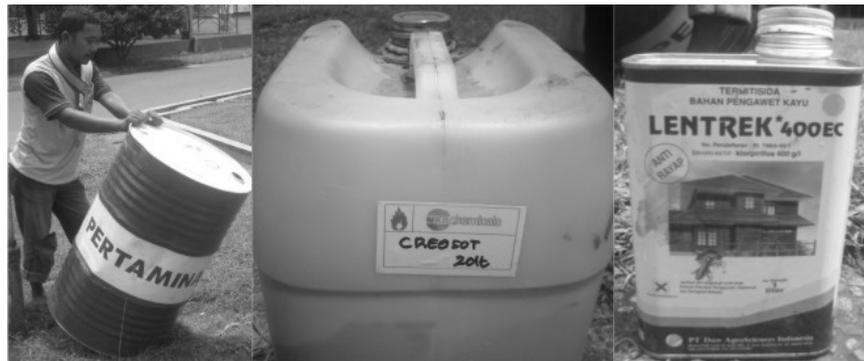
Chemicals used to prevent termites in Pendopo Ageng's restoration, as a mixture of kerosene, creosote, and Lentrek in the ratio 1:1:0.05

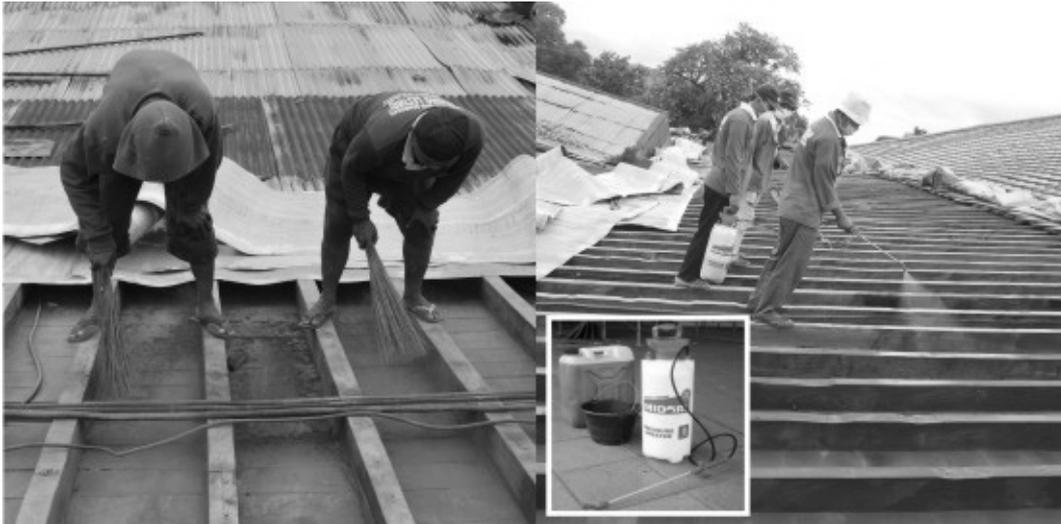
Treating materials. This integral part of building preservation efforts is aimed especially at preventing the occurrence of weathering which will indirectly affect the stability of the building. The main activities include the cleaning and conservation of material elements which have undergone weathering, and also the installation of a protective or waterproof layer suited to the building's structural condition. Chemical treatment to prevent termite attacks uses a mixture of kerosene, creosote, and Lentrek in the ratio of 1:1:0.05.

Conservation work on the roof of Pendopo Ageng

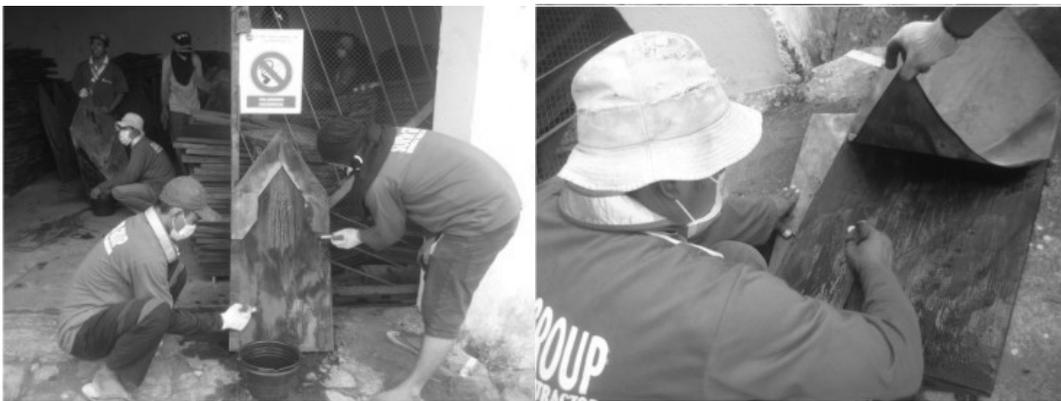
Application of chemicals to both sides of the original shingles, to prevent damage from termites

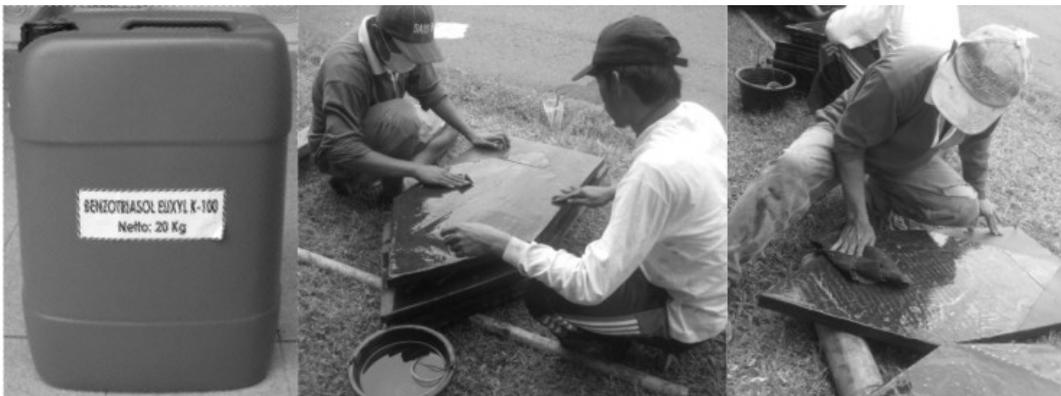
Using benzotriazole for conserving the copper plating on the original shingles

Conservation of the copper plating of the original shingles was also done by applying benzotriazole to the surface, to remove microorganisms and restore the copper's original color.

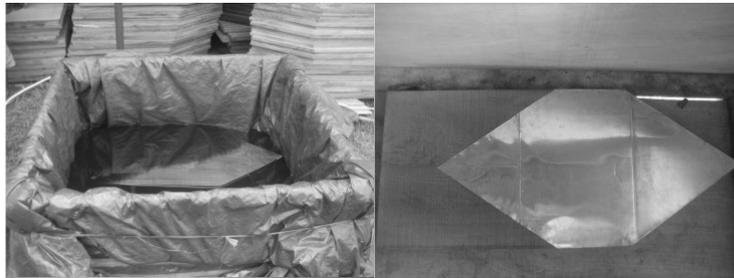
Left: soaking new shingles in kerosene, creosote, and Lentrek; *right*: copper plating applied to new shingles after soaking

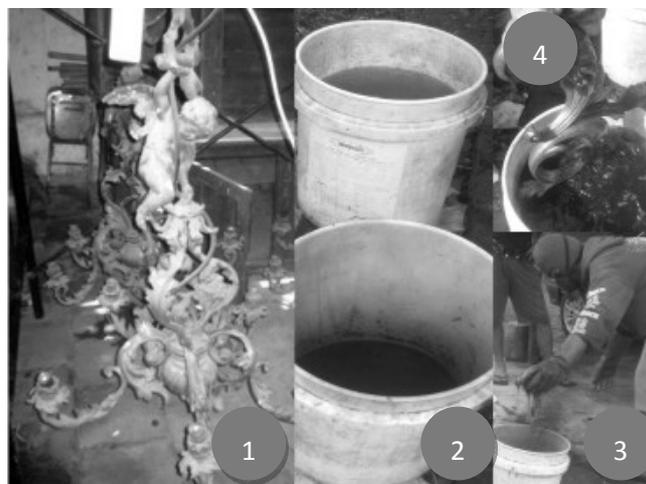
Conservation of a chandelier: (1) before conservation, (2) nitric acid (*top*) and sulfuric acid (*bottom*) used for conservation, (3) dipping parts in sulfuric acid, (4) dipping parts in nitric acid

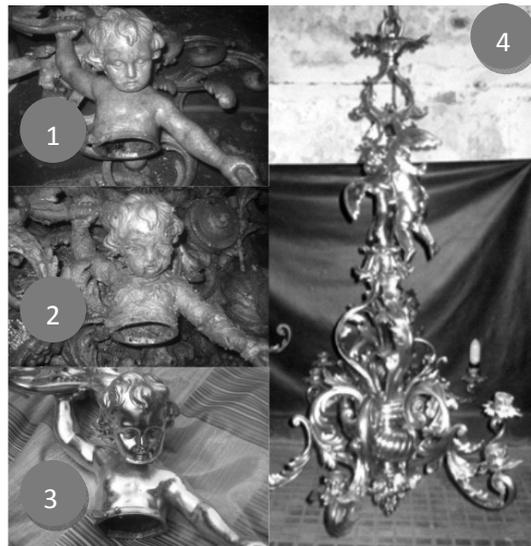
Conservation of a chandelier (continued): (1) a chandelier part before conservation, (2) after dipping in nitric acid then sulfuric acid, (3) after brushing, (4) chandelier after conservation

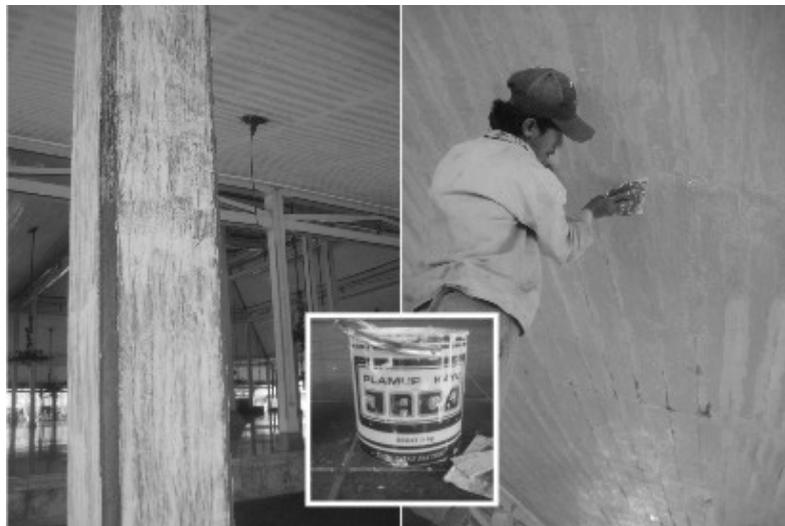
Further restoration work at Pendopo Ageng was done on the wood. Wood from which the paint had been peeled was then sanded and coated with putty so the fresh paint can easily adhere, then sanded again. Putty is applied not only to wooden pillars but also the ceiling, to prevent leakage.

The use of putty on the woodwork in restoration at Pendopo Ageng

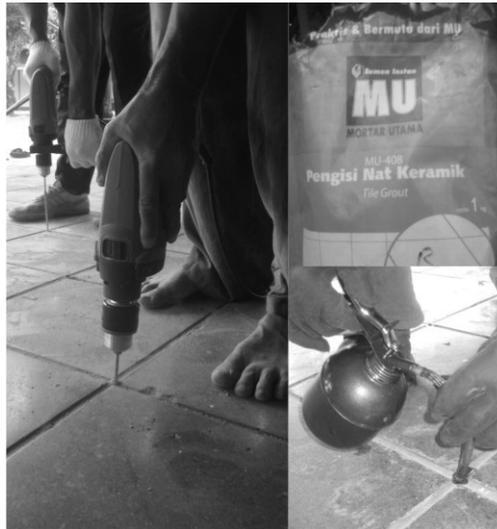
Injection of grout ceramic filler

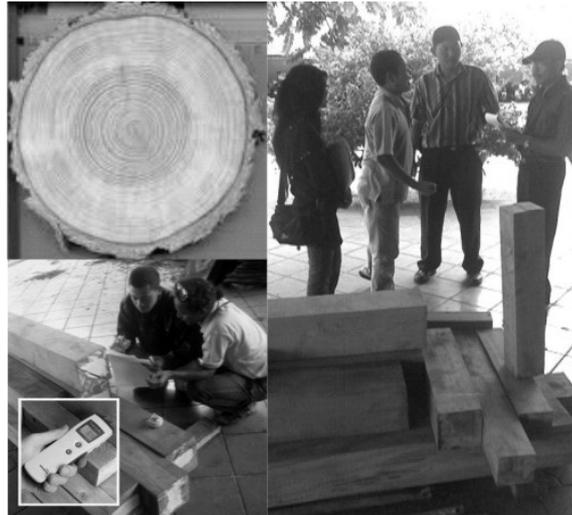
New teak wood for use to replace damaged components. The new teak wood must have the same quality as the original components and be at least 80 years old, with a moisture content of less than 14 percent. *Insert:* Protimeter, a tool for measuring the moisture content in wood.

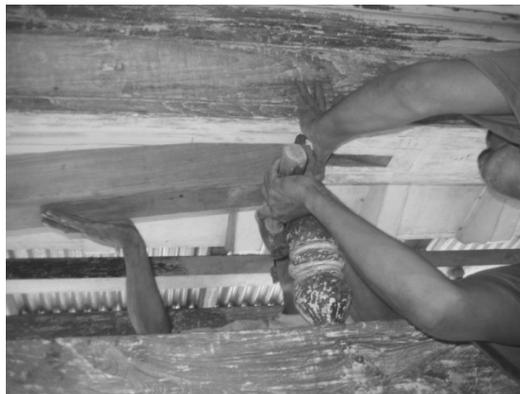
Replacement of wood components in the roof's trestlework

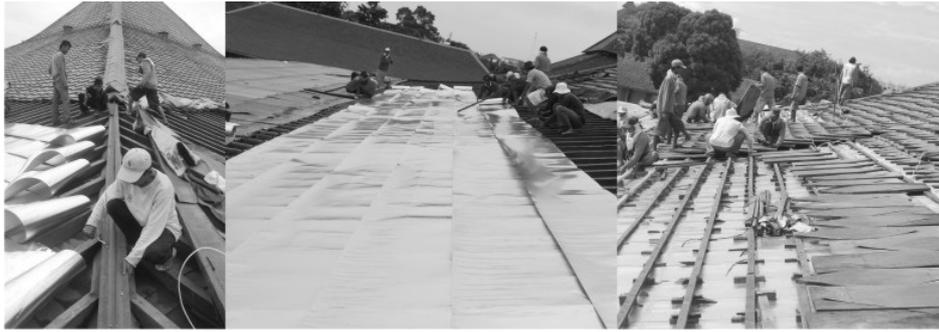
Installation of galvalume as a roof coating. Galvalume is used as a thermal barrier (insulator) and to prevent leakage. After the roof coating is laid, wooden ribs for the shingles are reinstalled.

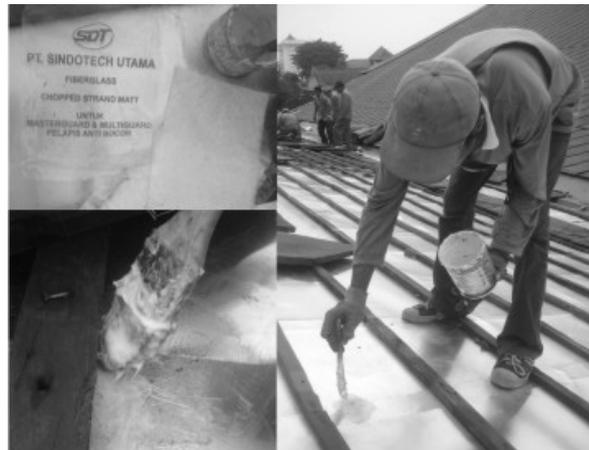
Fiberglass coating to cover cracks in the galvalume and to prevent further leakage

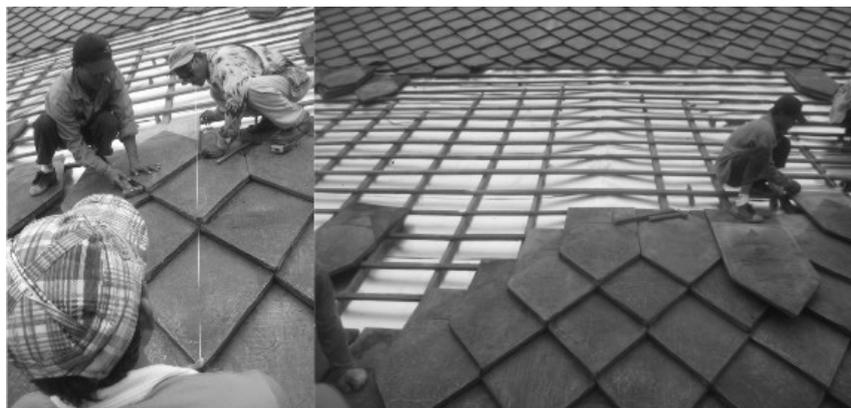
After work with galvalume and fiberglass is completed, the original shingles that are still usable are returned to their original positions by referring to the registration system.

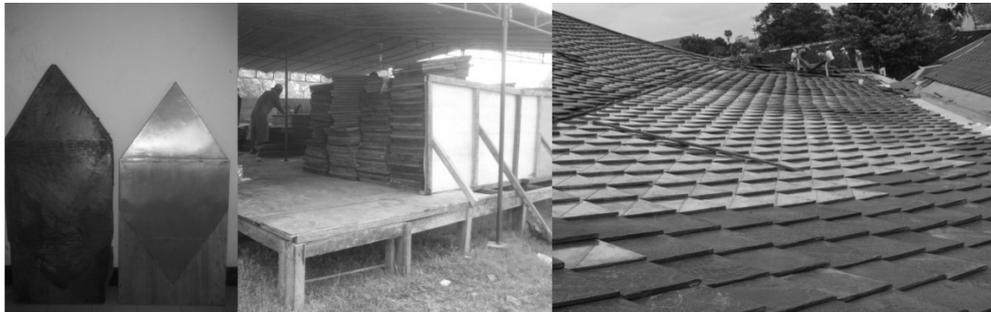
Installation of new shingles to replace damaged items

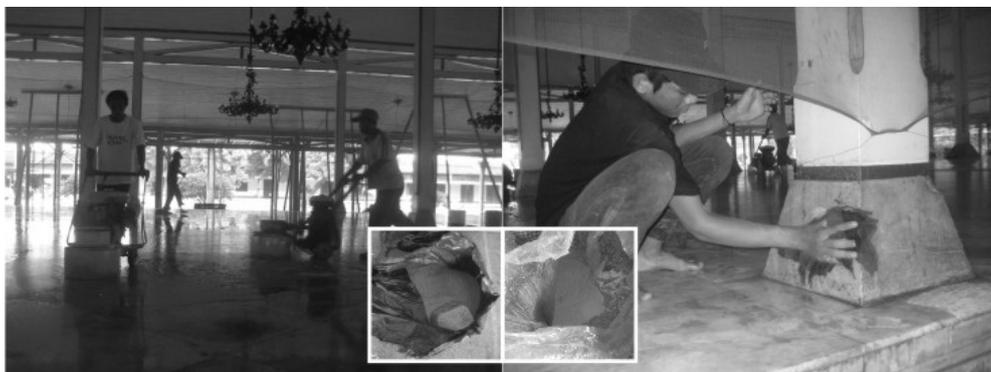
Activities post-restoration are to conduct land arrangement plans to protect and preserve the heritage building and its utilization. After all restoration work on Pendopo Ageng was completed, cleaning was done to remove trash and debris from the work. The floor was mopped to restore the shine to the ceramic tiles.

Finishing work on the floor, by mopping and wiping the floor and the pillar bases

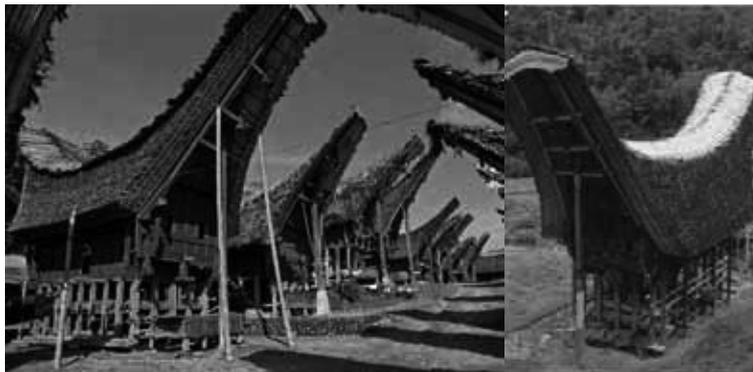
The orientation of the *tongkonan* is always to the north, the direction Toraja people believe symbolizes life. This is why in Torajan villages the houses stand in a row side by side from east to west. The rice granaries stand facing the *tongkonan* with their front gables facing south. *Parampa* is

the yard that lies between the *tongkonan* and *alang*. Here the crop is left to dry; it is also a place for children to play, women to work, and men to arrange cock fights.

Alang (right) and tongkonan (left)

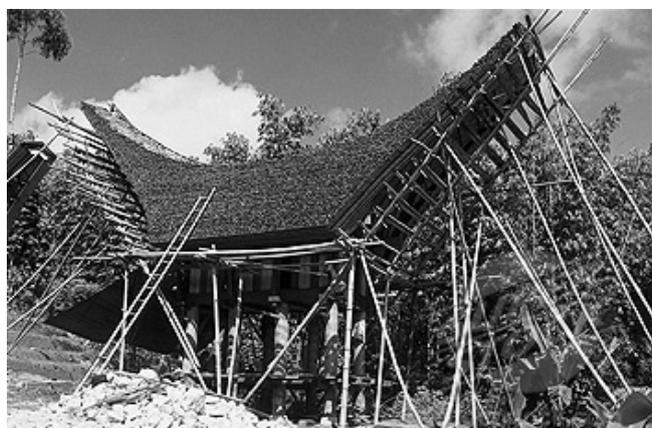
Tongkonan are built on wooden piles. They have saddleback roofs with ridge ends extending upward and so far beyond the walls they require an external free-standing post (*tulak somba*) for support. Traditionally, the roof was constructed with layered bamboo, and the wooden structure of the house assembled in tongue-and-groove fashion without nails. Nowadays, of course, zinc roofs and nails are increasingly used.

The construction of a traditional house is time-consuming and complex, and requires the employment of skilled craftsmen. First of all, seasoned timber is collected. Then, a shed of bamboo scaffolding with a bamboo shingle roof is erected. Here, components of the house are prefabricated, with the final assembly to take place at the actual site. Almost invariably now, a *tongkonan* is raised on vertical piles rather than a log cabin type substructure, so all wooden piles are shaped and mortises cut in them to take the horizontal tie beams. The piles are notched at the top to accommodate the longitudinal and transverse beams of the upper structure. The substructure is then assembled at the site. Next, the transverse beams are fitted onto the piles, then notched and the longitudinal beams set onto them, and the grooved uprights that will form the frame for the side walls are pegged in place.

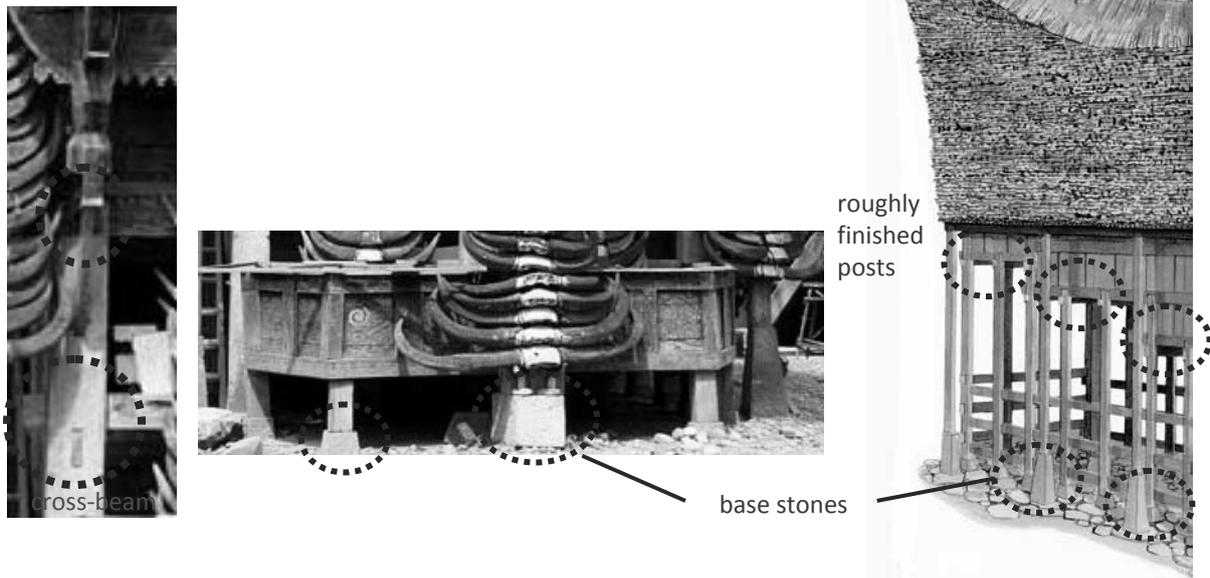
Atop the end of each post, a transverse beam and a longitudinal beam are set at right angles. These beams, called *tangdan*, transfer the load from the upper structure to the substructure. Below each partition of the ground floor stand posts running transverse to the main axis. One of these posts, called *ariri posi'* (navel post), is located in the center of the house, and is the main post in terms of philosophical meaning.

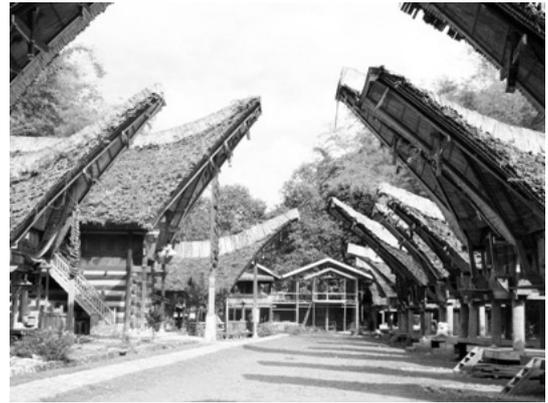
Tongkonan used bamboo and thatch for the roof covering

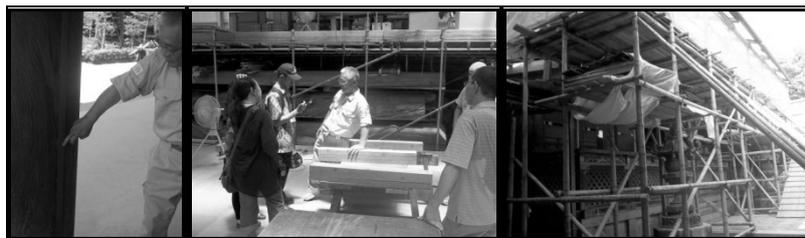
Mr. Imanishi explaining the reconstruction of pillars at Toshodaiji, and carpentry and conservation work on the roof at Tanzan shrine (*photo: Nikko Suko*)

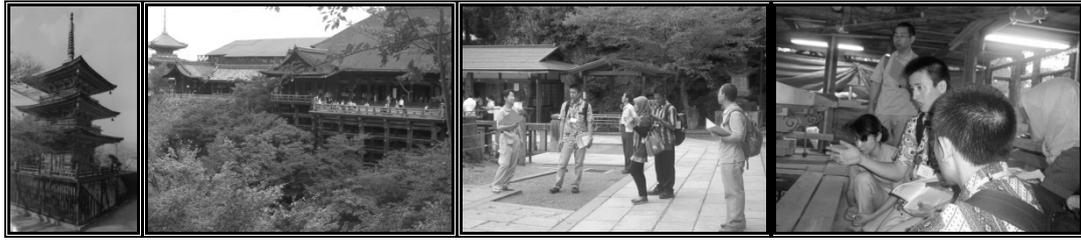
Field study at Kiyomizudera temple (*photo: Nikko Suko*)

The sixth lecture was at the Kiyomizudera temple complex in Kyoto. Aspects were explained of what is obtained in an effort to preserve heritage buildings. Also, the renovation of a heritage building or of a complex must have the necessary technical people and experienced carpenters. In renovation activities at Kiyomizudera one of the obstacles is the presence of so many visitors that it blocks the activities of renovation. The lecture also explained that conservation is increasing the resilience of buildings and also enhancing their cultural value.

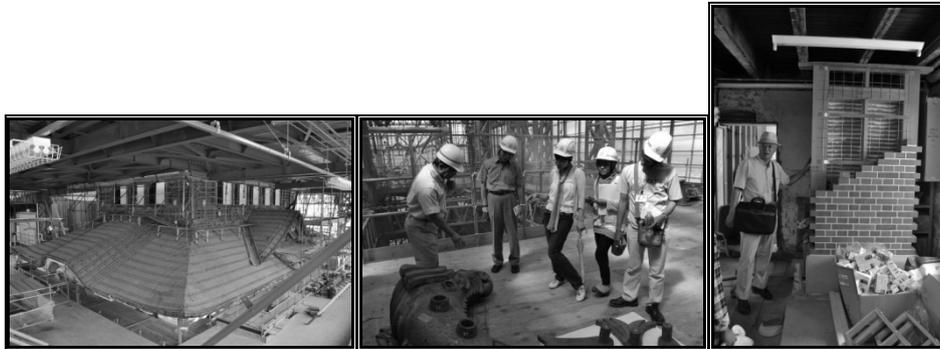
Renovation of roofs and walls at Himeji castle and explanations on building renovations in Kobe (*photo: Nikko Suko*)

The tenth lecture was held on-site at Himeji castle in the Hyogo prefecture. Apart from describing the history of the castle, it also explained the activities that were given priority in the current renovation, such as the renovations and plastering of the walls. There were explanations of the plastering techniques and materials used, and also about how many years they would hold up.
