ACCU Nara
International Correspondent **Vol.17** 2017
The Seventeenth Regular Report

The ACCU correspondents periodically send reports on cultural heritage protection activities in which they have been recently involved. This is a collection of fifteen reports submitted by international correspondents in the Asia-Pacific region.

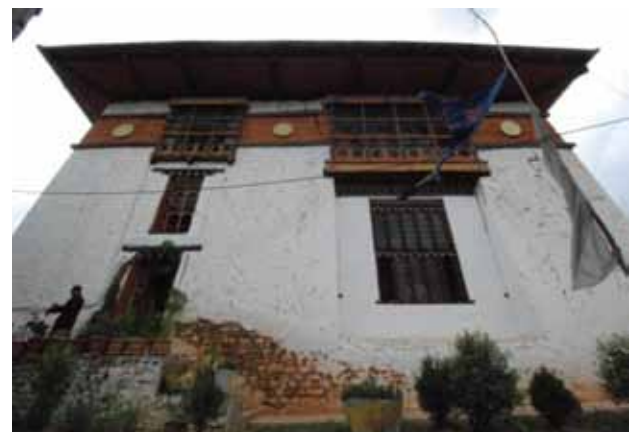
Fig.1 Front facade (East) of the Lhakhang before renovation

Wangditse Lhakhang under Thimphu Dzongkhag is one of the most important heritage sites in Bhutan. It is said to have been built by the 9th Desi, Druk Rabgye, in the early 18th century. However, the Lhakhang has suffered several areas of damage to the masonry walls, which worsened during the earthquake of September 2011.

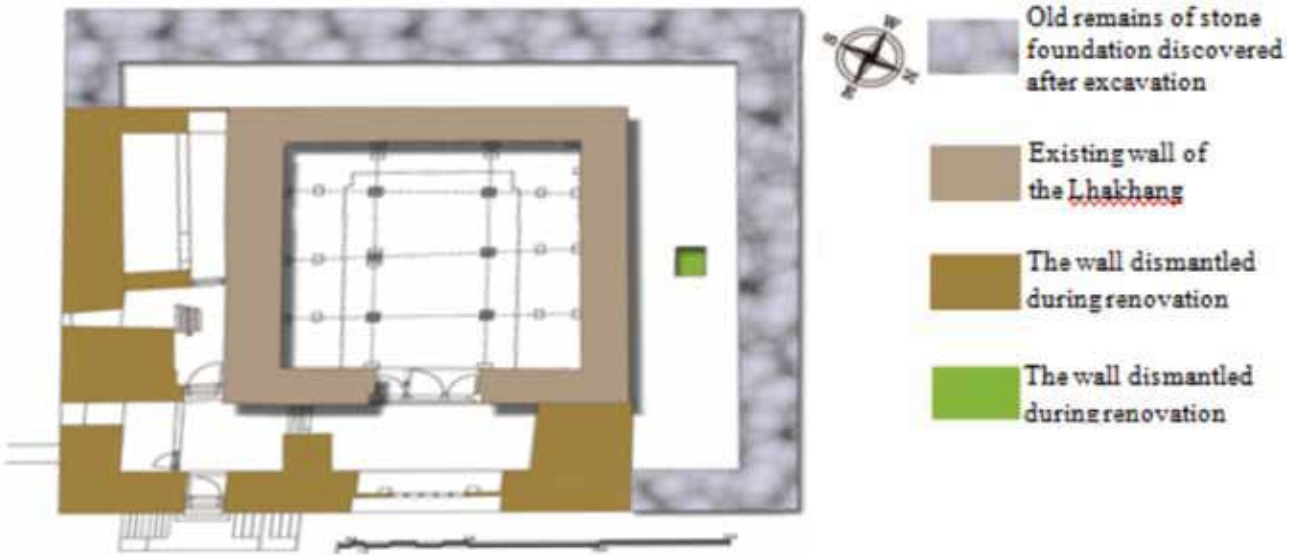
Fig.2 Plan showing existing wall, dismantled wall and stone foundation discovered after excavation

Therefore, the renovation of Wangditse Lhakhang started in July 2011. During the renovation, an archaeological survey was carried out and it was discovered that there were some remains of the stone foundation southwest and northwest of the current existing external wall. The existence of a circumambulation room around the main shrine room was also discovered.

As per the findings of the archaeological survey, construction of external walls on the southwest and northwest sides began. The existing southeast external wall was dismantled to be reconstructed, since the wall was in poor condition and unstable. Special stones ordered from Dawakha quarry under Paro Dzongkhag are being used for wall construction while granite stones from Sha Ngawang under Wangduephodrang are being used for corner stones.

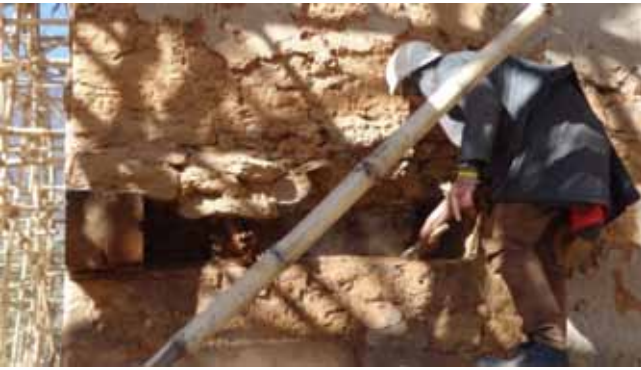
Fig.3 Surface being prepared for wall stitching

The old walls with cracks were consolidated by stitching and grouting as per the recommendation of conservation specialist David Michelmore. The areas where the walls were to be stitched were cut and cleaned thoroughly by removing loose mortar. The cut surface was wetted with sprinkled water, and mortar was laid over it. A stainless steel wire mesh was then placed above a layer of mortar and the new wall was constructed over it. The stitching was carried out at certain intervals. The grouting was carried out in order to fill up the voids that had developed inside the wall due to the crack and also to bind the inner and the outer leaf of the wall using an overhead tank and a 20 mm diameter flexible pipe. The grout was prepared on site by mixing local soil, lime and water in the ratio of **3:1:2.5** (3 parts of sieved soil: 1 part of lime: 2.5 parts of water). Holes 30 mm in diameter and 45 mm deep were drilled into the wall at certain intervals using a core drill. The grout was then injected into the holes.

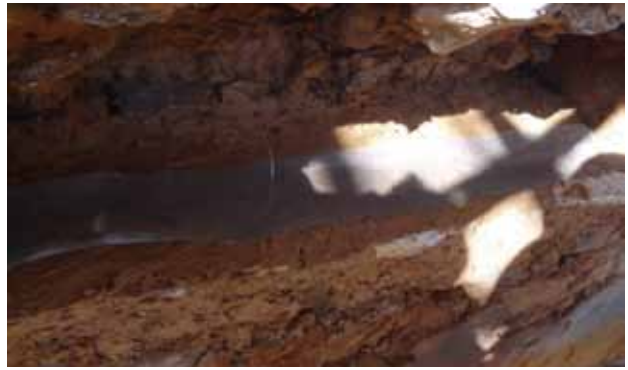
Fig.4 Wire mesh laid over the layer mortar

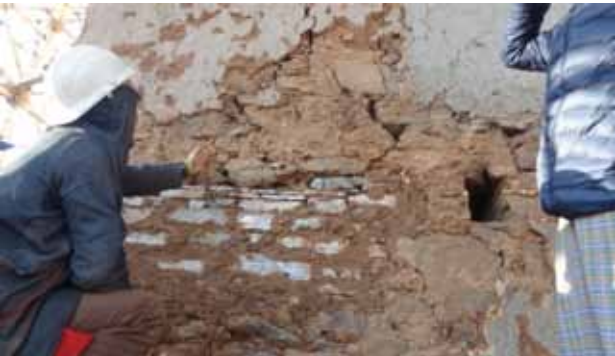
Fig.5 New wall constructed to stitch cracks on old wall

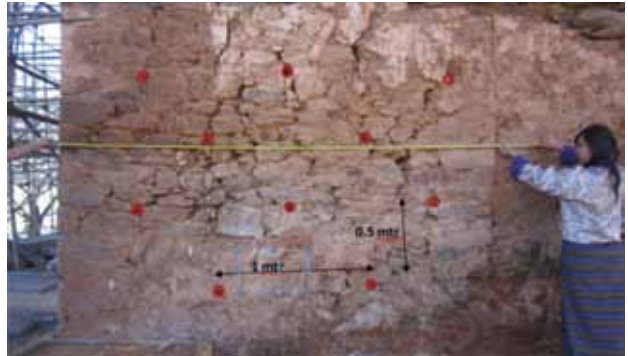
Fig.6 Red mark showing the location of drilled holes into which the grout was injected

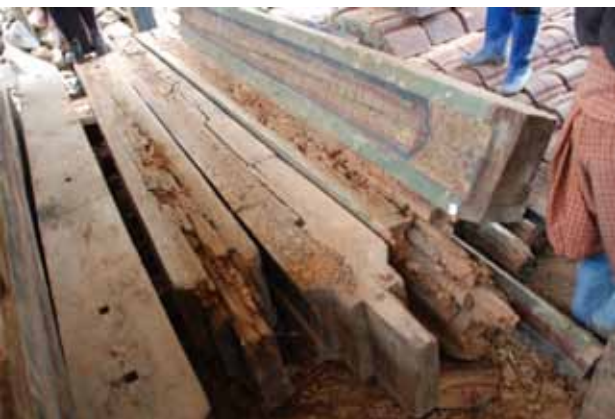
Fig.7 Decayed timber components which were not exposed to the air

It has been challenging when it comes to preserving timber components, which deteriorate much faster than other historic building materials, timber being an organic material. While carrying out the renovation works, it was found that most of the timber components were not reusable. Timber inserted into the wall and unexposed to the air was found to have decayed, thus hampering the structural stability of the Lhakhang. Timber is also affected

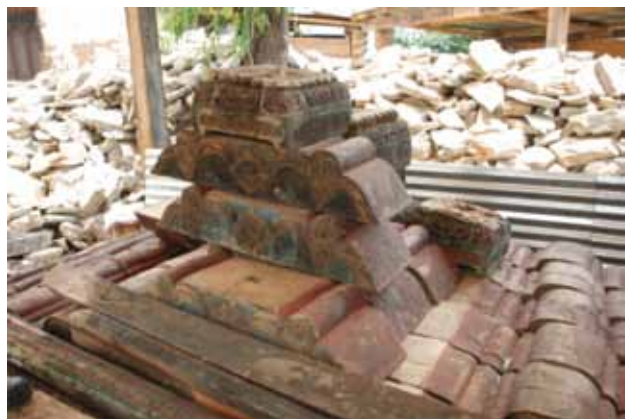
Fig.8 Reusable old timber members

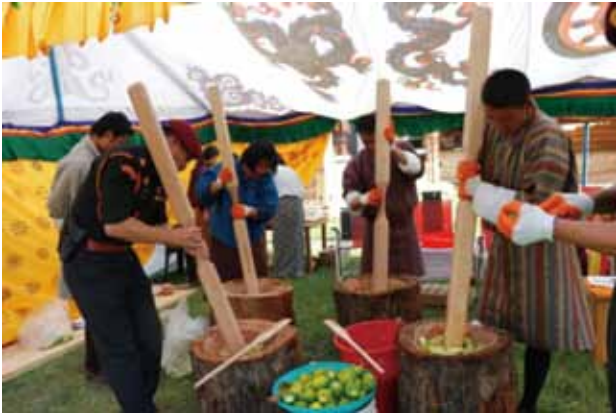
Fig.9 Persimmon being crushed with traditional mortar and pestle made of oak

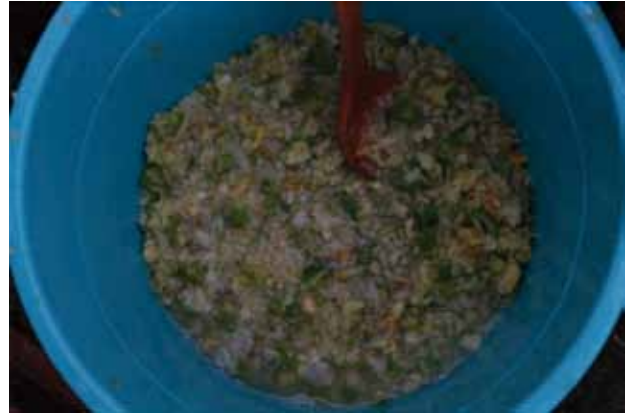
Fig.10 Crushed persimmon being mixed with distilled water

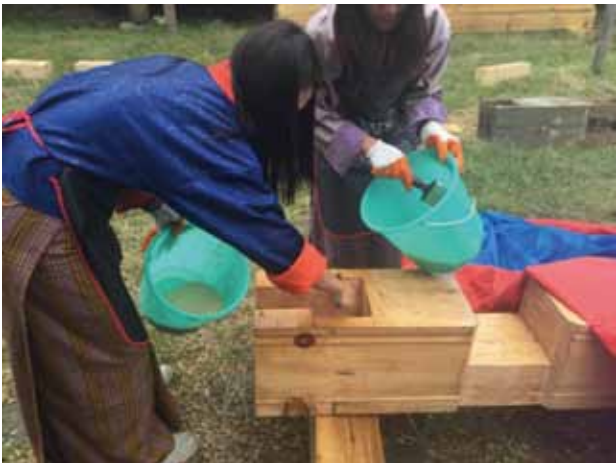
Fig.11 Applying fermented persimmon liquid to new timber components

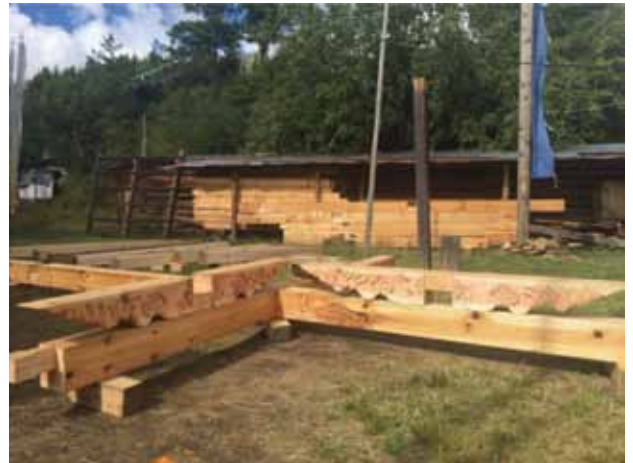
Fig.12 The timber components being allowed to dry after application of the persimmon liquid

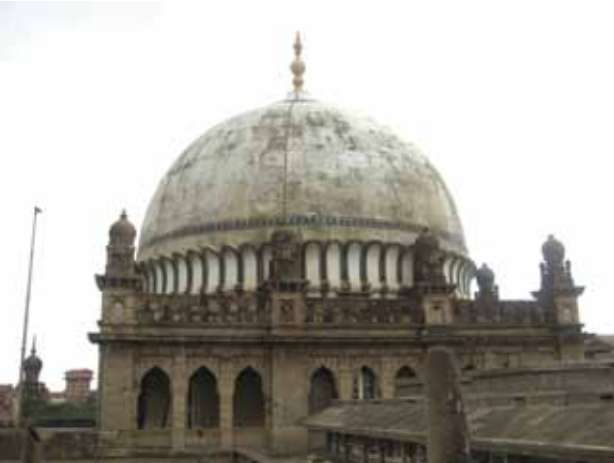
The discoloured main central dome with dust and grime deposits

The cement chemical membrane coating on the china mosaic of the main dome was removed by scraping and water washing with a non ionic detergent, followed by further scraping and cleaning with brass fine wire brushes.

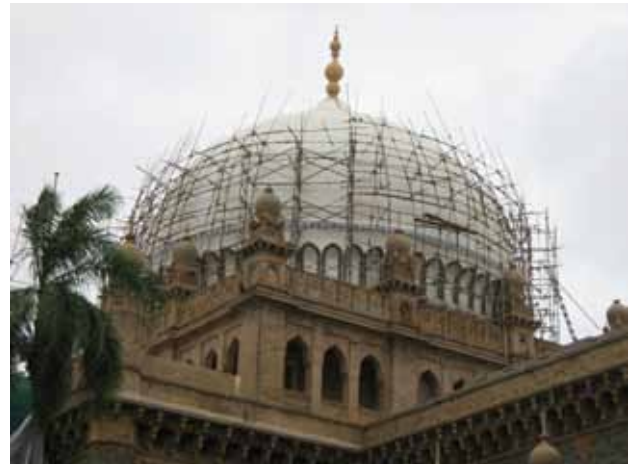
The original shine on the white dome after the non-abrasive and non-chemical cleaning process

The process of removal of the membrane was repeated until the original shine of the china mosaic was seen, followed by rubbing dry white cement to bring back the original glaze. The small domes were grouted by drilling holes through the china mosaic surface of the dome up to the depth of the inner concrete base and fixing 12 mm diameter pipe nipples at 1 meter c/c staggered spacing in both directions with removable putty. Acrylic polymer grout mixed with white cement was used in a standard grout pump, with calibrations to avoid rupturing of the shell. The same procedure was followed to grout the flat terrace area also. All the drain-mouths on the terrace were

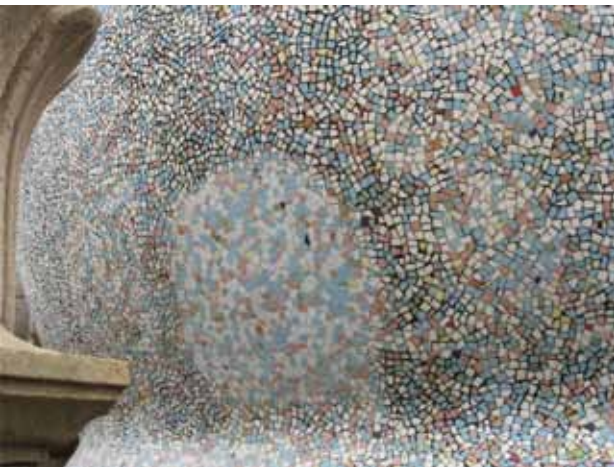
The China mosaic dome during the cleaning process

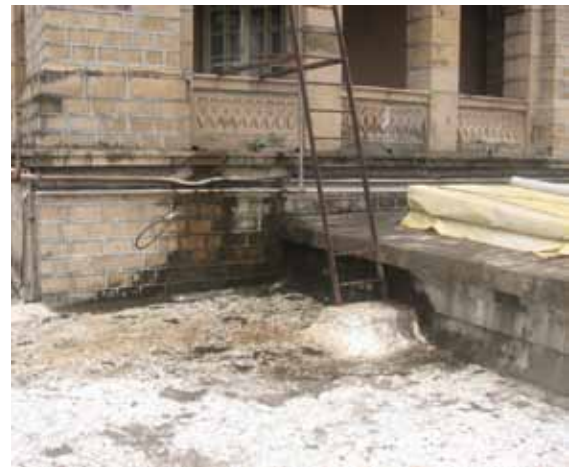
Leaking rainwater pipes and poorly managed storm water drainage on the terrace

The original rainwater drainage system was thoroughly inspected during monsoons to check for leakages and seepages as well as assess the functioning of the existing CI down-take pipe sections, and those found to be faulty or extensively corroded were to be replaced entirely or in part and along the bends. Faulty down-take pipes were causing moisture ingress in the masonry walls. The soil pipes were also to be replaced in part if there were any

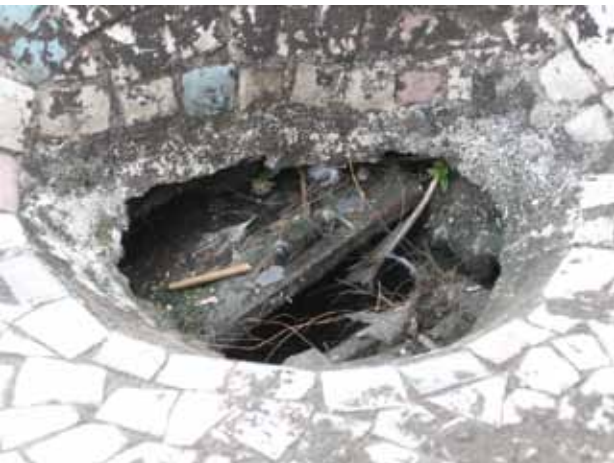
Clogged drain-mouths on the terrace surface that had prevented complete drainage of surface runoff rainwater

cleaned, the objects that had led to choking cleared, broken spouts replaced, and inner slopes corrected and protected by SS mesh.

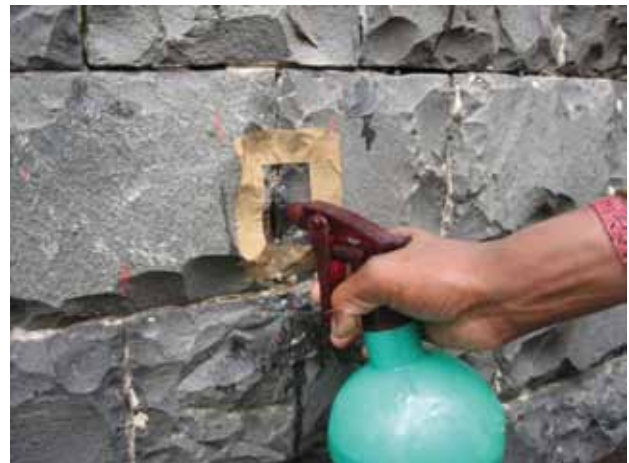
Removal of ficus growth and application of chemicals in the crevices to kill roots and prevent further growth

Ficus growth was found on the wall surfaces along the different components of the building, indicating defects in pointing and the presence of cracks and crevices in cornices and walls, brackets and other ornamental stone works. It was also proof of inadequate drainage of storm water. The plant growth was removed by pulling out the root systems embedded in the masonry, cutting the stems and roots, and the application of patented chemical biocide such as 'Glycol' so as to prevent any re-growth. The area was then made good with lime and mortar.

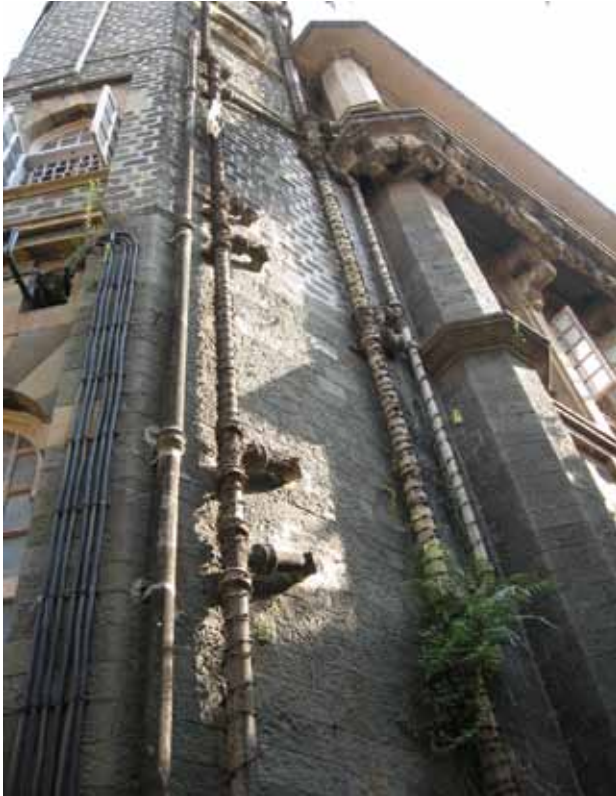
Leaking water pipes give rise to ficus growth and seepage of water into the masonry surface

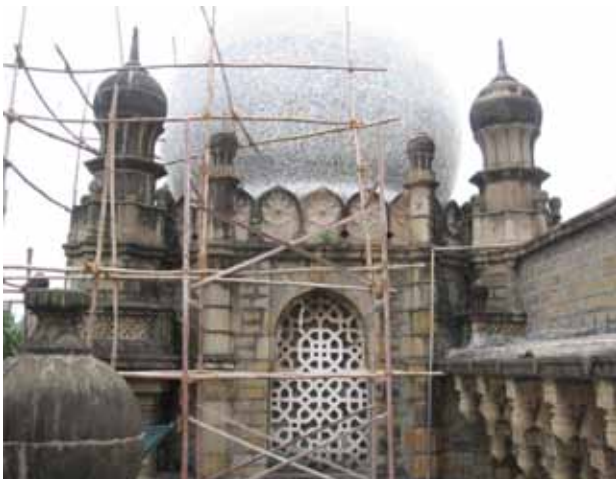
Discoloured masonry wall surface with dirt grime and salt deposits on the left and a cleaned clear surface on the right

façade before commencing the restoration works. The stone surface of the walls were gently cleaned with the 'Water Misting' technique employing an air water jet using a fine nozzle sprinkling system calibrated to spray a fine mist along the stone surface followed up by gentle brushing with soft nylon brushes. Chemical thinners and solvents were used to remove stubborn oil and emulsion stains on the stringer courses, decorative elements and stone surfaces. Clay poulticing was also adopted where required.

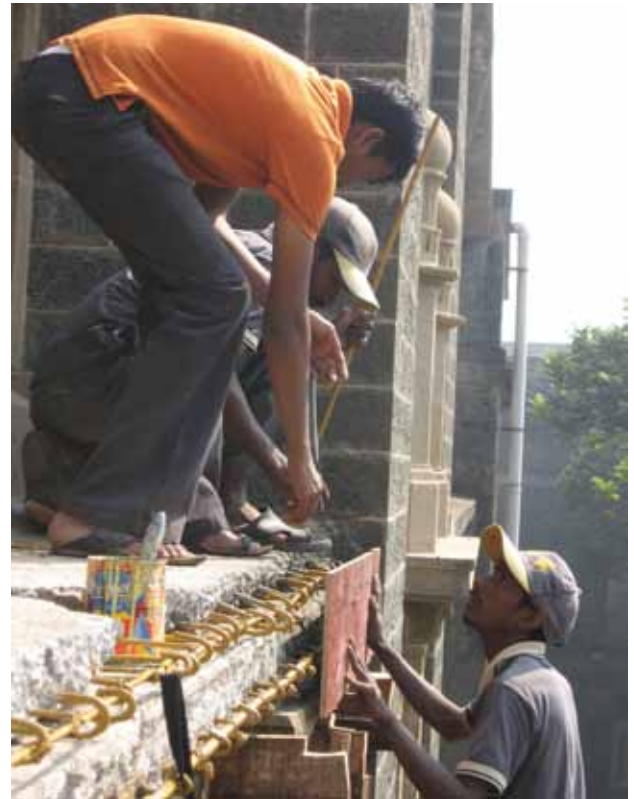
New reinforcement along the chajja and shuttering in progress for repair using acrylic polymer, cement and quartz sand

The *chajjas* (sunshades/eaves/overhang) with brackets, beams and slabs beneath were found to have deteriorated, and there was de-laminated plaster along some portions as well as exposed and/or corroded steel reinforcements. These needed to be structurally consolidated. The deteriorated plaster and concrete of the *chajjas*, beams and slabs were removed after adequate propping, the steel reinforcements were cleaned with wire brushes and rusticide, and chemical coating was applied. Acrylic

polymer, cement and quartz sand in appropriate proportion of weight were applied in layers to repair the chajja slabs after suitably shuttering along the edges.

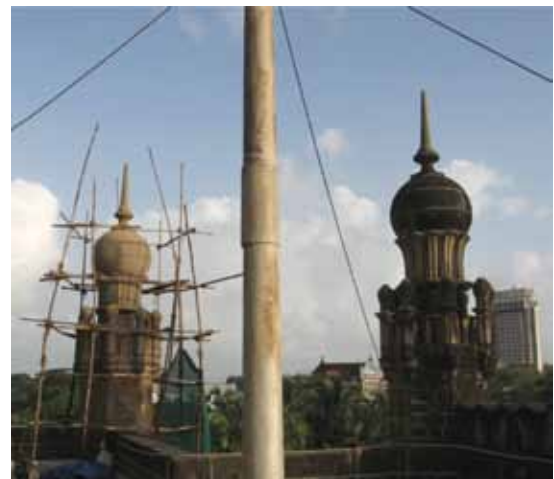
Discoloured urns and finials and other decorative elements with dirt grime and salt deposits on the right and a cleaned and repaired surface on the left

Parts of the ornamental Malad Stone urns like the finials, carved bases or the domes were either missing or damaged. Some portions of the masonry walls had small as well as major cracks and severely distressed stone sections in Kurla Basalt. New finials, stone bulbs and caps etc in matching Malad stone were carved by skilled craftsmen and fixed to damaged, missing stone guldastas, chhatris and other ornamental stone work in the urns. They were fixed with SS dowels and epoxy plugs by making the necessary grooves, keys and jointing etc with lime mortar and pozzollanic additives such as brick surkhi or white cement.

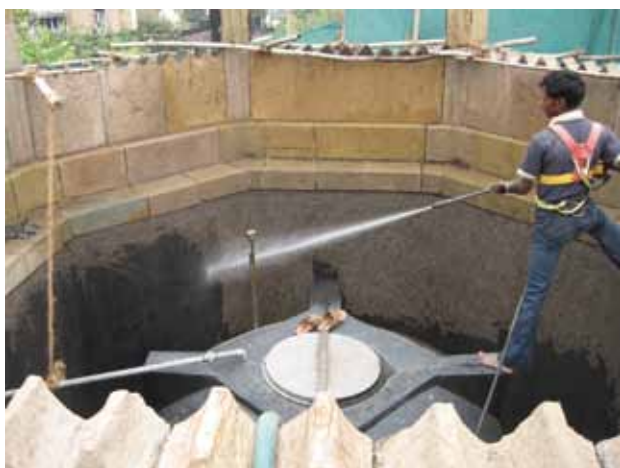
Cleaning discoloured surfaces using the water misting technique with a calibrated pressure pump and nozzle

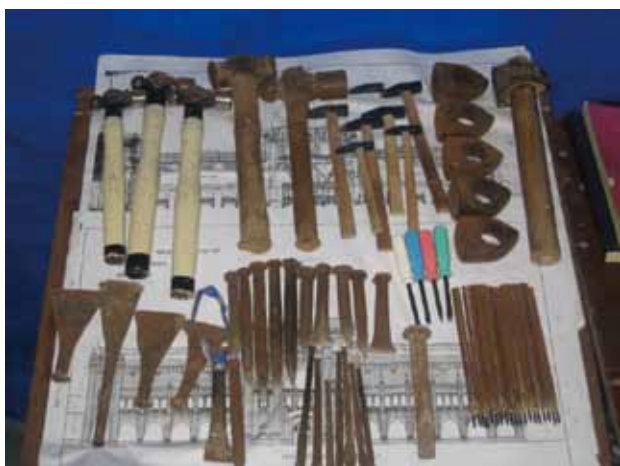
Tools used to remove the stubborn cement pointing, rake out incongruous mortar and carry out re-pointing in lime mortar

portions of all the walls at some point in time, which not only ruined the aesthetic value of the building but also prevented the effective breathing of the masonry walls. All the hard ribbon cement pointing was removed by raking out incongruous mortar very carefully so as not to damage the masonry, and re-pointing was done in lime mortar in a 1:3 ratio to match the original colour using traditional additive materials like katha. The missing pointing work along the entire exterior surface of the building masonry and decorative elements was also undertaken in a similar manner. Specialised tools and masking tape were used to ensure clear lines and a high level of workmanship on site.

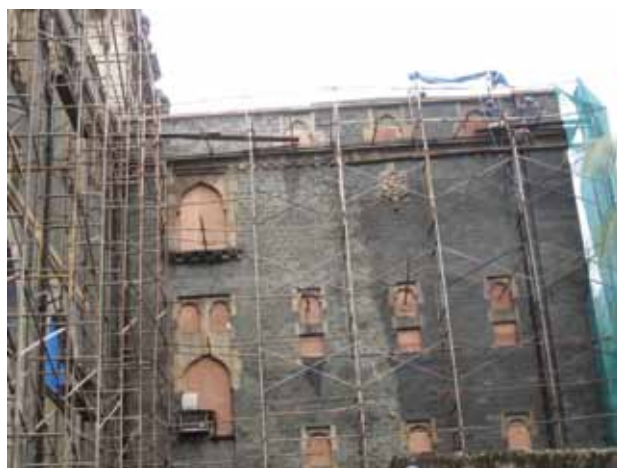
Temporary partitions using 4 mm thick commercial plywood were fixed to isolate the windows and other interior areas from the water misting and other works on the exterior

Masonry walls with ribbon cement pointing removed, re-pointing done in lime mortar, and washing using the misting technique after blocking all openings temporarily using plywood boards

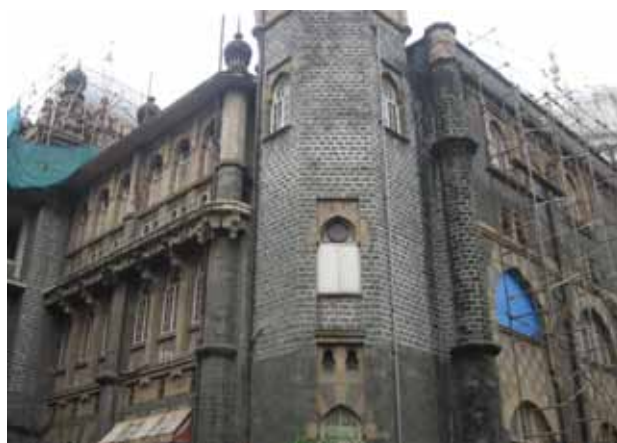
The ribbon cement pointing seen on the upper half of the corner tower has been added, while the original lime mortar pointing can be seen on the lower half

The original lime mortar pointing on the stone facade had been replaced by cement-based ribbon pointing on many

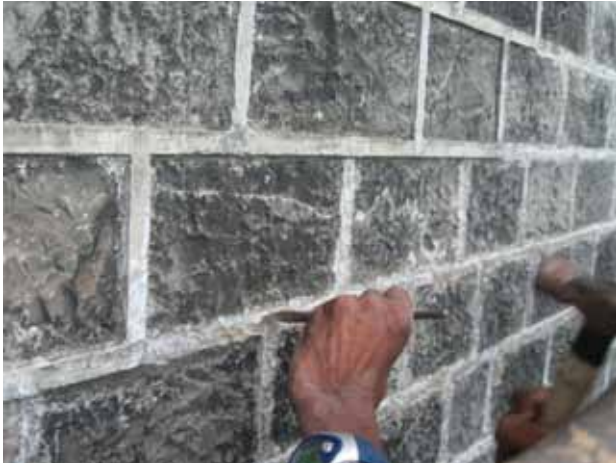
Removal of ribbon cement pointing

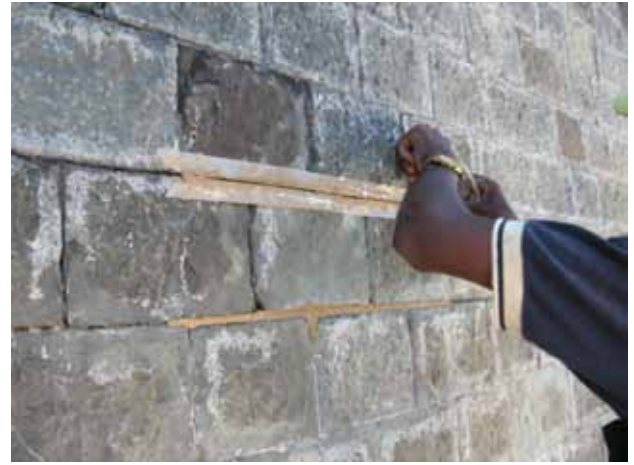
Re-pointing in lime mortar after covering the sides with masking tape

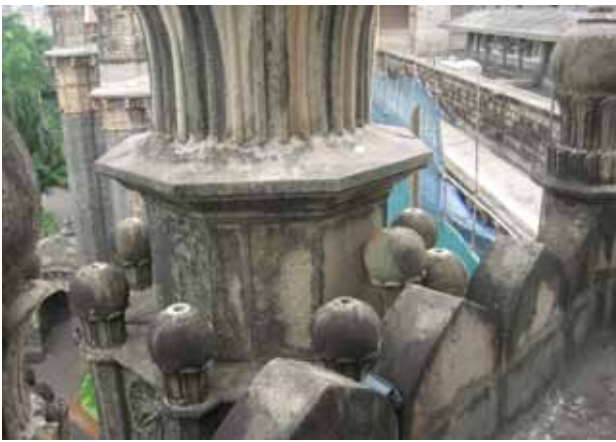
The domes and finials of the *guldastas* were in a damaged condition. The fallen domes were collected and refixed again

Where such elements of the ornamental work were found to be loosely held or lying around on the ground, they were re-fixed using the same method as above.

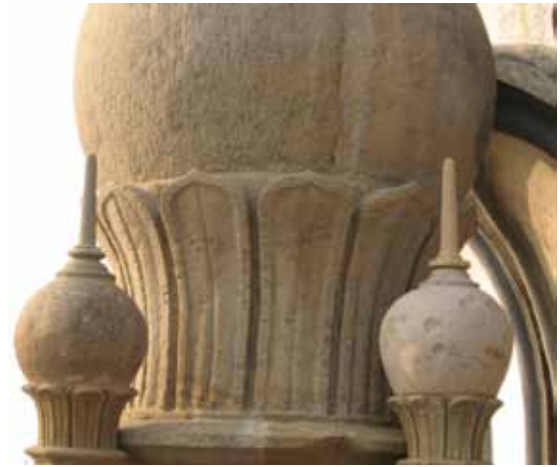
A newly carved *guldasta* dome and finial fixed beside an original and existing one

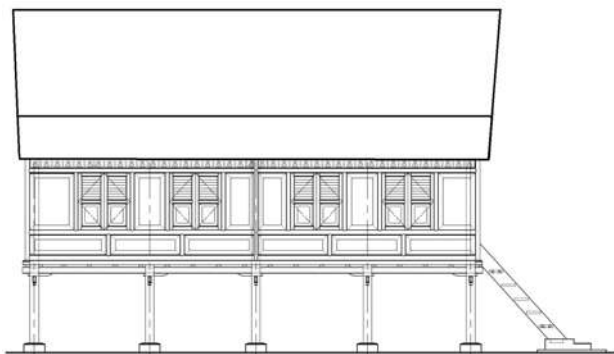
The front elevation of the Bugis house showing its timber stilts, louvered casement windows and decorated wall panels.

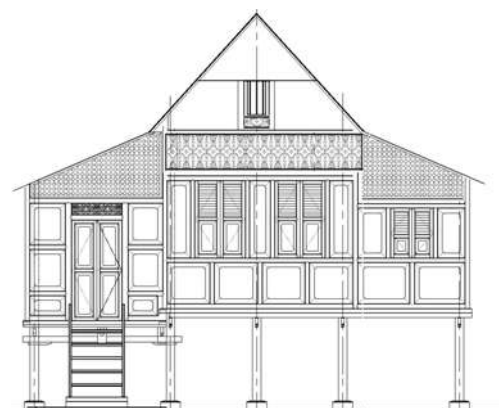
The right elevation of the Bugis house showing its external staircase leading to the entrance door, carved lattice panels, louvered casement windows of two sizes, double-layered gable end with a small window and a pitch roof.

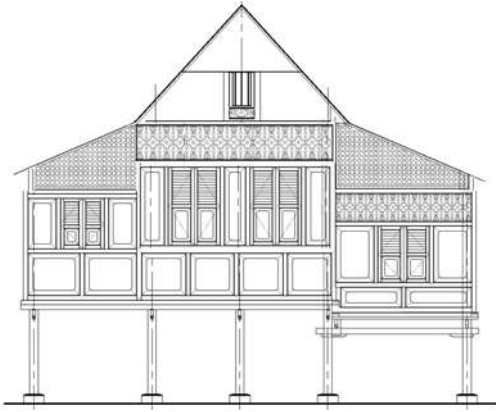
The left elevation of the Bugis house showing the two floor levels which are the lowered verandah (*serambi jatuh*) and main area (*rumah ibu*).

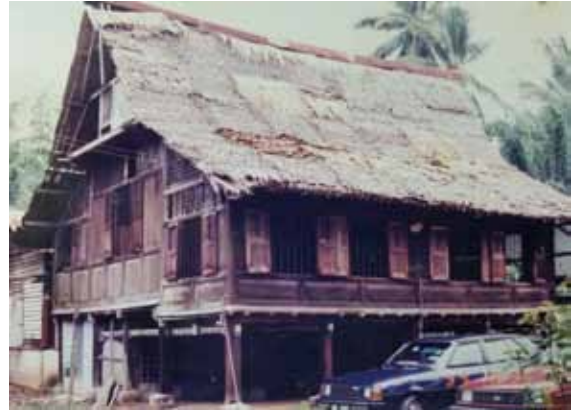
The front view of the Bugis house in 1999 revealing building defects such as a missing gable end, broken carved lattice panels and decayed thatched attap roof made of palm leaves.

The Bugis house, which was left abandoned for a period of time, deteriorated rapidly due to decayed timber structures, termite infestation, roof leakage and poor maintenance. The kitchen section fell into a state of disrepair and was demolished. A new annex was constructed using bricks, timber and zinc roofing to replace the kitchen section. A dilapidation survey was conducted prior to restoration works to identify major defects of the house, causes of the defects, methods and techniques of restoration as well as relocation. Decayed timber structures, poor condition of the palm leaf roofing, decayed windows and broken lattice panels were revealed as some of the common building defects. An architectural drawing or measured drawing of the house was drawn accurately to scale for reference during restoration and relocation.

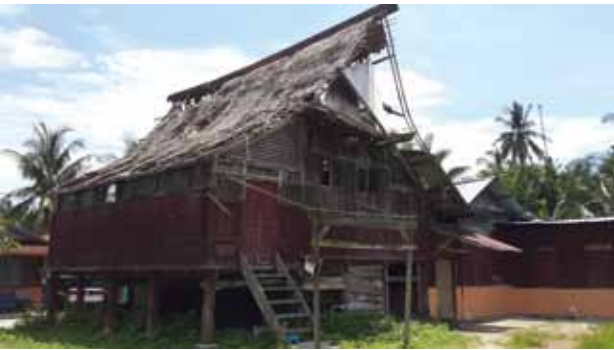
View of the Bugis house in 2014 after it was left abandoned and had deteriorated rapidly due to decayed timber structures, termite infestation, roof leakage and poor maintenance.

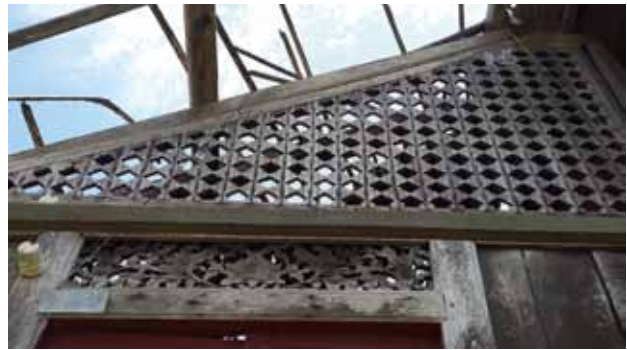
Carved lattice panels (*kerawang*) decorated in floral motif carvings and geometric patterns adorned the upper walls of the Bugis house.

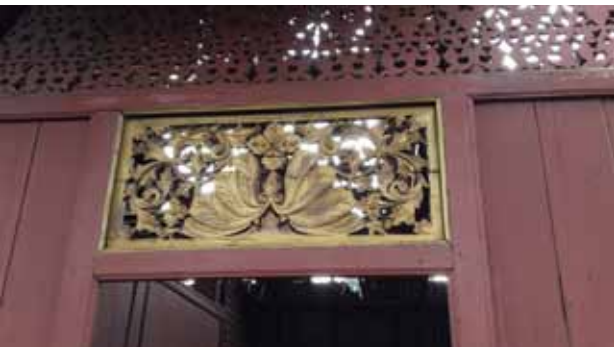
Painted in a shade of gold, the intricate floral motif carvings above the door frame reflect highly-skilled carpentry.

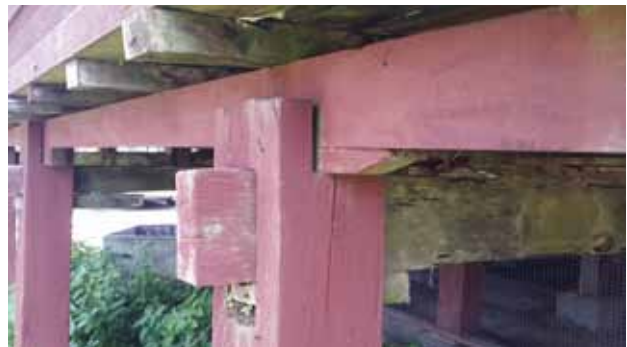
The entire Bugis house was constructed without the use of a single nail but it was locked using timber peg frames and wedges.

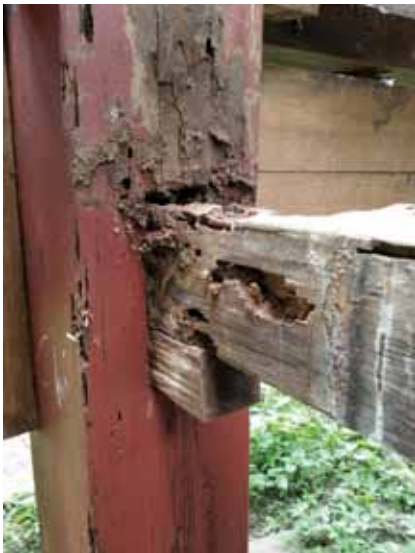
Decayed timber stilt and floor beam due to natural decay and termite infestation.

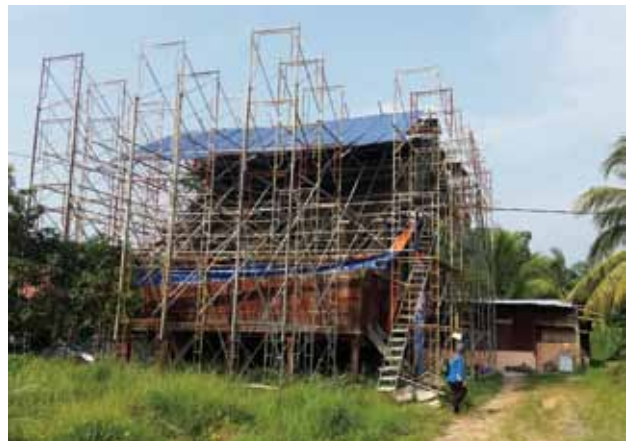
During the dismantling stage, scaffolding was erected around the Bugis house to support the building structures, while temporary roofing was constructed above the house to protect the interior from heavy rainfall.

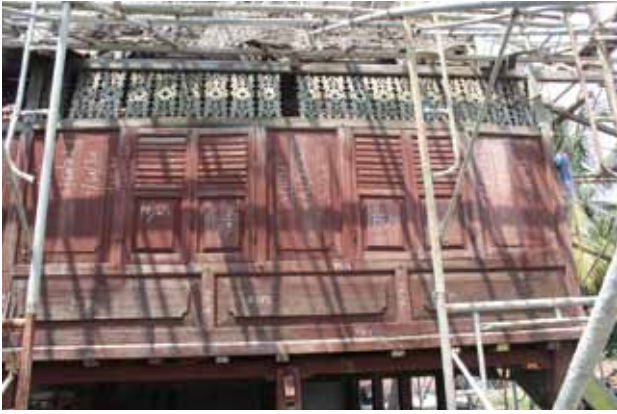
Special codes were marked on timber elements before dismantling and salvaging.

- Provide special codes for building structures and elements for reference.
- Dismantle the entire house and document the dismantling process in detail.
- Verify existing timber species and strength group.
- Identify timber condition.
- Salvage any existing timber for reconstruction.
- Document the condition of the house through the Historical Architectural Building Survey (HABS).
- Conduct video documentation of work on site.

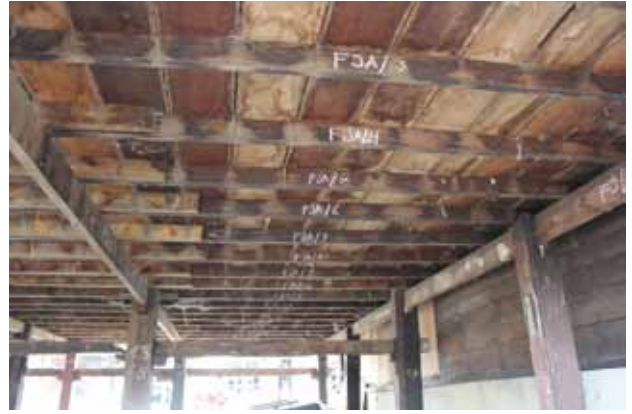
All timber structures including stilts, floor beams and floor joists were marked and coded for reference.

- Mark or label existing timber structures and elements for reference.
- Transport all dismantled building materials from the site to a sawmill in Kelang.
- Conduct timber treatment including repair, replacement and replication.
- Upgrade timber species and strength group.
- Pack and store treated old and new timber.
- Transport the timber structures and elements from Kelang to Shah Alam.
- Document the treatment, transport and relocation process.

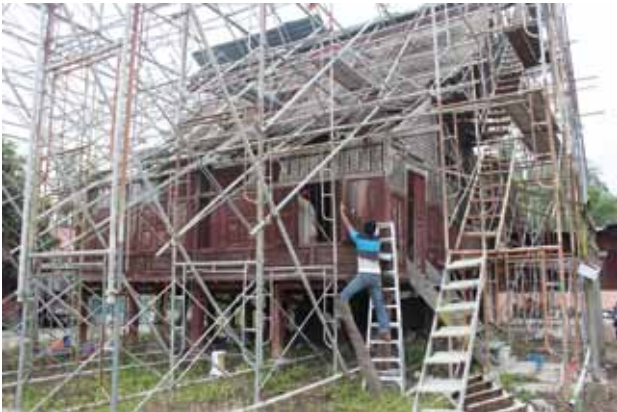
Dismantling the Bugis house.

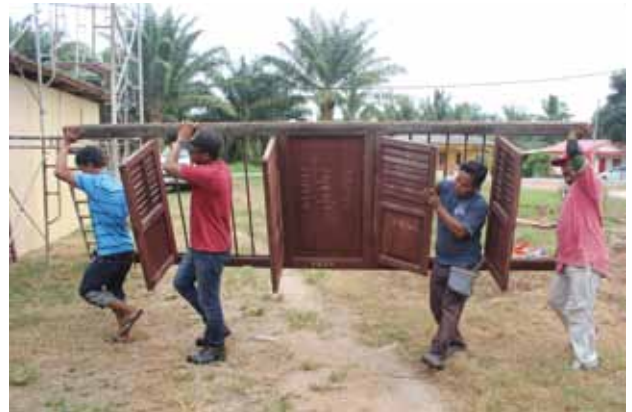
Dismantled louvered casement windows were taken down to the ground for investigation and salvaging.

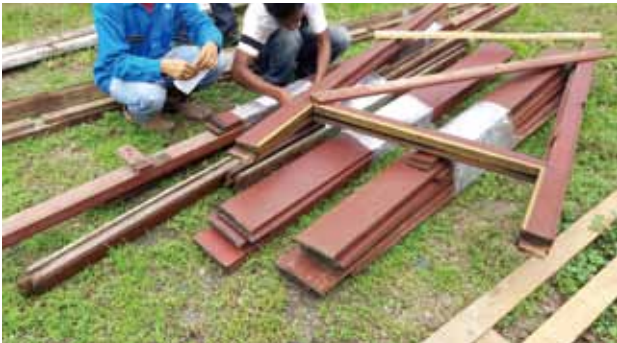
All dismantled timber structures and elements were transported to a sawmill for the process of timber selection and classification.

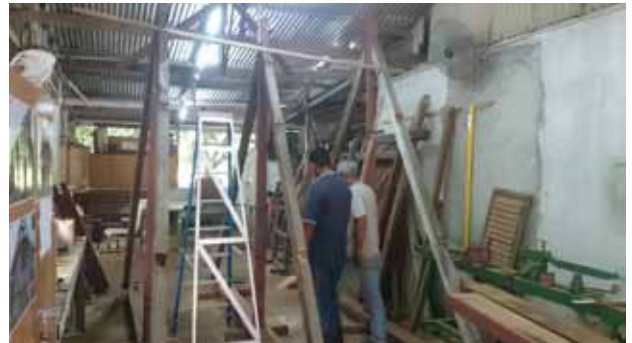
Timber structures and elements were repaired, replaced and replicated at a sawmill in Kampung Padang Jawa, Kelang, Selangor.

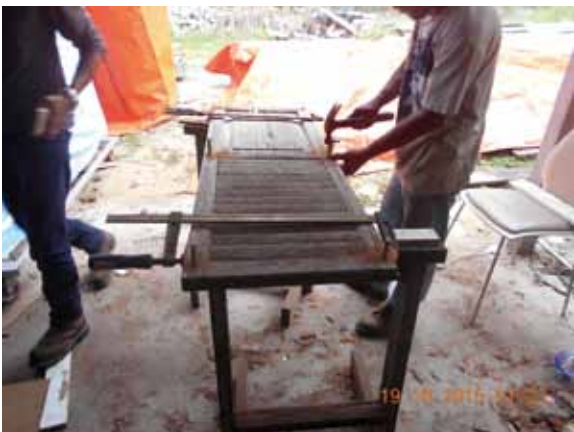
Restoration of casement window panel in progress.

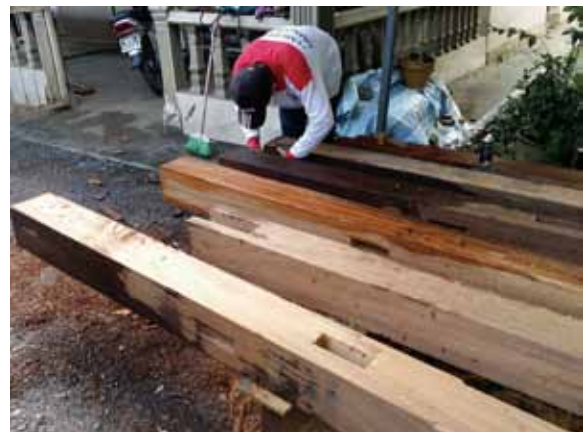
All new and old timber structures were treated against termite infestation.

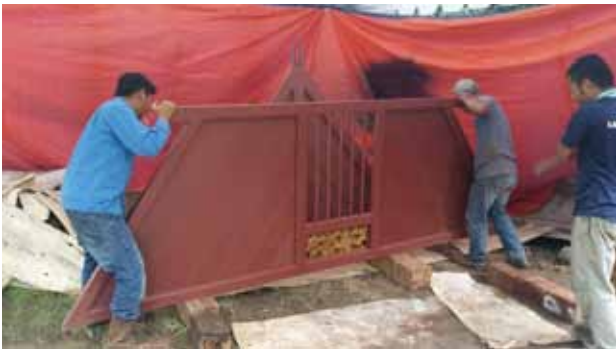
Carpenters handling a newly restored gable end.

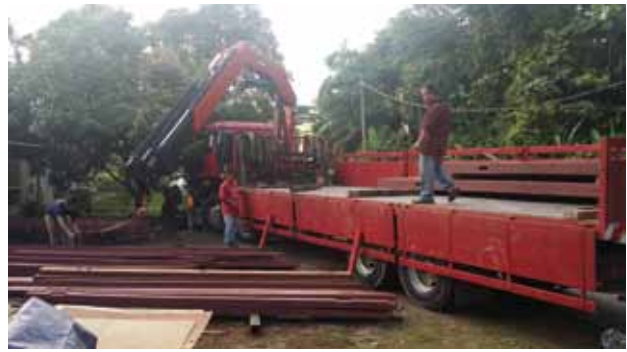
Treated timber structures and elements were loaded onto a truck at the sawmill before being transported to the new site.

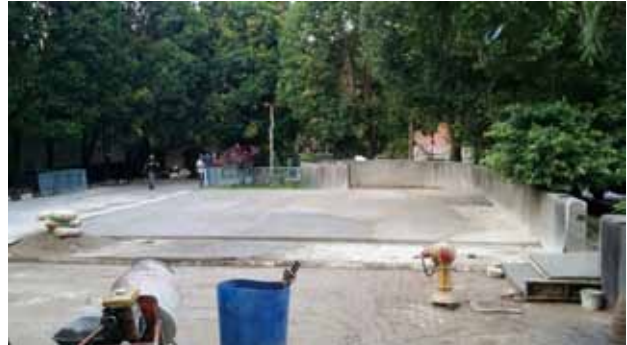
Reconstruction of the Bugis house in the grounds of the Sultan Alam Shah Museum began with the construction of a concrete-mix foundation floor to create a level surface.

Reconstruction of the Bugis house in the grounds of the Sultan Alam Shah Museum began with the construction of a concrete mix foundation floor to create a level surface. Based on the measured drawings, the original granite stones were positioned on the foundation floor in the exact layout as those laid at the old site in Kampung Permatang, Kuala Selangor. Once all the granite stones were secured in place on the foundation floor, timber stilts were erected followed by floor beams, columns, beams, roof trusses, wall panels and other building elements including windows, doors, carved lattice panels and new staircases. During reconstruction of the Bugis house, scaffolding was erected to

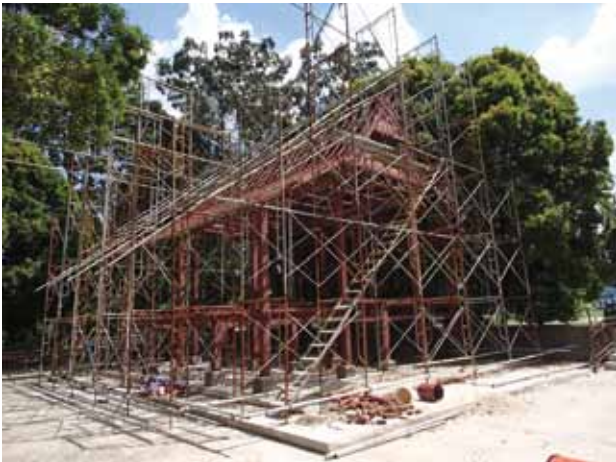
During reconstruction of the Bugis house, scaffolding was erected to support the building structures and elements, installation of new roofing materials and repainting.

support the building structures and elements, installation of new roofing materials, and repainting. One of the new elements introduced for the Bugis house is the roofing material. Palm leaf roofing is not suitable because it requires regular maintenance and replacement as well as being prone to natural decay and insect attacks. Asphalt shingles of a dark grey colour were used instead as the new roofing material for the Bugis house. Asphalt shingles are comparatively more durable, lower maintenance, less expensive in terms of up-front costs, and need only simple installation. They are also flexible to match the original roof shape and form. The Bugis house was repainted in its original dark red colour using locally-produced oil-based

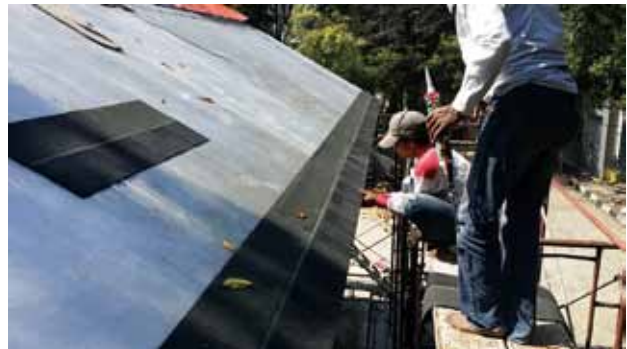
Installation of asphalt shingles on the roof.

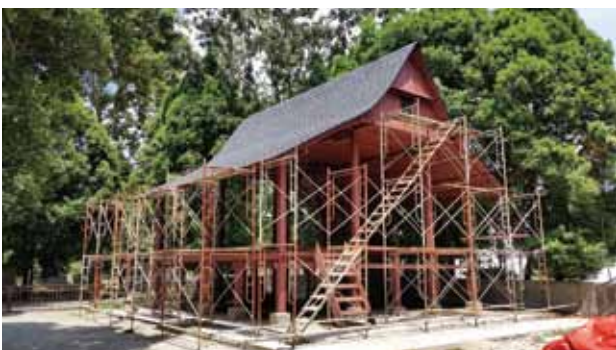
View of the Bugis house during reconstruction.

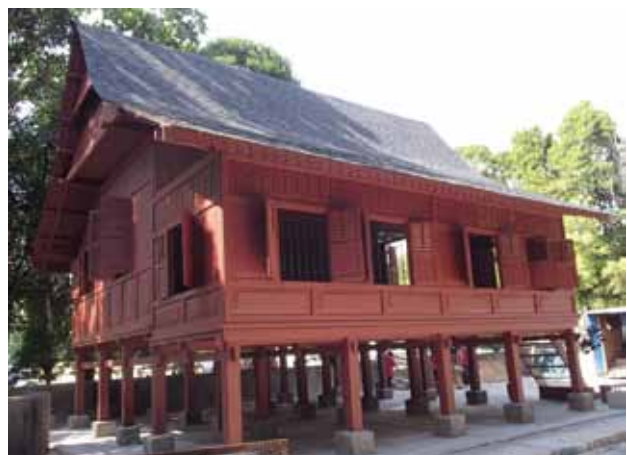
Front view of the Bugis house after reconstruction.

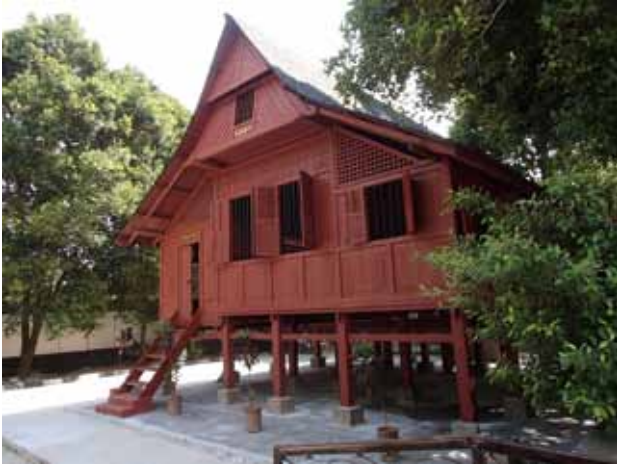
Right elevation of the Bugis house after reconstruction.

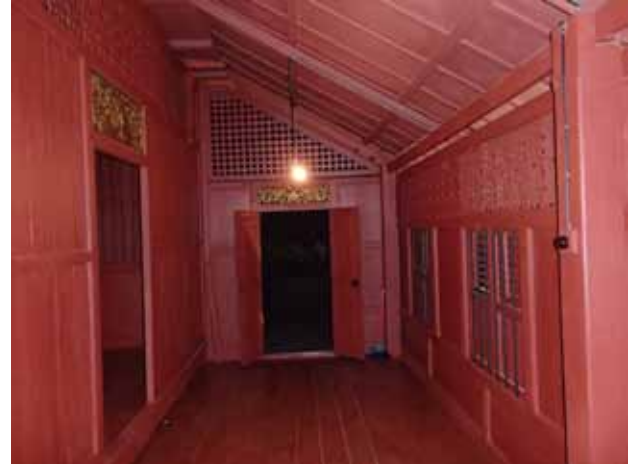
Interior view of the verandah after reconstruction.

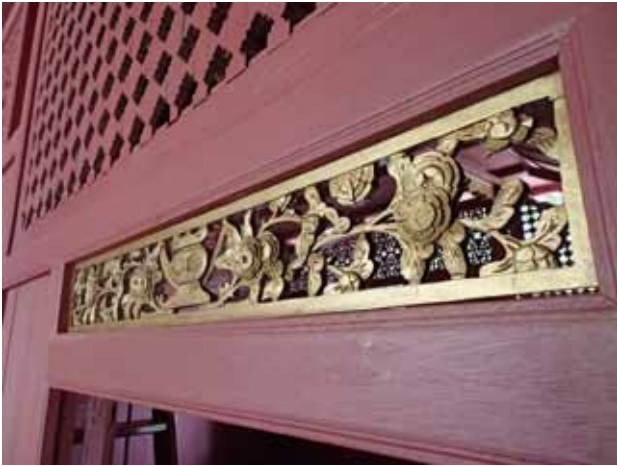
Newly restored floral motif carvings and geometric patterns on the upper walls.

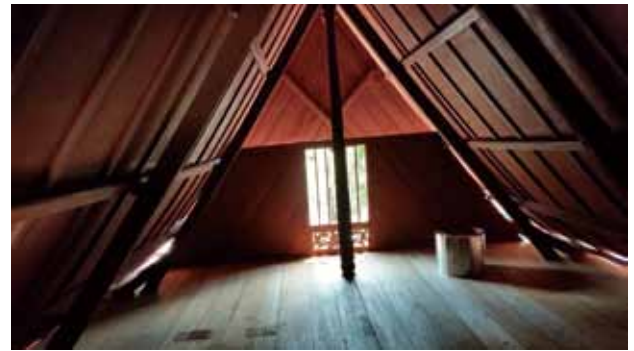
Storage attic featuring double-layered gable end, small opening and pitched roof ceiling after reconstruction.

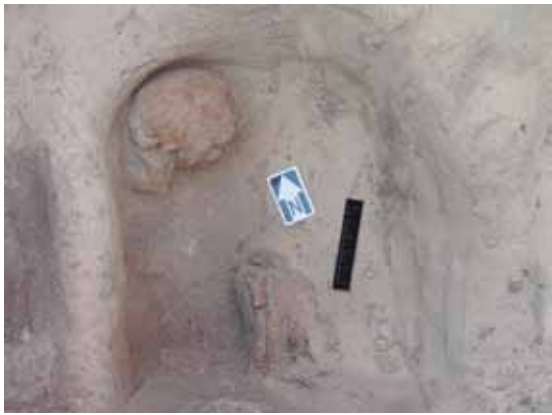
Fig 1: Female grave found in trench 5 in Ha. Uttheemu (Jaufar 2016)

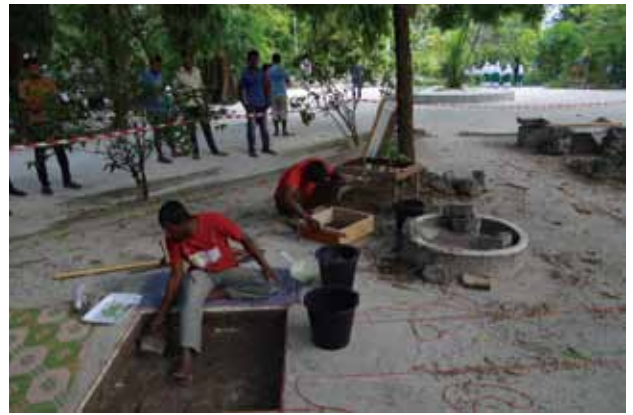
Fig 3: Excavations at K. Male' (Haour 2016)

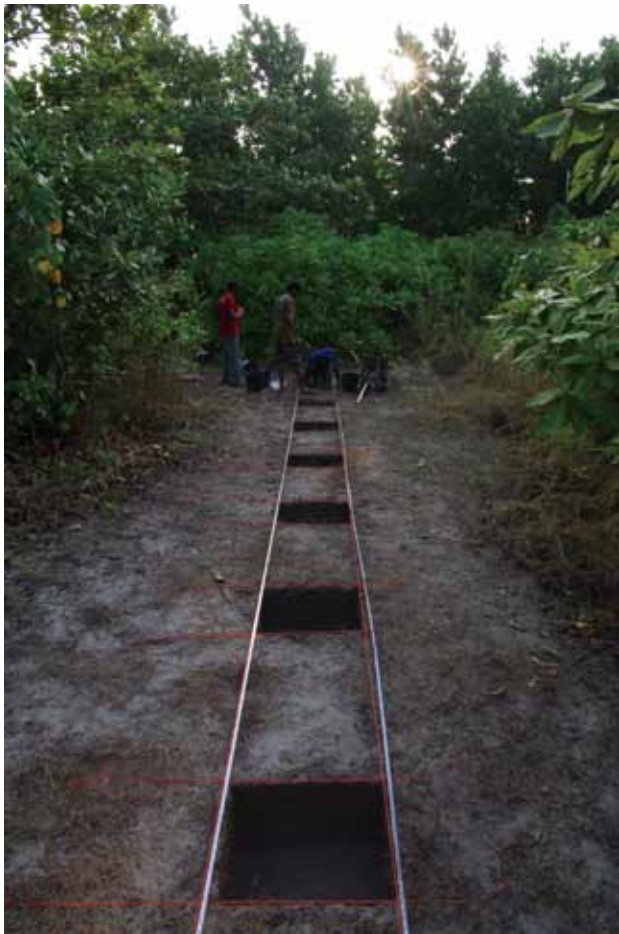
Fig 2: Unit 3 in Ha. Uttheemu (Haour 2016)

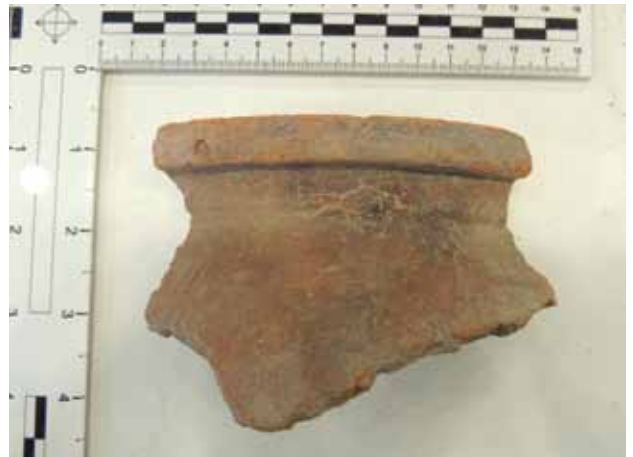
Fig 4: Pot sherd from the excavations (Jaufar 2016)

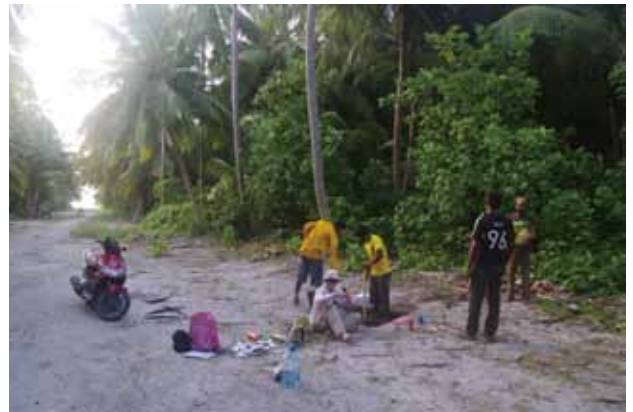
Fig 5: Excavations at M. Veyvah (Haour 2016)

The island of Veyvah in Meemu atoll was the final site for excavation and was selected due to the presence of an ancient coral stone mosque (about 400 years old) on the island, and also because it offered good prospects for a study of undisturbed levels. Due to most of the open spaces being used for habitation, excavations were targeted within the agricultural fields around the island. Five units were excavated in different areas, of which three units provided promising results. The finds from this island were also similar to those discovered at Utheemu and Male', again with the exception of human bones and less pottery. One bead was also discovered on this island.

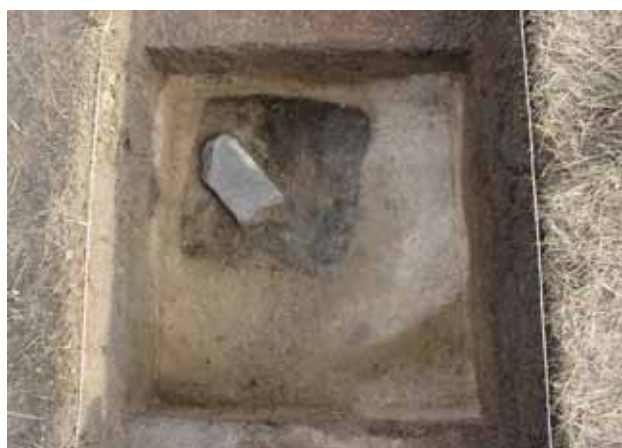
Fig. 3 Brick from the Tonyukuk complex has been used to fill a modern post-hole
