ACCU Nara
International Correspondent **Vol.17** 2017
The Seventeenth Regular Report

The ACCU correspondents periodically send reports on cultural heritage protection activities in which they have been recently involved. This is a collection of fifteen reports submitted by international correspondents in the Asia-Pacific region.

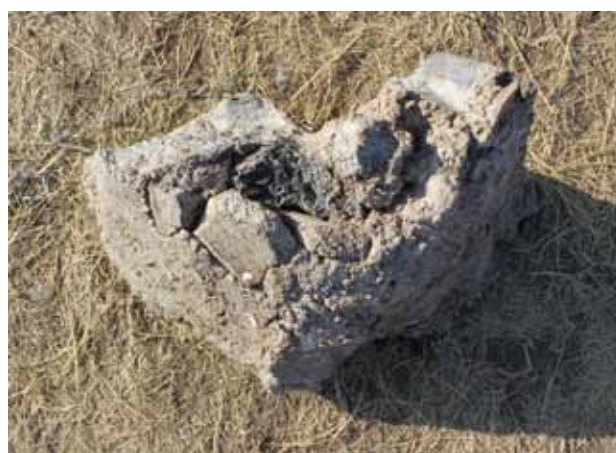
Fig. 4: Post-hole cement with roof-tile pieces

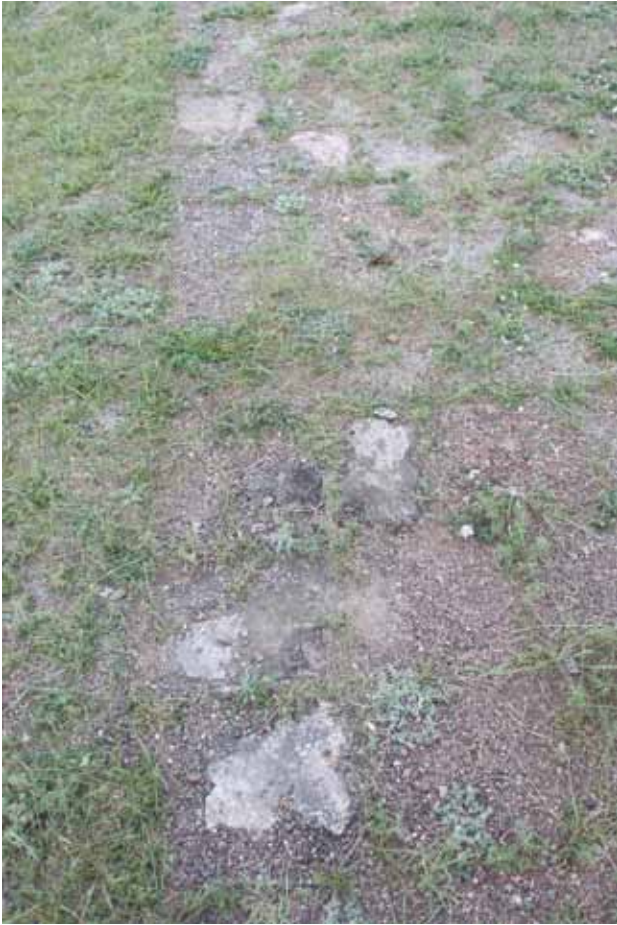
Fig. 5: Brick floor on a platform of the Tonyukuk complex

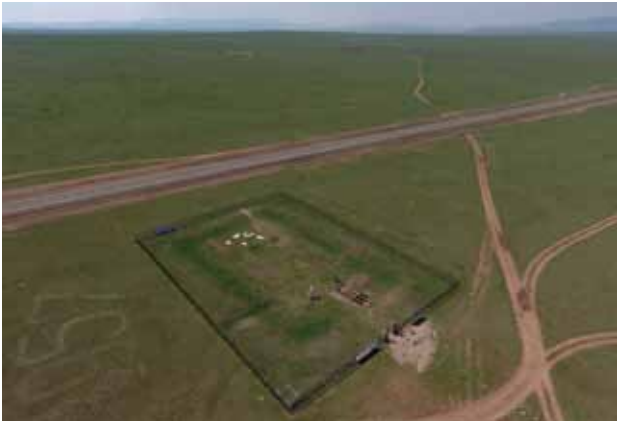
Fig. 16: Tonyukuk complex, road and place for short course off-road racing. From the south-east

Off-road racing. In August 2015, at a place 630 m to the west of the Tonyukuk complex, virgin soil was dug up by an excavator to create a place for short course off-road racing. (Figs. 16 and 17)

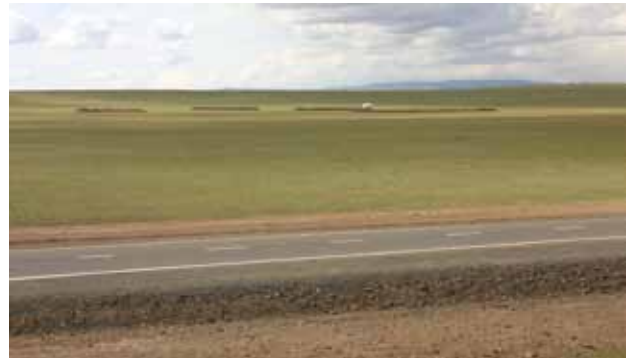
Fig. 17: View of the off-road racing place from the Tonyukuk complex

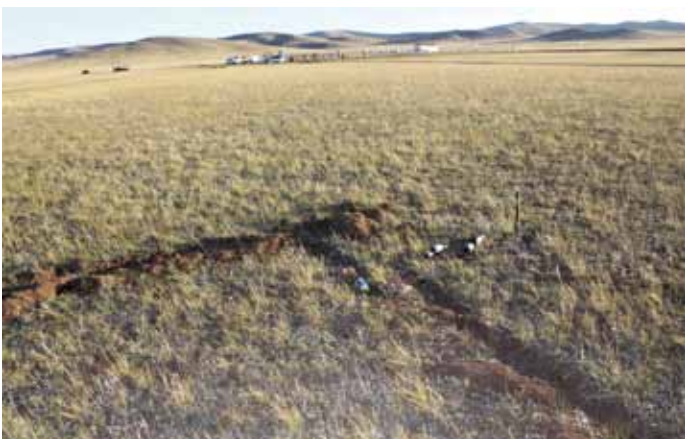
Fig. 20: Trench for base of block fence and the Tonyukuk complex. From the north-east

Trenches for bases of block fences. Also in spring 2016, very long trenches for bases of three extremely large rectangular block fences and numerous circular hollows for mixing cement were dug between the Tonyukuk complex and Complex 3. (Figs. 20-27) These trenches are located 80 m to the north of the Tonyukuk complex and 420 m to the south of Complex 3. Furthermore, the trenches are very close to Complex 2, which is located to the east of them; the distance between Complex 2 and the eastern line of the trenches is only 12 m. (Figs. 28 and 29) The area enclosed by these trenches is approximately 179200 m², almost 66 times larger than the fence around the Tonyukuk complex. (Fig. 1)

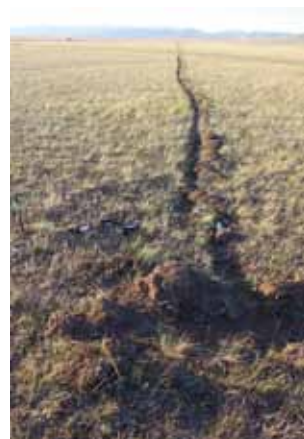
Fig. 21: Trench for base. From the south

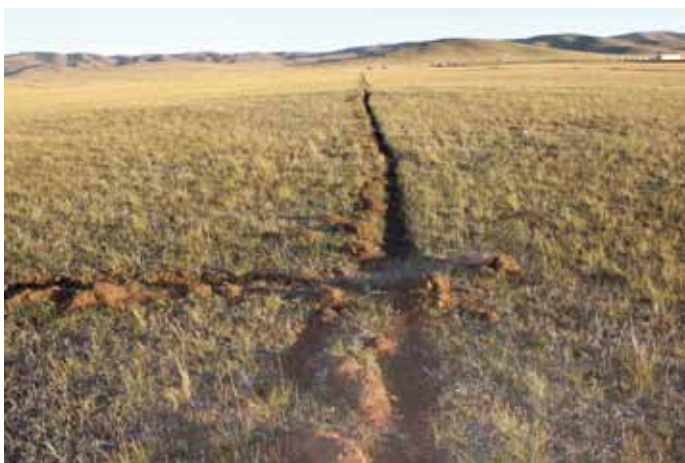
Fig. 22: Trenches for base of block fences and the Tonyukuk complex.
From the north

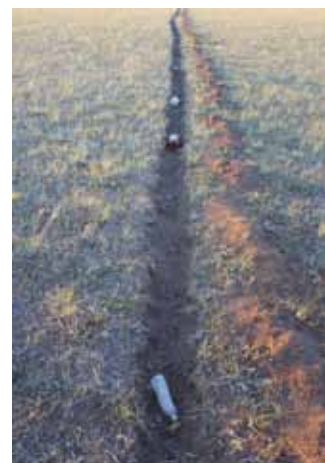
Fig. 23: Trench for base.
From the south

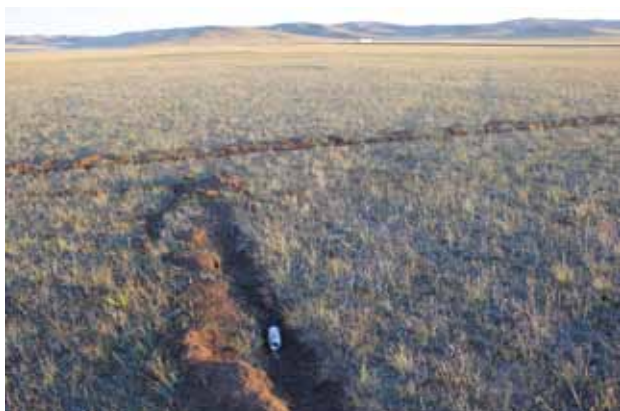
Fig. 24: Trenches.
From the north-east

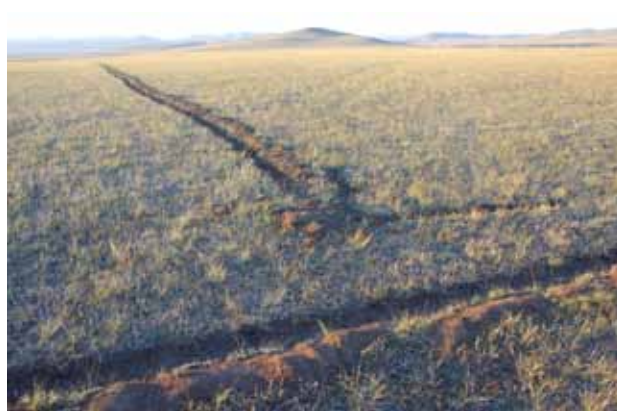
Fig. 25: Trenches.
From the south-east

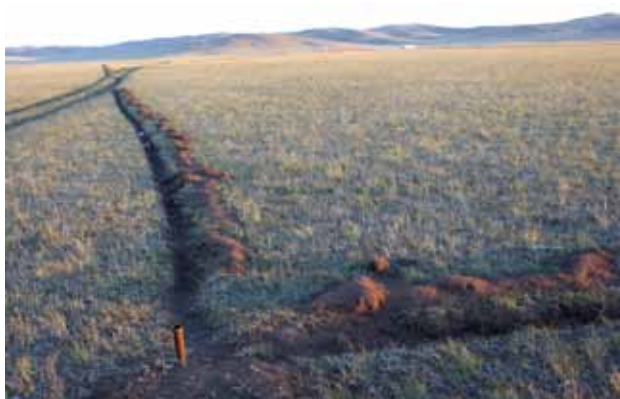
Fig. 26: Trench.
From the north-east

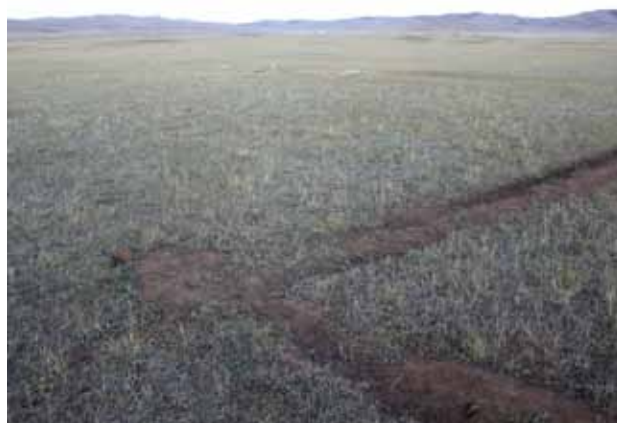
Fig. 27: Trench and Complex 2.
From the north-west

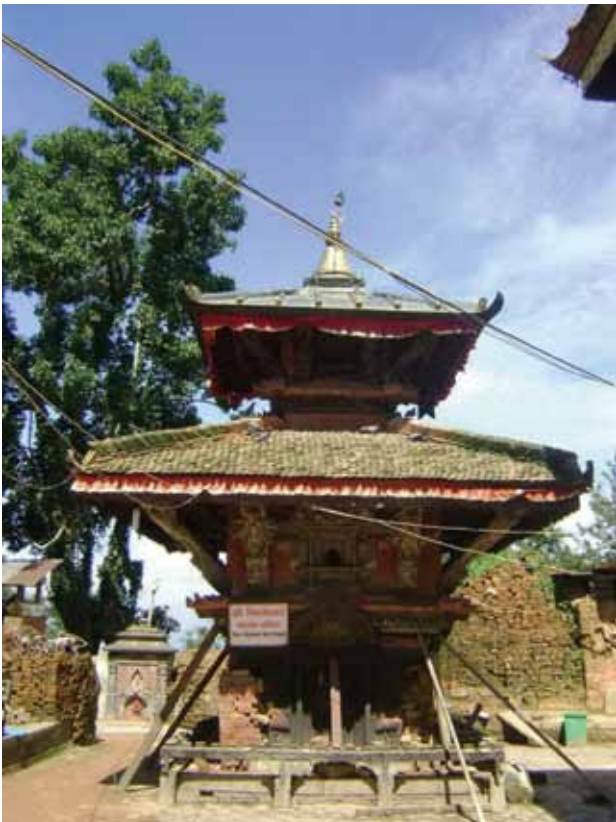
1. Kileshwor Temple, Changu Narayan Damaged by the Earthquake

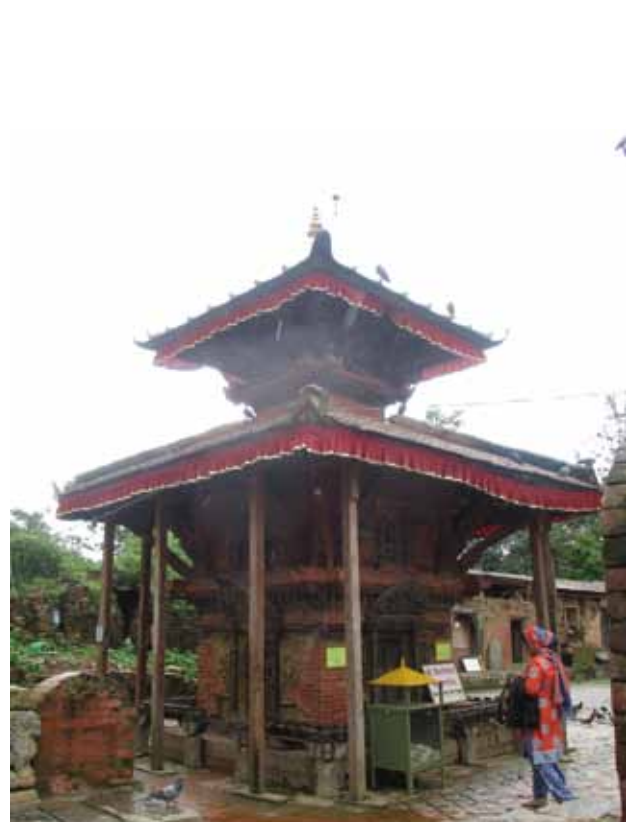
2. Kileshwor Temple, Changunarayan After Completion

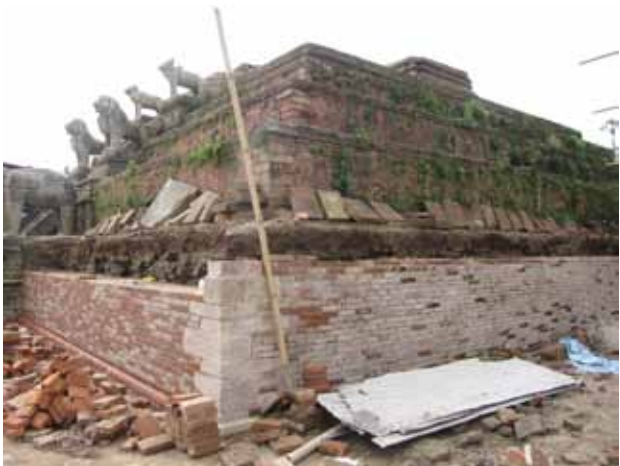
4. Reconstruction of Fasidega, Bhaktapur

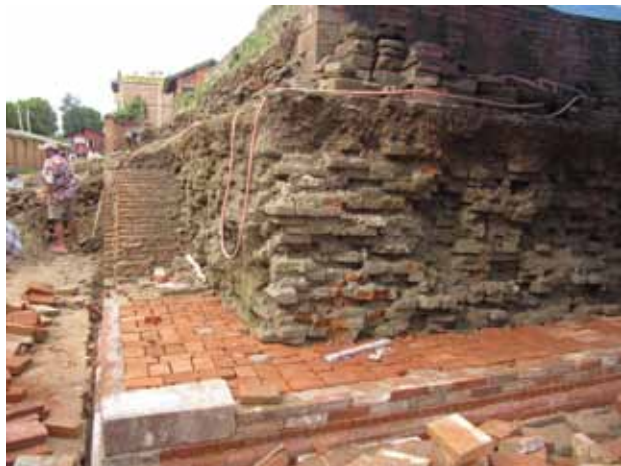
5. Reconstruction of Fasidega, Bhaktapur

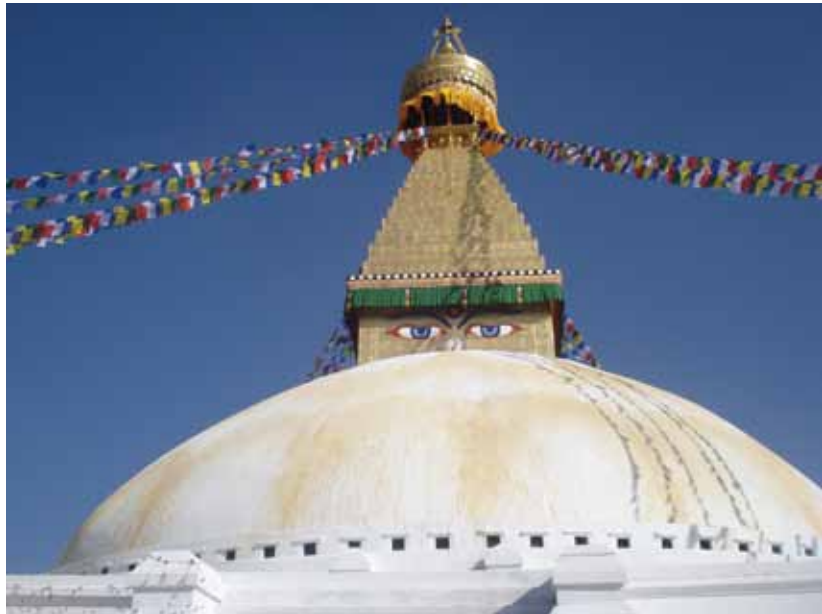
6. Completion of Conservation Work of Bouddha Sutpa After Earthquake 2015

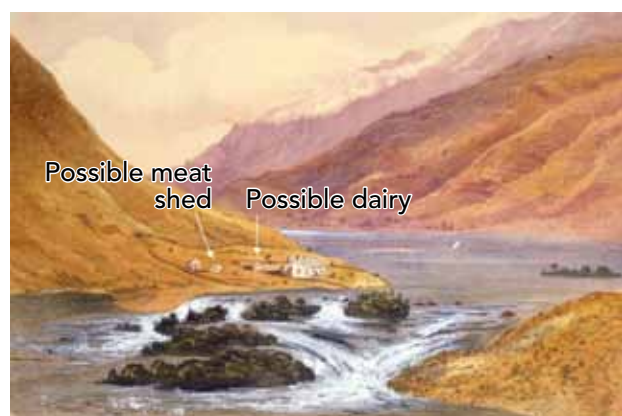
Figure 3. Painting of Rees Kawarau Falls Station by Sir William Fox, c.1864 (source: Alexander Turnbull Library. Image sourced and Meat Shed & Dairy indicated by Ben Teele of Origin Consultants).

In the figures and photographs below can be seen Rees Kawarau Falls Station at various times since 1863, as researched by archaeologists Andrew Winter and Ben Teele (Figures 3 to 10). In Figure 3 is shown the earliest pictorial of the Station painted by Sir William Fox in ca.1864. The ancillary buildings can be clearly seen and also what are possibly the Meat Shed and Dairy. Figure 4 is a survey plan from 1865 showing the main house at the Station. Ancillary buildings known to be present are not shown in the survey. Figure 5 is a cropped section of an 1866 painting by Nicholas Chevalier again possibly showing the Meat Shed and Dairy alongside the other original Rees buildings. These early paintings of the Station appear to support the age of the Meat Shed and Dairy to have been built between 1863 and 1865 (Teele 2016). This age is quite likely as such buildings were a crucial element for the functioning of a large sheep station.

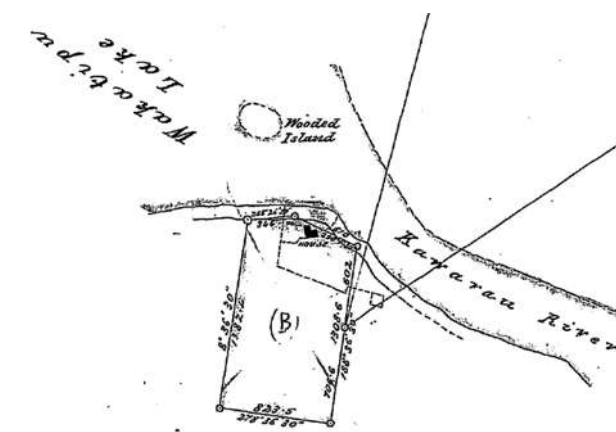
Figure 4. 1865 survey map of Rees Kawarau Falls Station (source: LINZ. Image sourced by Andrew Winter).

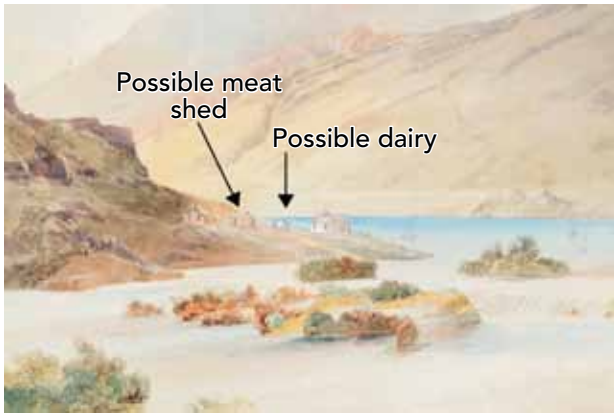
Figure 5. Crop of 1866 painting of Kawarau Falls and Rees Station by Nicholas Chevalier (source: Te Papa. Image sourced and Meat Shed & Dairy indicated by Ben Teele of Origin Consultants Ltd).

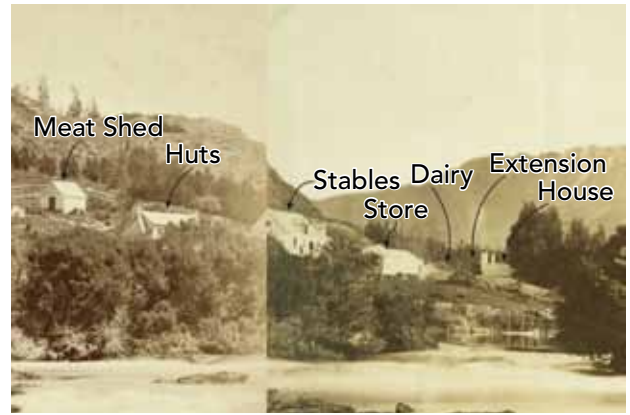
Figure 6. Crop of first known photograph of Rees Kawarau Falls Station probably from 1872. The Meat Shed & Dairy can be clearly seen. (source: Te Papa. Image sourced and Meat Shed & Dairy indicated by Andrew Winter).

The first known photograph of the Kawarau falls Station is from ca. 1872 (Figure 6). It can be clearly seen from this cropped version of the original larger image where the Meat Shed and Dairy reside and details of their construction. In Figure 7 is shown another image of the Station this time taken in 1874 which illustrates the complex of buildings. Figure 8 is an aerial photograph of the station taken in 1949. The completeness of the 19th century farmstead is still apparent with the original buildings still having a function in the running of the property.

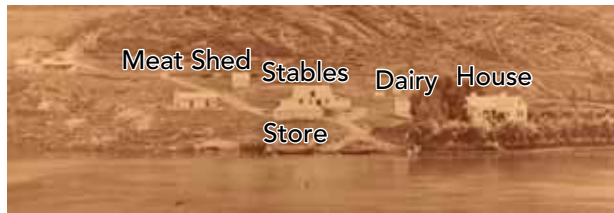
Figure 7. Photograph taken of the Station in 1874 (source: Lakes District Museum. Meat Shed & Dairy indicated by Matthew Schmidt HNZPT).

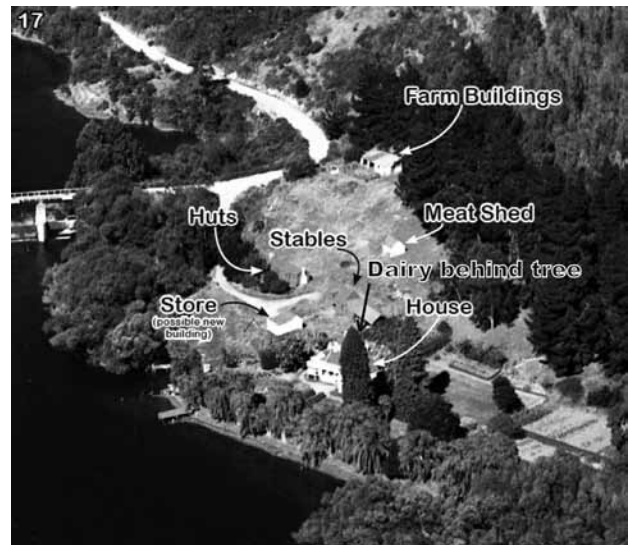
Figure 8. Aerial photograph of Kawarau Falls Station taken in 1949. Note that the 19th century buildings are still present (source: VC Browne & Son. Photo marked up by Andrew Winter and Matthew Schmidt, HNZPT).

It can be seen from Figure 3 to 8, that over the decades from 1863, when Rees built his first house at Kawarau Falls Station, until 1949, all the original buildings survived the changes in ownership of the property and this continued until 1960 (see Winter's 2014:7-10 research on the history of the Rees/Boyes Brothers station). From 1960 onwards, the farm buildings were gradually demolished as part of a campsite development with Rees homestead torn down in 1987 leaving only the Meat Shed and Dairy and the flat area where the homestead stood and its associated laurel hedge believed to have been planted in the 1920s. This change to the Kawarau Falls Station cultural landscape is effectively illustrated by a Google Earth image from 2004 (Figure 9) showing the terracing created for the camp site. The Meat Shed and Dairy only survived the camp site earthworks as they had a use with the Dairy utilised as a small cabin and the Meat Shed as a storage facility. By 2009, the camp site terracing had also been destroyed during site works for new apartments prior to the current

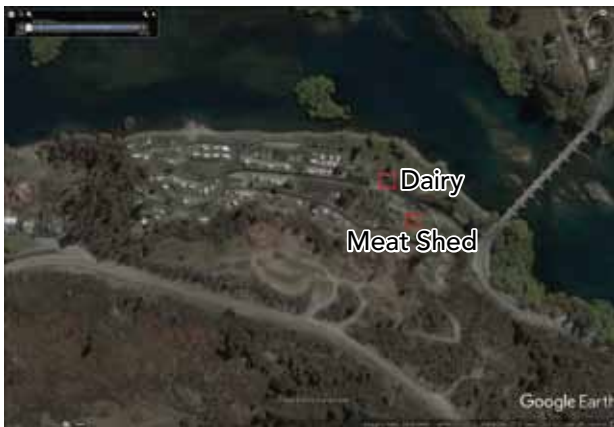
Figure 9. Google Earth image of the Kawarau Falls Station from 2004 showing the campsite terracing and the two remaining Rees buildings, the Meat Shed and the Dairy and the laurel hedge.

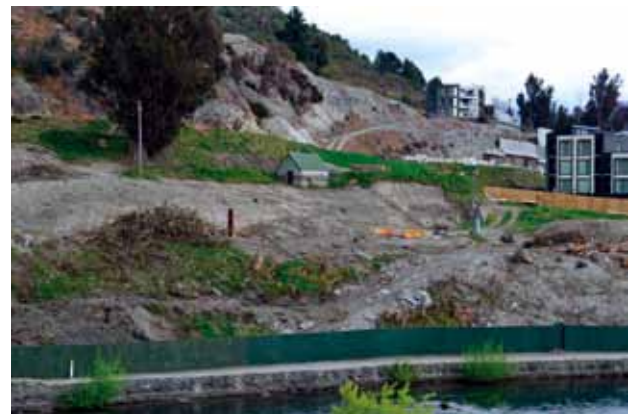
Figure 11. The Meat Shed in 2015 showing its isolation within the residential development (photo: Ben Teele, Origin Consultants Ltd).

The demolitions over the years meant that the only above ground tangible evidence left of Rees life in Queenstown would be these two small schist stone buildings, the Dairy measuring 3m/4m and the Meat Shed 2.5m/3m (Figures 11 to 17). These buildings are simple in design being made of lime mortared schist stone and having a timber roof structure with wooden shingles. In later years, both the Meat Shed and Dairy building had corrugated iron placed over the original shingles and as such these are still preserved beneath this iron. The Meat Shed still has most of its later brick floor but the Dairy has a 20th century concrete floor. Both structures therefore have high authenticity (see Winter 2014:12-13 for a more detailed description).

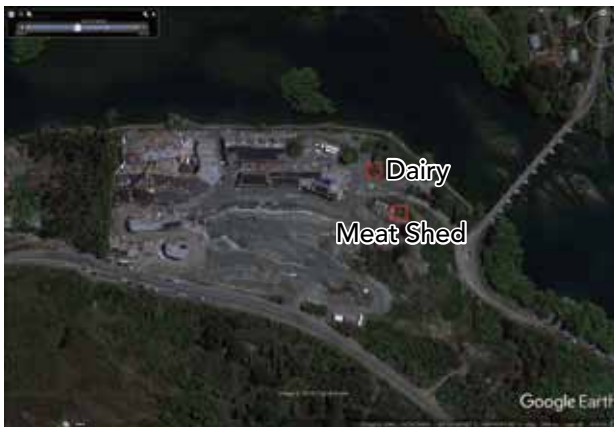
Figure 10. Google Earth image of the Kawarau Falls Station from 2009 showing the extensive earthworks undertaken by the owner of the property at that time.

owner's project (Figure 10).

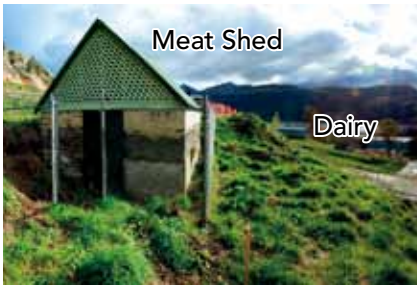
Figure 12. The front of the Meat Shed showing the Dairy in the background (photo: Andrew Winter, 2014).

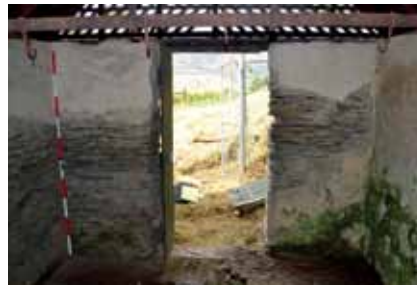
Figure 13. The interior of the Meat Shed showing the schist walls (parts rendered), timber roof, meat hanging bars and hooks and the doorway (photo: Ben Teele, Origin Consultants Ltd, 2015).

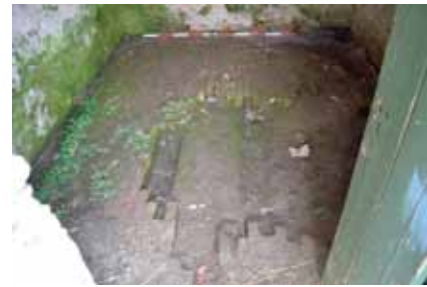
Figure 14. The interior of the Meat Shed showing the brick floor (photo: Ben Teele, Origin Consultants Ltd, 2015).

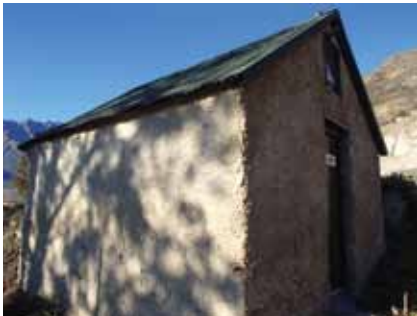
Figure 15. The Dairy building showing the entrance doorway. The schist is hidden by a cement render (photo: Matthew Schmidt, HNZPT, 2016).

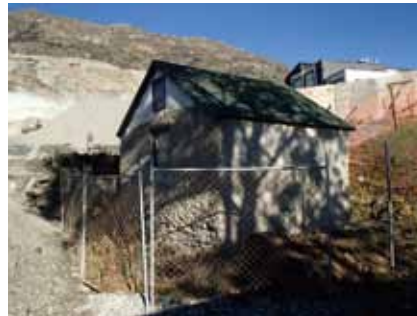
Figure 16. The back and side of the Dairy building (photo: Matthew Schmidt, HNZPT, 2016).

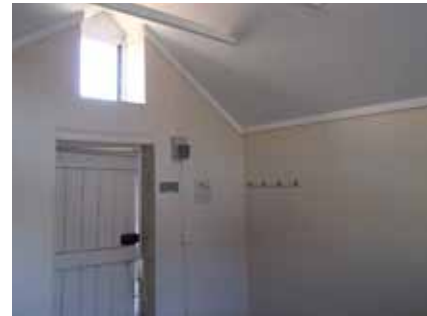
Figure 17. The interior of the Dairy building (photo: Matthew Schmidt, HNZPT, 2016).

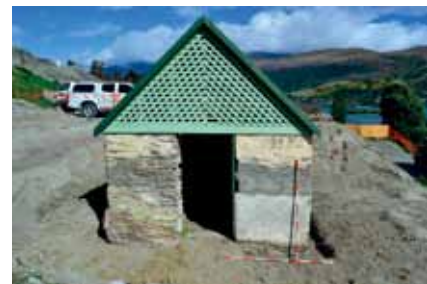
Figure 19. The Meat Shed prior to preparation for moving (photo: Ben Teele, Origin Consultants Ltd, 2016).

The project required the walls of the Meat Shed to be supported by a steel and concrete beam foundation installed around the base of the walls (Figures 19 & 20). The building was then braced on the inside and outside and the walls sandwiched using polystyrene, wood ply panels and studs (Figures 18 & 21). This resulted in a solid 'box' within which the schist stone Meat Shed sat with a new foundation. The final weight of the structure to be moved was 59 tons. After some months of preparing the area around the Meat Shed for the move as well as a road to its final resting place and the final position, on 1 July 2016 two 100 ton cranes lifted the shed in tandem and placed it onto a house moving truck (Figures 22 & 24). The truck then slowly moved the shed away from the original site, the cranes moved to the new position, and from there it was lifted off the truck to its final location (Figures 25 to 28). The concrete strip foundation became the shed's new permanent foundation. The shed was then left to 'settle' for a few weeks before the boxing and bracing were removed.

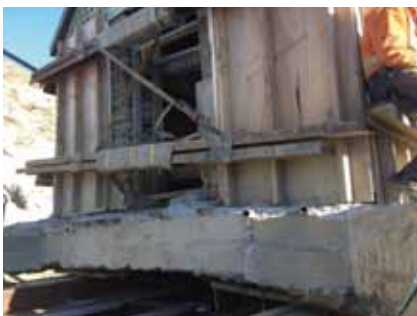
Figure 20. Close view of the concrete beam strip foundation and other bracing prior to the move (photo: Matthew Schmidt, HNZPT, 2016).

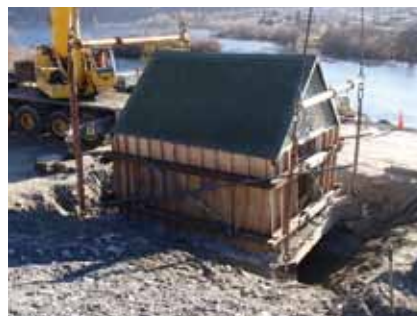
Figure 21. The Meat Shed all braced with crane straps connected to the lifting corbels (photo: Matthew Schmidt, HNZPT, 2016).

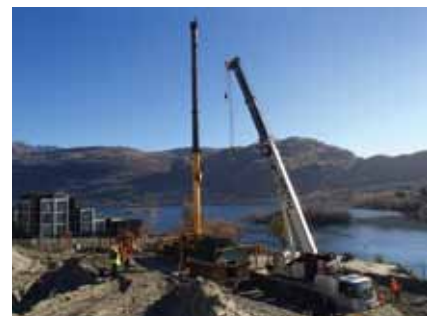
Figure 22. The cranes ready to lift the 59 ton Meat Shed (photo: Matthew Schmidt, HNZPT, 2016).

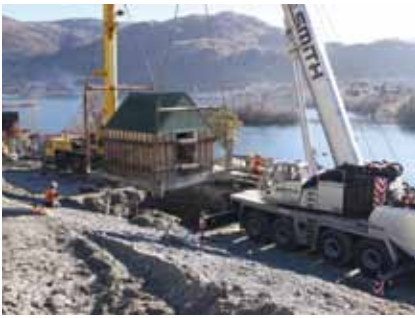
Figure 23. The Meat Shed successfully lifted and the beginning of the slow move over to the moving truck (photo: Jackie Gillies, Origin Consultants Ltd, 2016).

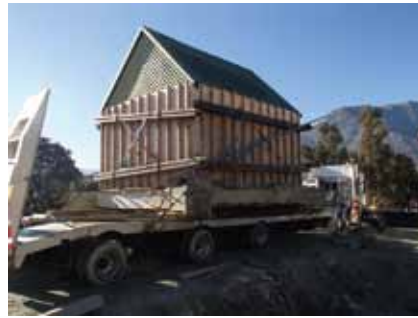
Figure 24. The Meat Shed on the house moving truck on its way to the new location 50m from its original location (photo: Matthew Schmidt, HNZPT, 2016).

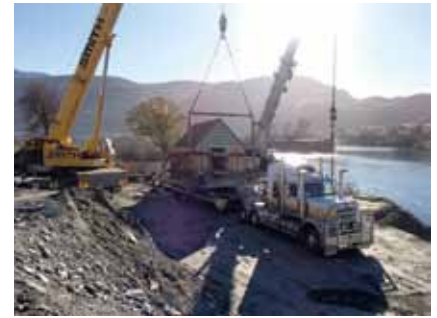
Figure 25. The Meat Shed being backed into place next to its new location (photo: Matthew Schmidt, HNZPT, 2016).

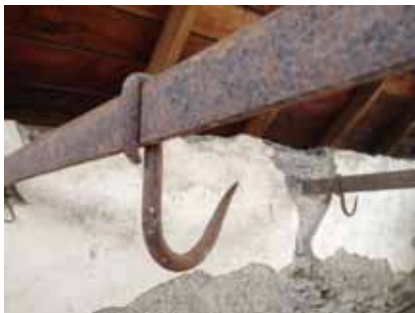
Figure 27. The carcass hanging hooks in place (photo: Matthew Schmidt, HNZPT, 2016).

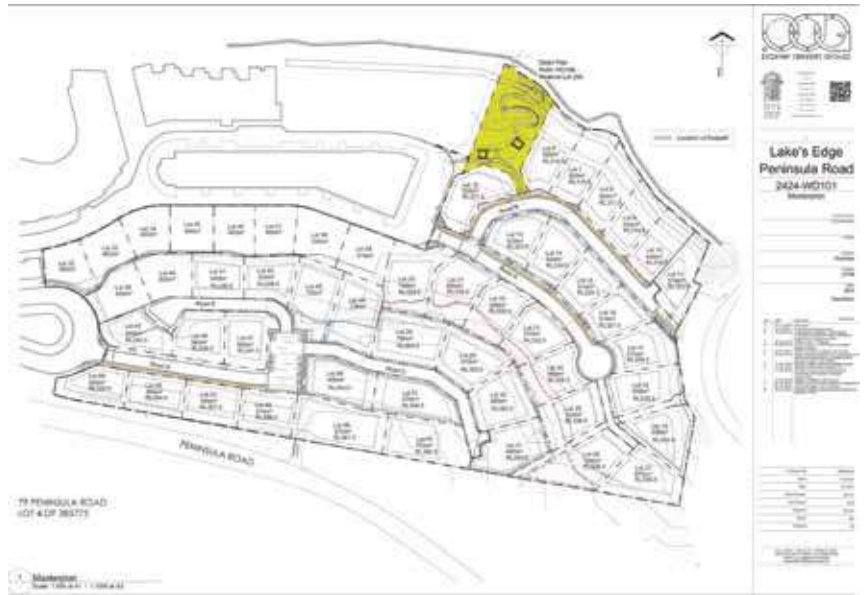
Figure 28. Plan showing the new location of the Meat Shed next to the Dairy in the public reserve (plan supplied by Lake's Edge Developments Ltd).

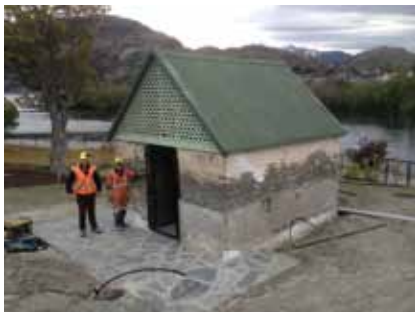
Figure 29. Landscaping works underway around the Meat Shed as well as initial repairs to the building. Pictured from left are Scott Sutherland of Civil Construction Ltd and Dean Kirk who undertook the repairs (photo: Matthew Schmidt, HNZPT, 2016).

After removal of the boxing and bracing, the shed was checked for cracks and other issues and initial repairs were made (Figure 29). Work was also begun on reinstalling the original brick floor (Figures 30). By October 2016, the area around the Meat Shed and Dairy was landscaped. Plants lining the path down to the Meat Shed and Dairy from the new development were sourced from cuttings of the laurel hedge which used to grow along the path leading to the old homestead from the lake (Figures 31).

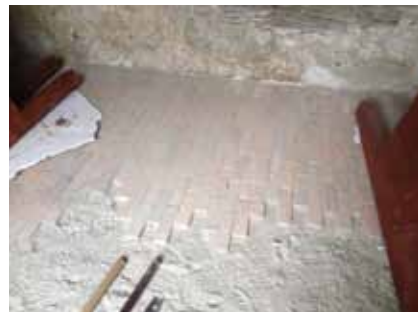
Figure 30. The brick floor of the Meat Shed being reinstated (photo: Matthew Schmidt, HNZPT, 2016).

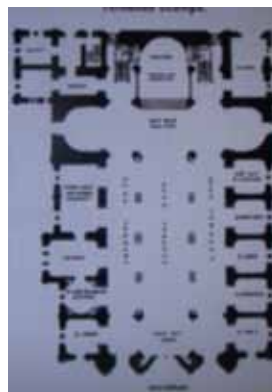
Floor plan by Arch. Ocampo

The reconstruction of the *8th and present Cathedral* started in May 1954 and was completed in December 1958 under the direction of Archbishop Rufino Cardinal Santos, designed by Architect Fernando Ocampo. The stained glass windows were by Galo Ocampo. The Cathedral received donations from Japan, Spain, and the United States among others. Inspired by Serrano's design, he added to its previous appearance. He made use of marbled floors, mosaic panels, arcaded colonnades, lovely columns, and an Immaculate Conception themed Cathedral. His Neo-Romanesque design is a combination of Revival, Renaissance and Modern styles. The present Cathedral is a product of the old Cathedral's great design mixed with Ocampo's architectural touch. The cathedral adopted the Neo-Byzantine and Neo-Romanesque styles. The ceilings, arches, pineapple finials, stained glass depicting the life of the Virgin Mary, the belltower, large dome, bronze door portraying the history of the Cathedral, and images of saints on the doorways contribute to the harmonious aesthetic appearance of the structure.

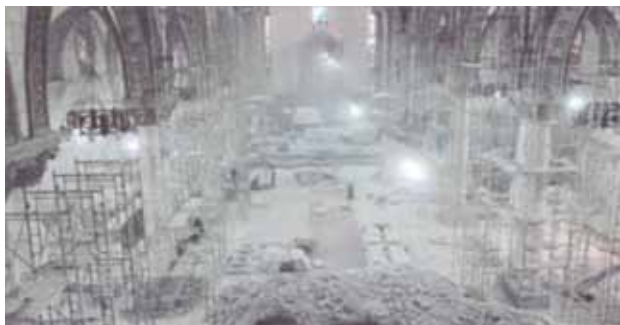
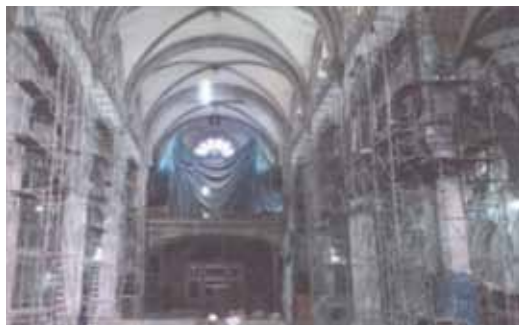
Cathedral during restoration works on August 2013 (photos by SPCastro, Inc.)

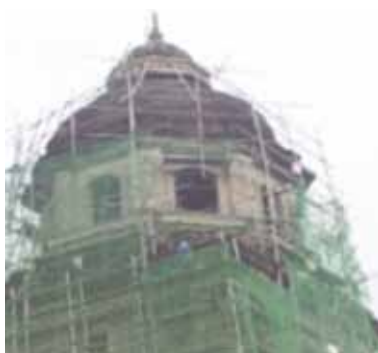
Retrofitting and plastering of the belltower

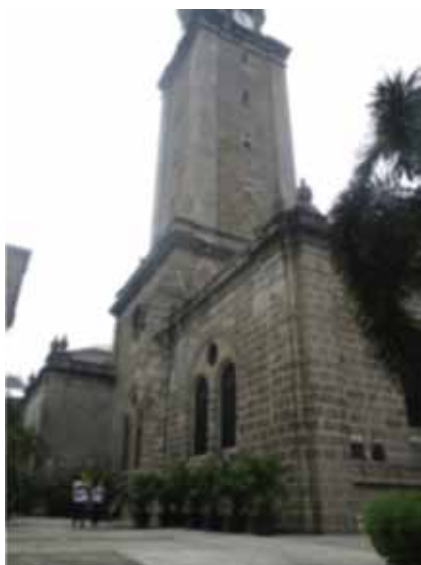
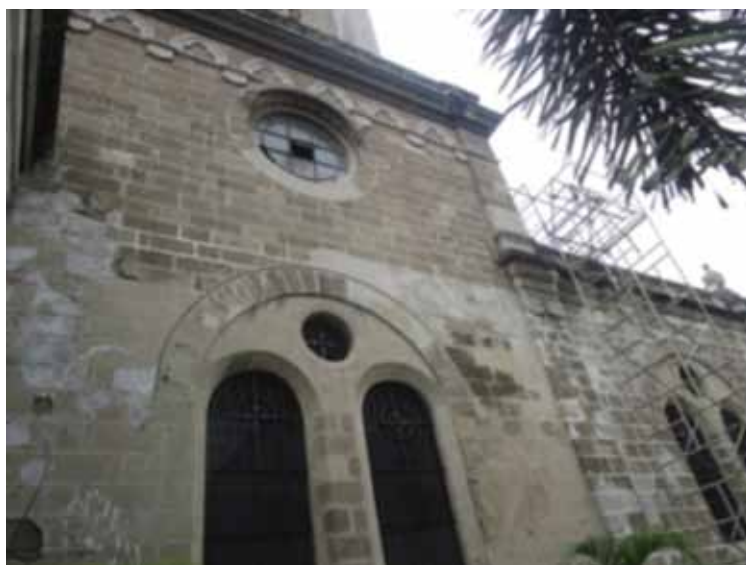
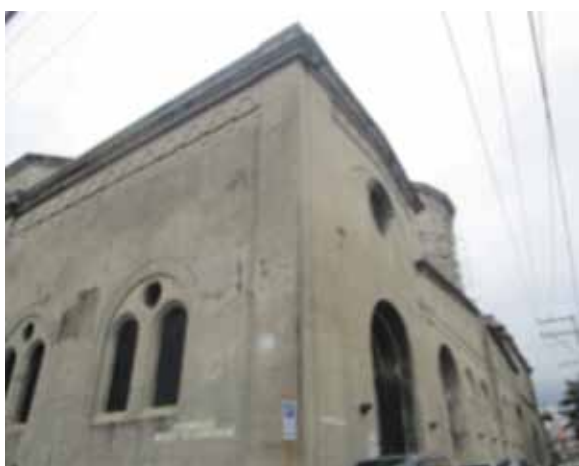
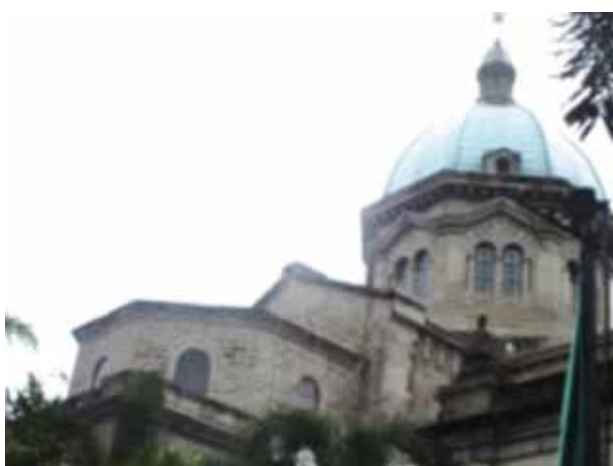
On-going restoration works: Plastering of exterior adobe walls and waterproofing of roof deck (Photos of the author, September 2016).

improvements: Restoration of exterior adobe walls which have deteriorated over years of exposure to the elements; landscape enhancement to complement the Neo-Romanesque architectural ambience of the Cathedral; waterproofing of roof deck; conversion of the belfry tower into a museum; make-up water tank; and the upgrading of the emergency power back-up to ensure an uninterrupted power supply.

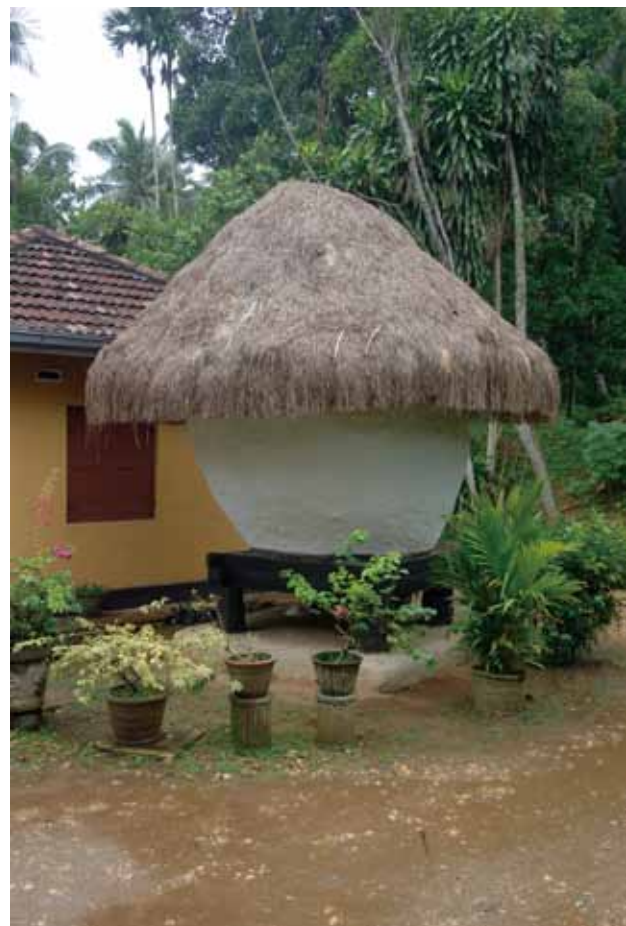
Figure 1: Vee bissa at Thotupala Walawwa

For the construction, four timber logs are placed horizontally on a minimum of four rock boulders or stone columns. Timber planks are fixed on it as a floor. The superstructure consists of woven cane, finished with mud/clay and cow dung plaster on both sides (Figure 1). Sometimes these structures are lime washed. The paddy bins are cylindrical in shape with an independent roof structure. The roof is made of palm leaves or paddy straw. According to the roof style, one can enter the bin with the help of the pole by raising the roof or simply by entering the gable side.

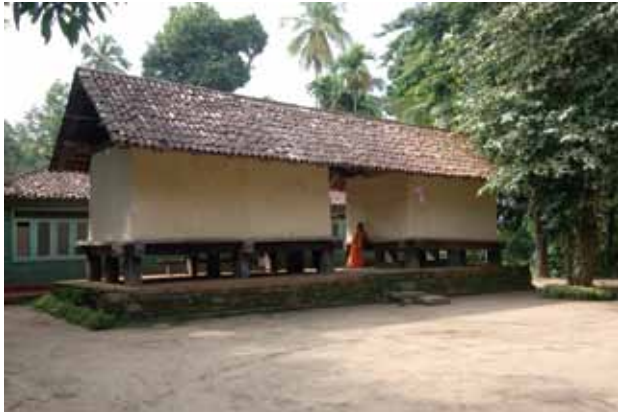
Figure 2a: Atuwa at Lankatilaka Temple, Kandy

above case, the roof of the atuwa is an independent structure with a palm leaf or paddy straw roof. Normally the shape is rectangular (Figure 2a & 2b).

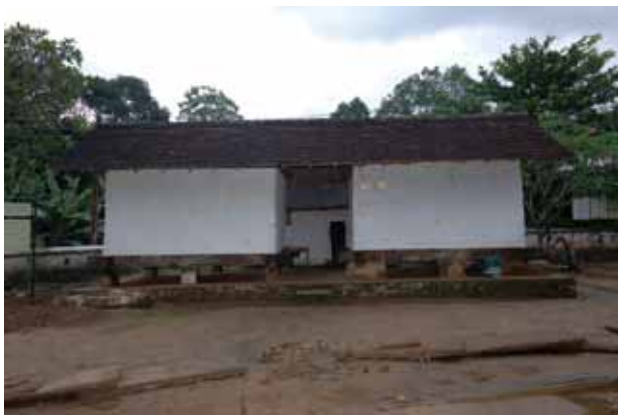
Figure 2b: Atuwa at Embekka Devala (Temple)

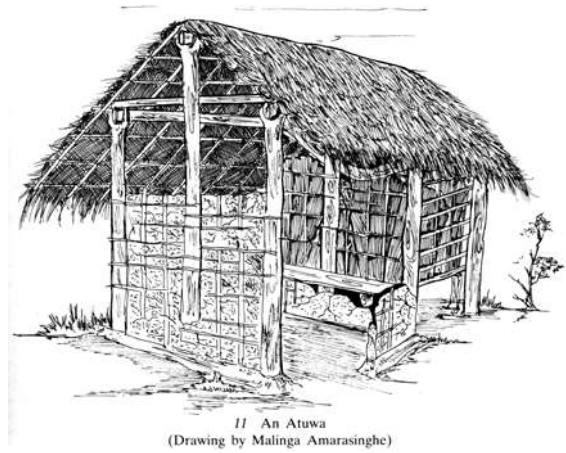
11 An Atuwa
(Drawing by Malinga Amarasinghe)

Figure 3: Line drawing of an atuwa by Malinga Amarasinghe. Further Studies in the Settlement Archaeology of the Sigiriya-Dambulla Region, Colombo: PGIAR, Myrdal-Runebjerg, E. Gunawardane, D. Fernando, S. (1994)

Thin sticks are placed and another stick is fixed horizontally to vertical posts. Two rows of this kind of framework are erected and clay balls are placed in between this frame. After a few days the walls are plastered using clayey earth mixed with fine sand on both sides (Figure 3).

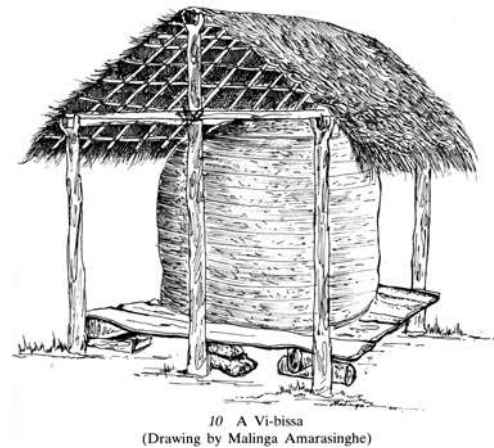
10 A Vi-bissa
(Drawing by Malinga Amarasinghe)

Figure 4: Line drawing of a vee bissa by Malinga Amarasinghe. Further Studies in the Settlement Archaeology of the Sigiriya-Dambulla Region, Colombo: PGIAR, Myrdal-Runebjerg, E. Gunawardane, D. Fernando, S. (1994)

Bundles of paddy straw are placed on each other horizontally in the shape of a circle and fixed together. When the required height is reached, plaster containing clay and cow dung is applied to both sides (Figure 4).

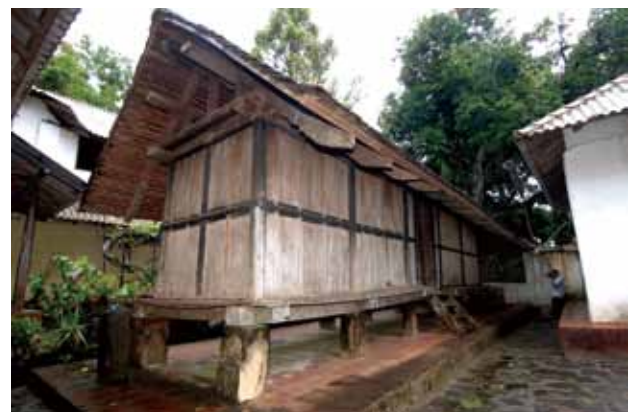
Figure 5: Atuwa with wooden planks at Pusulpitiya Temple

In some cases walls are made of wooden planks or palm leaves with a frame of sticks (Figure 5).

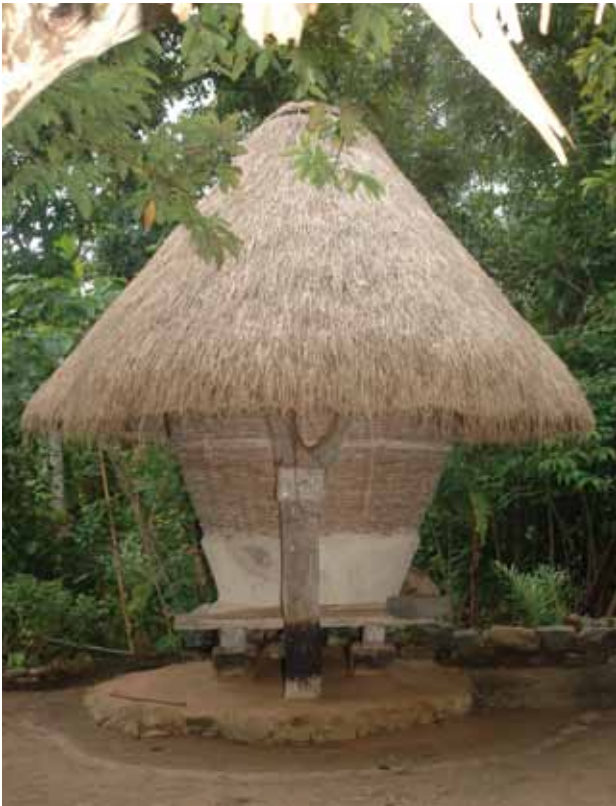
Figure 6a: Vee bisssa

According to the availability and knowledge of technology, woven cane was used in the construction of granaries. Clay, mud or cow dung plaster was applied to this surface externally and internally as desired (Figure 6a & 6b).

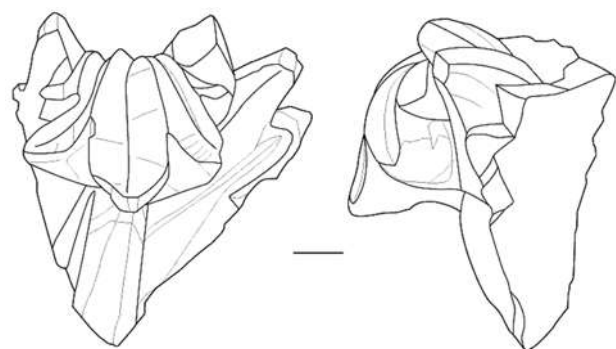
B) Fragments of the statue Garuda and its leg.

In the layer of rubble in the uncovered areas many fragments of stone sculptures were found. One of the stone fragments shows the head of an elderly man, apparently an ascetic. The character demonstrated expressive. The statue is small (8.7 x 6.2 x 7.6 cm) sculpted by scabbing of white limestone. Other fragments, a head (10.5 x 11.3 x 12.7 cm), and part of a pair of legs (12 x 9, 4 x 5.05 cm) were probably a bird of prey - Garuda (Figure 5 a, b).

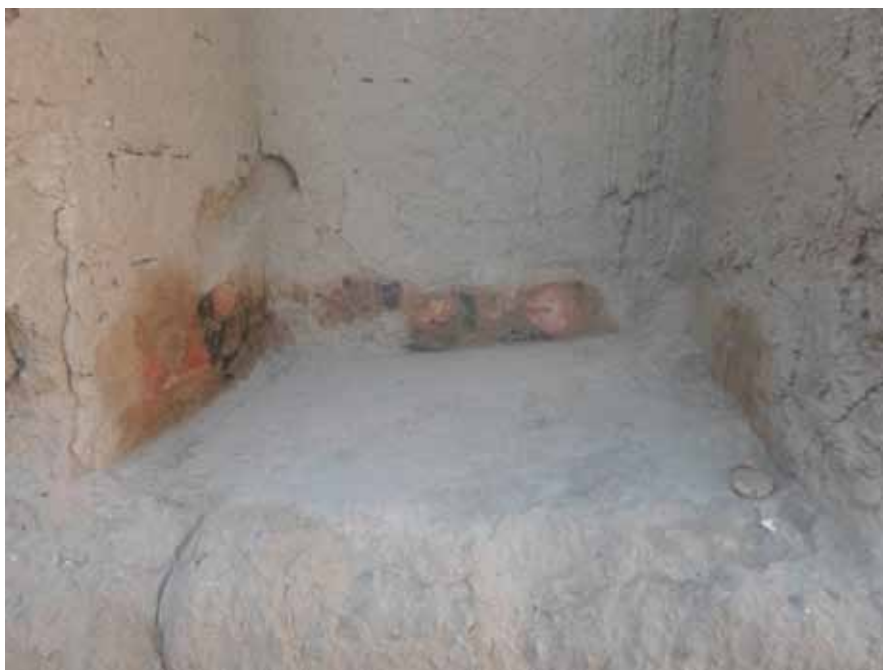
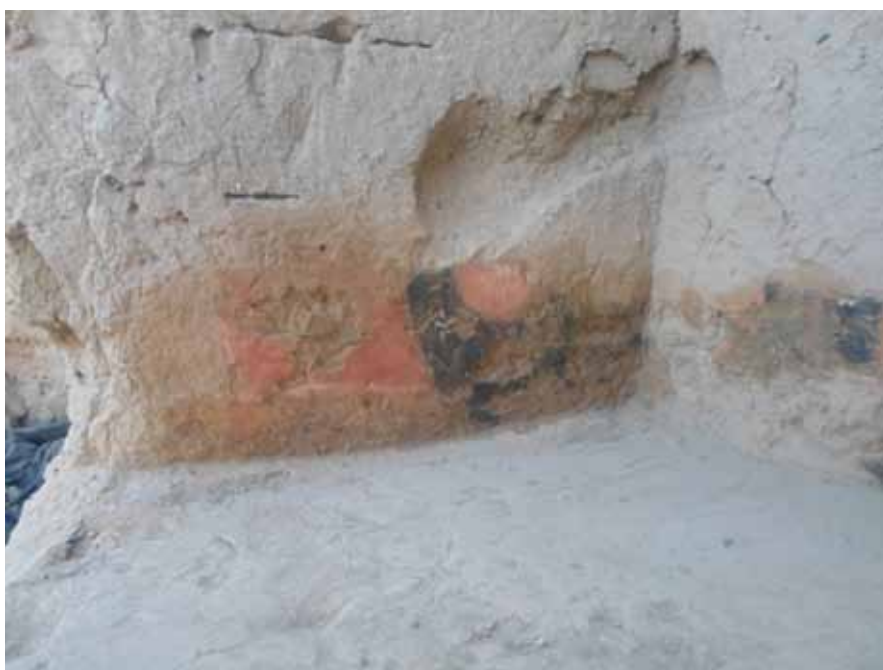
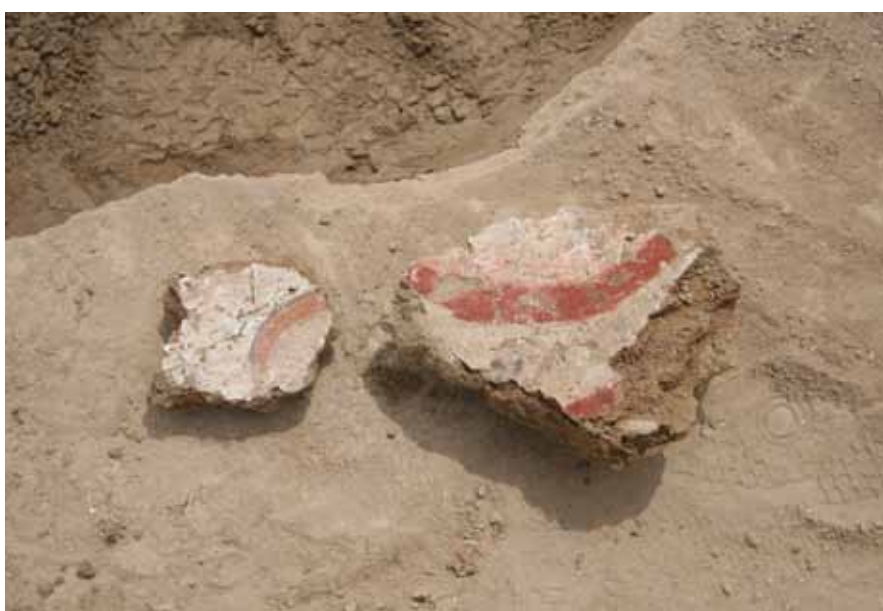
Fig. 7 a-c. Conservation of the wall paintings.

Parallel with the excavations in the author's report, conservation work at another monument site has been carried out. This involves fragments of wall paintings preserved only in the lower parts (5 cm by 30 cm) of niches in the yard of complex B at West Hill Karatepa (Fig. 7a-c). The polychrome paintings are poorly preserved because first, loess plaster was placed on them, and second, the niches were located in a semi-open place where the paintings were exposed to rapid destruction

caused by dust and bright lighting. The opinion was that, judging by the condition of the paintings, after opening, they were left open and not preserved. On the preserved parts of these paintings can be seen the lower part of human figures, painted bright red on a black background. And on this background are freely transferred irregular shaped circles, painted pink, the inside of which depicts a lotus flower.

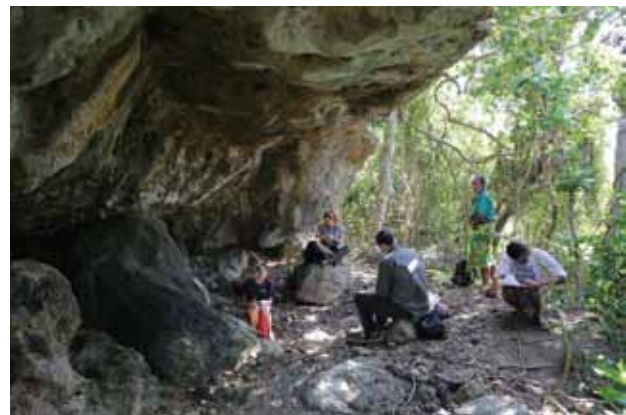
Visiting rock shelter excavated by the Shutlers

On arrival, visits were made to the rock shelters that the Shutlers had excavated, to register GPS coordinates and to identify if further investigation was needed. The method the Shutlers used nearly 60 years ago is somewhat outdated, so it was decided that other excavations had to be conducted beside some of the Shutler's excavations. Further expeditions over the top of the island and around it provided more opportunities to identify other sites of archaeological interest, and the following sites and activities of cultural heritage were identified for future archaeological investigations:

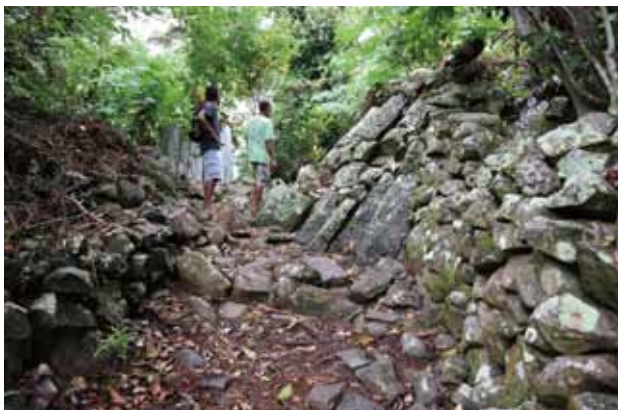
Stone basalt walls along a track

3. Stone walls - The island of Futuna is littered with stone walls. Both basalt and limestone rocks are used depending on the availability of the resource within the vicinity. Stone walls are built to:
 - i. Mark land boundaries – these normally run in a vertical pattern up a slope.
 - ii. Prevent soil erosion – these garden terraces normally run in a horizontal pattern along a slope to prevent soil runoff and to create a gentler gradient to cultivate crops.

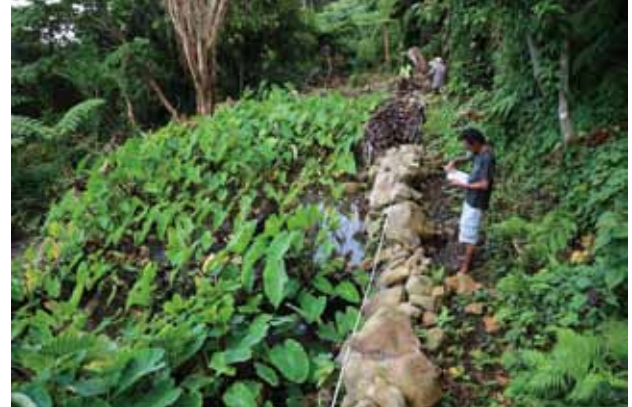
Mapping of taro garden terraces
