Group Training Course 2025

Case Study Reports

Identification of the problems and the required measures for a wooden structural element. (Bangladesh)

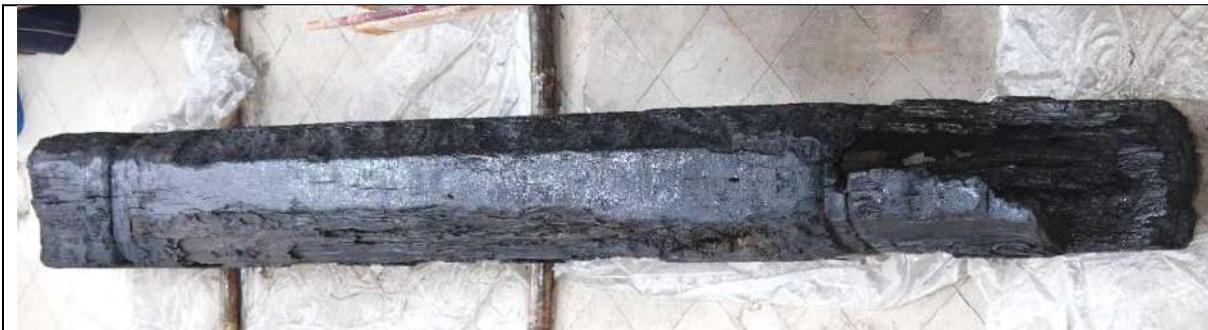
The wooden pillar, which appears to have been part of an architectural structure, measures 4.65 meters in length. Three distinct sections of the pillar can be identified: the base, the shaft, and the capital. The base is quadrangular, decorated with petal motifs and 65 cm in length, each side measuring 50 cm wide. The shaft is octagonal, decorated with flower motifs and 3.25 m in length, the width of each side of this octagon varies from 15-20 cm. The capital is quadrangular, decorated with flower and petal motifs and 3.25 m in length. The majority of the capital is decayed.

Fig 1: Wooden pillar, after primary treatment

Fig 2: Pillar base

Fig 3: Pillar shaft

Fig 4: Pillar capital

Fig 5: Pillar capital (top)

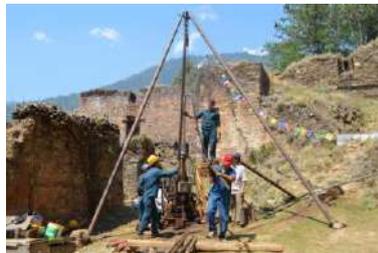
The Drukgyel Dzong restoration included detailed archaeological documentation of its defensive features, geotechnical investigations to assess soil and slope stability for foundation design, and a comprehensive 37.6-acre topographical survey, producing precise maps to guide the restoration planning.

images show: (1) soil stability and foundation tests conducted by DGM, in Drukgyel Dzong.

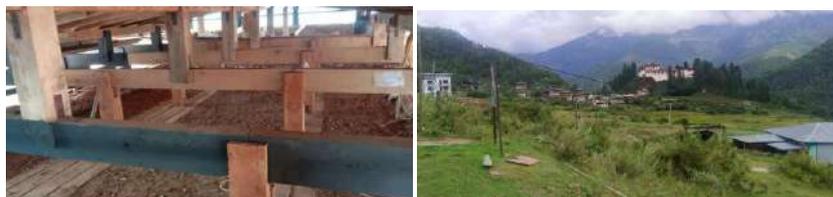
The seven-phase Drukgyel Dzong reconstruction prioritized traditional materials and craftsmanship but faced challenges like legal gaps, expertise shortages, and harsh high-altitude conditions. These issues led to replacing original timber, joinery, and roofing with modern materials. Similarly, the Tango project struggled to reuse wooden components due to inadequate surveys and stakeholder conflicts. The cases underscore the need for stronger legal protections, artisan training, thorough documentation, and preventive maintenance to preserve Bhutan's wooden heritage.

images (1) show Drukgyel Dzong's reconstruction using CGI sheets and modern clamping instead of traditional timber, (2) shows the surrounding area where modern development has overtaken neglected residential buildings.

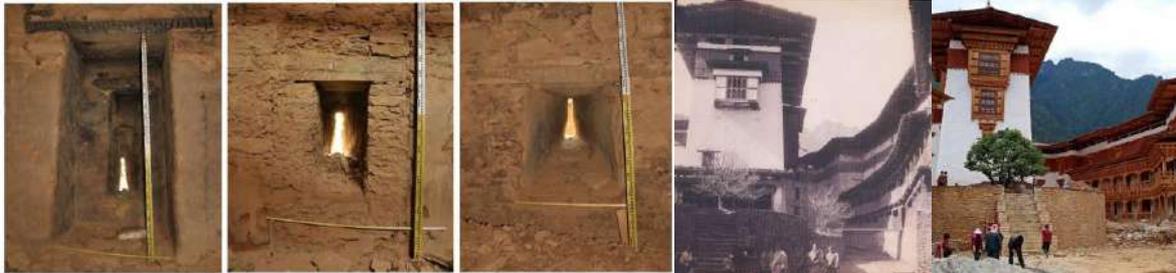
The reconstruction work began with the central tower, a four-storied structure with an attic featuring arrow slits for defense and ventilation, which was reconstructed to its former glory. Work then continued on the adjoining structures, maintaining their original dimensions. In some areas, the old walls were preserved and extended upward using the tooting method, employing local materials and craftsmanship to uphold Bhutanese traditional building techniques.

The images (1,2&3) show various types of arrow slits in the Utse identified during the archaeological survey, (2&3) shoes a historic 1905 photo of a traditional corridor by John Claude White, which was replicated in the Phase III reconstruction.

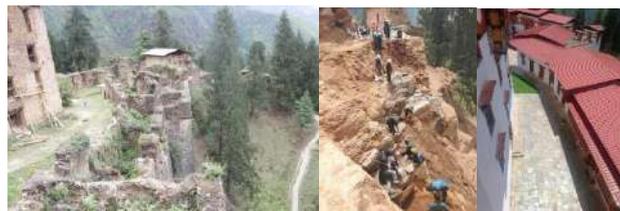
Most Bhutanese dzongs were built on hills for defense, and although the structure was restored to its original form, the steep slope required a foundation supported by beams. Originally, timber beams were used, visible before reconstruction. In the recent work, timber was replaced with concrete due to durability concerns, this substitution raises significant concerns for conservation, as it compromises traditional authenticity and highlights the challenges of balancing structural stability with heritage preservation.

Picture1,2,3(left to right): illustrates Phase IV, depicting the ruined structure of the Dzong along the cliffside, highlighting its condition during the reconstruction process and progressing towards the finishing stage.

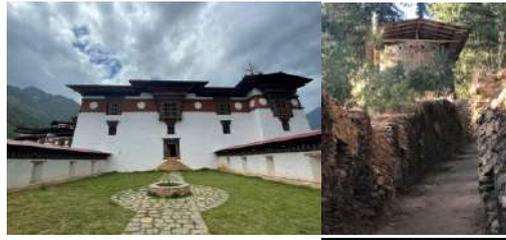
Drukgyel Dzong's reconstruction restored key functional and defensive elements, including entrance structures, arrow slits, and internal walls, while adapting certain areas like the former horse stable. The final phase added lower courtyard structures with rooms, a conference hall, and public toilets, preserving access to the old footpath as an emergency exit.

The images (1) show the main entrance to Drukgyel Dzong's after reconstruction, and (2) the old fortified footpath tunnel once used to fetch water, stored in large circular stone tanks.

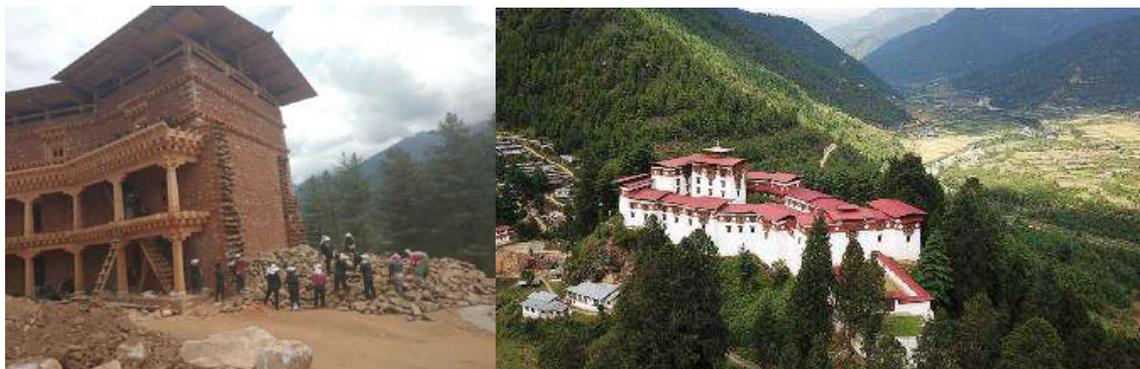
During reconstruction, some original materials were replaced with modern ones. Due to the Dzong's circular layout, work was phased, and wall junctions were later joined with concrete bonding, fritz stones, and flat stones. Since concrete has a shorter lifespan than traditional wood and mud-mortar, are there alternative traditional methods for joining walls may offer better integrity, authenticity, and durability.

The images (1) show: a wall junction awaiting interconnection, and (2) shows the overall completed structure.

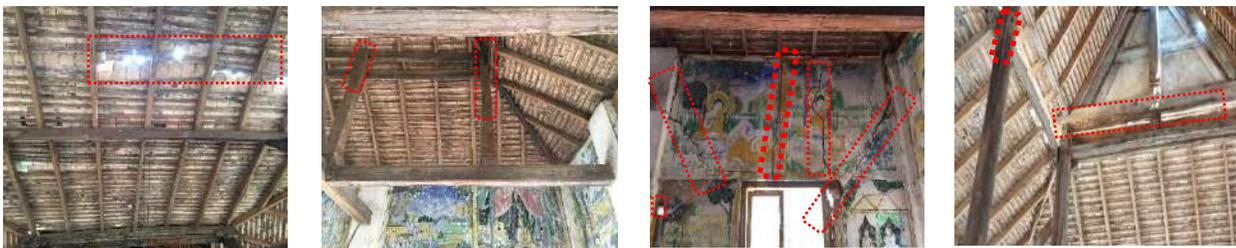
-Roof and Water Damage: The wooden roof structure was rotten and termite-infested in many places. This led to significant roof leaks, which allowed water to penetrate the interior, damaging the murals and leading to widespread moisture issues. The traditional "srakalinh" tiles were missing or broken.

Picture3-6. (left to right) Showing the damage of the wooden structure from the inside of the building.

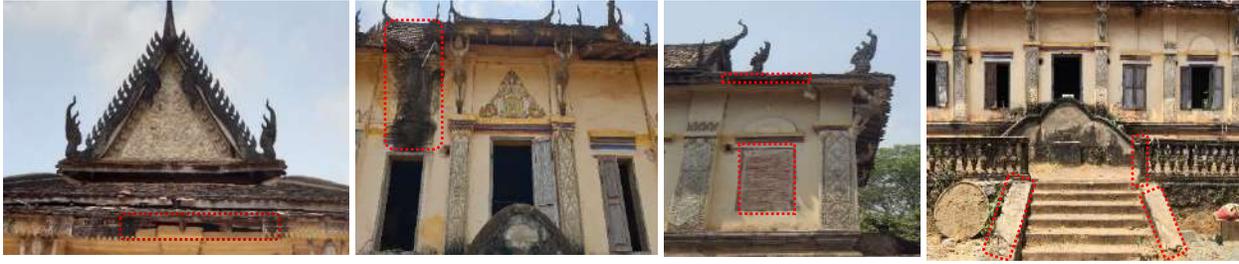
Picture7-10 (left to right) Showing the damage of the wooden structure from the outside of the building.

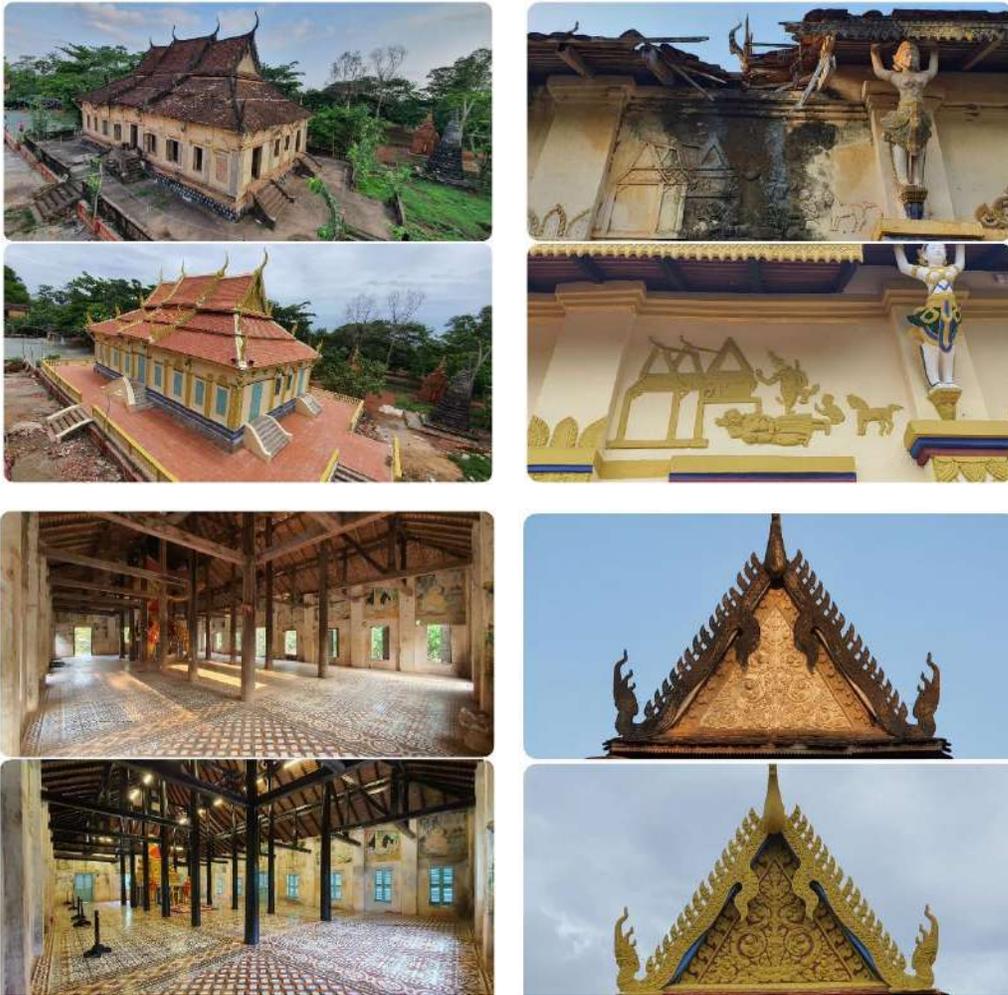
Picture10. Showing the comparison before and after restoration from interior and exterior.

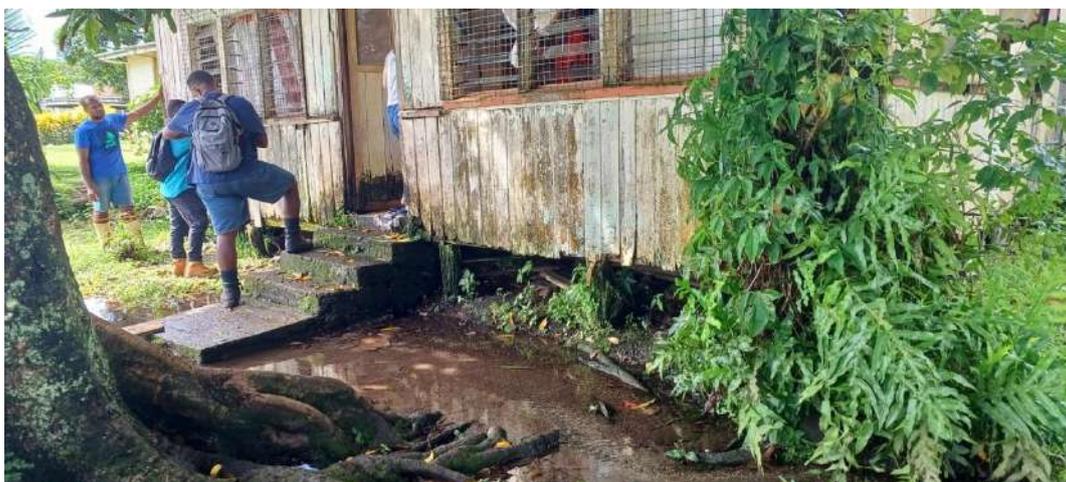
Fig 7. Case Study Building – Building Survey team in front of the residence.

Fig 7 shows how the water collects in front of the house as described in ‘Problem 1’. This is a result of the underground public storm water drain not being able to take the surface water because it has collapsed over the years and as a result all the water collects on the surface, forms a significant pool of water which remains in front of the residence for a few days until it is soaked into the ground or evaporates. The case study building has been severely affected by this water issue as demonstrated in the photograph, where the front of the building clearly shows the moldy walls and foundation timber posts and floor bearers have deteriorated

For this case study, one of the key contributors to the deterioration of the building is the absence of proper storm water drainage in front of the house which has caused the building foundations along the front of the building to rot and deteriorate rapidly over the years. The main drain that needs to remove water from the area has collapsed and causes water to collect in front of the residence and remain there until it is slowly soaked into the soil and eventually soaks up all the ground in front of the residence. Over time this has caused the timber piles of the foundations to rot and deteriorate and also drop the floor level along the front as the ground continues to be inundated with water.

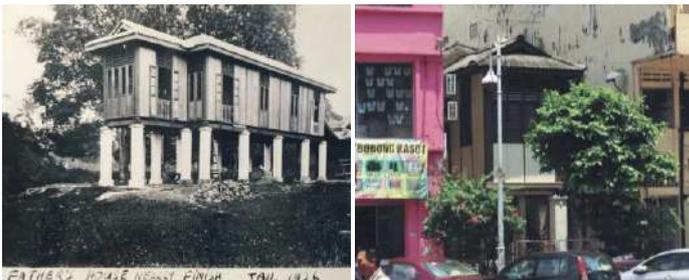
Picture 4 and 5 (left to right): Original photo of Rumah Degil, 1926 and 2014.

The picture above shows the house in its original form in 1926, and later in 2014 before the conservation works began. The conservation of Rumah Degil was initiated by a collective of heritage enthusiasts, architects, and community members who recognized the house's historical significance. The conservation of Rumah Degil was a collaborative effort involving multiple organizations and experts.

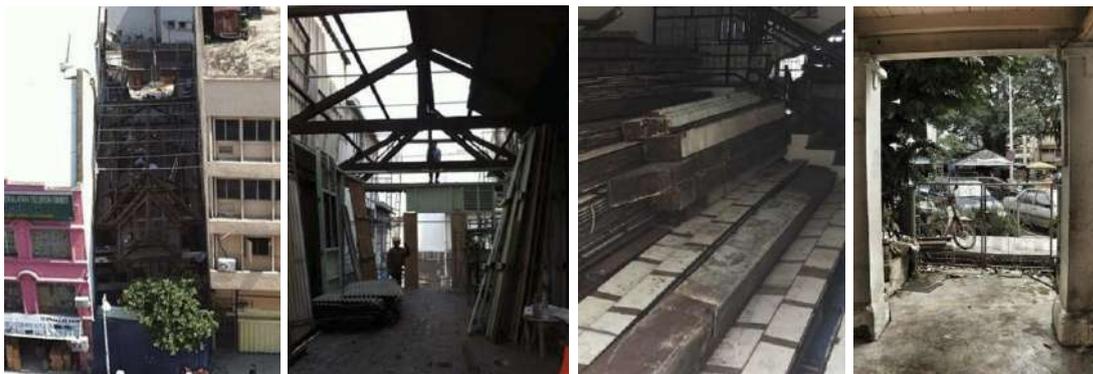
Picture 6, 7 and 8 (left to right): Rumah Degil timber structure showing partial damage and salvaged sections.
Picture 9 (right): Entrance view facing outward.

The timber structure, built in 1926, had been left largely unattended for decades. Termite infestation, together with rot and weathering, had weakened many of the original timber members. When dismantled in 2014, several beams were found to be badly infested with termites, requiring selective replacement using matching cengal timber. The fragile condition of its timber was one of the reasons the dismantling process in Chow Kit had to be done manually, beam by beam, instead of using heavy machinery. The relocation also revealed weaknesses in the original stilts, prompting reinforcement during reconstruction at the National Art Gallery.

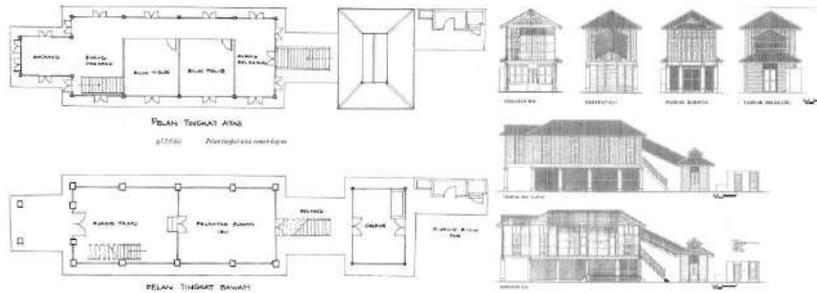
Picture 10 and 11 (left to right): The measurement drawings done by Universiti Teknologi Malaysia in 1997.

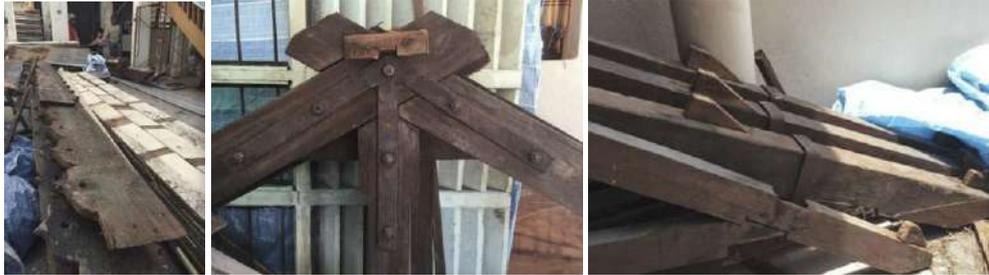
Pictures 12: (Above) shows the documentation inventory and original and later added element identification during dismantling.

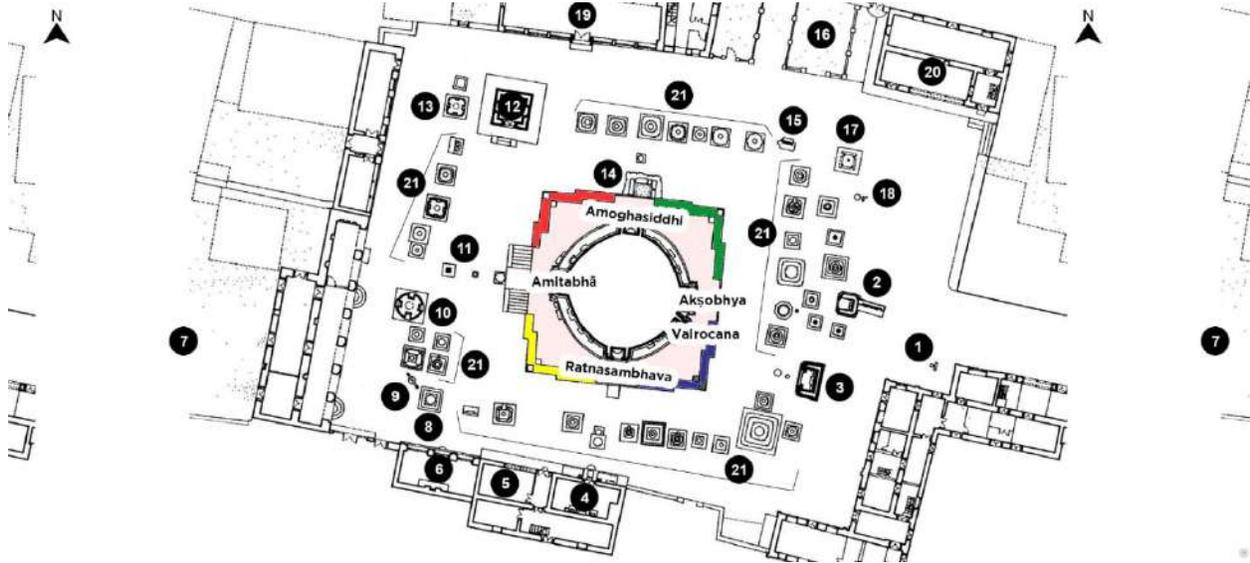
Figure 1: *Shri Gha Bah* premises with location of *harati ajima temple* at no 12 (MONA,2024)

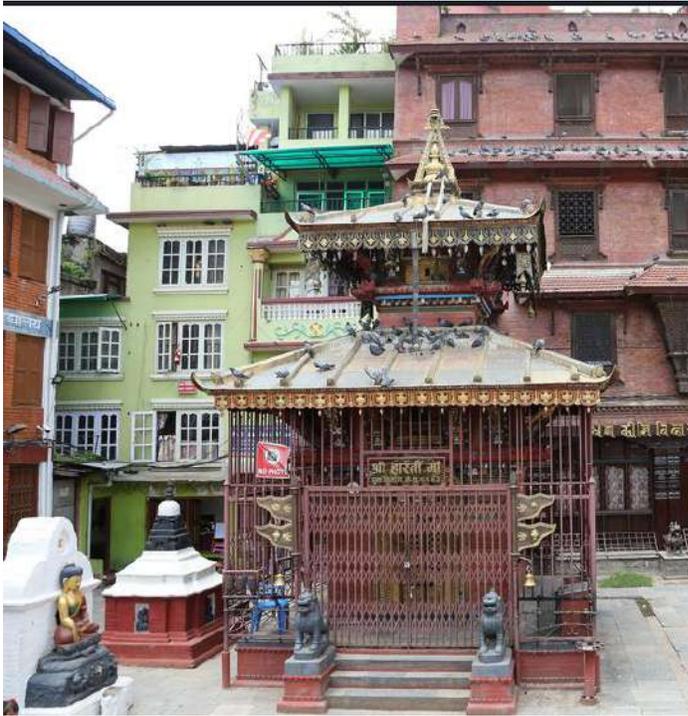
Figure 3: completed photo of Harati ajima Temple (MONA,2024)

The temple of *Harati Ajima* is a pagoda-styled, small, two-storied temple with gilded copper roof resting on intricately carved struts. The need for conservation of this monument emerged from its severity of damage from the Gorkha Earthquake of 2015, the west wall of first window had shear cracks and North wall was weak, there was an overall drift of the structure towards the left side. The wooden ceiling of the ground floor was budging down and pigeon droppings could be found everywhere. Overall, the temple structure was damaged due to the disaster and lack of the maintenance.

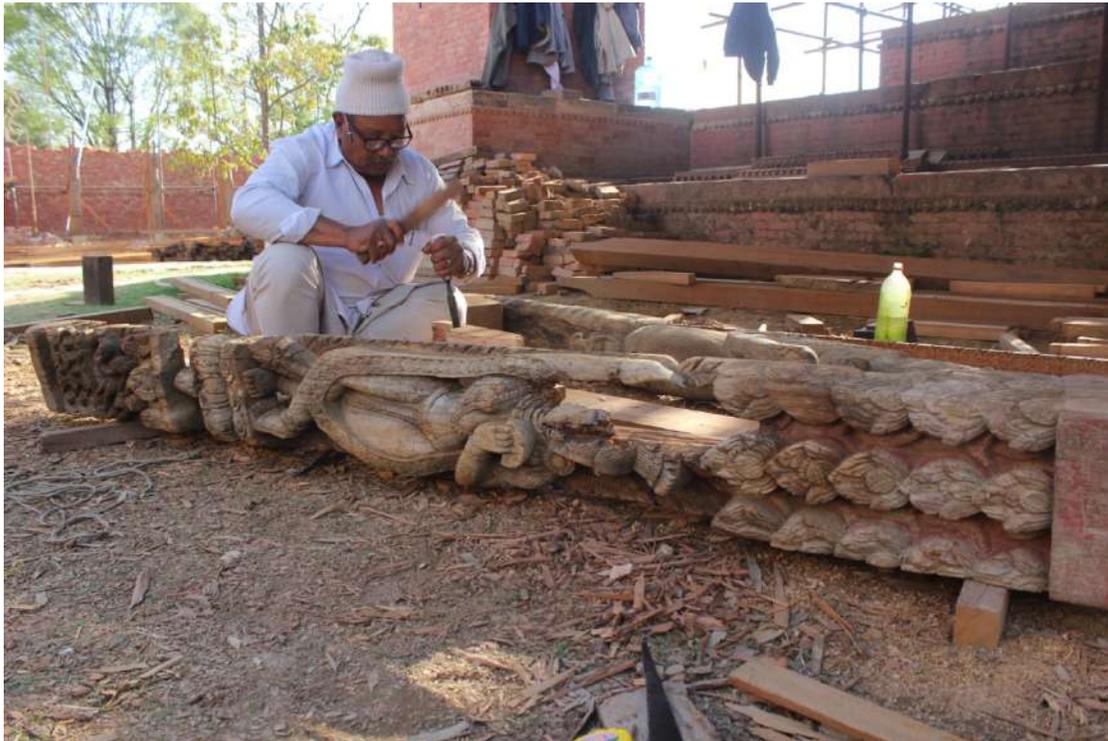
Picture 3: An experience heritage artisan (carver cum carpenter) in repairing one of the struts of temple.

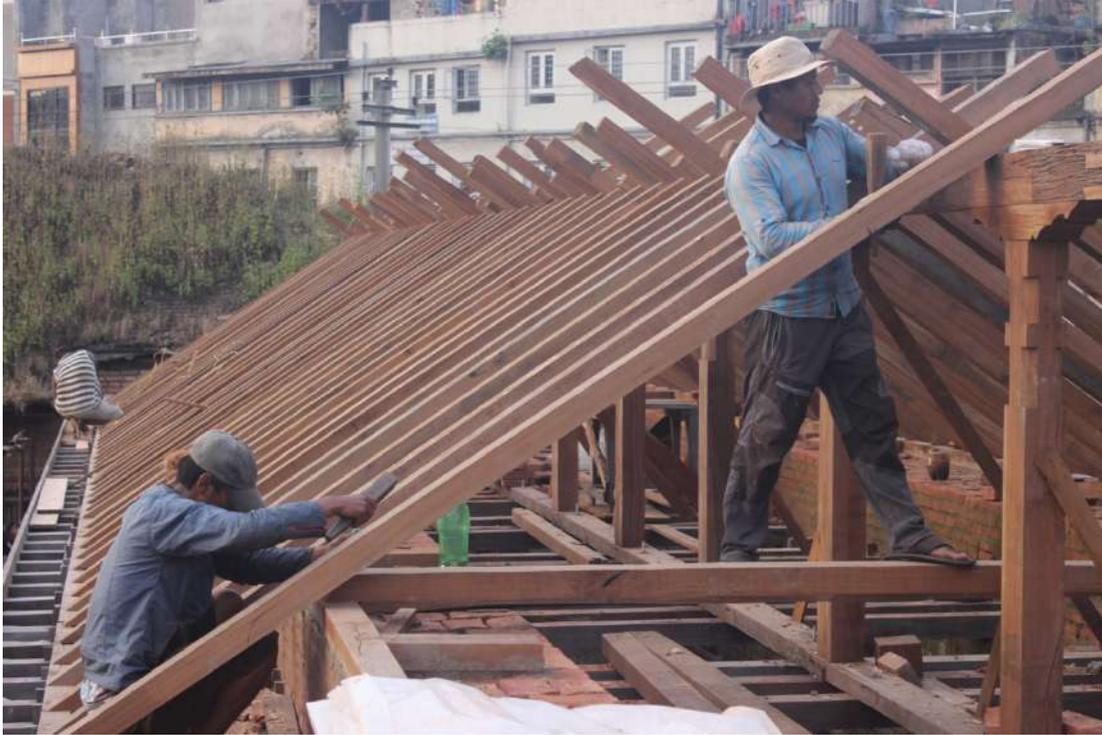
Picture 4: Salwood in use as rafters for sattal building roofs and new generation on work.

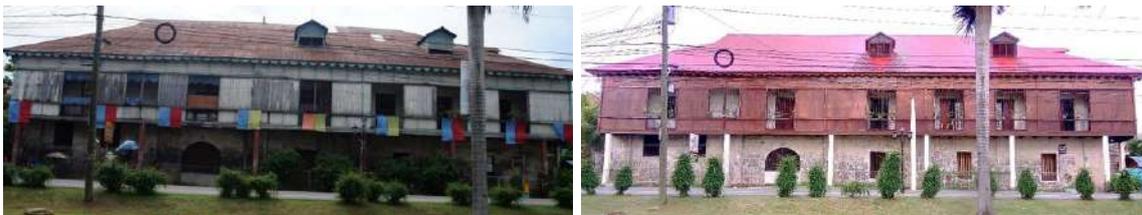
Figure 1 (left) showing the façade of Sibonga convent before the restoration and Figure 2 (right) showing after the restoration.

The Sibonga convent, built in 1839, is an example of a *bahay na bato* (literally translates as stone house) made of coral stones and wood. Its wooden components include the floorboards, windows, doors, truss and the *volada* – an overhanging gallery which is a distinct feature of a bahay na bato. Before the restoration, the old convent was in a dilapidated state with many alterations and interventions that damaged its original fabric, though it may be done in good faith to repair and sustain its function. The project aimed to (1) restore all intact original parts of the structure such as the masonry walls, doors and windows; (2) reconstruct parts are useful for its end users such as the reconstruction of the rear volada; and (3) rehabilitation of the parts which posed danger such as the replacement of roofing sheets and the rehabilitation of the dilapidated truss system. Aesthetically, the project aims to restore the structure as much as possible to be close to its original design by highlighting its prominent features which are the masonry walls and the volada walls. New materials and methodologies were used in reconstructing the rear volada but similar materials were still used for the walls.

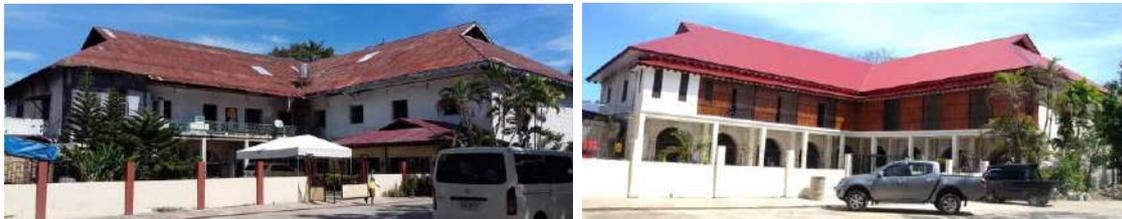
Figure 3 (left) showing the rear part of Sibonga convent before the restoration where the original volada does not exist anymore. Figure 4 (right) showing restoration of the volada with new materials.

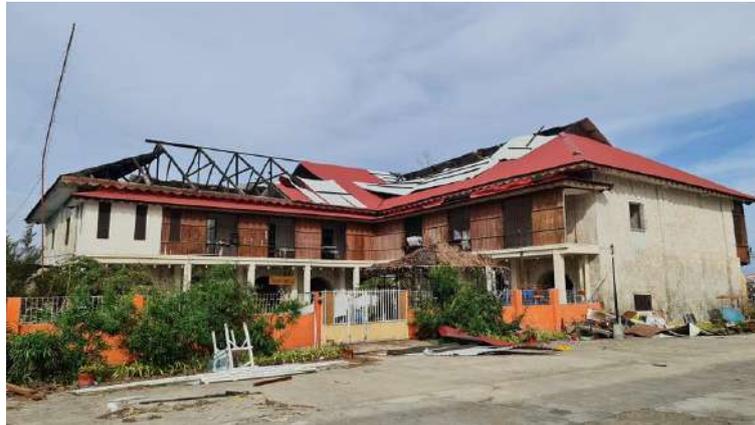
Figure 5. Aftermath of Super Typhoon Odette

Philippines and affected many cultural properties in Cebu including those restored after the Bohol-Cebu earthquake and the Sibonga convent. Just three years after the completion of its restoration in 2018, the old convent is needing an even greater and immediate roofing repair. The roof of the Sibonga church and convent was reported to be severely damaged that the church was closed to the public and the convent considered to be not livable. Although Typhoon Rai was known to be an extremely deadly typhoon, better **countermeasures could be studied** to be applied to the protection of cultural properties at large and invested on to avoid such aftermath. To this day, no major interventions were made yet, but design and engineering studies were conducted for possible rehabilitation.

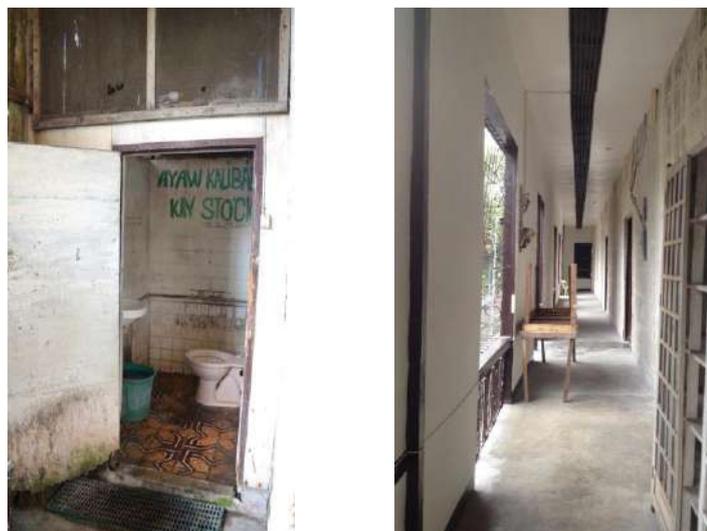
Figure 6 (left) toilet located along the volada and Figure 7 (right) the volada hallway after the restoration.

Lastly is the concern on establishing **proper property management to ensure the conservation and protection of its attributes**. As mentioned, the volada is a distinct feature of a bahay na bato. This area functions as a protective buffer to the heat of the sun and, originally, as a passage area for servants to go across the rooms without passing through the main hallway. Before the restoration project, it was found that the original wooden floorboards were covered with concrete, and toilet and bathrooms were constructed in it. These were removed and a new toilet and bathroom was constructed adjacent the reconstructed rear volada. With proper understanding of the structure and better property management system, I think it could be avoided to implement such interventions that would compromise the integrity of a cultural heritage and to promote a better approach to its protection and conservation.

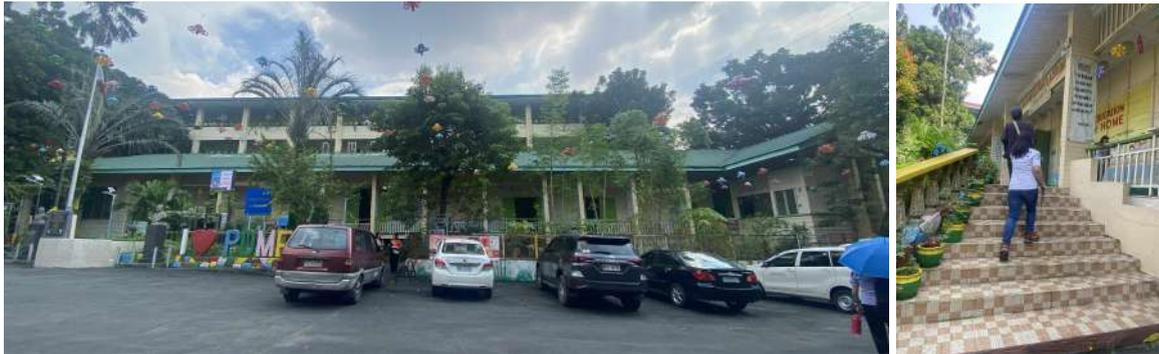
Picture 1. (left) Main facade of the Gabaldon school building. Source: C.Bautista, 2023
Picture 2. (right) Concrete stairs for the entrance to the school building. Source: C.Bautista, 2023

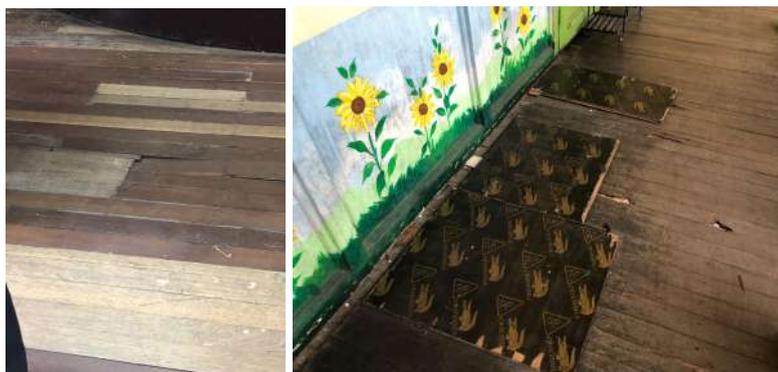
Picture 5. (left) Change of wood flooring. Source: F. Quito, 2023
Picture 6. (right) Damaged flooring covered with phenolic board. Source: F. Quito, 2023

The inspection further revealed significant alterations, particularly in the flooring materials, as well as modifications in the configuration of interior spaces to accommodate the building's new functions. However, due to the lack of records regarding the replacement of flooring and reconfiguration of spaces, it was not possible to identify when these modifications were carried out or determine the condition of the property at the time such changes were implemented. This information was deemed crucial in guiding the recommendations and approval process of the national cultural agencies for the proposed rehabilitation project.

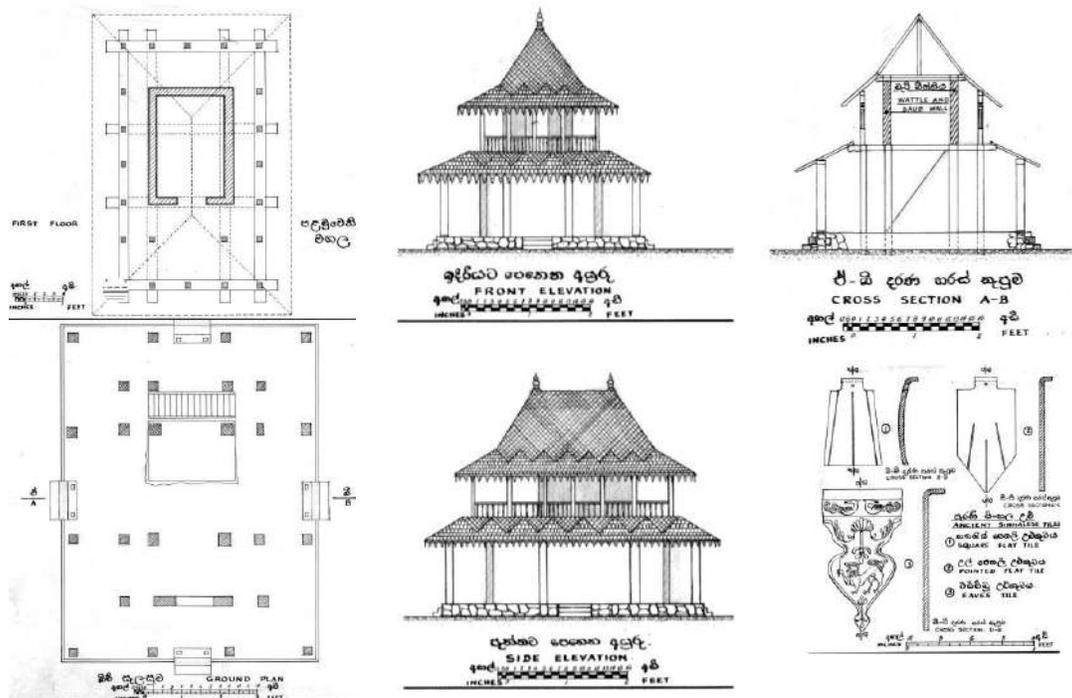
Figure 1,2,3,4,5,6 Plans, Elevations, Sections and tile Details of Ambulugala Danthapaya Tampita Vihara (Source: Conservation report, Department of Archaeology, Sri Lanka. 2024)

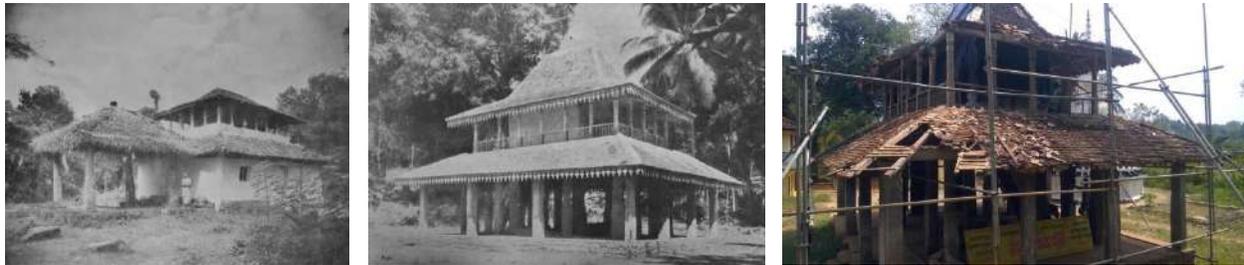
Figure 7: Before conservation **Figure 8:** After first conservation in 1961 **Figure 9:** After the damage has occurred (Source: Conservation report, Department of Archaeology, Sri Lanka. 2024)

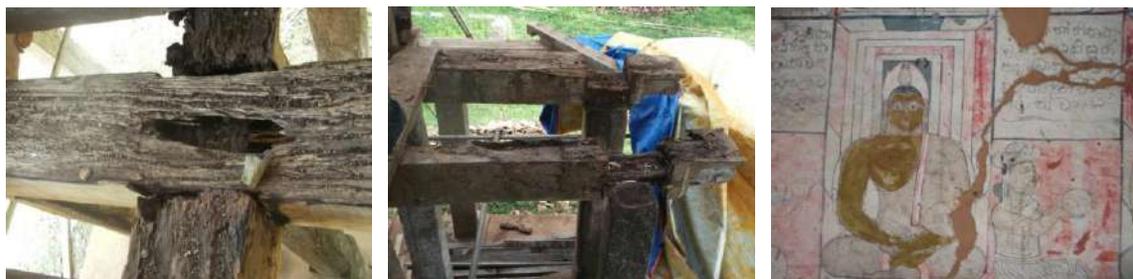
Figure 10, 11: Decayed wooden beams & joineries **Figure 12:** Cracked walls with paintings (Source: Conservation report, Department of Archaeology, Sri Lanka. 2024)

Due to the fall of a branch of *Na tree*, the image house constructed by using Wattle and daub walls on the wooden platform has faced to the structural damage and it was in a completely cracked and unstable state. Large portions of the clay components of the Wattle and daub walls have detached, while the interior paintings have developed cracks and were flaking. Several rafters of the roof have decayed, and in the section where the *Na tree* fell, the main rafters, wooden beams, and purlins have been destroyed. The roof tiles in this area have also been broken. In addition, the painted walls and Buddha statues have suffered direct damage from the impact of the fallen tree. Many of the decorative roof tiles on both levels of the *Tampita Vihara* are broken, further decreasing the structural and architectural value of the monument. Moreover, the painted wooden ceiling inside the temple are deteriorating rapidly and were at risk of collapse, posing an urgent threat to the preservation of the structure, its architectural value and authenticity. In this situation, the foremost task that should be undertaken is the removal of the hazardous *Na tree* from the premises. Following a detailed survey of the existing damage before conservation and restoration process, several problems have been identified, which are outlined as follows.

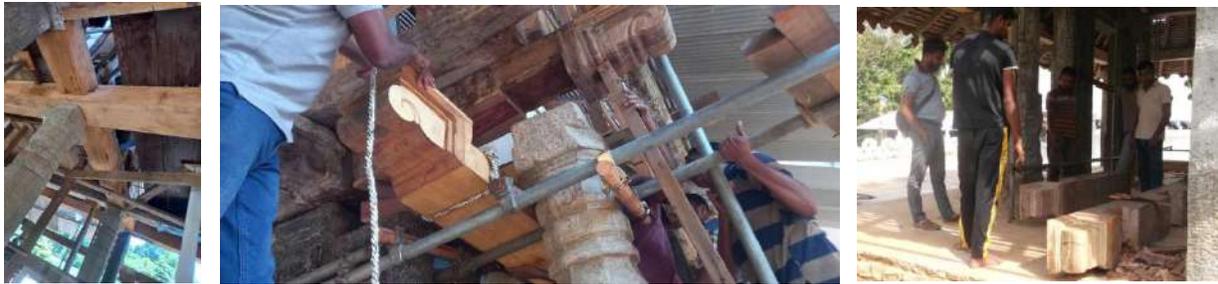
Figure 13, 14, and 15: assembling of wooden joineries
(Source: Conservation report, Department of Archaeology, Sri Lanka. 2024)

Since approximately 90% of the *Tampita Vihara* is wood including the wooden flooring, staircase, handrails, columns, beams, doors and windows, and roof structure. The process of carefully dismantling and labeling the original reusable timber required the removal of many wood components that had been damaged by termites and other pests. The subsequent challenge was finding suitable trees to provide the required quantity of timber. On the result of inspection, conservators determined that the wood obtained during the initial phase was of substandard quality, and consequently, it was rejected and considered as unsuitable for use in the restoration process.

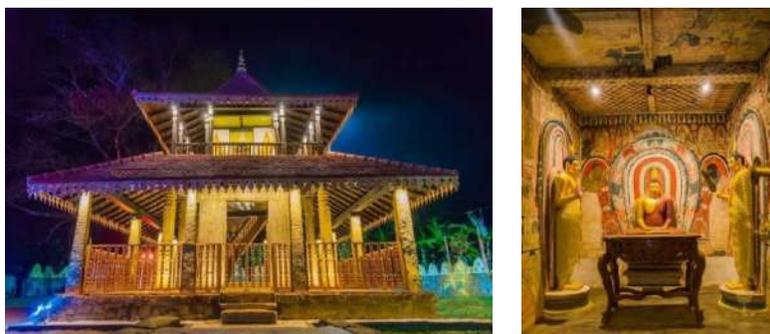
Figure 18, 19: The Tampita Vihara after the conservation and restoration work
(Source: Conservation report, Department of Archaeology, Sri Lanka. 2024)

During the conservation, the structure is carefully dismantled while recording and documenting each step. Detailed investigations are conducted on the roof, wooden components, and wattle-and-daub walls, painted surfaces to identify construction techniques, modifications, and parts to be change. All the original wood and roofing tiles that could be used in this conservation process were carefully numbered and safely stored in a temporary shed. Only parts that could not be reused were added. The painted clay walls had been damaged by the fall of the Na tree, and the wooden frame inside the walls had been destroyed, and the first step to be restored was those where the walls were damaged. The Assistance was received from the Chemical Conservation Division of the Department of Archaeology for this. When conserving the paintings, they were preserved without altering their original appearance, and only the cracked and peeling parts were treated. Later, the wooden staircase, wooden beams, joinery, damaged parts of the wooden floor, the roof, and other decorative wooden elements were preserved. Finally A sophisticated lighting system was also installed a feature that was not available before. Illuminating a wooden heritage building after conservation work holds significant importance in attracting the Buddhist community. By linking conservation outcomes with living traditions, lighting ensures that the monument remains both authentic and meaningful within the cultural landscape. This *Tampita Vihara* also highlighted with these additions while protecting the authenticity.

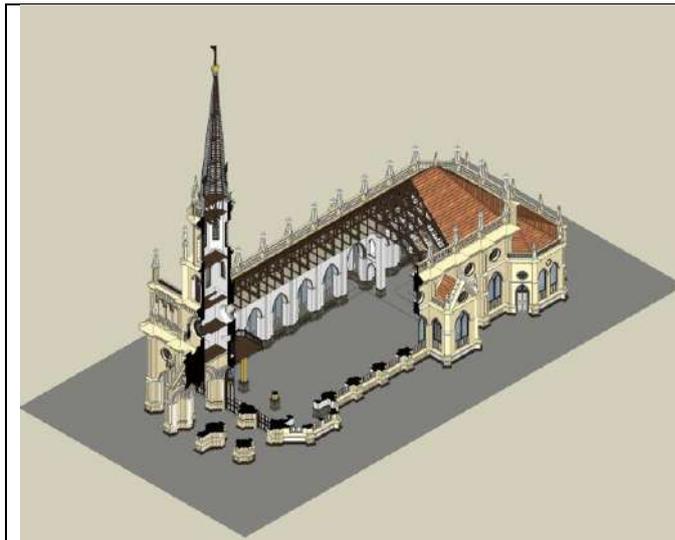
Fig. 1 Isometric drawing of the Holy Rosary Church showing roof and spire structure.

The Holy Rosary Church in Bangkok, built between 1891 and 1894, is a Gothic Revival building with a massive timber roof structure and one of the tallest historic timber spires in Thailand. The roof covers a span of approximately 36 x 13 meters and supports a spire of 50 meters in height, which carries 16 bells. Much of the original timber structure remains intact, retaining carpenters' marks from the late 19th century. However, later interventions have compromised its integrity. During the restoration of the 1990s, one-third of the timber section at the gutter line was cut to widen drainage, weakening the load transfer system. The roof structure now channels forces directly into adjacent masonry walls, causing stress and damage at critical joints. A recent gutter repair exposed water infiltration and timber decay, leading to localized failure of both the wooden members and the attached historic plaster.

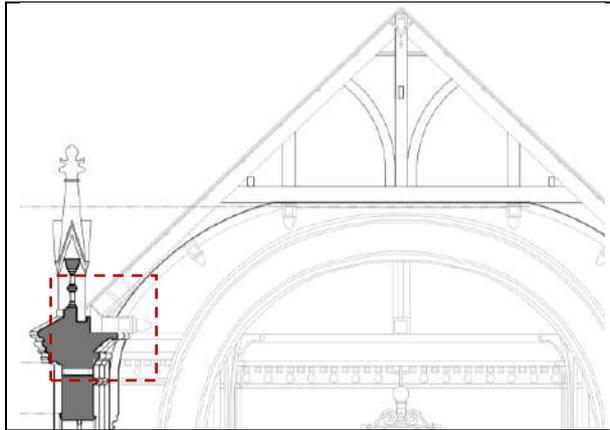
Fig.2 Section detail of the rafter resting on the brick masonry wall, showing cross-section cut for gutter widening.

Structural Loading and Alteration of Rafters: During the 1990s restoration, one-third of the timber rafter cross-section was cut away to widen the rainwater gutter. This intervention changed the way loads are transferred from the roof into the masonry. Some engineers have warned that structural failure could occur within decades, yet the modified structure has already stood for nearly thirty years. Still, without formal structural analysis, it remains uncertain whether the current system is sufficient to bear the combined loads of roof tiles, the ceiling, and the spire.

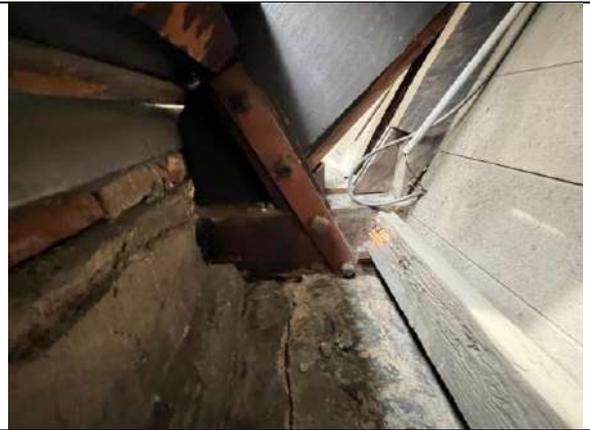
Fig.3 Close-up of the timber-masonry junction affected by moisture ingress.

Dampness at Rafter Ends: The widened gutter has also increased exposure of rafter ends to moisture where they abut the masonry wall. This has resulted in persistent dampness, leading to decay of the timber fabric. Rotten timber has already been observed, though systematic strength analysis and repair proposals remain pending. The ongoing deterioration of these connections further threatens the stability of the entire roof system.

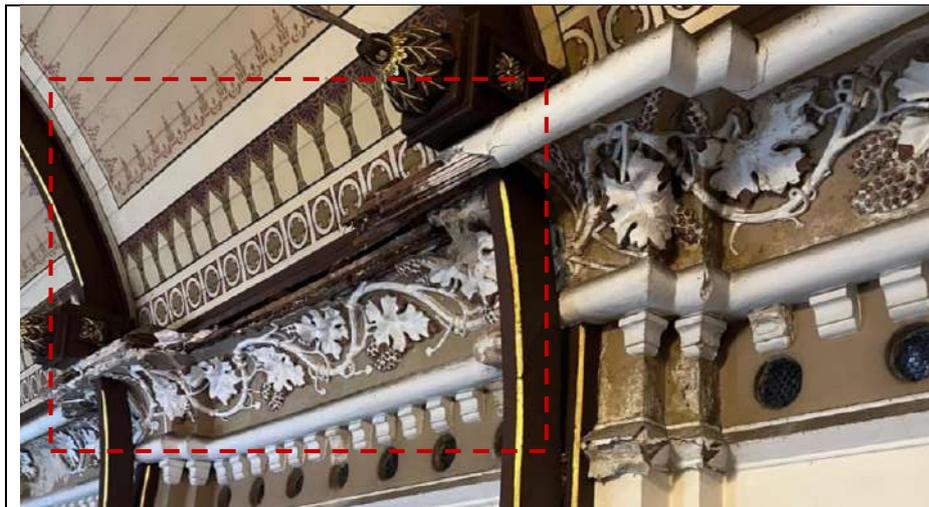
Fig.4 Deteriorated lath and plaster ceiling at the Holy Rosary Church caused by roof leakage.

Damage to Lath and Ornamental Plaster: Moisture infiltration has spread from the gutter into the timber frames that support the lath and plaster of the interior ceiling. As these timber elements weaken, the ornamental plasterwork they carry has begun to fail. This issue is not limited to structural repair alone but also involves conserving delicate craftsmanship. Repair methods must therefore address both the stability of the timber framework and the preservation of traditional plastering techniques, ensuring that future conservation enhances understanding of workmanship.

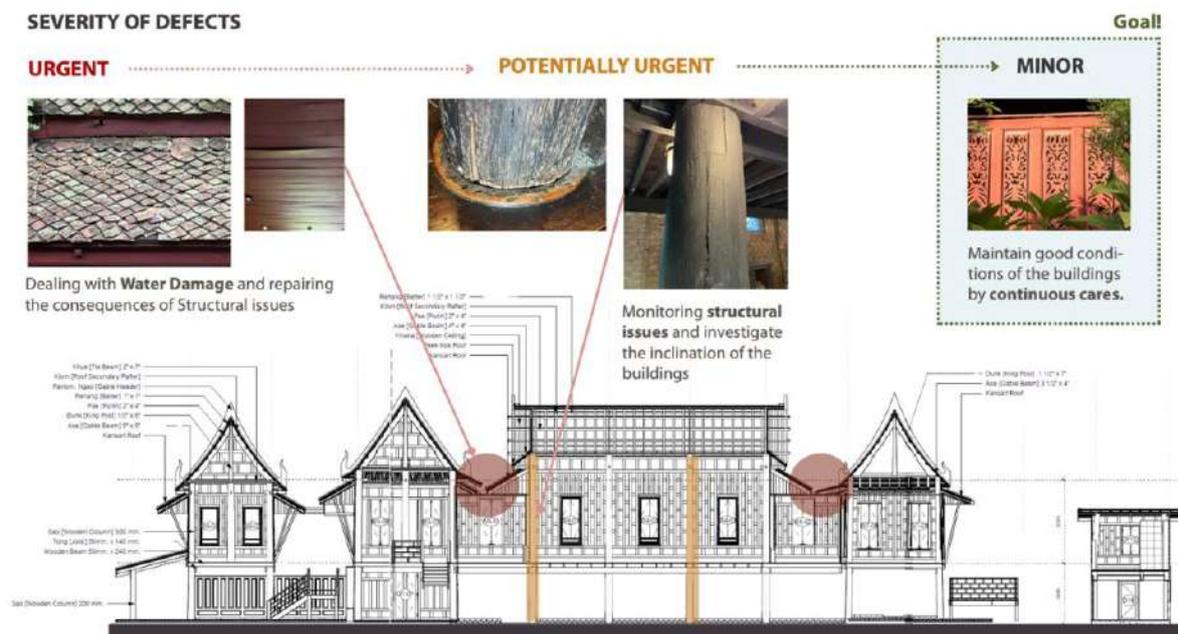
Fig. 5 Longitudinal section of the main house at the Jim Thompson House Museum.

The Jim Thompson House Museum in Bangkok, established in the 1950s, is an assemblage of traditional Central-Thai teak houses that were dismantled, transported, and reassembled on site. The structures showcase modular timber architecture, with mortise-and-tenon joints and wall panels designed for relocation. This system reflects the adaptability of Thai wooden heritage but also presents distinctive conservation challenges.

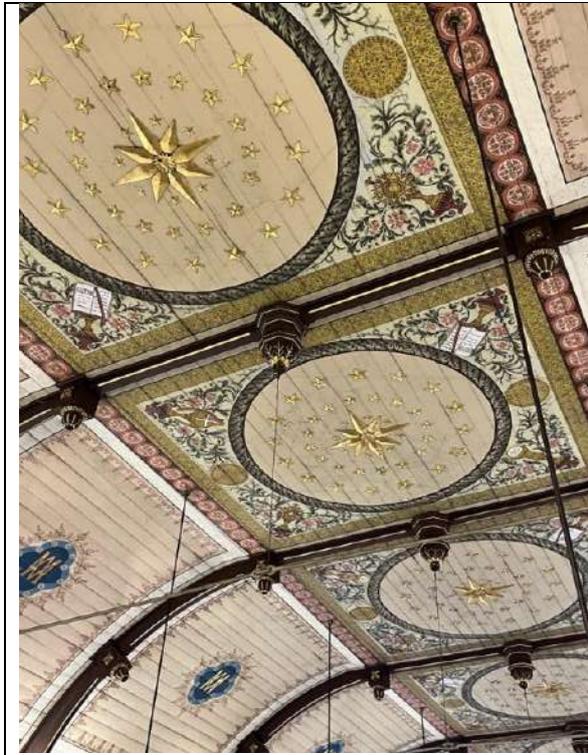
Fig. 6 Painted timber ceiling of the Holy Rosary Church interior.

These finishes are now highly vulnerable. At the Holy Rosary Church, moisture infiltration from the roof has caused discoloration, flaking, cracks, and localized loss of painted layers. In some areas, timber decay beneath the paint has further compromised adhesion, making conservation difficult without addressing the underlying structural problems. At the Jim Thompson House Museum, prolonged urban exposure has led to fading, uneven weathering, and surface deposits that alter the intended appearance of the timber. Increased visitor traffic and cleaning routines also risk unintentional abrasion of original coatings.

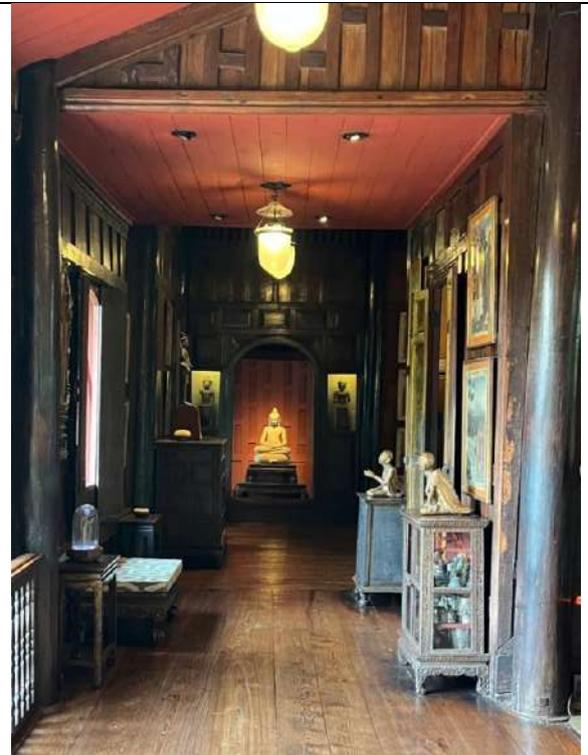
Fig. 7 Blackened interior timber finishes of the Jim Thompson House Museum.

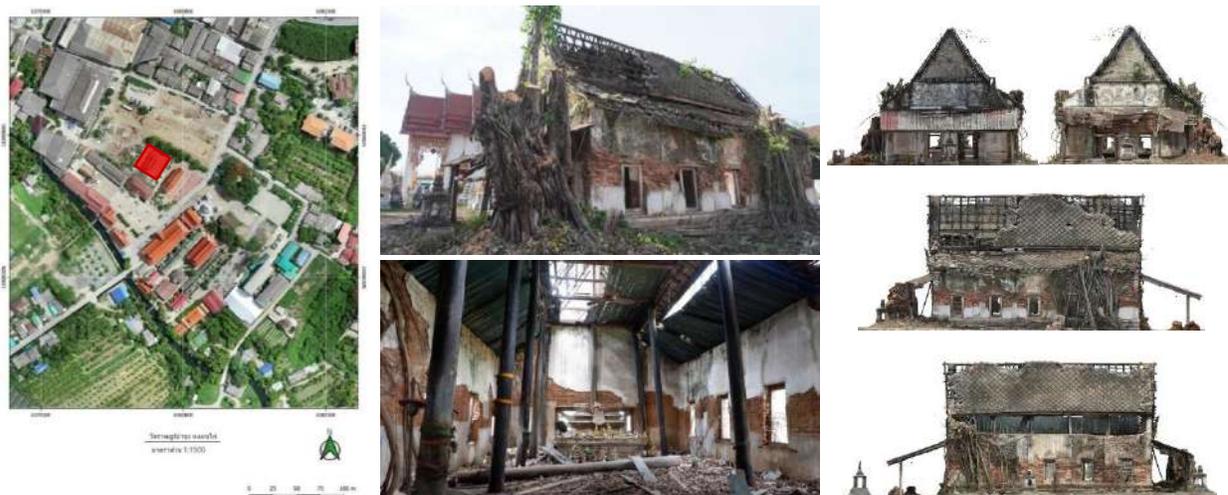
Left: Map showing the location of Wat Hong Kai
Center: Photo of the building before restoration
Right: 3D image of data recording before restoration

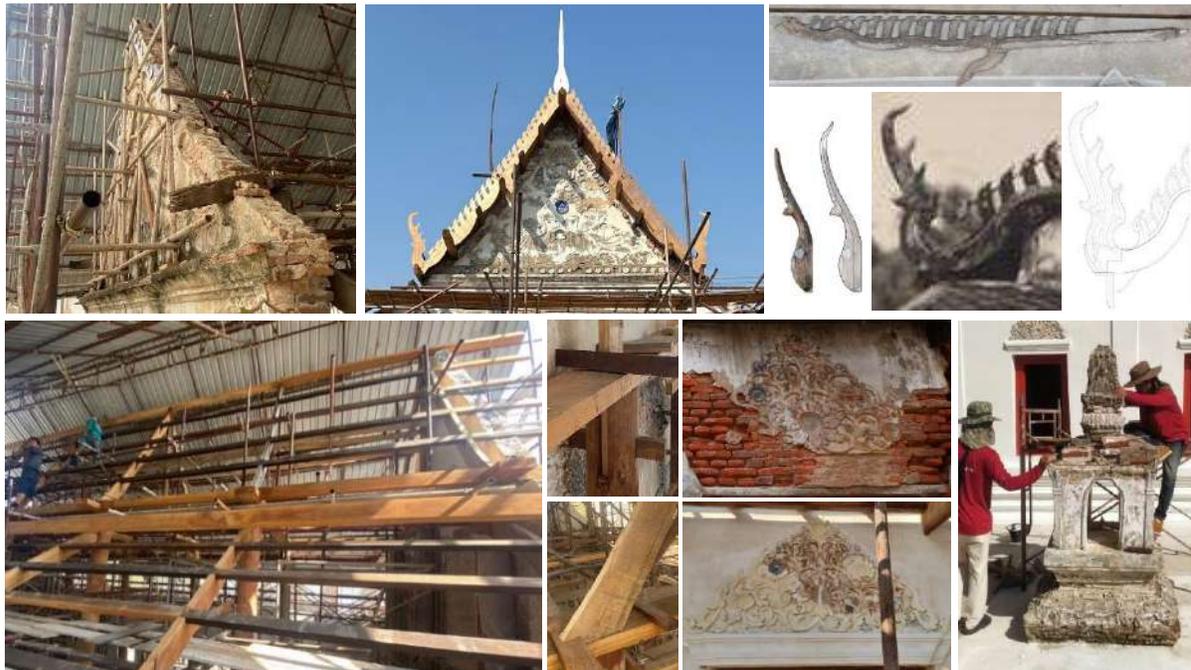
Top left: Supporting the gable lime stucco

Top center: Strengthening the gable

Bottom left: Restoring and repairing the wooden roof structure

Bottom right: Repairing the boundary arch of the Ordination Hall (stone)

- 1.1 Lime stucco on doors, windows and painting traces:** Restored the form according to assumed information, using the original material and technique. The new stucco will not be painted.
- 1.2 Roof structure design:** Although heavily damaged, the original form, wooden joinery technique, and structure can be assumed the form. Restored will follow original materials, style, and methods.
- 1.3 Roof Ornaments:** Restored based on remaining samples and old photos, using the same material and technique.
- 1.4 Boundary arch of the Ordination hall (stone):** Repaired in its present state due to lack of reference and limited budget.
