Group Training Course 2025

Case Study Reports

Identification of the problems and the required measures for a wooden structural element. (Bangladesh)

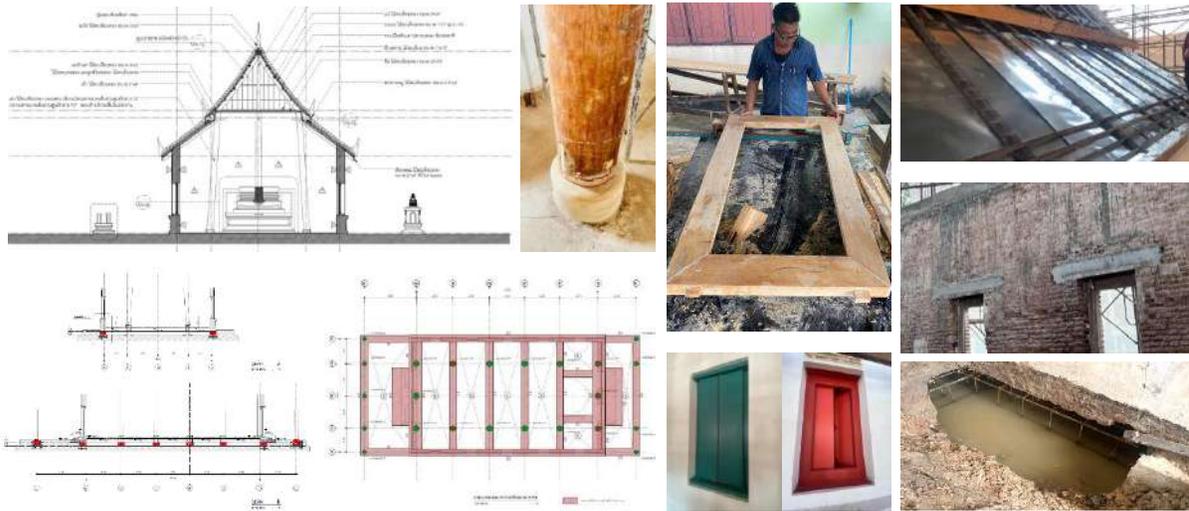
Left image: Reinforcing with reinforced concrete and raising the wooden columns above the ground

Center image: Restoring doors and windows

Top right image: Installing zinc sheets under the tiles to prevent rainwater leakage

Bottom right image: Reinforcing with reinforced concrete under the foundation and above the door and window lintels

- 2.1 Doors and windows:** Almost completely damaged. Restored in original form with traditional installation technique, adding brass mortar equipment at hinge points.
- 2.2 Brick bearing walls:** To strengthen the building and protect the gable, reinforced concrete structures were hidden inside the walls.
- 2.3 Original brick foundation base:** To prevent settlement and lift the wooden columns above ground level (not bury wooden columns in the ground.), reinforced concrete beams were added

under the old foundation line, and new concrete pedestals were built to raise the wooden columns 20 cm above floor level.

3.1 Roofing material: Previously large cement tiles, but traces of battens and roof curve show that the original was small clay tiles (large tiles could not bend to the roof form). Therefore, clay tiles were used again and add a zinc sheet under the tiles to prevent rainwater leakage.

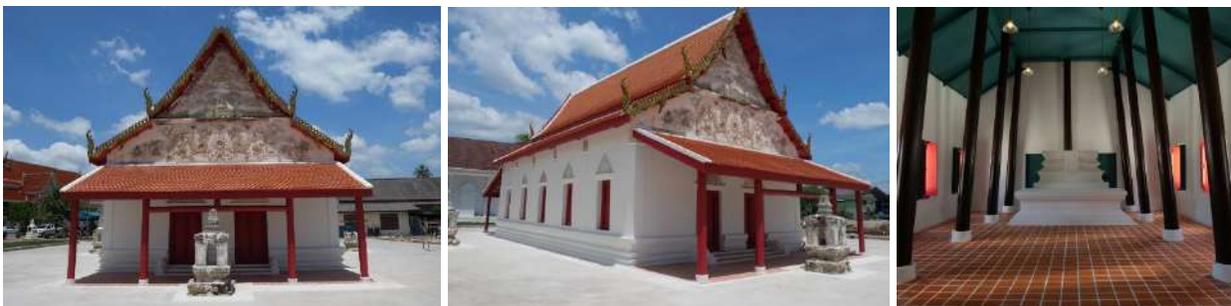
Left and center images: Ordination Hall building after restoration completed.

Right image: Inside the Ordination Hall building after restoration completed.

The work was completed in 2024. After restoration, the building returned to normal usable condition.

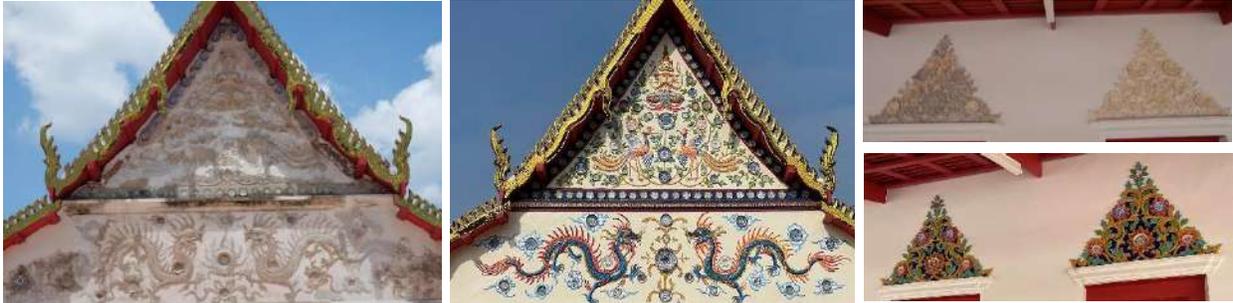
Comparison of the conservation approach for lime stucco on door and window frames with the paint later added by the temple

In early 2025, the temple painted the gable stucco and stucco around doors and windows. Investigation found that it was painted over without damaging the old paint layers.
