ACCU Nara International Correspondent Vol.28 2022 The Twenty-eighth Regular Report

The Twenty-eighth Regular Report

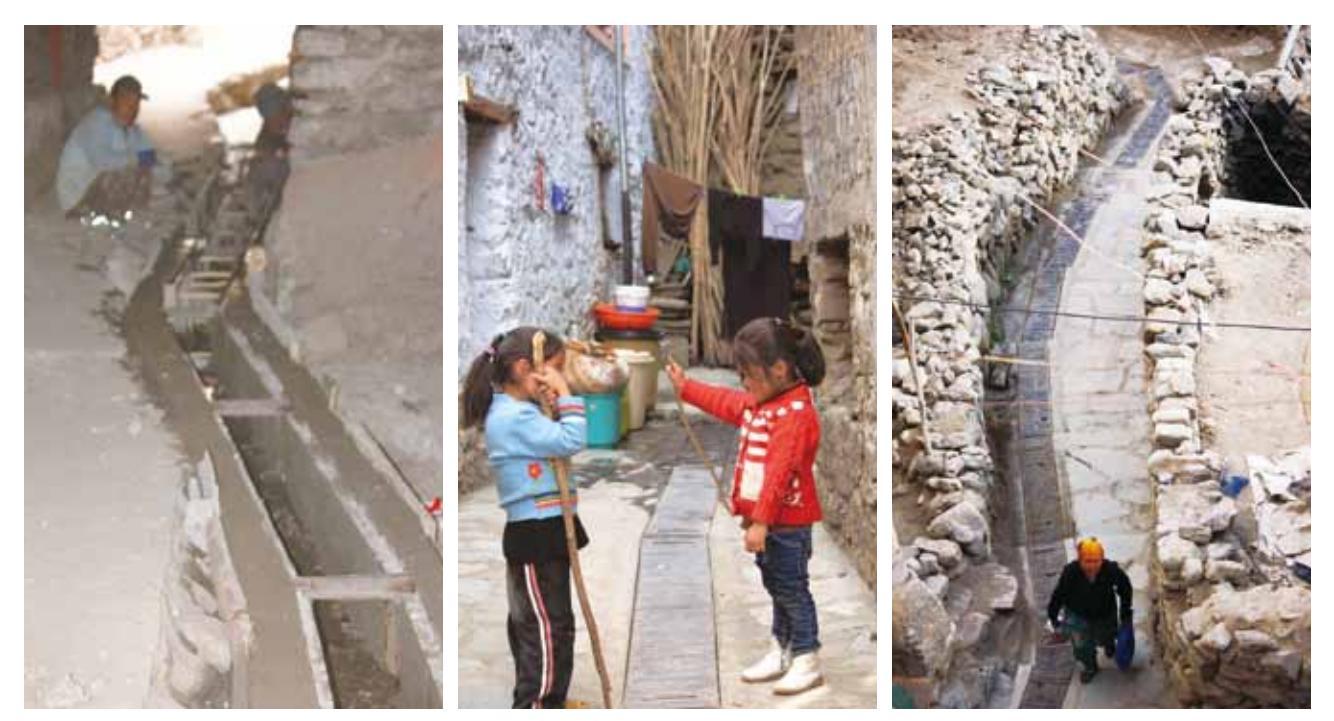
Fig. 10. Construction of drain in progress in May Figs. 11 & 12. Life in different parts of the old town after the infrastructure addition in May 2013

Following the example of Stagophilok, most of the streets of Leh Old Town have now been built with proper drains and paved with cut stones by THF (Figs. 10, 11 and 12) with support from the community and sponsors over the years, and better living conditions prevail in the precinct as the streets are no longer flooded with drain water and filth because of choked drains. The enormous task of building infrastructure in a historic setting could be accomplished well with the dedicated efforts of the community when provided with the right kind of technical knowledge and motivation.

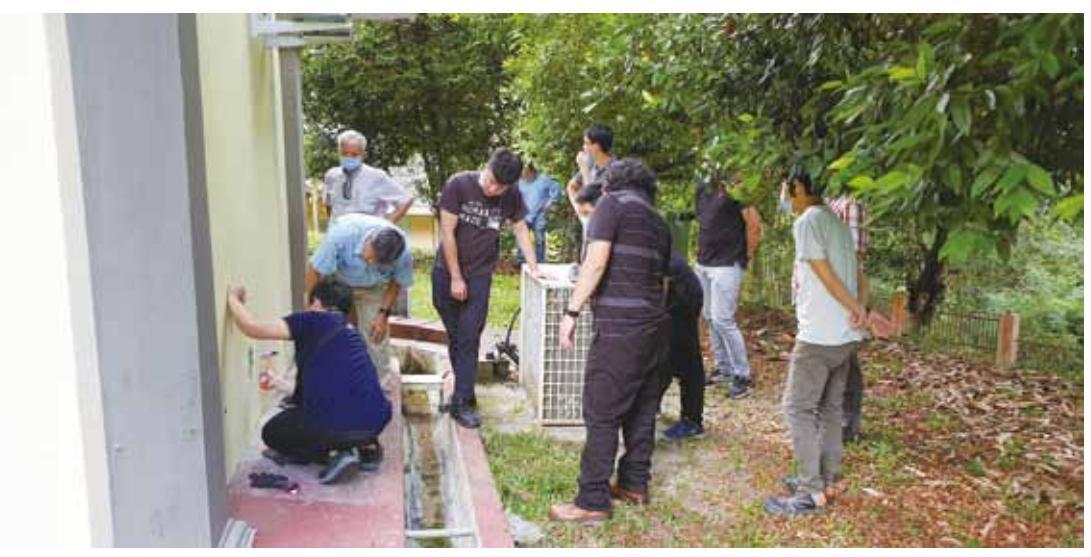
Structural inspection of the existing exterior walls of Rumah Sri Aman was conducted by the consultant team.

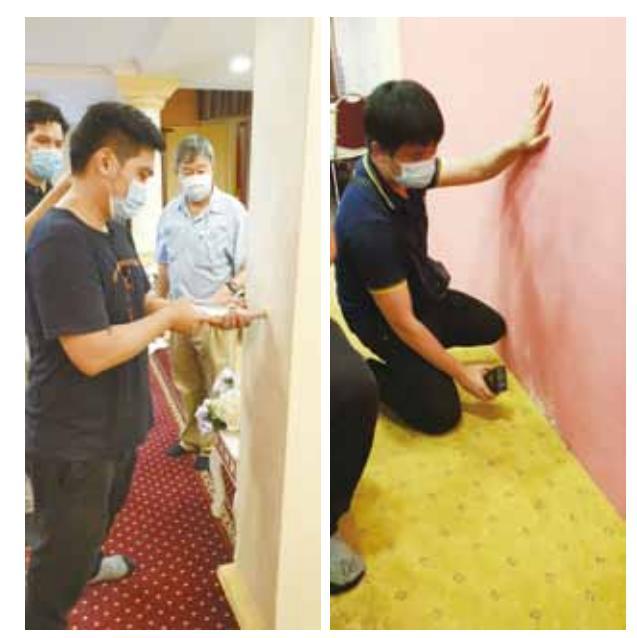
The dilapidation survey of Rumah Sri Aman began by identifying and recording the building defects by using non-destructive methods including observation, inspection, examination, identification, and photo documentation using tools such as a moisture detector, Schmidt hammer, scrapper, and high-density camera.

The dilapidation survey of Rumah Sri Aman began by identifying and recording the building defects by adopting non-destructive methods including observation, inspection, examination, identification, and photo documentation using tools such as a moisture detector, Schmidt hammer, scrapper, and high-density camera. Measured drawings were carried out conventionally on site using a measuring tape, scaled ruler, or distance meter. The measured drawings consisted of a site plan, location plan, floor plans, elevations, sections, and architectural details. Building plans were produced digitally using the AutoCAD software. The dilapidation survey of Rumah Sri Aman was instrumental in providing the consultants, clients, and government agencies with key information as follows:

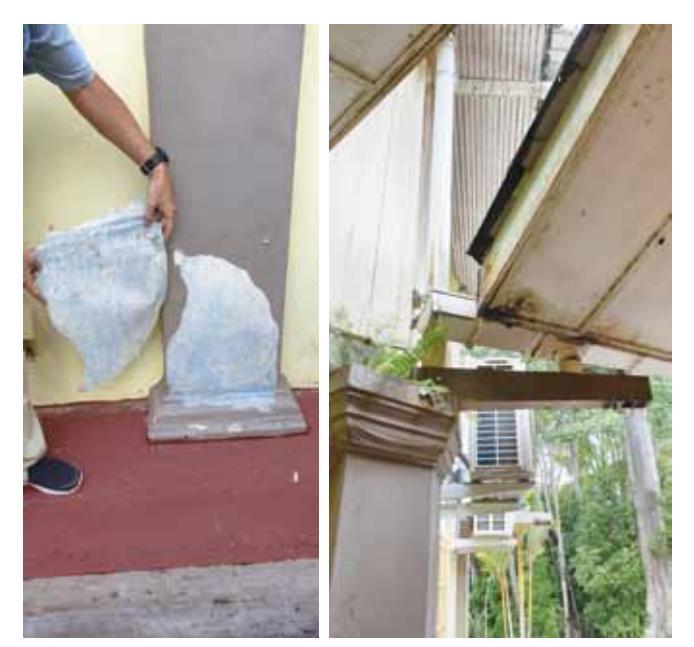
Examples of common building defects of Rumah Sri Aman including peeling off paint (left) and leakage, stains and plant growth (right).

The dilapidation survey report prepared by the consultant architect revealed that Rumah Sri Aman faced several common building defects. Each building defect was carefully analysed to determine the possible cause. No structural examination was carried out on the existing building and no material testing was conducted outside the premises. All building defects were identified and categorised according to the level of defect, and indicated on the building plans in the dilapidation survey report. This practice is vital for the purposes of determining quantity and cost estimates for future reference. Some of the common building defects found at Rumah Sri Aman are leakage, cracks, peeling off or faded paint, stains, corrosion, plant and fungal growth, and defective floors. The main causes of these building defects were lack of maintenance, ageing of building materials, climatic or environmental conditions, and soil settlement or slope instability. Rumah Sri Aman also faced issues of ineffective building services including poor air conditioning, fire protection, electrical wiring and conduits, and water pump system. Table 1 shows the common building defects of Rumah Sri Aman and their respective locations. Leakage, cracks, and peeling off or faded paint are the most common building defects observed at Rumah Sri Aman.

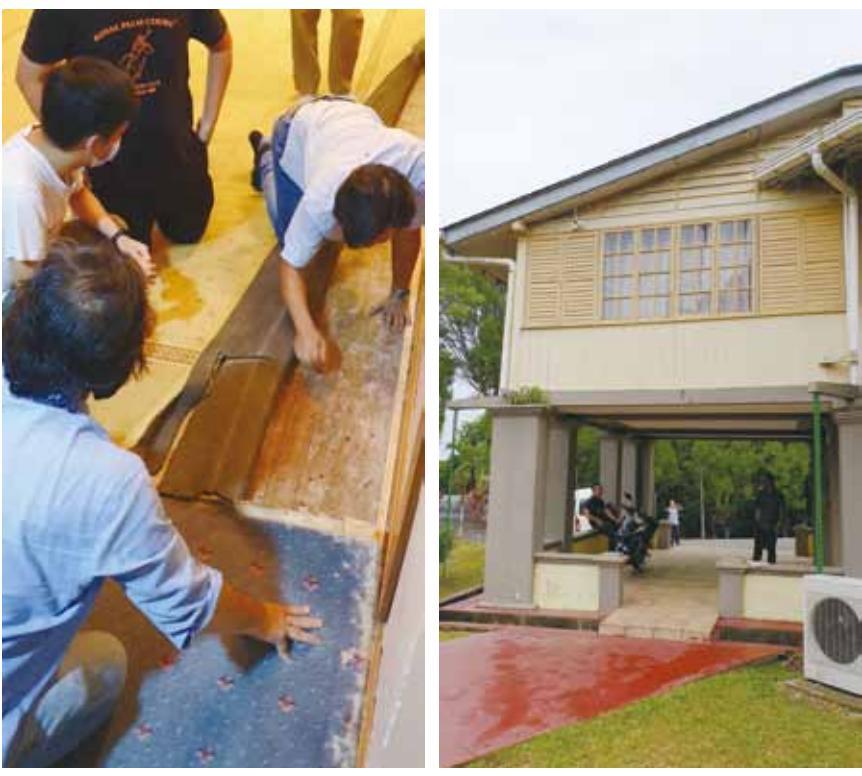
Detailed inspections of Rumah Sri Aman, particularly of its squeaky floorboards (left) and porch structures (right).

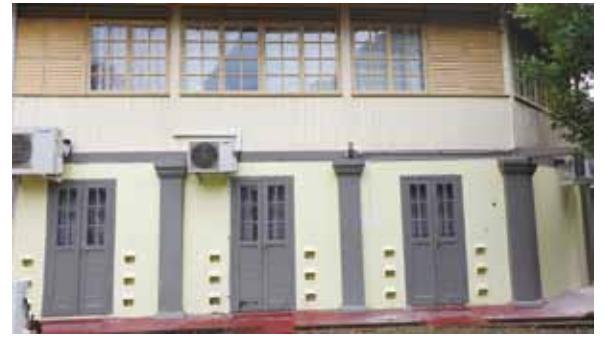
Cracks were found in the building apron, dry walls, columns, and perimeter drain, while the timber doors, windows, and wall panels were damaged.

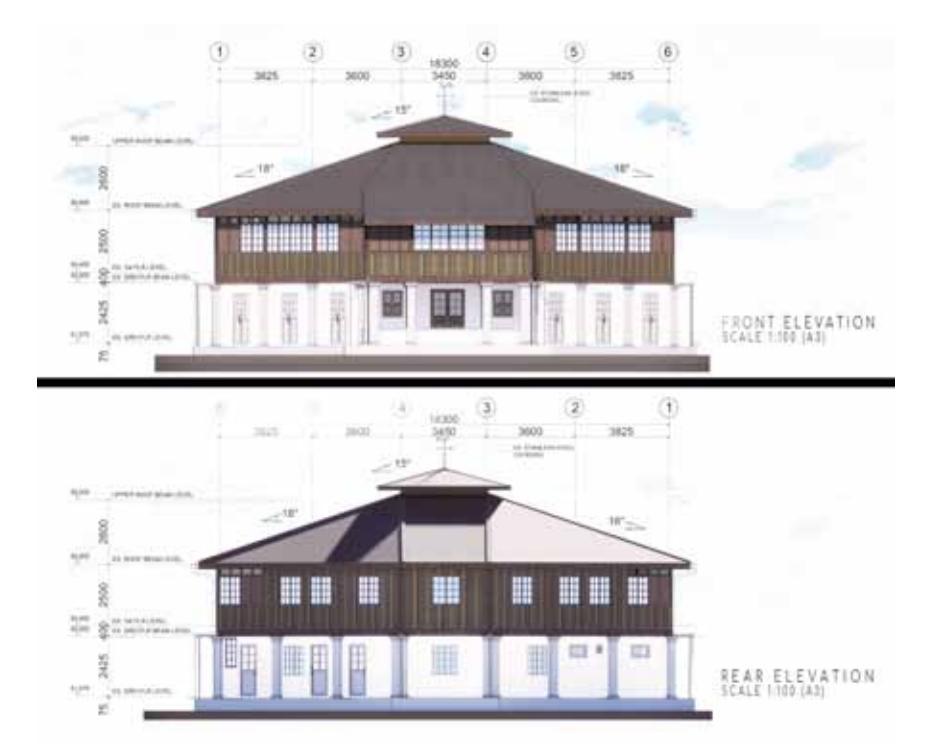
Front and rear elevations of Rumah Sri Aman showing the jack-pitched roof. (Drawing courtesy of Konsortium Bumi Consultants and Services Sdn. Bhd.)

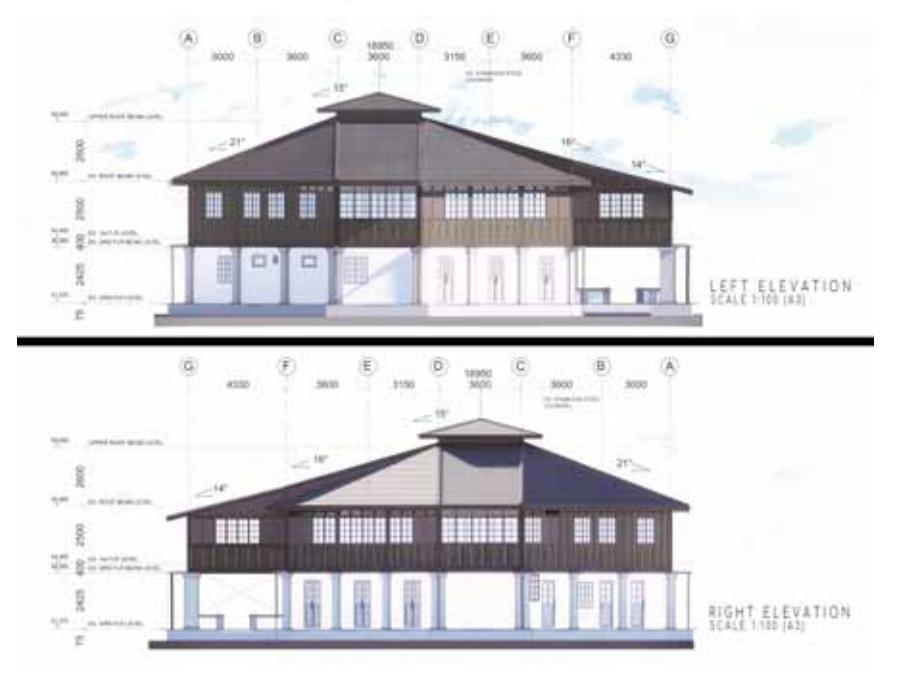
Left and right elevations showing the porch of Rumah Sri Aman. (Drawing courtesy of Konsortium Bumi Consultants and Services Sdn. Bhd.)

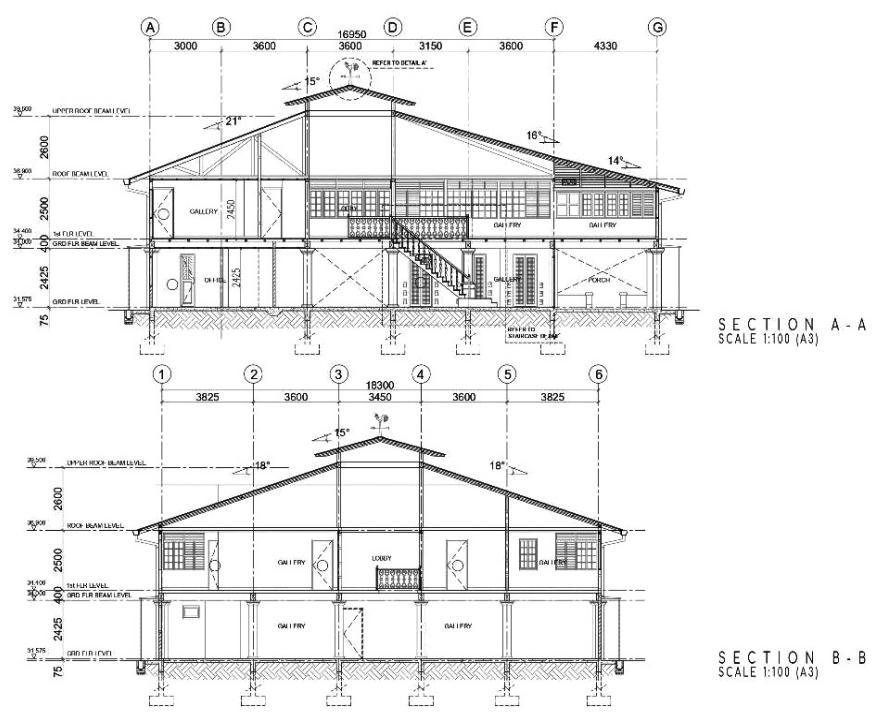
Sectional elevations showing the staircases and floorboards on the first floor of Rumah Sri Aman. (Drawing courtesy of Konsortium Bumi Consultants and Services Sdn. Bhd.)

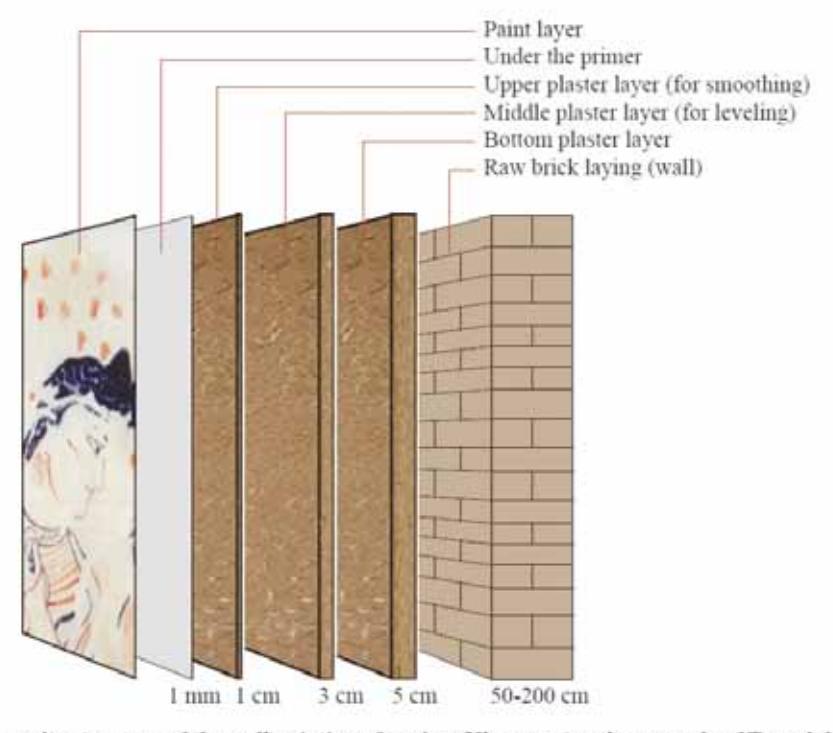
The composite structure of the wall painting of ancient Khorezm (on the example of Toprak kala) (Source: Kovaleva N.A., Rapoport Yu.A. Funeral scene in a wall painting from Khorezm // VDI,1991, No 2. – P. 198-224)

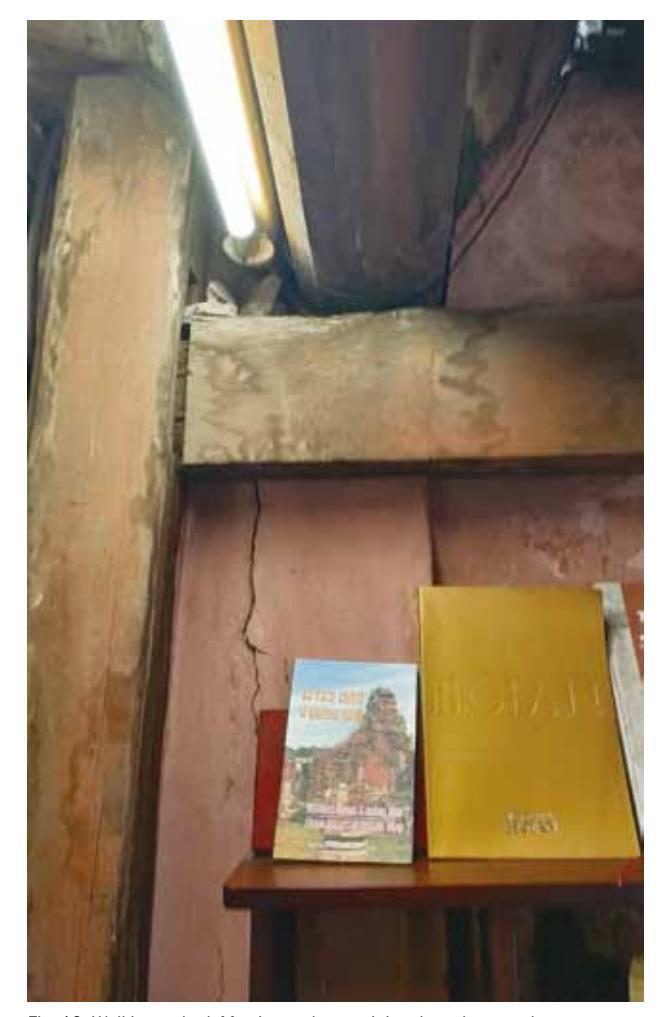
Fig. 10. Wall is cracked. Mortise and tenon joints have loosened.
