ACCU Nara International Correspondent Vol.29₂₀₂₂ The Twenty-ninth Regular Report

ACCU Nara International Correspondent

The Twenty-ninth Regular Report

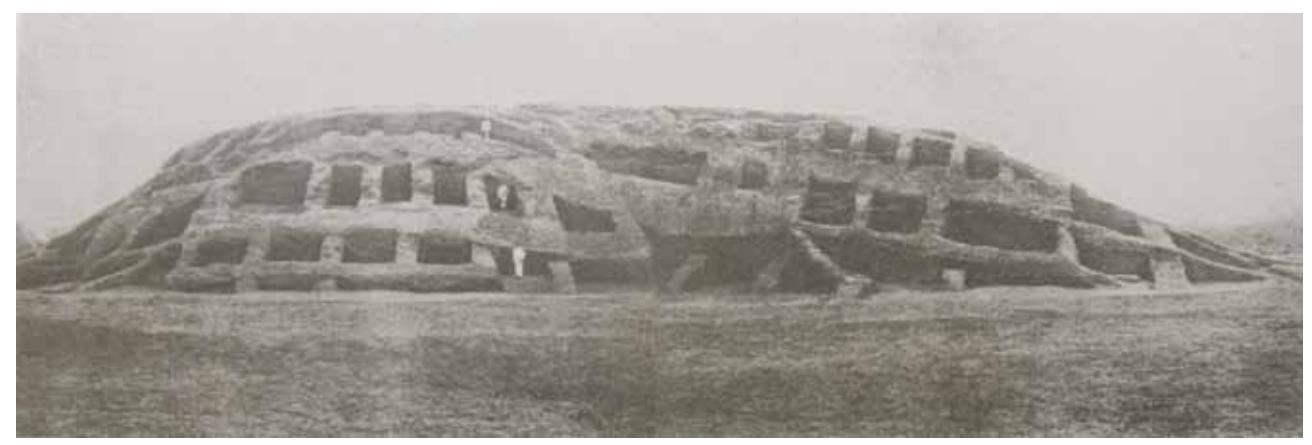
Fig. 2. Gokul Medh, after excavation; the photo taken from the ASI annual report in 1935-36.

of special significance. This type of construction style is rare in ancient Bengal. A total of 172 chambers have been unveiled in various shapes and sizes from archaeological excavations. The chambers, built at different heights, were arranged in ascending order from the bottom to the top. These chambers were placed at several heights but built in the same row and were filled strongly with adhesive earth. It can be easily presumed from the location of the chambers built at different heights that these were used as foundations for a lofty temple or stupa. Such a multi-storied parallel buttress-walled foundation is a significant architectural feature of ancient Bengal (Figures 2, 3, & 4).

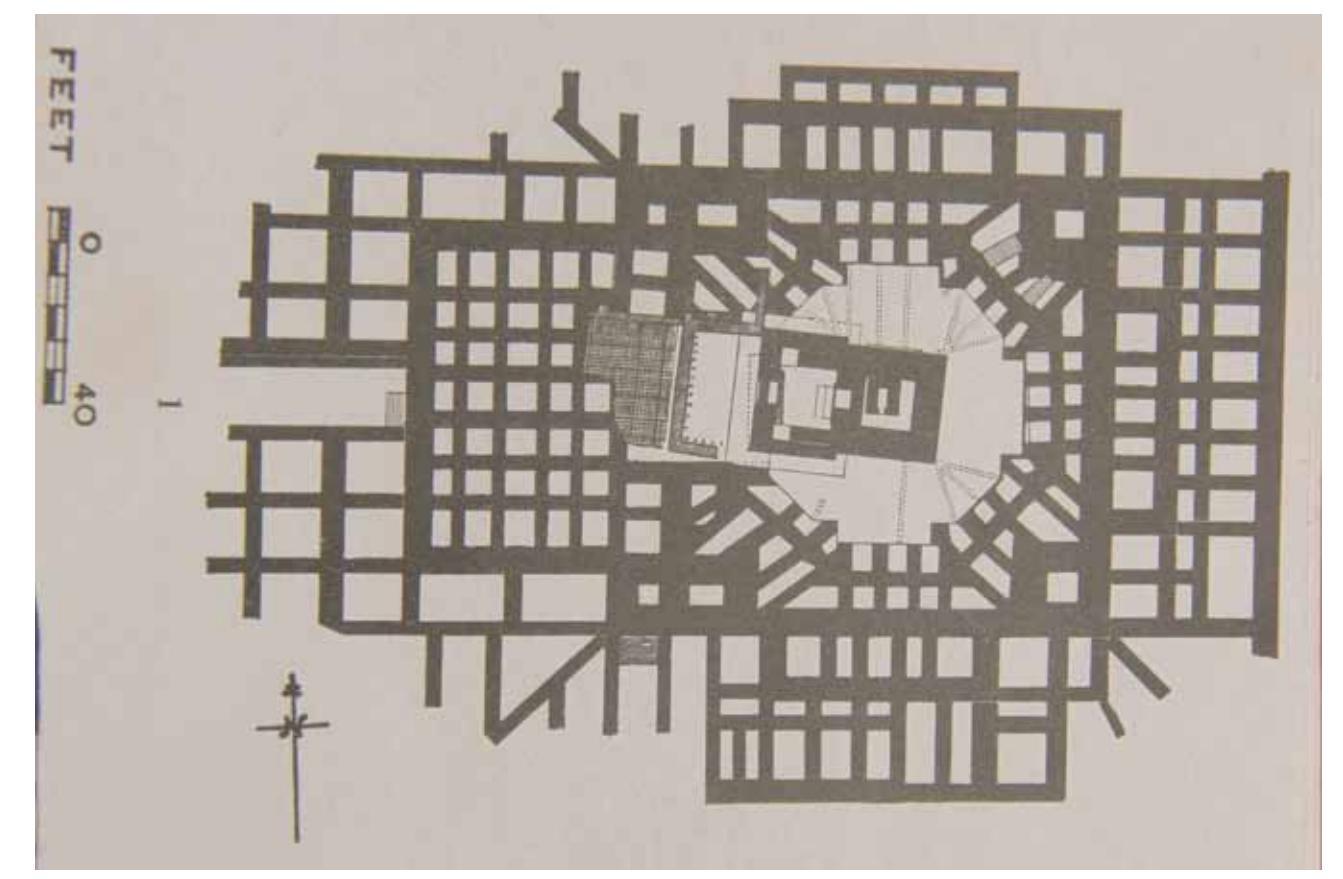
Fig. 5. Ground plan and circular pit of Gokul Medh; the photo taken from the ASI annual report in 1935-36.

This innovative construction technique was prevalent in Bengal for five centuries before the arrival of Islam. This method can be compared to our present-day piling system. The technique was very useful and effective in the alluvial soil of Bangladesh for constructing any religious or sacred building of large size as well as high above the flood plain. Similar construction methods are also found in *Abicbchbatra* in the Bareilly district of Uttar Pradesh in India far from Bengal (Ahmed1997:41-42). The plinth of the shrine is a polygon of twenty-four sides and an octagonal floor can be seen above it. Most probably a Buddhist temple or stupa was built on this floor. However, at present, there is no evidence of walls built above this floor (Figure 5).

Inside the later period temple, a human skeleton was found in the chamber. Below this chamber, there is a circular brickbuilt pit measuring 3.68 m in diameter (Figures 11 & 12). A stone with 12 holes was found inside the pit and a gold leaf was discovered in the middle hole. A depiction of a bull can be seen on the gold leaf. Researchers believe that the exposed architectural structure was a Shiva temple due to the depiction of a bull on the gold leaf. "It appears that the gold leaf was placed here as the foundation deposit of a shrine, and it may be suggested that the shrine, judging from the bull figure, was dedicated to the worship of Siva" (Majumdar 1990:68).

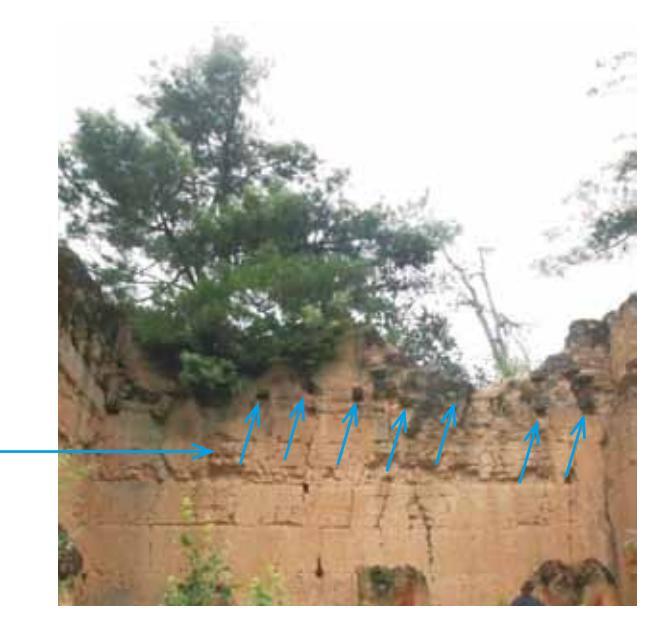
Fig. 2. Joist holes in the rear façade of the ruins

The *lhakhang* is double storied, as one can clearly see the joist holes in the rear façade of the ruins (Fig. 2). The main entrance to the *lhakhang* is from the south and there is another entrance to the room from the east (Fig. 3). The ground floor of the ruins comprises a platform which is raised about one meter above the ground. The raised platform houses five large statues (Fig. 4). The statues are about 7 feet tall. All the statues are significantly damaged without faces or arms. These statues are made from earth. Twigs and bamboos were used to form the shape of the statues and hold the plaster from outside. The statues,

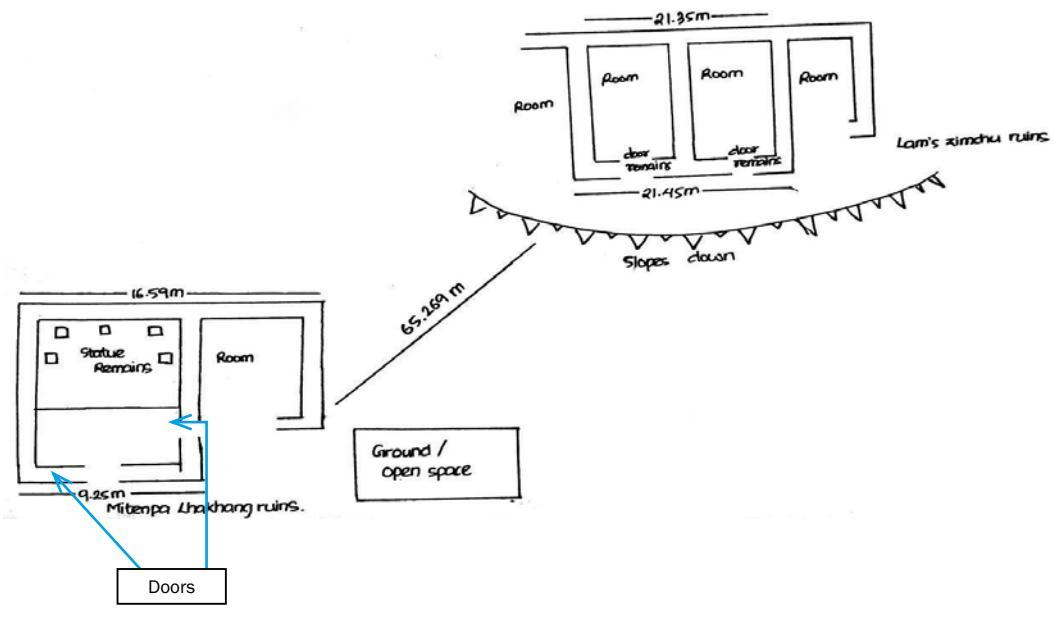
Fig. 3. Plan of Mitenpa Lhakhang, Lam's zimchu, and choeten ruins

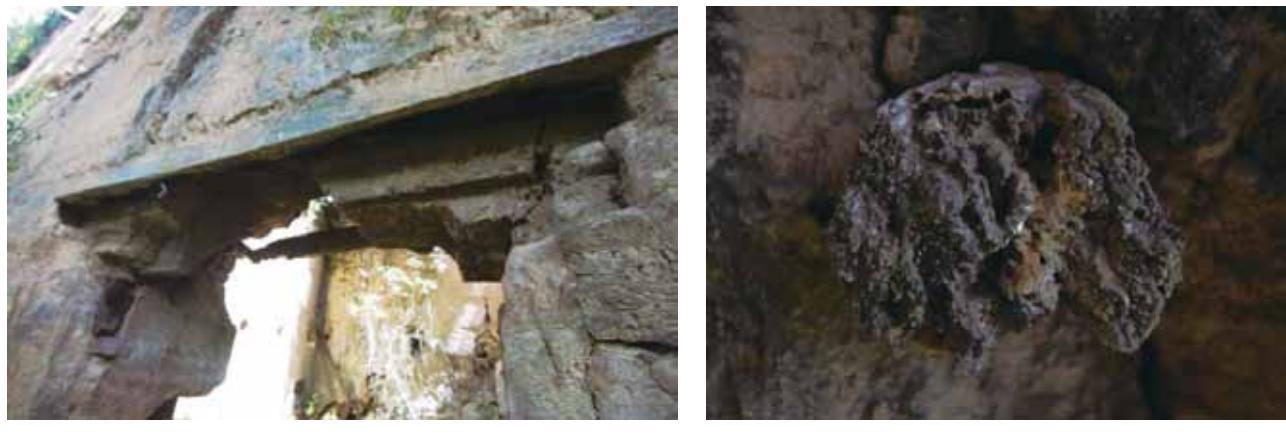
Fig. 10. Wooden lintels of doors

The wooden lintels of the doors and windows are still intact, but blurred with soot (Fig. 10). The remains of soot and the blackened portion of the wall corresponds to the oral history which says that the structure was lost to fire. Part of the structure is partially buried under the soil (Fig. 11). Thus, scientific research and excavation is crucial to determine its age, form, layout, and function of the entire complex.

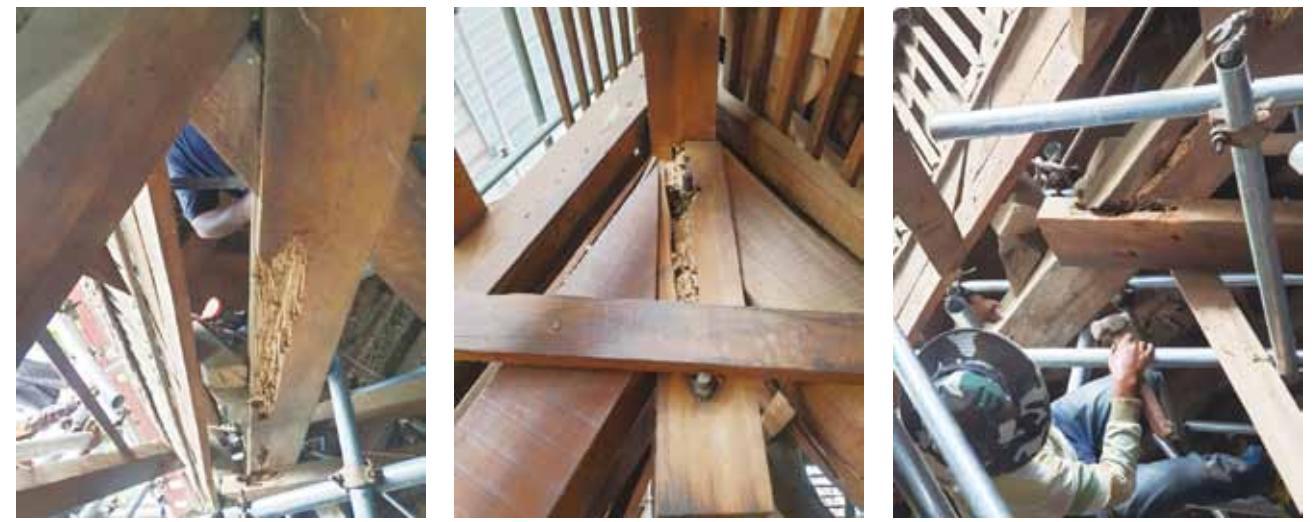
Fig. 1. Timber components of the roof structure, which are rotten

Damage in Block 1: The roof structure is the most damaged, especially the roof timber and wooden ceilings. The timber flashing such as principal rafters, rafters, and purlins are very rotten due to termites and moisture from seepage (Figure 1). The repair technique requires the dismantling of all roof tiles and removal of the rotten parts, restoration of the main structure timber which is not in place, and the addition of supporting accessories to stabilize the timber to make it stronger. Some rotten timber was removed and replaced with new timber, which was soaked or sprayed with termite repellent.

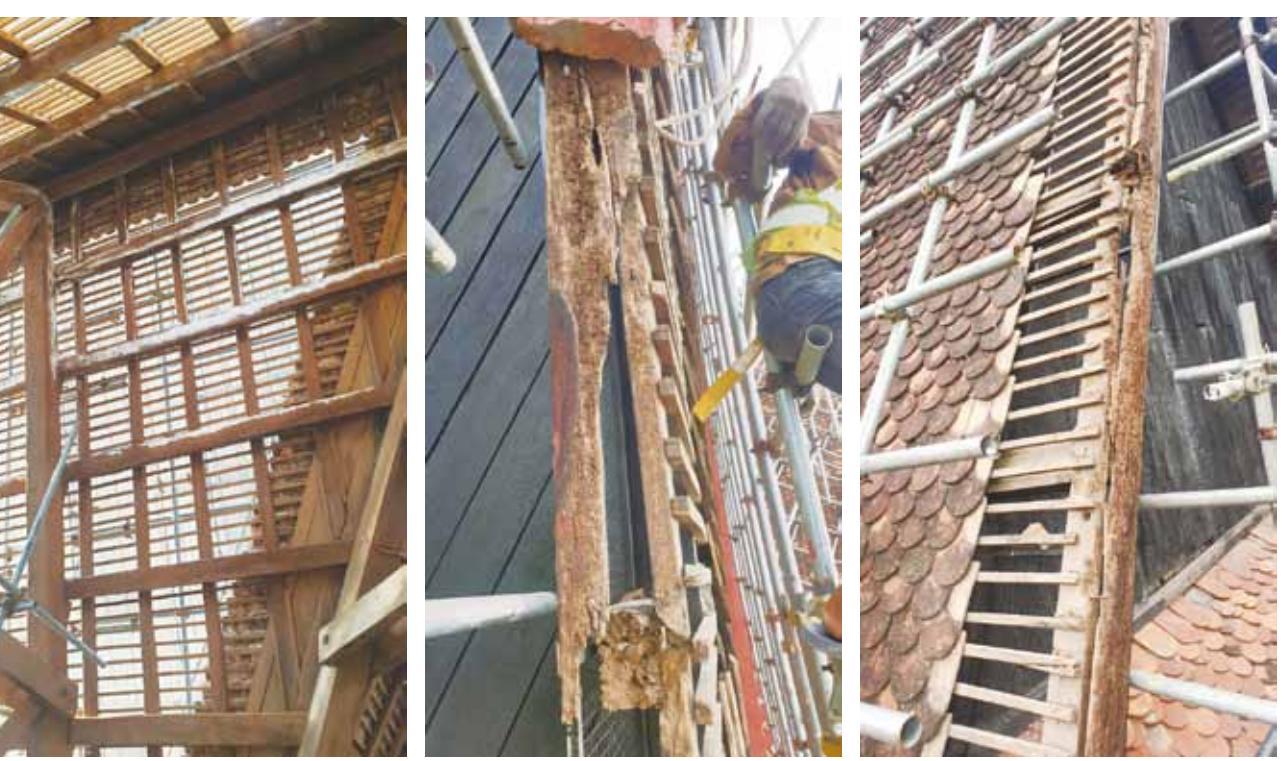
Fig. 2. Mold on timber components

Damage in Block 2: Construction components are damp and moldy (Figure 2), and we found that in this part most of timber components were covered with mold and some of them were also decayed and cracked. The plates of the wooden pediment on both sides have shrunk to enable water to leak into the roof when it rains. Restoration needs to remove the tiles, clean the mold on the timber, check the level of damage of the components and make repairs, and apply anti-fungal paint to the components.

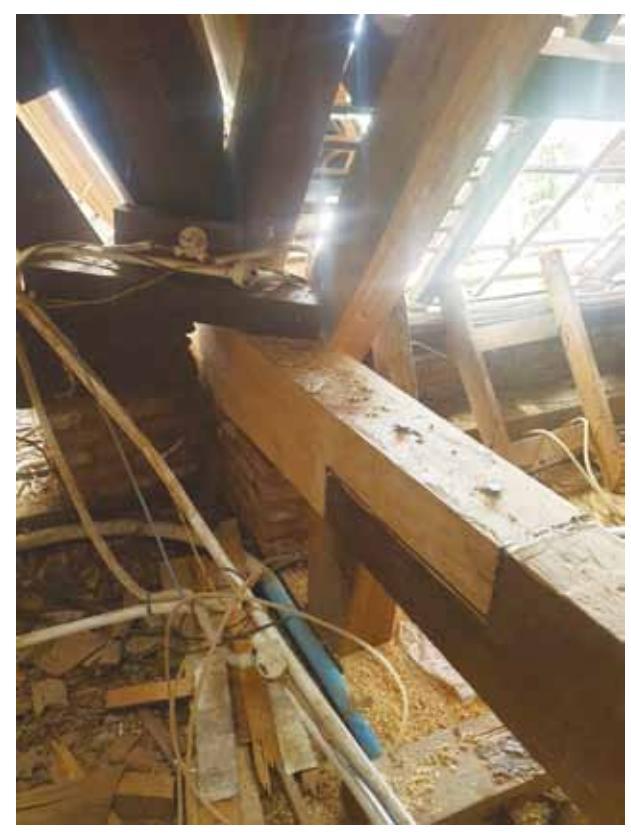
Fig. 4. Restoration of the beam and replacement of the strut timber

Dismantling the damaged area: Start dismantling the damaged area to check the actual damage situation, make notes and take photos of the damage before starting restoration work to keep as a document for reporting after completion of the restoration project. For disassembly to repair, be very patient and pay attention to each part, especially roof components, to ensure that this disassembly does not add further damage. Another precaution is to preserve as much of the timber as possible. All these components of the roof structure need to be reused to avoid complete replacement (Figure 4). The repair and dismantling steps are as follows:

- Remove all damaged tiles, as they are convex and leaky.
- Remove unusable timber that is seriously damaged.
- Repair the damaged parts of timber components, such as principal rafter, purlins, common rafters, battens.
- Reinforce principal timber components that are damaged but cannot be dismantled by adding new wood.
- Clean mold and moisture from the roof structure by applying a moisture-proof coating on the timber and inspecting the damaged parts and testing how it affects the timber.
- Clear out insects and apply pesticides to structure timber.
- Add plate wood to fill in cracking wooden pediment

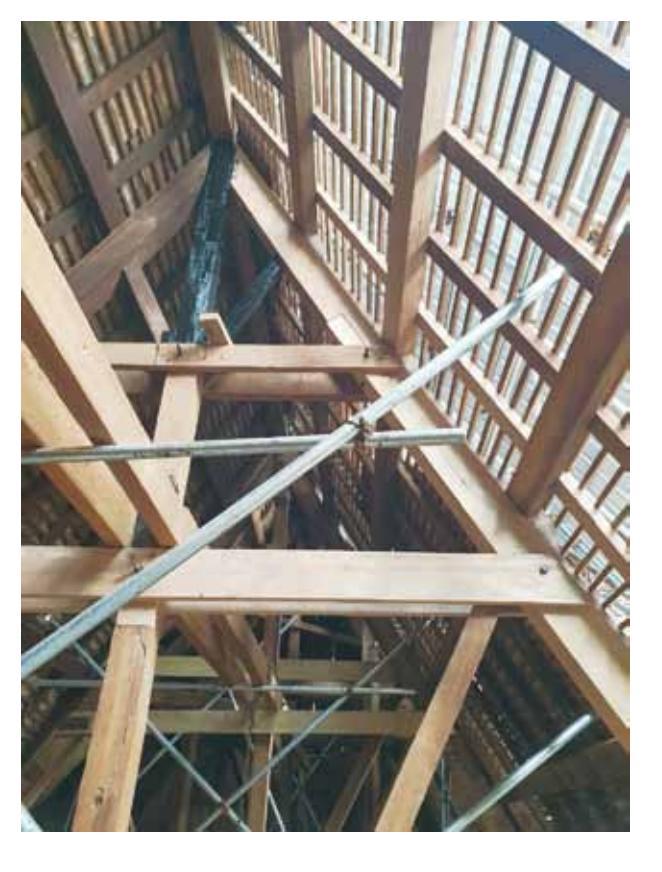
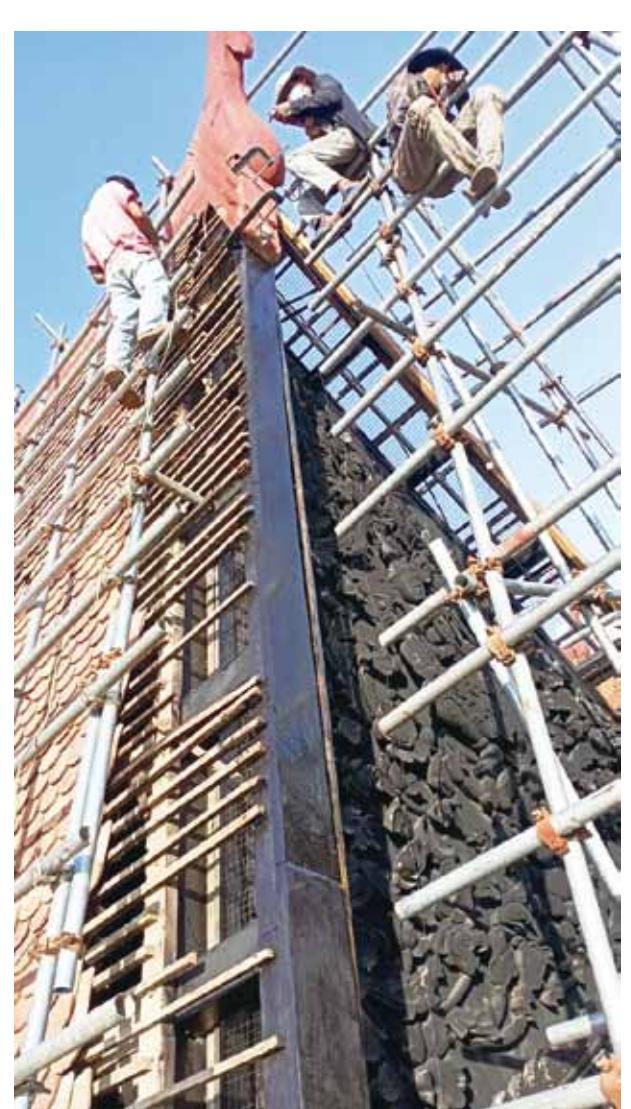
Fig. 5. Gable timber and Neak Cheng

and mixing material to fill in cracking wooden timber. - Repair, clean, and repaint the decorative gable and fill the shrinking of the pediment with wooden plate and Nagasfinials. The decorative gable of the pediment has a twopart wooden structure and is covered with mortar which appears as an ornament. But the structure of the decorative gable is decayed and needs to be removed and replaced with new timber (Figure 5).

- ⁽¹⁾ Part of the ornamentation in the shape of a dragon head (Neak Cheng)
- ⁽²⁾ In the middle part of the gable of the pediment and shaped as a sham dragon body which is covered with mortar on the timber (Nesk Dog Kda)
- ⁽³⁾ Top part of the roof gable (Javes)

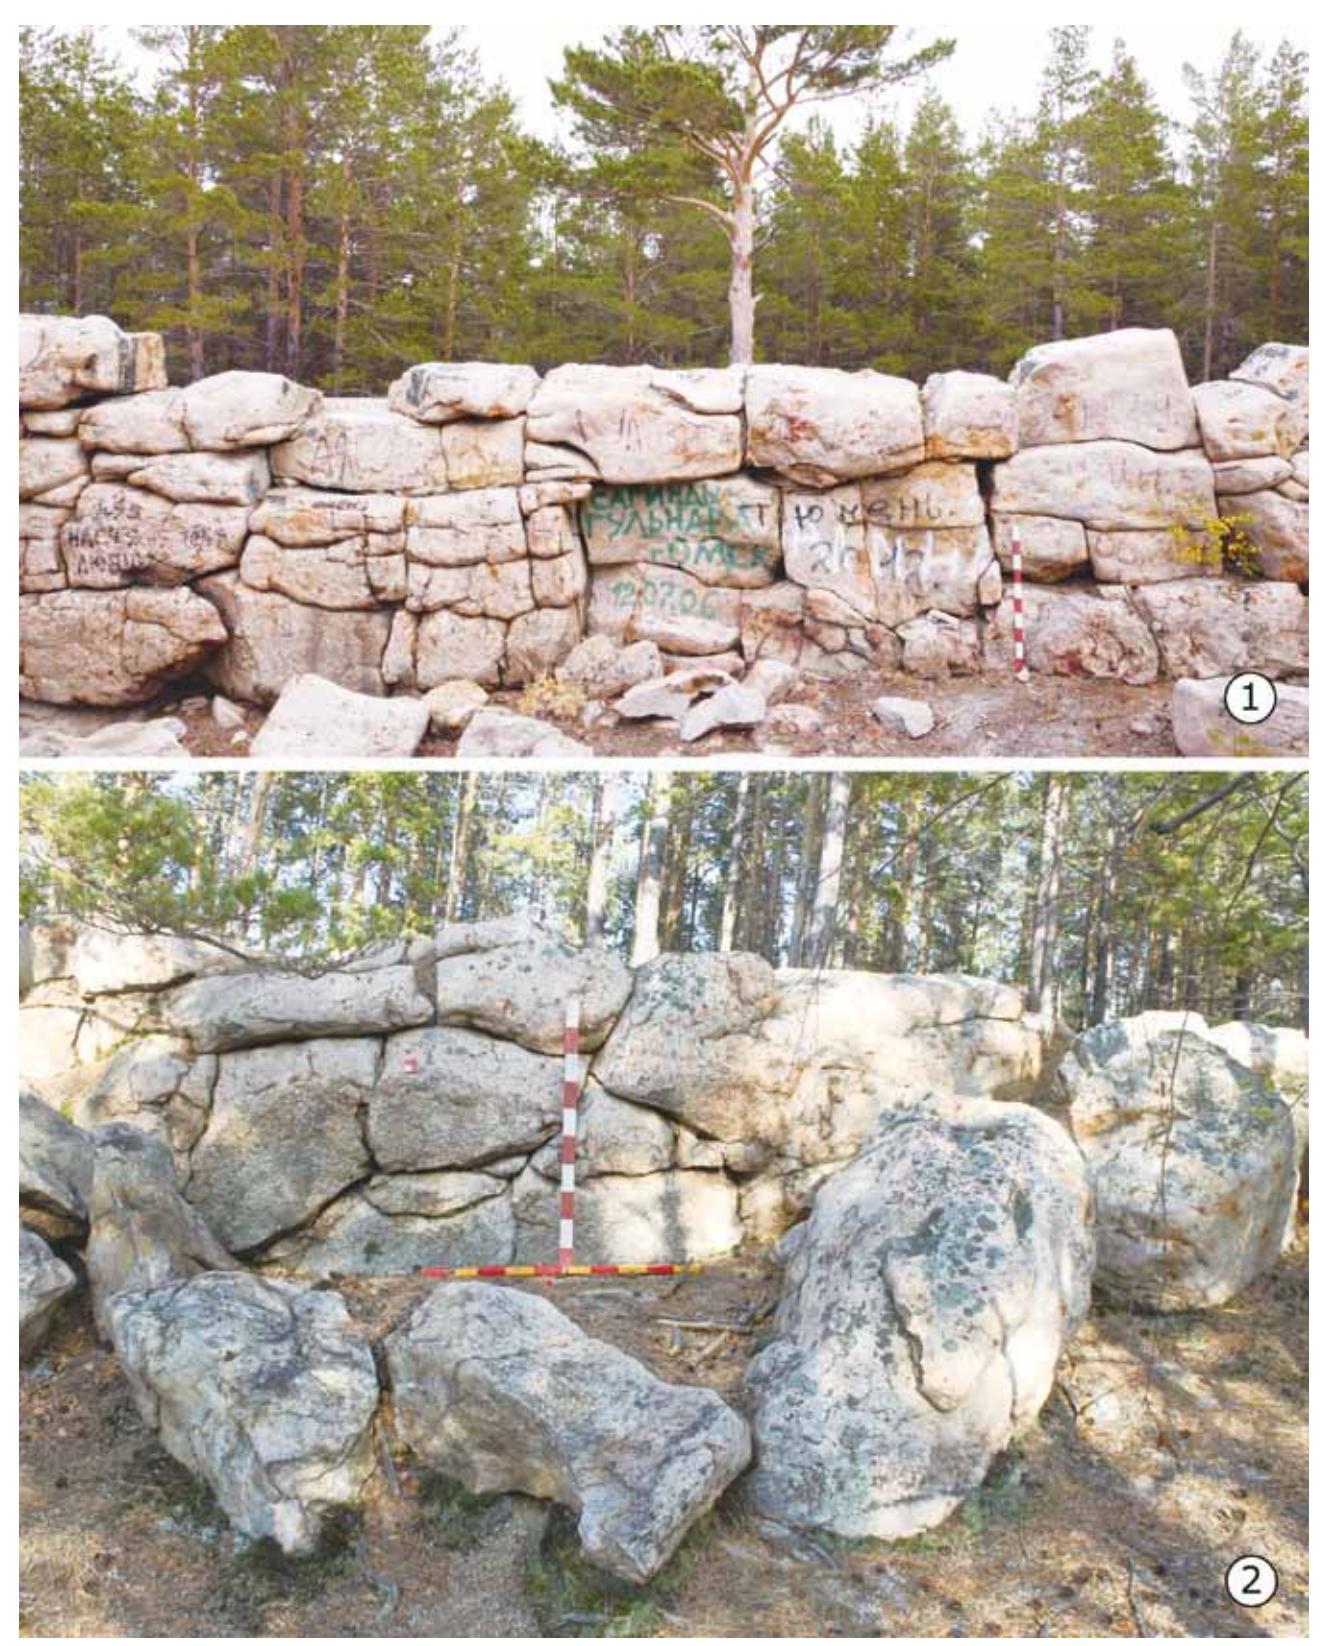
Fig. 4.1. Masonry against the terrace; 4.2. Masonry at the end of the northeastern ramp

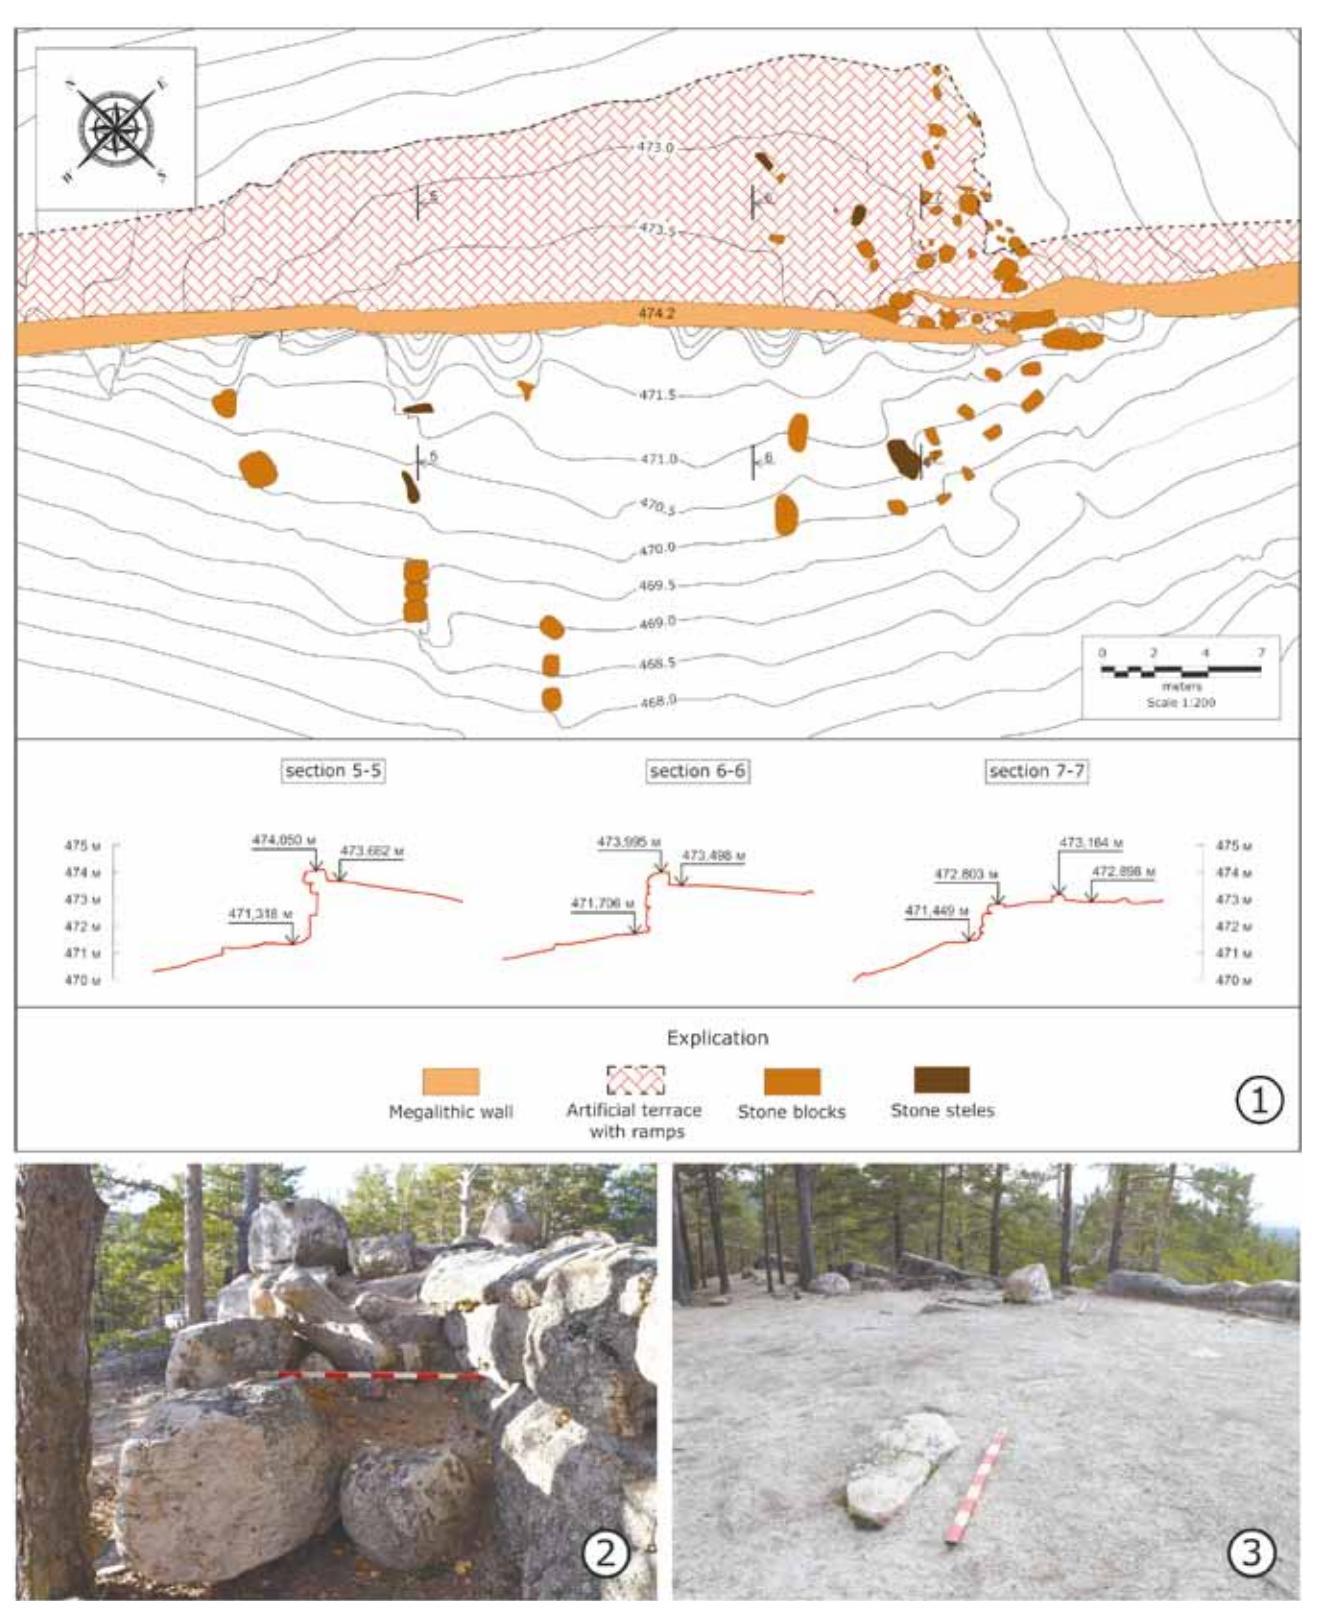
Fig. 5.1. The plan of the terrace area and sections; 5.2. Southwestern entrance; 5.3. Outdoor terrace area with a fallen stele

of the terrace and across the ramps. On the long northeastern ramp, 14 lines of crepes in different states of preservation were found.

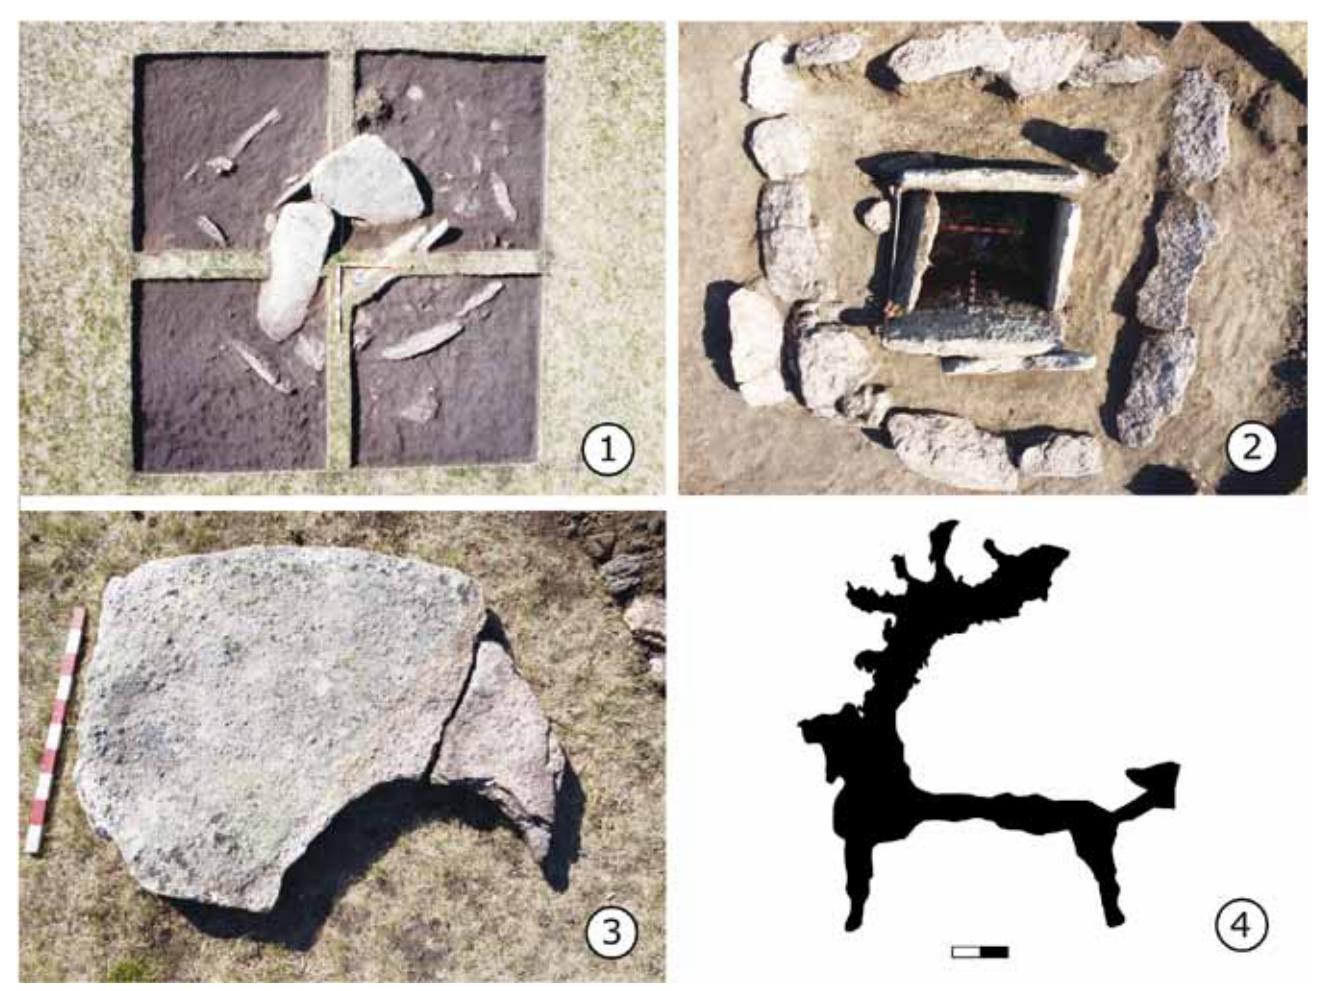
Fig. 6. Fence No. 50 - Kyzyltobe burial ground: 6.1. Excavation at a level of -15 m from the modern surface; 6.2. Cleared walls of the fence and the central stone box; 6.3. Floor slab with a knocked-out round hole; 6.4. Drawing of a petroglyph of a deer from the inner surface of the wall of the box

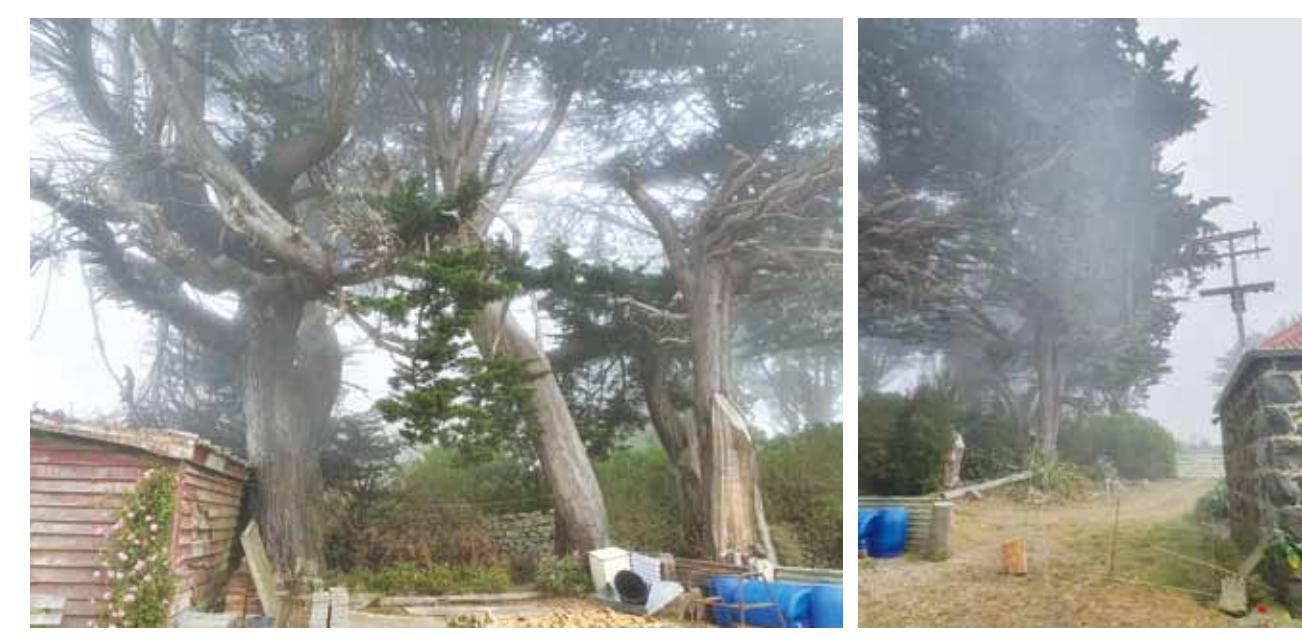
Fig. 8. Huge macrocarpa trees endangering buildings and stone walls at McMeeking's Farmstead (Photo: DOC).
