## ACCU Nara International Correspondent The Fifth Regular Report

(財) ユネスコ・アジア文化センター 文化遺産保護協力事務所 Cultural Heritage Protection Cooperation Office, Asia-Pacific Cultural Centre for UNESCO (ACCU)

## The Fifth Regular Report

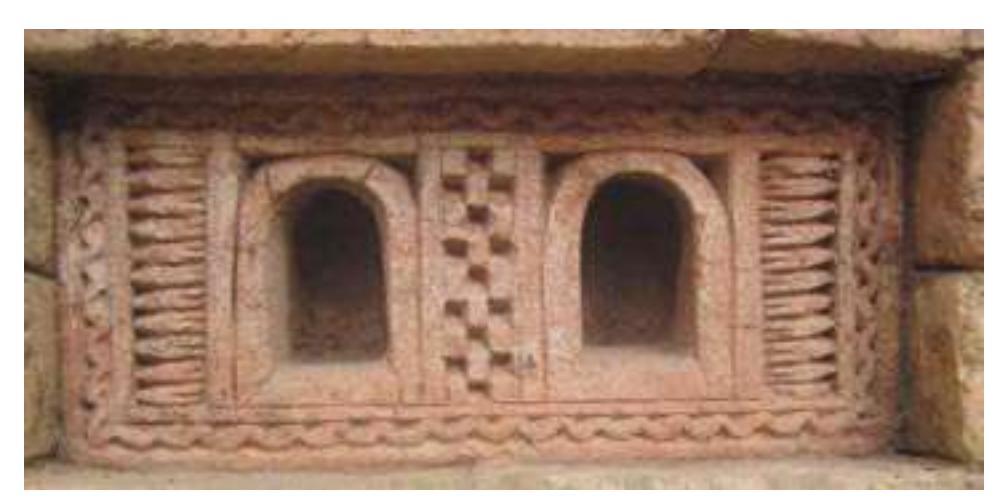
Arch-based Ornamentation

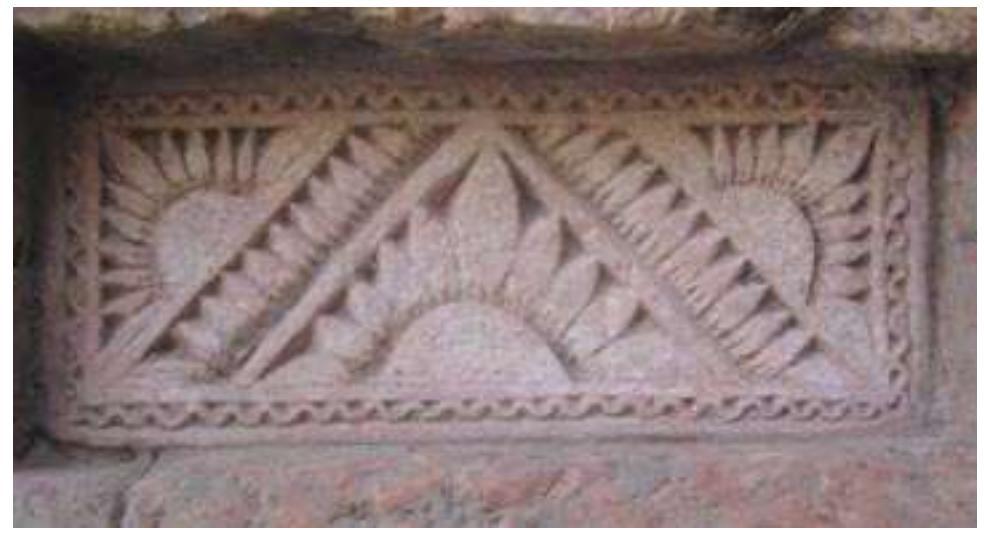
Half-floral design based ornamentation

(6) Half-floral design based ornamentation: The bricks were divided into three panels. At the middle of the panels, full-flowered china roses were set. Again the panels were divided into triangles and those were filled with half bloomed sun flowers and flower petals. (7) Own self's design: In the seventh part of the work, it was observed that the five ornamented bricks were quite different from others. Here, one brick contained geometrical ornamentation of floral designs in it and another brick with four rows of dog teeth covering the whole portion were found. The third was found to have been ornamented geometrically with four-petal flower design. In the fourth, we observed a four centered arch divided into two parts and set at the middle of the panel. In the fifth, we found two tridents were set horizontally with spiral design ornamentation.

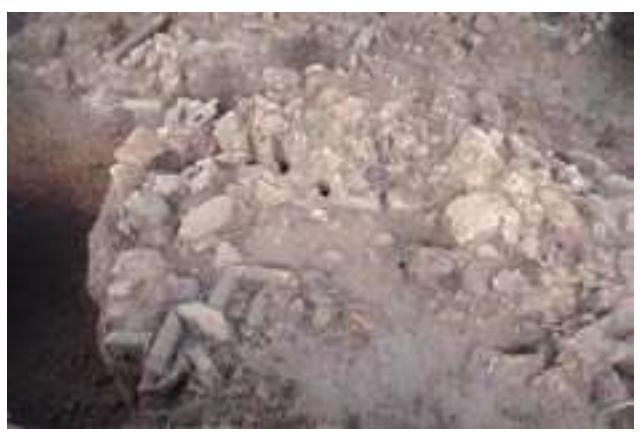
Tuyères, metal slag and debris of furnace wall (burned clay)

The smelting furnace was demolished after they finished the smelting iron work. The furnace wall was made by clay with bamboo stick. The team temporally identified that this site existed in the same period as the Angkor by comparing with the fragments of Khmer and Chinese potsherds excavated in the same trench [*Report of LARP team, 2009*].

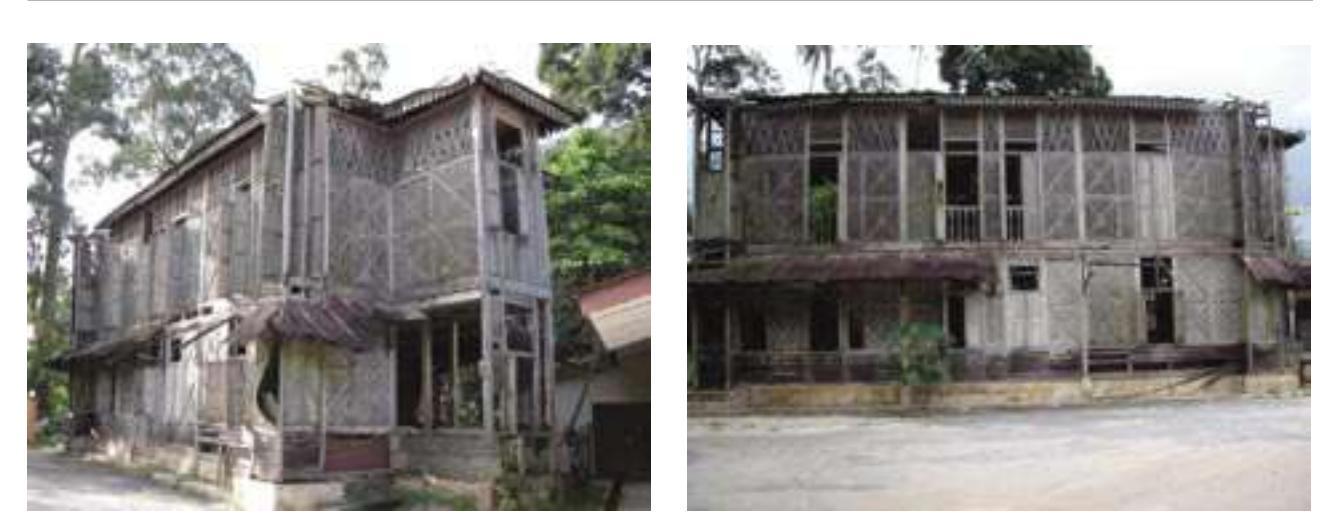
The Old Mosque of Kampung Kuala Dal before restoration. The building was in poor condition with signs of ageing, rotting and insect attacks.

A dilapidation survey conducted by the Department of National Heritage has identified the major defects of the Old Mosque comprised the timber and bamboo components. One of the timber columns was badly decayed, while the remaining columns were still intact with minor superficial decays on the surface and joints. Continuous rainfall and dampness from the leaking roofs have accelerated the decaying process of the timber structures and bamboo weavings of the Old Mosque. The bamboo-weaving walls and timber lattice panels were in poor condition with signs of ageing, rotting and insect attacks. Measures to restore the Old Mosque were determined based on building defect diagnoses. The building elements to be restored included roofing, timber floor, column, concrete staircase at entry door, timber staircase en route to upper floor, windows and doors, timber carvings; and bamboo-weaving walls. Other restoration works involved repairing defective rainwater goods, sewerage system, electrical and mechanical works; and termite treatments.

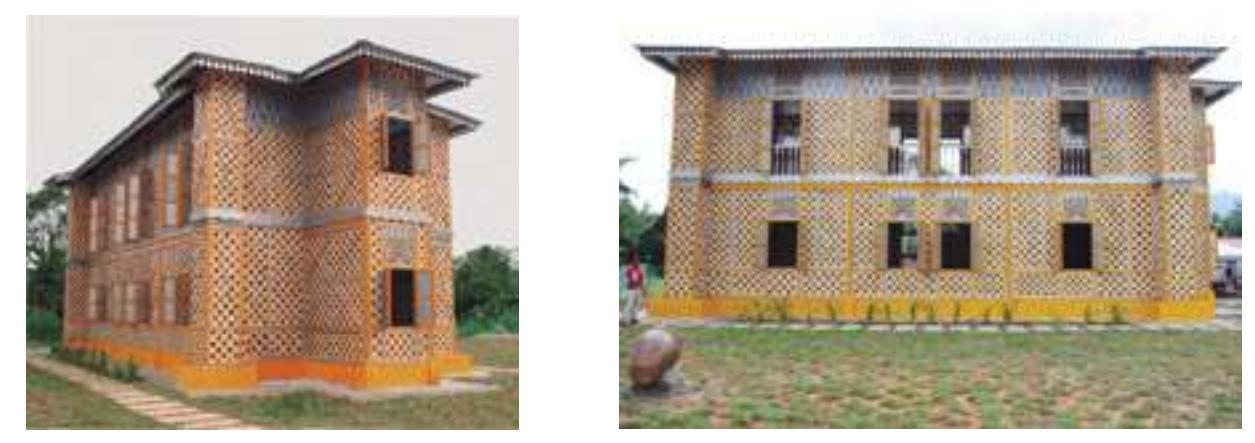
The Old Mosque of Kampung Kuala Dal after restoration. Among building elements that were restored included roofing, timber floor, columns, concrete staircase at entry door, timber staircase en route to upper floor, windows and doors, timber carvings;and bamboo-weaving walls.

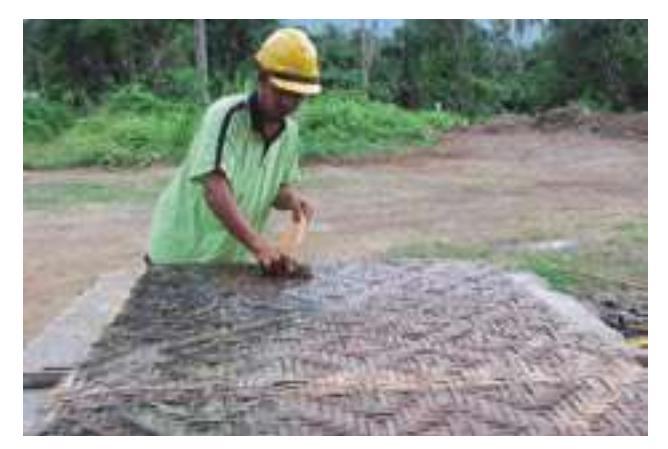
Restoration of bamboo-weaving walls involved making an inventory according to sections and locations, cleaning the original intact weaving panels using a soft brush, drying and repainting.

Damaged bamboo weavings were removed and replaced with new ones. To prepare bamboos for the traditional weaving process, bamboos of 0.5 meter in length were soaked overnight to cleanse them. These bamboos were left to dry for several days before they were sliced into pieces of 0.02 mm thickness using a special machine. Bamboos of a softer texture and flexibility, similar to the original ones at the Old Mosque, were used to make new diamond-shaped weavings. Weavings were painted using the colours of the Perak flag to complete the pieces.

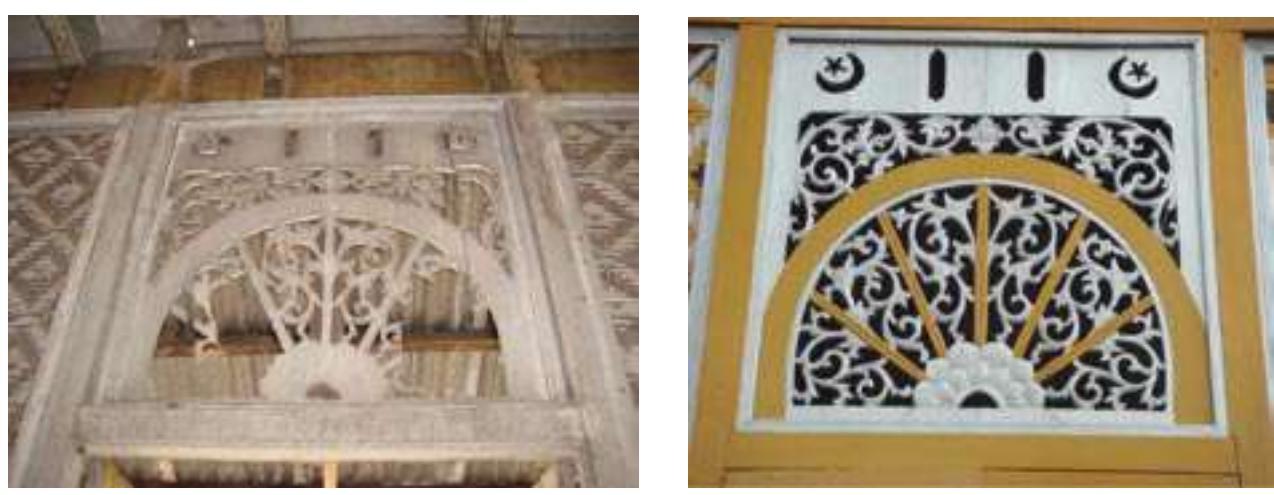
All missing and broken timber carvings found at fanlights and panels above window were restored and repainted based on the original motifs and colours.

The restoration of timber carvings involved making an inventory of the original intricate patterns, and determining the size of timber panels and timber species. Defective timber carvings were identified for repair or replacement. The newly replaced timber carvings were hand-made by skilled carpenters. While the restoration of bamboo weavings involved making an inventory of the original bamboo-weaving panels by building section and location; cleaning the original intact weavings using a soft brush; and drying and repainting the weavings to their original colours.

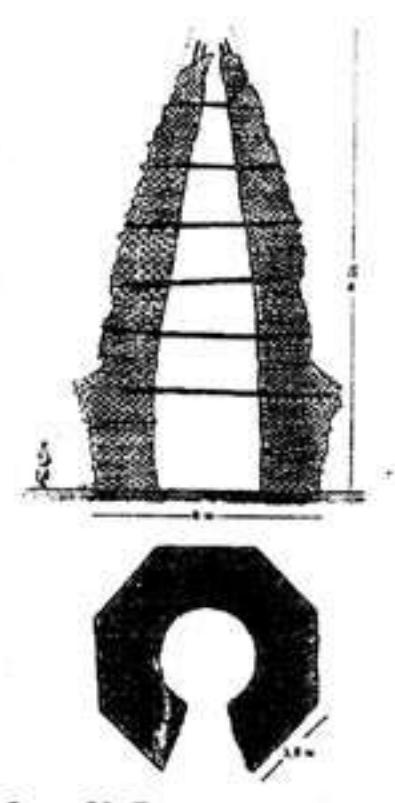
Зураг 88. Барс-1 хотын долоон давхар суваргын зүсэлт (Х.Пэрлээгийн-хээр)

Cross sections of Kherlen Bars tower

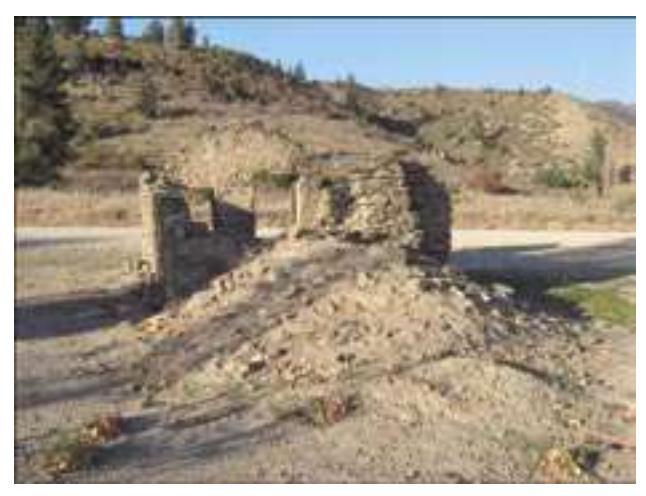
Figure 3. Bendigo Bakery viewed from the back before the mound was investigated to determine if any thing remained of the bread oven structure (photograph: Matthew Schmidt).

Prior to excavation, it was clear that the 'mound' at the back of the bakery was certainly partly the product of debris being bulldozed around the back of the ruin in the 20th century. Only through direct investigation, however, could the nature and extent of any

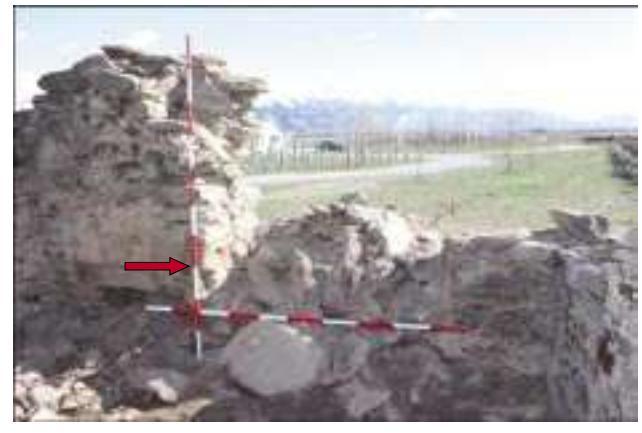
Figure 9. The inside back wall of the bakery with some of the loose debris and soil removed prior to stabilisation of the wall and chimney (left of photograph). The brick bread oven(s) was originally accessed between the left measuring pole and the red vertical line. The red arrow indicates remnants of brickwork from the opening of the bread oven(s). It appears that the opening to the oven(s) was about waist height as below the red arrow the back wall is solid schist stonework (photograph: Matthew Schmidt).

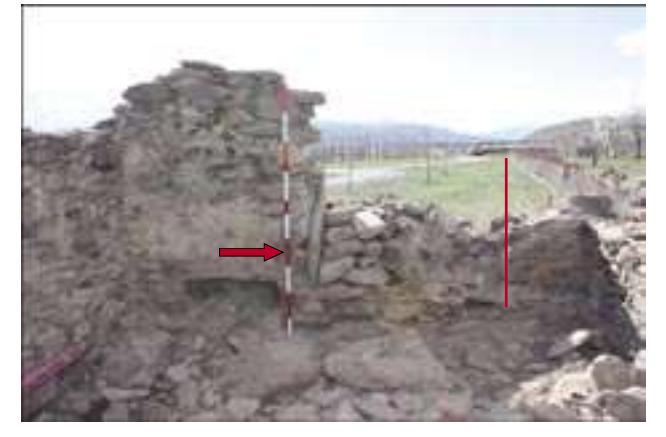
Figure 10. Inside back wall of the bakery after stabilisation. Schist has been dry stacked against the right side of the chimney to prevent any future movement of original stonework and along the front wall of oven structure. The large vertical schist slab used to stabilise the chimney is a lintel found beneath where the oven(s) opening would have been located in the back wall. The red arrow indicates remnants of brickwork from the opening of the bread oven(s) (photograph: Matthew Schmidt).

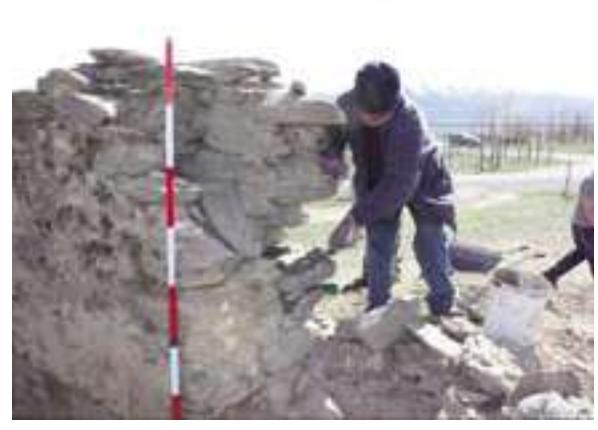
Figure 11. Stonemason Keith Hinds mortaring in schist slabs to stabilise the right side of the chimney. Each slab introduced was recorded (photograph: Matthew Schmidt).

Stabilisation of the stonework entailed re-pointing of stonework where mortar had deteriorated and in areas where mortar was missing; capping on the top of walls where weather was causing or could cause further deterioration of a wall; the introduction of stone to areas of the structure where collapse of stonework was imminent or highly possible in the near future (stone introduced was sourced immediate to the area requiring intervention).

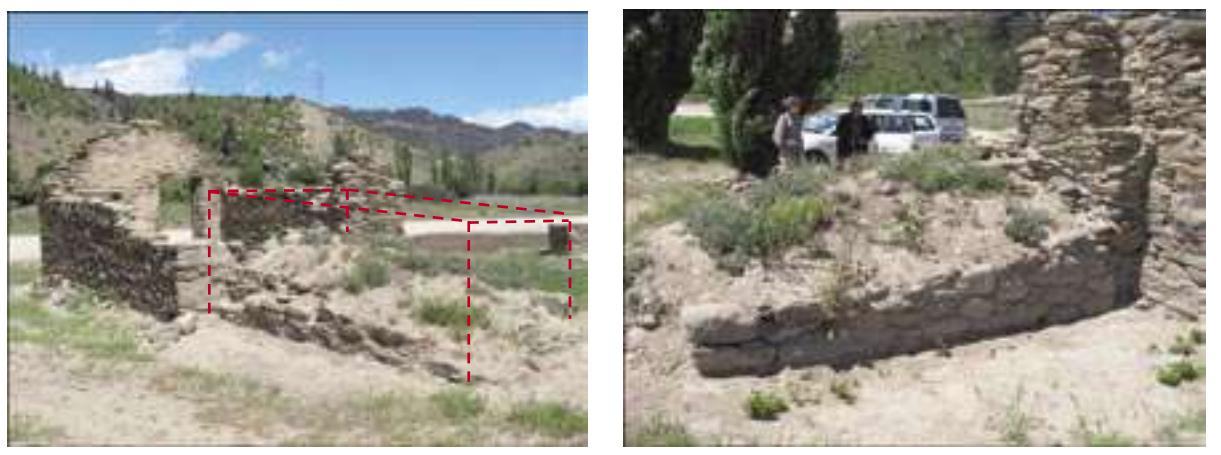
Figure 19. Oven structure two months after stabilisation. The site has settled and weeds have grown in the light soil. The weeds will be replaced by a hardy grass species which will aid in consolidating the surface. A possible shape of the original oven structure is indicated by the red dashed line in the top photograph (photographs: Matthew Schmidt).

The Bendigo Bakery is now being managed as a stable heritage ruin (Figures 19 & 20). This entails monitoring of the building with an annual visit to check on movement of any stonework and to check and maintain the mortaring undertaken. During the three

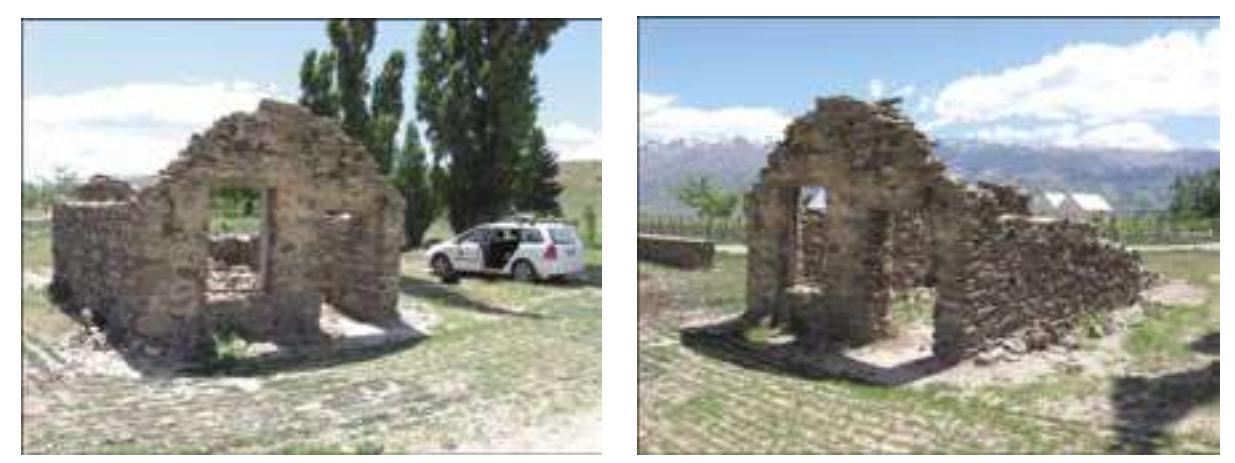
Figure 20. Front/side views of bakery two months after stabilisation. Drainage around the front and sides of the building will be installed soon as well as an interpretation panel and bollards to keep vehicles away from the structure (photographs: Matthew Schmidt).

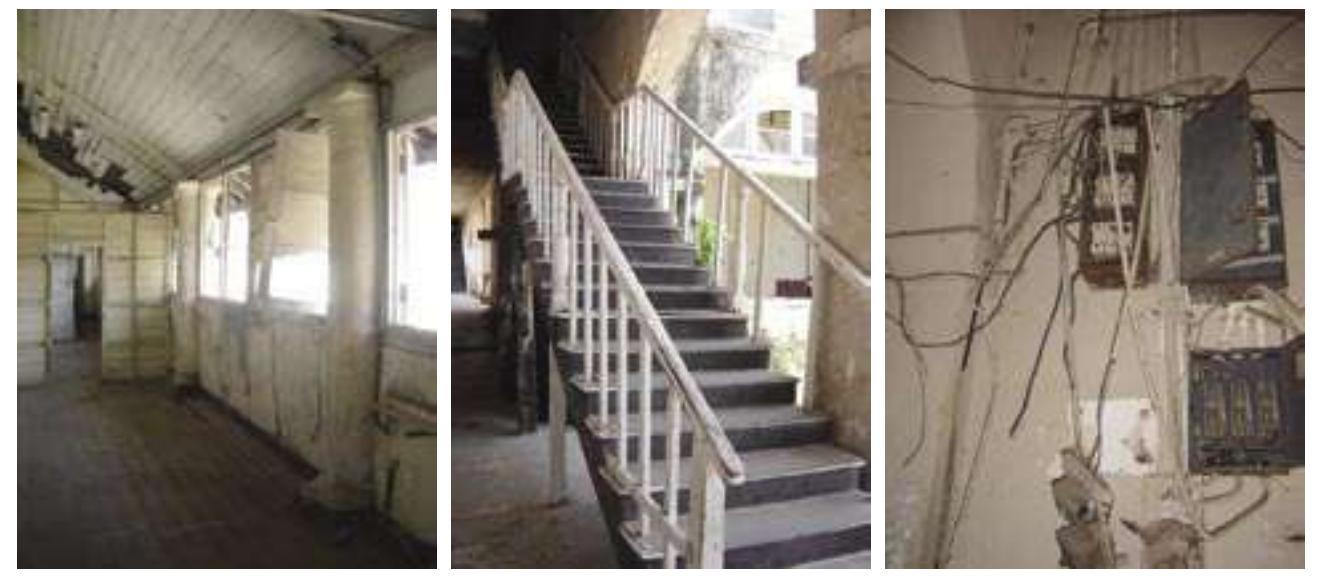
Partitions and broken timbers of upper floor

Deteriorated timbers of the stairways

Unsafe electrical wiring

- b. Upper floor Original timber decks are to be repaired by removing the cement rendering.
  - c. Stair ways All three stair ways are worn out and need extensive repairs. Specially the one at the North wing has worn off severely and this must be strengthened properly. Deteriorated members must be replaced with matching ones.

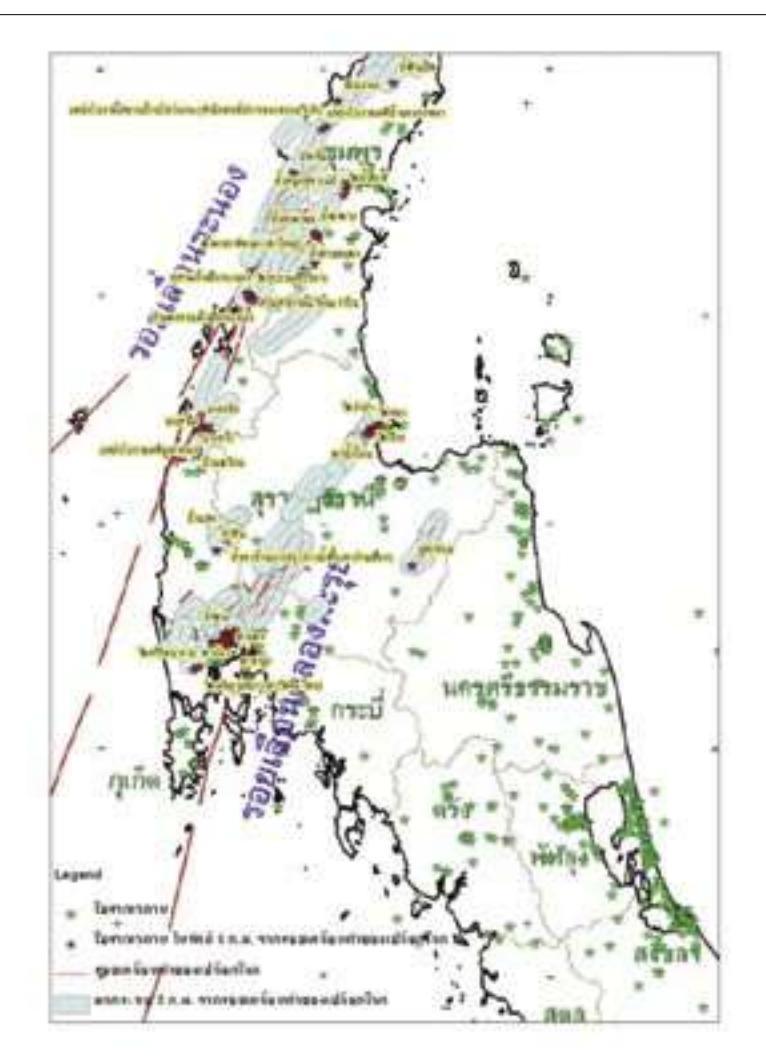
Figure 1: A map of risk cultural heritage (Registered ancient monument) and active faults in southern Thailand

The Office of Archaeology does not only use GIS to manage database, but also to predict the impact of disaster on ancient monuments such as flood, fault, landslide, sinkhole, creep, and bank erosion. Most disaster impacts in Thailand's ancient monument are caused by floods in monsoon season and geo/ seismic hazards along three main faults: (1) the northeastern-southwestern; (2) the northwestern-southeastern; and (3) the north-south faults, which cover nearly a third of the country.

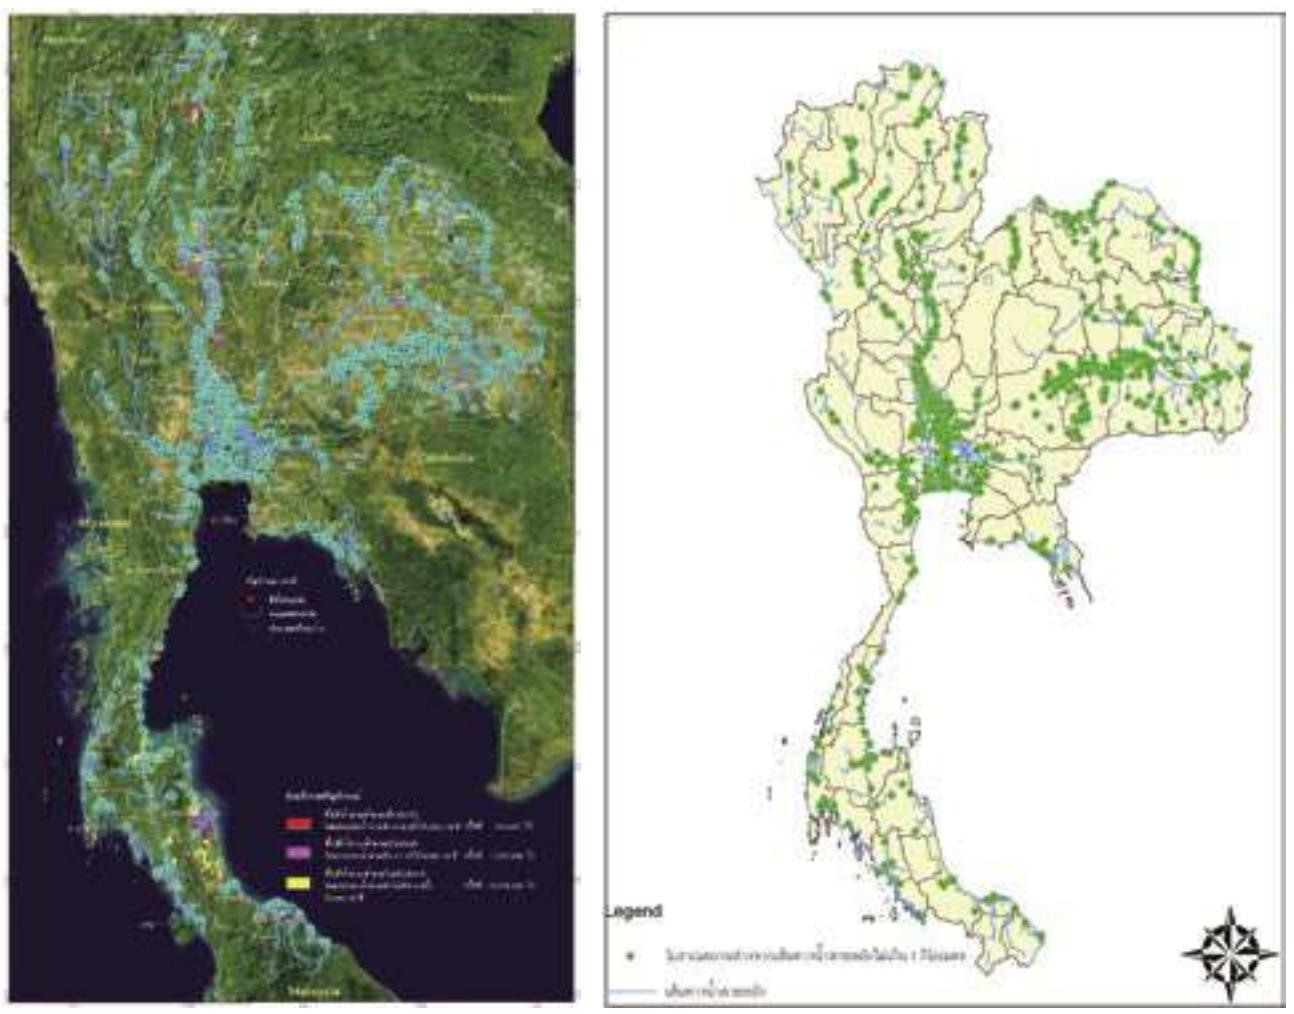
Figure 2: Maps of risk cultural heritage (registered ancient monument) and flooding zones of the Chao Phraya and other rivers of Thailand

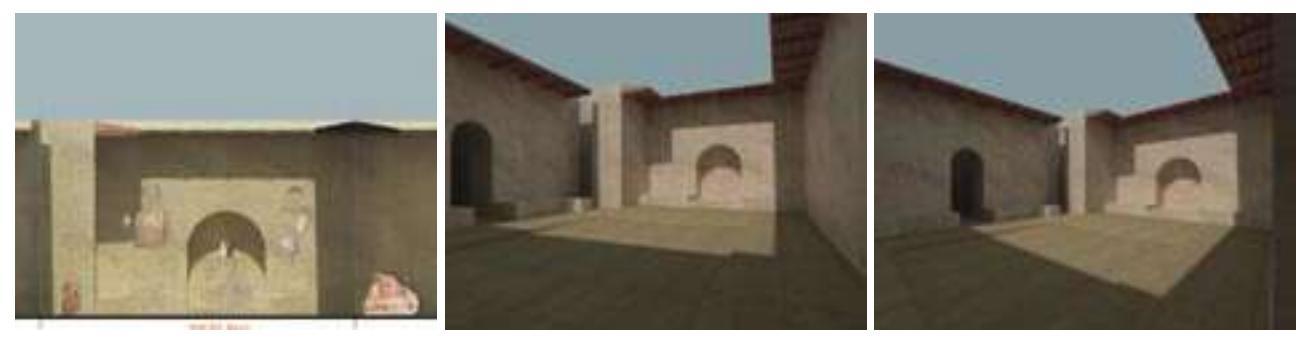
A 3D section of room 3 (a central hall)
