ACCU Group Training Course 2022

Country Reports

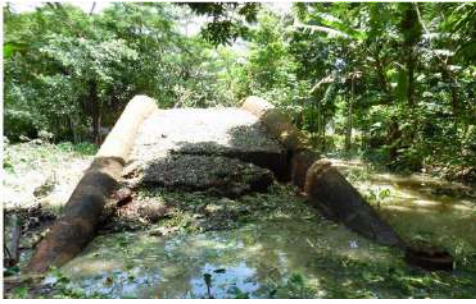
Figure 1 An example of an ancient bridge that was partially destroyed and inundated.

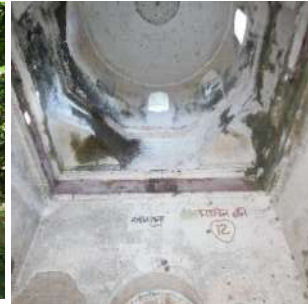
Figure 2 An example of the wall of a temple defaced by tourists.

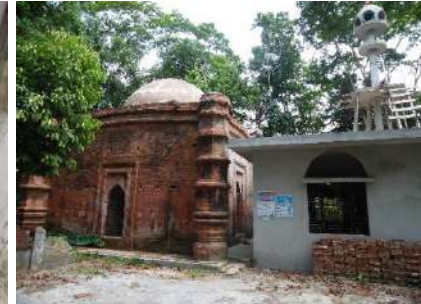
Figure 3 An example of an ill-matched building set up next to an ancient mosque.

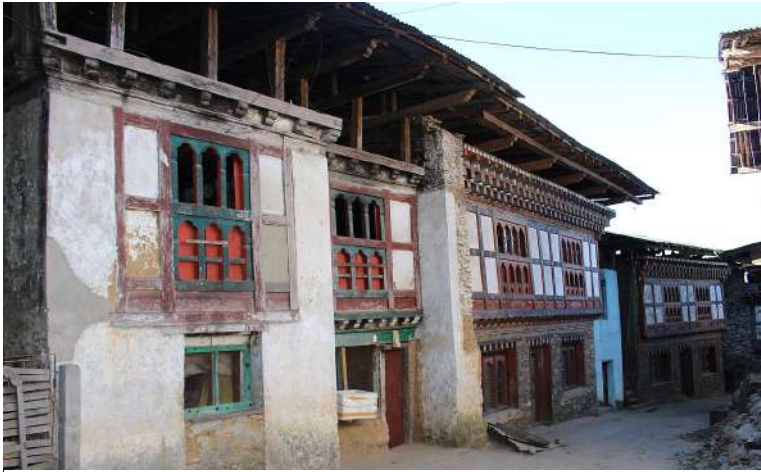
Figure 3 Trong village in Zhemgang district. This clustered village is a cultural site where the traditional houses display the most beautiful workmanship of stone masonry walls. However, urbanization has resulted in the construction of modern concrete buildings in between traditional houses with beautifully built stone masonry.

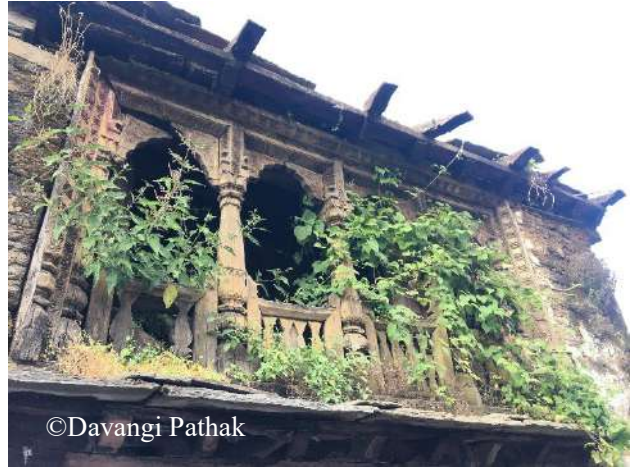
Biological growth on wooden facade
known as *likhai*

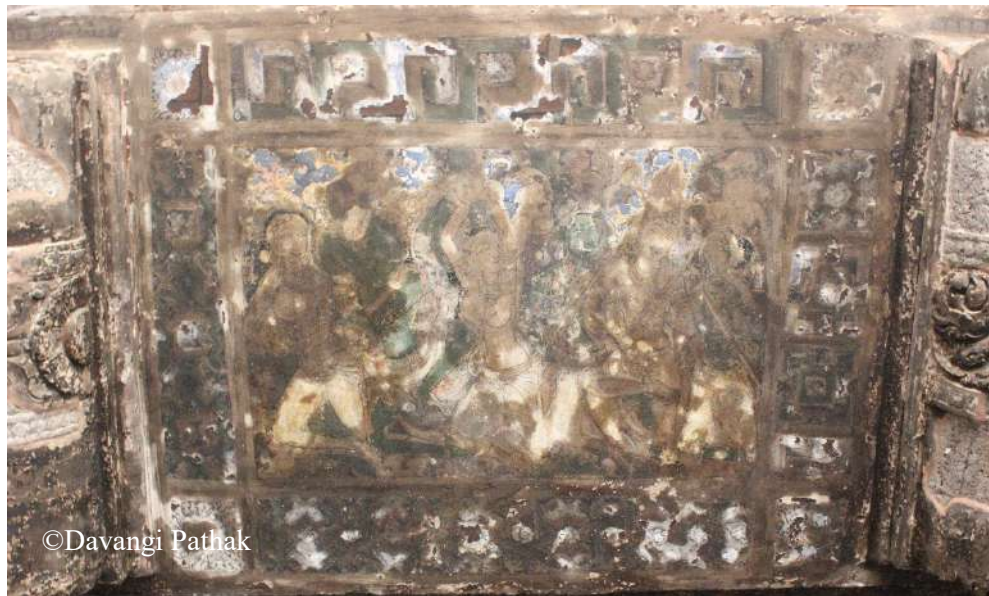
Deterioration of a wall painting on the ceiling of Cave no. 32, depicting celestial beings dancing and singing

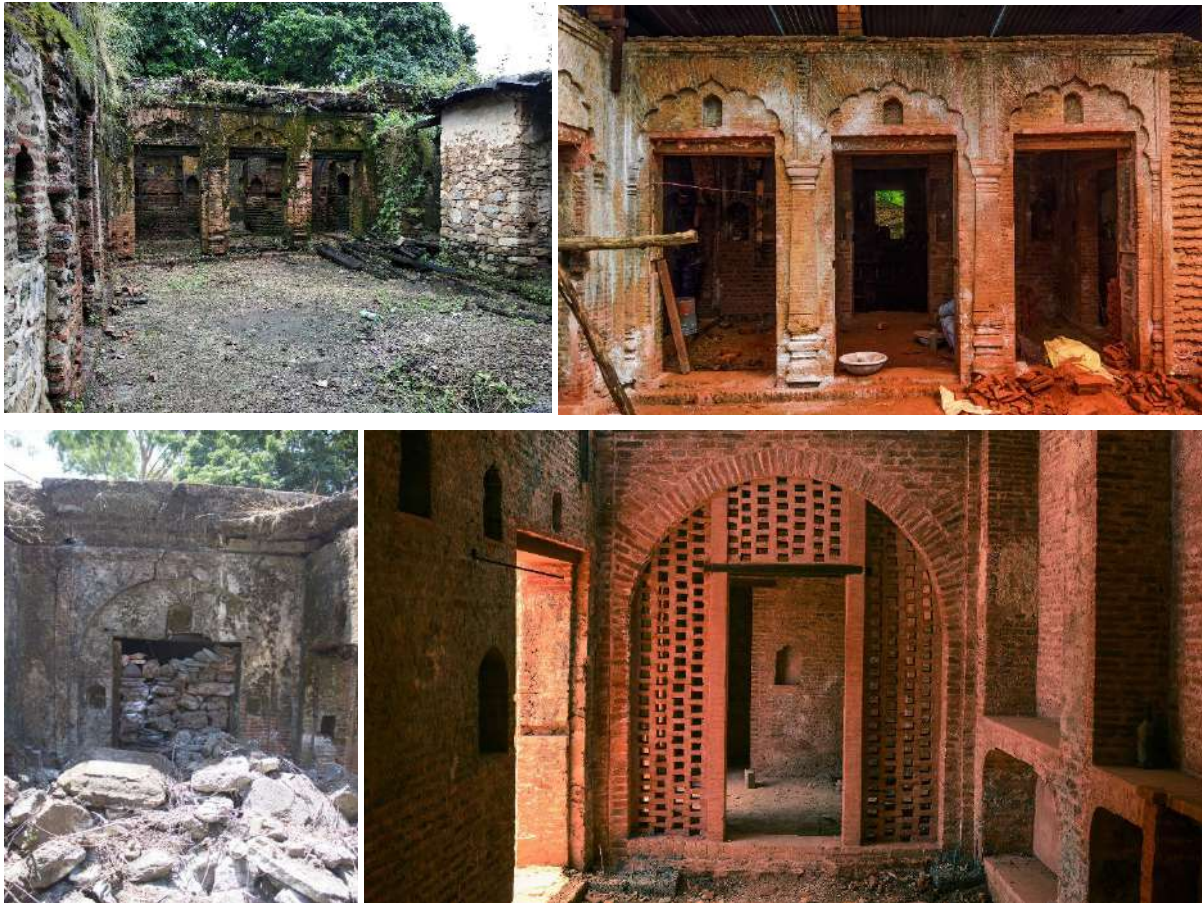
Images of a historic structure before (Left) and during restoration (Right), belonging to a private stakeholder.
Image Credits: Author

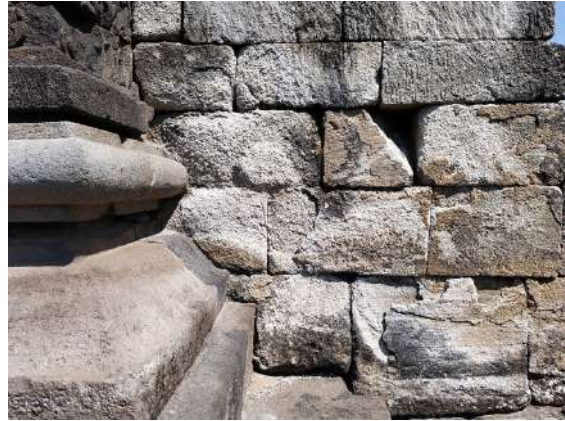
Fig. 2 Weathered tuff*

this zone, the surface is hardened and suffers from flaking, delamination and spalling. It is postulated that the mechanism causing this condition is the action of water dissolving the silica in the matrix and rock fragments, and transporting the dissolved silica towards the surface of the stone. There it evaporates to form a precipitate of amorphous silica which will subsequently harden into a deposit. This reduces the surface porosity of the tuff, further impeding the evaporation of water, so that any further silica deposition now occurs at the subsurface level. This in turn leads to spalling. The cycle repeats itself as long as there is a sufficient supply of water and moisture to dissolve the silica.

North Plaosan Temple was built with two types of stone, andesite and tuff. Most of the structures built with andesite were in stable condition while the tuff stones were endangered. Climate strongly influences or even determines the nature of the mechanism by which a stone will weather. In Indonesia, which has a tropical climate, seasonal and diurnal temperatures are more constant while the humidity is consistently high. Moreover, annual precipitation in the form of rainfall is almost double the level of precipitation in temperate regions. These differences imply lower susceptibility to thermal stresses, but more importantly, greater susceptibility to water and moisture.

The disparity in weathering between climates may be exacerbated by the porosity of the stone. In the case of tuff, the large volume of open pores (the porosity of tested stones varied from 41% to 49%) implies a larger surface area accessible to deteriorating factors, thus increasing its propensity to weather as compared to less porous stone such as andesite. The Plaosan Temple site is part of a natural landscape, and as such, it

includes many forms of vegetation and animal life which can only thrive in an environment that has a constant supply of moisture. Water is suspected to be the main deteriorating factor, causing powdering, spalling, and flaking of the stone (Fig. 2). These conditions are presumably responsible for the loss of the stone surface. The deleterious effects of capillary rise are evidenced at the base of the structure. The zone of rising damp exhibits disaggregation, powdering of the surface, and some softening of the subsurface. Immediately above

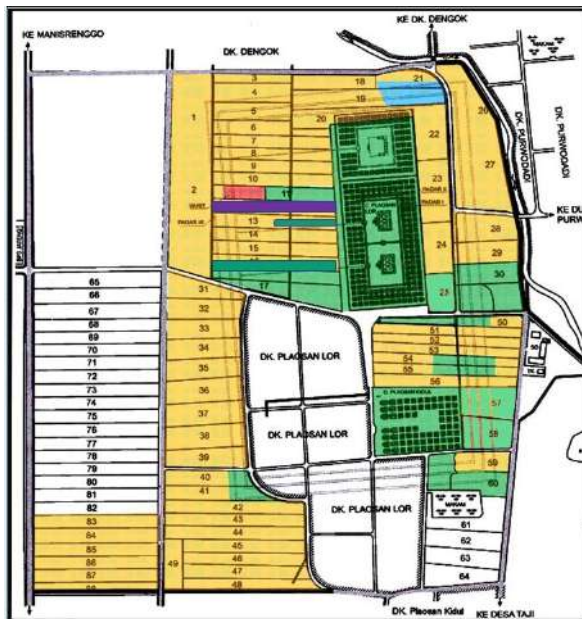
Fig. 4 Situation map of the Plaosan Site*

Figure 1 shows a map of the current situation of Plaosan. It can be seen that only a small part of the area is owned by the state (the green areas) while most of the land is privately owned. This can result in uncontrolled growth. Therefore public land acquisition is an activity that has always been carried out until now.

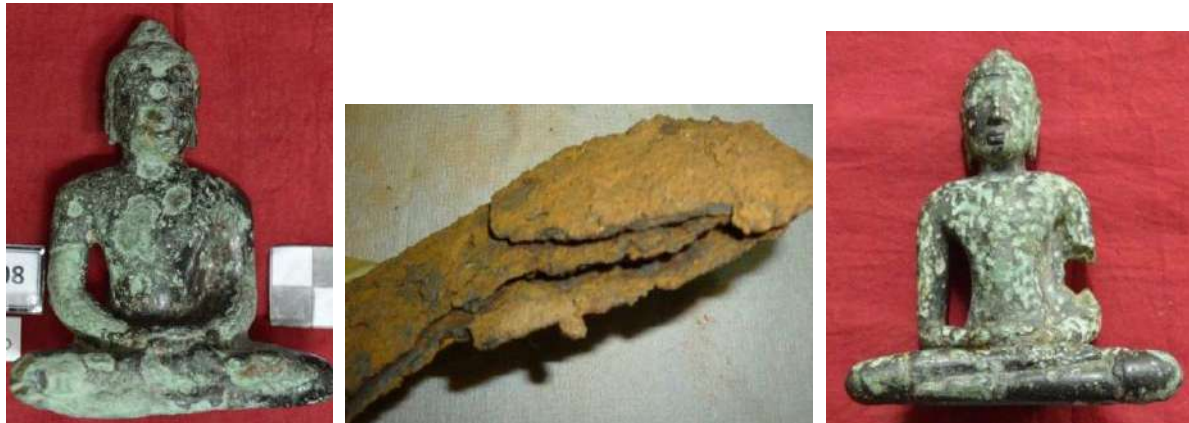
Fig. 1 Products covered by corrosion

The majority of metal objects in Sri Lanka face dire situations regarding active corrosion, including crevice corrosion, pitting corrosion, and bronze diseases due to the effects of chloride. Chlorides are present in almost all types of water and soil and cause problems mainly when metal is used, such as pitting and bronze disease, and also corrosion cracking at high temperatures. Iron rust is caused by the oxidation of iron in the presence of moisture in the tropical environment. The chemically unstable orange appearance of rust is porous, which allows moisture, oxygen, chlorides, sulfide and sulphate to reach the bare metal.

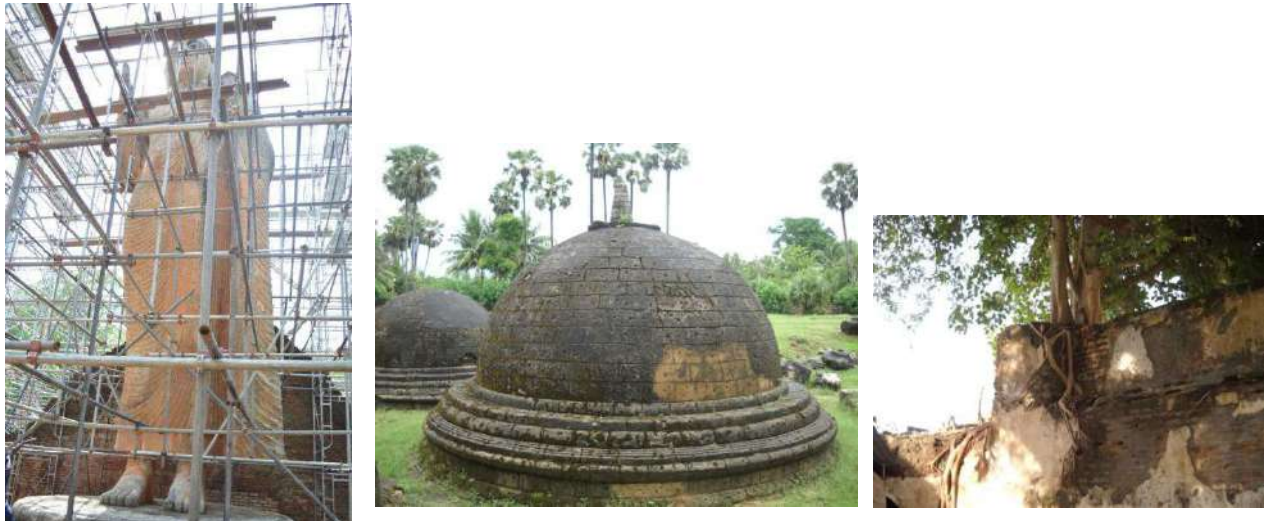
Fig. 2 Damage due to weathering

In Sri Lanka, it appears that one of the leading causes of the deterioration of stone, especially for crystalline limestone, is rain. Moisture and salt can do the most damage to porous stone. Porous stones sitting on the ground can absorb dissolved salts through capillary action. When the moisture evaporates, the soluble salt left behind crystallizes and gradually breaks the structure of the stone. In addition, inappropriate older conservation methods or materials such as cement provide soluble salts to the objects, for instance the Maligawila statue. This may also be the reason for the flaking that can be seen in many of the gneisses, particularly at Pollonnaruwa in the North-Central province in Sri Lanka—weathering first of all inflicts damage as humidity, but large and small plants also damage monuments and historic buildings in Sri Lanka. Substantial erosion by wind is another significant cause of damage in Sri Lanka.

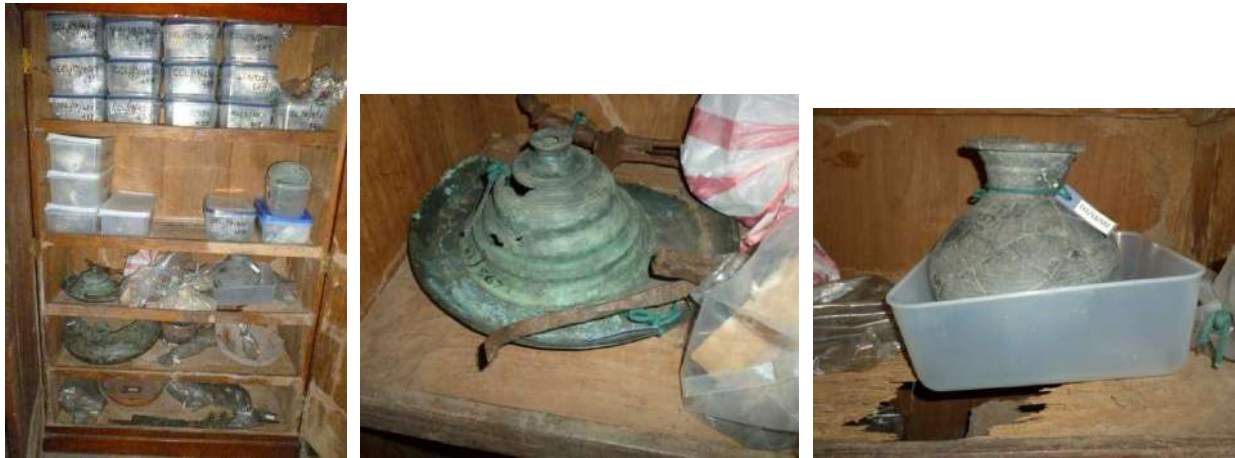
Fig: 3 Inappropriate placement (Bad Storage)

Another reason is lack of space in museum storage premises. Whole artifact collections of the museum are stored in the same storage room, even though they need different climatic conditions for proper keeping. Therefore, objects have been abrasive to each other or have become severely stuck together.
